ARCHITECTURAL/HISTORIC INVENTORY FORM

1. Survey No. CO-AS-005-001		2. Survey name: Moreau Drive Neighborhood Survey	
3. County: Cole		4. Address: 1202 Elmerine Ave.	
5. City: Jefferson City	Vicinity: <input type="checkbox"/>	6. UTM: / /	7. Township/Range/Section: T: R: S:
8. Historic name (if known):		9. Present/other name (if known):	
10. Ownership: <input checked="" type="checkbox"/> Private <input type="checkbox"/> Public		11. Historic use (if known): Residential	11. Current use: Residential

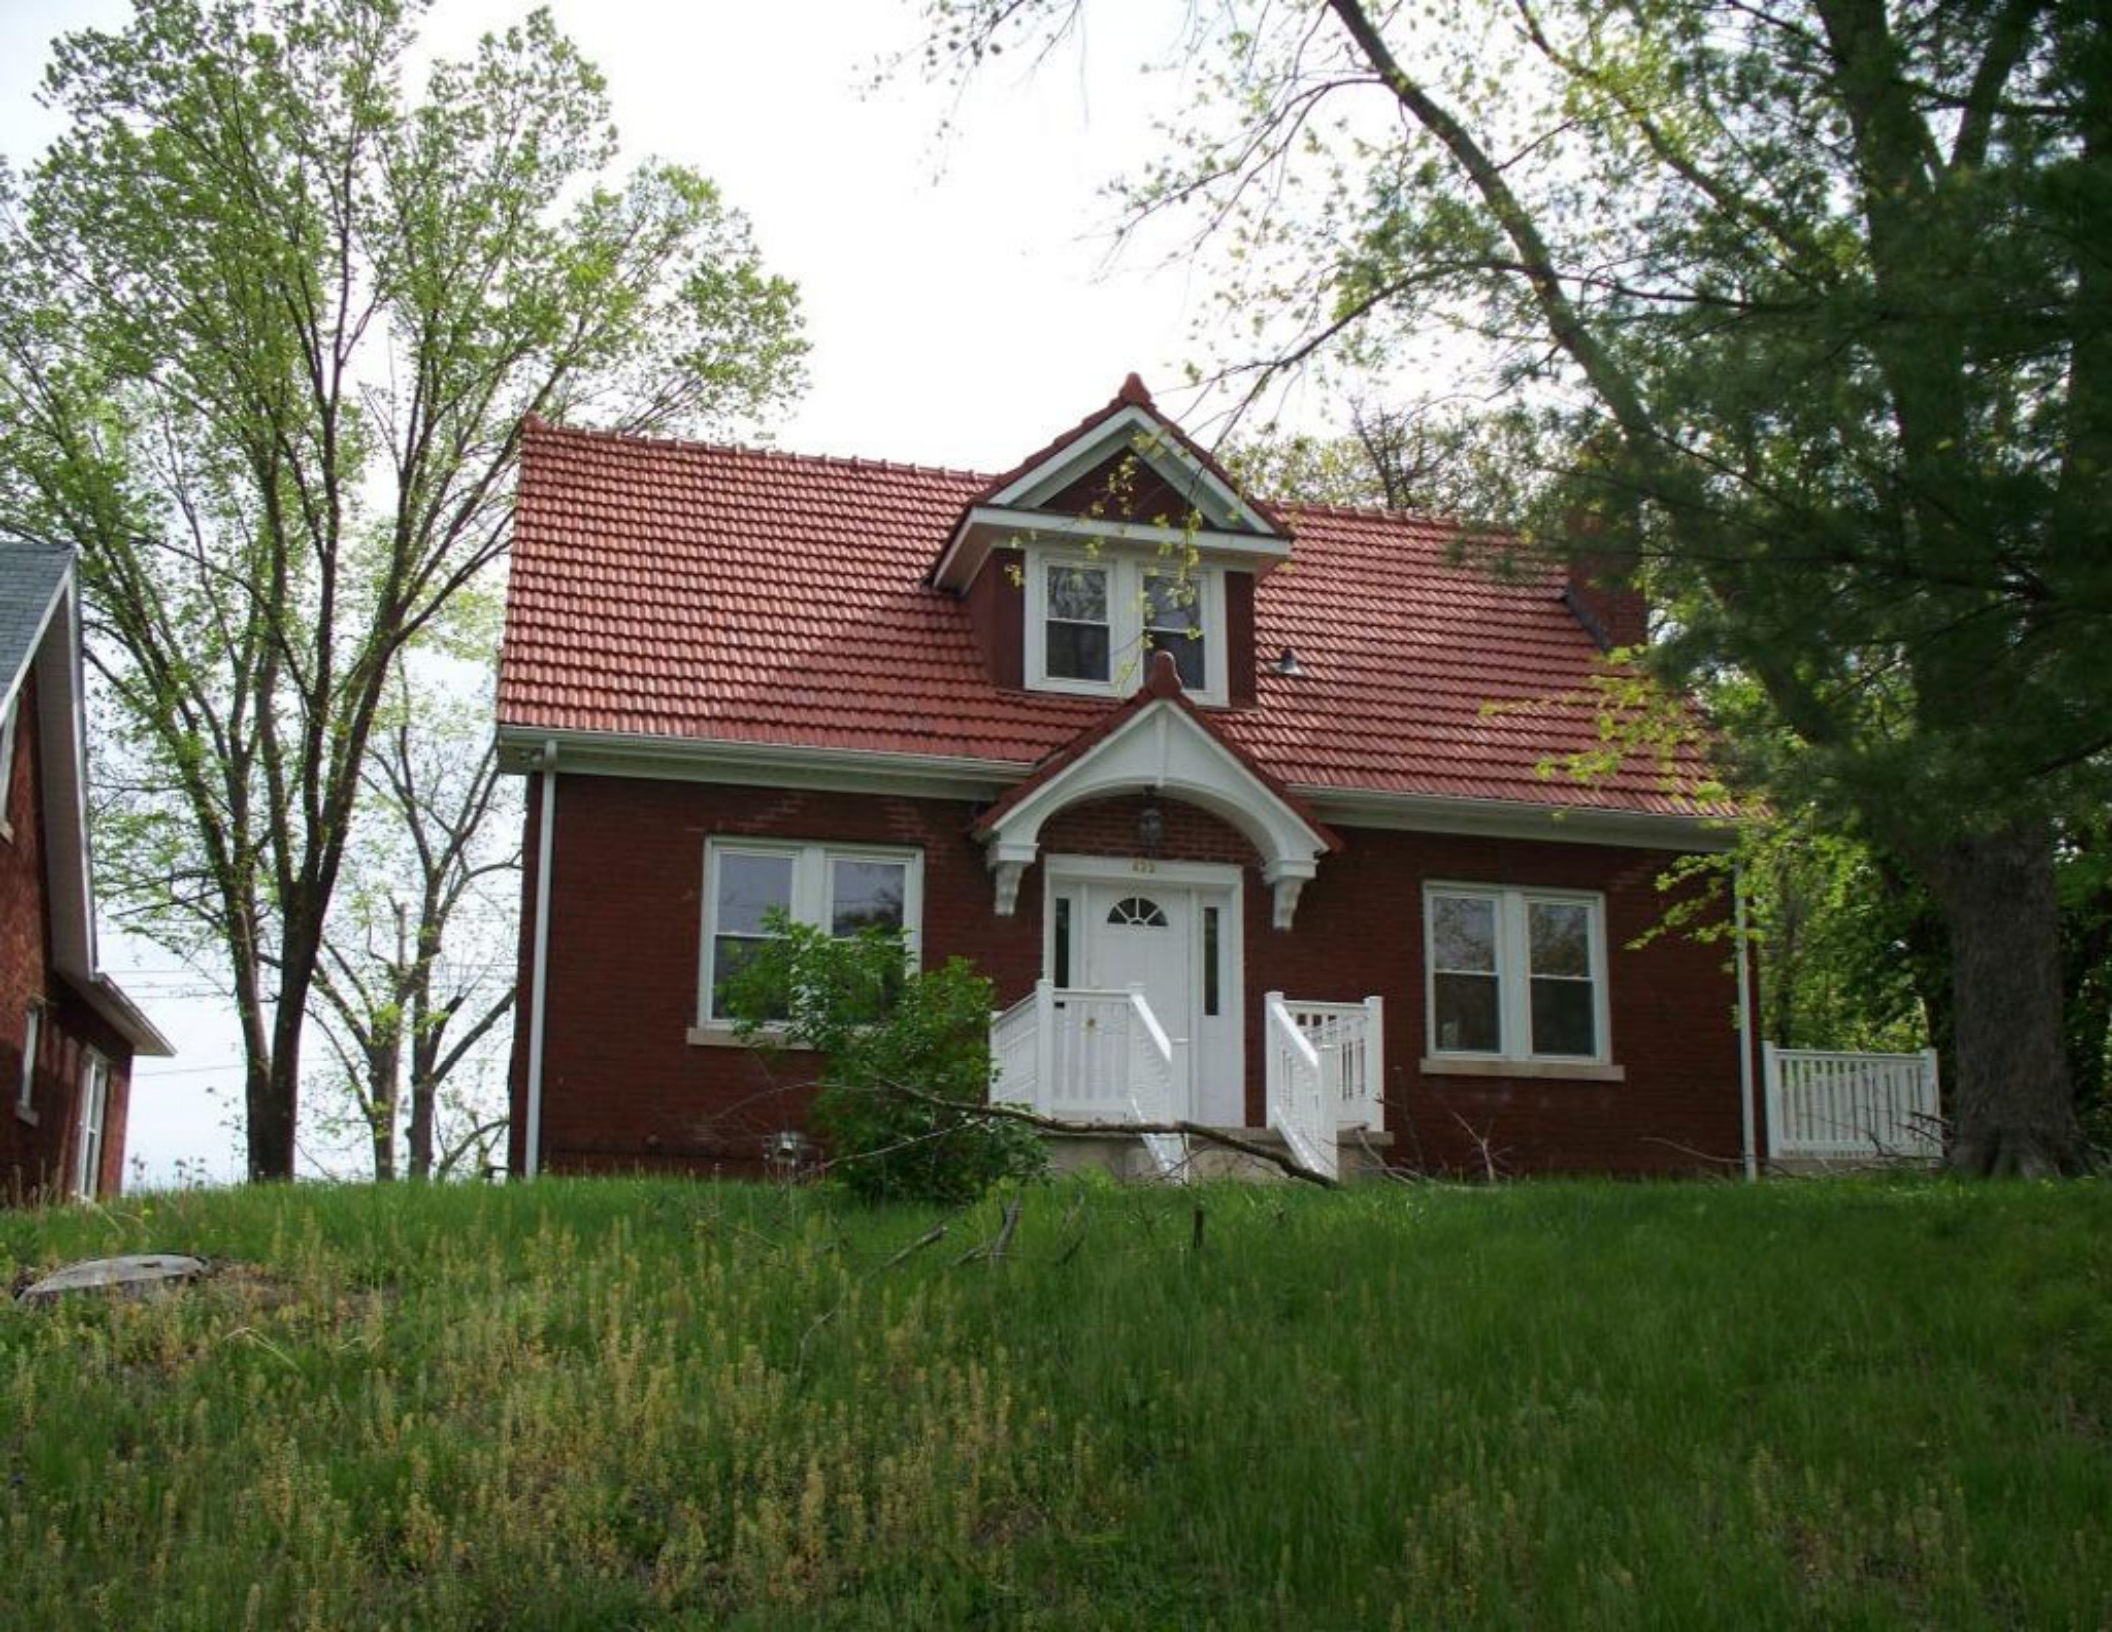
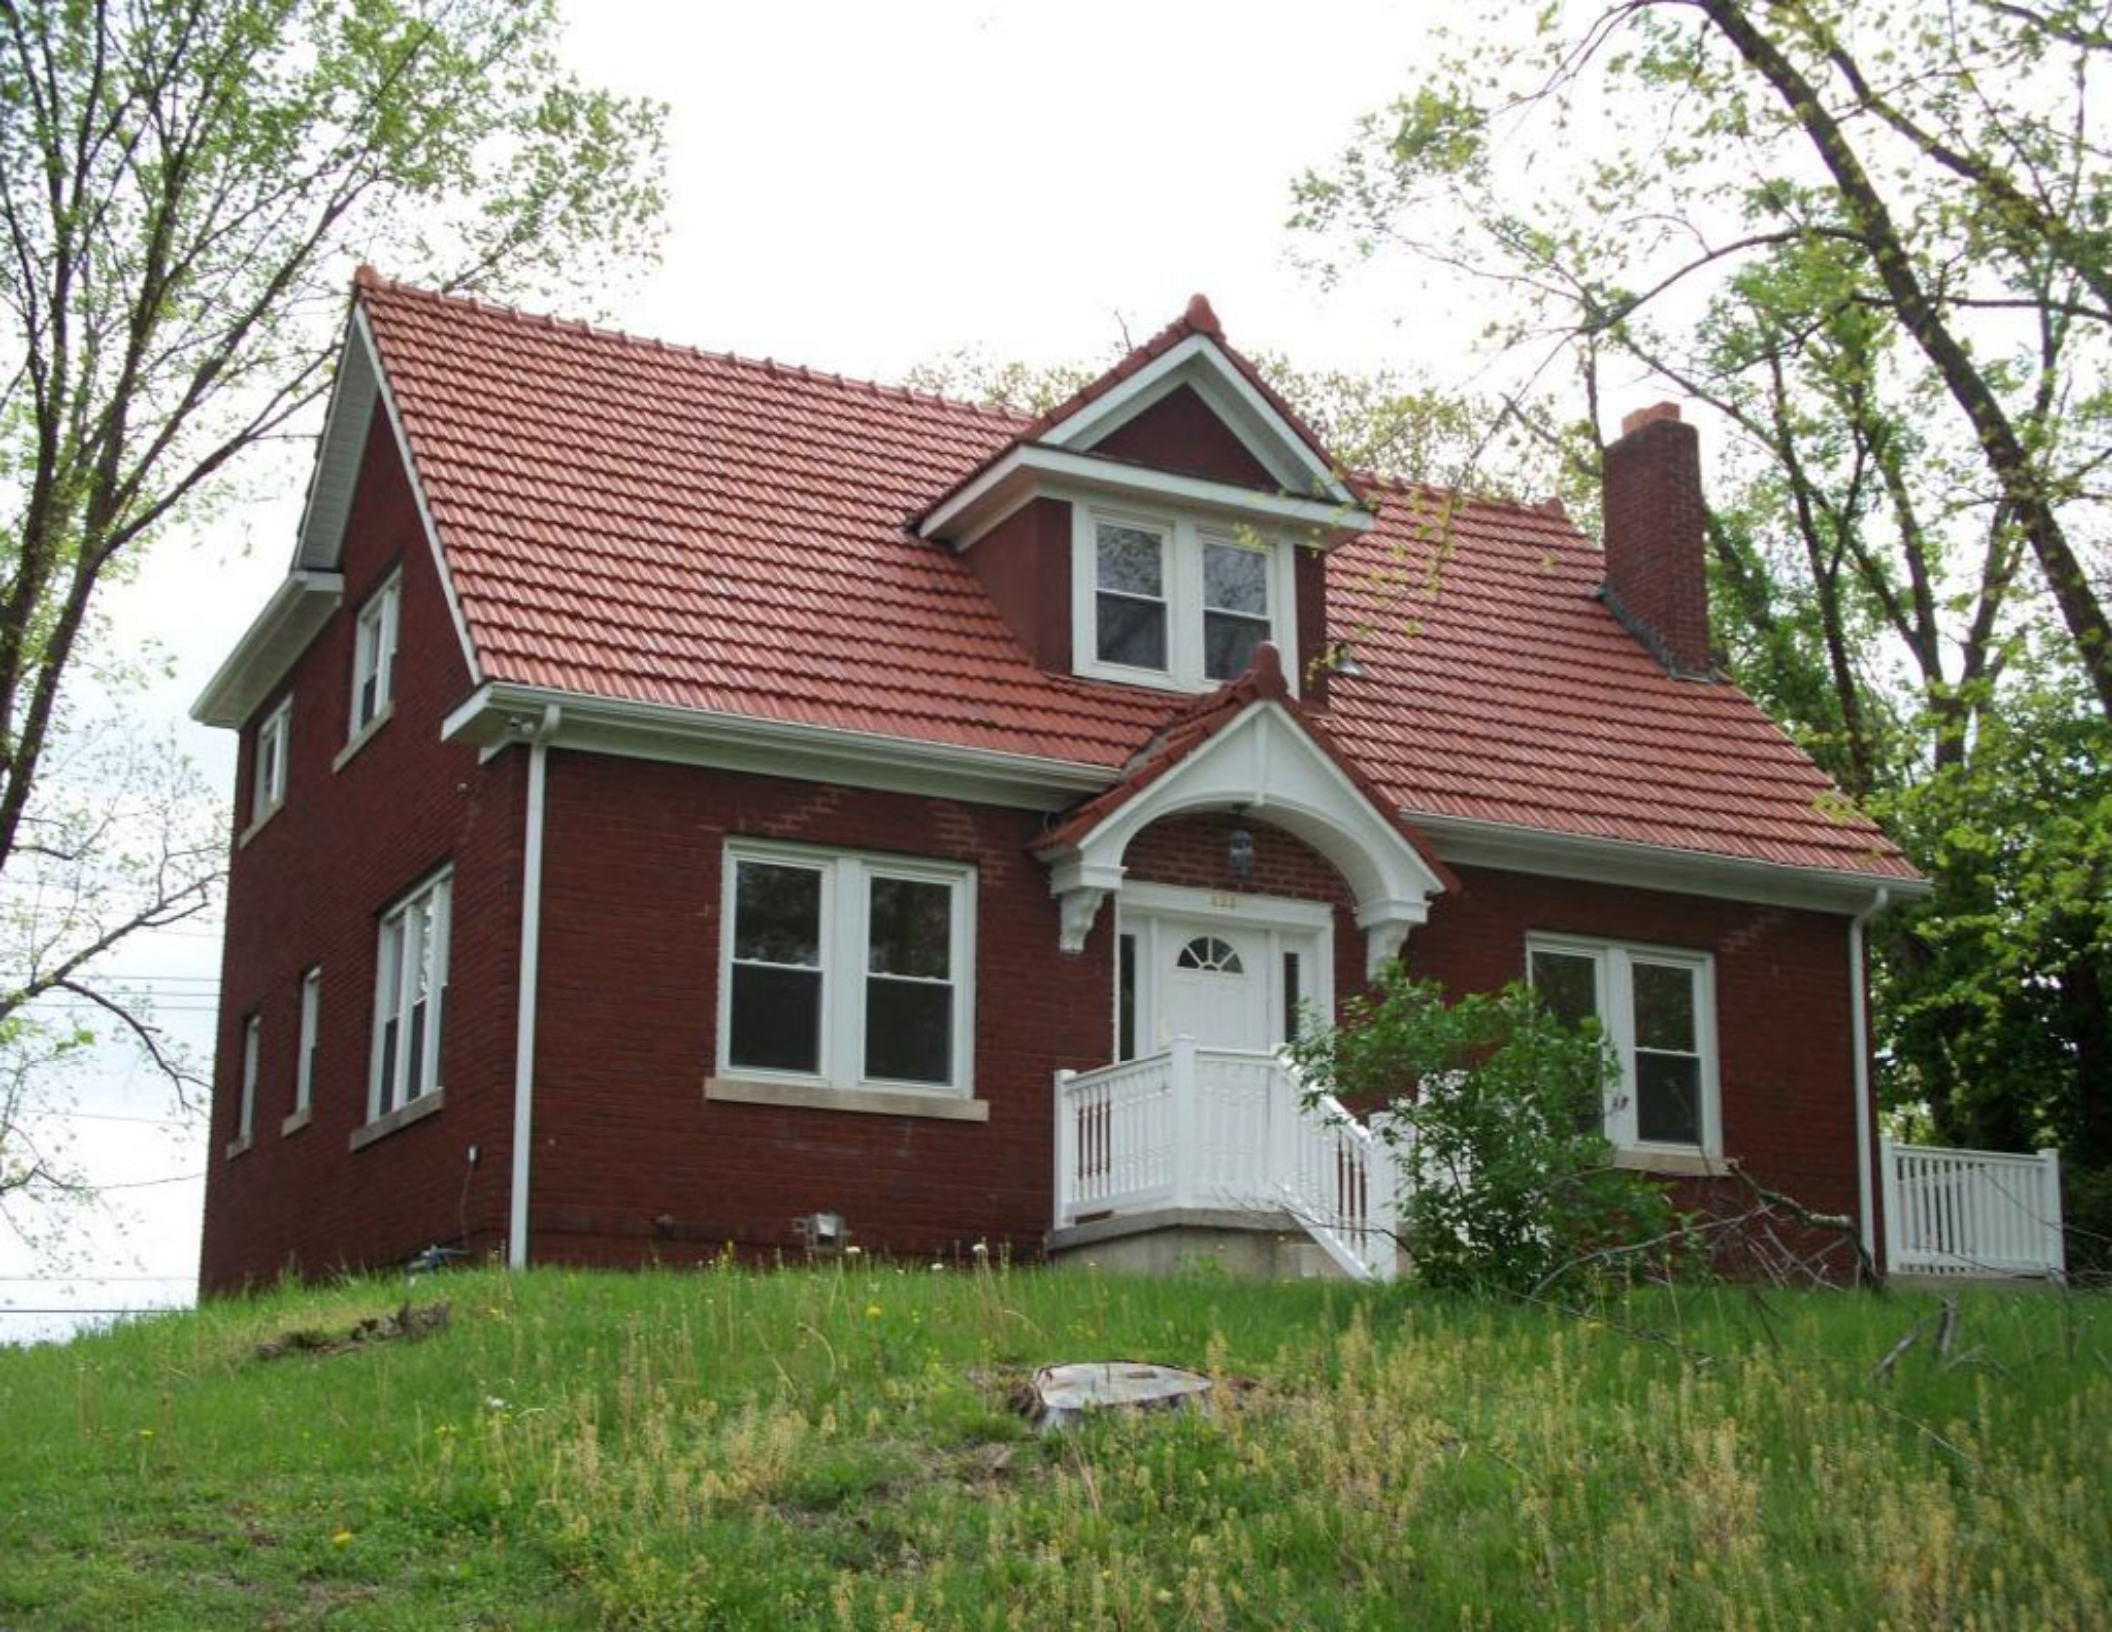
This one-and-a-half to two-story side gabled brick property has a red tile roof that may or may not be historic. There is a central pediment dormer with two replacement 1/1 windows. The first floor has paired replacement 1/1 windows with concrete or limestone sills flanking the central entrance. The entrance has sidelights, a replacement door and a pediment hood with brackets. The concrete stoop, stairs, and railing are not original to the building. There is a slab porch with railing to the right of the building. There is a light fixture hanging from the hood over the door.

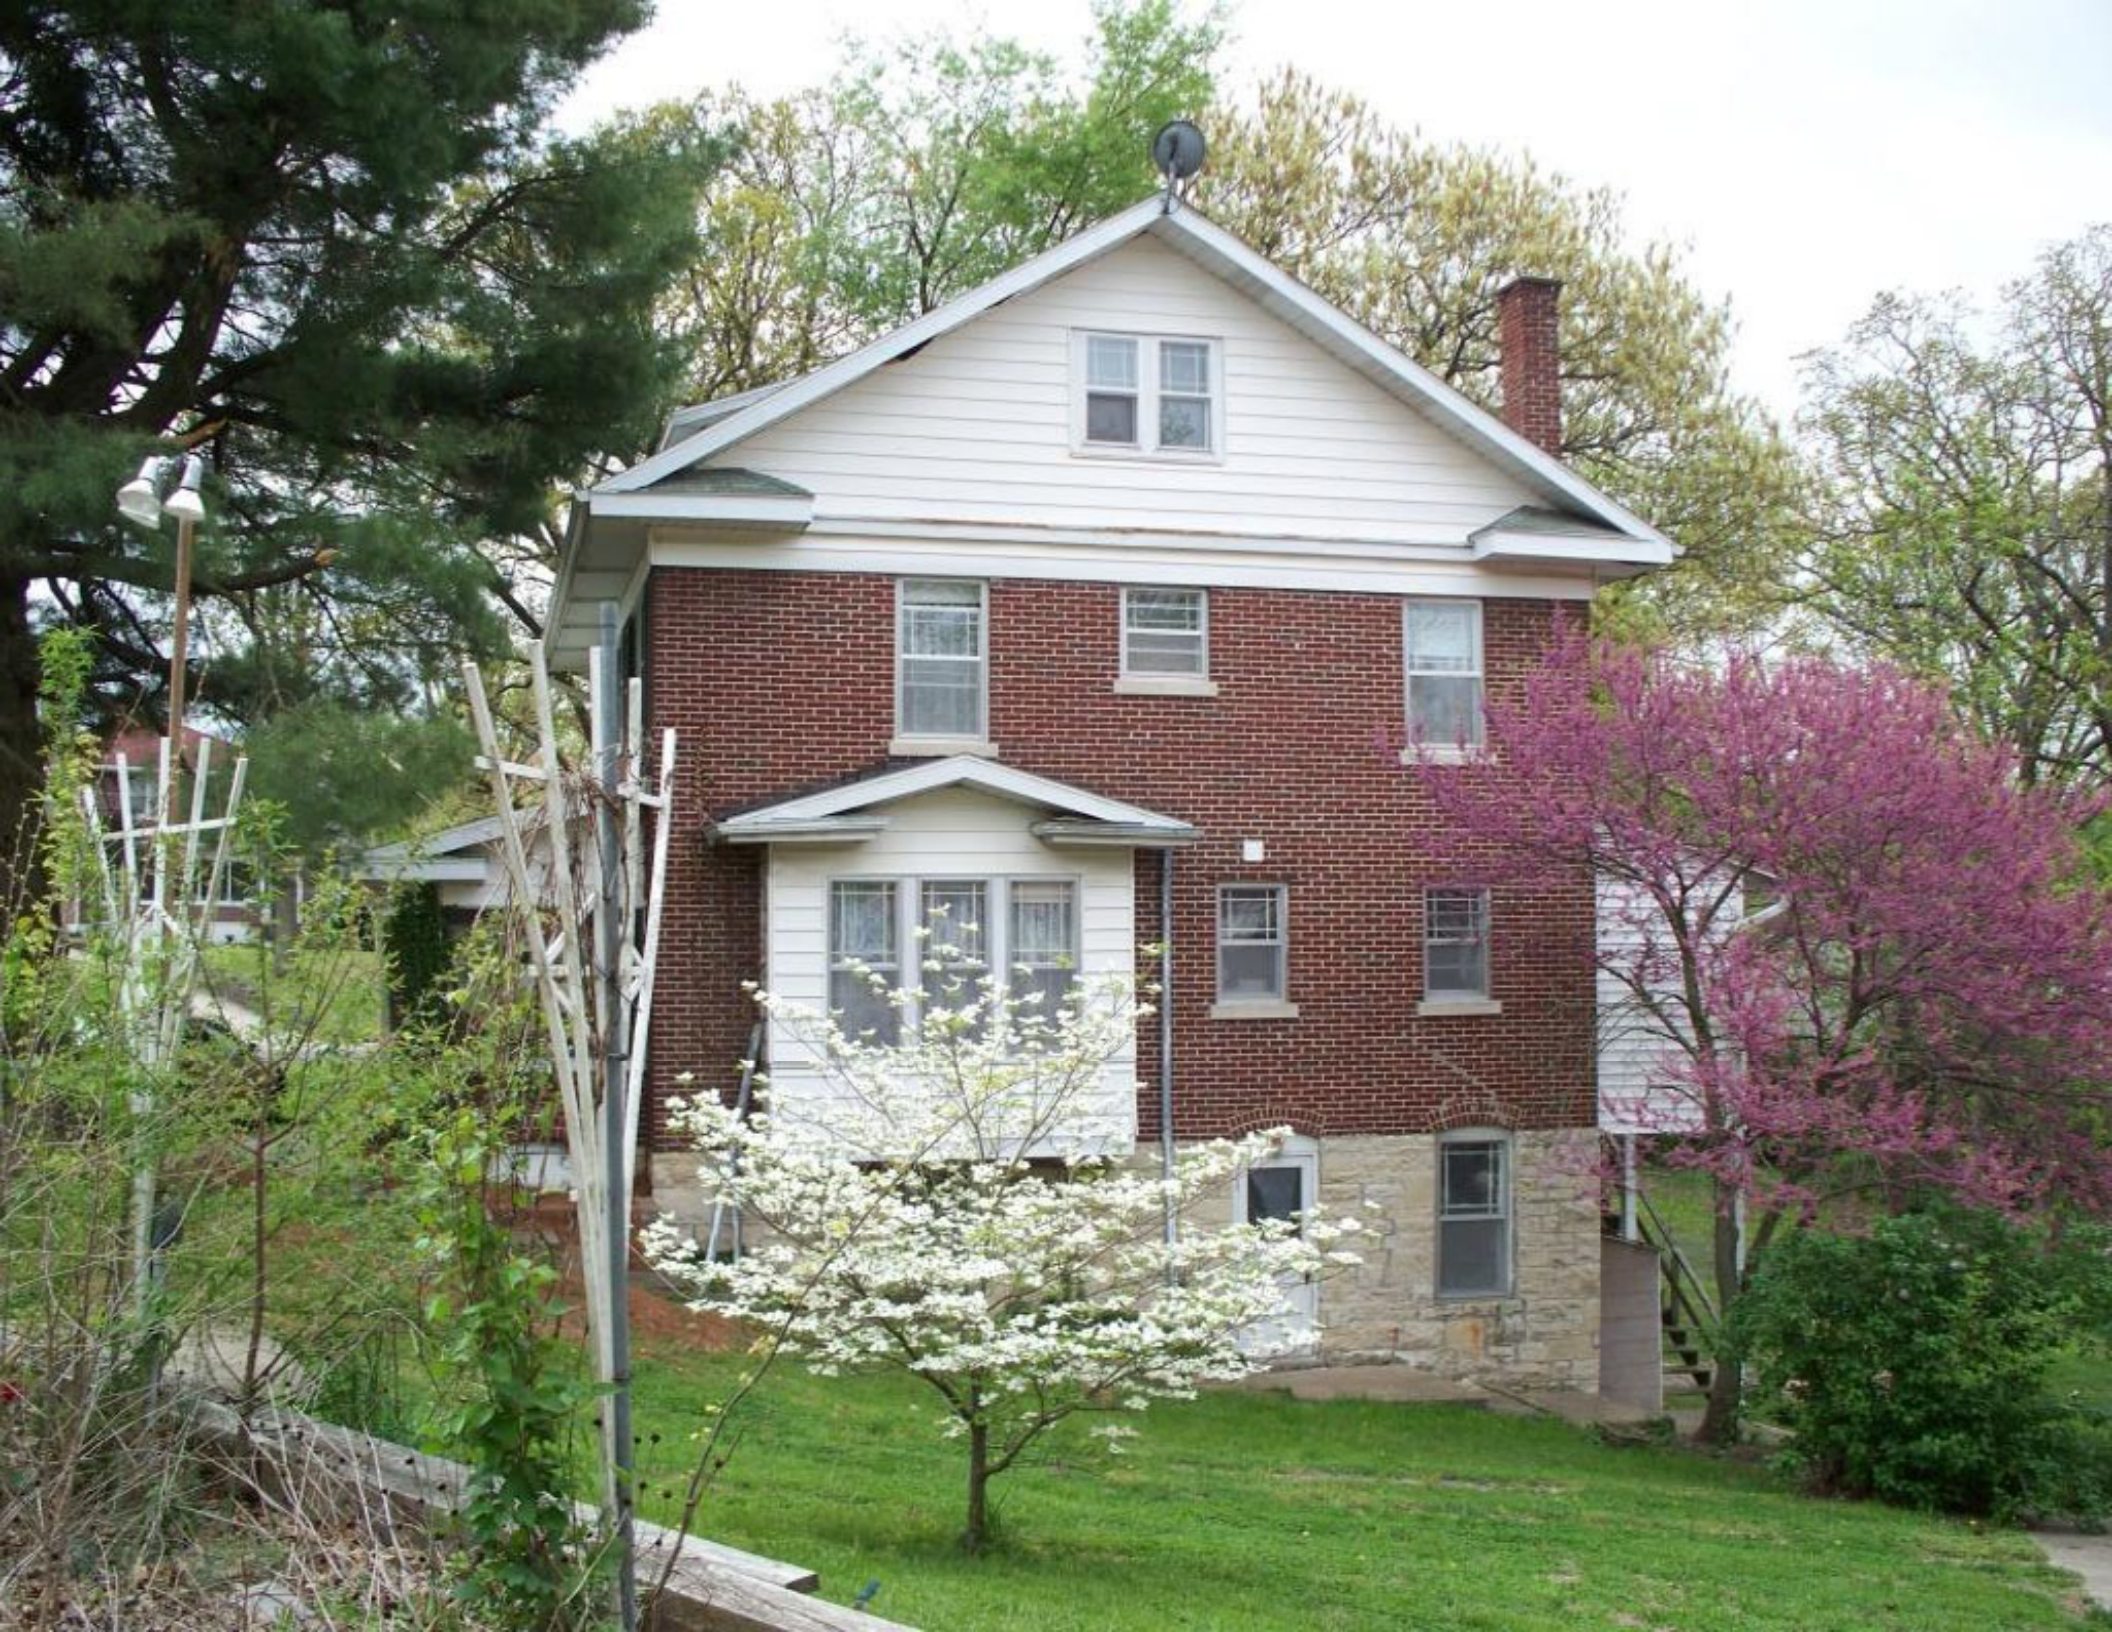
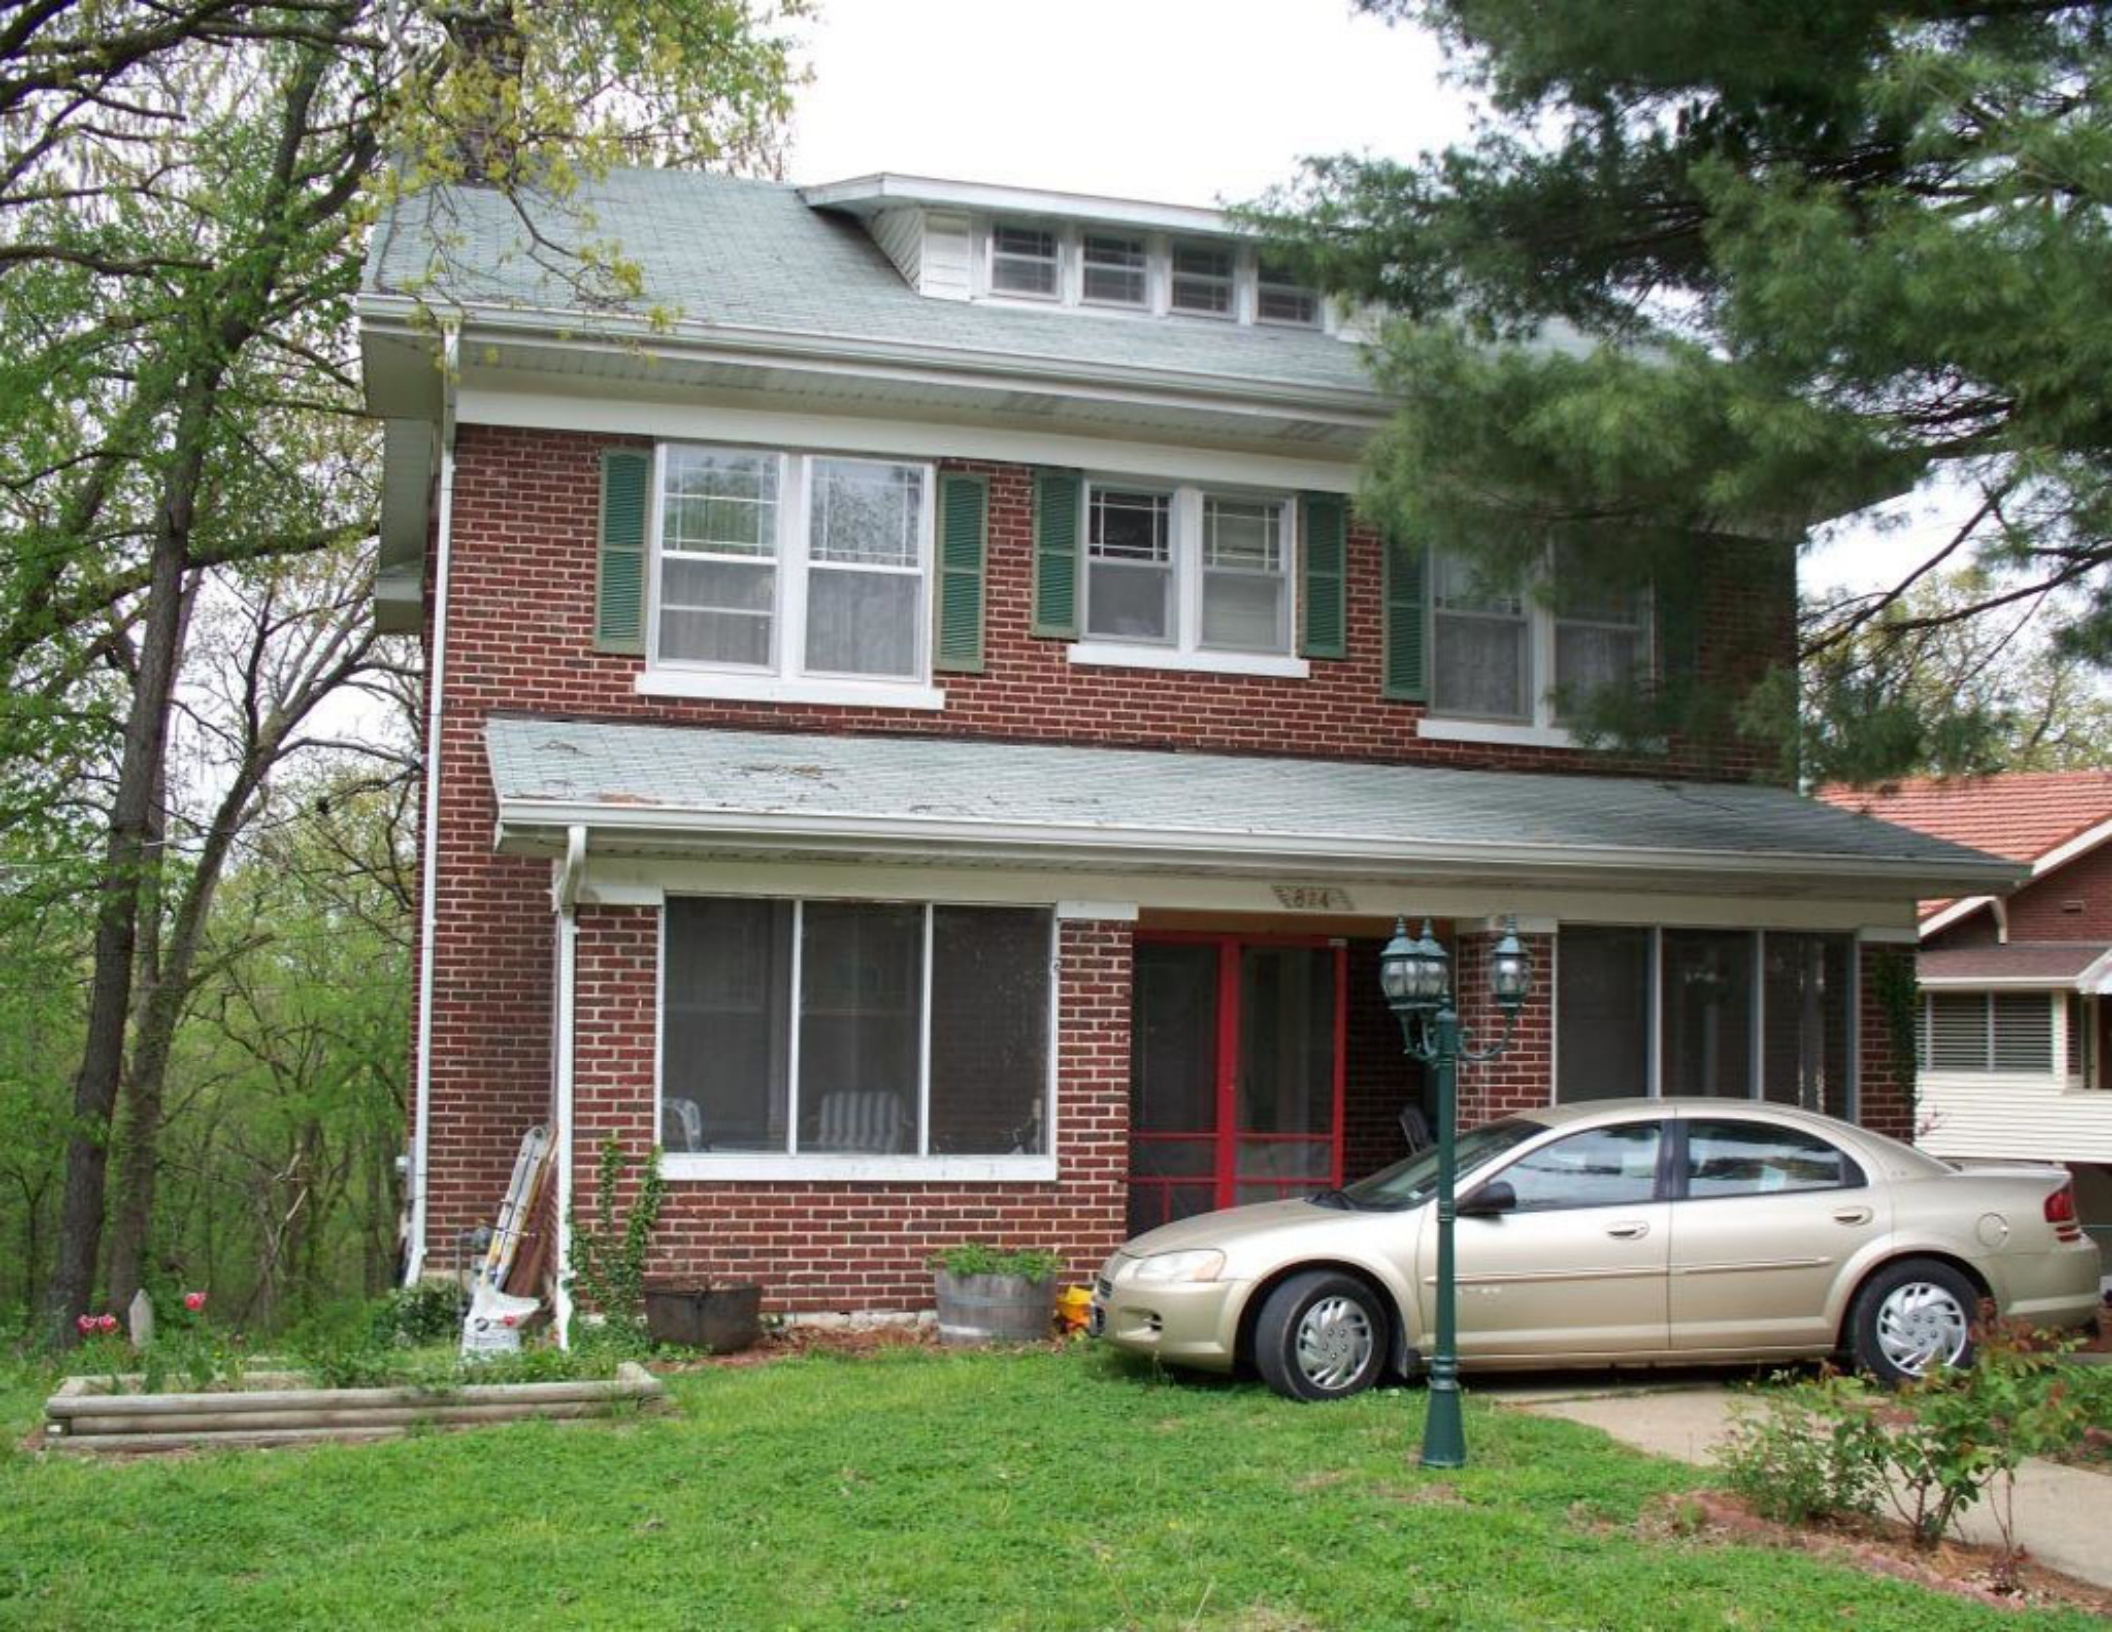
This two-and-a-half story brick Four Square has a side gable roof and a long shed dormer with four small patterned windows (all windows appear modern). The second floor has paired patterned windows flanking a smaller set of similar windows. The windows on this level all have limestone sills and shutters. A shed roof projects over the screened-in full-width porch with brick half walls and pilasters. It is difficult to see through the screening, but it appears paired windows flank the central entrance on the first floor.
