ARCHITECTURAL/HISTORIC INVENTORY FORM

1. Survey No. CO-AS-005-001		2. Survey name: Moreau Drive Neighborhood Survey	
3. County: Cole		4. Address: 1202 Elmerine Ave.	
5. City: Jefferson City	Vicinity: <input type="checkbox"/>	6. UTM: / /	7. Township/Range/Section: T: R: S:
8. Historic name (if known):		9. Present/other name (if known):	
10. Ownership: <input checked="" type="checkbox"/> Private <input type="checkbox"/> Public		11. Historic use (if known): Residential	11. Current use: Residential

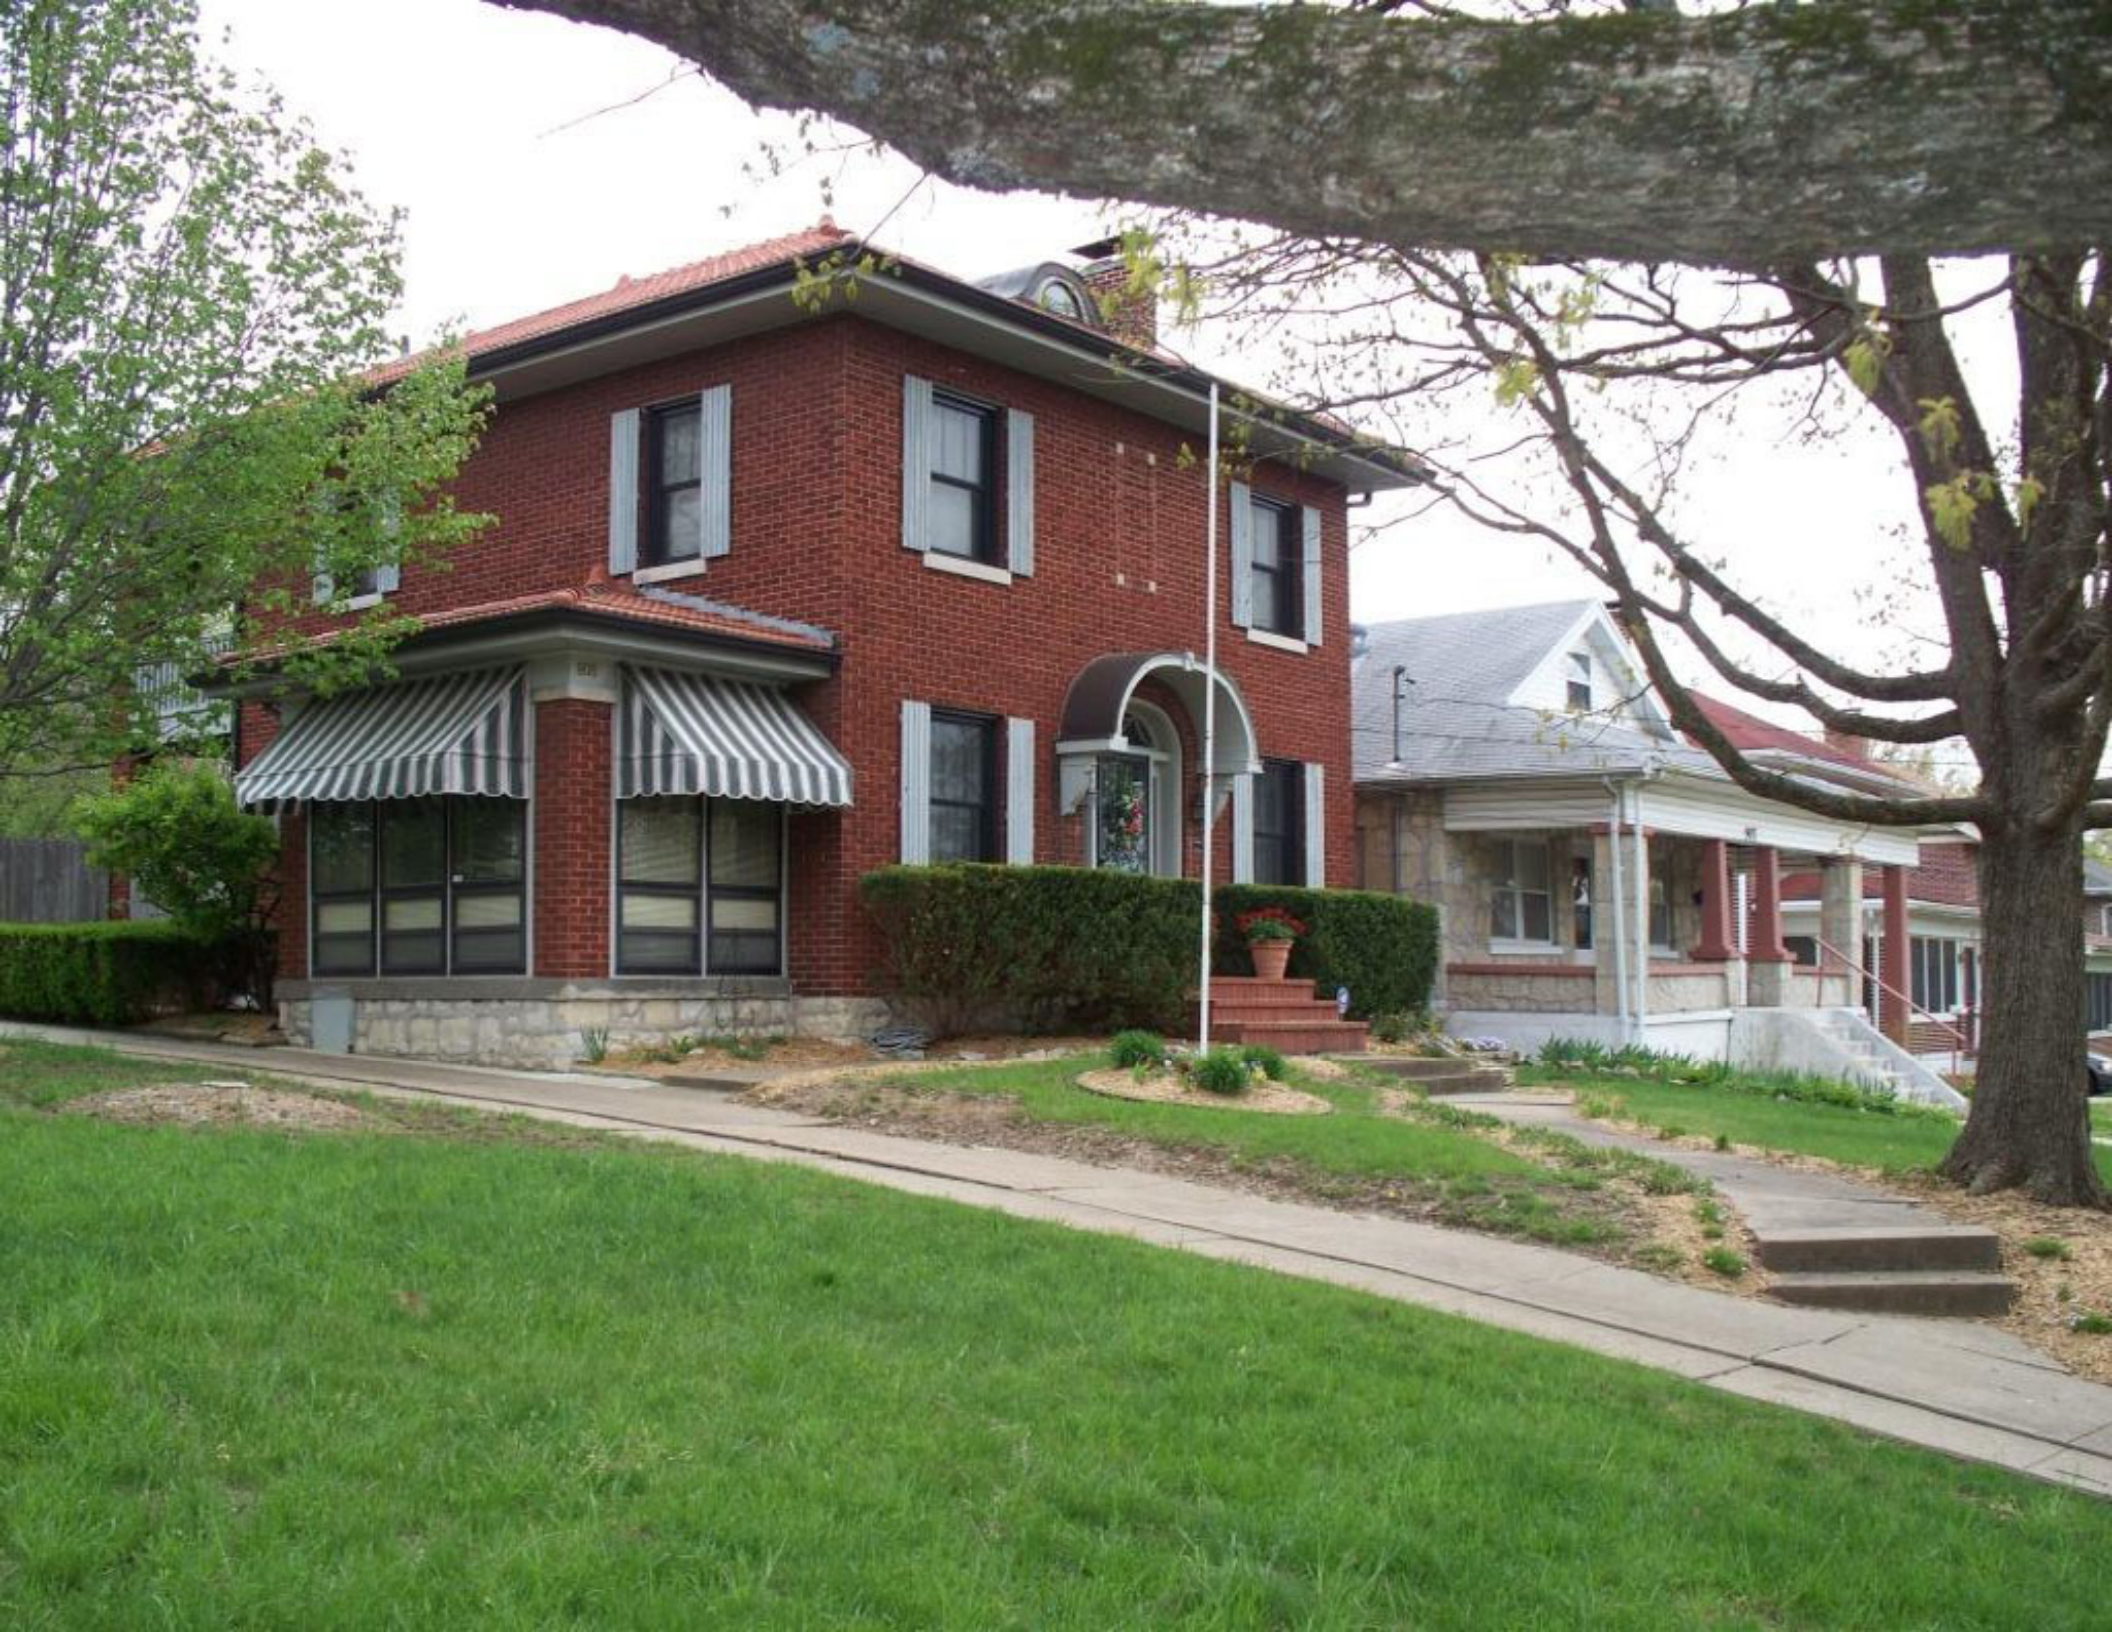
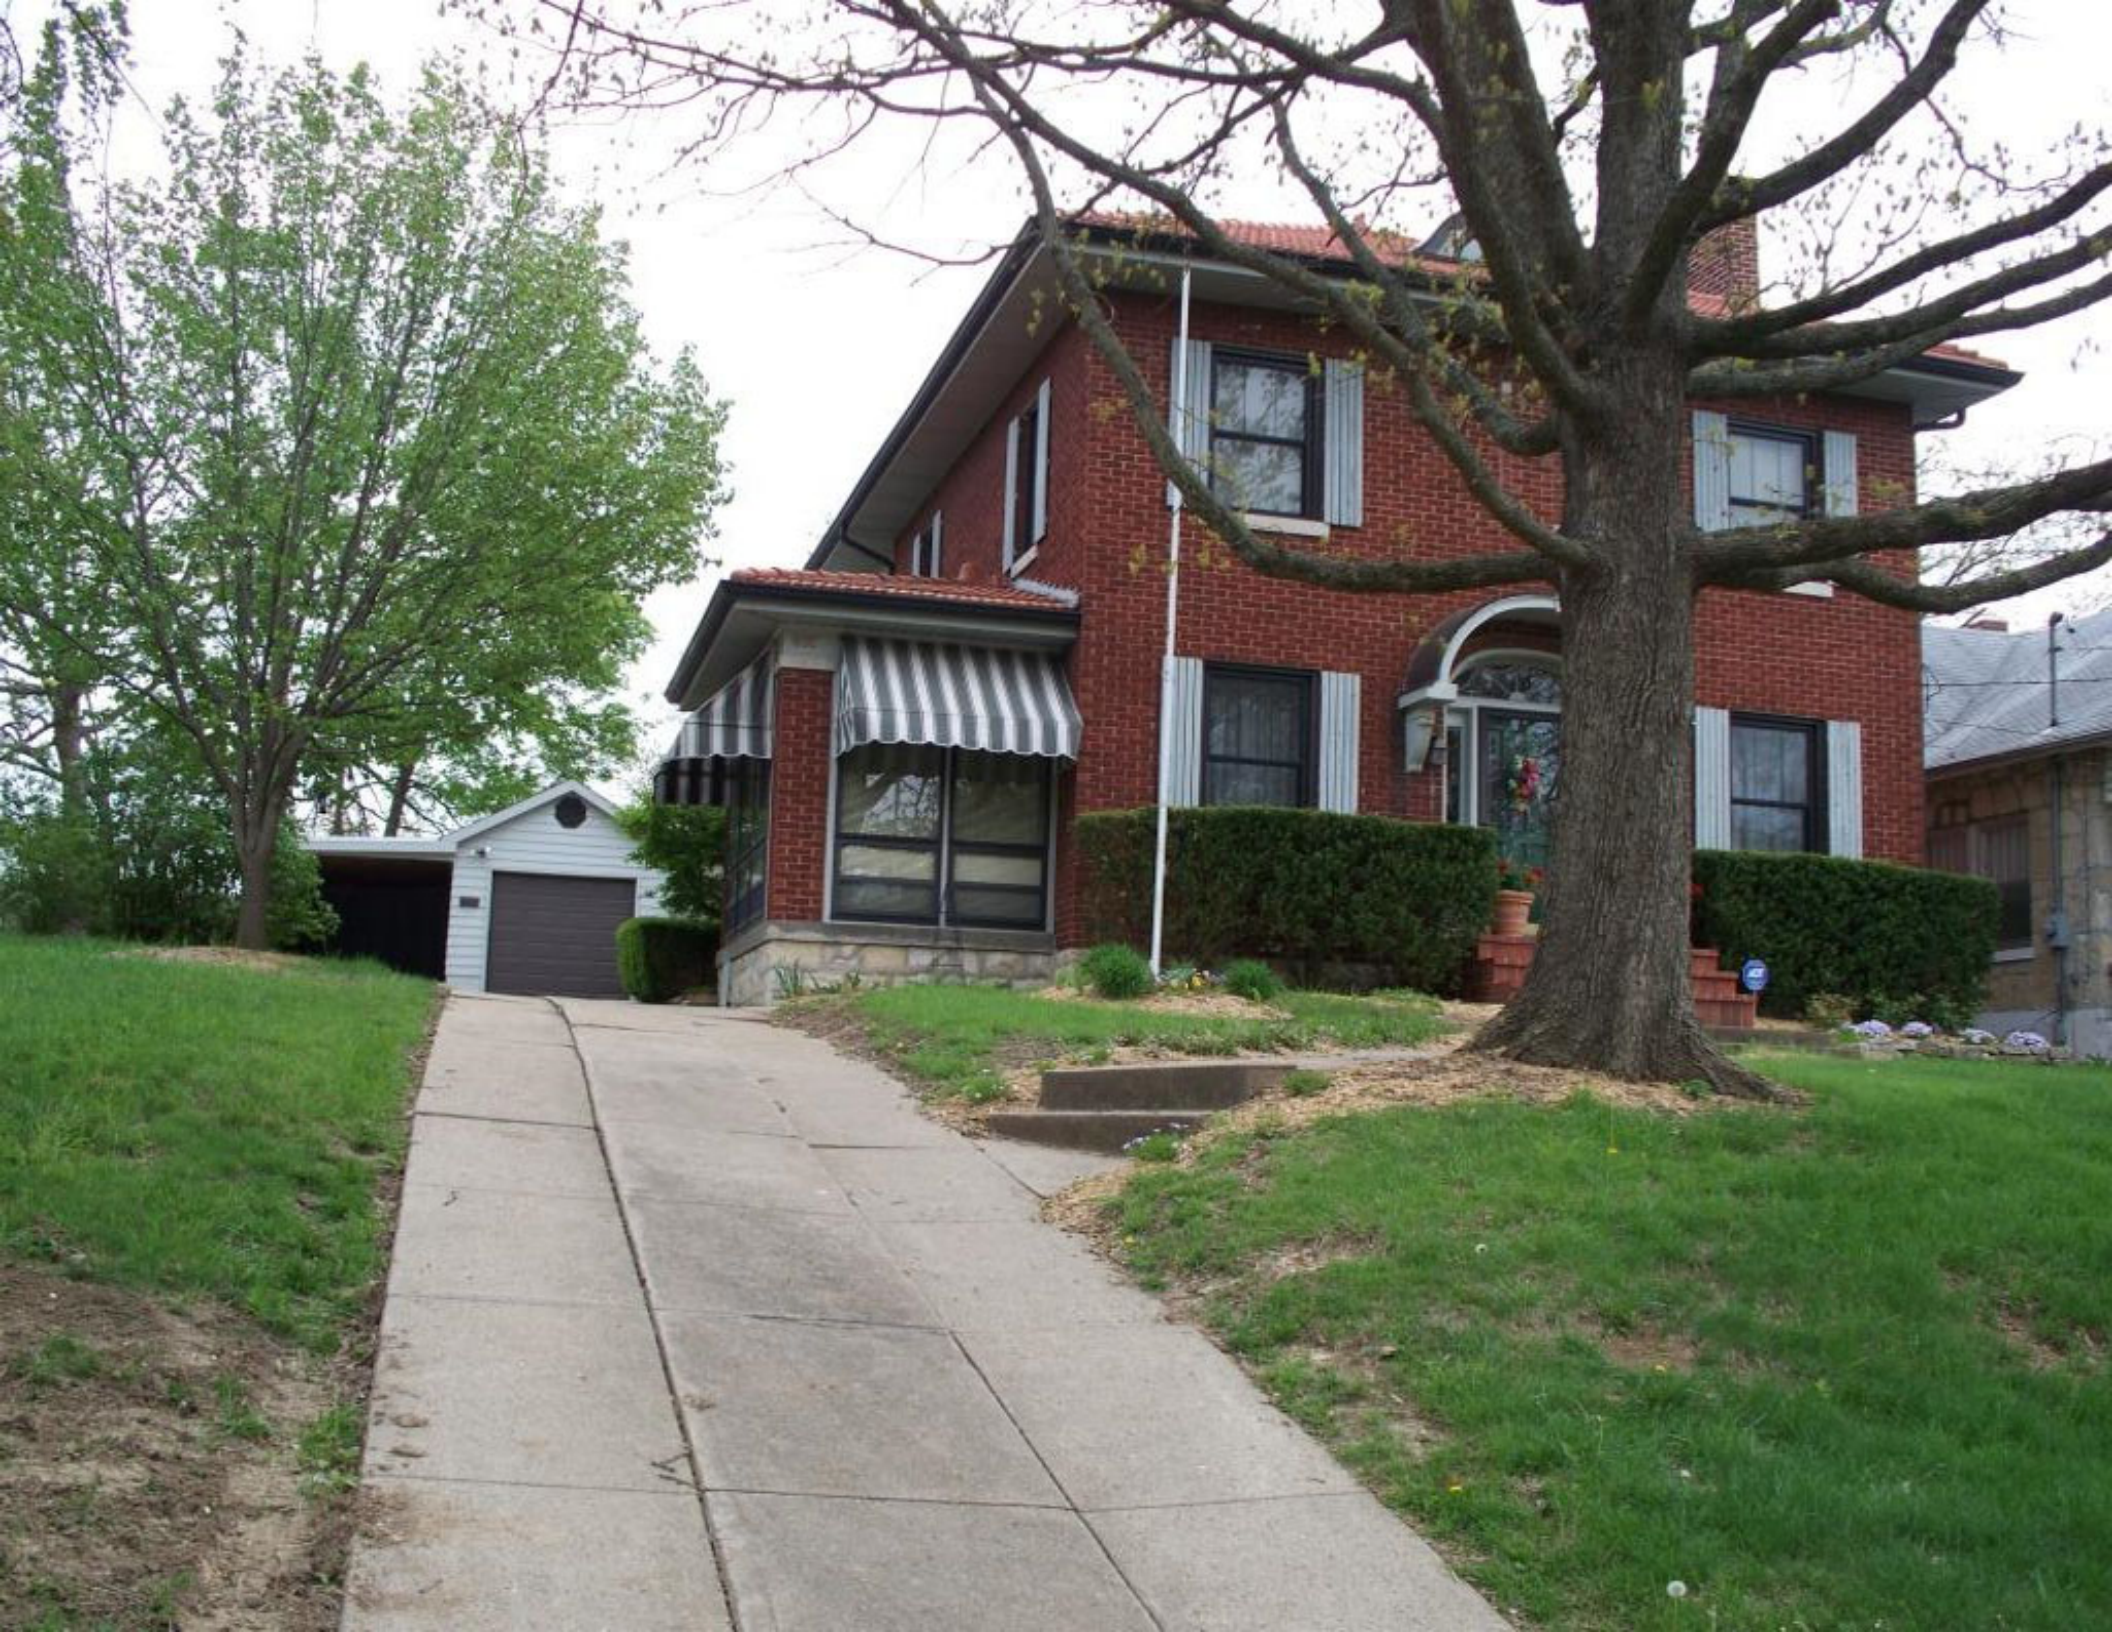
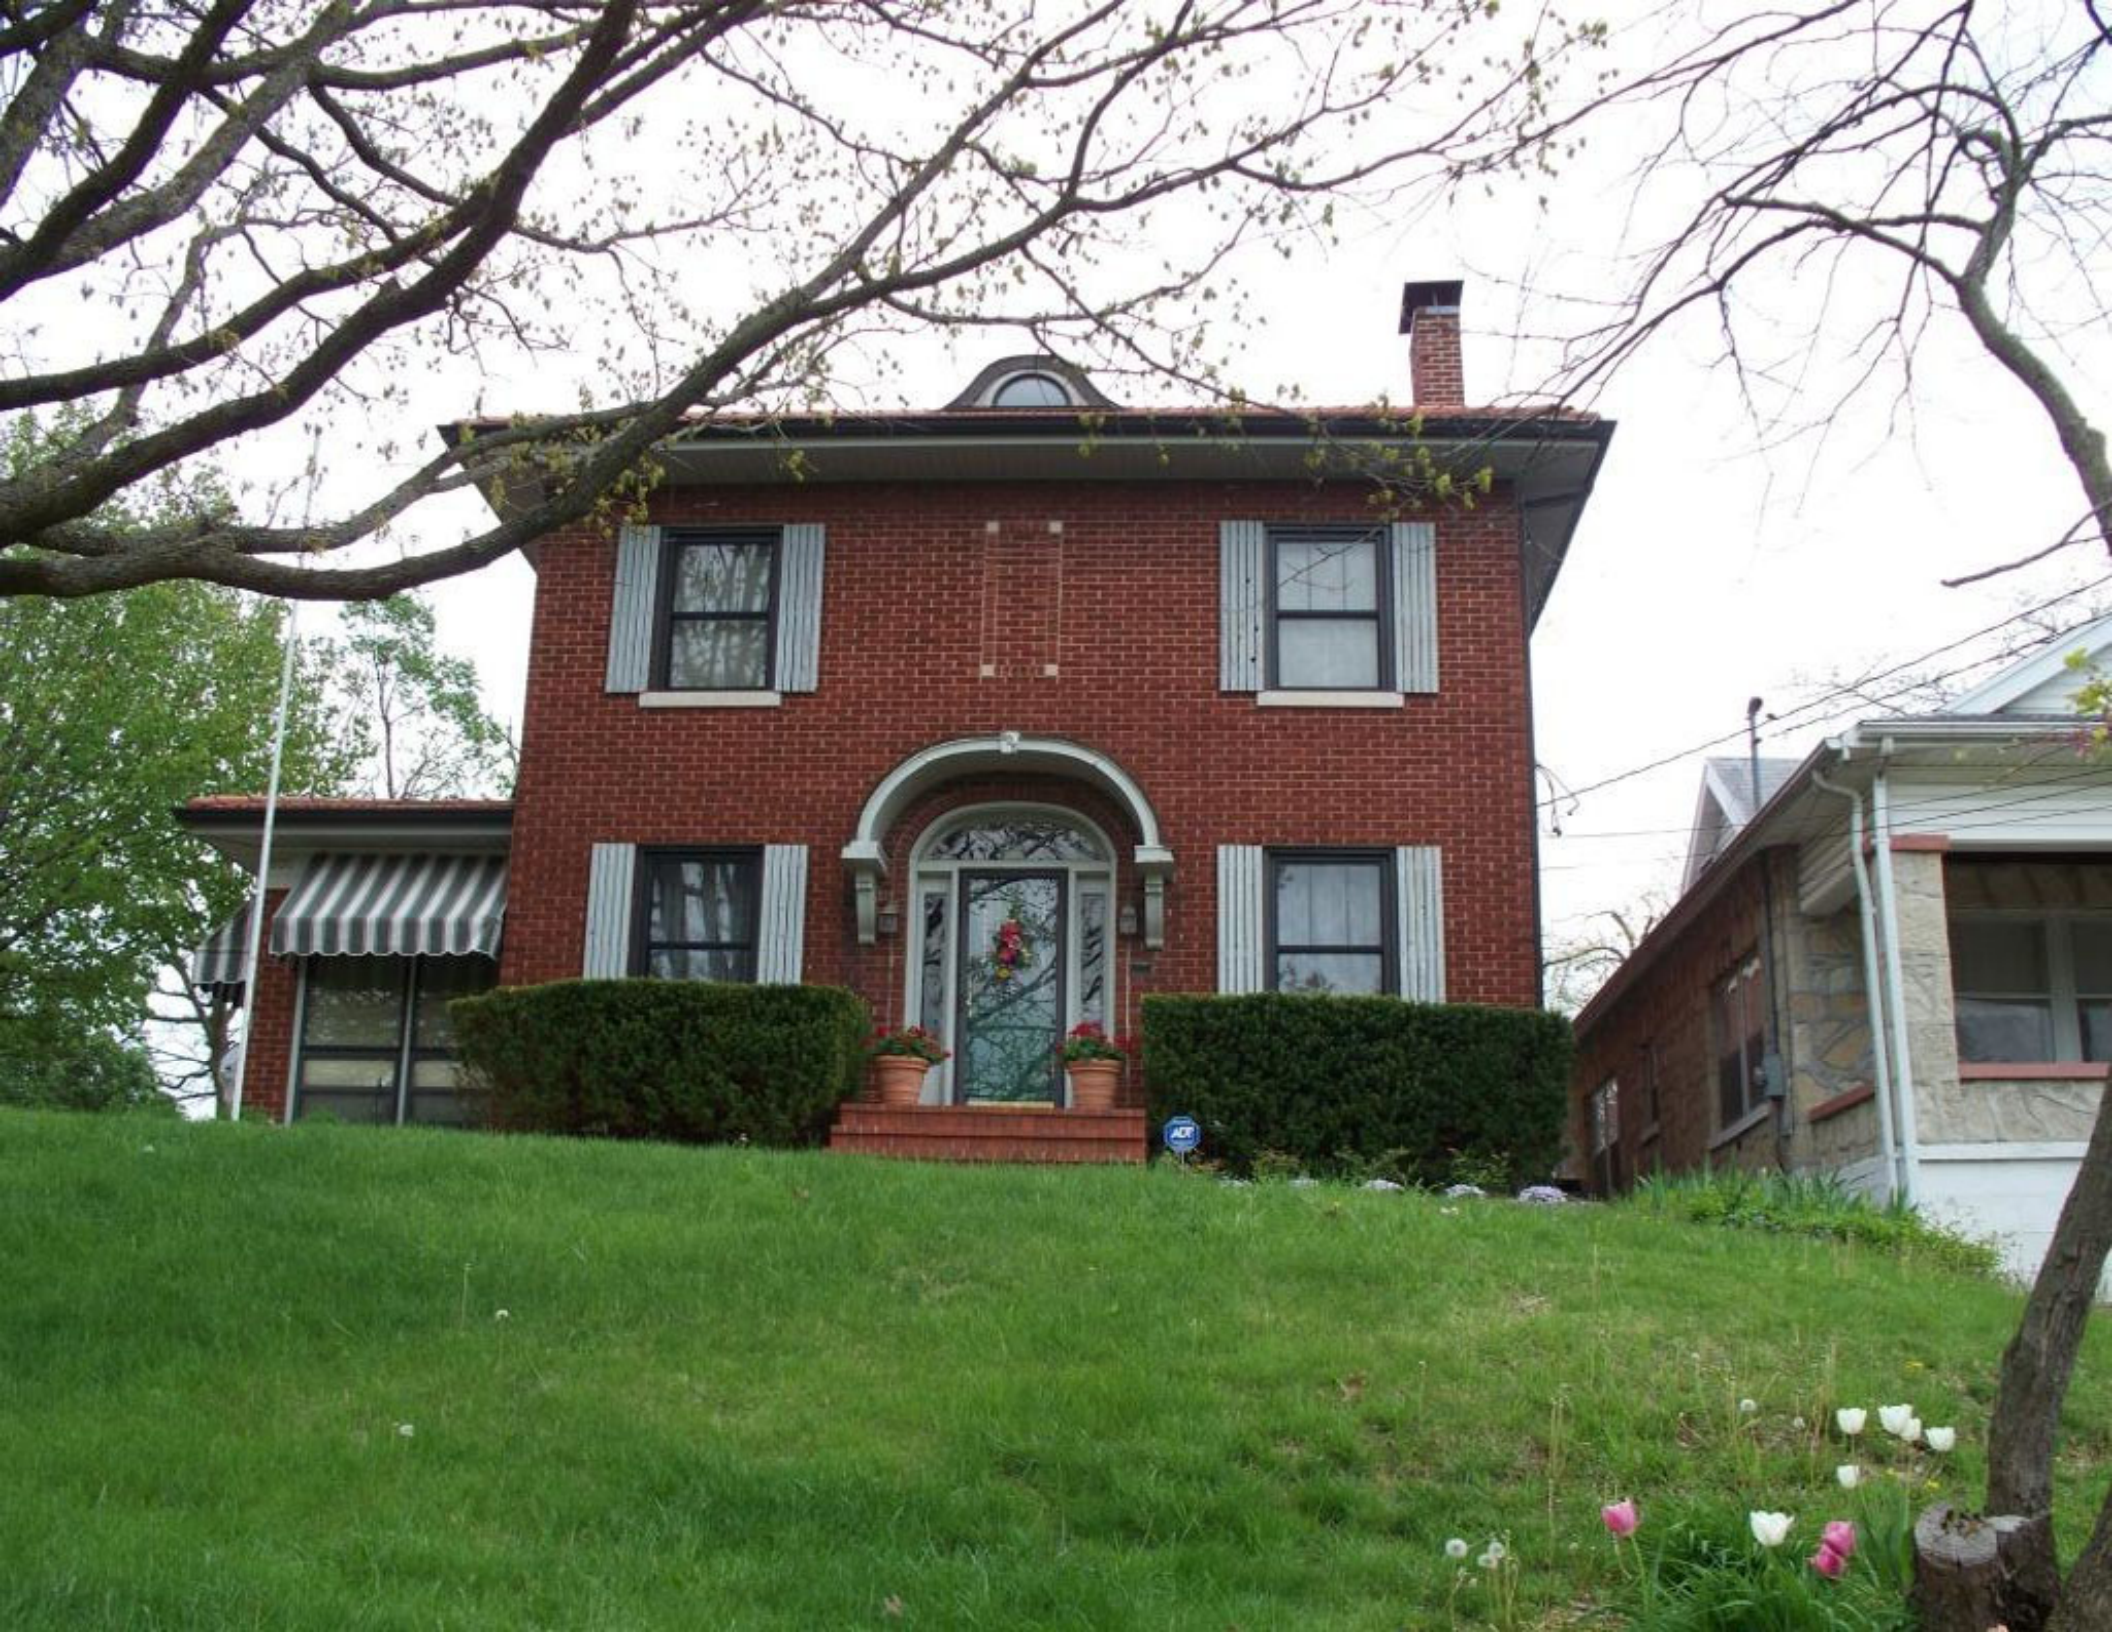
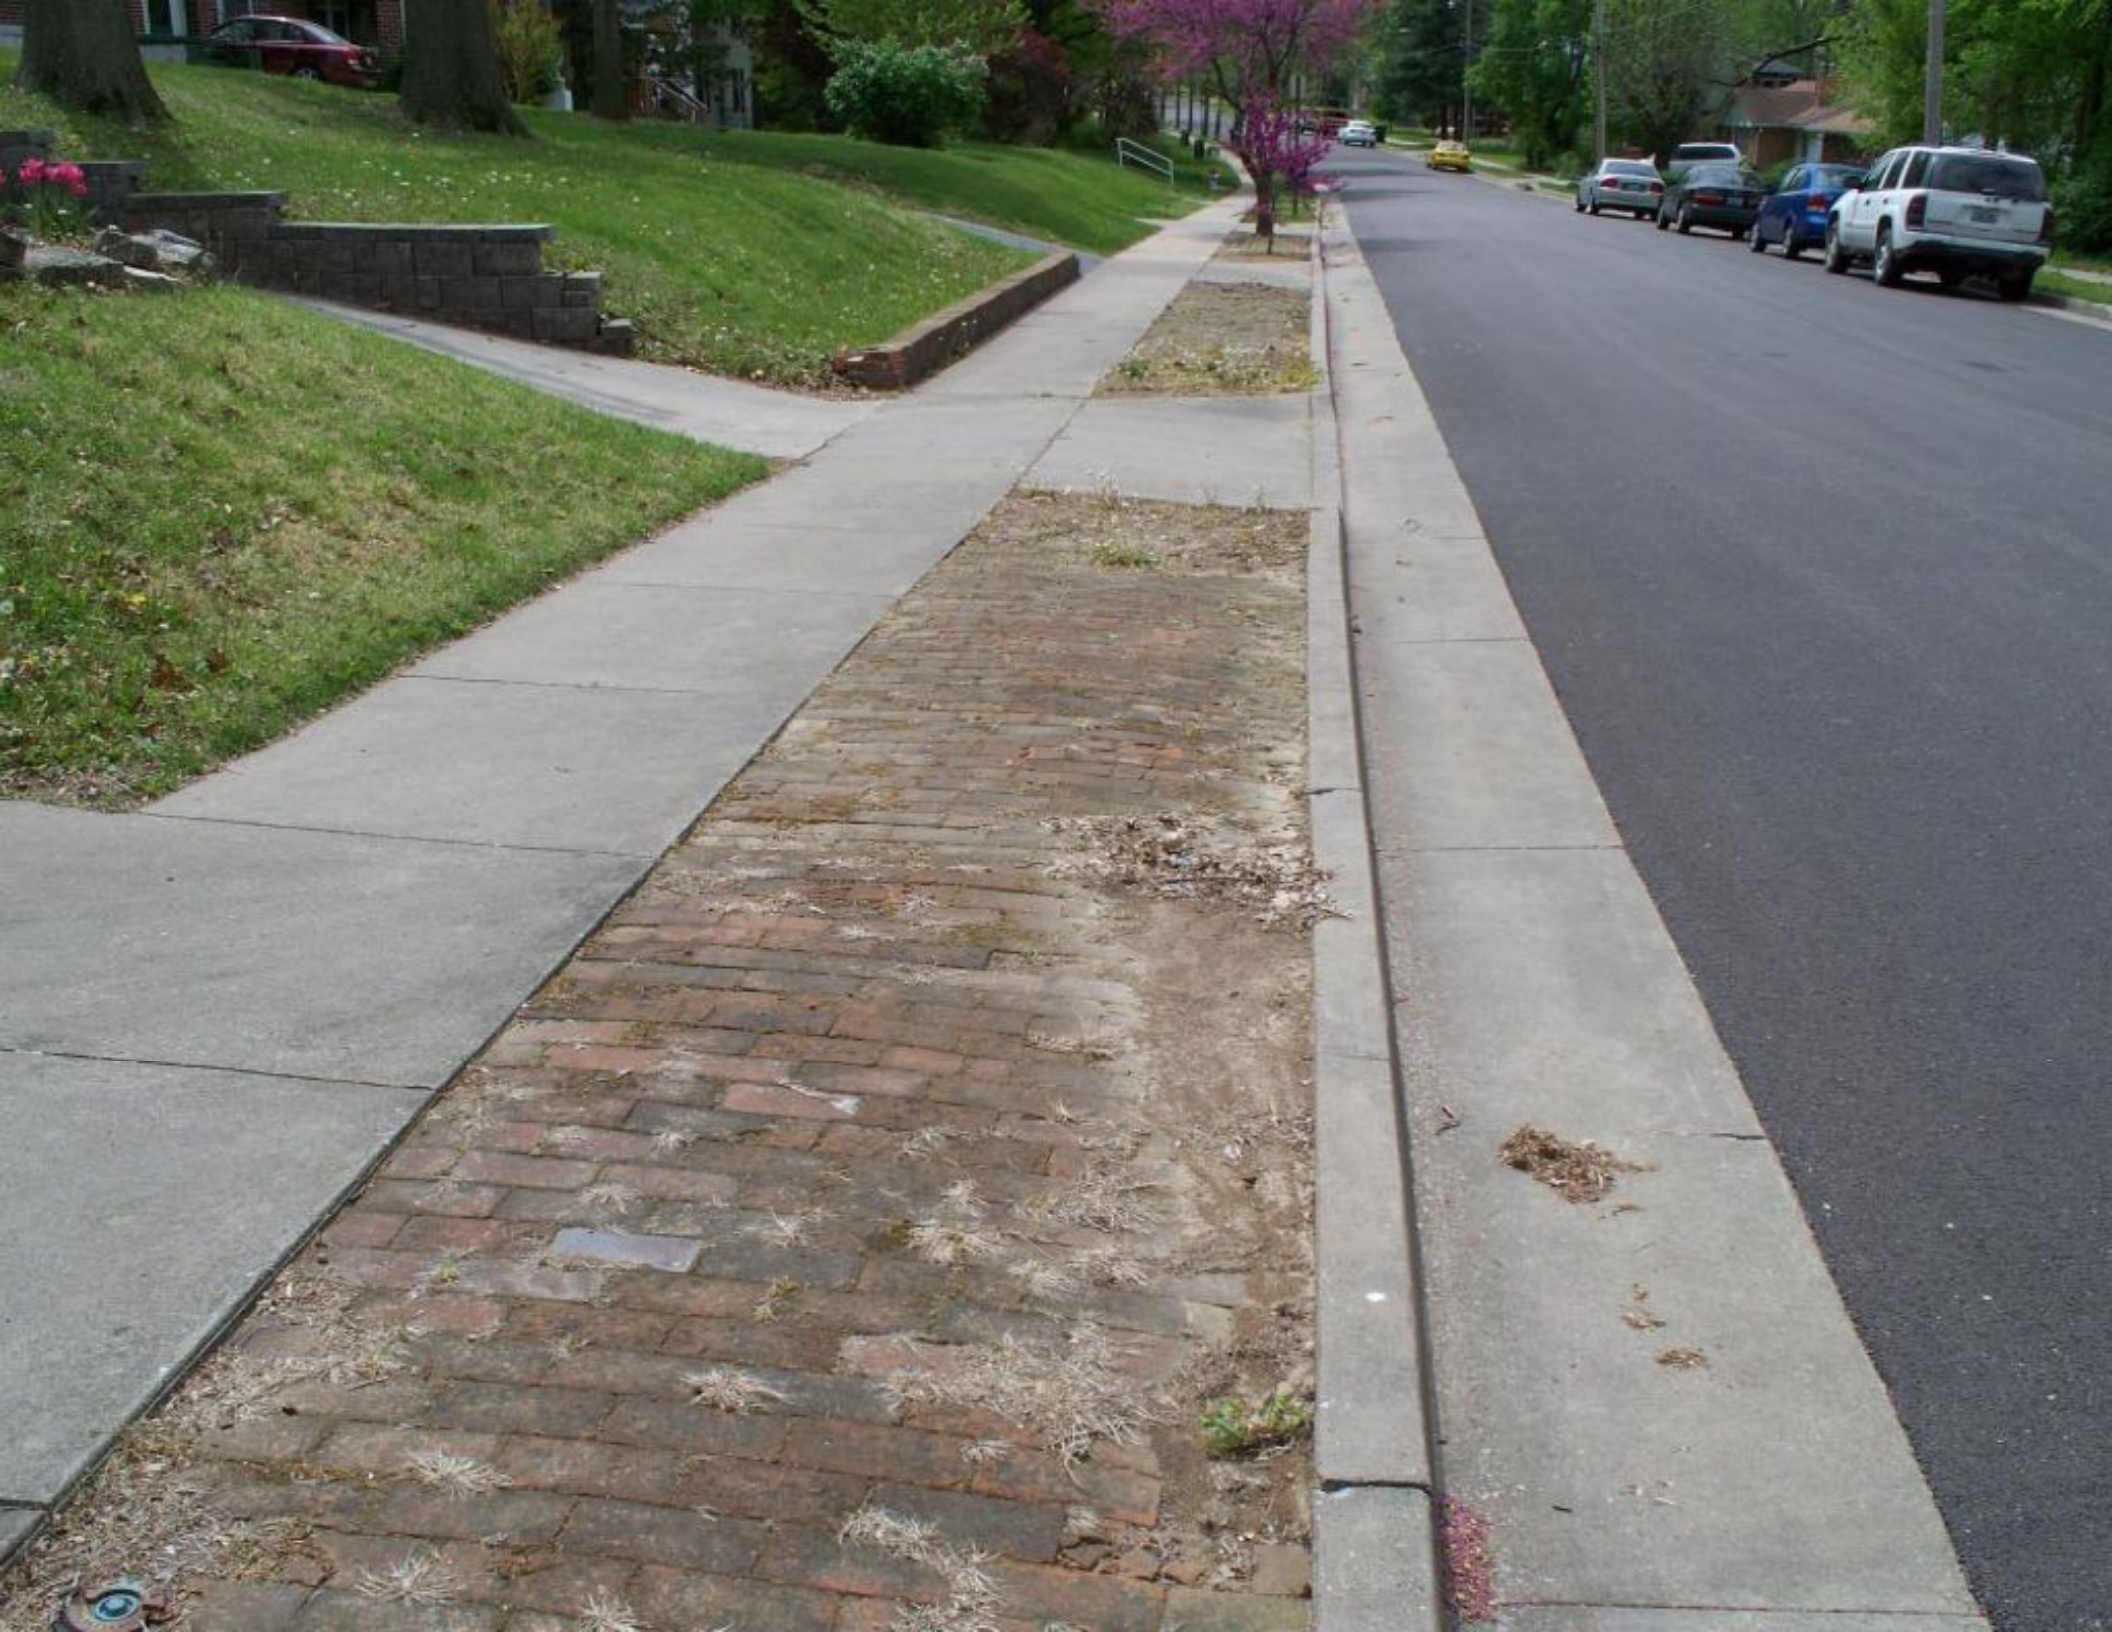
This brick Italian Renaissance home has a hipped terra cotta tile roof with an ornate swept or eyebrow dormer with a single fixed half-round window. The upper story has two symmetrical 3/1 windows with shutters. Between them is a rectangle frame of decorative brick work with limestone squares in the corners. The ground floor has two windows and shutters identical to and directly below those on the second floor. Between the windows is an ornate basket handle hood supported on knee braces. Beneath is an arched entryway with an arched decorative transom and sidelights. There are light features on either side of the door in line with the knee braces. It is unknown if the door is original or not, likewise the windows may or may not be historic. A set of brick stairs and small landing comprise the stoop. To the left of the third bay and setback is an enclosed sunroom. It also has a hipped tile roof. The windows are modern as is the fabric awnings that extend from both sides of the sunroom.

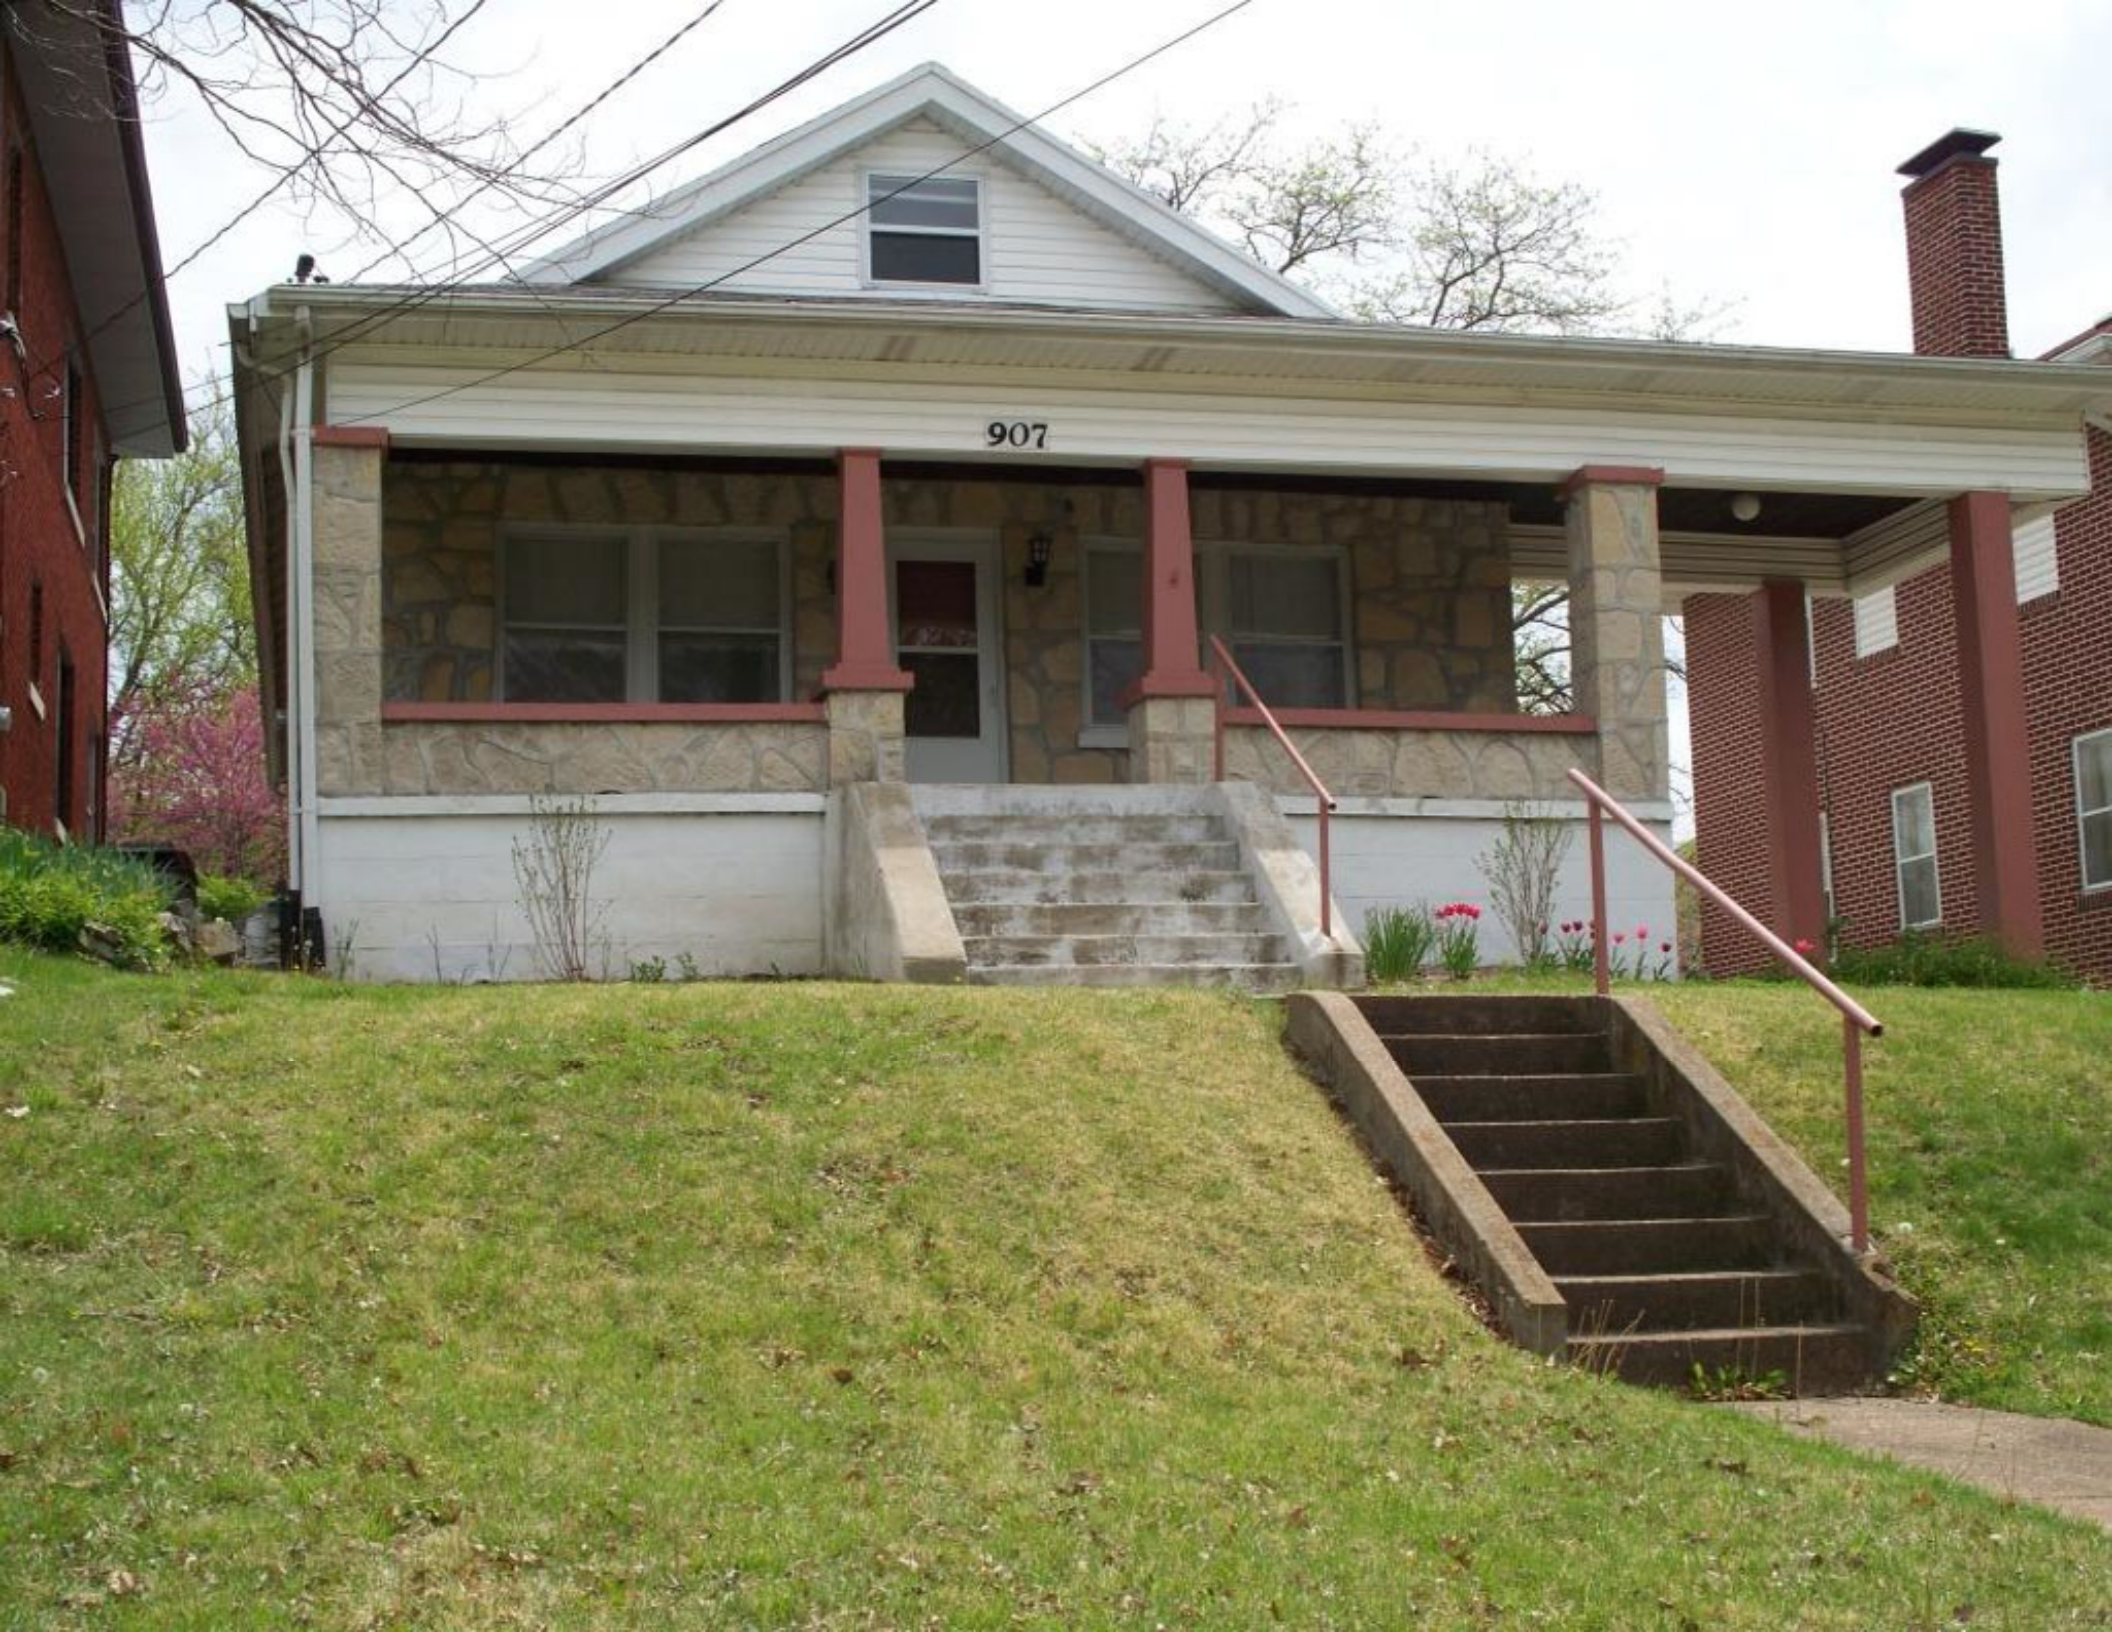
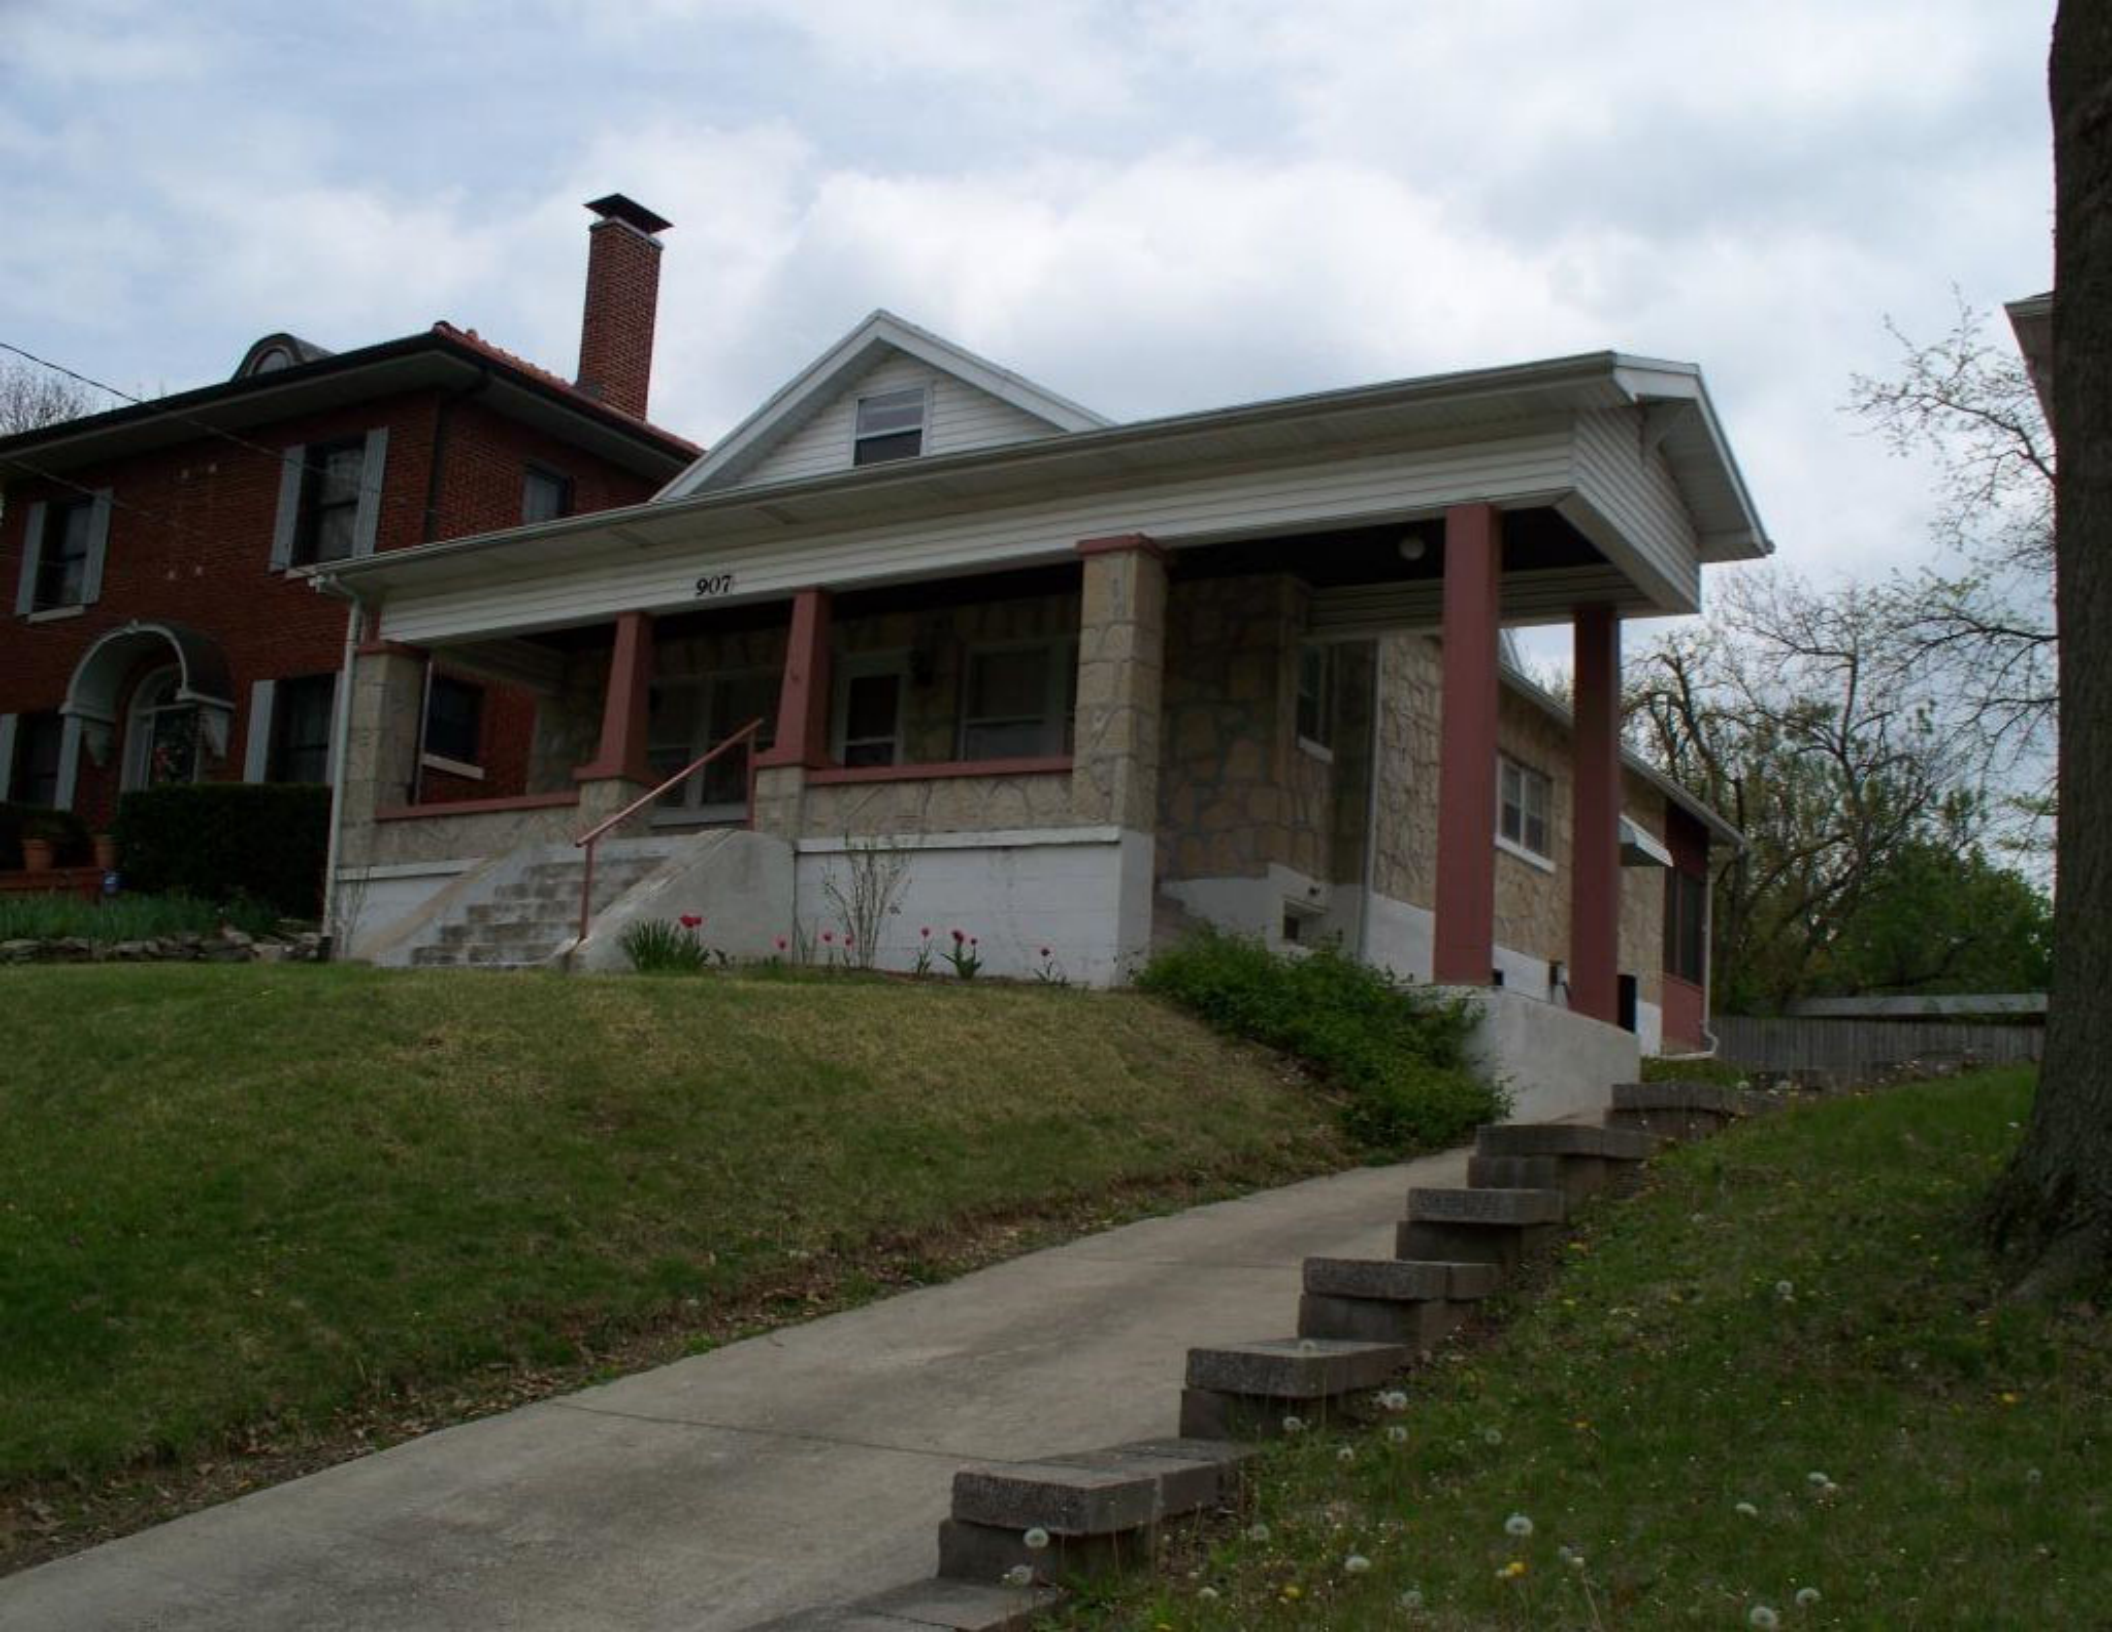
This stone bungalow has a gable roof that has been sided with vinyl. There is a single 1/1 window. This may be another half floor or it simply could be attic space. It is difficult to determine because the roof porch was at some point lifted or replaced to accommodate a wide vinyl-sided modern frieze that extends across the length of the property and one bay to the right to create a roof for the car port. The frieze is boxed over the car port where it terminates in a gable end. The car port is supported by two large square columns. The porch has stone piers and half walls capped in limestone. Two wood tapering square pillars are centered on the porch and rest on stone piers. The porch is set on a high concrete block foundation and is reached by a set of concrete stairs. Two paired 5/1 historic windows flank the central entrance. Despite the addition of the large frieze and car port the property appears to minimally retain its historic integrity and thus would contribute to a historic district. Interestingly the Sanborn map shows the porch extending a bay to the right so there is a possibility this was an early modification, or perhaps the actual stone porch extended or wrapped around the property.
