ARCHITECTURAL/HISTORIC INVENTORY FORM

1. Survey No. CO-AS-005-001		2. Survey name: Moreau Drive Neighborhood Survey	
3. County: Cole		4. Address: 1202 Elmerine Ave.	
5. City: Jefferson City	Vicinity: <input type="checkbox"/>	6. UTM: / /	7. Township/Range/Section: T: R: S:
8. Historic name (if known):		9. Present/other name (if known):	
10. Ownership: <input checked="" type="checkbox"/> Private <input type="checkbox"/> Public		11. Historic use (if known): Residential	11. Current use: Residential

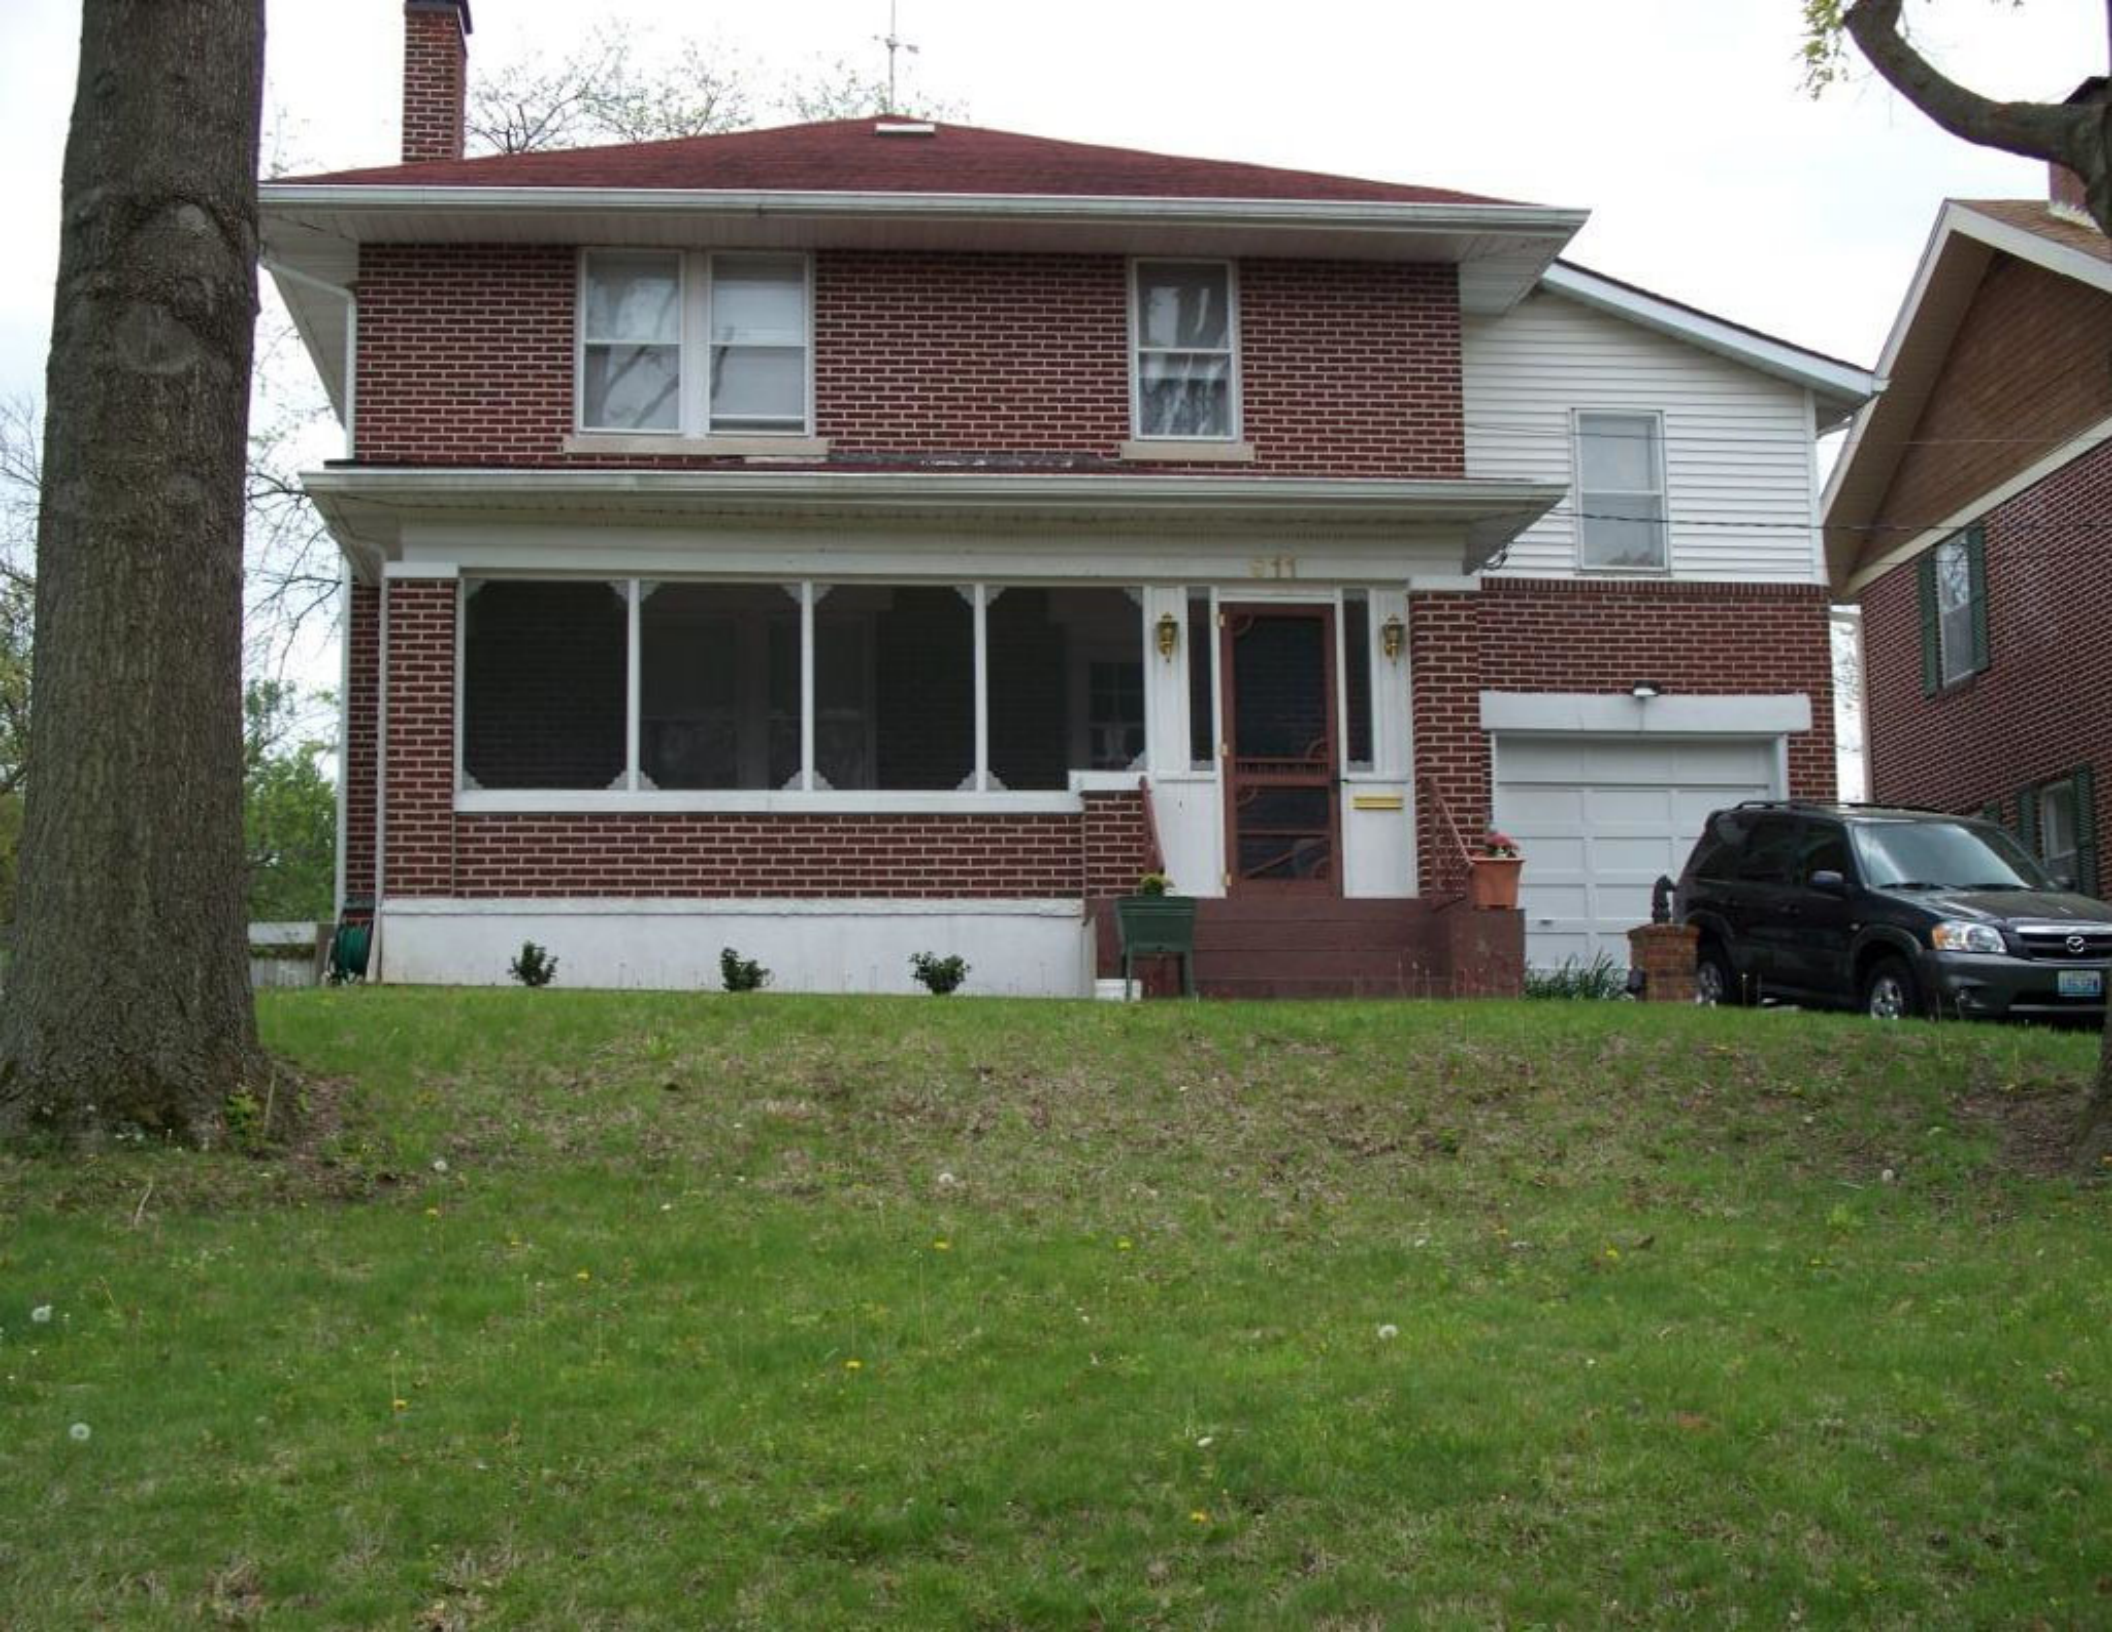
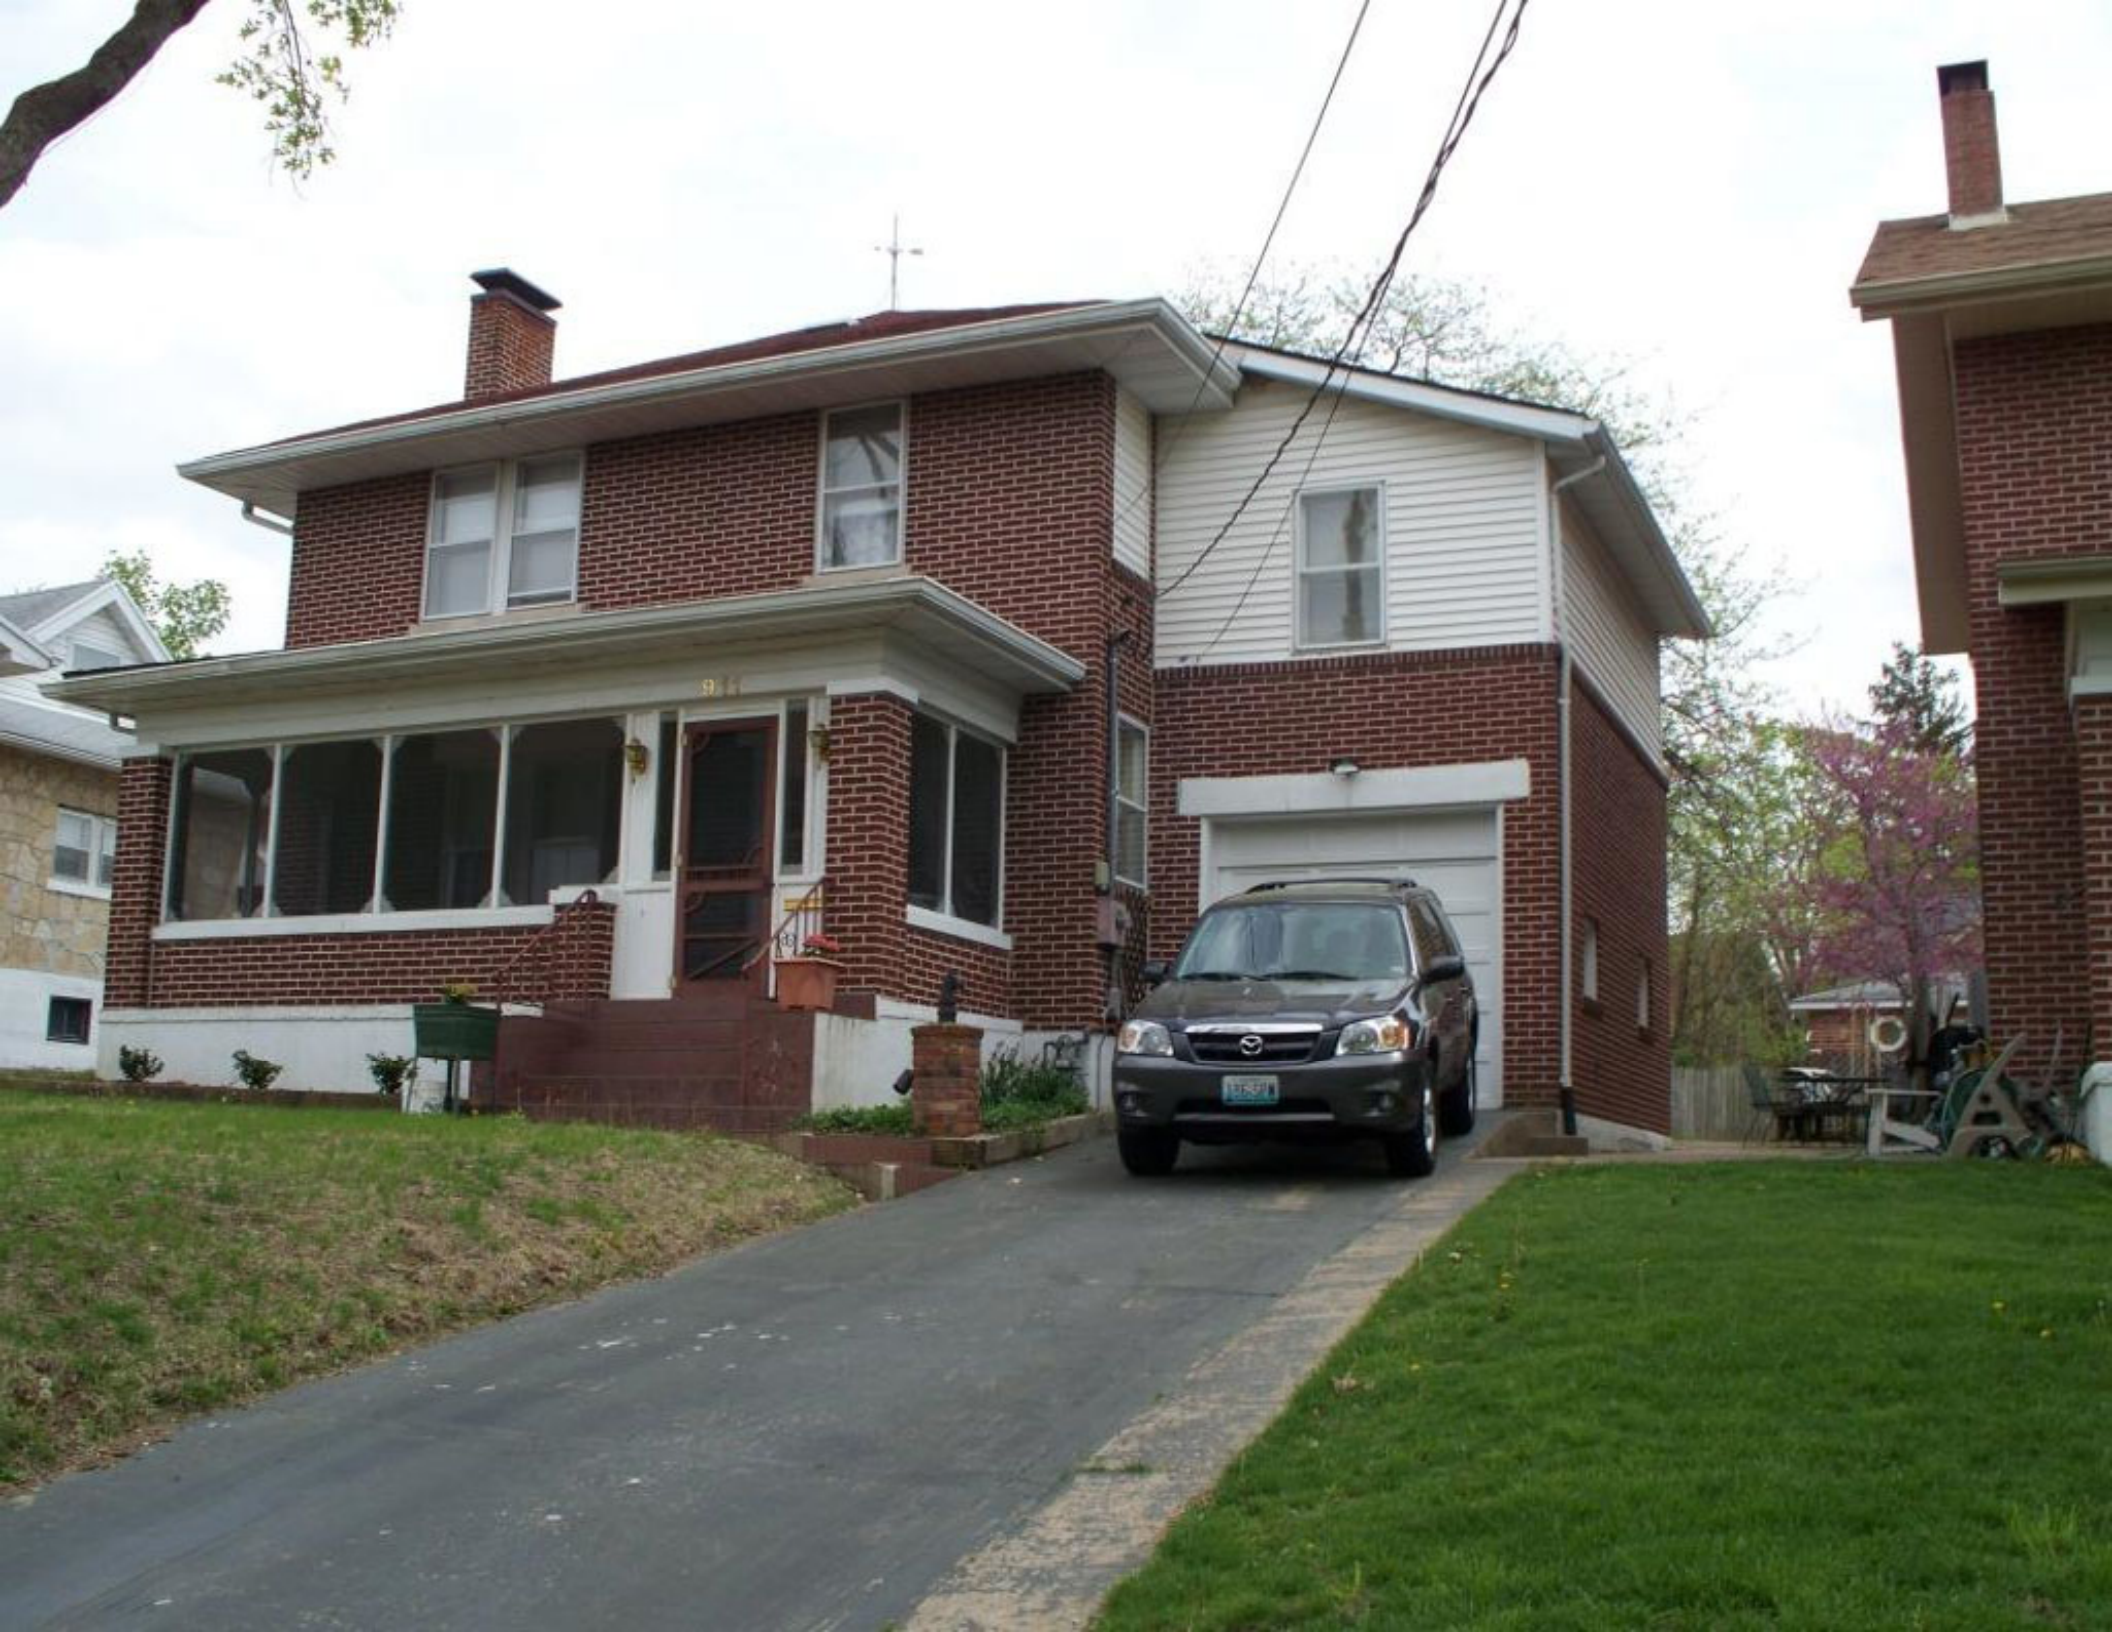
This two-story brick four square has a hipped roof. The second floor has a paired 1/1 windows in the left bay and a single 1/1 in the right. The windows are set deep behind storms, thus it was difficult to determine if they are historic or not. The porch has a flat or low pitched roof with a large box frieze. It has brick half walls and piers capped in limestone. The space between has been screened-in making it difficult to see the fenestration on the first floor, but it appears there are paired windows in the left bay with the entrance on the right. There is an attached brick one-car garage setback off the right side of the building. A second story clad in vinyl sits atop, has a shed roof and a single 1/1 window. It is difficult to tell but the second floor over the garage may be a historic addition. The garage appears on the Sanborn but it may be marked as two stories (lack of quality made map hard to decipher). Either way the property retains enough significance to contribute to a historic district.

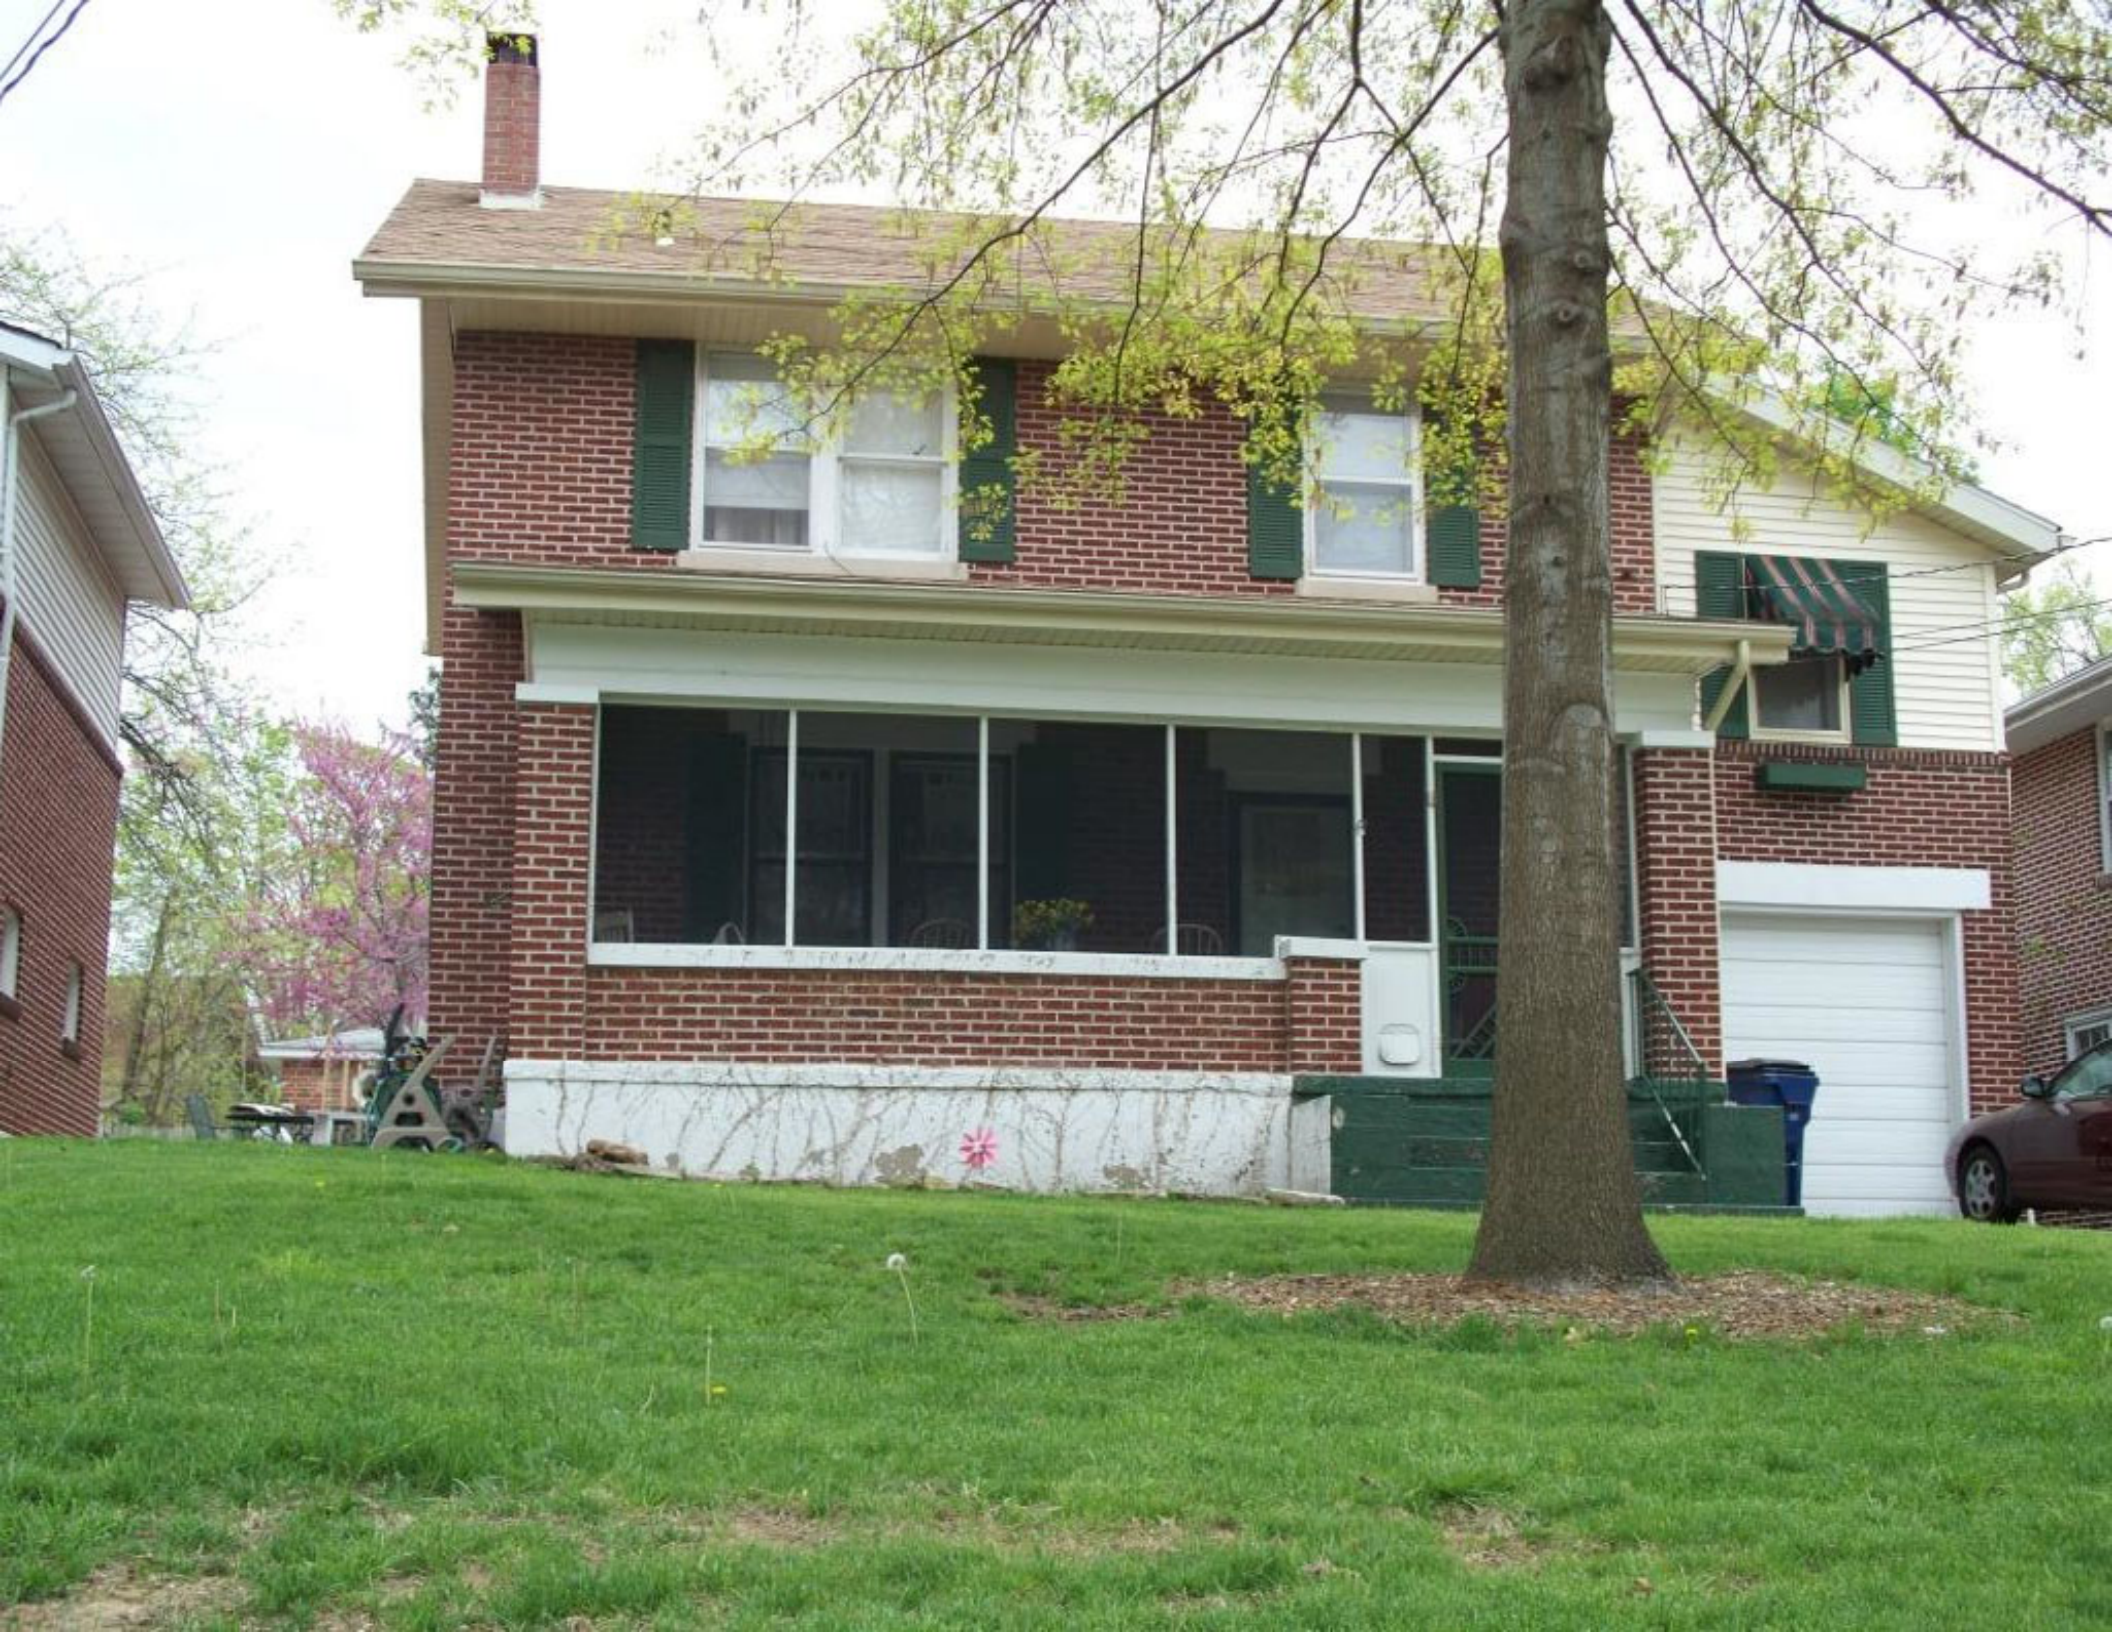
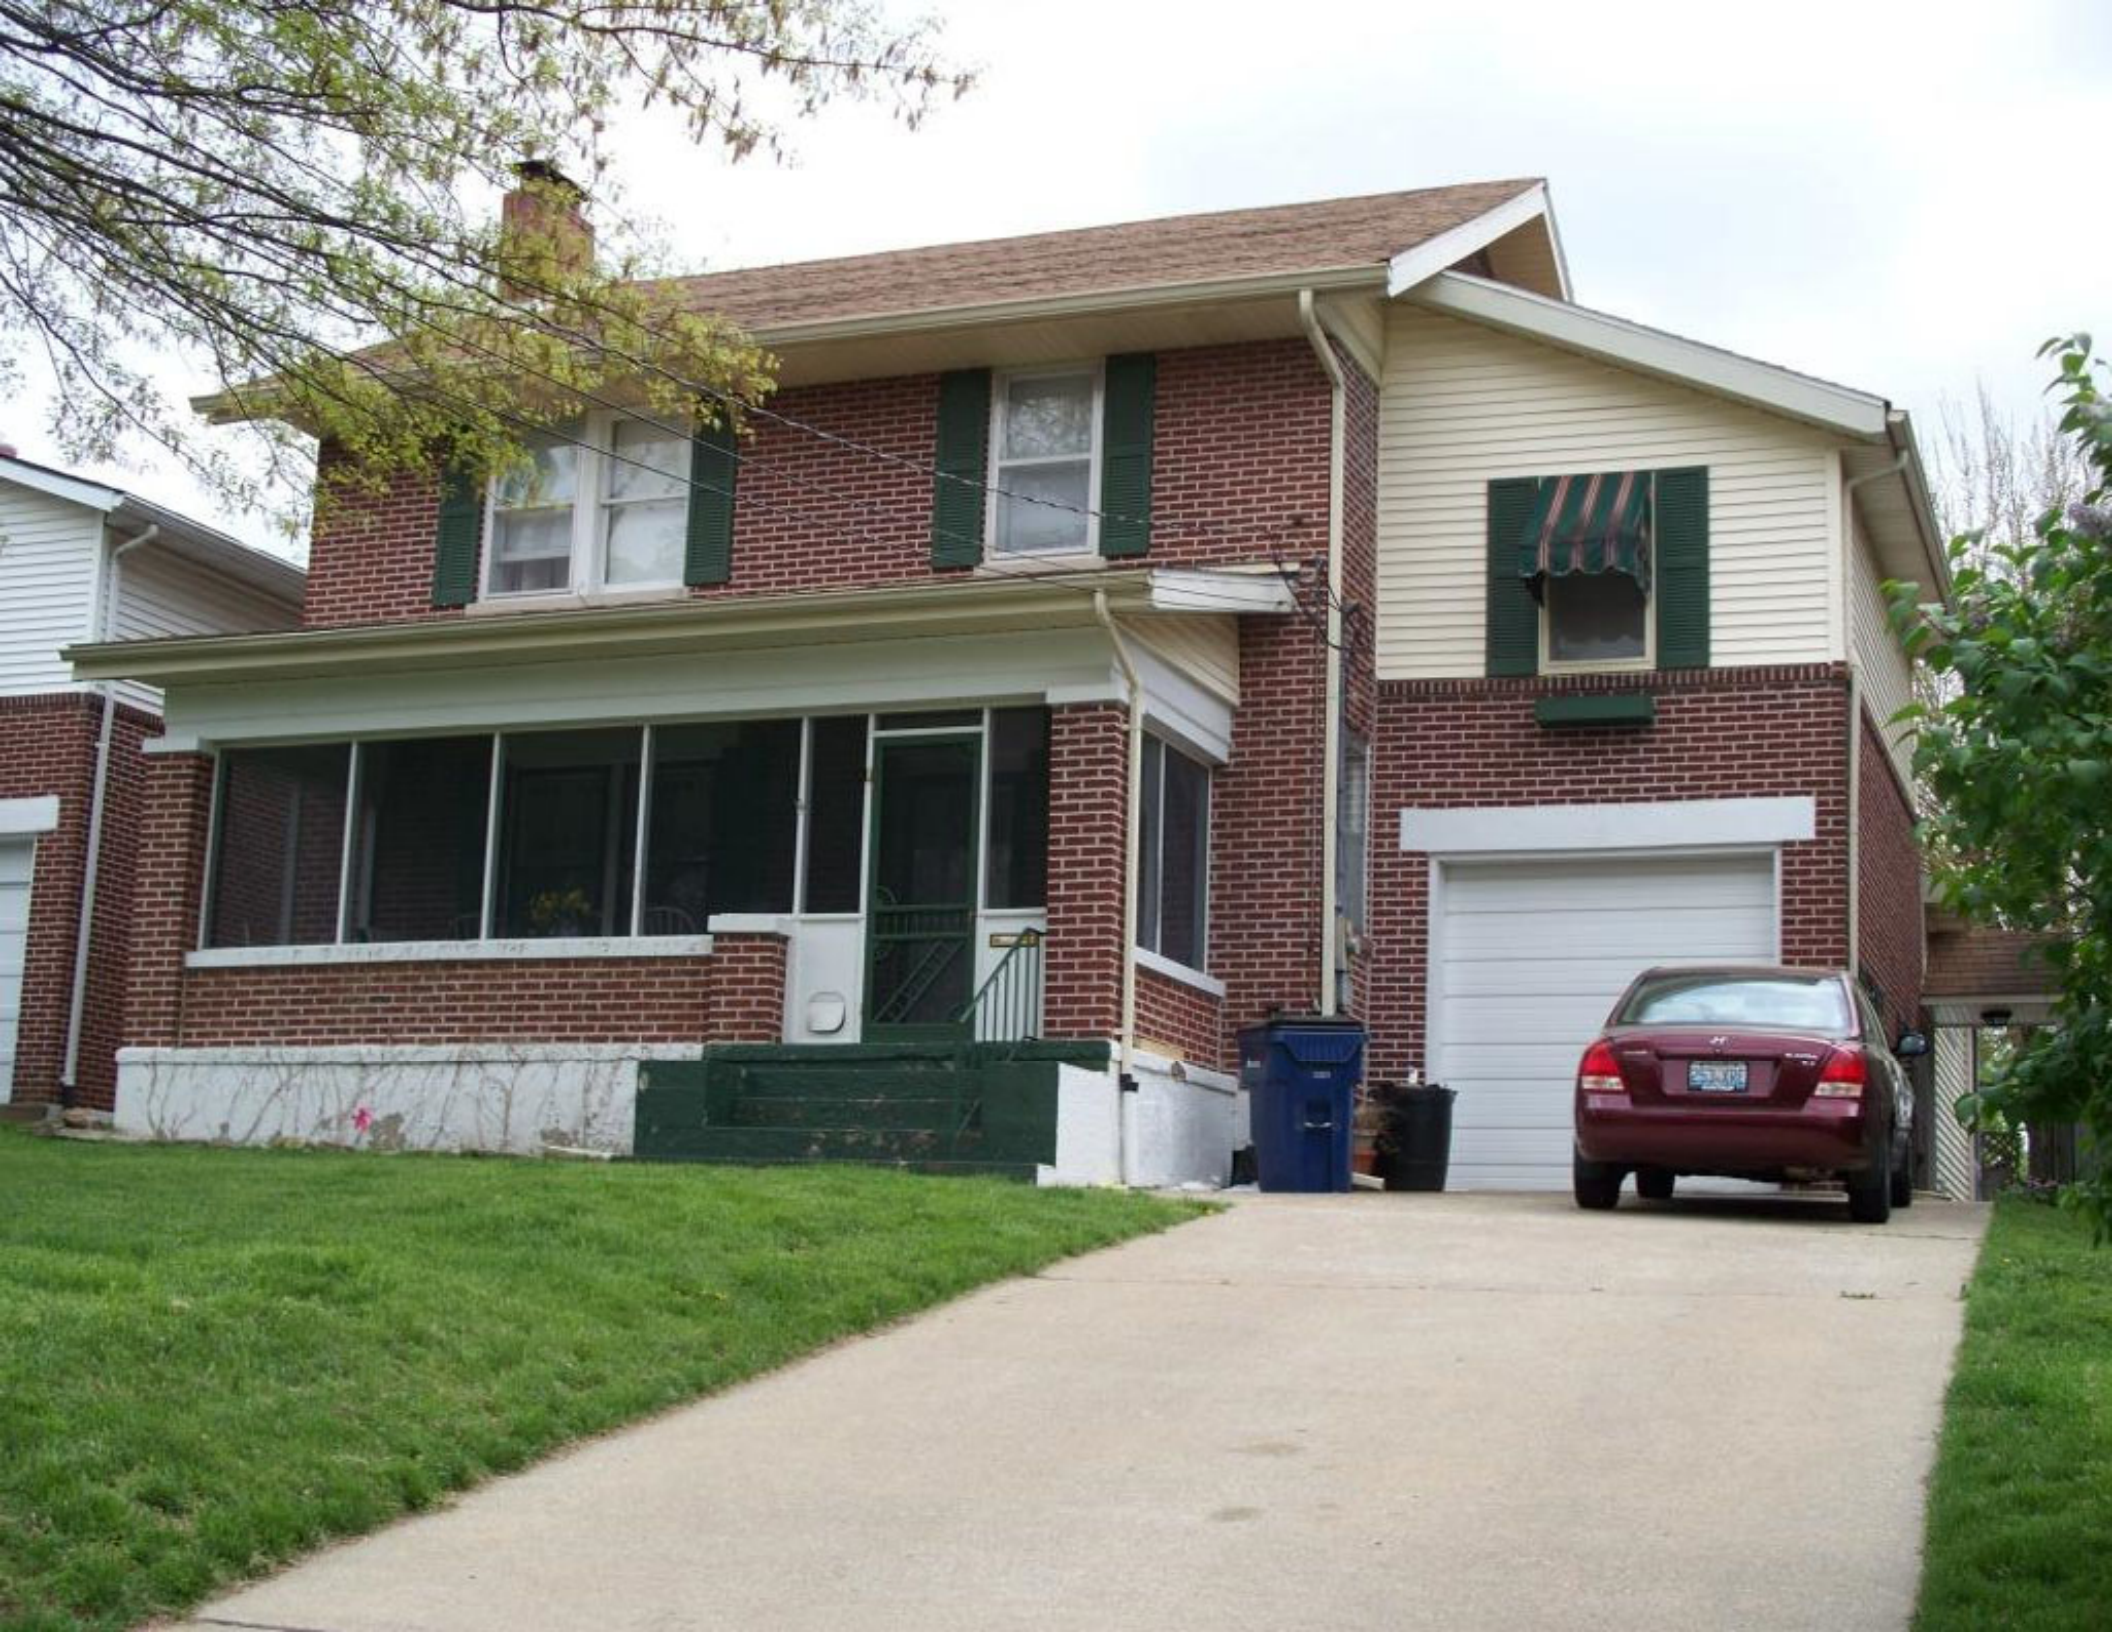
This property is similar to 911 Fairmount Blvd save that it has a side gable roof and shutters on the windows of the upper floor. It is a two-story brick four square with paired 1/1 windows in the left bay and a single 1/1 in the right. Both have shutters and a limestone sill. The porch has a shed roof, a wide frieze, brick piers and a half wall capped in limestone. The porch has been screened-in put it appears there are paired windows in the left bay and the entrance is in the right. A one-car brick garage is set back and features a second story that is clad in vinyl and has a shed roof. It also has a single 1/1 window with a fabric awning, shutters, and a flower box.

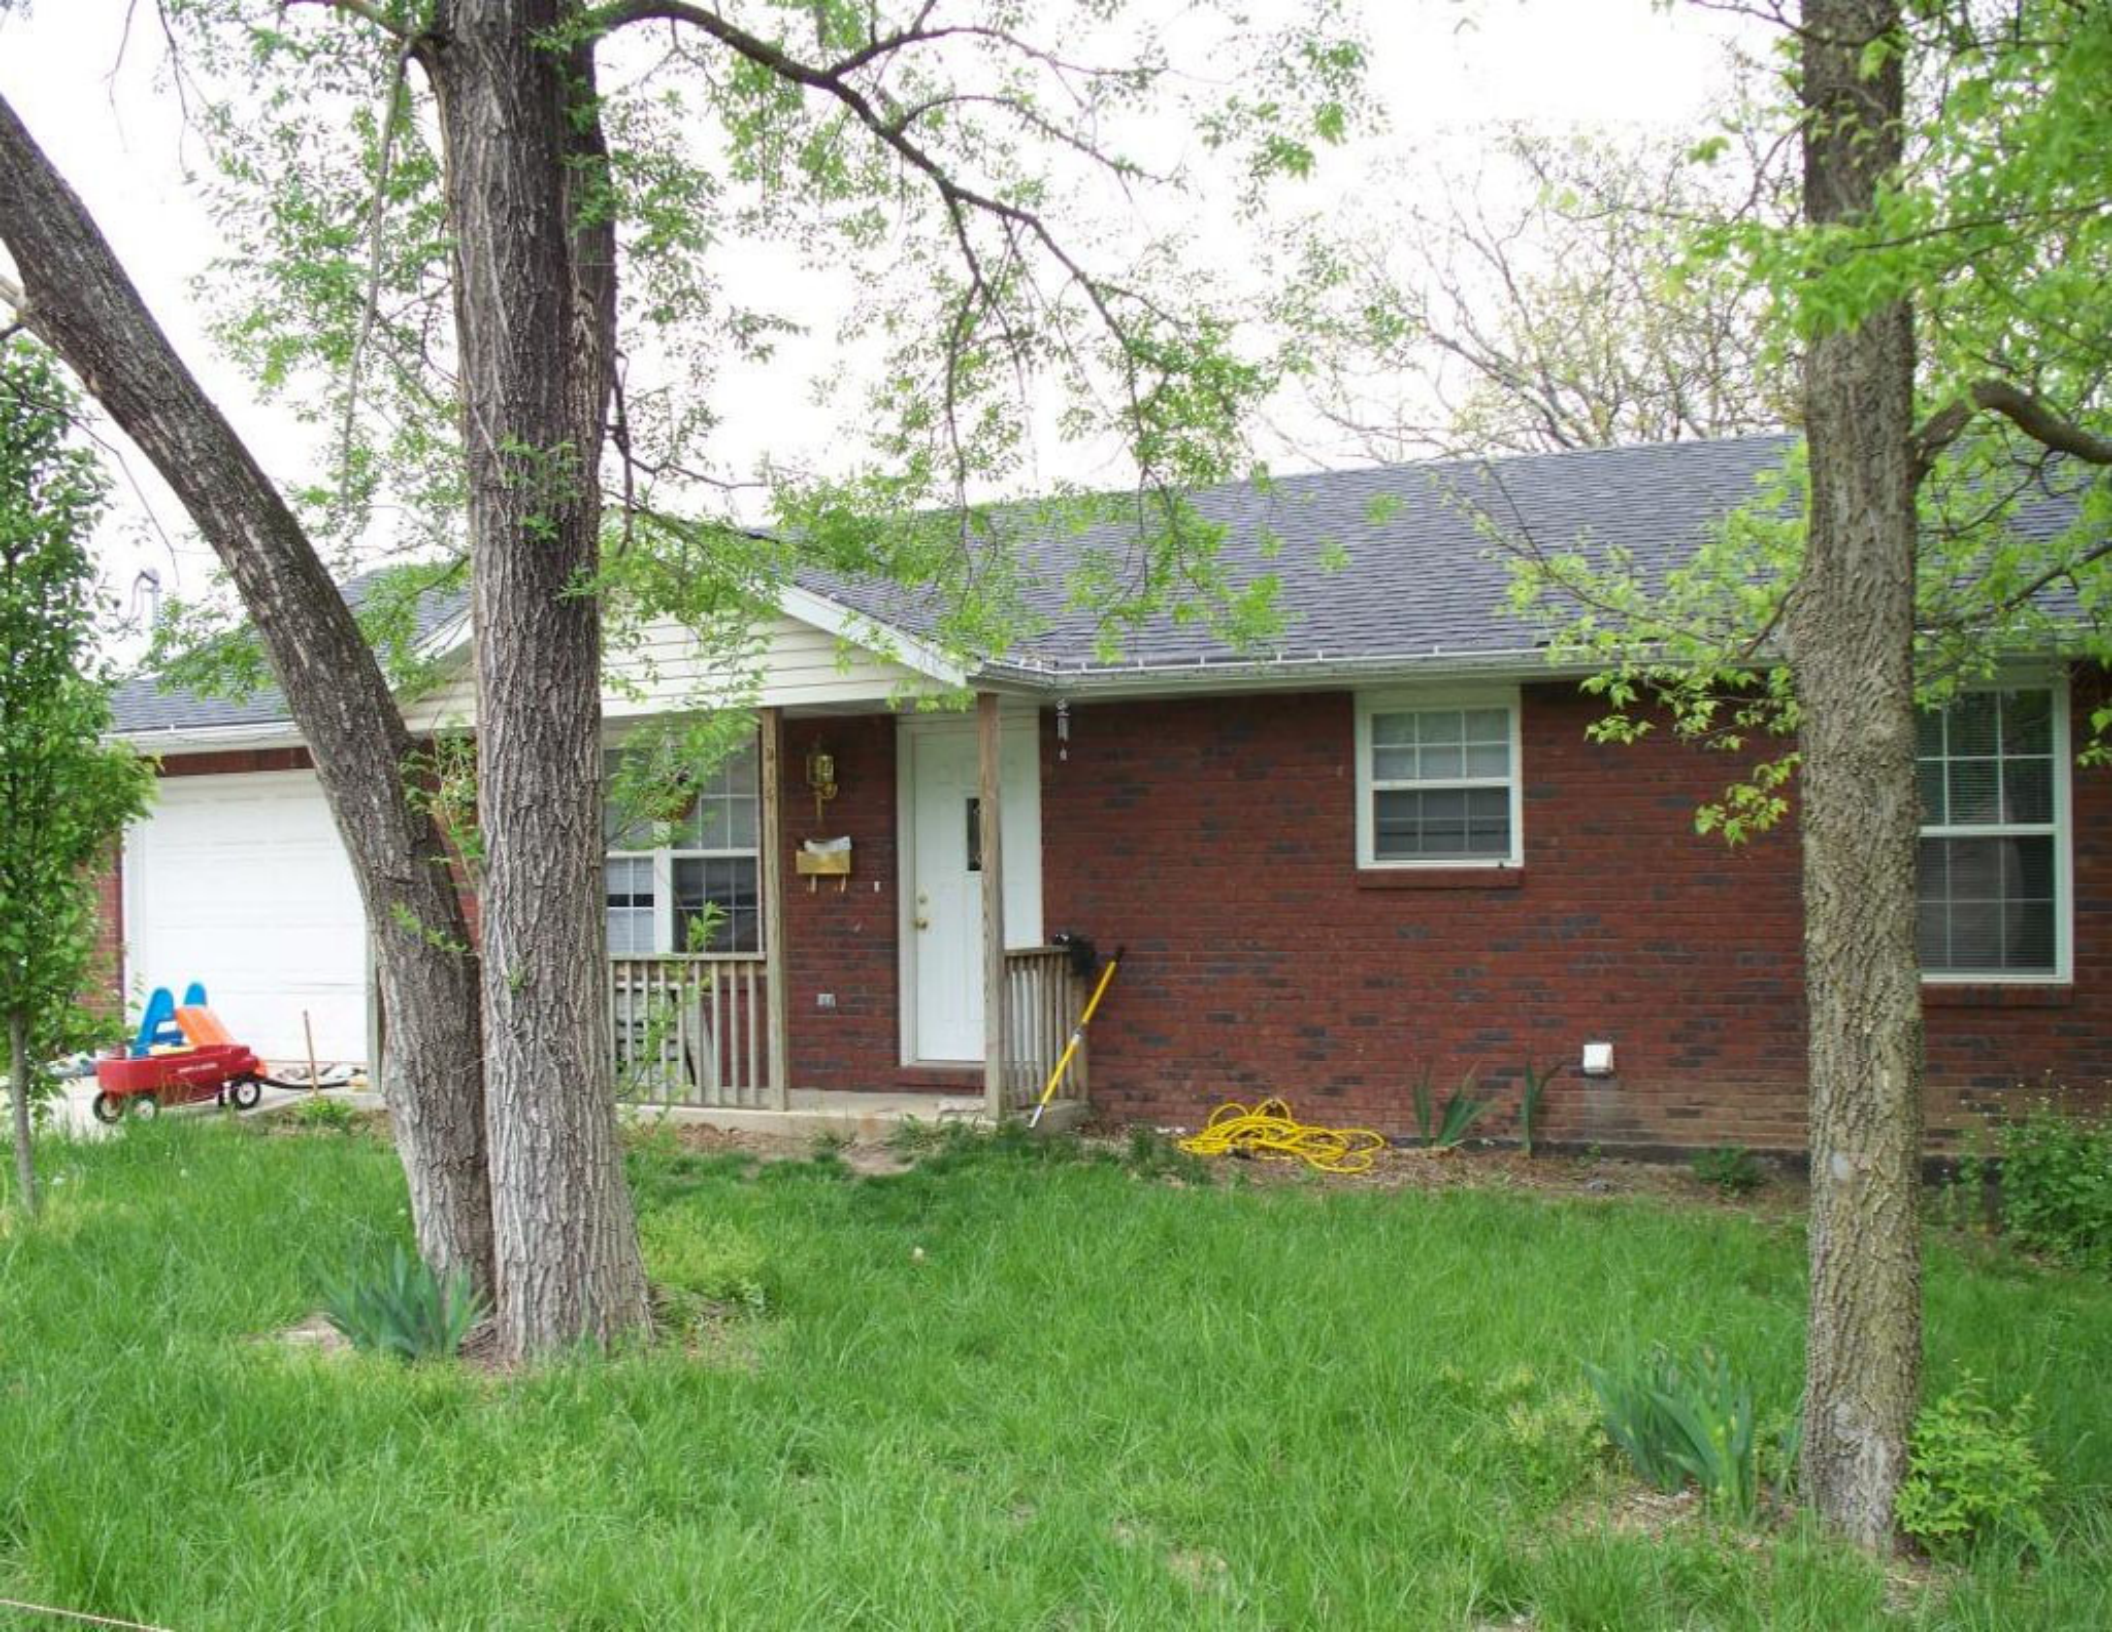
41. (cont.)
Modern infill. One story brick ranch with attached garage and gabled partial porch with wood railing in the center of the facade. From the right there is a 1/1 window (pseudo-divided 6/6) in with a smaller to the left then the entrance and paired 1/1 (pseudo 6/6) before ending with a one-car front facing garage.
