ARCHITECTURAL/HISTORIC INVENTORY FORM

1. Survey No. CO-AS-005-001		2. Survey name: Moreau Drive Neighborhood Survey	
3. County: Cole		4. Address: 1202 Elmerine Ave.	
5. City: Jefferson City	Vicinity: <input type="checkbox"/>	6. UTM: / /	7. Township/Range/Section: T: R: S:
8. Historic name (if known):		9. Present/other name (if known):	
10. Ownership: <input checked="" type="checkbox"/> Private <input type="checkbox"/> Public		11. Historic use (if known): Residential	11. Current use: Residential

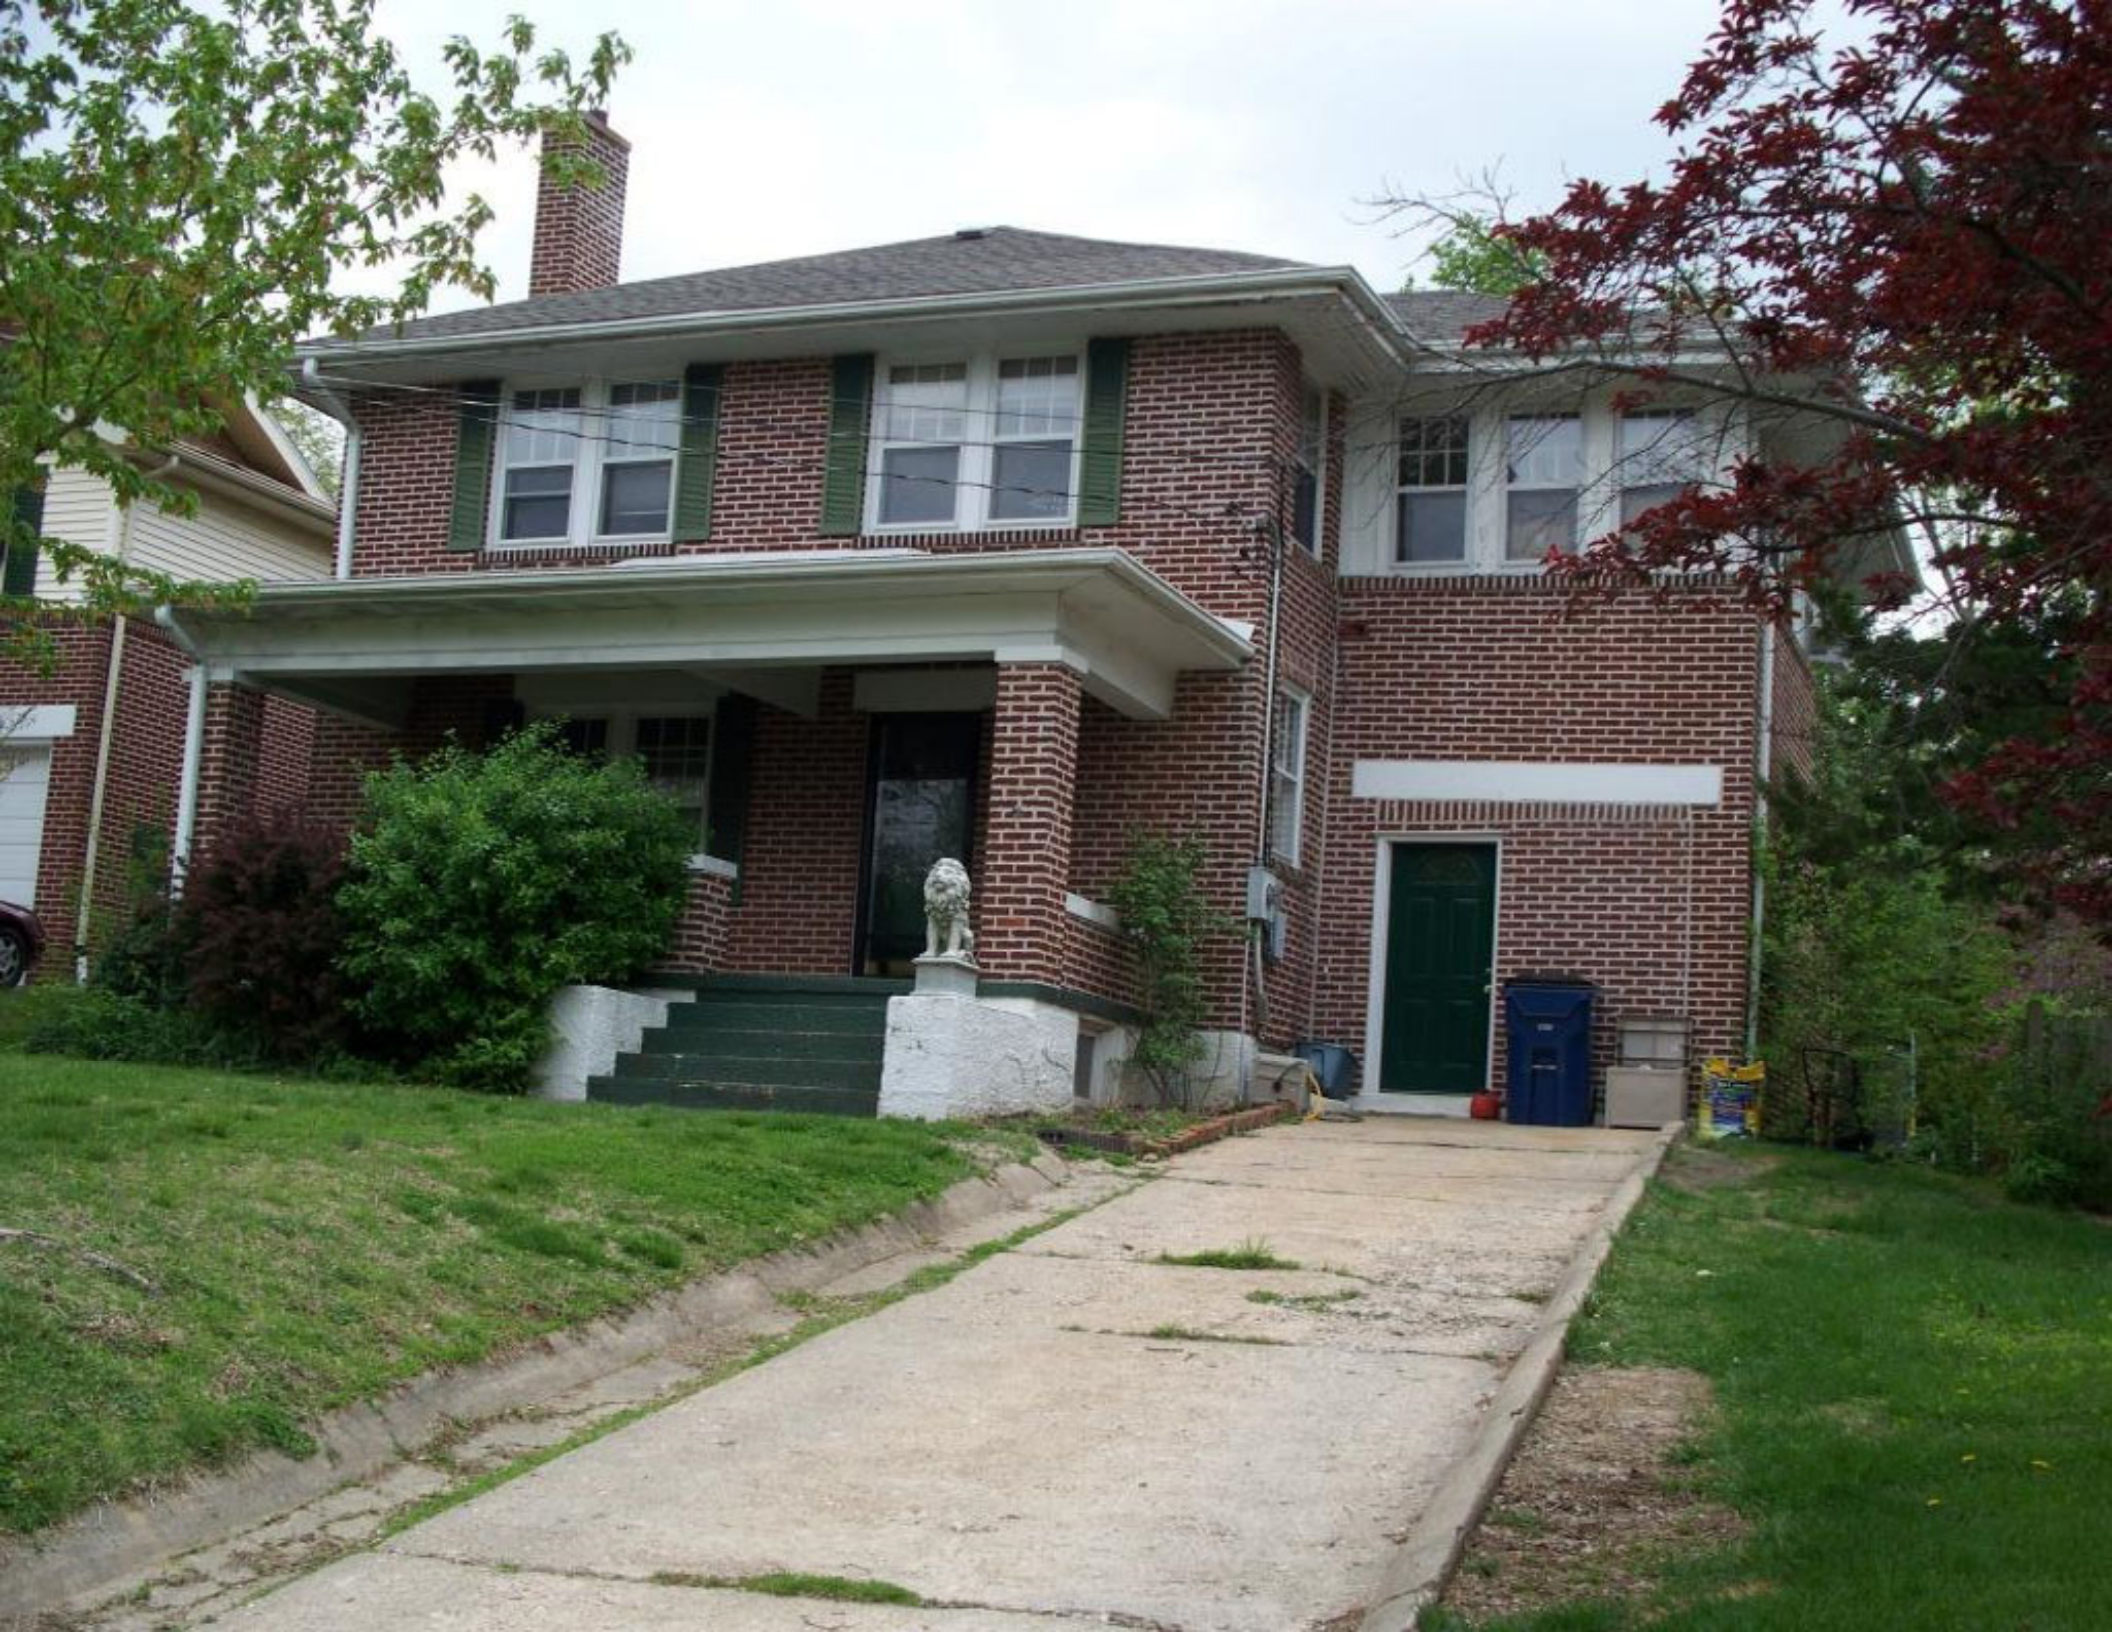
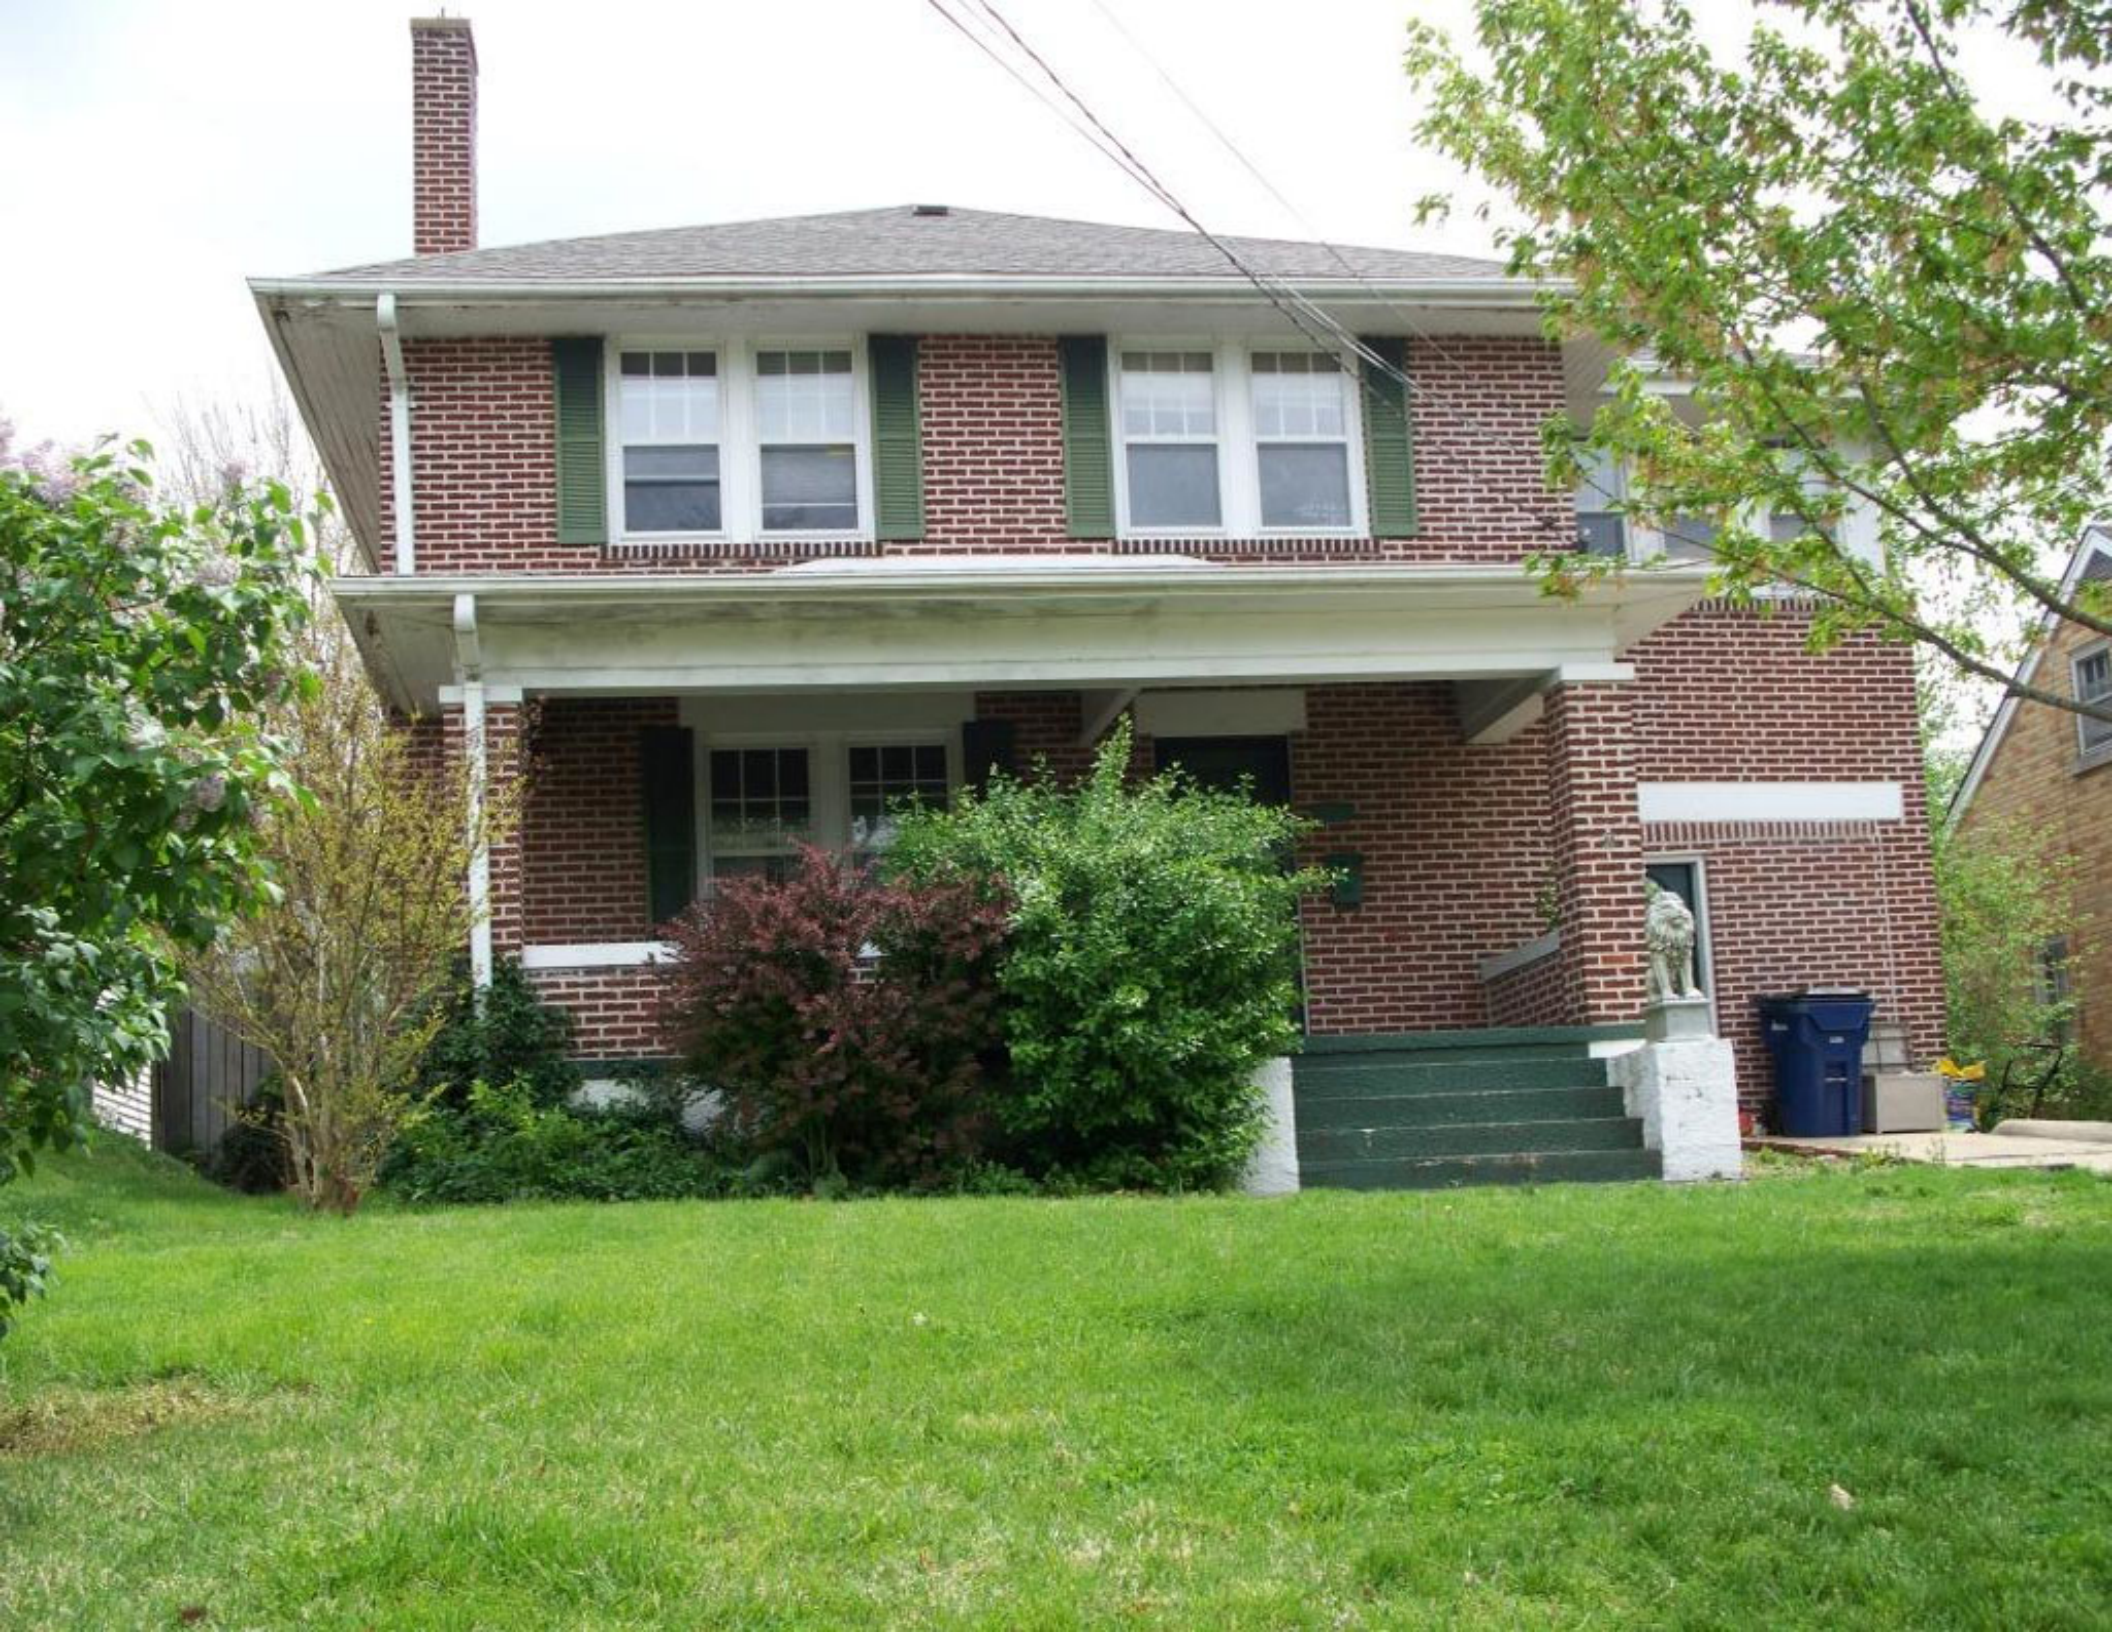
This property is similar to 911 and 913 Fairmount. The two-story brick four square has a hipped roof and two paired 6/1 windows with rowlock brick sills. The porch has a shed roof and a wide frieze. Unlike 911 and 913 Fairmount the front porch has not been screened-in. It features brick piers and half walls capped in limestone. Paired 6/1 windows are in the left bay and have a wide limestone lintel as does the door in the right bay. The windows may or may not be historic and all of them have shutters (save the ones over the garage). What used to be a one-car garage is set back and off the right of the building. It has been enclosed with brick leaving a single entrance with a non-historic door. The second story over the garage consists of a row of three 6/1 windows.

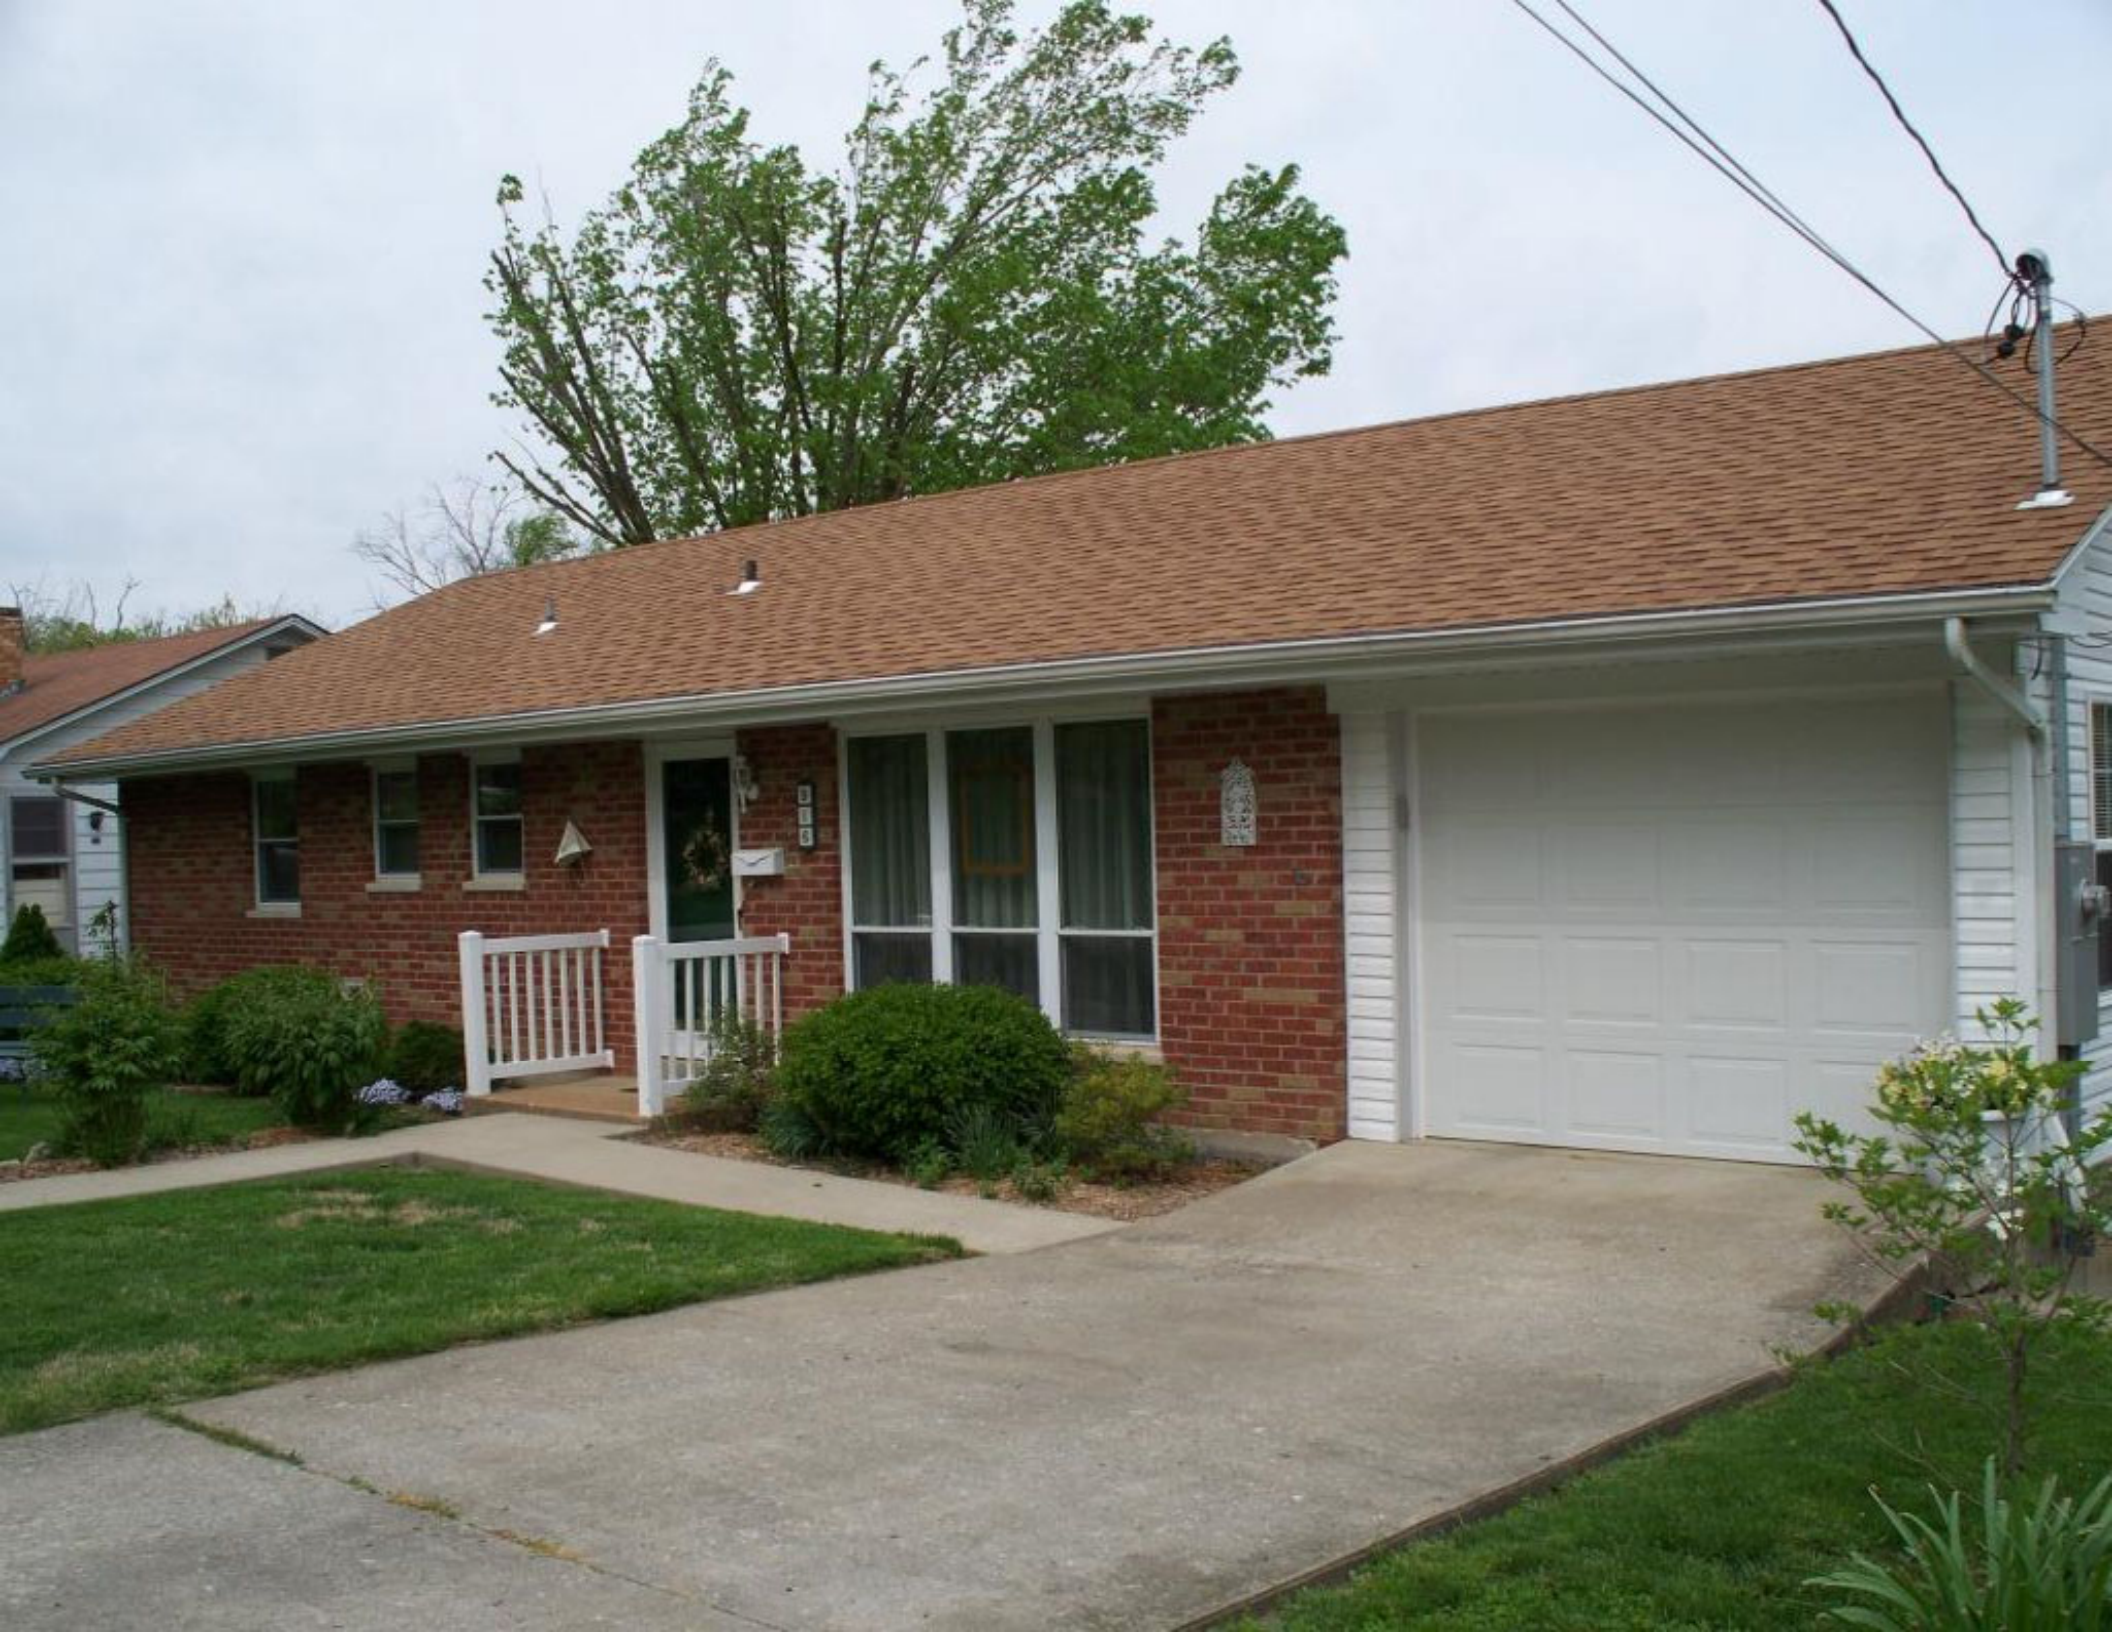
41. (cont.)
Modern infill. Similar to 914 Fairmount this is a one story brick ranch with attached garage and a central stoop with railing. From the right there is a one-car garage a three-part window with longer upper panes and shorter lower, the entrance and three 1/1 windows.

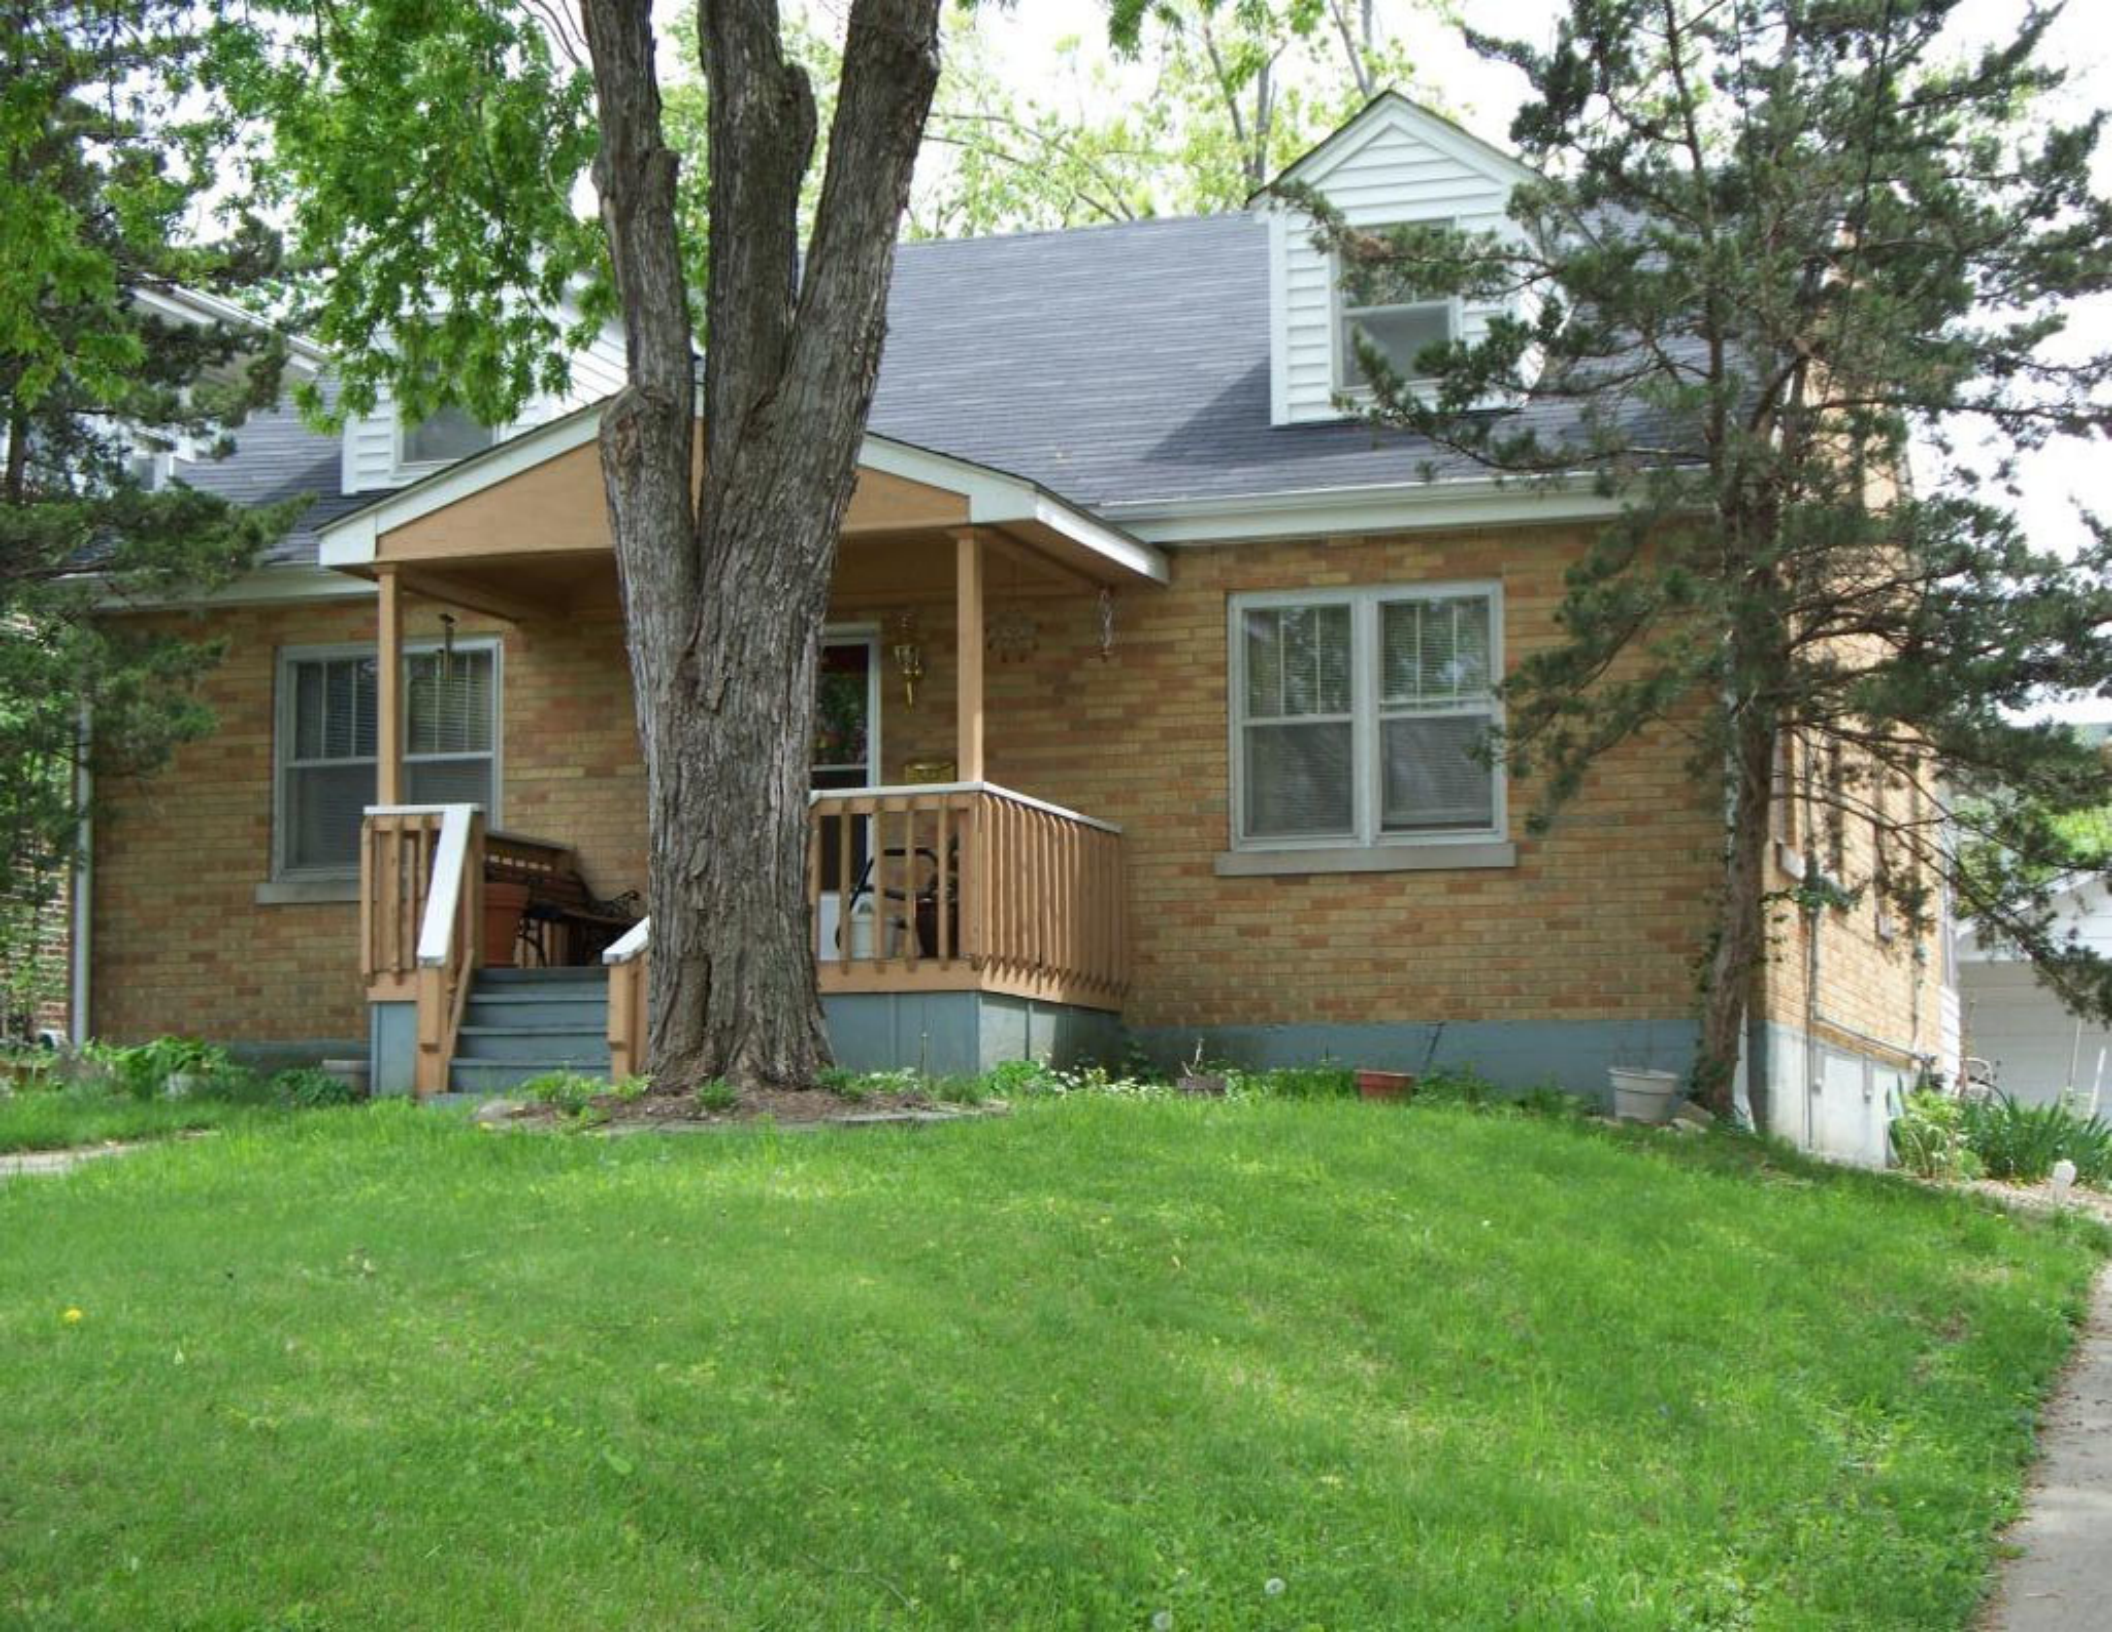
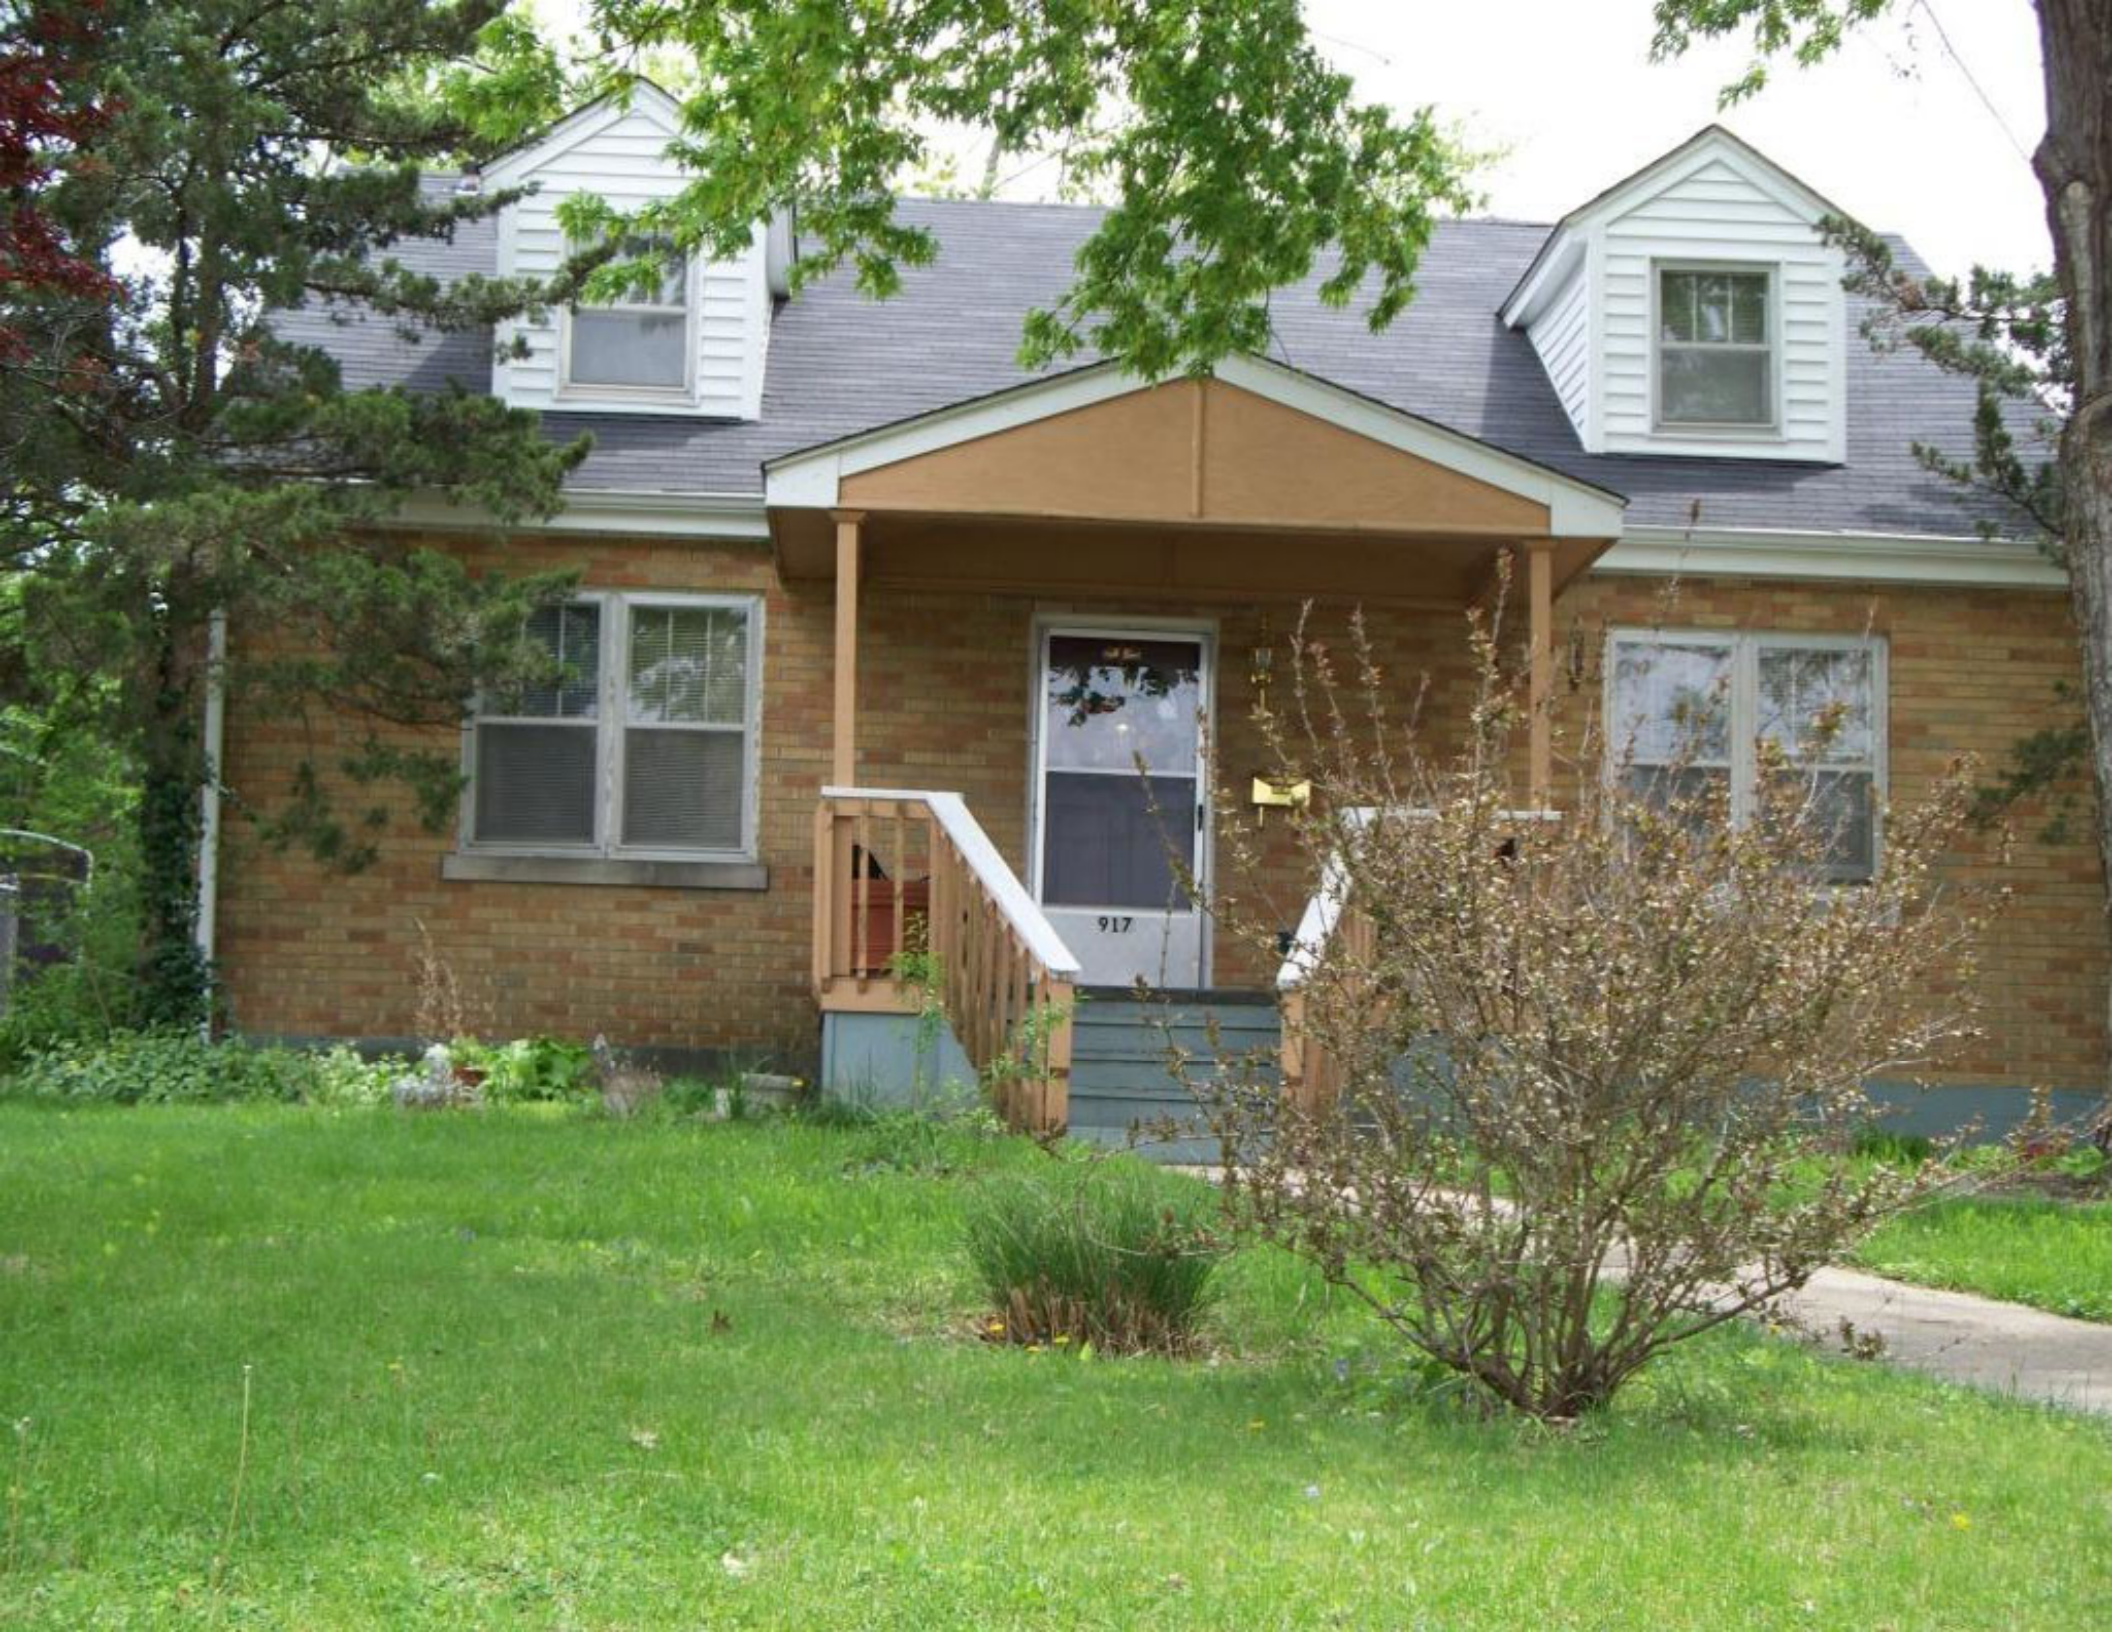
40. (cont.) Description of environment and outbuildings. Expand box as necessary, or add continuation pages.
There is a large three car garage at the back of the building that may be shared with 919 Fairmount. It is considered modern and non-contributing to the district.

41. (cont.)
This brick Cape Cod has a side gable roof and two gabled dormers clad in vinyl with a single historic 3/1 window. The first floor has paired 3/1 windows with limestone sills flanking each side of the central entrance. The porch has a projecting stucco-clad or possibly wood gable that meets metal posts and wood railing that is likely modern. The railing extends in a “V” shape to serve as a rail to the concrete stairs.

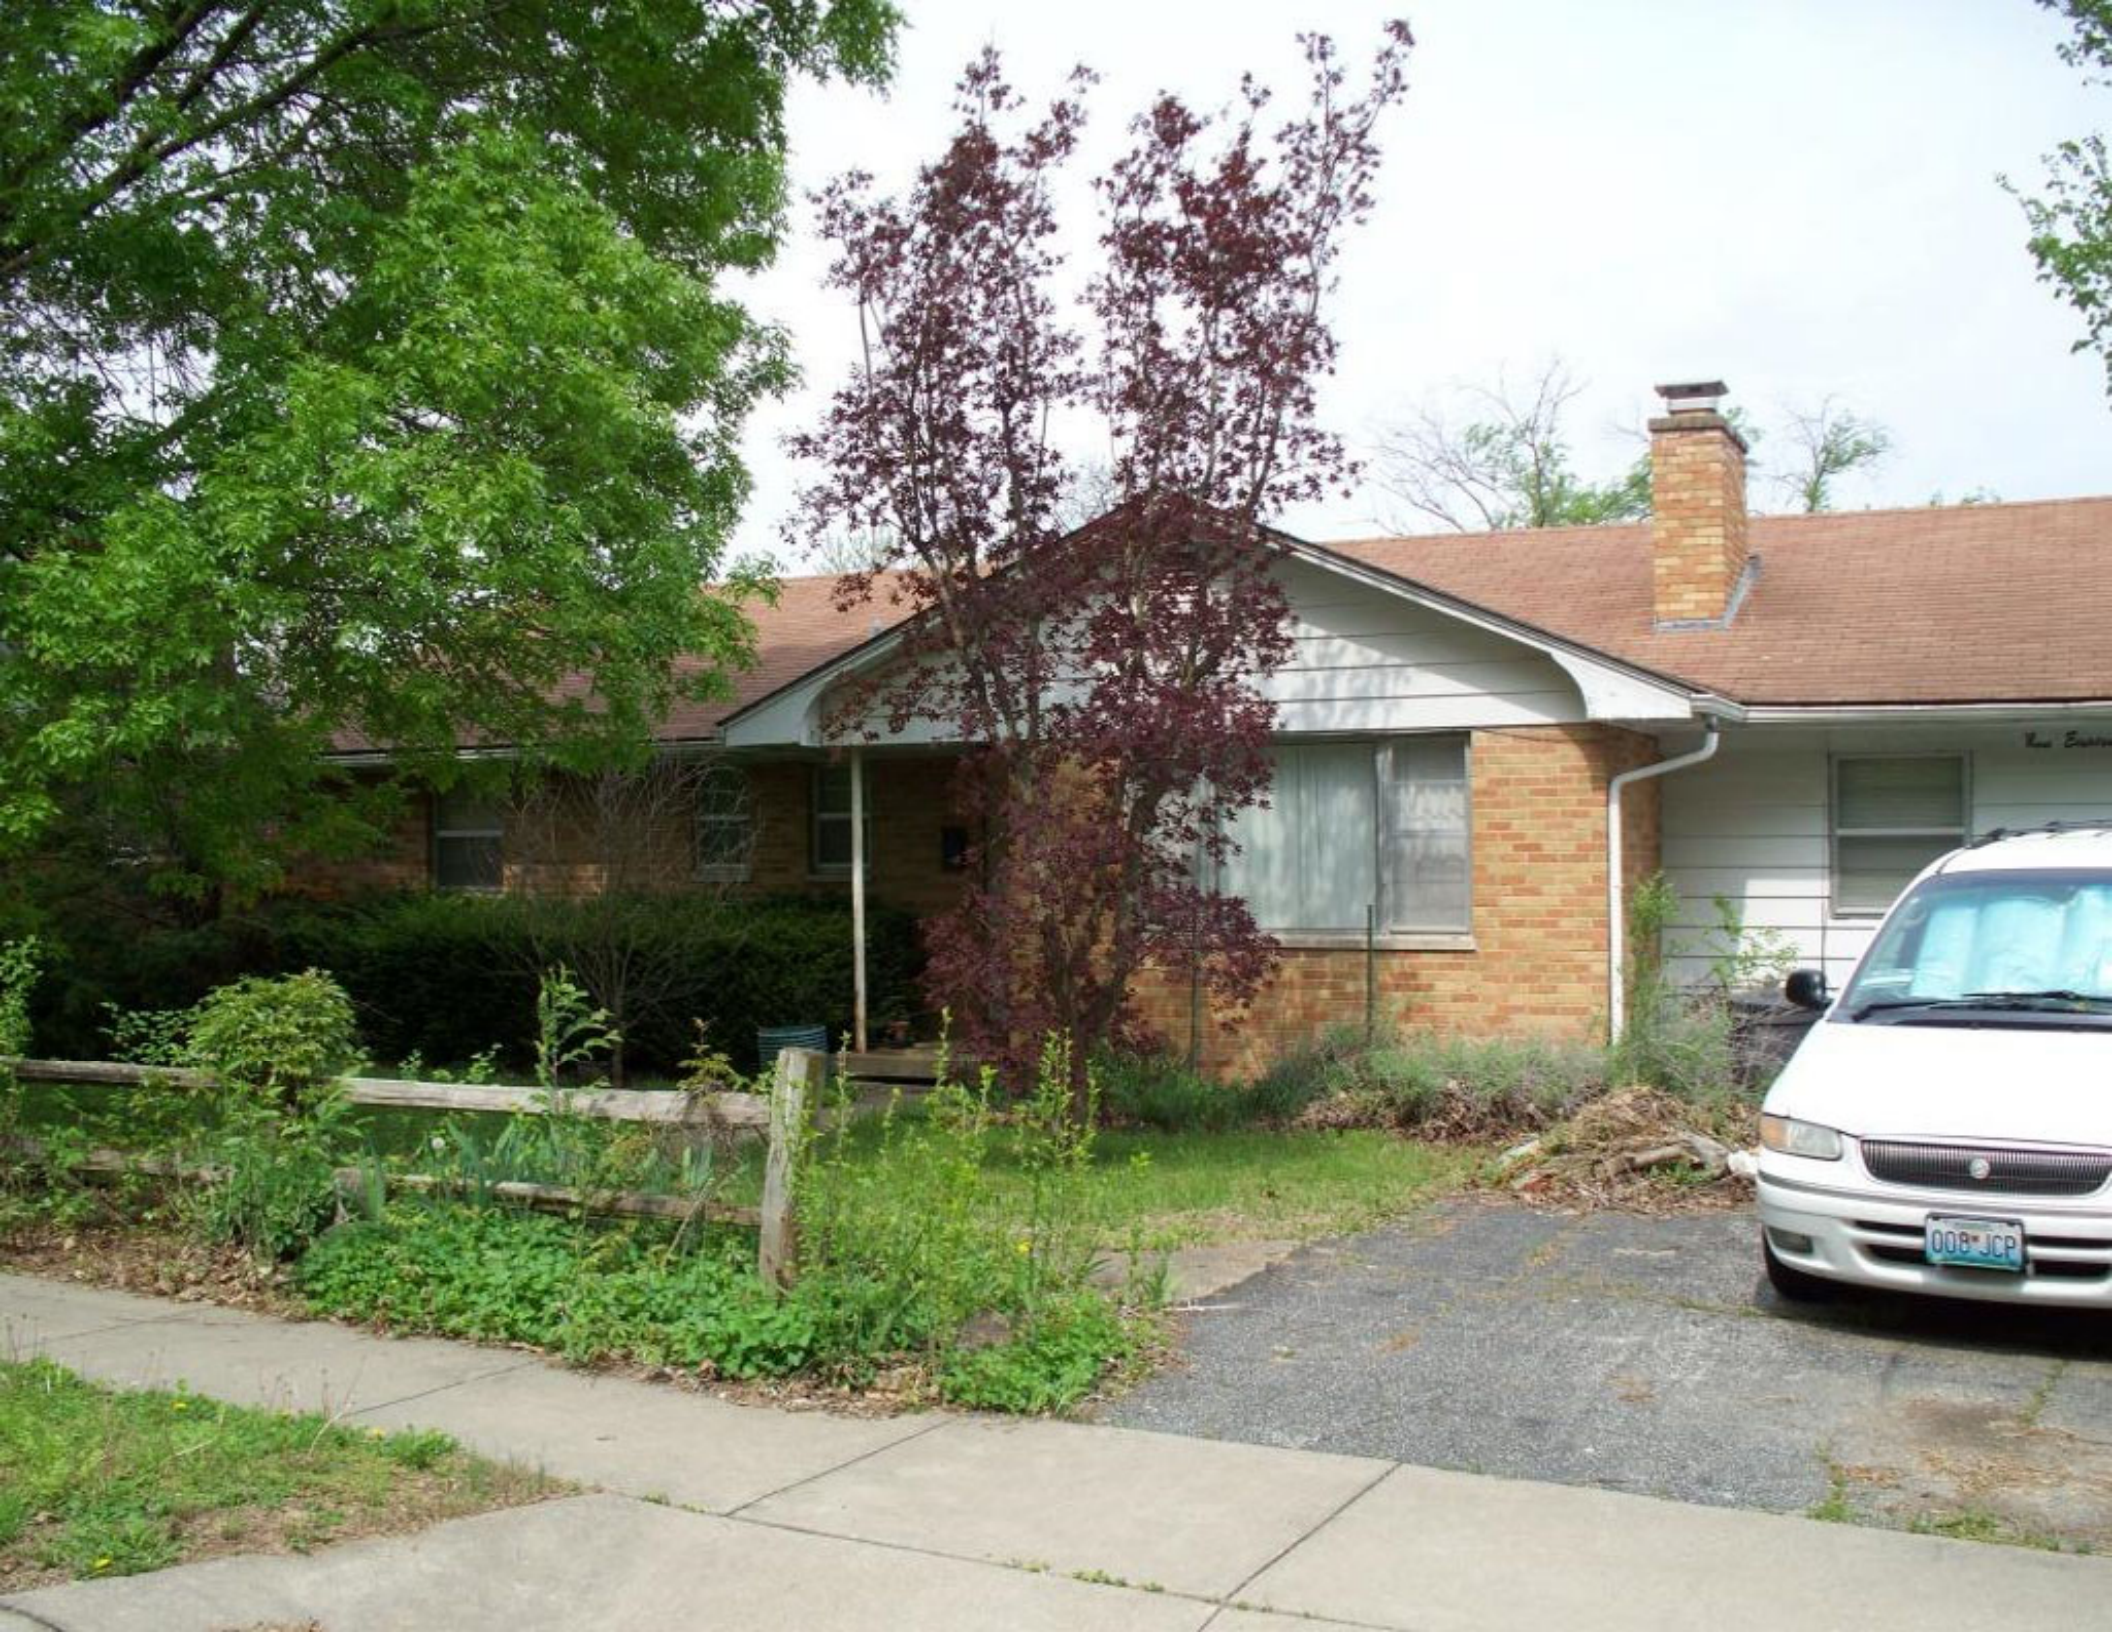
41. (cont.)
One story brick ranch house with furthestmost right bay clad in vinyl with a 1/1 window. The next bay (to the left) projects from the rest of the façade and contains a picture window with sidelights. A front gable is over this portion and extends over the recessed door which is flush with the rest of the property. There are two smaller 1/1 windows and the final left bay has an additional 1/1. Due to its construction date it is considered non-contributing to a potential district.
