ARCHITECTURAL/HISTORIC INVENTORY FORM

1. Survey No. CO-AS-005-001		2. Survey name: Moreau Drive Neighborhood Survey	
3. County: Cole		4. Address: 1202 Elmerine Ave.	
5. City: Jefferson City	Vicinity: <input type="checkbox"/>	6. UTM: / /	7. Township/Range/Section: T: R: S:
8. Historic name (if known):		9. Present/other name (if known):	
10. Ownership: <input checked="" type="checkbox"/> Private <input type="checkbox"/> Public		11. Historic use (if known): Residential	11. Current use: Residential

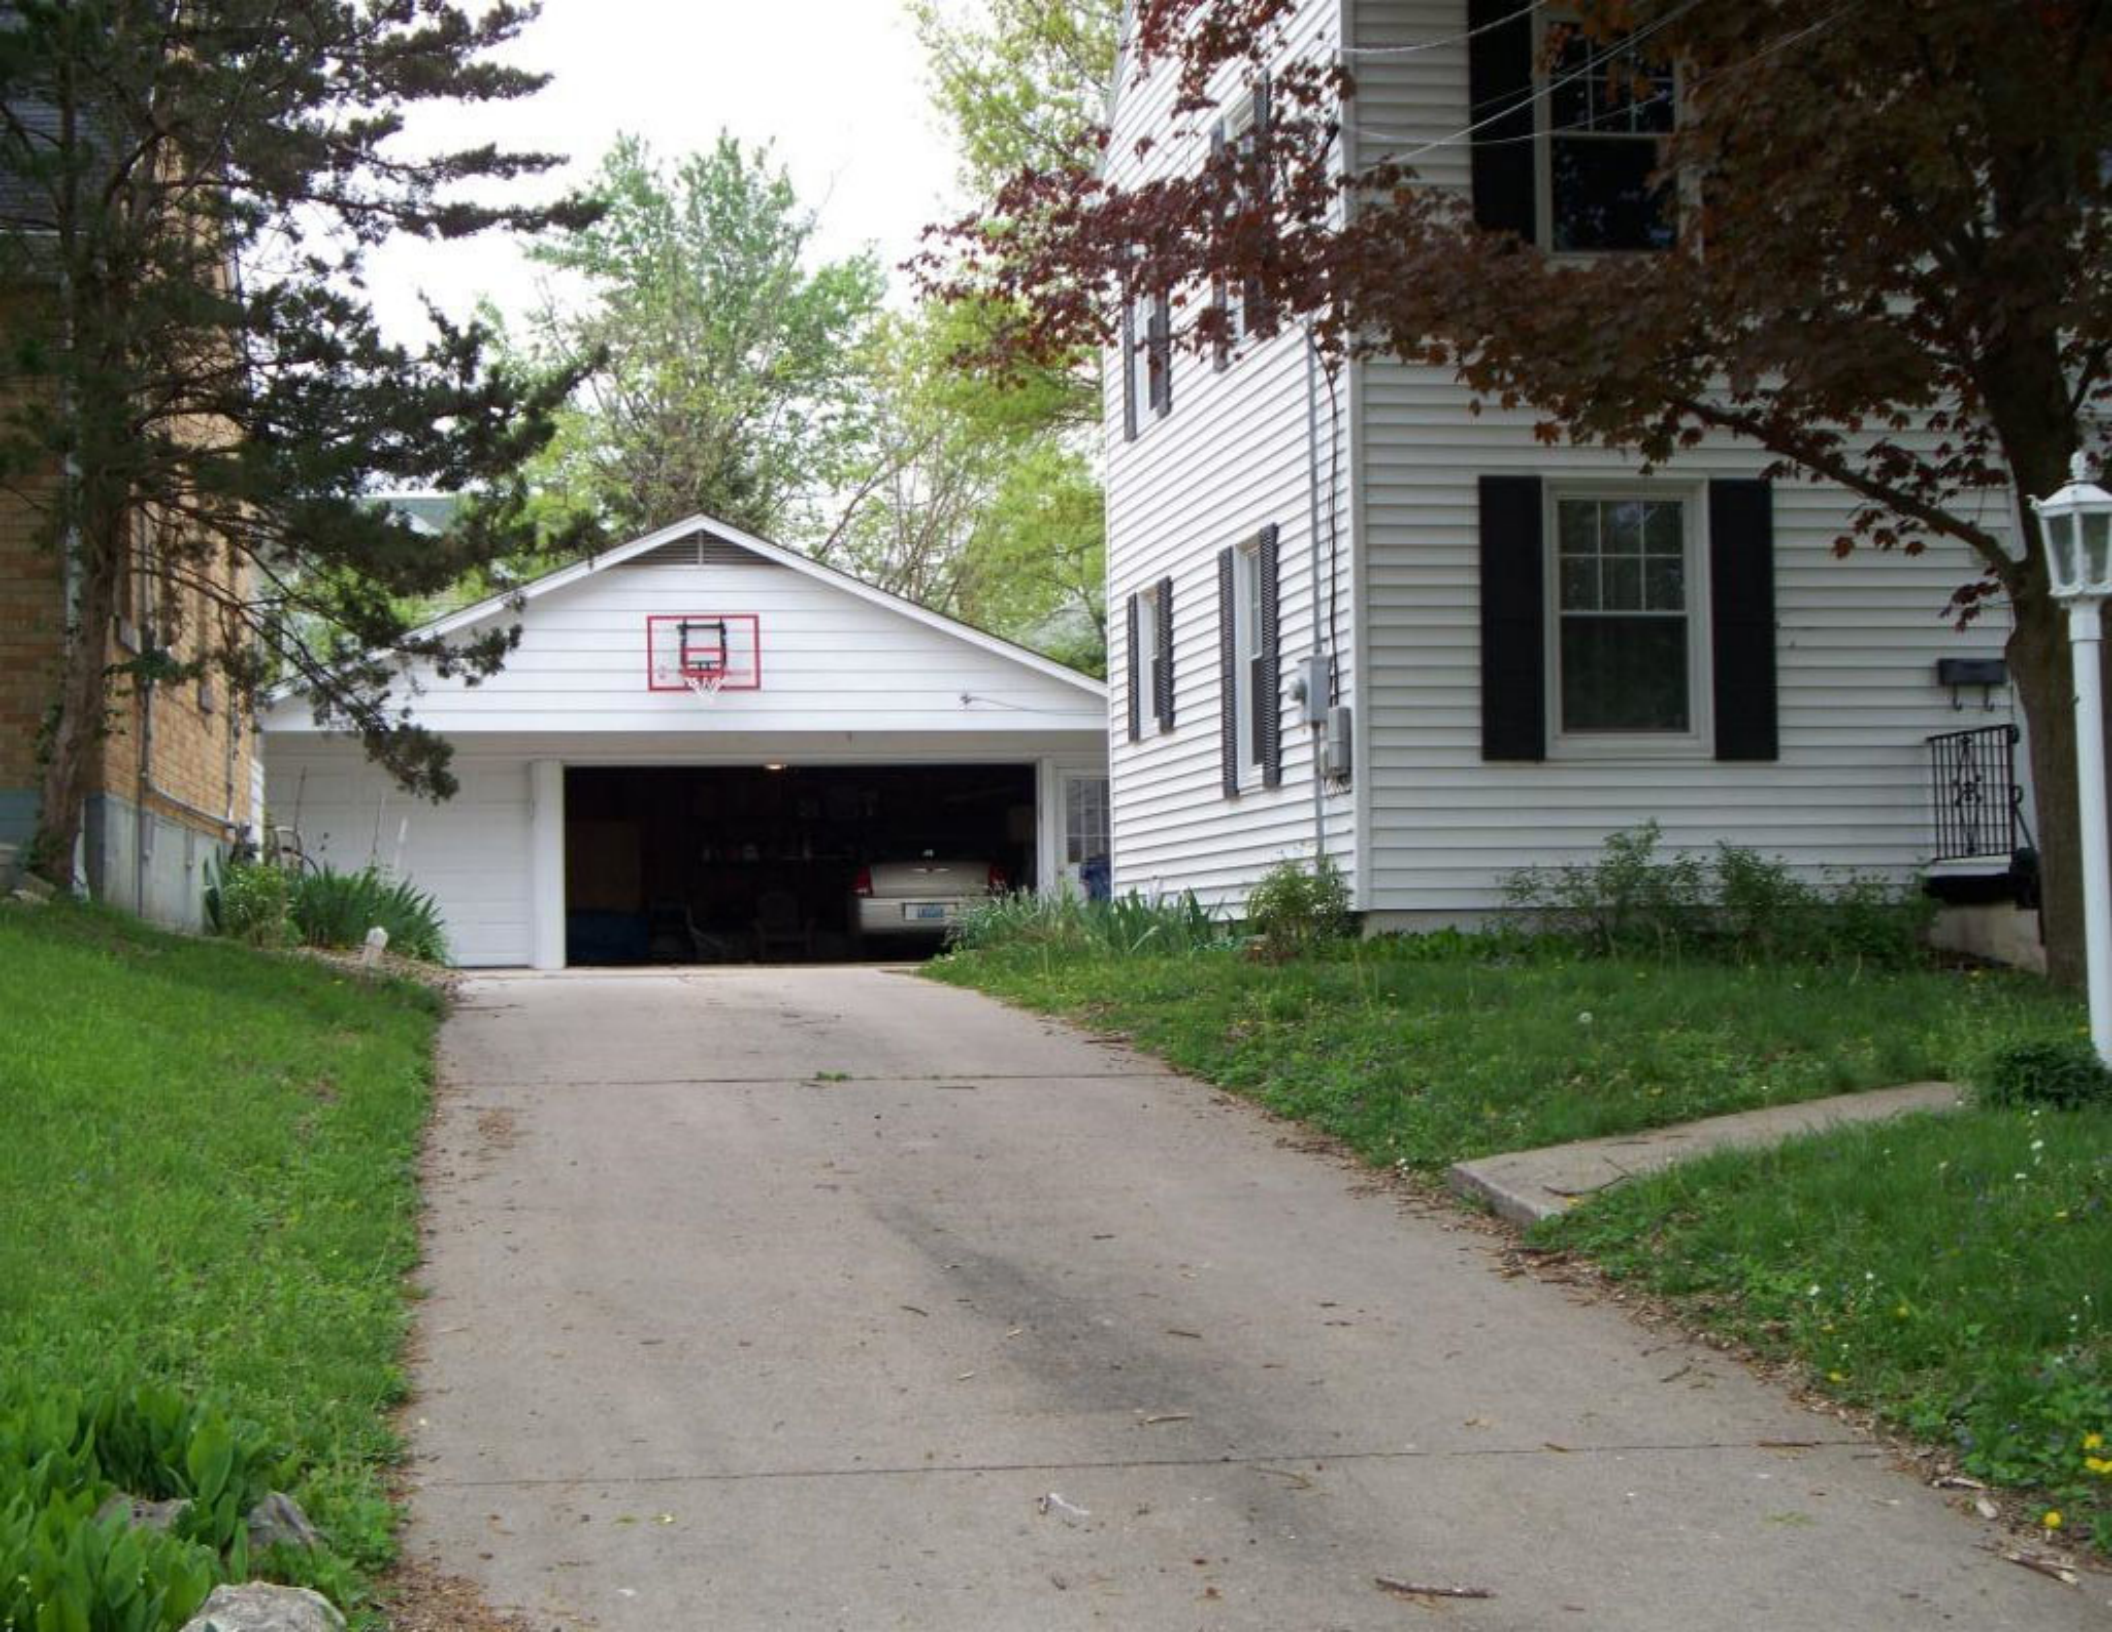
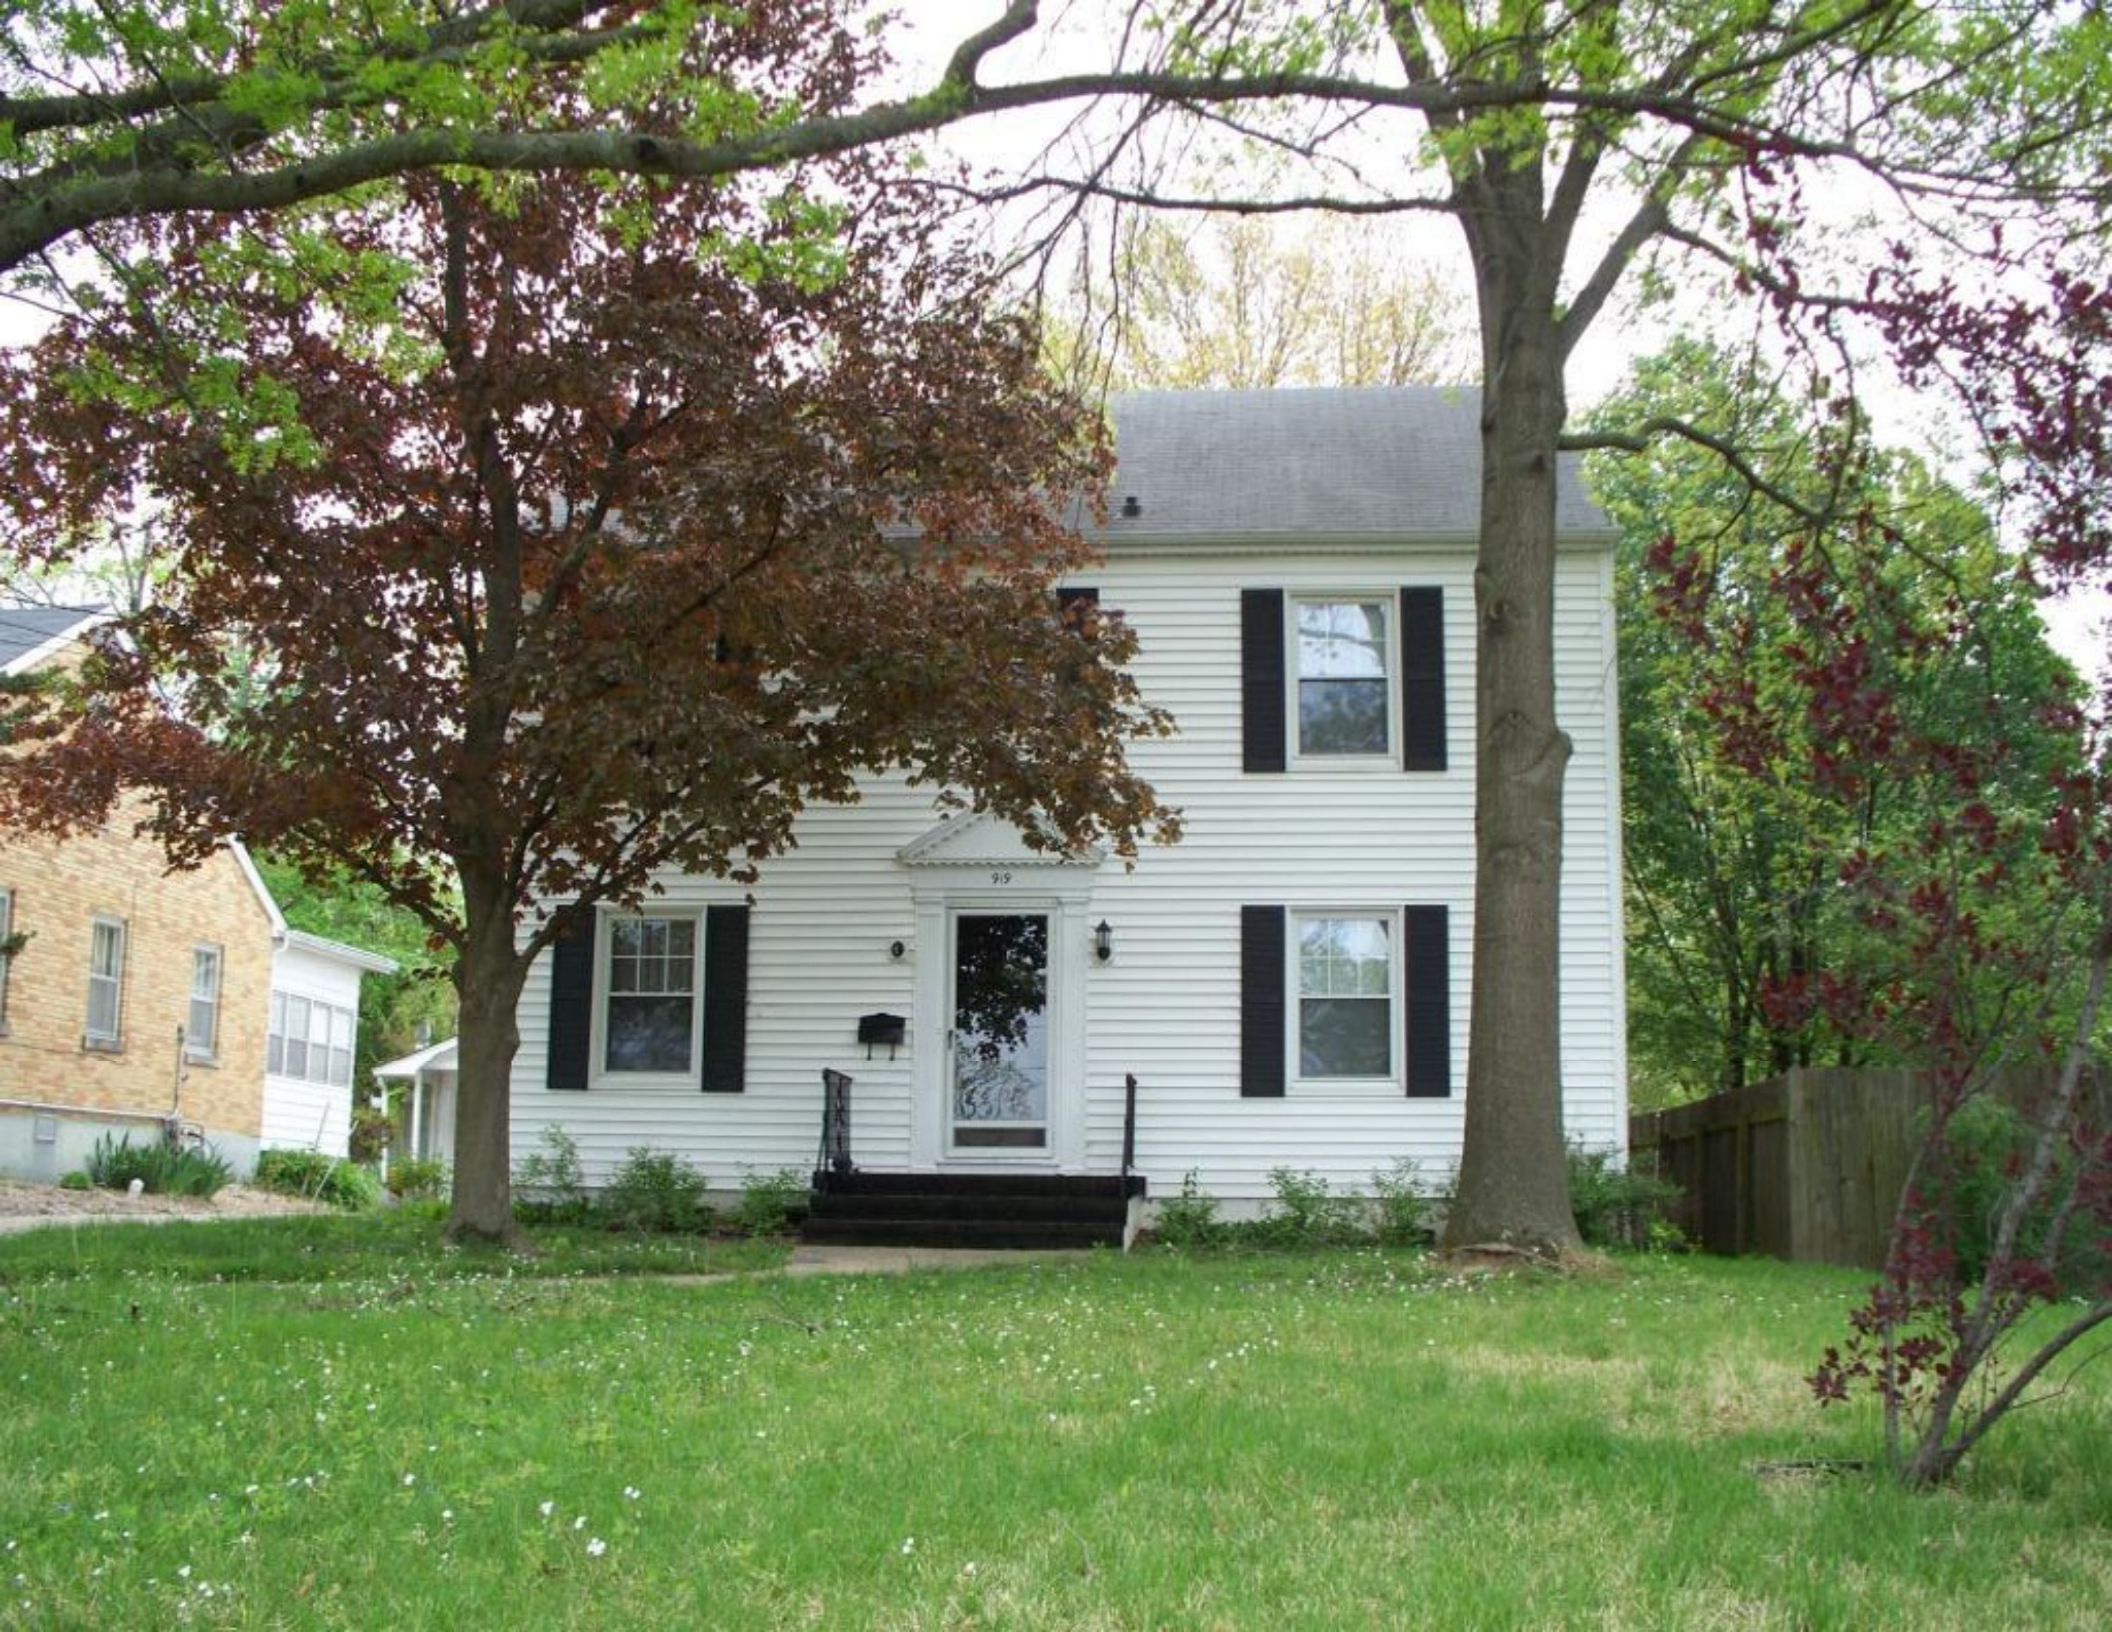
40. (cont.) Description of environment and outbuildings. Expand box as necessary, or add continuation pages.
There is a large three car garage at the back of the building that may be shared with 917 Fairmount. It is considered modern and non-contributing to the district.

41. (cont.)
This two-story side gabled Colonial Revival house has vinyl siding but retains its historic 6/1 windows. They are symmetrically placed, two on each floor with an additional smaller window in-between on the second story. All of them have shutters. The entrance has a classical pediment surround that may or may not be historic. A set of wide concrete stairs and metal railing serves as a stoop. A brick chimney extends from the right side of the property. This house may or may not contribute to a potential historic district. If the house siding was originally brick then the vinyl siding would likely need to be removed for it to contribute, otherwise it's probably minimally contributing.

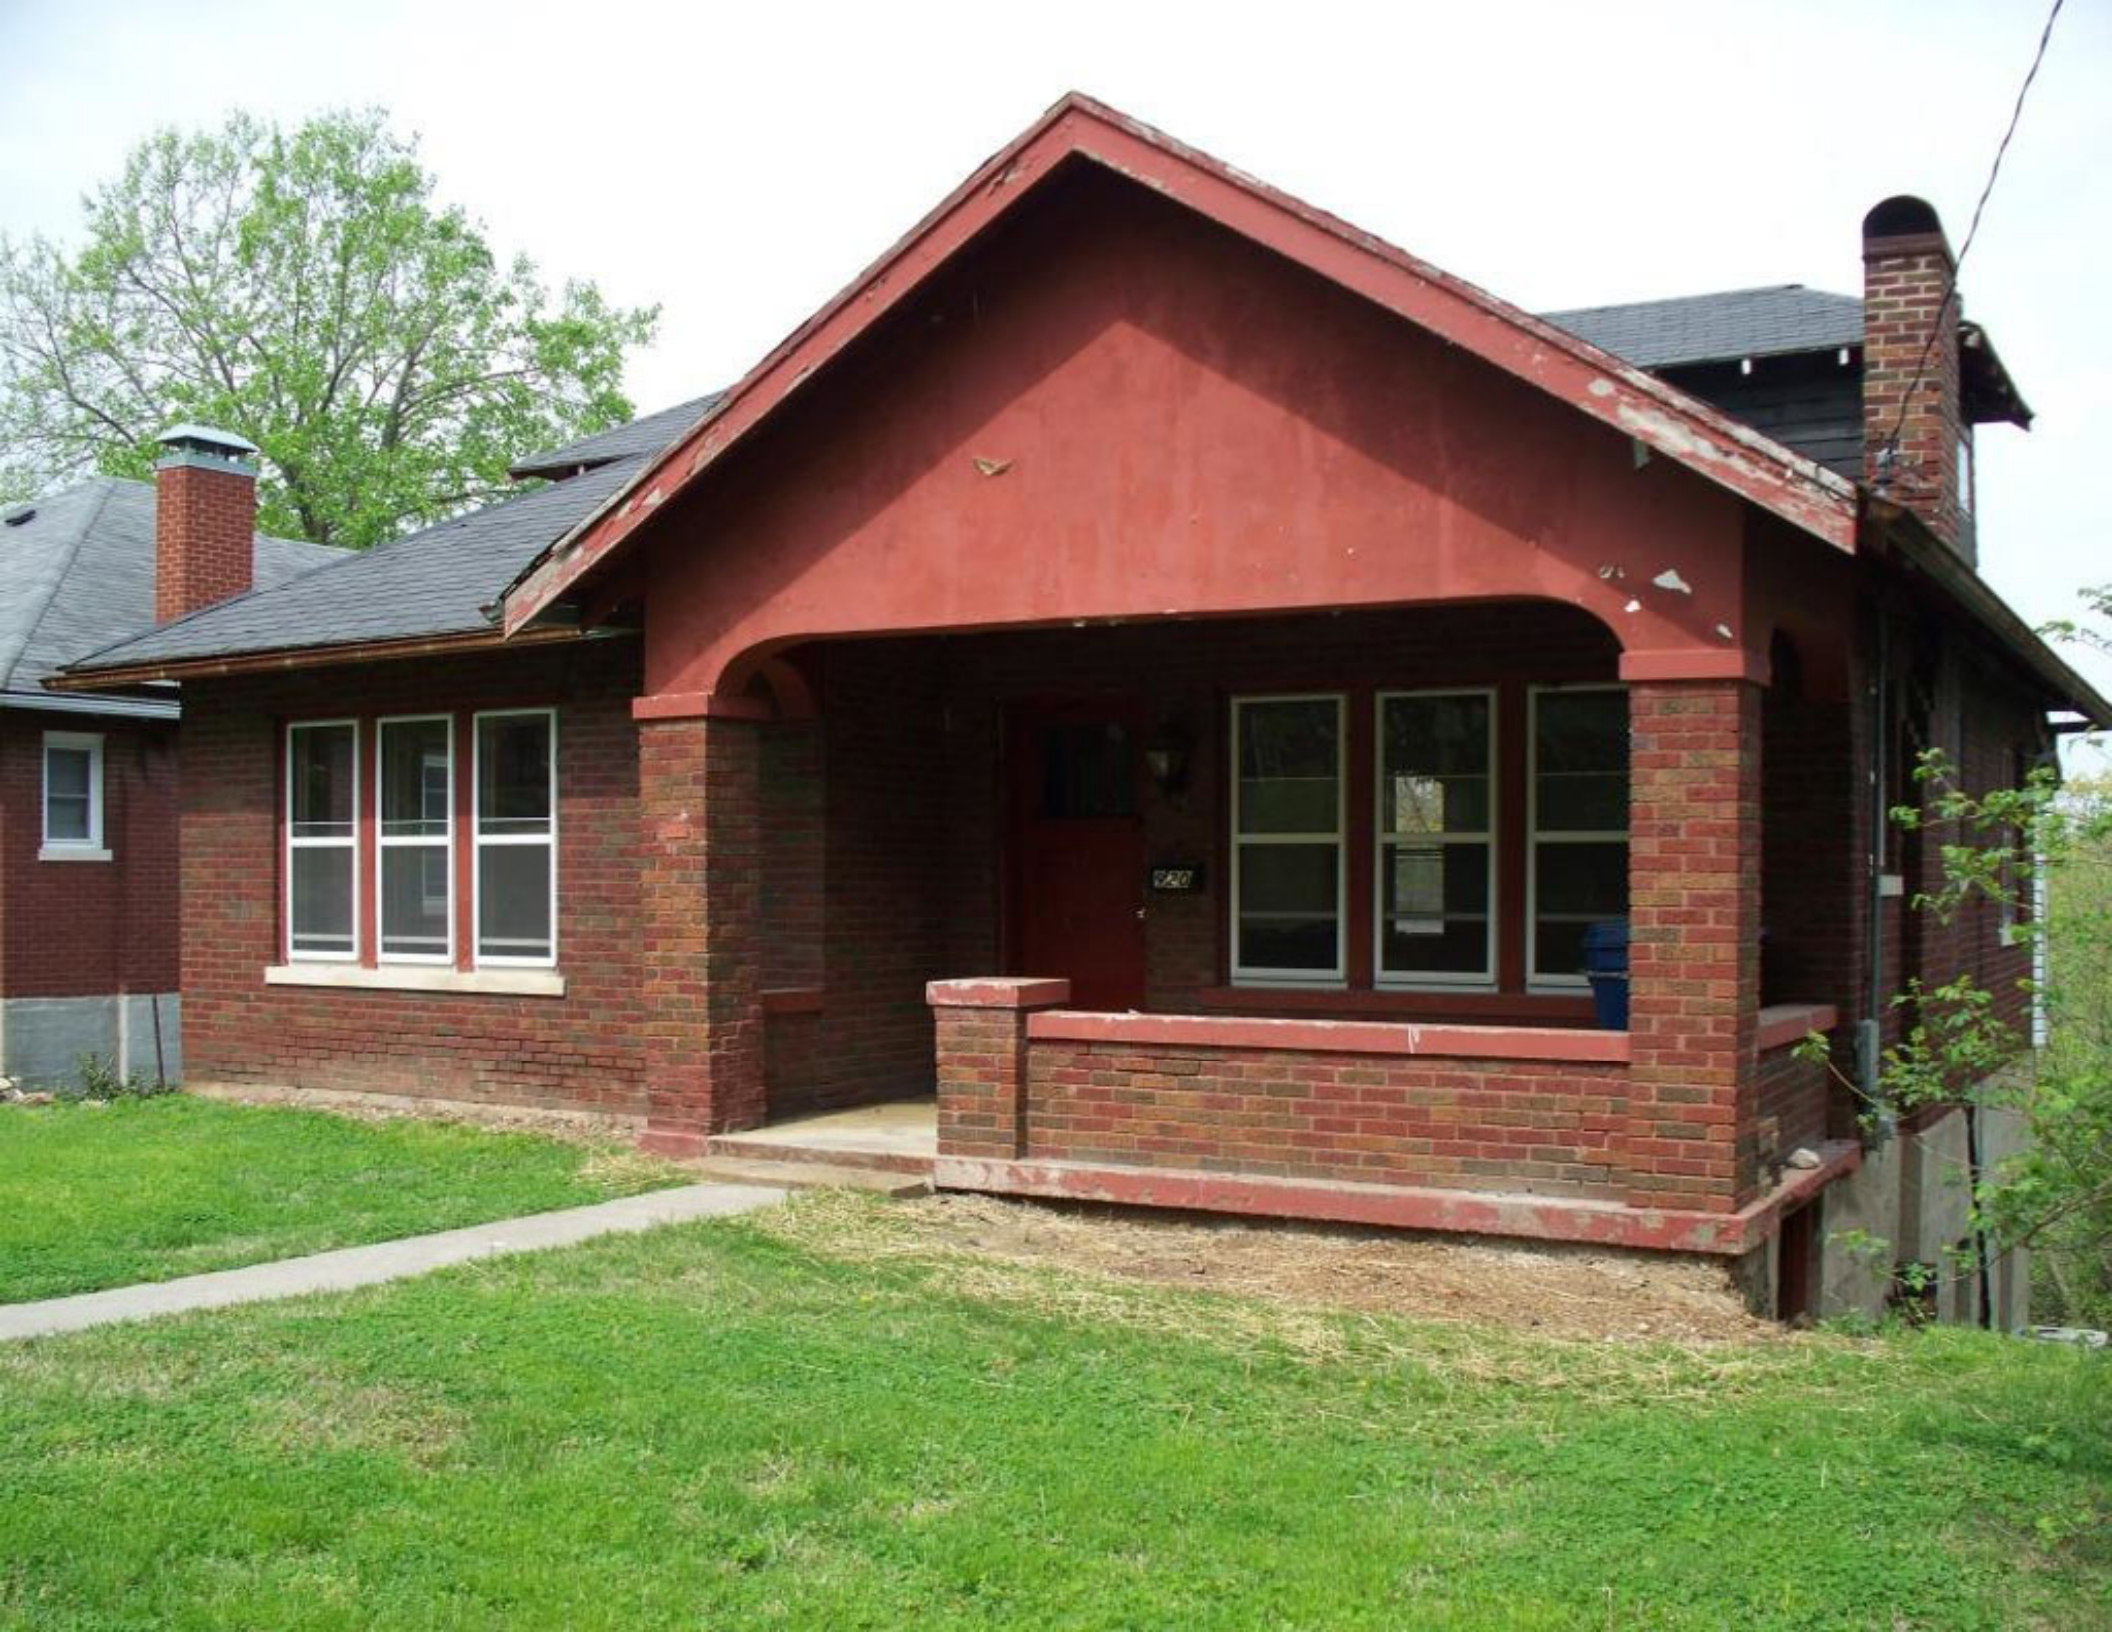
This one and a half story bungalow has a deep hipped roof with a hipped dormer coming off the left and right sides of the building. The left bay on façade of the home has a row of three replacement 1/1 windows with a concrete sill. The next bay features a front gable porch that extends slightly from the rest of the building and acts as the porch roof of the entrance, which is set back from the main façade. The porch features knee walls and pilasters capped in concrete. To the right of the entrance is an identical row of three 1/1 replacement windows with concrete sills. The deep overhang of the gable over the porch suggests there was once rafter tails present. The dormer off the left and right sides of the house have rafter tails, further supporting the idea this property had Craftsman details that have since been removed.

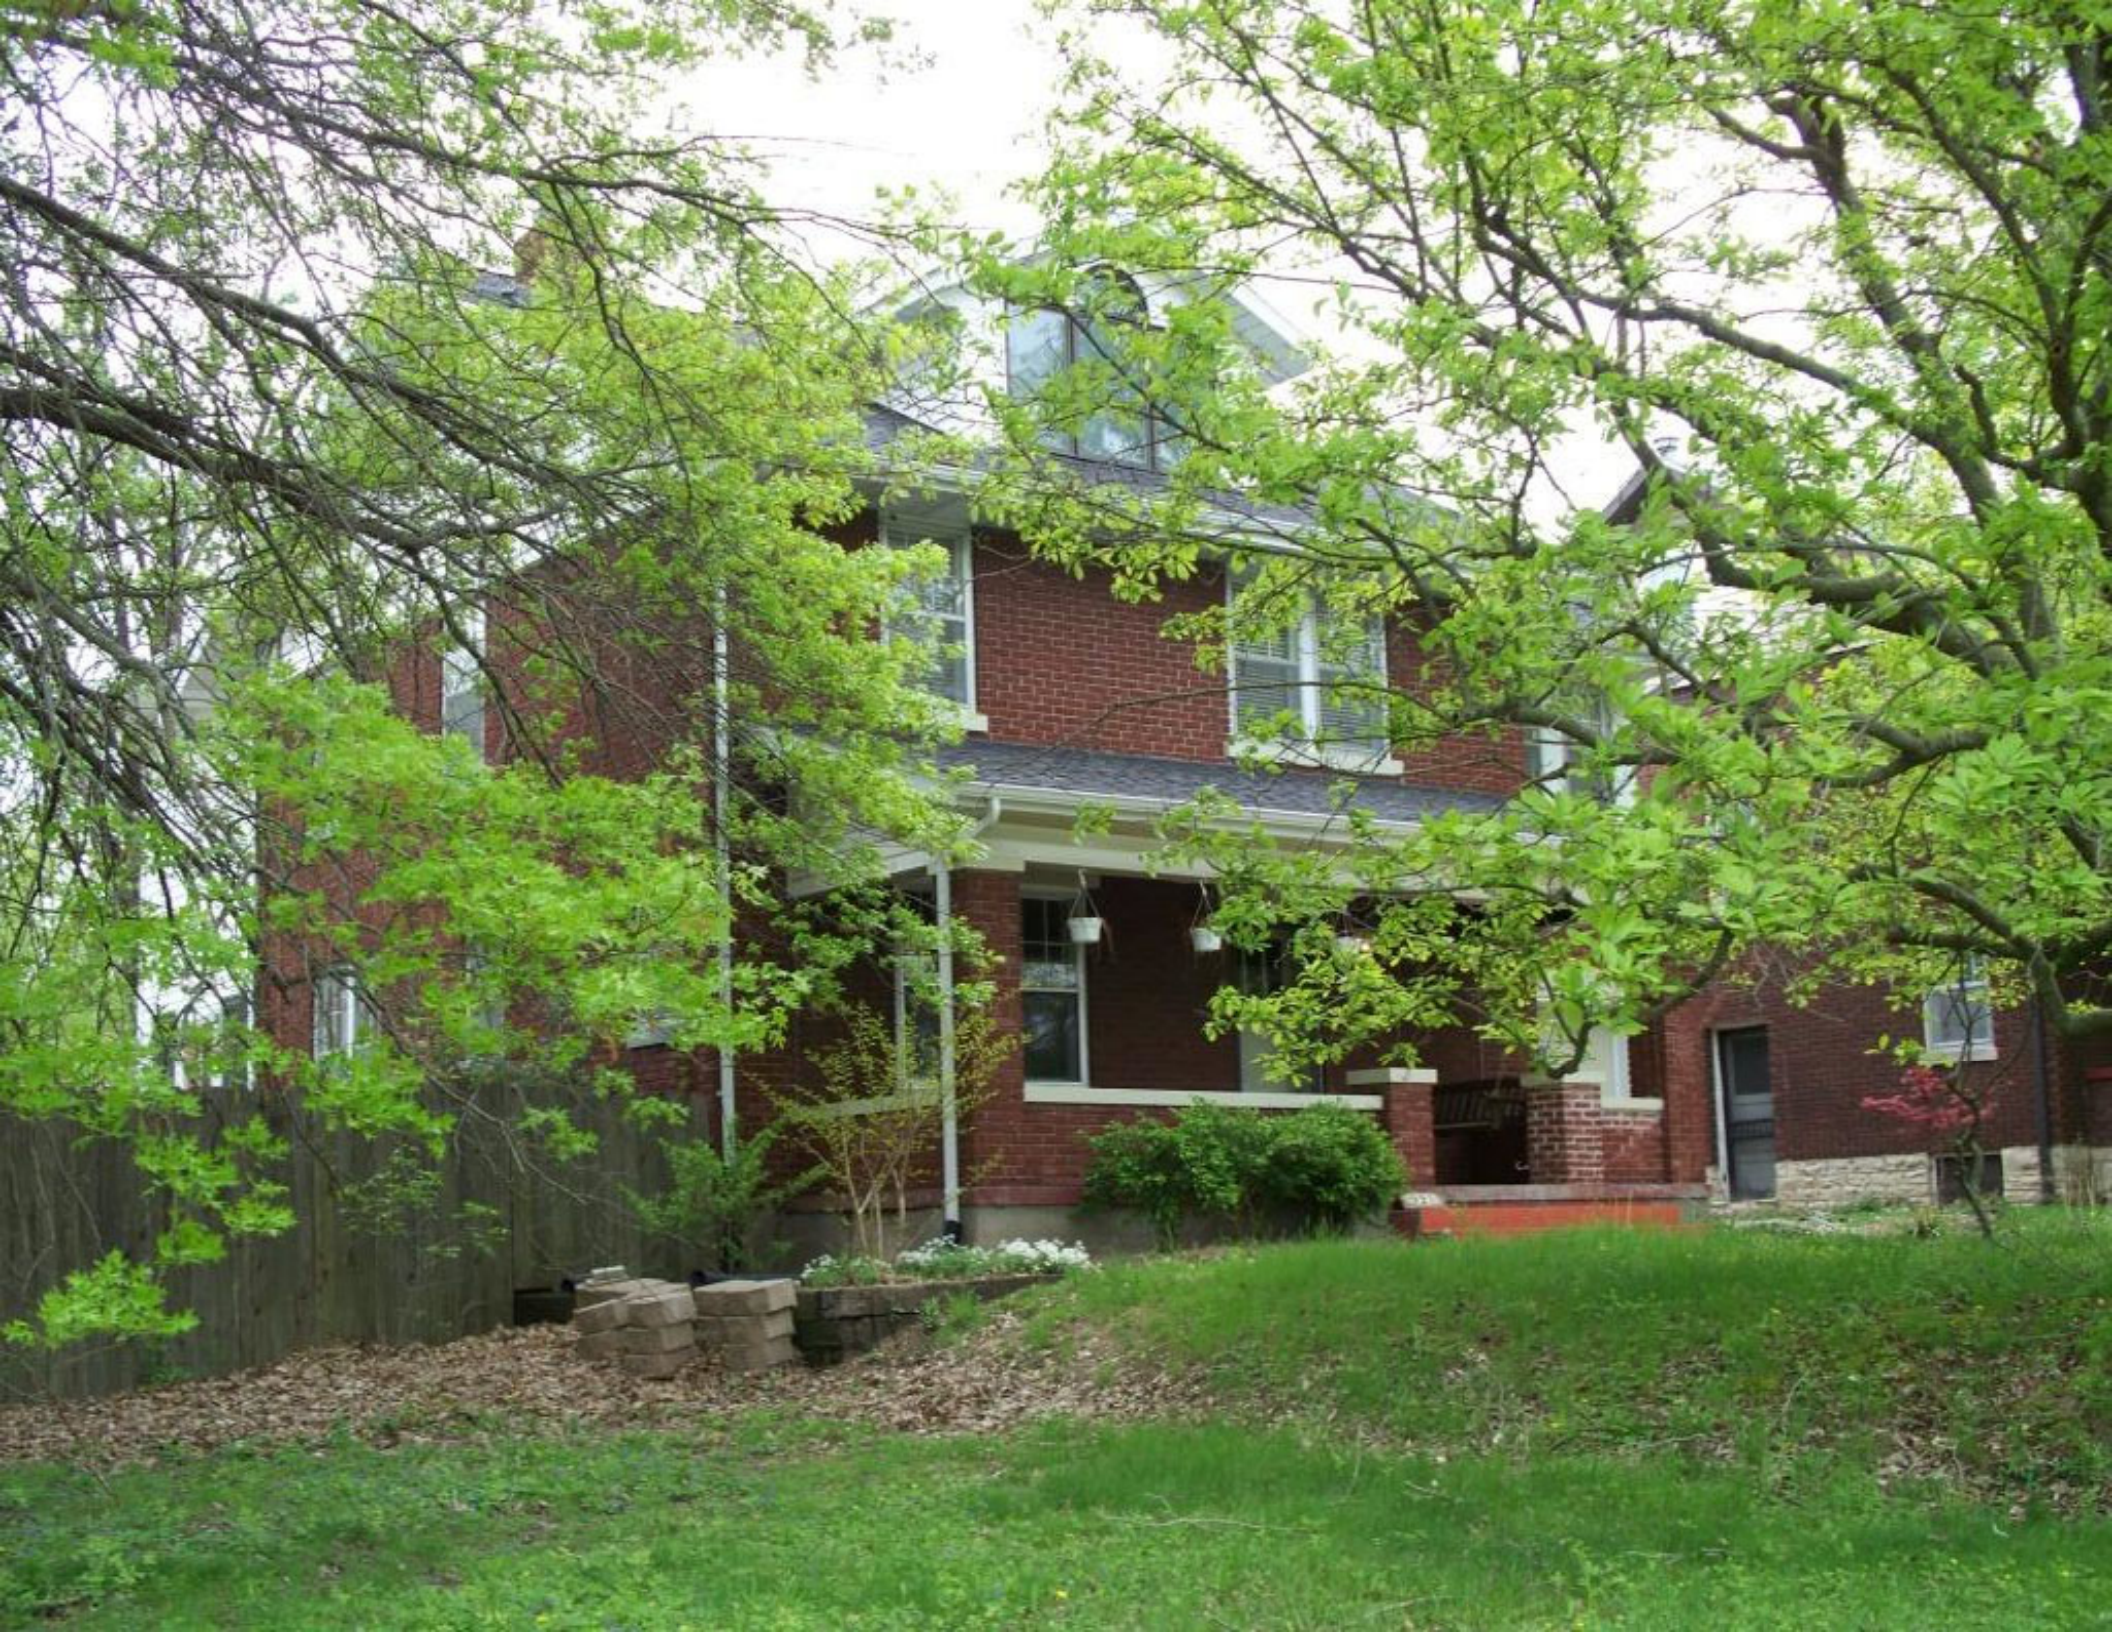
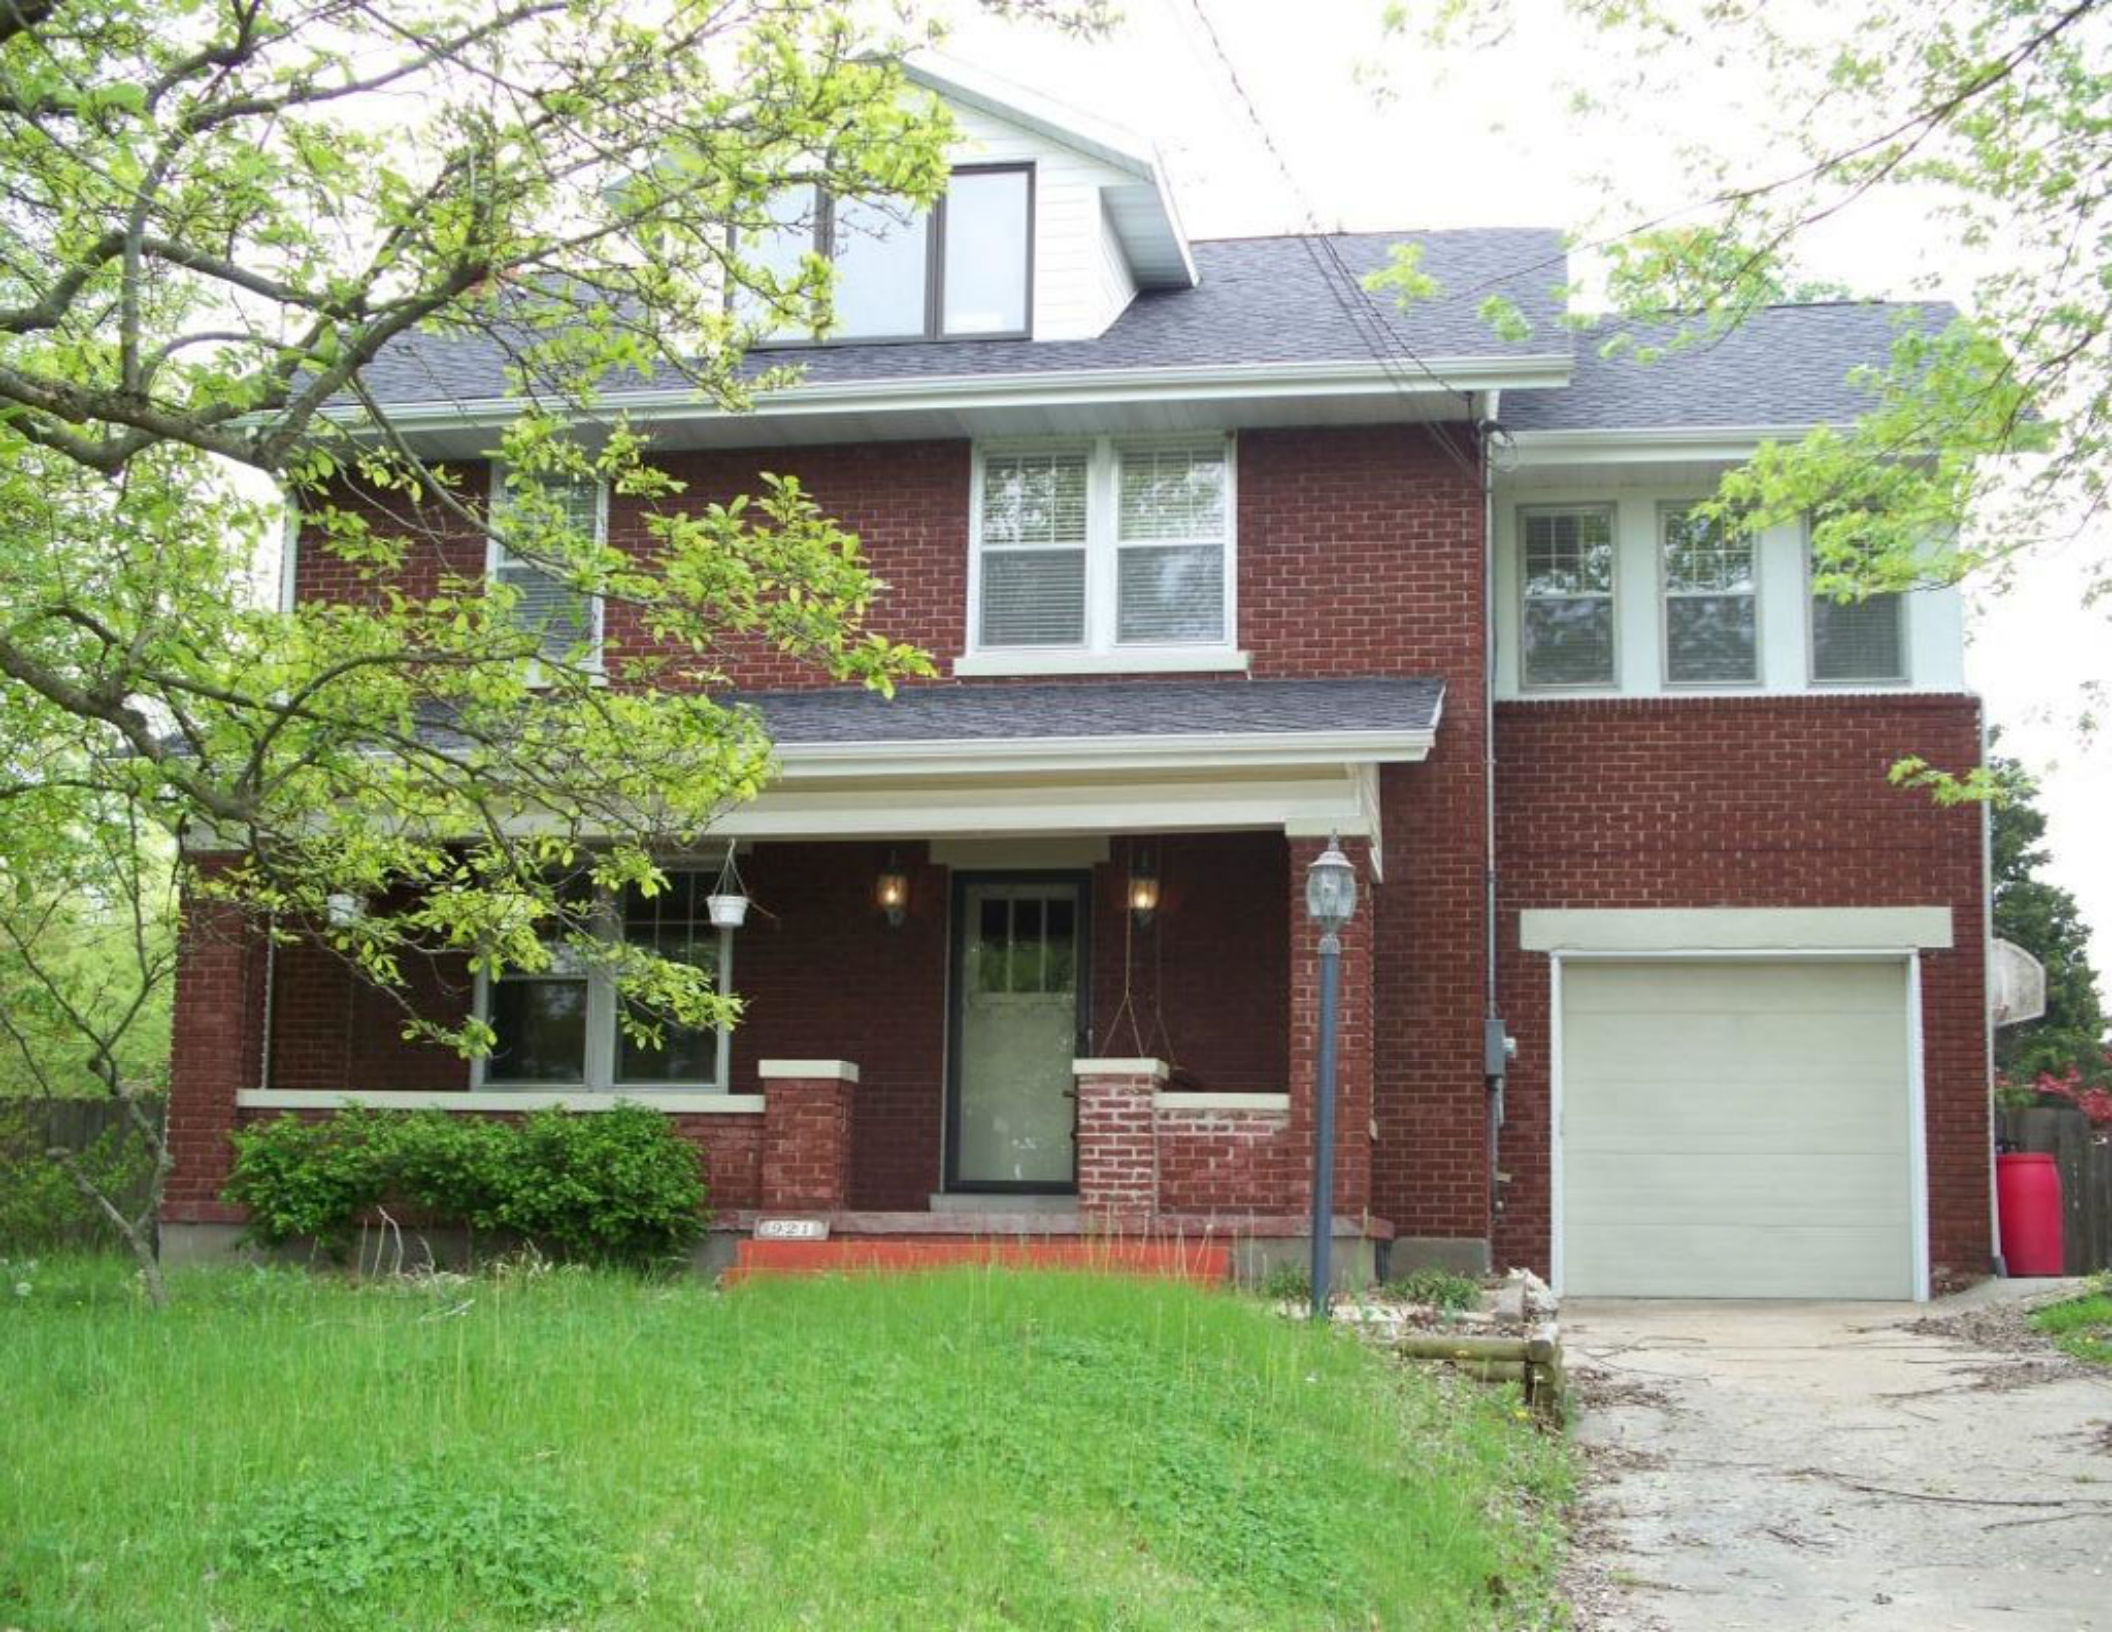
This two and a half story brick four square has a side-gabled roof with a large central gabled dormer that appears modern. The dormer is clad in vinyl and features three modern casement windows. The second floor has two paired 6/1 windows with limestone sills. The first floor has paired 6/1 windows in the left bay and the entrance retains the original three-light door in the right bay. The porch has a full width with a shed roof and features brick piers and knee walls capped in concrete or limestone. Slightly setback on the right side is a two story section that contains a one-car garage with a large limestone lintel. The first story of this section is clad in brick and the upper in stucco, which features three 6/1 windows and is covered by a side-gabled roof, slightly stepped back and lower from the main roof.
