ARCHITECTURAL/HISTORIC INVENTORY FORM

1. Survey No. CO-AS-005-001		2. Survey name: Moreau Drive Neighborhood Survey	
3. County: Cole		4. Address: 1202 Elmerine Ave.	
5. City: Jefferson City	Vicinity: <input type="checkbox"/>	6. UTM: / /	7. Township/Range/Section: T: R: S:
8. Historic name (if known):		9. Present/other name (if known):	
10. Ownership: <input checked="" type="checkbox"/> Private <input type="checkbox"/> Public		11. Historic use (if known): Residential	11. Current use: Residential

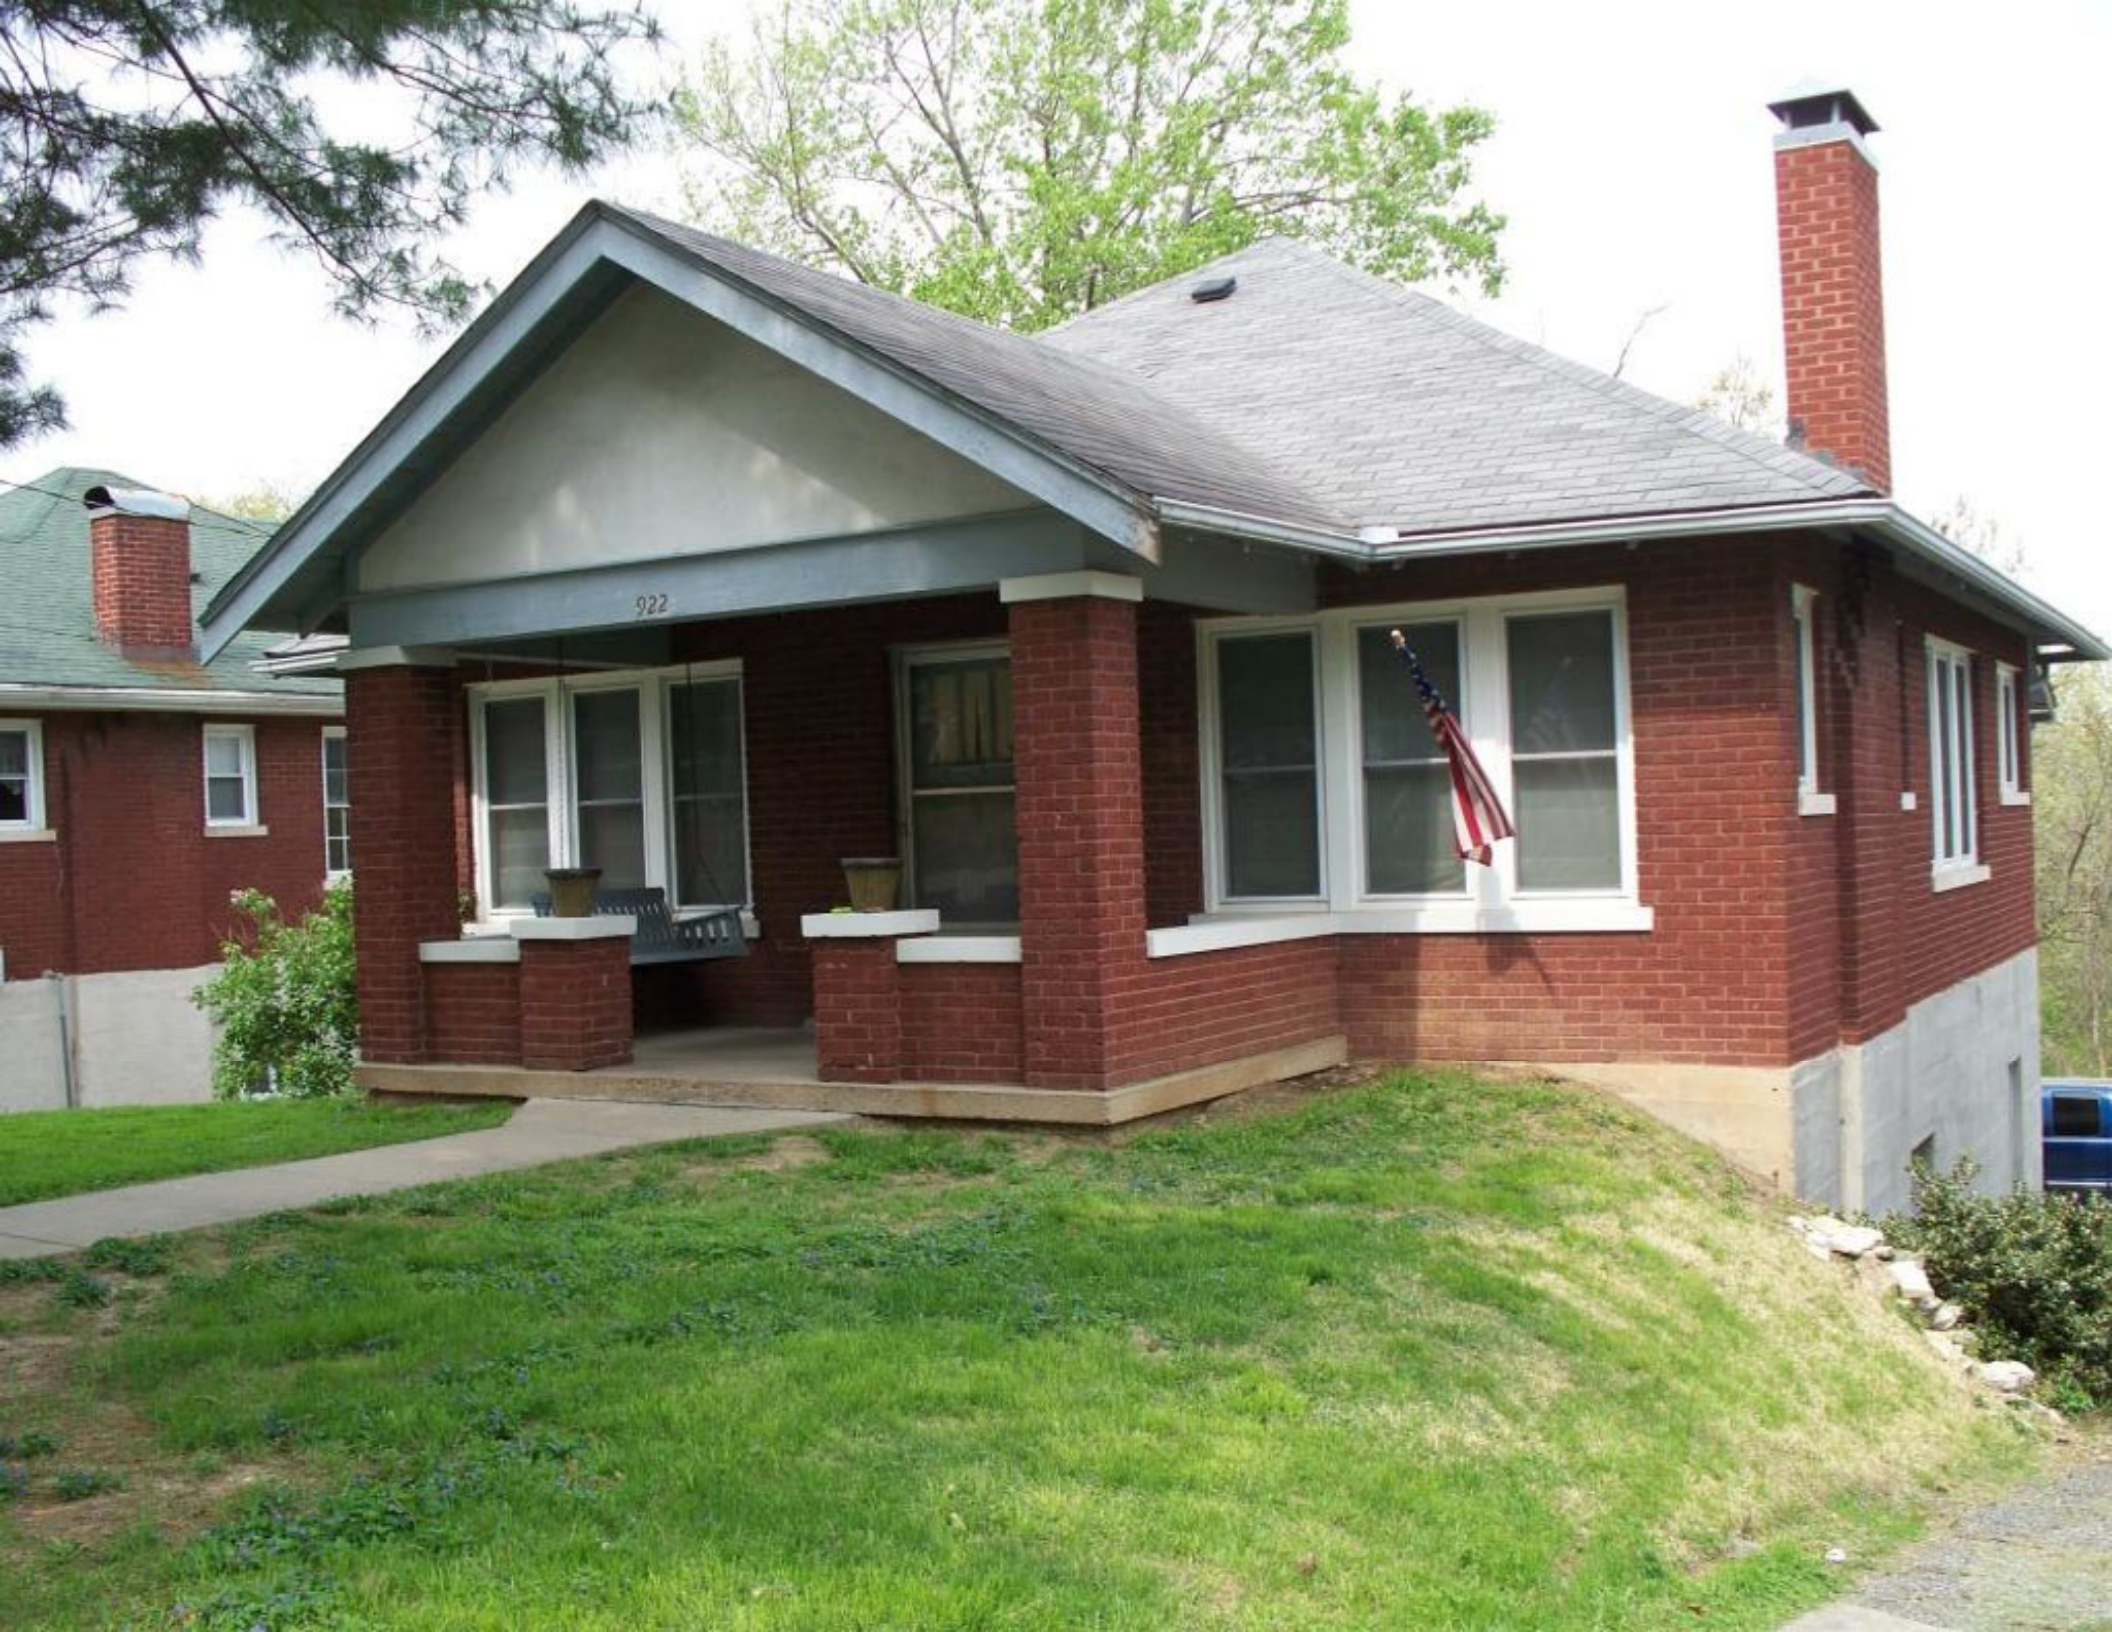
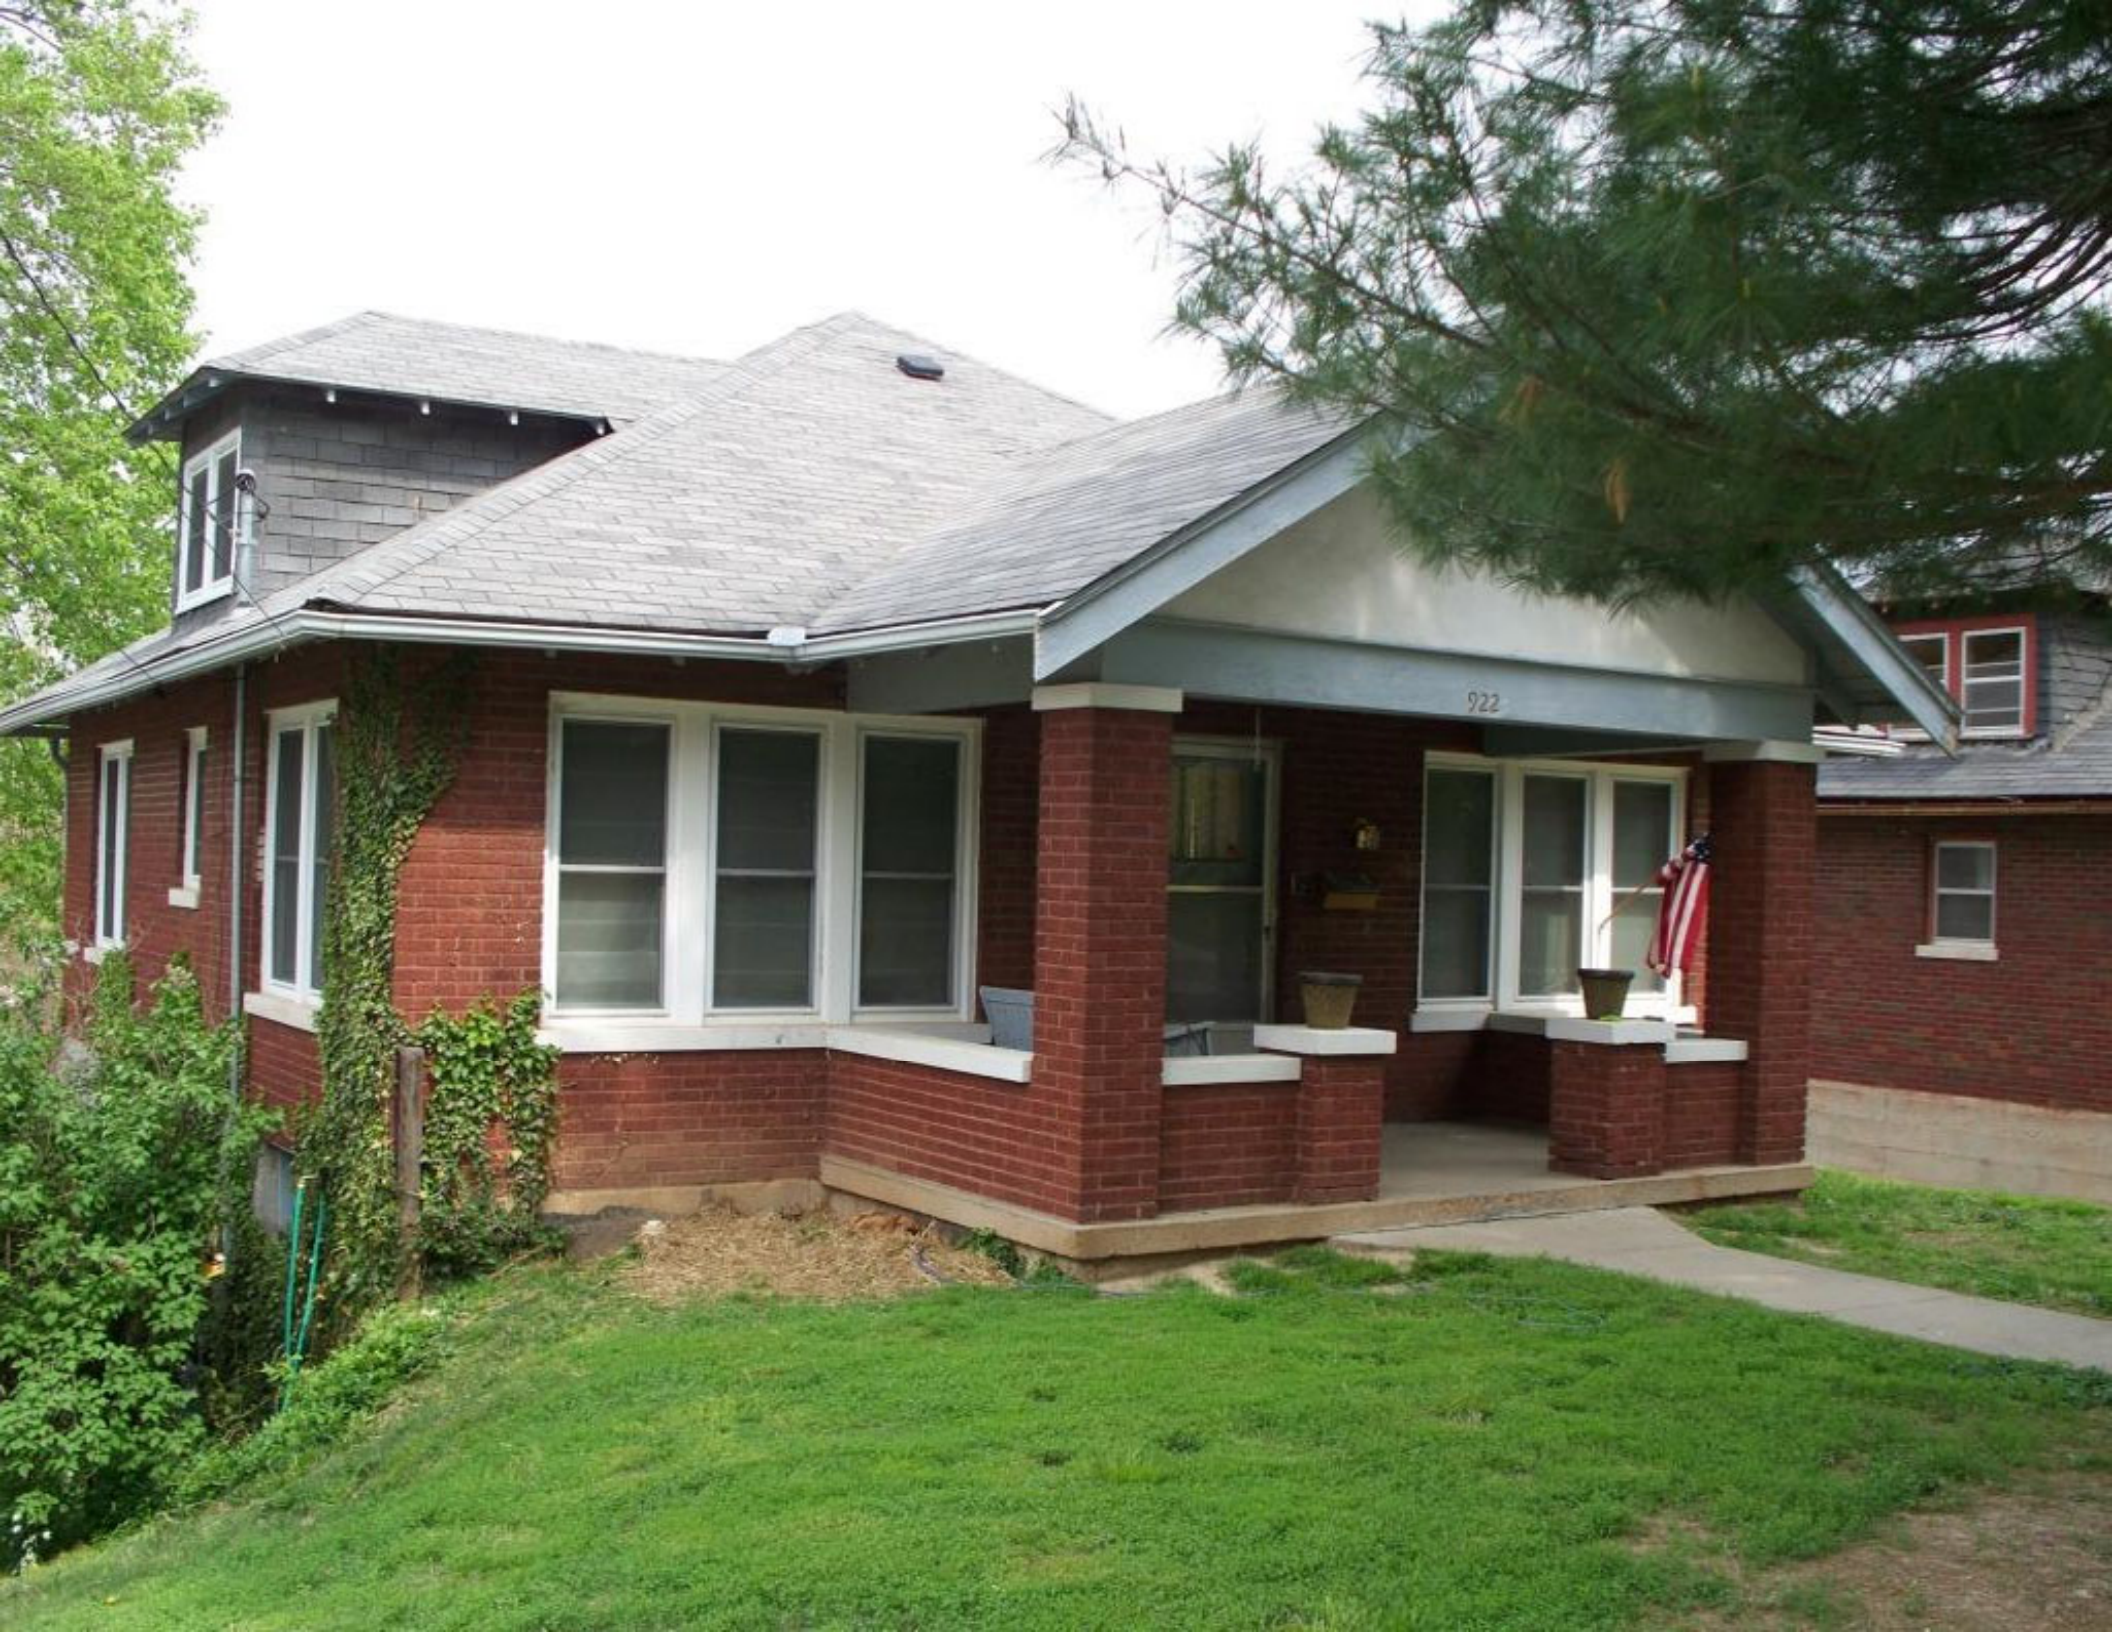
This one story brick pyramidal bungalow has a projecting gable central porch trimmed with wood and in-filled with stucco. The porch features half walls and brick pilasters capped in limestone. The property appears to retain its original door, which is flanked by a row of three replacement 1/1 windows with limestone sills on each side. Rafter tails are just visible under the sill of the roof.

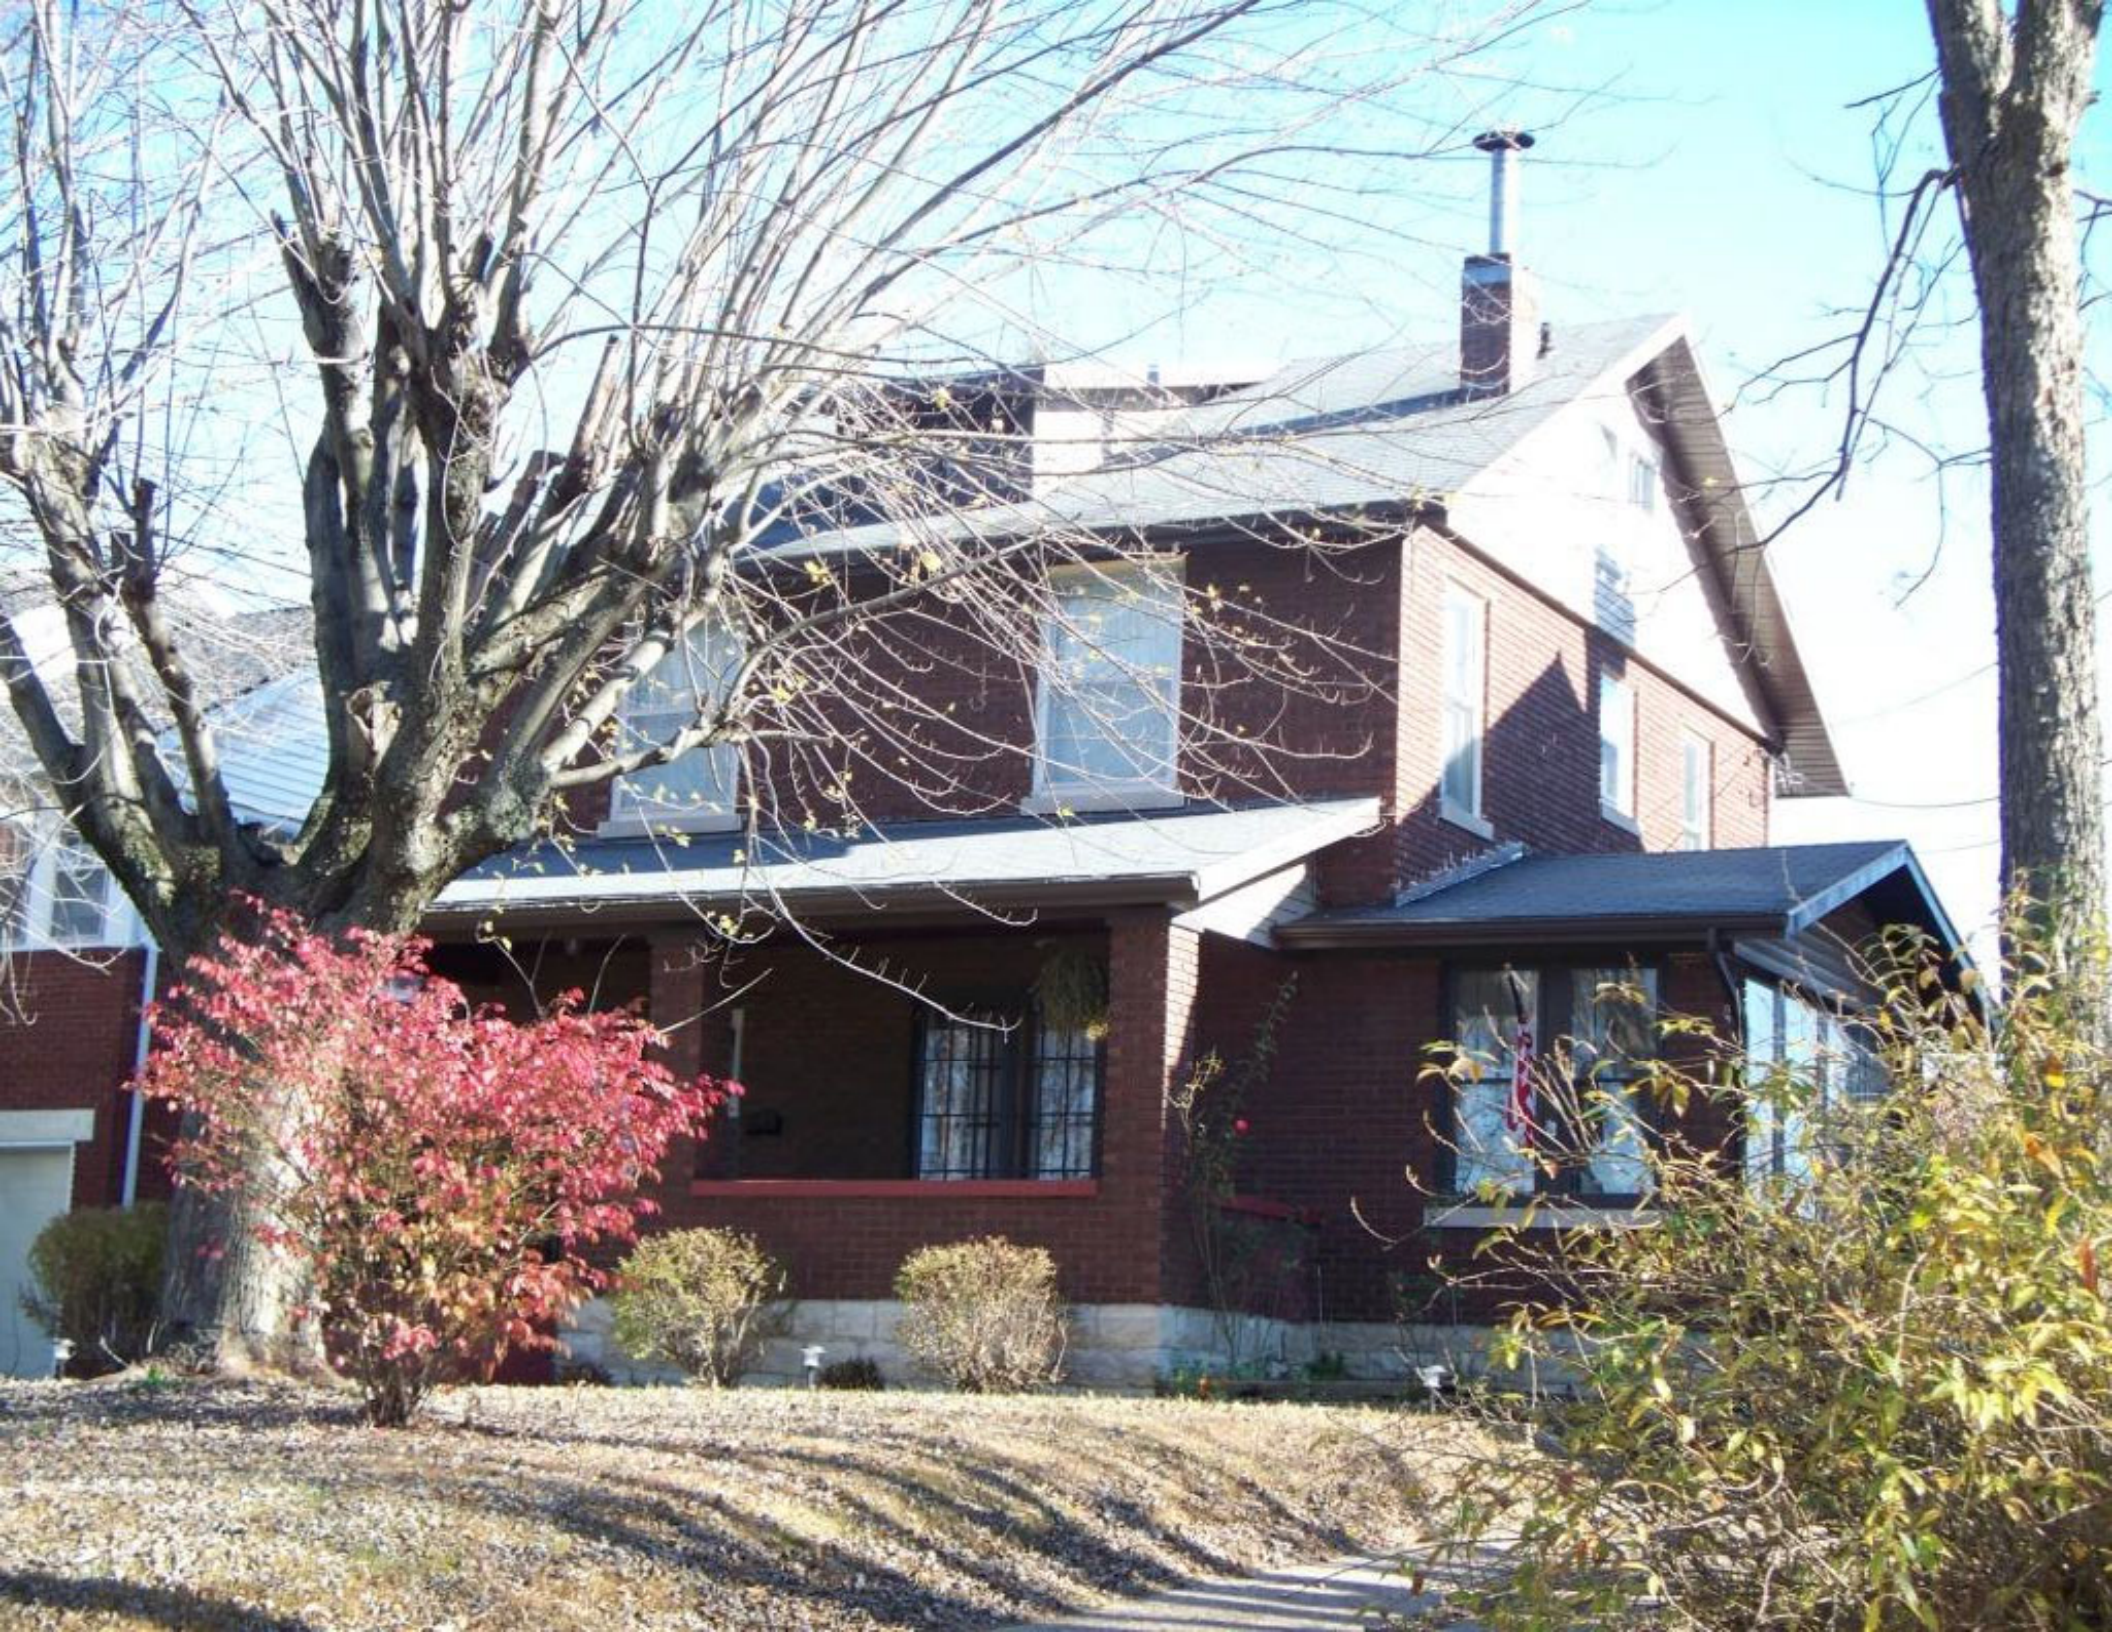
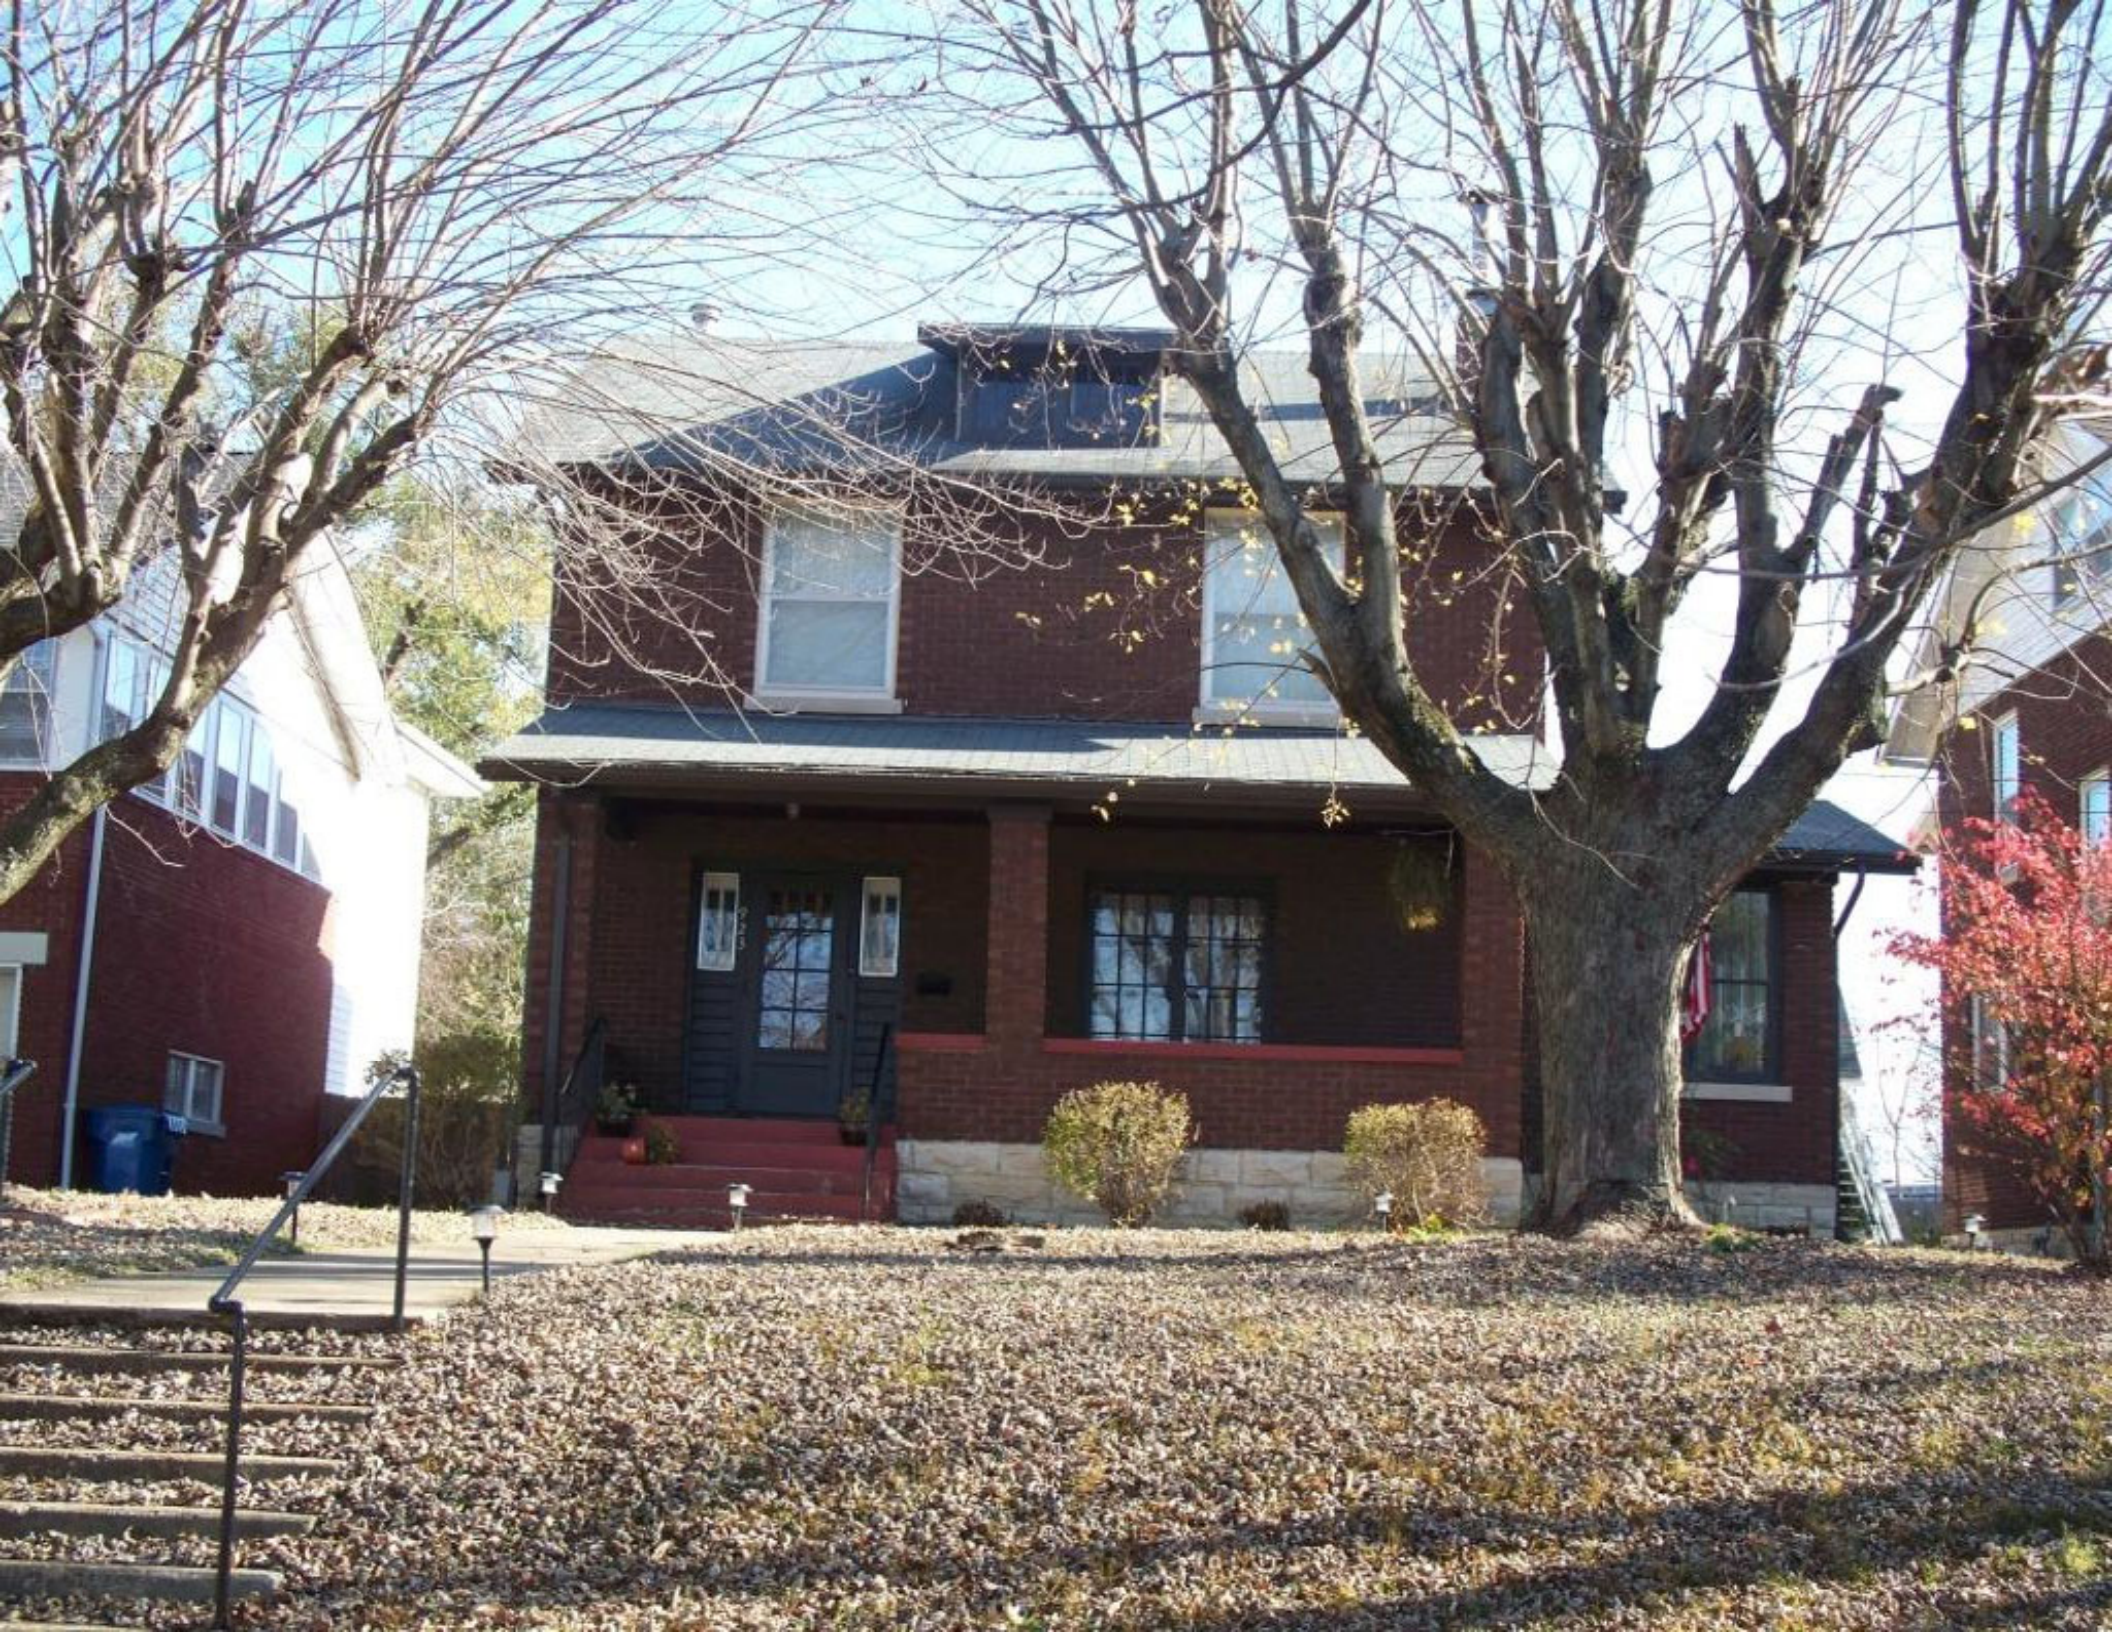
This two story four-square is clad in dark red brick and features a side-gable roof and a stone foundation. The upper story has two historic 6/1 windows with limestone lintels. The main entrance is off-center to the left and appears to retain its original door and sidelights (currently behind a screen door). The next bay to the right appears to be an additional entrance with a multi-light glass door. The final bay is a single story sun room with a side gable roof. It has paired 4/1 historic windows with stone lintels on each side. The porch covers the first two bays and has a shed roof, brick half-walls and piers and is reached by an off-center concrete stair with metal rails.

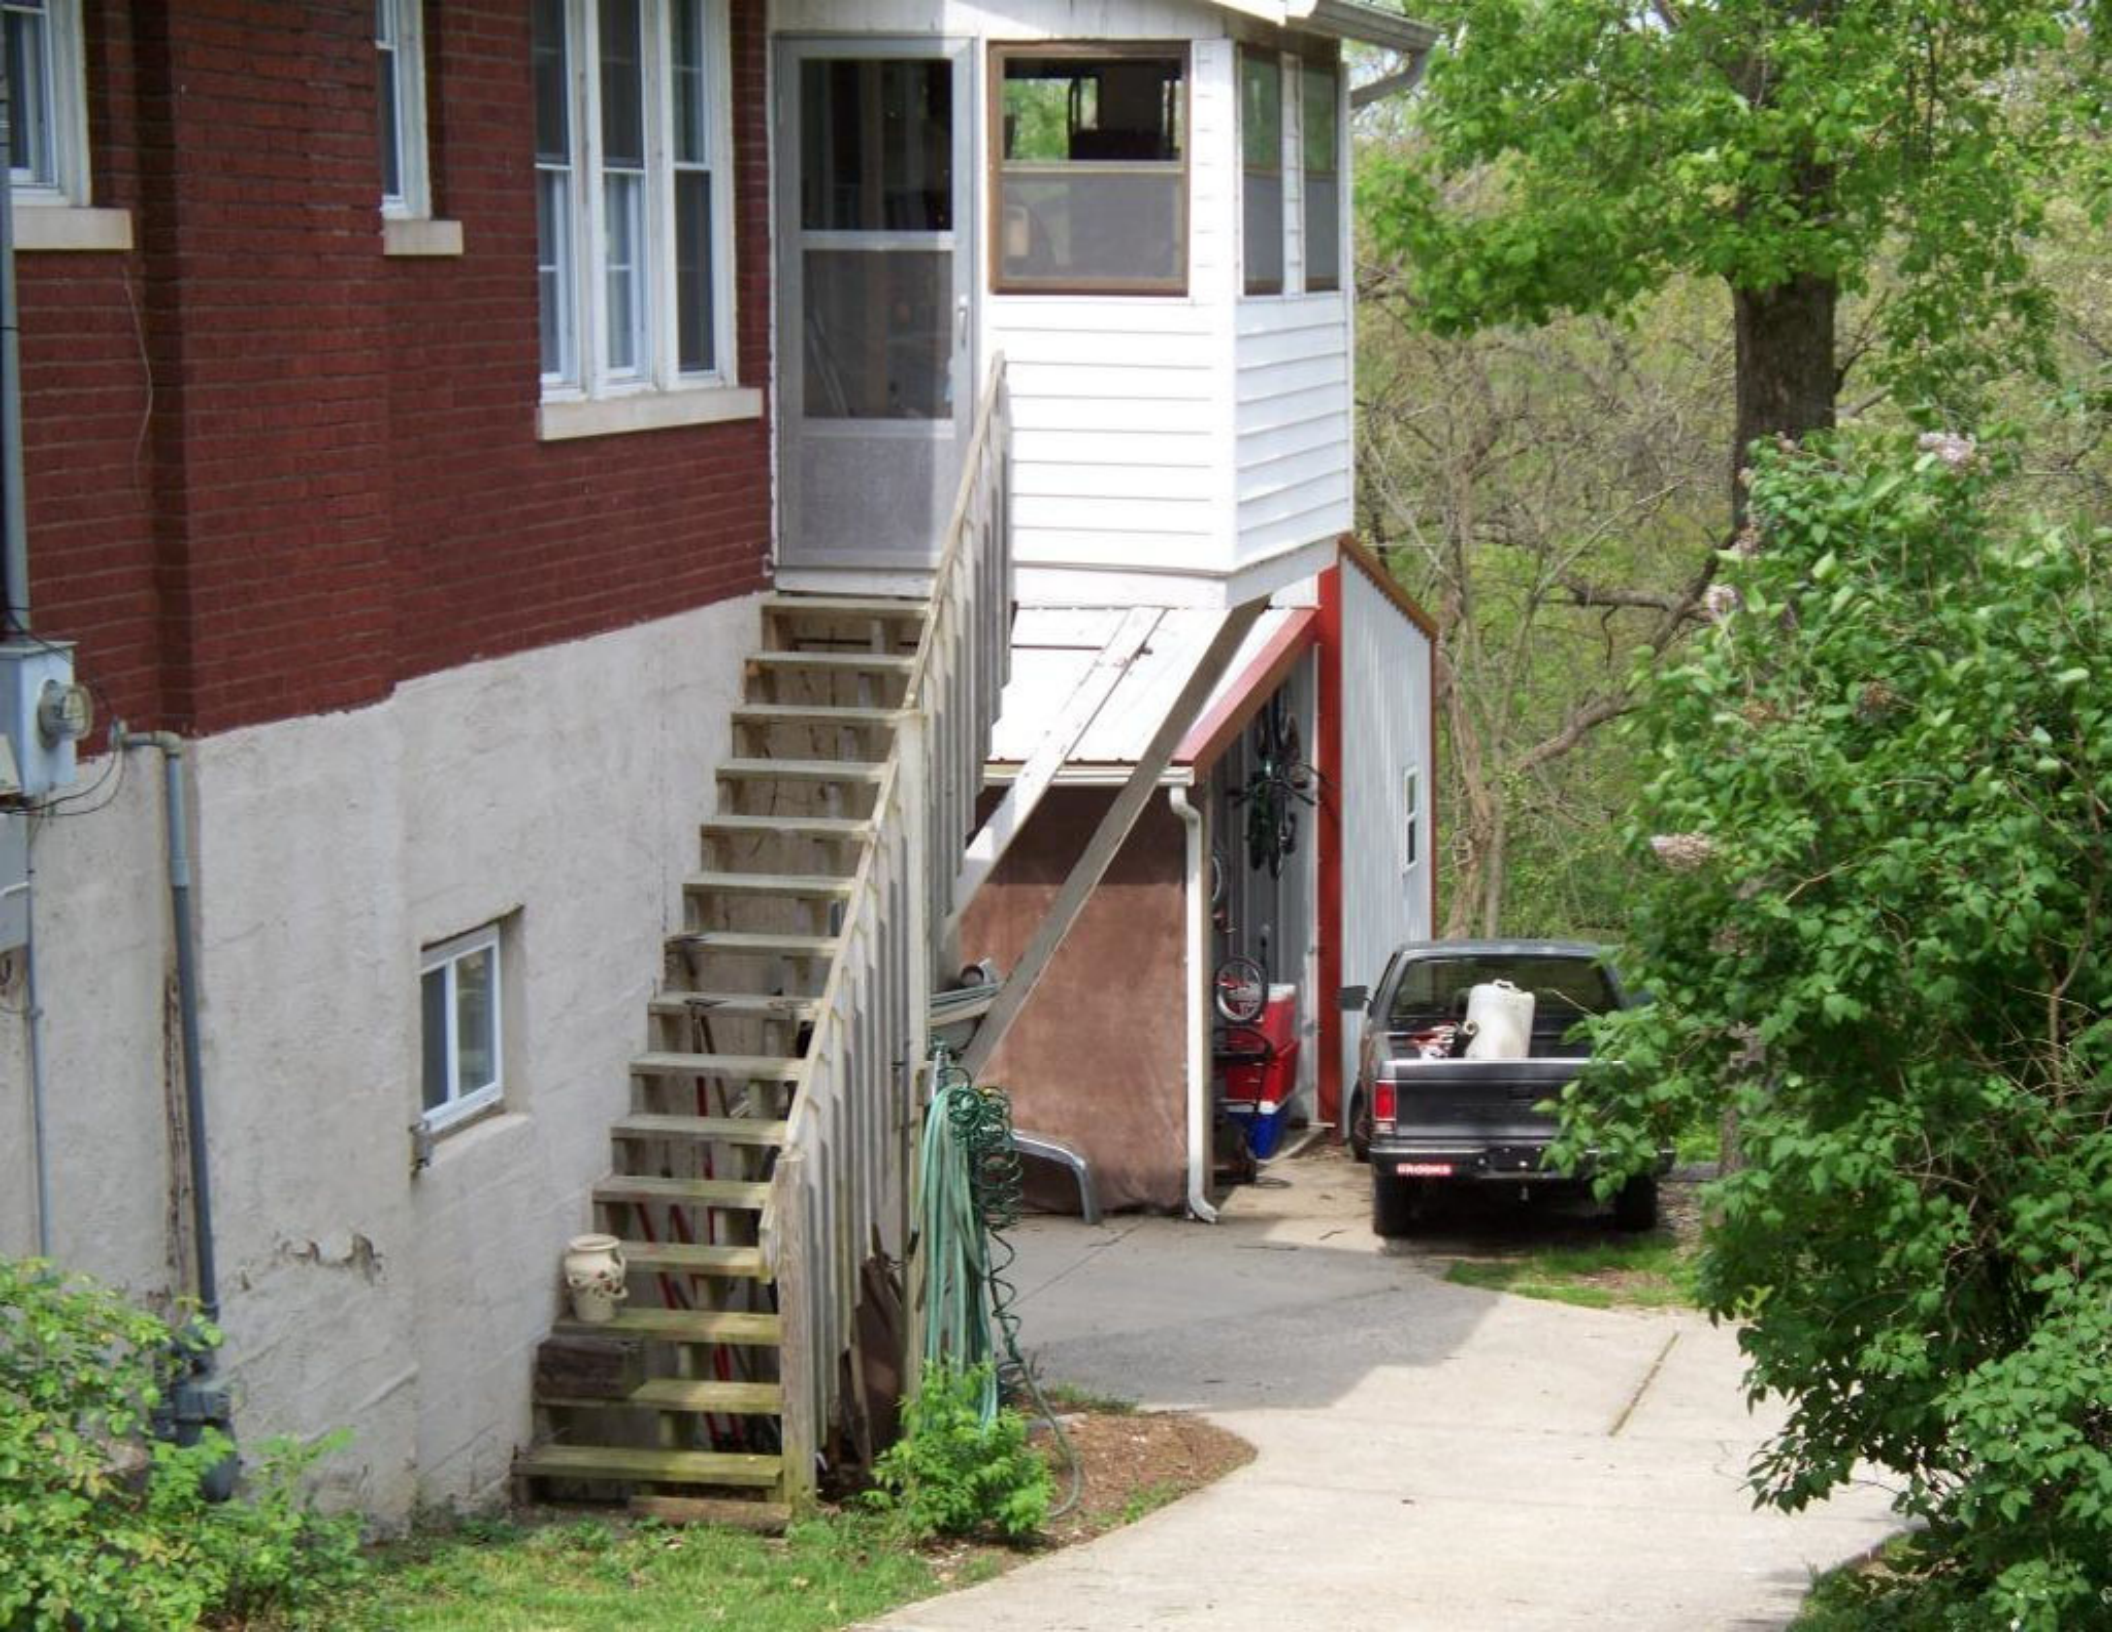
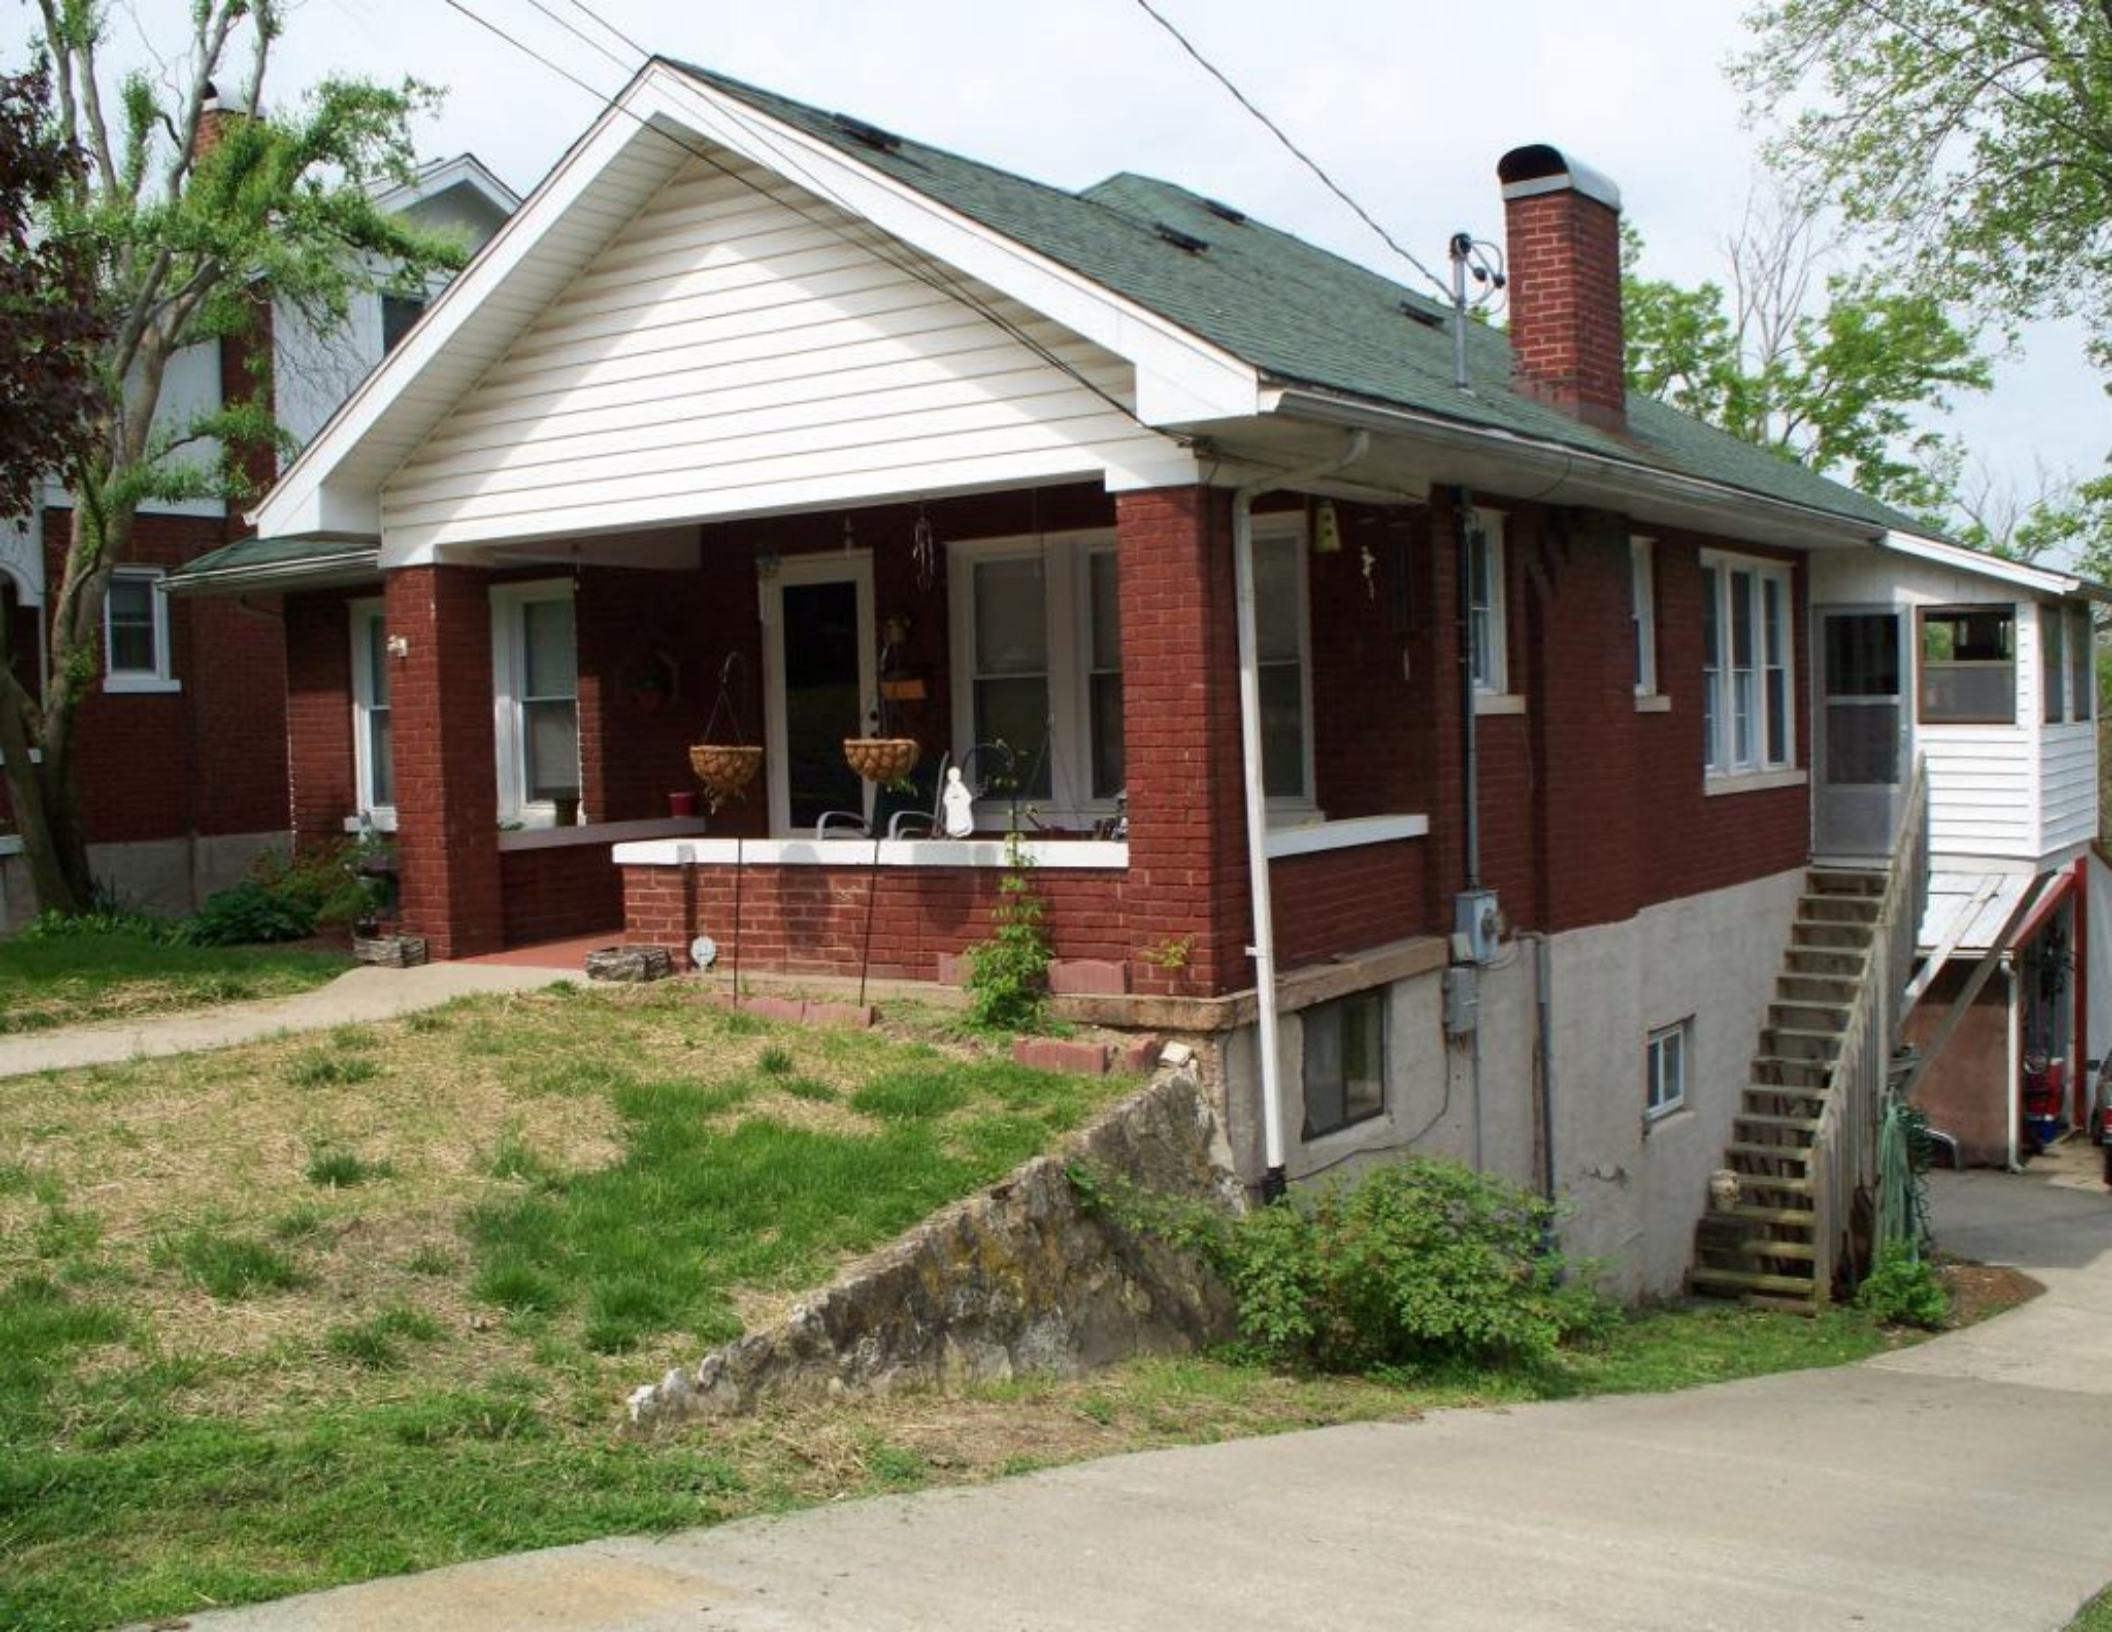
41. (cont.)
This is a one and a half story bungalow with a pyramidal roof and a central dormer. Foliage made it difficult to see what kind of roof the dormer has but it appears to have a 3/1 historic window. A large front gable projects over the center and right bay of the house. The gable is in-filled with vinyl and serves as the roof of the porch, which has brick half-walls and pilasters capped in limestone. A row of three replacement 1/1 windows flank each side of the central door. An additional hipped dormer extends from the left side of the house.
