ARCHITECTURAL/HISTORIC INVENTORY FORM

1. Survey No. CO-AS-005-001		2. Survey name: Moreau Drive Neighborhood Survey	
3. County: Cole		4. Address: 1202 Elmerine Ave.	
5. City: Jefferson City	Vicinity: <input type="checkbox"/>	6. UTM: / /	7. Township/Range/Section: T: R: S:
8. Historic name (if known):		9. Present/other name (if known):	
10. Ownership: <input checked="" type="checkbox"/> Private <input type="checkbox"/> Public		11. Historic use (if known): Residential	11. Current use: Residential

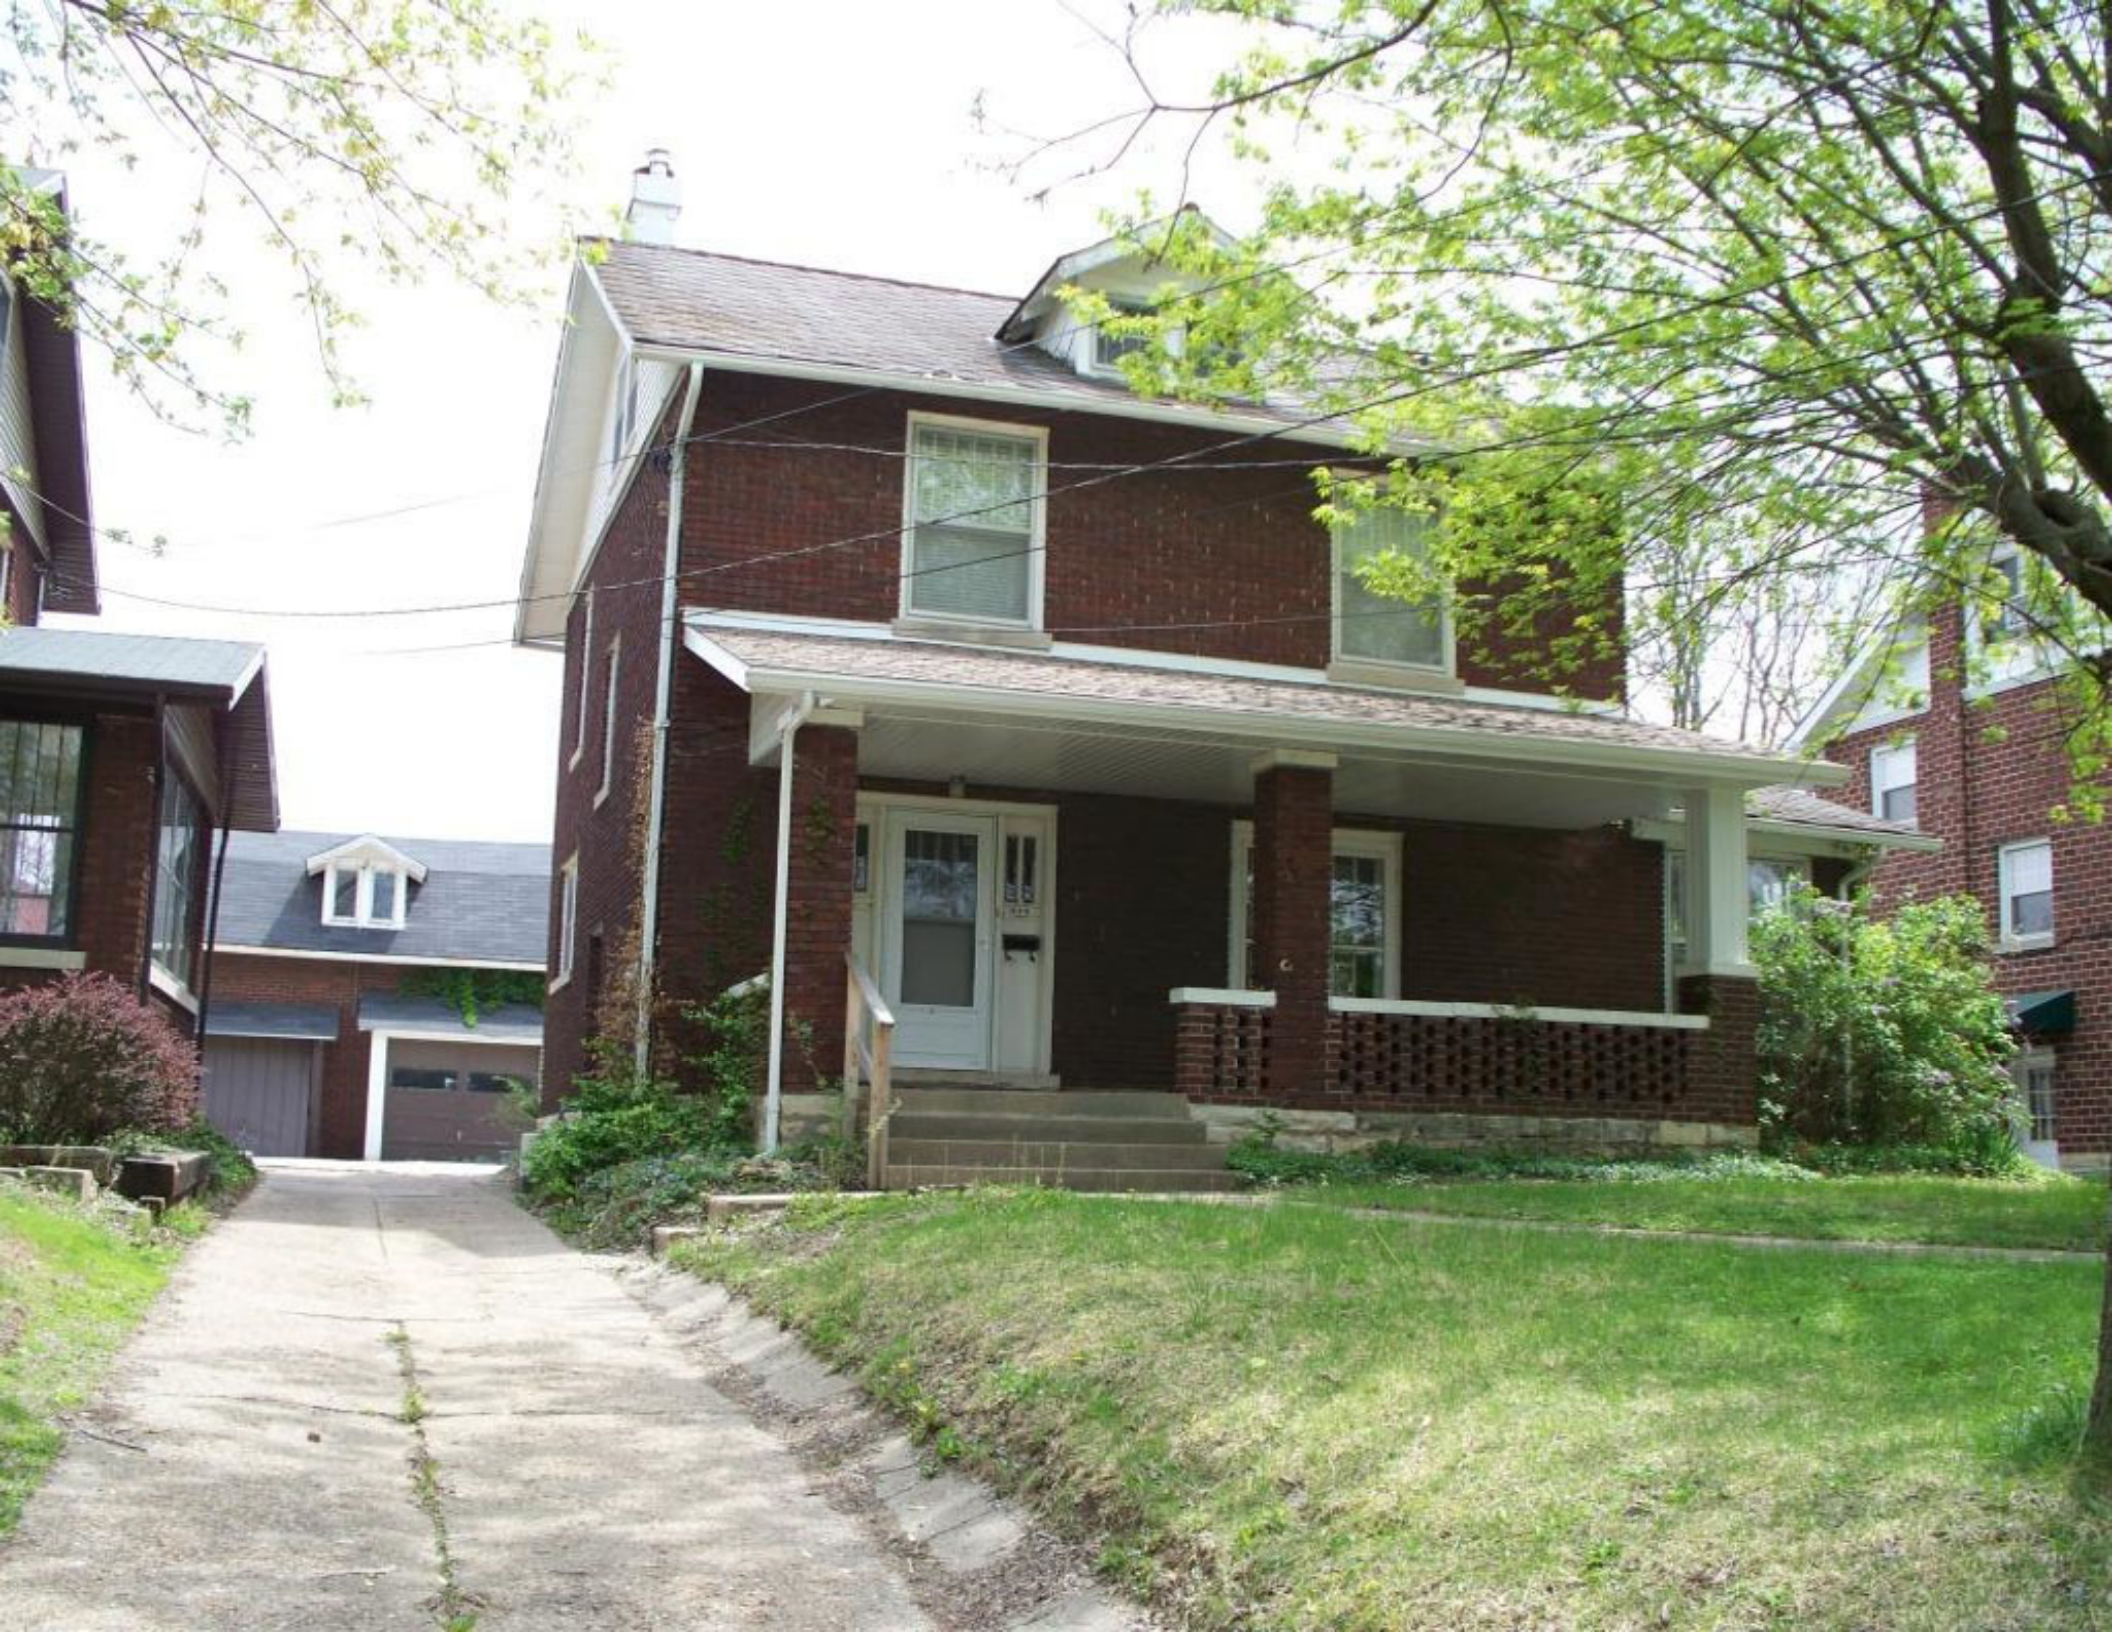
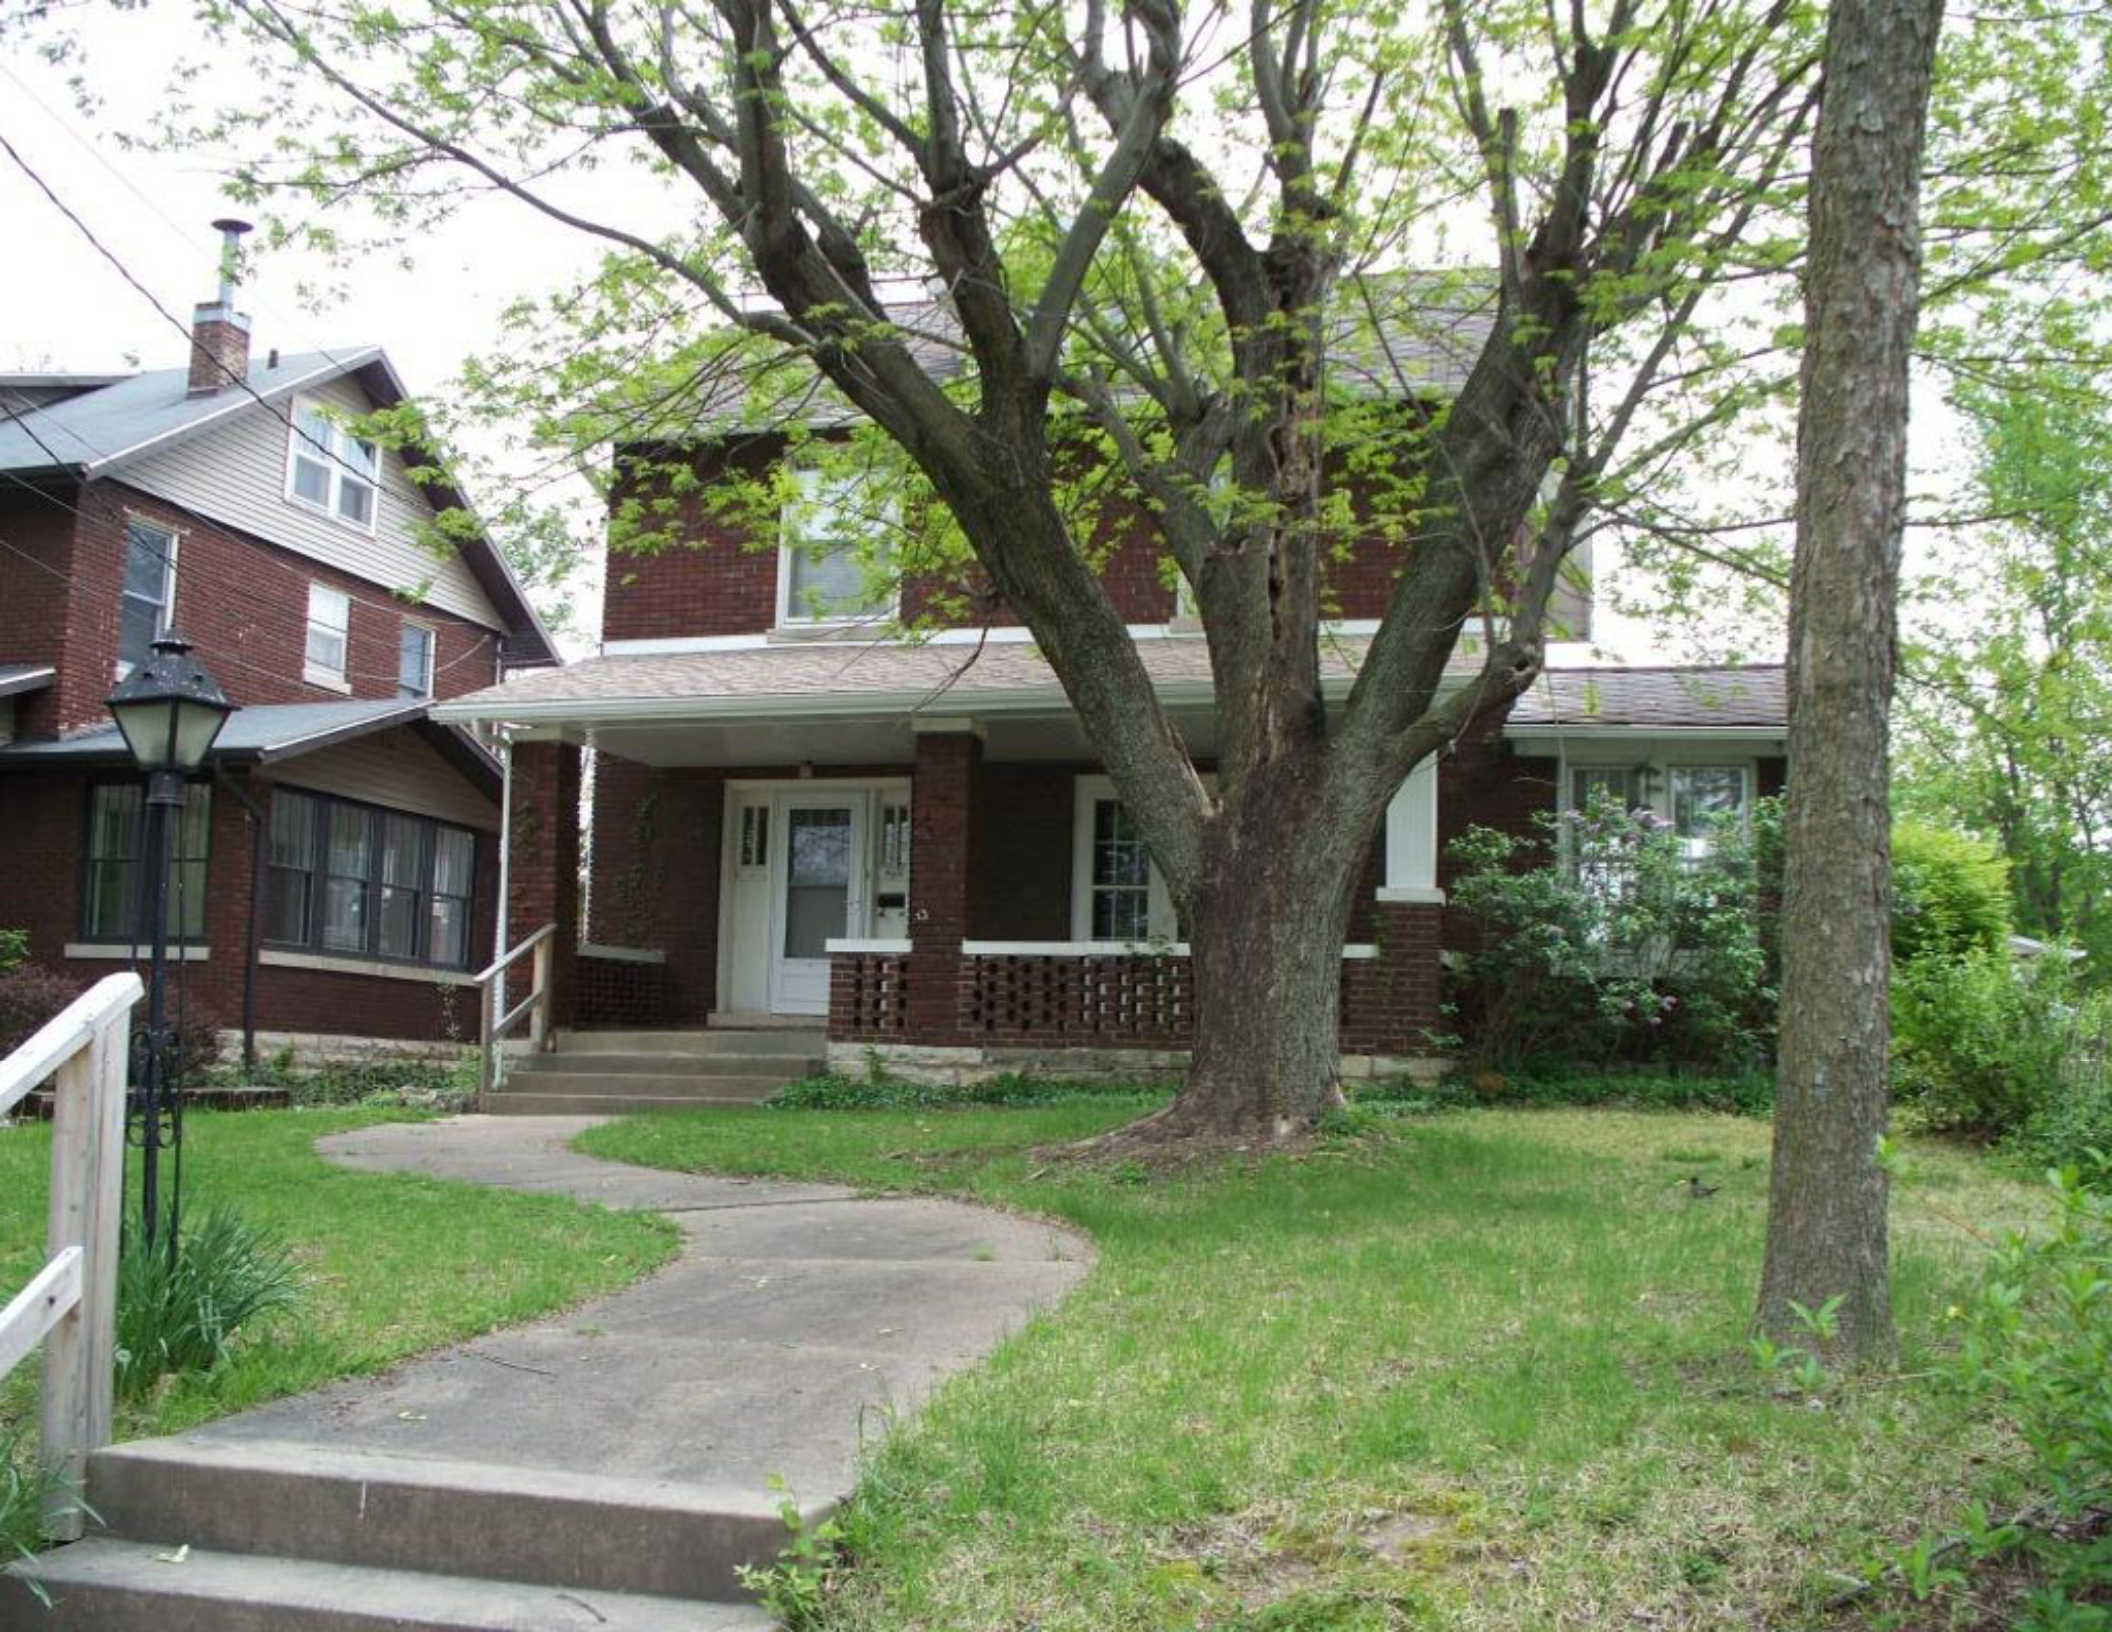
This 2 ½ story brick four square has a stone foundation, a side gabled roof with a central gabled dormer with two multi-paned historic windows. Like 923 Fairmount, the second floor has two historic 6/1 windows with stone lintels, and the first floor main entrance is off center to the left and retains its original door and side lights. The central bay, however, has multi-light French doors. The sun room is one story and has a side gabled roof and paired 4/1 historic windows with limestone sills on each side. The porch covers the first two bays and has a shed roof with brick piers and half walls, which has a decorative open block pattern on the central façade. The last pier (on the right) is clad in modern siding (aluminum? plastic?). The porch is accessed by concrete stairs on the left bay, a modern wood rail has been added to its left side.

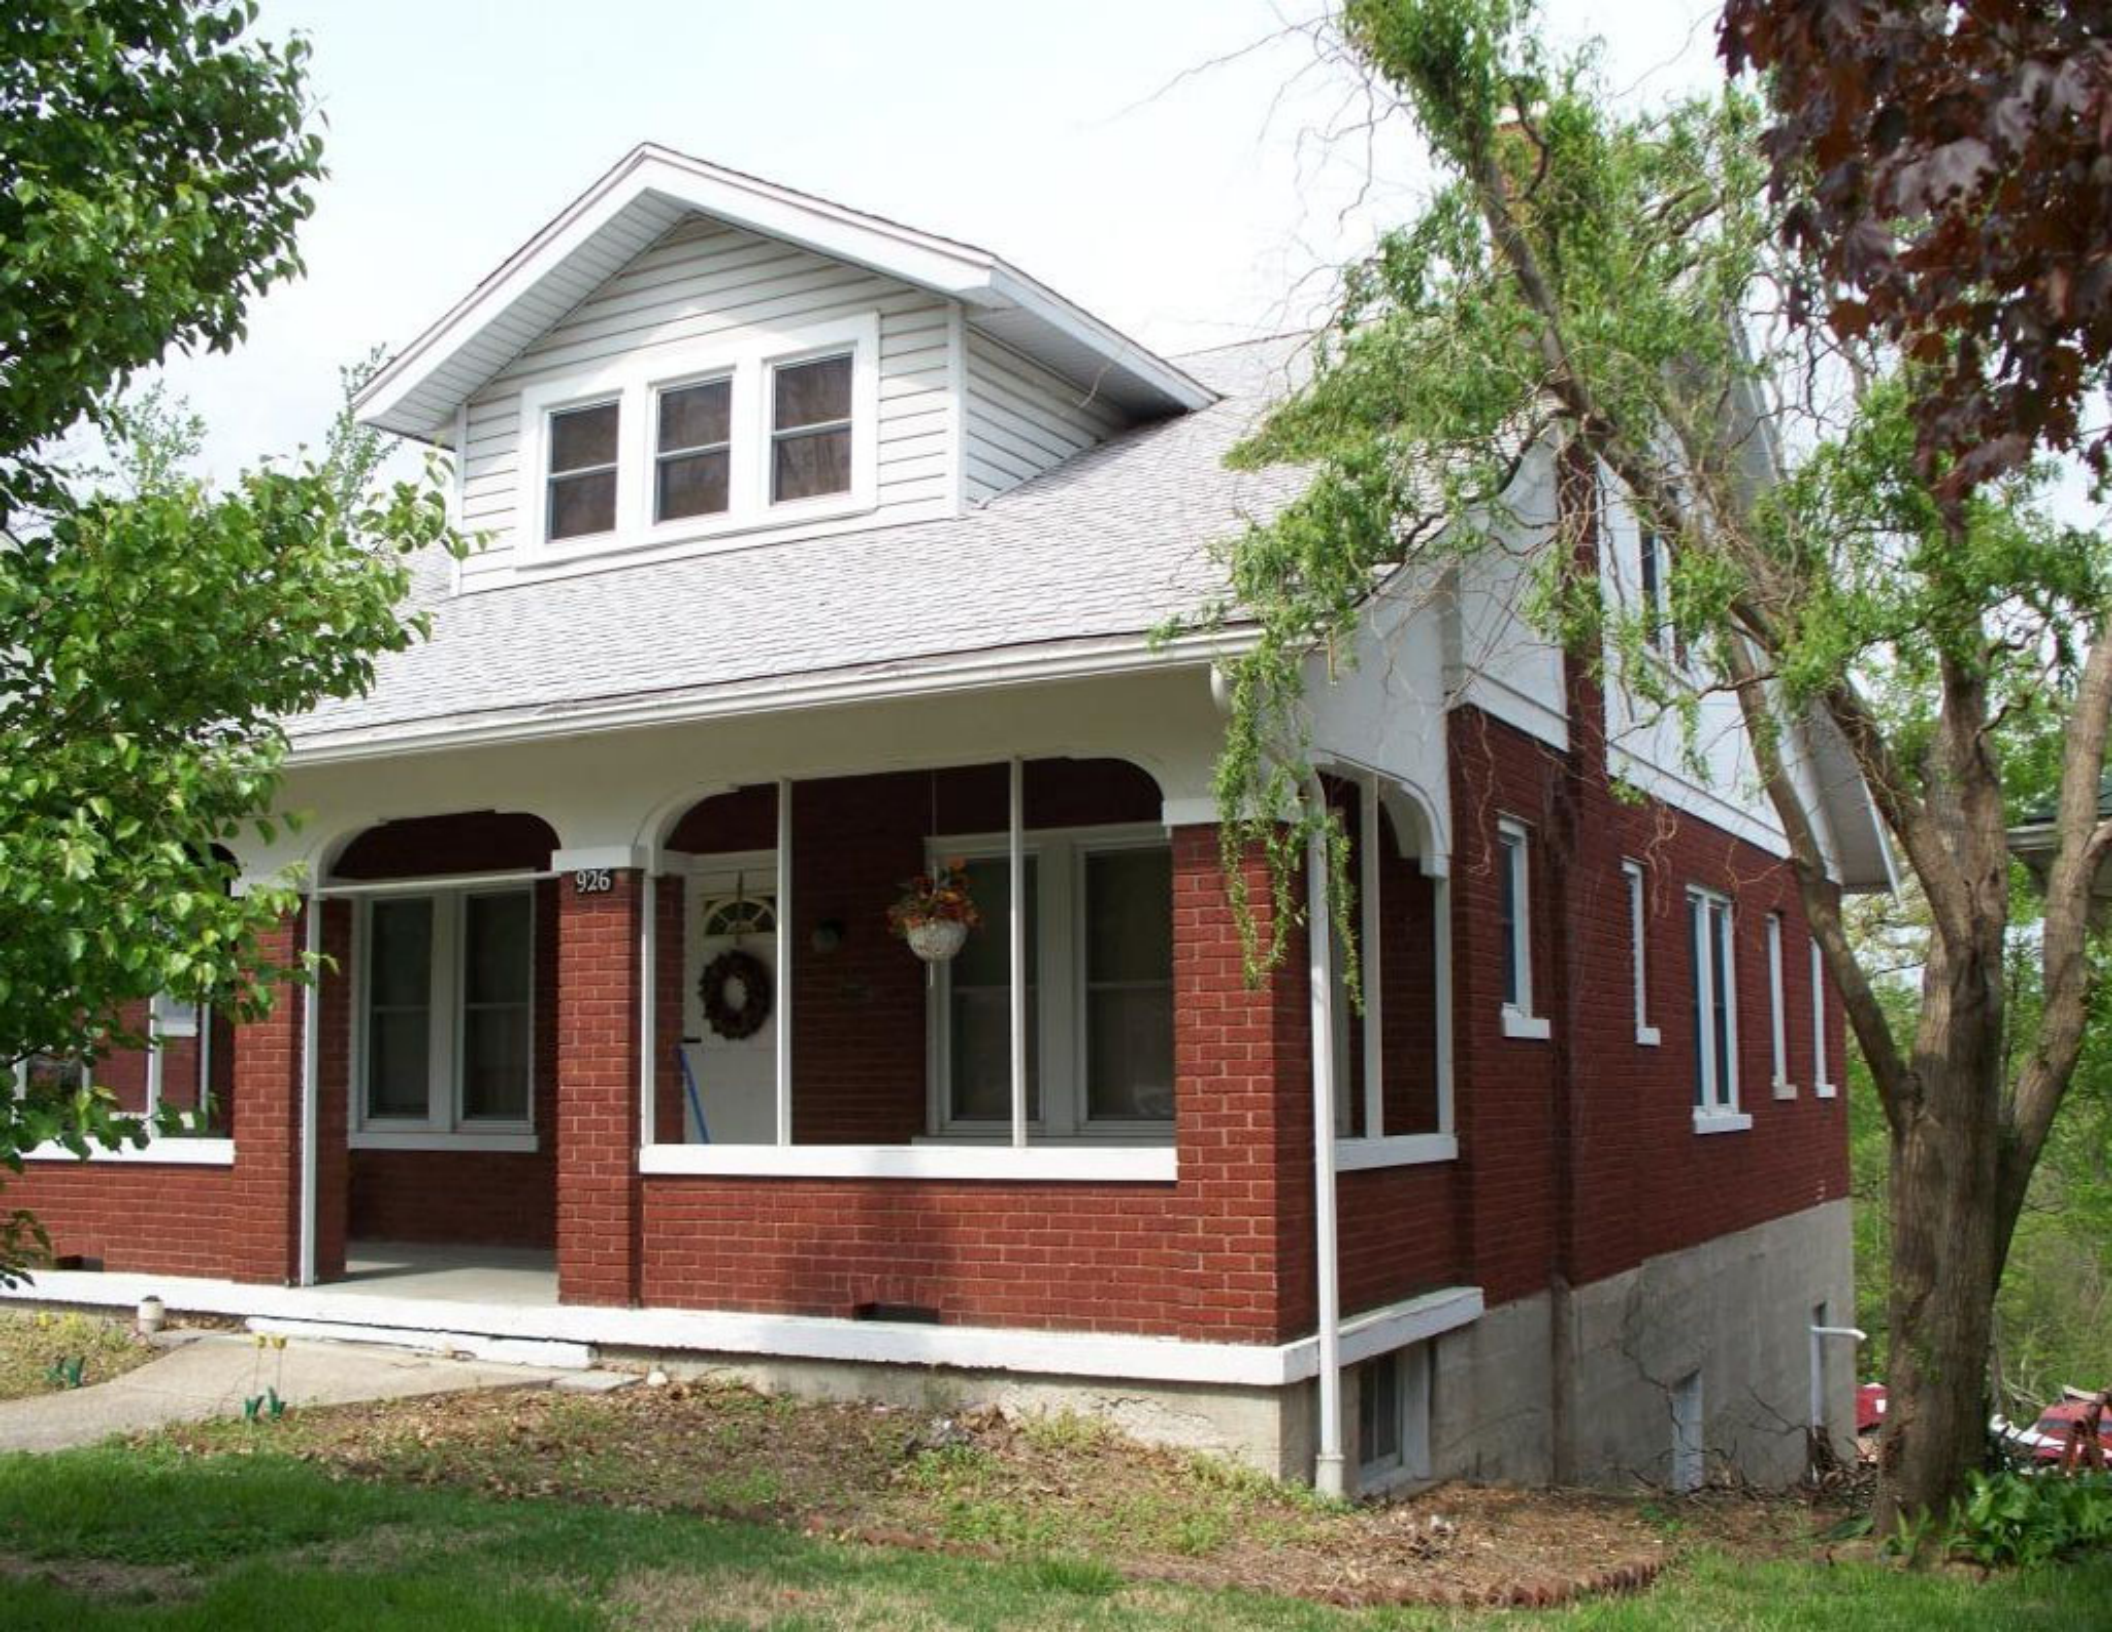
926

This is a one and a half story bungalow with a side gable roof and a central gabled dormer with three vinyl 1/1 windows. The dormer is sided in vinyl. The full porch has large decorative wide-arched openings. At the time of this survey the porch was either in the midst of being screened in or perhaps the screening was being removed but there are slender pieces of framing in the openings. The central entrance (likely a replacement door with sunburst transom) is flanked on each side by a row of three 1/1 replacement windows. The porch features brick half walls and pilasters capped with limestone.

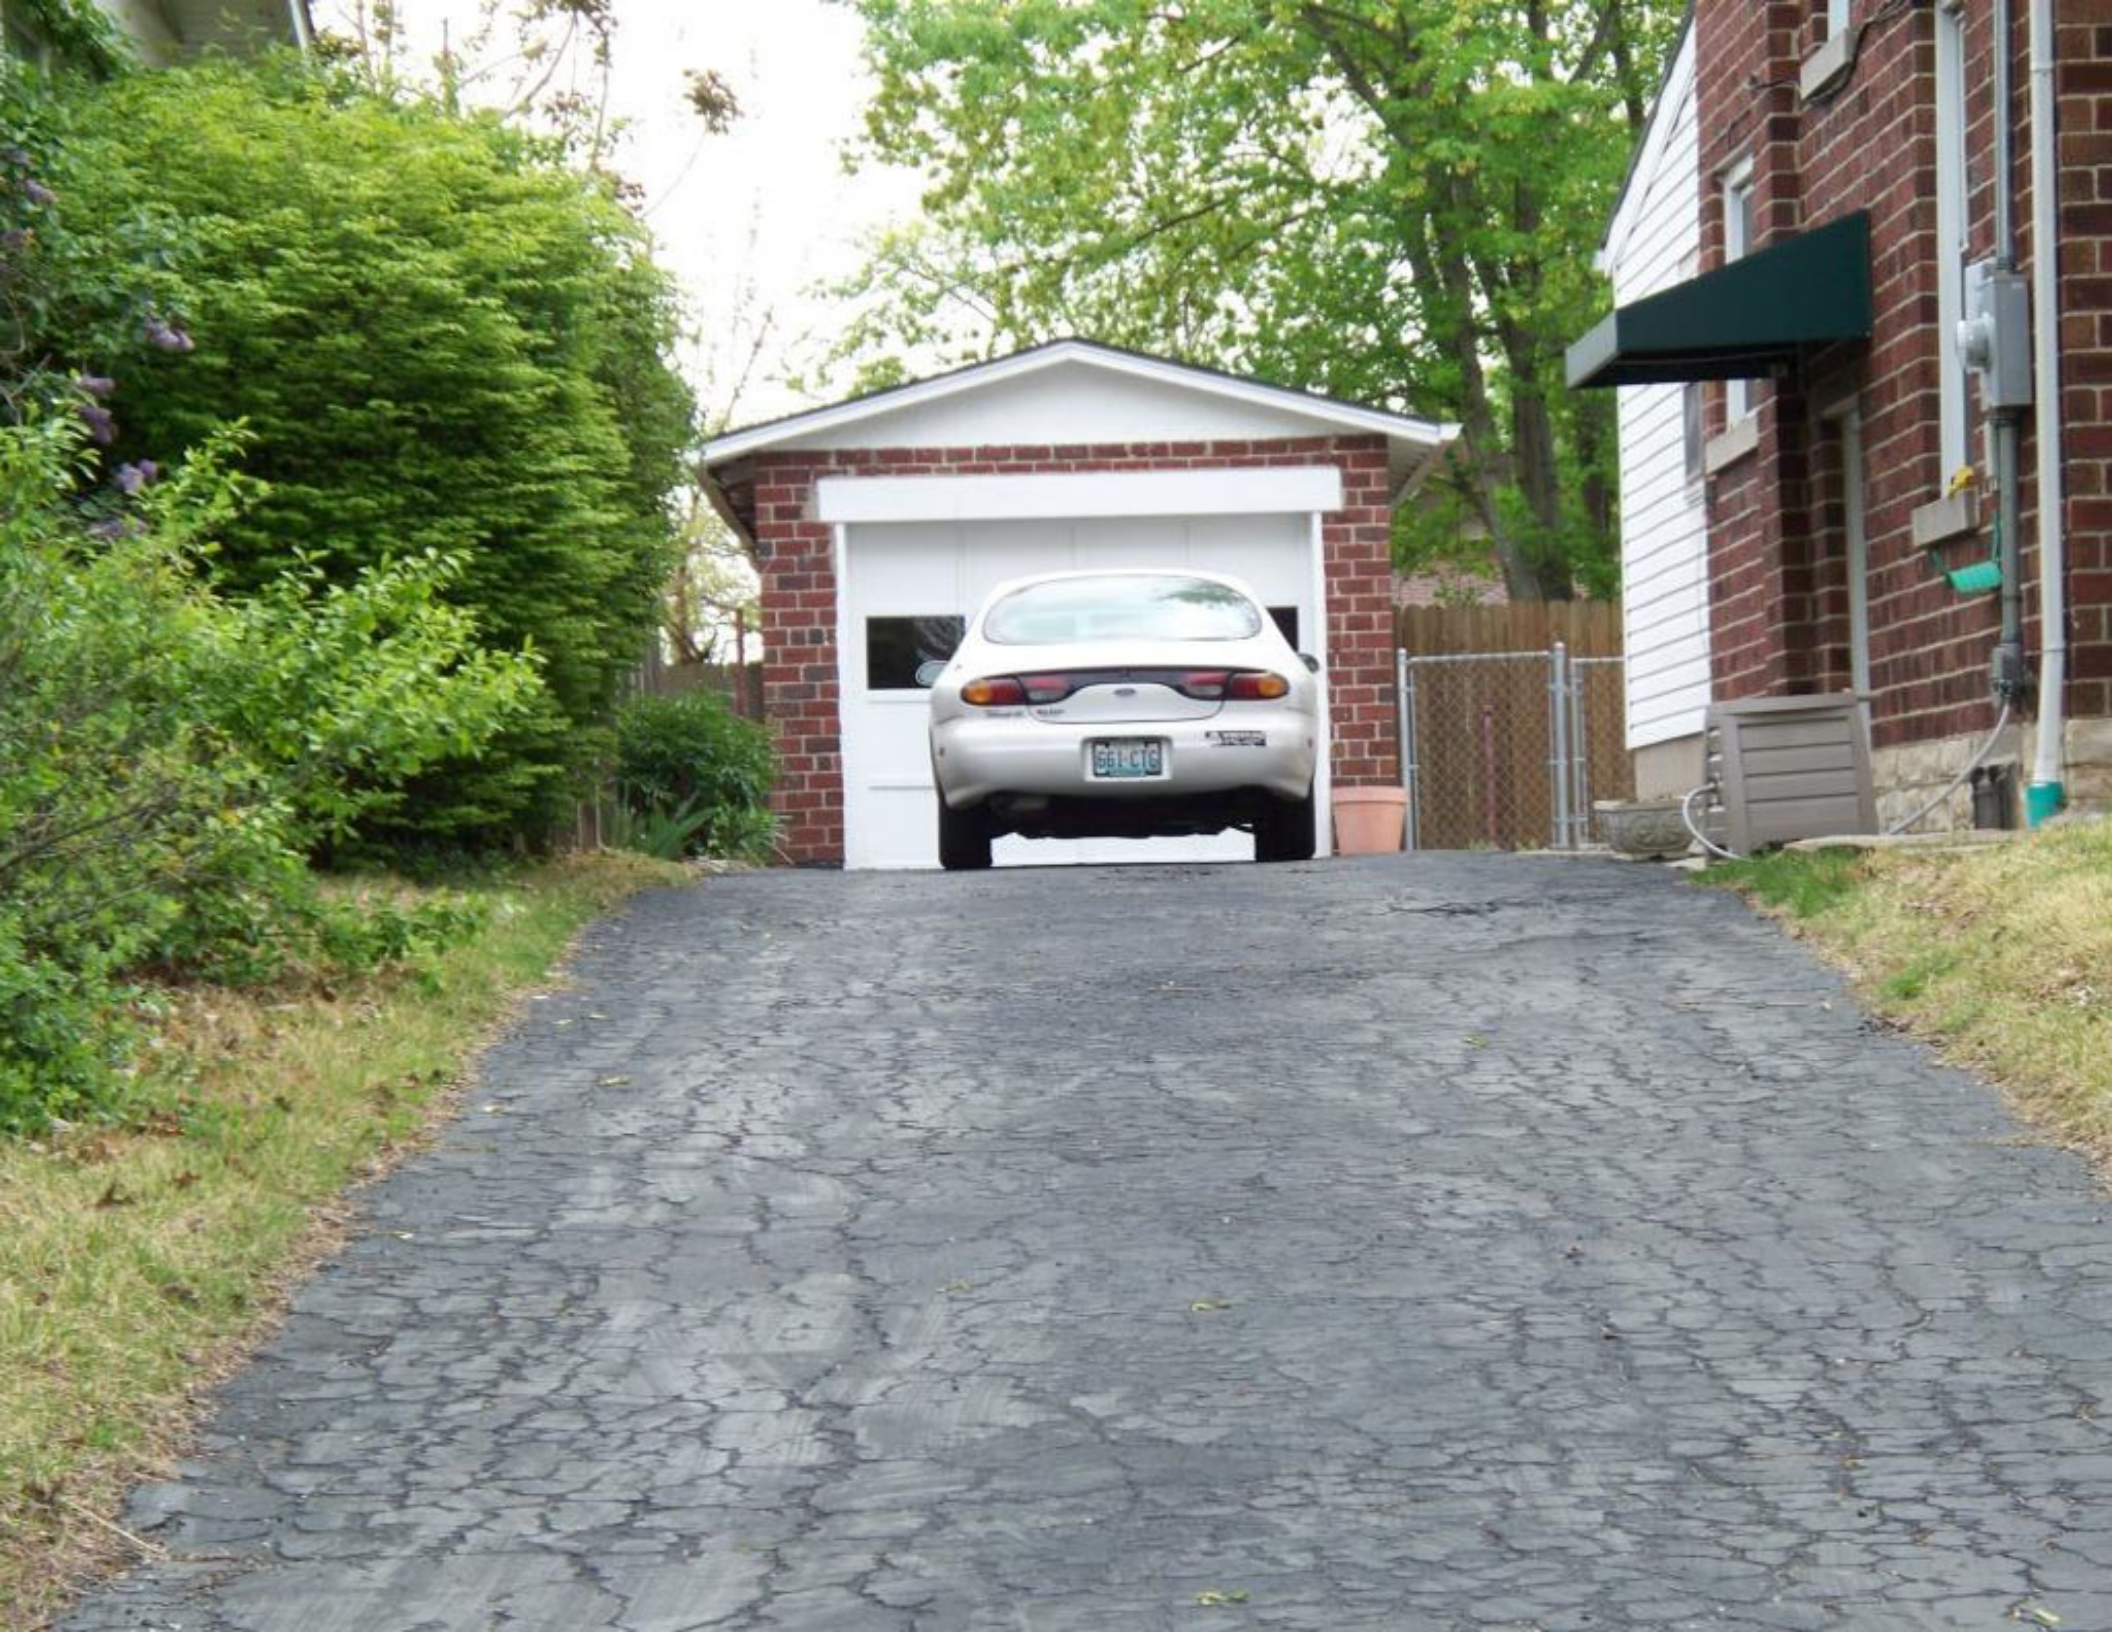
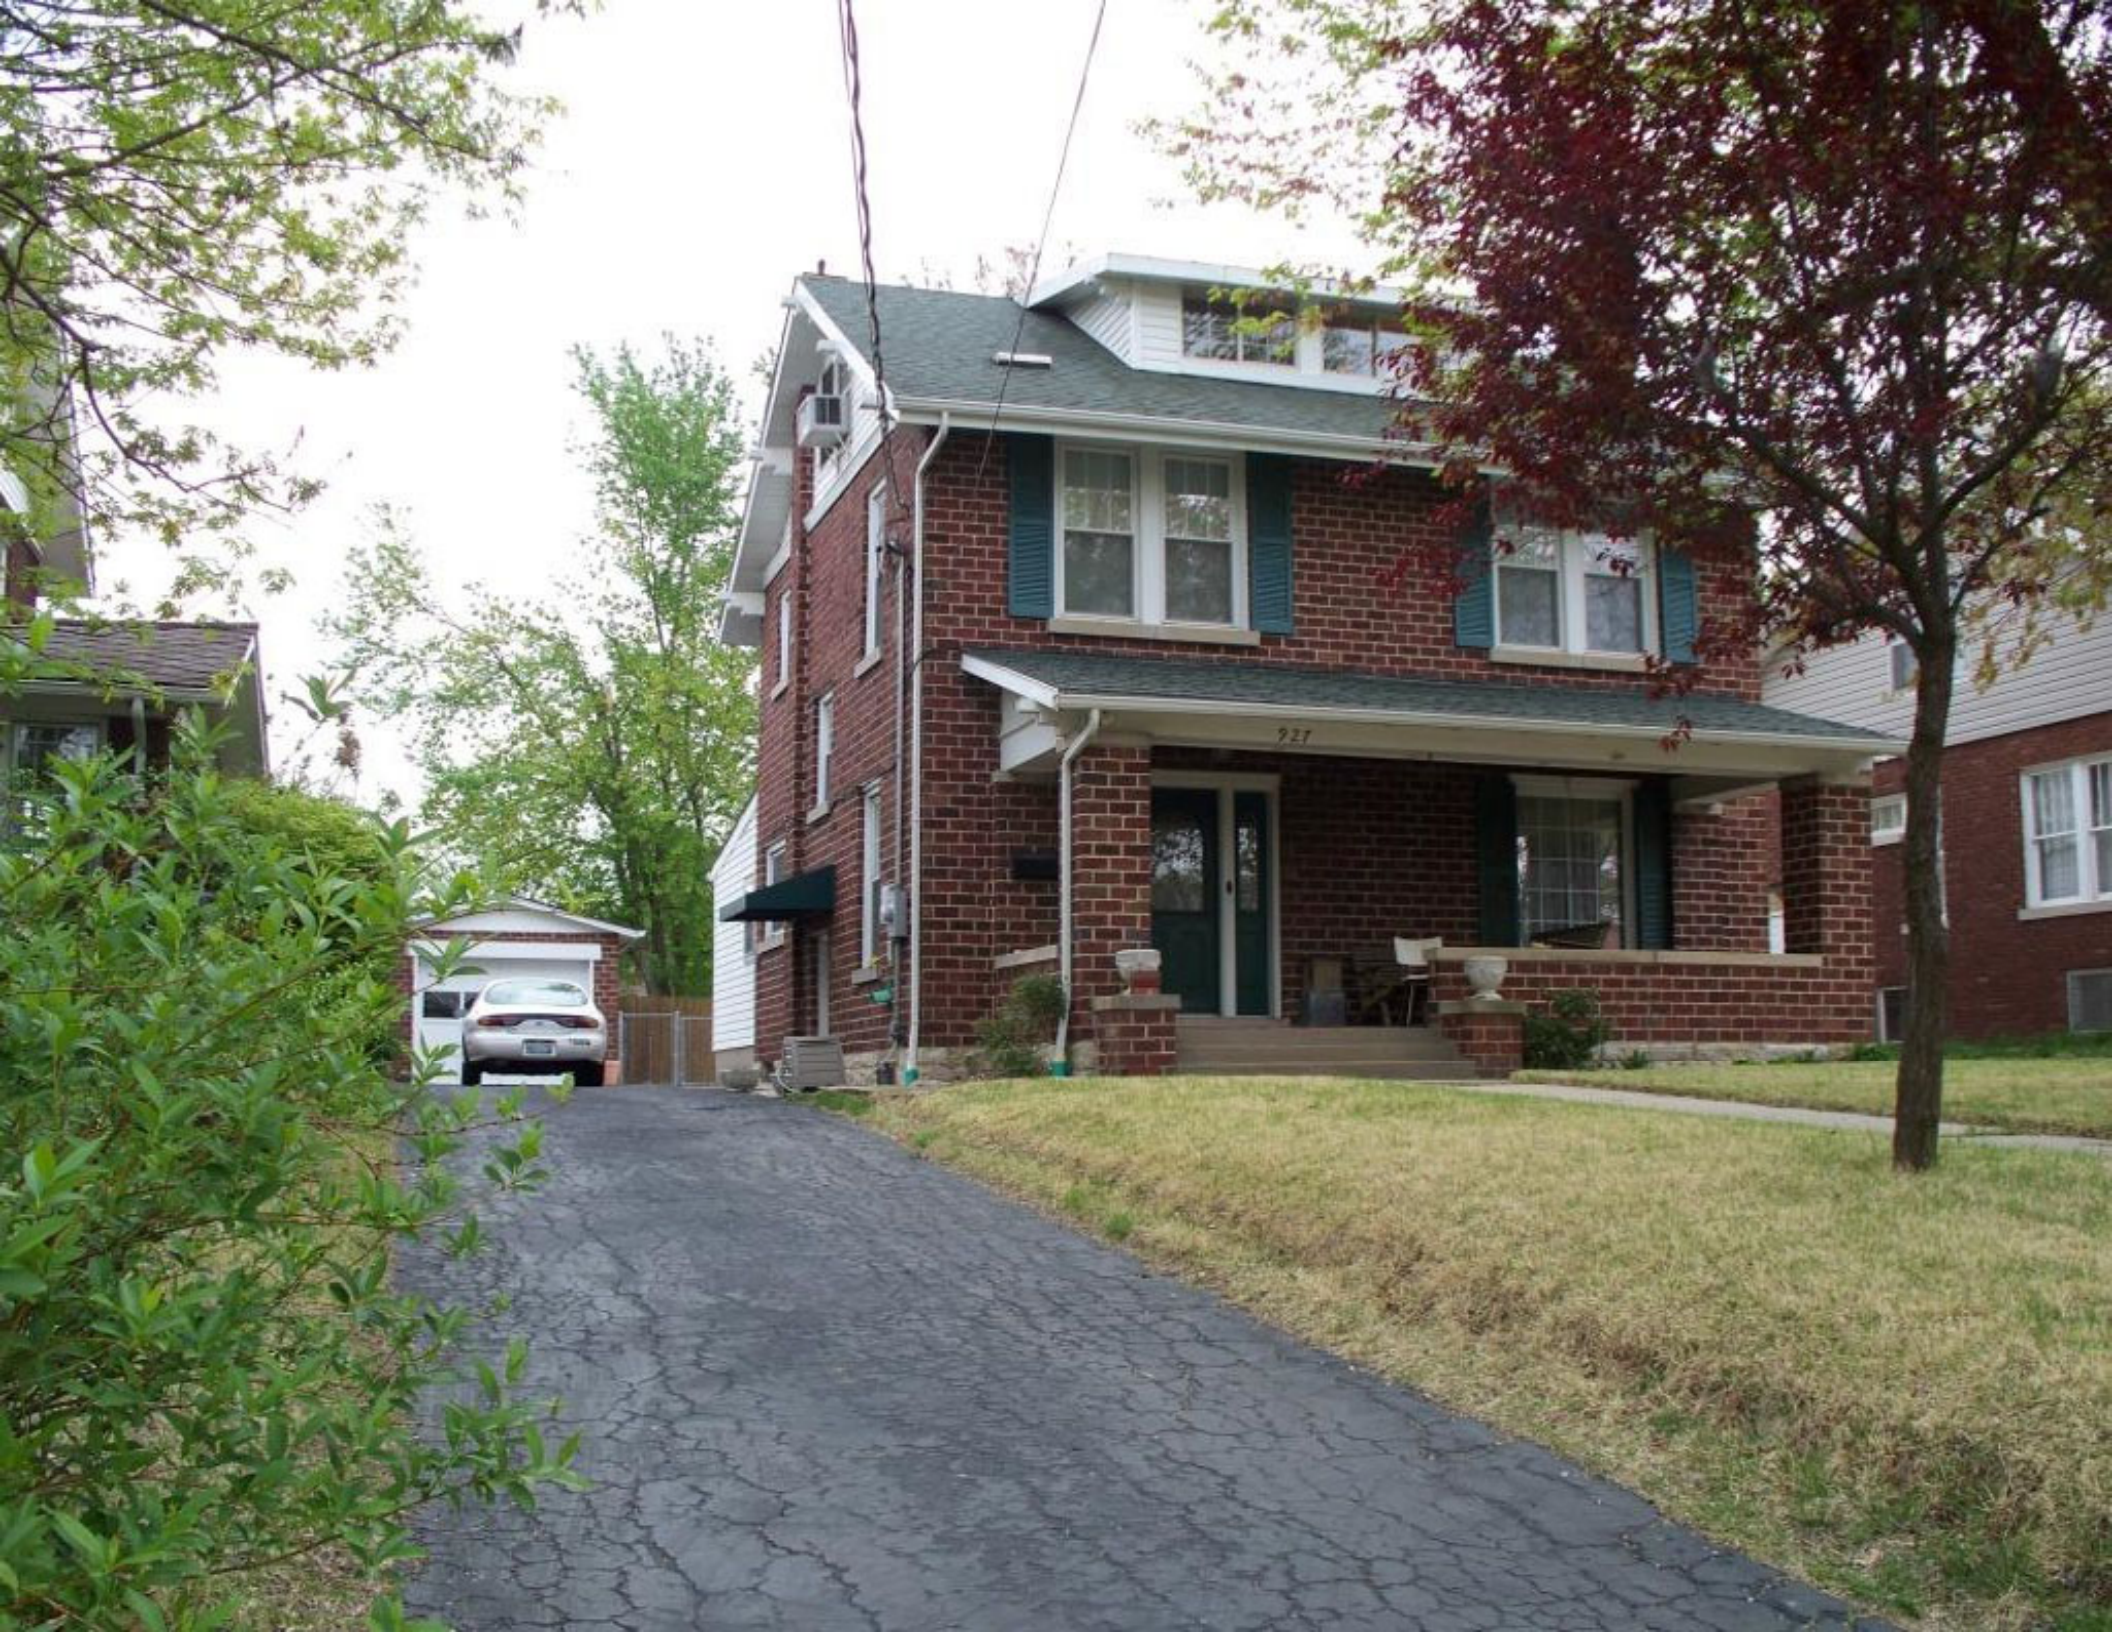
41. (cont.)
This 2 ½ story brick four square has a stone foundation, a side gabled roof with brackets and a central shed dormer clad in vinyl. The two windows have multi-lights and appear to be modern. The second story has two sets of paired windows with limestone/concrete sills and shutters. The windows are 6/1 and may be modern replacements. The first story appears to retain its original door and sidelights in the left bay. The right bay probably had French doors but is now a multi-light window (modern). The full width porch has brick piers and half-walls that are capped in limestone or concrete.

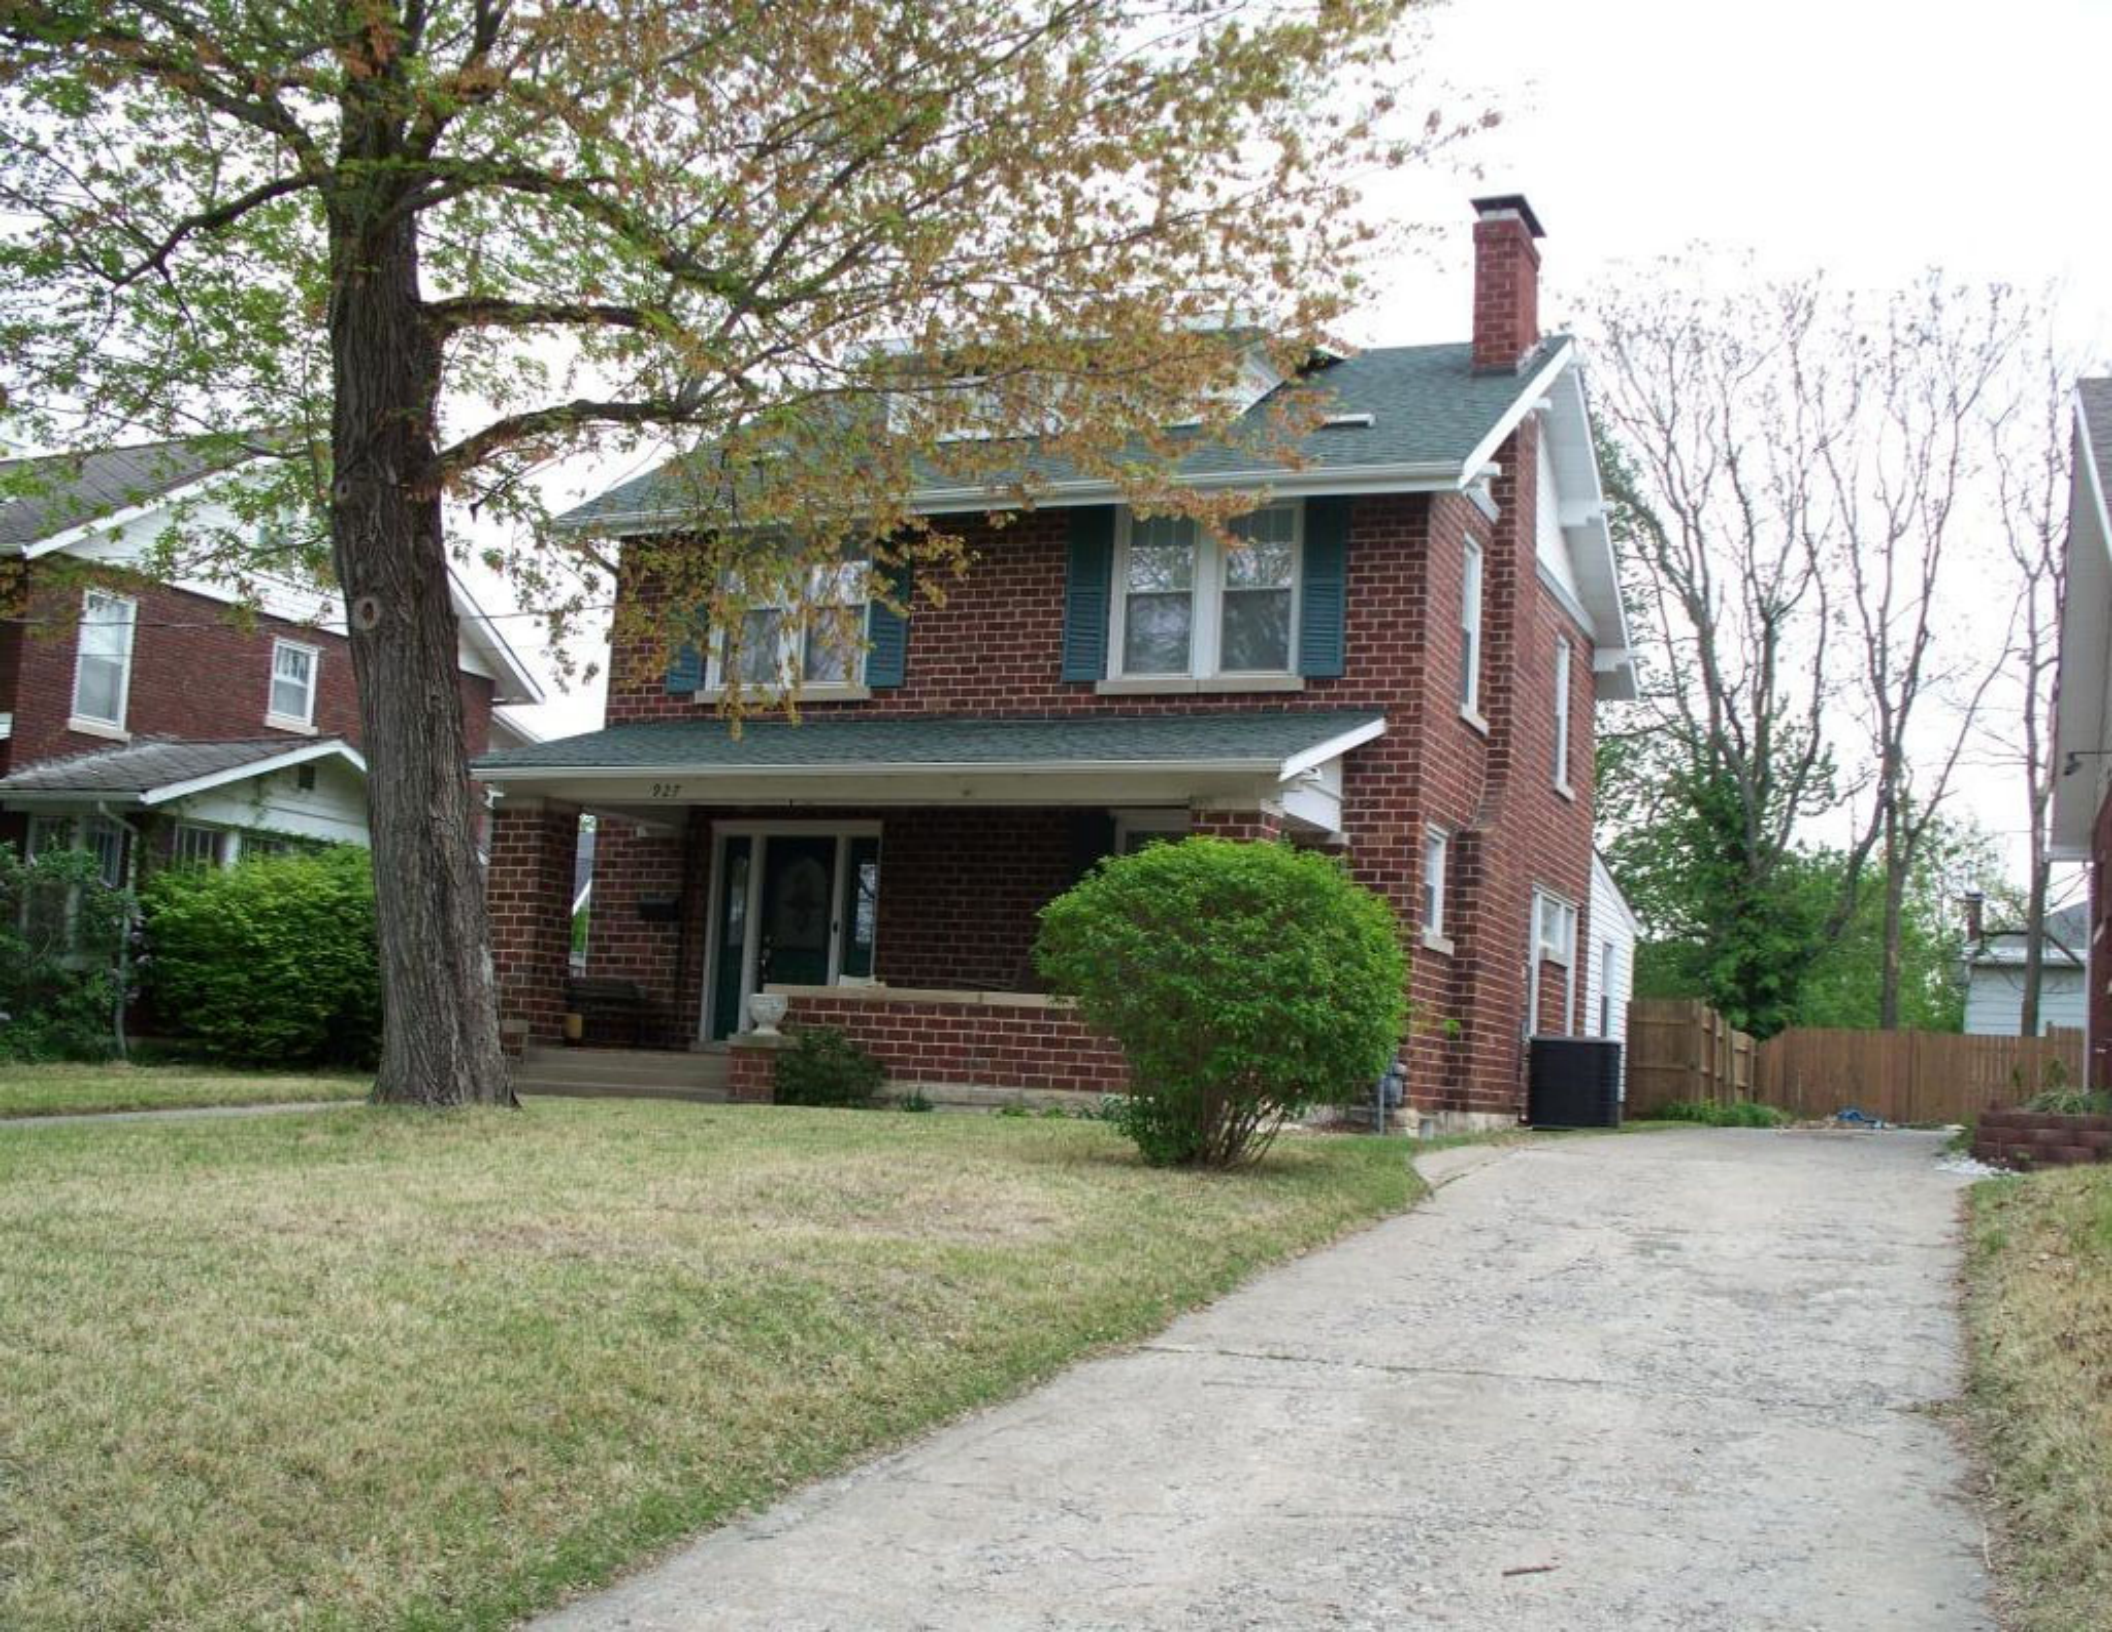
This one and a half story brick bungalow has a central gabled dormer clad in vinyl with three historic 3/1 windows and a vent in the peak of the gable. The full length porch has wide arched openings that meet brick pilasters and half walls capped in limestone. The entrance is in the center and is flanked on each side by a row of historic 3/1 windows with limestone sills.
