ARCHITECTURAL/HISTORIC INVENTORY FORM

1. Survey No. CO-AS-005-001		2. Survey name: Moreau Drive Neighborhood Survey	
3. County: Cole		4. Address: 1202 Elmerine Ave.	
5. City: Jefferson City	Vicinity: <input type="checkbox"/>	6. UTM: / /	7. Township/Range/Section: T: R: S:
8. Historic name (if known):		9. Present/other name (if known):	
10. Ownership: <input checked="" type="checkbox"/> Private <input type="checkbox"/> Public		11. Historic use (if known): Residential	11. Current use: Residential

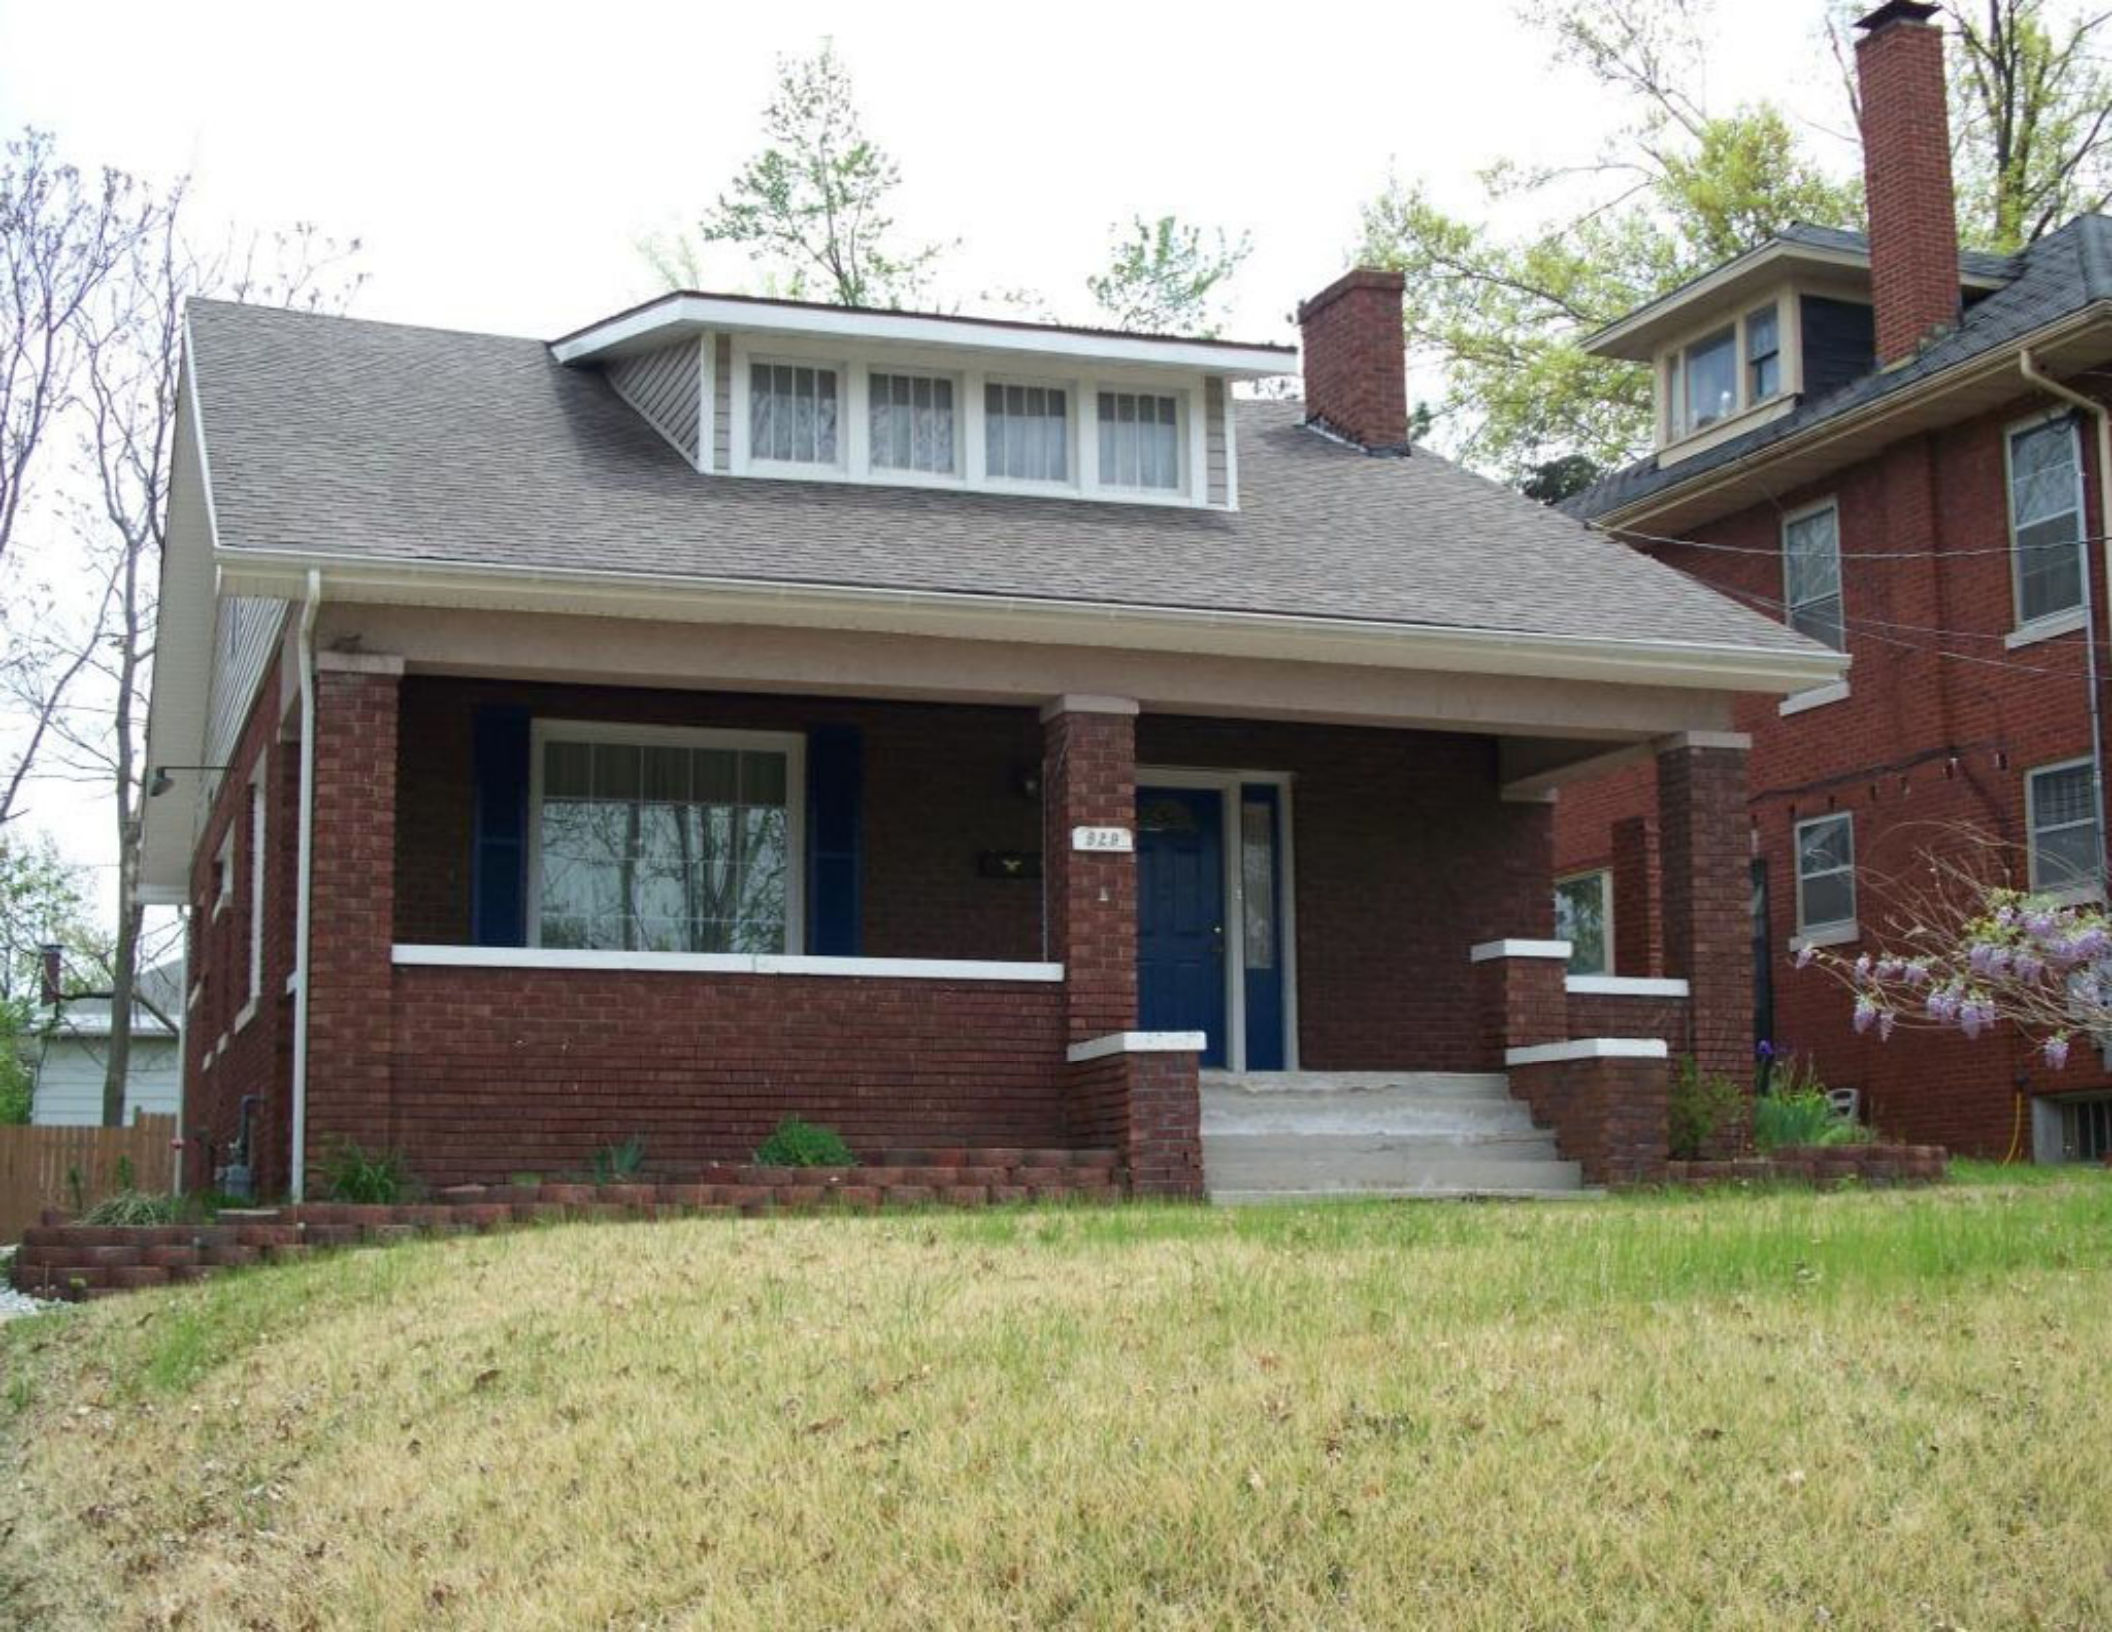
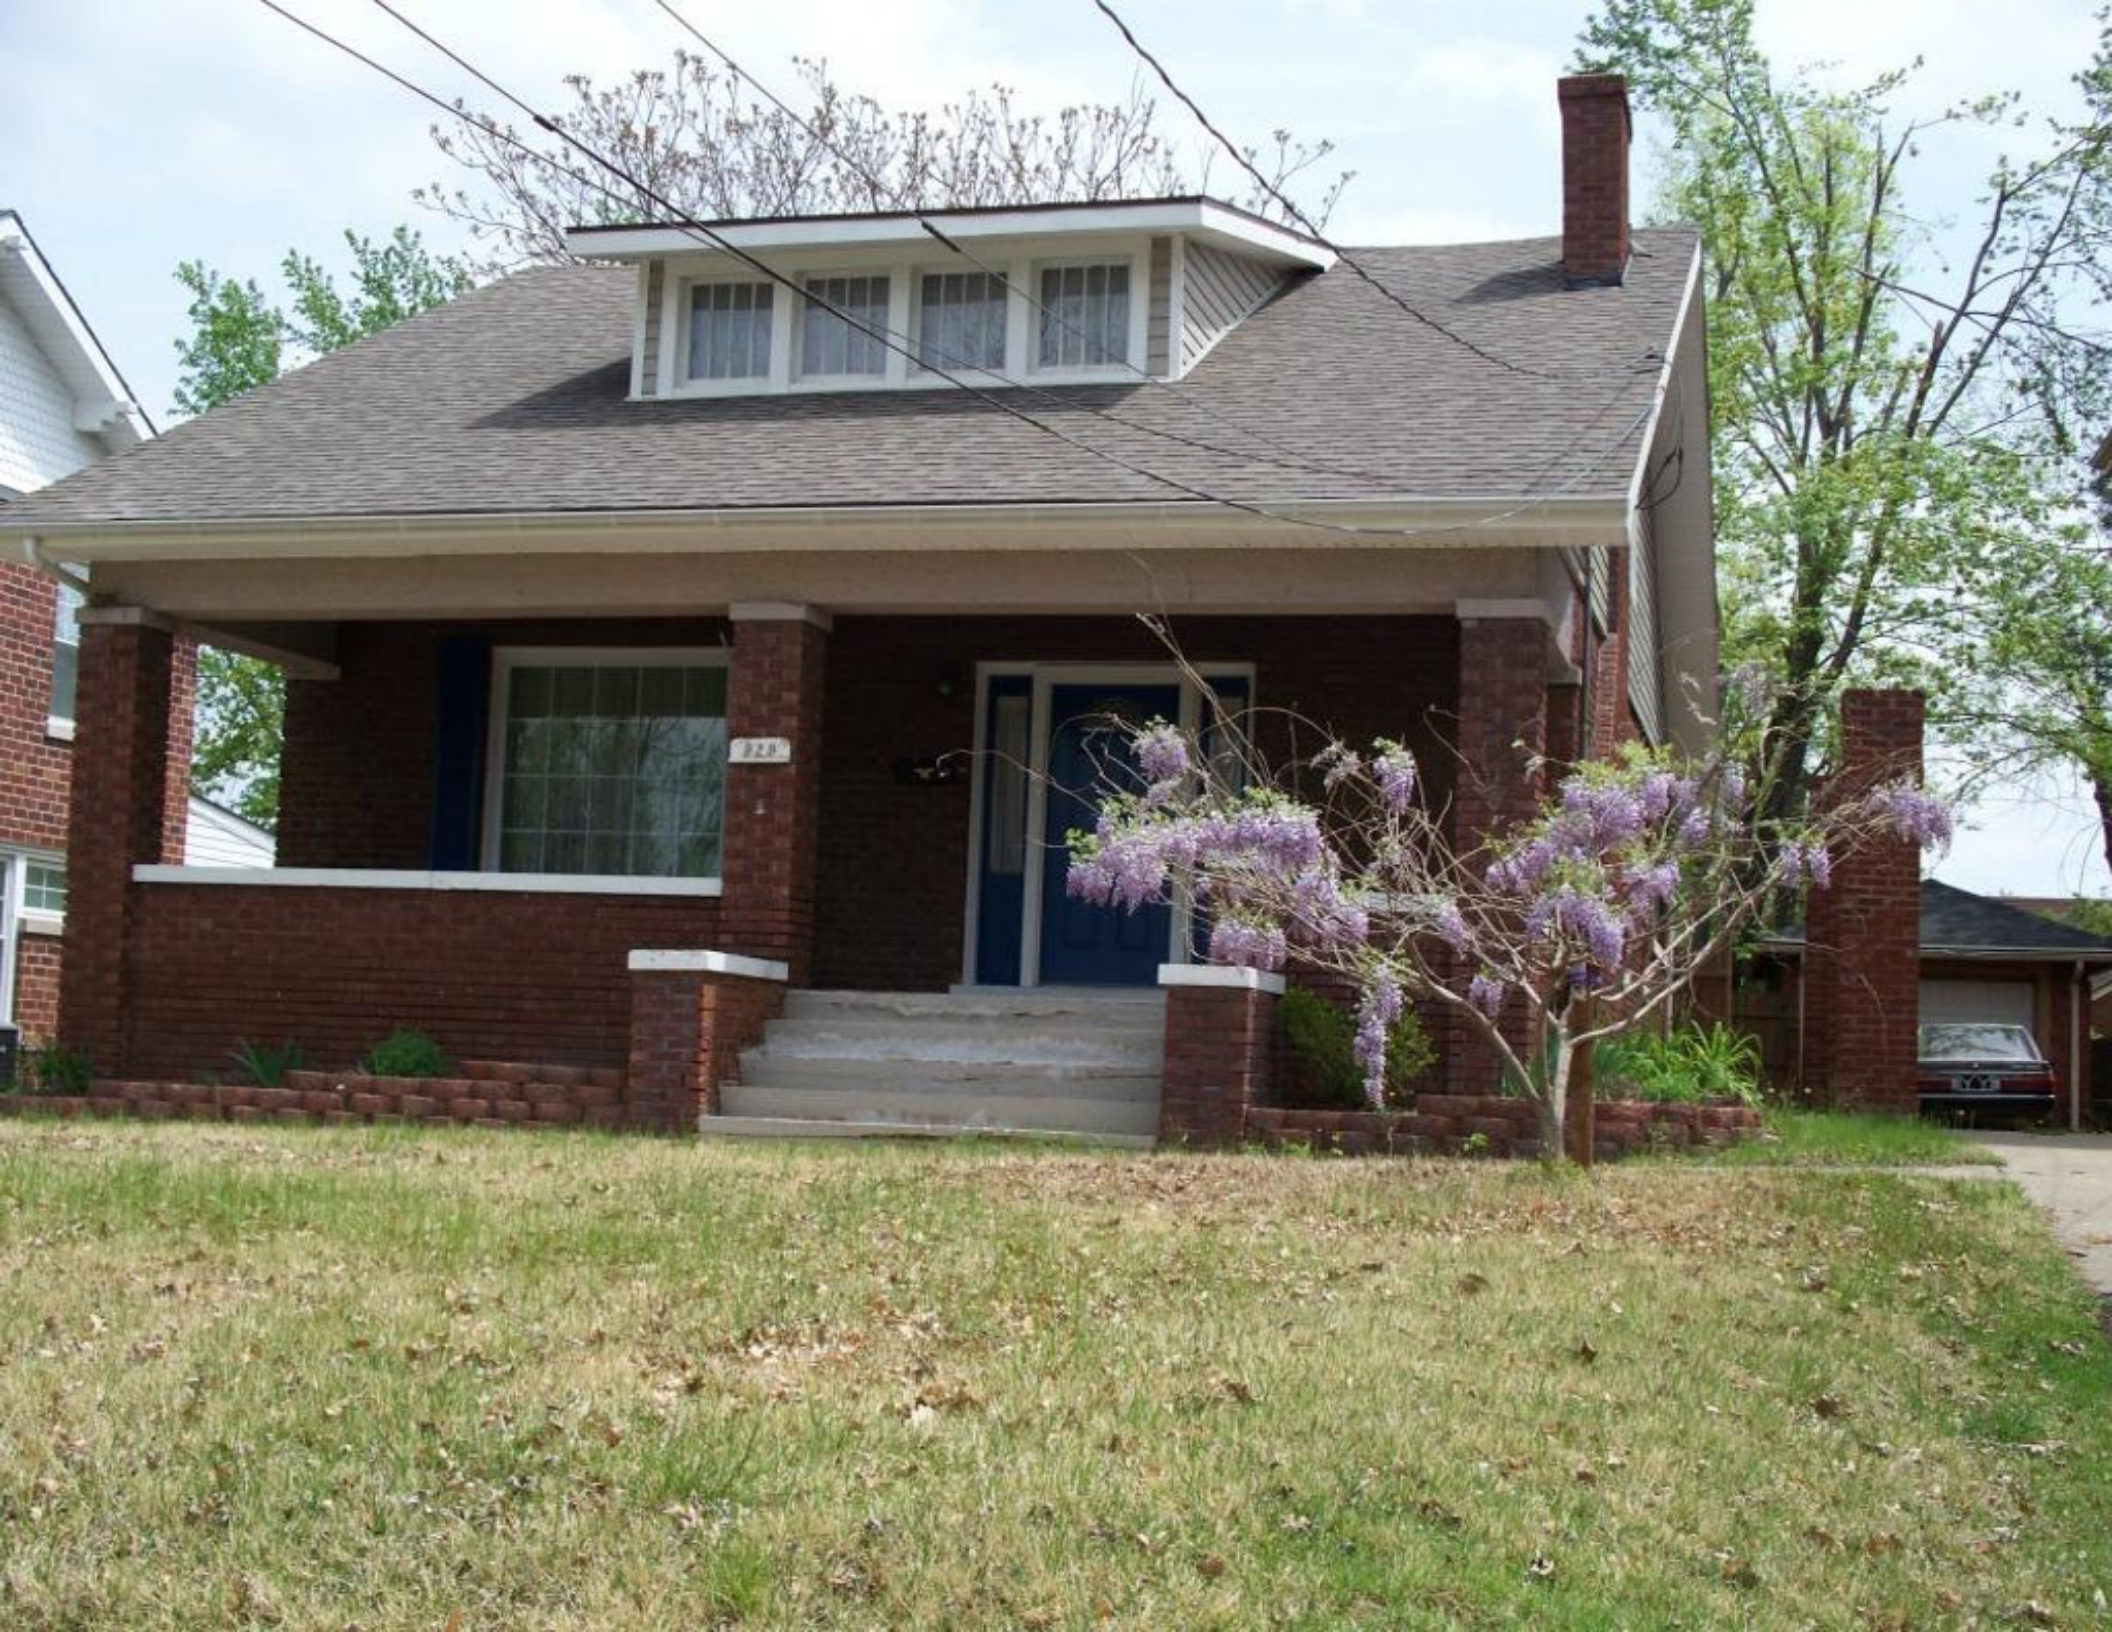
41. (cont.)
This 1 ½ story brick bungalow has a side gabled roof with a wide shed dormer with four four-light casement windows. The entrance in the right bay appears to retain its original sidelights although the door may or may not be a replacement. The left bay has a large modern multi-light casement window. The property has a full width brick porch with brick piers and half walls capped in limestone.

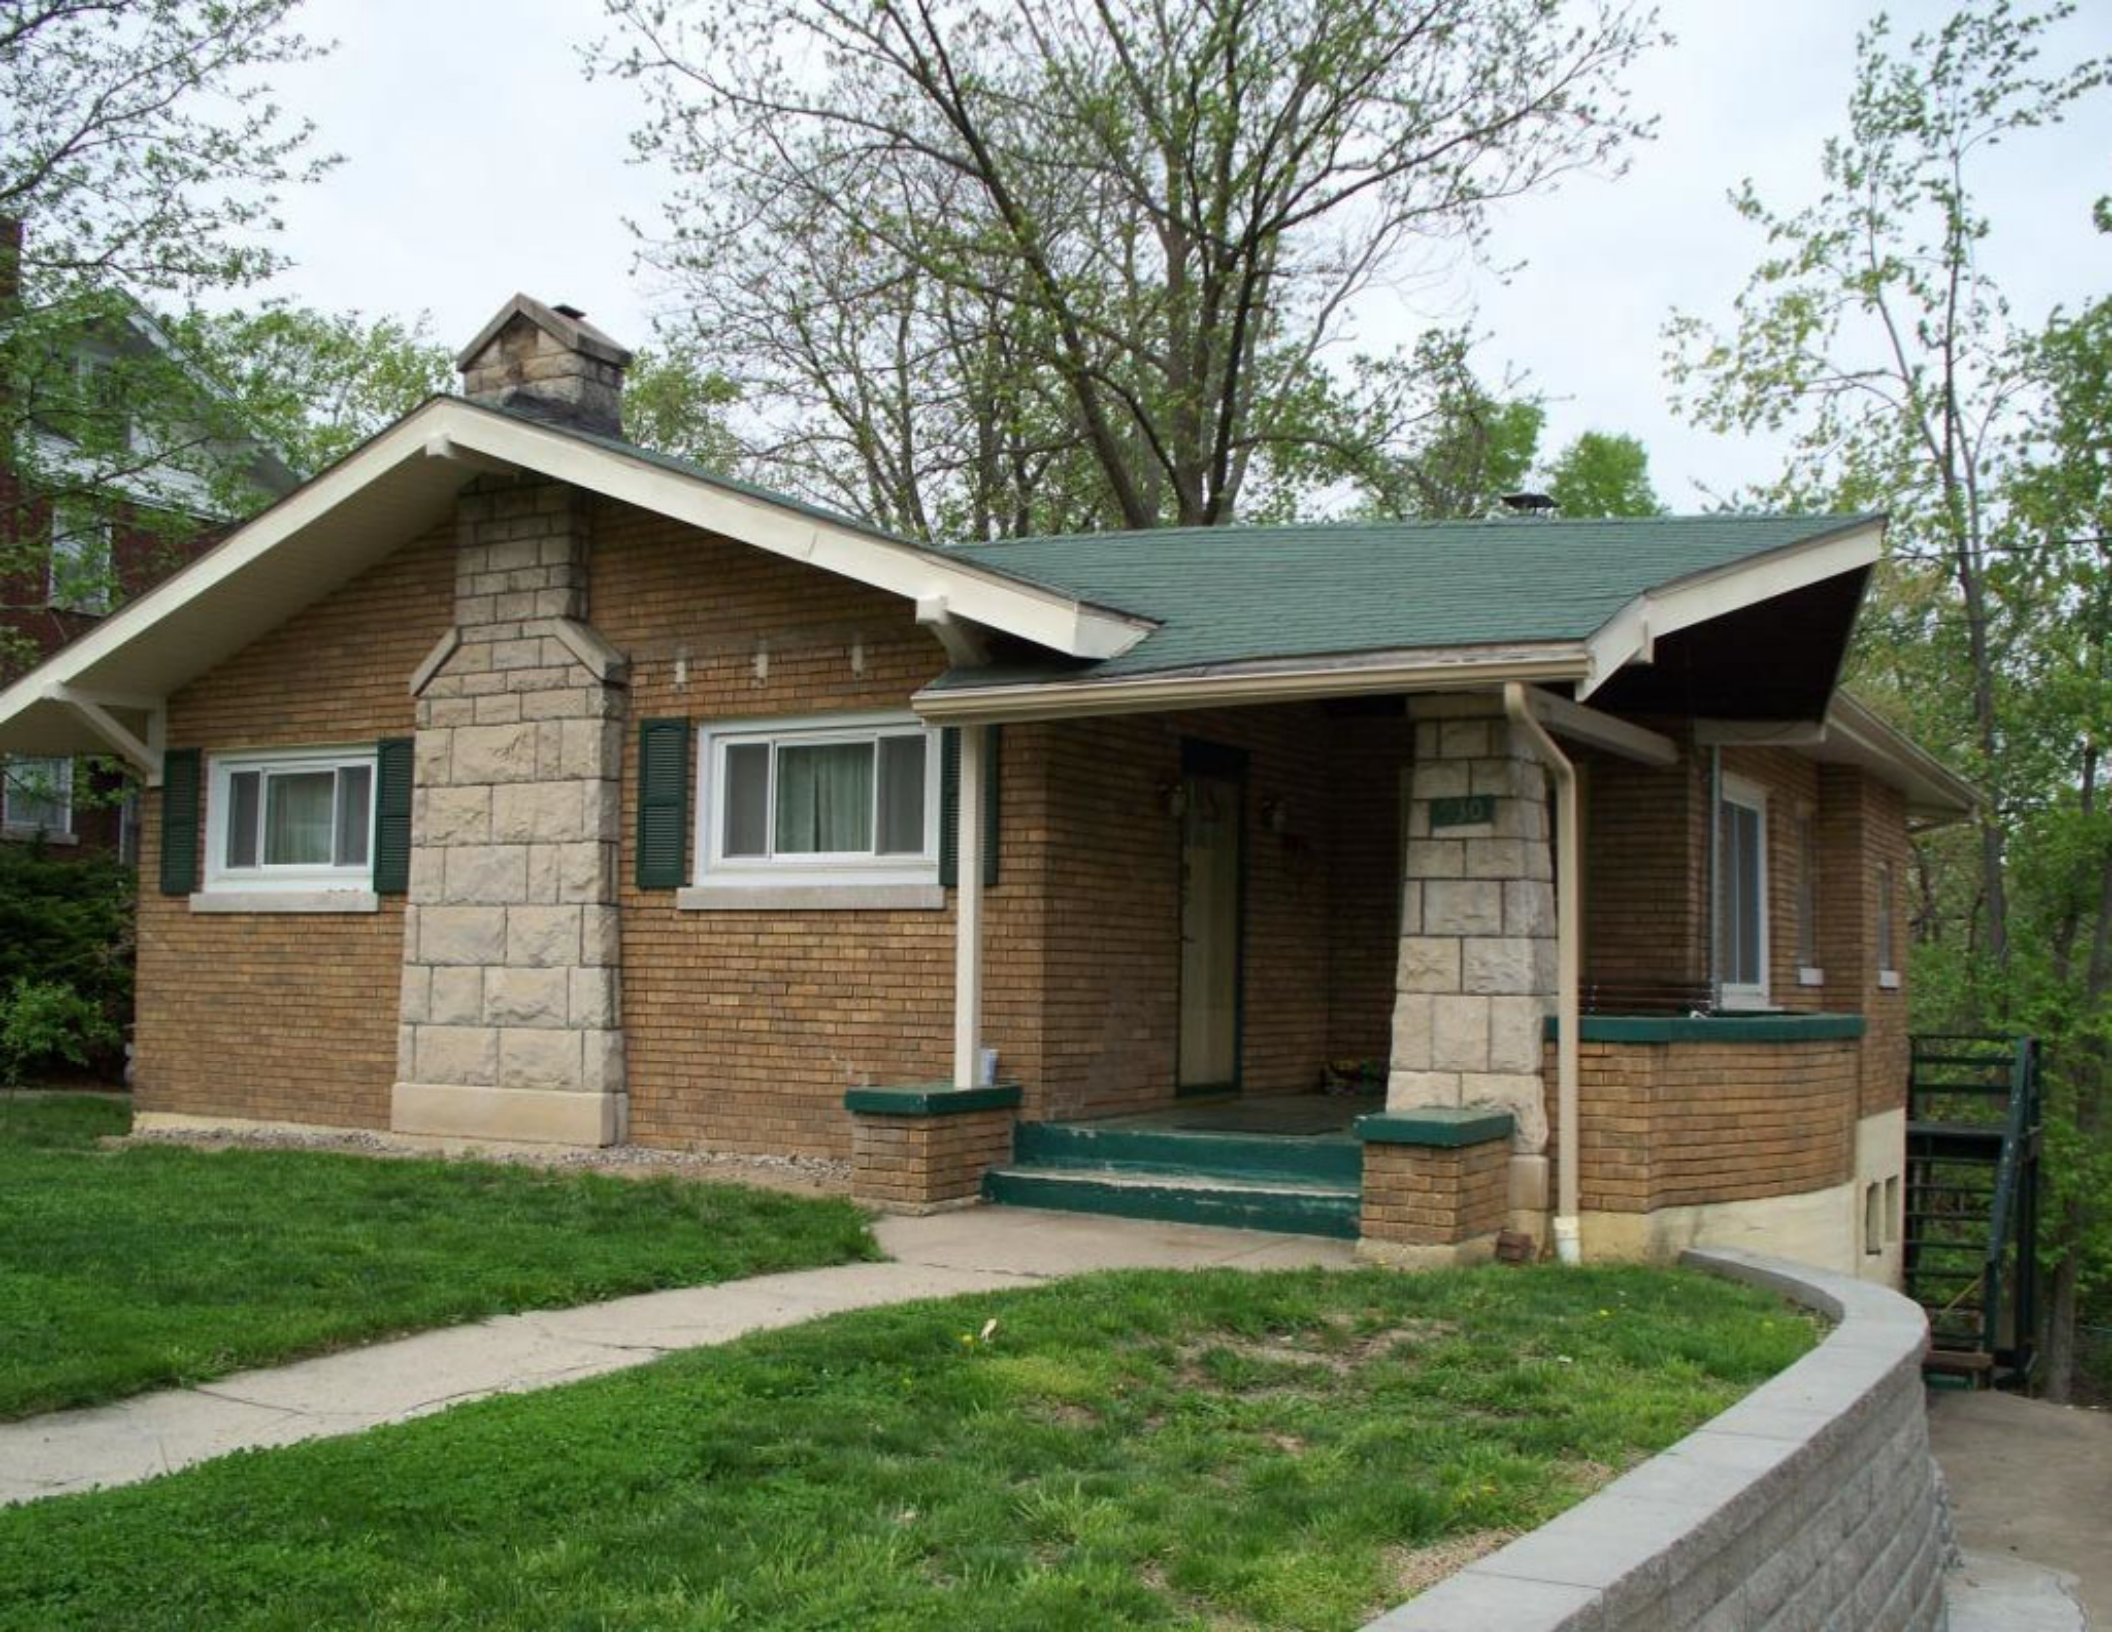
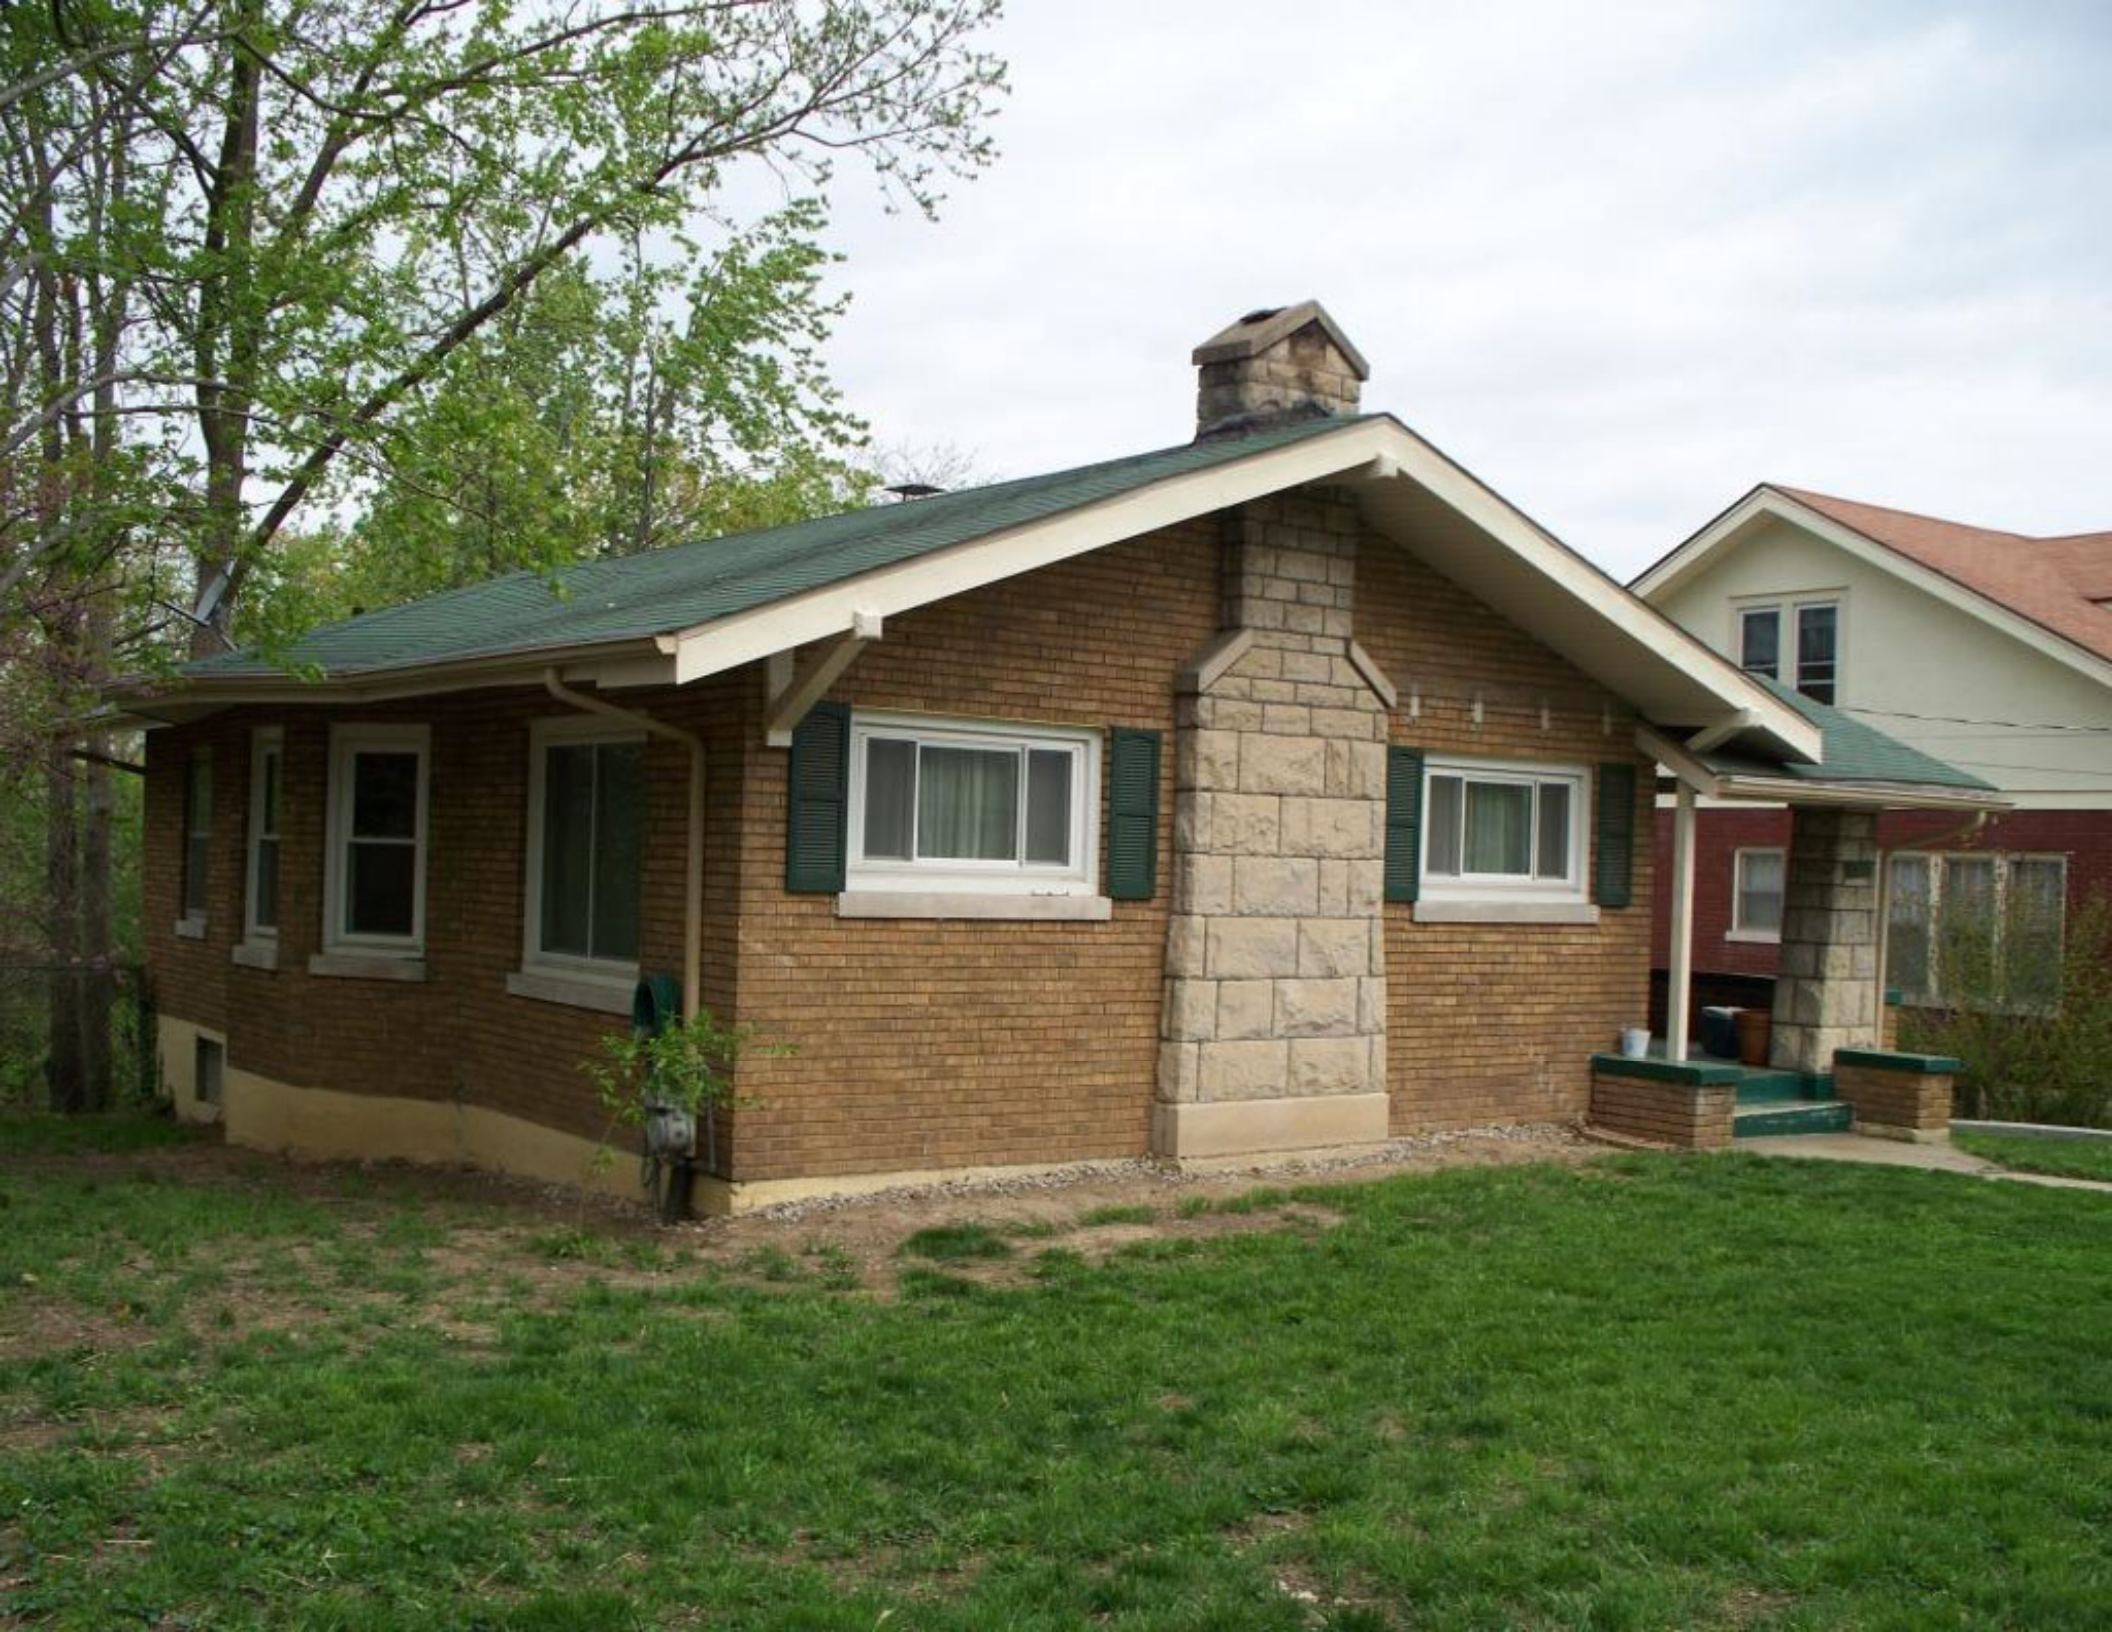
This property has a somewhat gable and wing footprint with a recessed porch situated in the seam of, and flush with, the front gable and set back wing. The front gable contains two small tri-part replacement casement windows divided by a slightly projecting chimney constructed of square rock-faced limestone. The base of the chimney has a limestone sill, which is repeated at the tapering body midway up the building and the inverted V top of the structure that pierces the large overhanging bracketed eaves. The windows have limestone sills shutters and it appears there was once something above the window in the right bay due to the shadow on the brick and what appears to be the remains of wooden brackets or braces. The porch has a single battered limestone column and brick knee walls. The porch roof projects to a point off the side of the porch and the knee wall beneath bows out and is capped with limestone. The entrance is in the side of the gabled portion of the building. While probably not individually eligible due to the replacement windows, the property is nonetheless an excellent example of a Craftsman bungalow.

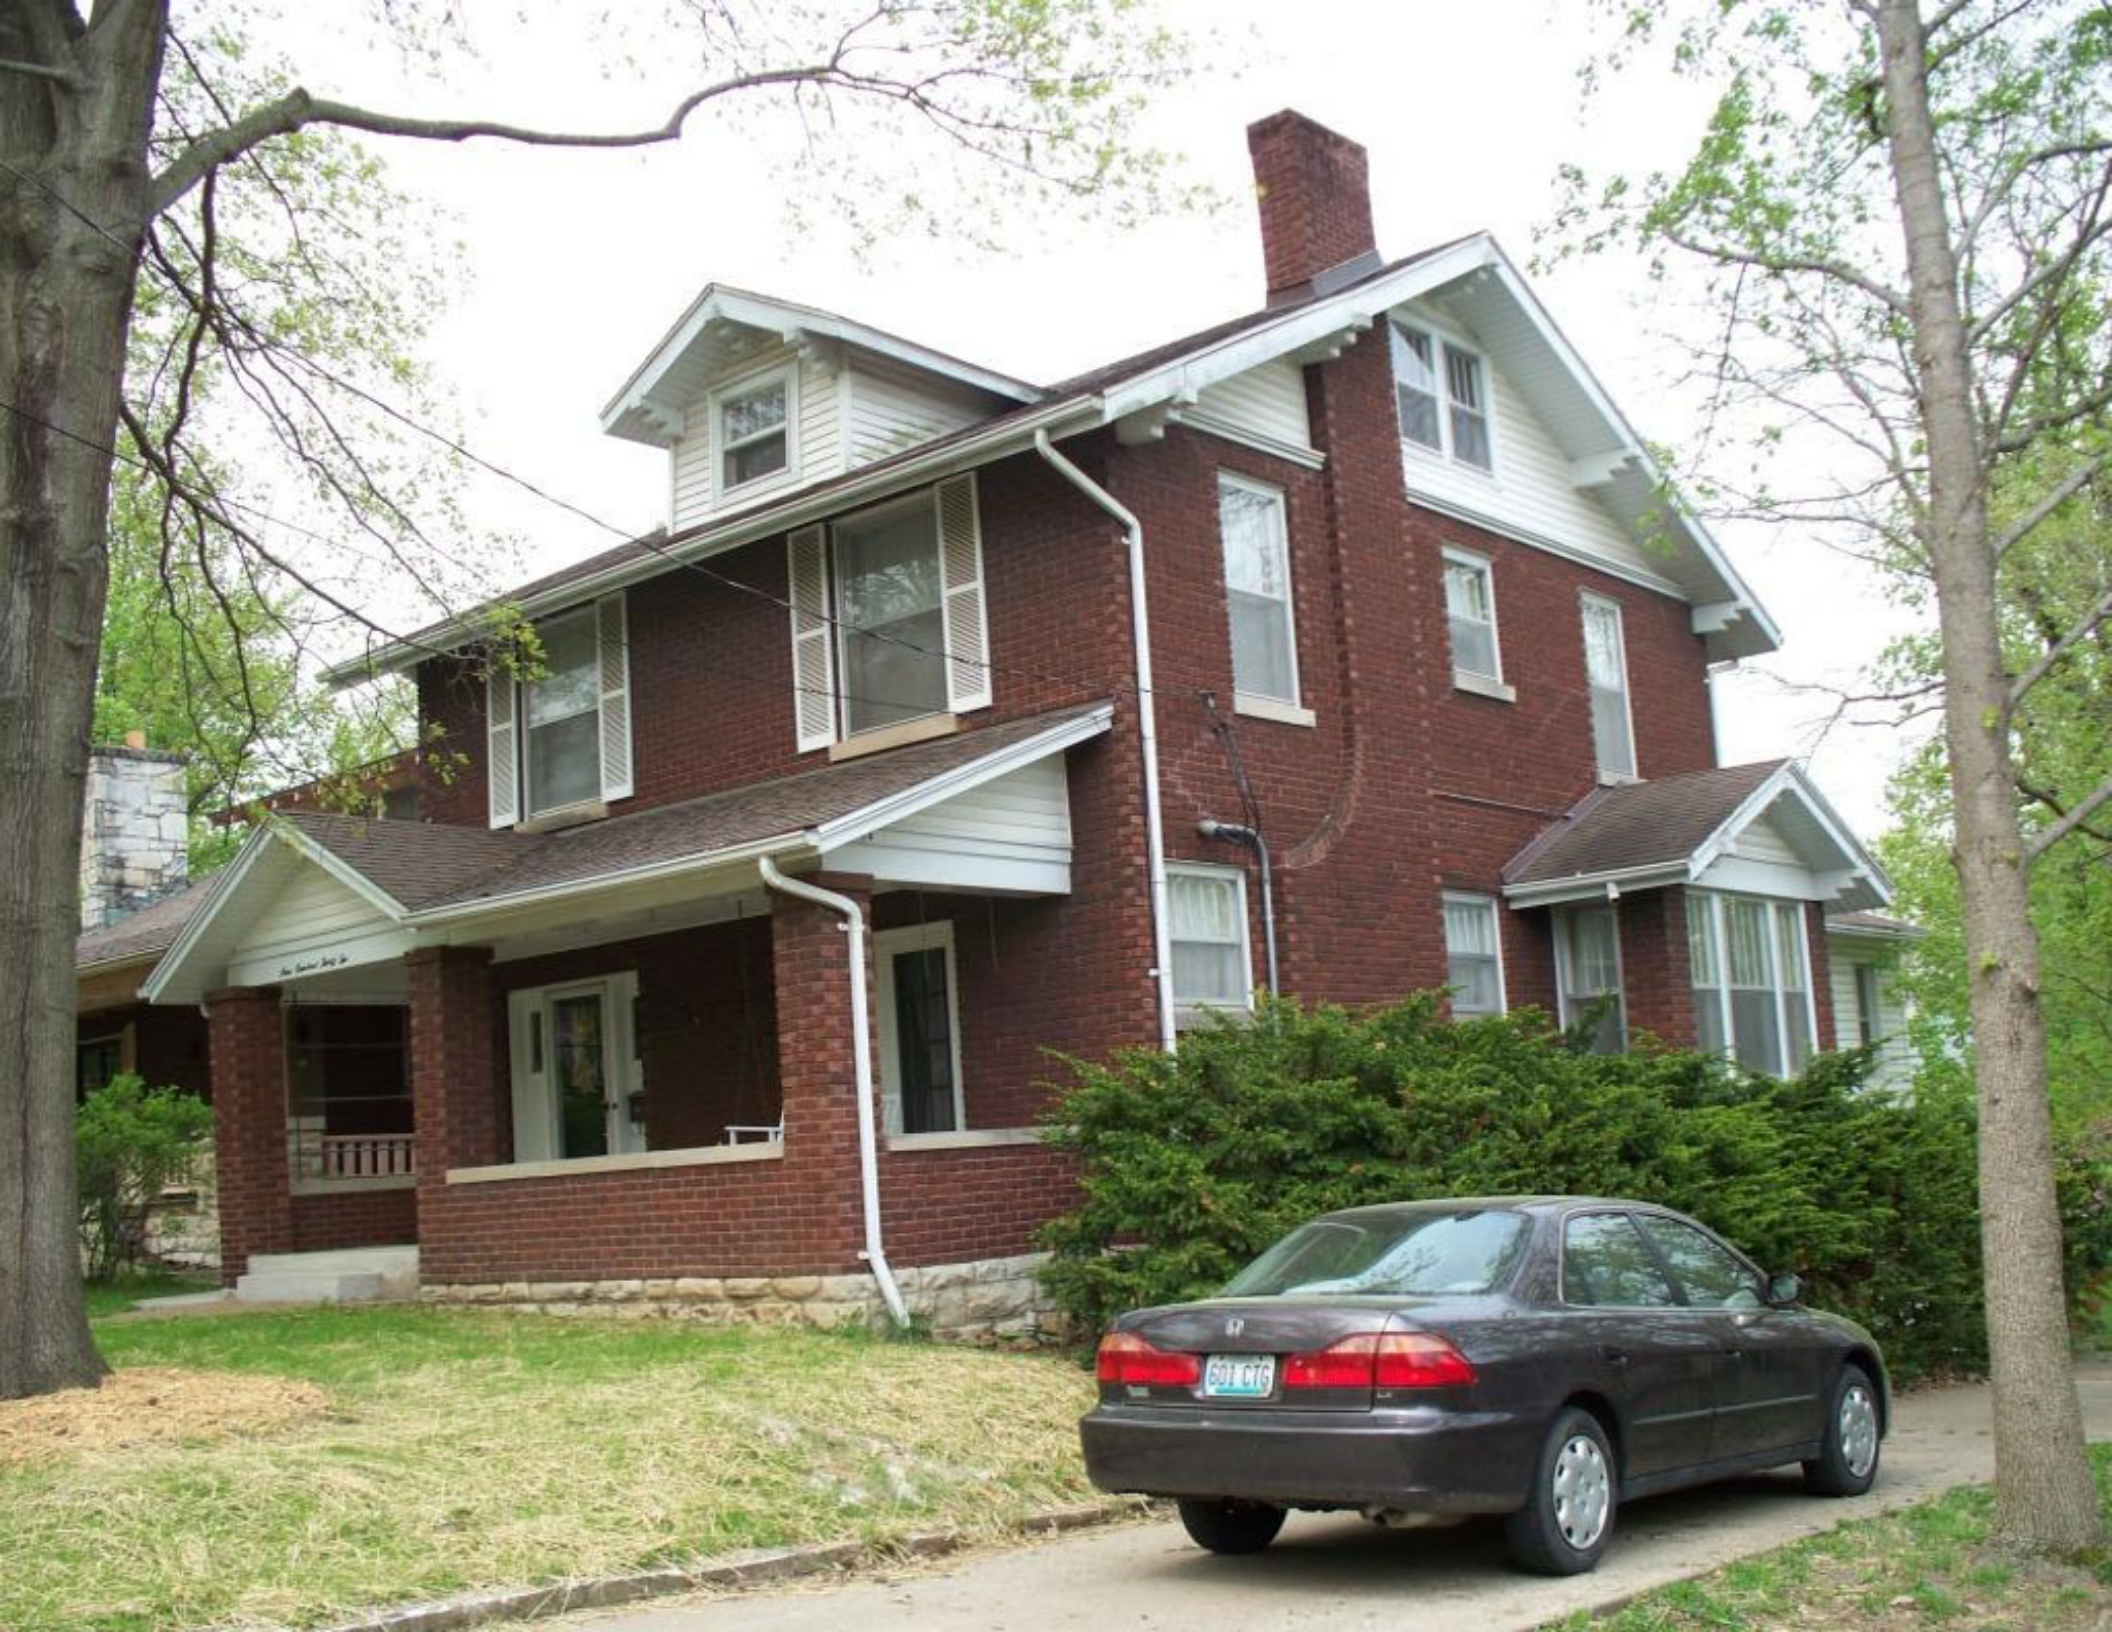
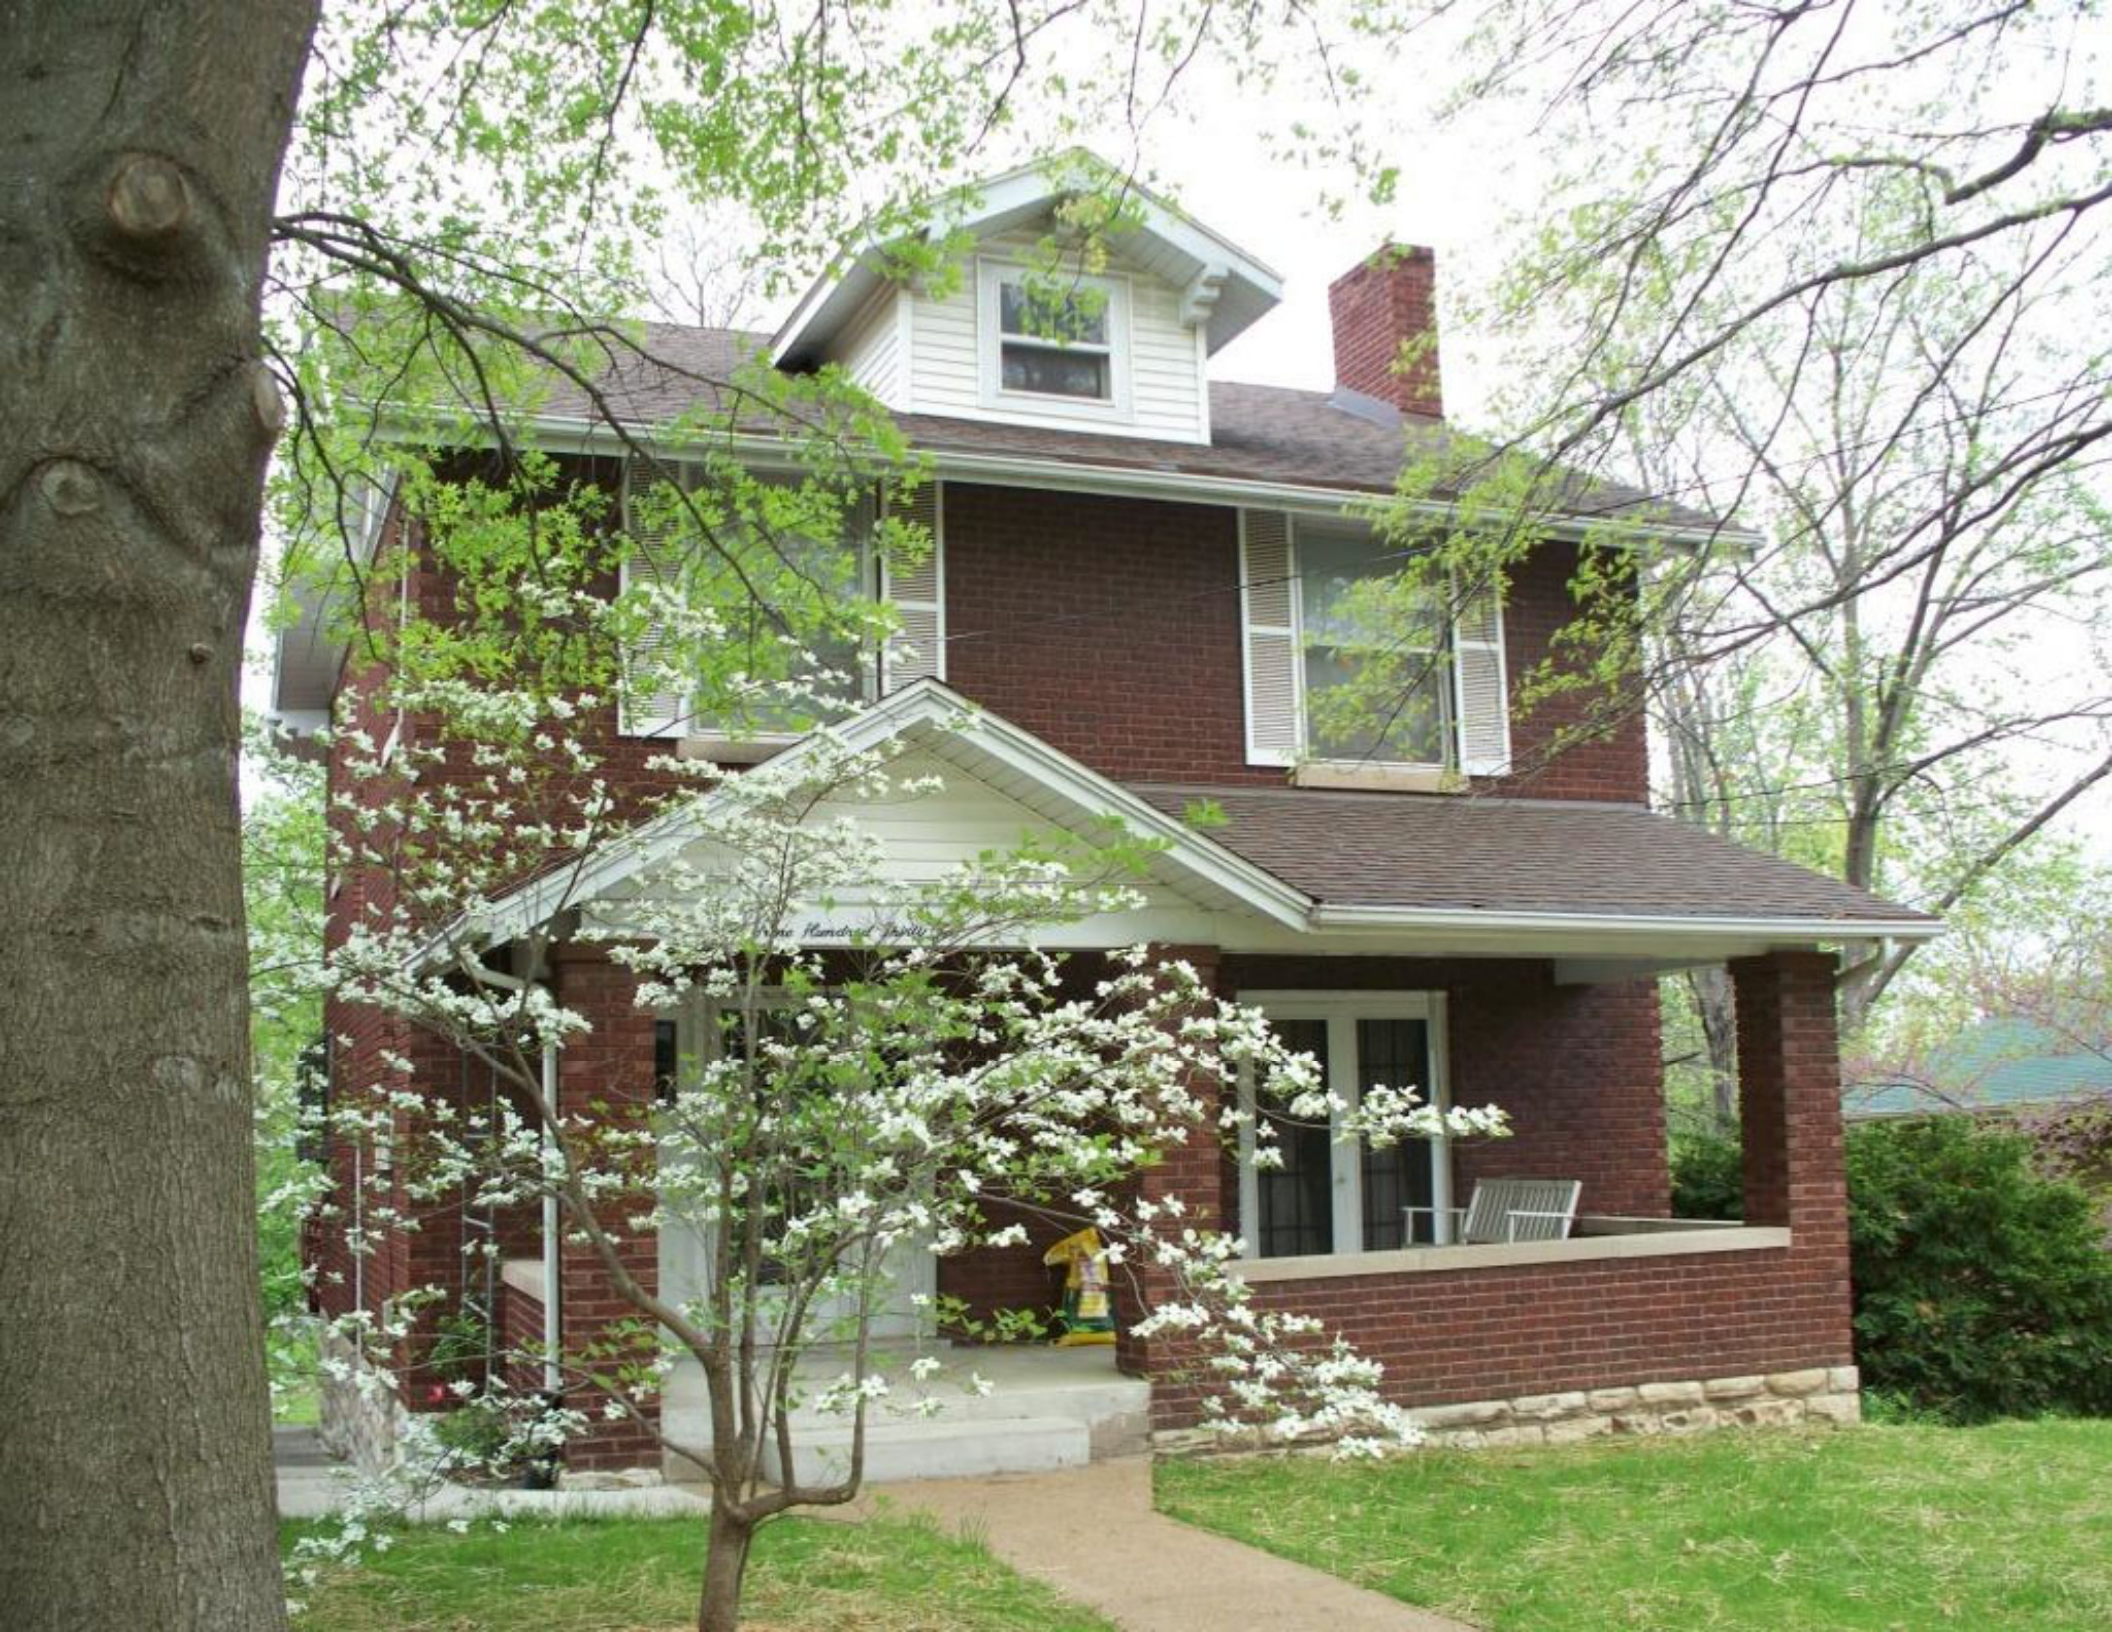
This brick four square is two and a half stories tall and has a gabled dormer in the center of the side-gabled roof. The dormer has been resided with vinyl but the trim around the historic 4/1 window was left exposed. The dormer has jigsaw brackets as does the gabled portions of the roof. The brick is laid in a running bond that interlocks at the edges of the building, window openings, and the chimney, which creates visual interest. The second floor has two historic 5/1 windows with shutters and limestone sills. The full width porch has a shed roof and a gable portion clad in vinyl over the entrance. It features a brick knee wall and square columns. The main entrance is in the left bay and features sidelights. The right bay has a double door mulit-light second entrance that is likely original to the house as several other four squares in this neighborhood have this feature.
