ARCHITECTURAL/HISTORIC INVENTORY FORM

1. Survey No. CO-AS-005-001		2. Survey name: Moreau Drive Neighborhood Survey	
3. County: Cole		4. Address: 1202 Elmerine Ave.	
5. City: Jefferson City	Vicinity: <input type="checkbox"/>	6. UTM: / /	7. Township/Range/Section: T: R: S:
8. Historic name (if known):		9. Present/other name (if known):	
10. Ownership: <input checked="" type="checkbox"/> Private <input type="checkbox"/> Public		11. Historic use (if known): Residential	11. Current use: Residential

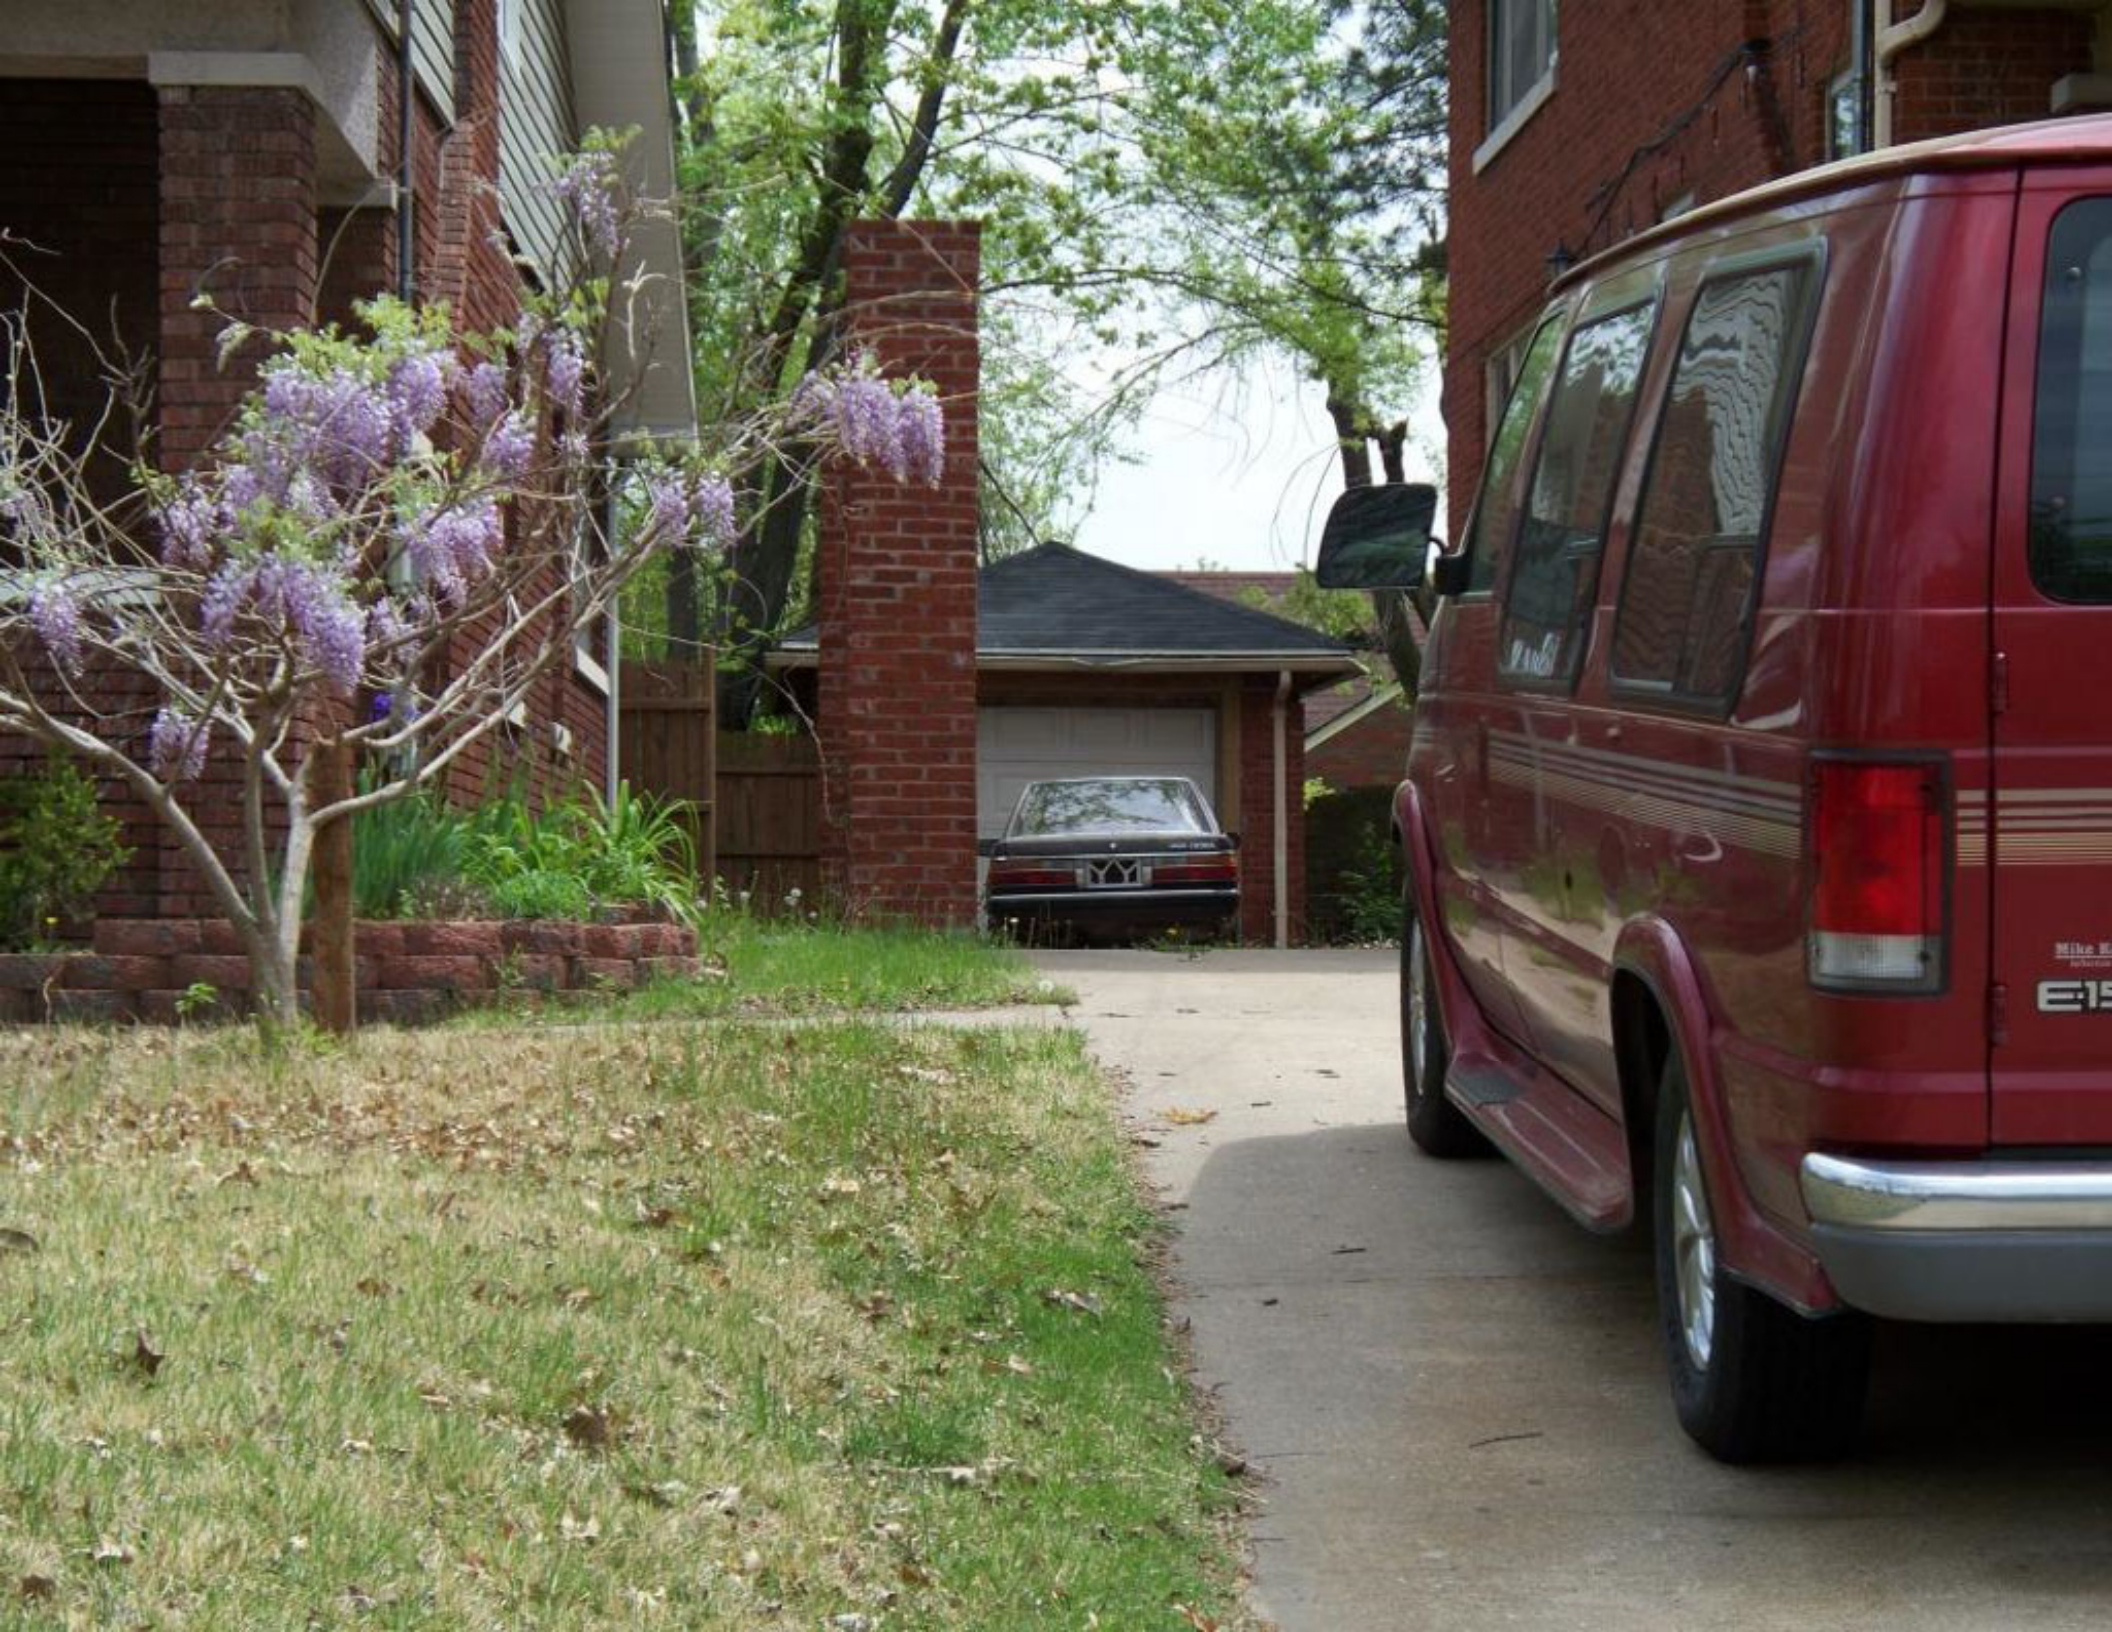
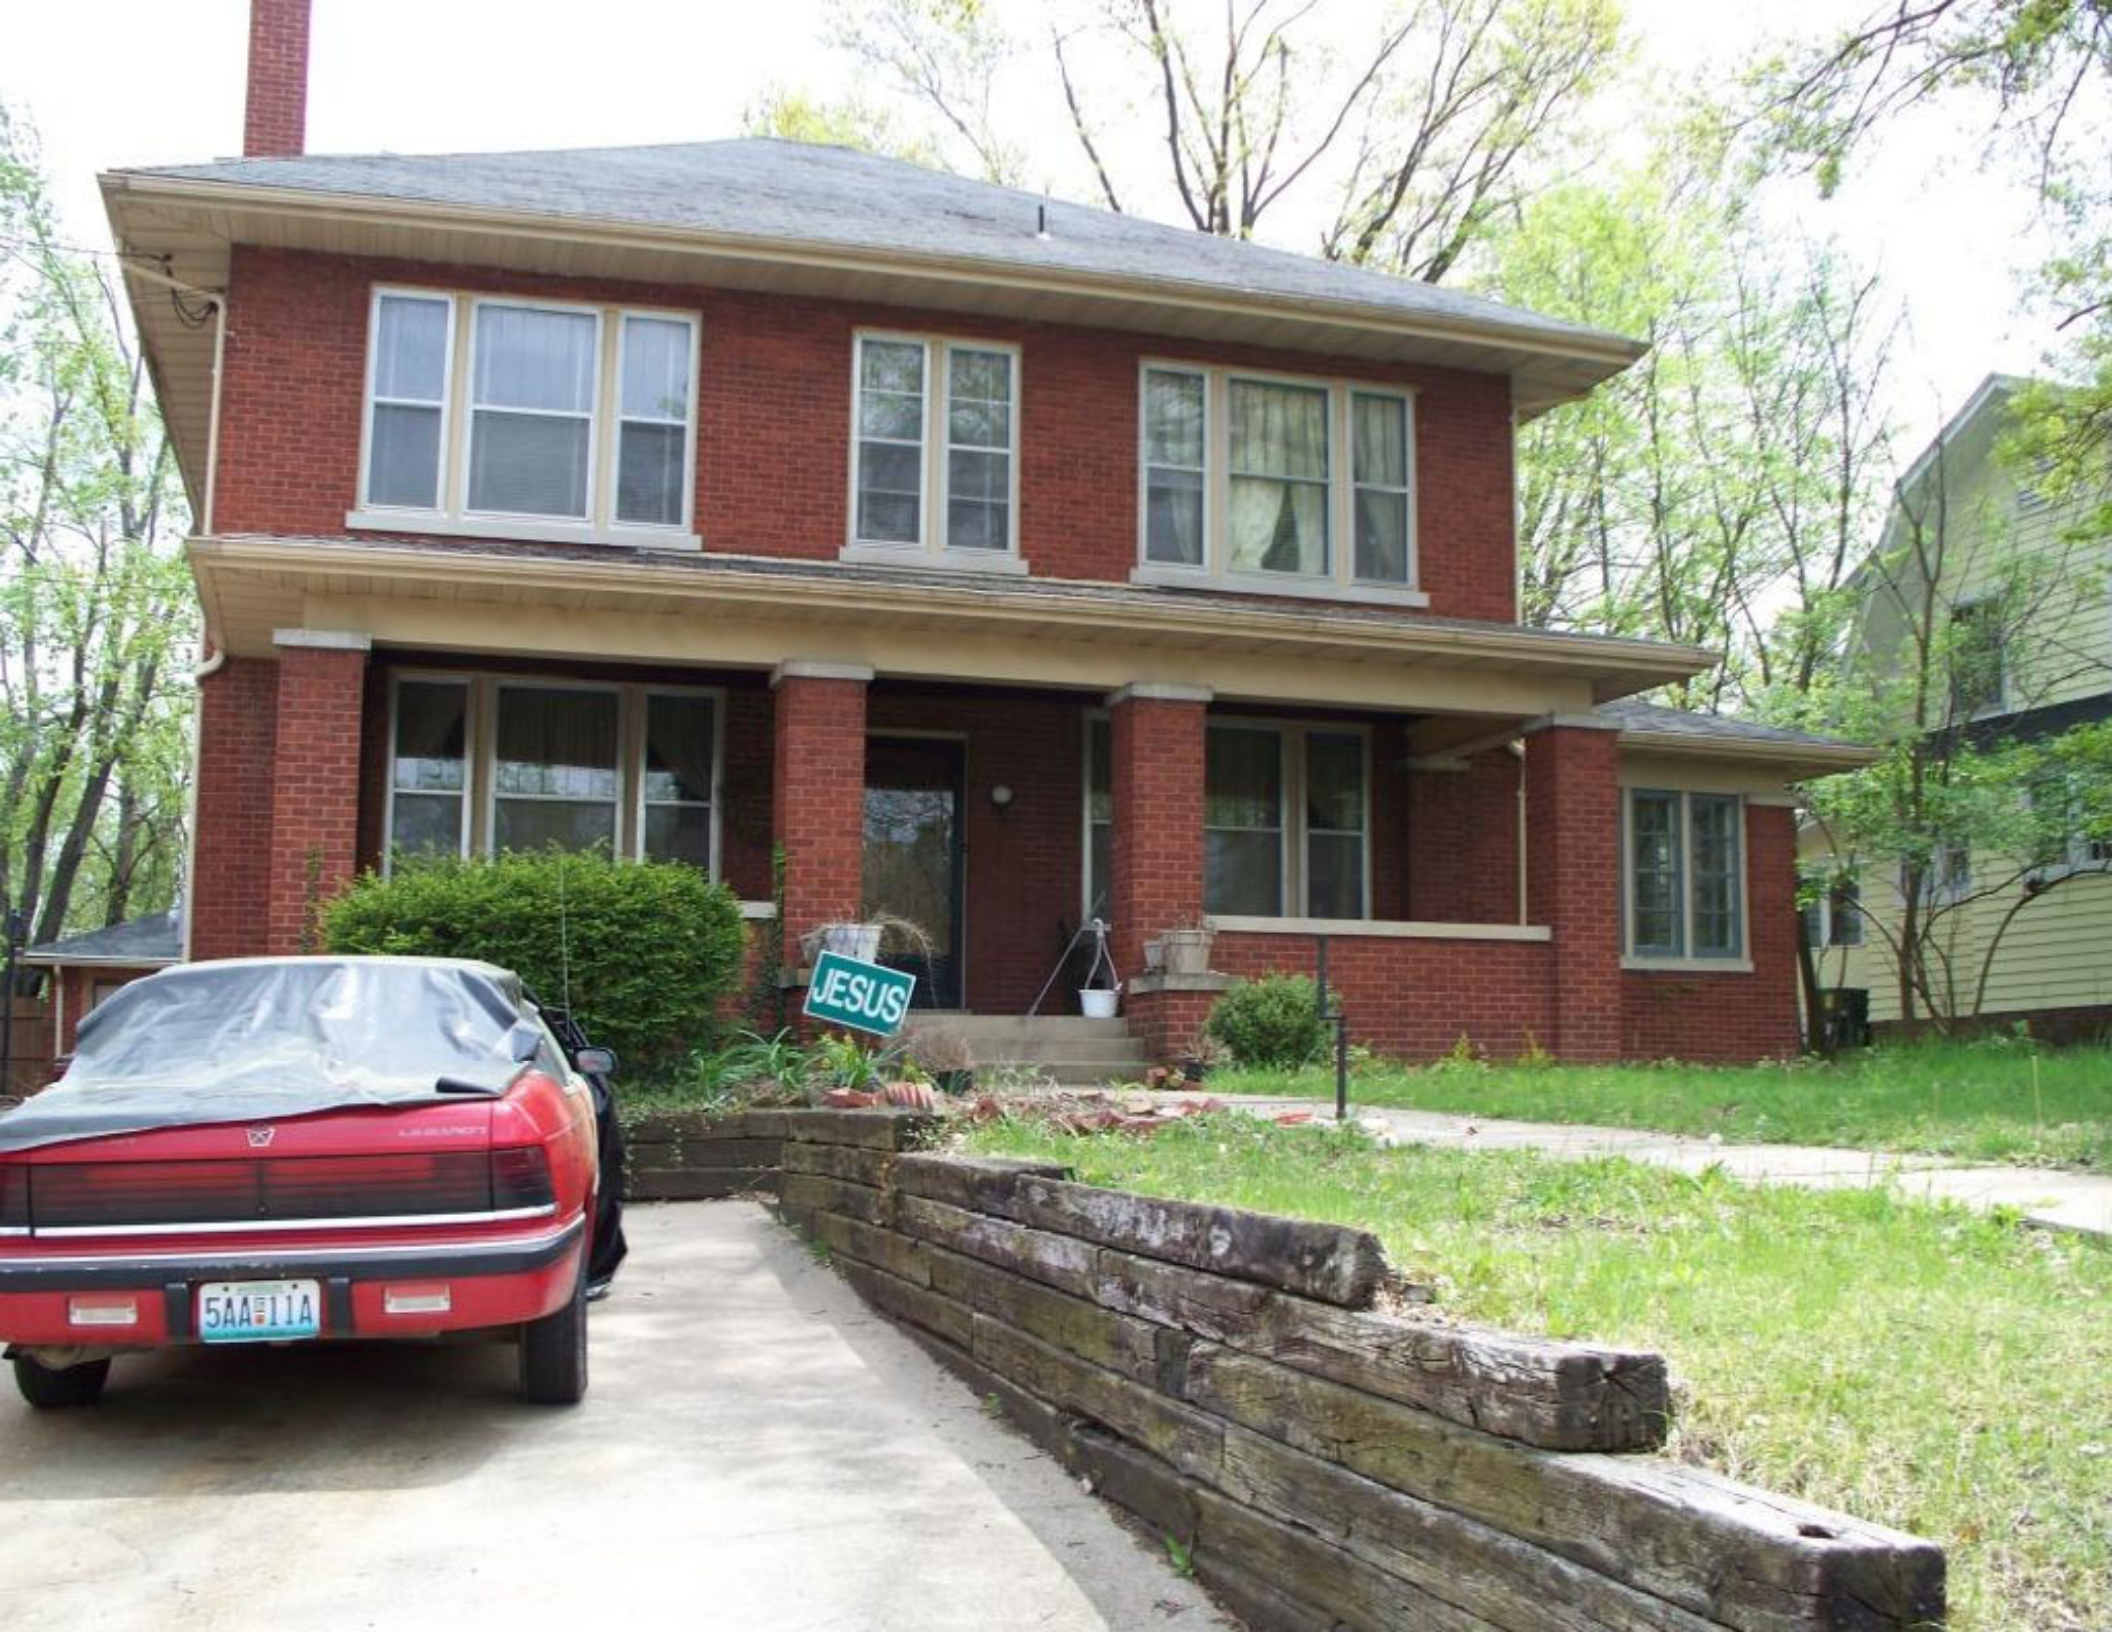
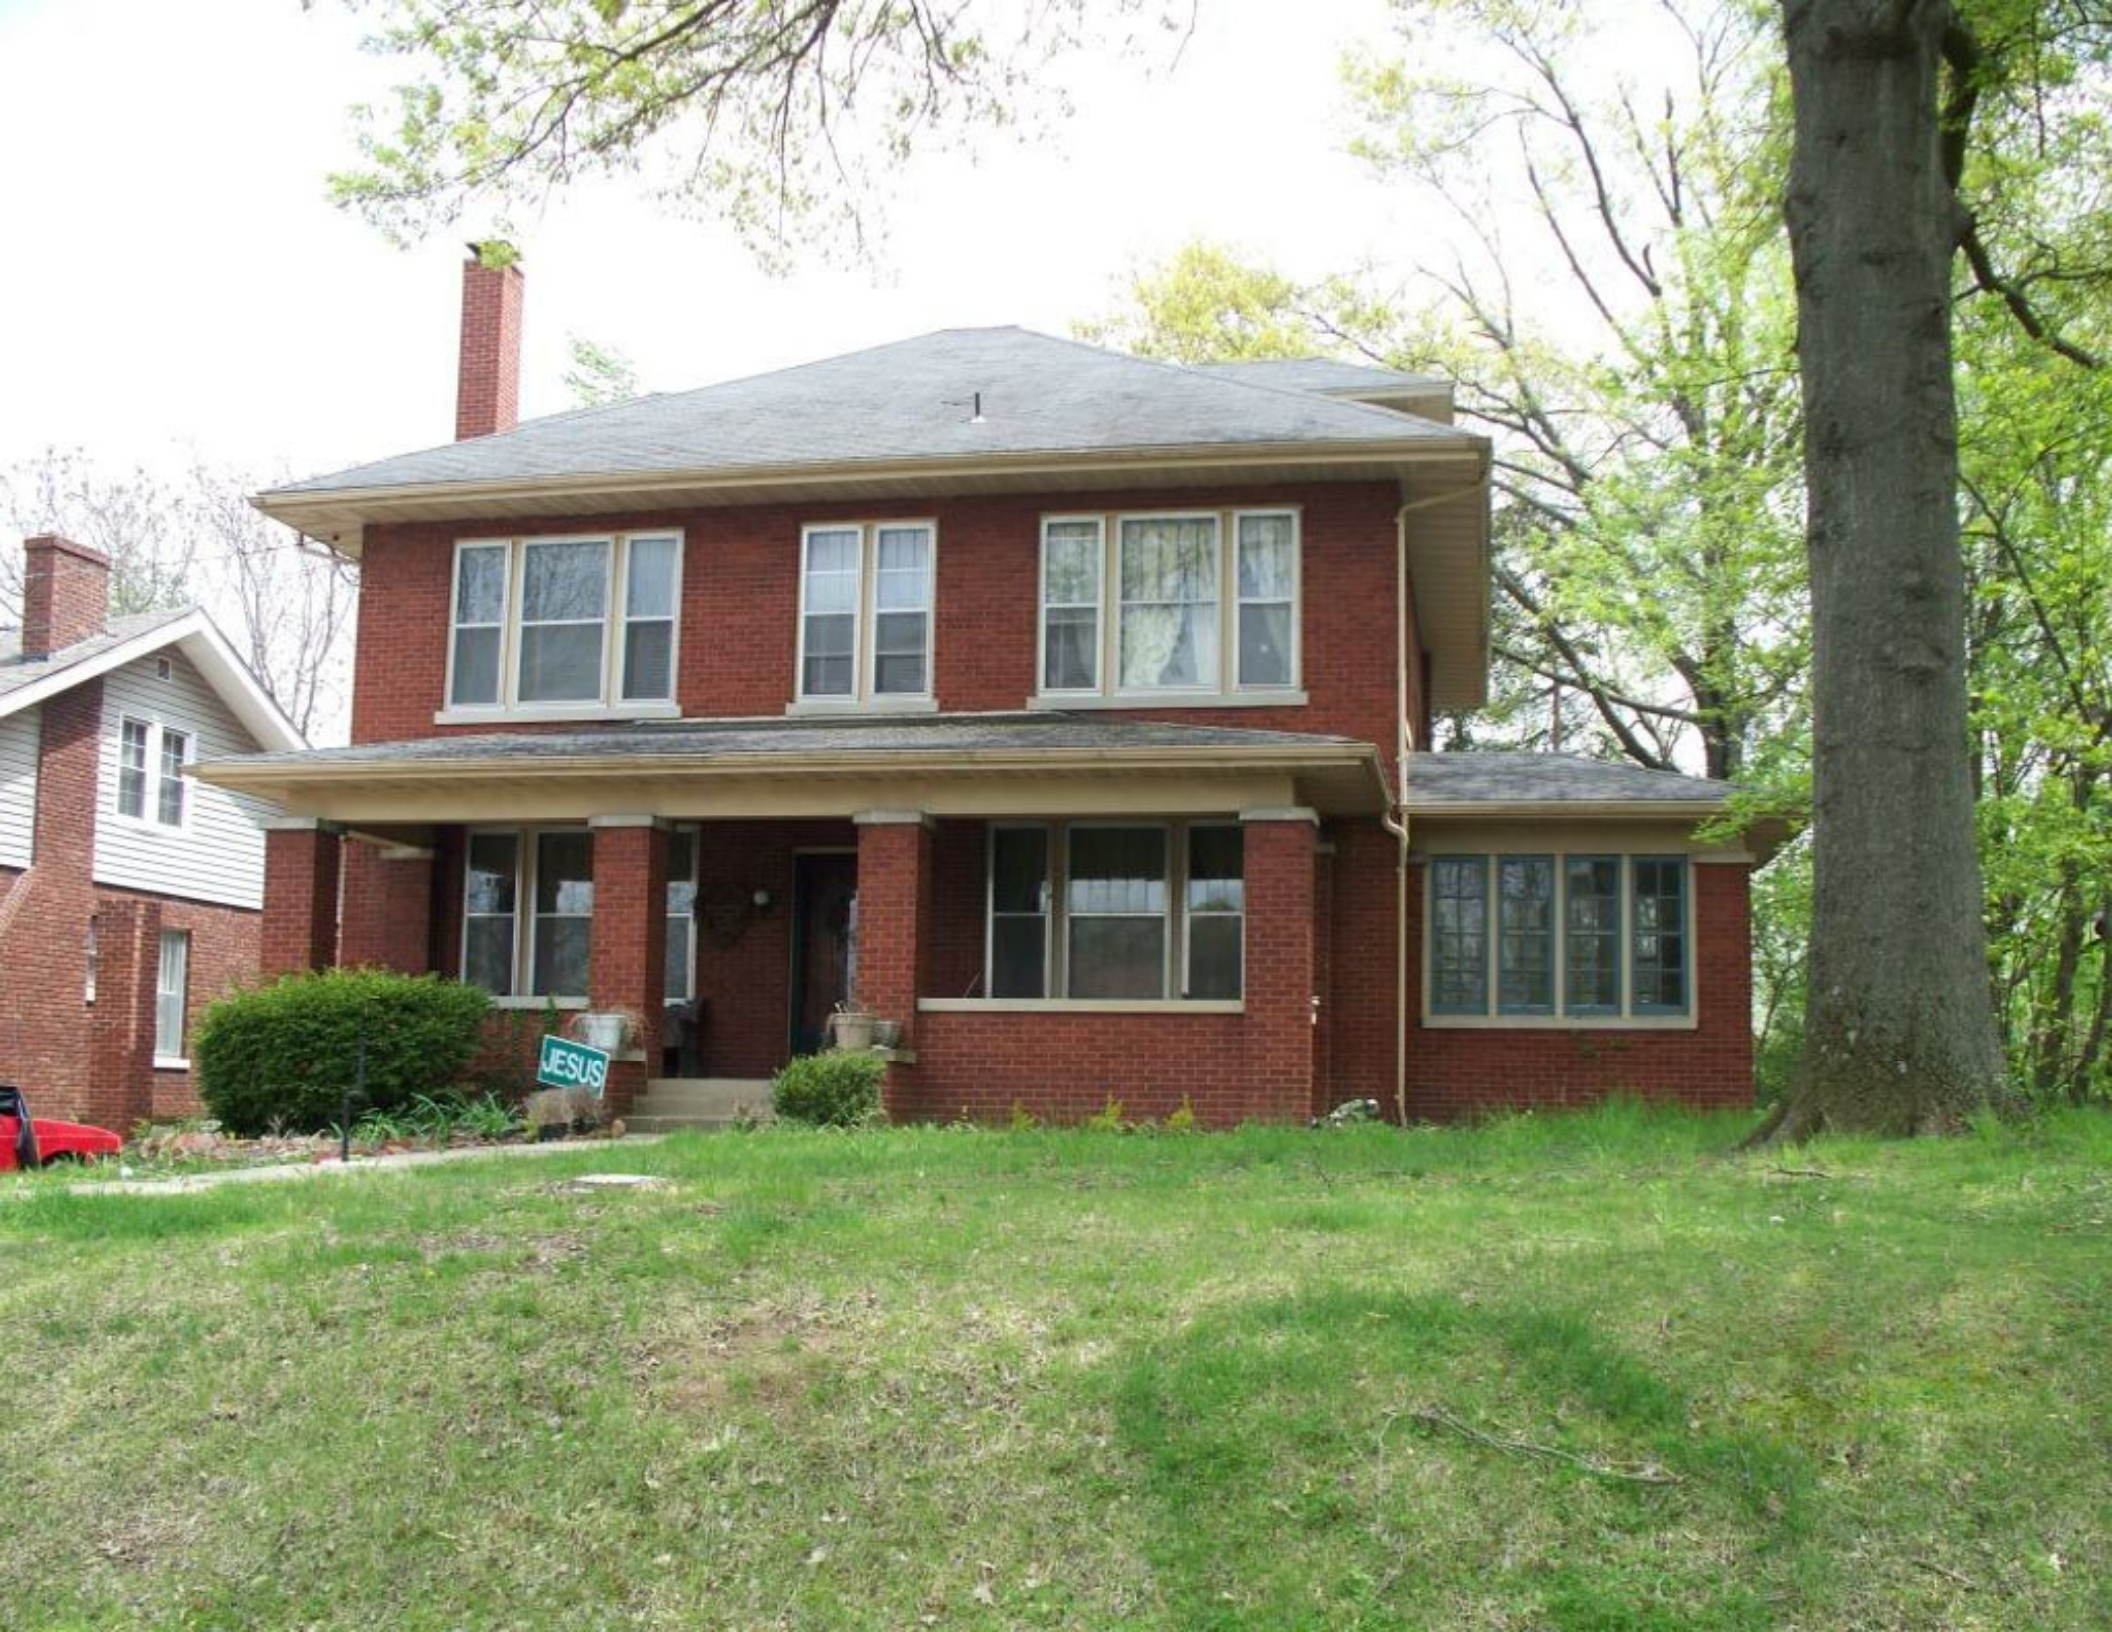
41. (cont.)
This two story brick home has a hipped roof with wide eaves. The second floor has two historic tri-part windows that flank a pair of windows that appear to be historic 3/1 (the storm windows obscure view). The tri-parts are 3/1 flanking 5/1; identical windows are placed directly below on the first floor, separated by the porch roof. All of the windows have storms and concrete/limestone sills. The porch roof also has wide overhanging eaves and with the placement of the windows suggests some Prairie influence. However, there also appears to be some Colonial Revival influence due to the massing and symmetrical fenestration. The entrance is centrally placed and appears to retain its original door. The porch covers the first three bays (all but the sunroom) and features brick piers and knee walls capped in limestone/concrete. The fourth bay (far right side) is a one-story sunroom with a hipped roof and wide eaves with four tall multi-light windows that appear to be historic.

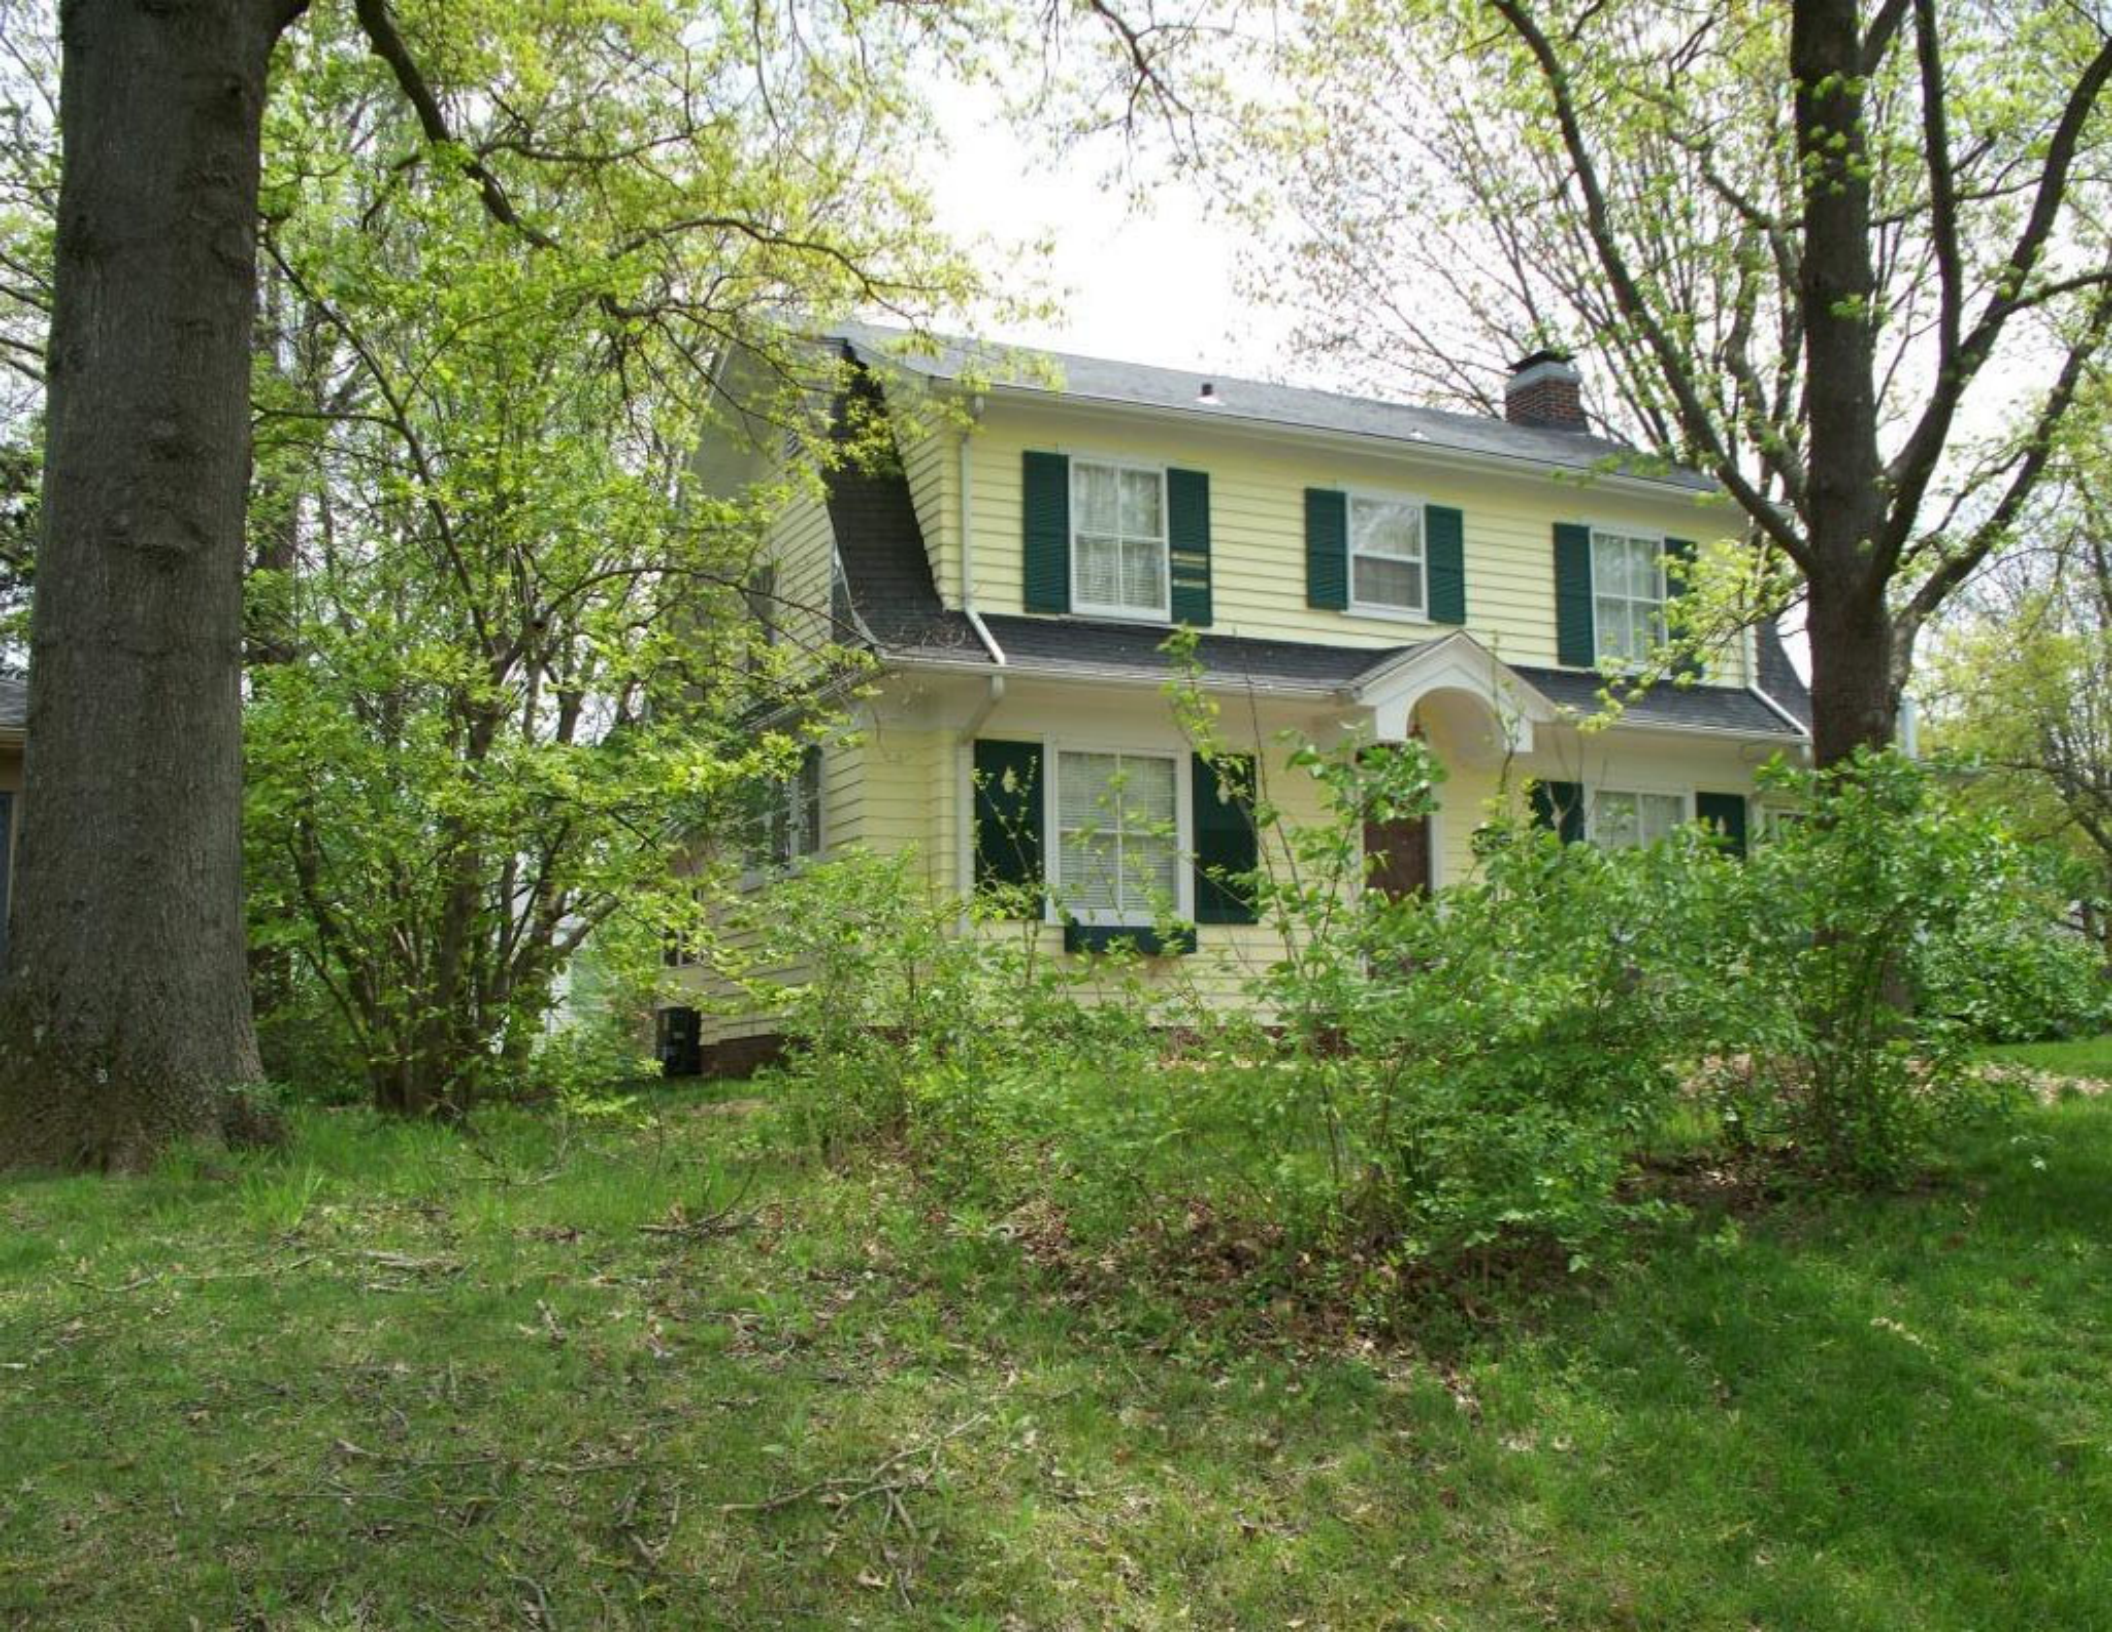
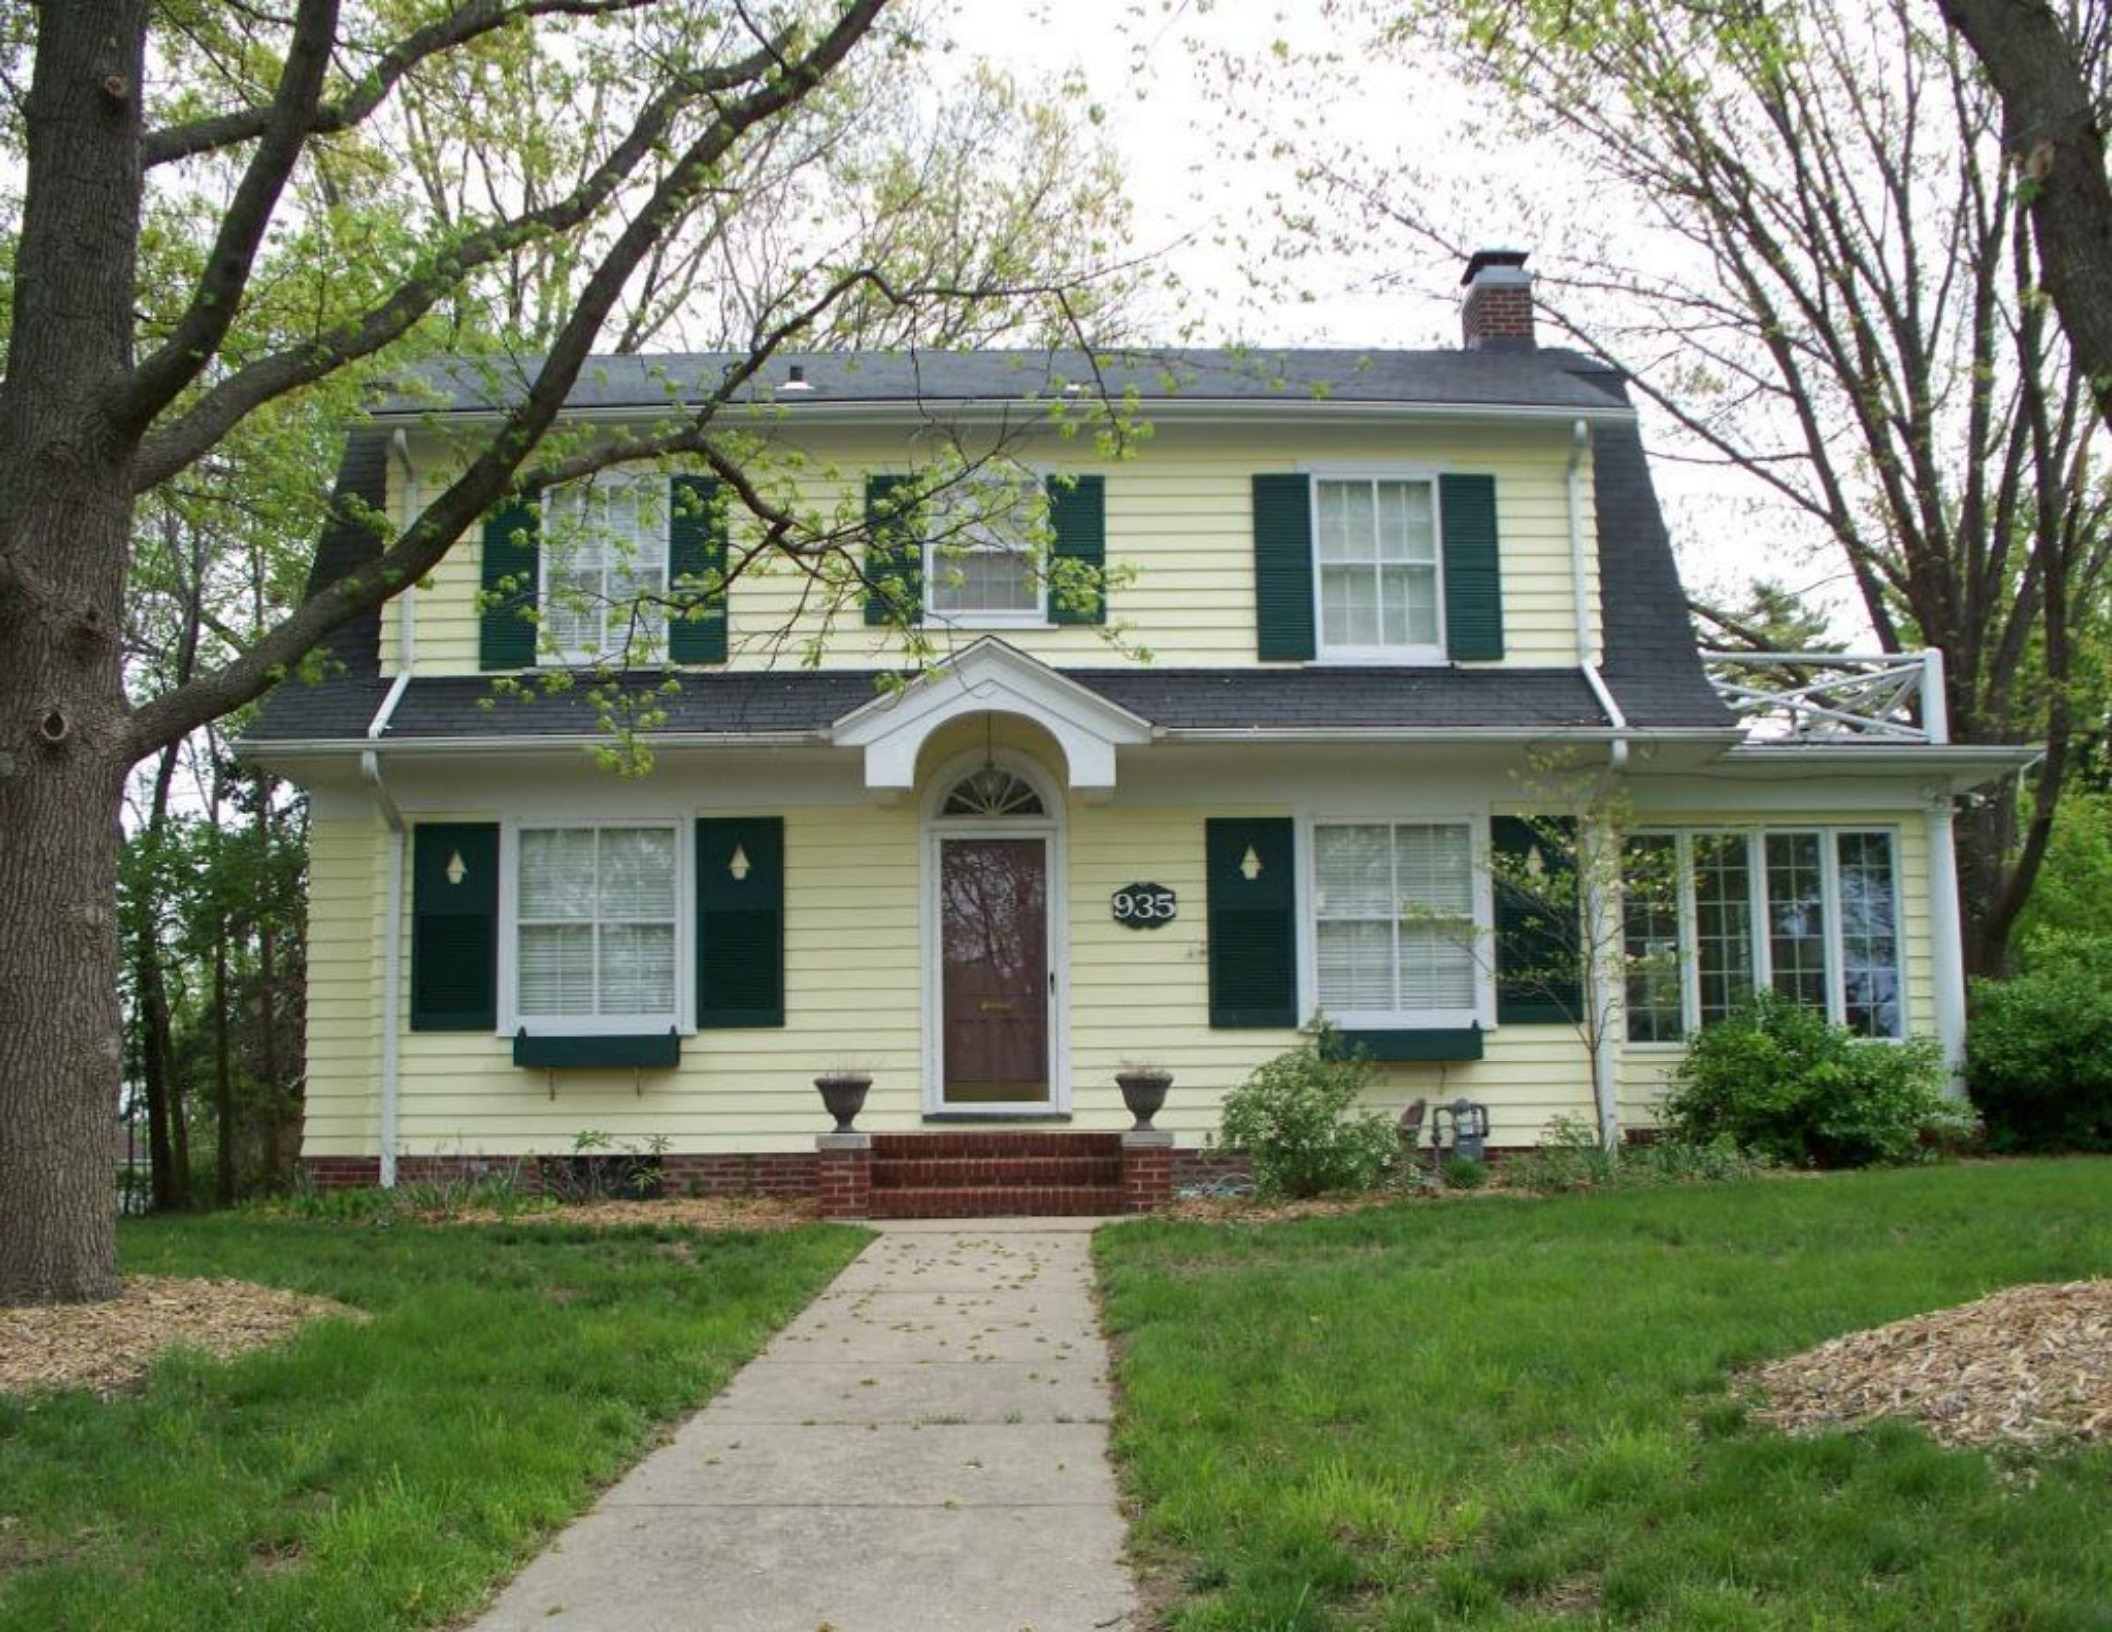
935

41. (cont.)
This two story home has a side-gambrel roof with a continuous dormer with two 8/8 windows flanking a smaller 8/8 window. All of the windows on the property have shutters and storms and appear historic. The first floor has two wider 8/8 windows flanking the entrance. The shutters for these windows feature decorative cut-outs and flower boxes. The central entrance (door may or may not be historic, obscured by glass door) retains the original fanlight above. The upper and lower stories are separated by the eave of the side gambrel roof, over the entrance the eave is broken by a gabled hood with a large arched cornice. A small brick stair serves as a stoop. Slightly recessed from the central façade is a one-story sunroom with wide eaves and decorative wood railing on the roof. There are four multi-light casement windows in this bay that appear to be modern. A single Doric pilaster caps the end of the sunroom. Although it's difficult to make out, the sunroom doesn't seem to be on the 1939 Sanborn map so it may be a later addition.
