ARCHITECTURAL/HISTORIC INVENTORY FORM

1. Survey No. CO-AS-005-001		2. Survey name: Moreau Drive Neighborhood Survey	
3. County: Cole		4. Address: 1202 Elmerine Ave.	
5. City: Jefferson City	Vicinity: <input type="checkbox"/>	6. UTM: / /	7. Township/Range/Section: T: R: S:
8. Historic name (if known):		9. Present/other name (if known):	
10. Ownership: <input checked="" type="checkbox"/> Private <input type="checkbox"/> Public		11. Historic use (if known): Residential	11. Current use: Residential

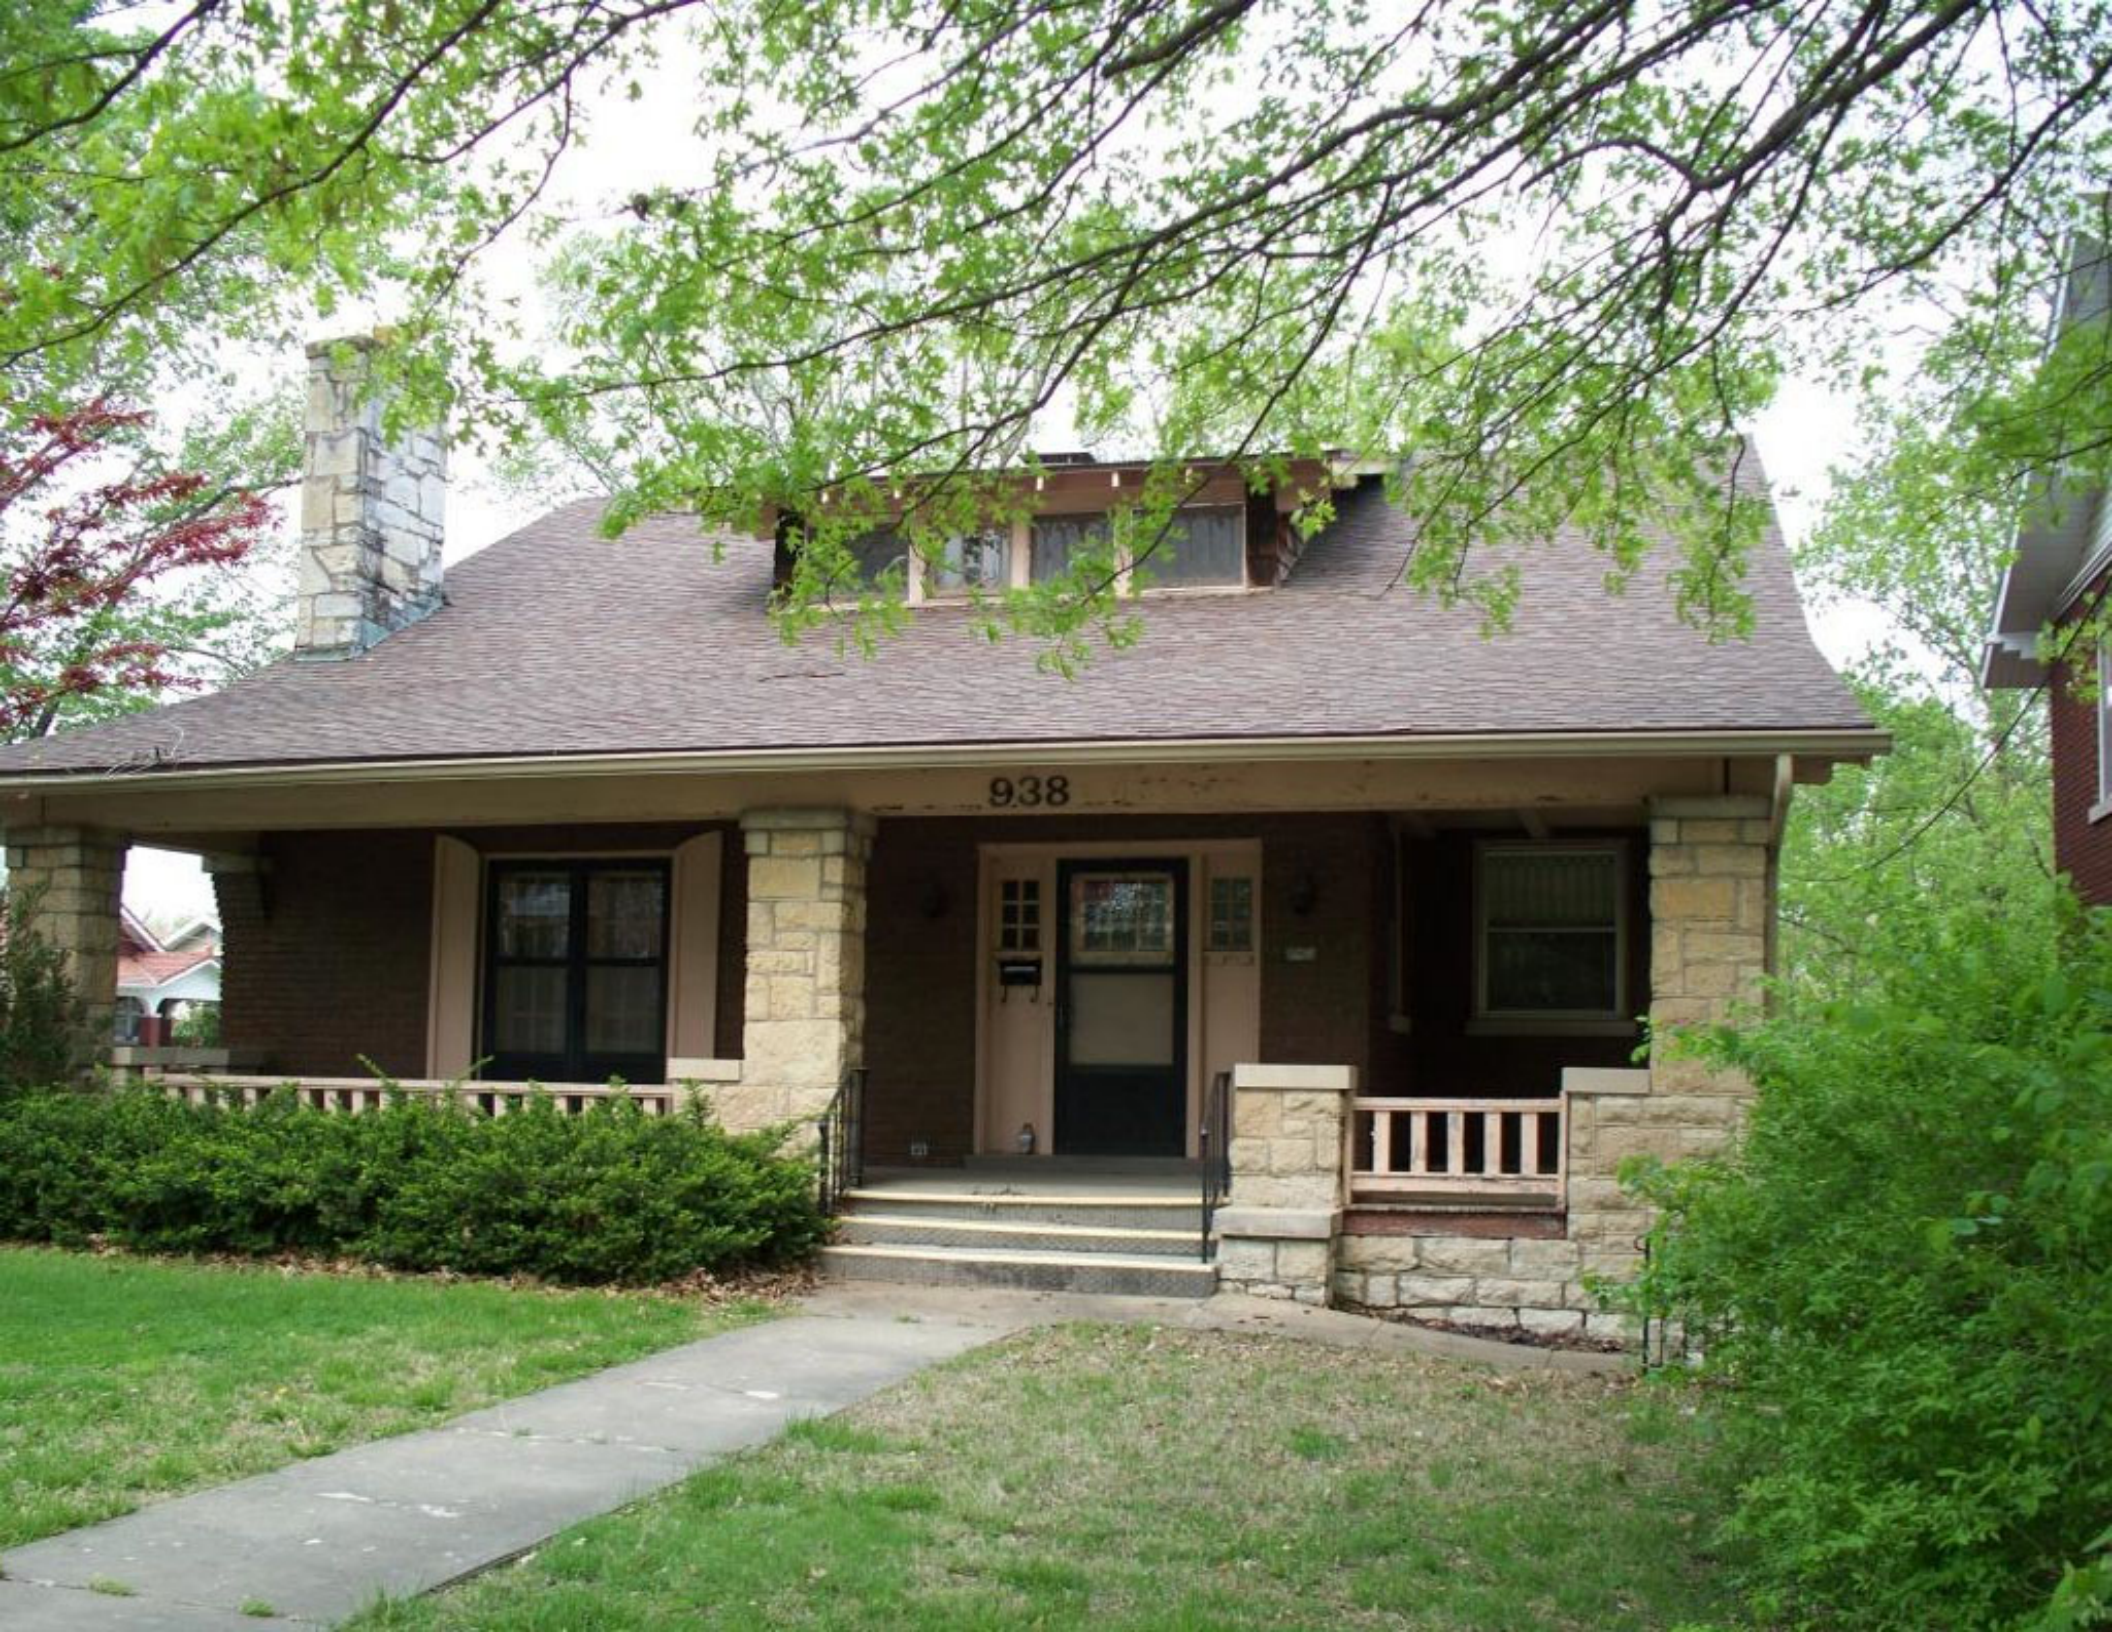
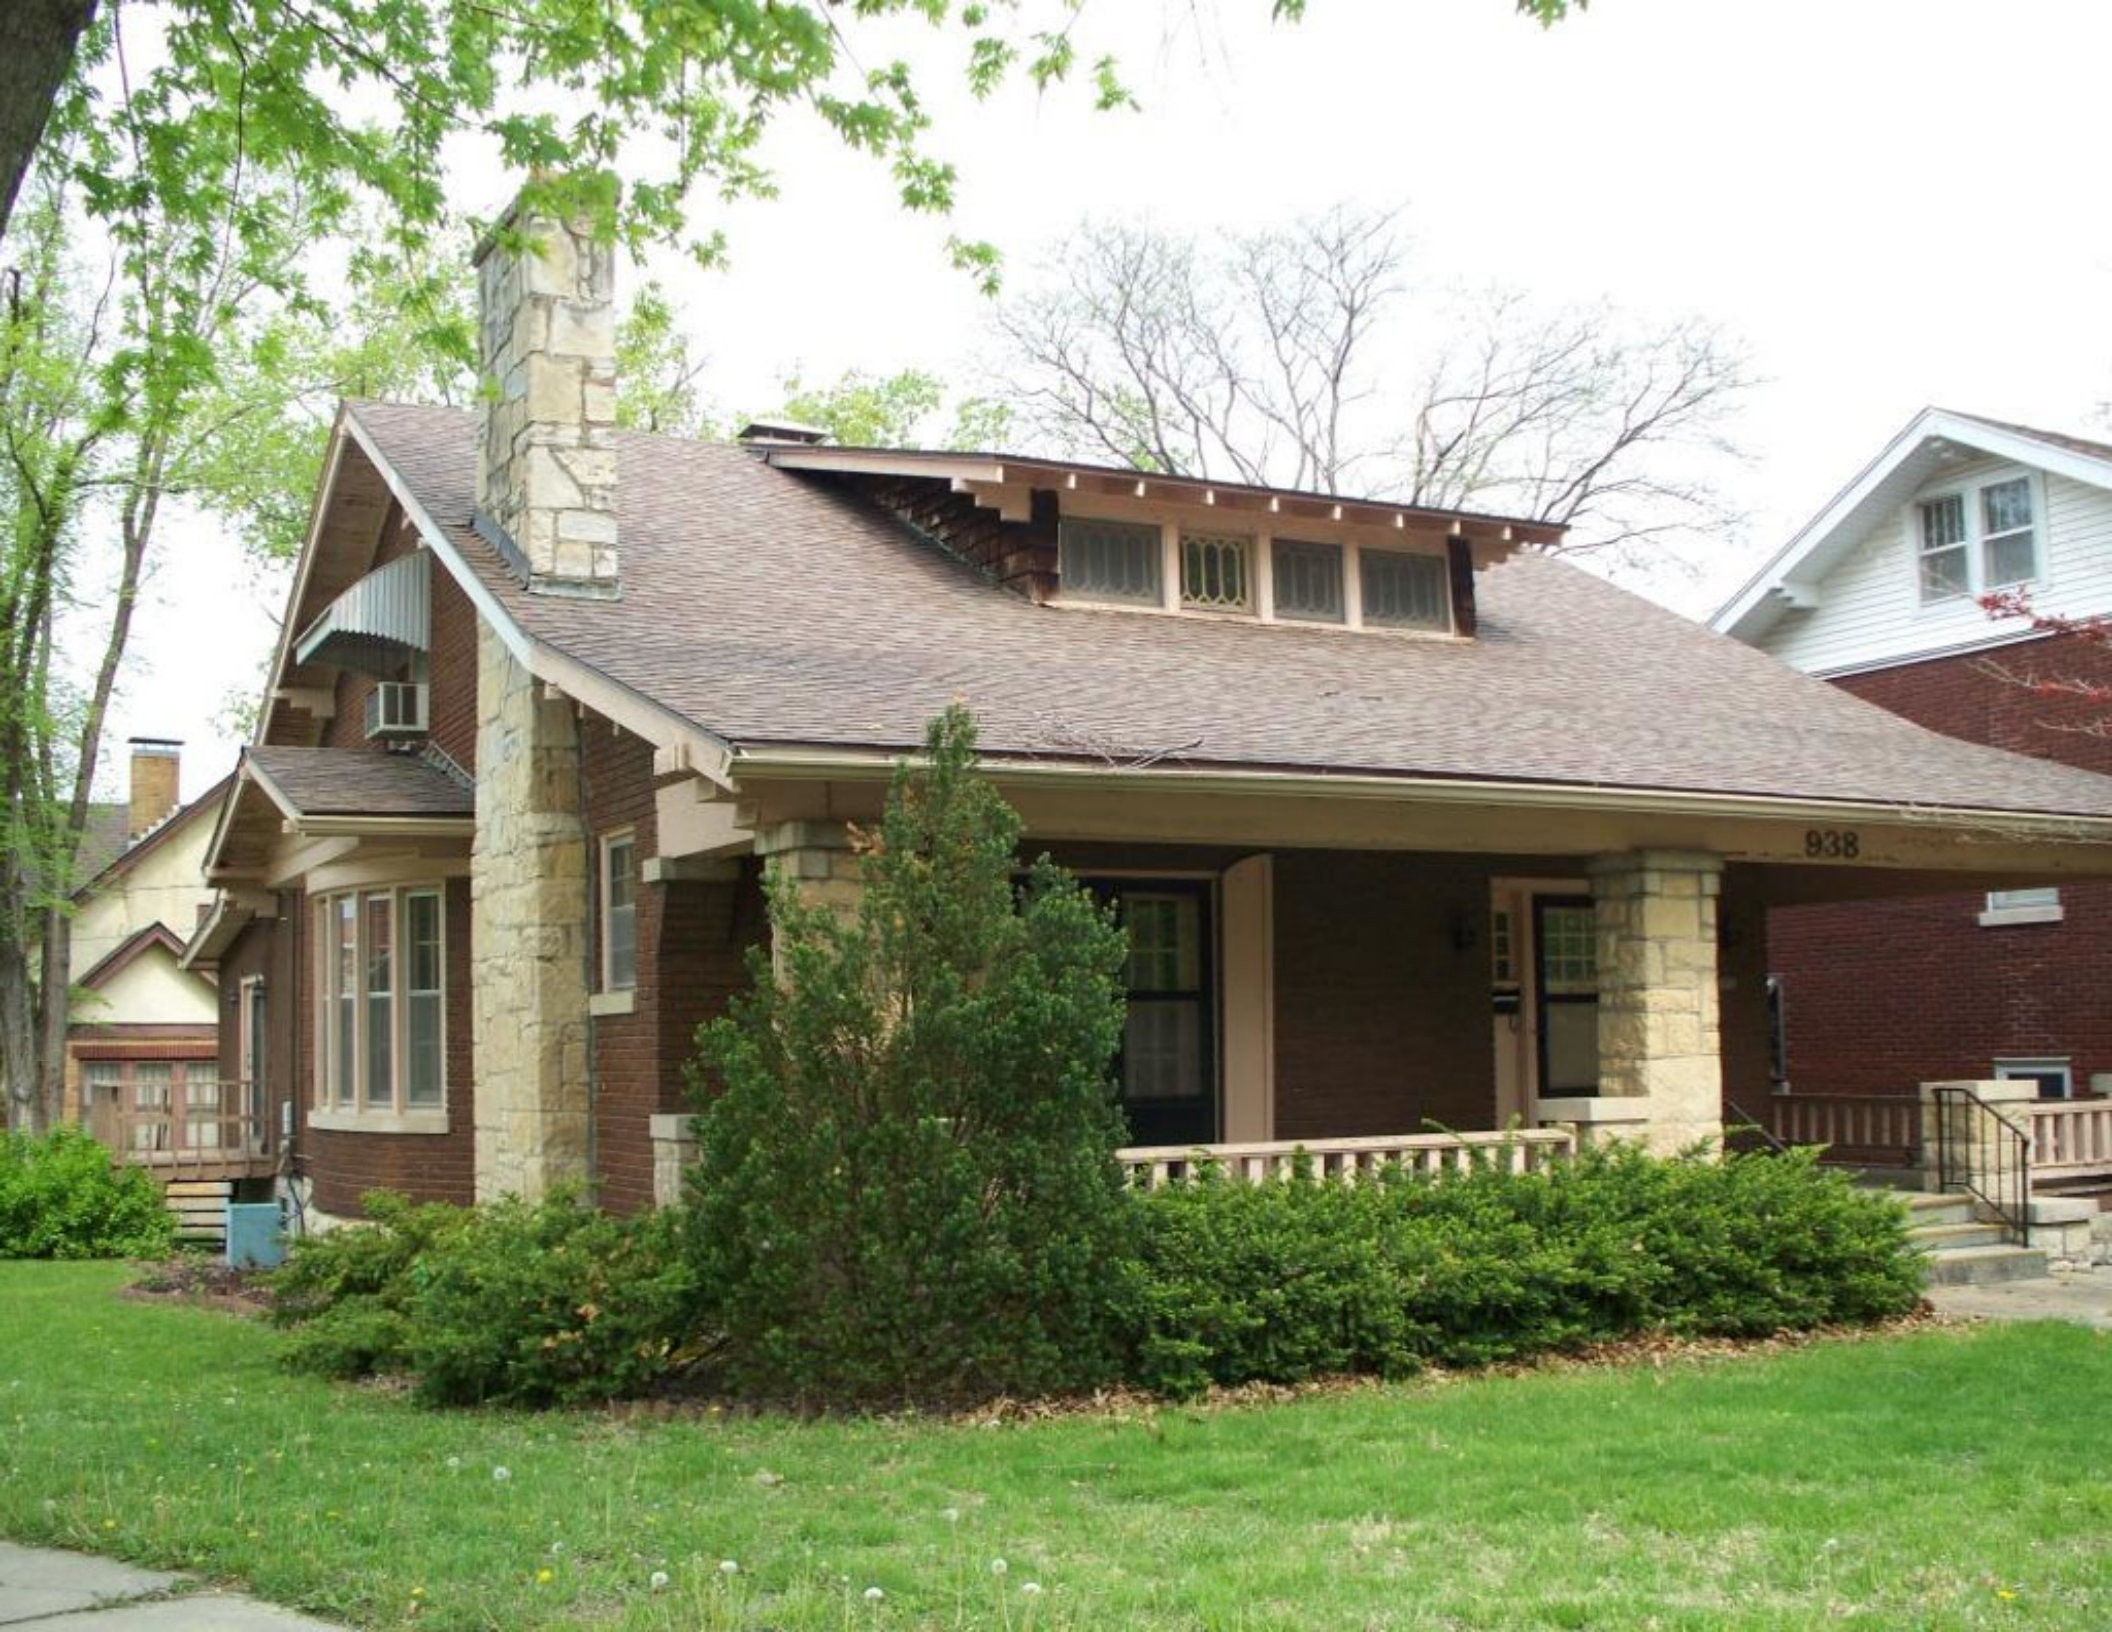
938

This brick one and a half story Craftsman has a deeply sloping side gabled roof with a shed dormer with wood shingles and four fixed art glass leaded windows. The dormer has exposed rafter tails and the gable of the roof has jigsaw brackets similar to those at 930 Fairmount. A large stone chimney projects from the left side of the home and pierces the roof. The central façade has three bays, the right most have a single 1/1 leaded art glass window in the same pattern as those in the dormer. The entrance is centrally located and appears to retain its original side lights and door, which both have multi-lights in the upper portion. The left bay has multi light French doors similar to those at 932 Fairmount (four square). The doors have a heavy wood framing painted the same color as the entrance (pink). The full width porch features large stone piers with wooden railing in between.

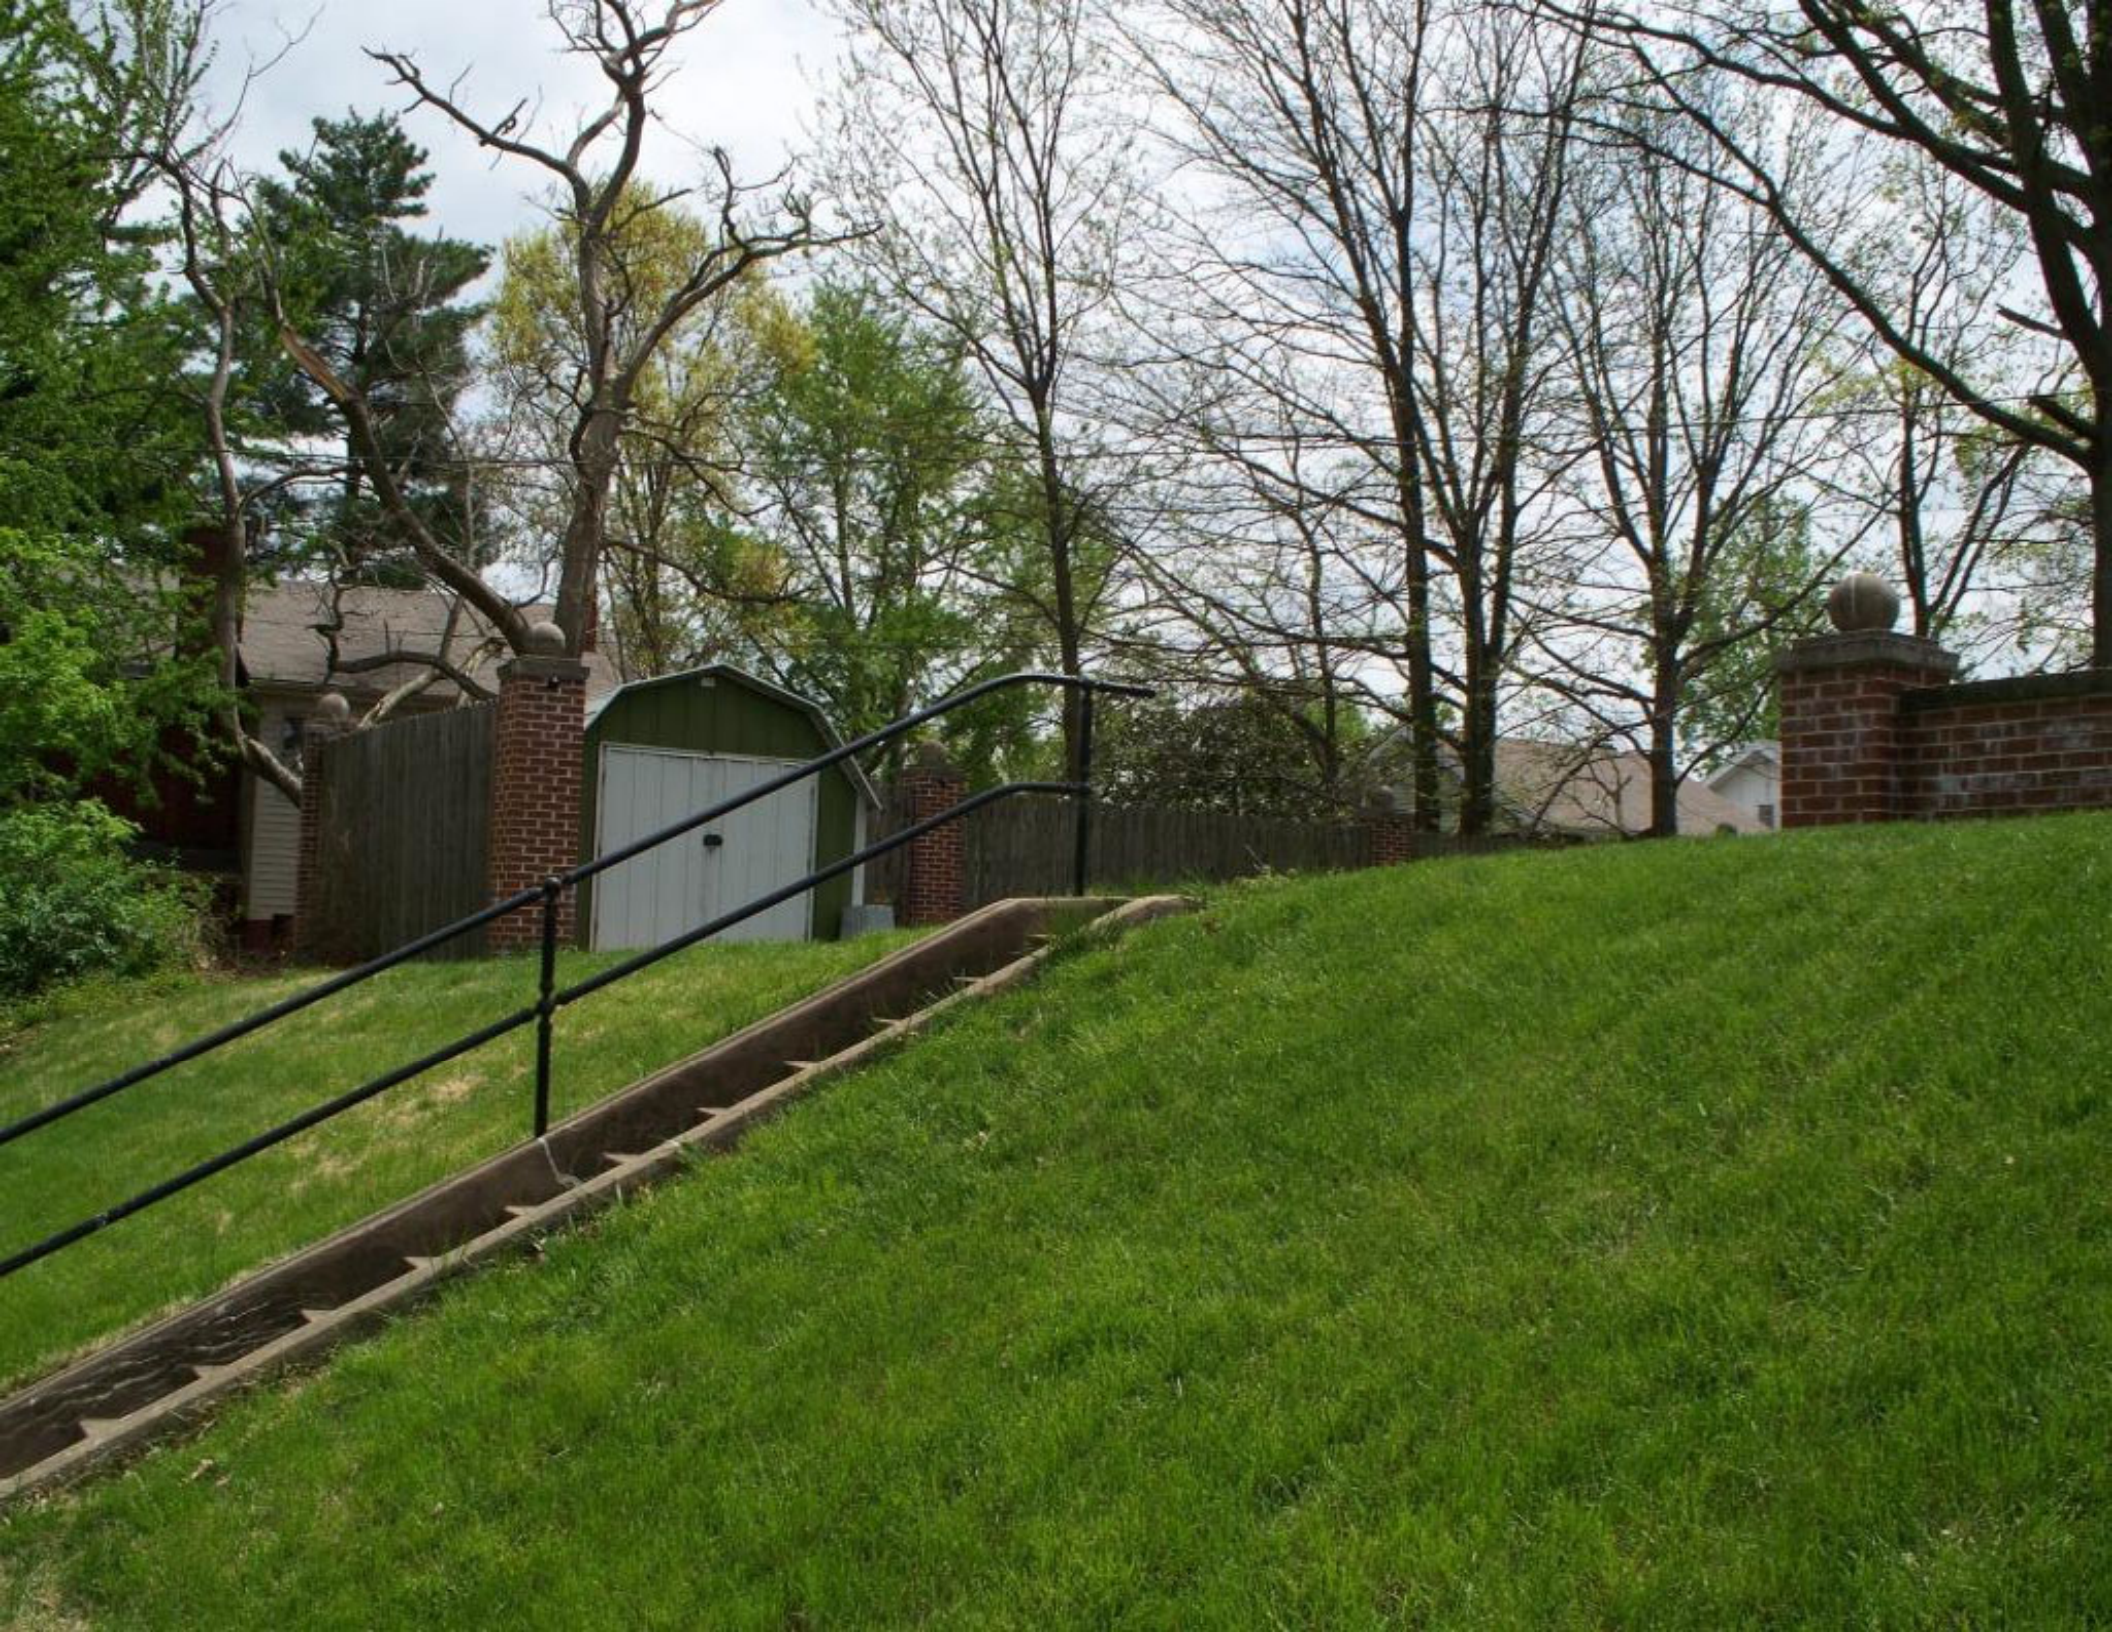
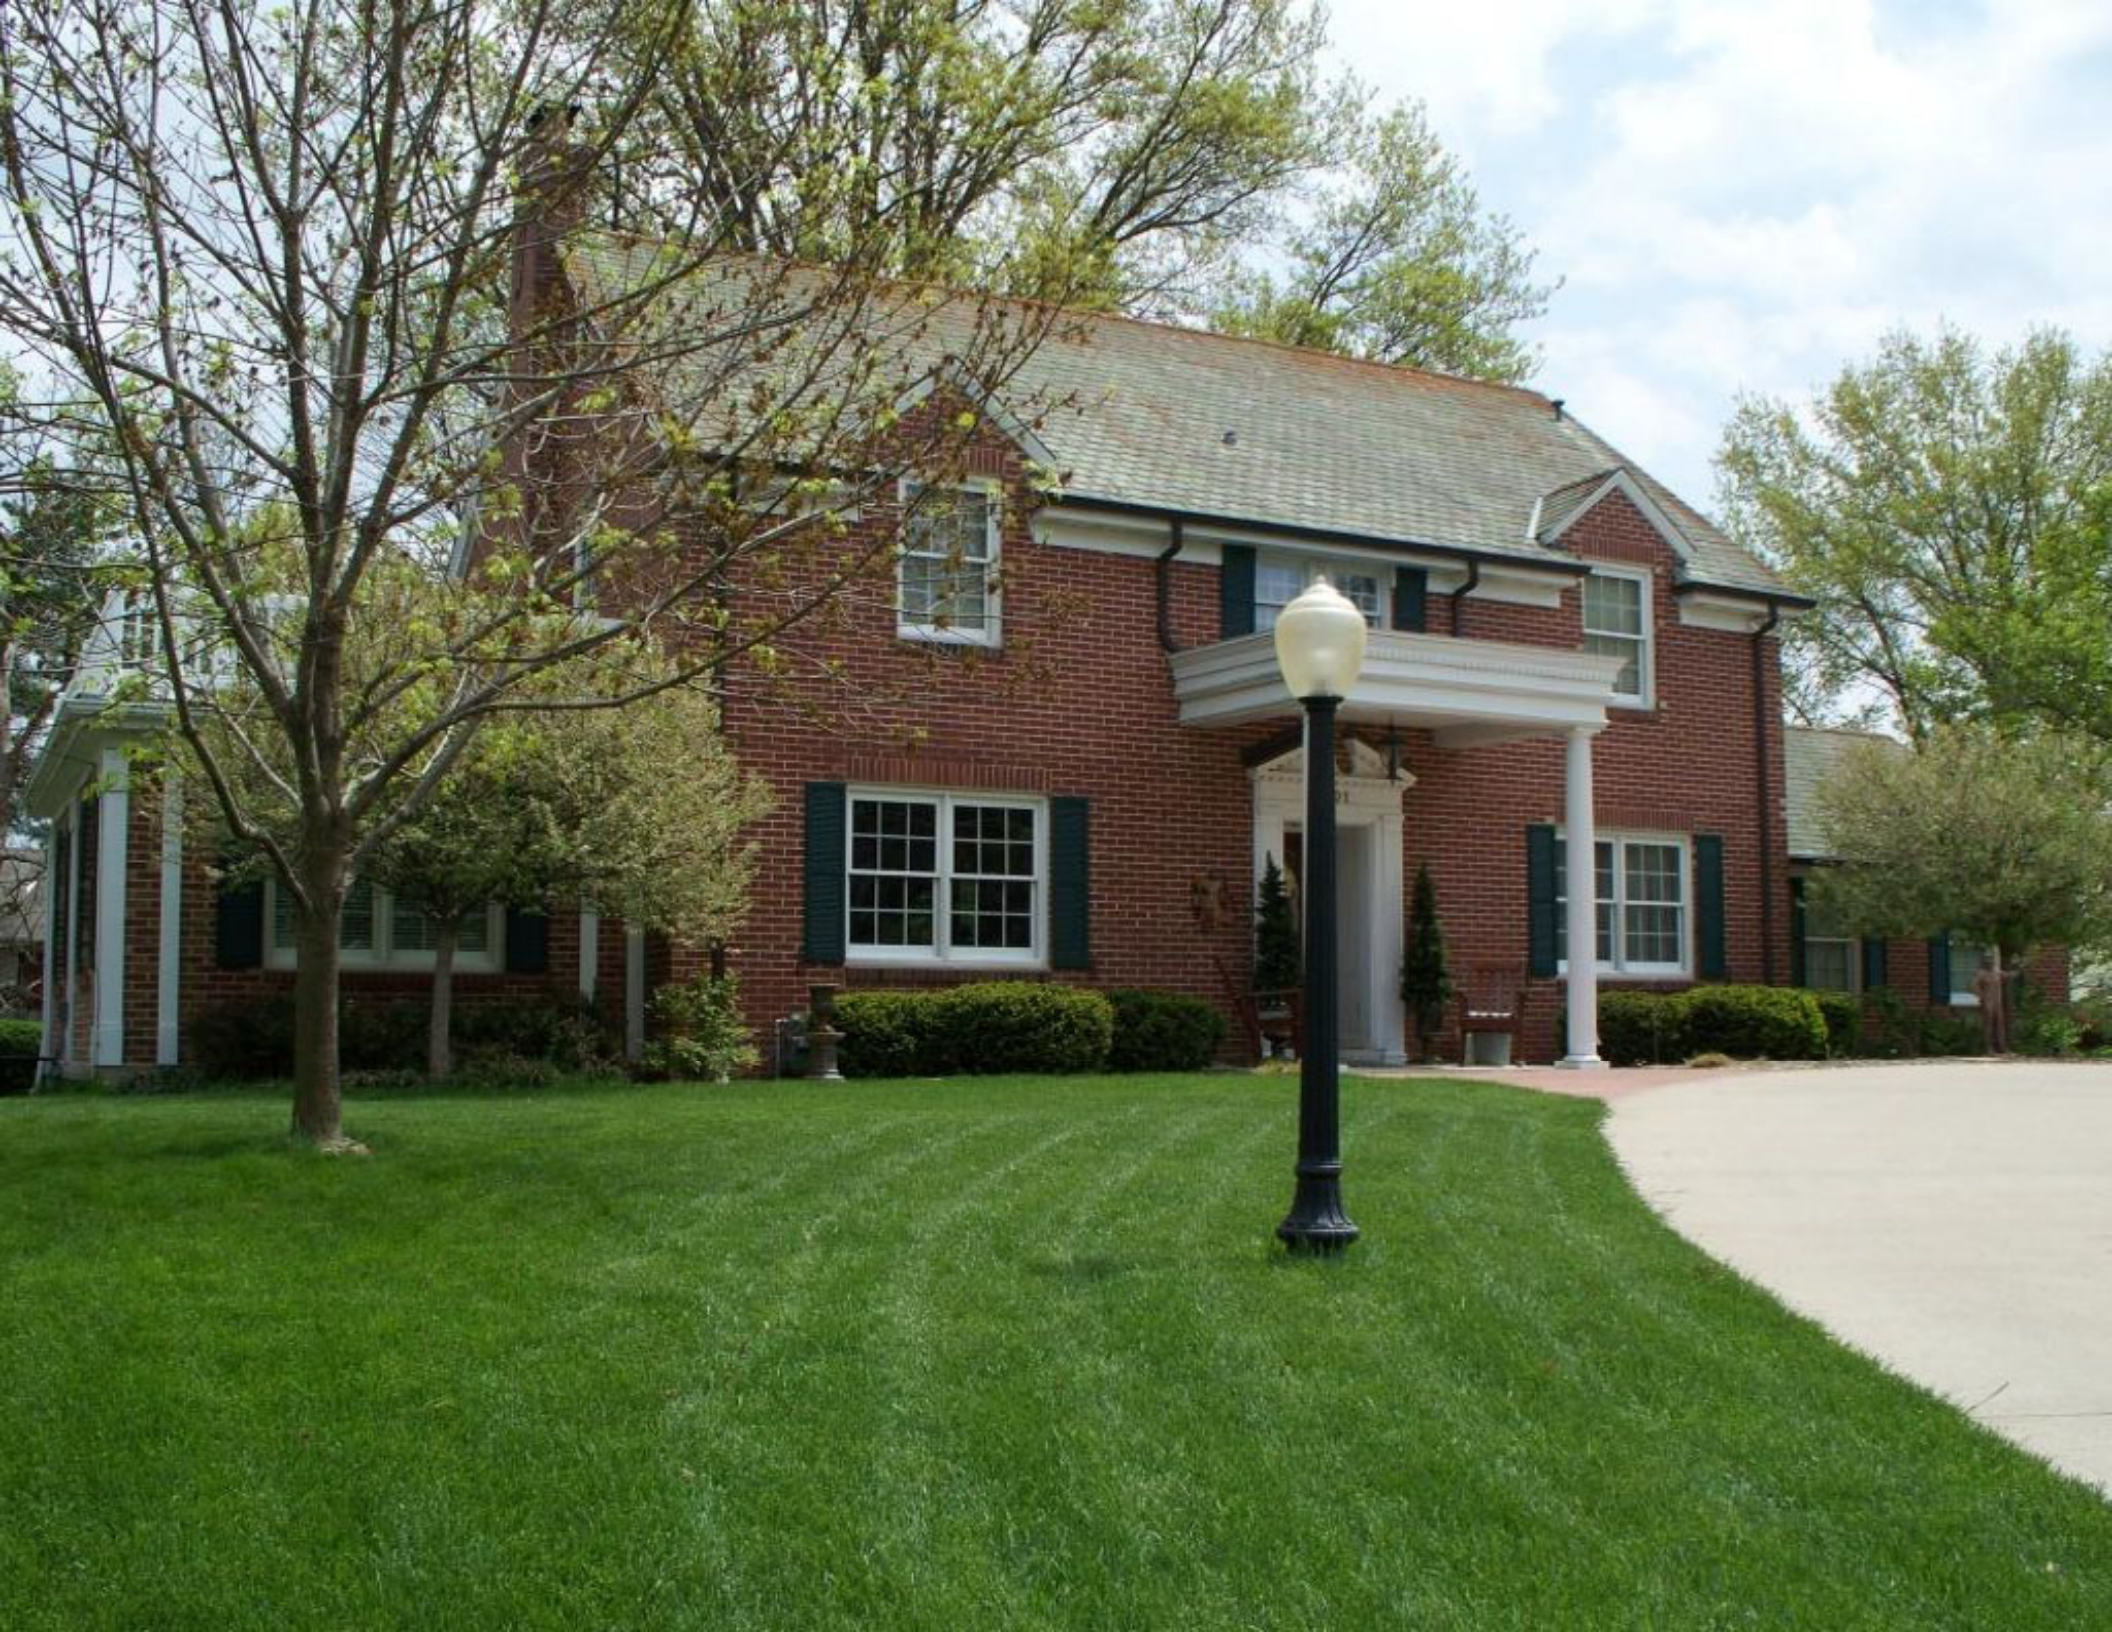
41. (cont.)
This sprawling home has a large semi-circle drive. It is a two story Colonial Revival with a side gable roof that is pierced with two “gables” over the second story 6/6 windows in the left and right bays. The windows of the property appear mostly modern although the smaller paired 6/6 windows over the portico may be historic. The windows on the first floor are replacement 6/6 with shutters that flank the central entrance that features an elaborate broken pediment door surround. The entrance is framed by a large portico with a flat roof that consists of an entablature with dentil detail supported by two fluted Doric columns. One story wings flank each side of the primary façade. The one on the left has a flat roof capped with wood railing, featuring paired windows identical to those on the rest of the property. The right wing is actually the garage that is accessed at the side of the building. There are two 6/1 windows on the primary façade. There is an additional two-story garage set slightly back and facing the street. It’s unclear when this was built but it’s not likely historic. It was unclear if this was attached to the other garage or unattached. It is also in brick and set slightly back so does not greatly detract from the integrity of the home if it is attached.

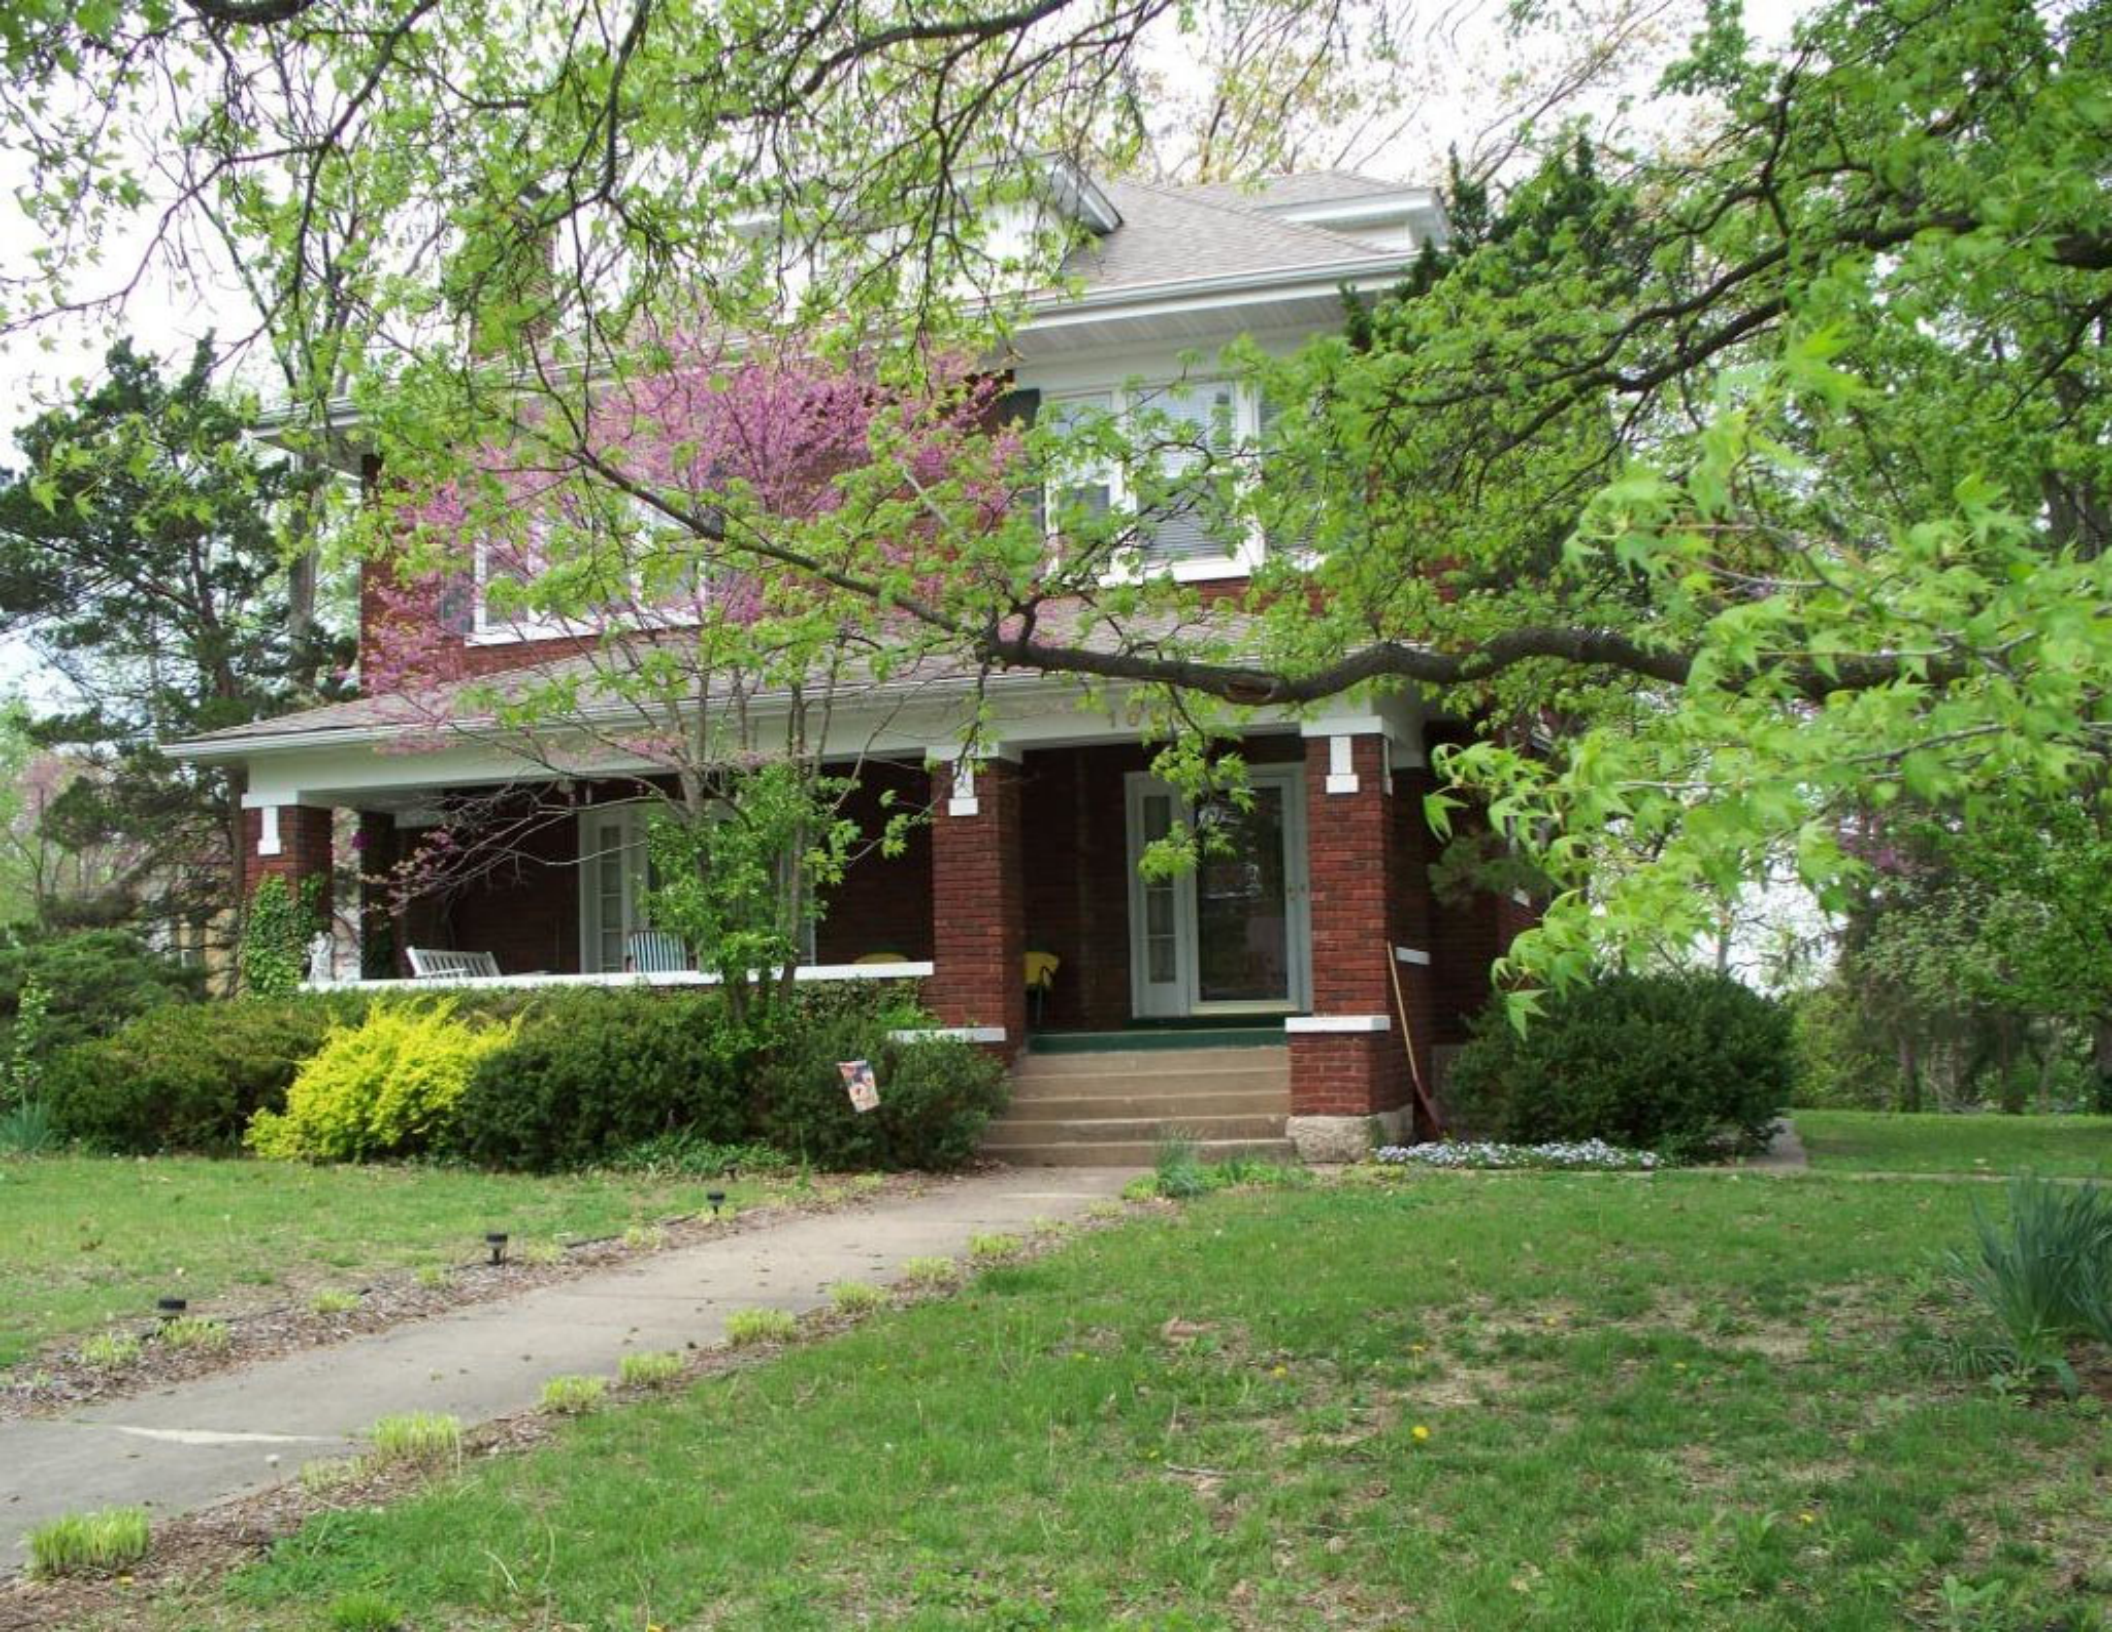
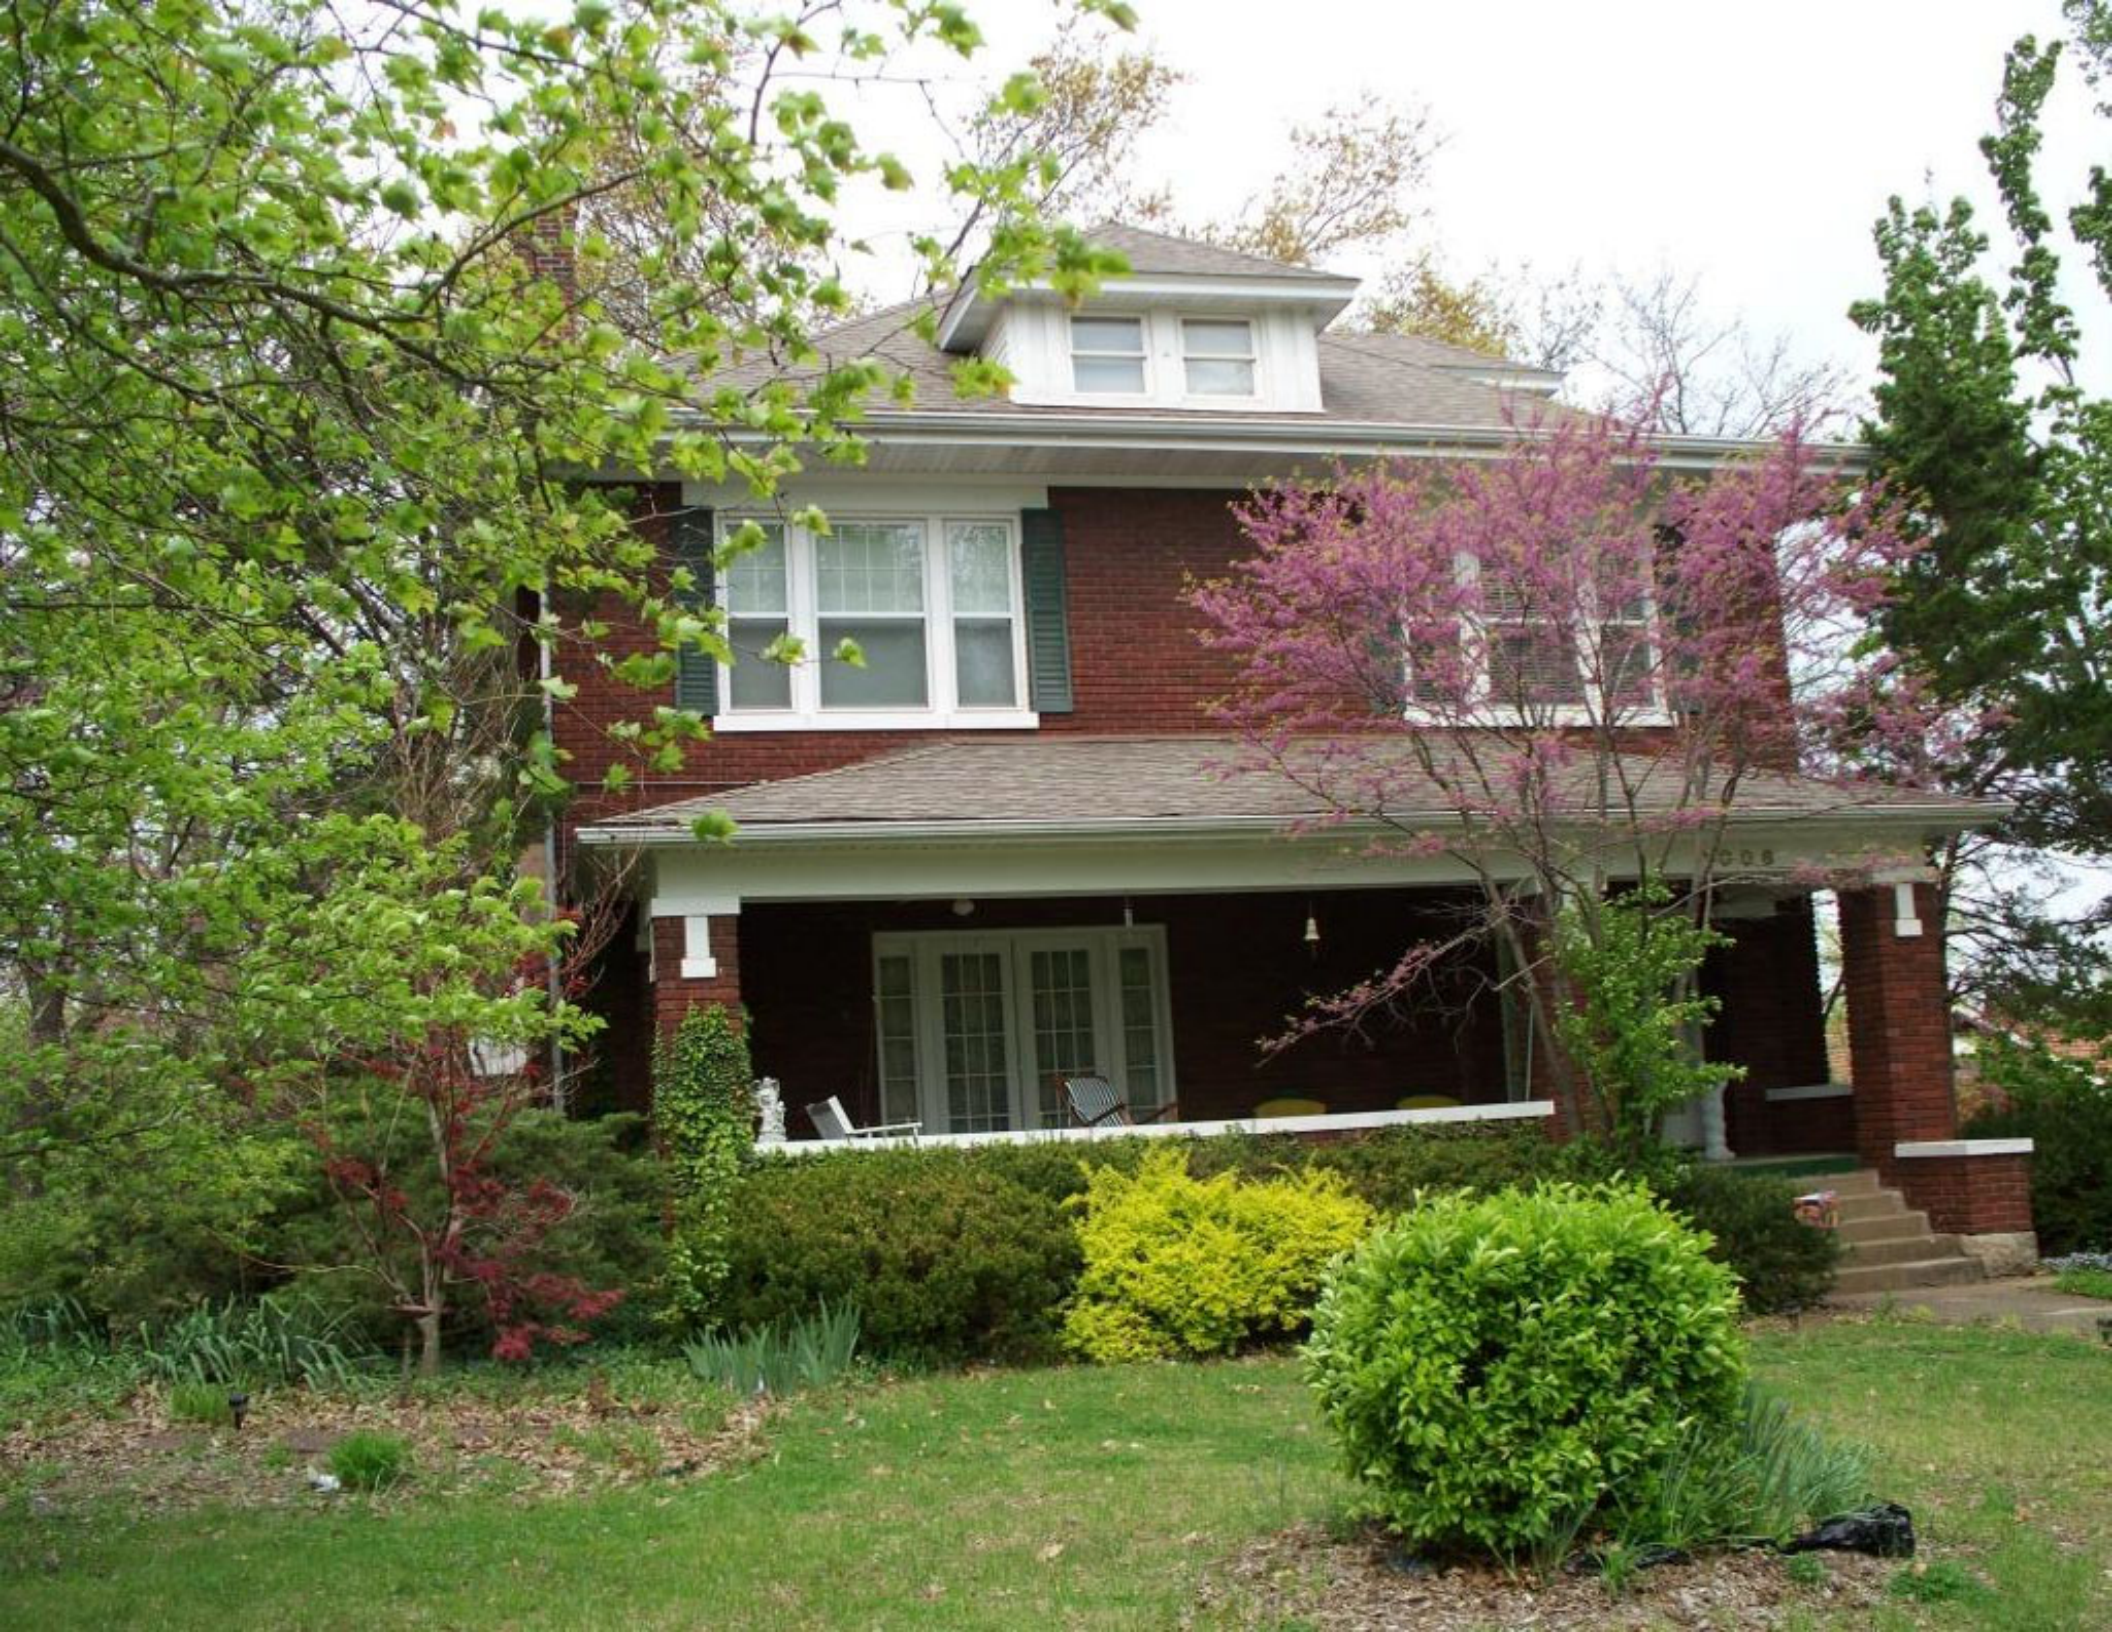
This 2 ½ story brick four square has a central dormer with pyramidal roof and two 1/1 replacement windows. The second floor has two tri-part windows that feature 8/1 flanked by smaller 4/1 windows with storms. On the first floor there is a full width porch with a hipped roof and a wide entablature. The porch has brick piers that are topped with decorative accents and brick knee walls capped in limestone. In the left bay are French multi-light doors with multi-paned sidelights. The main entrance is in the right bay and also features sidelights and appears to retain its original wood door behind a modern screen door.
