ARCHITECTURAL/HISTORIC INVENTORY FORM

1. Survey No. CO-AS-005-001		2. Survey name: Moreau Drive Neighborhood Survey	
3. County: Cole		4. Address: 1202 Elmerine Ave.	
5. City: Jefferson City	Vicinity: <input type="checkbox"/>	6. UTM: / /	7. Township/Range/Section: T: R: S:
8. Historic name (if known):		9. Present/other name (if known):	
10. Ownership: <input checked="" type="checkbox"/> Private <input type="checkbox"/> Public		11. Historic use (if known): Residential	11. Current use: Residential

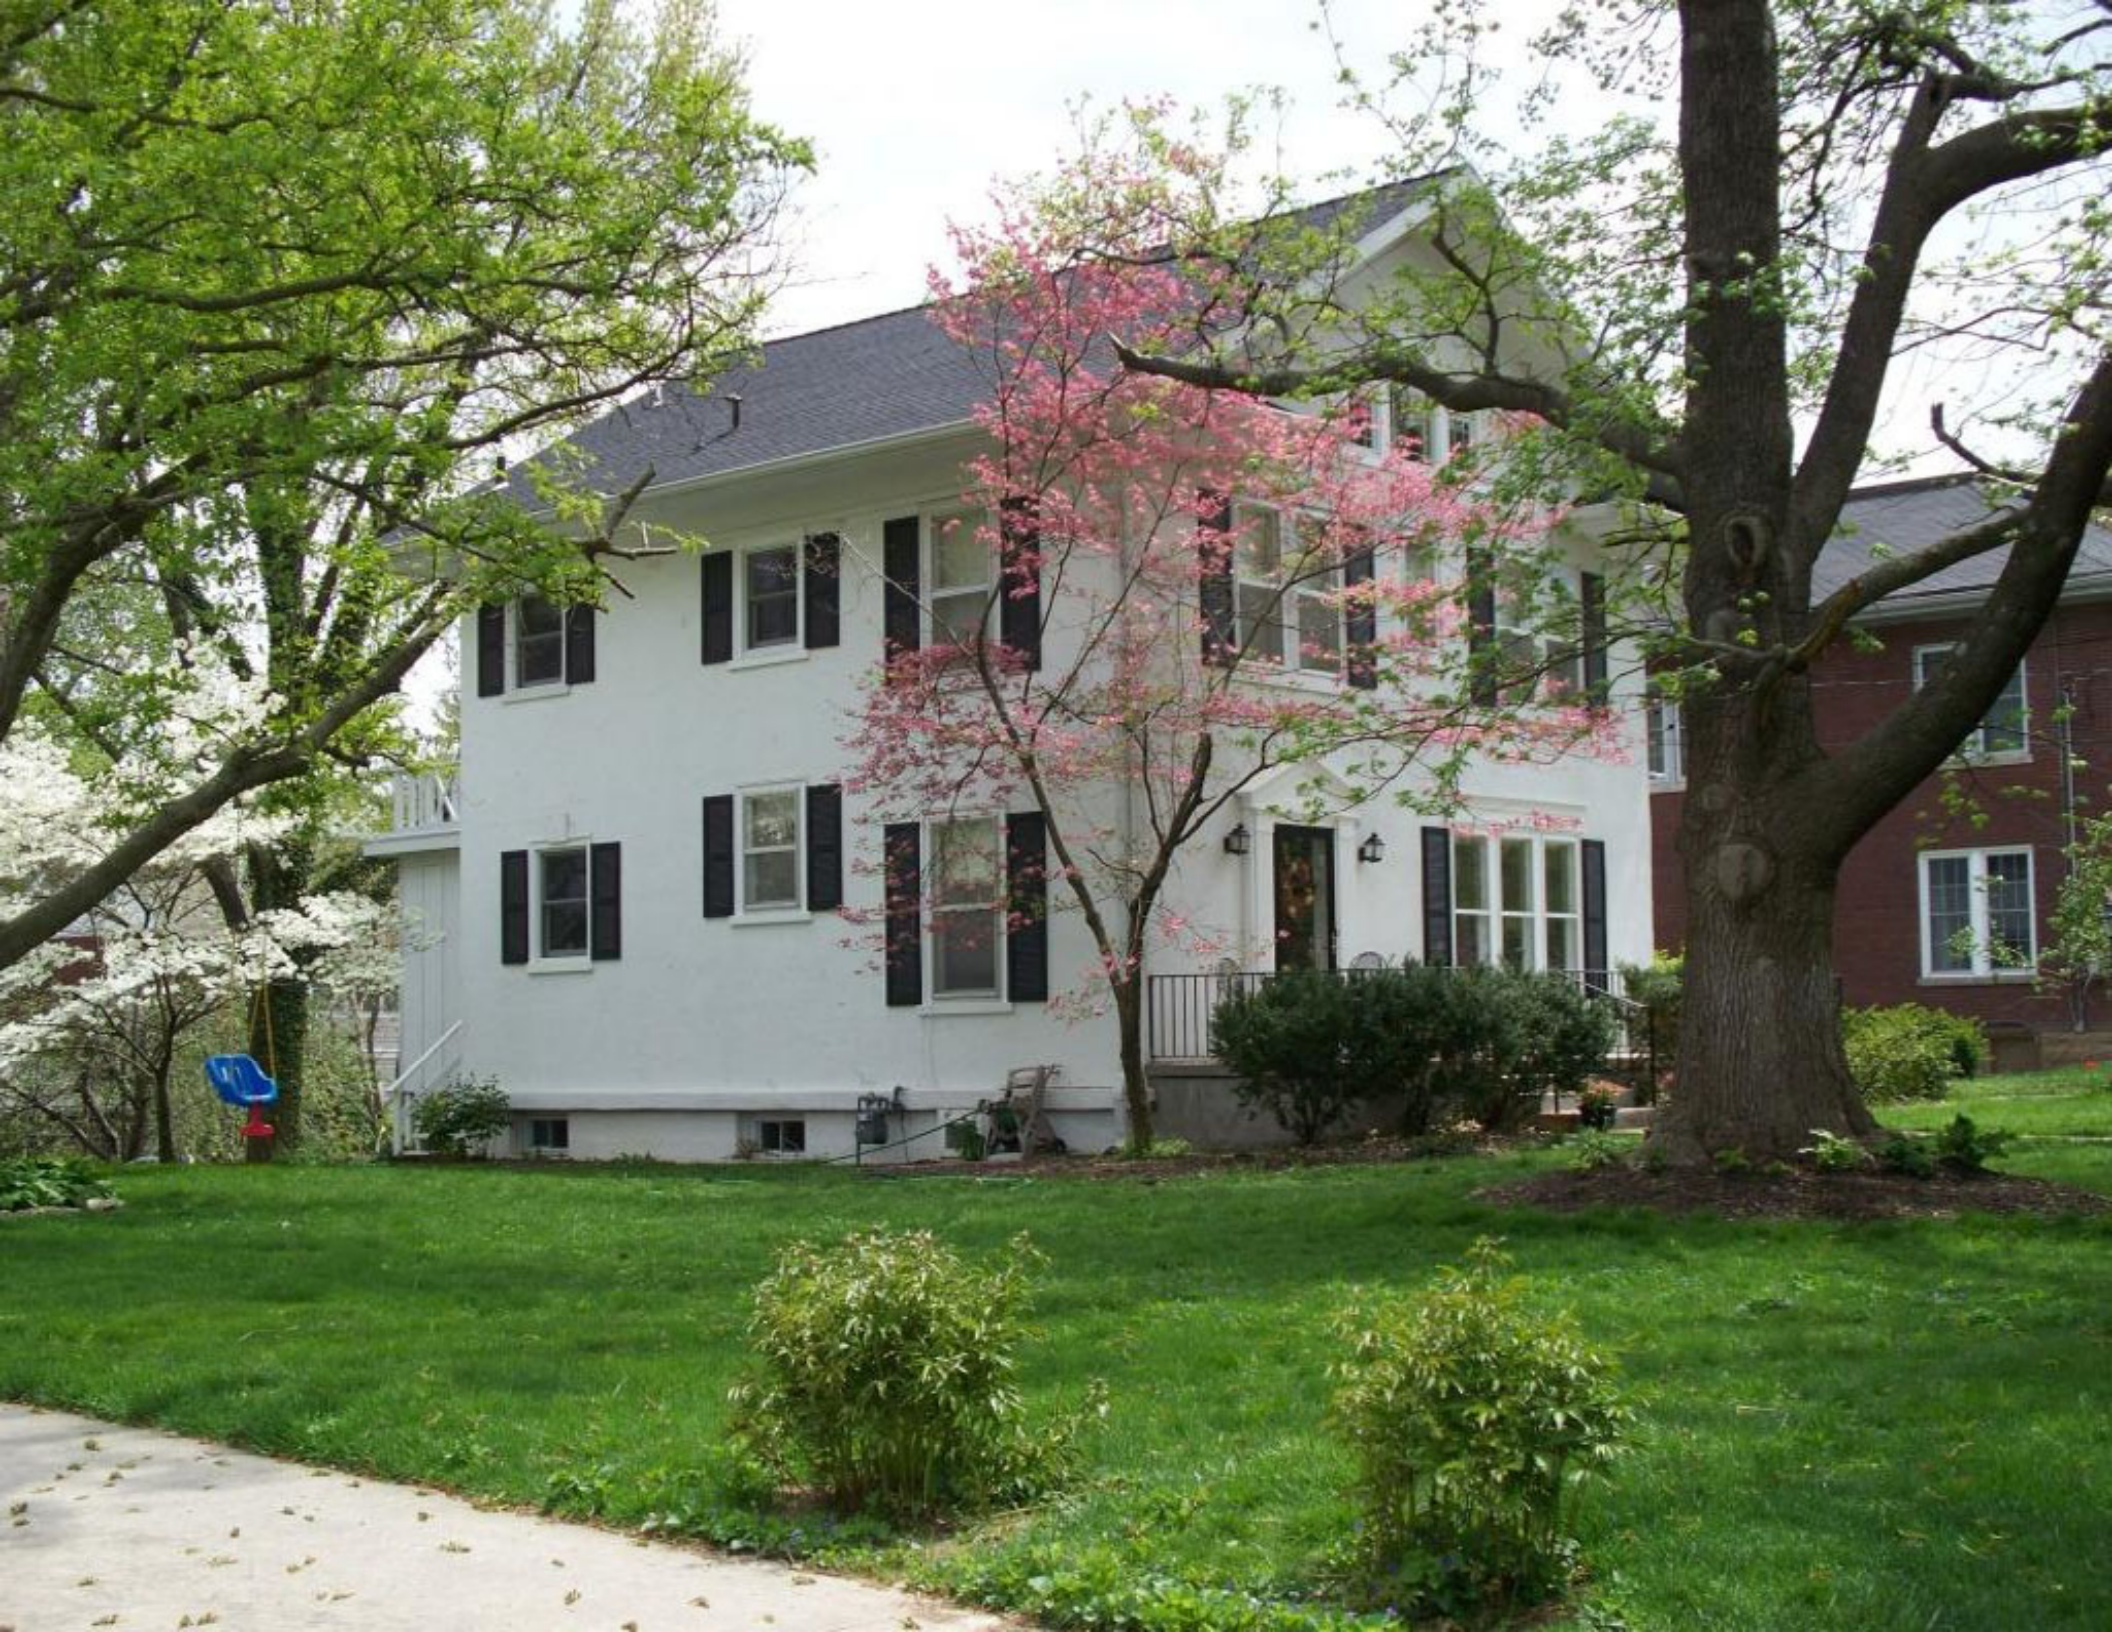
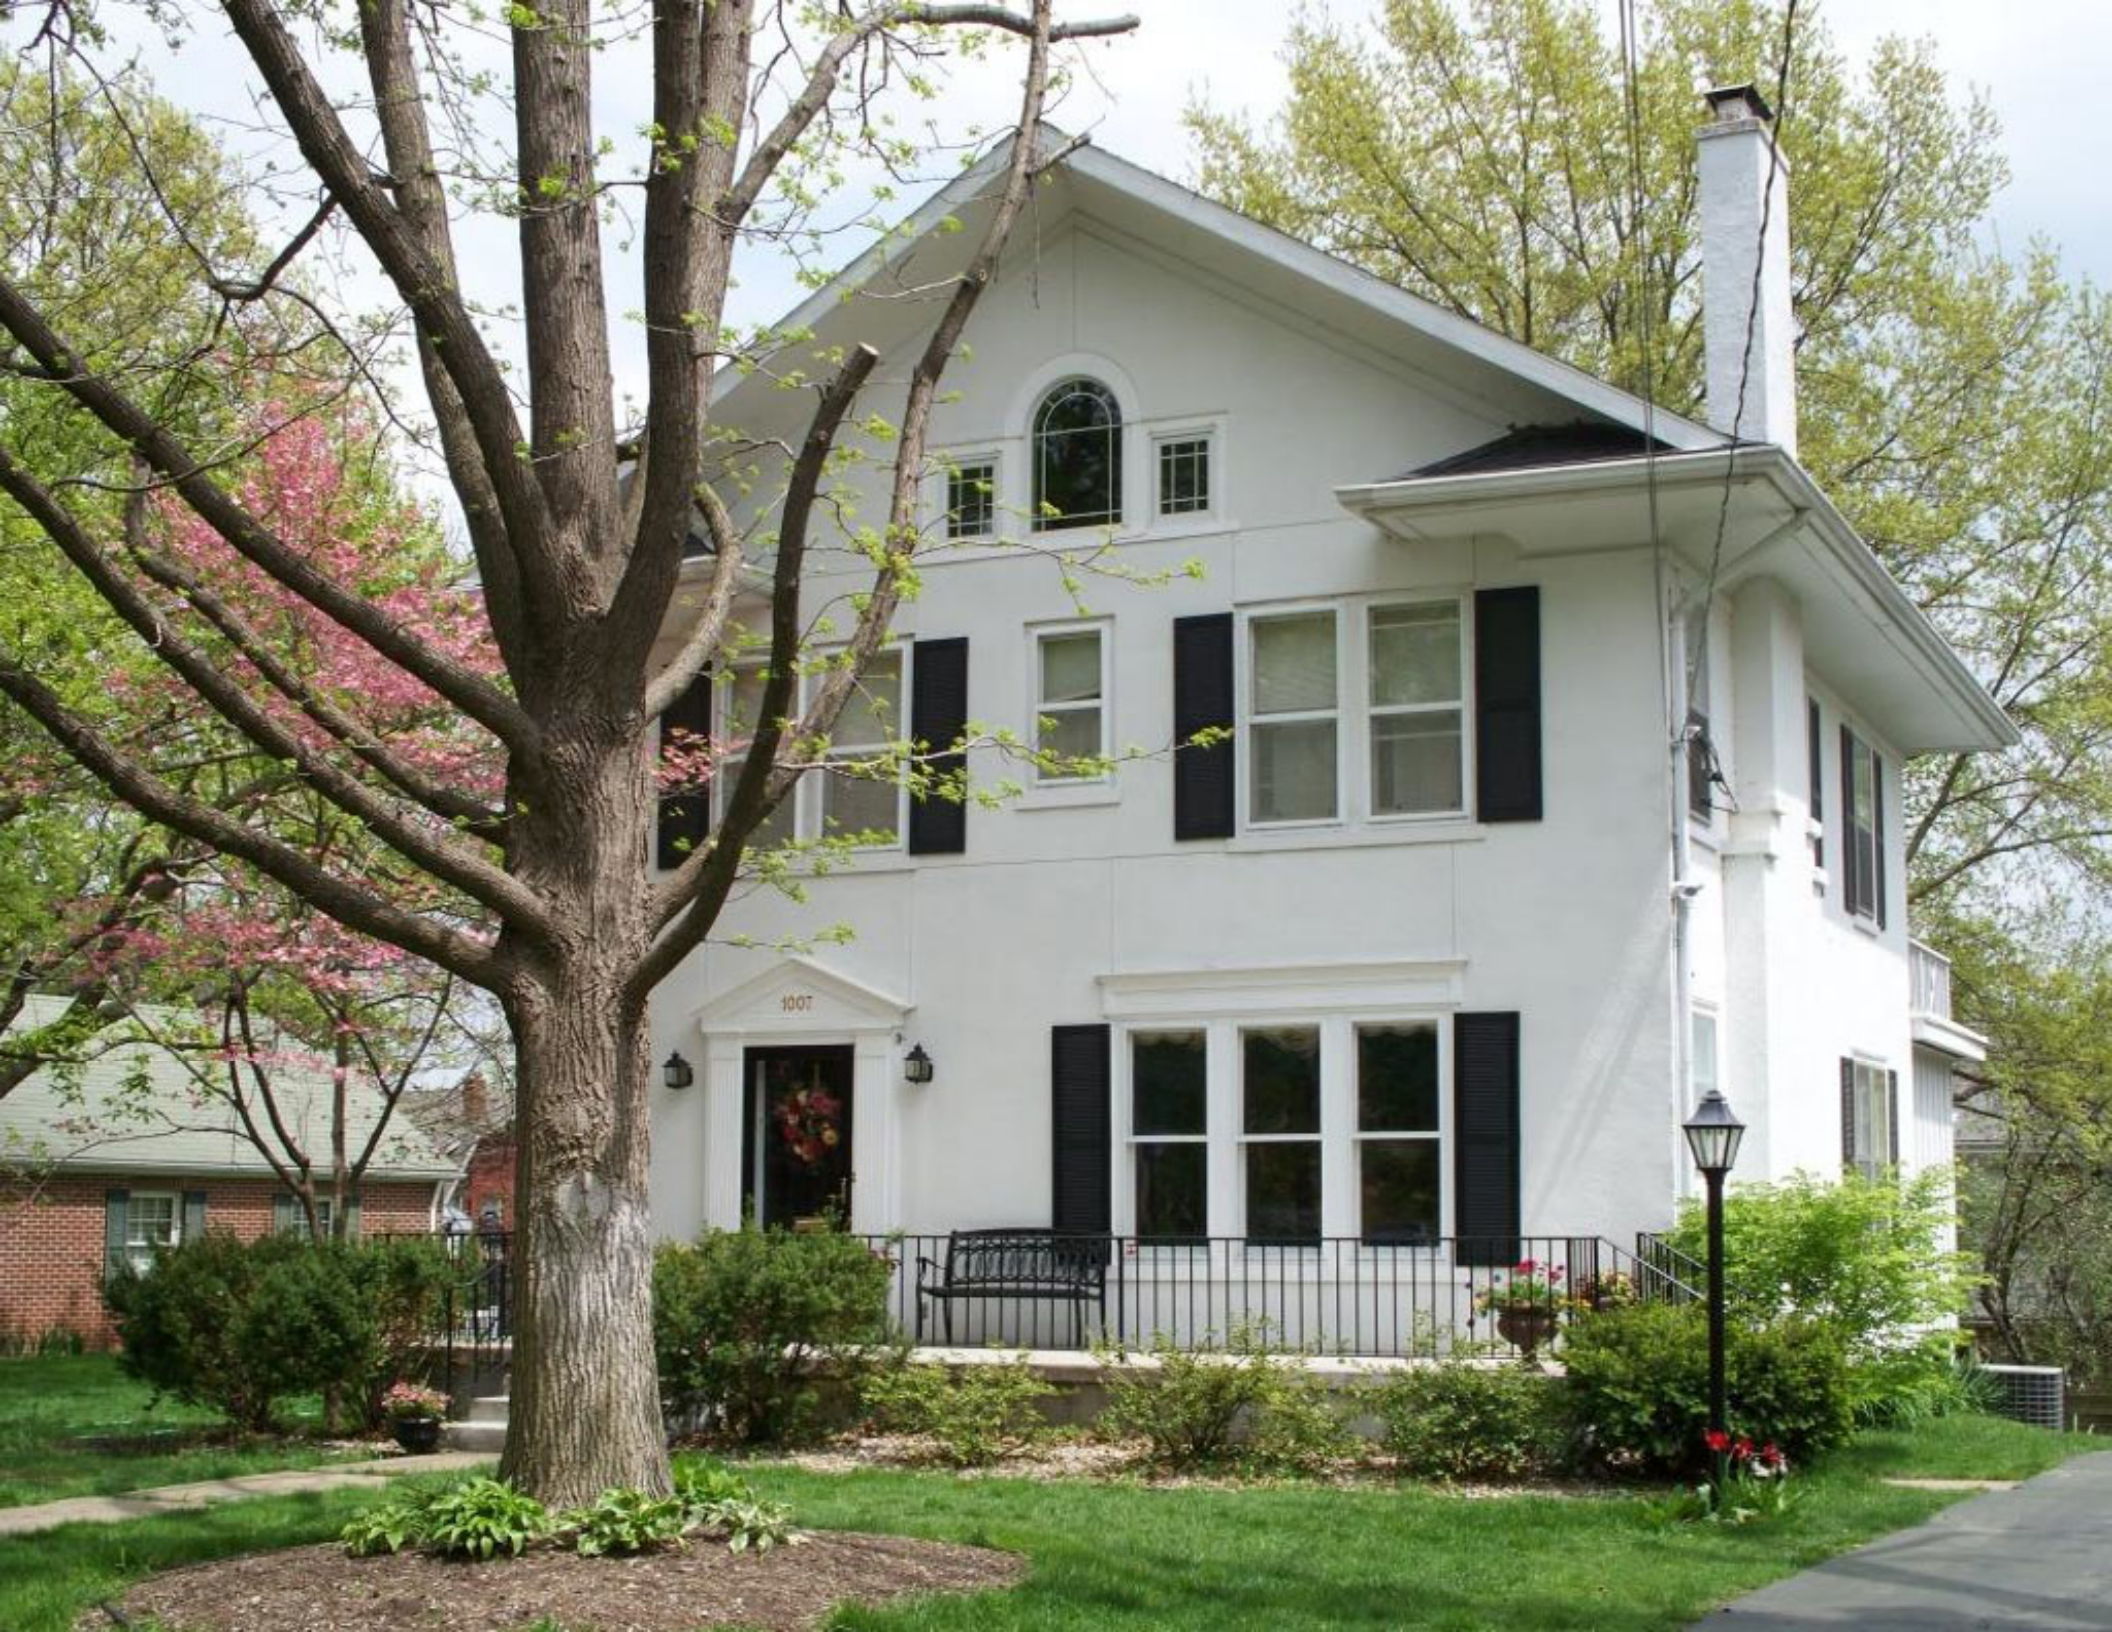
This property may or may not be contributing depending on the date the Dryvit was applied. The home has a front gable roof with deep returns, between which is a Palladian window that looks modern. There are paired 1/1 windows with storms and shutters that may or may not be historic flanking a smaller 1/1 window. The first floor entrance is off-center to the left and has a gabled surround. To the right is a row of three replacement 1/1 windows with shutters that are topped by an entablature. All of the windows have sills, but the material is difficult to determine since the whole facade is painted white. A full width concrete platform with metal railing serves as the porch. For the purposes of this survey this property is considered contributing, however if the Dryvit was recently added then the property would be n/c.

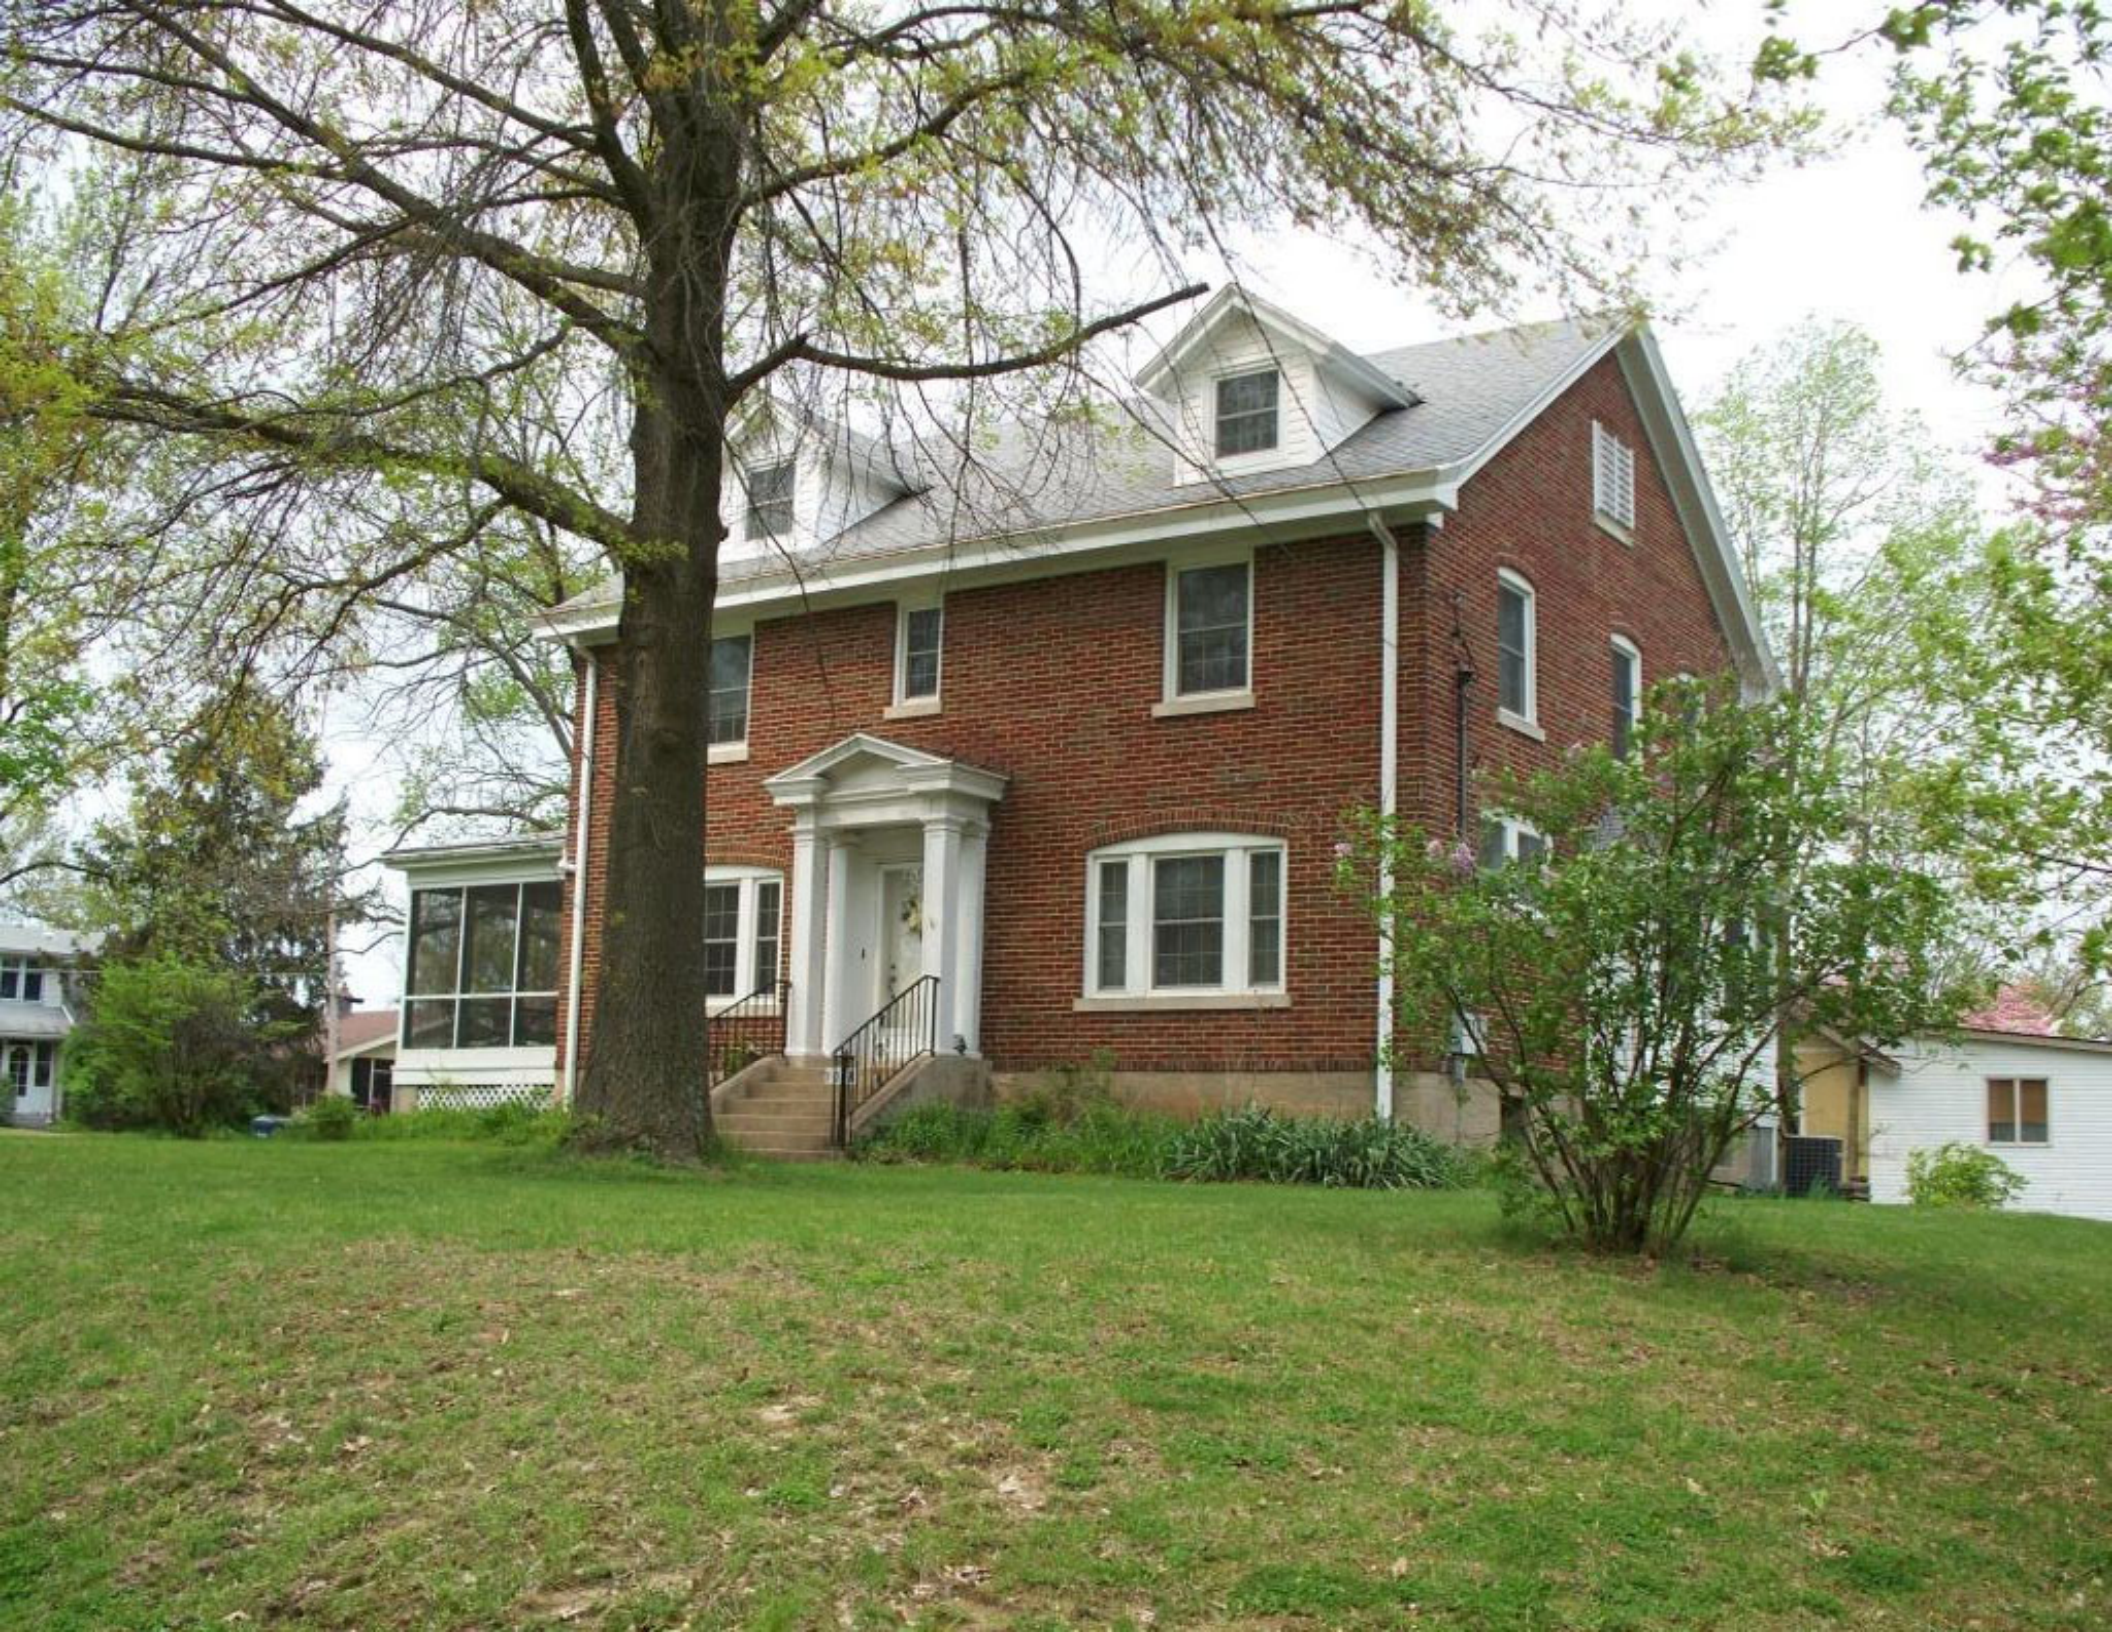
This is a nice example of a Colonial Revival property. The 2 ½ story brick home has a side gable roof and two gable dormers with vinyl siding each with a 6/6 window. The second floor has two 6/6 windows with a smaller 4/4. The two tri-part windows on the first floor have basket handle brick arches that contain 6/6 windows flanked by smaller 4/4. All of the windows have screens/storms that make it difficult to ascertain if the windows are historic or not. The windows on both floors have limestone sills. The centrally located entrance has a portico that consists of a projecting ornate pediment with return and entablature and two square columns pilasters. The portico sits on a concrete stoop and stairs with metal railing. To the left of the building is an attached one story screened-in sunroom with a flat roof.

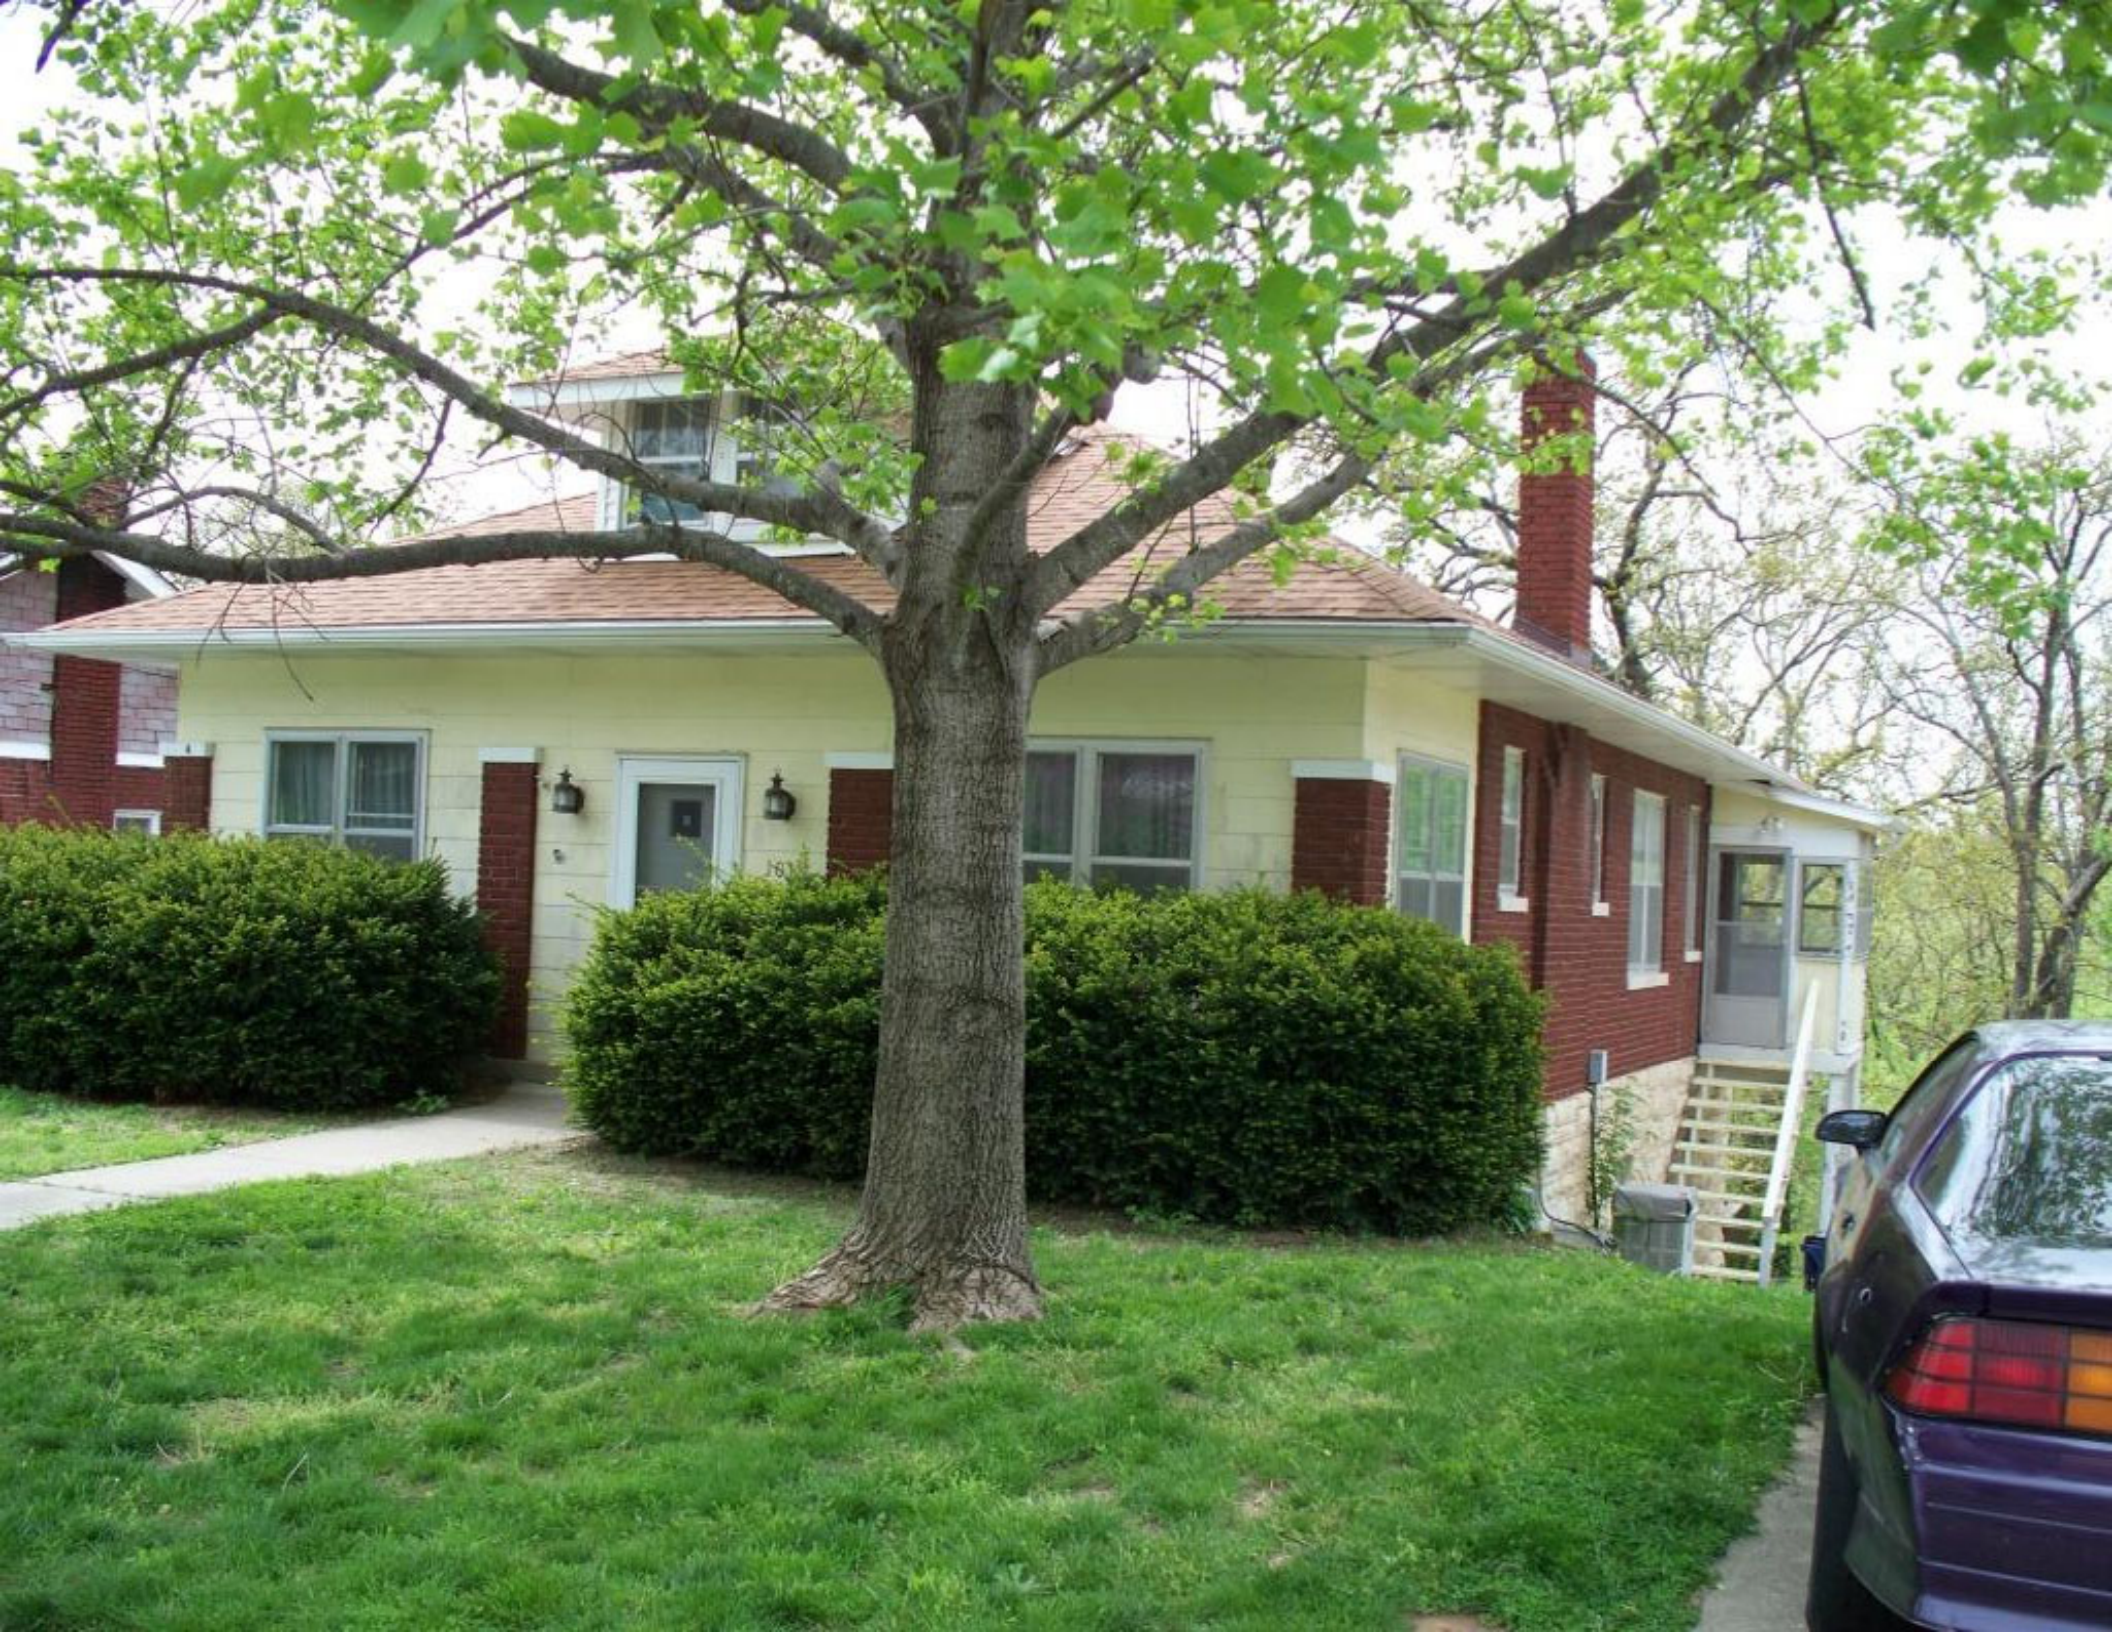
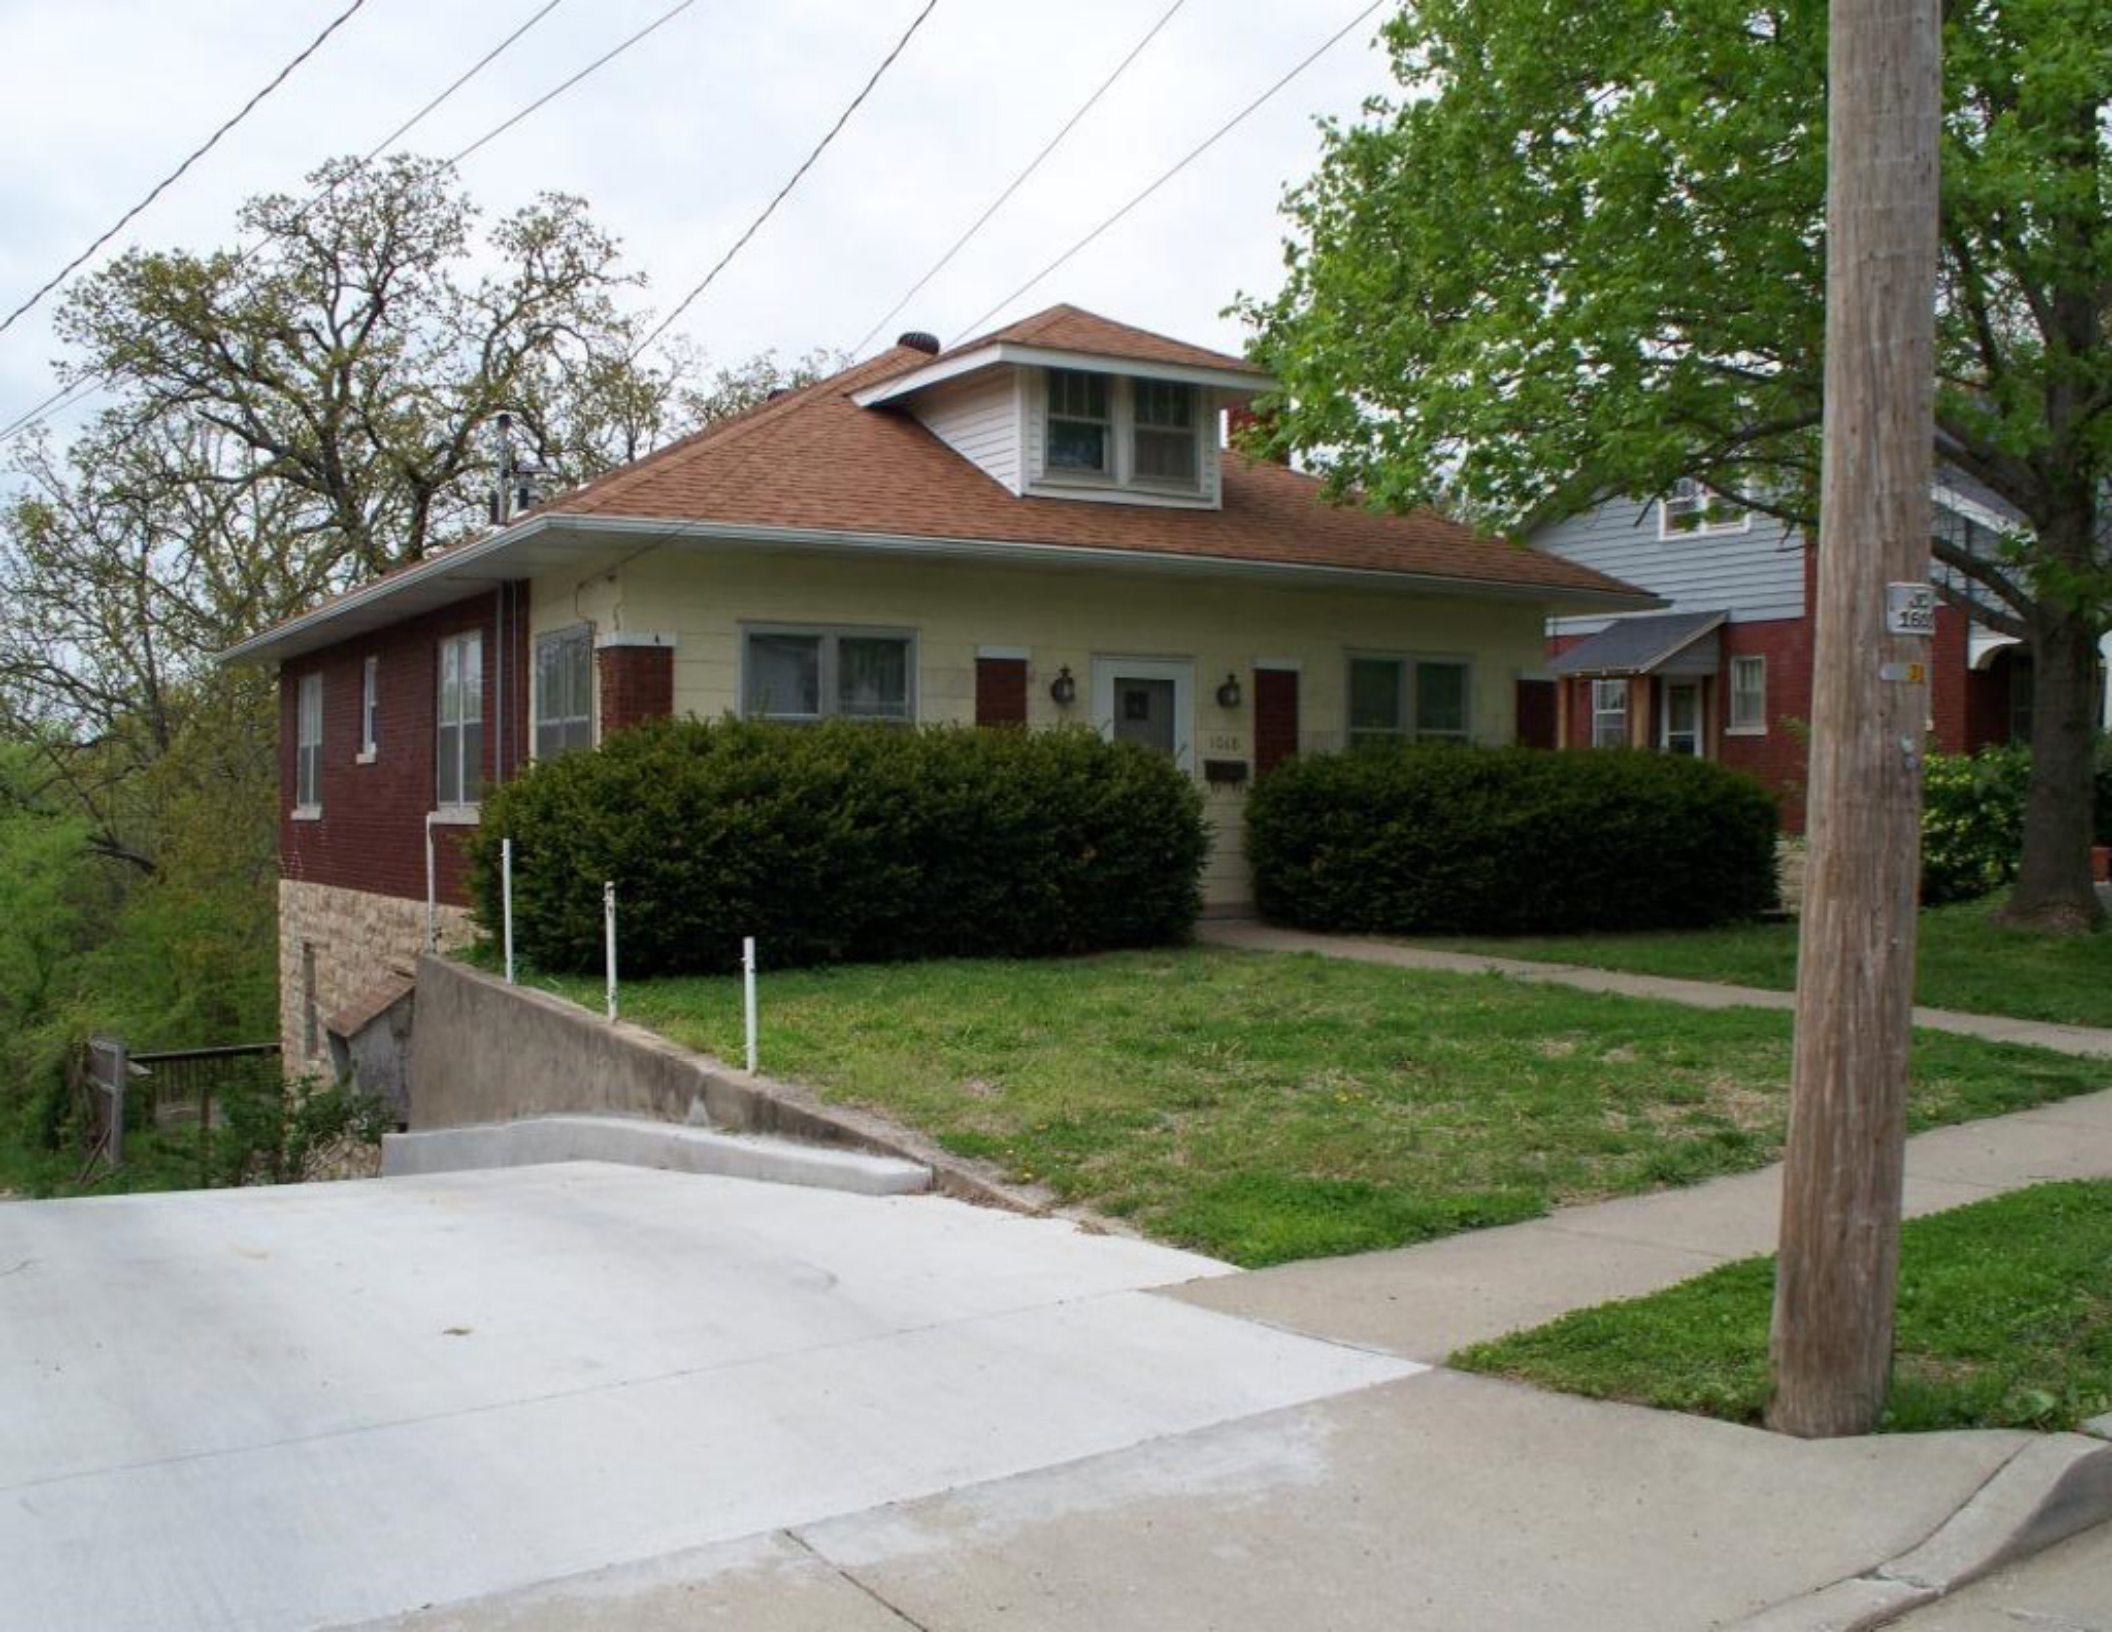
This 1 ½ story brick bungalow has a central pyramidal dormer clad in vinyl with two historic 3/1 windows. The front porch has been in-filled and sided with asbestos shingle save for the original brick piers. Aluminum paired 1/1 windows flank the central entrance. Due to the alterations to the porch the property would be non-contributing to the district.
