ARCHITECTURAL/HISTORIC INVENTORY FORM

1. Survey No. CO-AS-005-001		2. Survey name: Moreau Drive Neighborhood Survey	
3. County: Cole		4. Address: 1202 Elmerine Ave.	
5. City: Jefferson City	Vicinity: <input type="checkbox"/>	6. UTM: / /	7. Township/Range/Section: T: R: S:
8. Historic name (if known):		9. Present/other name (if known):	
10. Ownership: <input checked="" type="checkbox"/> Private <input type="checkbox"/> Public		11. Historic use (if known): Residential	11. Current use: Residential

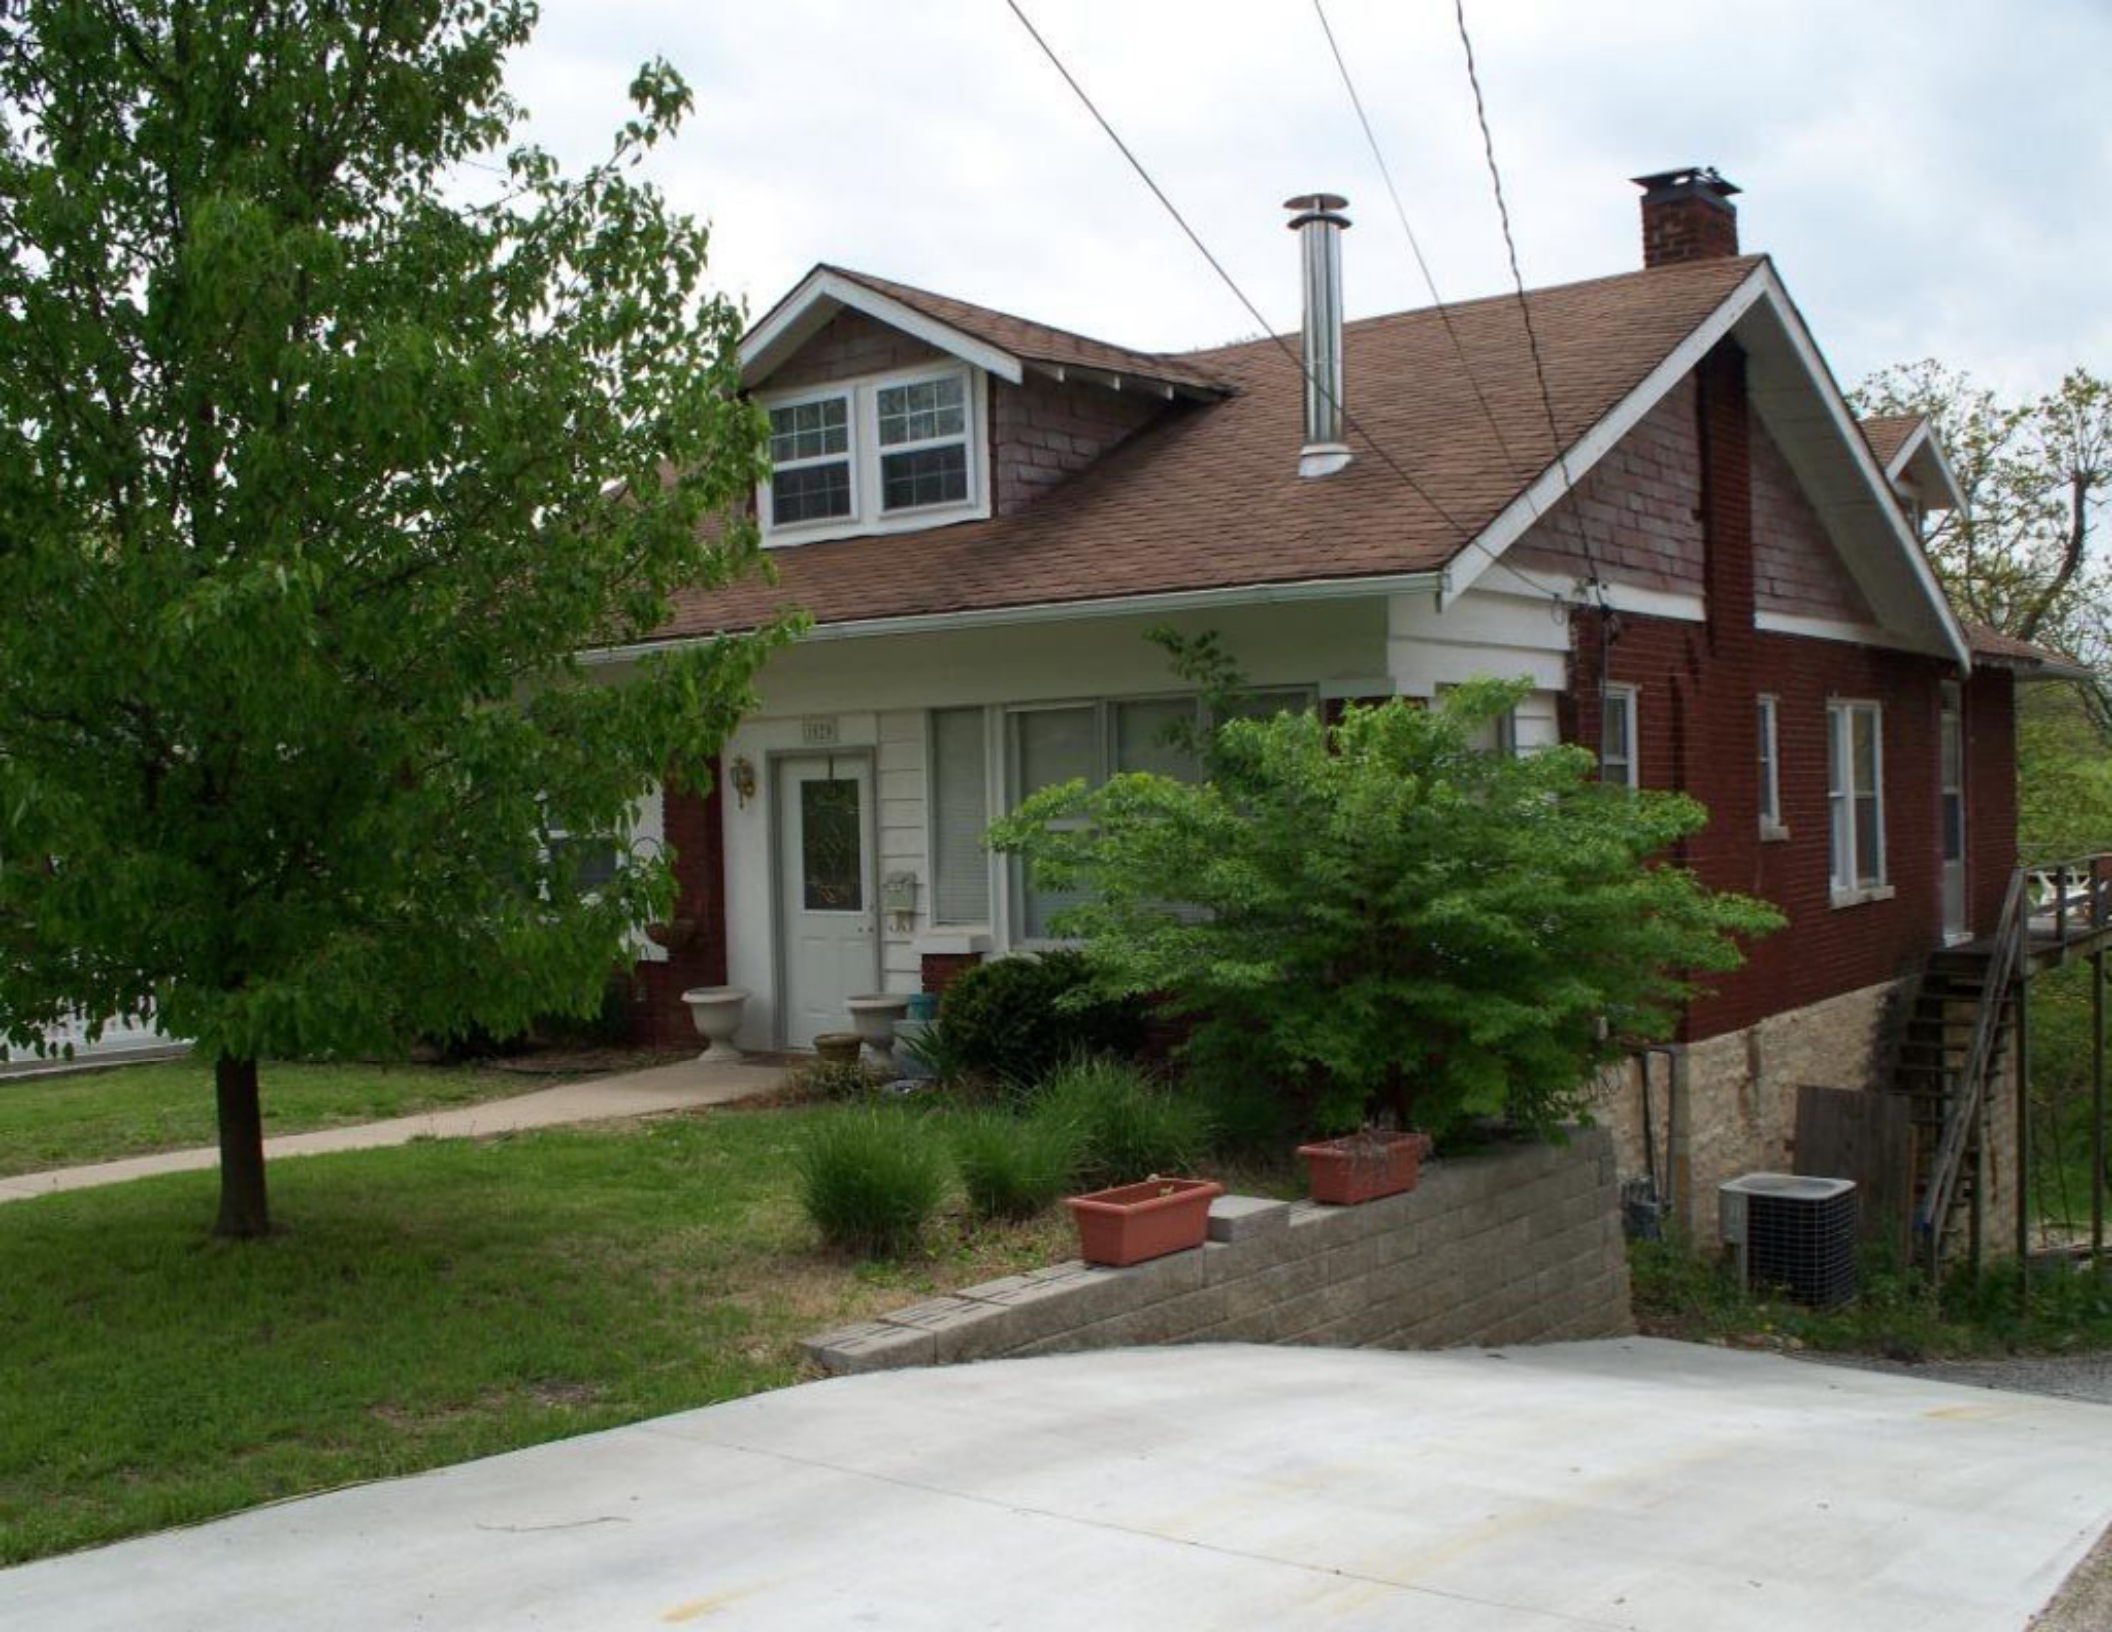
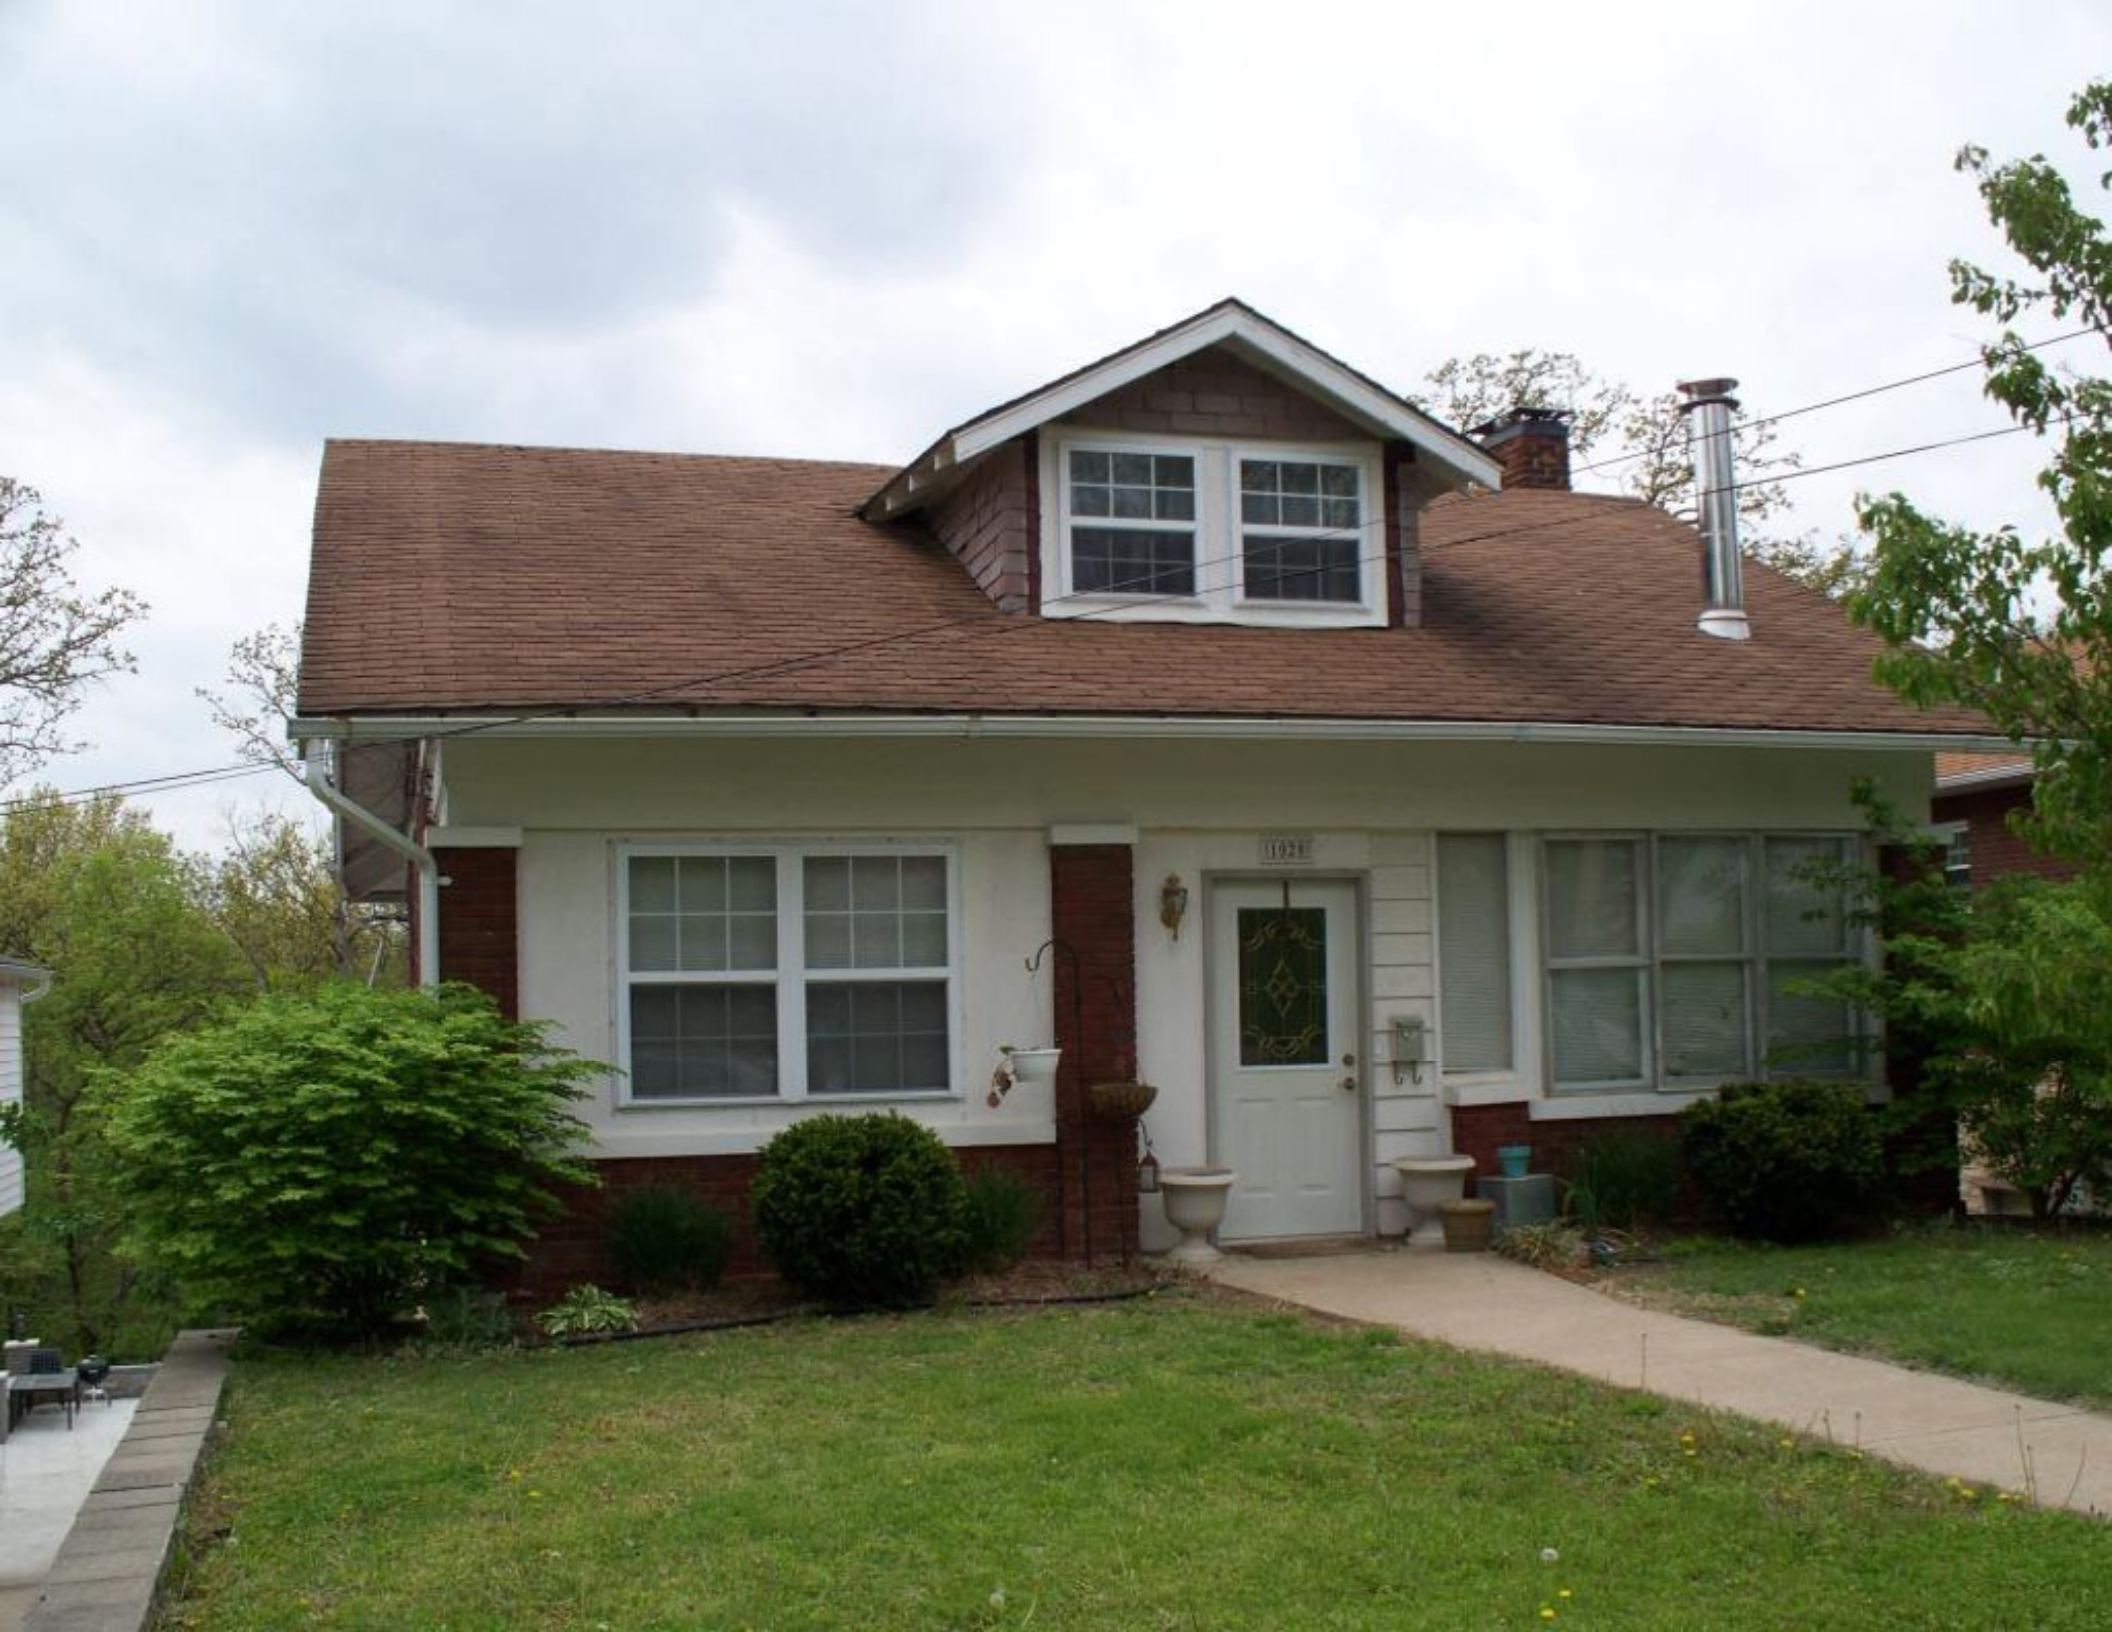
This 1 ½ story brick bungalow has a central gable dormer clad in asphalt shingle with rafter tails and non-historic paired 6/6 windows. Like 1018 Fairmount the full-width porch has been enclosed. The brick half walls and piers are exposed. The right bay has a row of three 1/1 windows and a single light casement window (to the left). The center bay has been partially sided in vinyl and contains a modern door. The final bay has modern 6/6 windows. Due to the extensive alterations this property would not contribute to a historic district.

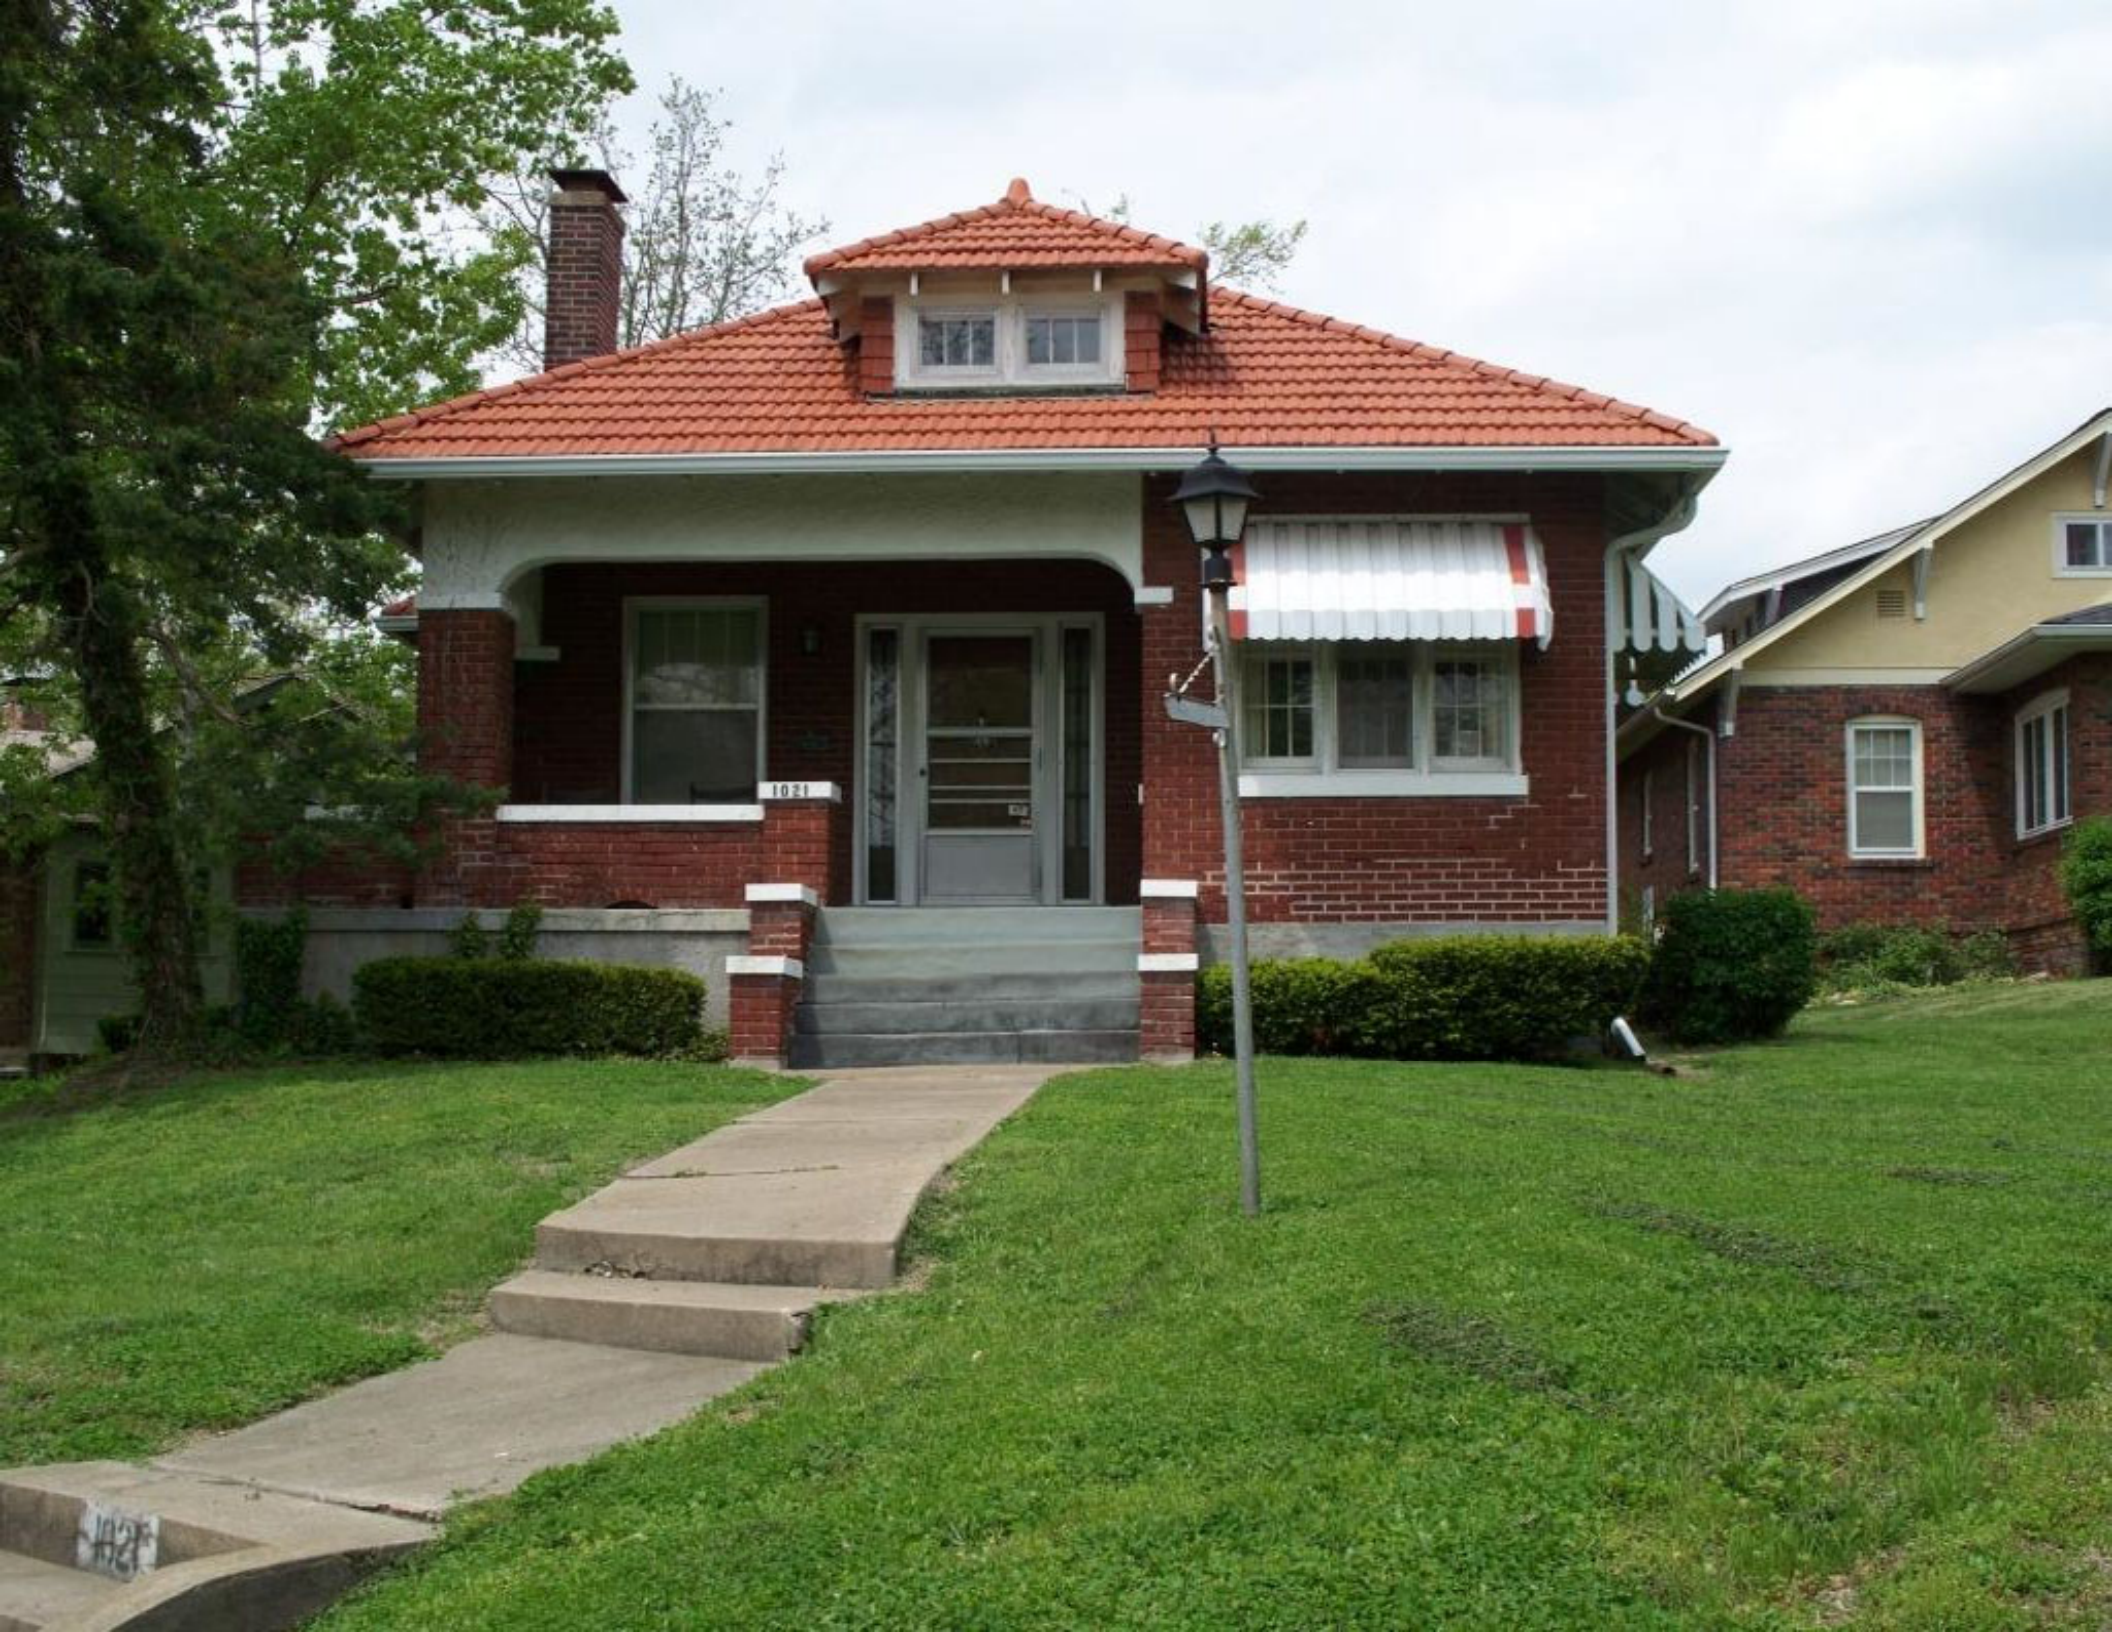
This one and a half story brick bungalow has a hipped clay tile roof and a central dormer that also has a hipped tile roof with capping and rafter-tails and two historic three-light windows. The first two bays (from the left) of the first floor are recessed and serve as the porch. There is a historic 4/1 window in the left bay and the original door and sidelights in the right. The third bay is brick and contains a row of three windows with a concrete or limestone sill that may or may not be historic. A metal hood is over this window and a window on the right side of the property. The porch has brick half walls and piers capped in limestone or concrete that meets a basket handle stucco entablature under the roofline. The foundation is set high and appears to be parged.

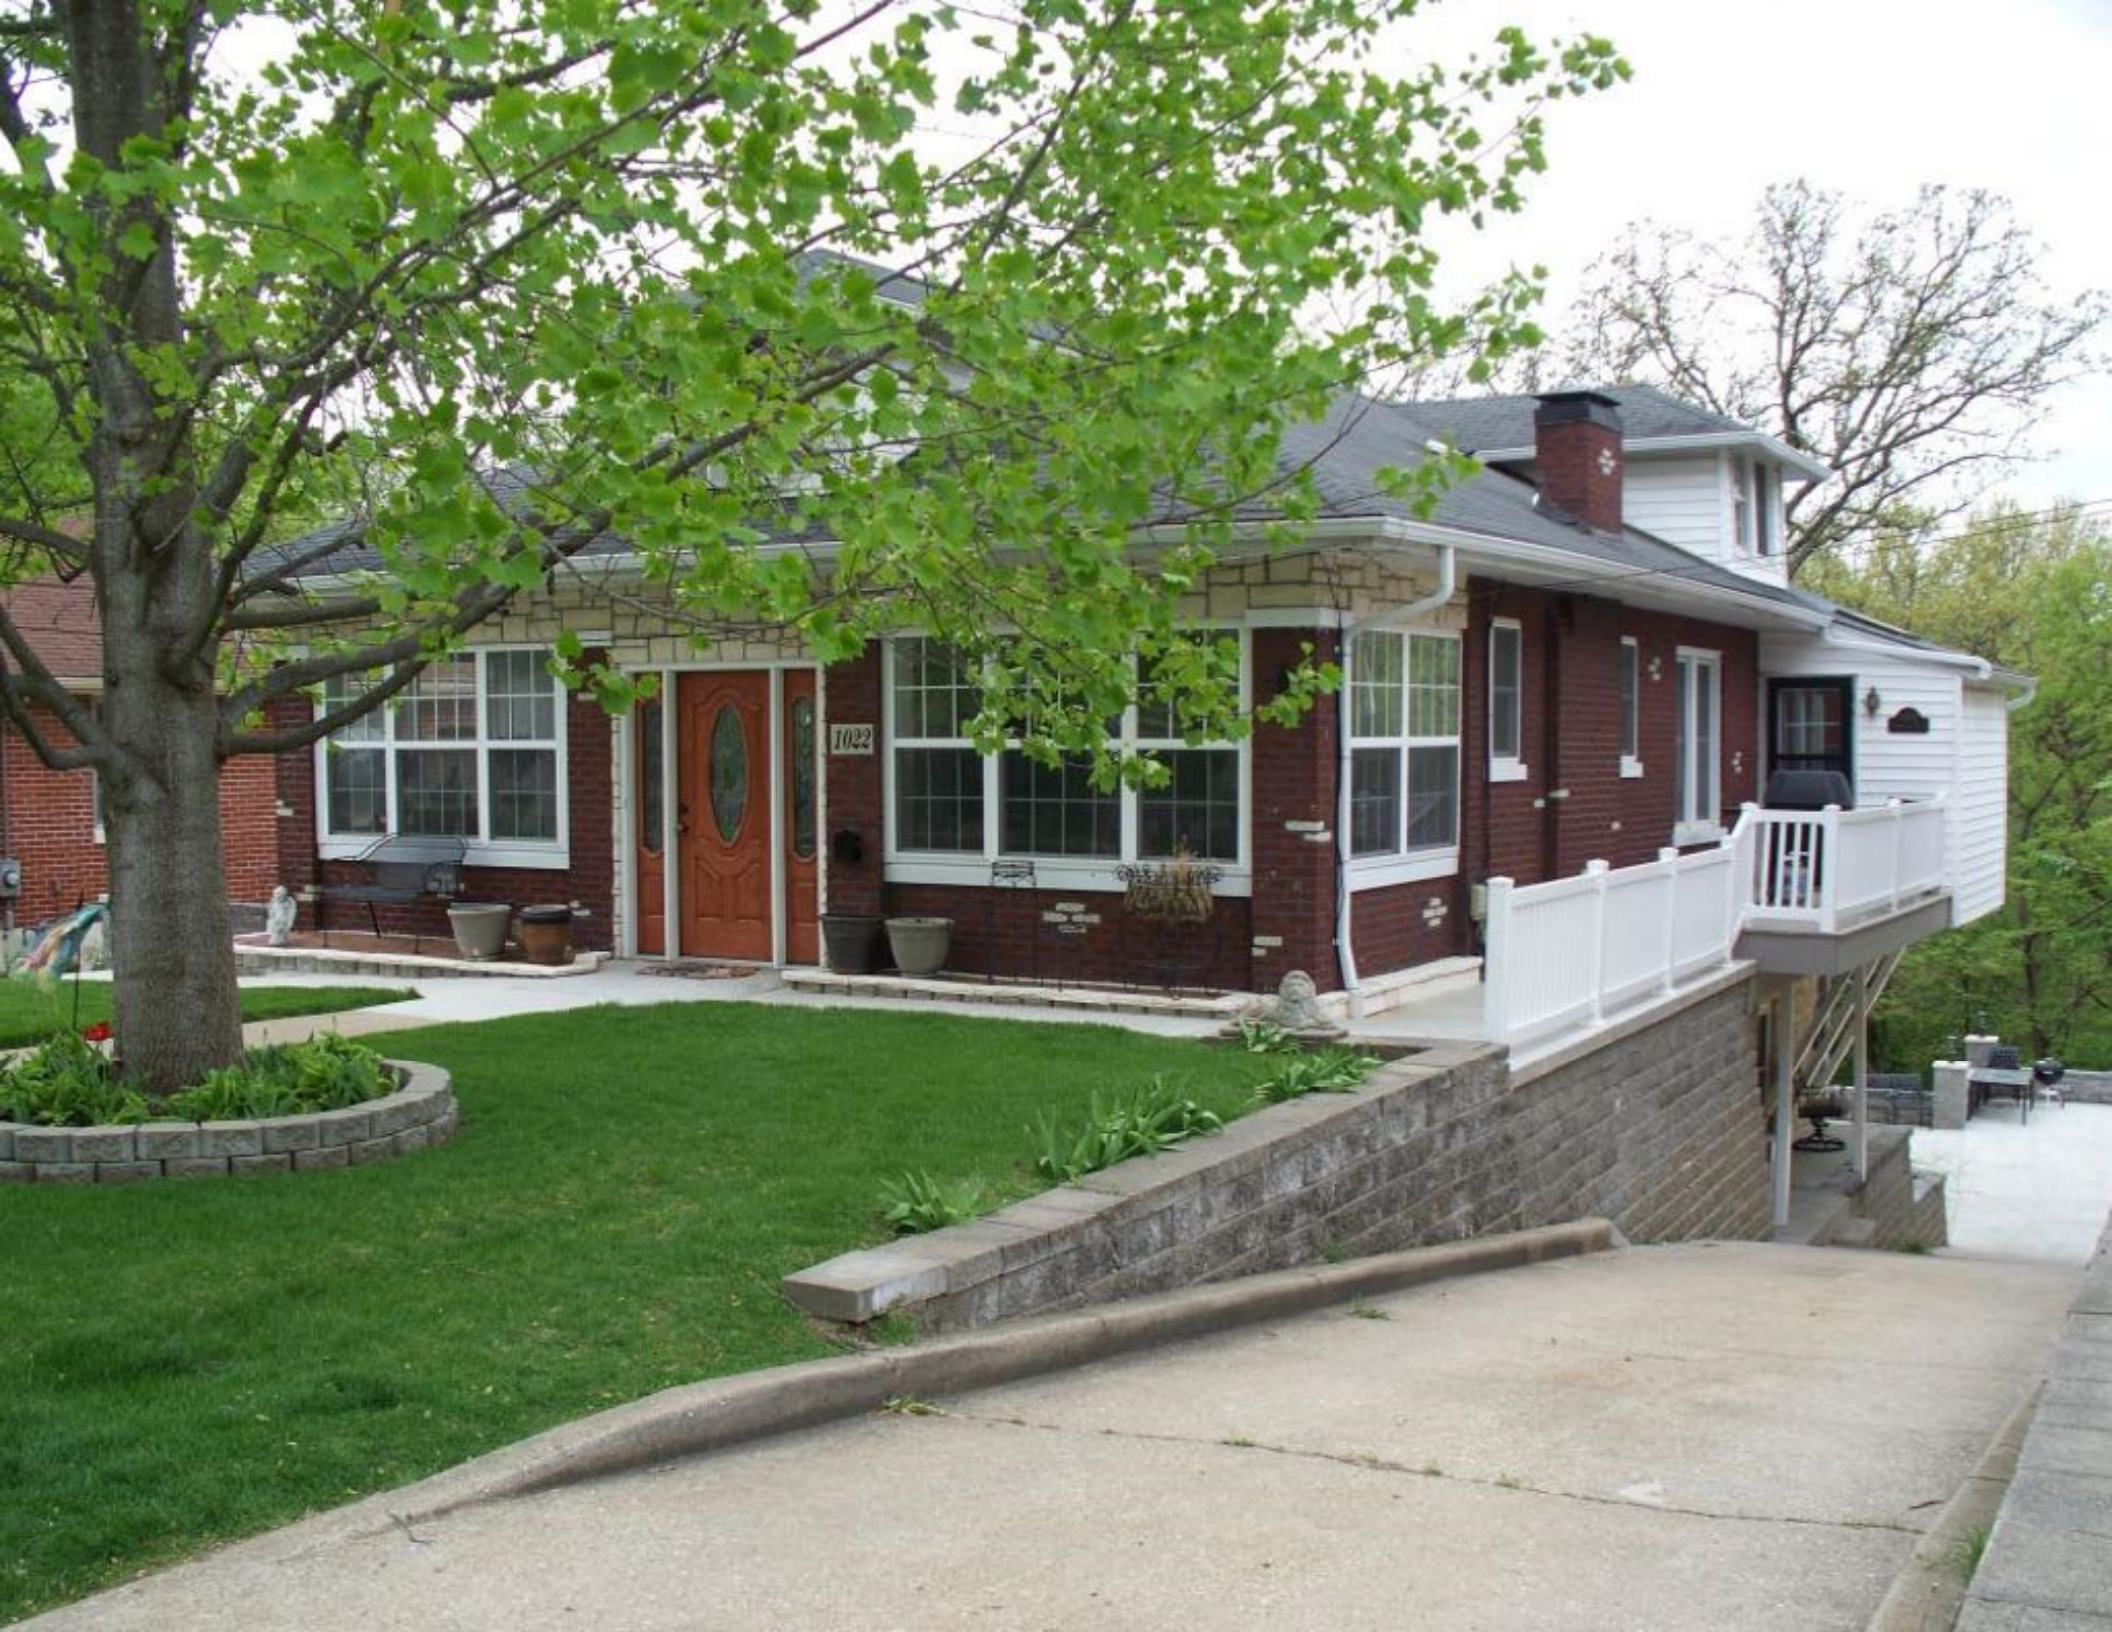
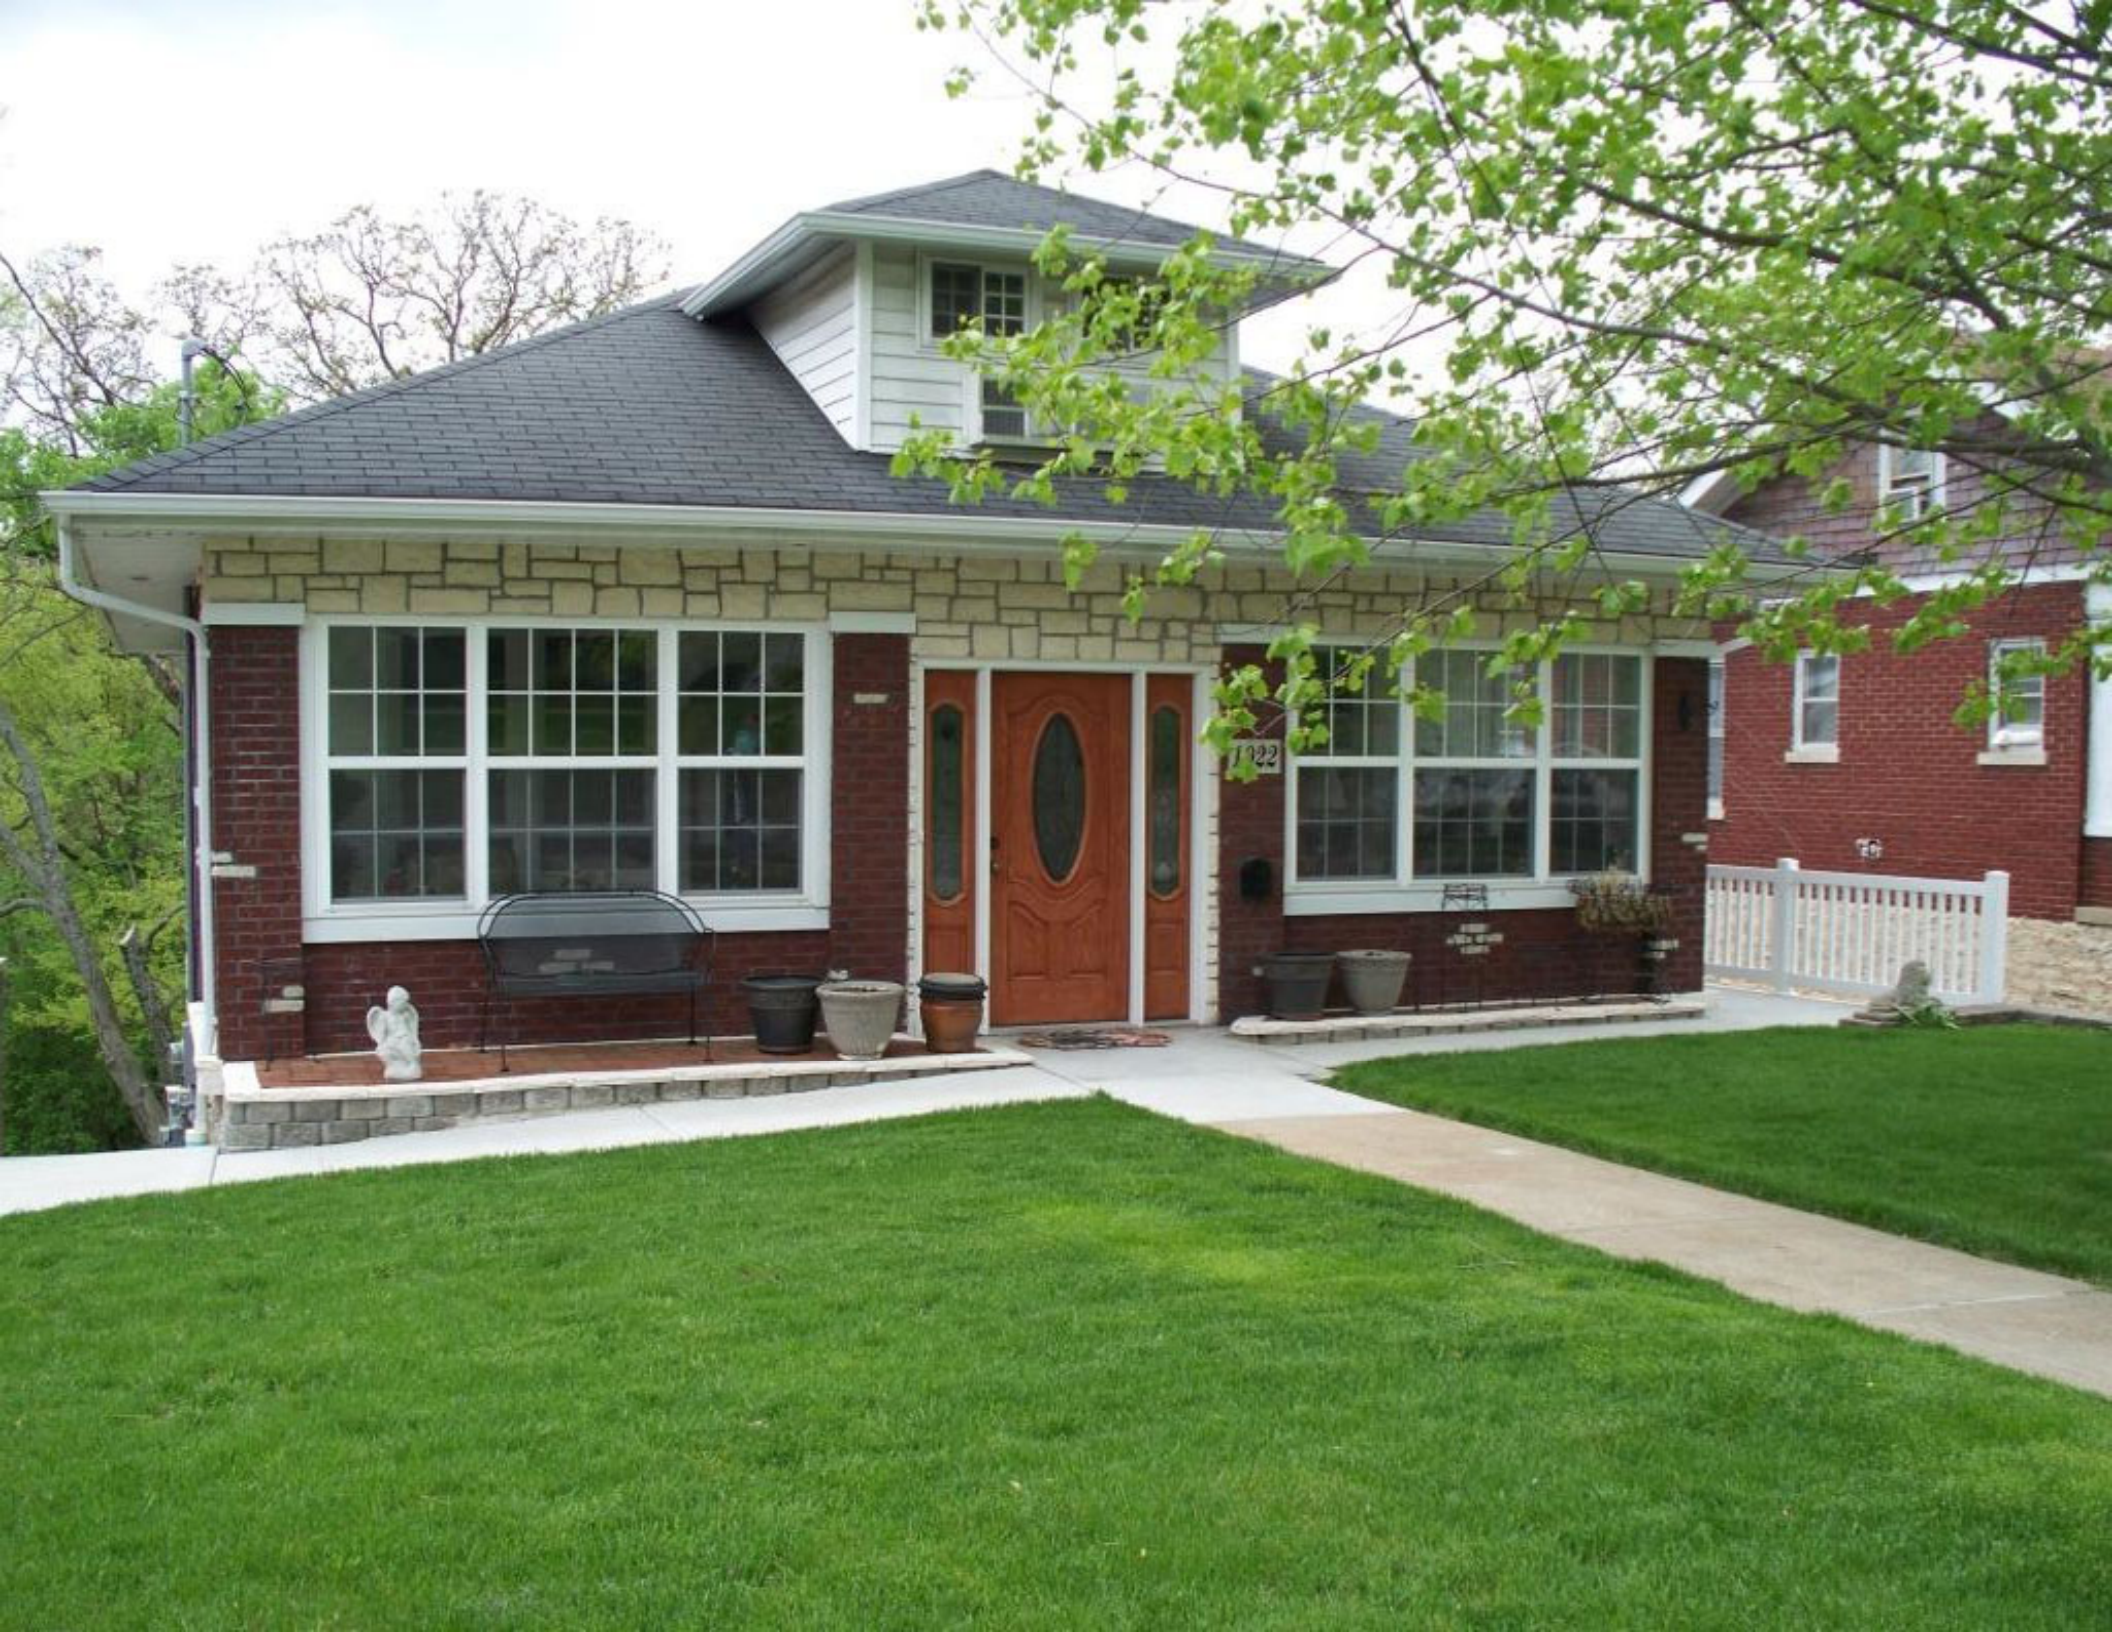
This 1 ½ story brick bungalow has a central pyramidal dormer clad in vinyl with two replacement six by six windows and what appears to be an air conditioning unit installed below. The porch has been enclosed with a row of three modern 6/6 windows flanking each side of a modern wooden door and sidelights. There is a row of stone (possibly faux) along the top of the porch and along the entrance. The original brick piers and half walls are exposed and appear to have decorative stonework throughout. Due to the extensive alterations this property would be non-contributing to a historic district.
