ARCHITECTURAL/HISTORIC INVENTORY FORM

1. Survey No. CO-AS-005-001		2. Survey name: Moreau Drive Neighborhood Survey	
3. County: Cole		4. Address: 1202 Elmerine Ave.	
5. City: Jefferson City	Vicinity: <input type="checkbox"/>	6. UTM: / /	7. Township/Range/Section: T: R: S:
8. Historic name (if known):		9. Present/other name (if known):	
10. Ownership: <input checked="" type="checkbox"/> Private <input type="checkbox"/> Public		11. Historic use (if known): Residential	11. Current use: Residential

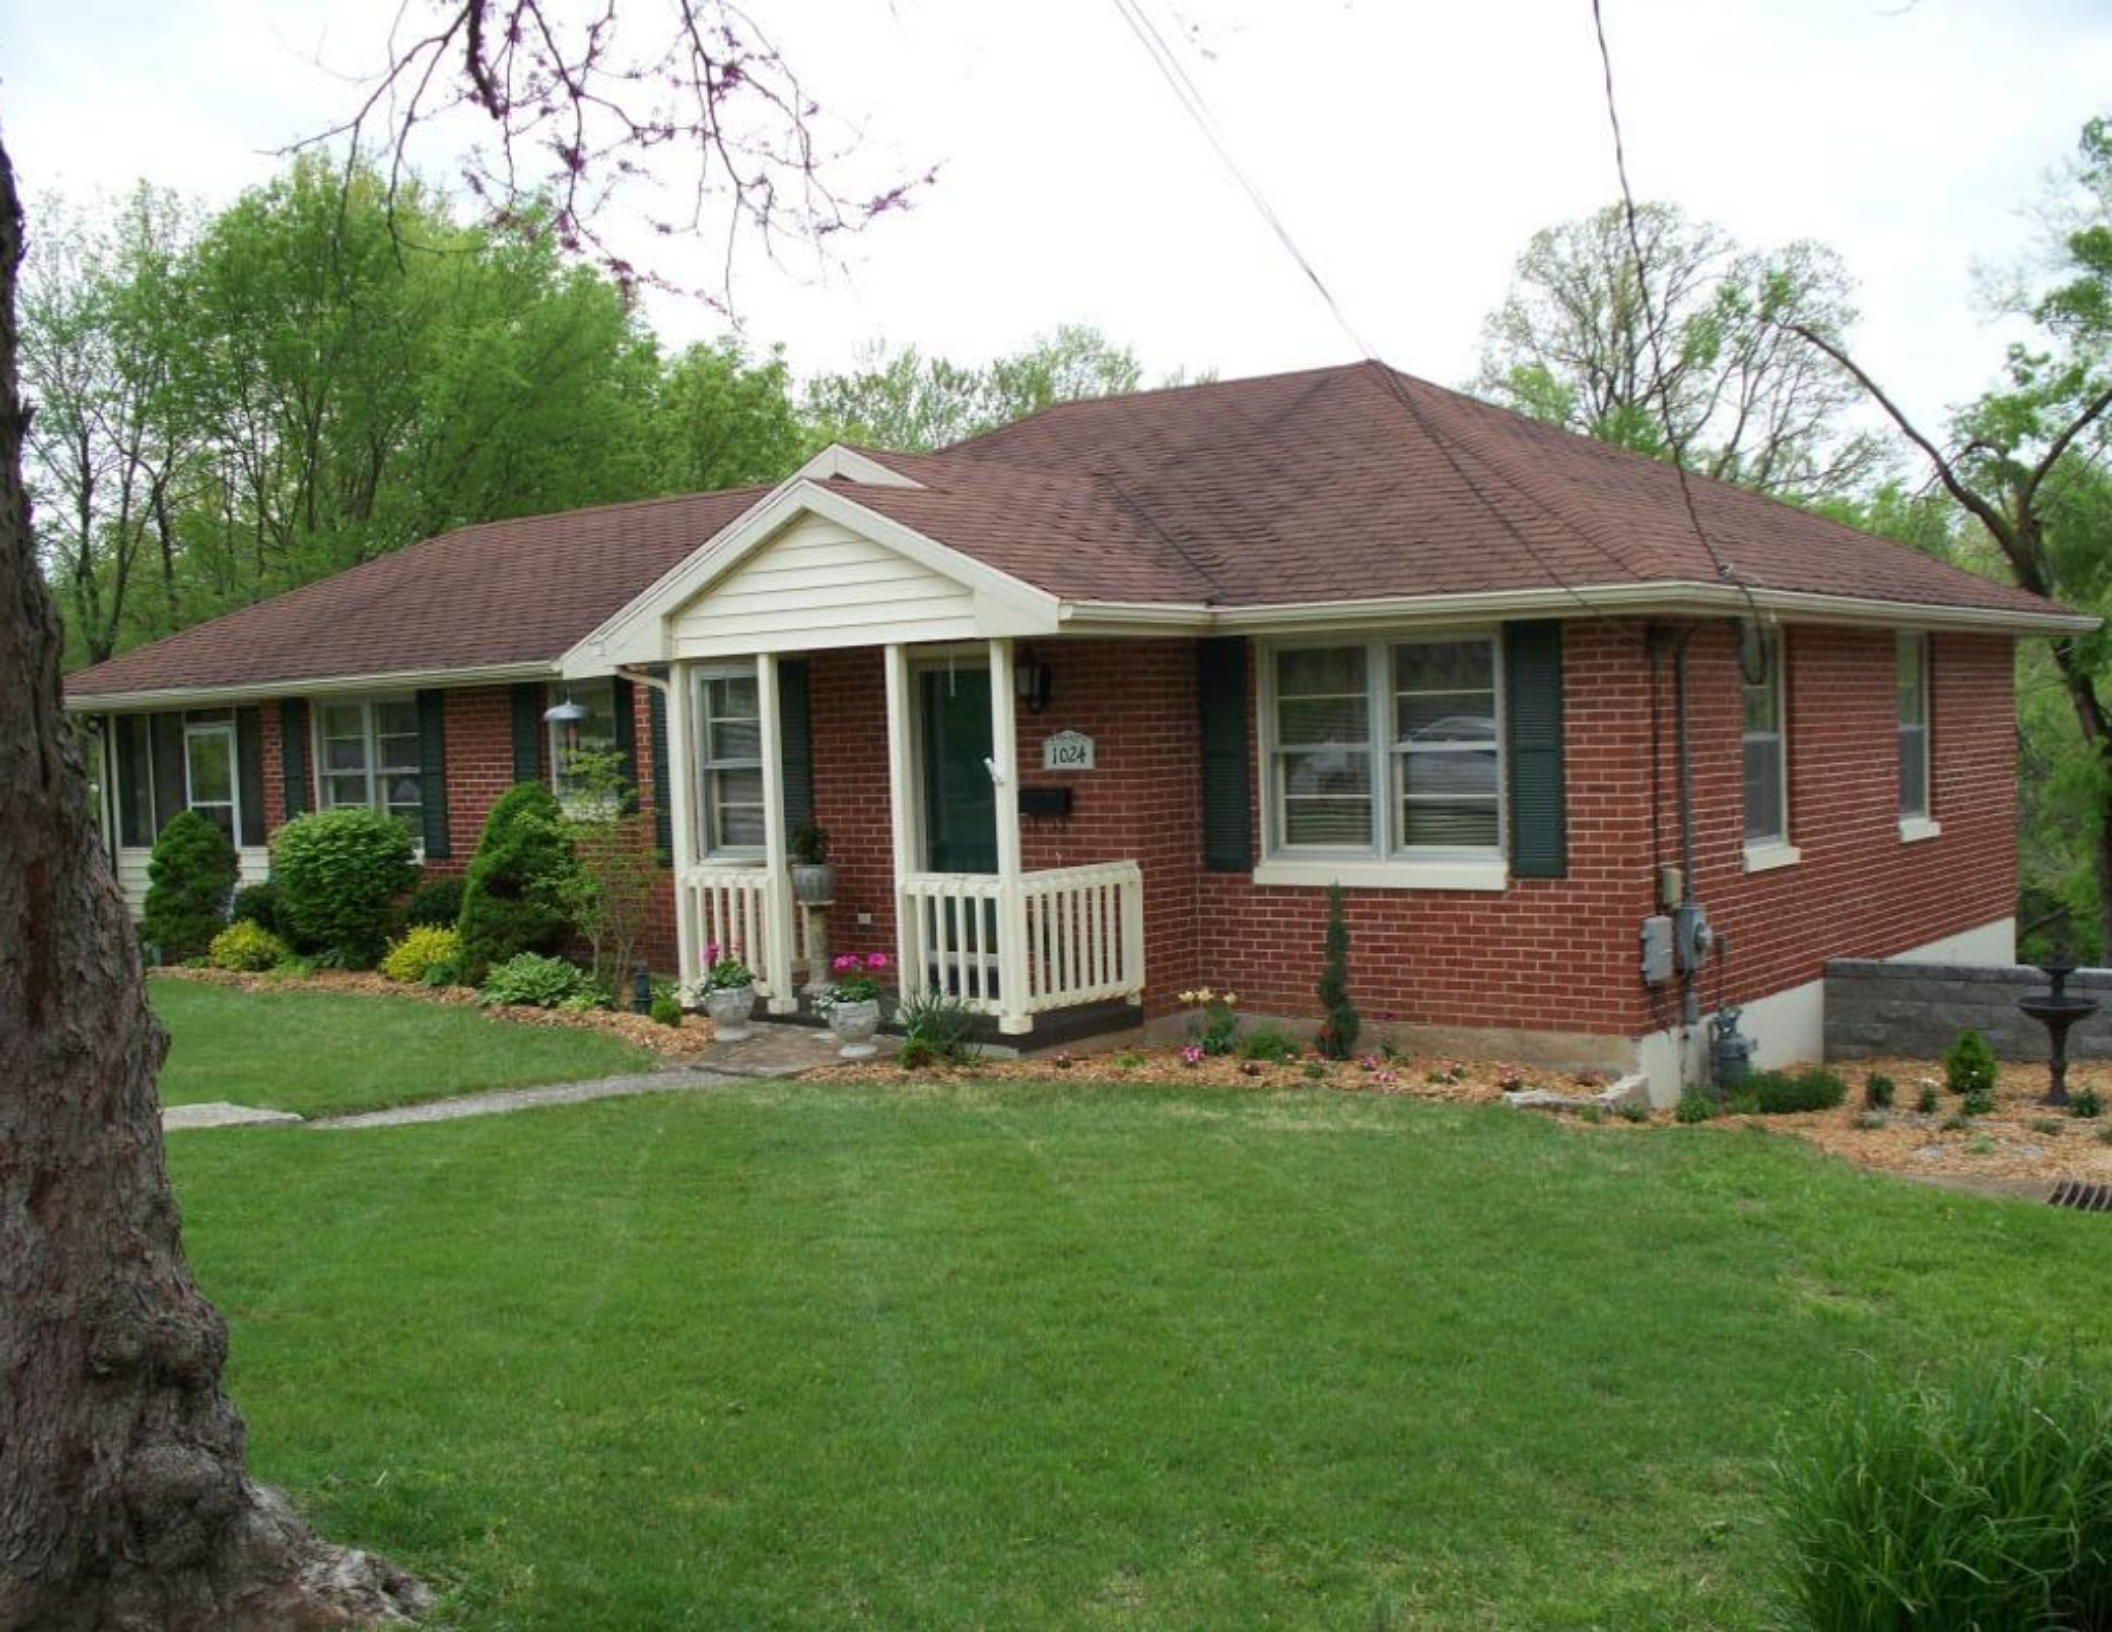
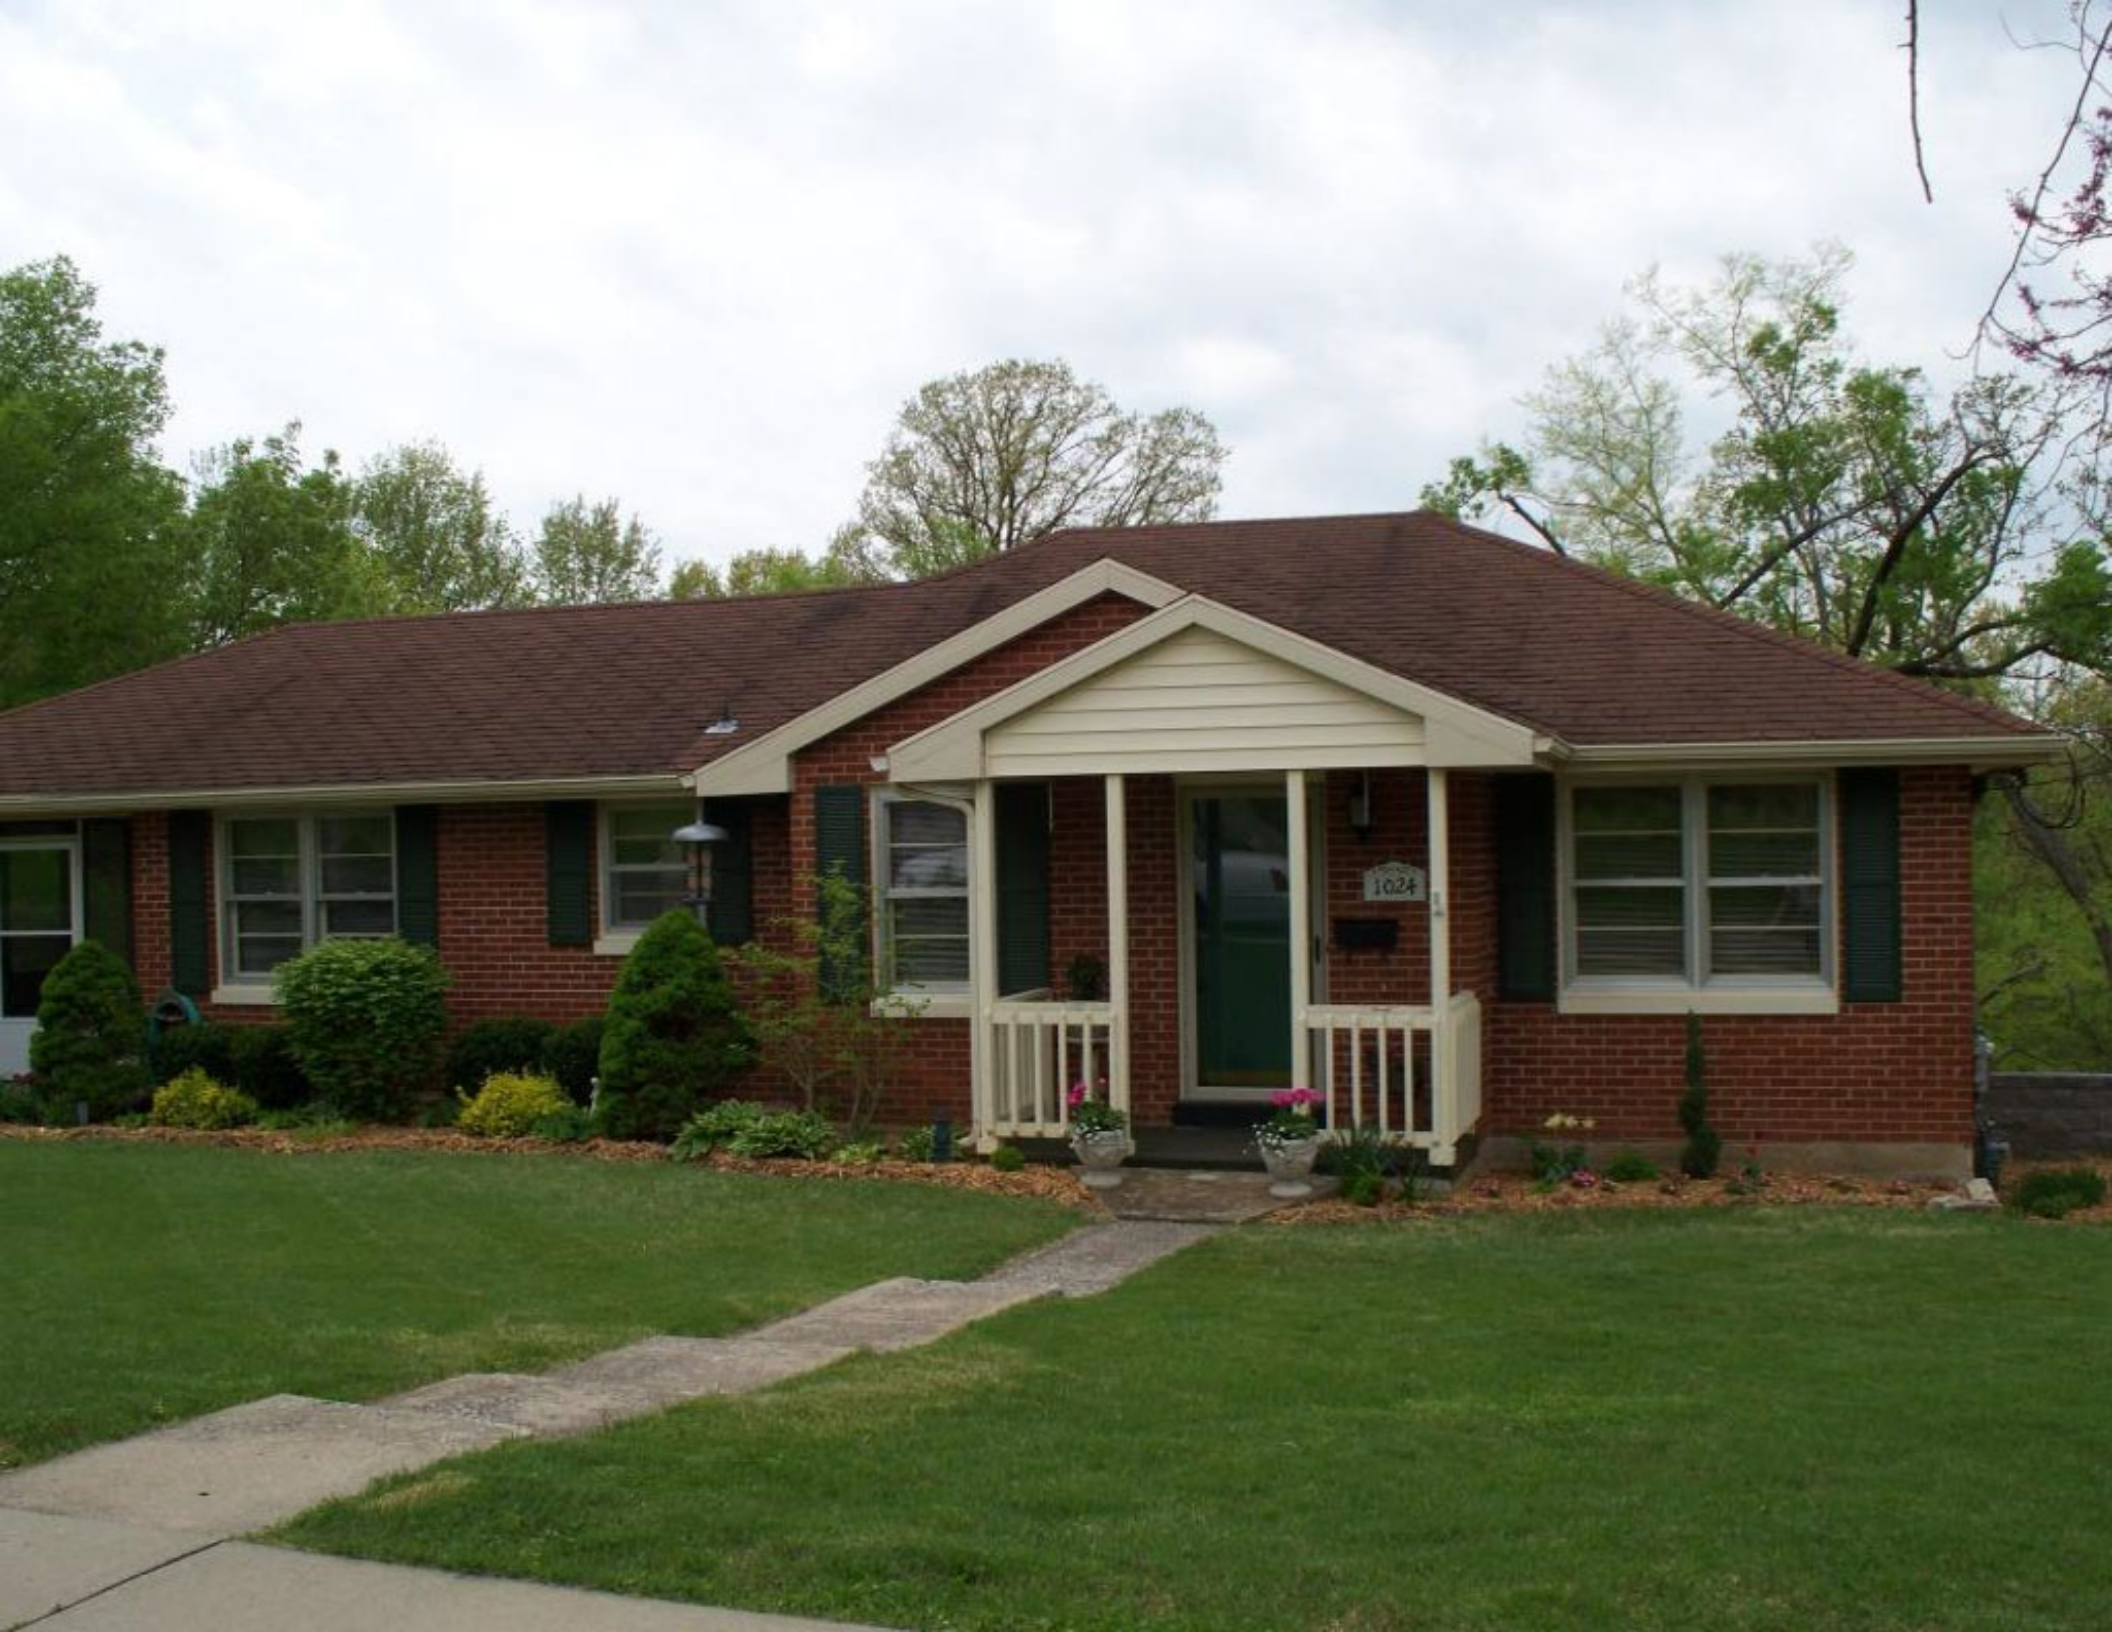
This 1 story brick ranch house has a hipped roof with a projecting vinyl gable for the porch. From the right, the first bay has paired 1/1 windows with concrete sills. The second bay projects slightly and holds the entrance and porch. The projecting gable connects to wood posts and railing that act as a very small porch. The next bay has a 1/1 window, the fourth a smaller 1/1 window and the fifth paired 1/1 windows. All of the windows have shutters. The final bay is a screened in sun porch that is sided in vinyl. If the period of significance extends to the early 1960s this property would contribute. For the purposes of this study it was built after the period of significance (1950) thus is marked non-contributing.

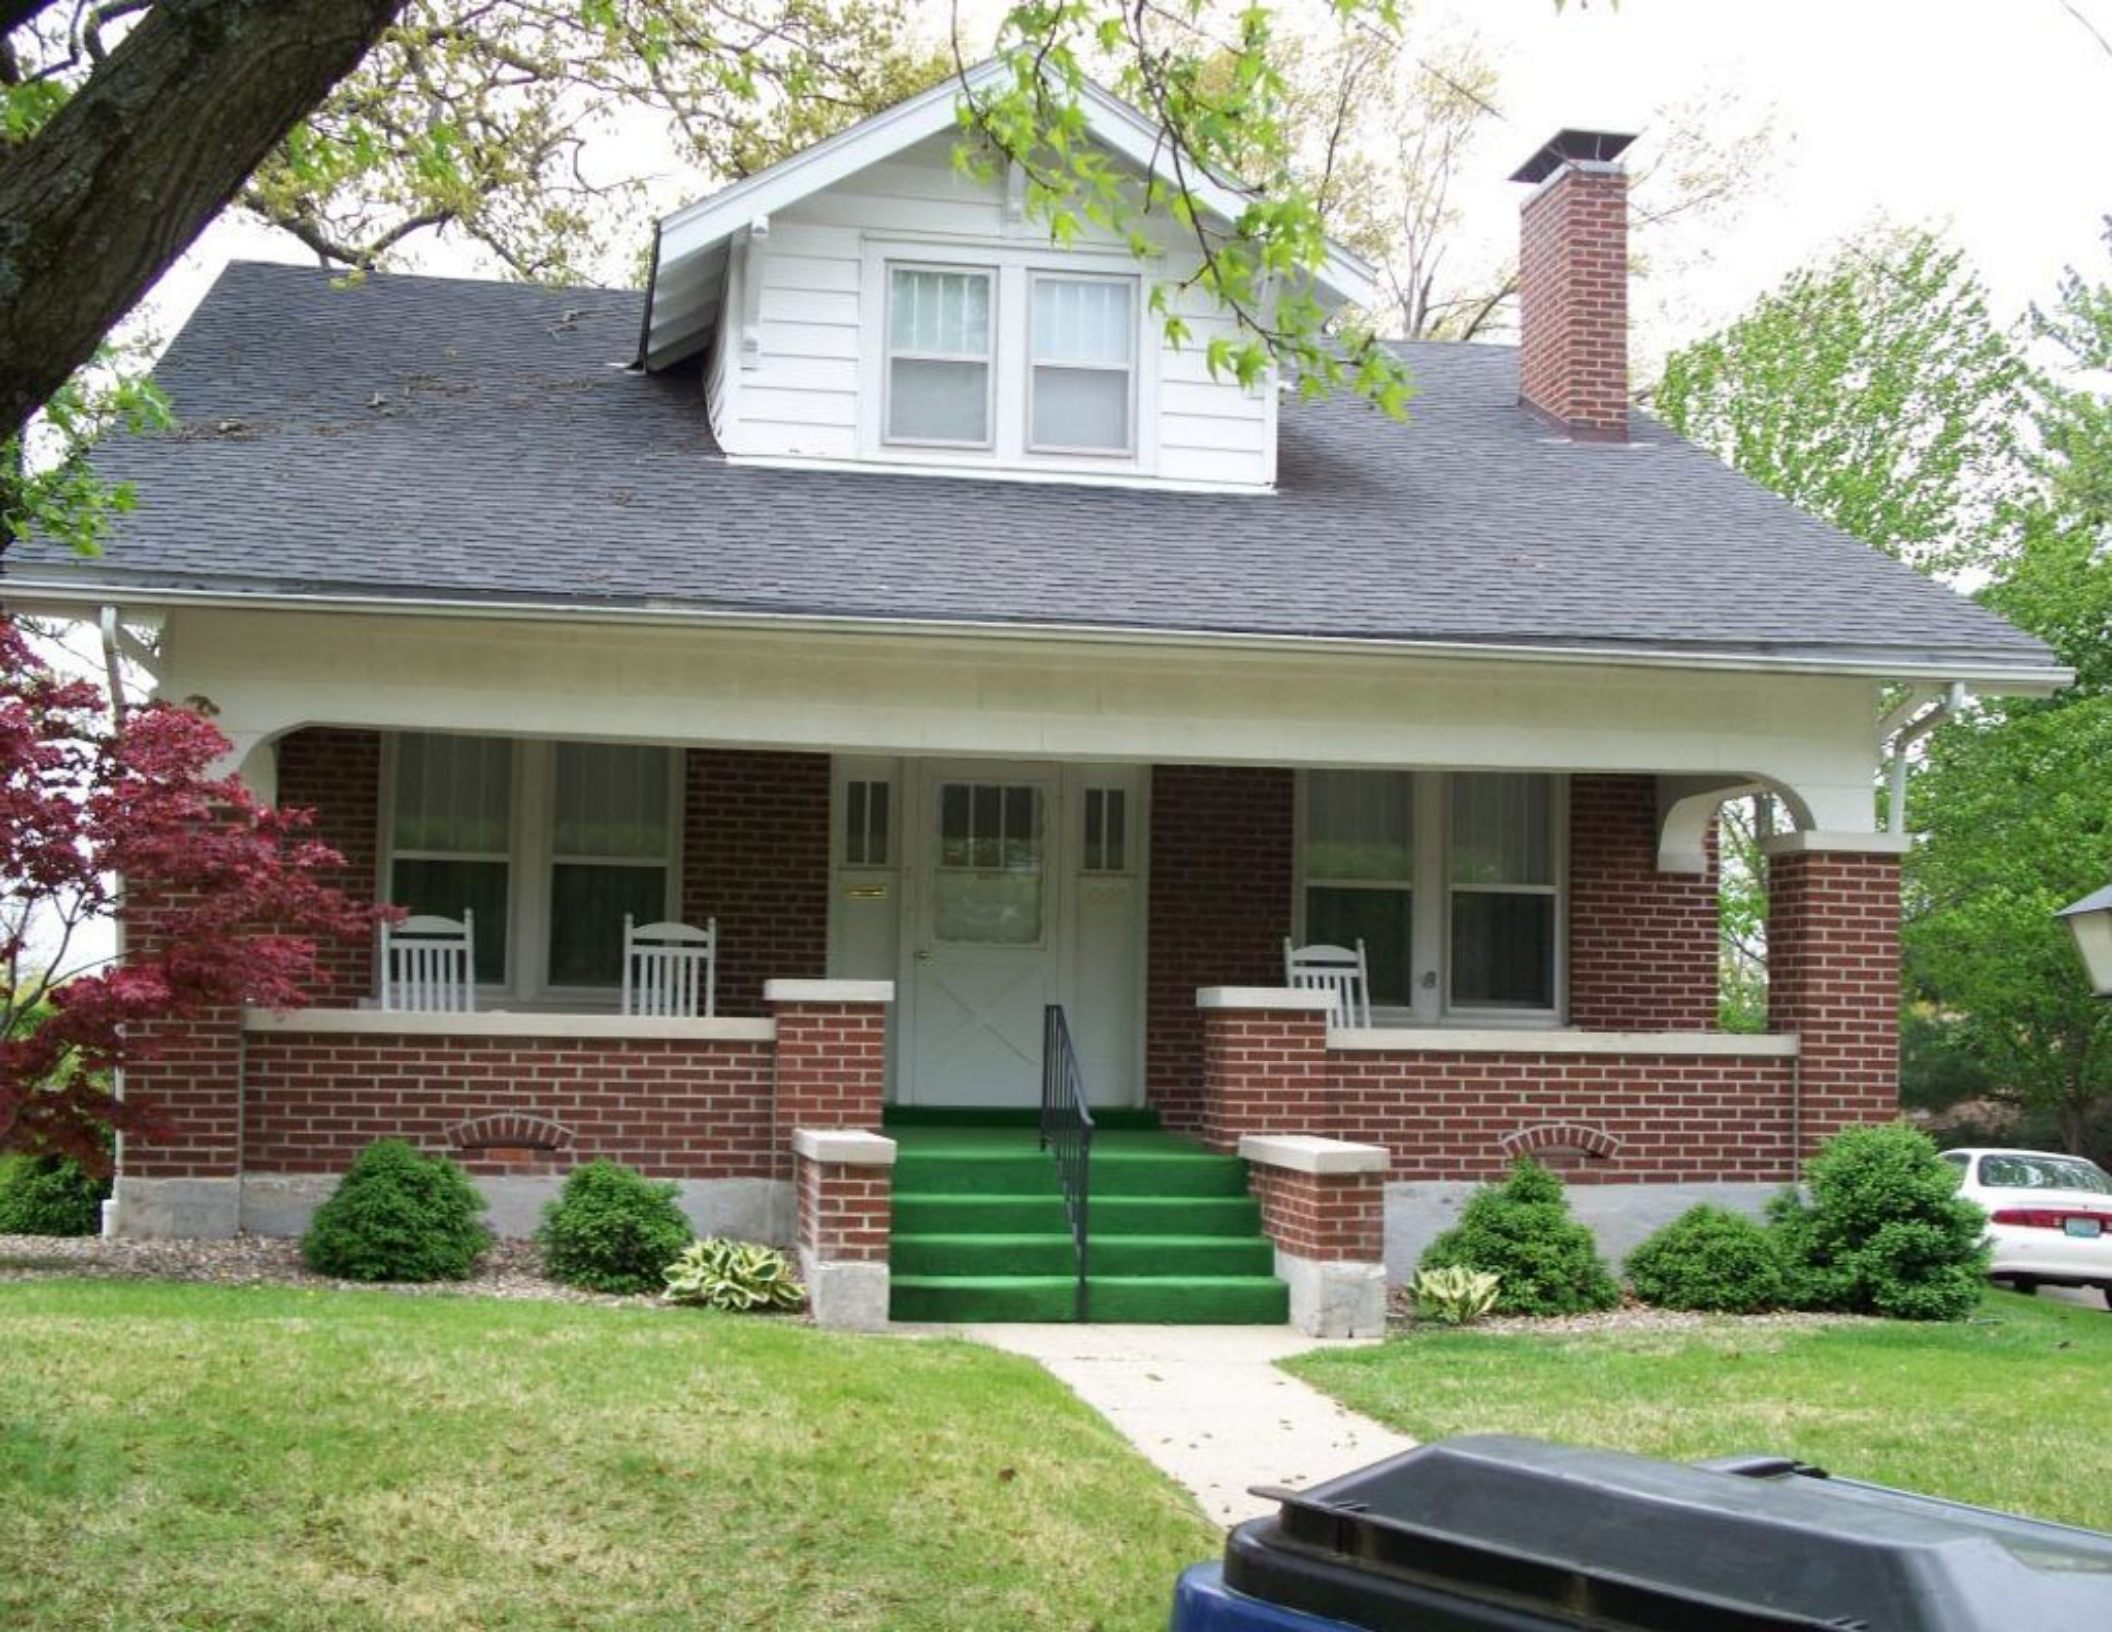
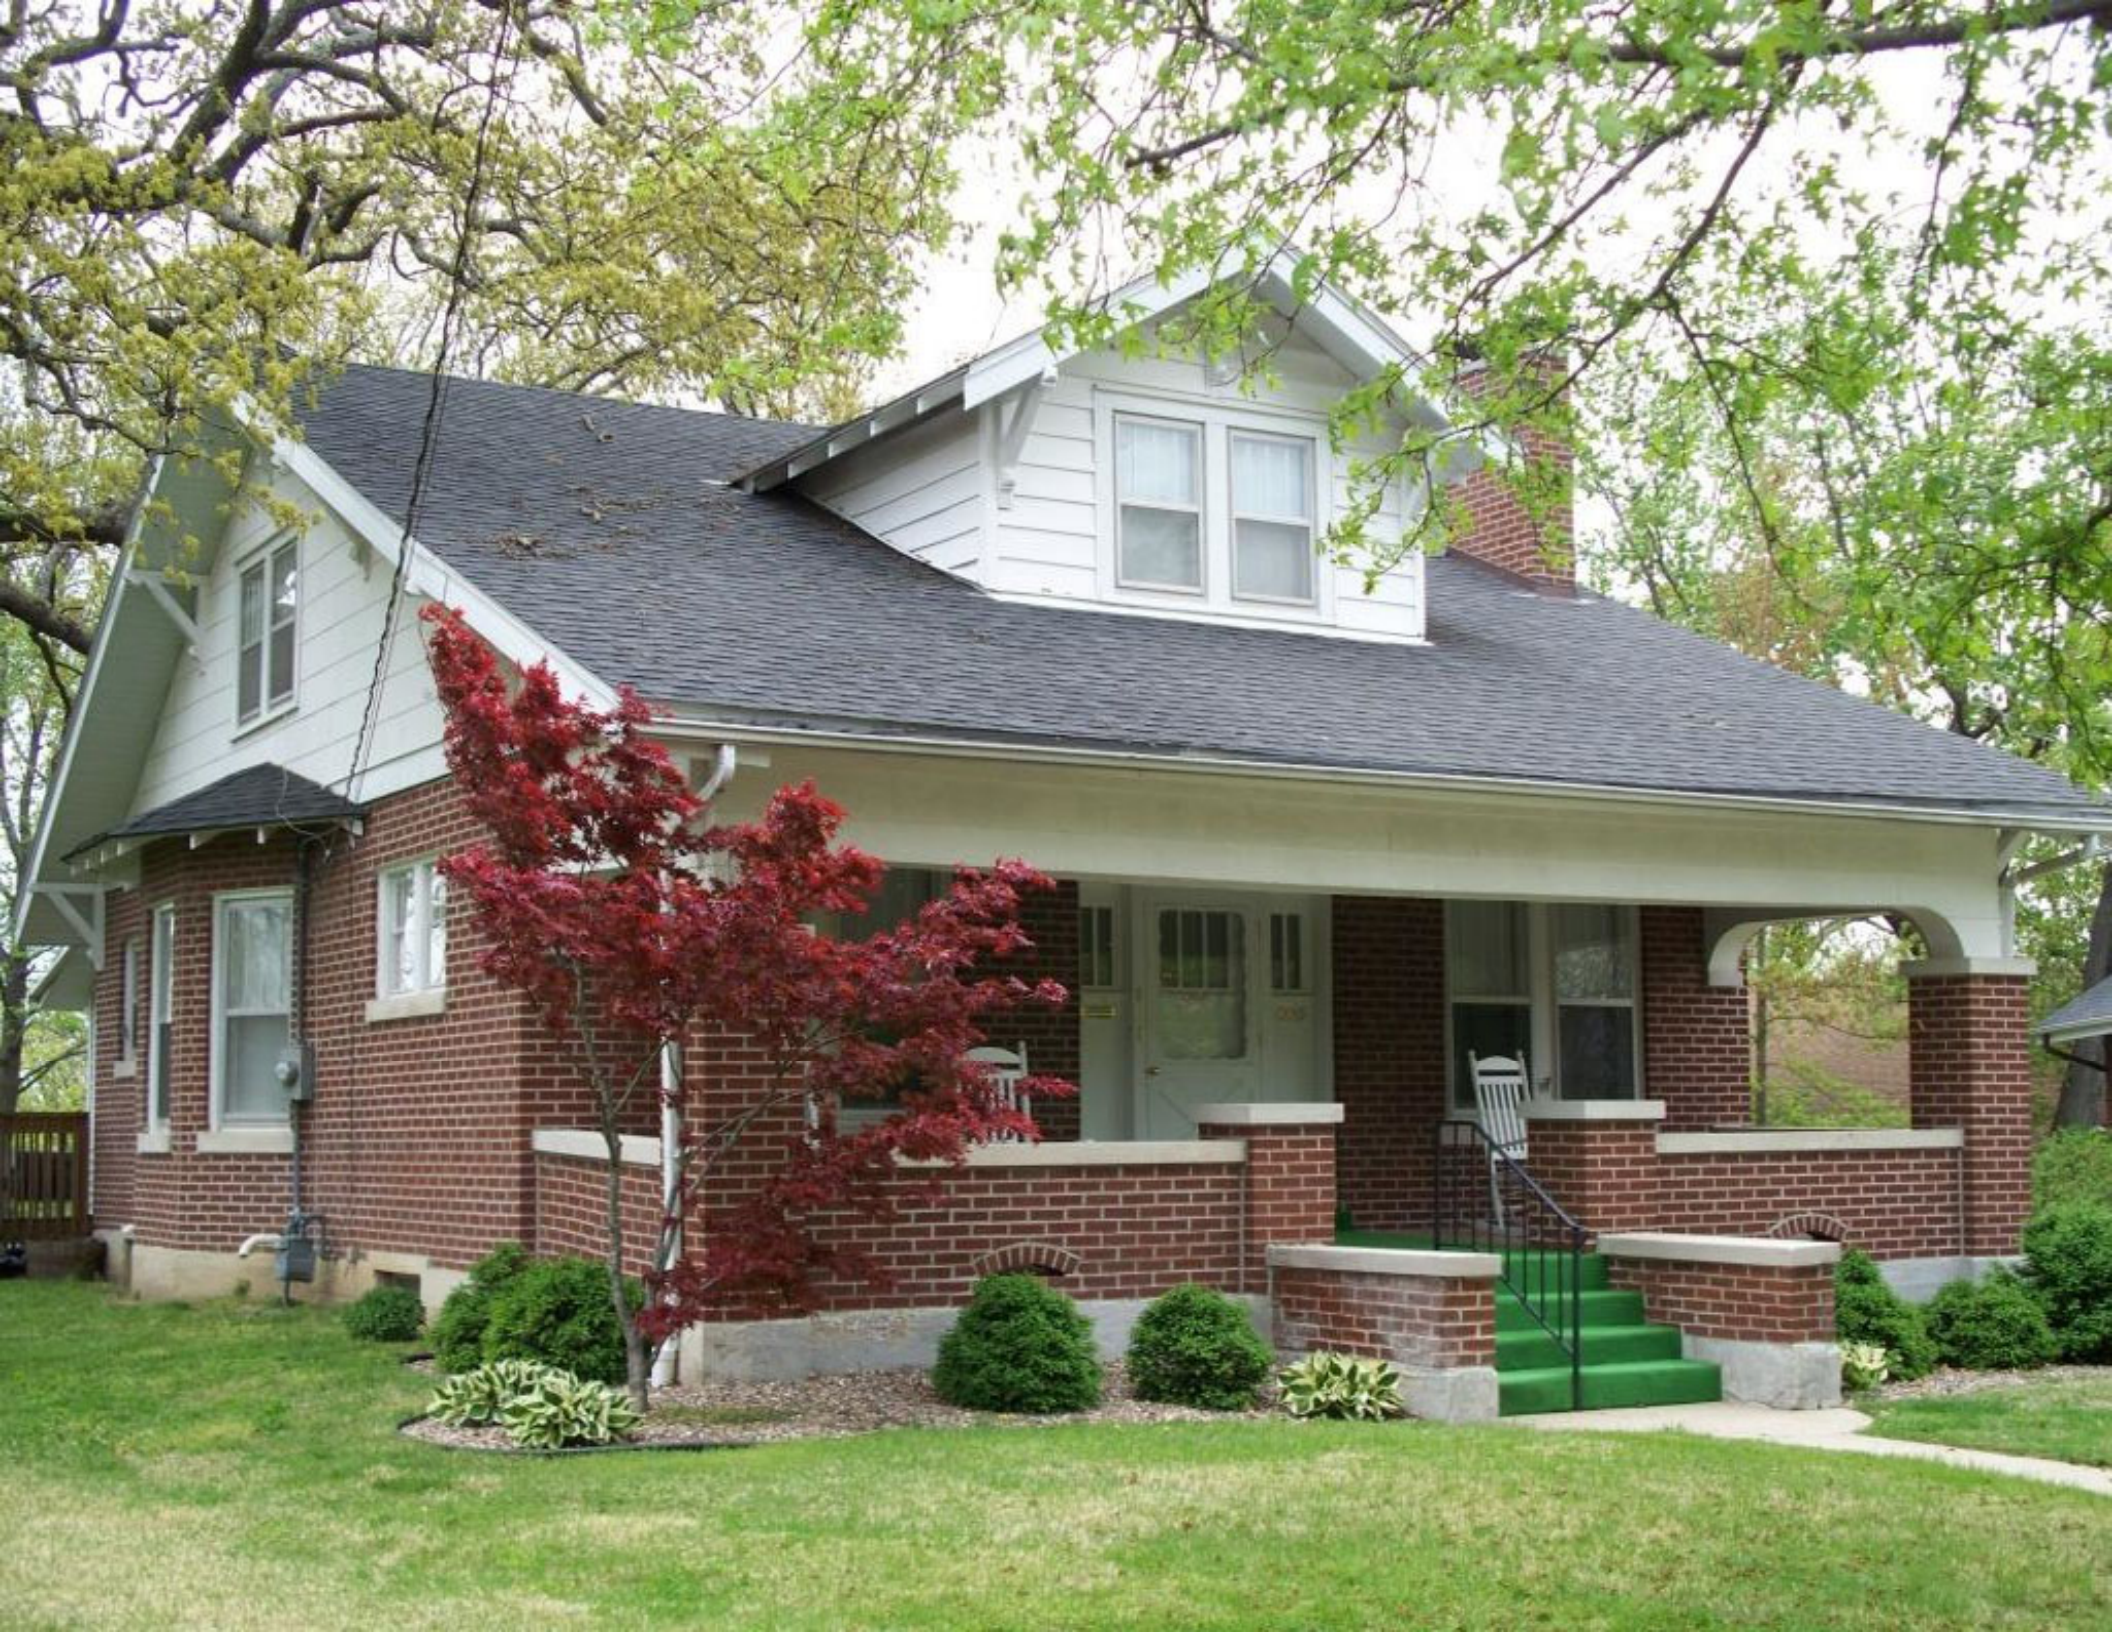
This is 1 ½ story brick side gable roof has a large gable dormer sided in vinyl, however it retains paired 4/1 historic windows, rafter tails and knee braces. There are two paired historic 4/1 windows with limestone sills flanking the entrance, which appears to retain its original door and sidelights. The full width porch has brick piers and knee walls capped in limestone. The piers meet a stuccoed architrave and entablature creating a wide shallow basket handle arch. In the knee walls are two small eyebrow vents above the concrete foundation.
