ARCHITECTURAL/HISTORIC INVENTORY FORM

1. Survey No. CO-AS-005-001		2. Survey name: Moreau Drive Neighborhood Survey	
3. County: Cole		4. Address: 1202 Elmerine Ave.	
5. City: Jefferson City	Vicinity: <input type="checkbox"/>	6. UTM: / /	7. Township/Range/Section: T: R: S:
8. Historic name (if known):		9. Present/other name (if known):	
10. Ownership: <input checked="" type="checkbox"/> Private <input type="checkbox"/> Public		11. Historic use (if known): Residential	11. Current use: Residential

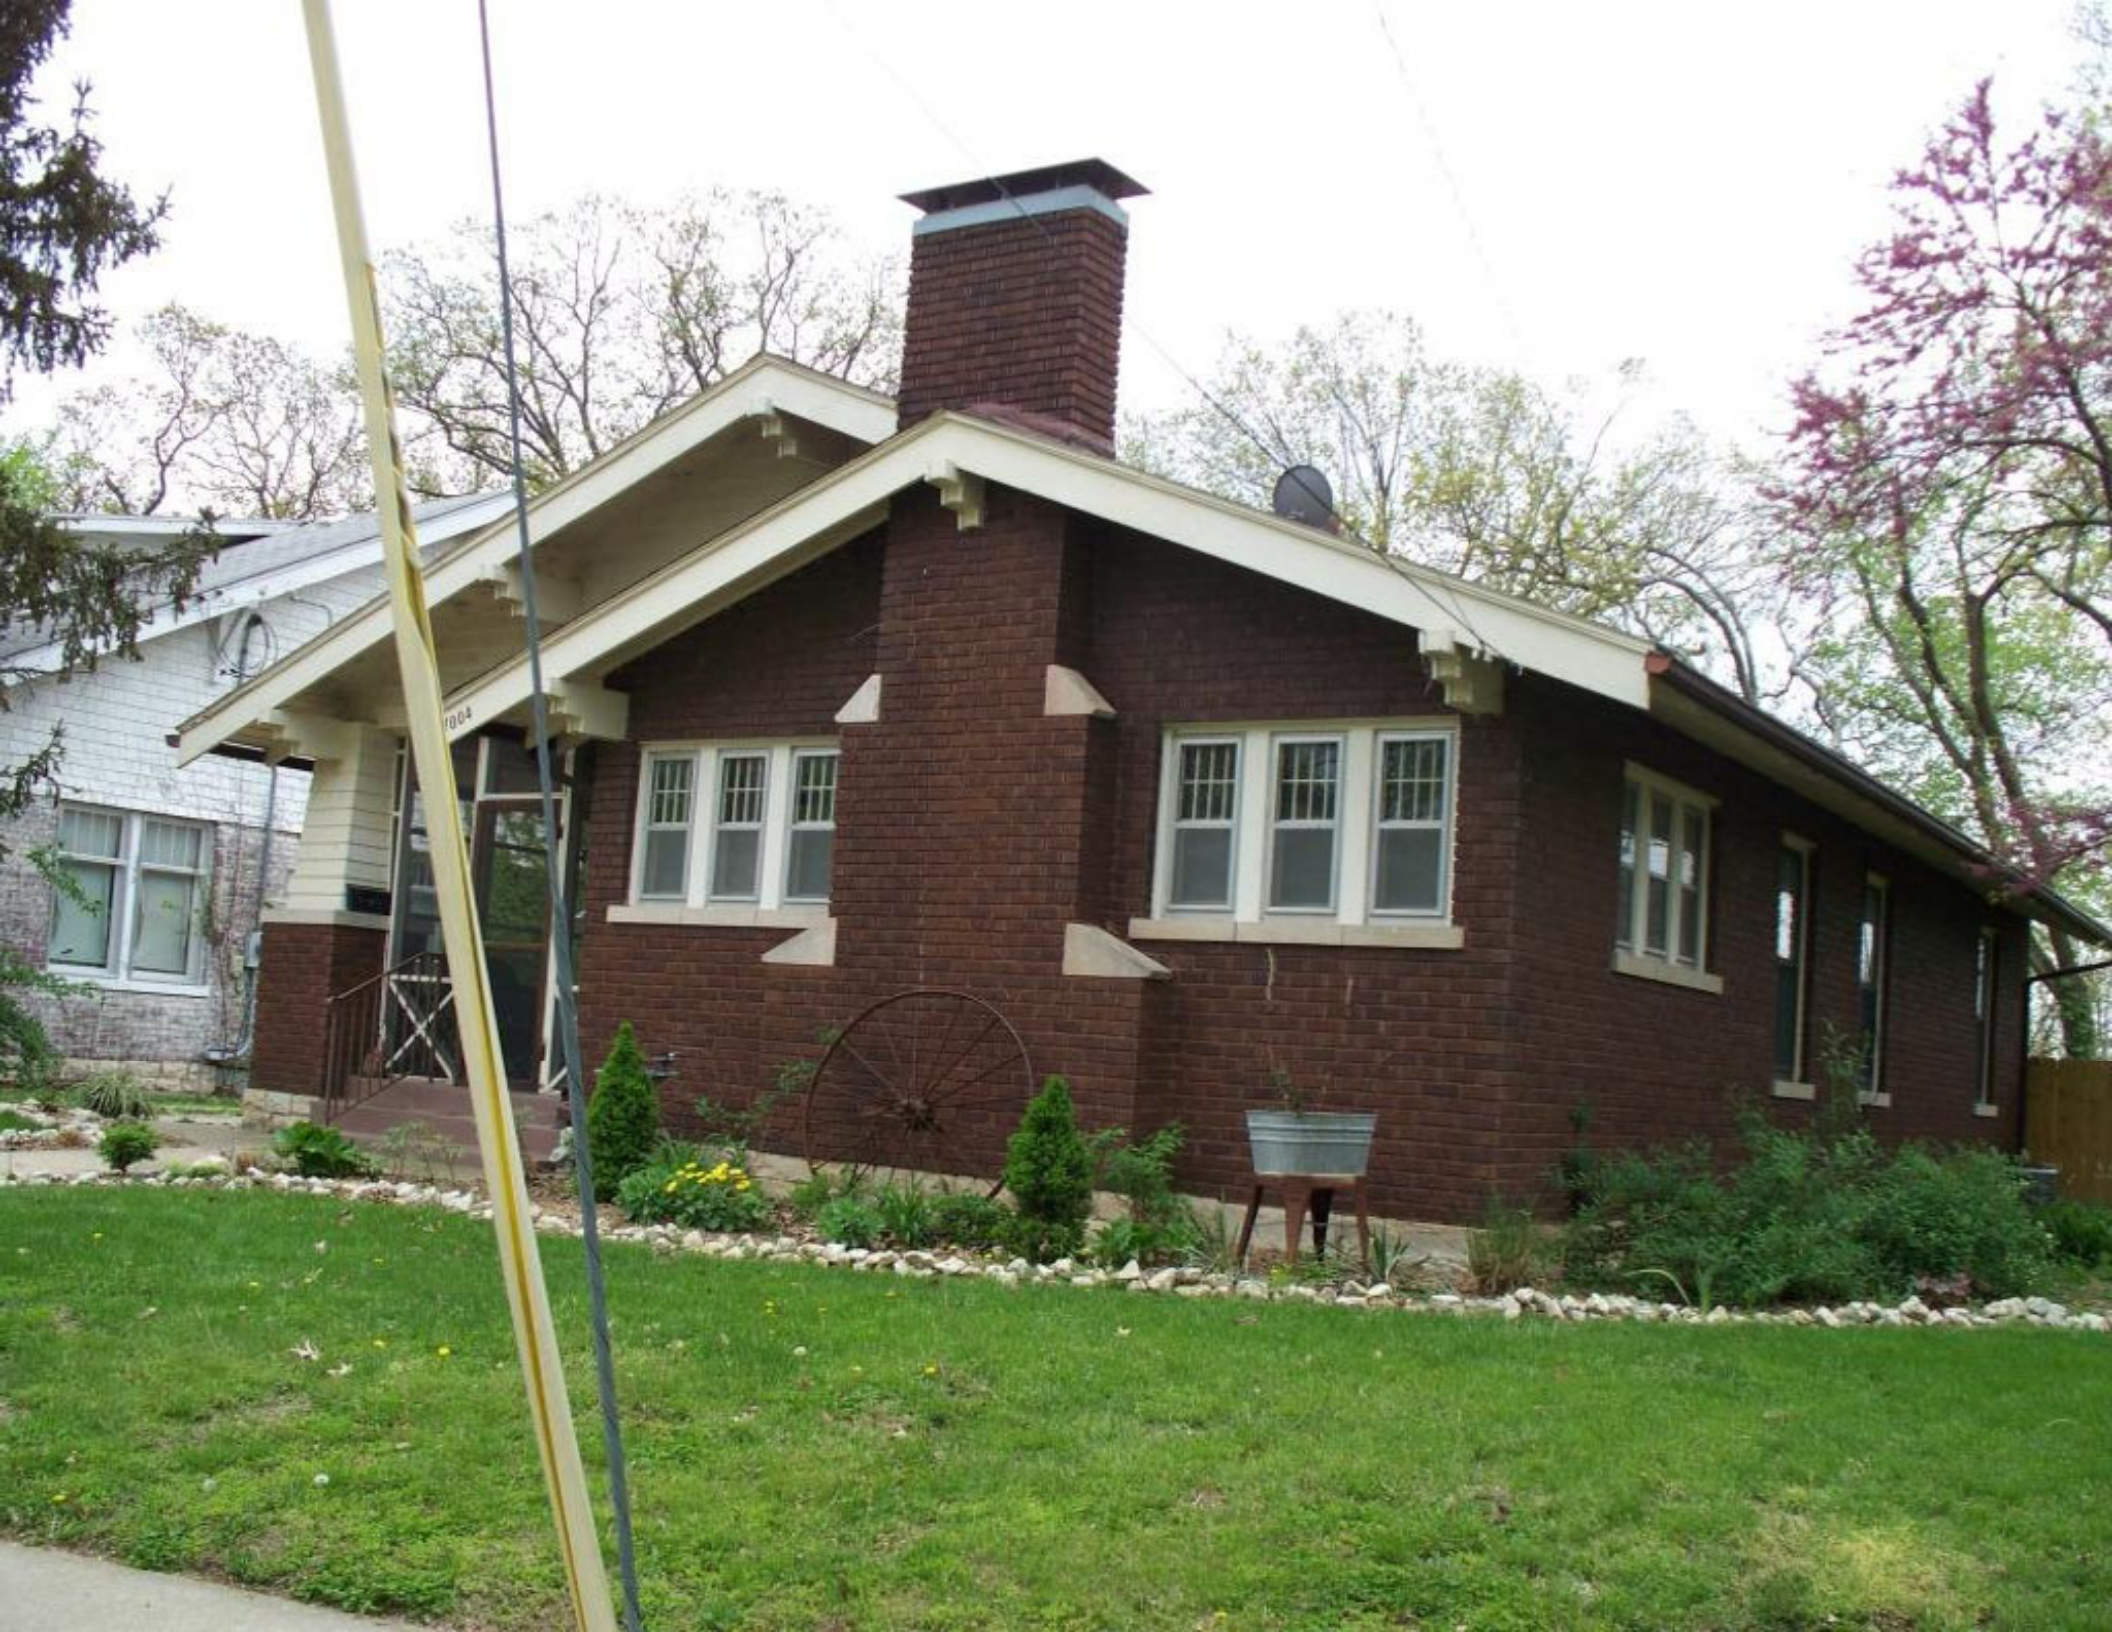
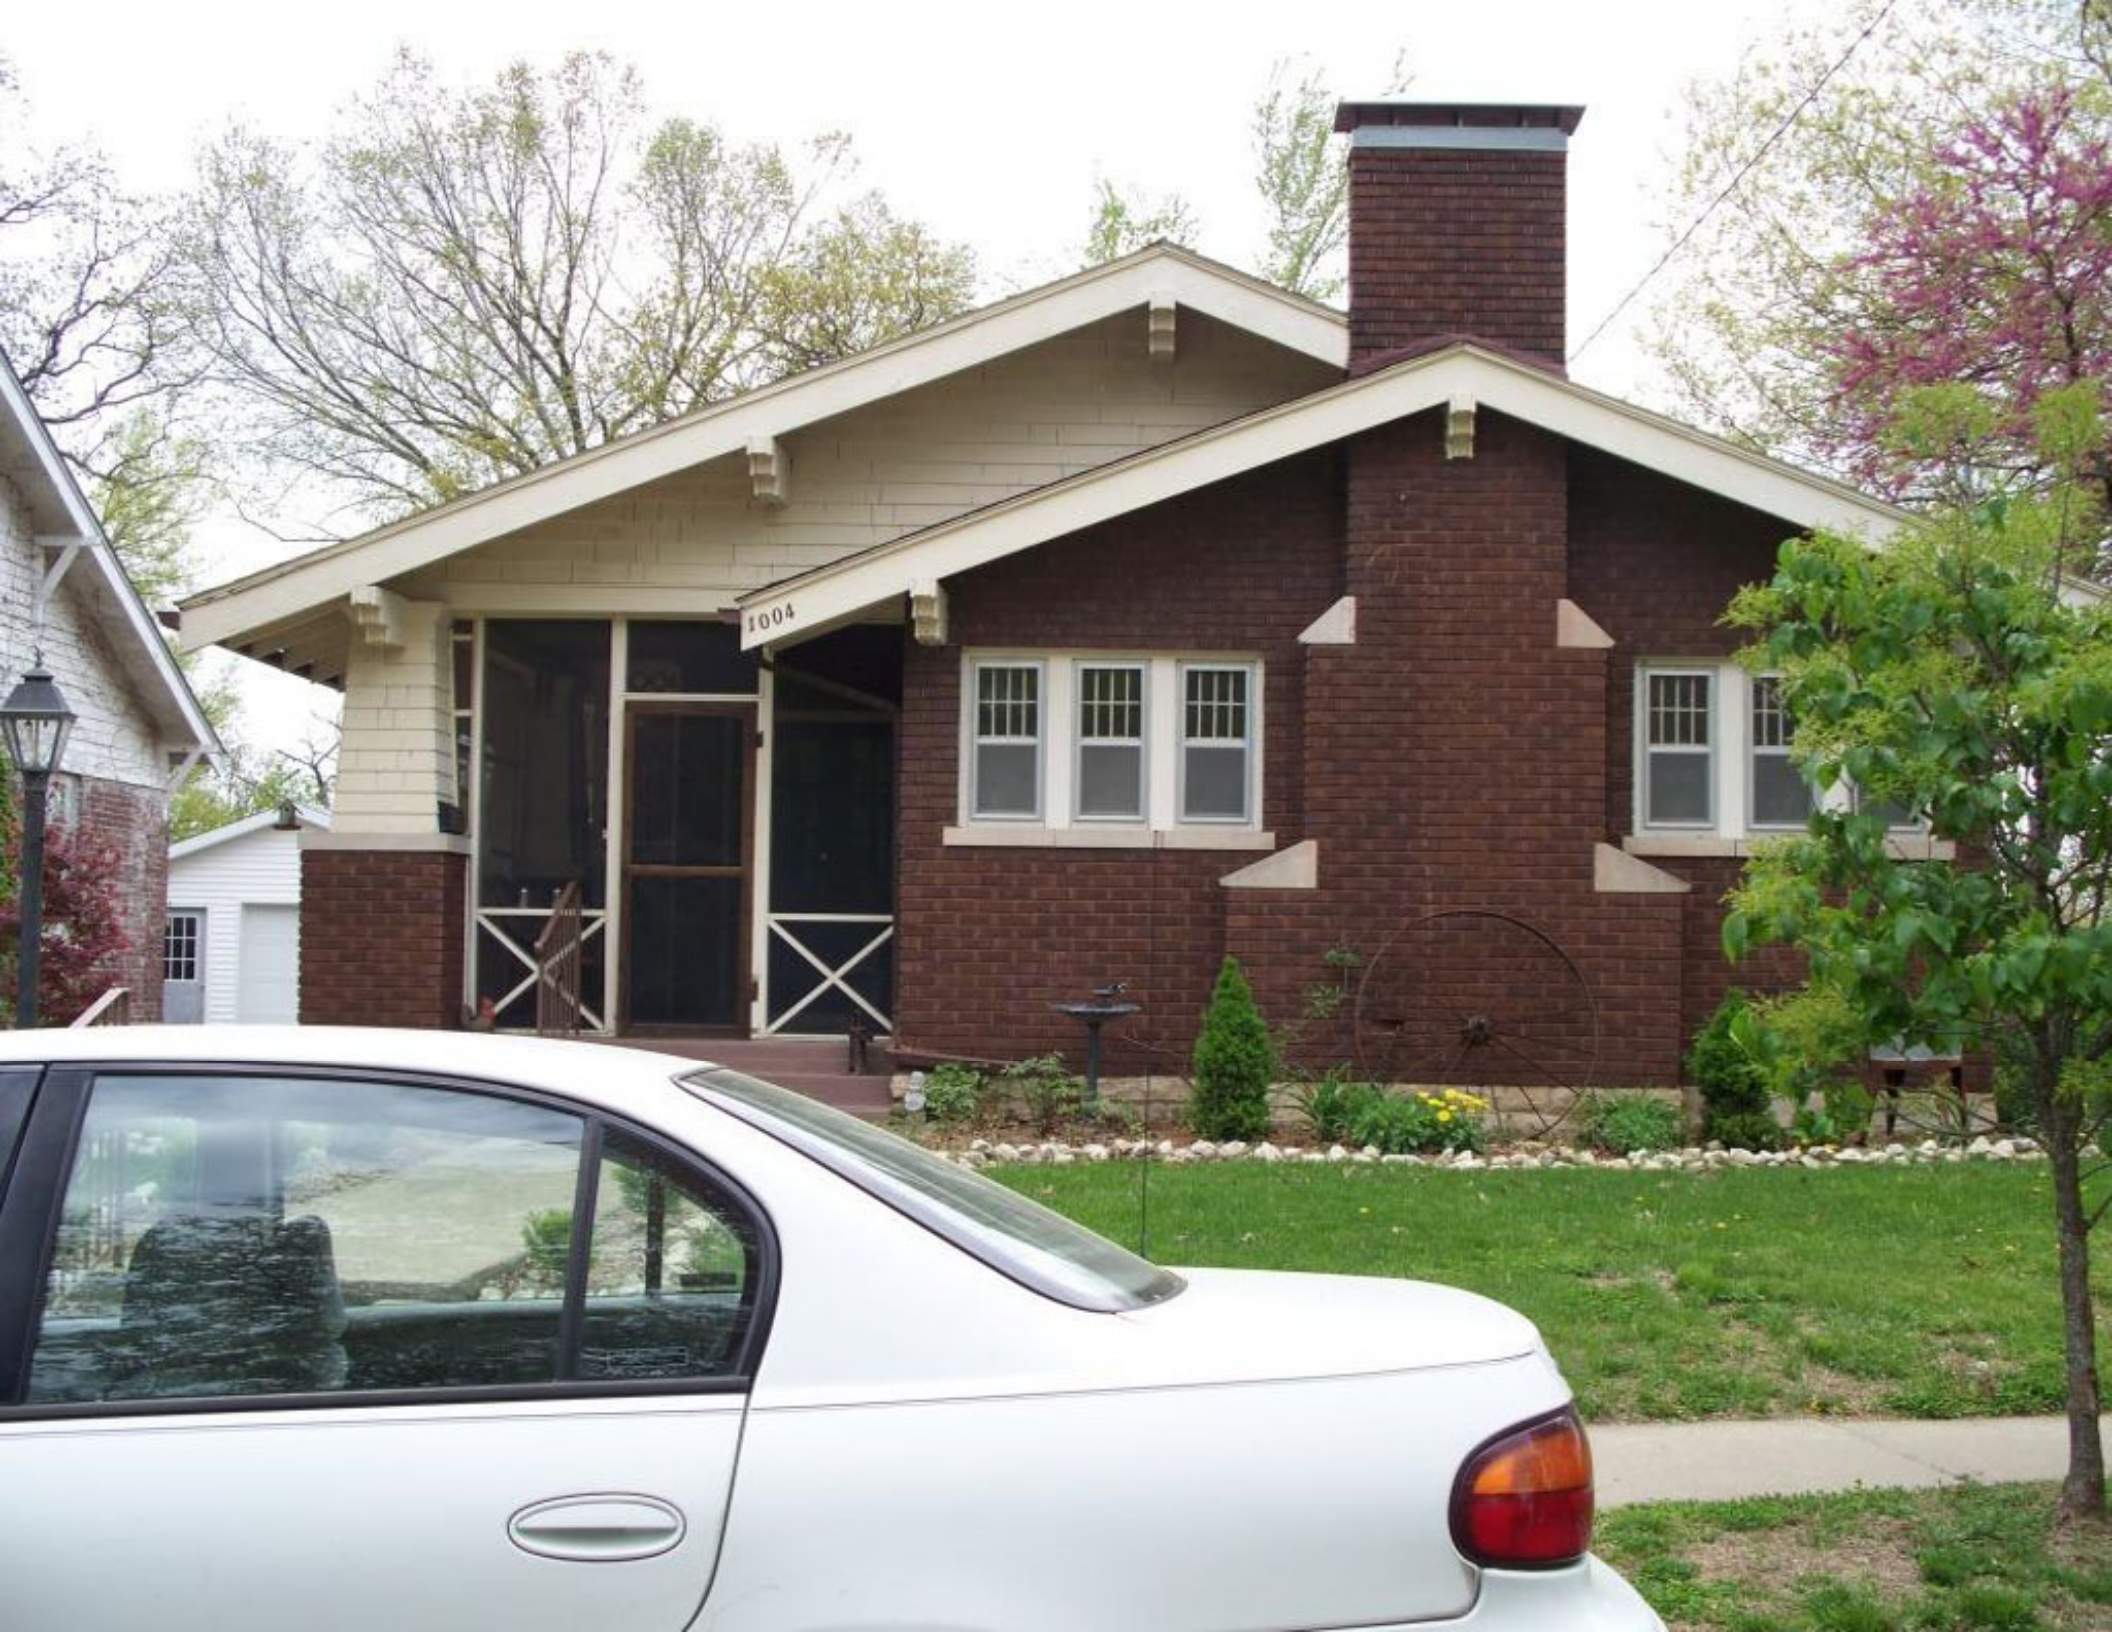
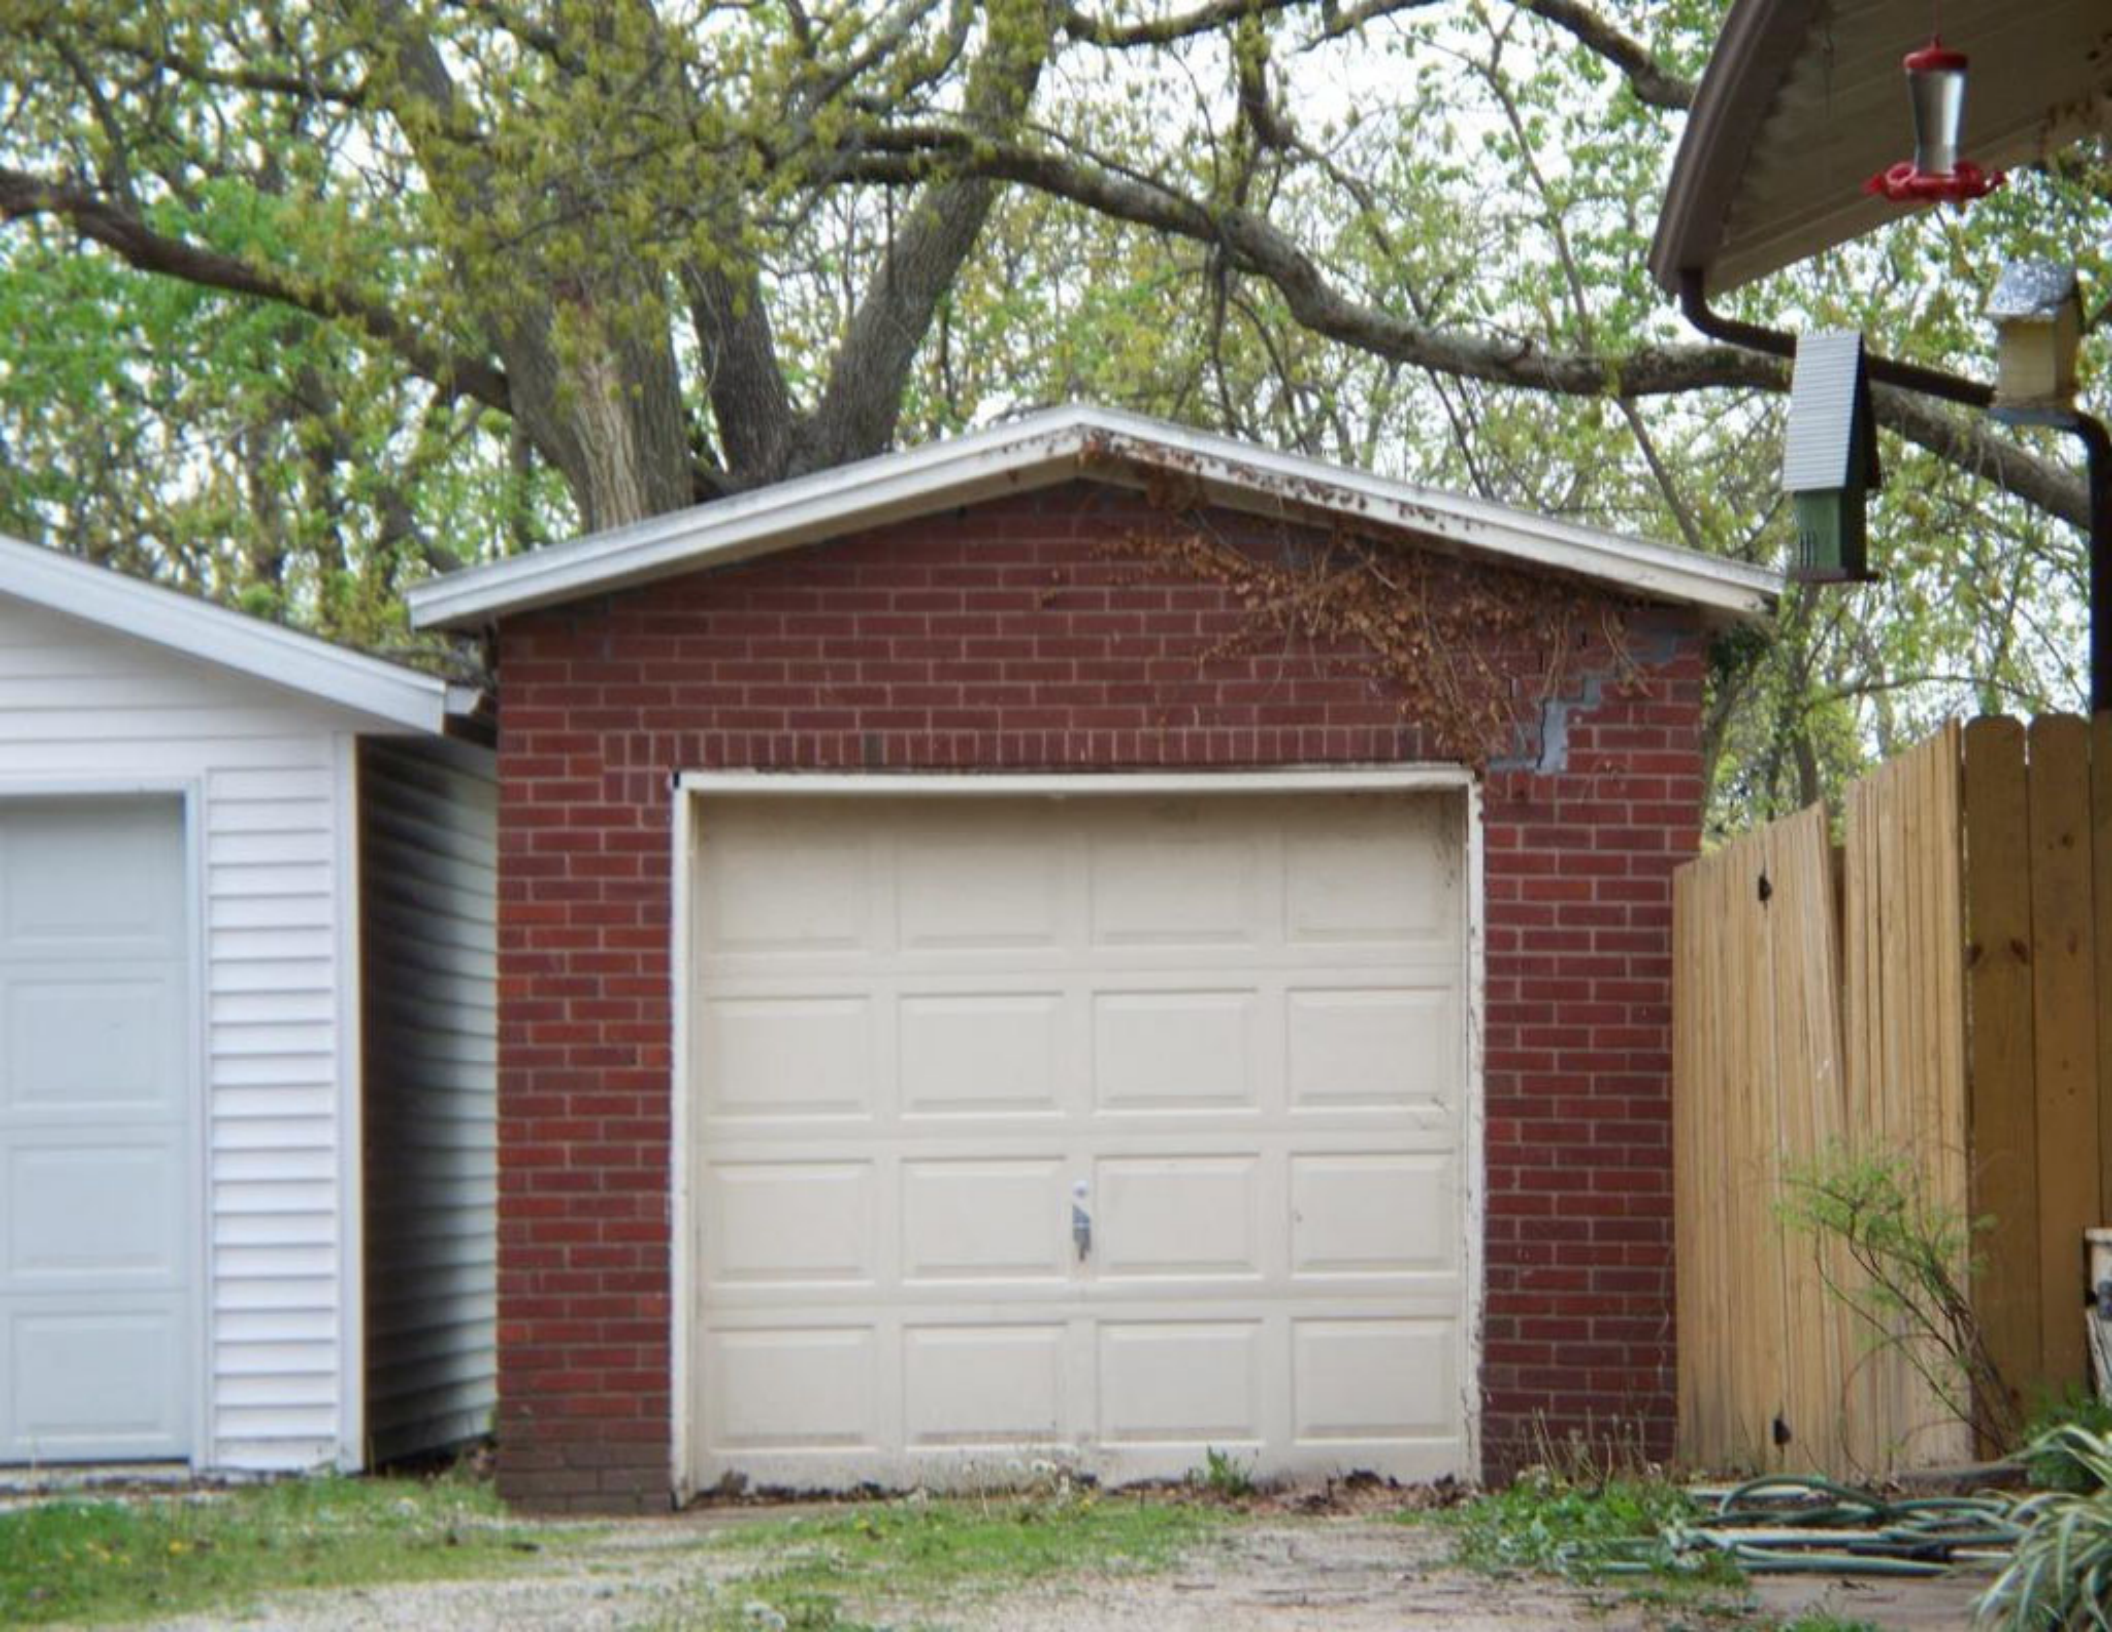
There is a one car brick garage with a gable roof behind the property. It appears on the 1939 Sanborn map and was likely built with the house. The door appears to be a replacement, however the garage retains enough integrity to be contributing to the district.

This is one story brick Craftsman bungalow that has a low pitched double front gable roof with exposed rafter tails, jigsaw brackets and wide eaves. From the right, the first gable end contains two bays that are separated by a large exterior brick chimney that pierces the roof. Each of the two bays contain a row of three historic 8/1 windows that have limestone or concrete sills. There is also limestone/concrete detail in the returns of the chimney. The last bay is recessed slightly and contains a recessed porch that has been screened-in and features a door that leads to the entrance (obscured in photo). There is a single brick pier capped in limestone with a battered column sitting atop supporting the second wider gable. This gable end and battered column are sided in what appears to be shingle but could also be vinyl. While it probably isn't individually eligible, the property is a great example of a Craftsman home in the neighborhood.

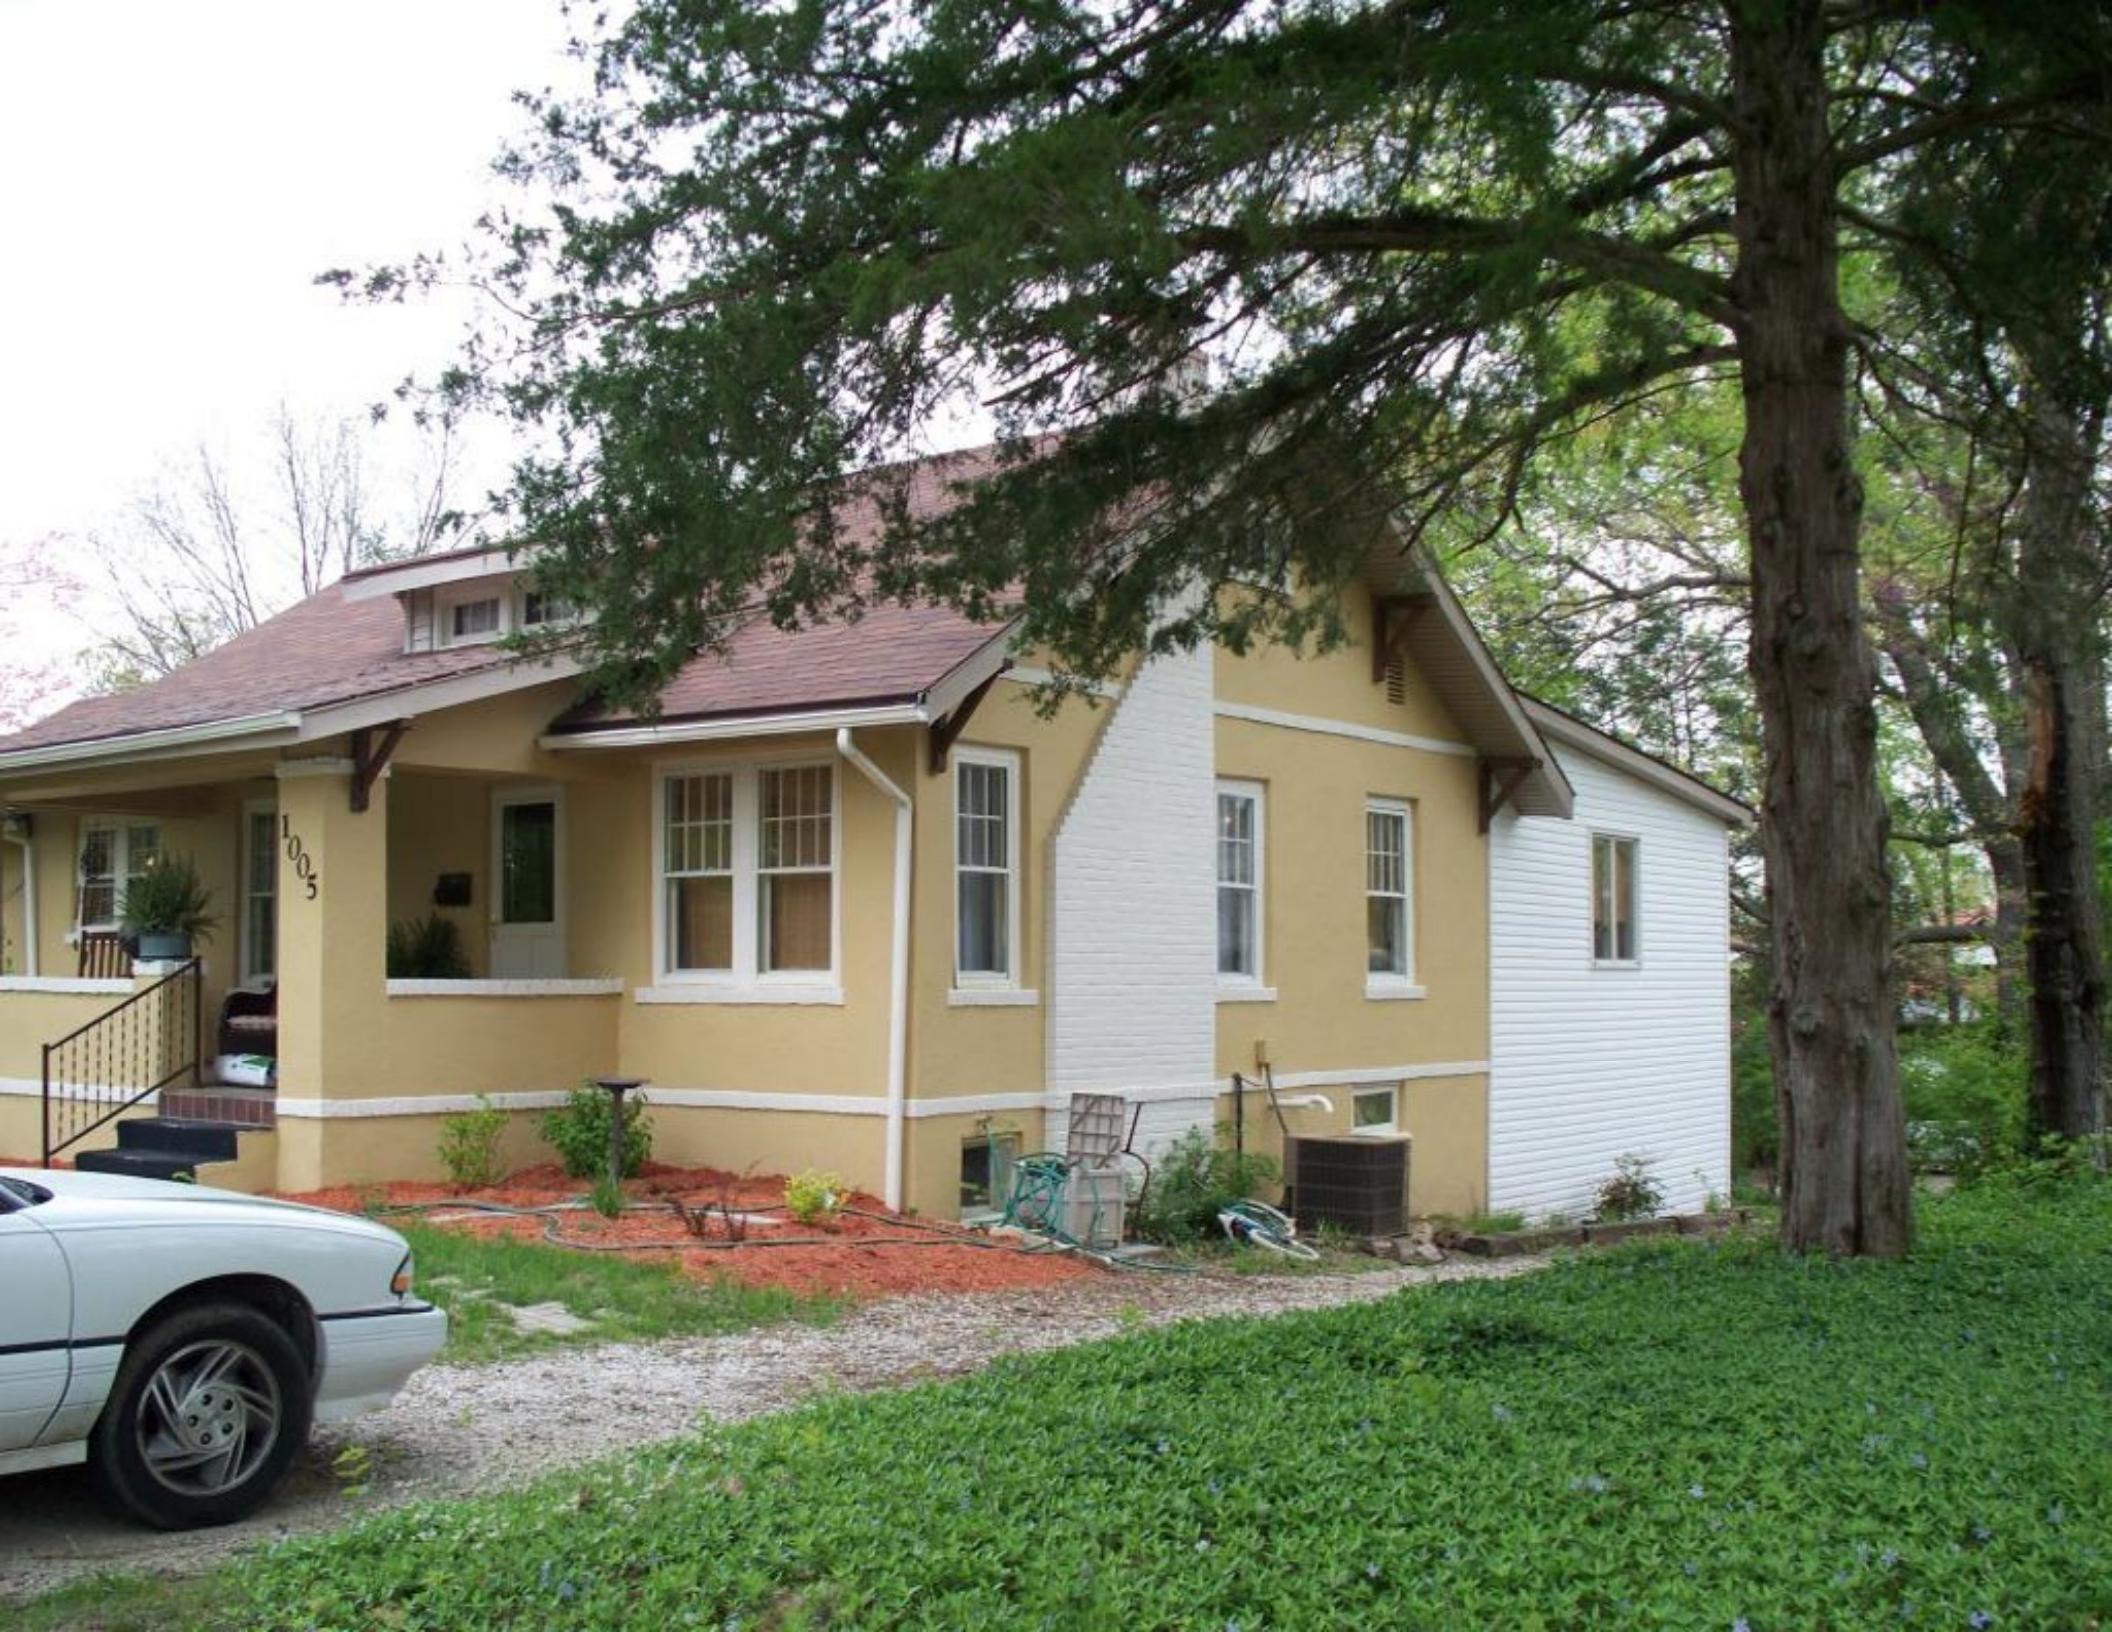
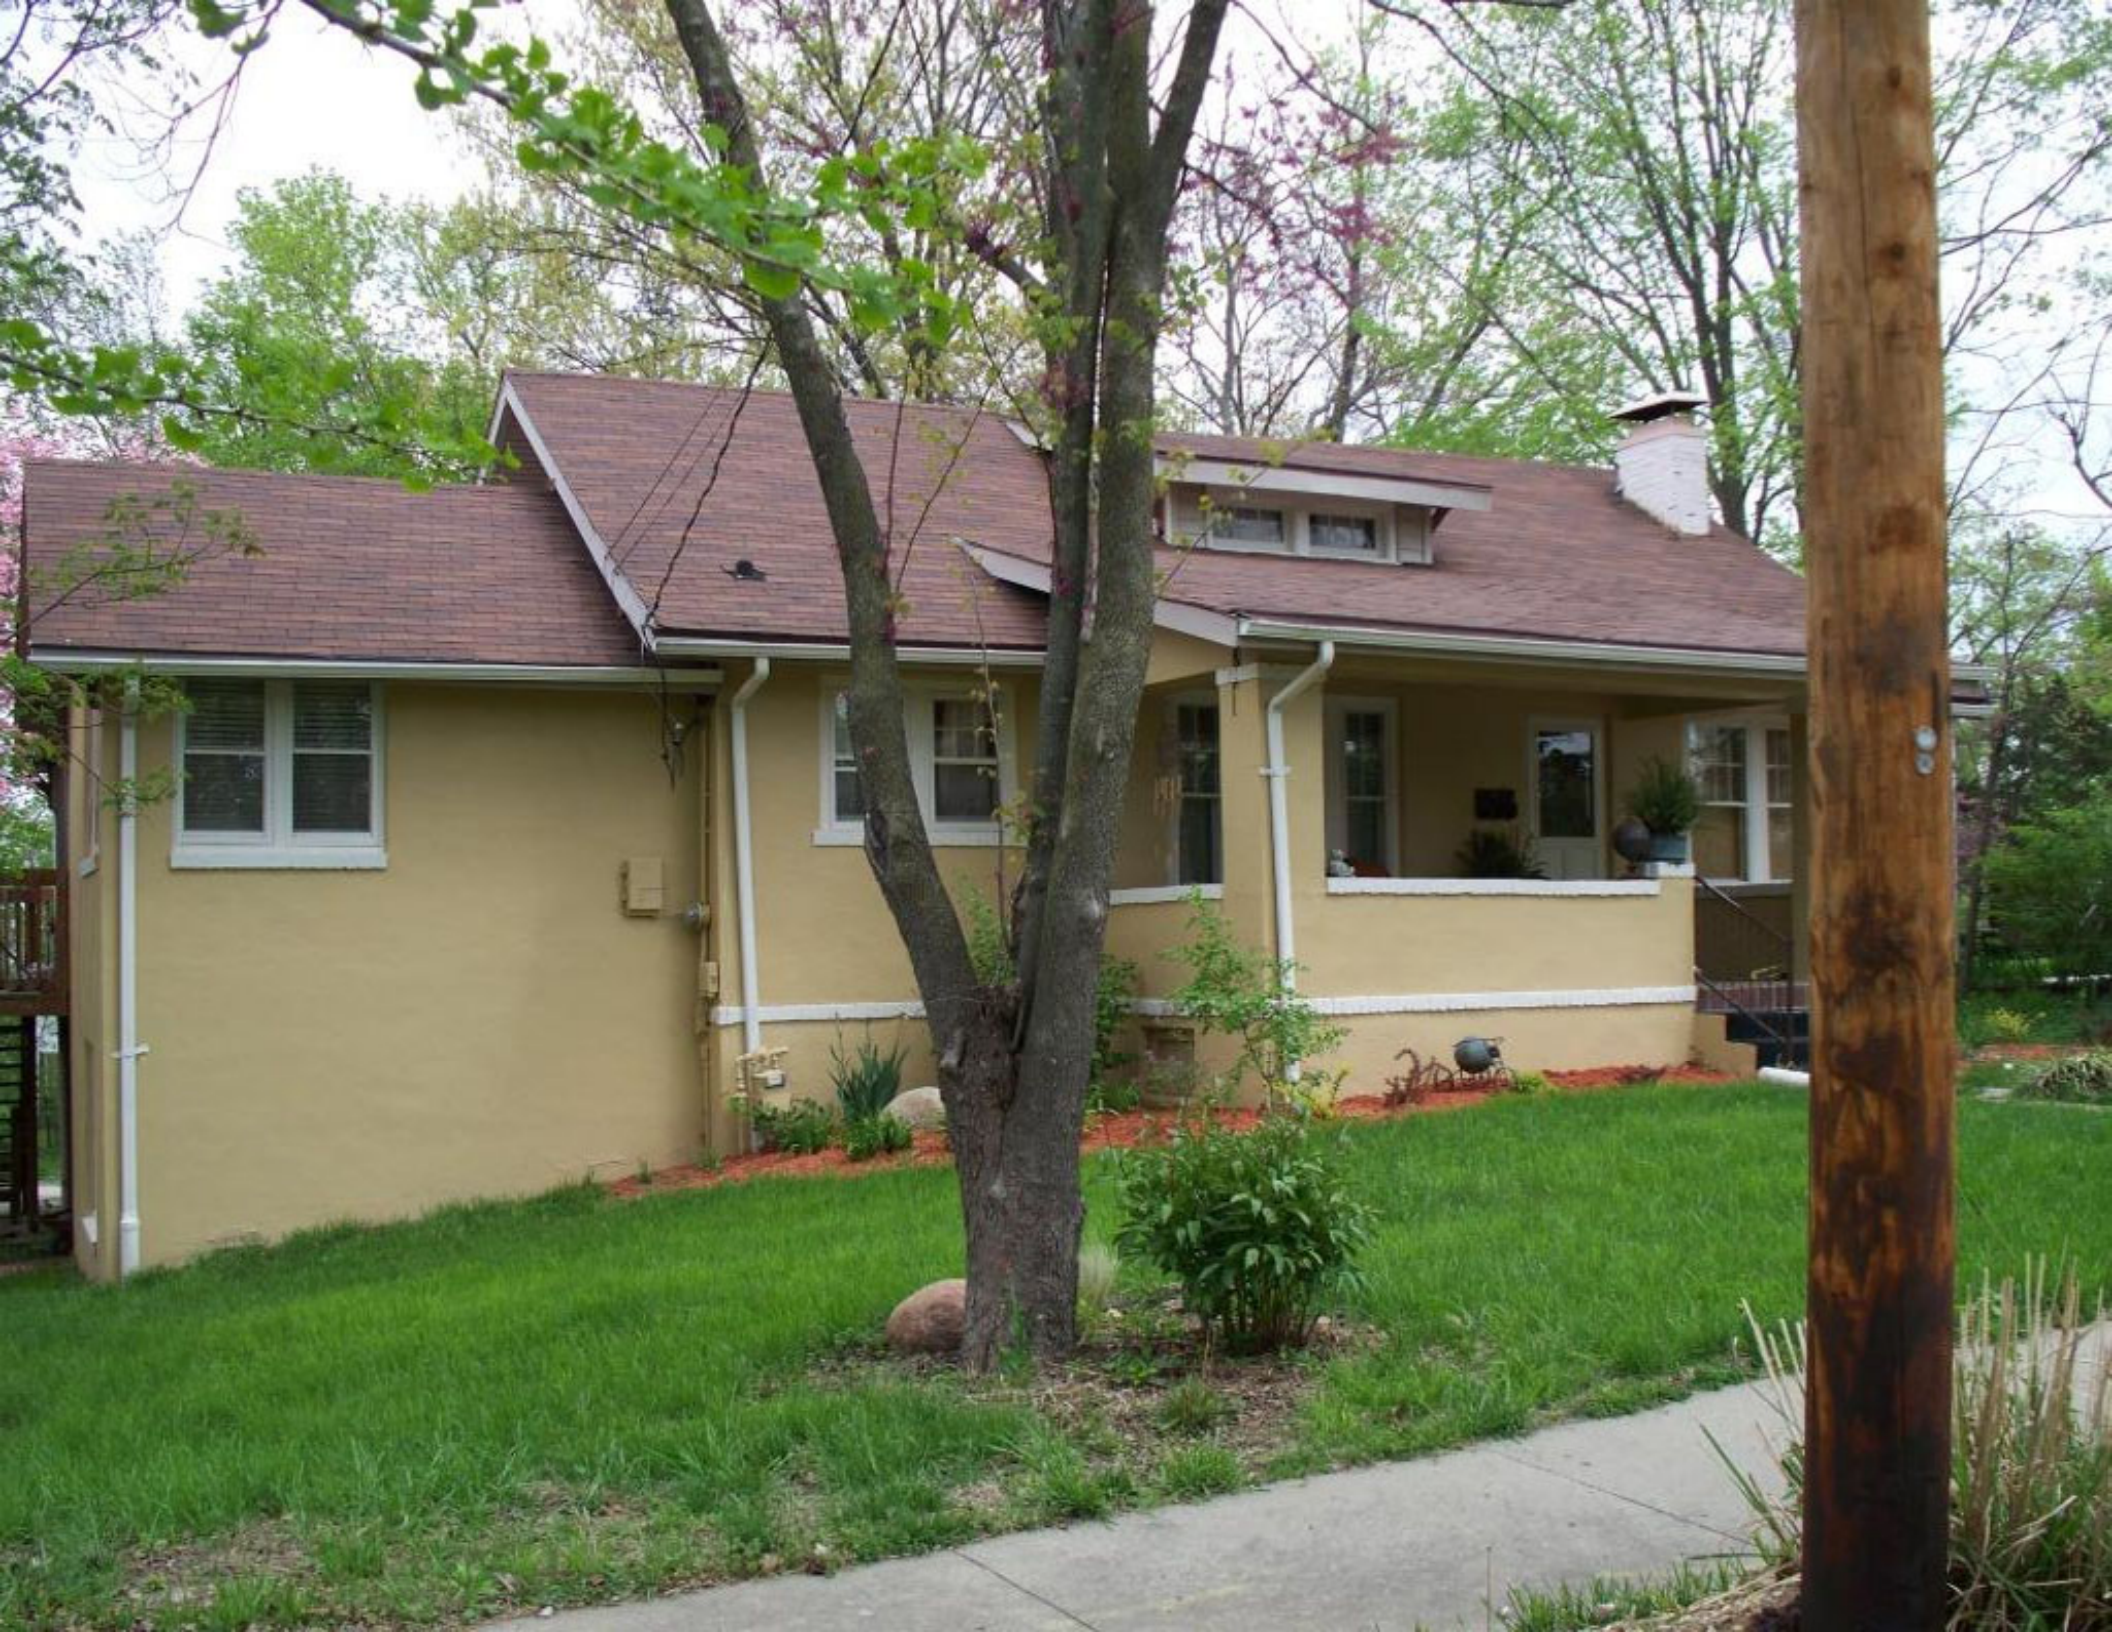
1005

This is 1 ½ story stucco side gable roof has a squat shed dormer with fixed historic three pane windows. From the right, the first bay has paired 8/1 windows with rowlock brick sills. The partial porch is centrally located and covers two bays. It features stucco half-walls and piers capped in rowlock brick. Its shed roof extends up slightly from the central roof and features a knee brace at either end. The second bay contains the entrance which may retain its original wooden door and third bay has a tri-part window (obscured in photo). The third bay has smaller paired 6/1 windows. All of the windows have rowlock brick sills and appear to be historic. The final bay is slightly setback and has small paired 1/1 windows. A rowlock brick water table runs along the first four bays.
