ARCHITECTURAL/HISTORIC INVENTORY FORM

1. Survey No. CO-AS-005-001		2. Survey name: Moreau Drive Neighborhood Survey	
3. County: Cole		4. Address: 1202 Elmerine Ave.	
5. City: Jefferson City	Vicinity: <input type="checkbox"/>	6. UTM: / /	7. Township/Range/Section: T: R: S:
8. Historic name (if known):		9. Present/other name (if known):	
10. Ownership: <input checked="" type="checkbox"/> Private <input type="checkbox"/> Public		11. Historic use (if known): Residential	11. Current use: Residential

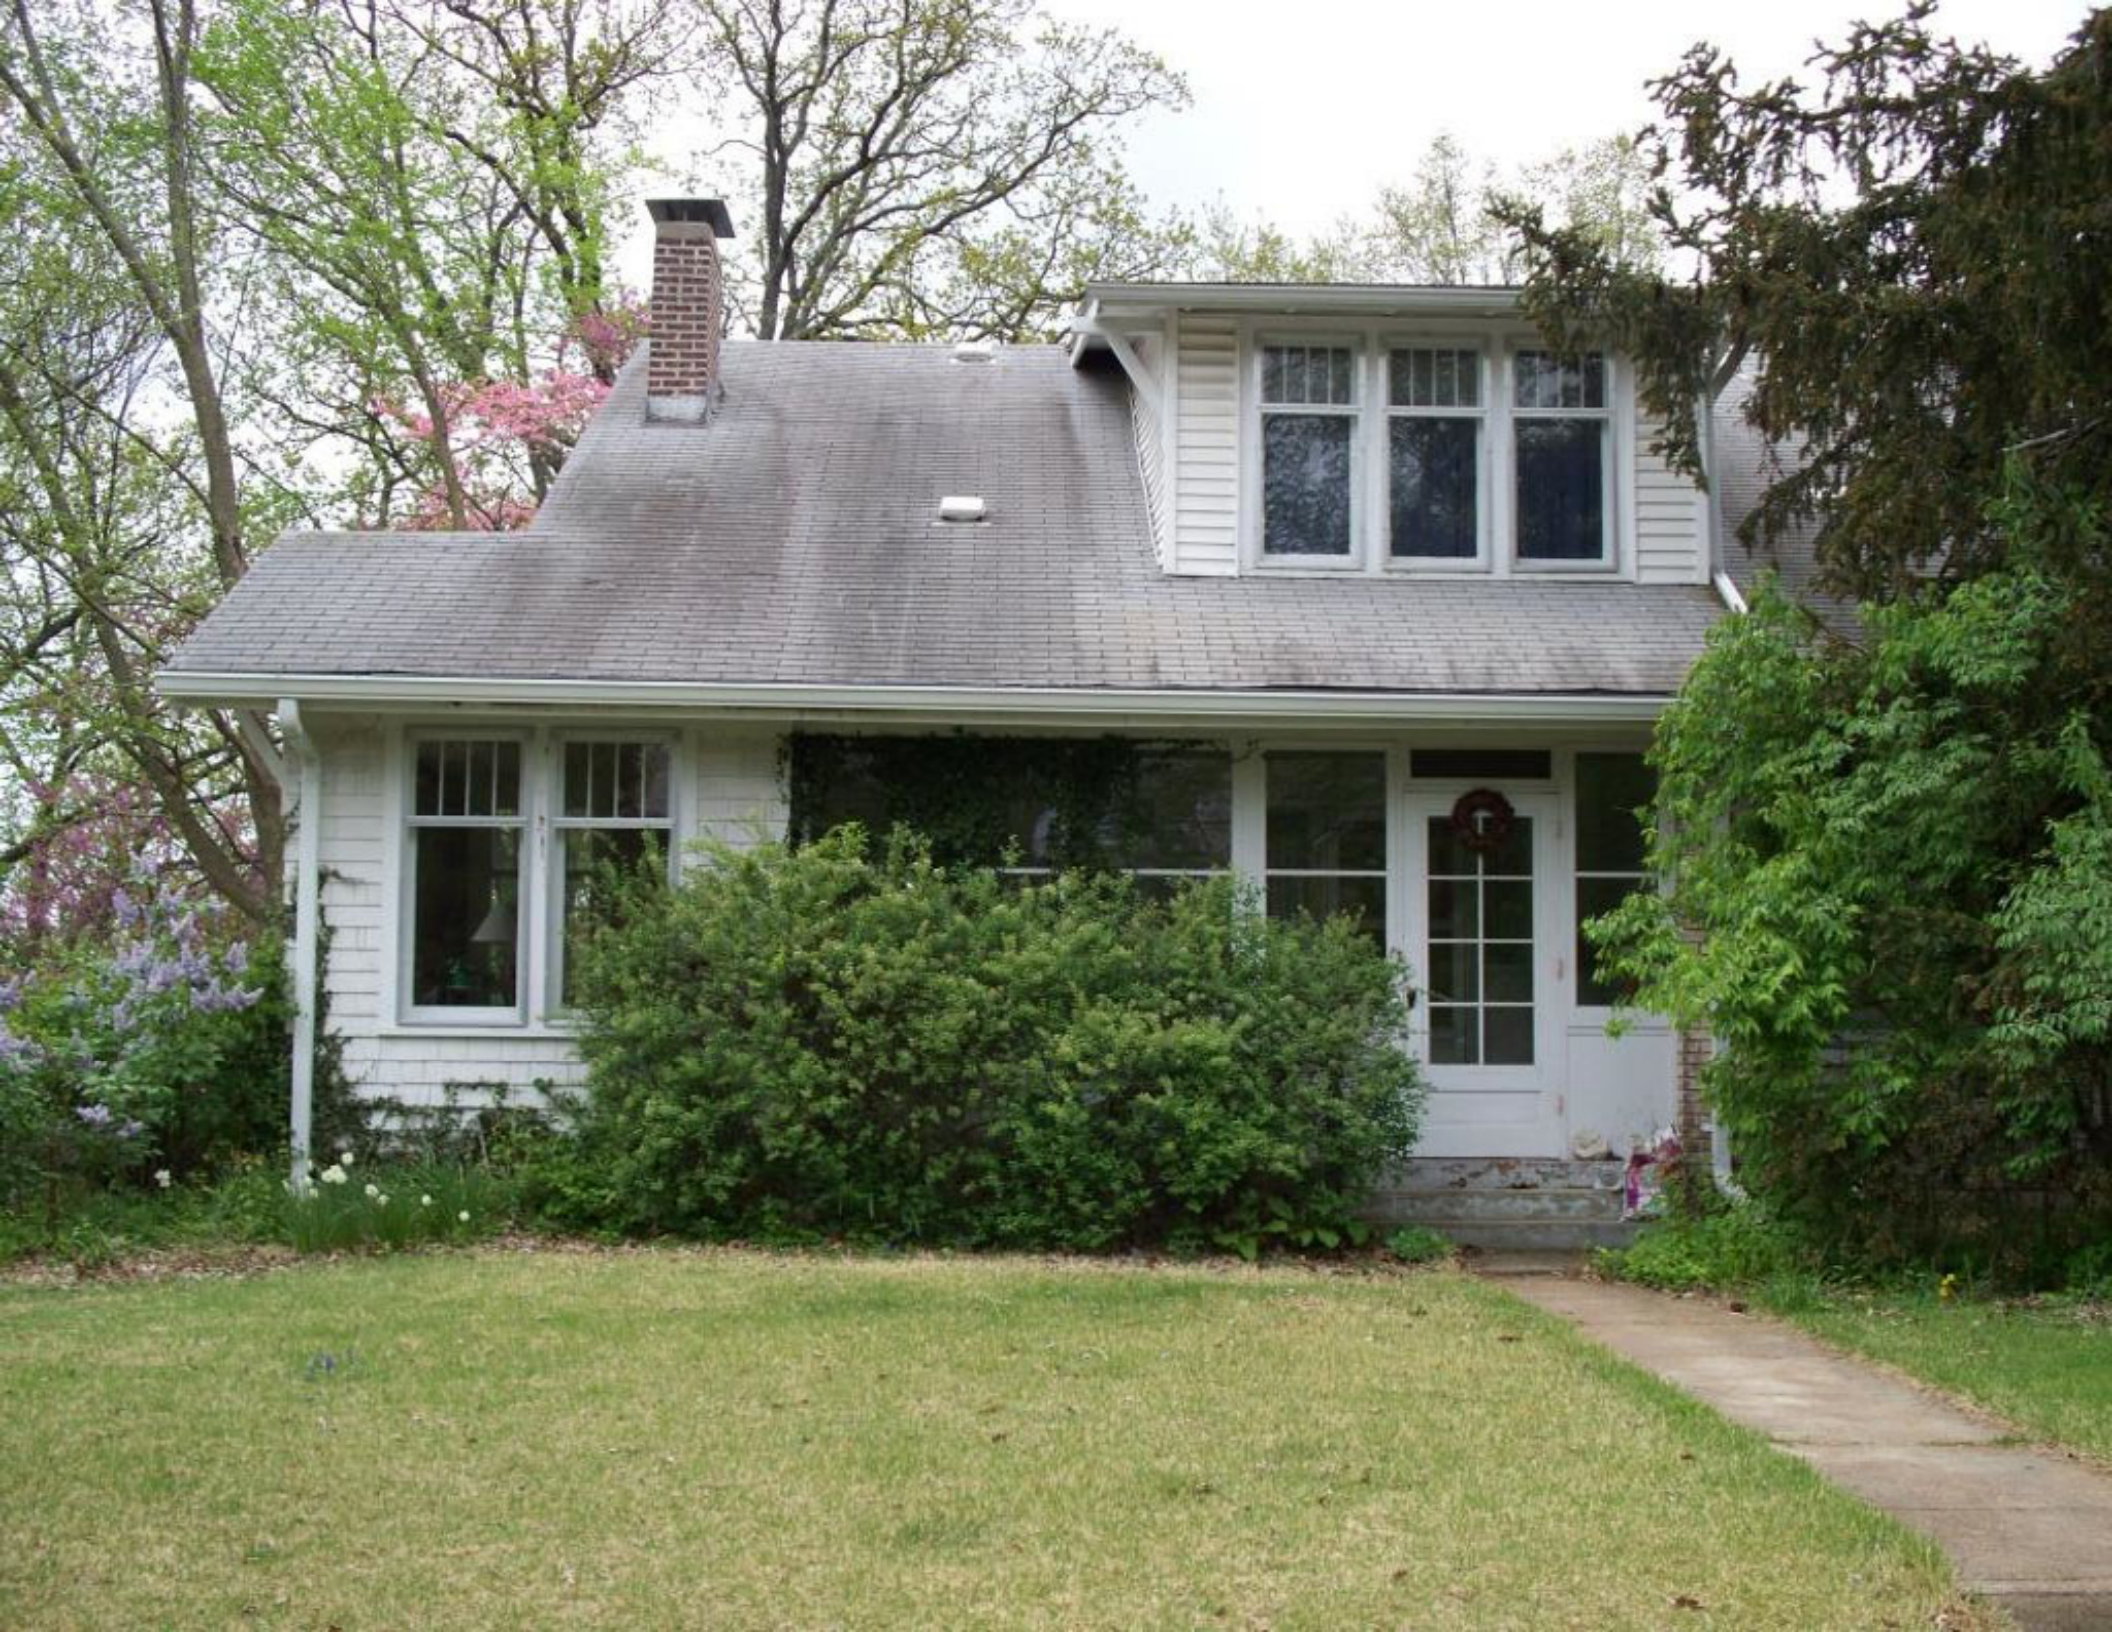
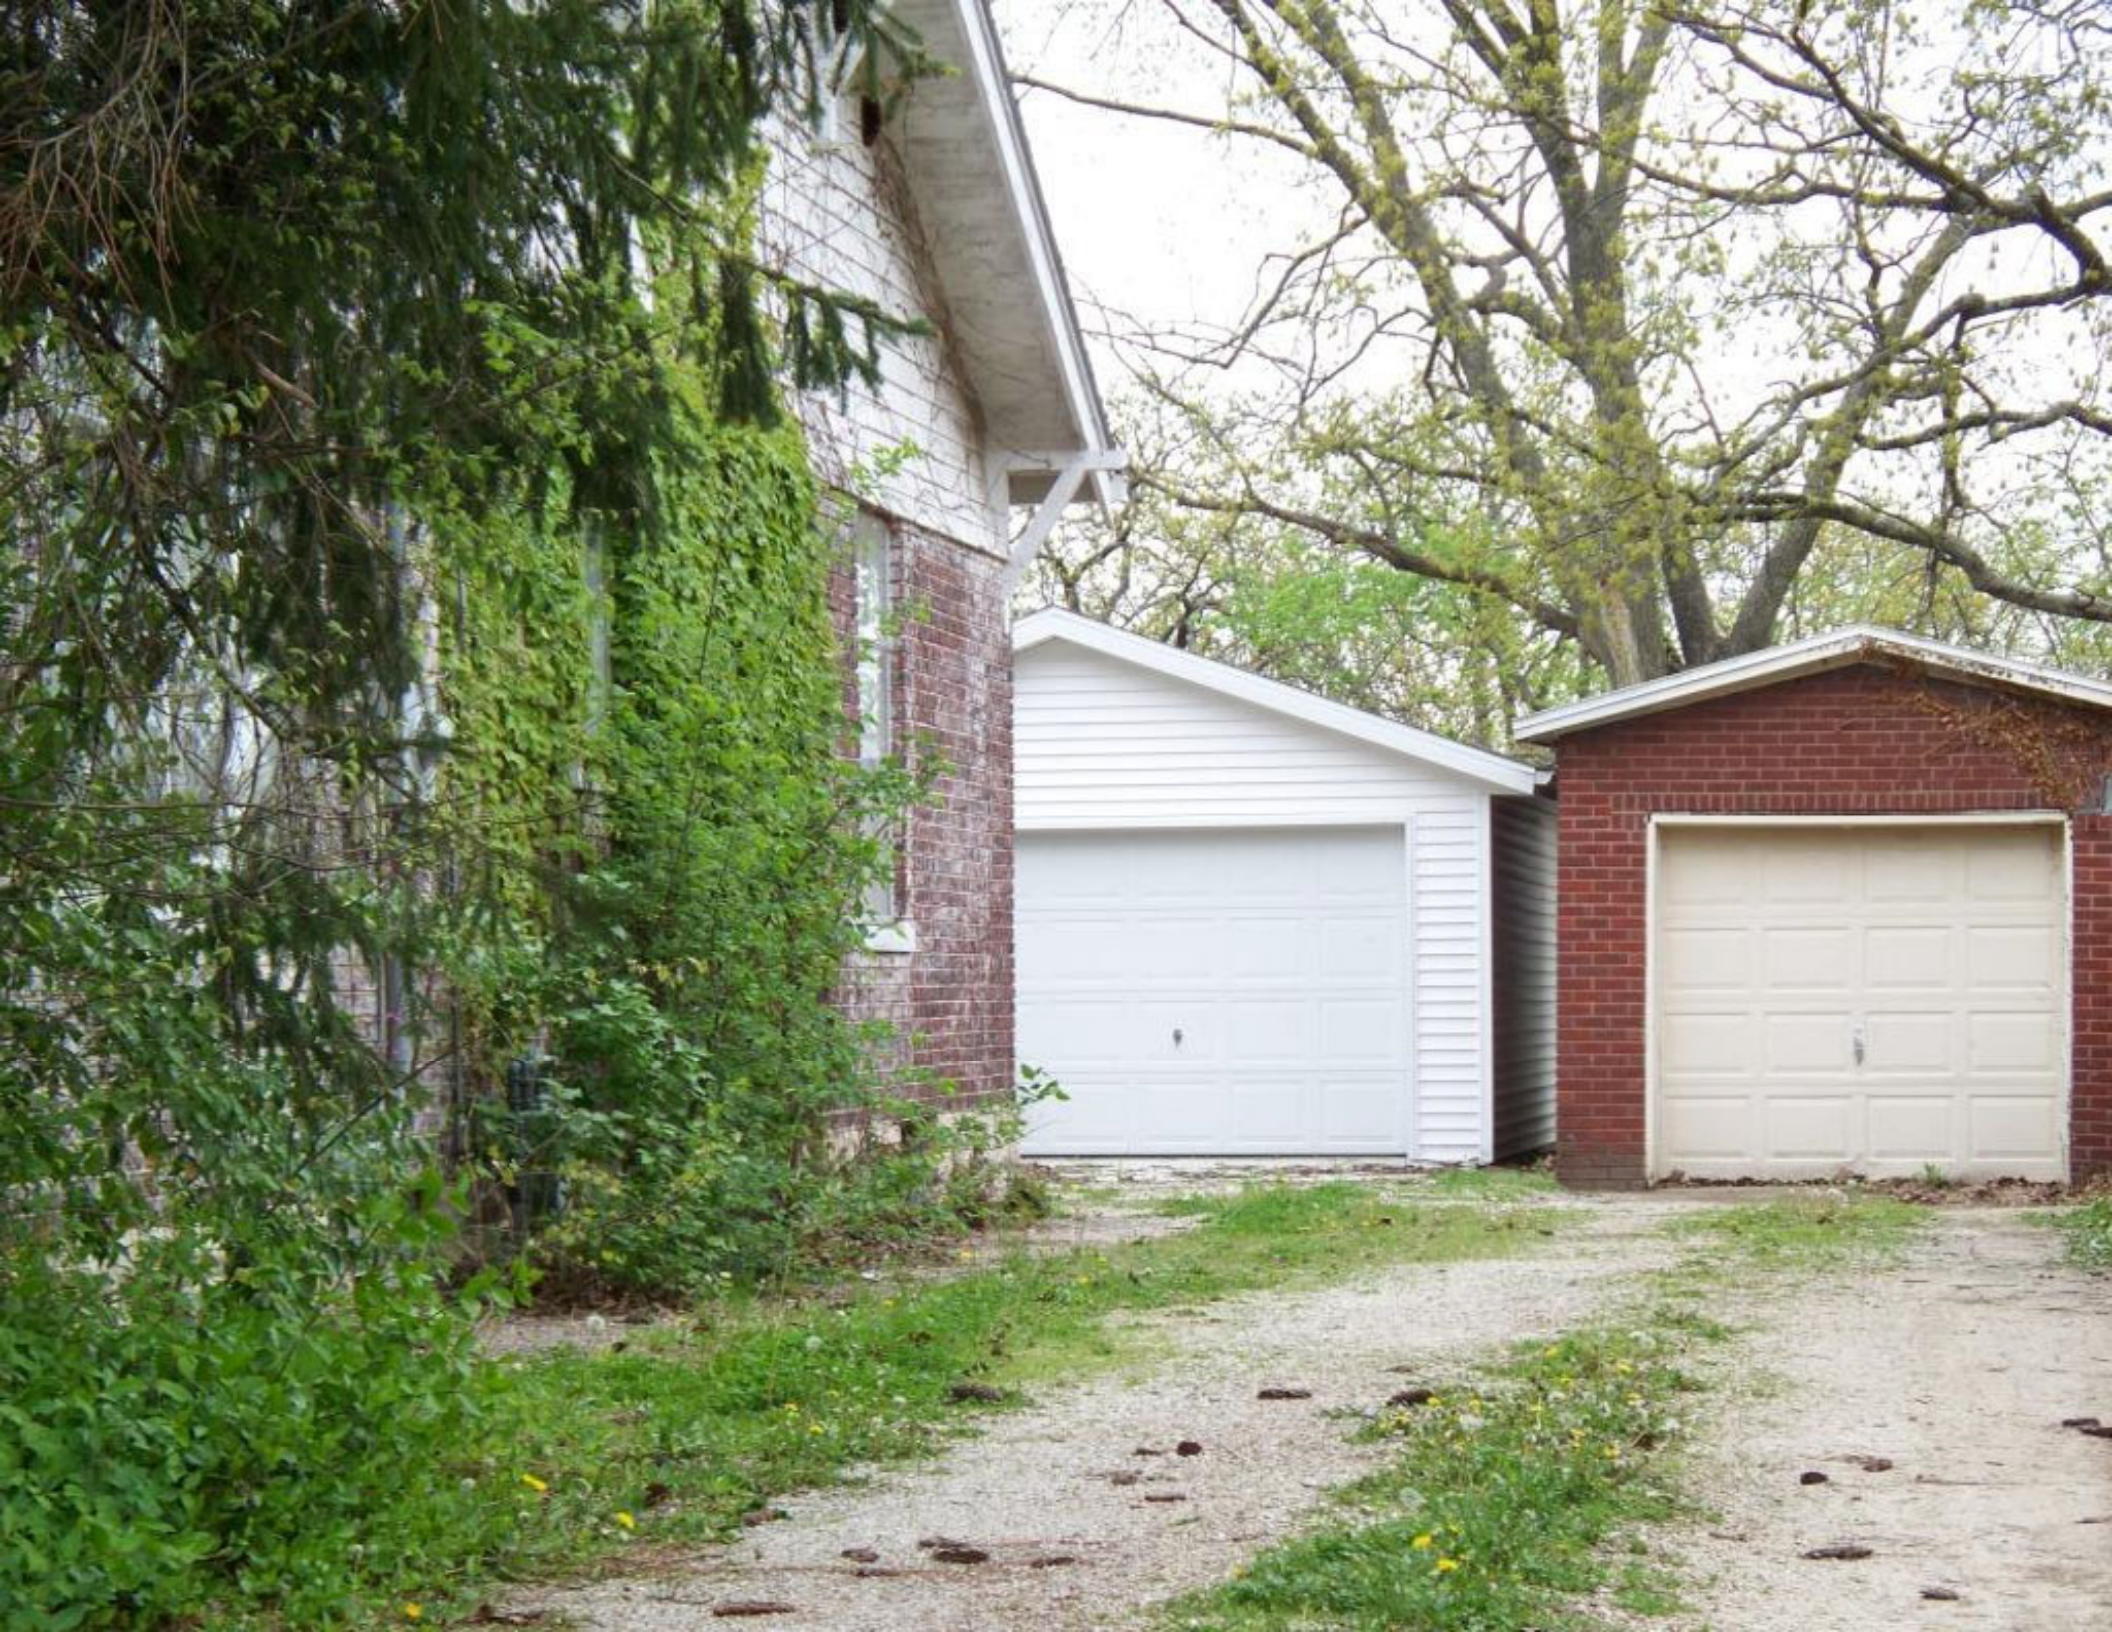
This 1 ½ story bungalow has a side gable roof with a large shed dormer sided in vinyl with a row of three historic 4/1 windows. The upper portion of the window is much shorter than the single light beneath it (true of all windows). There are two knee braces beneath the dormer's eaves. The first floor was originally clad in brick but the left bay have been covered with wood shingle. The left bay contains paired 4/1 windows. The central porch is recessed and screened in. The alterations obscure any further details about the entrance or porch although a square brick pillar is visible on the right side of the porch. The right bay was not visible at the time of the survey due to vegetation. Although the tax assessors office dates this as 1904 it was likely built later.

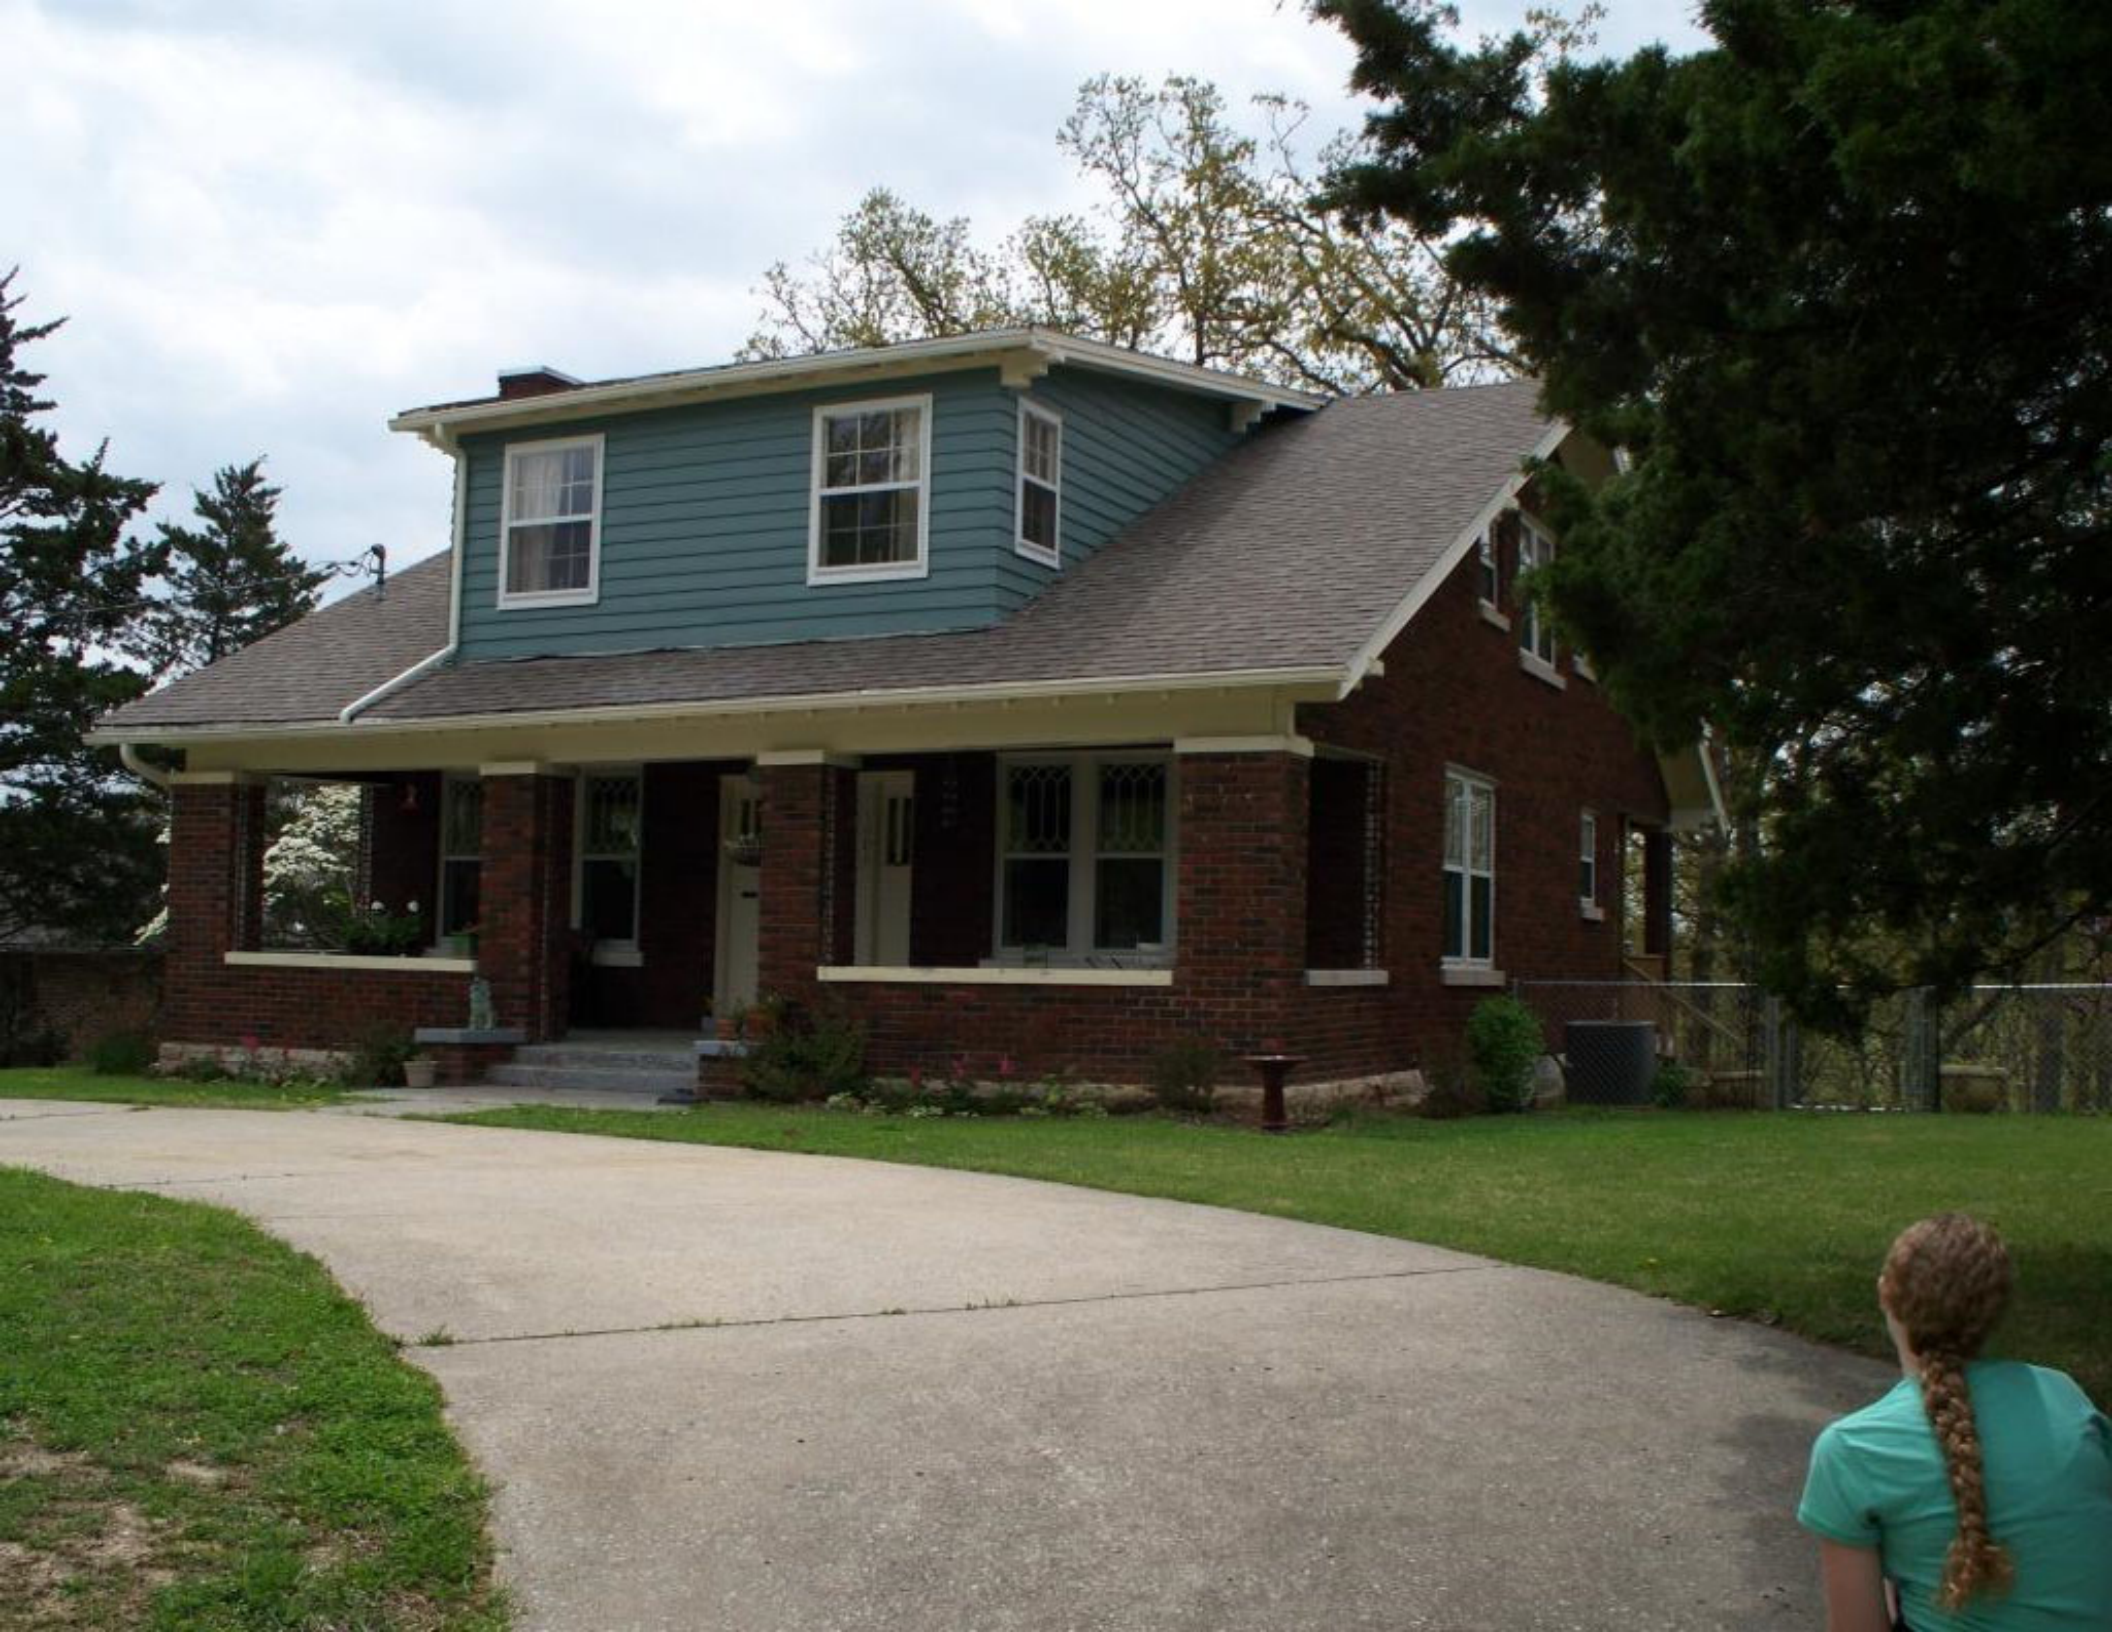
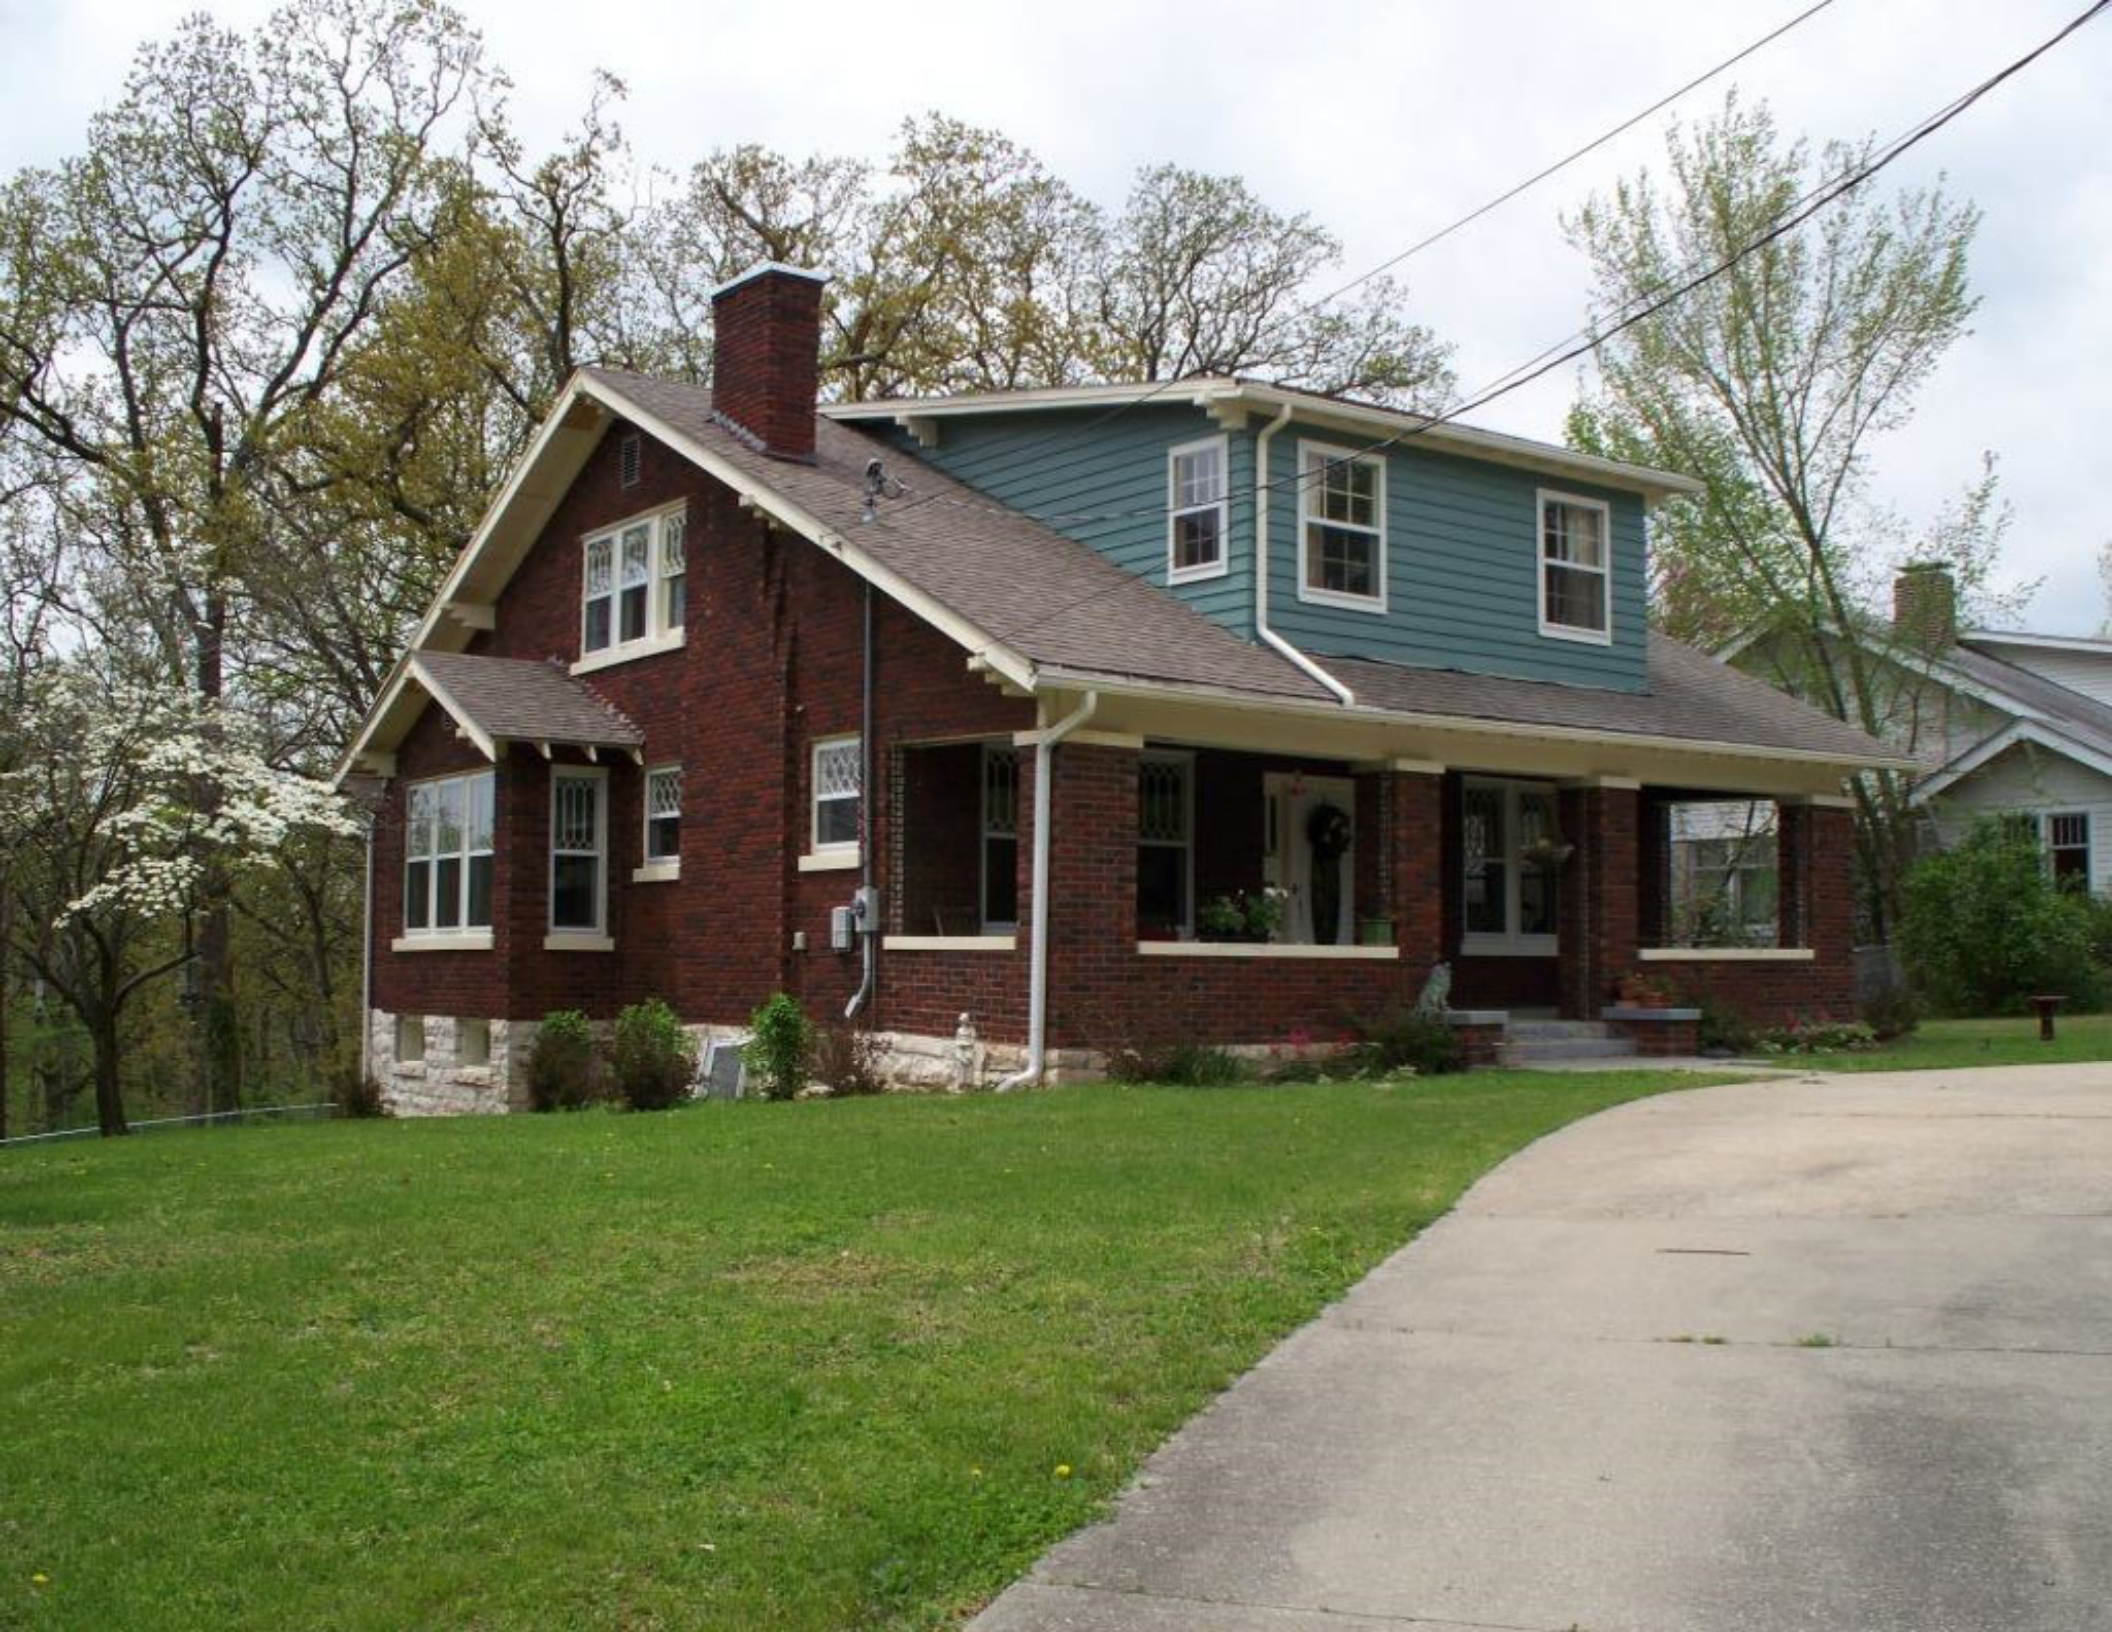
This 1 ½ story brick Craftsman bungalow has a side gable roof with exposed rafter tails and jigsaw brackets. There is a large shed dormer with jigsaw brackets and two 6/6 windows. The first floor has two rows of three windows with decorative glass flanking the central entrance and its sidelights. The porch has brick pilasters and knee walls capped in limestone. The windows are probably not historic.

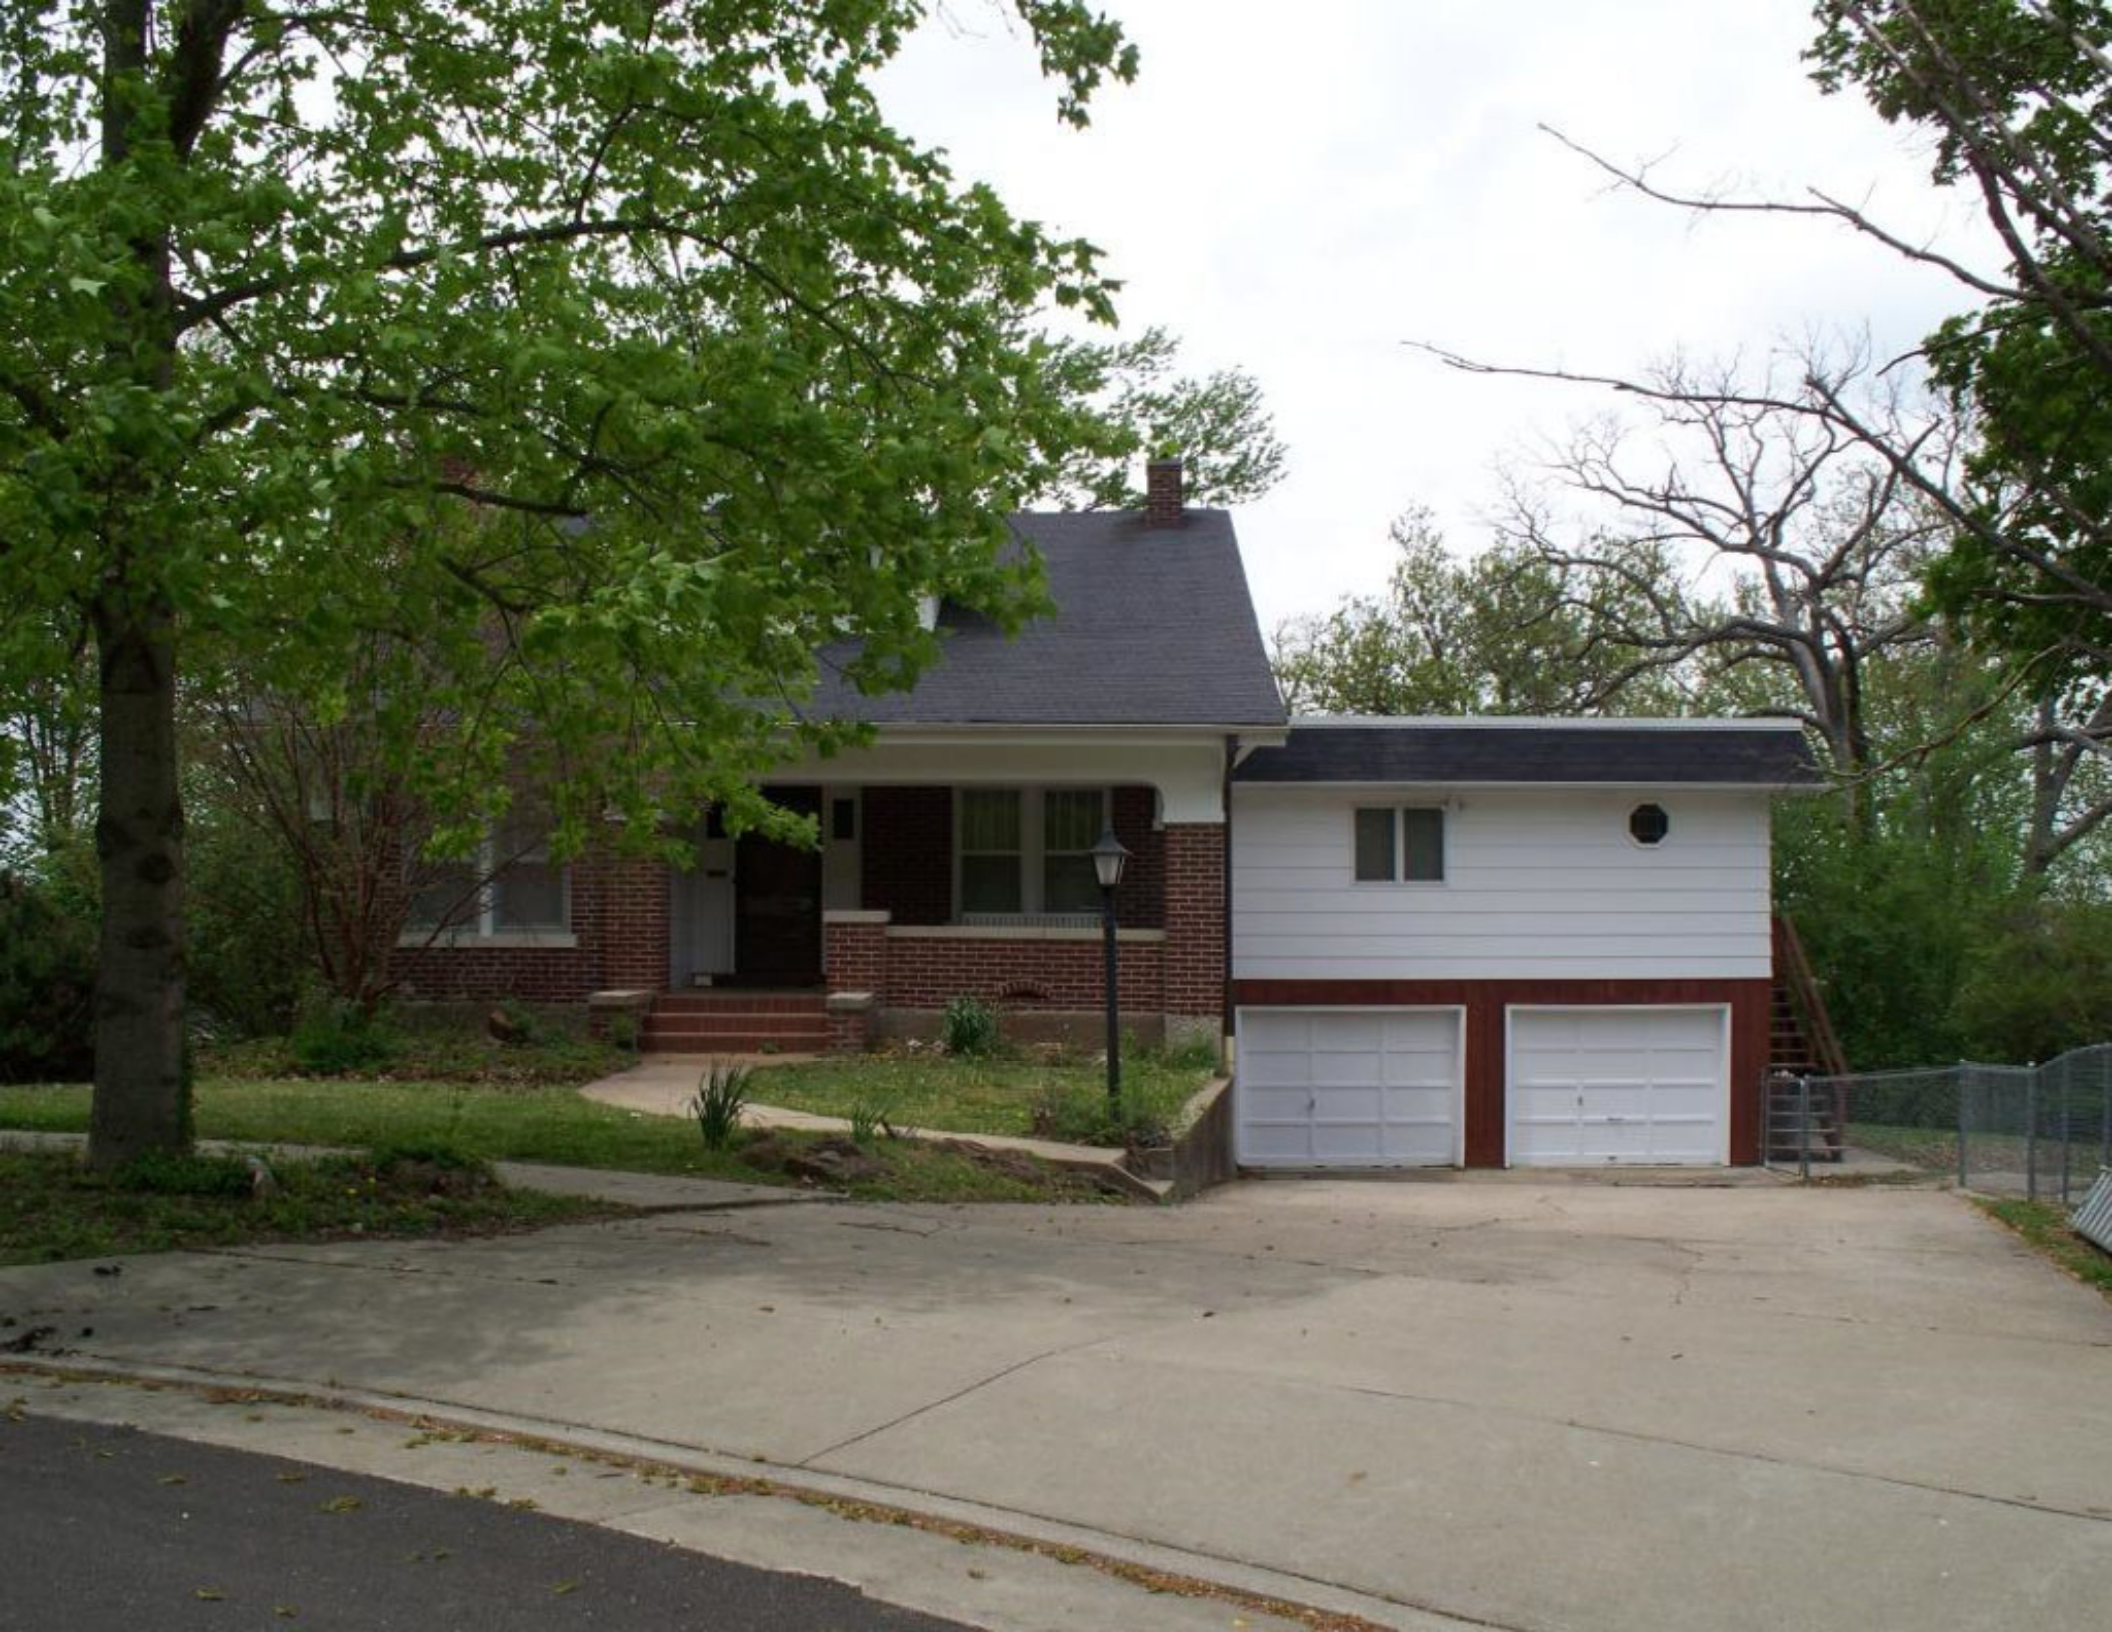
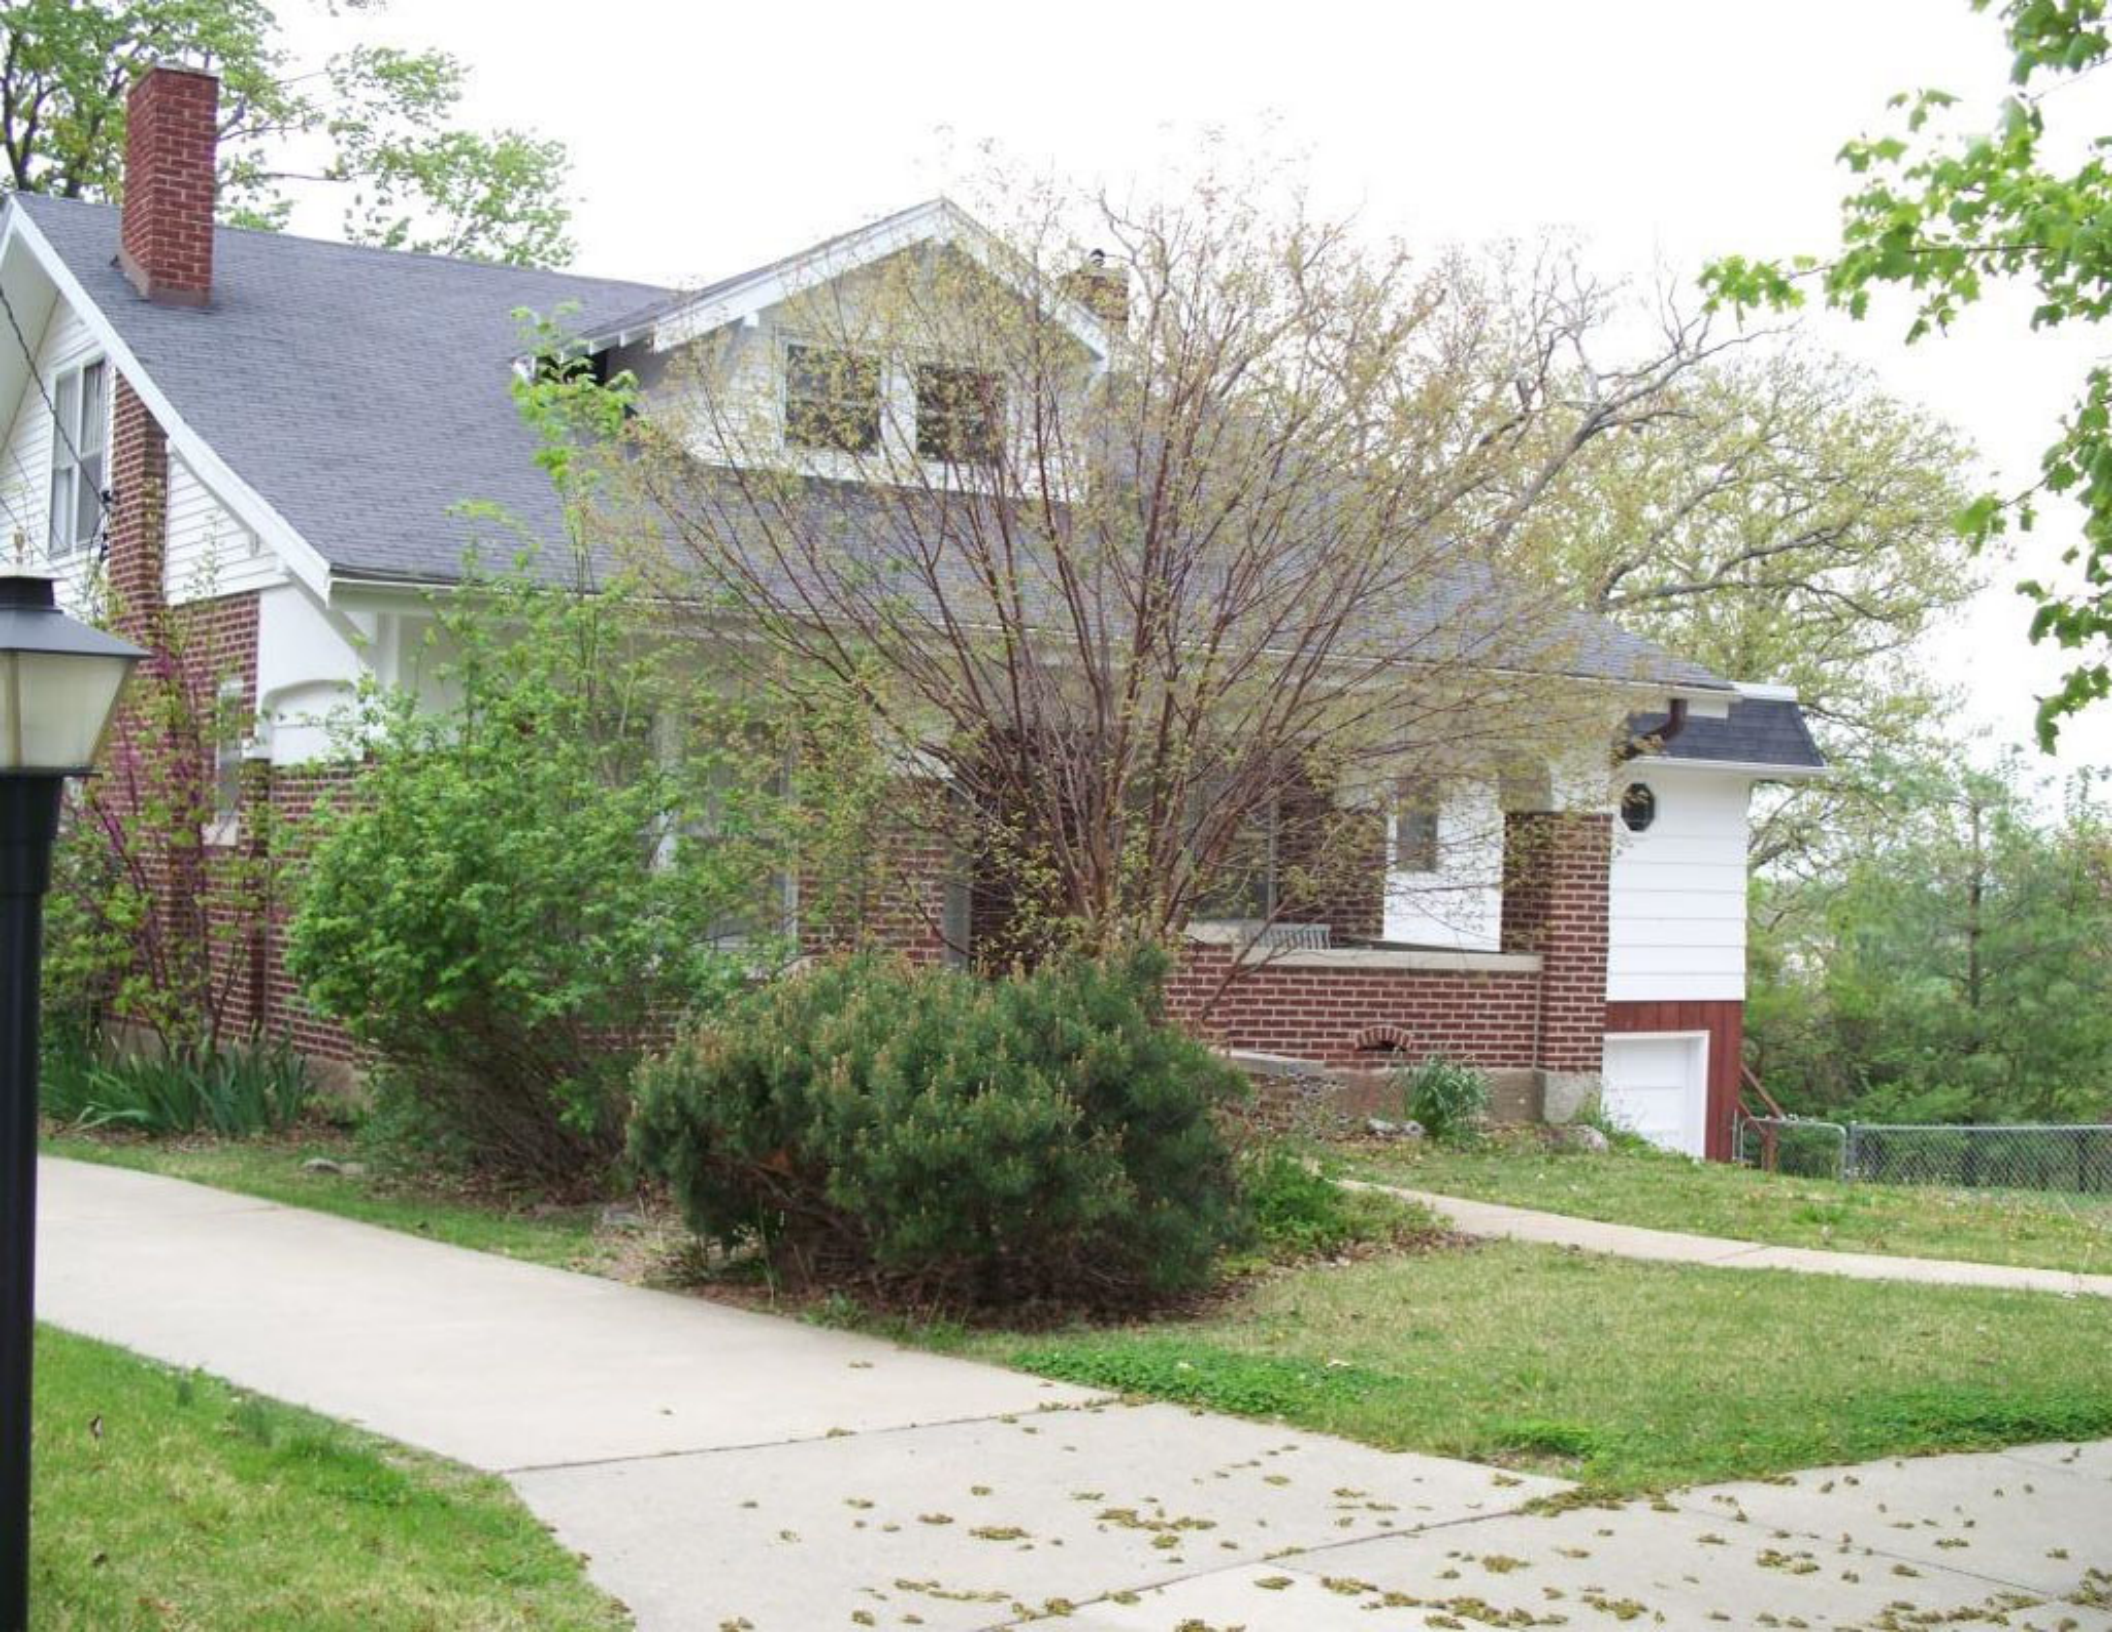
This is 1 ½ story brick side gabled bungalow has a two story modern attached garage with a false mansard roof paired casement windows and a polygonal window. The two paneled garage doors below are framed in brick. Since the garage is at the bottom of a slope and set back slightly from the main house, the property may still contribute, but only just. The home has a side gable roof with a central gable dormer with exposed rafter tails, knee braces and two windows (obscured in photo). The first two bays are recessed and have a partial porch that is flush with the last bay. The porch has brick knee walls capped in concrete or limestone and have two small eyebrow vents above the concrete foundation. The piers meet an architrave and a slight basket handle entablature. In the first bay (right) has paired historic 4/1 windows and the second central bay contains the entrance with sidelights. The final bay has paired historic 4/1 windows with limestone or concrete sills. There are a few knee braces in the gable ends of the roof which probably had exposed rafter tails in the eaves but have since been removed.
