ARCHITECTURAL/HISTORIC INVENTORY FORM

1. Survey No. CO-AS-005-001		2. Survey name: Moreau Drive Neighborhood Survey	
3. County: Cole		4. Address: 1202 Elmerine Ave.	
5. City: Jefferson City	Vicinity: <input type="checkbox"/>	6. UTM: / /	7. Township/Range/Section: T: R: S:
8. Historic name (if known):		9. Present/other name (if known):	
10. Ownership: <input checked="" type="checkbox"/> Private <input type="checkbox"/> Public		11. Historic use (if known): Residential	11. Current use: Residential

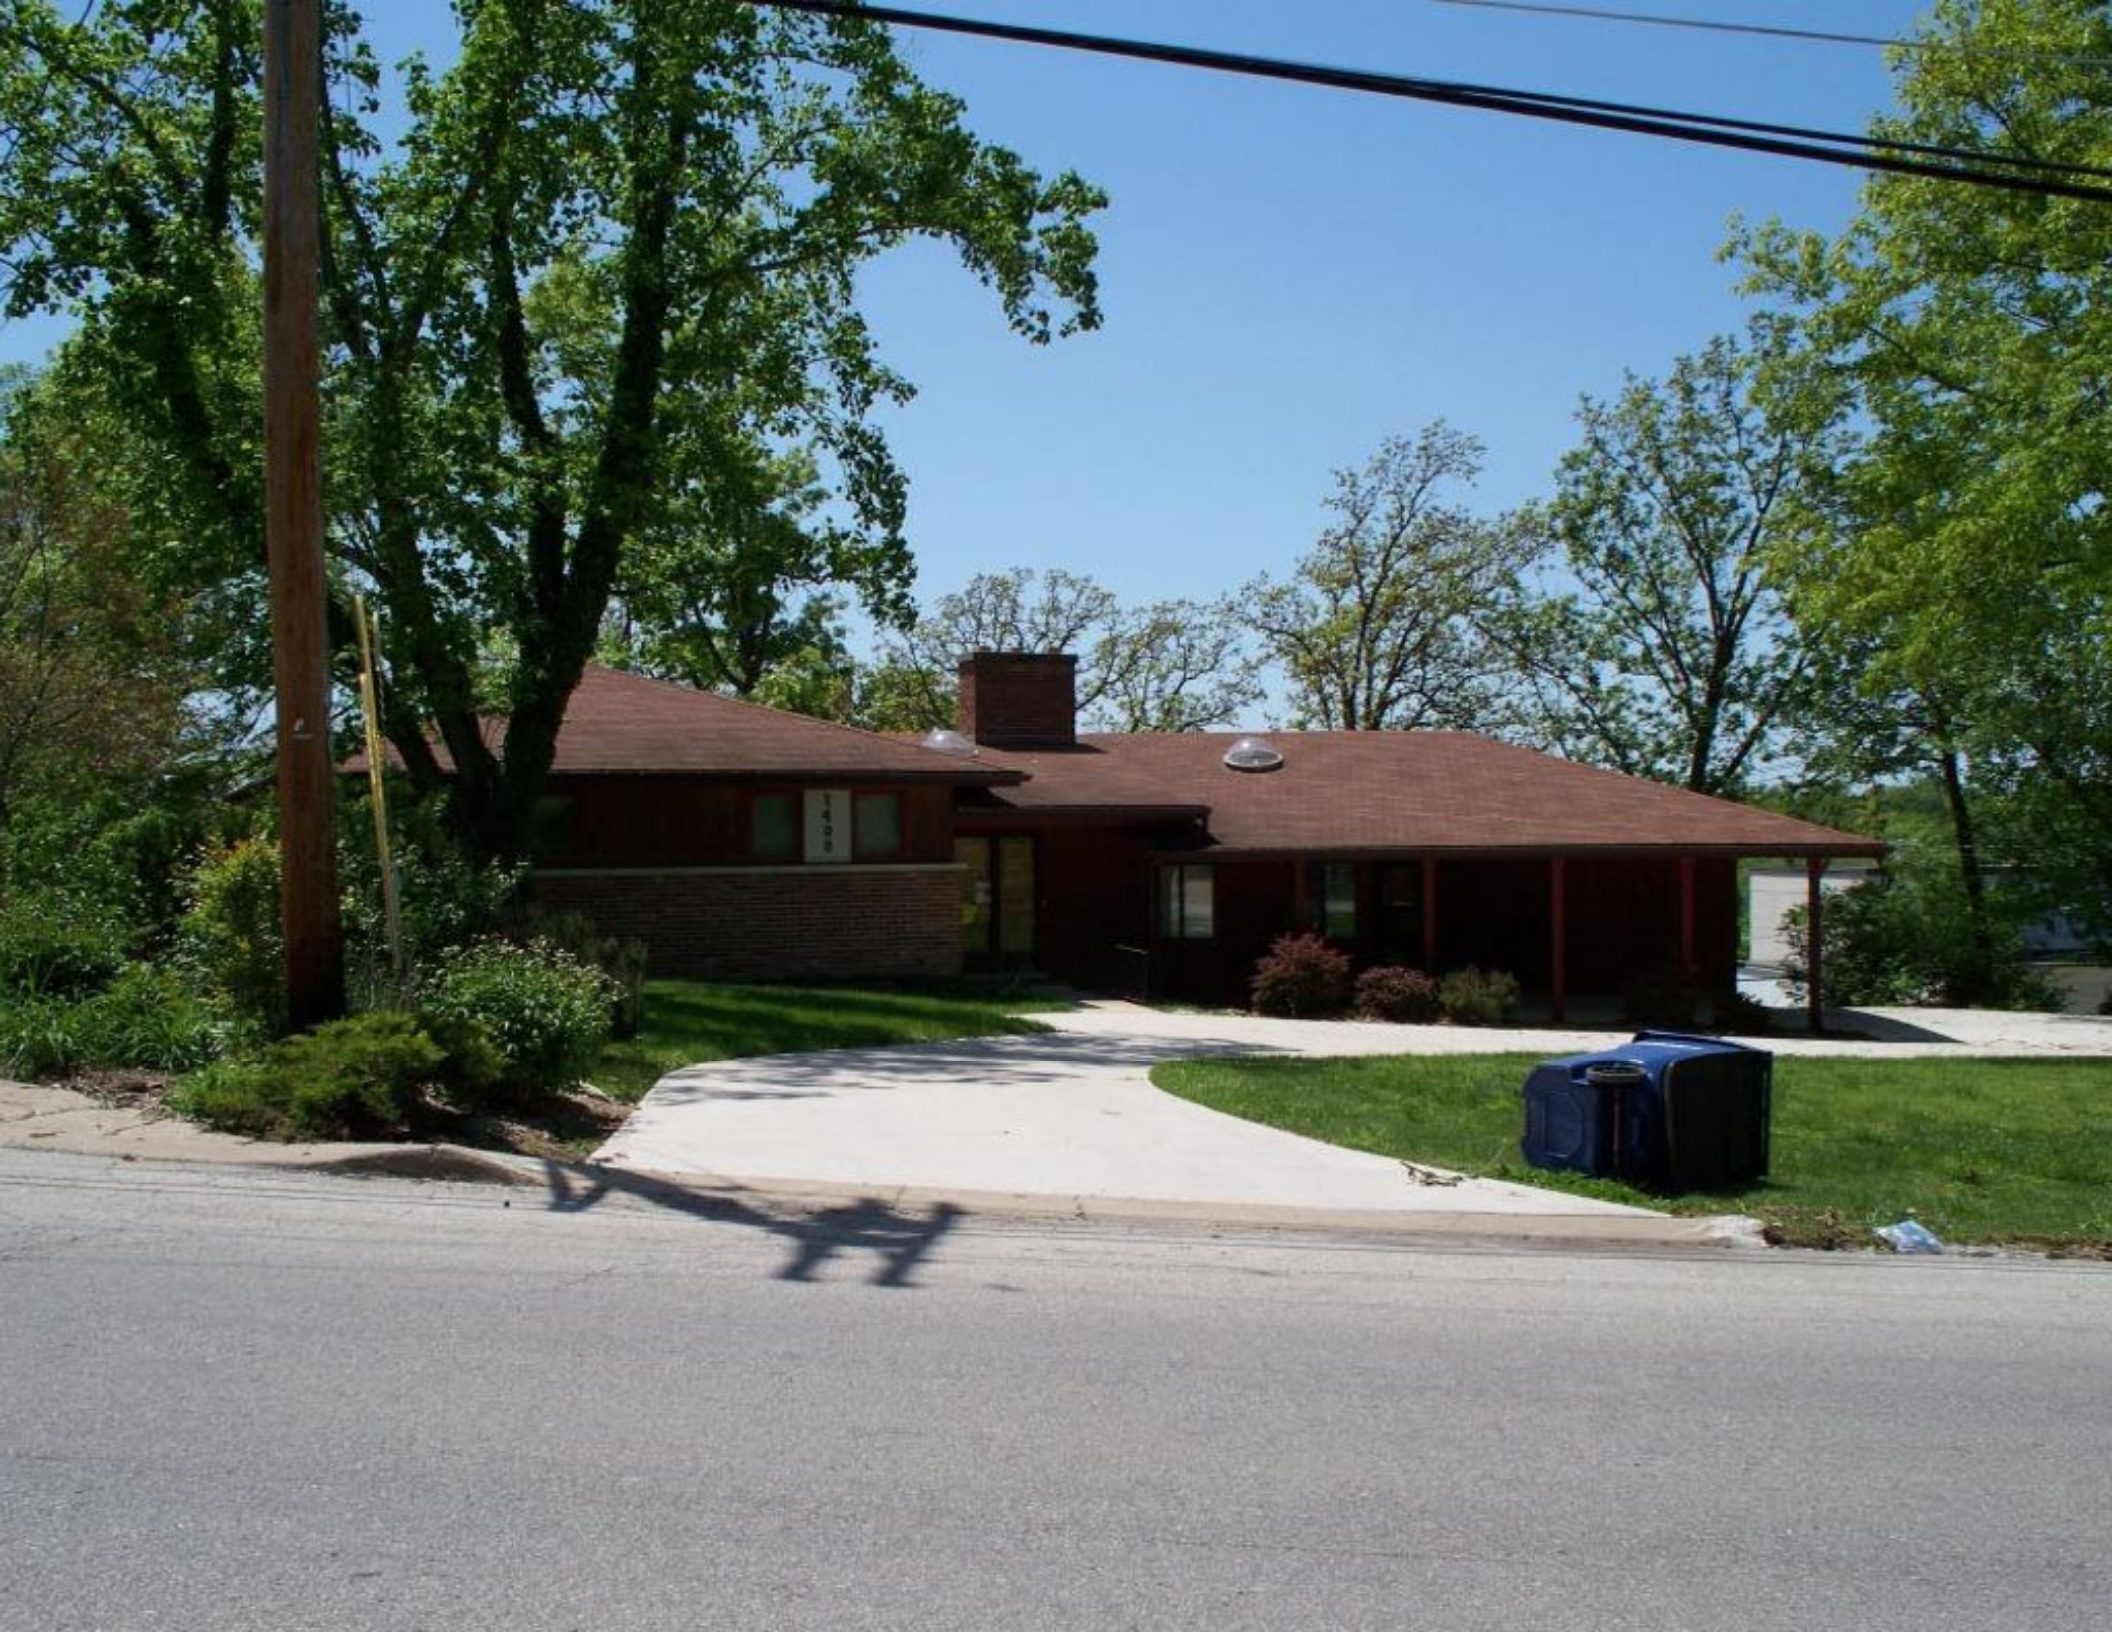
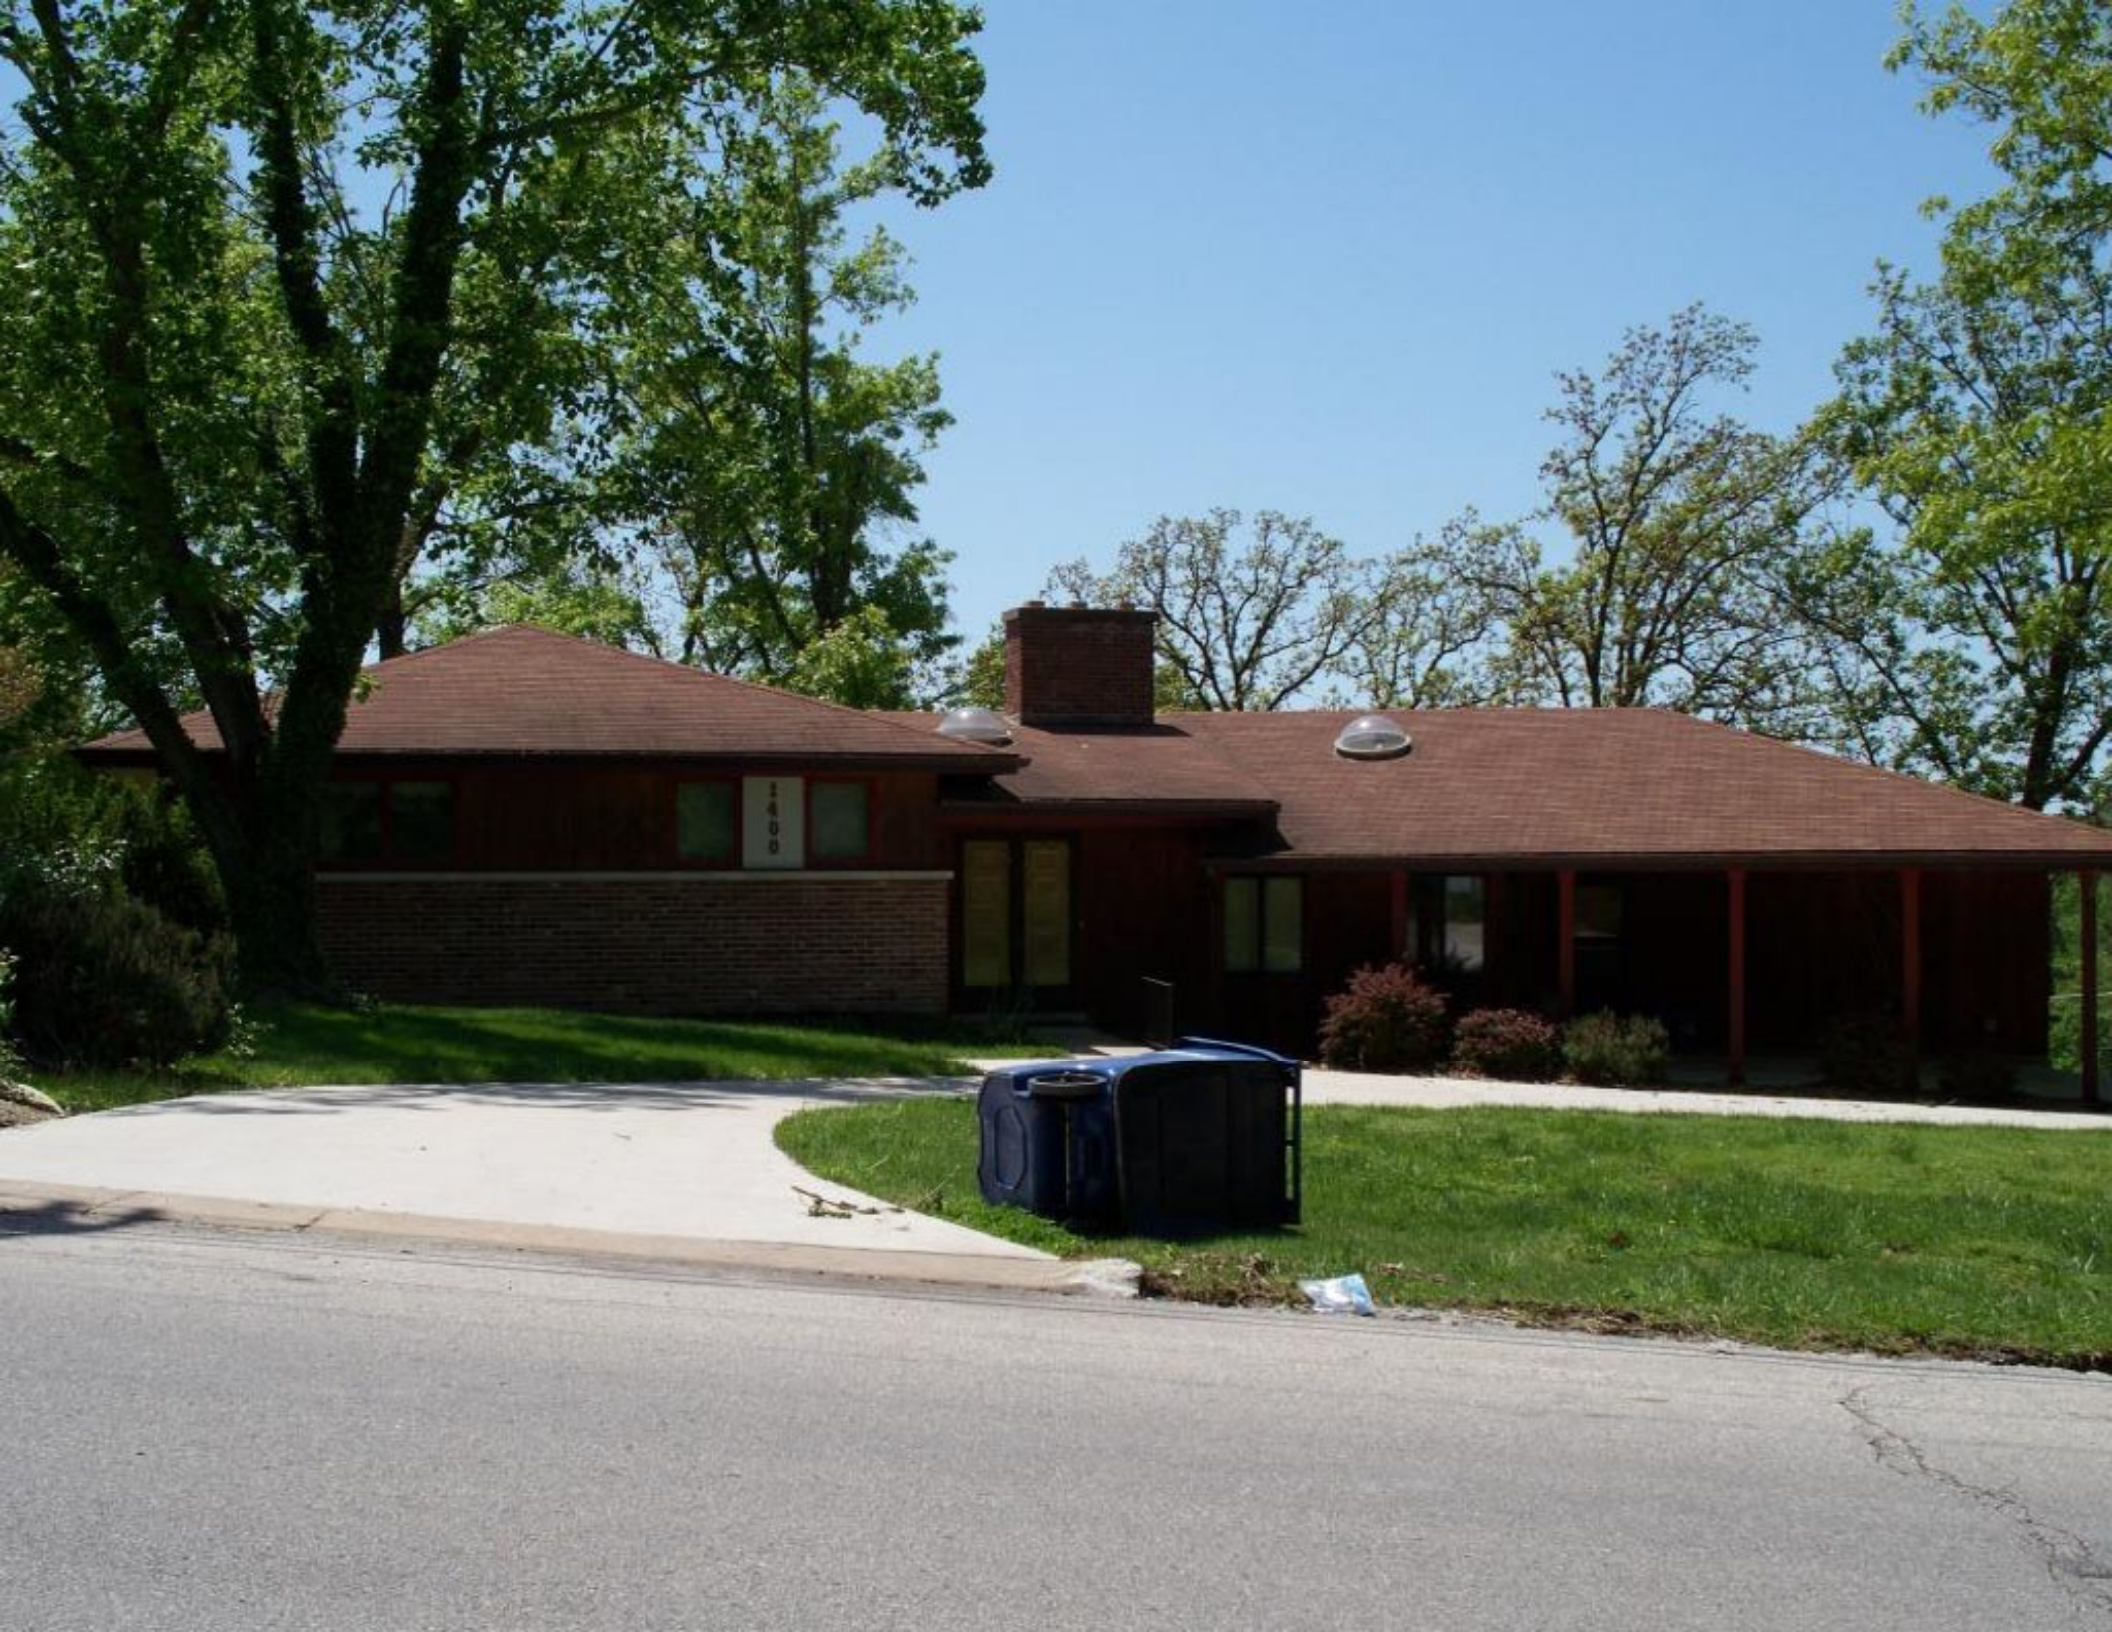
41. (cont.)
This one story brick ranch house has a hipped roof on the left portion of the house and a shed stepped roof over the rest of the property. From the left, the first bay contains several casement windows. Brick extends up $\frac{3}{4}$ of the façade to a concrete belt course. The rest of the property is set slightly back and contains a recessed entrance, the rest of the details were obscured by shadow at the time of this photo. A large rectangular brick chimney with caps extends from the center of the roof.

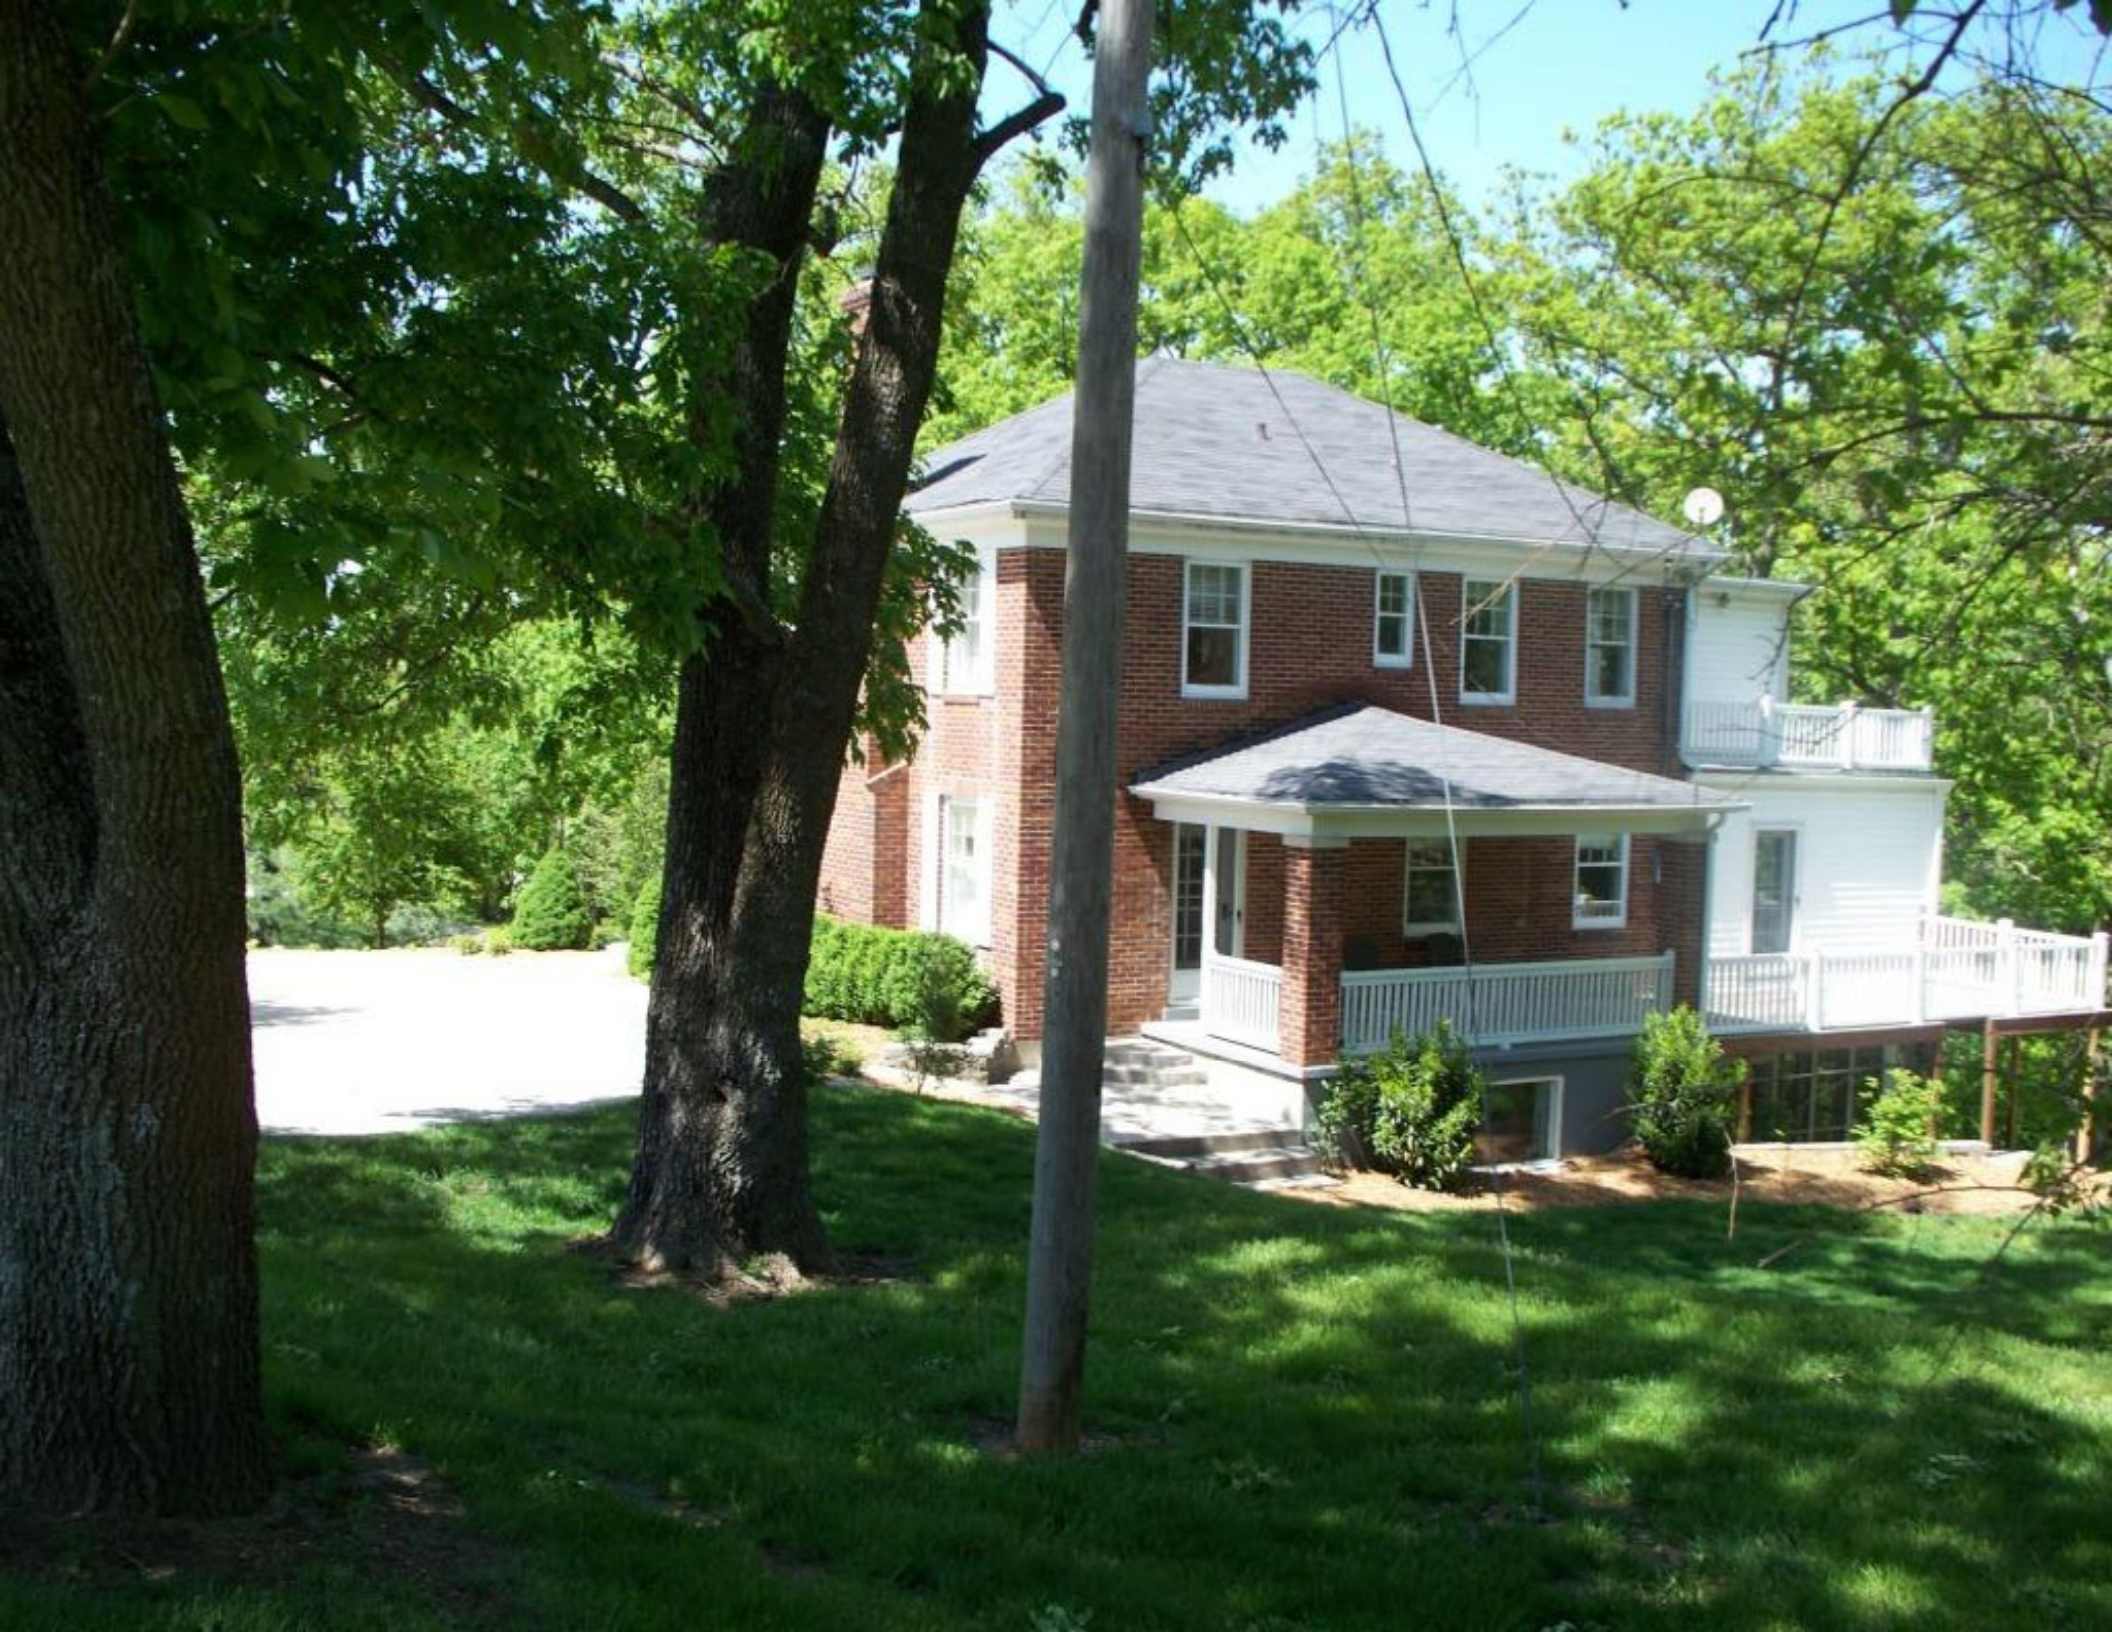
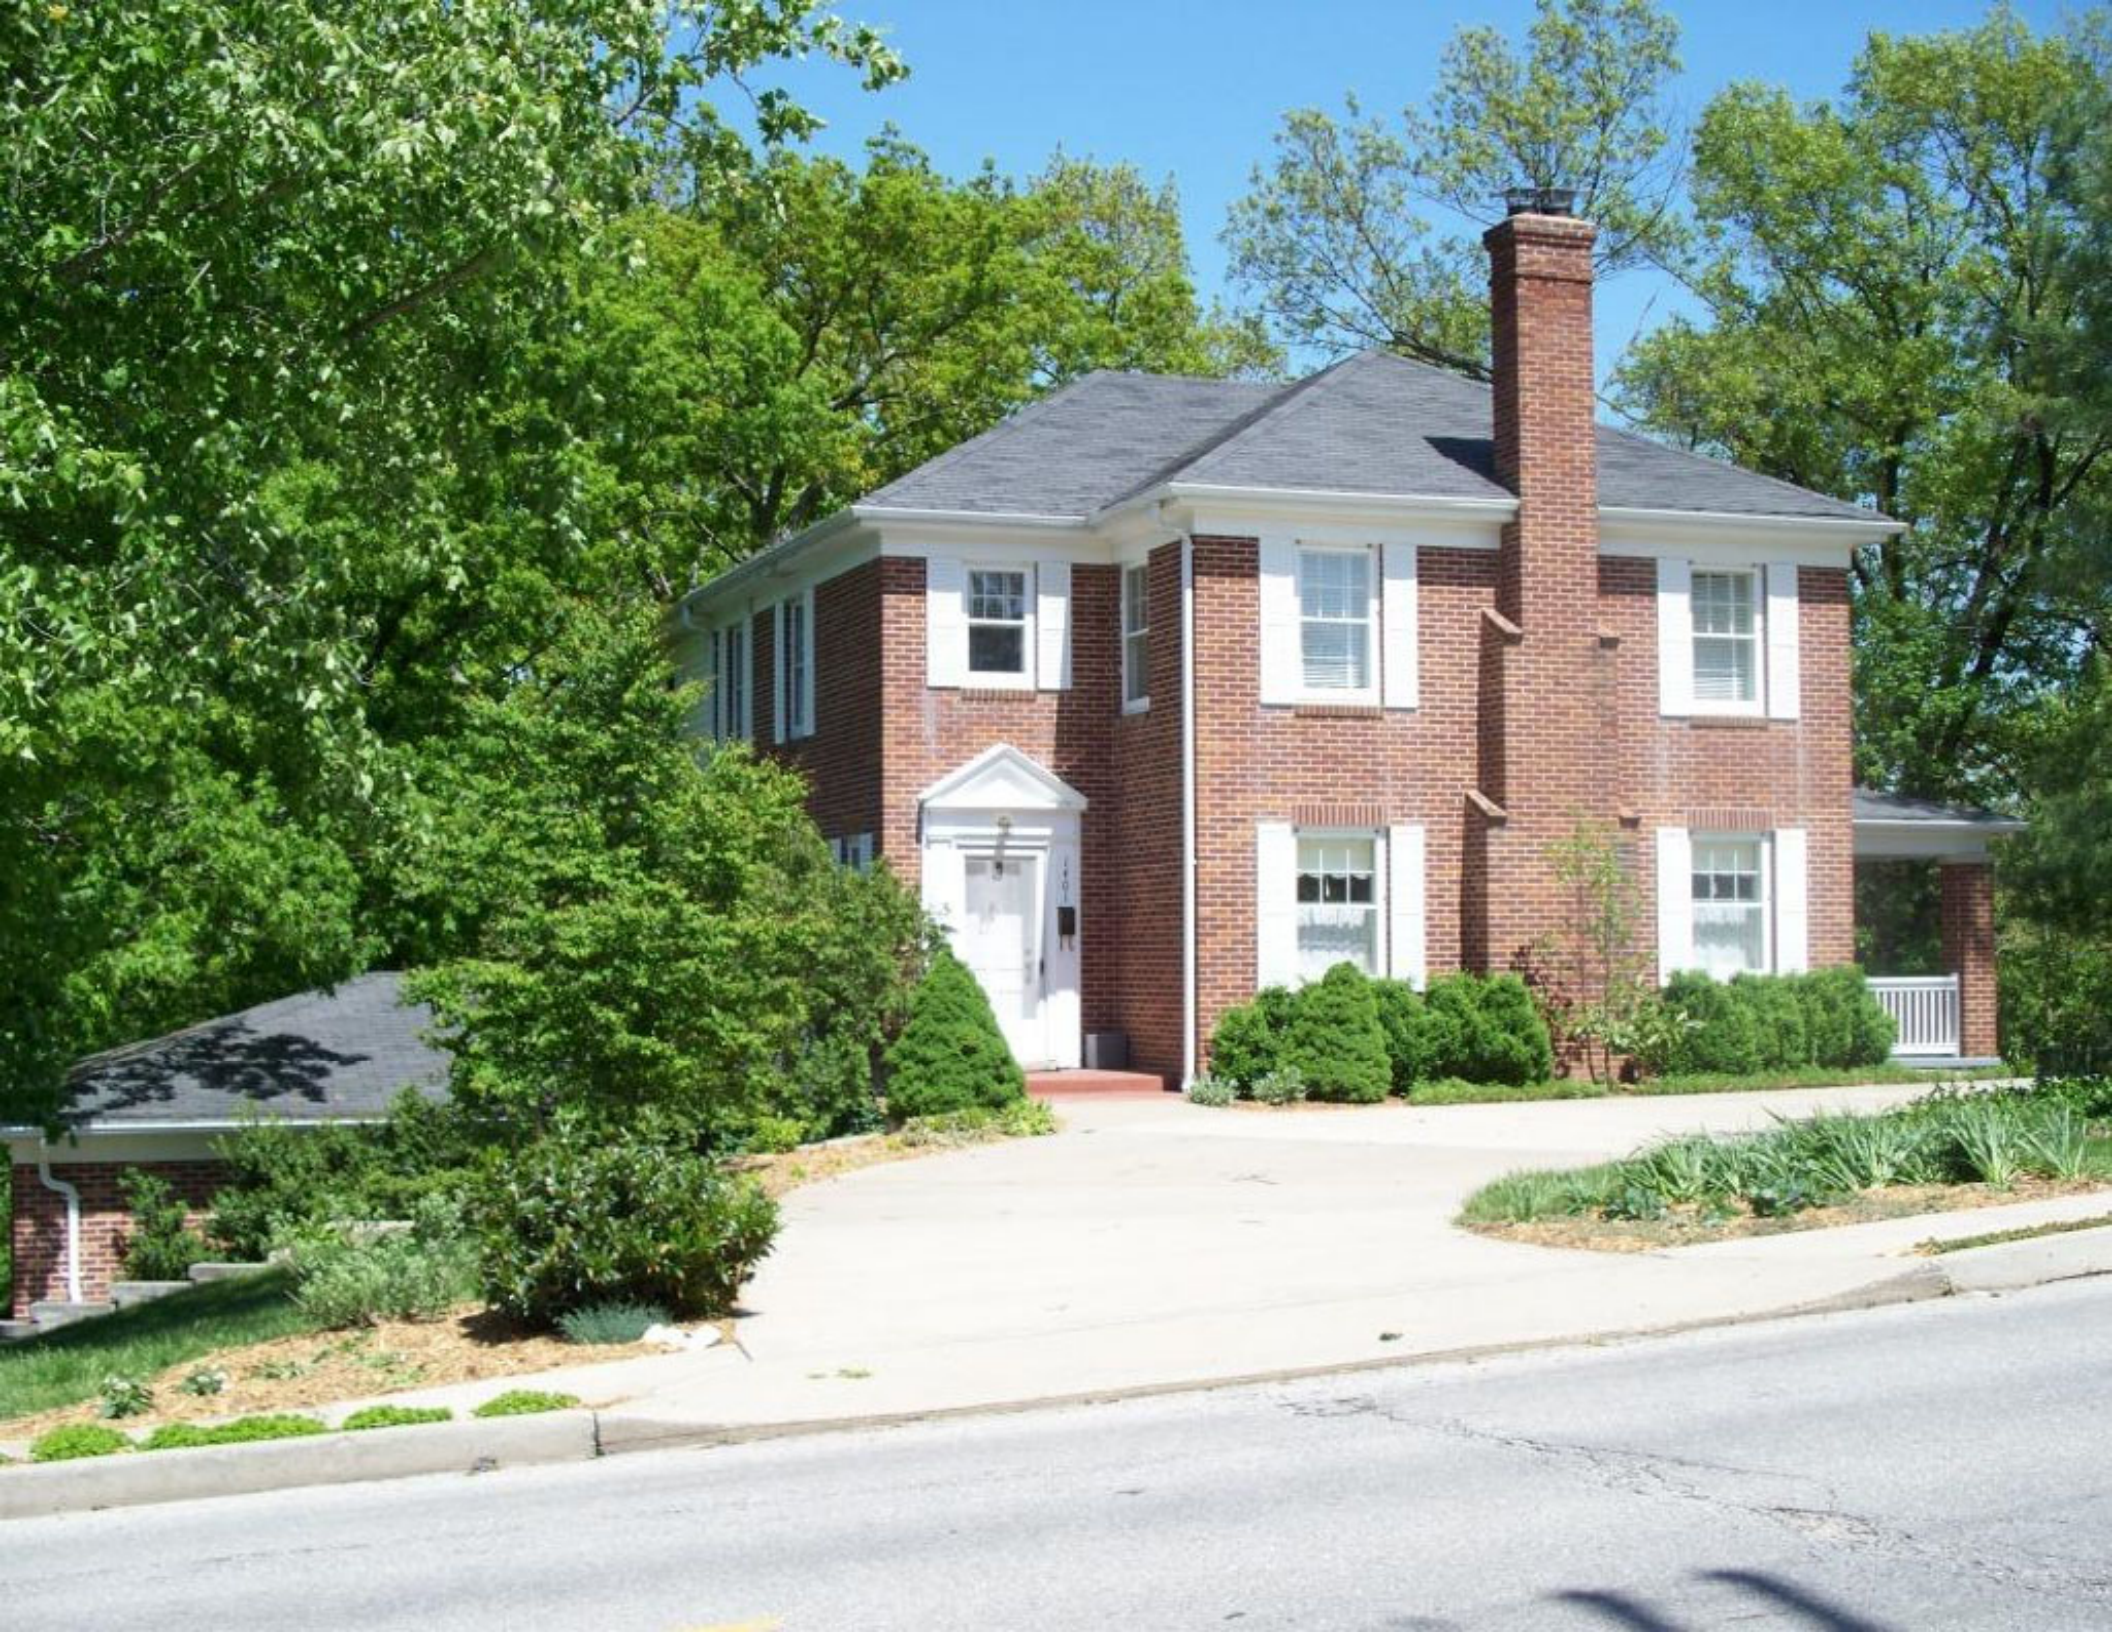
41. (cont.)
This two story brick Colonial Revival has a hipped roof. The first bay on the left is recessed on both floors. On the second story it contains a 6/1 window with shutters, an additional window is in the ell of this wing. There are two other 6/1 windows with shutters on the second floor separated by the chimney. The windows have partial brick sills. On the first floor the entrance has a pediment ornate surround and a brick or tile stoop. The next two bays are similar to those on the second floor save the windows are a little longer. Attached to the right is a hipped porch with brick piers. Attached to the left is an addition below grade with a hipped roof. It was not visible at the time of photography but it is likely a garage.

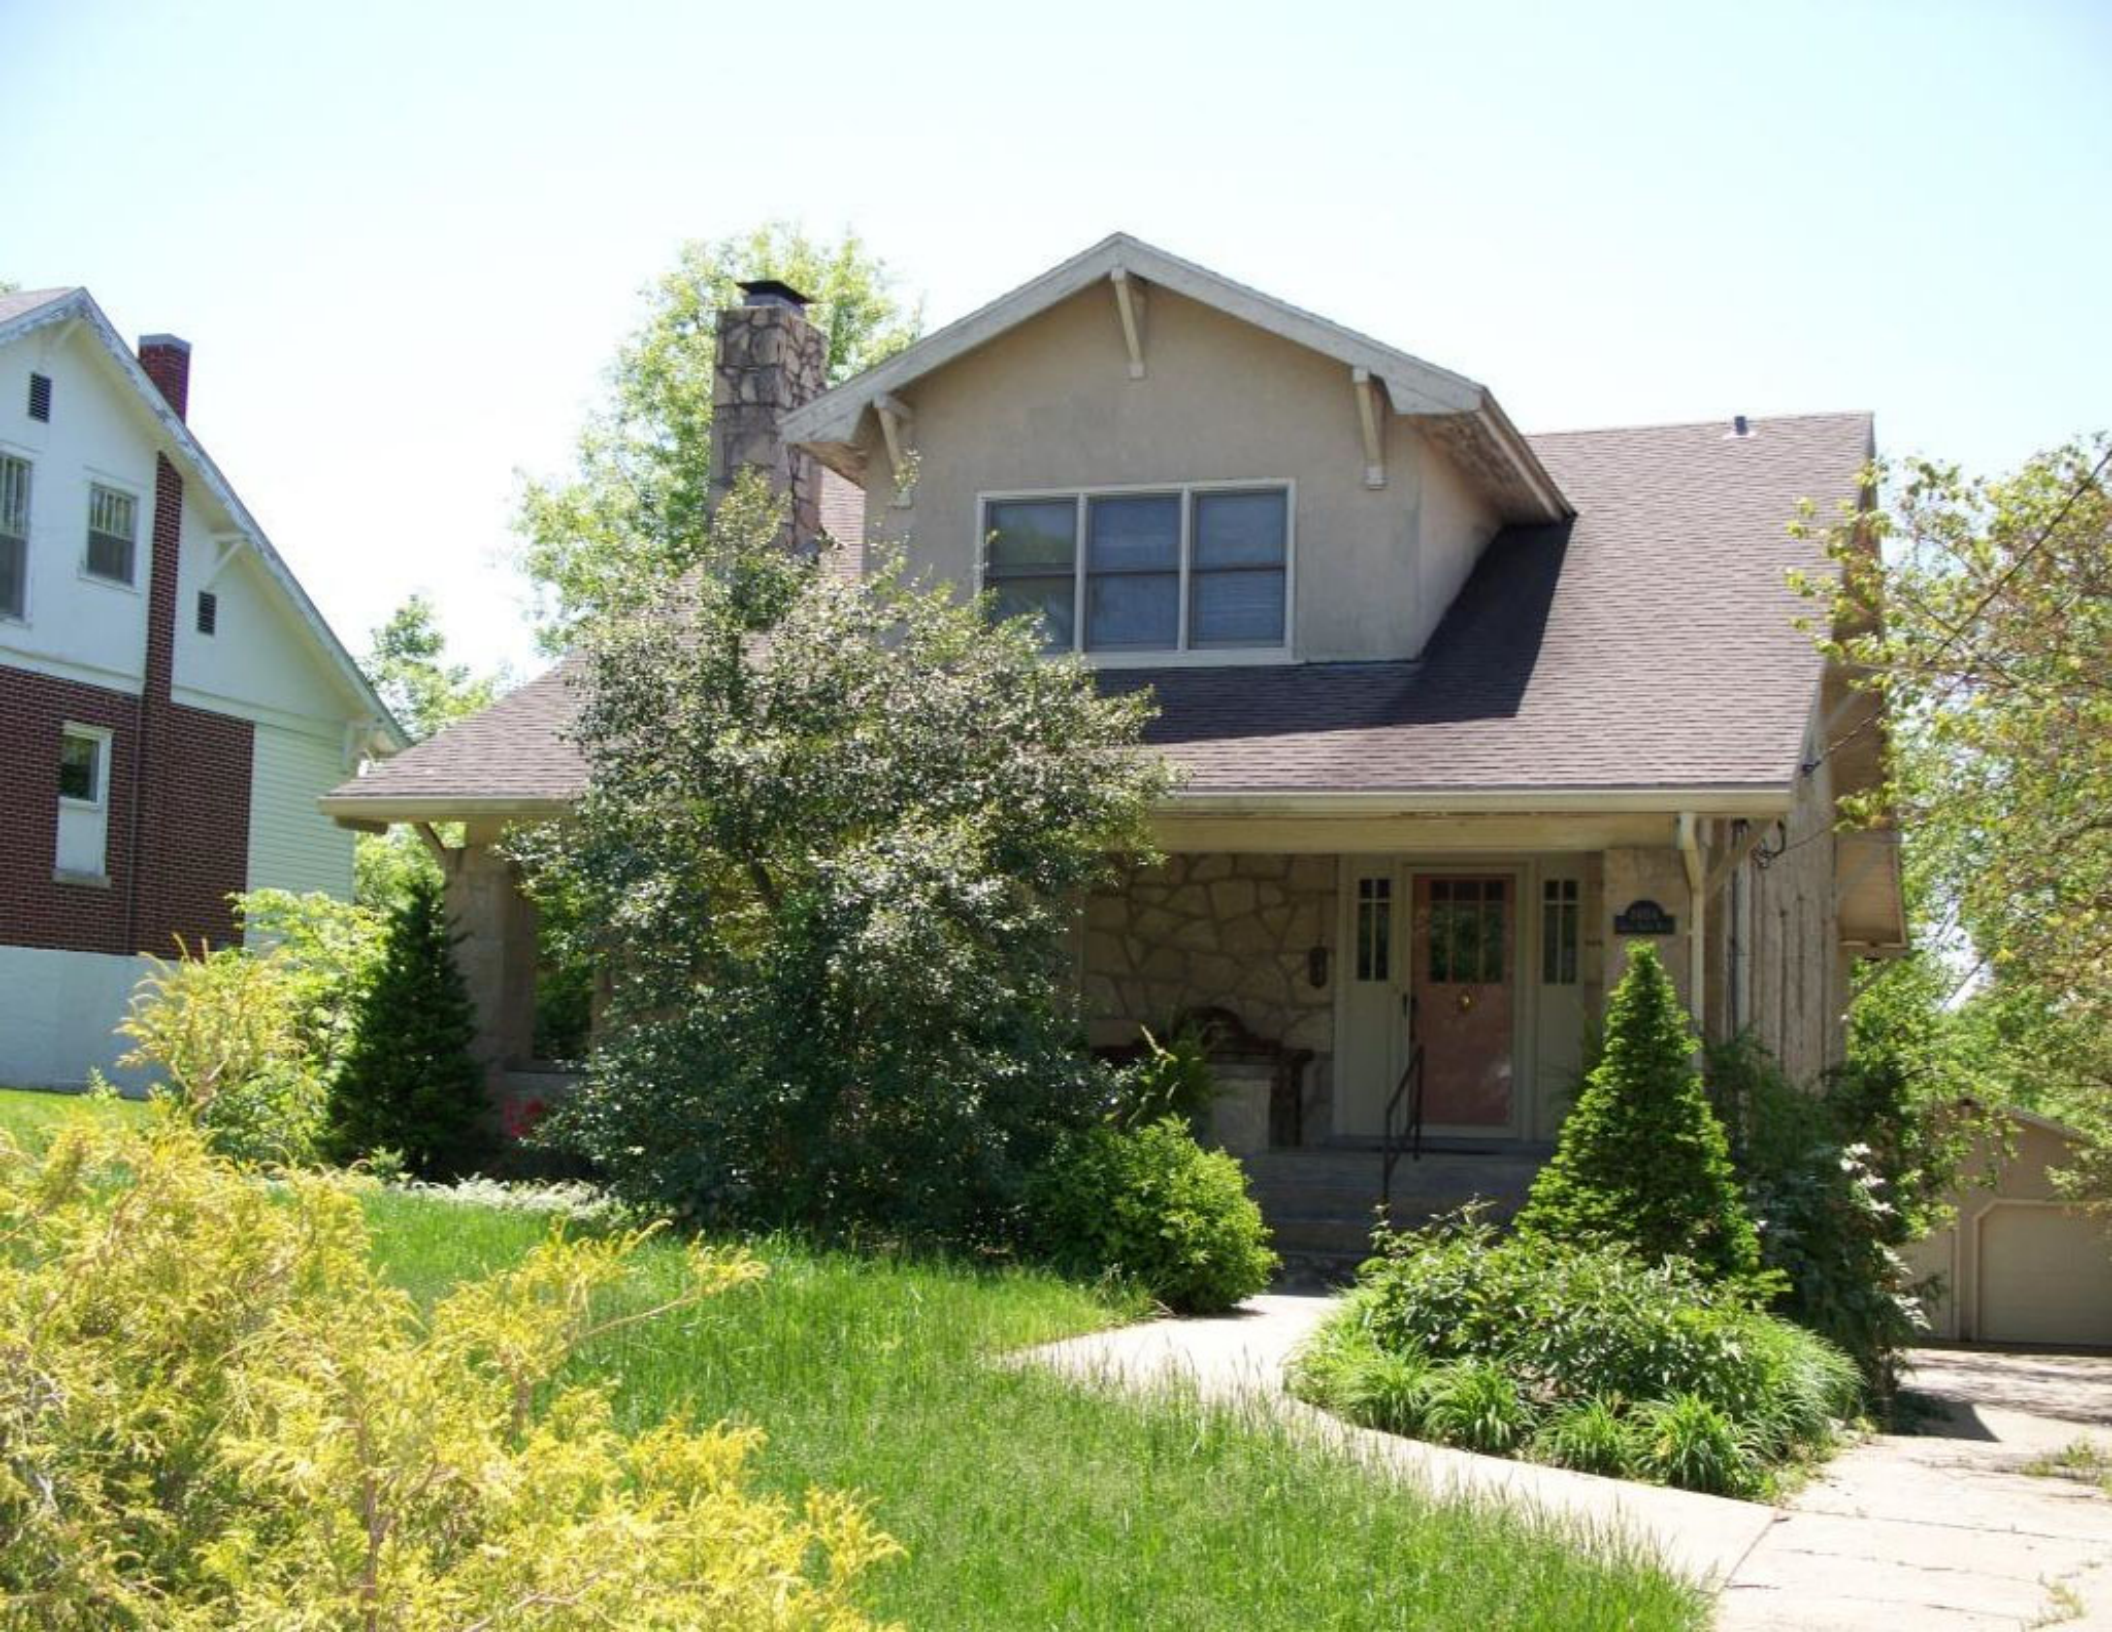
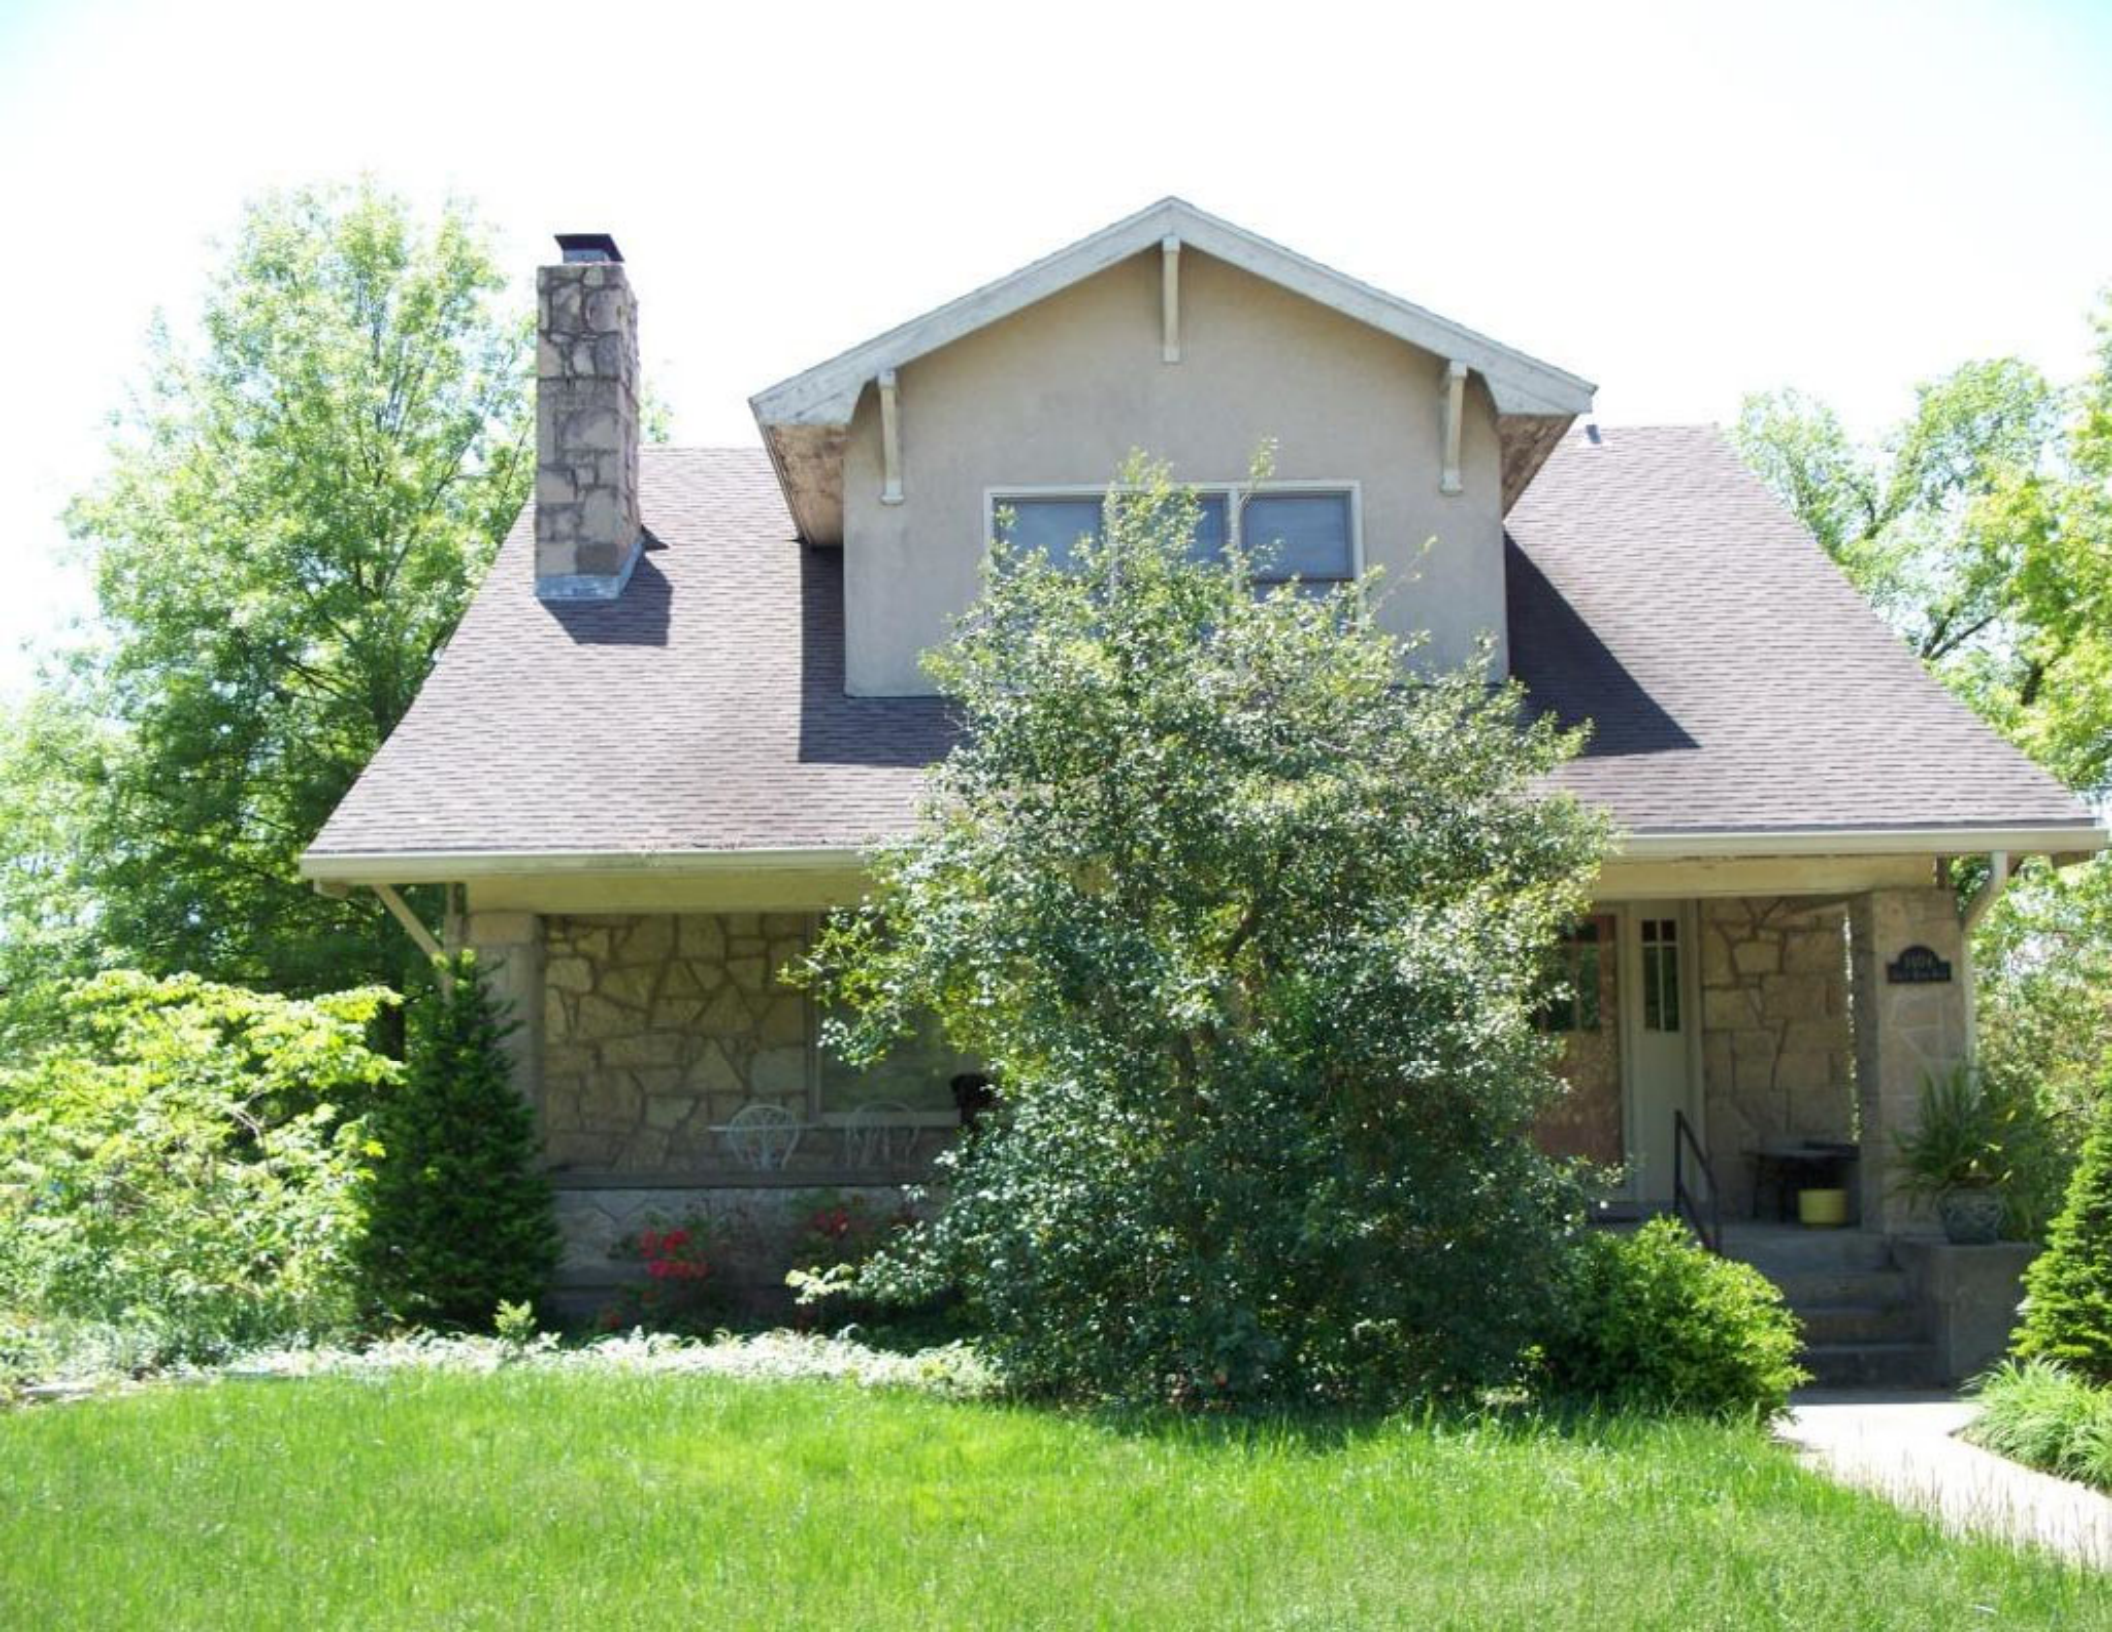
41. (cont.)
This 1 ½ story stone bungalow has a deeply pitched side gable roof with a larger gable center stucco dormer with brackets and three 1/1 replacement windows. The first floor has a full width porch with stone piers and half walls capped in limestone or concrete. Although it was obscured by vegetation it appears the left bay has a large picture window (likely replacement) and the right bay contains the entrance that retains its historic wooden door and sidelights.
