ARCHITECTURAL/HISTORIC INVENTORY FORM

1. Survey No. CO-AS-005-001		2. Survey name: Moreau Drive Neighborhood Survey	
3. County: Cole		4. Address: 1202 Elmerine Ave.	
5. City: Jefferson City	Vicinity: <input type="checkbox"/>	6. UTM: / /	7. Township/Range/Section: T: R: S:
8. Historic name (if known):		9. Present/other name (if known):	
10. Ownership: <input checked="" type="checkbox"/> Private <input type="checkbox"/> Public		11. Historic use (if known): Residential	11. Current use: Residential

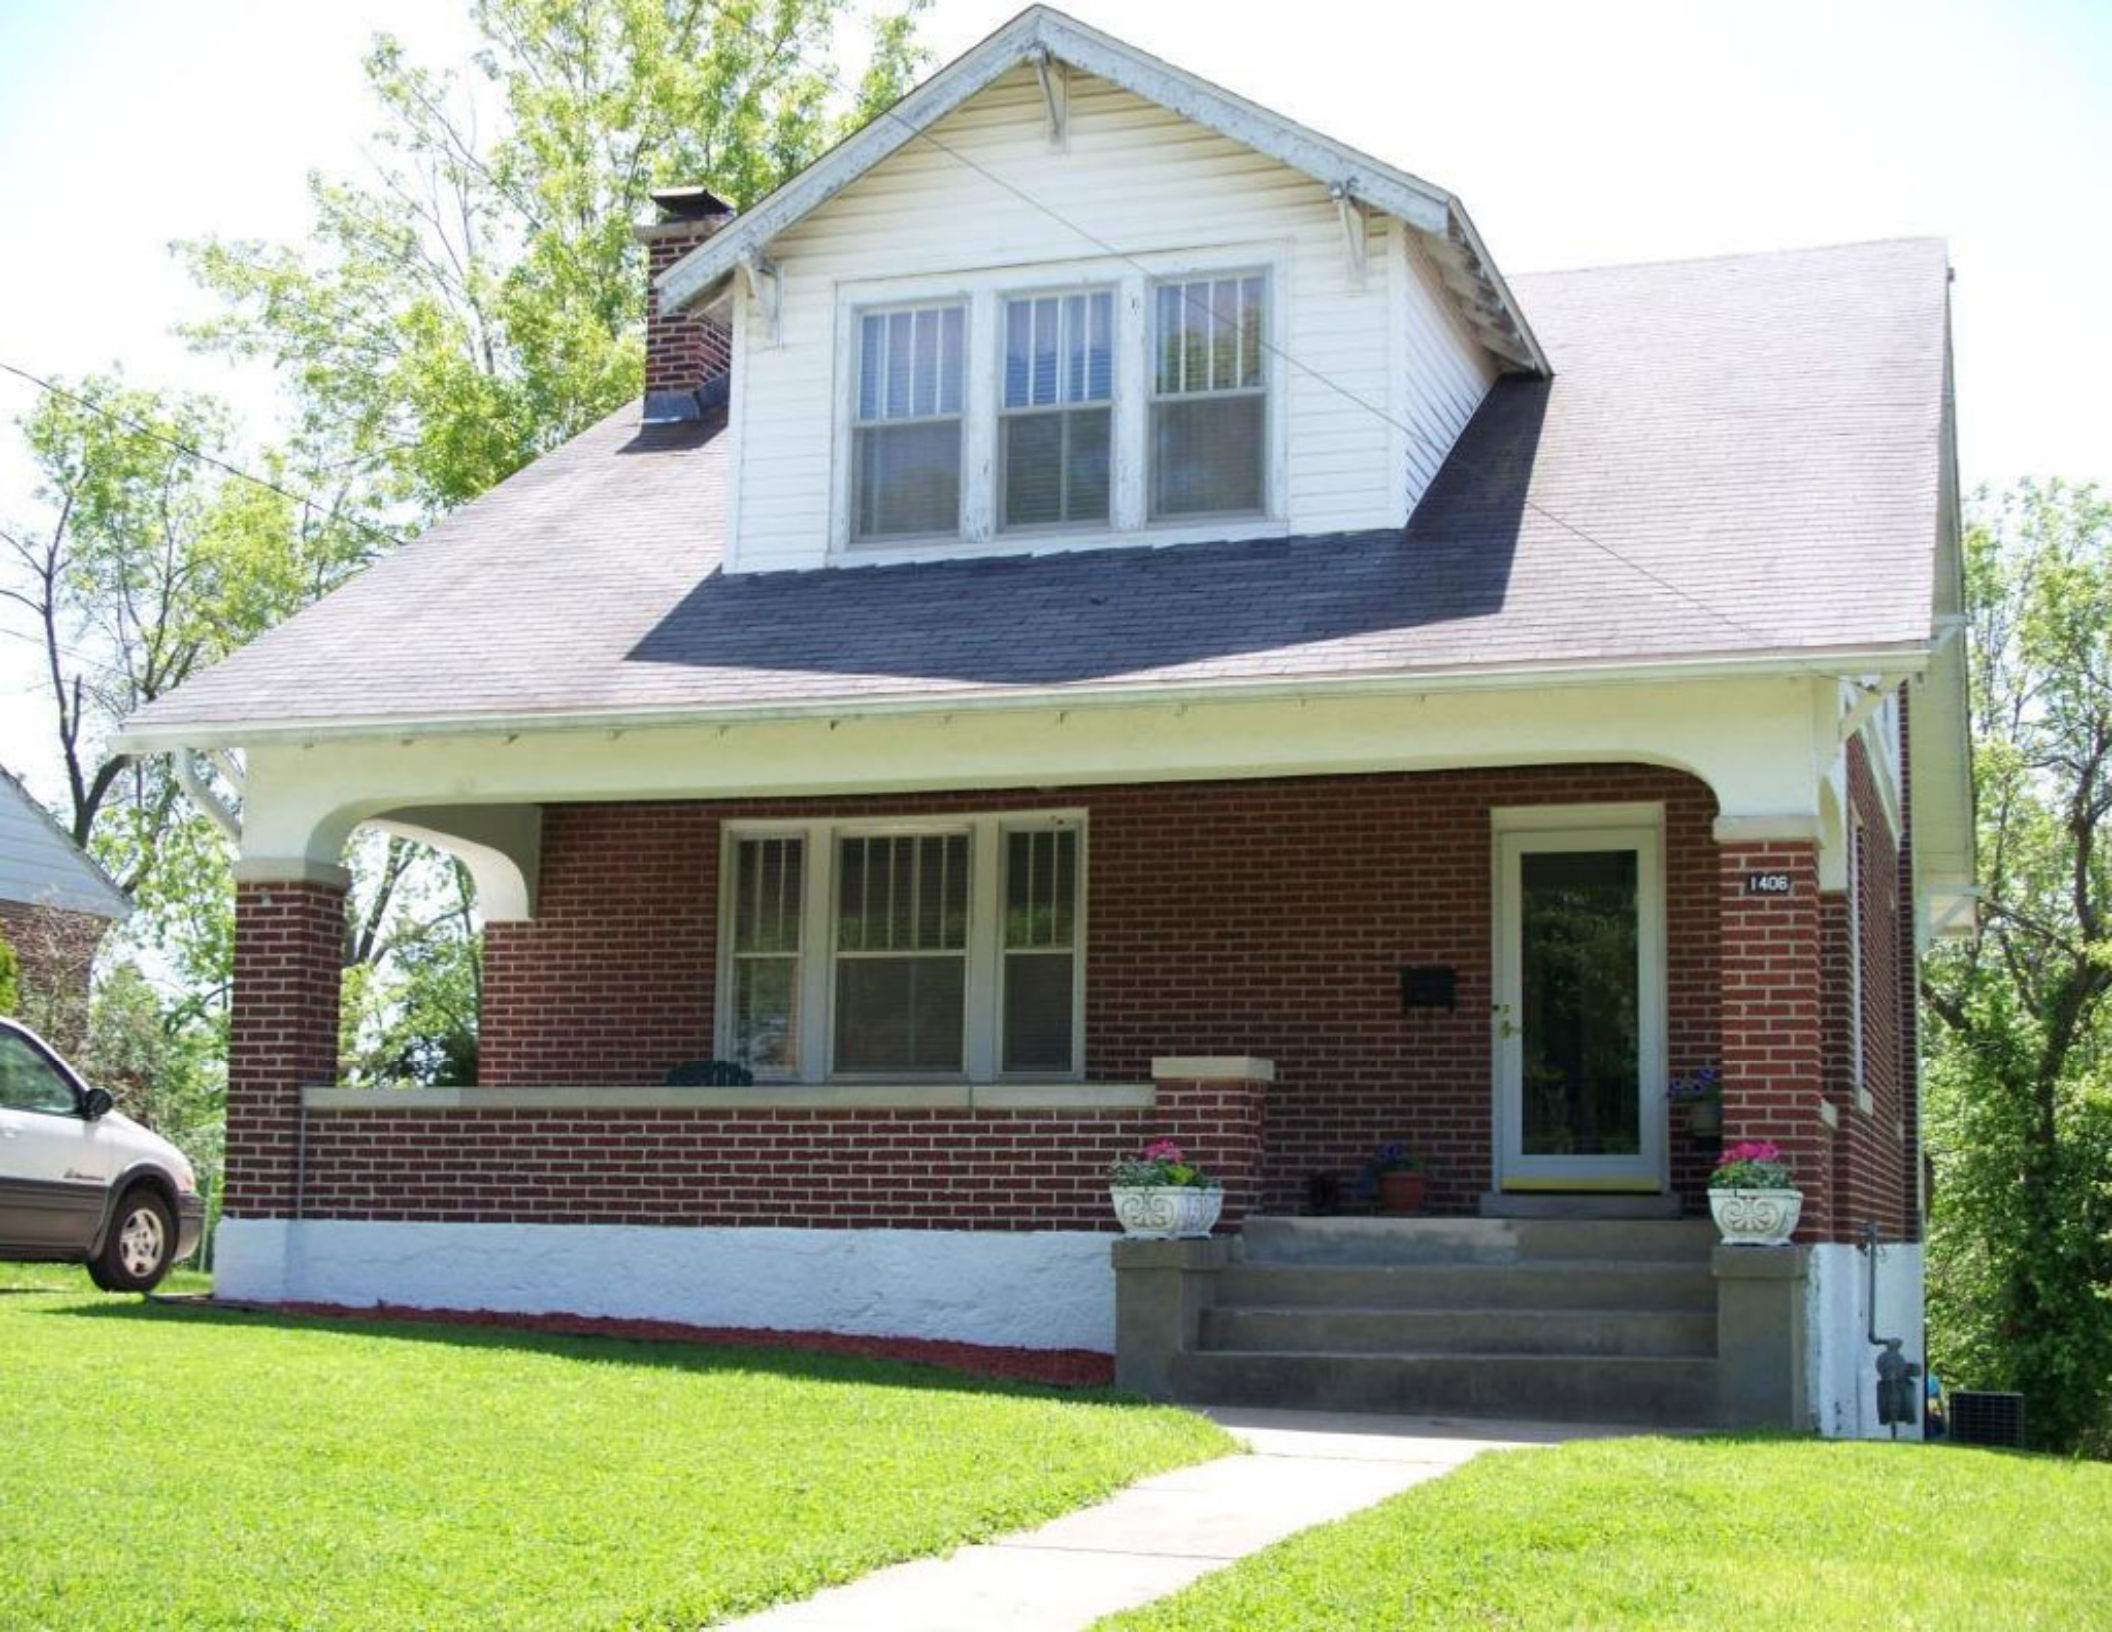
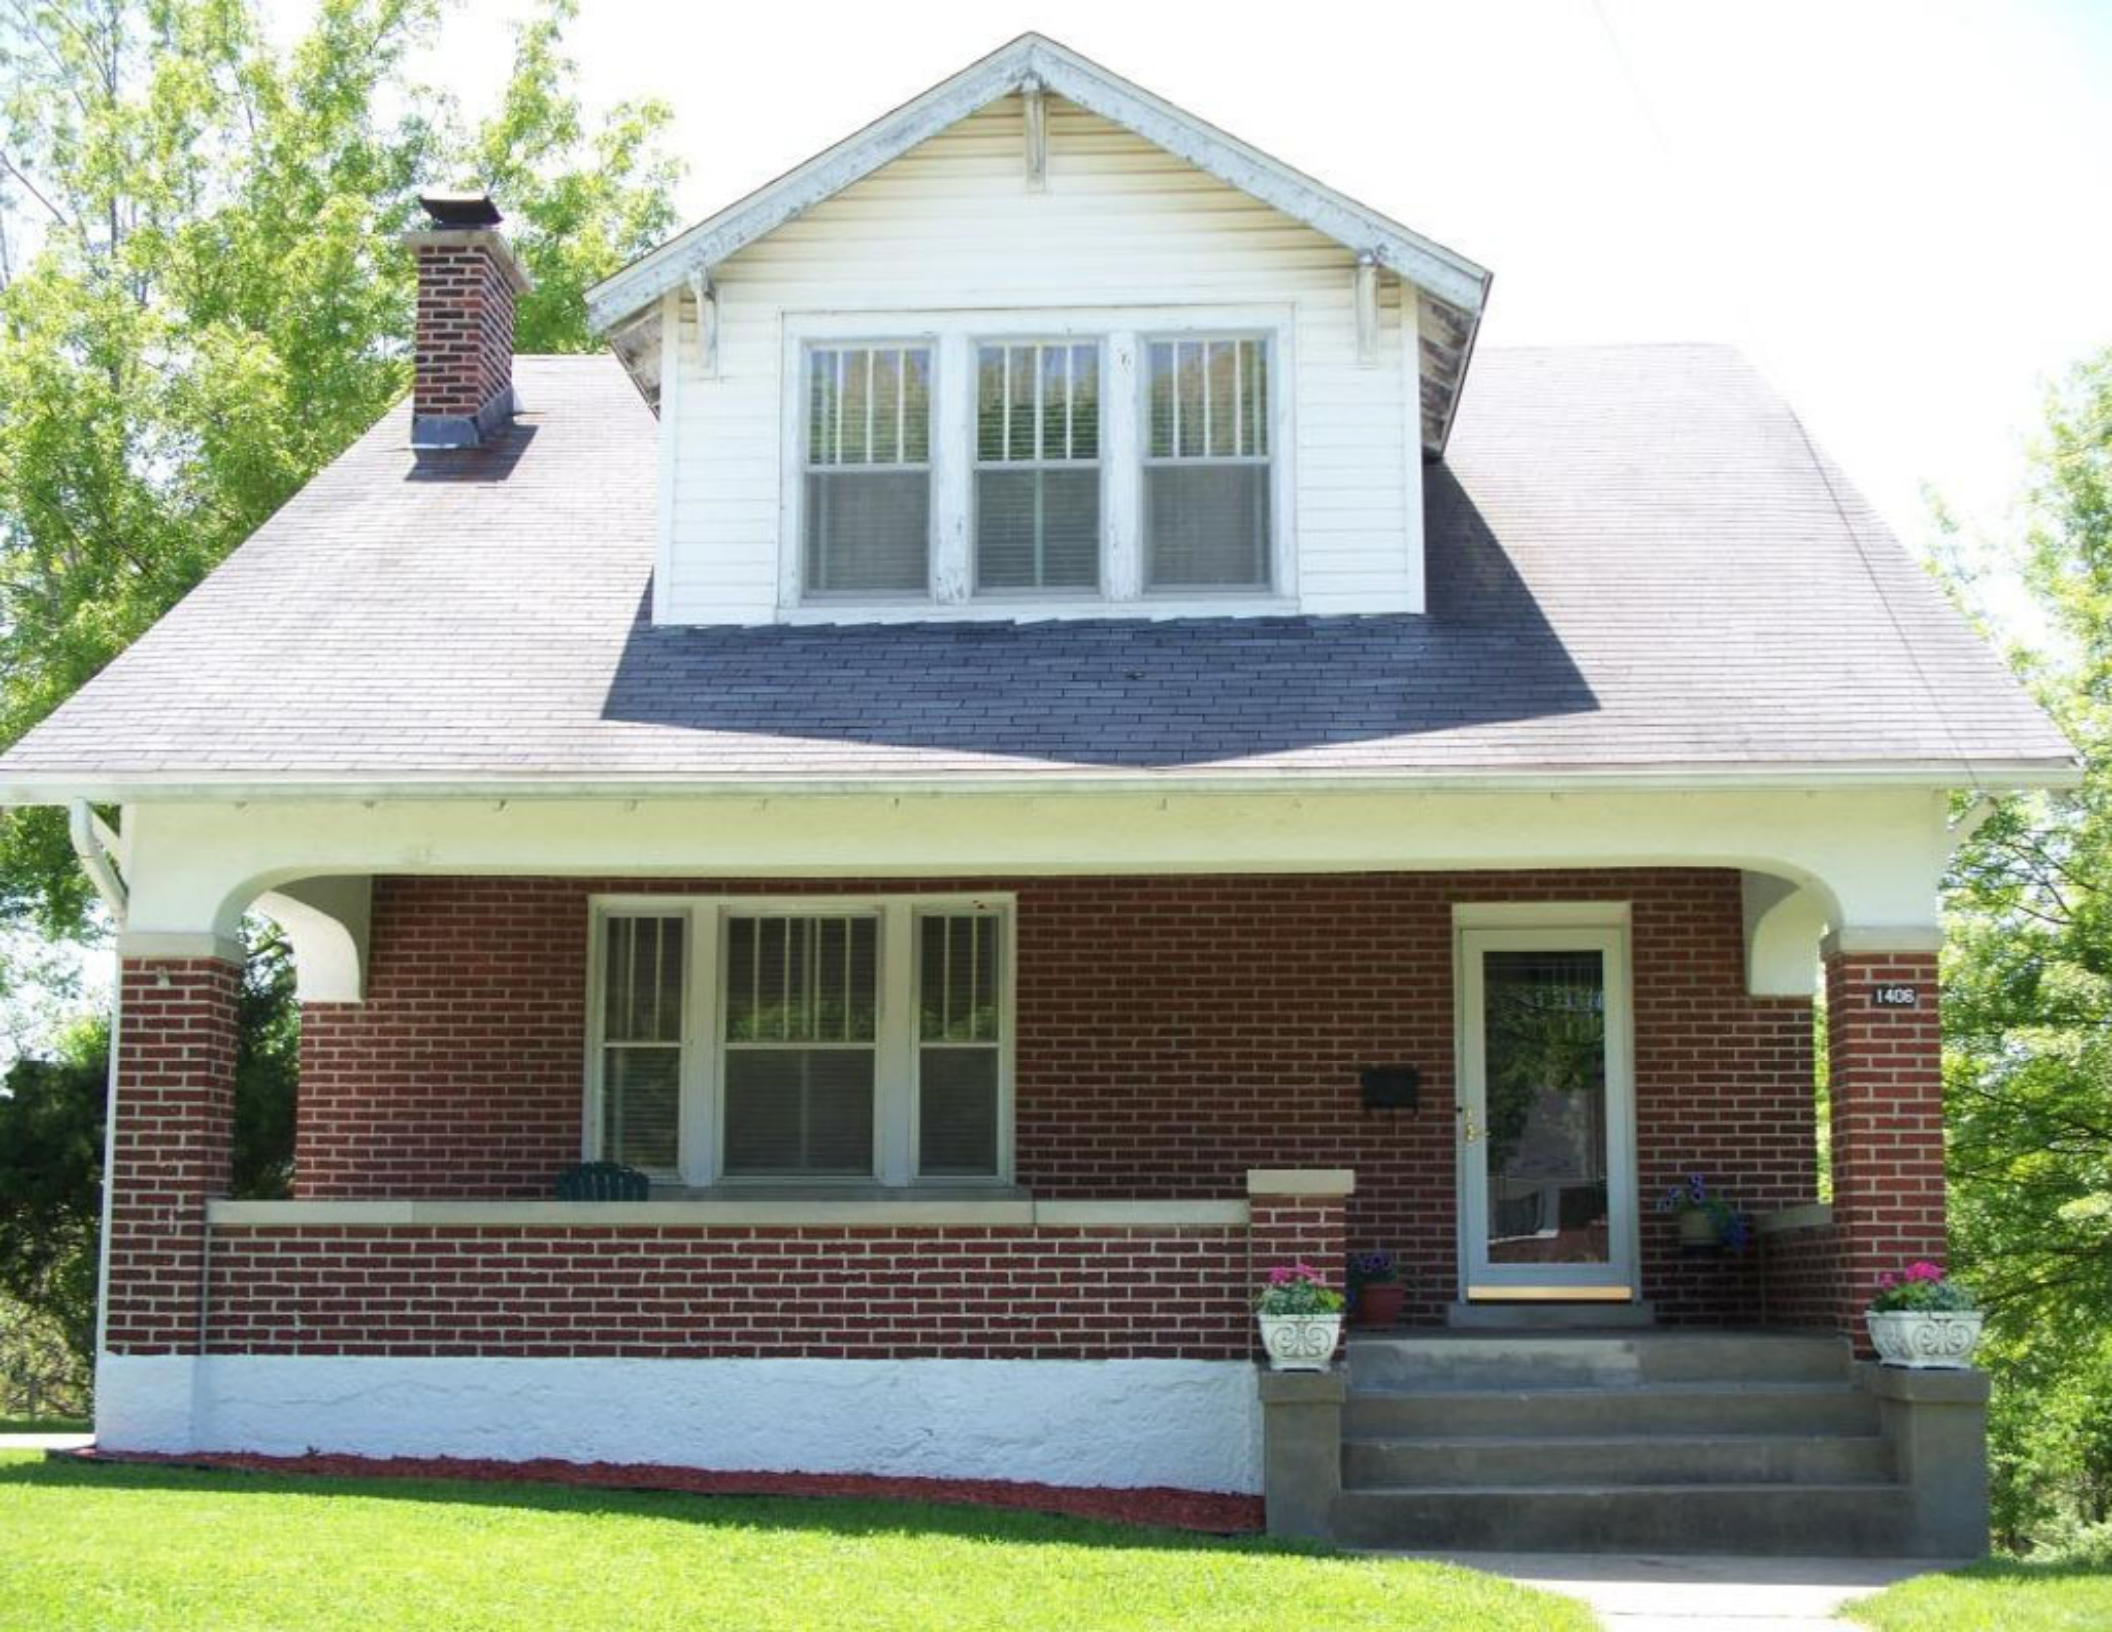
1406

This 1 ½ story brick bungalow has a side gable roof with a larger gable dormer clad in vinyl with brackets and three 4/1 historic windows. The first floor has a full width porch with basket handle entablatures and brick piers and half walls capped in concrete. The left bay contains a historic tri-part window (3/1 flanking 5/1). The right bay contains the entrance which appears to retain its original wooden door. The foundation is parged and comes up to the porch creating a high water table. A pair of concrete steps lead up to the entrance.

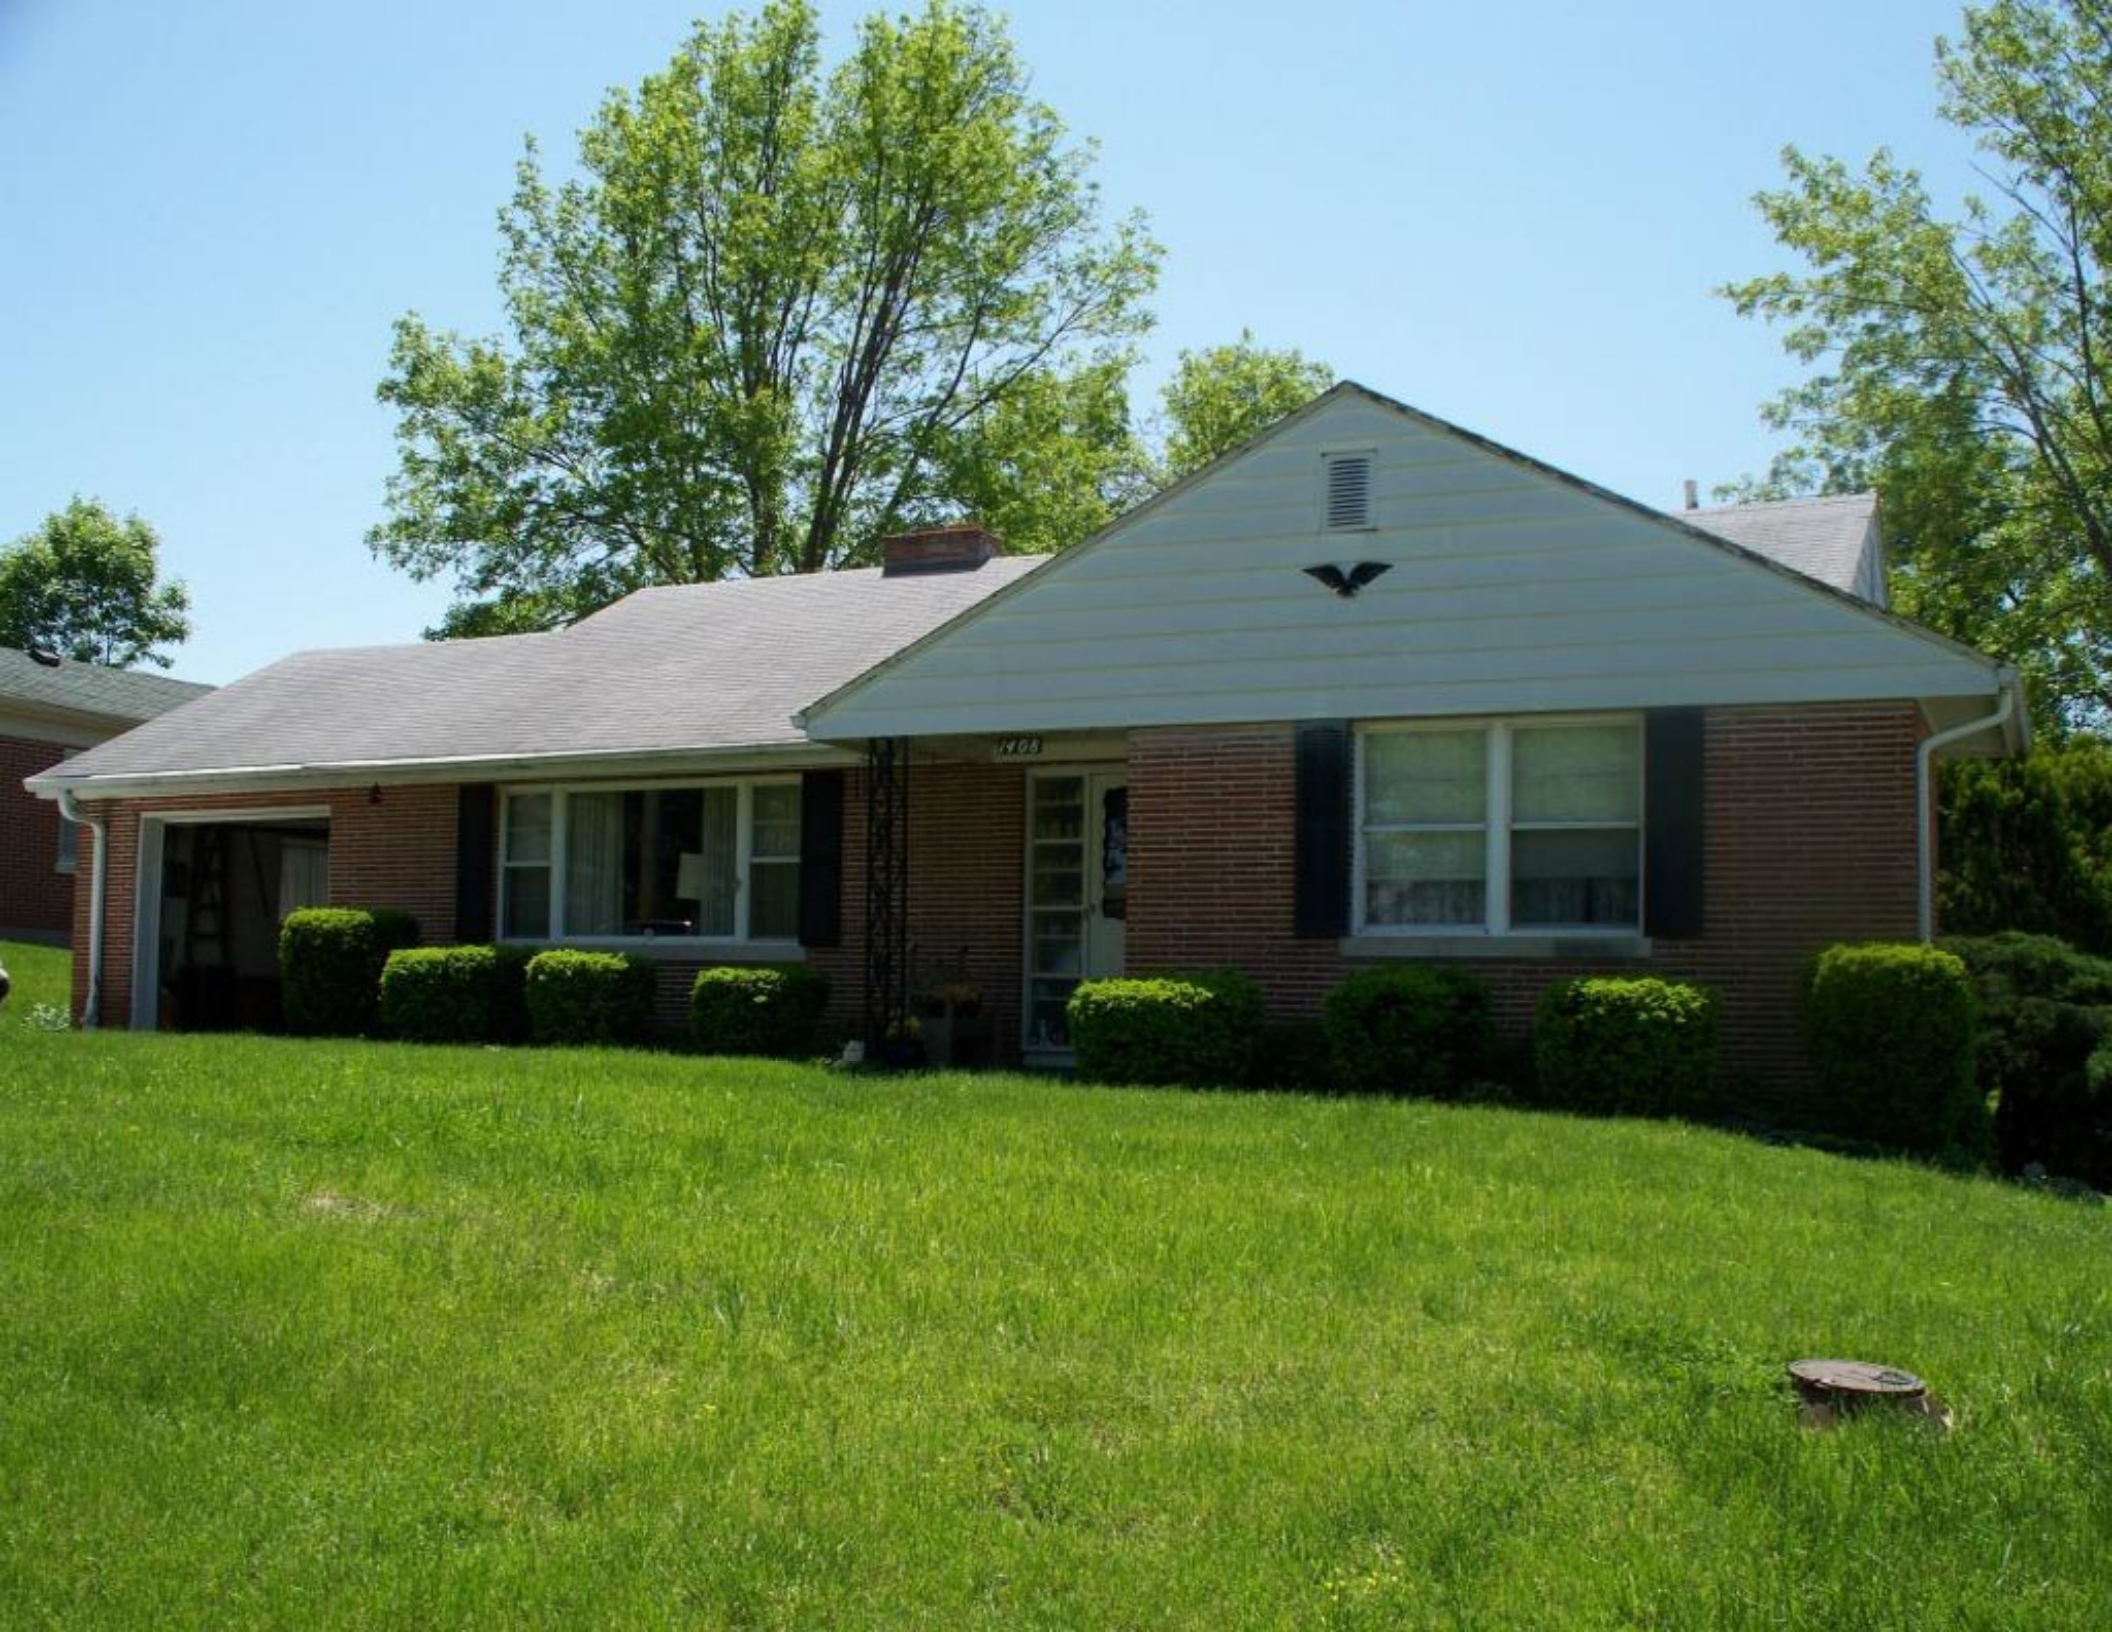
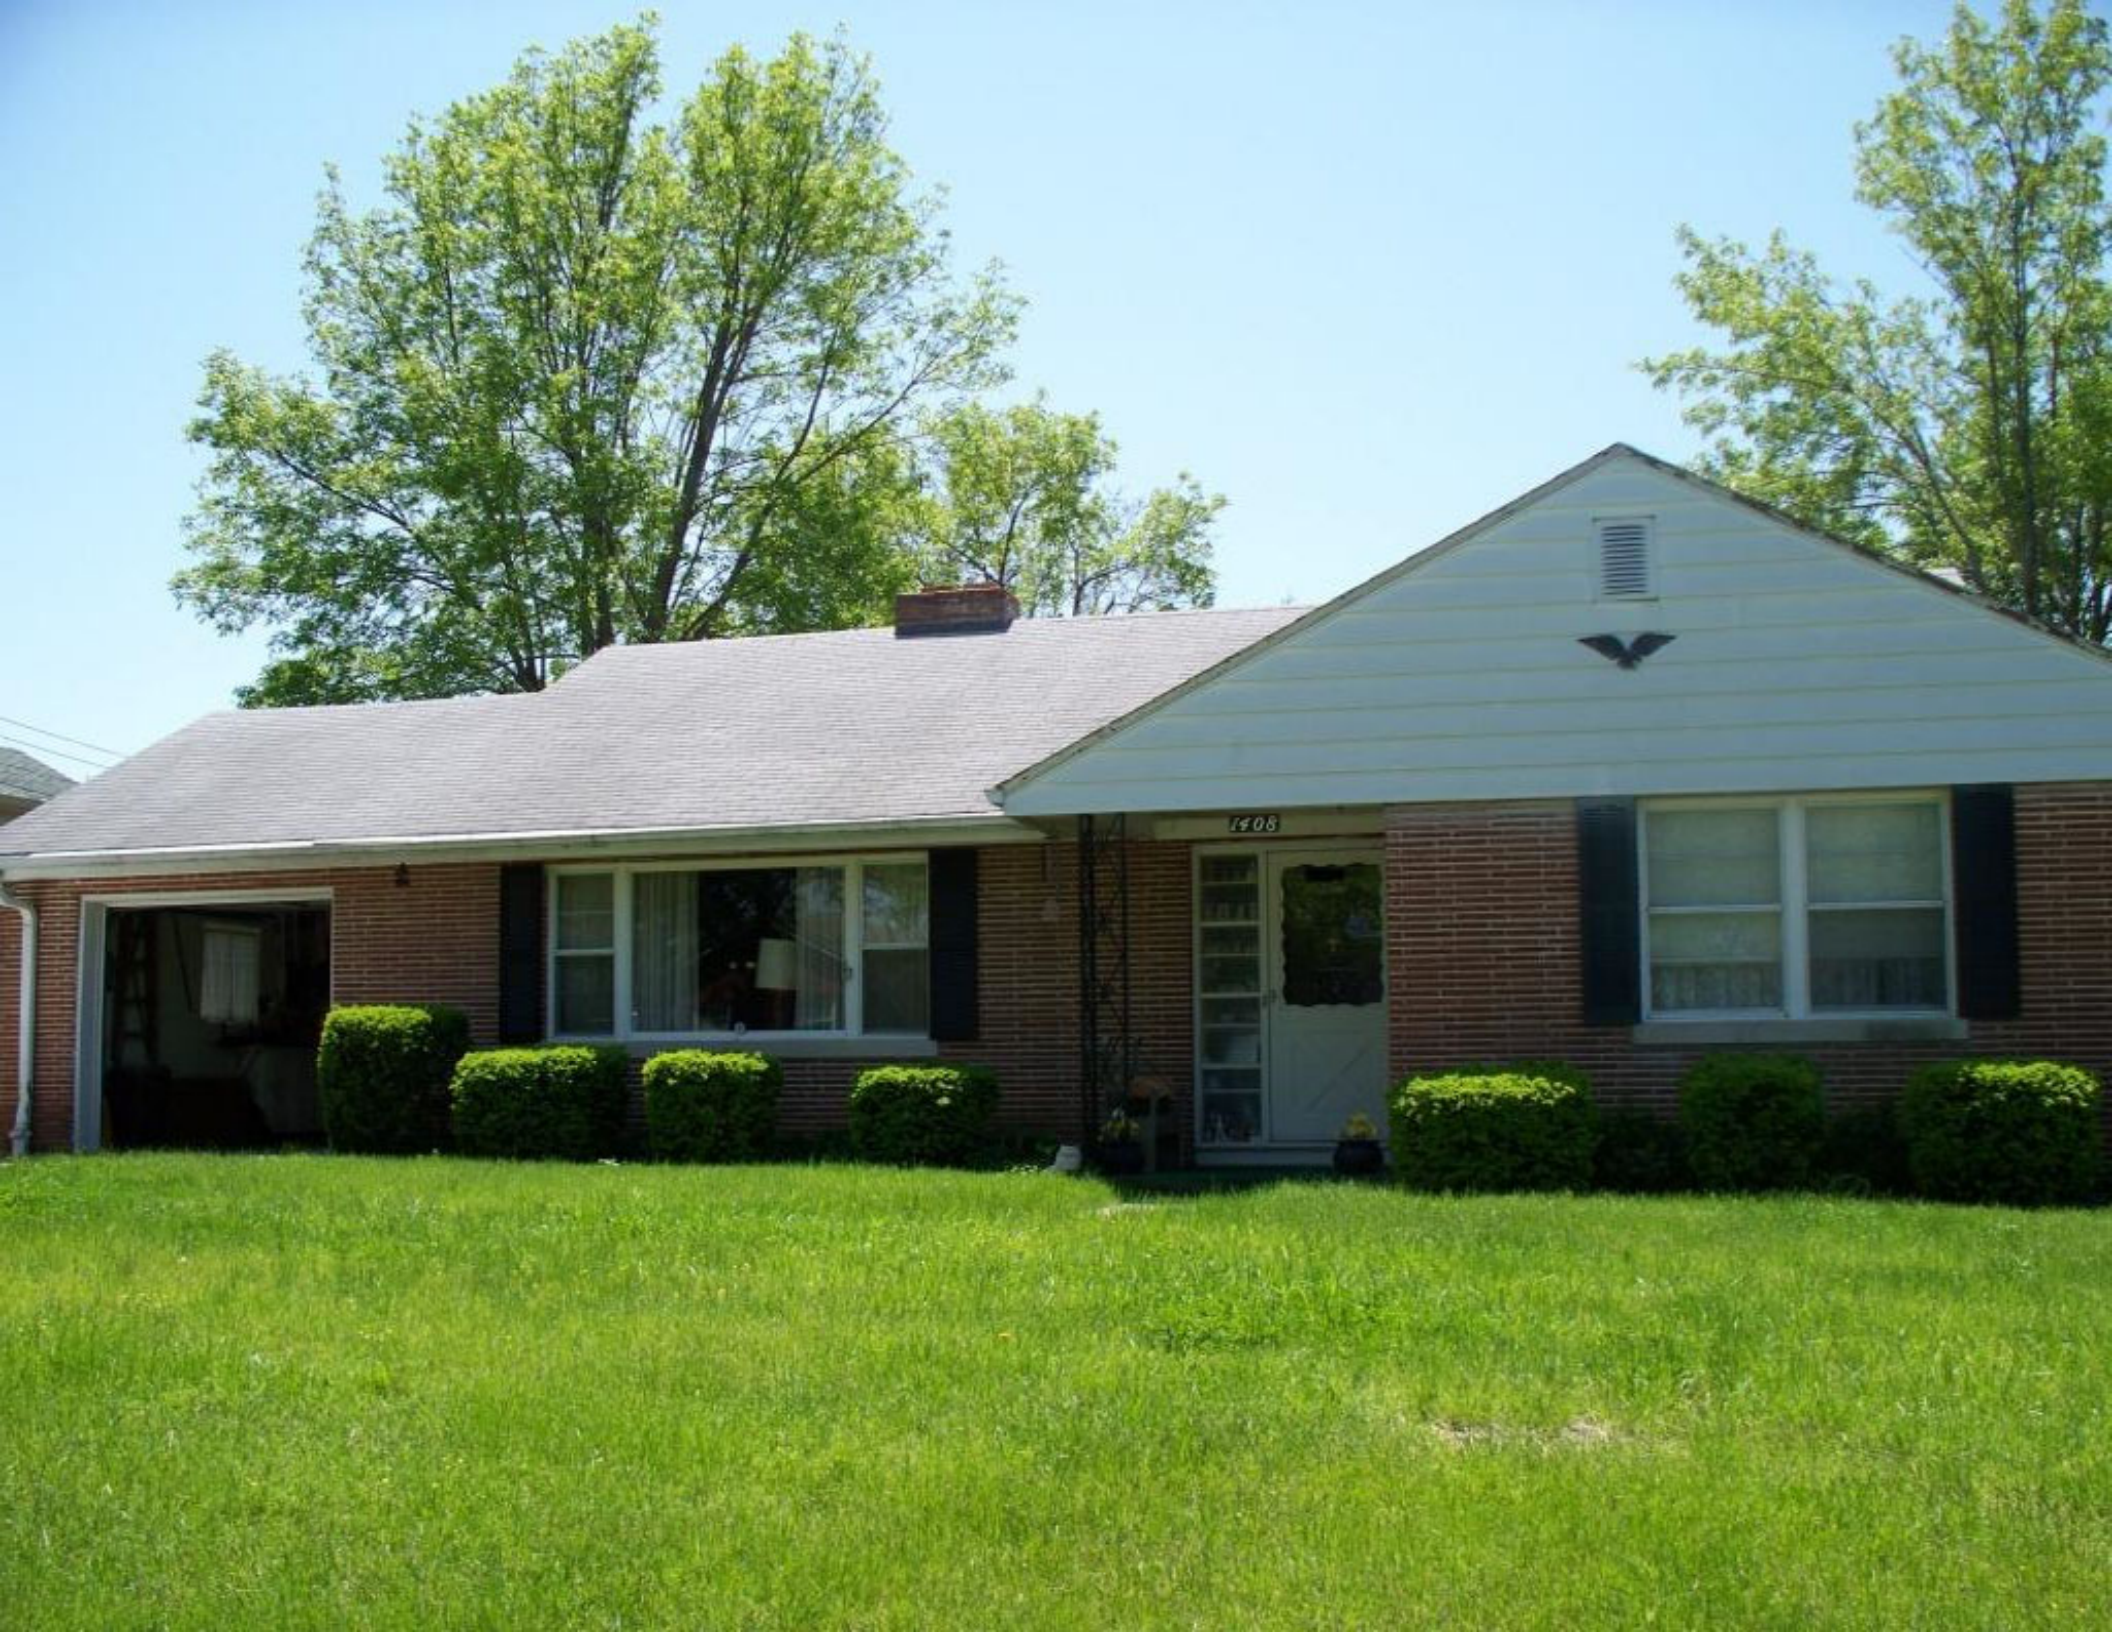
41. (cont.)
This 1 story brick ranch has a cross gable roof. The right bay has a large front gable clad in vinyl and projects from the rest of the home. It contains a vent in the gable peak. Below are paired 1/1 windows with shutters and a concrete sill. To the left is the recessed entrance that appears to retain its original sidelights and door. The next bay to the left contains a large picture window and finally the last bay contains a one car garage.

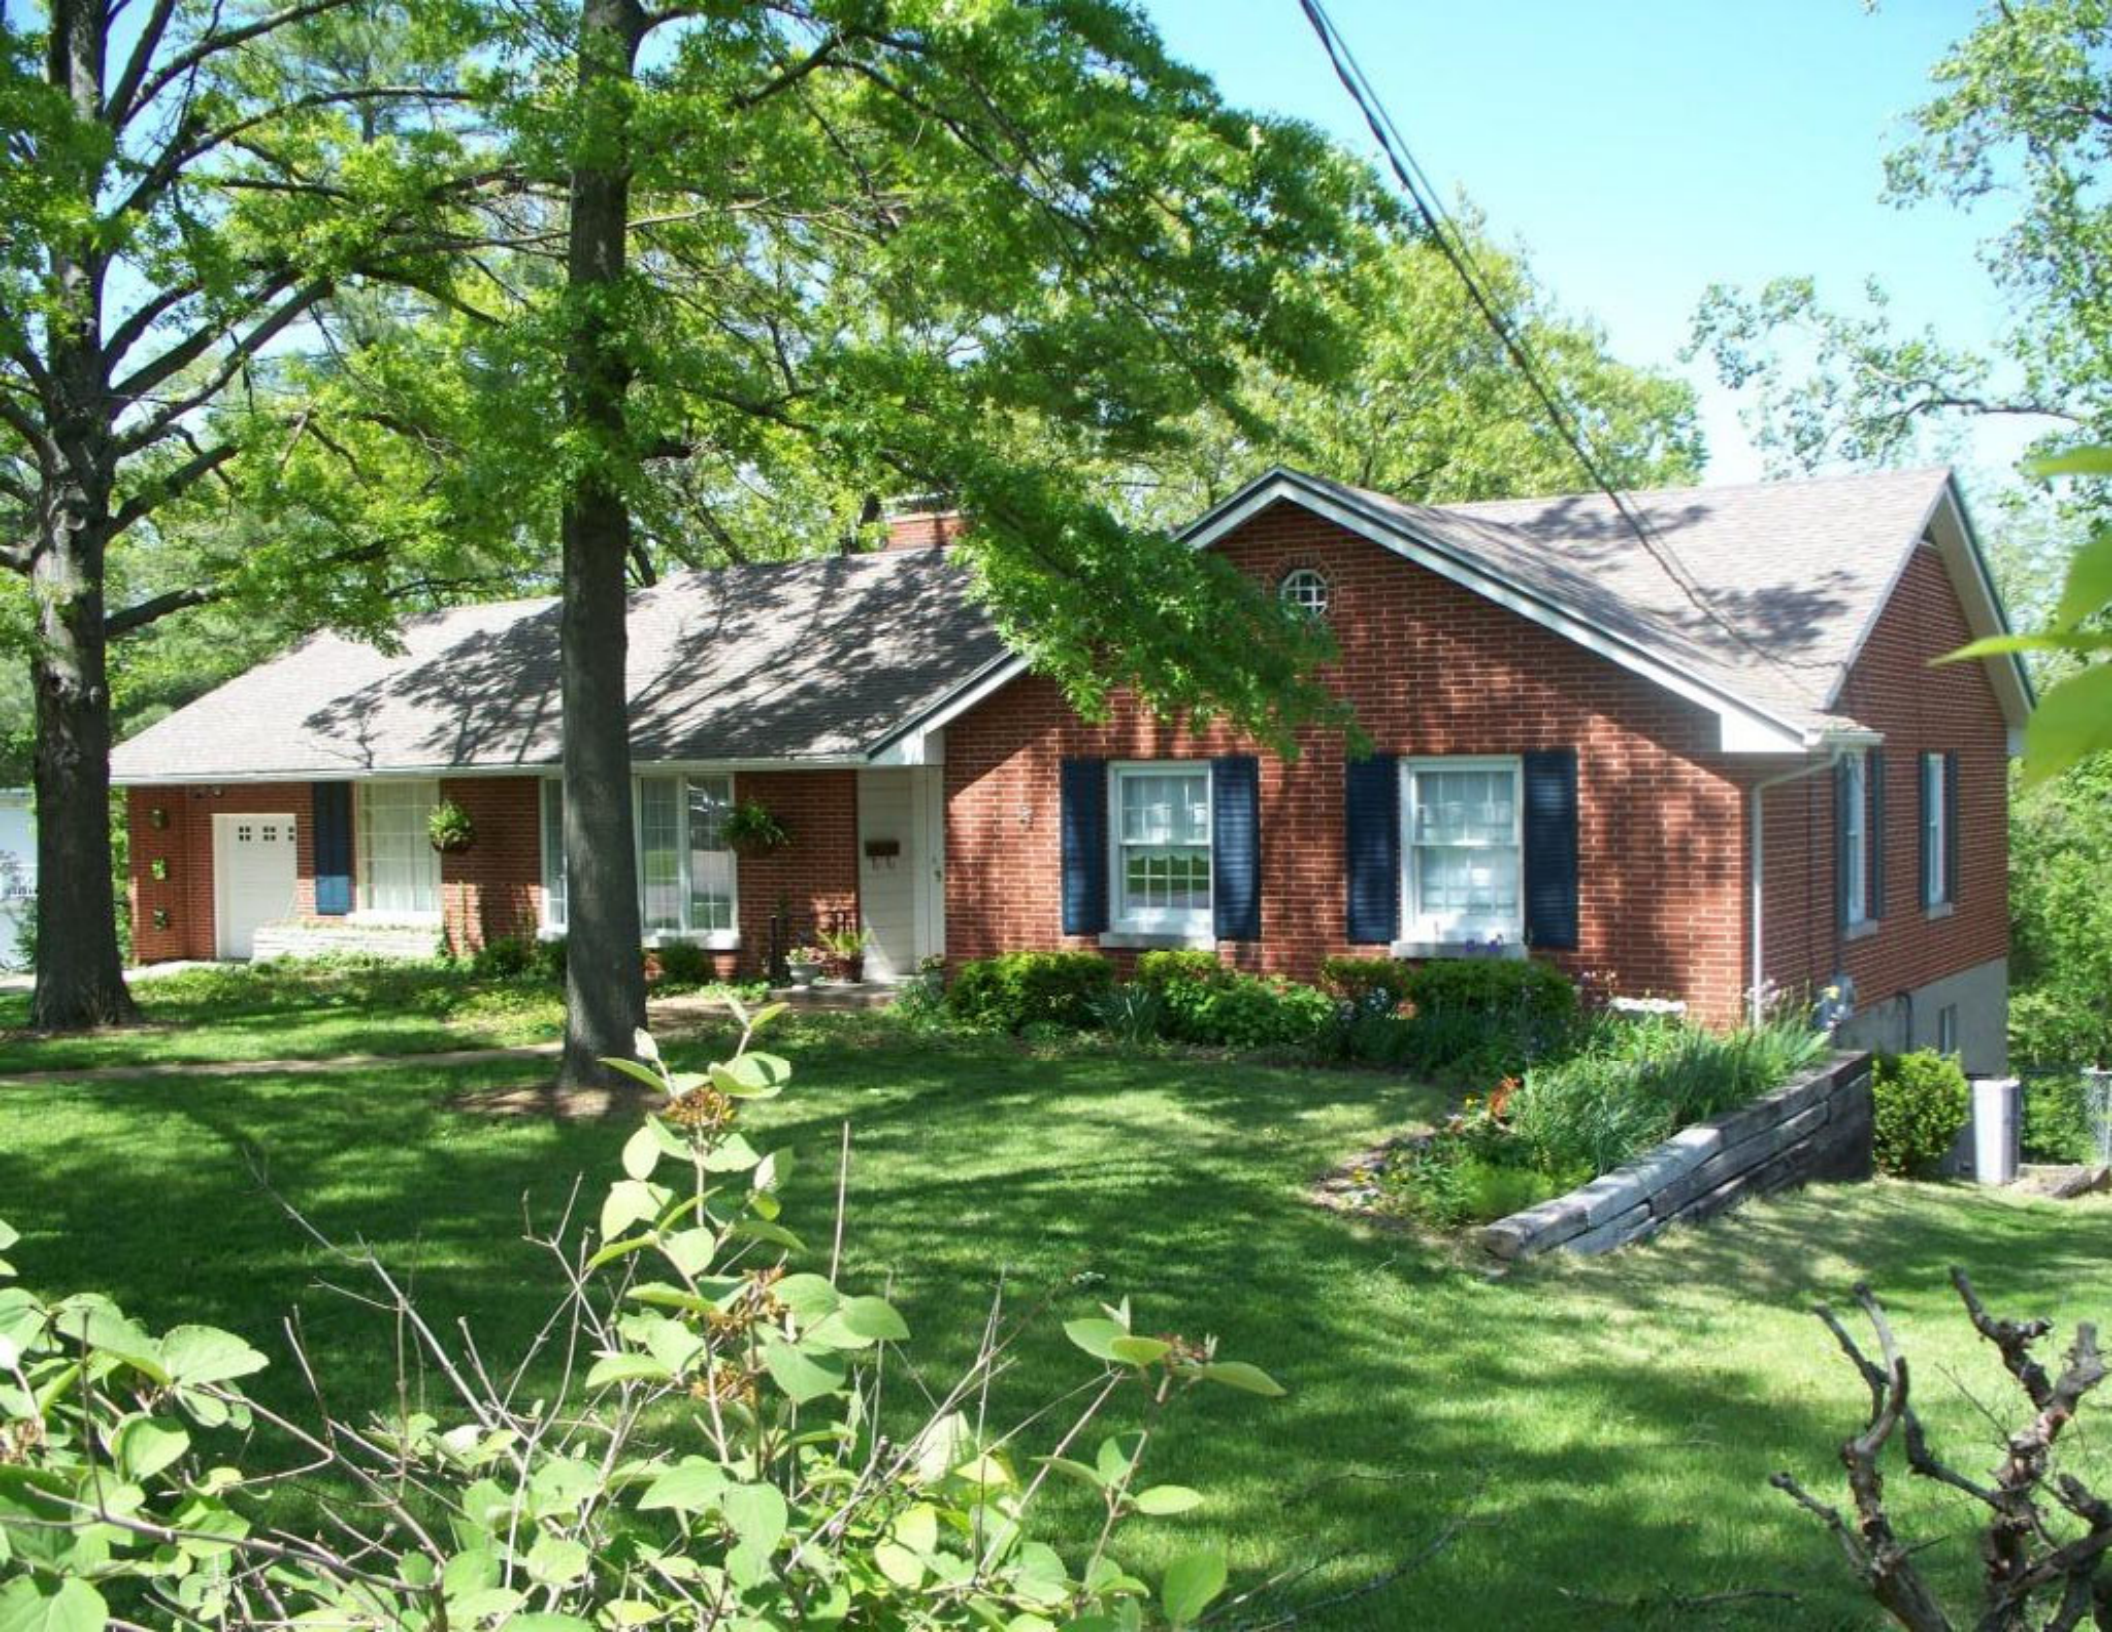
This one story brick ranch has a side gable roof and a front gable over the right two bays. The front gable has a small multi-light oriel window in the gable with decorative brick around it. Below are two 8/8 modern windows with shutters. To the left of this is the recessed entrance, which is clad in wide vinyl siding or some other material (hard to determine), following that is a row of five narrow multi-light casement windows. The next bay contains a large multi-light picture window with shutters and finally there is a one car garage that is slightly recessed. It is capped on the side by a partial brick wall with three square openings.
