ARCHITECTURAL/HISTORIC INVENTORY FORM

1. Survey No. CO-AS-005-001		2. Survey name: Moreau Drive Neighborhood Survey	
3. County: Cole		4. Address: 1202 Elmerine Ave.	
5. City: Jefferson City	Vicinity: <input type="checkbox"/>	6. UTM: / /	7. Township/Range/Section: T: R: S:
8. Historic name (if known):		9. Present/other name (if known):	
10. Ownership: <input checked="" type="checkbox"/> Private <input type="checkbox"/> Public		11. Historic use (if known): Residential	11. Current use: Residential

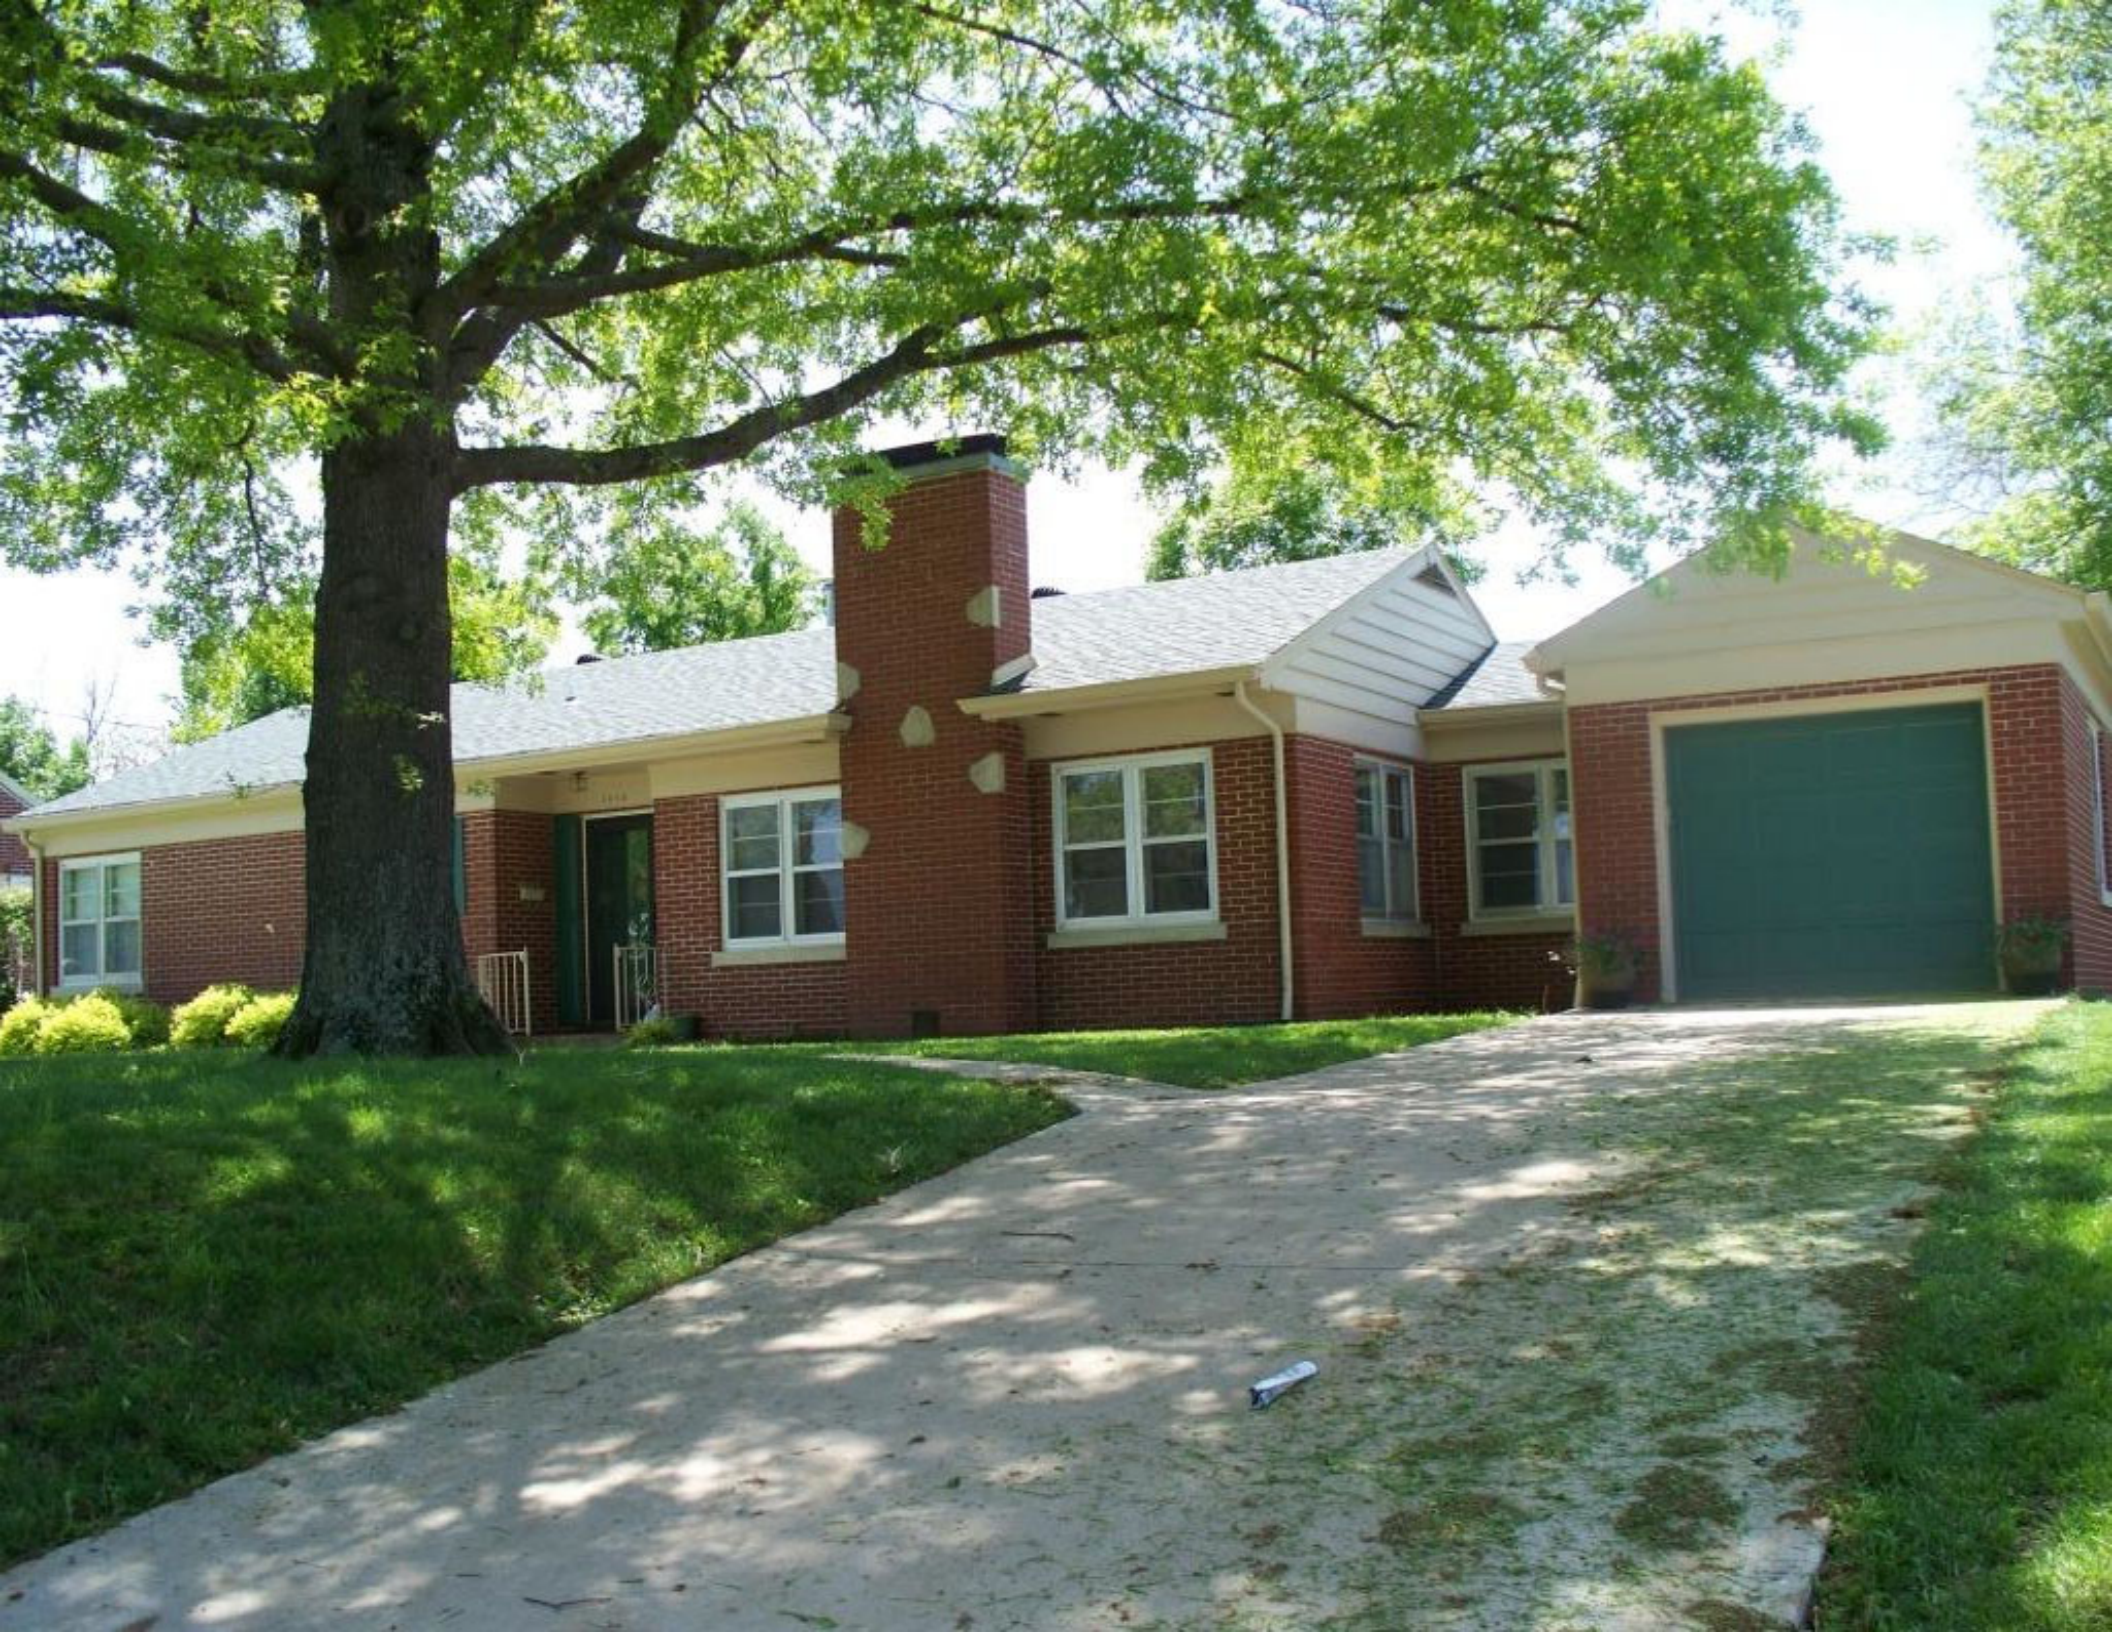
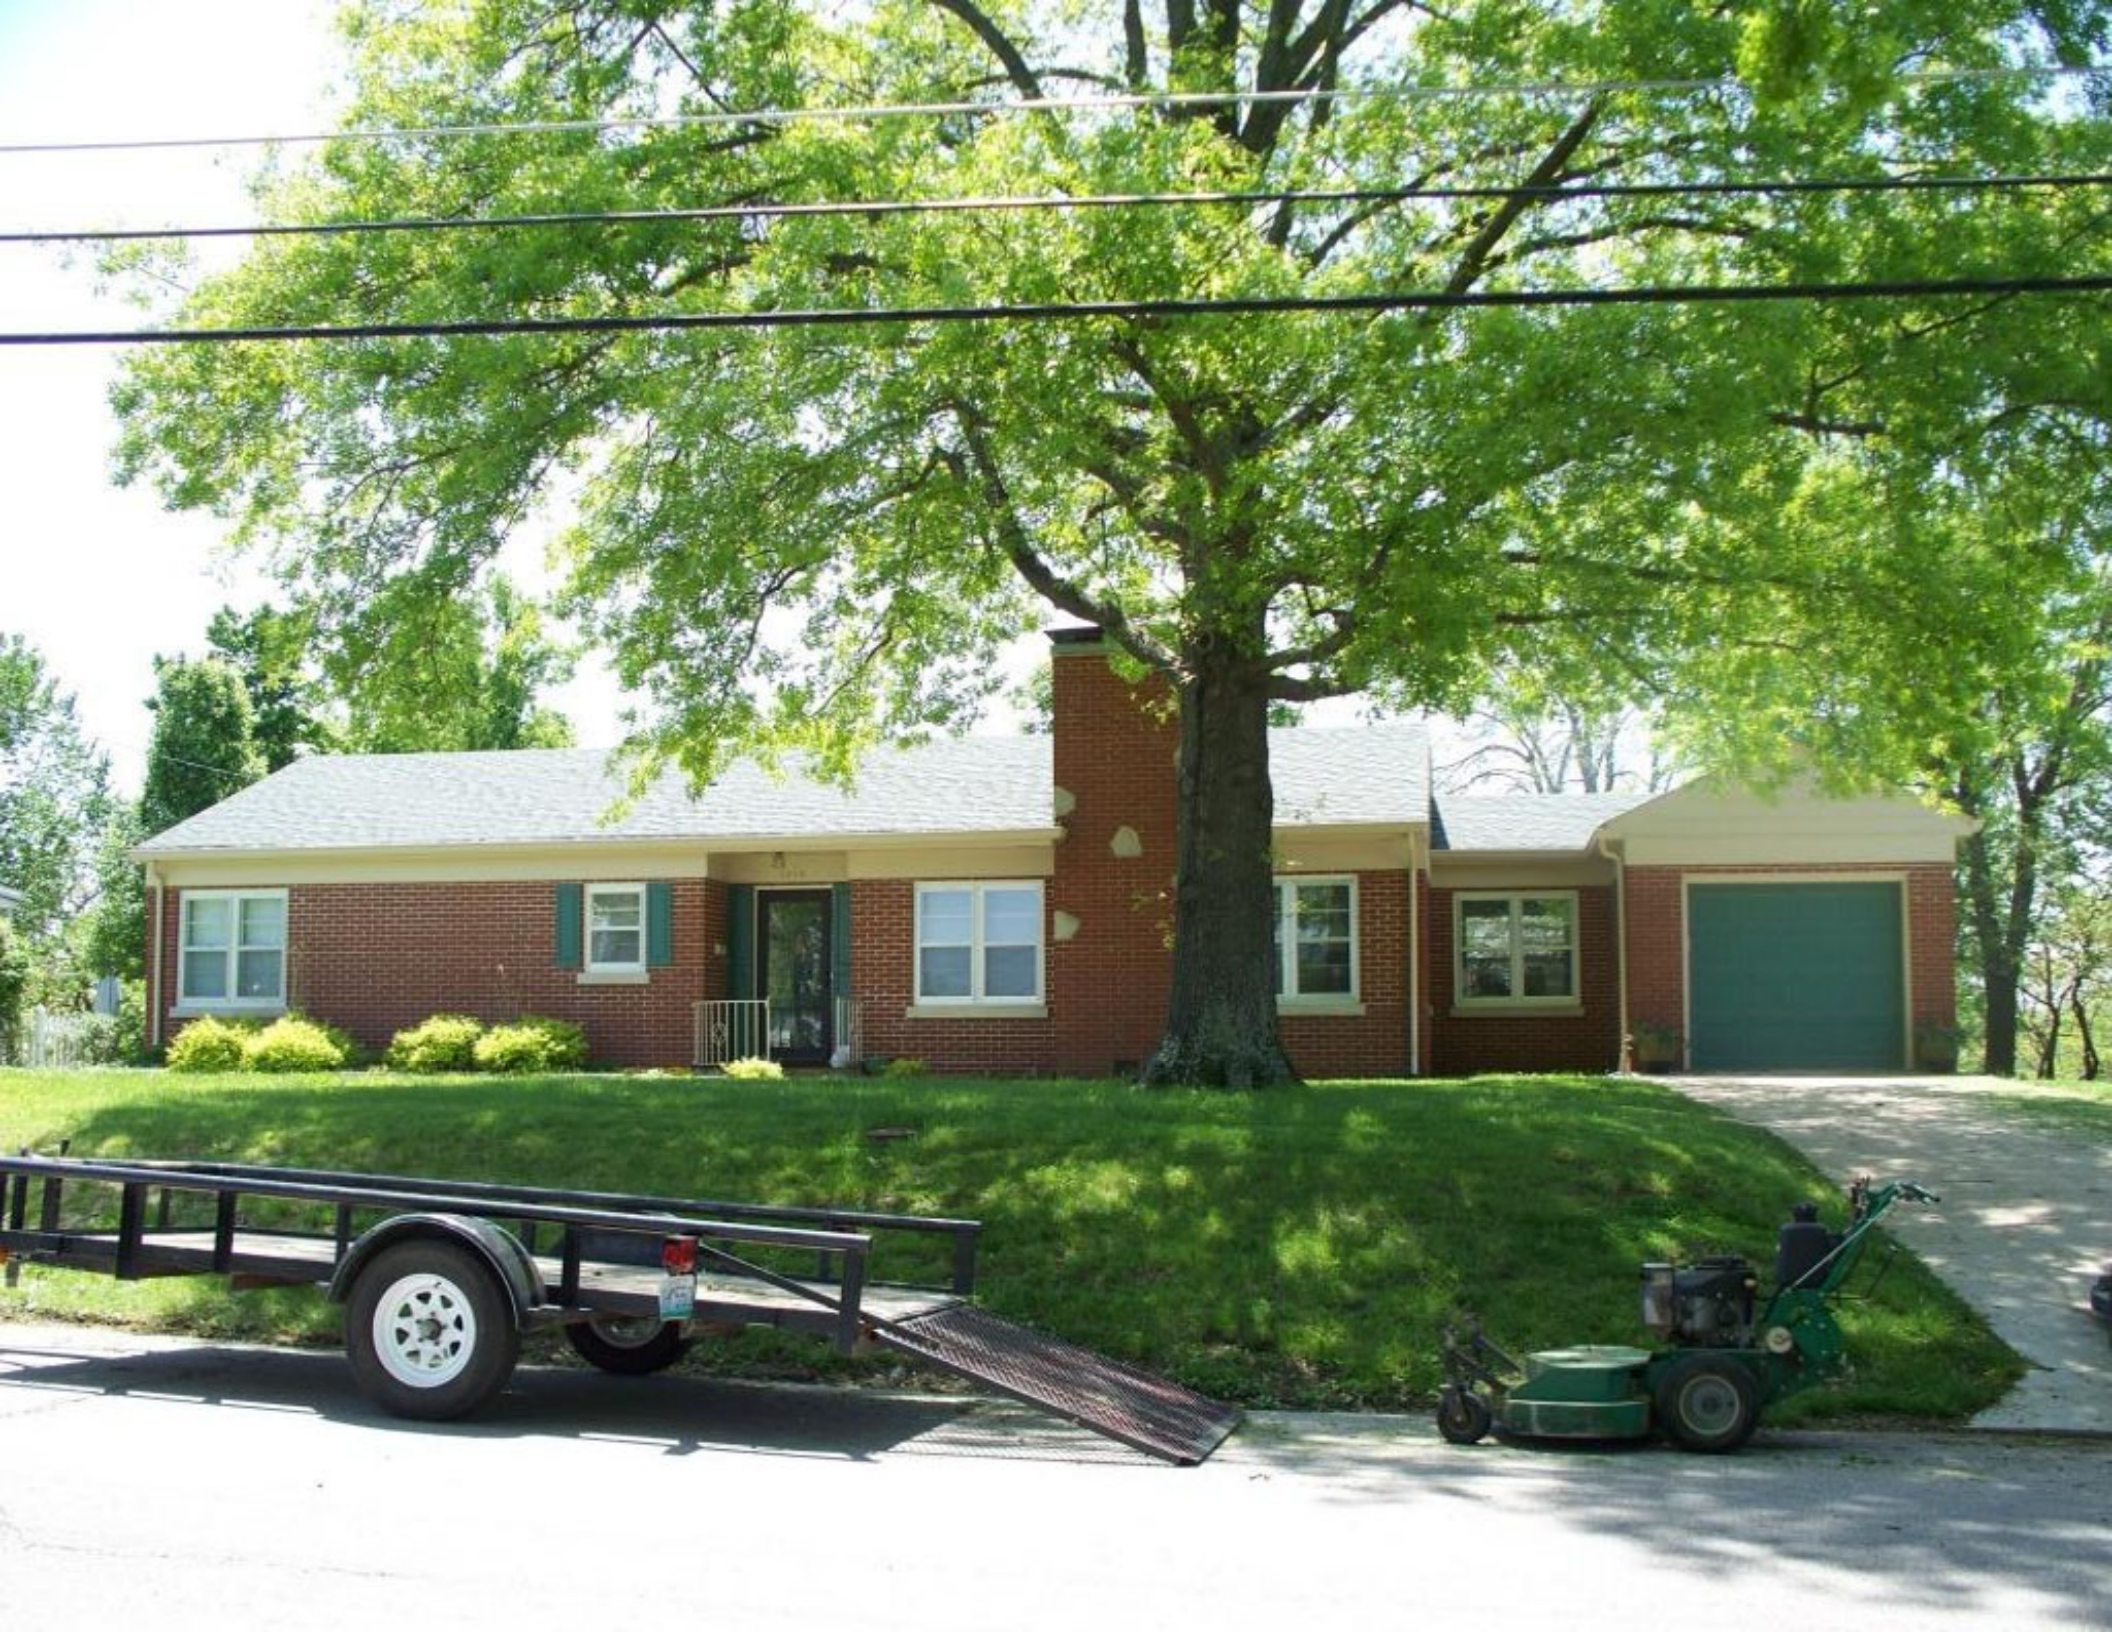
41. (cont.)
This 1 story brick ranch has a side gable roof with a large chimney on the exterior of the building's main façade (offset right) piercing through the roofline. It is brick with stone detailing (five randomly dispersed stones). The property has 1/1 windows (a smaller one with shutters in the second bay from the left). The entrance is in the center bay which is recessed. Attached and set back is a brick breeze way that leads to the one car front gable brick garage.

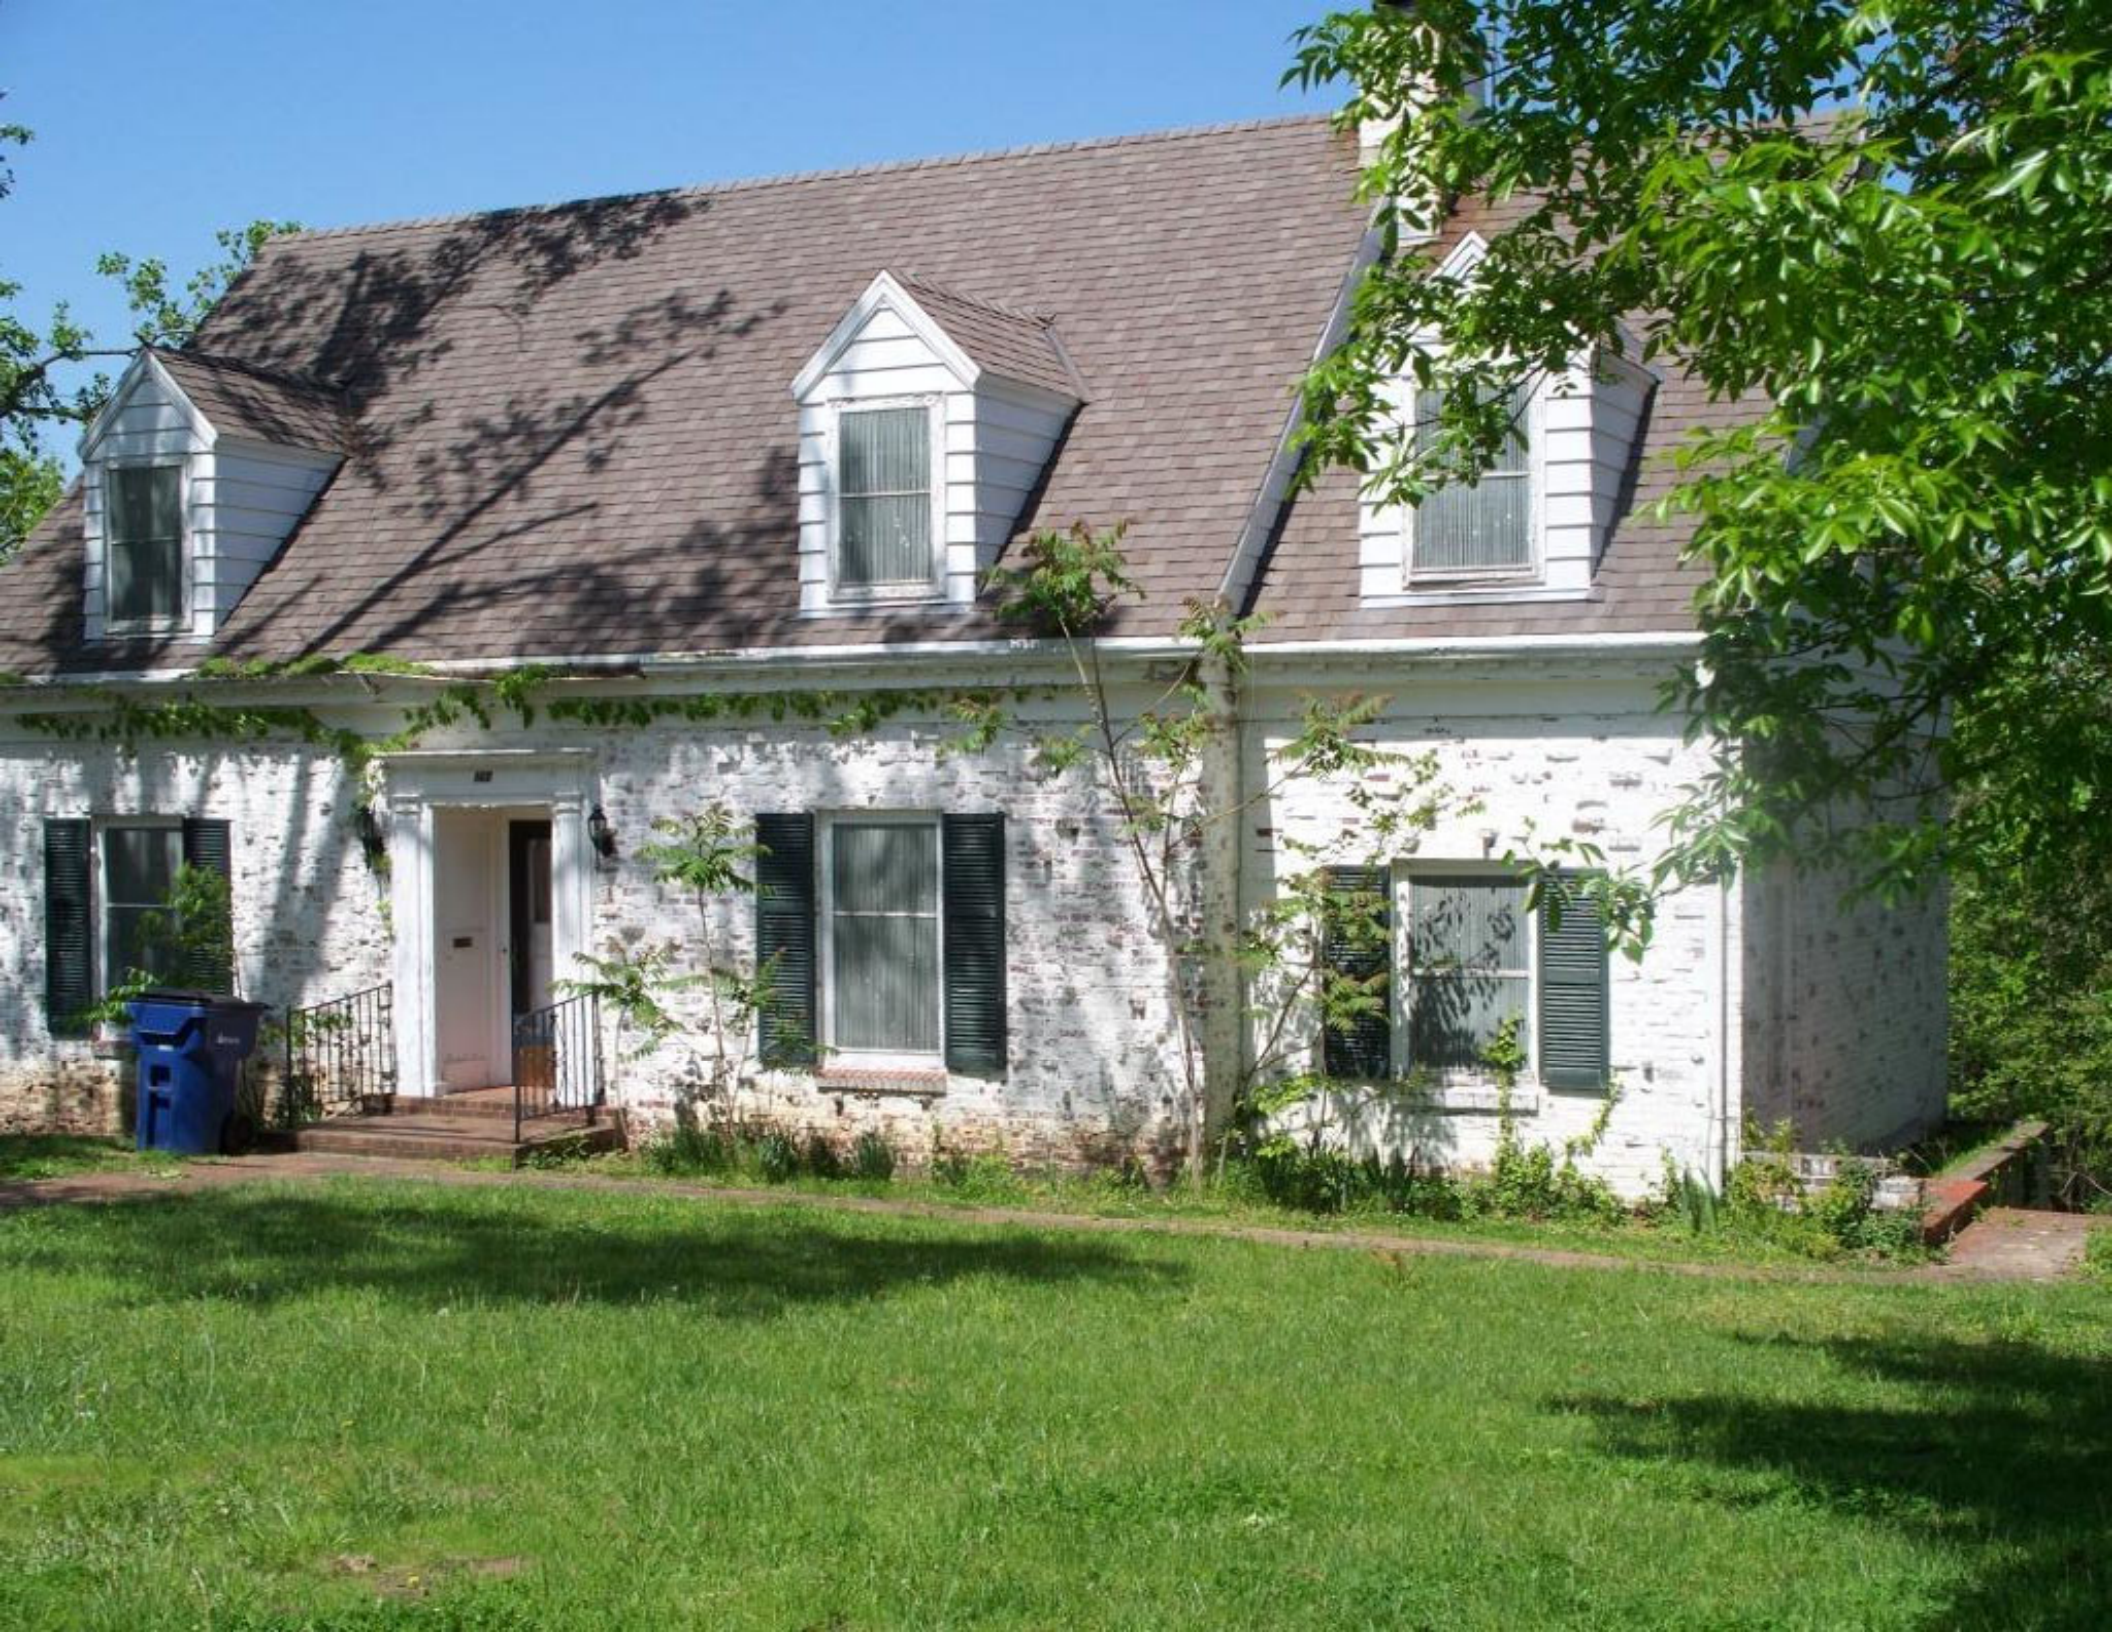
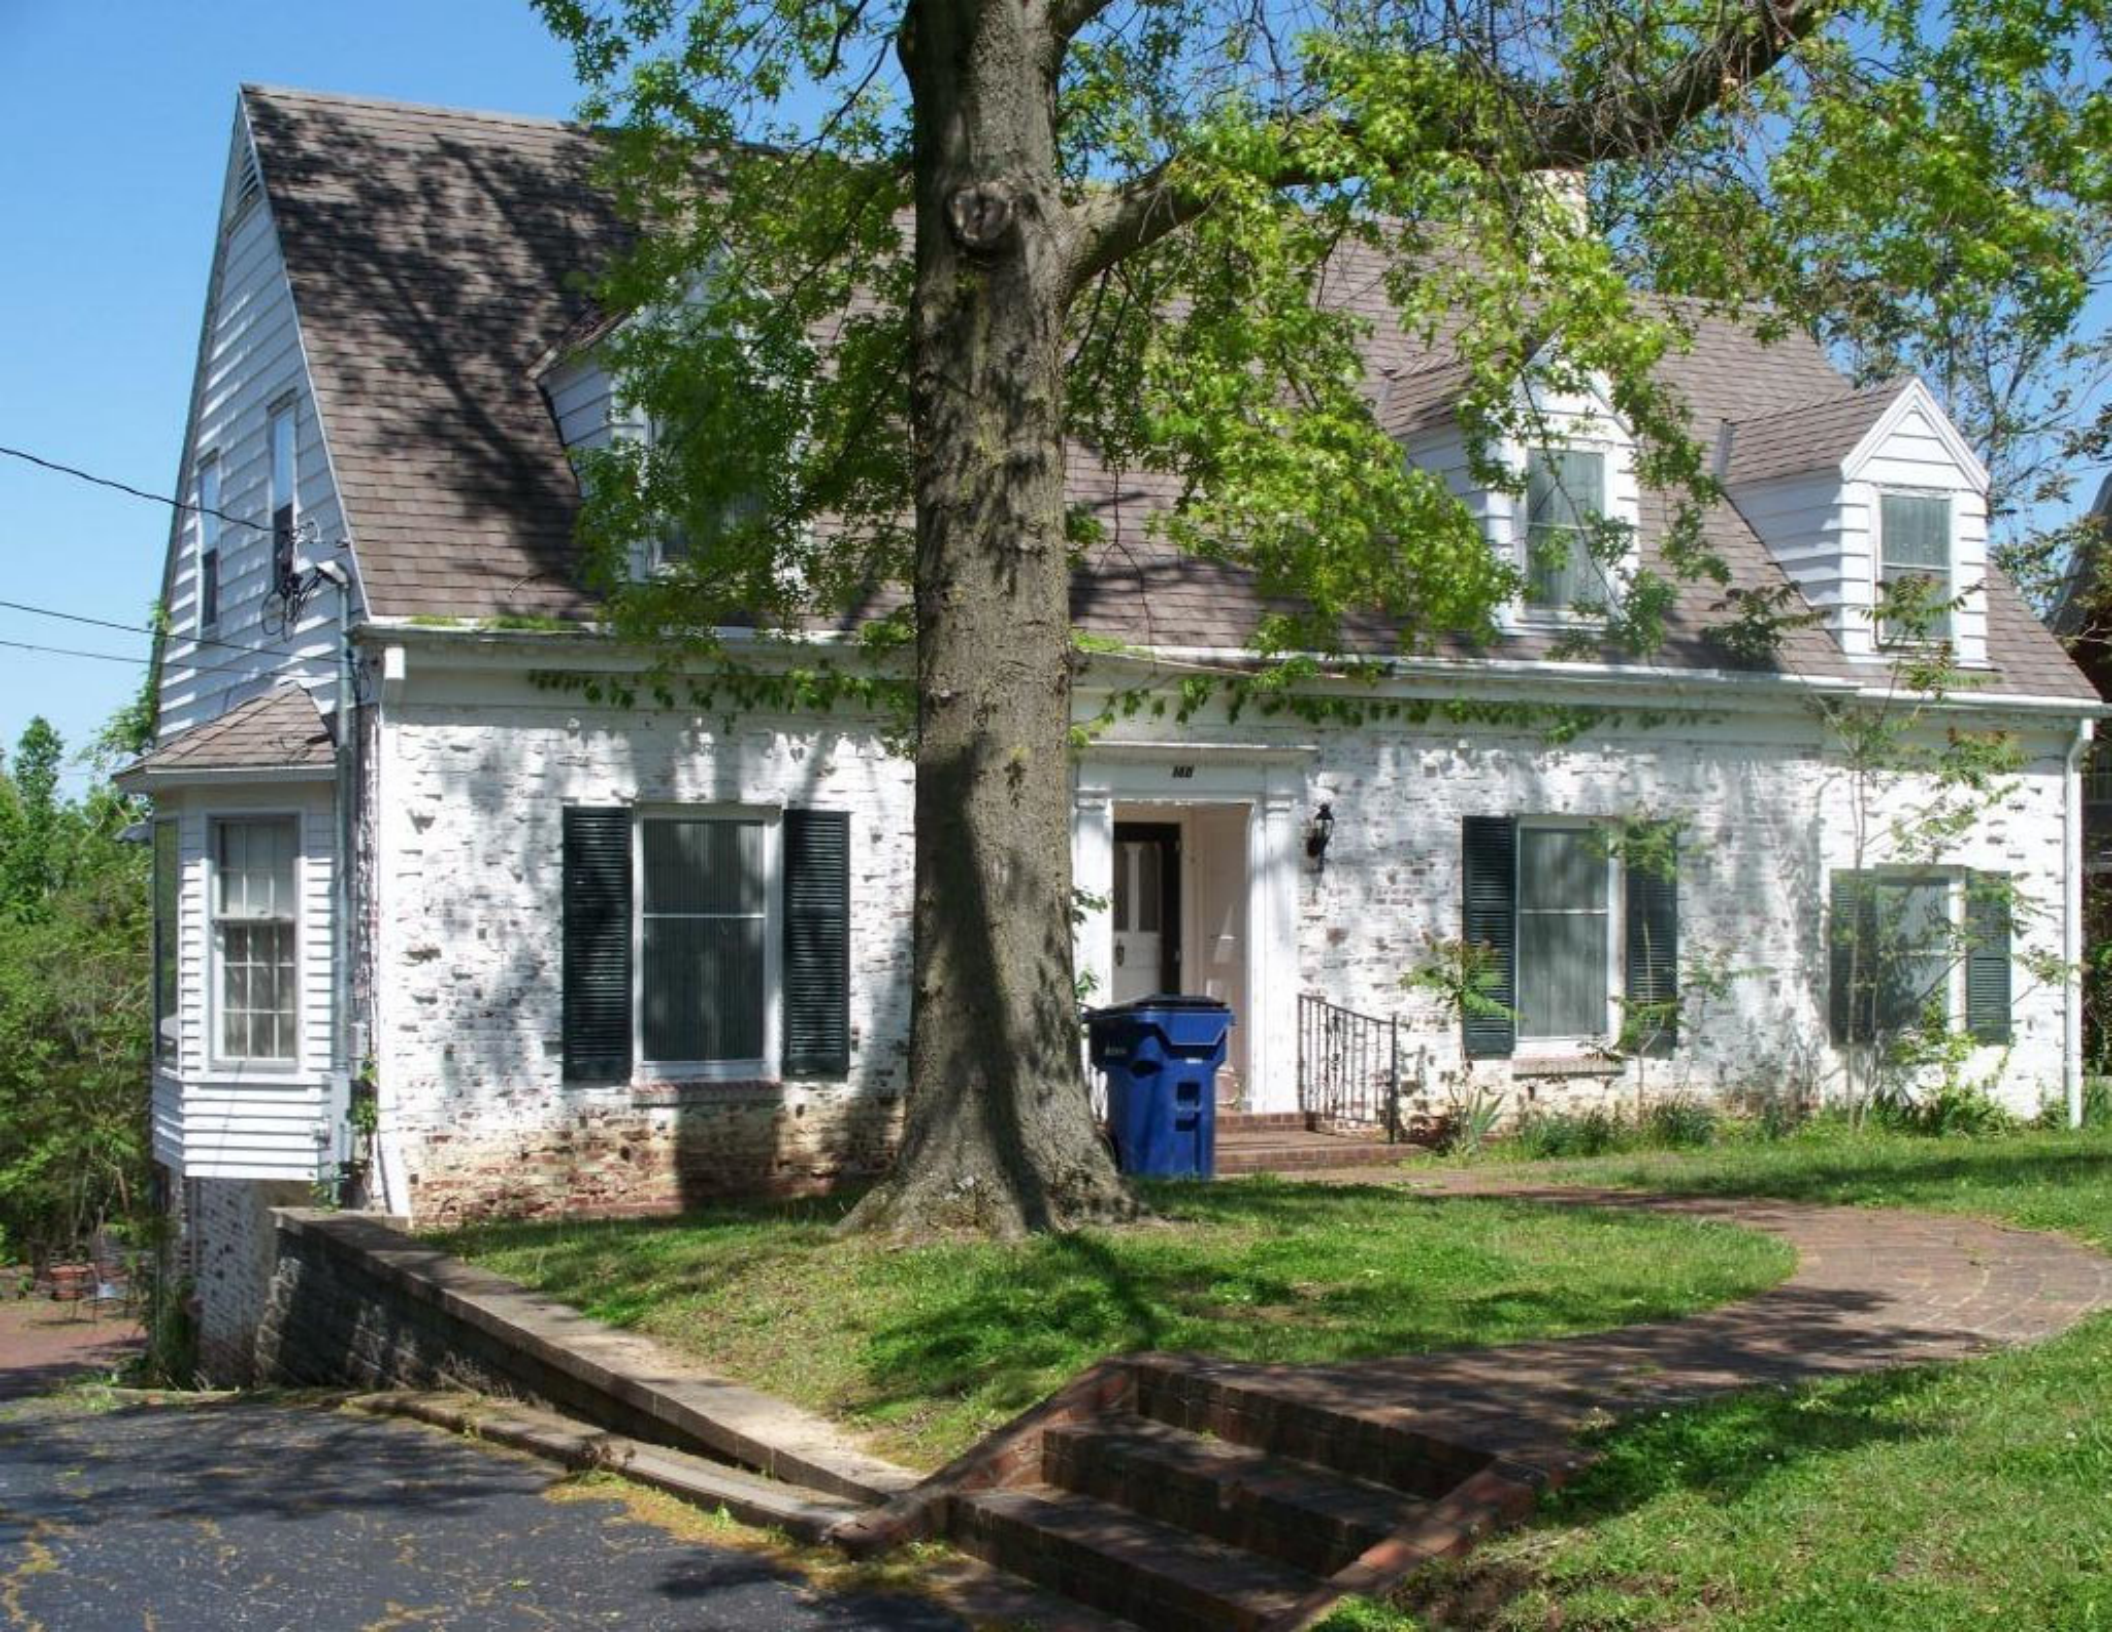
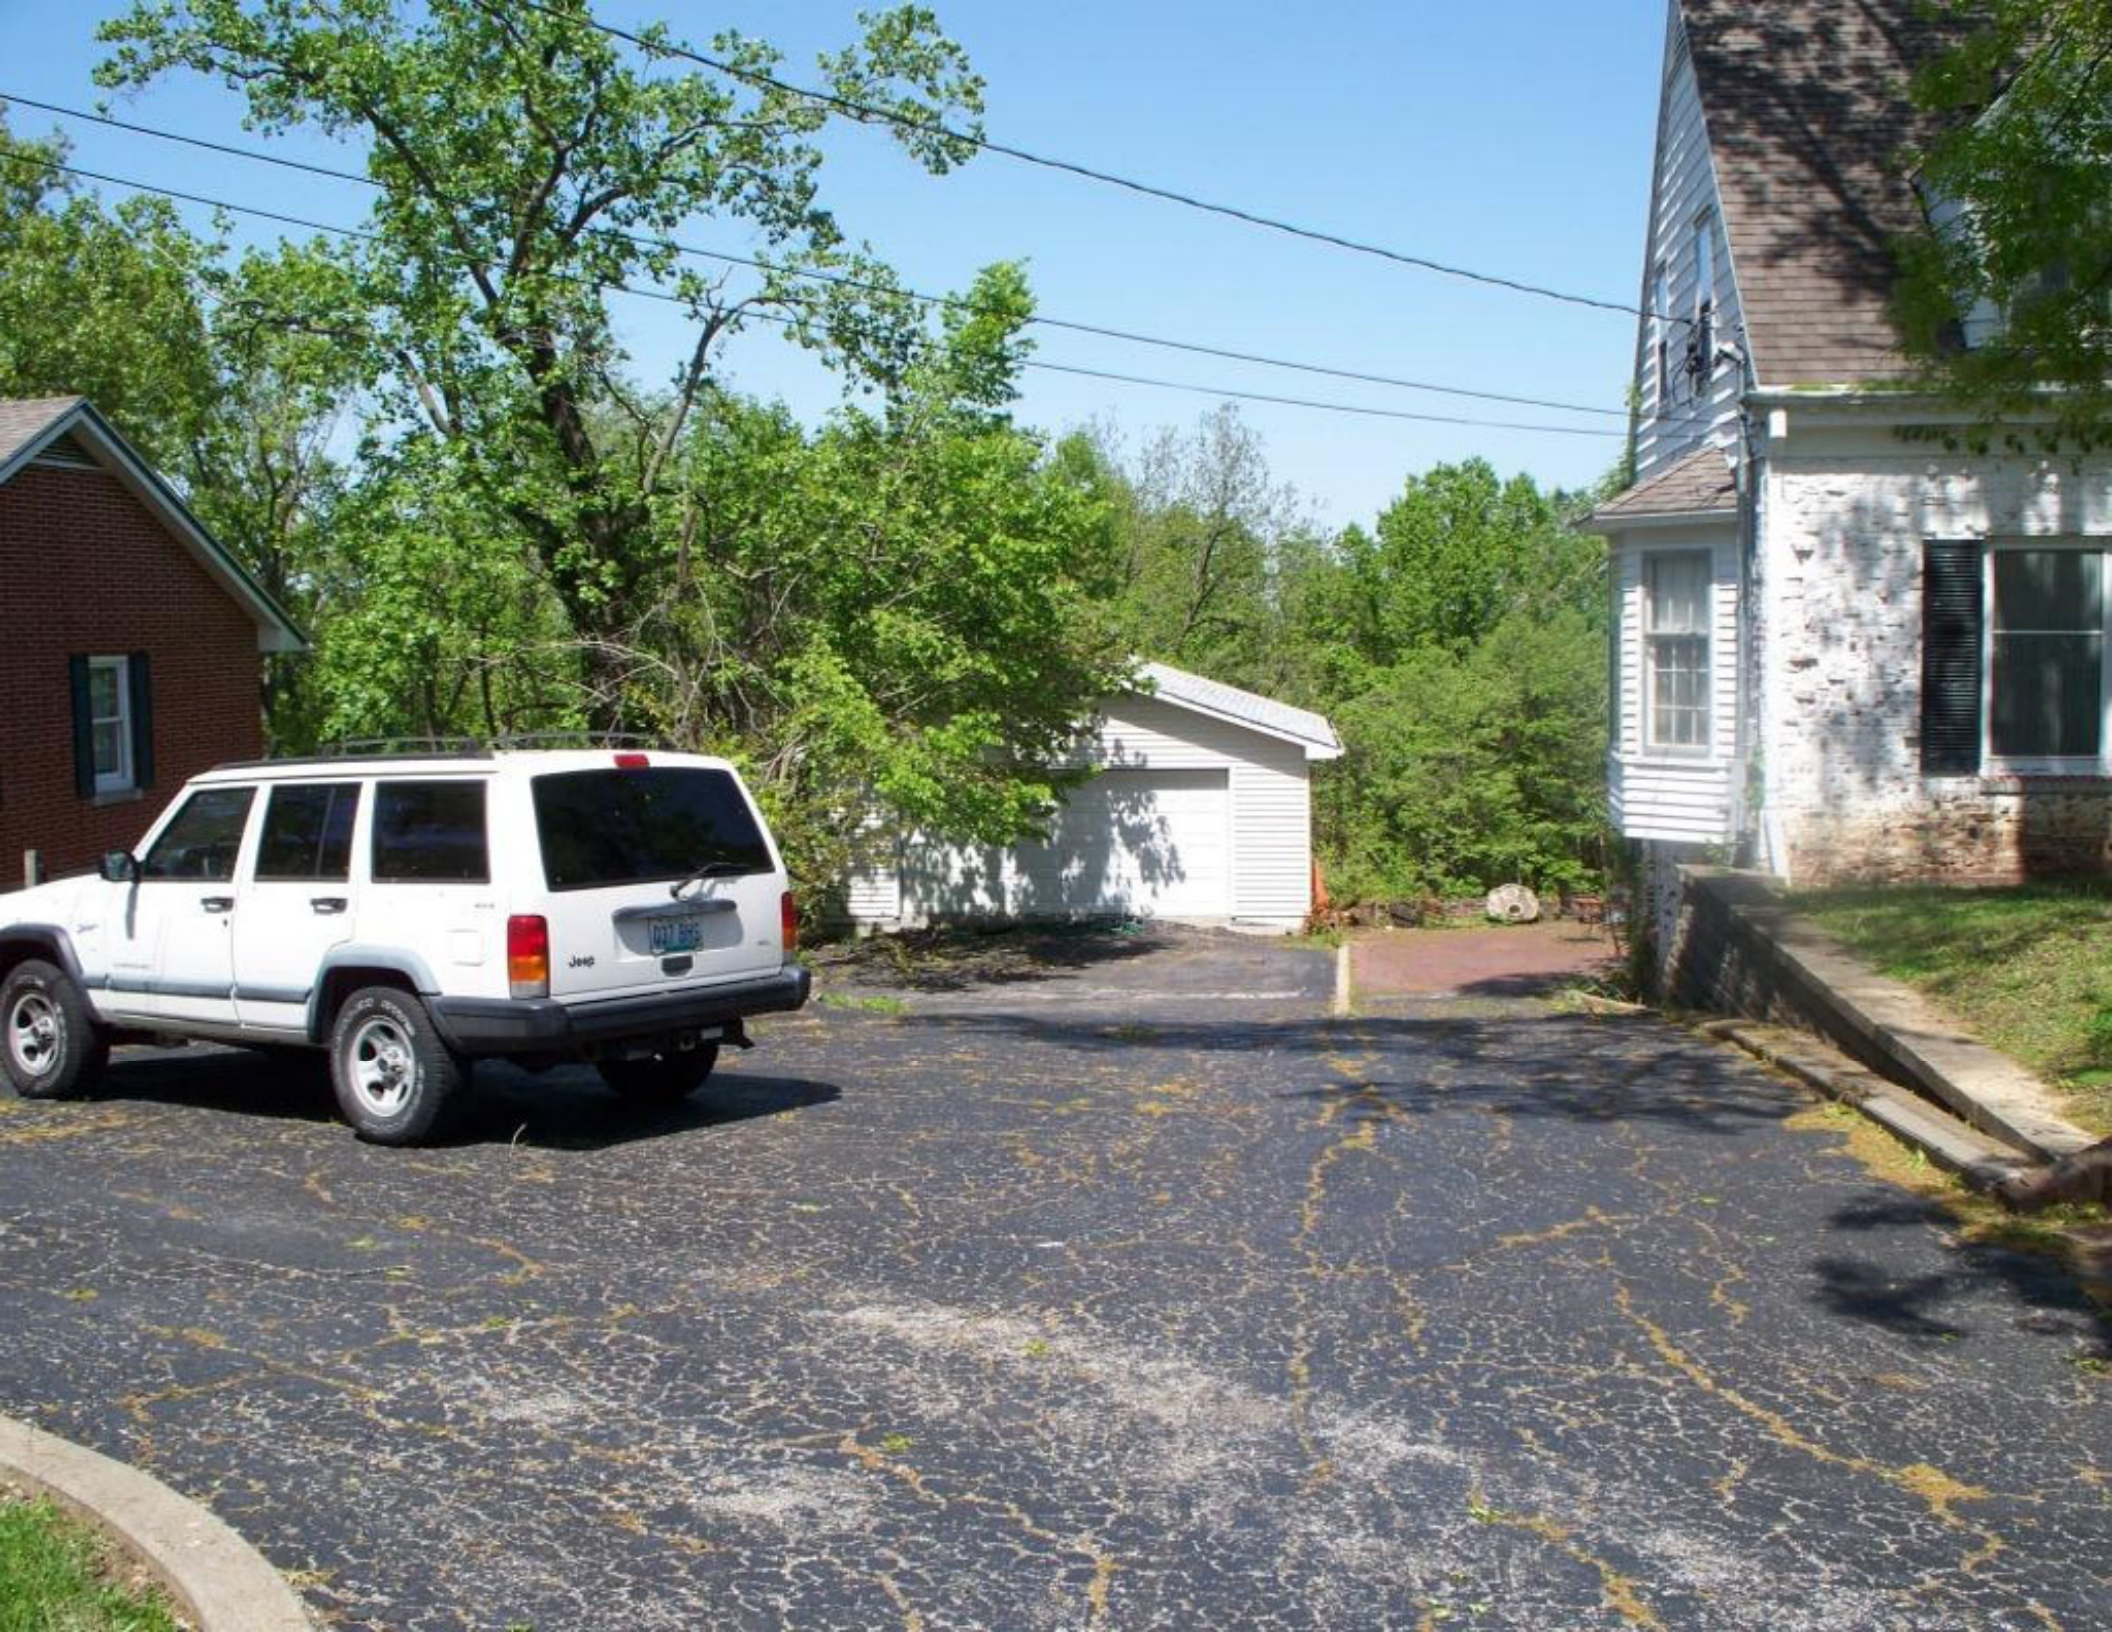
41. (cont.)
This 1 ½ story white wash brick Cape Cod has a side gable roof and three gable dormers clad in vinyl with 1/1 wooden storms with some sort of narrow vented paneling. All of the windows are clad this way. A canted bay window extends from the left side of the house. From the left there is a 1/1 window with shutters and a brick sill, the next bay contains the recessed entrance that features an ornate door surround and a stoop with metal railing, the final bays each contain a 1/1 window with shutters and brick sills. The last bay is set slightly back. Under the roof overhang is brick dentiling.
