ARCHITECTURAL/HISTORIC INVENTORY FORM

1. Survey No. CO-AS-005-001		2. Survey name: Moreau Drive Neighborhood Survey	
3. County: Cole		4. Address: 1202 Elmerine Ave.	
5. City: Jefferson City	Vicinity: <input type="checkbox"/>	6. UTM: / /	7. Township/Range/Section: T: R: S:
8. Historic name (if known):		9. Present/other name (if known):	
10. Ownership: <input checked="" type="checkbox"/> Private <input type="checkbox"/> Public		11. Historic use (if known): Residential	11. Current use: Residential

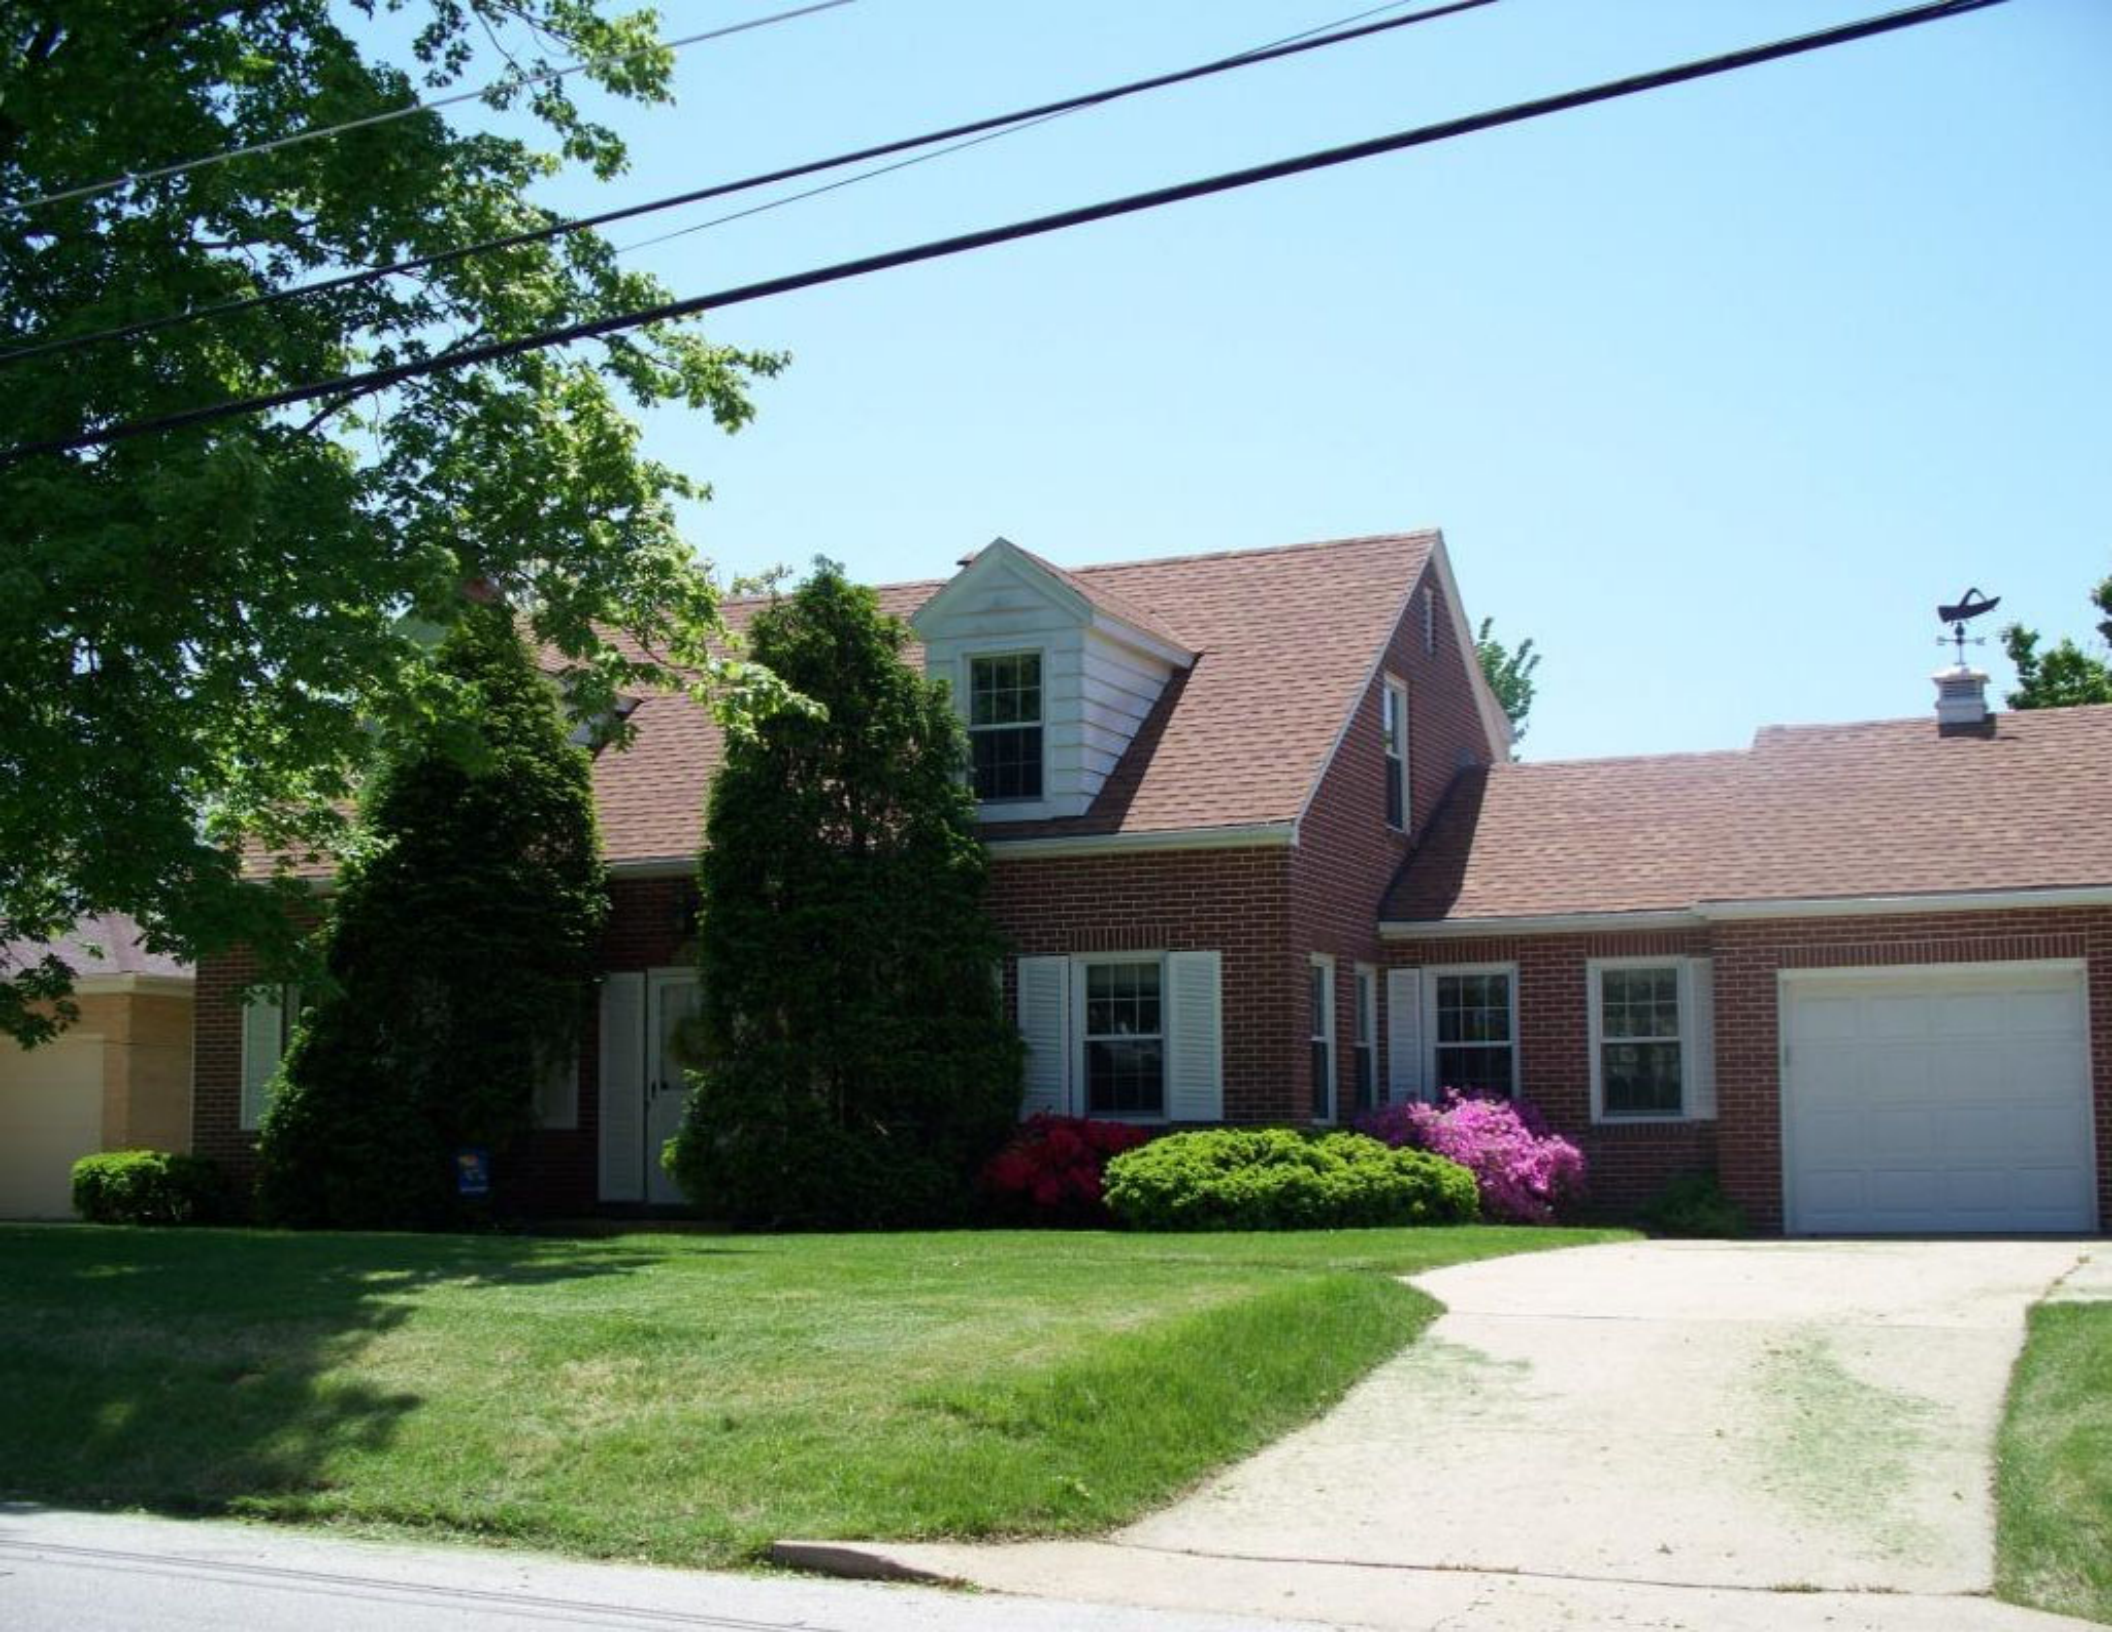
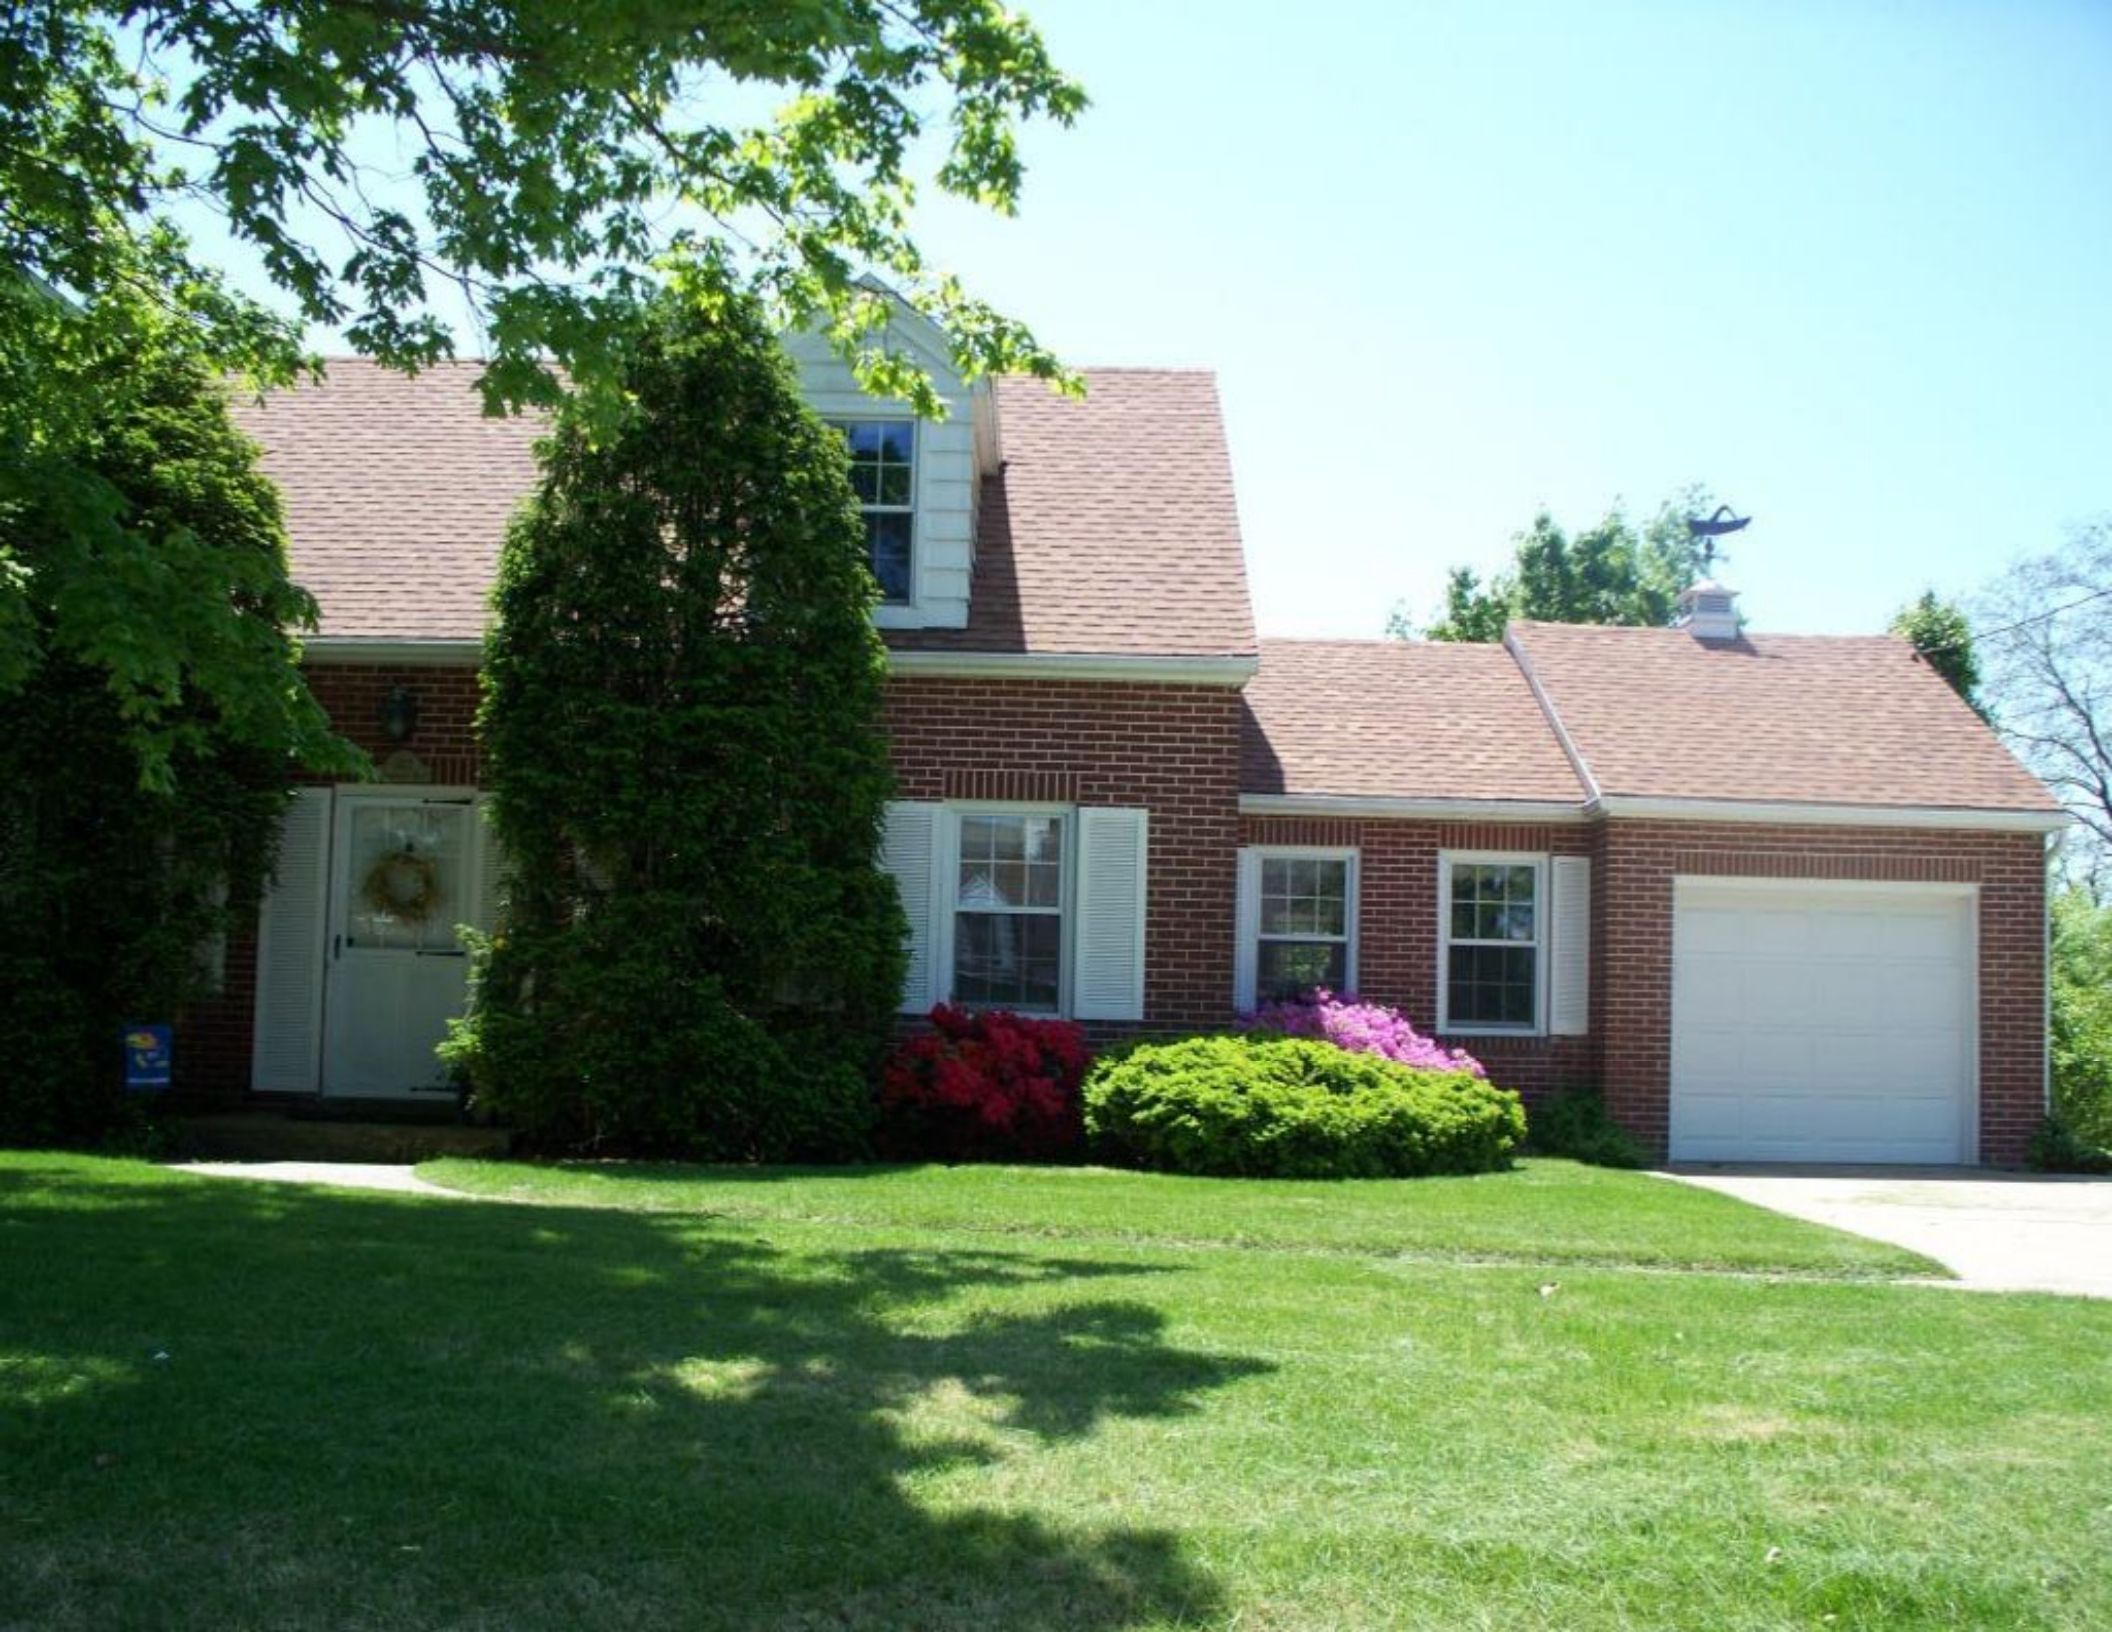
41. (cont.)
This 1 ½ story brick Cape Cod has two gable dormers sided in what appears to be wood. They each contain a single 6/6 window. The first floor has 6/6 windows with shutters flanking the centered entrance, which also has shutters. Attached and set back to the right is a brick breezeway connected to a one car garage.

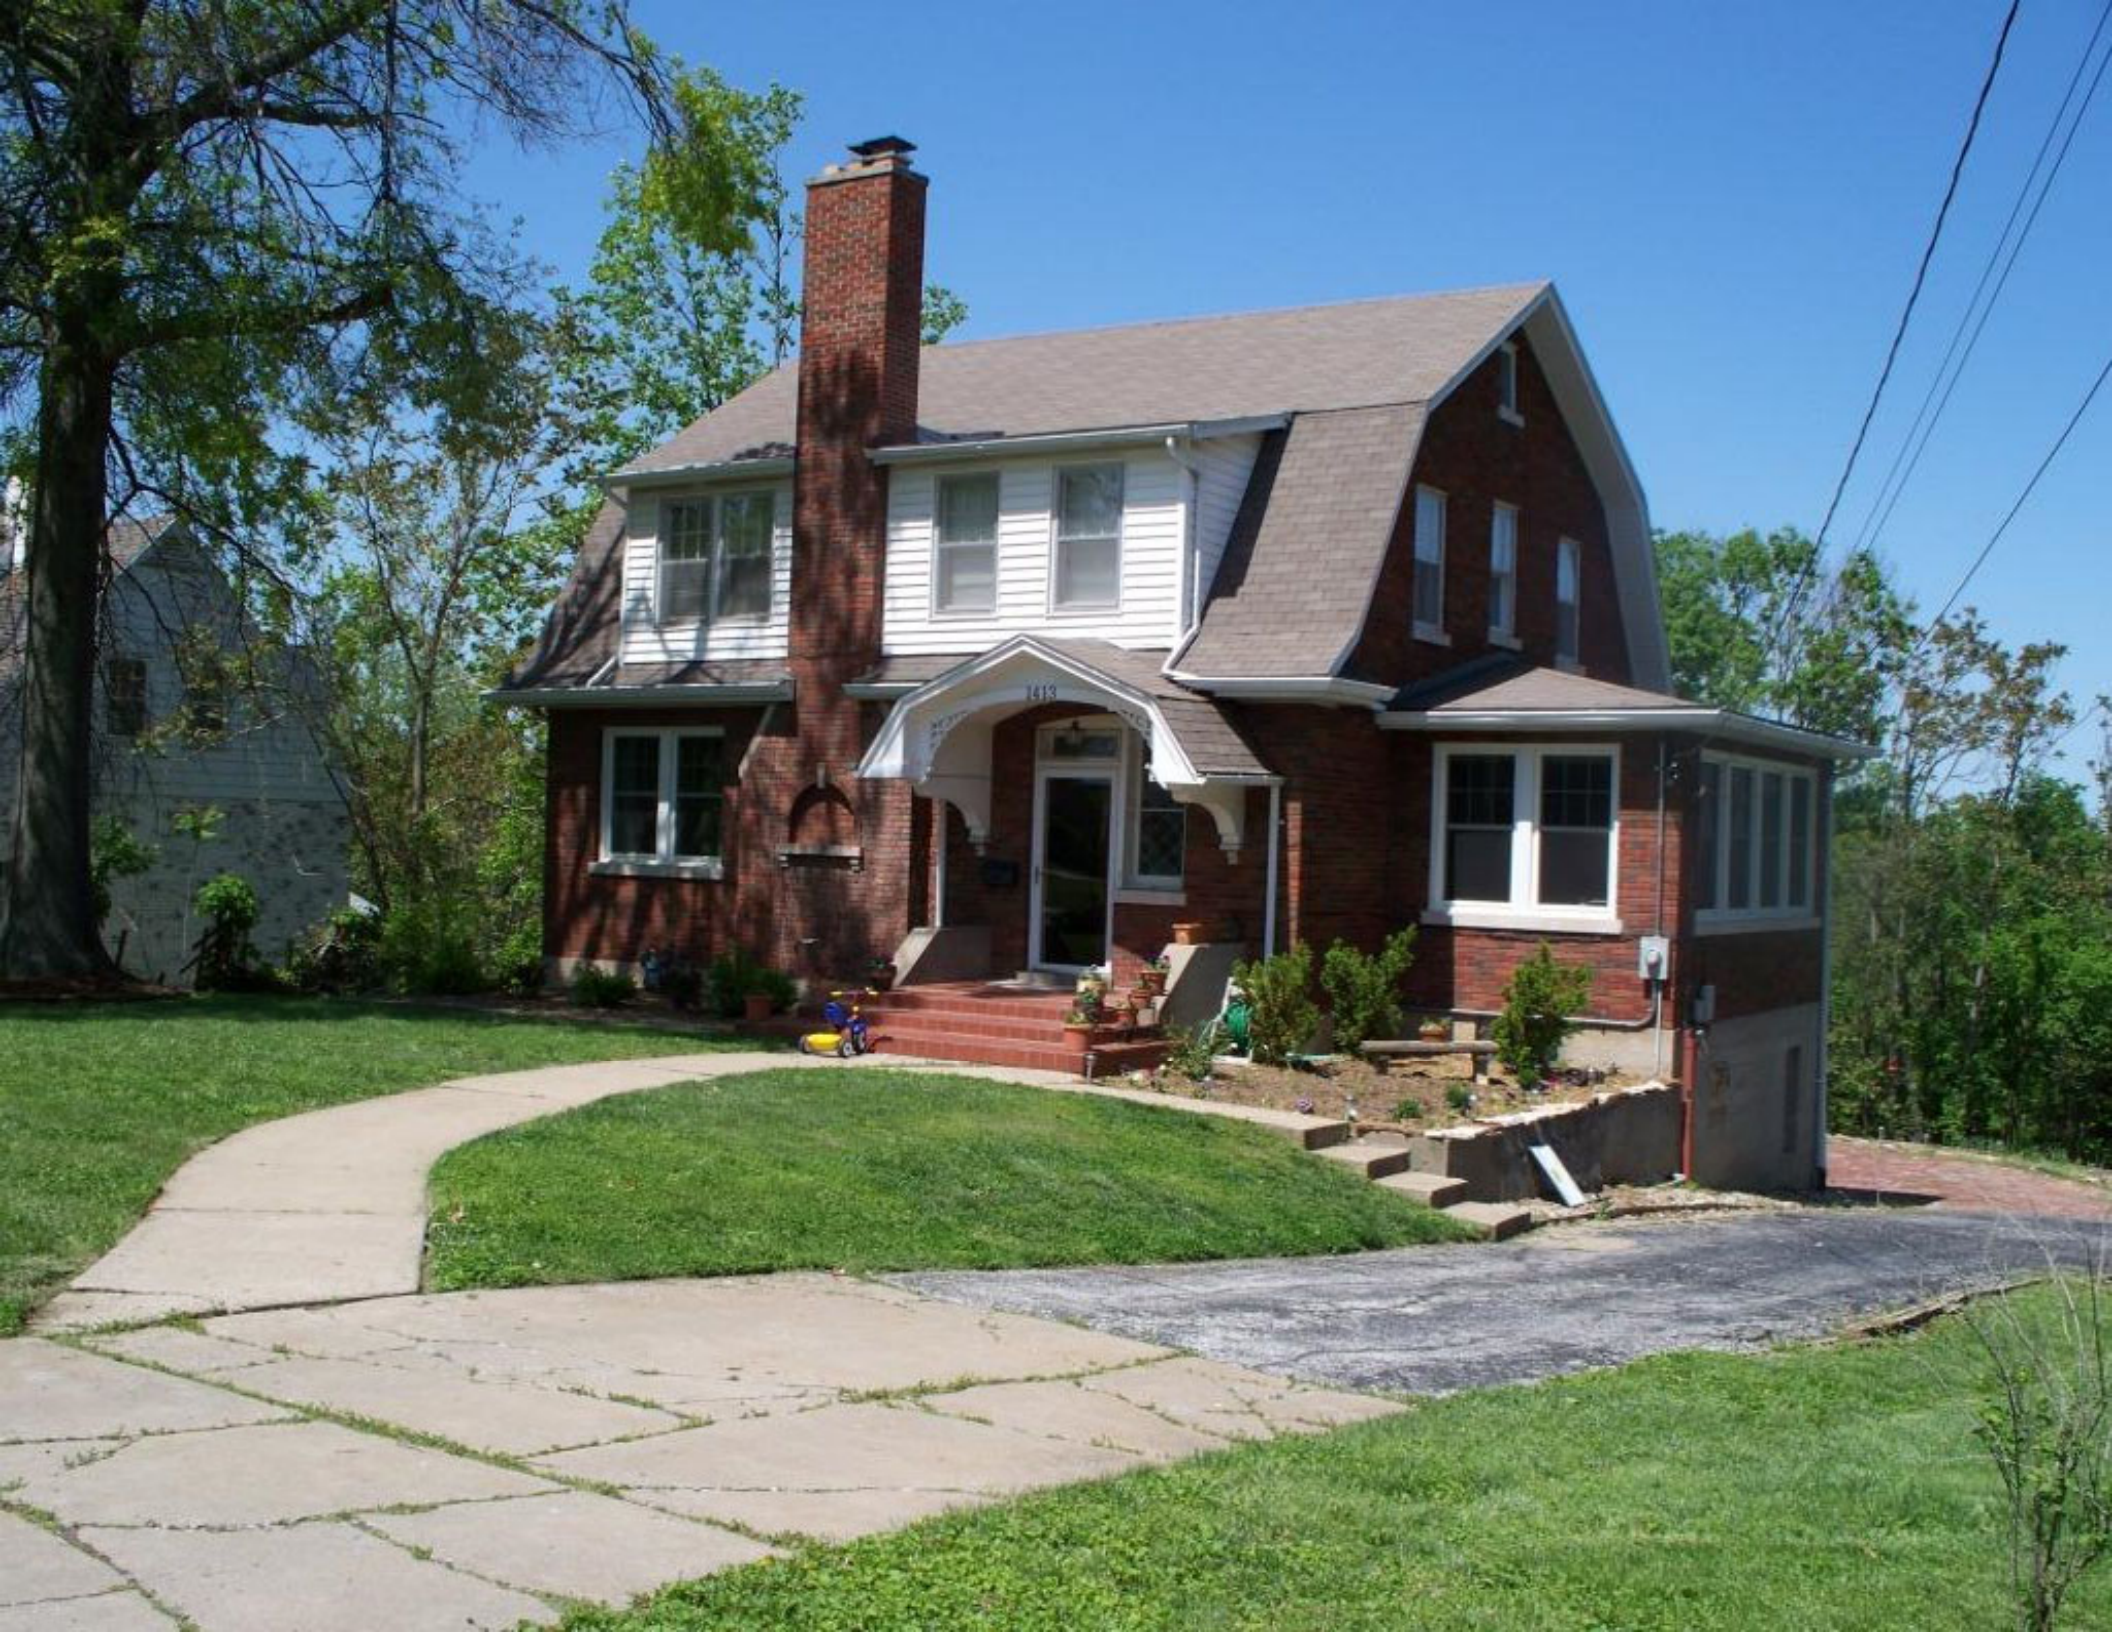
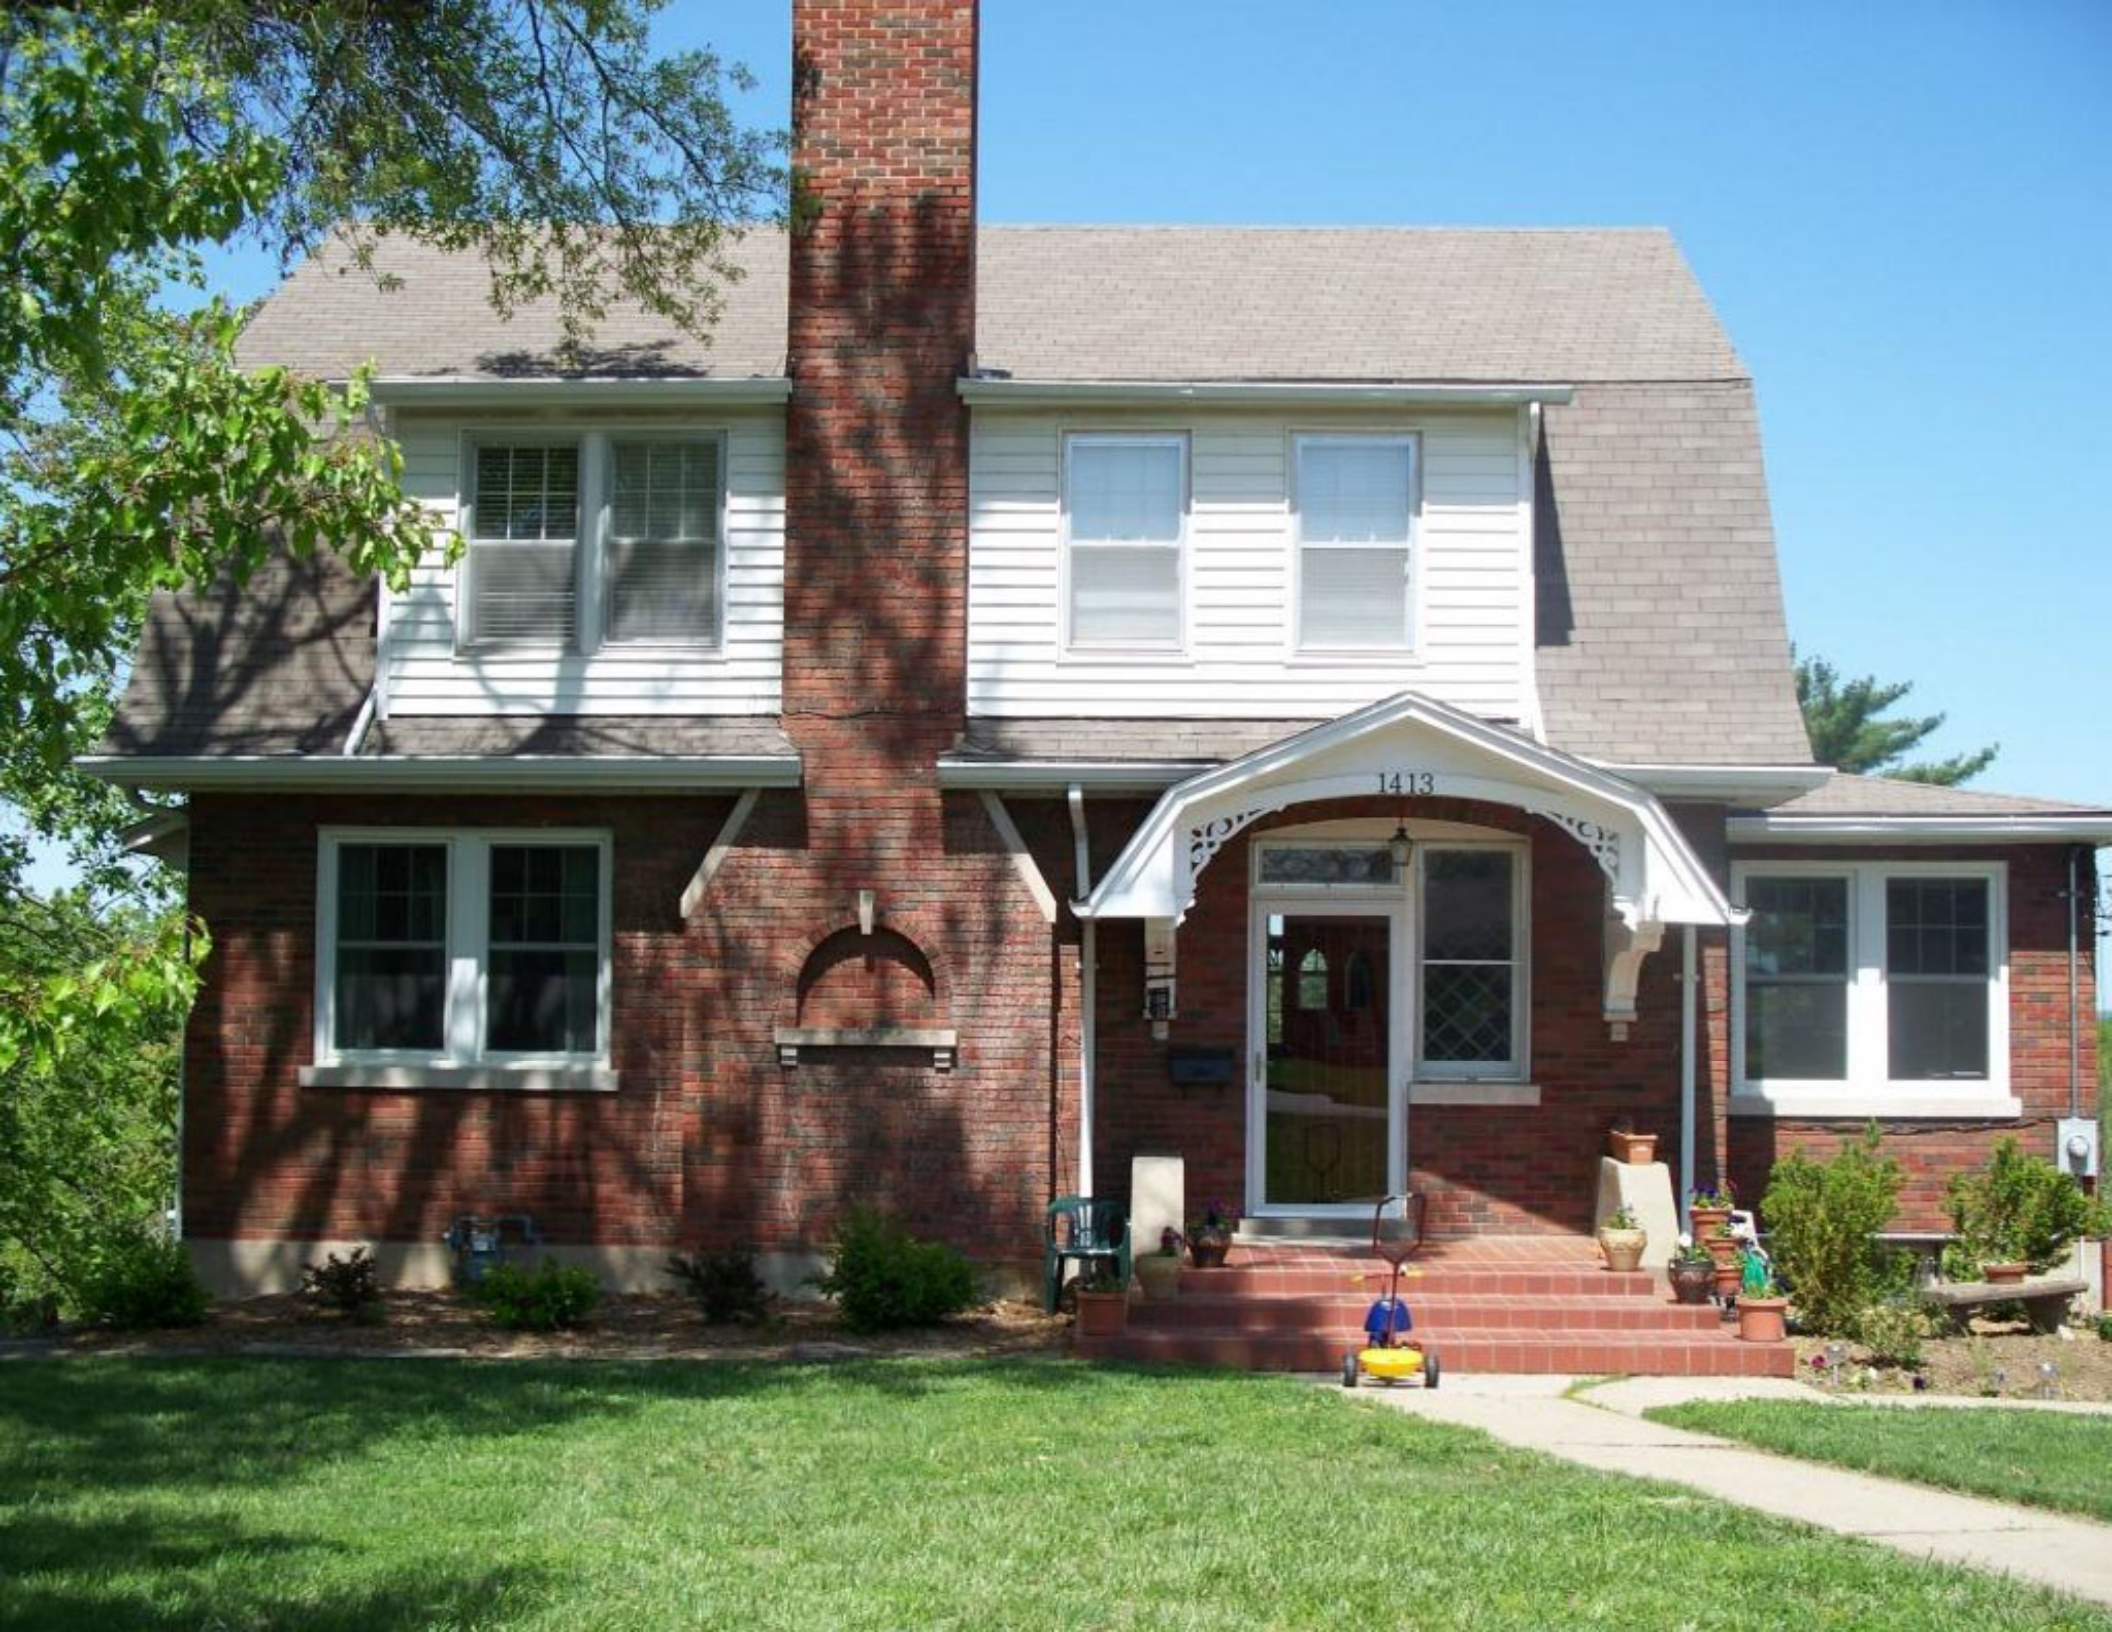
This two story brick Dutch home has a continuous dormer with a shed roof that is pierced in the center by the front brick chimney. The dormer is clad in vinyl and contains paired 6/1 windows that could be historic. On the other side of the chimney are two 6/1 windows that also could be historic. From the left on the first floor there are paired 6/1 windows that appear modern (muntins are thinner than those on the second floor). The next bay contains the base of the chimney which flares out and contains an arched recessed niche with a concrete sill, “brackets” and keystone. The right bay is recessed and contains the original wooden door and art glass transom. There is a small sashed art glass window directly to the right that has a thick concrete sill. These features are all set in an arched opening that has been partially in-filled. Above is a gambrel hood with a basket handle arch with scroll work is supported on brackets that rest on concrete braces. The entrance is reached via a set of tiled stairs and landing. There is an additional one story bay with a hipped roof to the right that is set back from the rest of the property. It has paired 6/6 windows with a concrete sill.

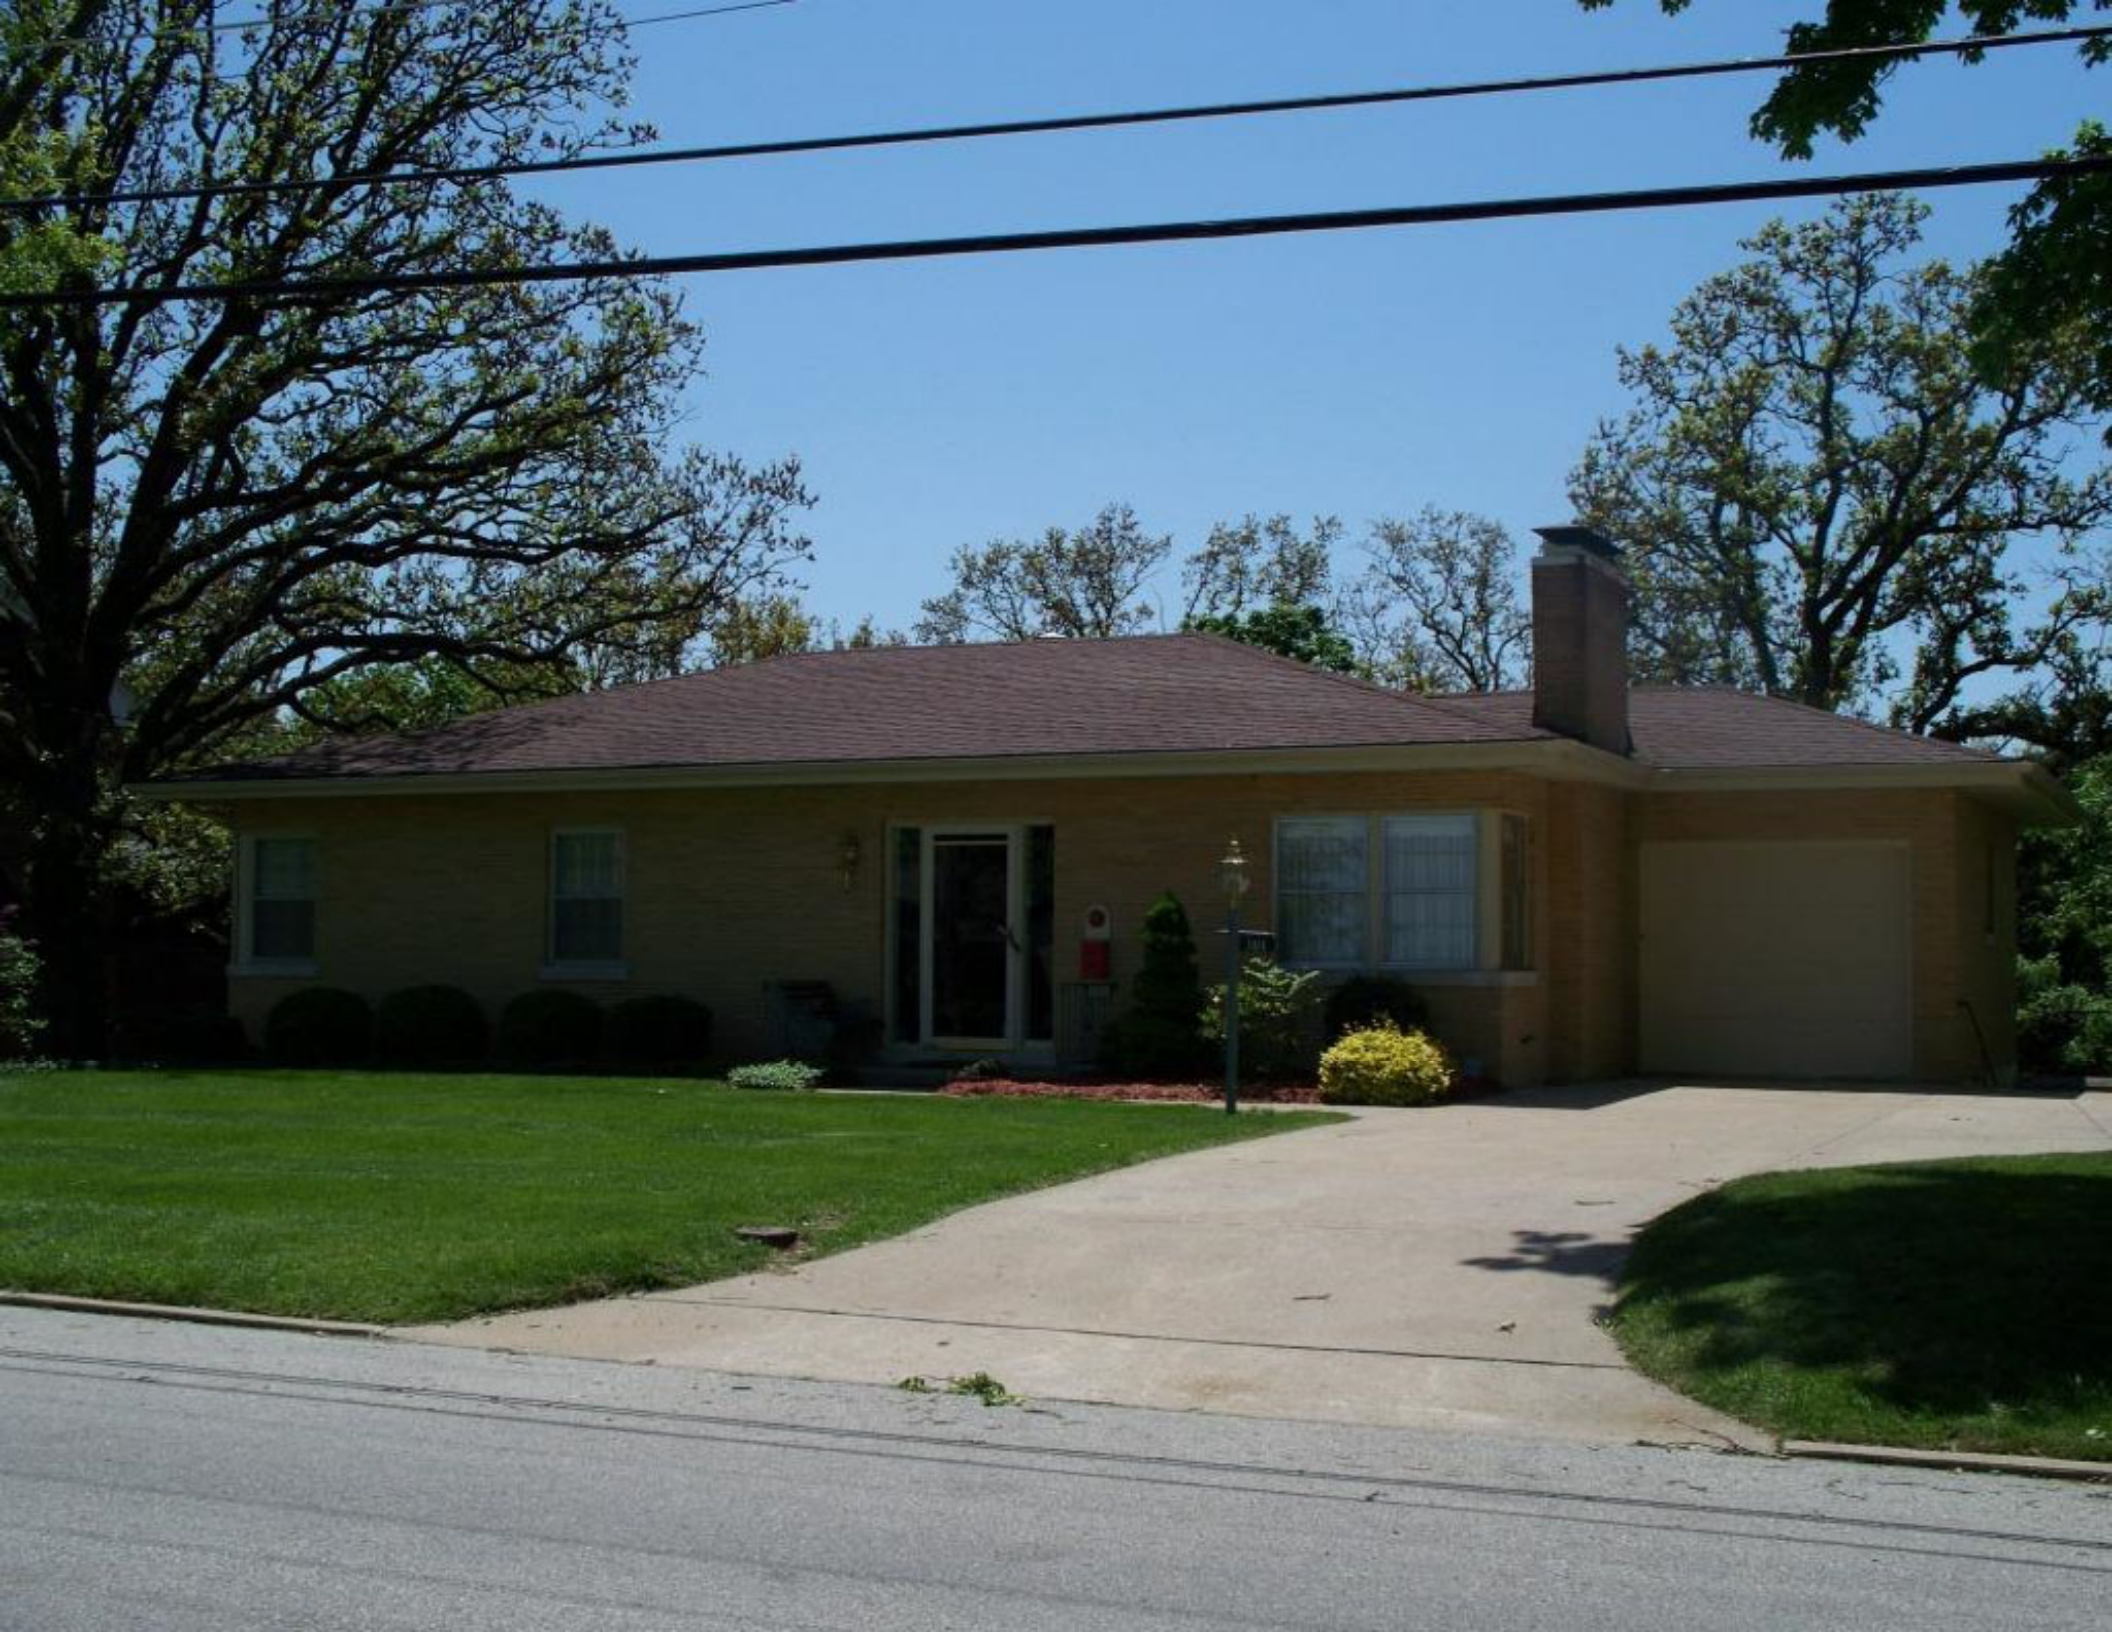
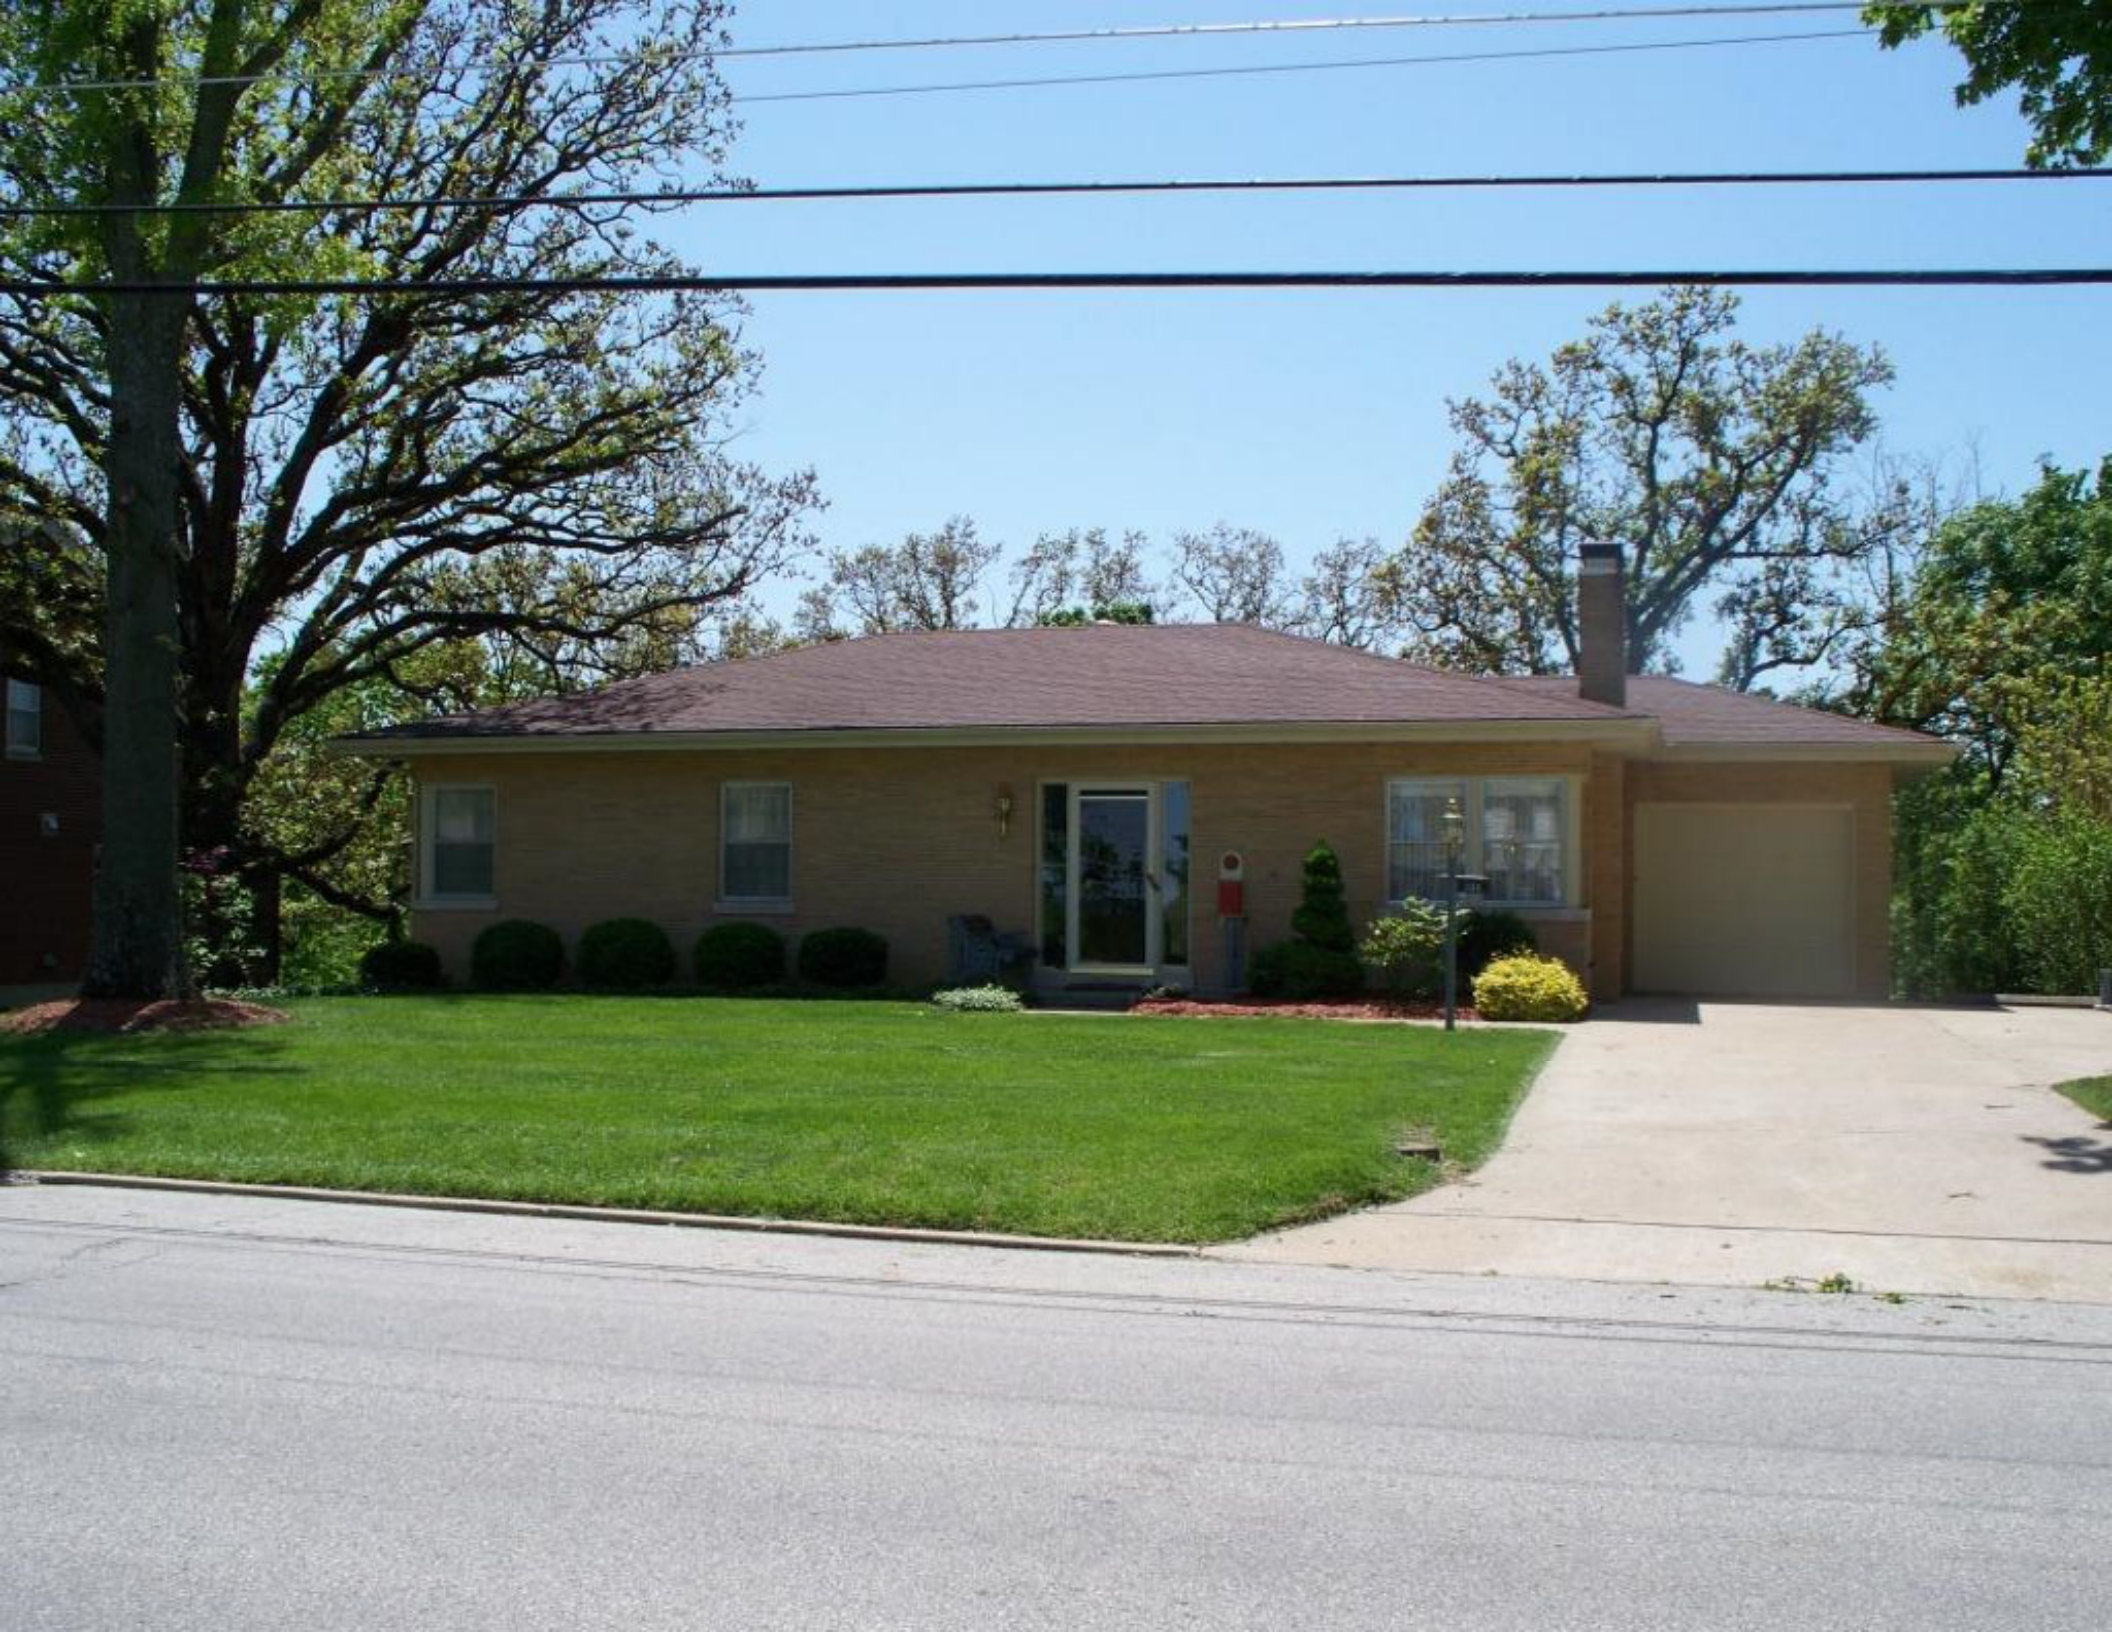
41. (cont.)
This one story brick ranch home has a hipped roof. From the left the first two bays contain 1/1 windows. The entrance is in the third bay and features sidelights. The fourth bay has paired 1/1 windows with an additional window that continues around the corner of the house. Set back on the right side is an attached one car garage.
