ARCHITECTURAL/HISTORIC INVENTORY FORM

1. Survey No. CO-AS-005-001		2. Survey name: Moreau Drive Neighborhood Survey	
3. County: Cole		4. Address: 1202 Elmerine Ave.	
5. City: Jefferson City	Vicinity: <input type="checkbox"/>	6. UTM: / /	7. Township/Range/Section: T: R: S:
8. Historic name (if known):		9. Present/other name (if known):	
10. Ownership: <input checked="" type="checkbox"/> Private <input type="checkbox"/> Public		11. Historic use (if known): Residential	11. Current use: Residential

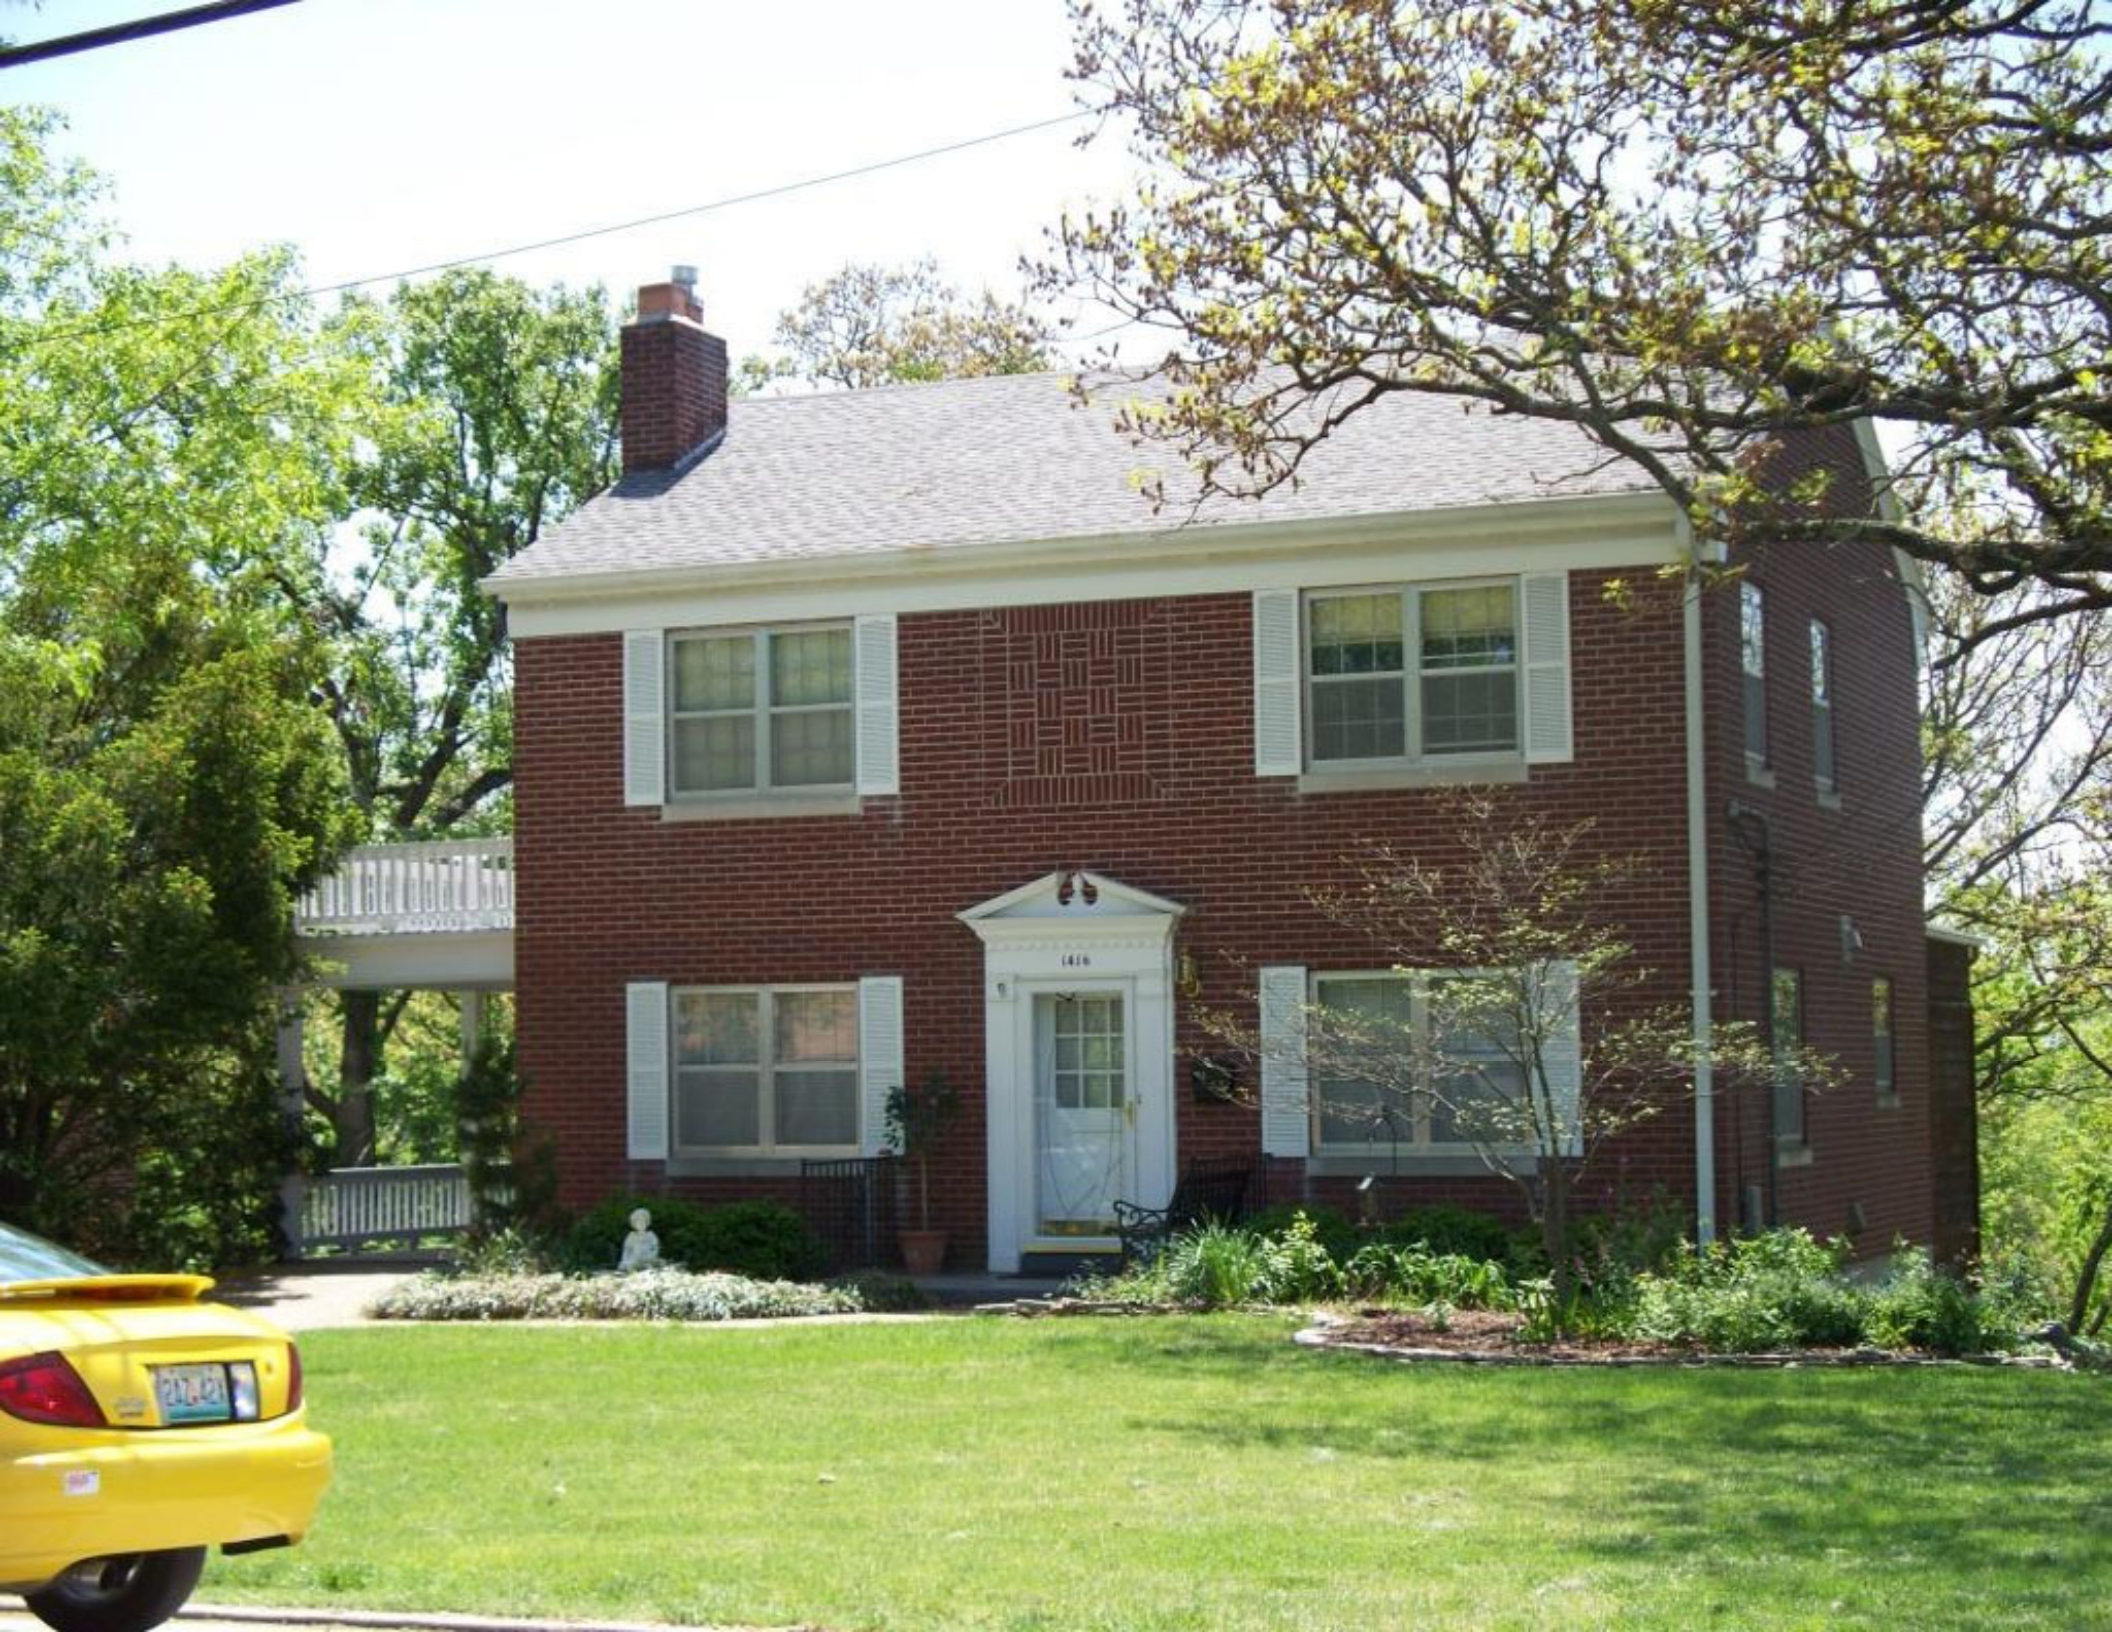
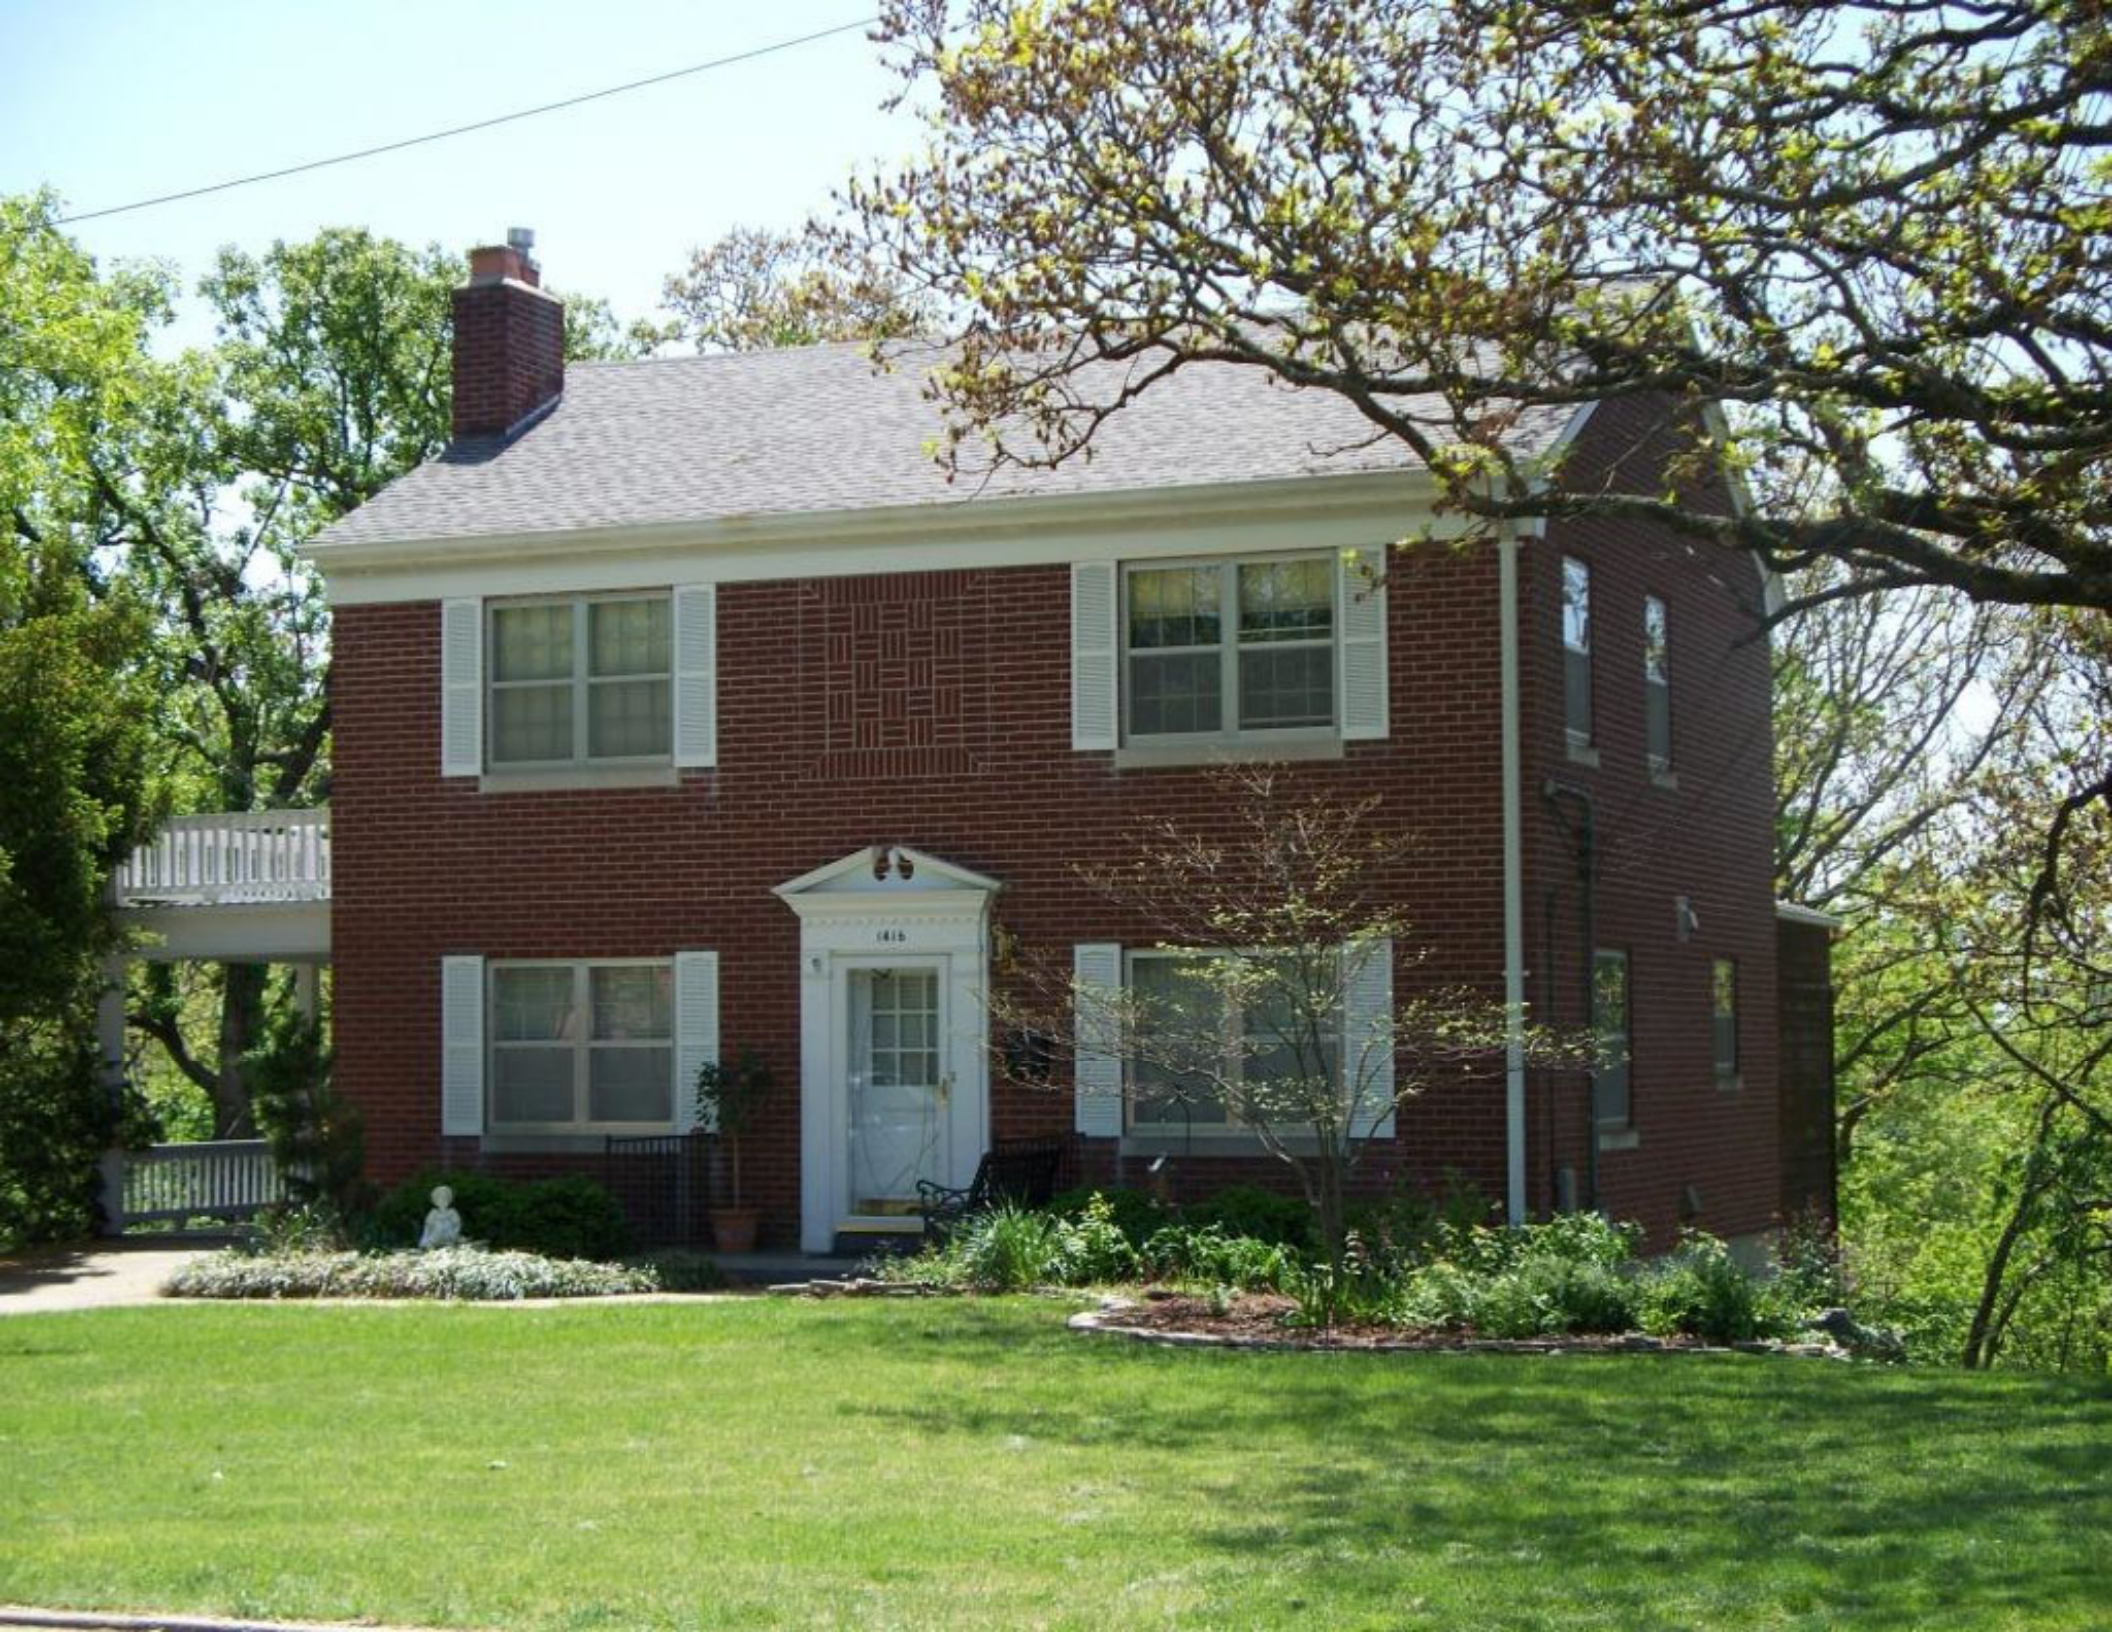
This two story brick Colonial Revival has a side gable roof. The second floor has two paired 6/6 windows with shutters. Between them is a square of decorative brick work in a quilt design. The first floor has paired windows with shutters identical to those on the second floor flanking the centered entrance, which has an ornate broken pediment door surround. A concrete slab with metal railing serves as the stoop. Attached to the left side of the building is either a side porch or a car port with wood railing. The flat roof acts as the floor to the second story balcony, also with wood railing.

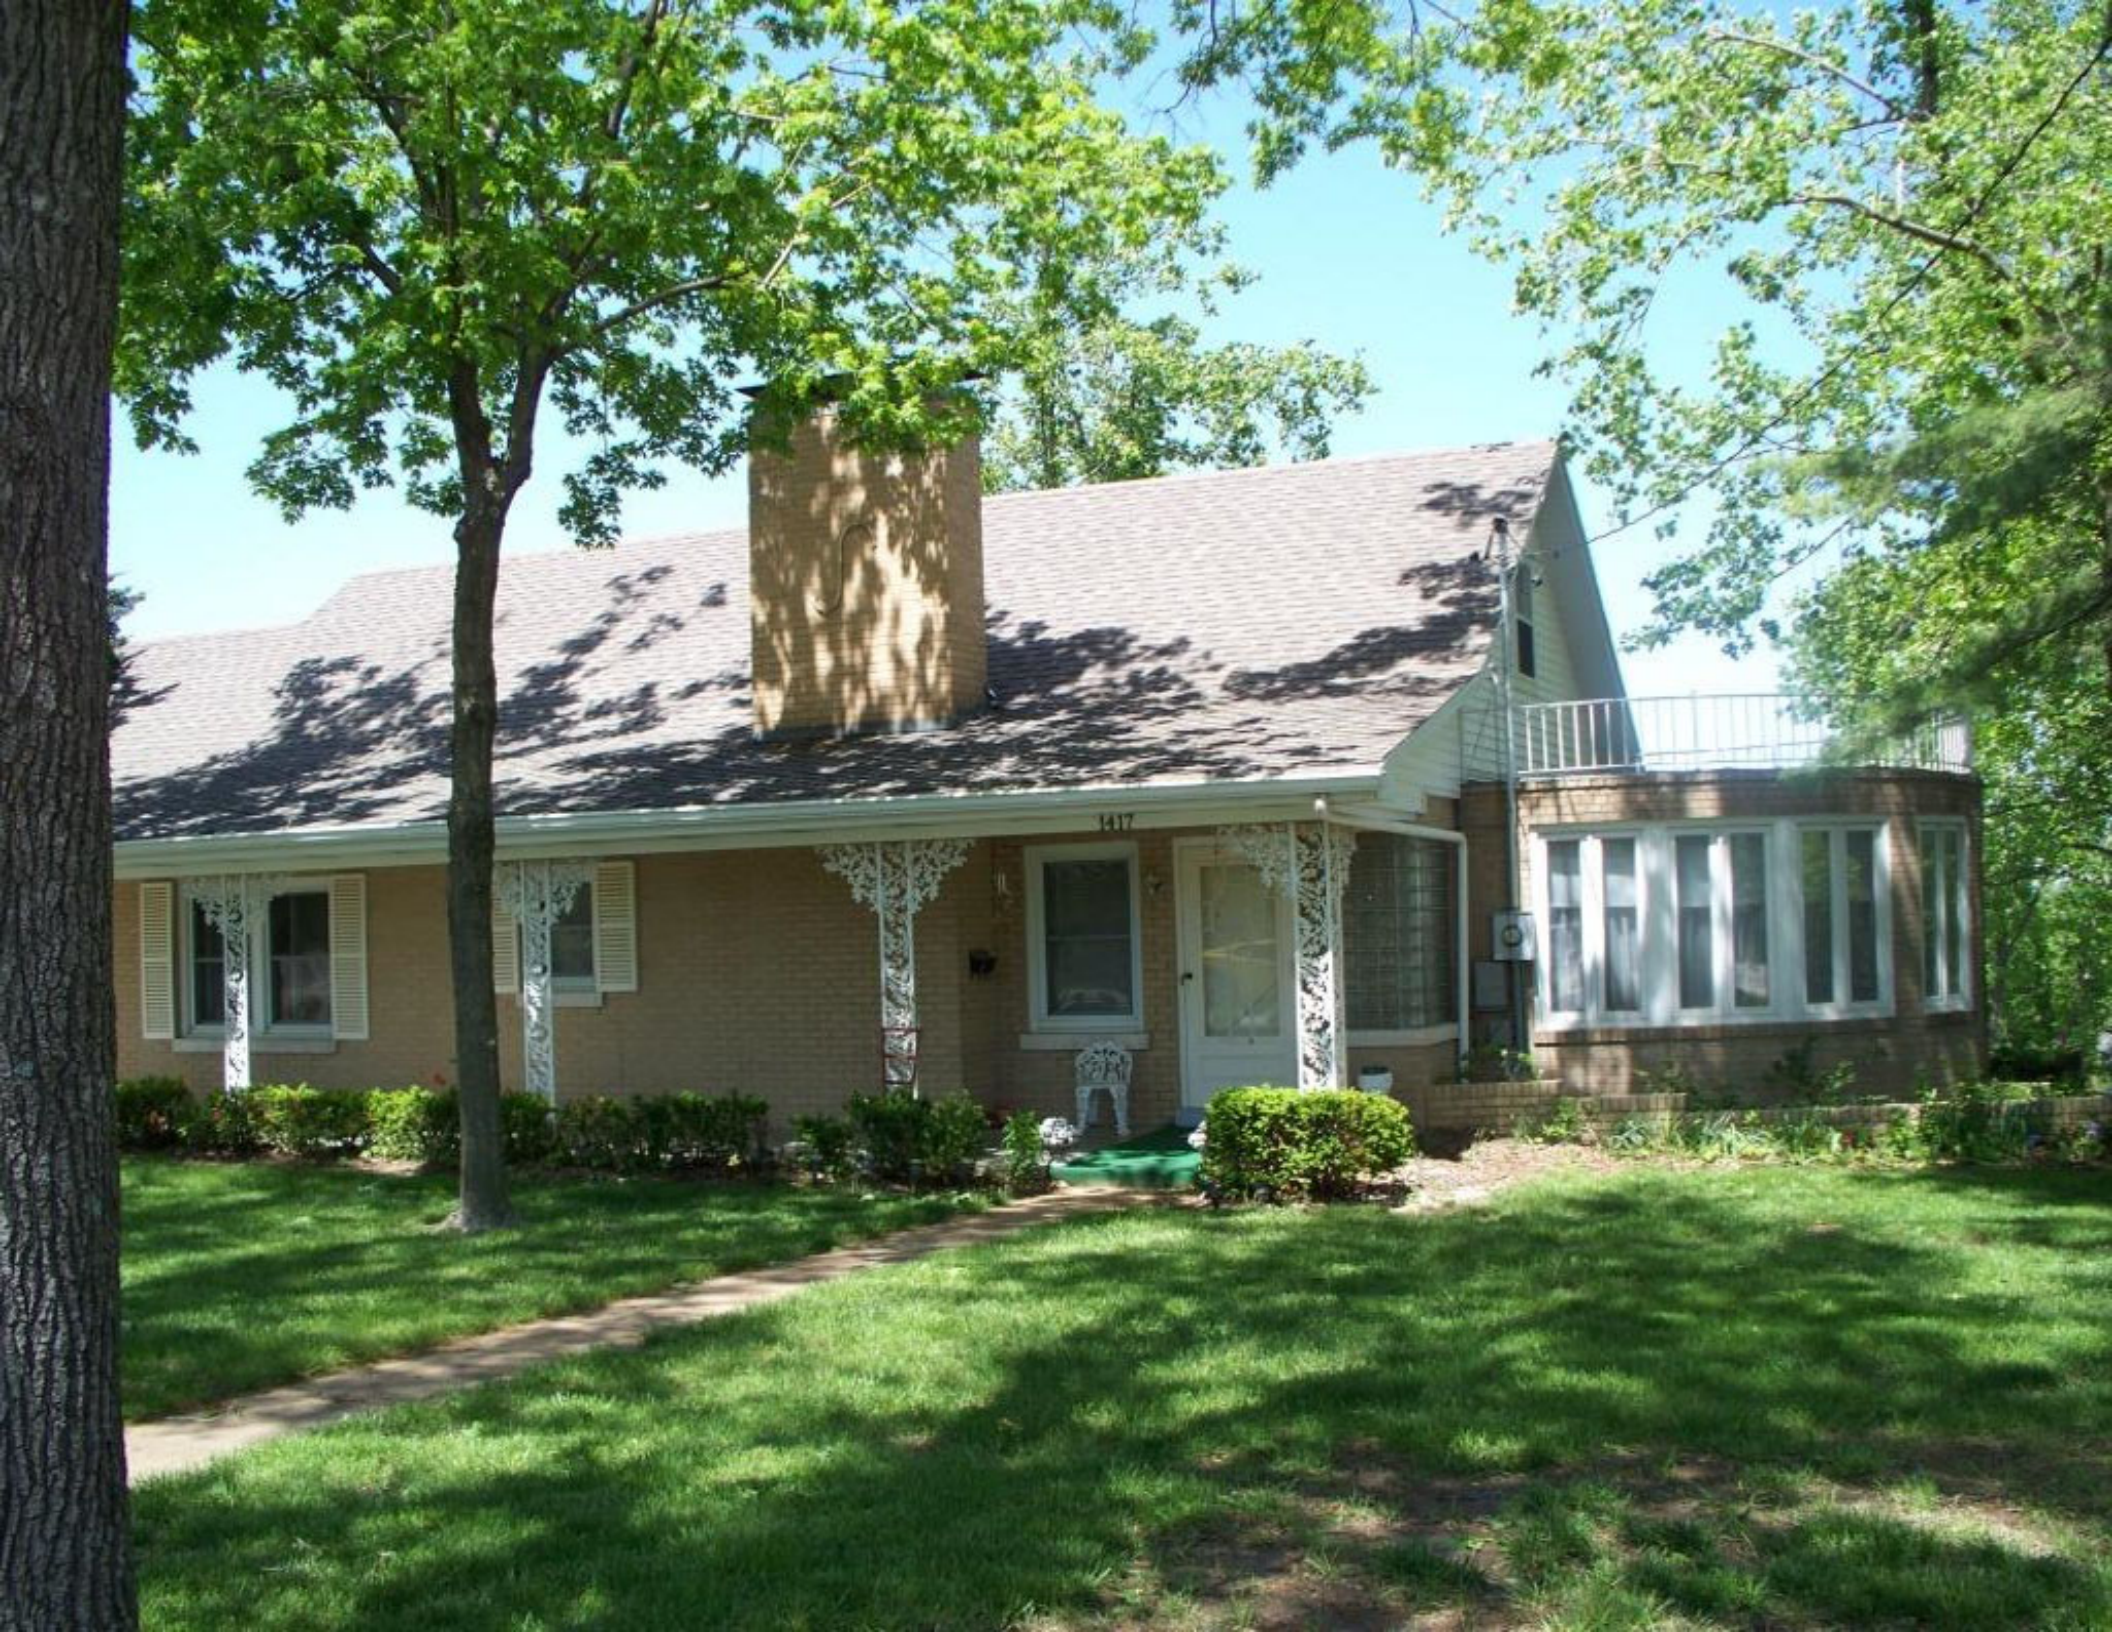
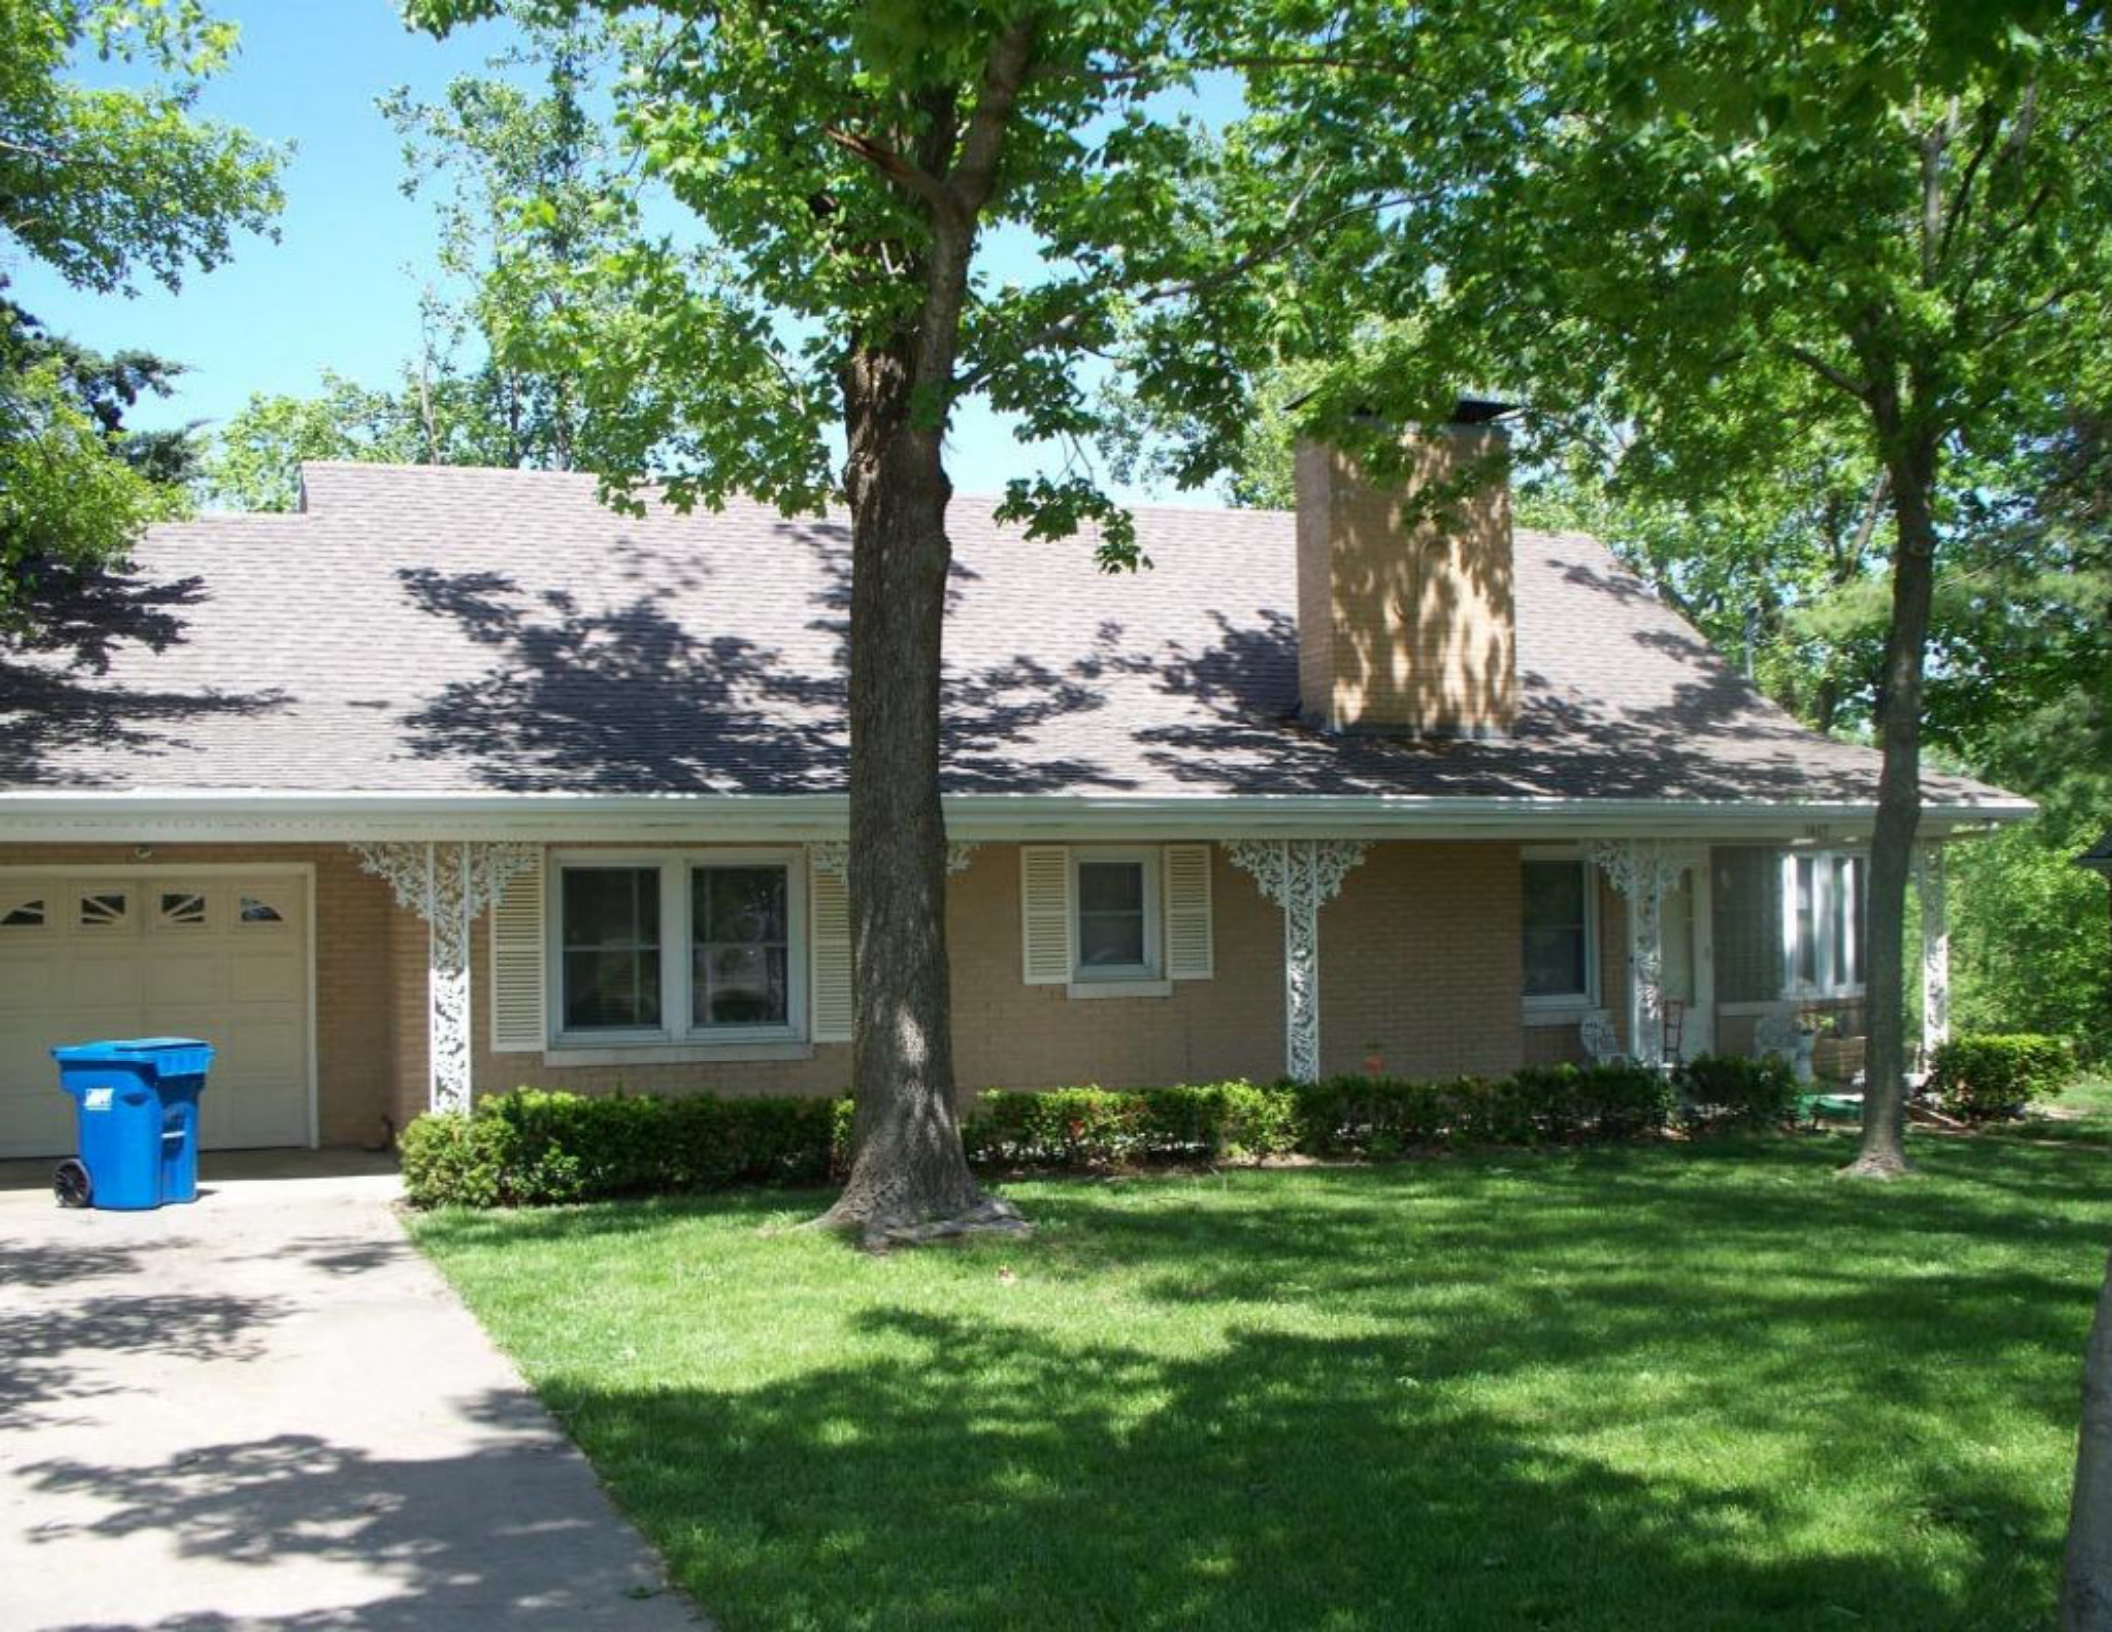
This one story brick ranch house has a side gable roof which is pierced off set to the right and front by a large rectangular chimney. The roof flares slightly to provide an overhang for the length of the property. Three decorative metal posts with filigree serve as “supports” for what could be considered the porch. The floor of which is a concrete. From the left is a one car garage that is slightly recessed. The next bay has paired 1/1 windows with shutters, then there is a small 1/1 window with shutters. The right bay is recessed and contains a 1/1 window, the entrance, and glass blocks that wrap around the corner of the property. All of the windows are vinyl and have concrete sills, as does the glass blocks. Set back on the right side is a curved sunroom with bands of narrow one light windows. Above the structure is a metal balustrade.

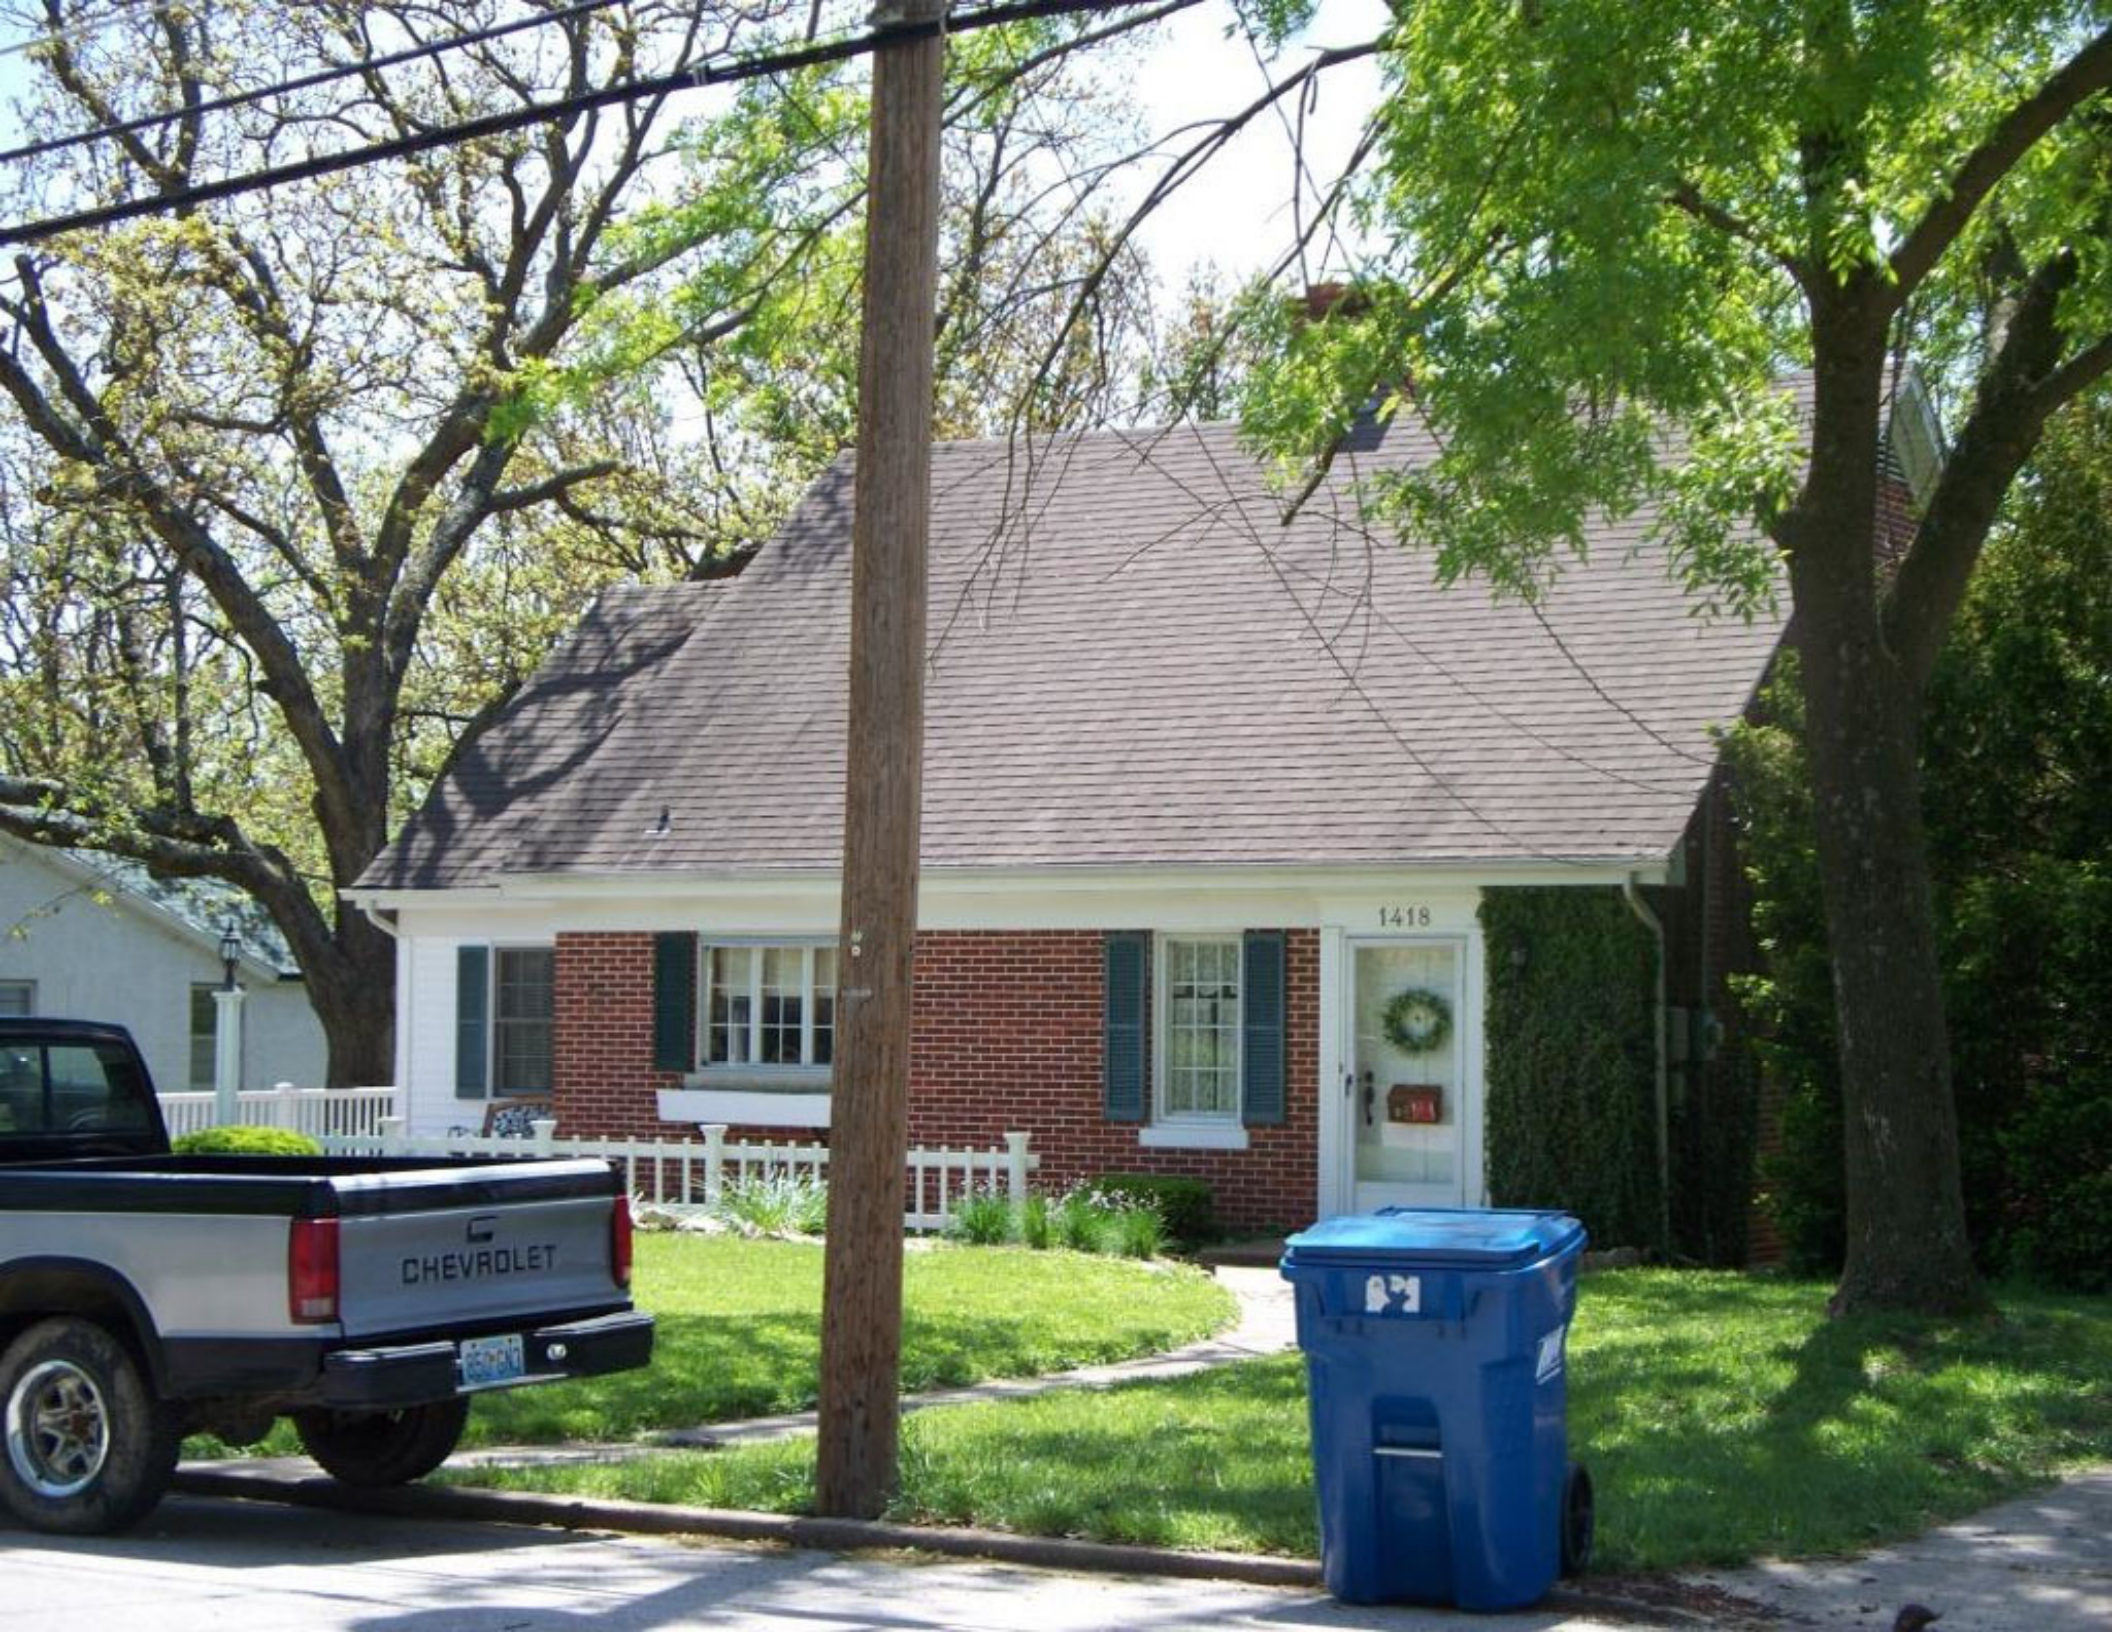
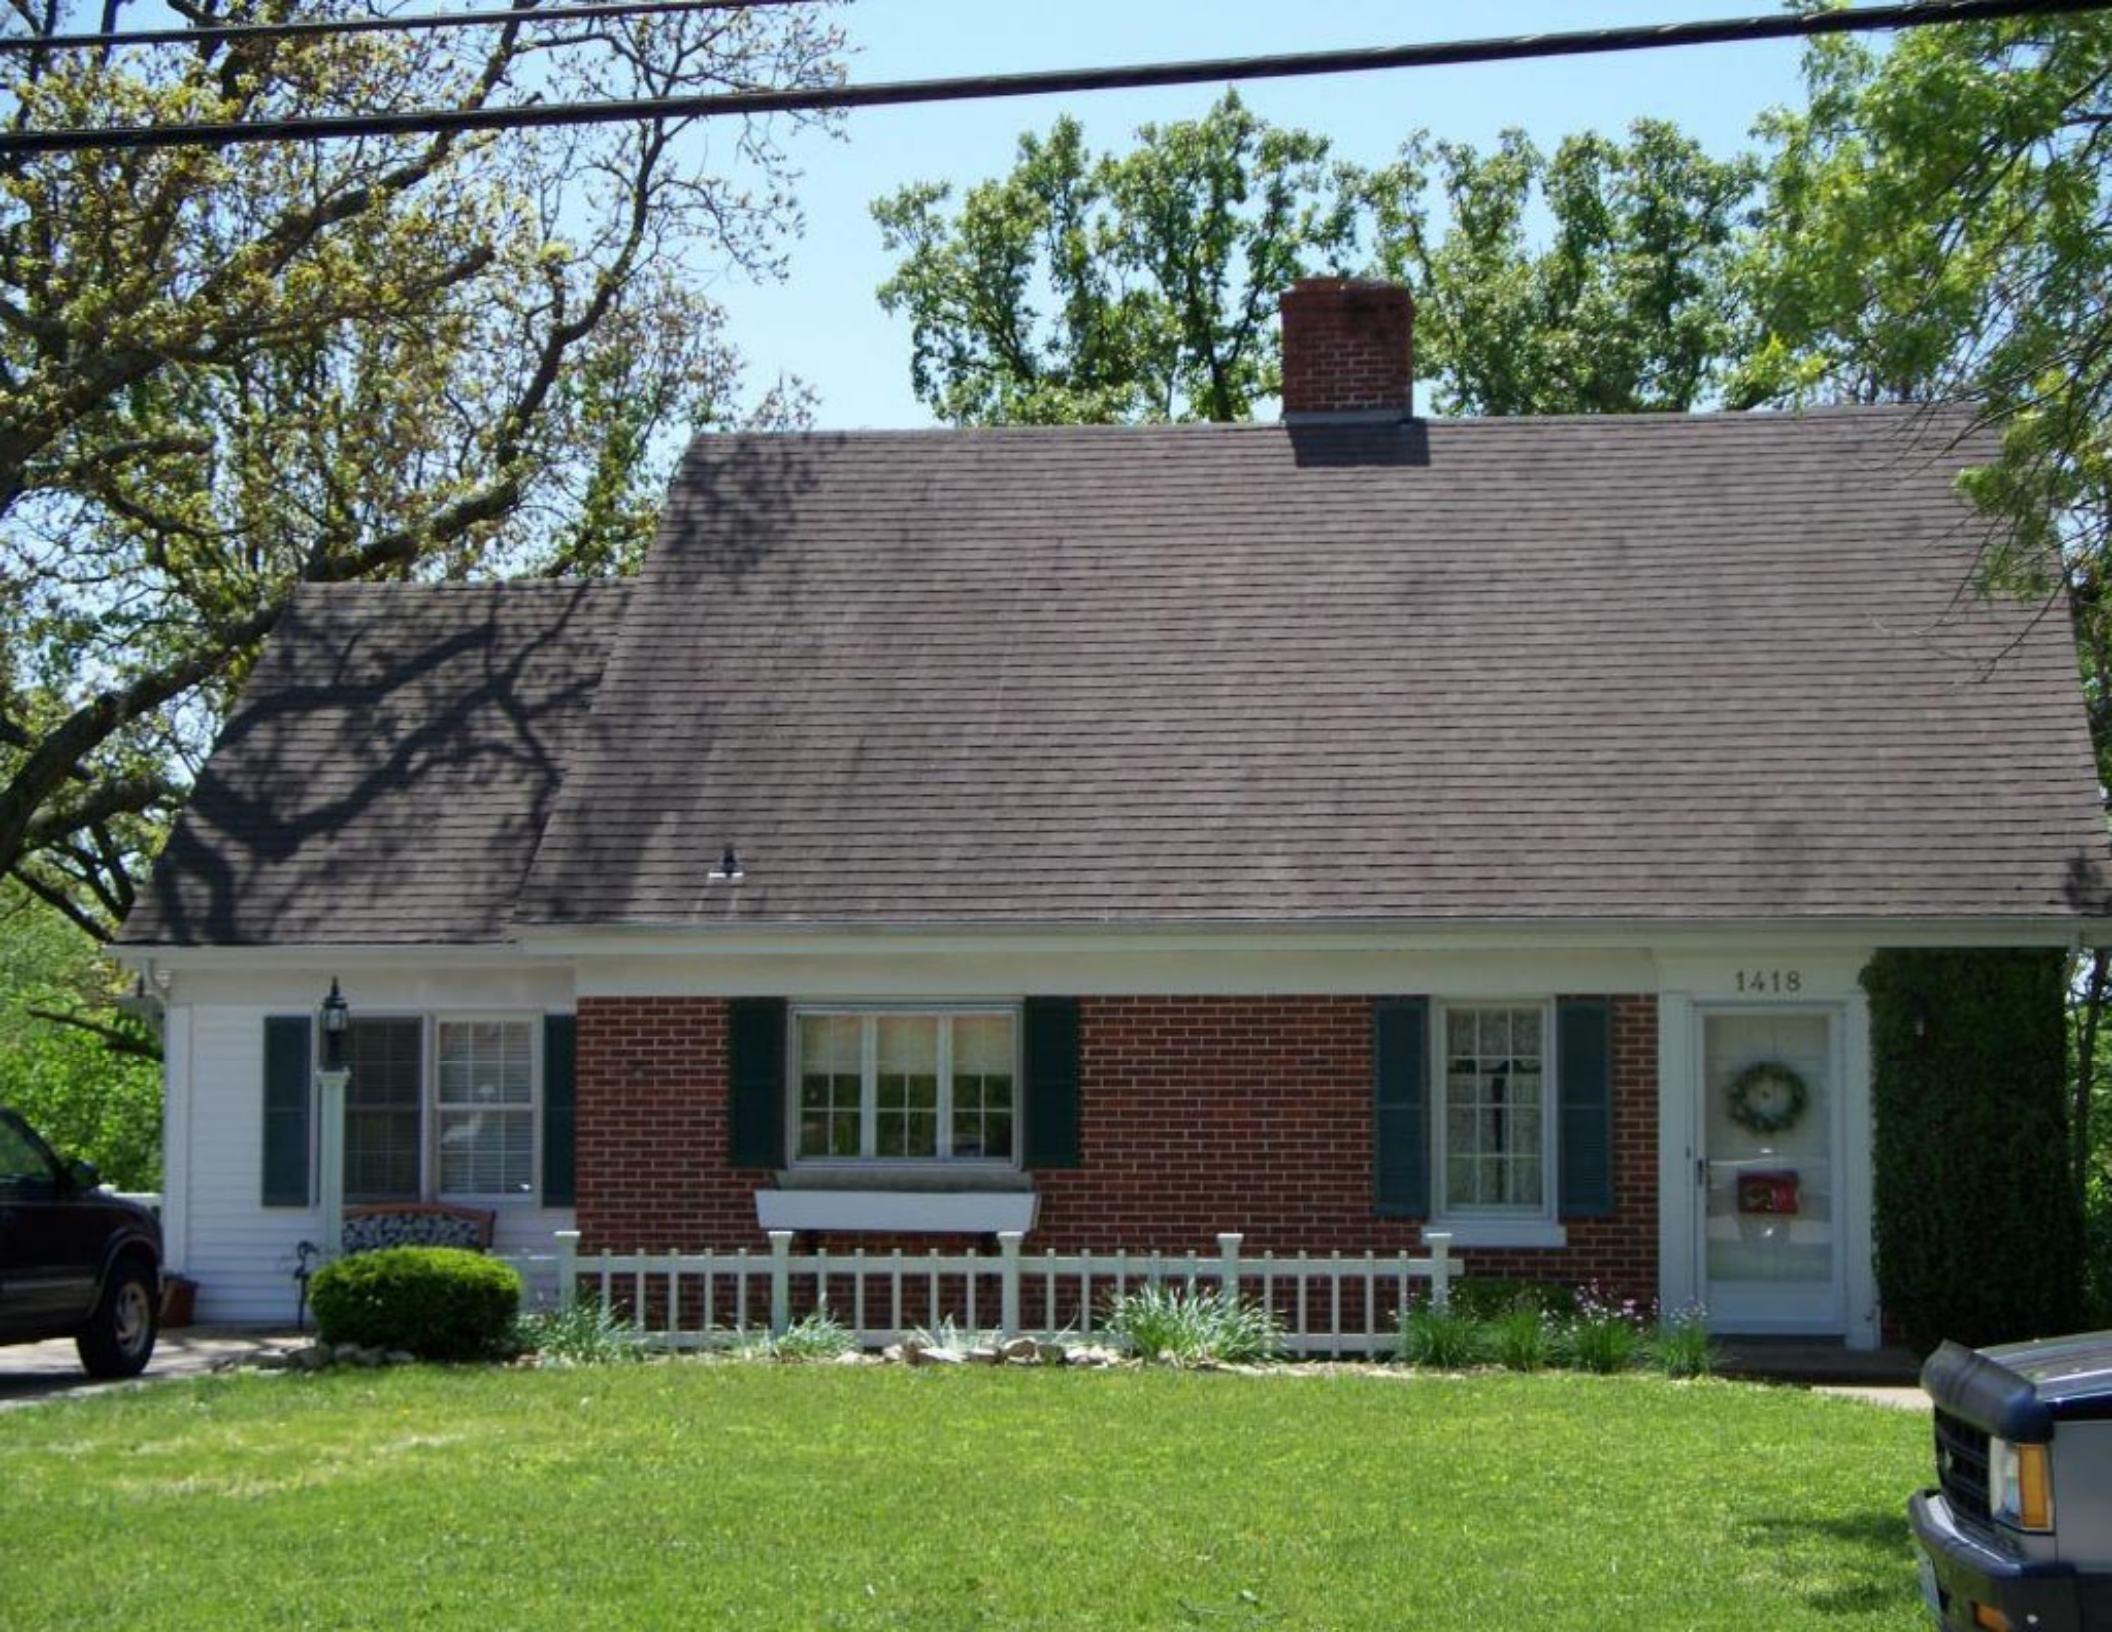
1418

41. (cont.)
This 1 ½ story brick home has a deeply sloping side gable roof. From the right, the first bay contains the entrance. The next bay contains a modern 6/6 window with shutters and a painted concrete sill. The third bay contains a row of three casement windows with what appears to be snap in muntins. These windows feature shutters and a flower box. Set back from the left is an additional bay clad in vinyl with paired 6/6 windows with shutters.
