ARCHITECTURAL/HISTORIC INVENTORY FORM

1. Survey No. CO-AS-005-001		2. Survey name: Moreau Drive Neighborhood Survey	
3. County: Cole		4. Address: 1202 Elmerine Ave.	
5. City: Jefferson City	Vicinity: <input type="checkbox"/>	6. UTM: / /	7. Township/Range/Section: T: R: S:
8. Historic name (if known):		9. Present/other name (if known):	
10. Ownership: <input checked="" type="checkbox"/> Private <input type="checkbox"/> Public		11. Historic use (if known): Residential	11. Current use: Residential

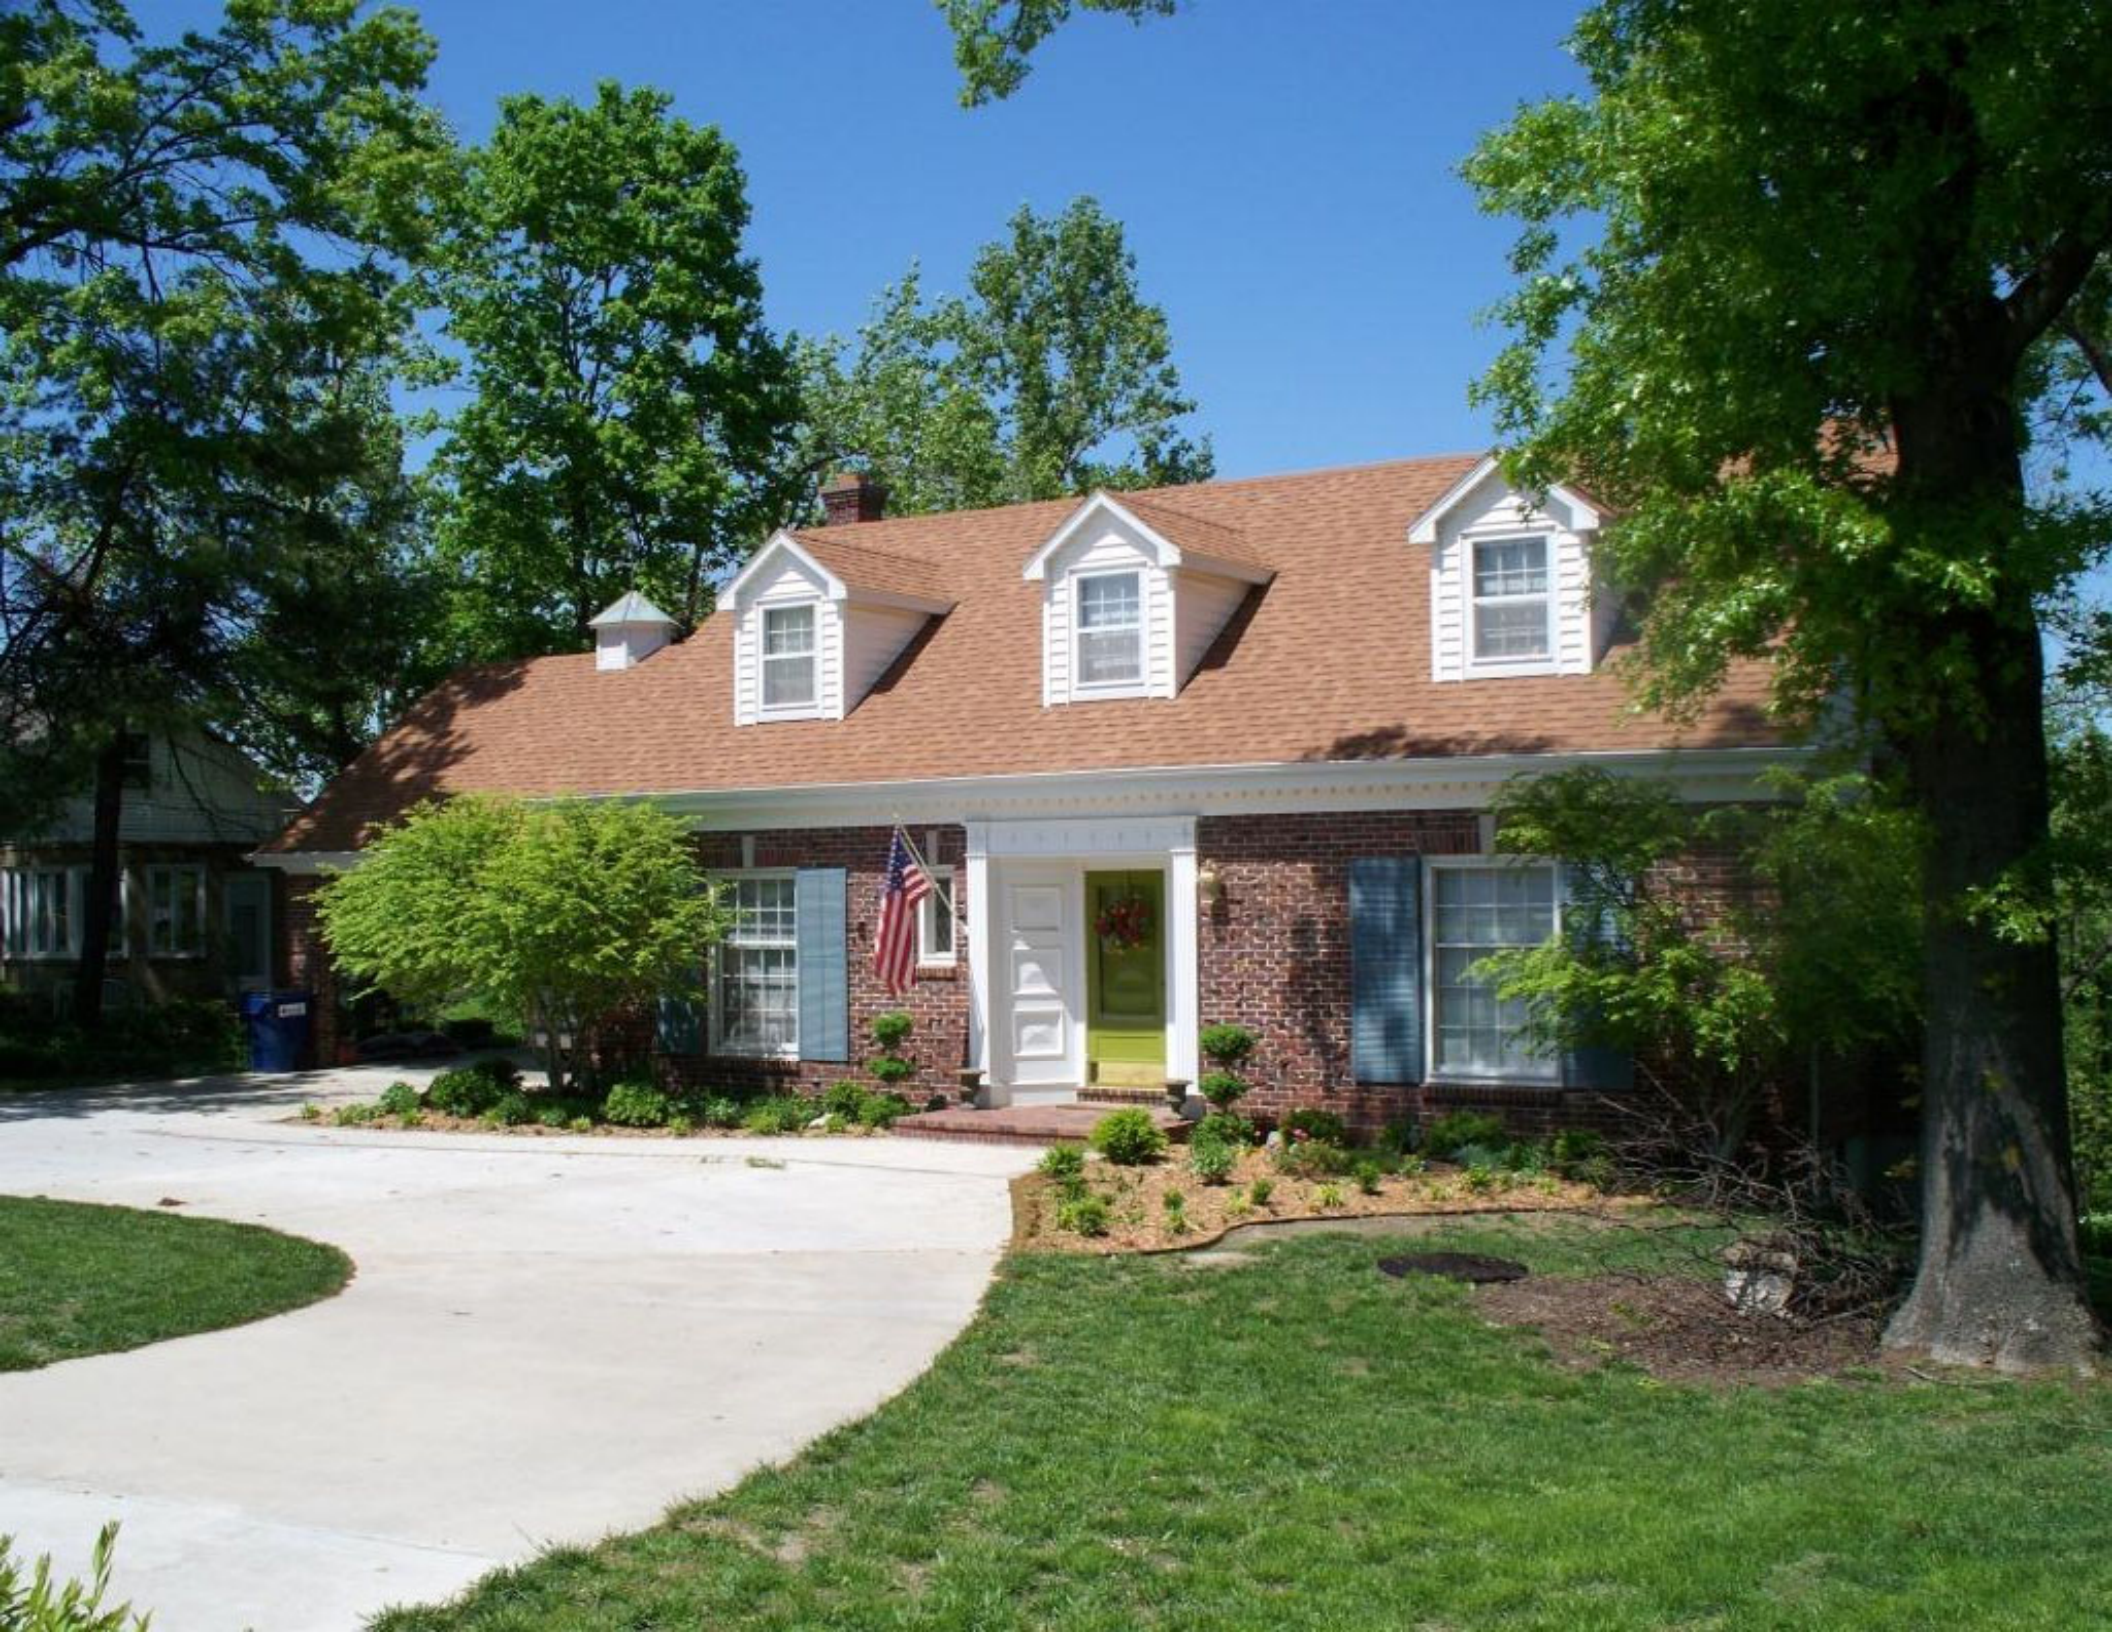
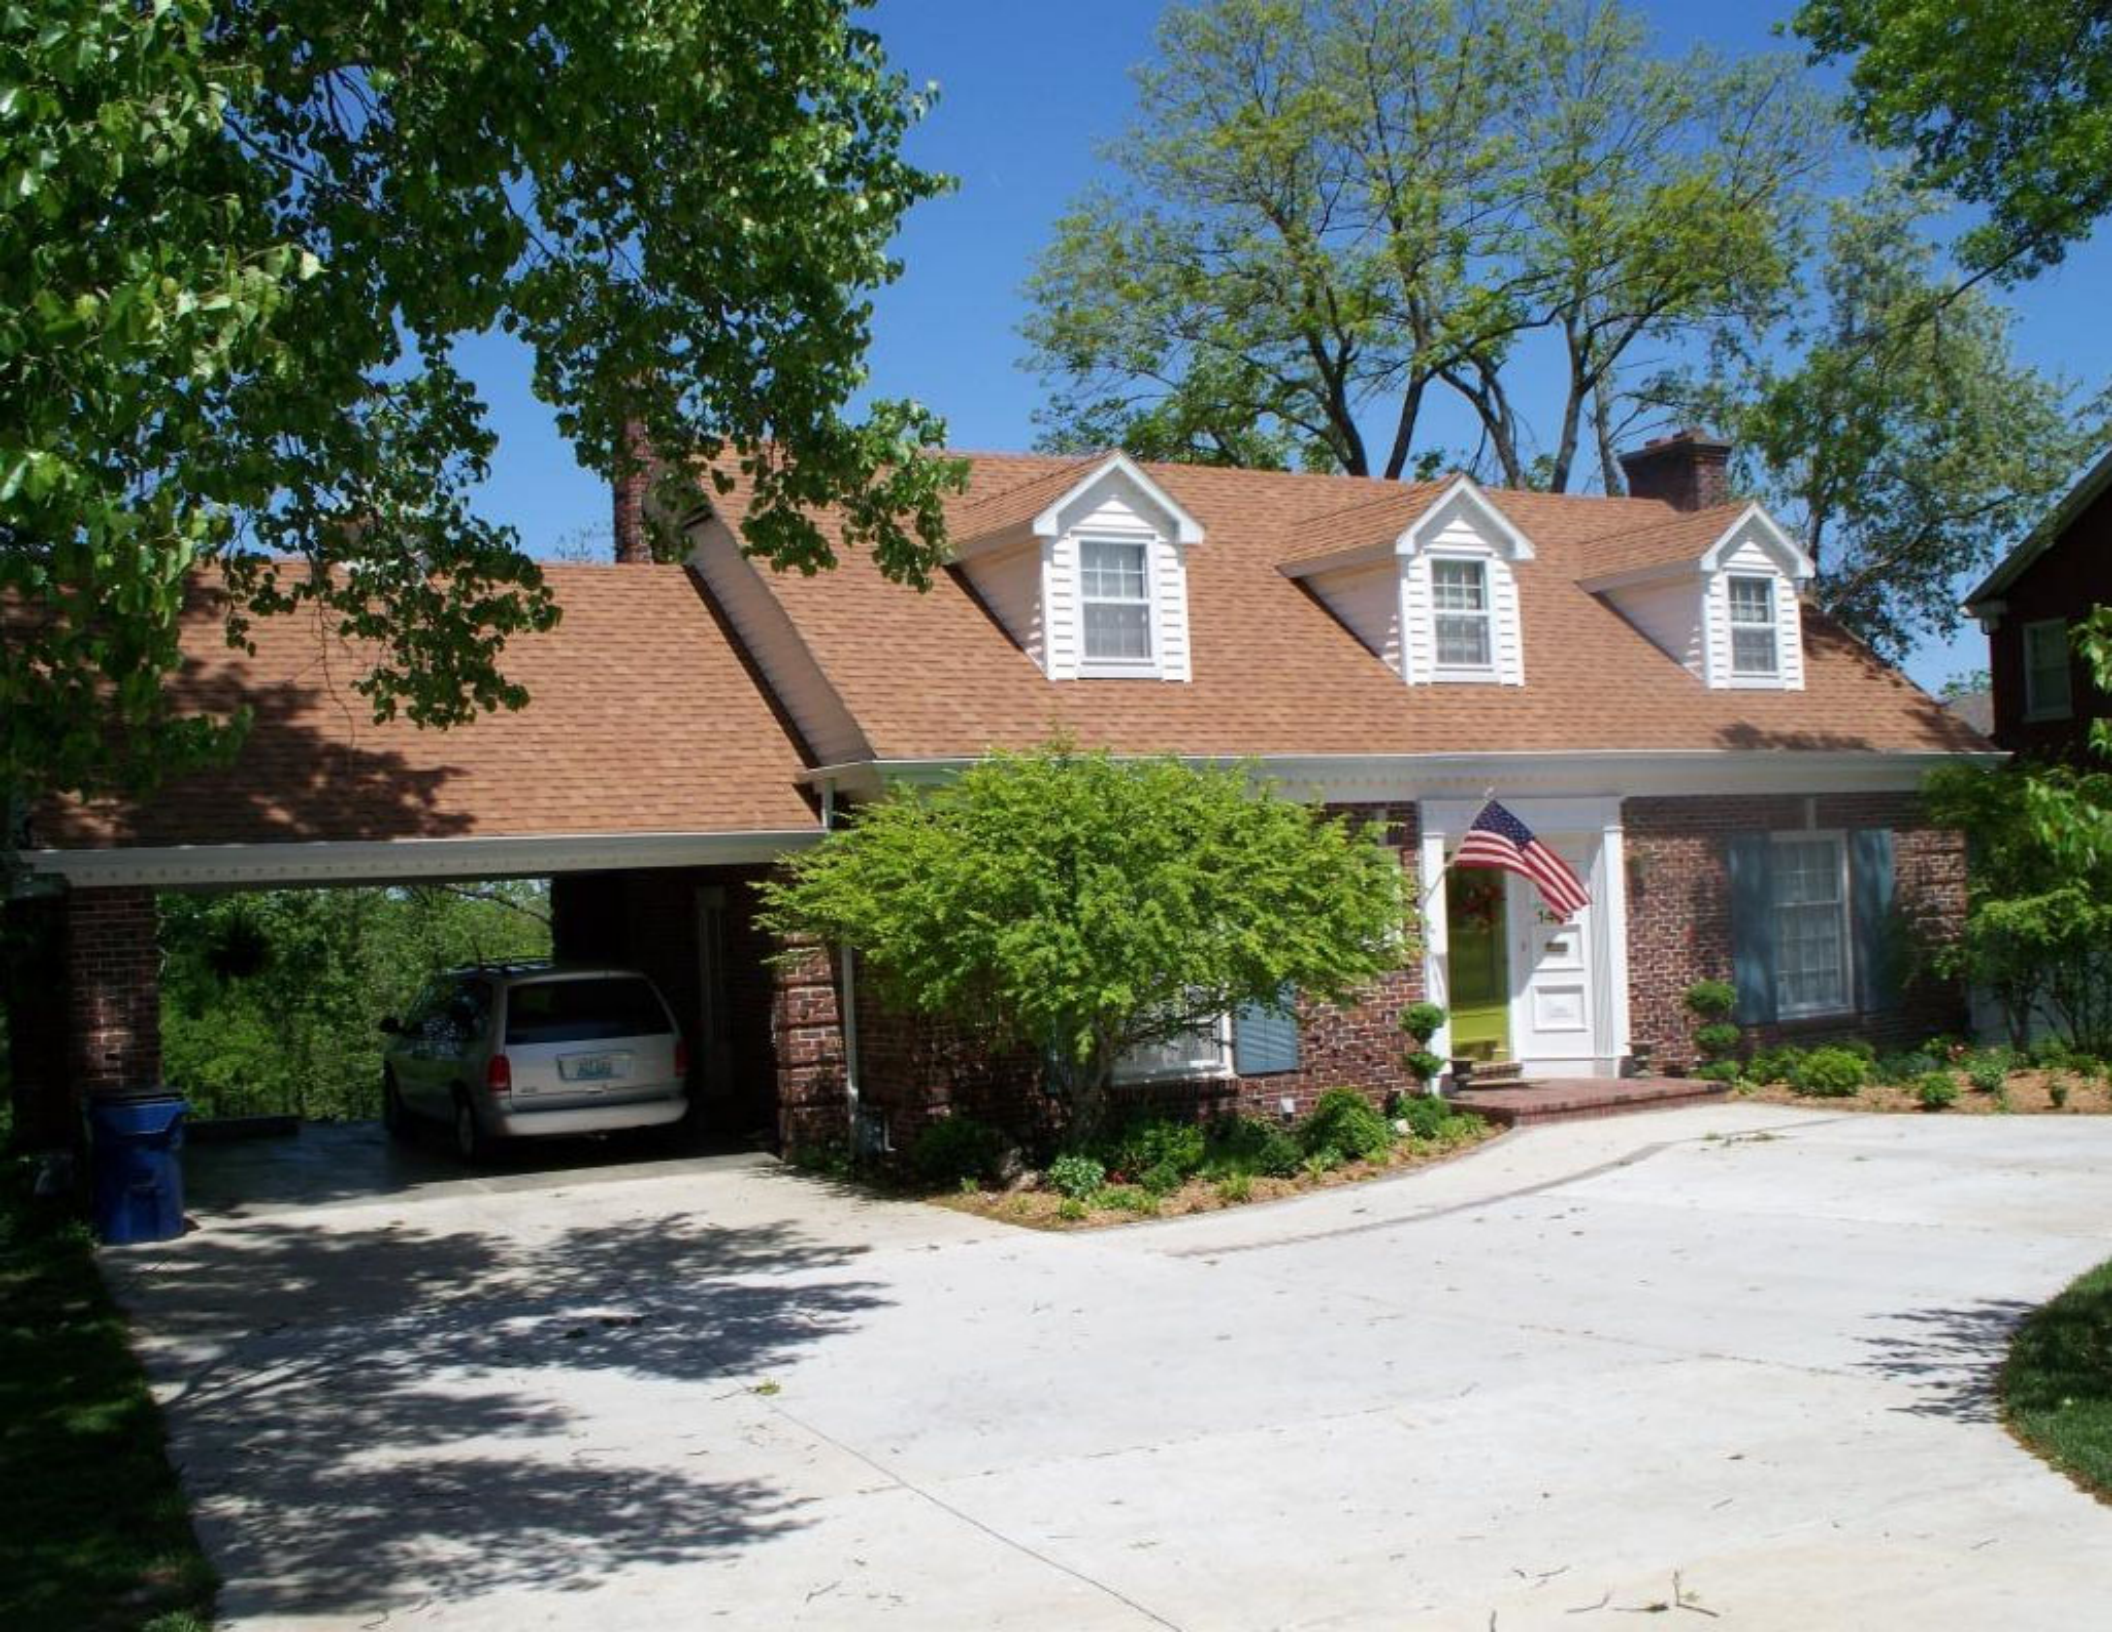
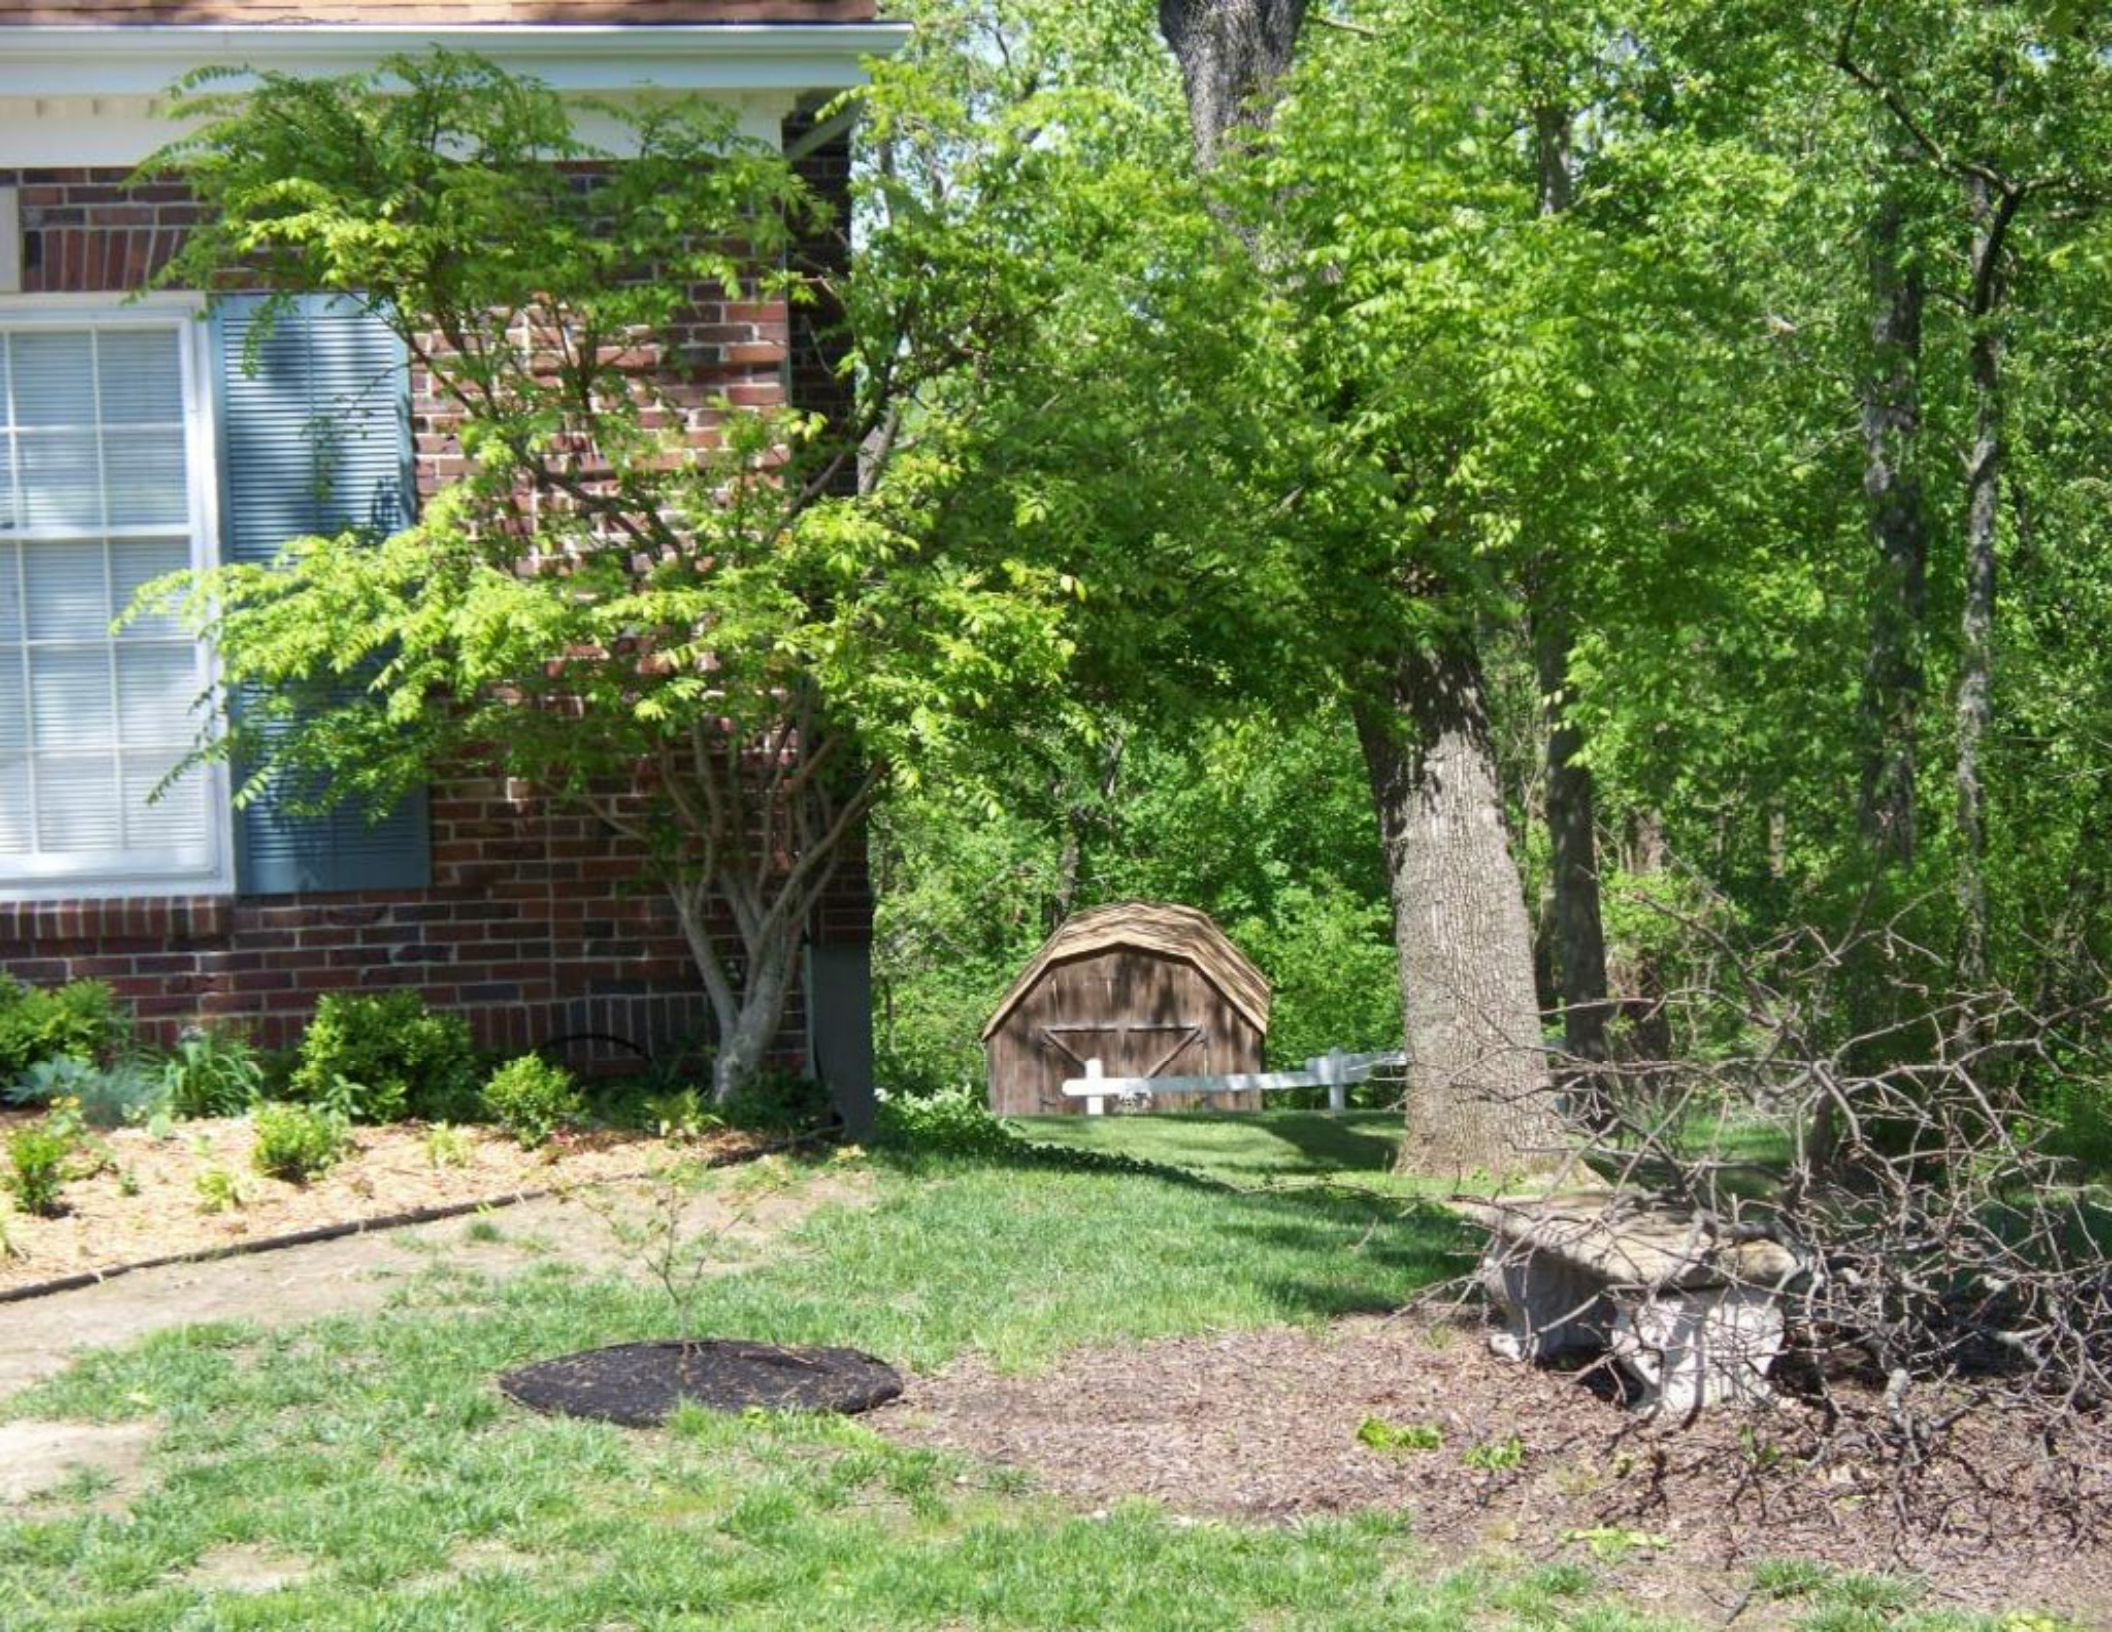
41. (cont.)
This one story brick ranch house has a side gable roof with three gabled dormers clad in vinyl with 6/6 modern windows. Two large 8/12 windows with flat arches and a keystone with shutters flank the recessed entrance. An ornate door surround and paneling clads the opening and recessed portion of the home. A small rectangular window with art glass is to the left of the entrance it also has a flat arch and a keystone. Set slightly back to the left of the building is a brick carport with a side gable roof. A small cupola straddles the roof ridge.

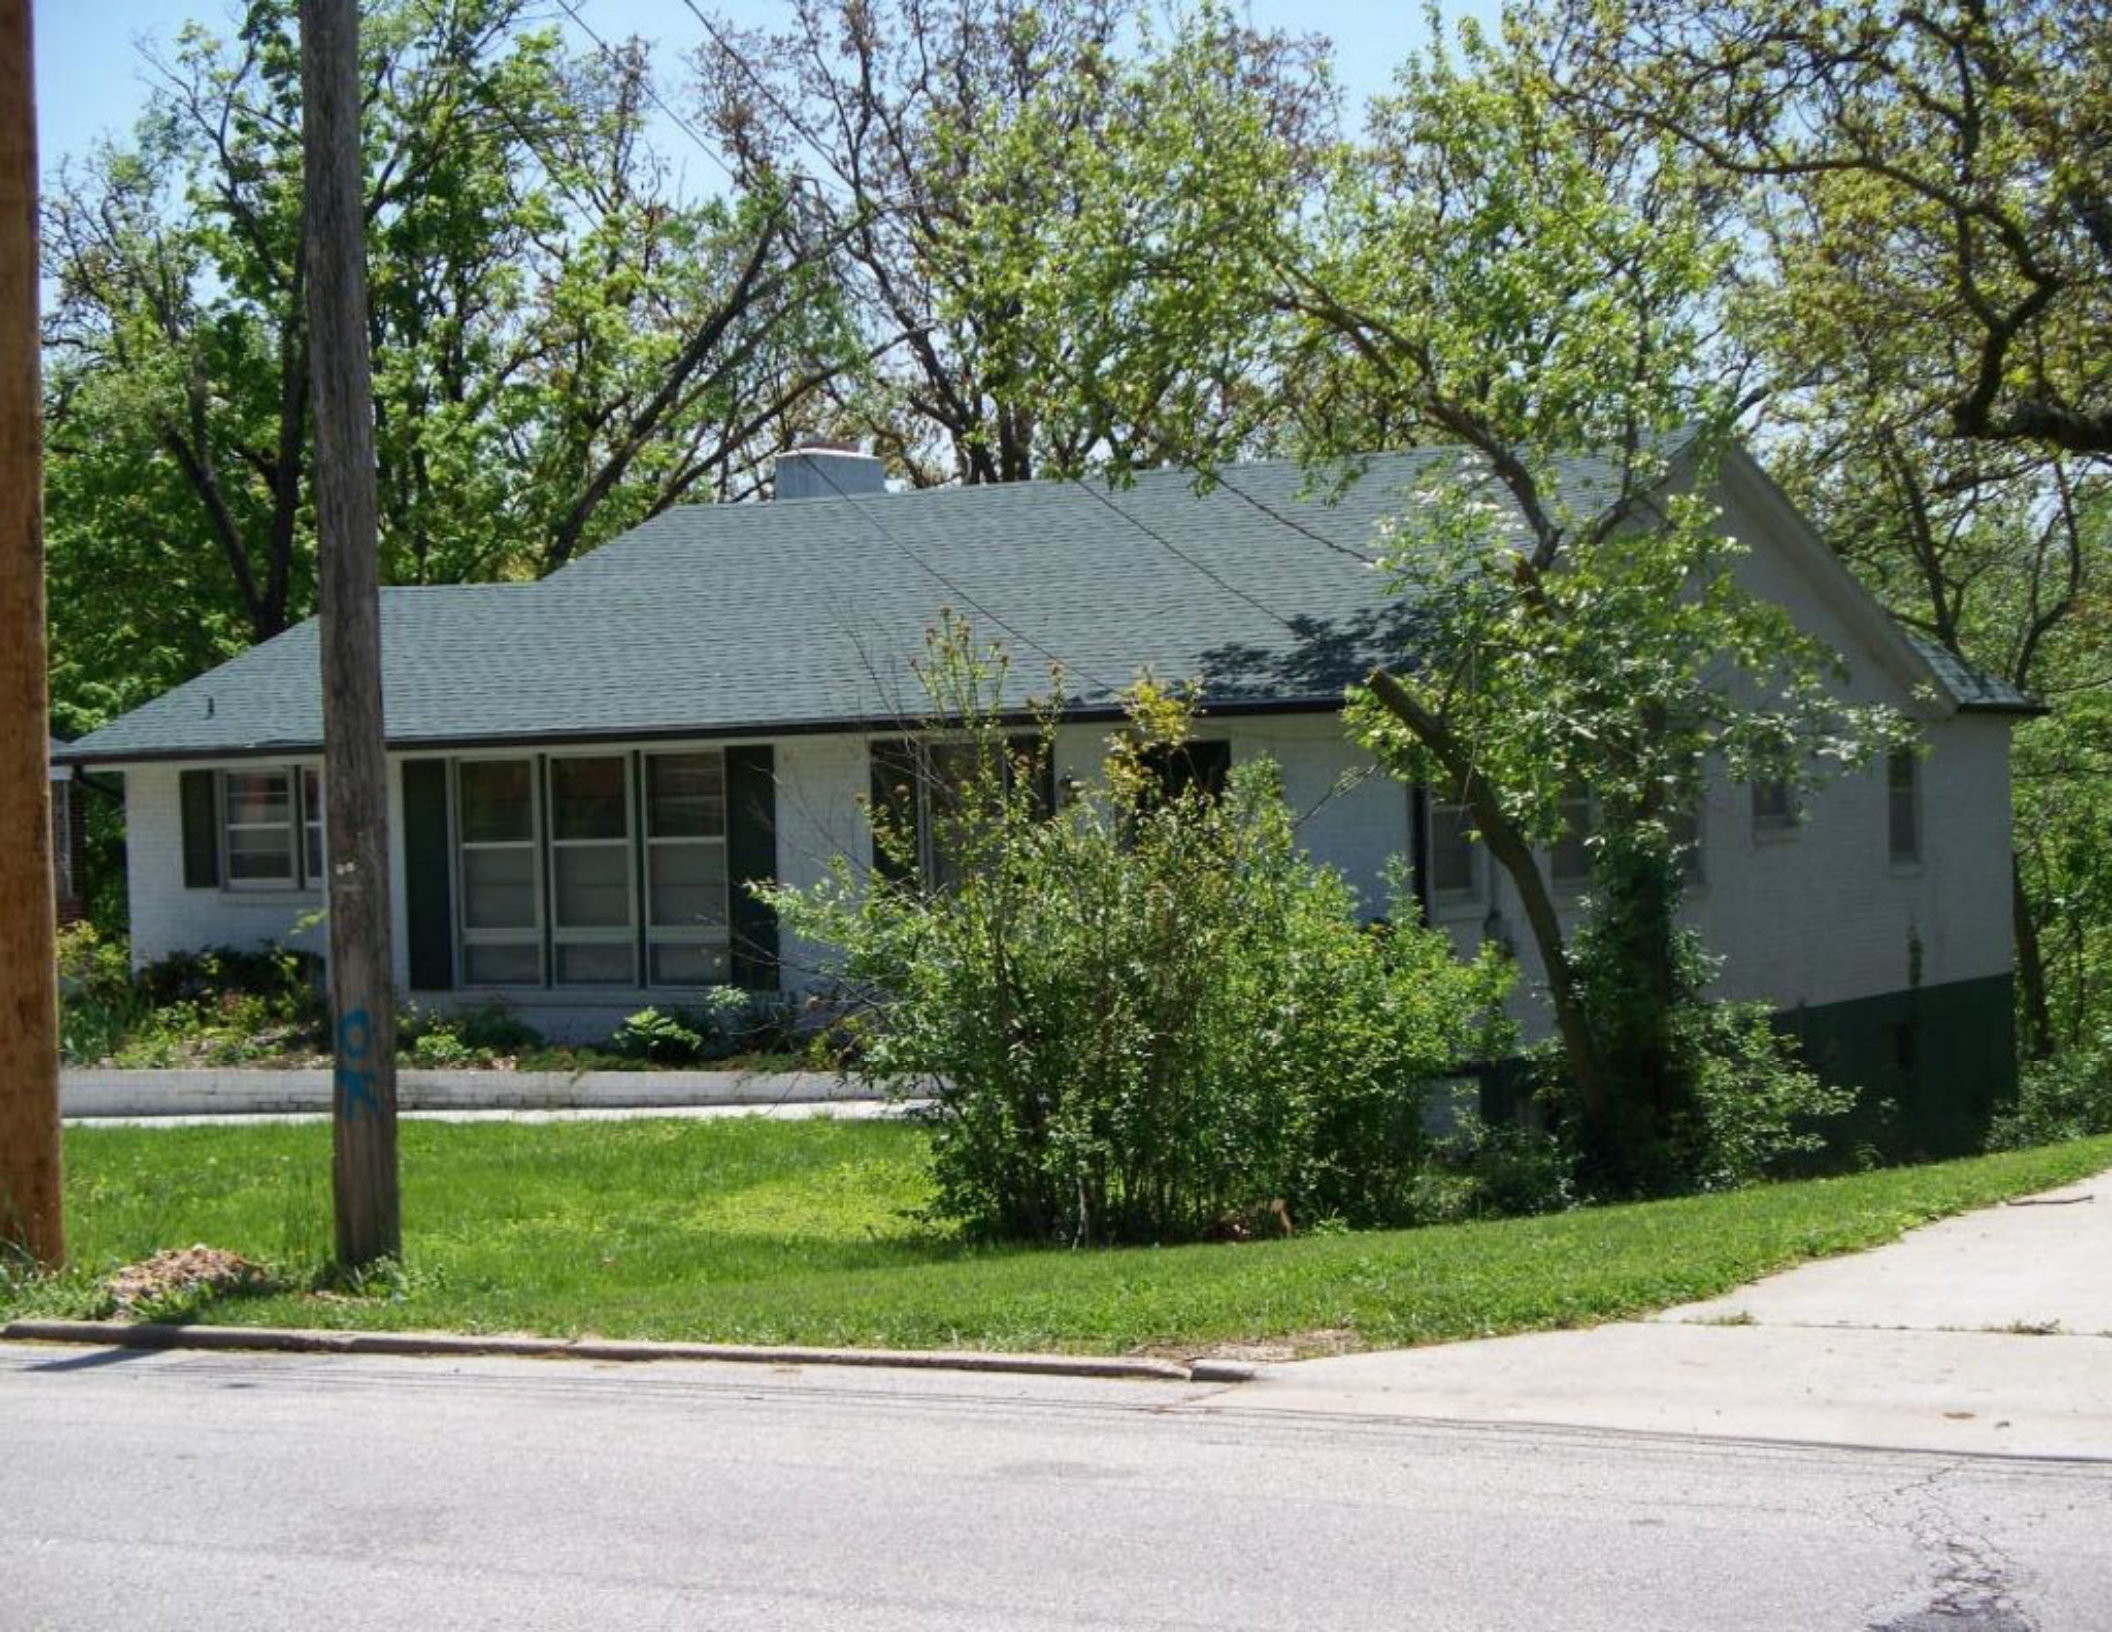
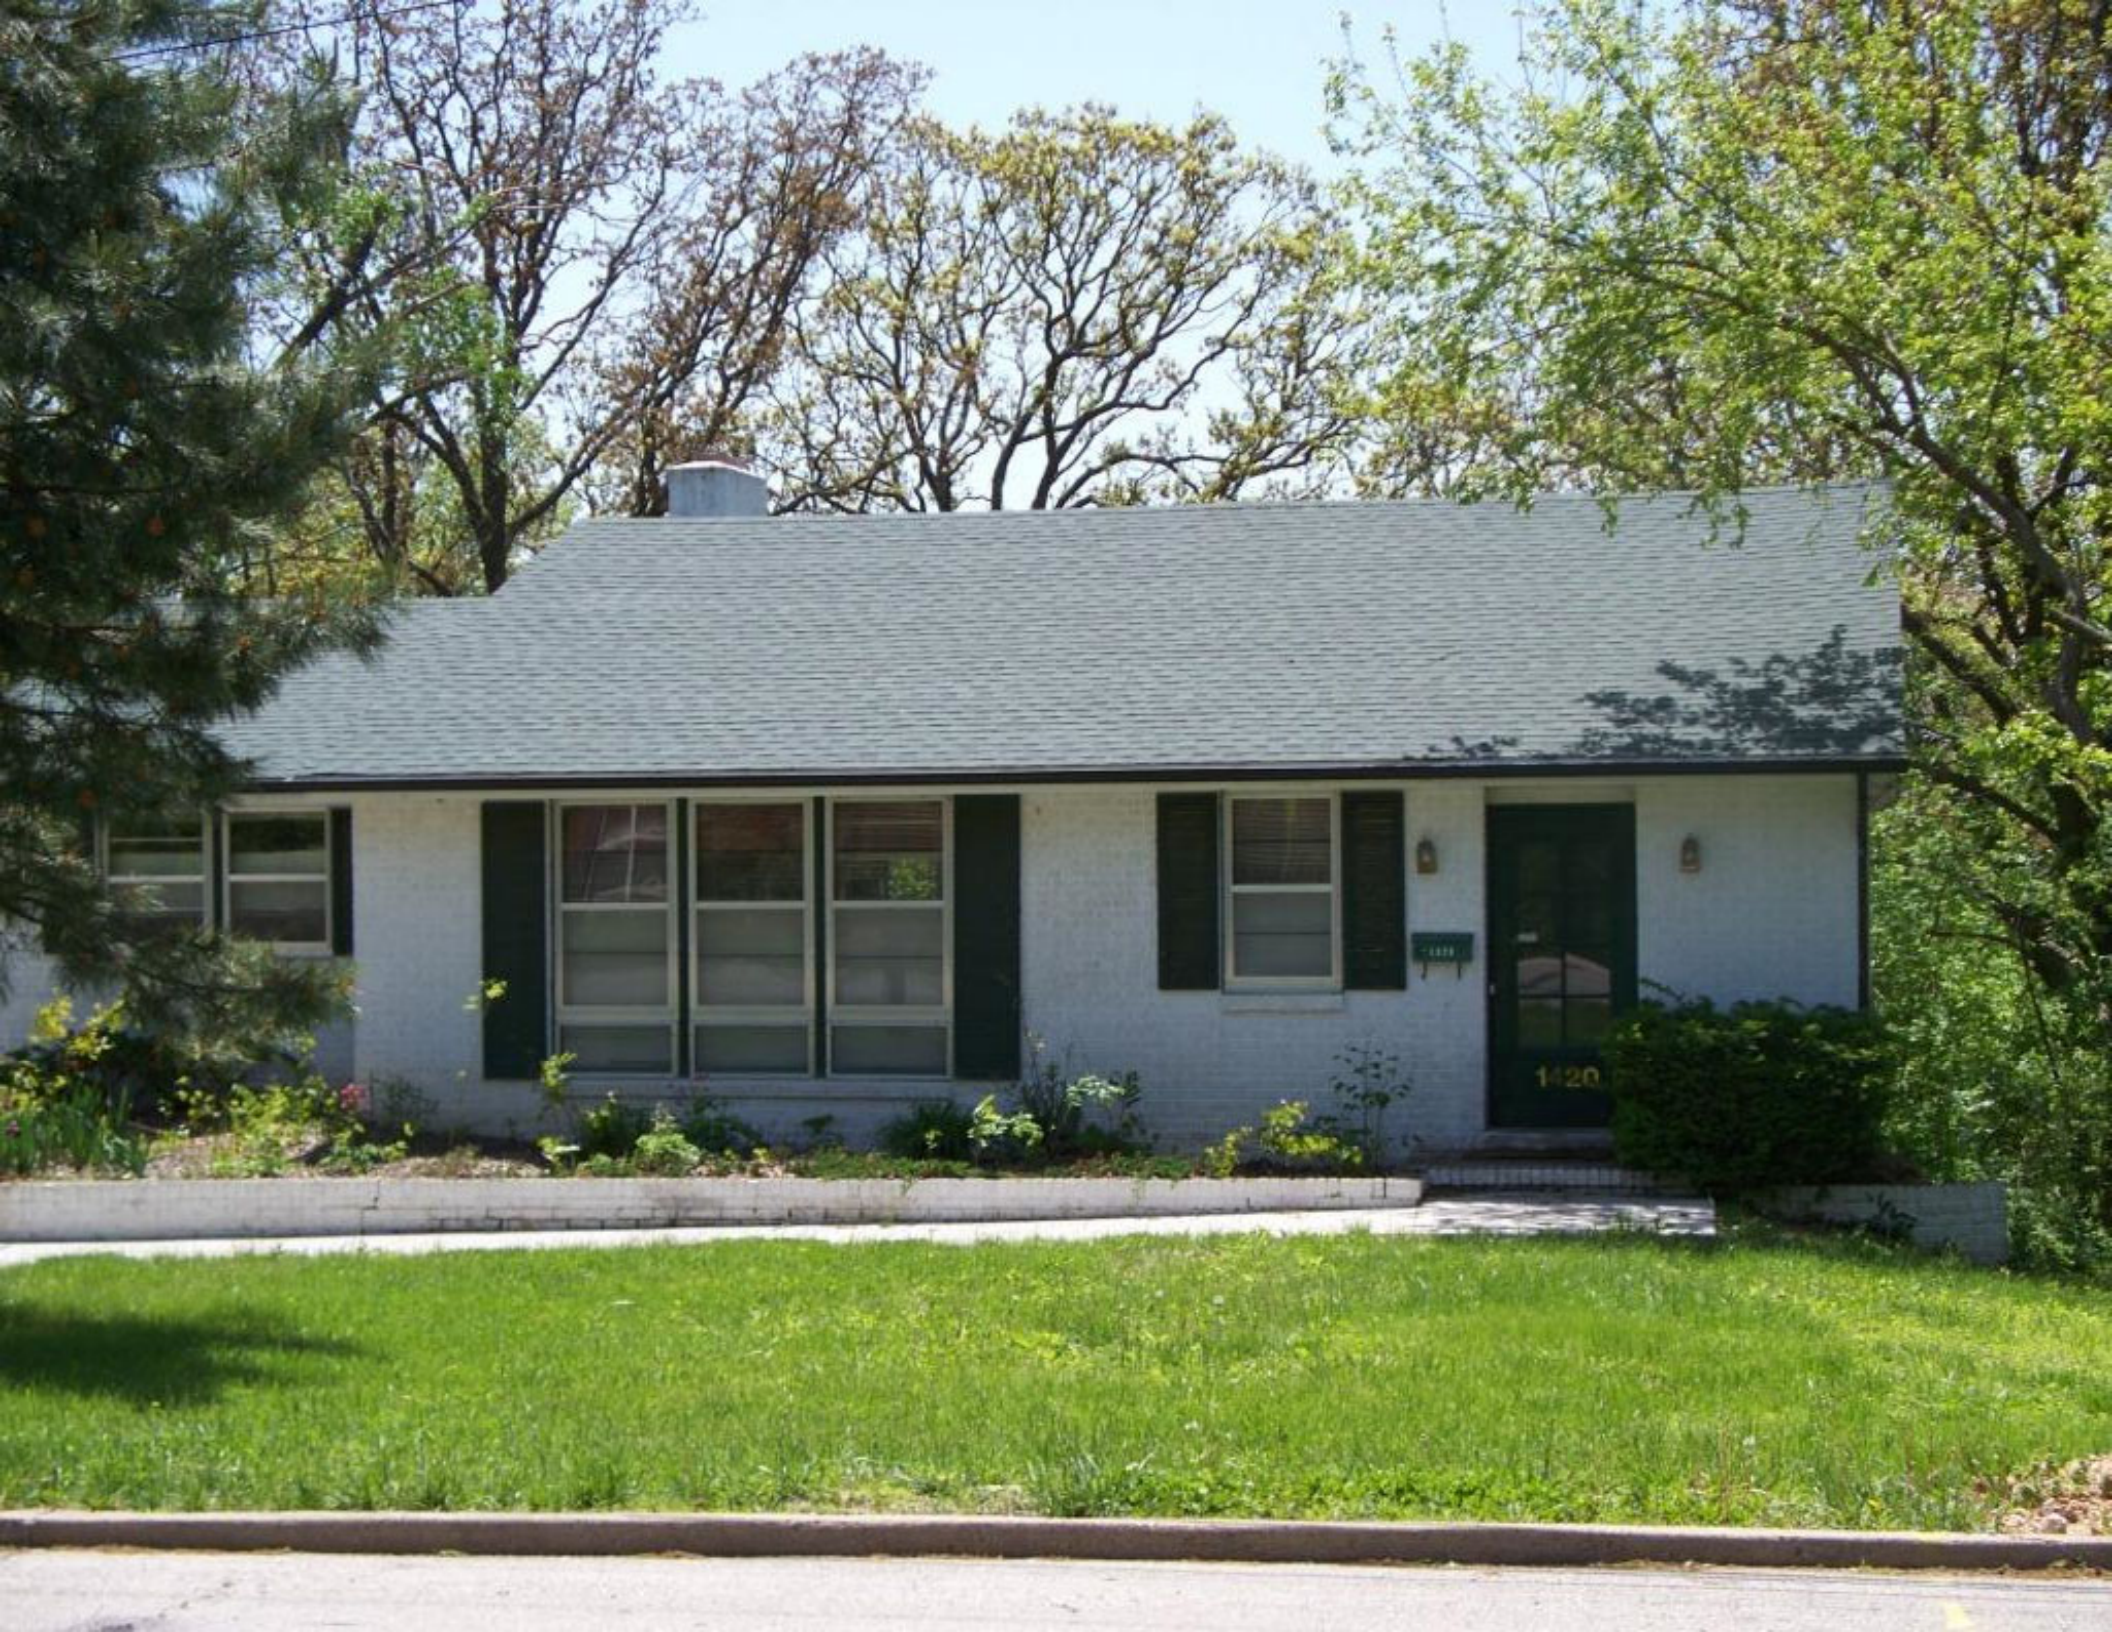
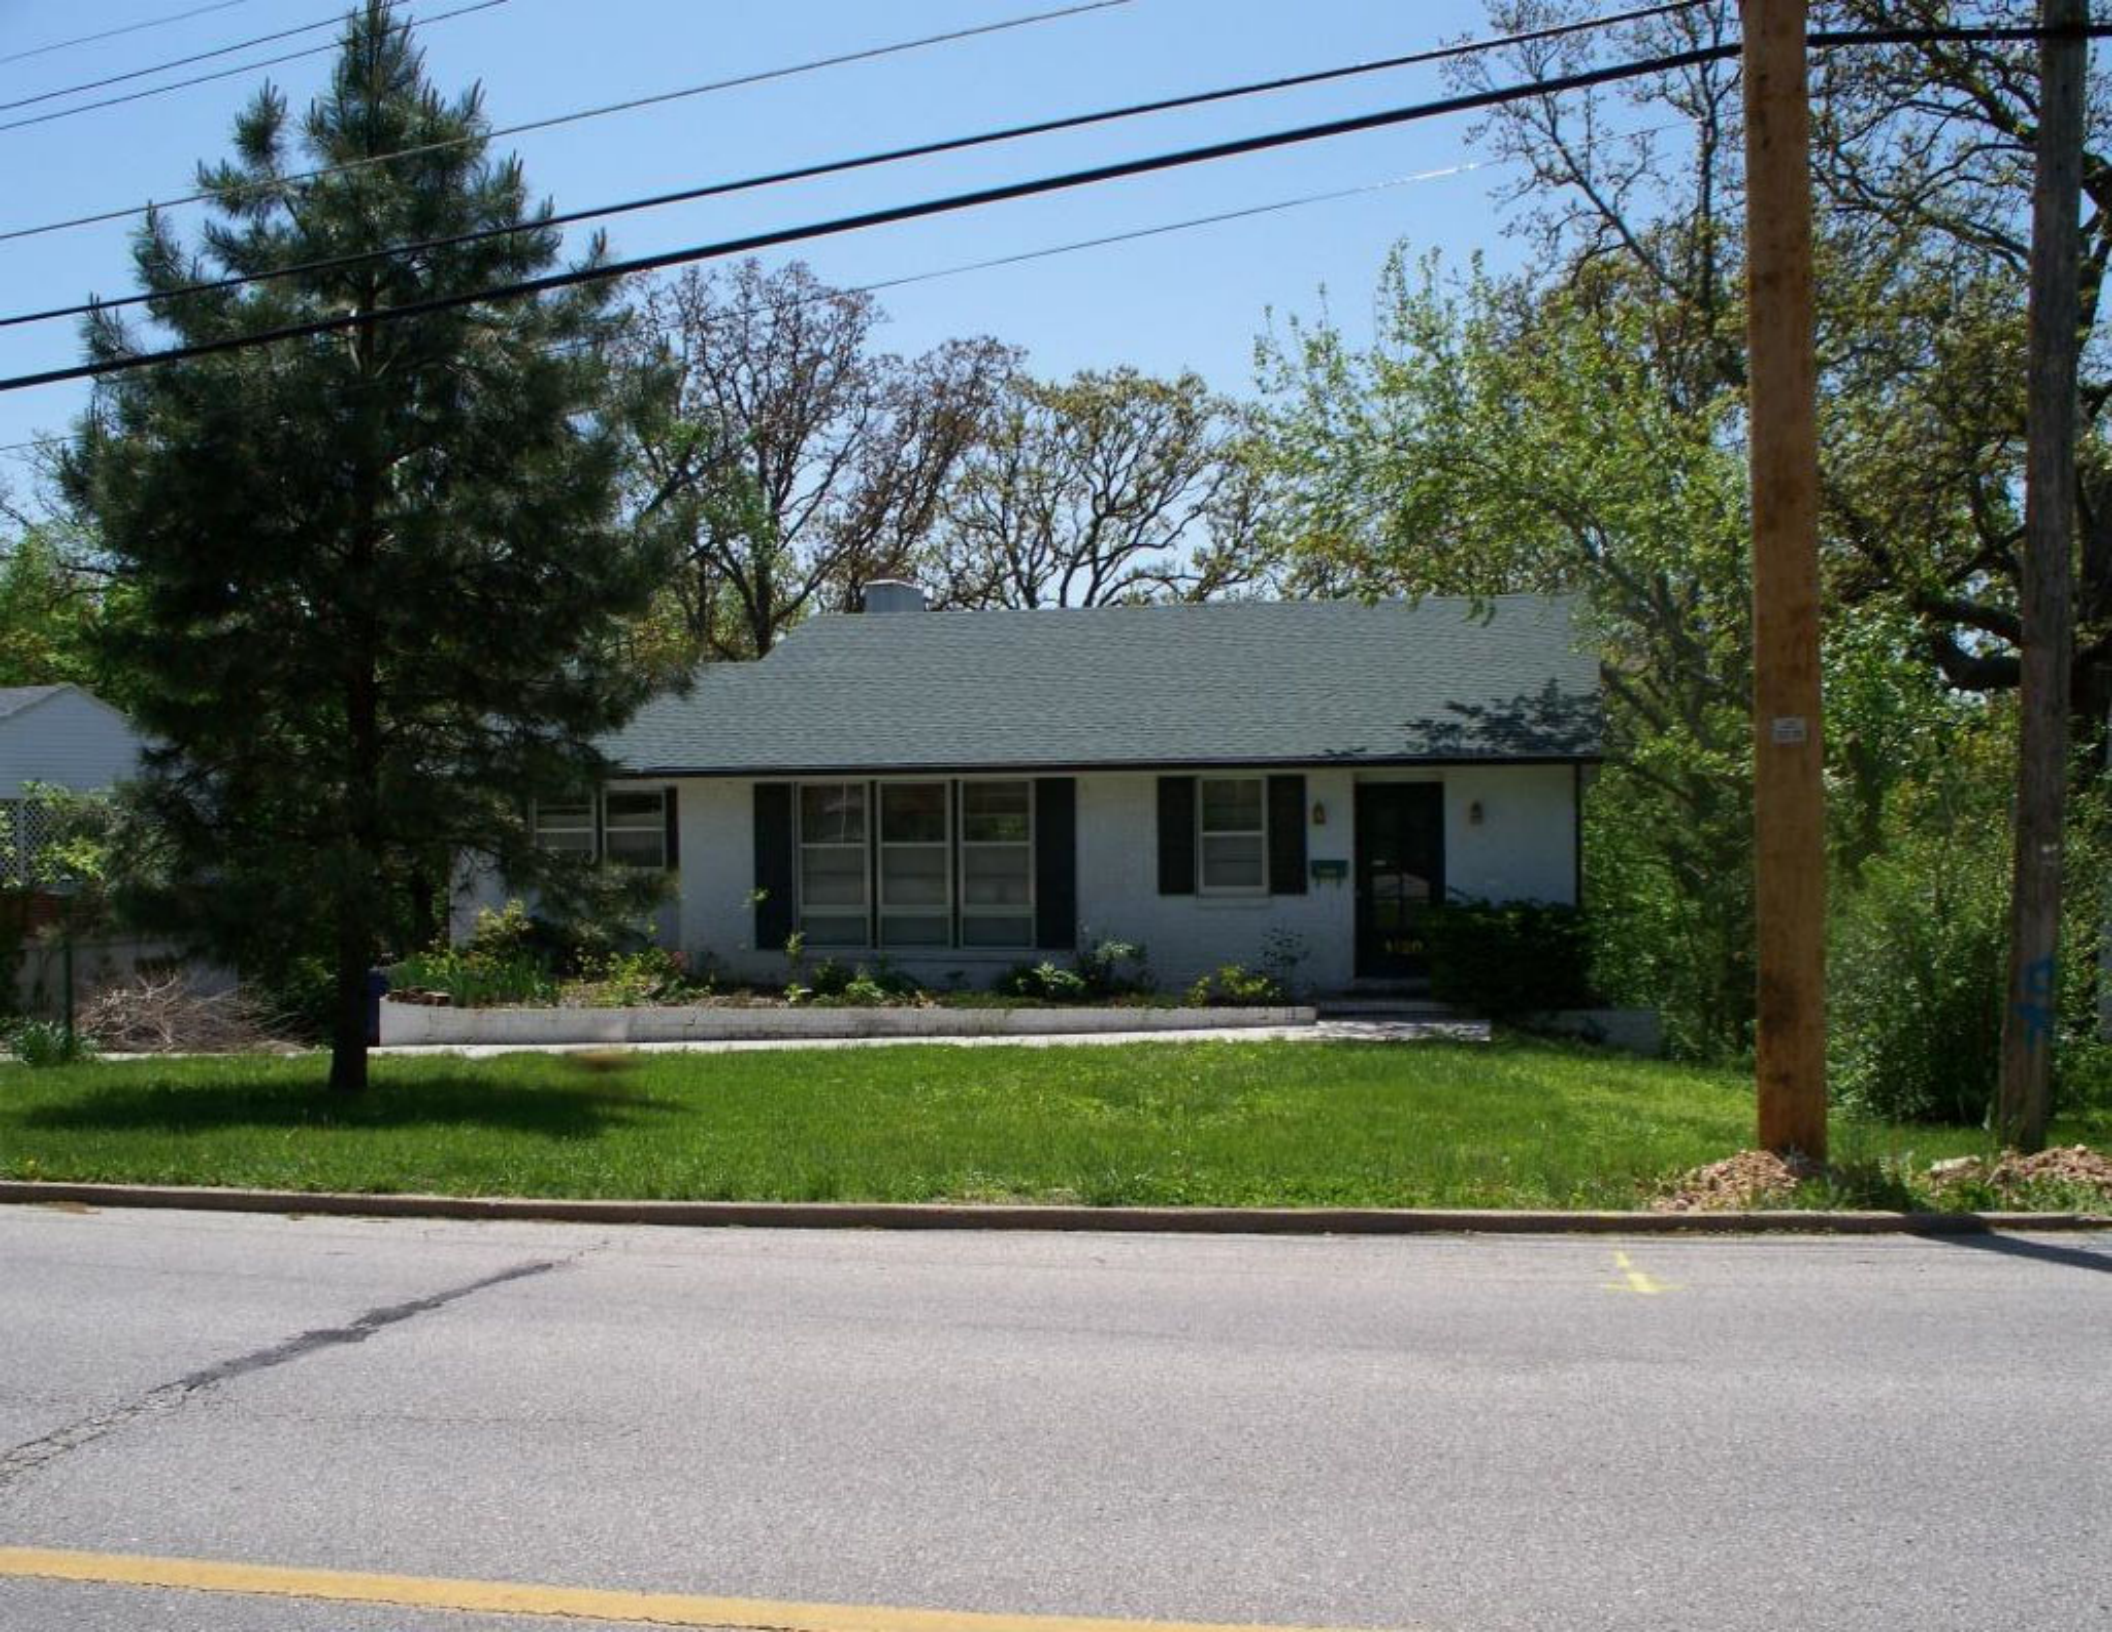
41. (cont.)
This 1 story brick ranch home has a side gable roof. The entrance has a wooden multi-light storm door and is located in the right bay and features a brick stoop. The next bay to the left has a single 1/1 window with shutters. A row of three longer 1/1 windows with shutters is in the next bay. The final bay, which is flush with the building but has a break in the roof, features shorter paired 1/1 windows with shutters.
