ARCHITECTURAL/HISTORIC INVENTORY FORM

1. Survey No. CO-AS-005-001		2. Survey name: Moreau Drive Neighborhood Survey	
3. County: Cole		4. Address: 1202 Elmerine Ave.	
5. City: Jefferson City	Vicinity: <input type="checkbox"/>	6. UTM: / /	7. Township/Range/Section: T: R: S:
8. Historic name (if known):		9. Present/other name (if known):	
10. Ownership: <input checked="" type="checkbox"/> Private <input type="checkbox"/> Public		11. Historic use (if known): Residential	11. Current use: Residential

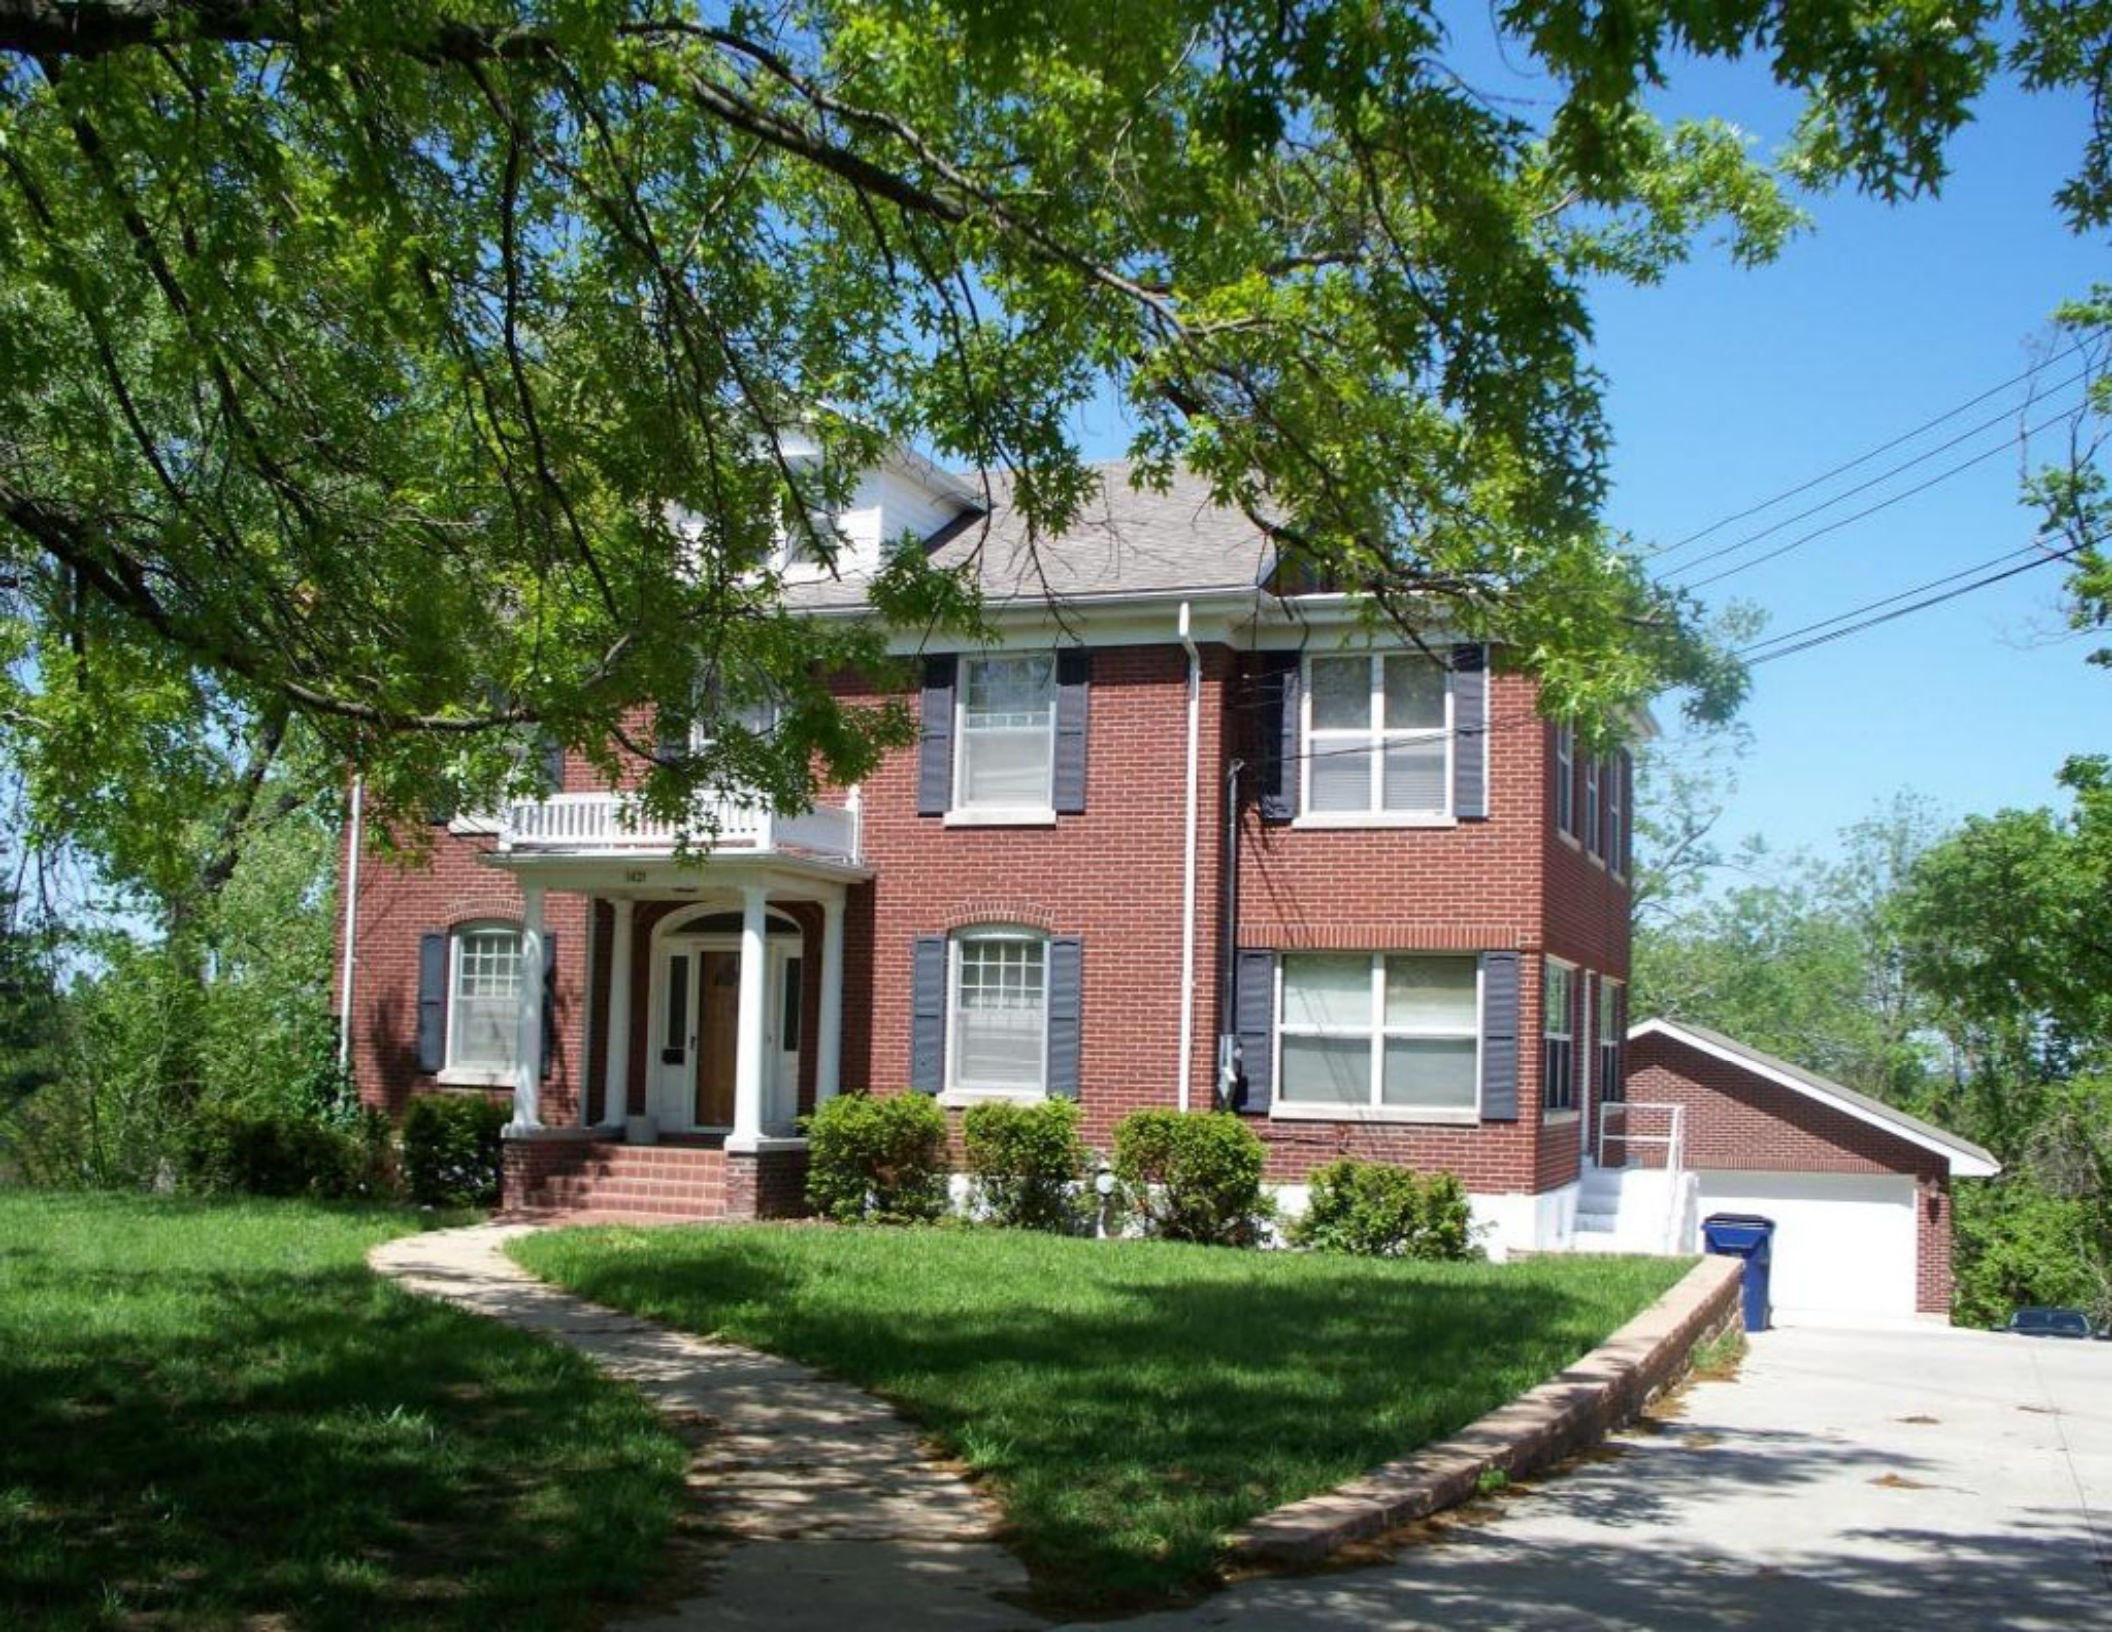
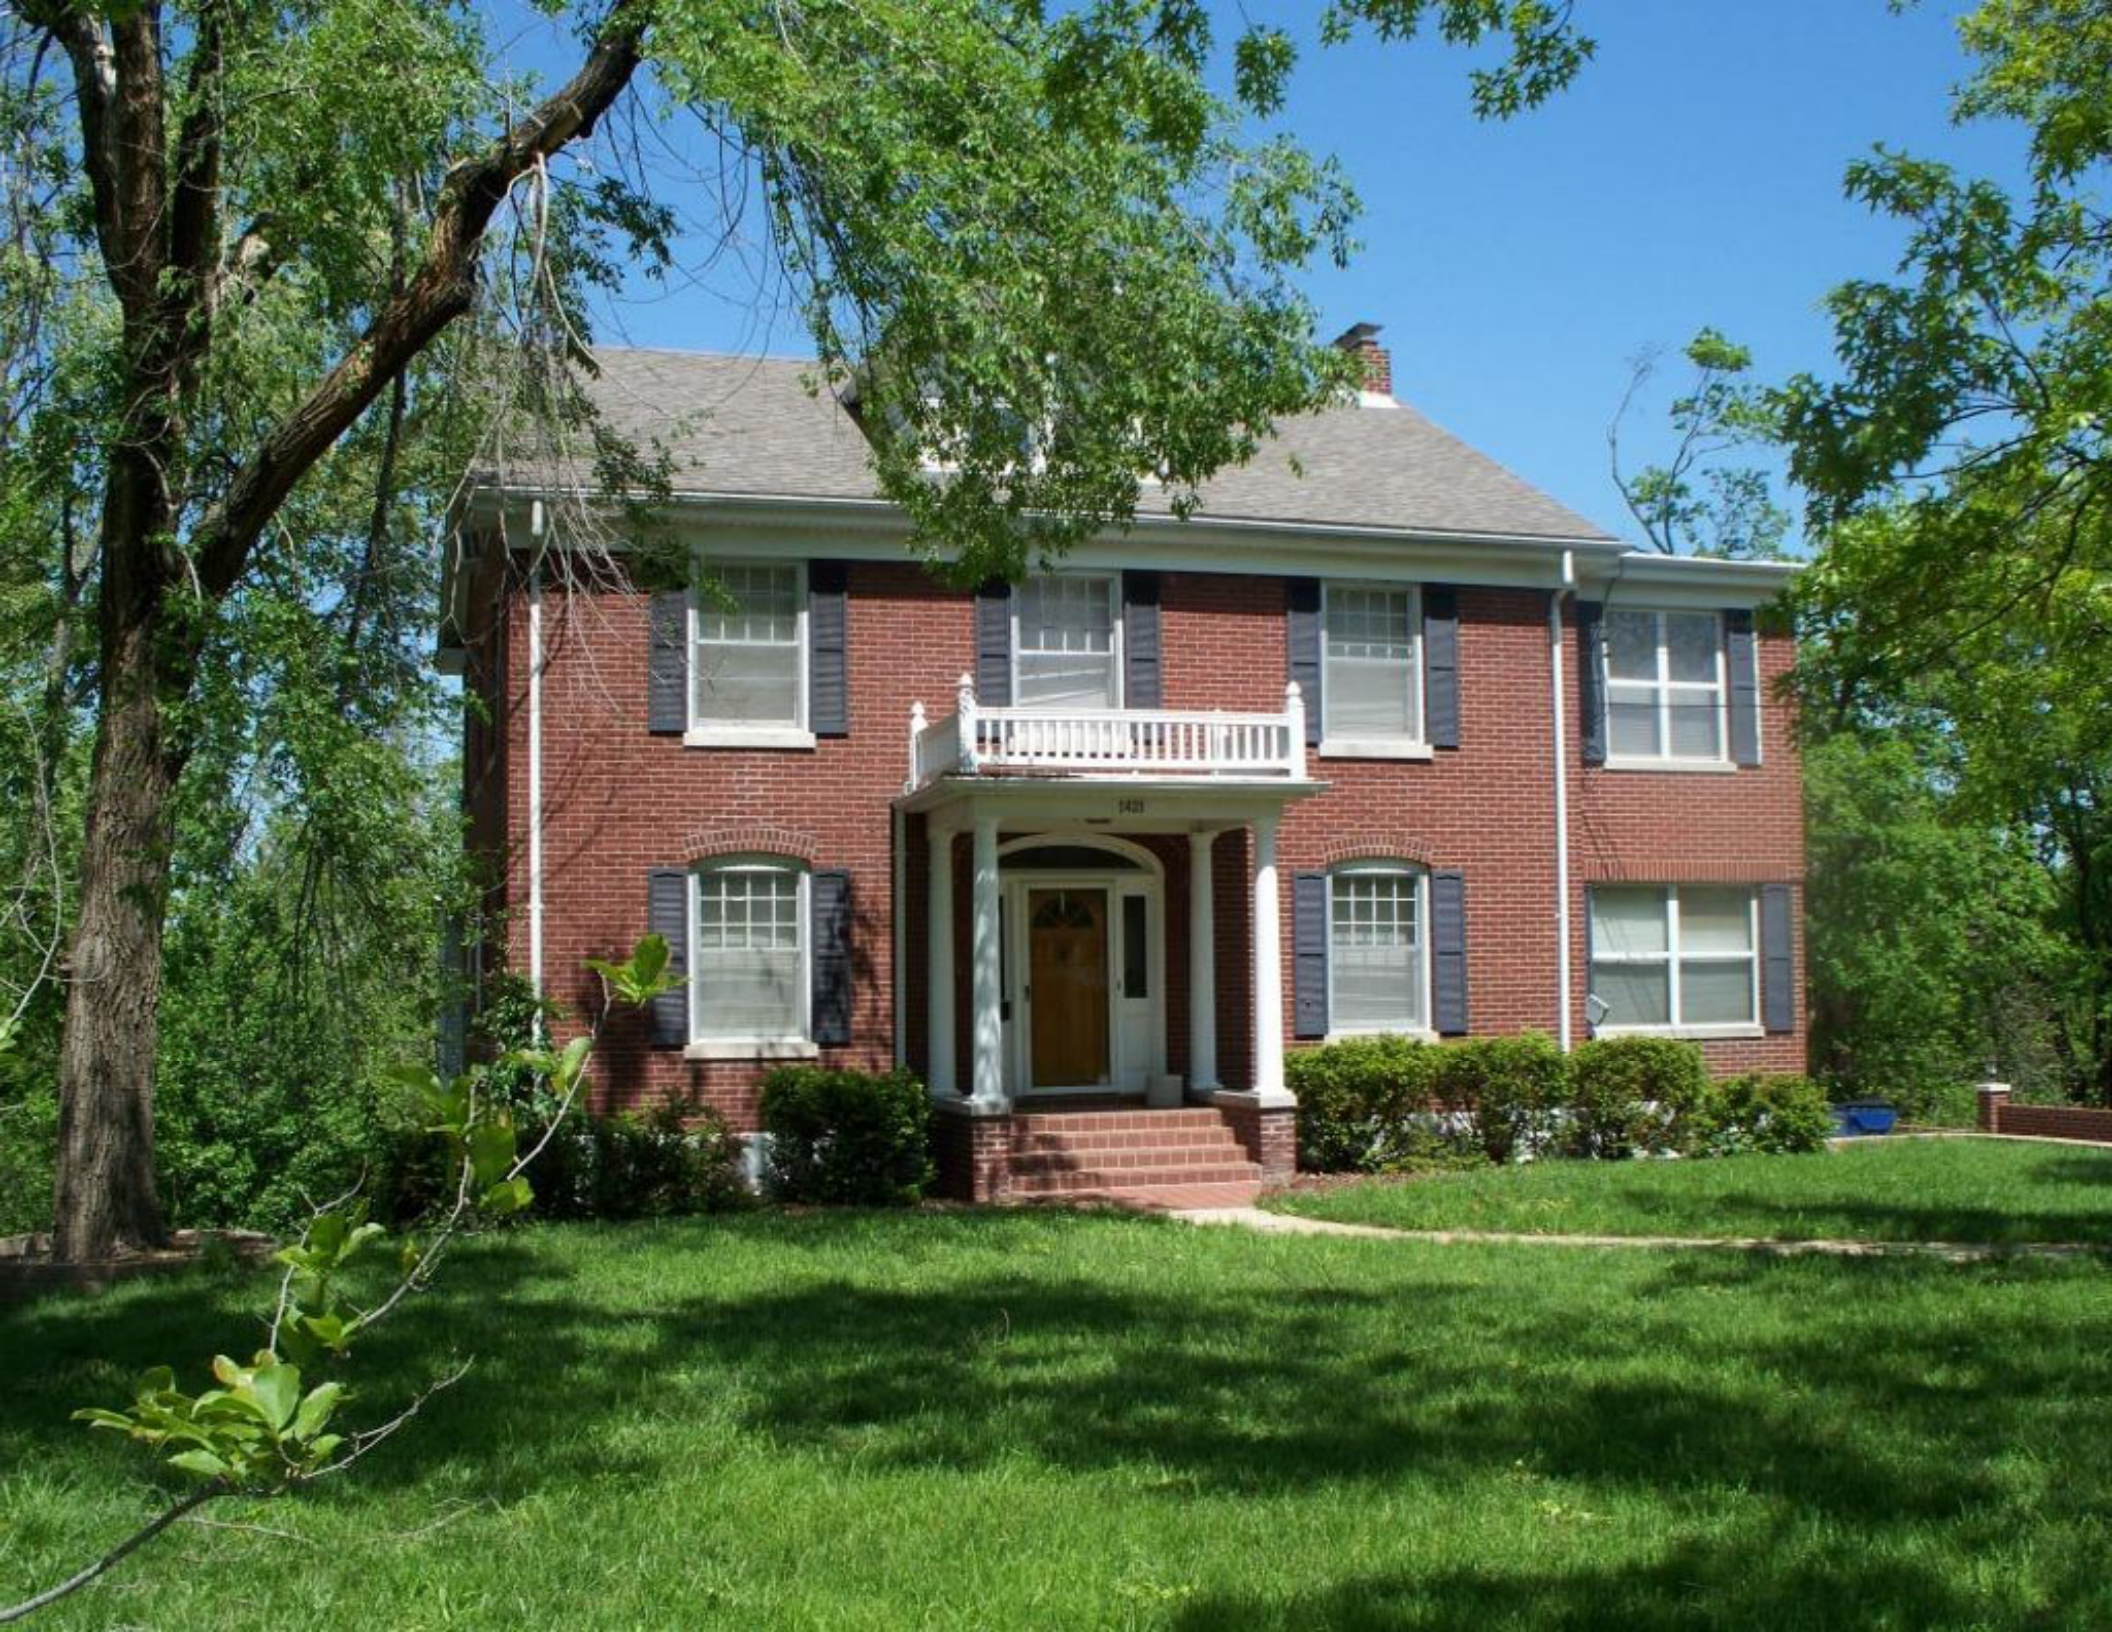
41. (cont.)
This 2 ½ story brick Colonial Revival has a side gable roof with a gabled dormer clad in vinyl with two windows (obscured by tree). The second floor has three 12/1 replacement windows with shutters. All of the windows have concrete sills (saves those in the dormer). The second floor has two flat 12/1 windows in segmental arched openings, which flank the entrance. The entrance has a narrow fanlight/transom and sidelights. It is sheltered by a flat roof with railing on top and is supported by two pillars and two pilasters. A brick stoop and stair lead up to entrance. Set back to the left is a two story wing with a flat roof and paired 1/1 windows on each floor with shutters. The windows on the lower floor are wider and a feature soldier course lintel. This wing was likely a sleeping porch.

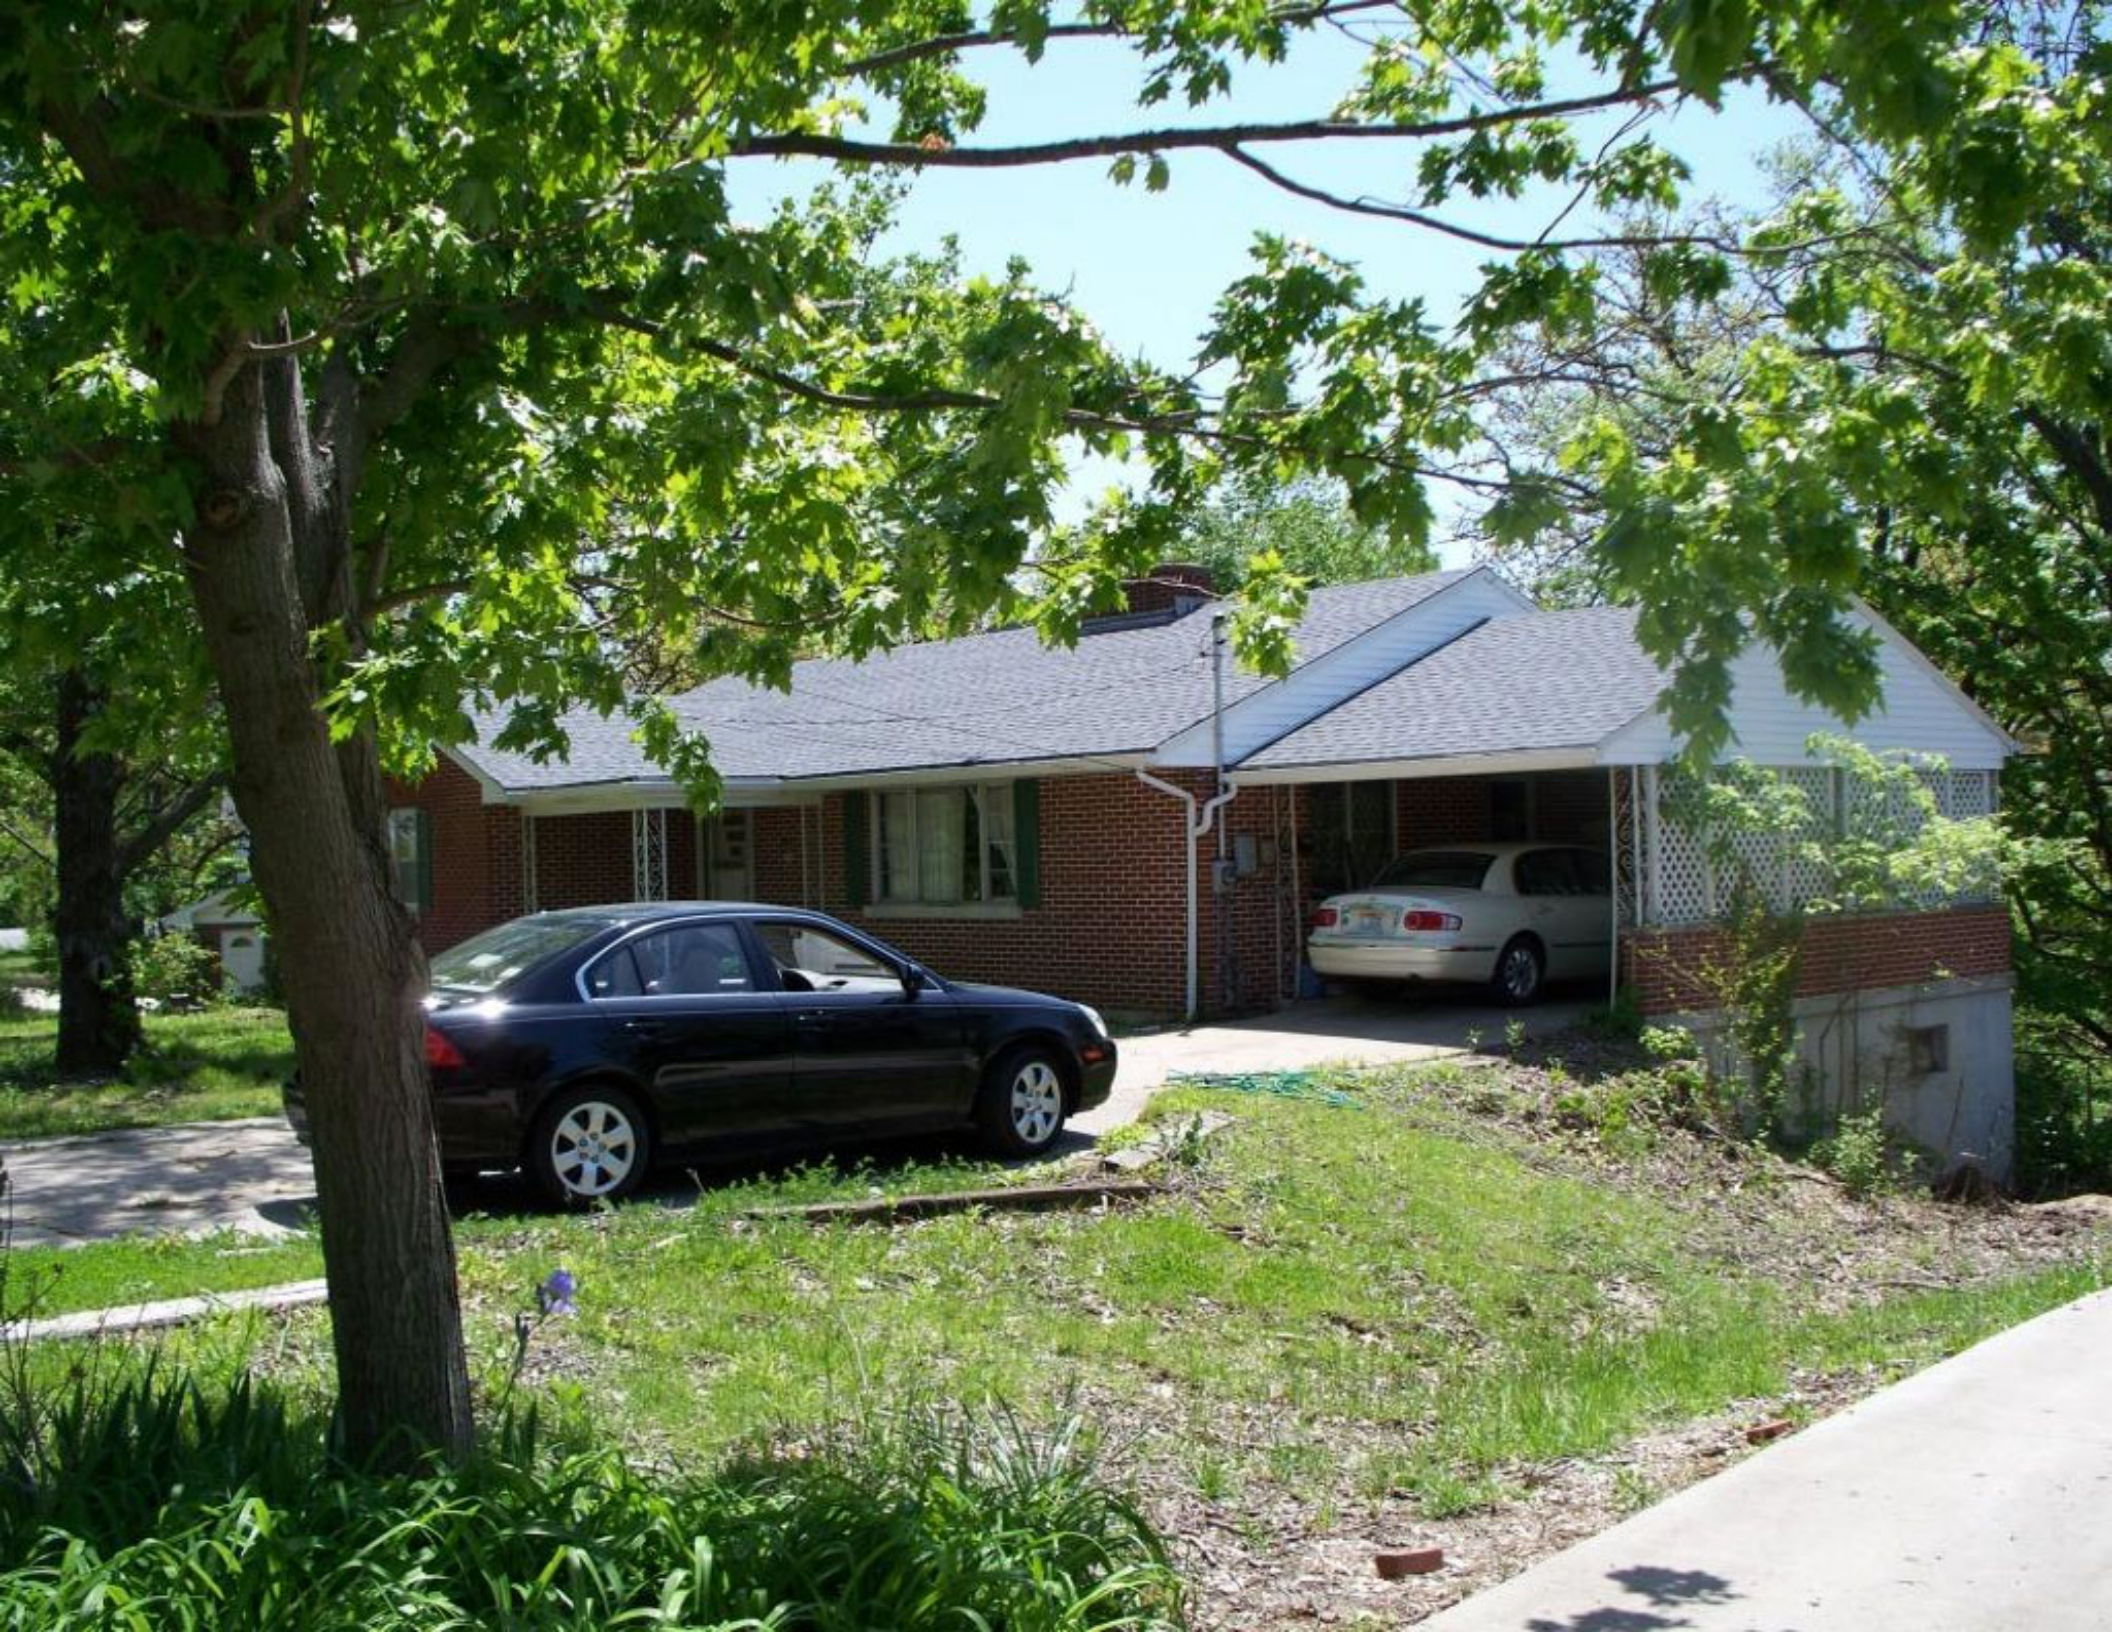
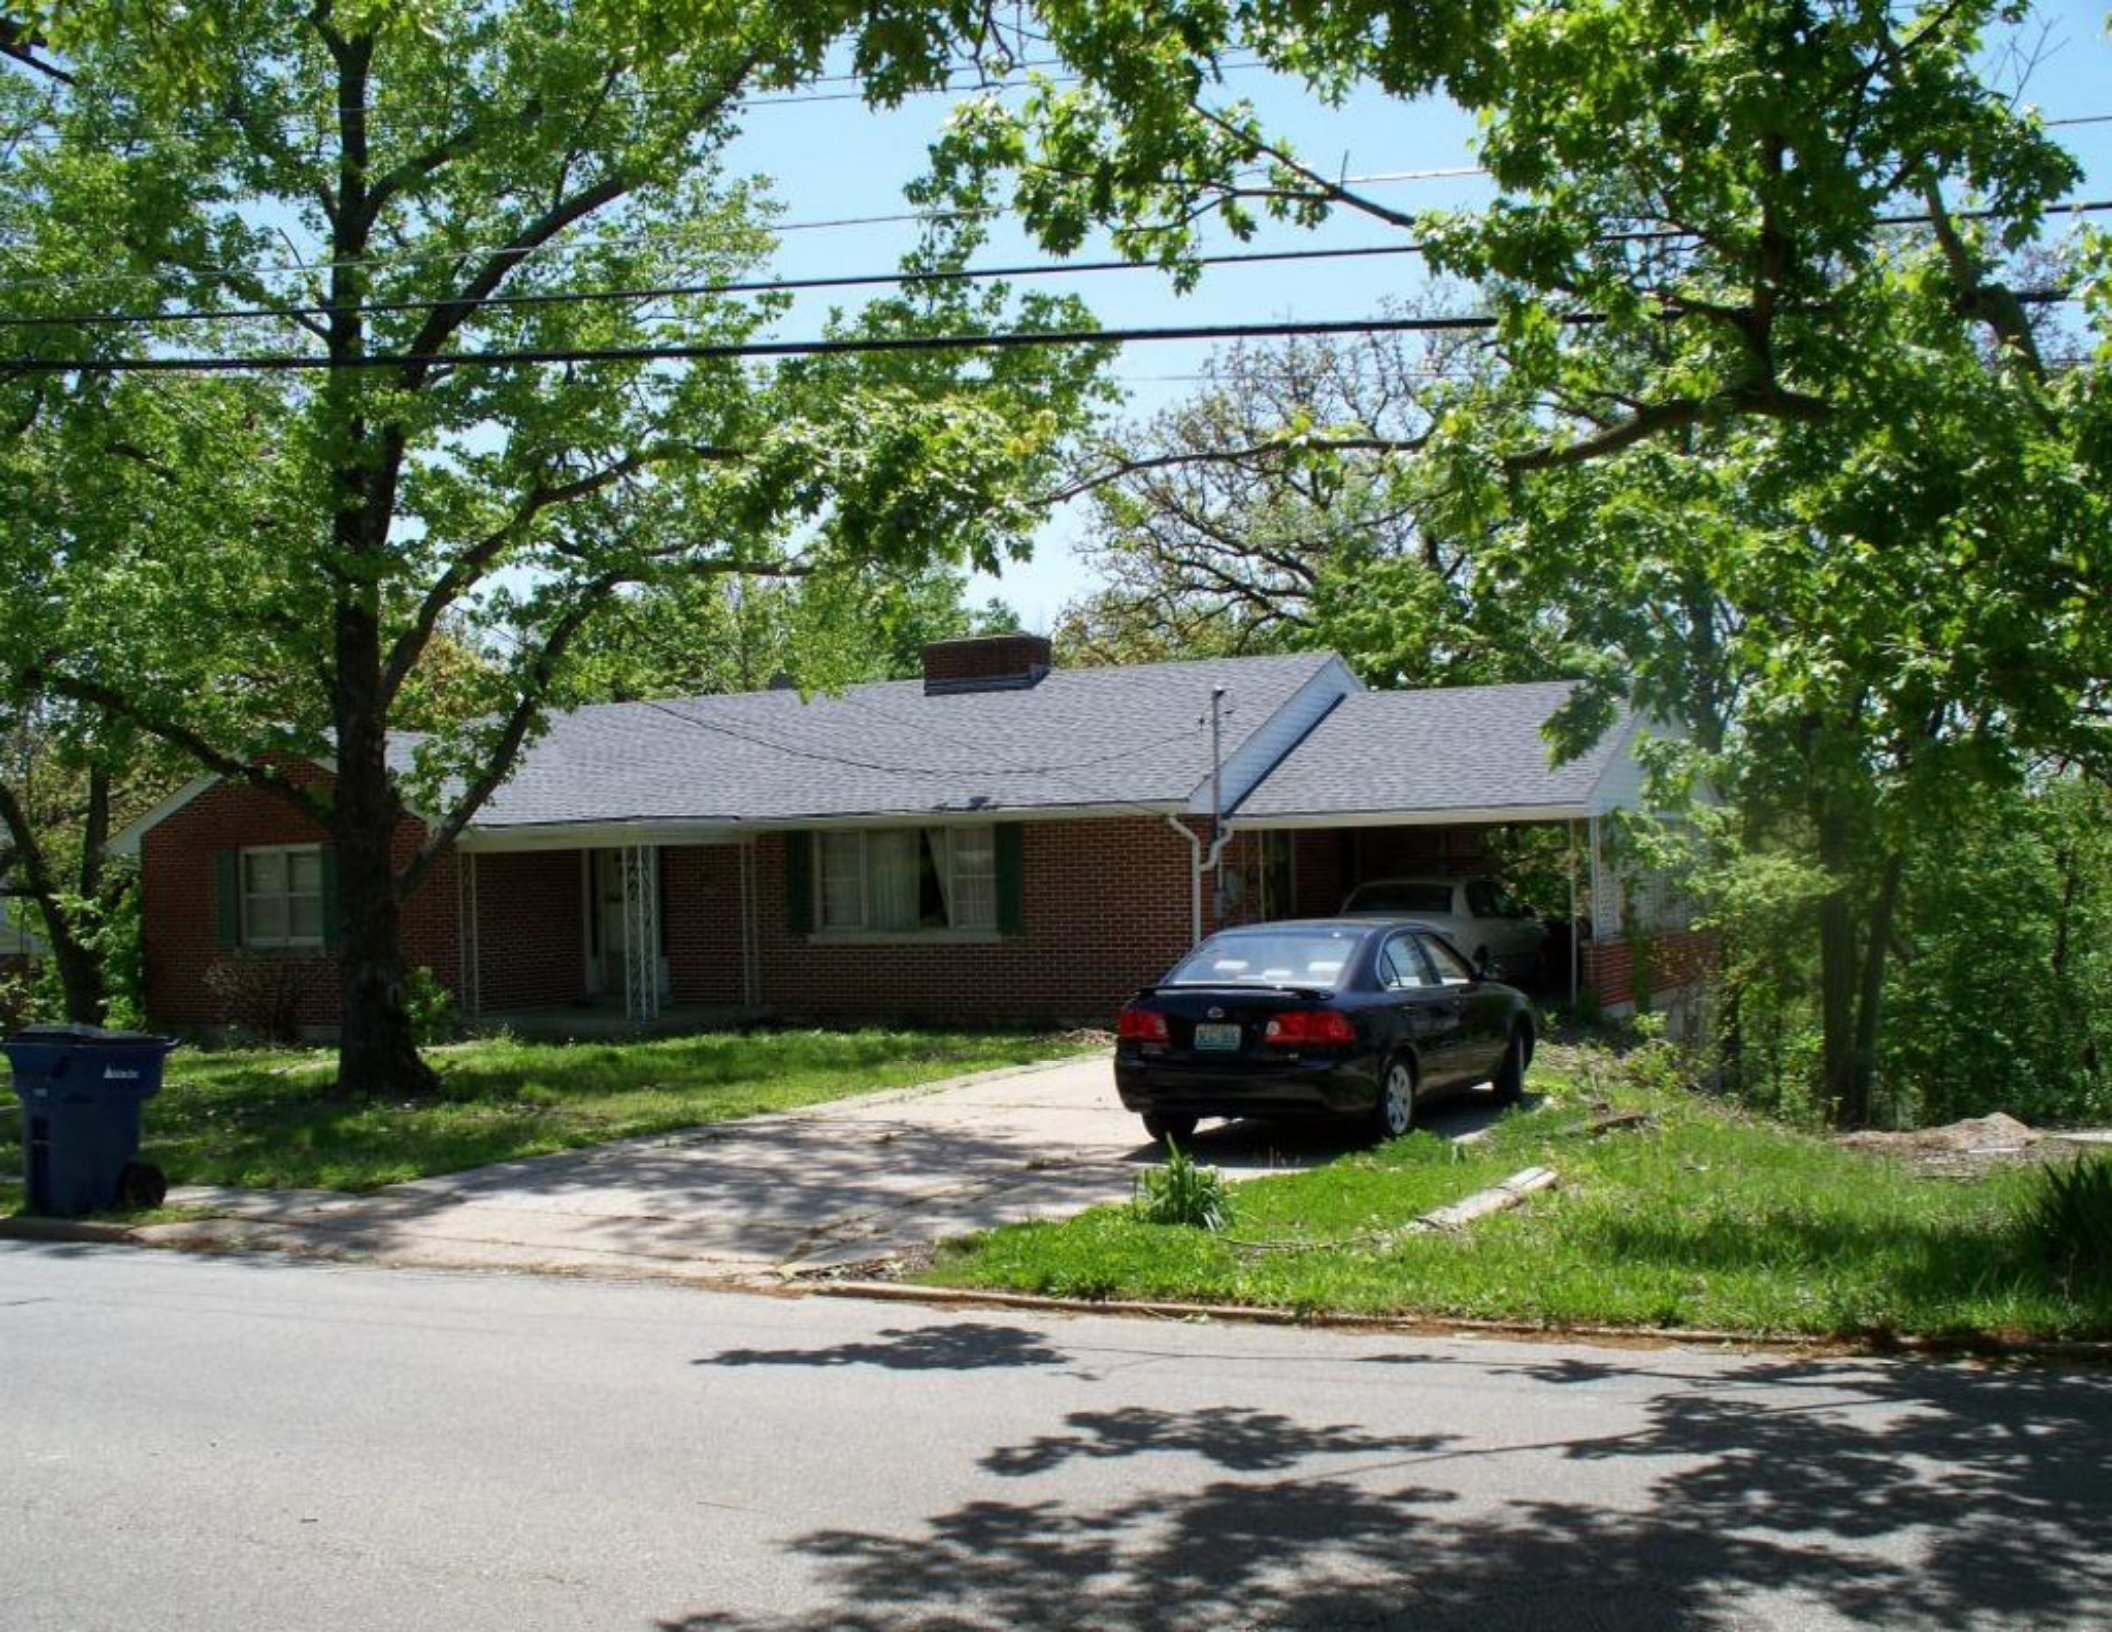
41. (cont.)
This 1 story brick ranch home has a cross gable roof. From the left the first bay projects with a front gable and contains paired 1/1 windows with shutters. The rest of the property has a side gable roof. The entrance is tucked into the ell of the first and second bays and is covered by a flat extension of the roof with decorative metal rails extending to the ground in three corners. The next bay to the right contains a picture window with shutters. The final bay is a covered carport.

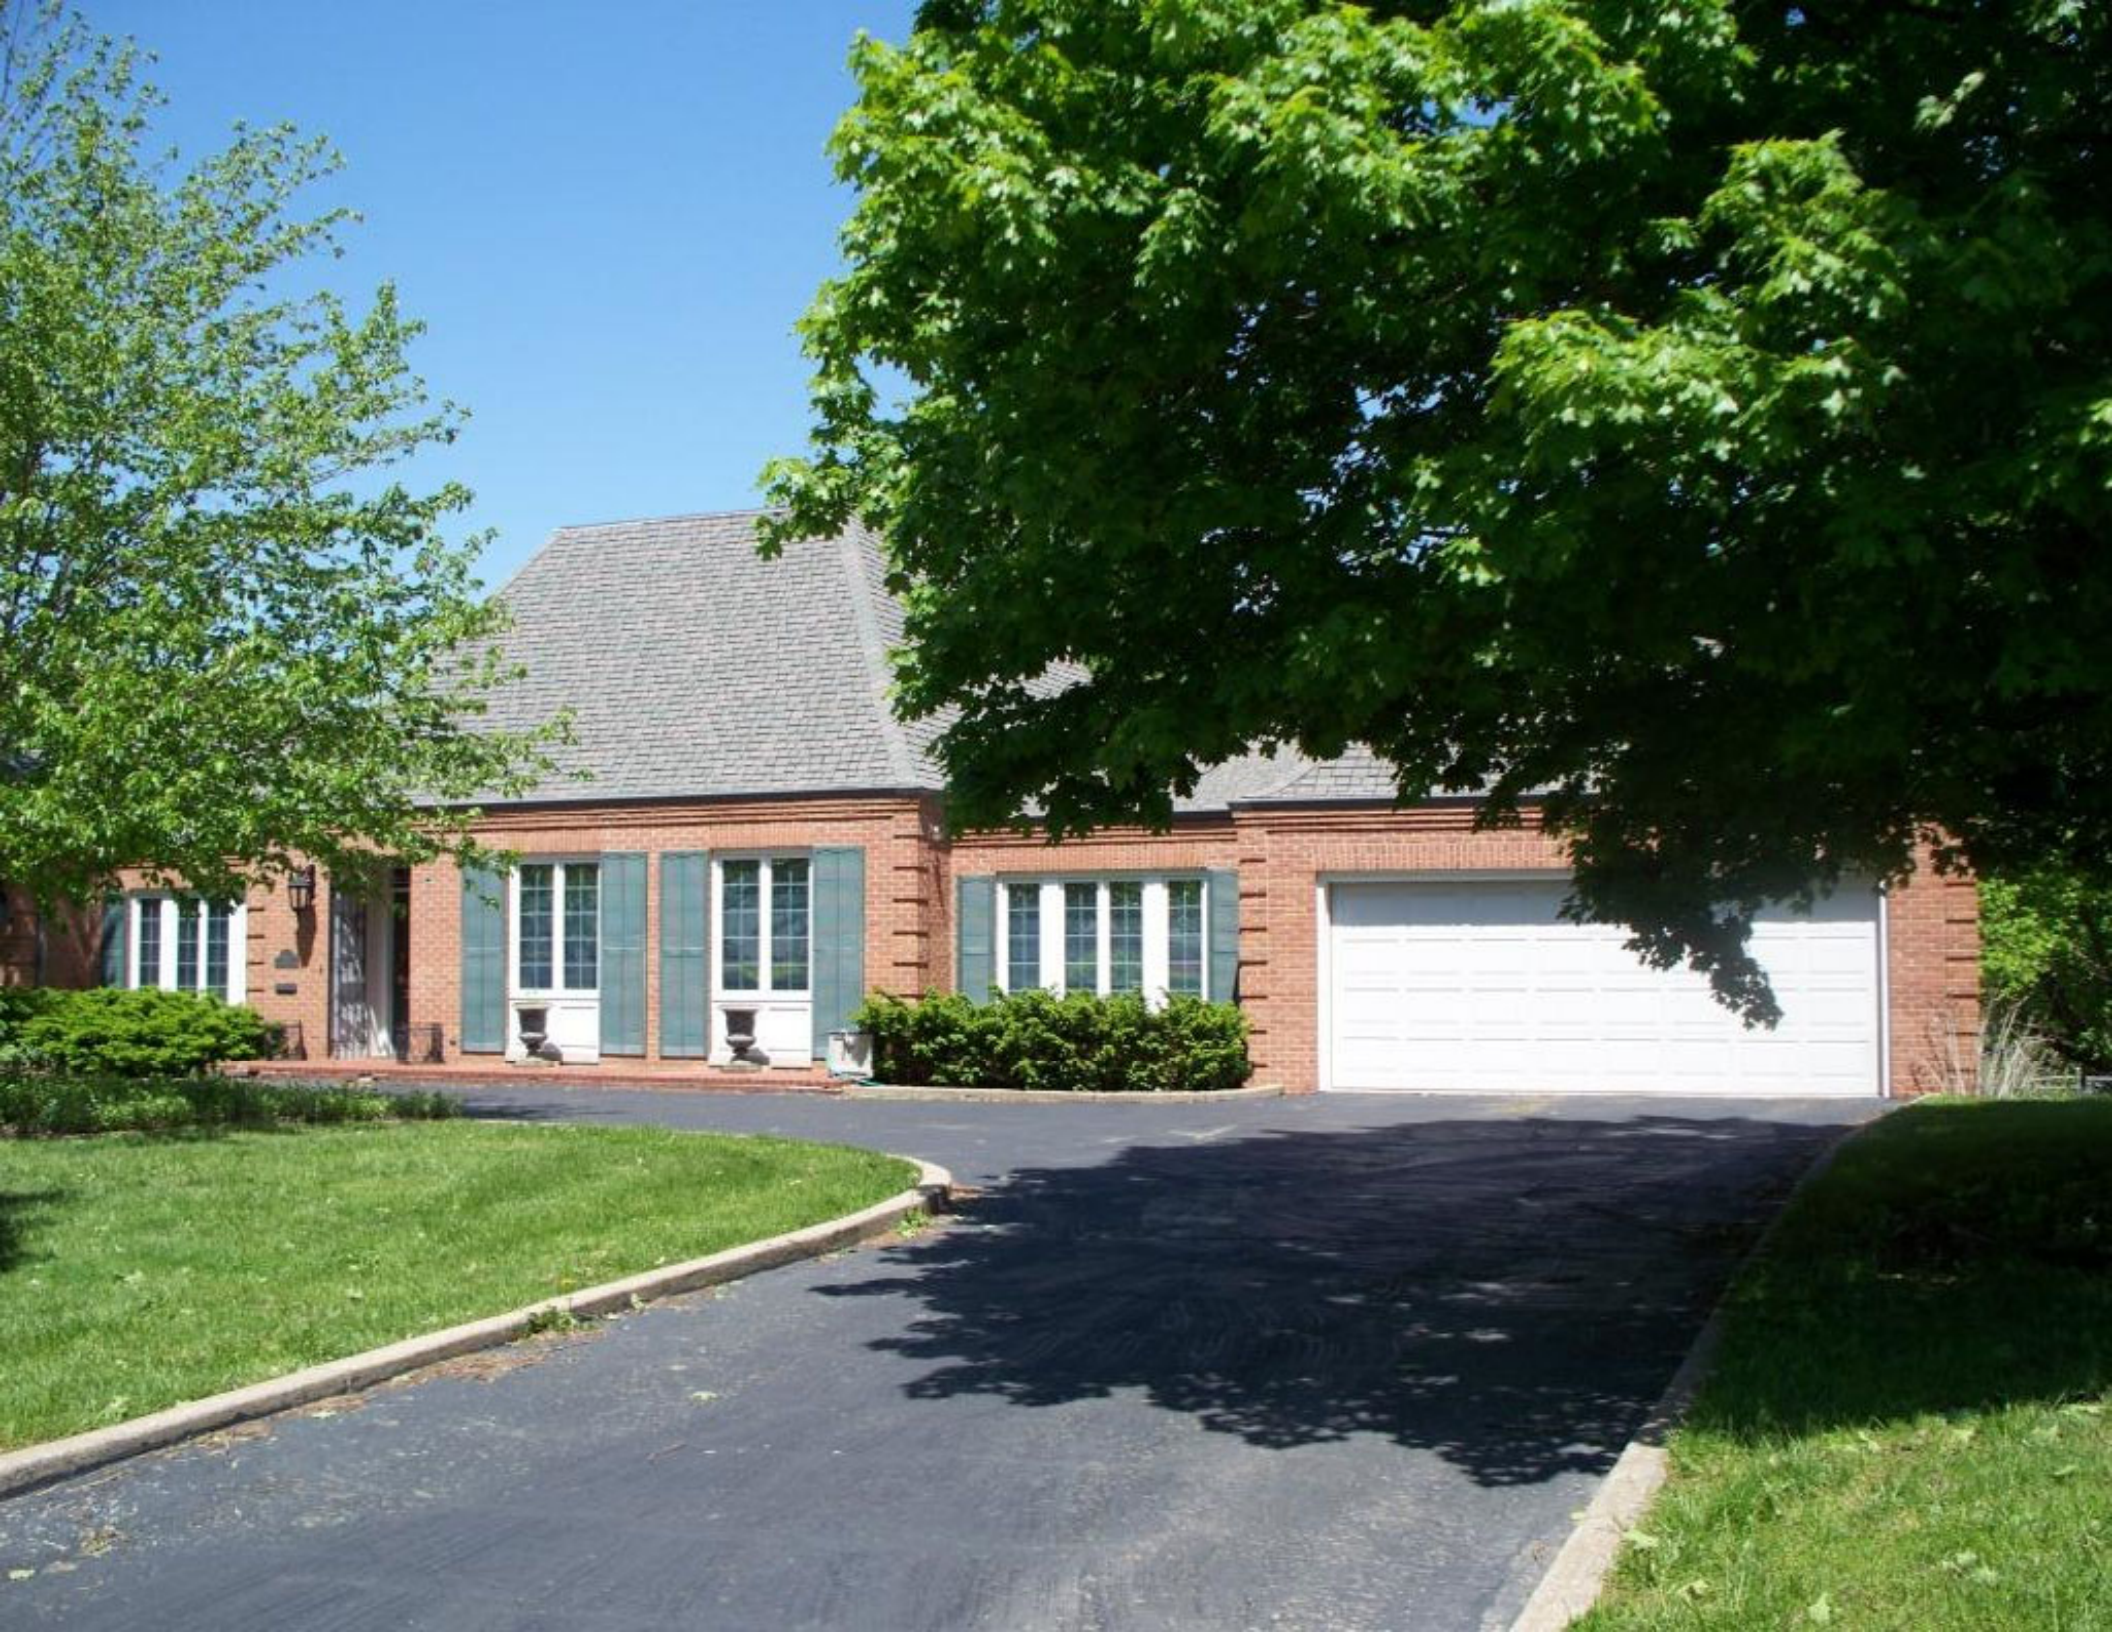
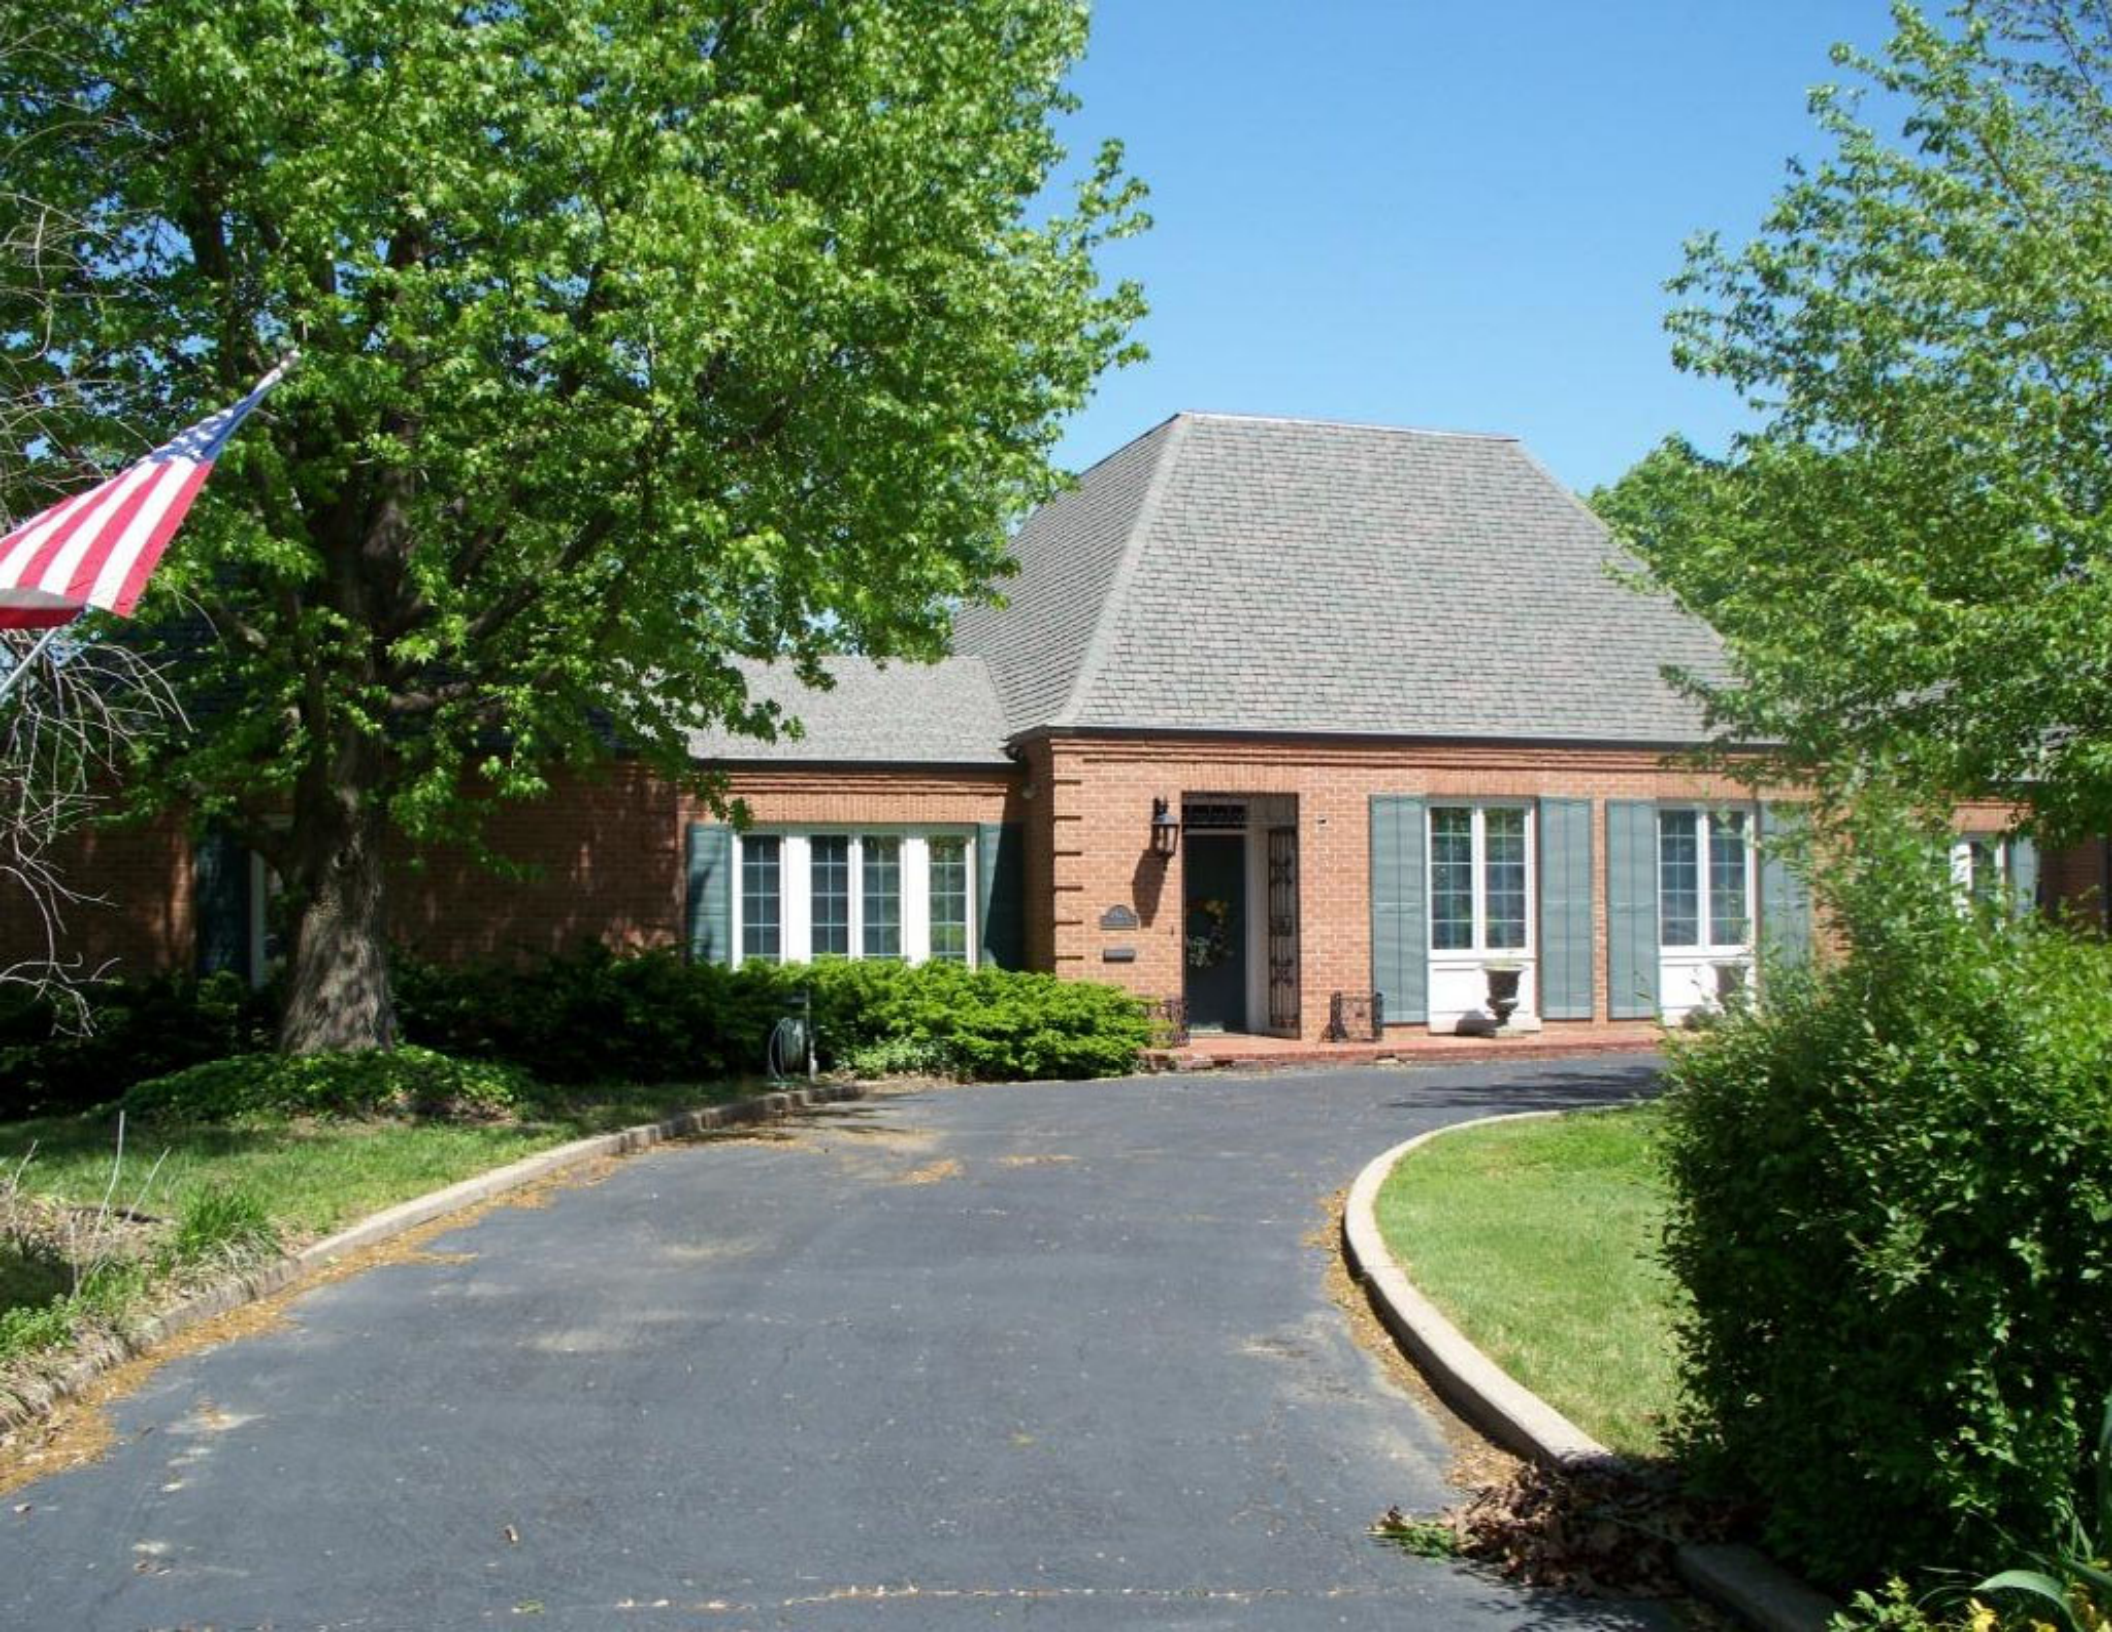
41. (cont.)
This one story brick Neo-French home has a high hipped roof; so high that it almost appears to be a mansard roof. This is the defining characteristic that gives it its style (See McAlester). Although mostly a liner plan the façade steps every few bays and features decorative brick quoining at the resulting edges. From the right is a single door two car garage, four multi-light casement windows with shutters, two paired multi-light windows with shutters and wainscoting, the recessed entrance (not visible) and finally the last two bays both feature another row of multi-light casement windows with shutters. The driveway is a semicircle blacktop with a straight driveway to provide direct access to the garage.
