ARCHITECTURAL/HISTORIC INVENTORY FORM

1. Survey No. CO-AS-005-001		2. Survey name: Moreau Drive Neighborhood Survey	
3. County: Cole		4. Address: 1202 Elmerine Ave.	
5. City: Jefferson City	Vicinity: <input type="checkbox"/>	6. UTM: / /	7. Township/Range/Section: T: R: S:
8. Historic name (if known):		9. Present/other name (if known):	
10. Ownership: <input checked="" type="checkbox"/> Private <input type="checkbox"/> Public		11. Historic use (if known): Residential	11. Current use: Residential

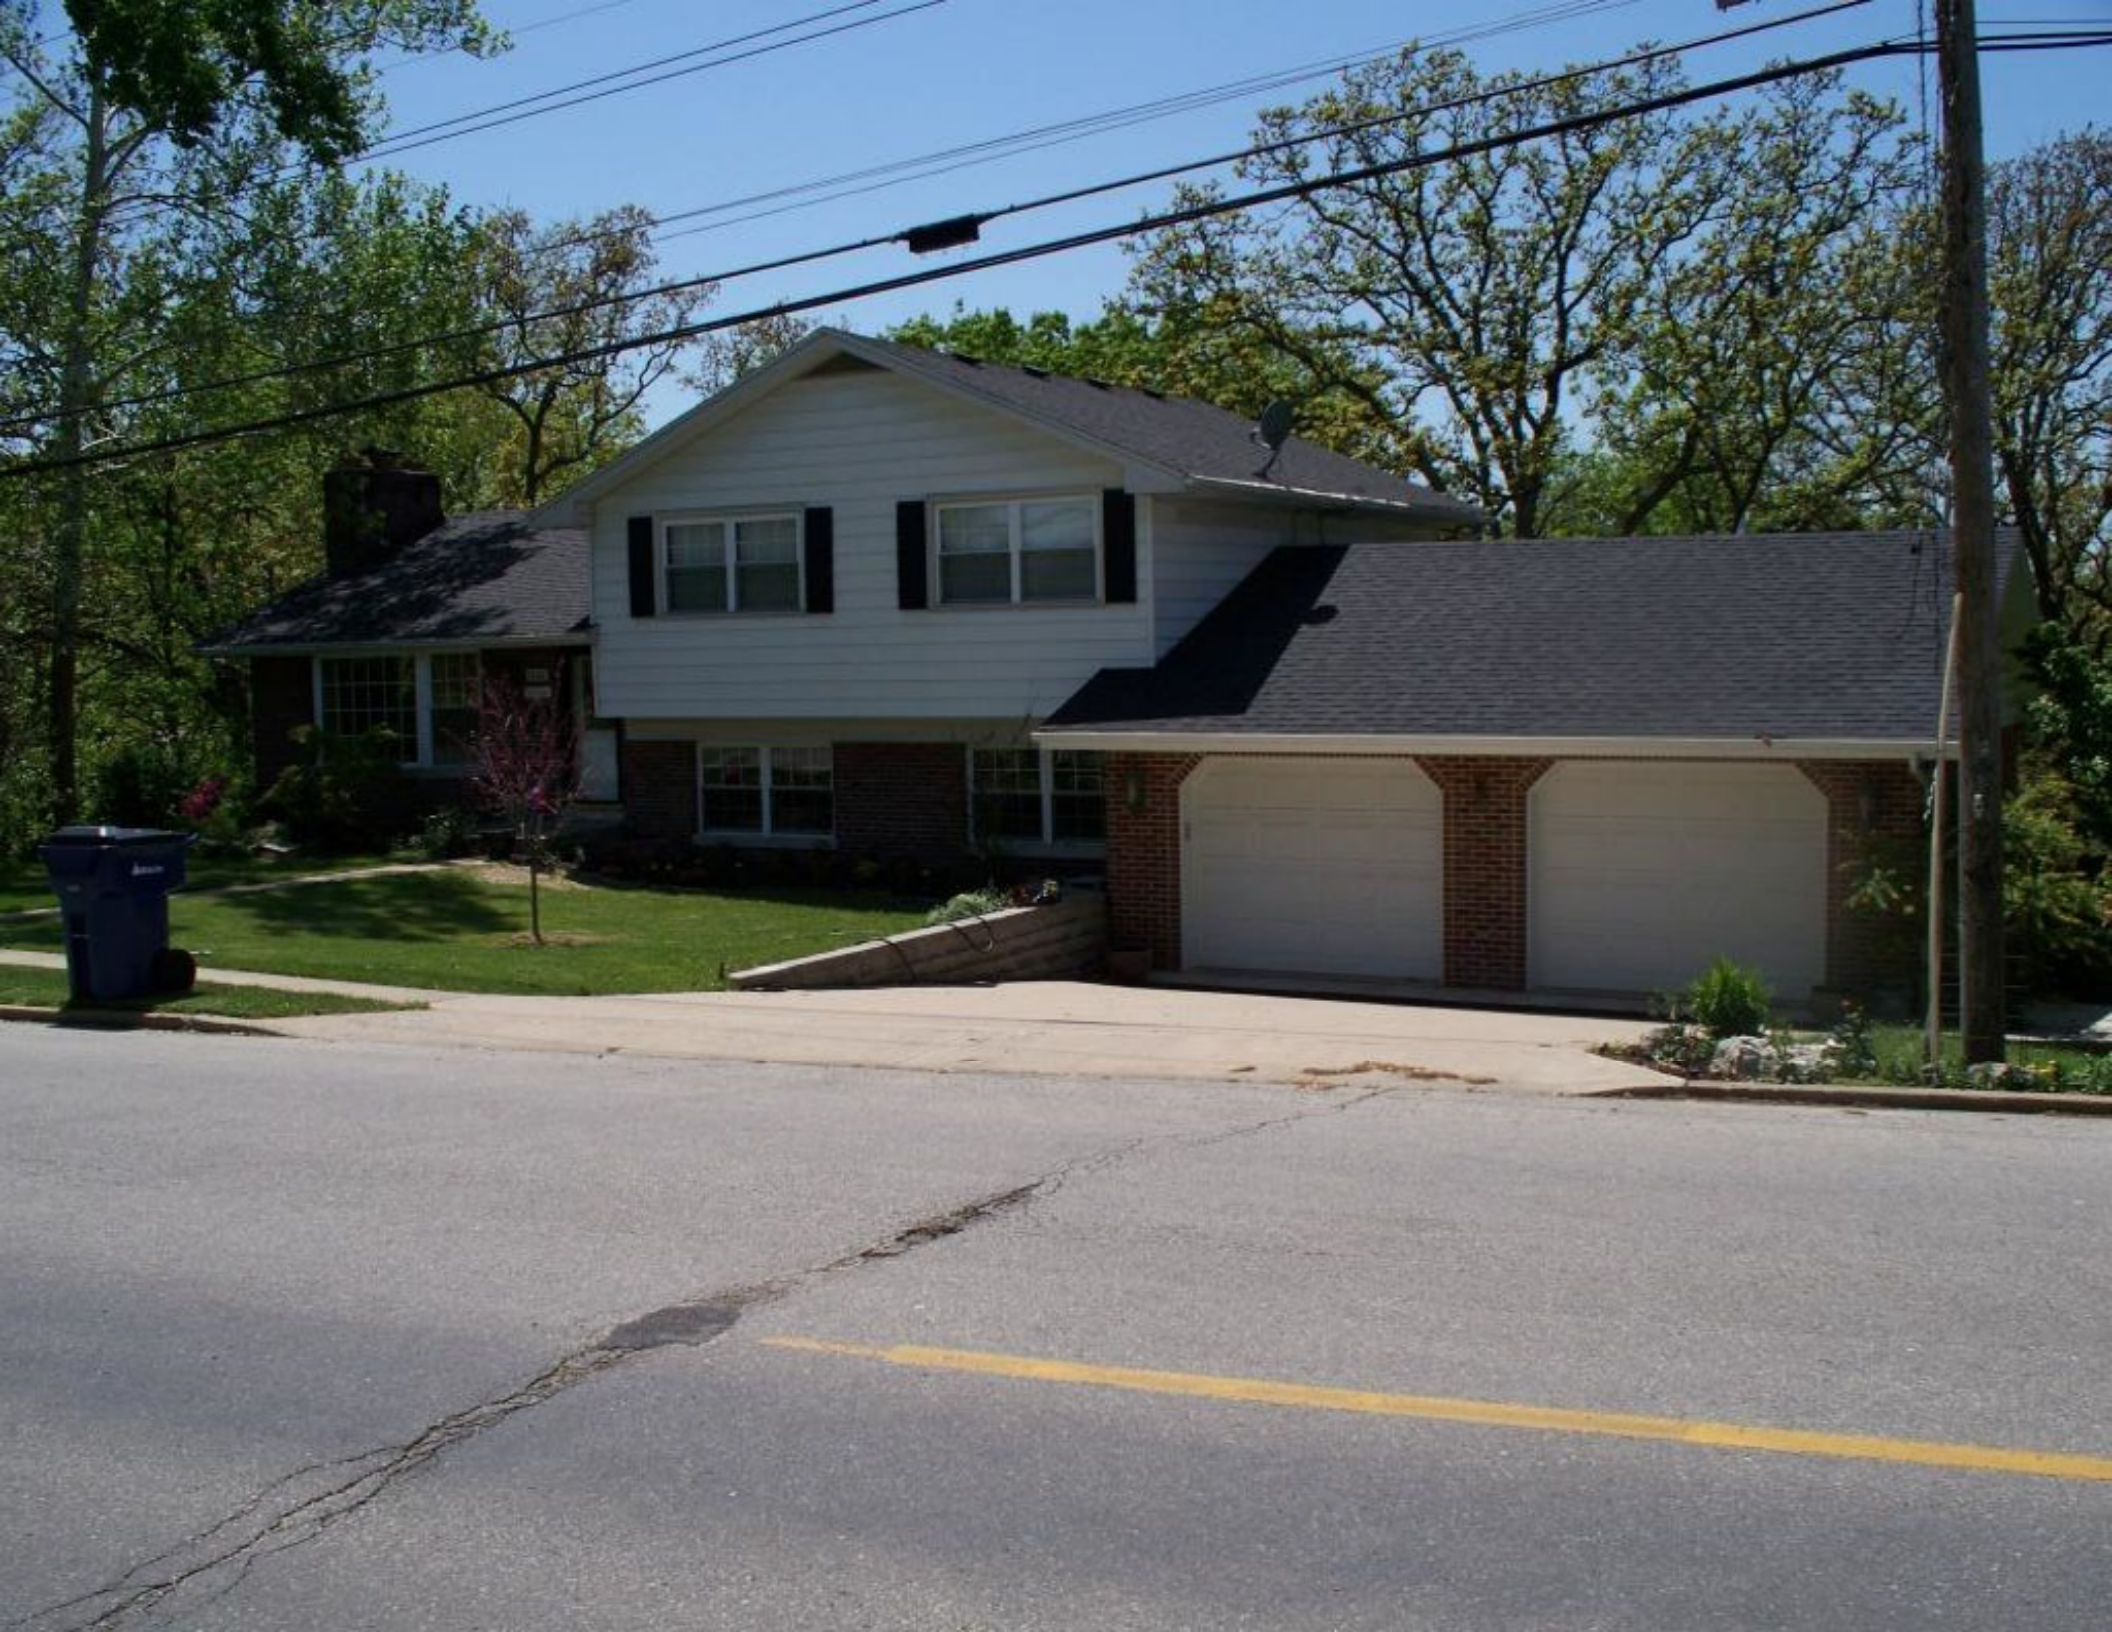
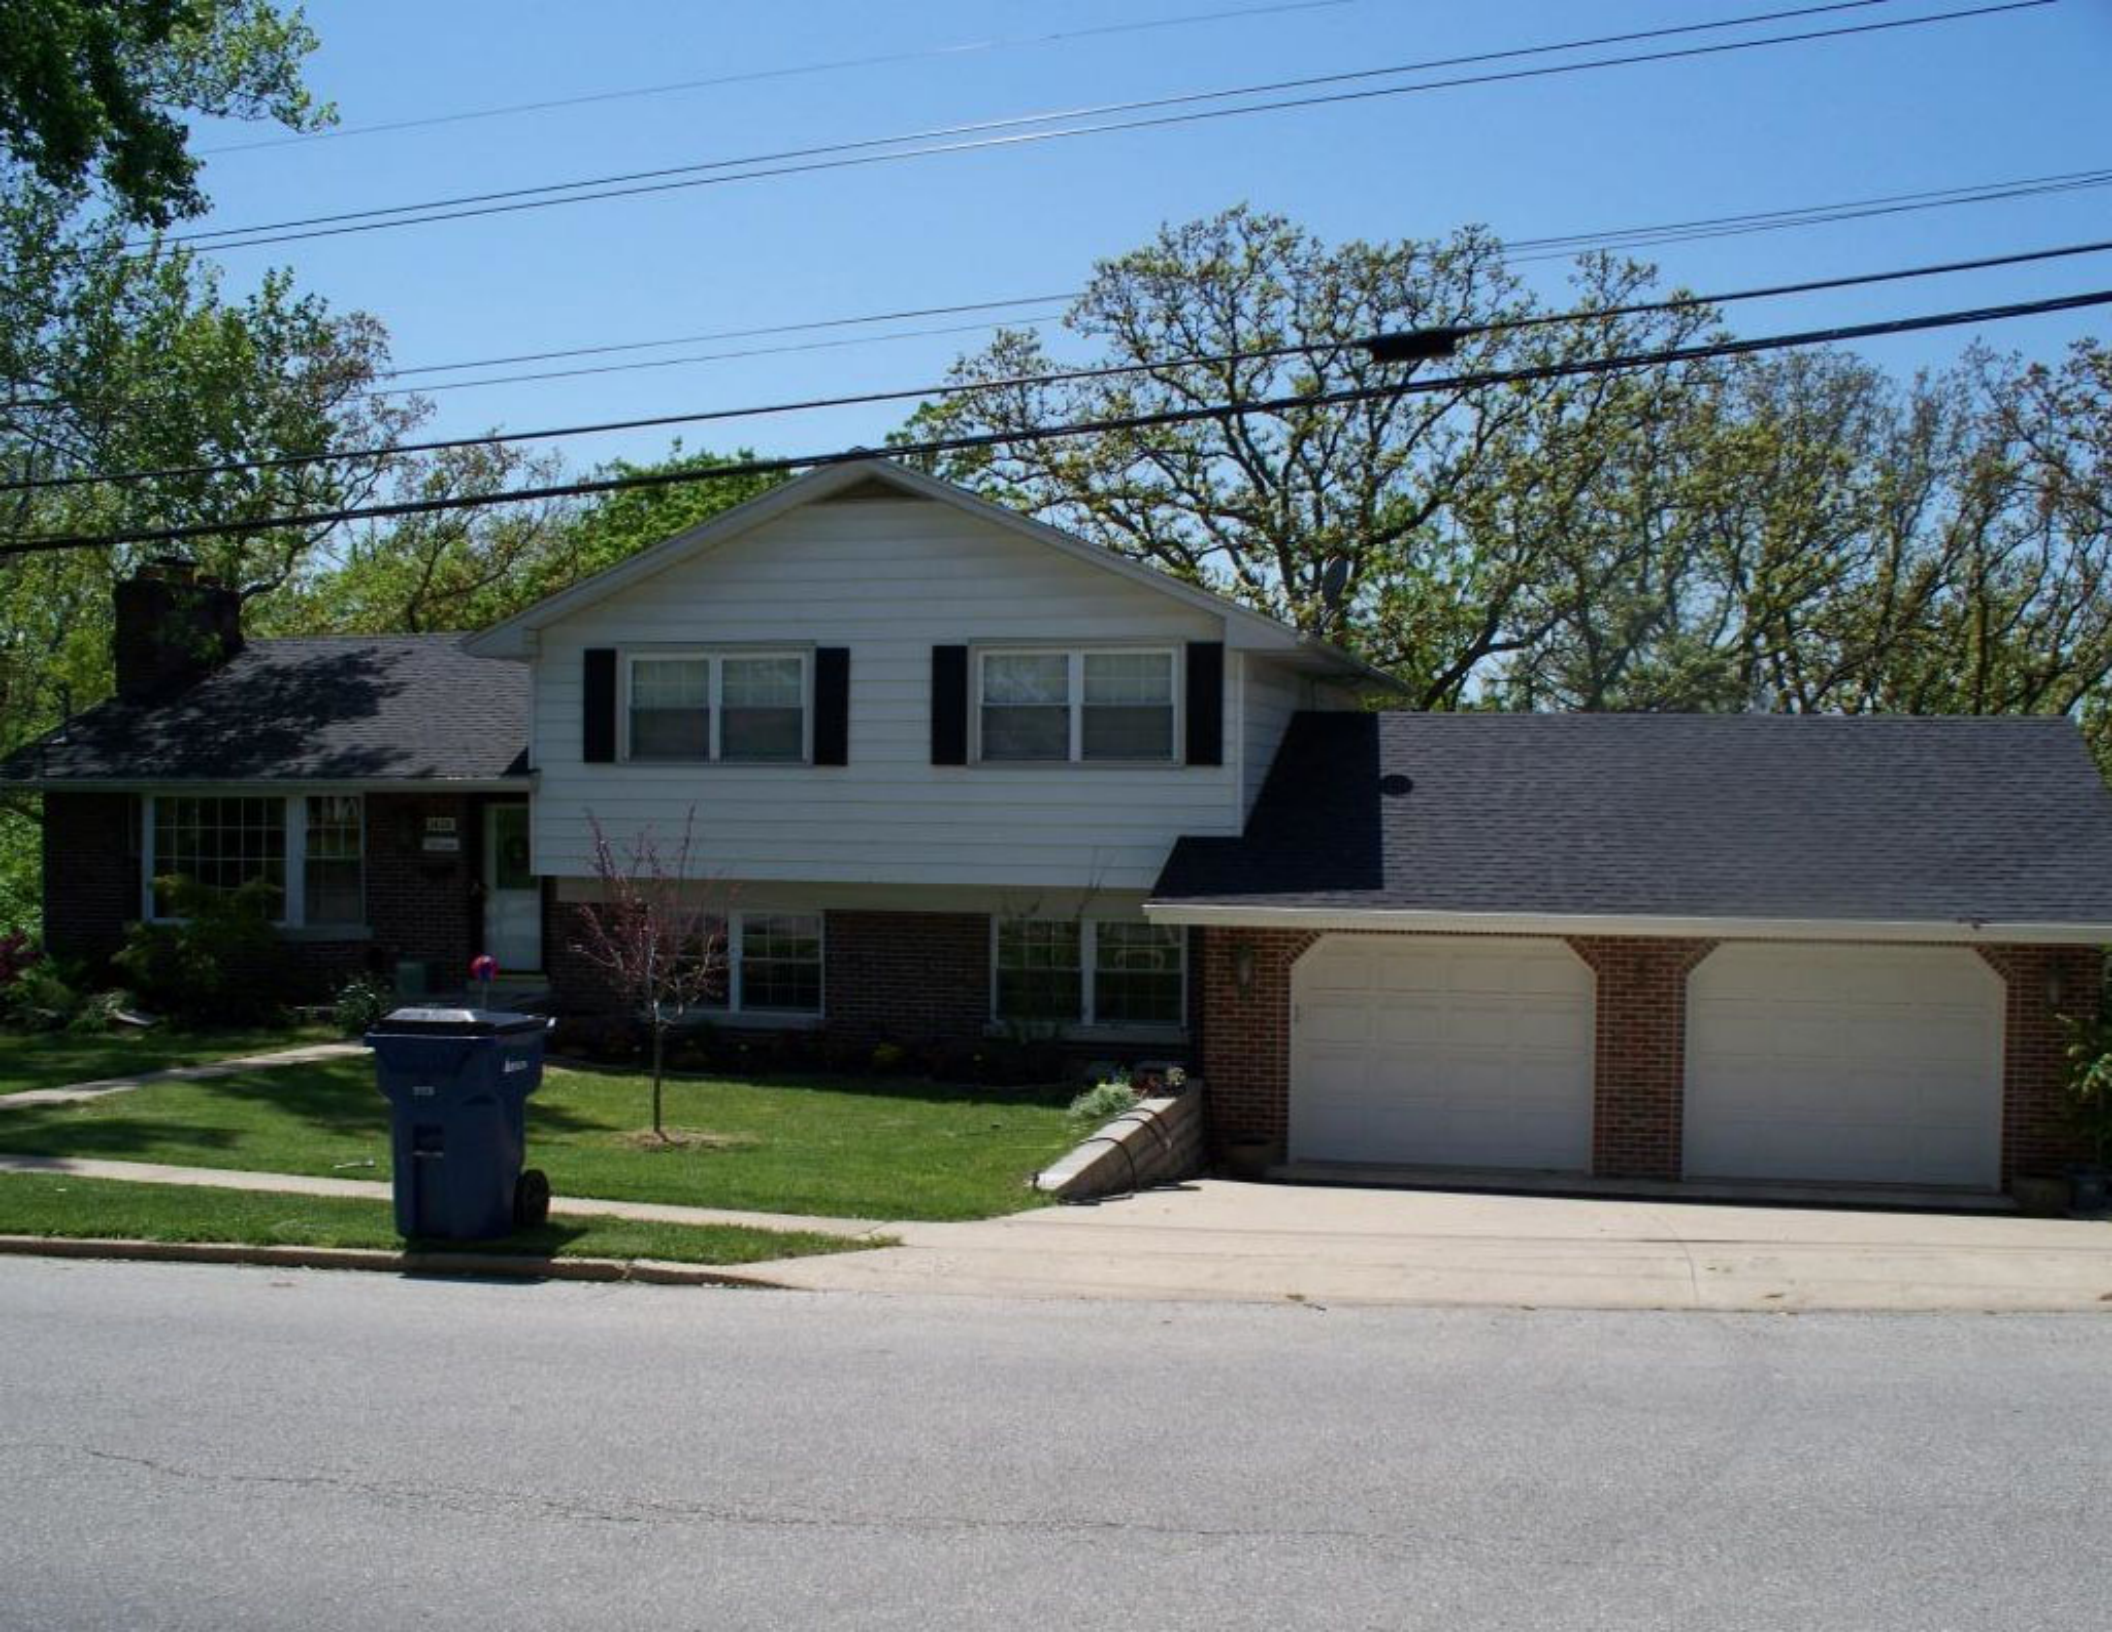
41. (cont.)
This 1 ½ story brick split level has a side gable roof covering the first two one story bays that contain a multi-light picture window and the entrance. The second two bays are two stories with a front gable roof clad in wide vinyl that contain two paired 6/6 windows with shutters. The first floor is clad in brick and contains two 6/6 windows. The final bays on the right have a side gable roof over a two car garage that sits slightly below grade.

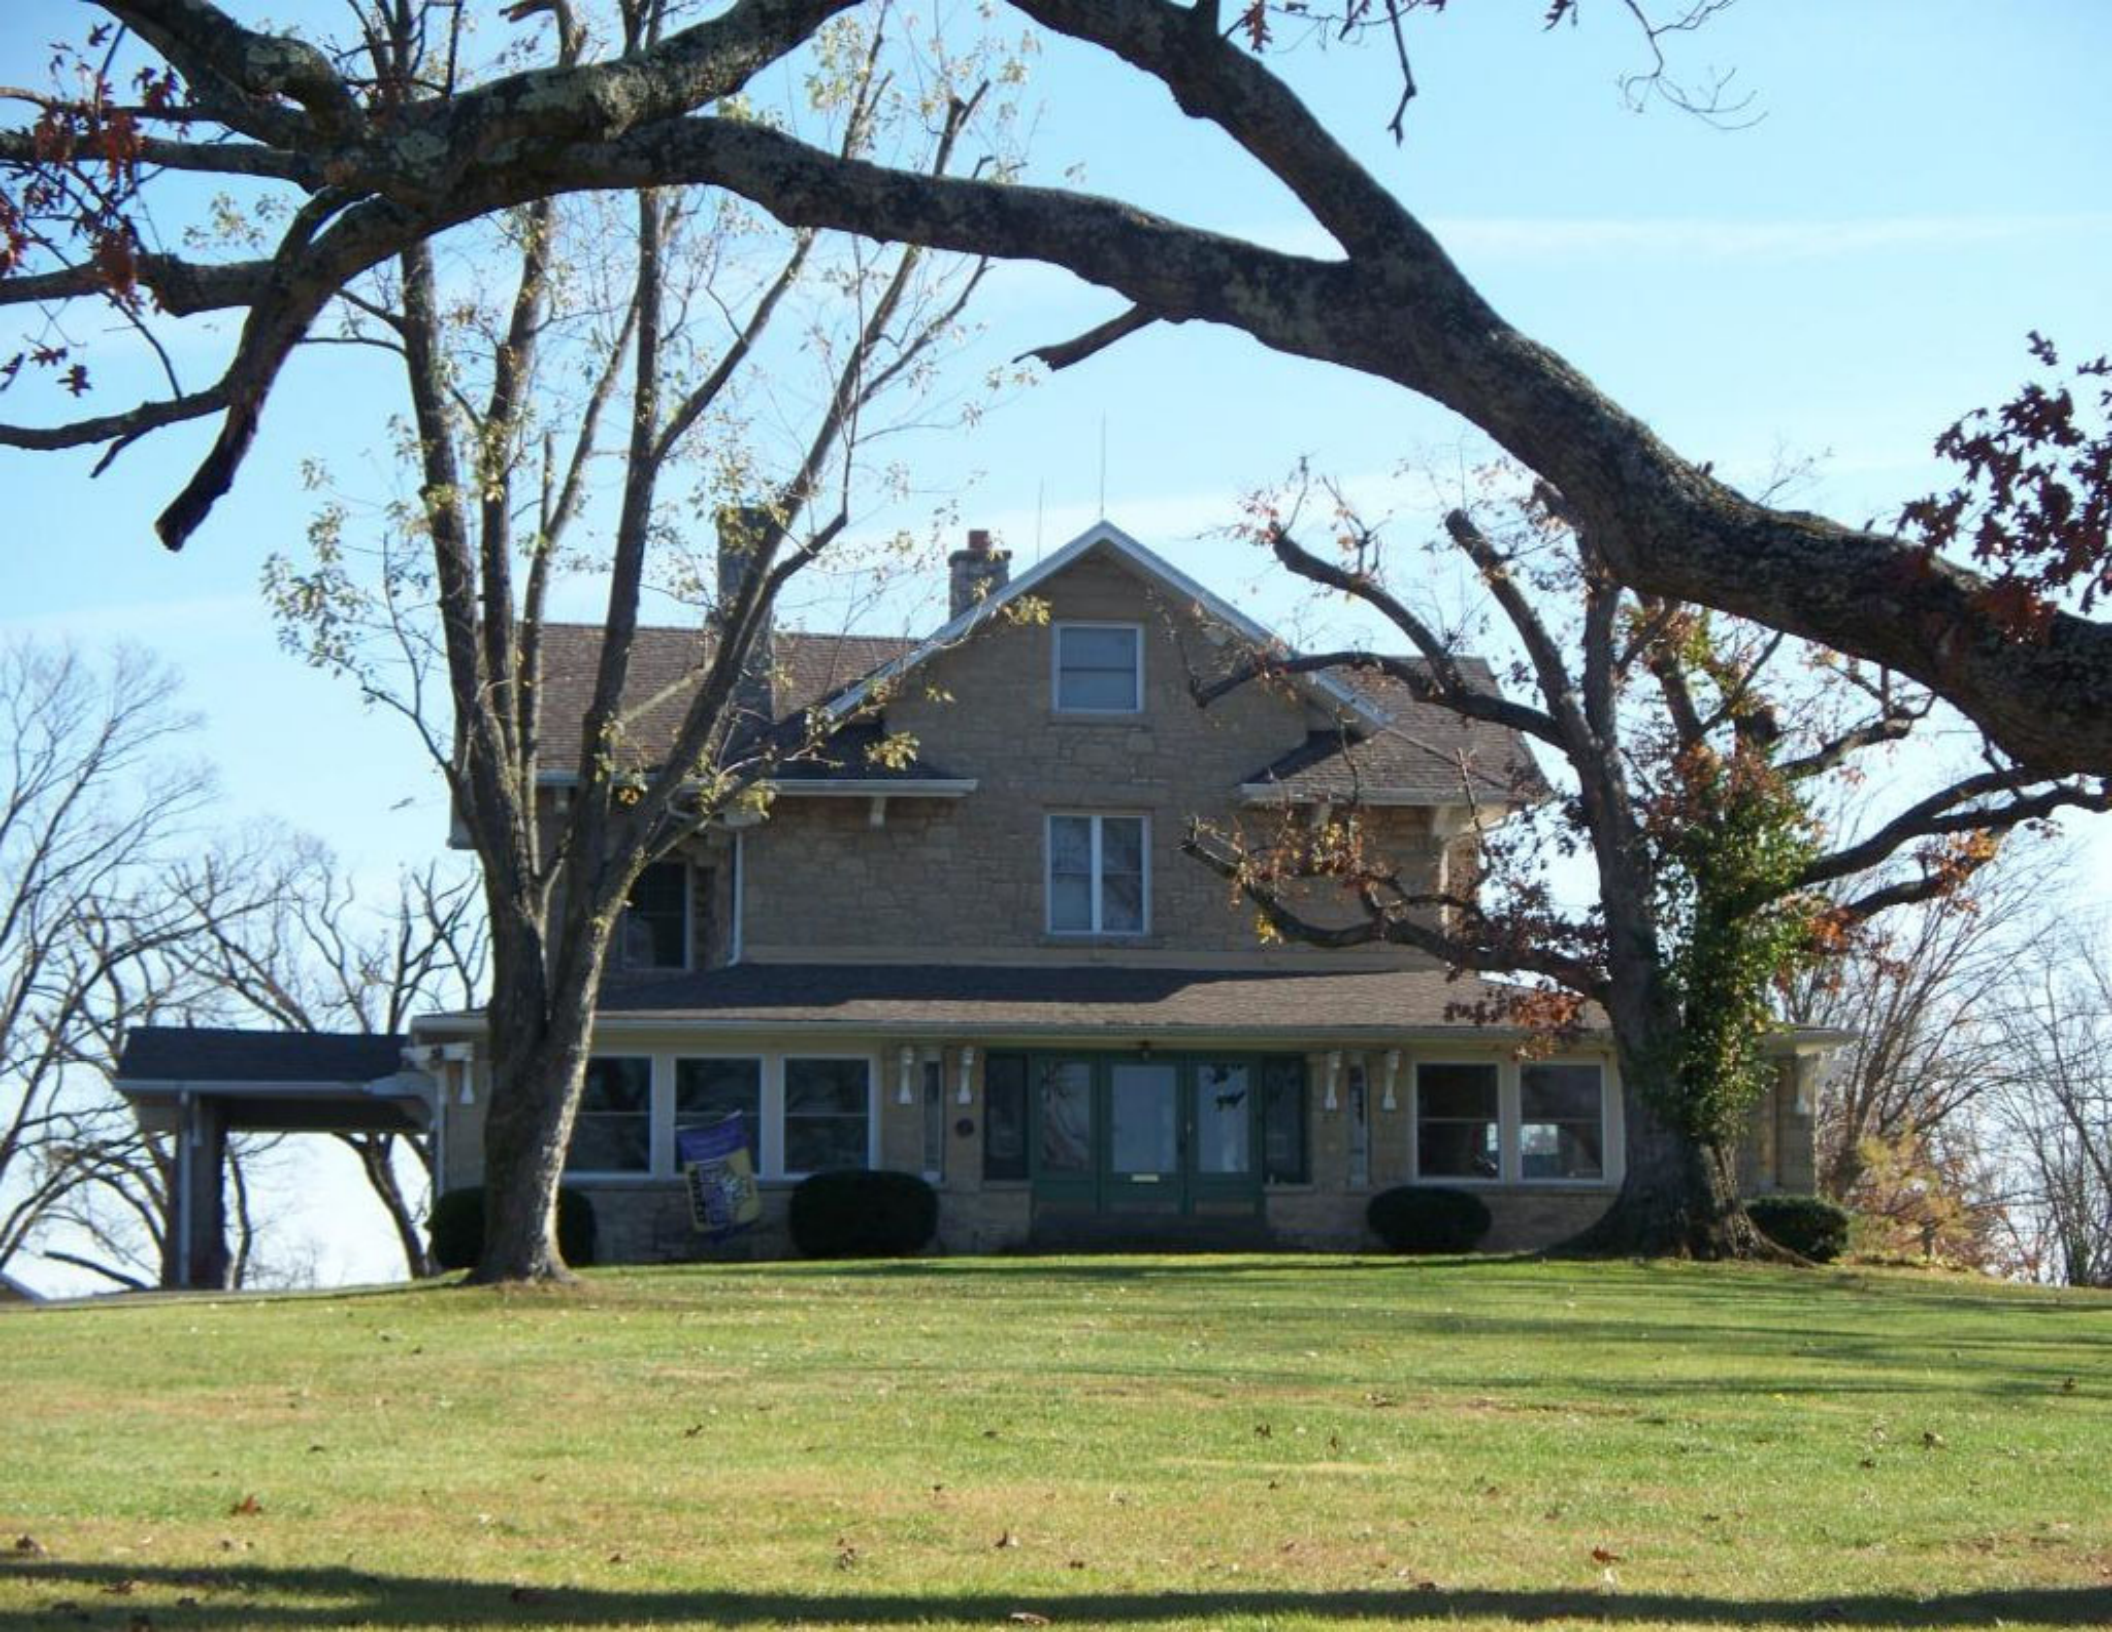
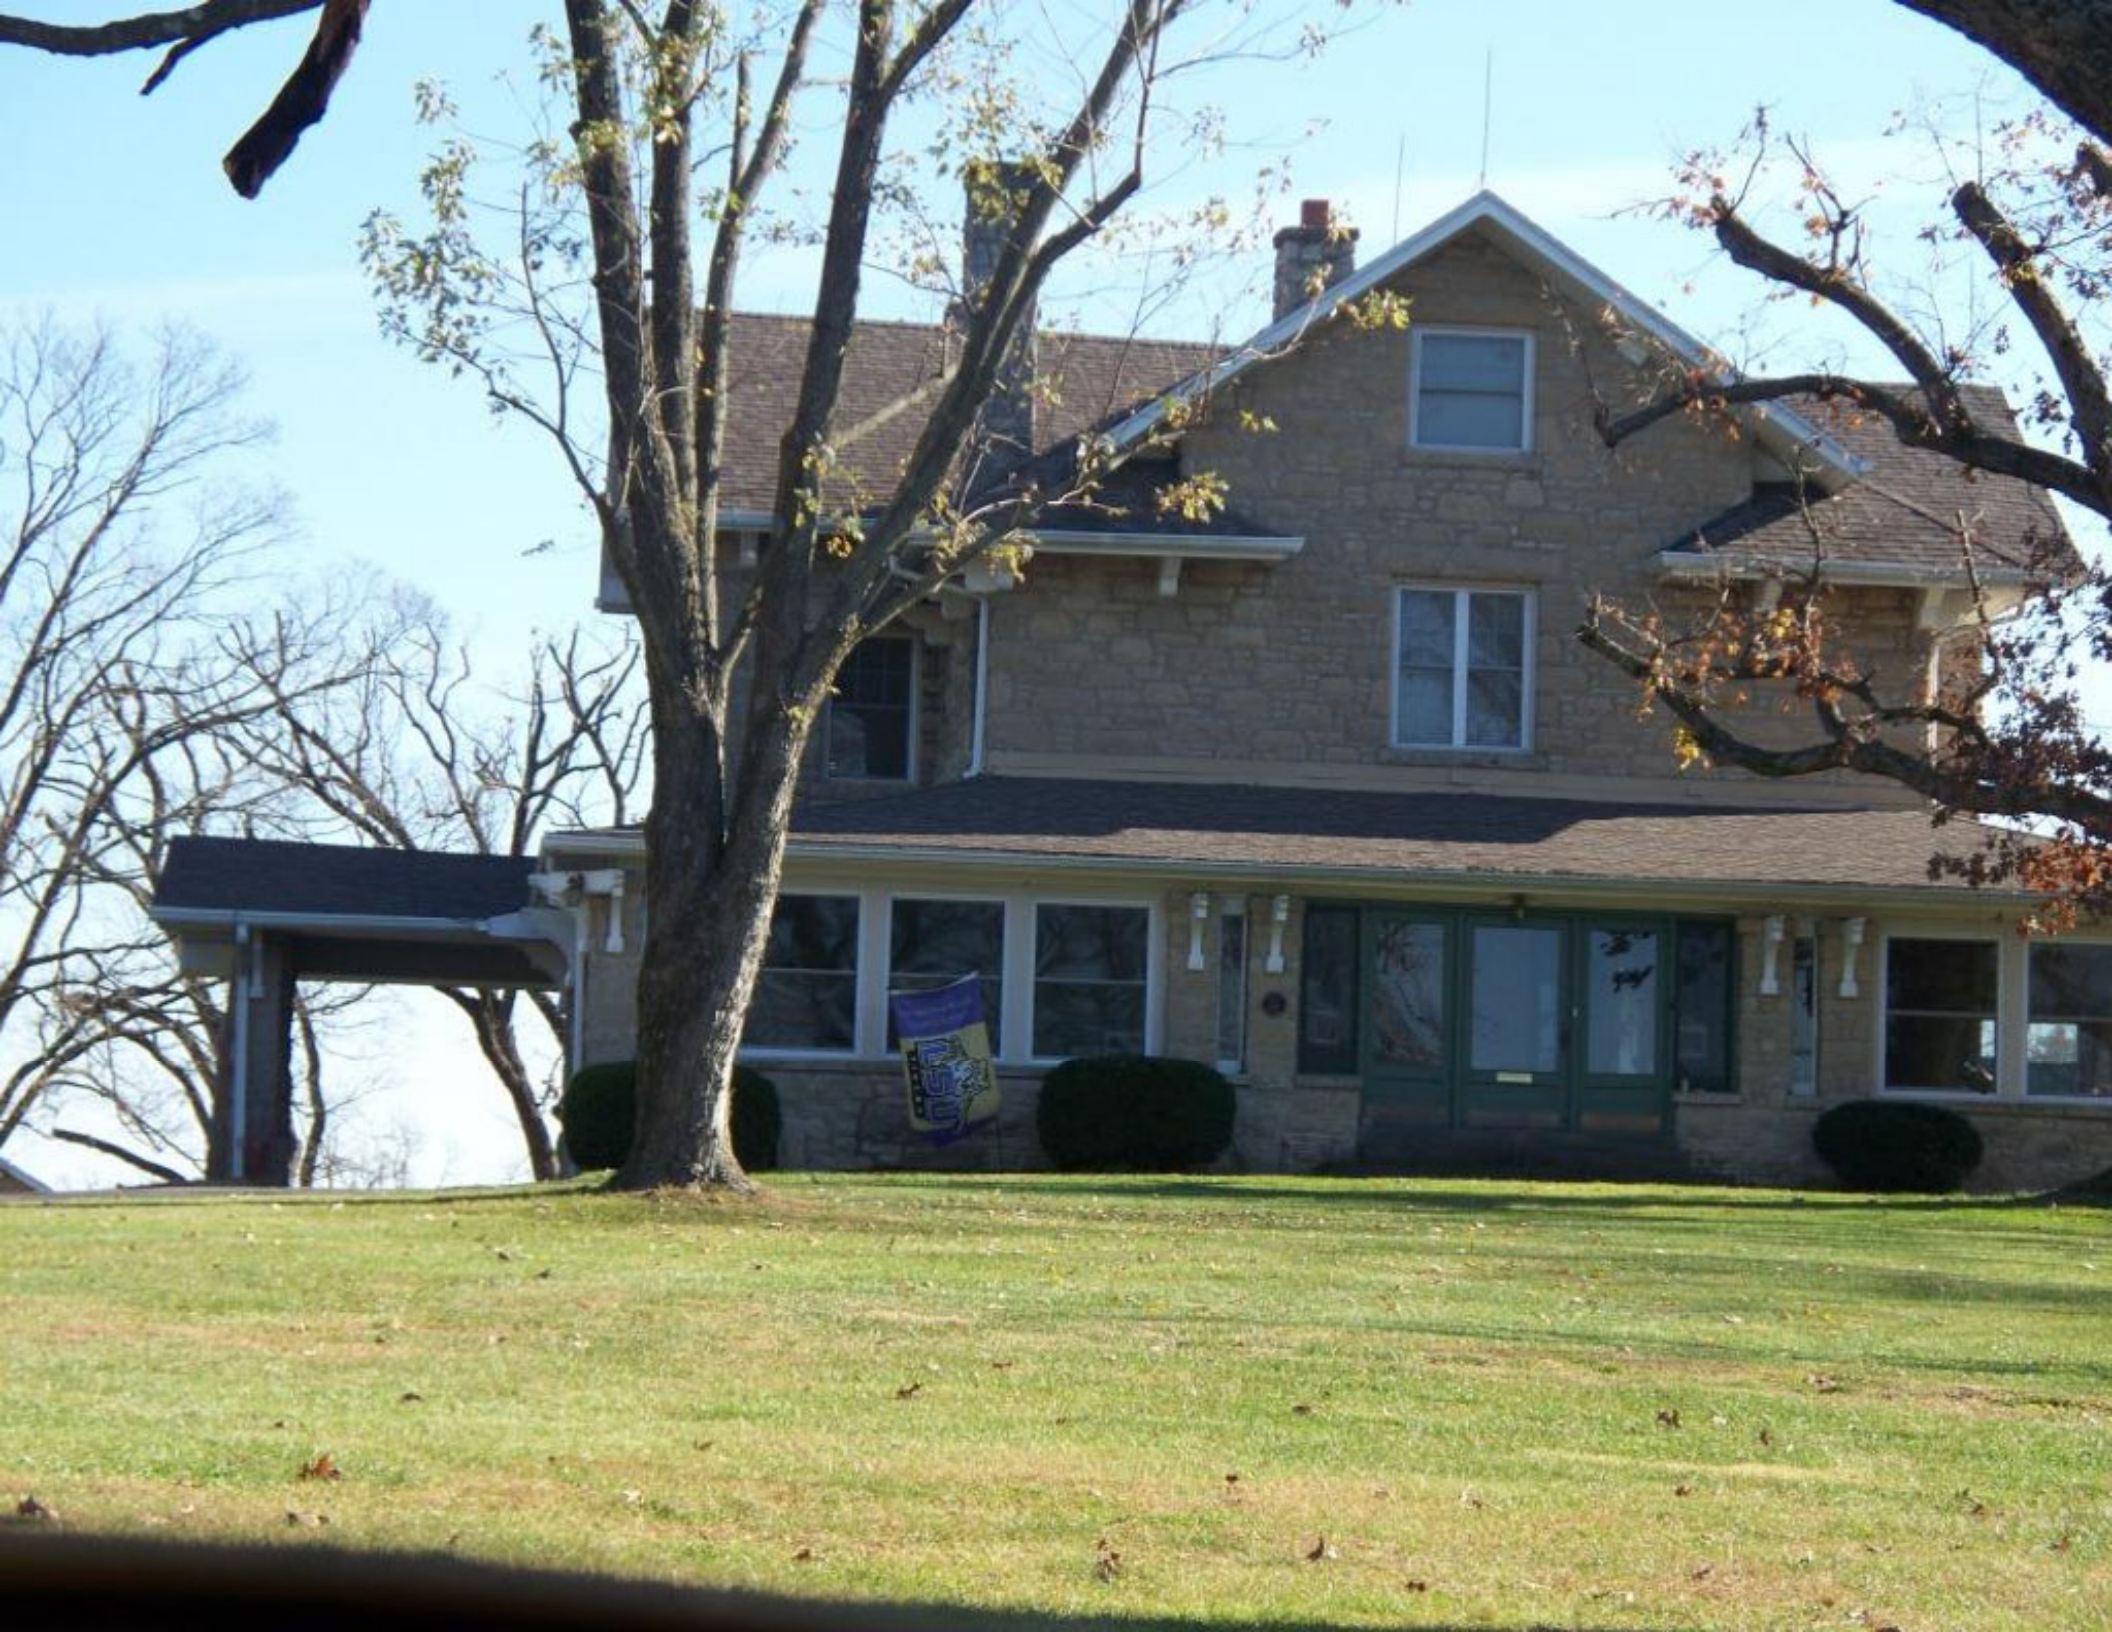
Behind the home is a front gable stone outbuilding, possibly a garage (hard to tell from public right-of-way) and a shed clad in wood with a shed roof and stone foundation. They both would be contributing.

This massive 2 ½ story stone bungalow is individually eligible for architecture as an excellent example of the Craftsman style. The central front gable has deep returns with brackets created by the cross gable wings that extend a bay in each direction (a single window is on the side of these wings on the front of the facade). In its peak is a 4/1 window. All the windows seem to be replacements. Below this window are paired 4/1 windows. A hipped roof flares beneath this window and wraps around the property. It covers the porch, which has been enclosed with two rows of three 1/1 windows and a large door with two sets of sidelights: big sidelights with half paneling (as big as the door) and smaller single pane on the outer). Next to this is a narrow strip window on either side flanked with brackets. Fortunately the stone piers and half walls were left in tact. The wrap around porch on the right hand side remains open. To the left and set back is a porte-cochere with a side gable roof stone battered piers and brackets. This could also contribute to a small Frank B. Miller district (with 1431 and 1503 Green Berry).
