ARCHITECTURAL/HISTORIC INVENTORY FORM

1. Survey No. CO-AS-005-001		2. Survey name: Moreau Drive Neighborhood Survey	
3. County: Cole		4. Address: 1202 Elmerine Ave.	
5. City: Jefferson City	Vicinity: <input type="checkbox"/>	6. UTM: / /	7. Township/Range/Section: T: R: S:
8. Historic name (if known):		9. Present/other name (if known):	
10. Ownership: <input checked="" type="checkbox"/> Private <input type="checkbox"/> Public		11. Historic use (if known): Residential	11. Current use: Residential

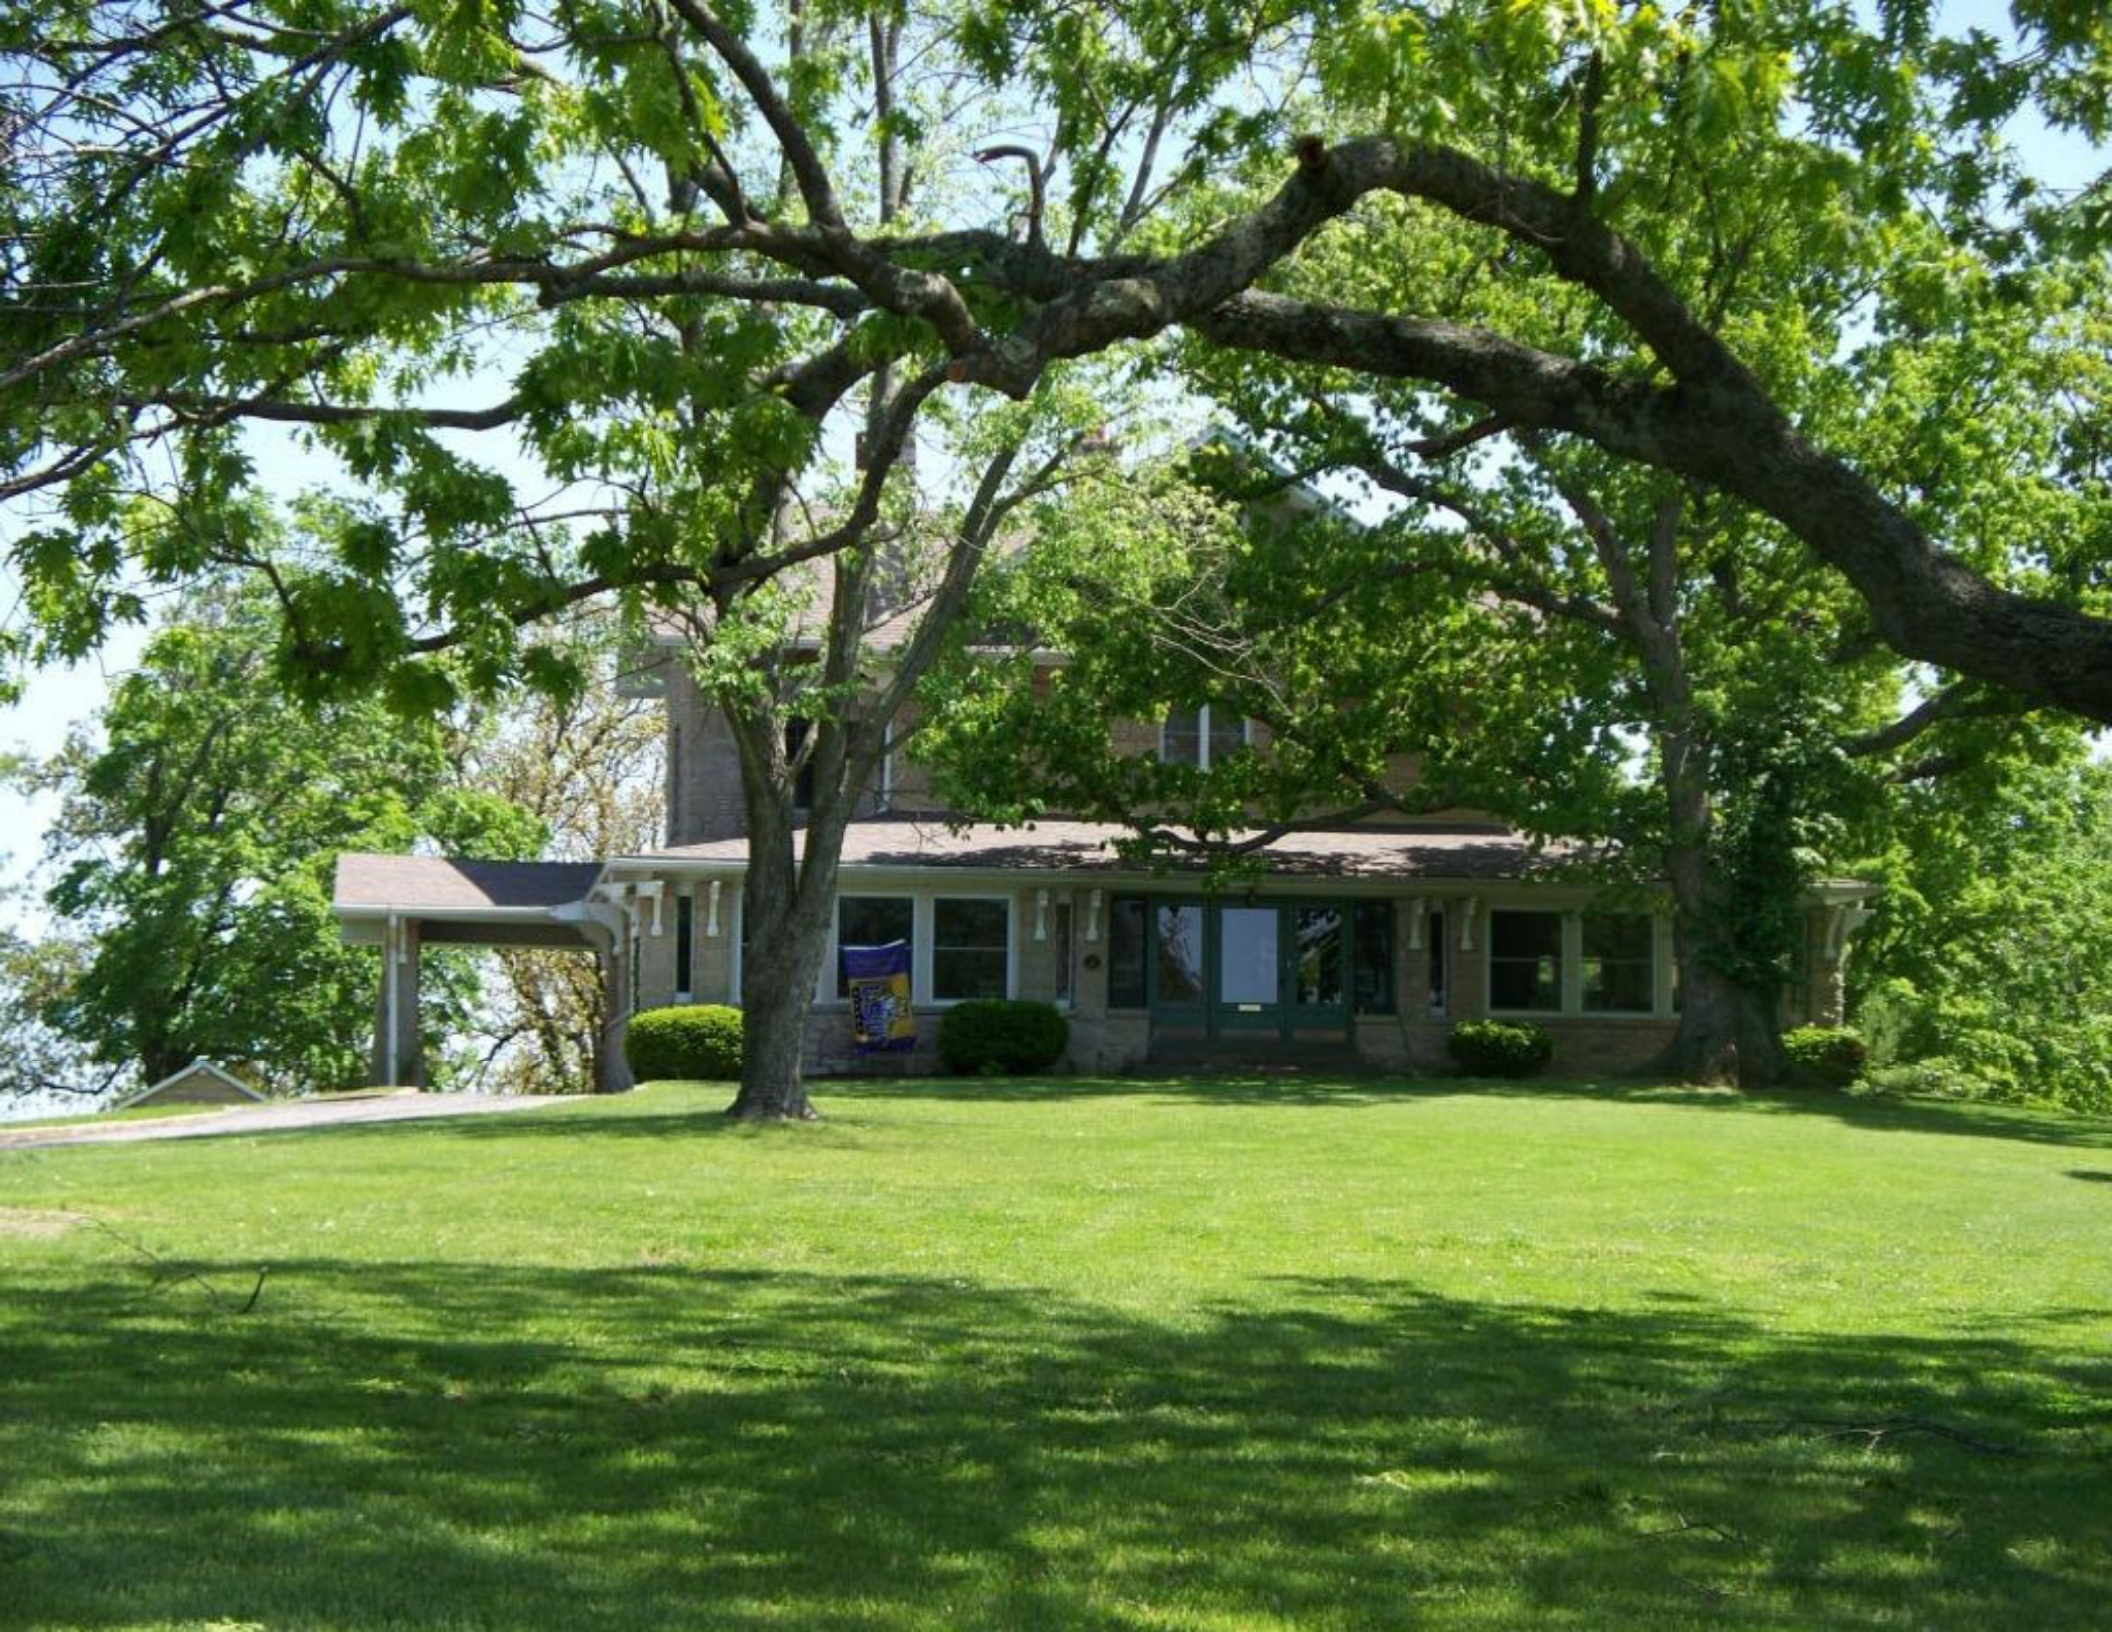
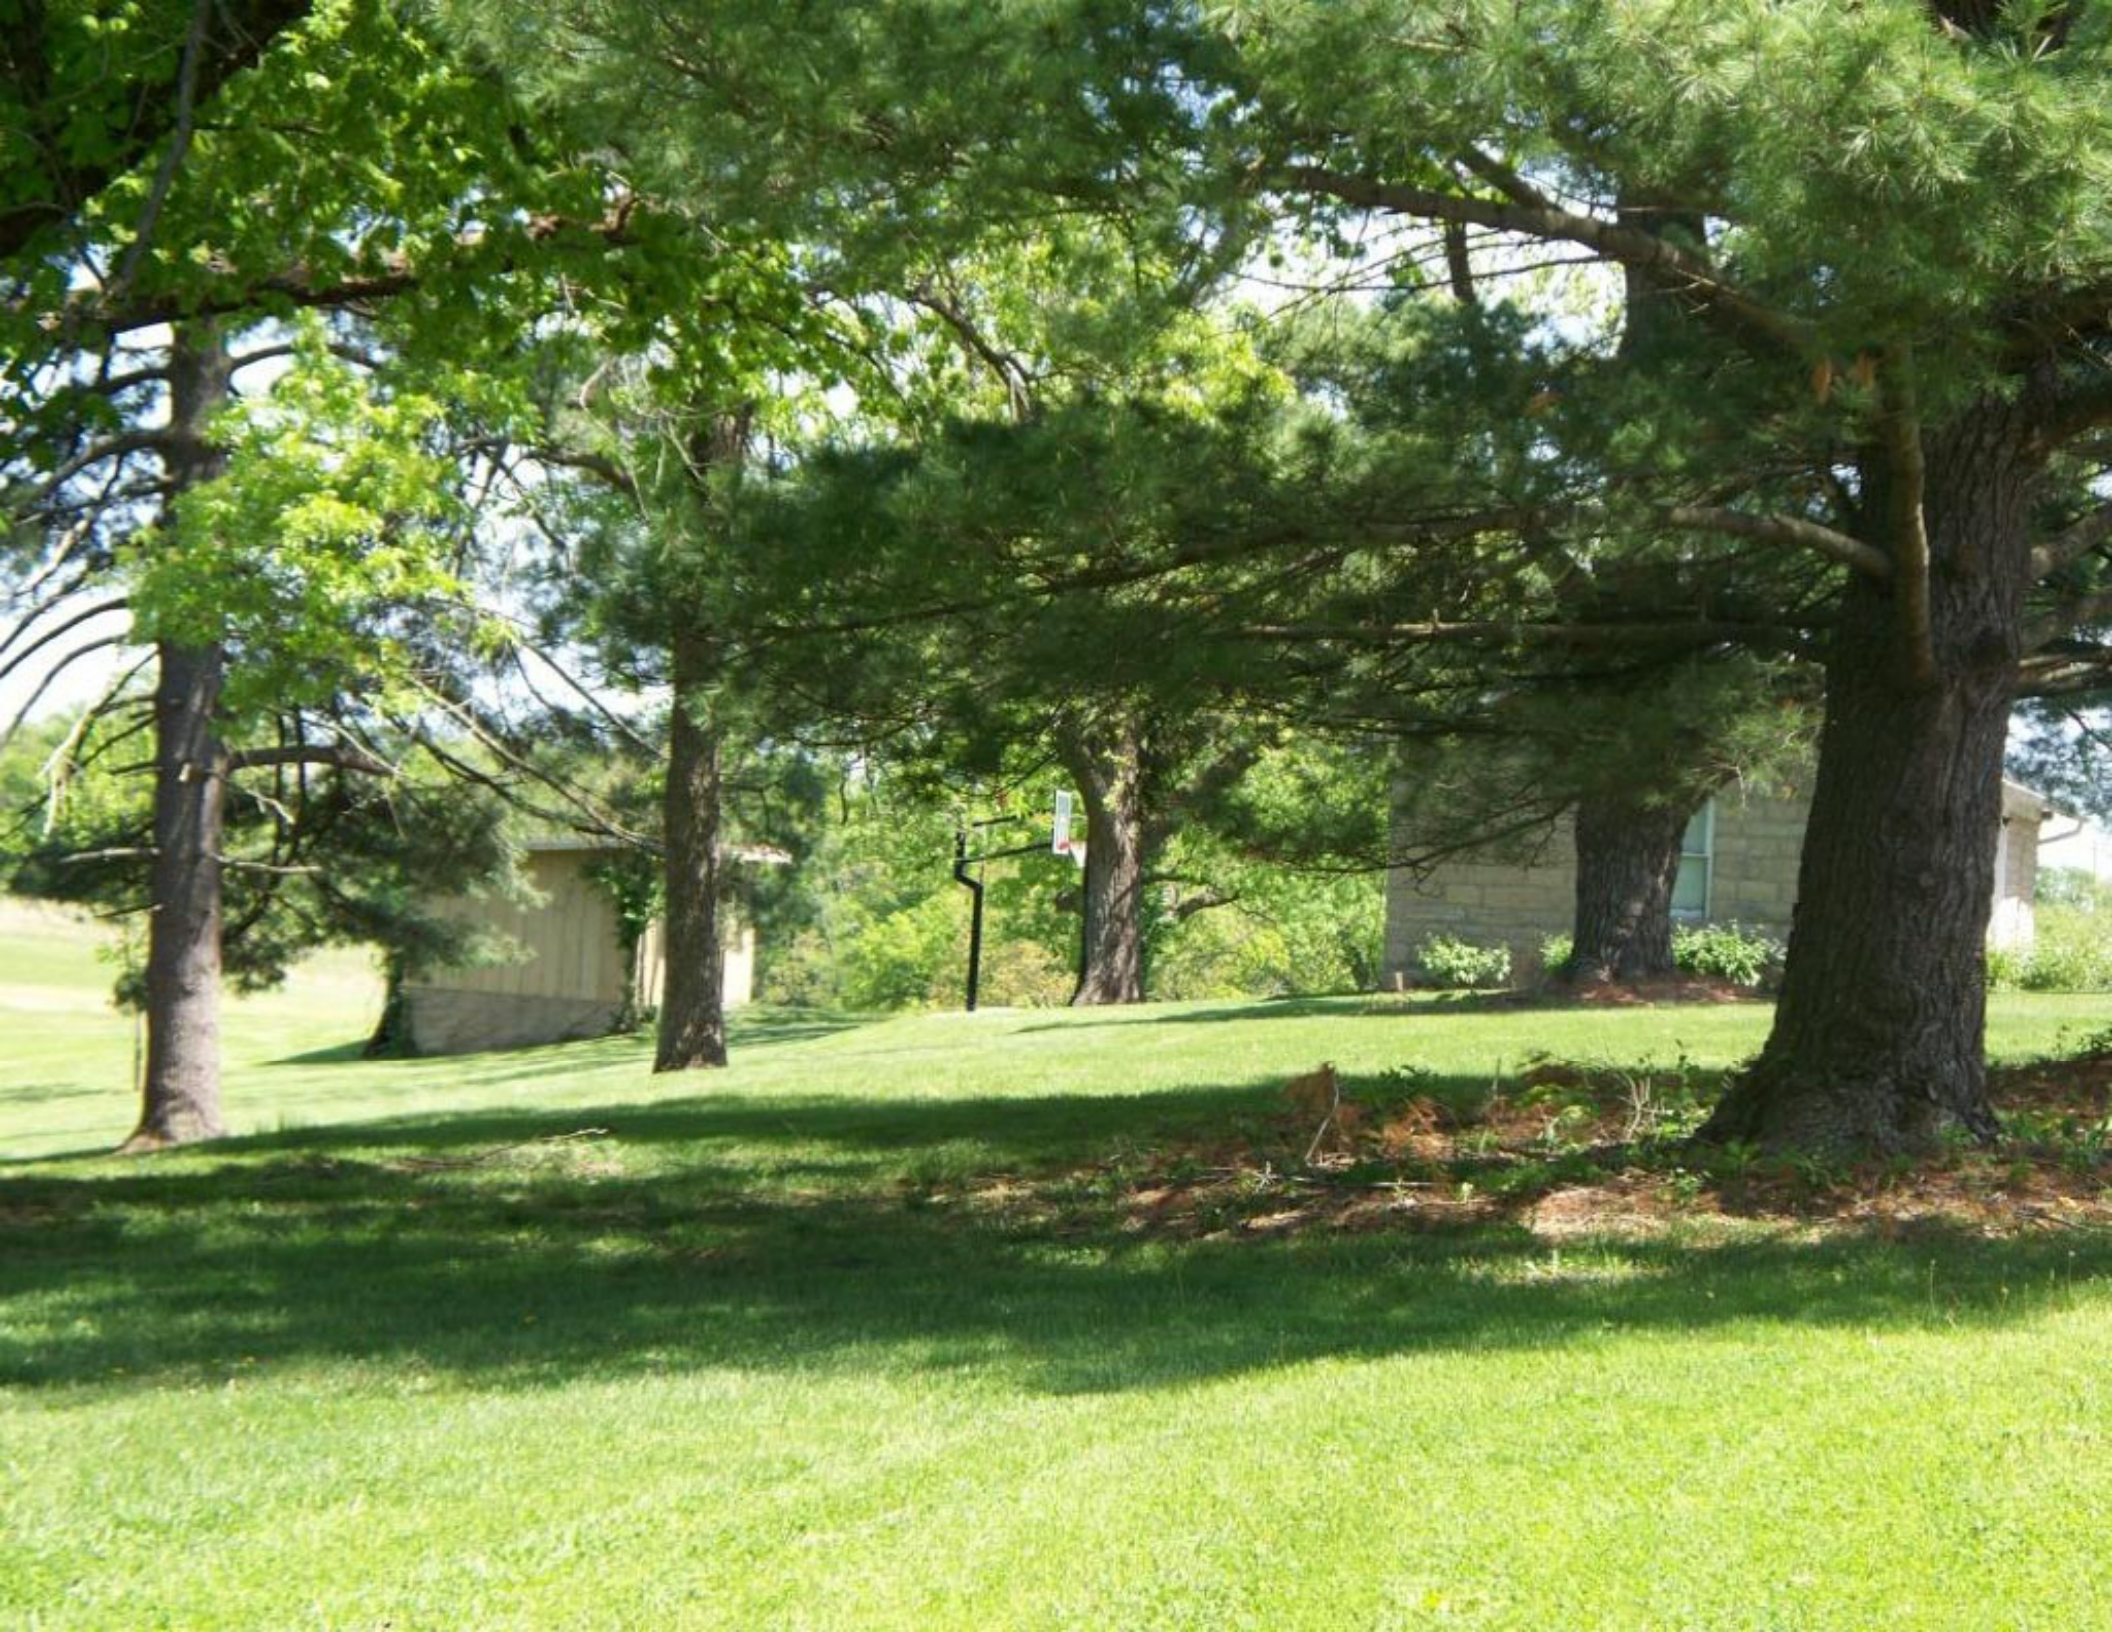
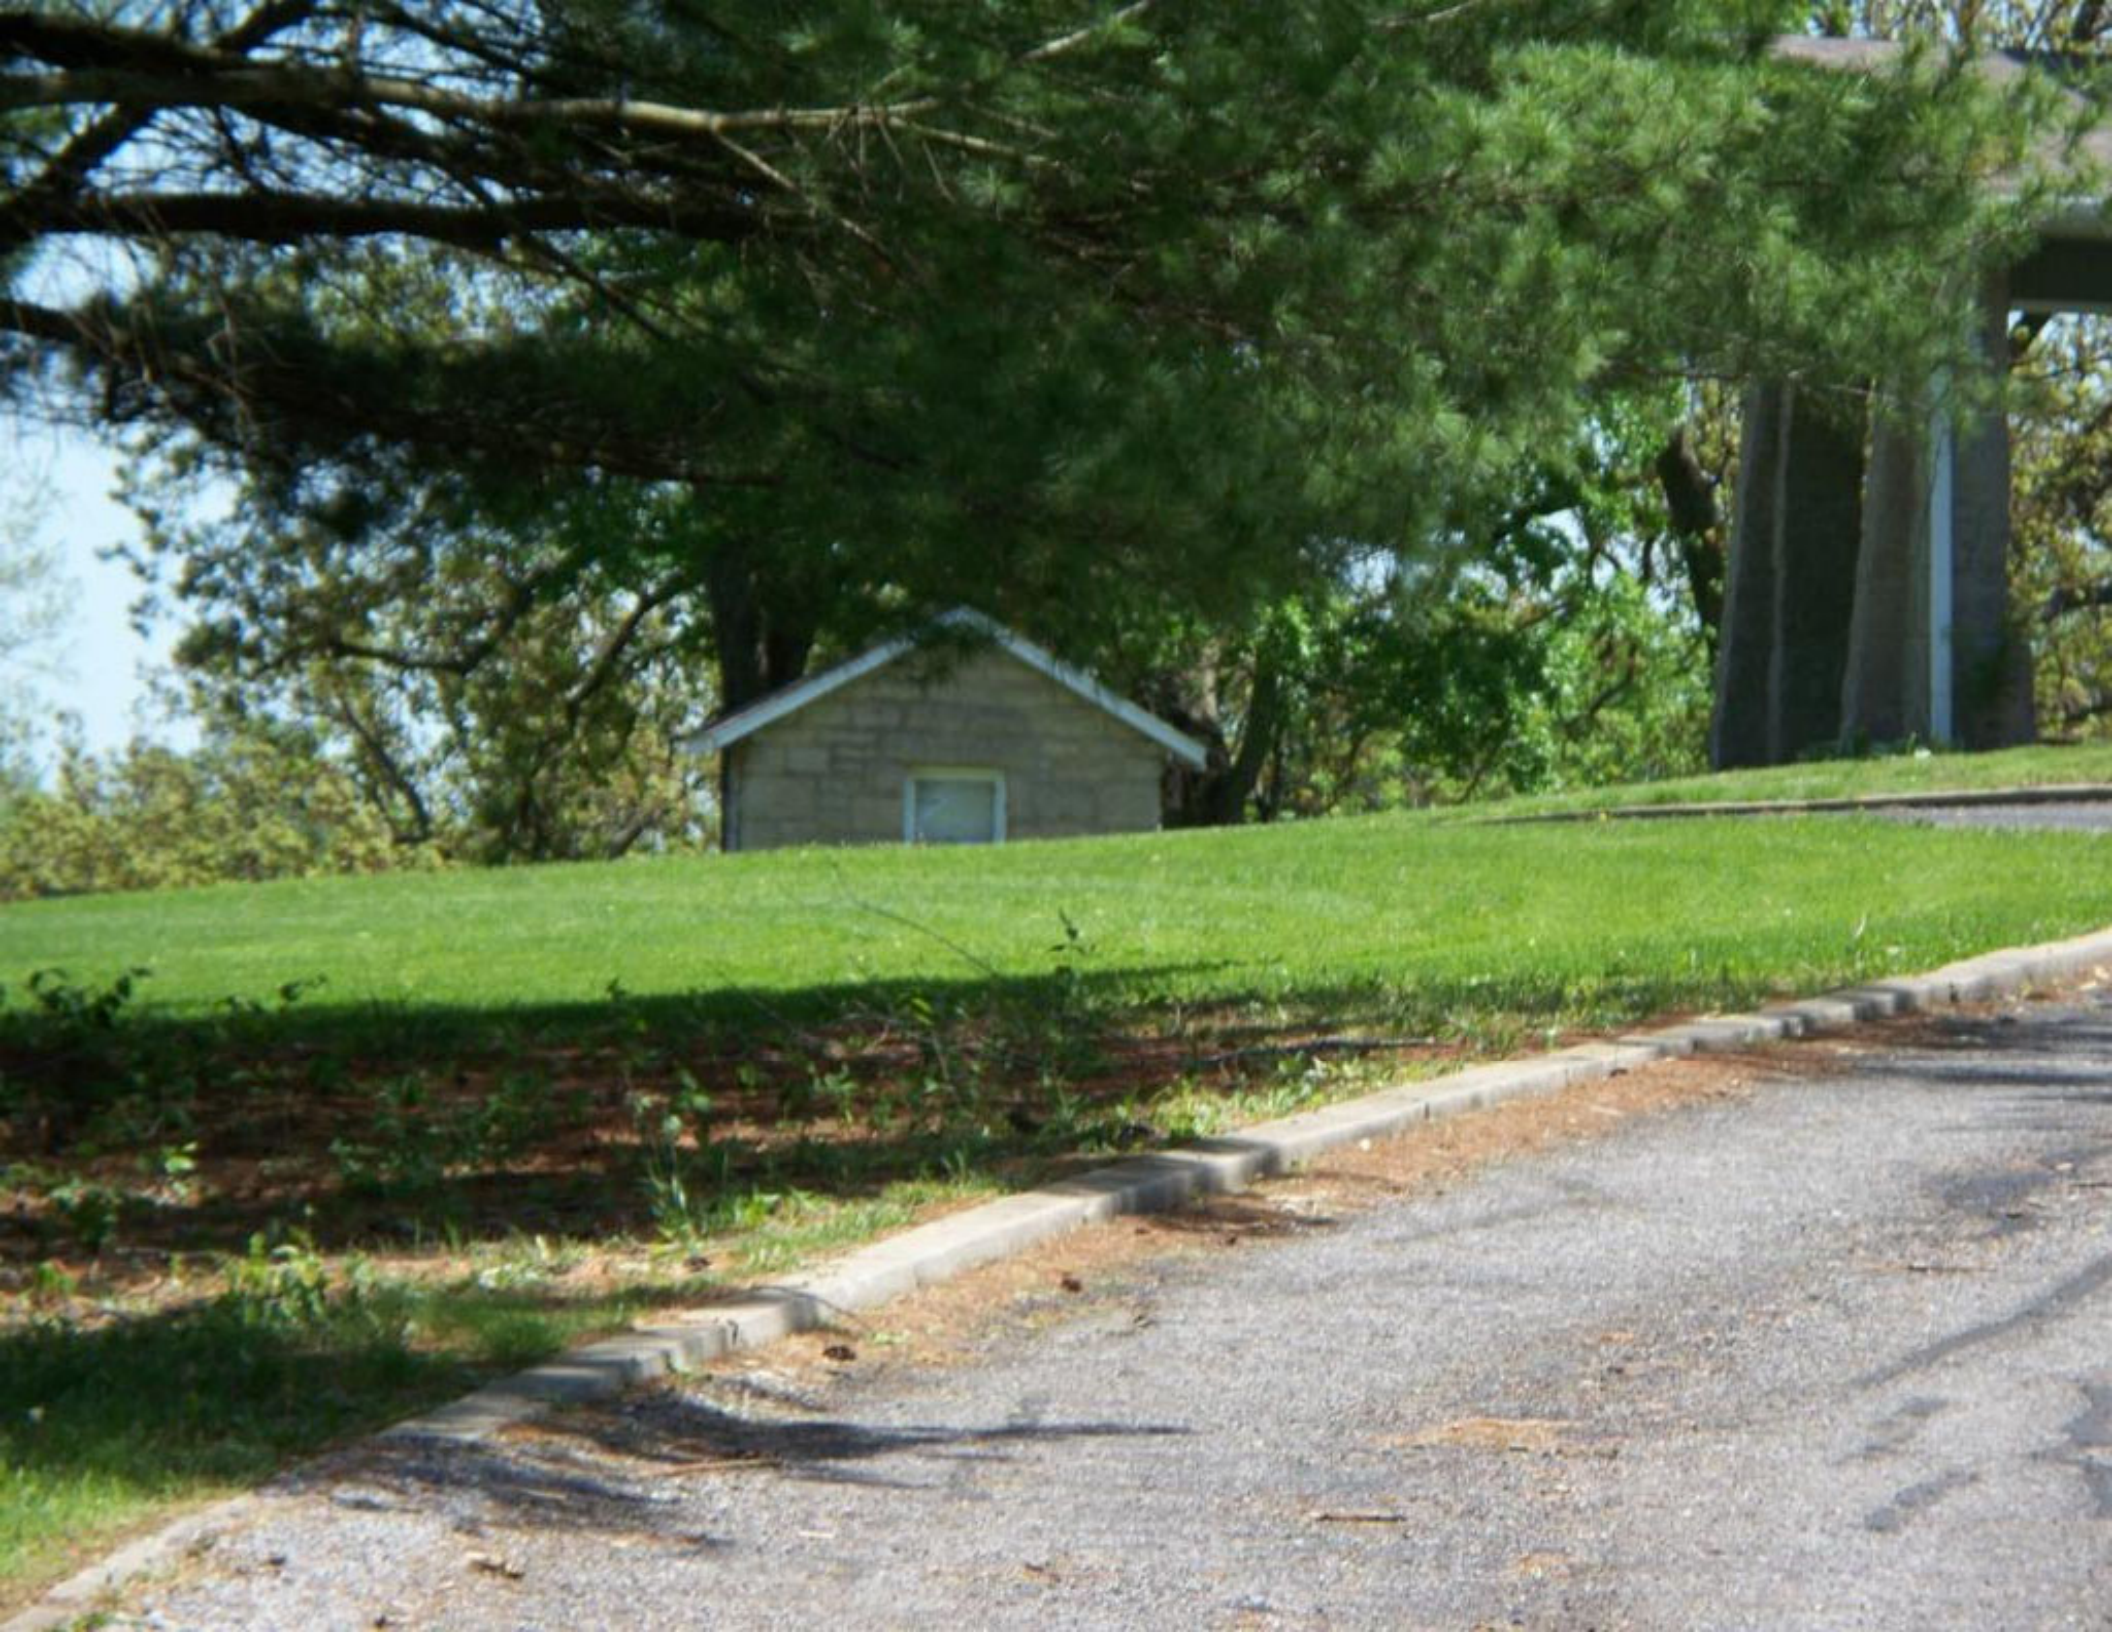
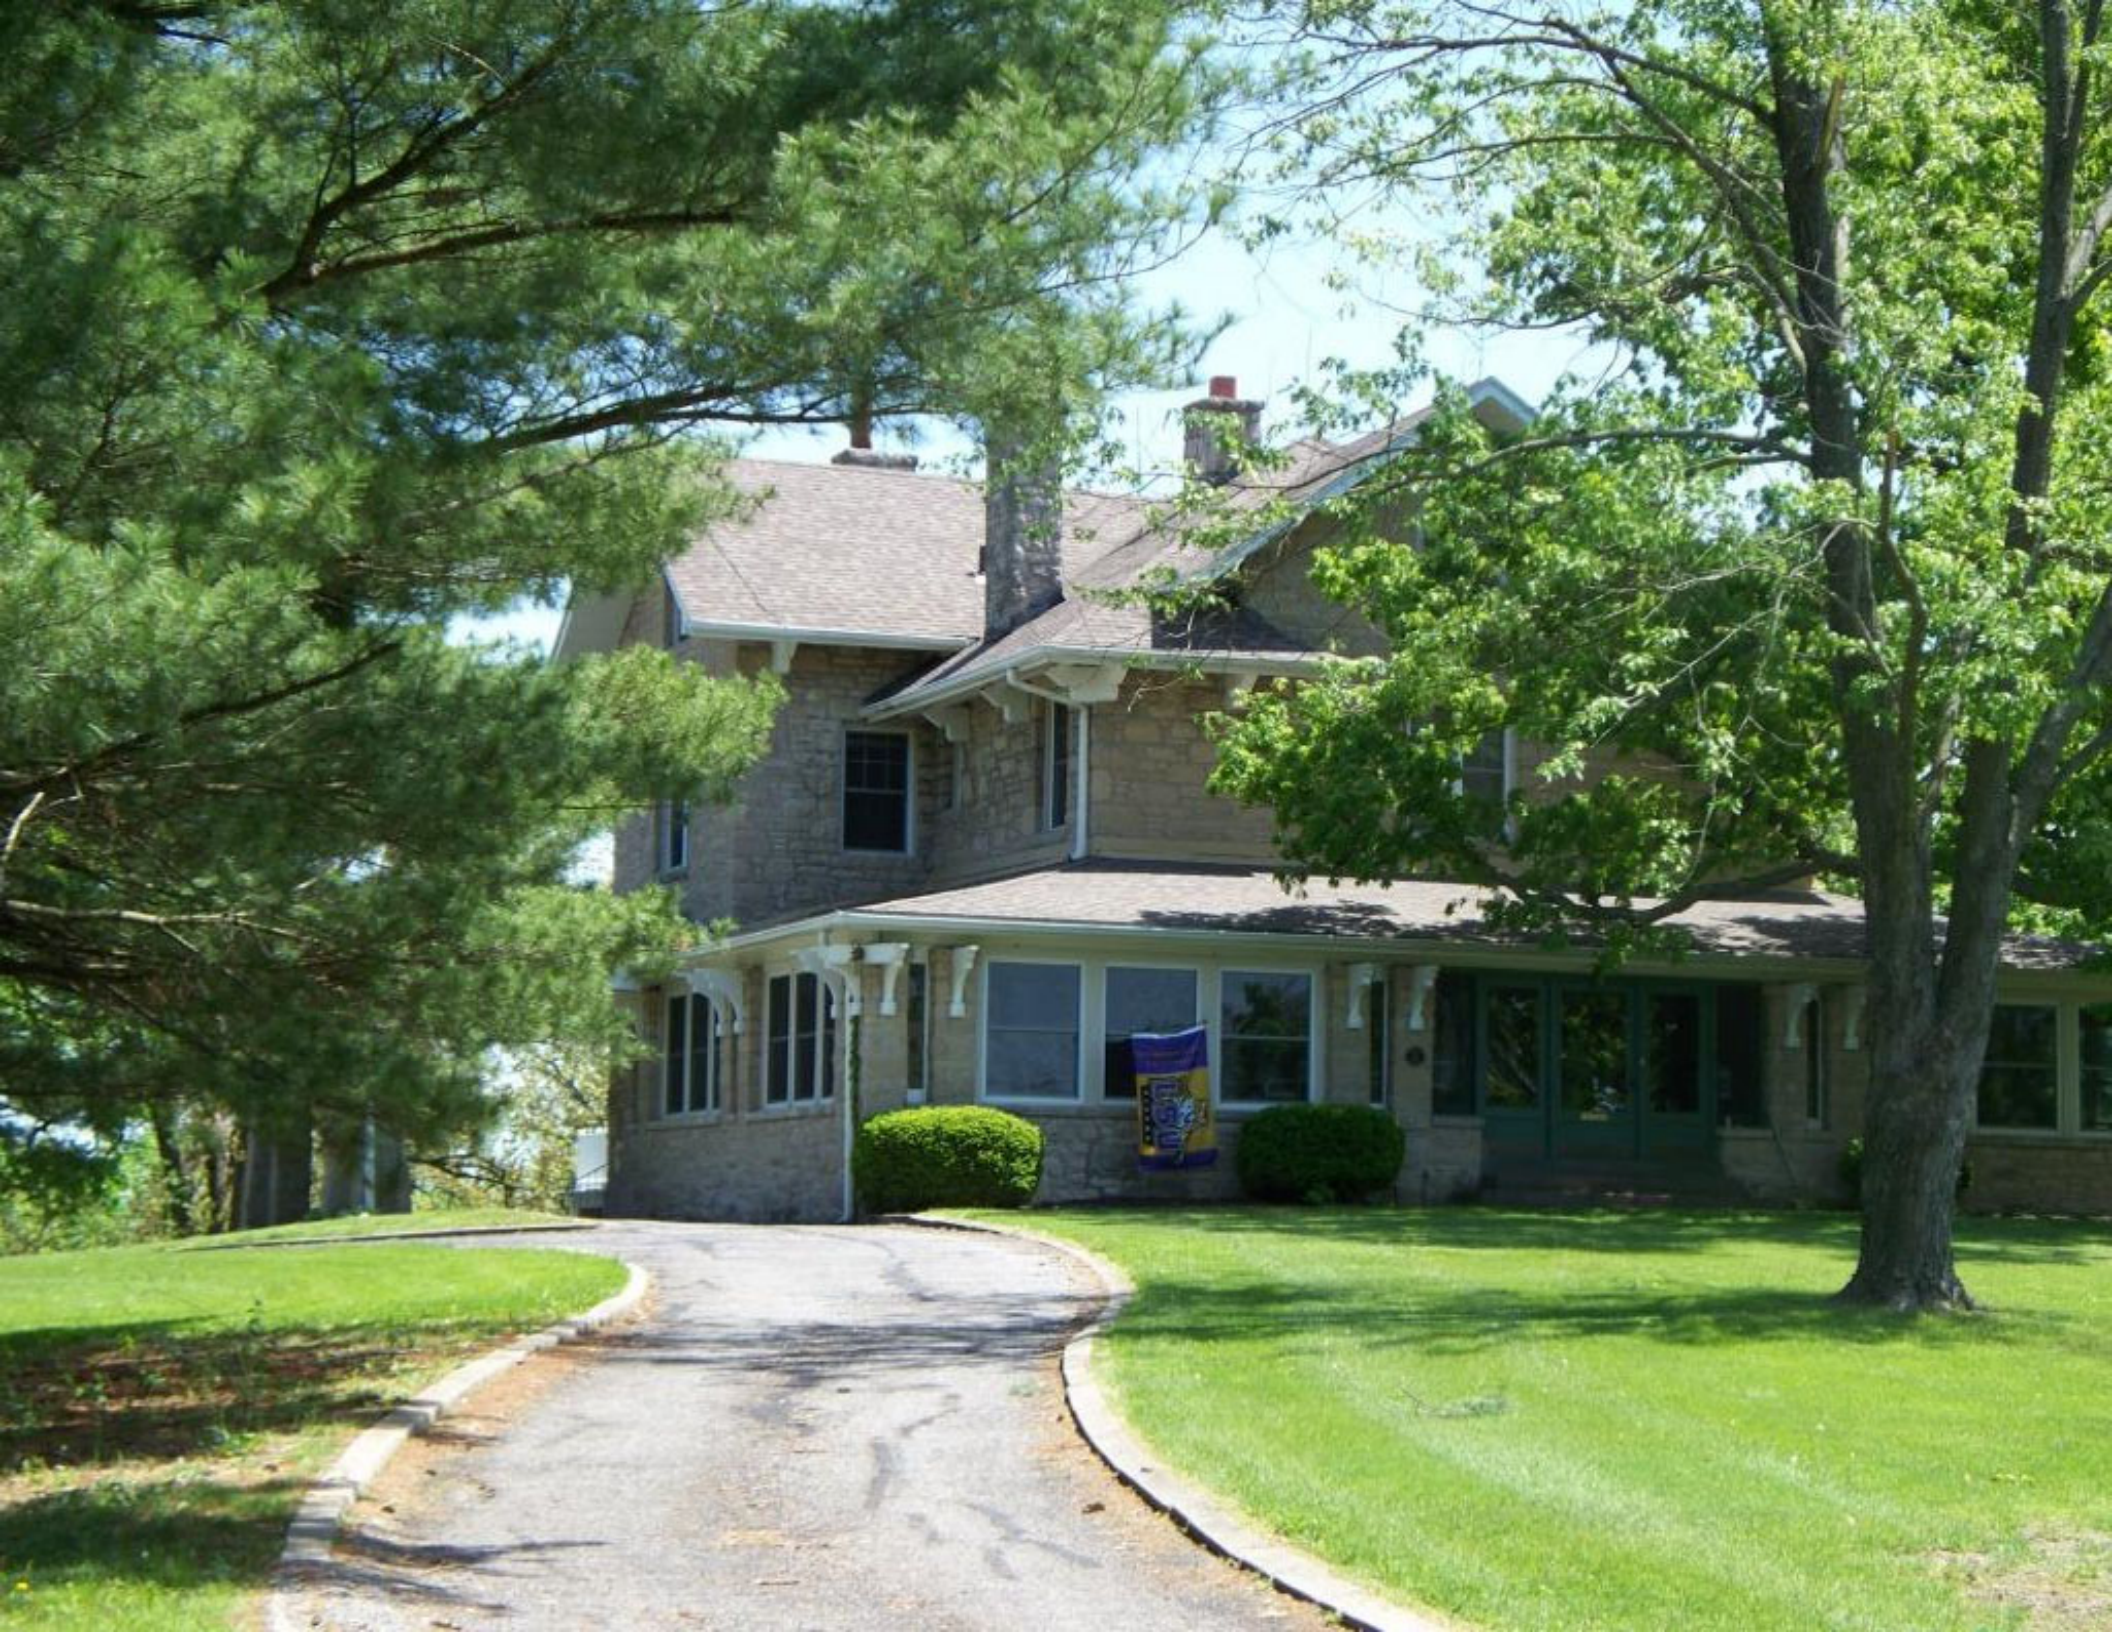
Behind the home is a front gable stone outbuilding, possibly a garage (hard to tell from public right-of-way) and a shed clad in wood with a shed roof and stone foundation. They both would be contributing.

This massive 2 ½ story stone bungalow is individually eligible for architecture as an excellent example of the Craftsman style. The central front gable has deep returns with brackets created by the cross gable wings that extend a bay in each direction (a single window is on the side of these wings on the front of the facade). In its peak is a 4/1 window. All the windows seem to be replacements. Below this window are paired 4/1 windows. A hipped roof flares beneath this window and wraps around the property. It covers the porch, which has been enclosed with two rows of three 1/1 windows and a large door with two sets of sidelights: big sidelights with half paneling (as big as the door) and smaller single pane on the outer). Next to this is a narrow strip window on either side flanked with brackets. Fortunately the stone piers and half walls were left in tact. The wrap around porch on the right hand side remains open. To the left and set back is a porte-cochere with a side gable roof stone battered piers and brackets. This could also contribute to a small Frank B. Miller district (with 1431 and 1503 Green Berry).
