ARCHITECTURAL/HISTORIC INVENTORY FORM

1. Survey No. CO-AS-005-001		2. Survey name: Moreau Drive Neighborhood Survey	
3. County: Cole		4. Address: 1202 Elmerine Ave.	
5. City: Jefferson City	Vicinity: <input type="checkbox"/>	6. UTM: / /	7. Township/Range/Section: T: R: S:
8. Historic name (if known):		9. Present/other name (if known):	
10. Ownership: <input checked="" type="checkbox"/> Private <input type="checkbox"/> Public		11. Historic use (if known): Residential	11. Current use: Residential

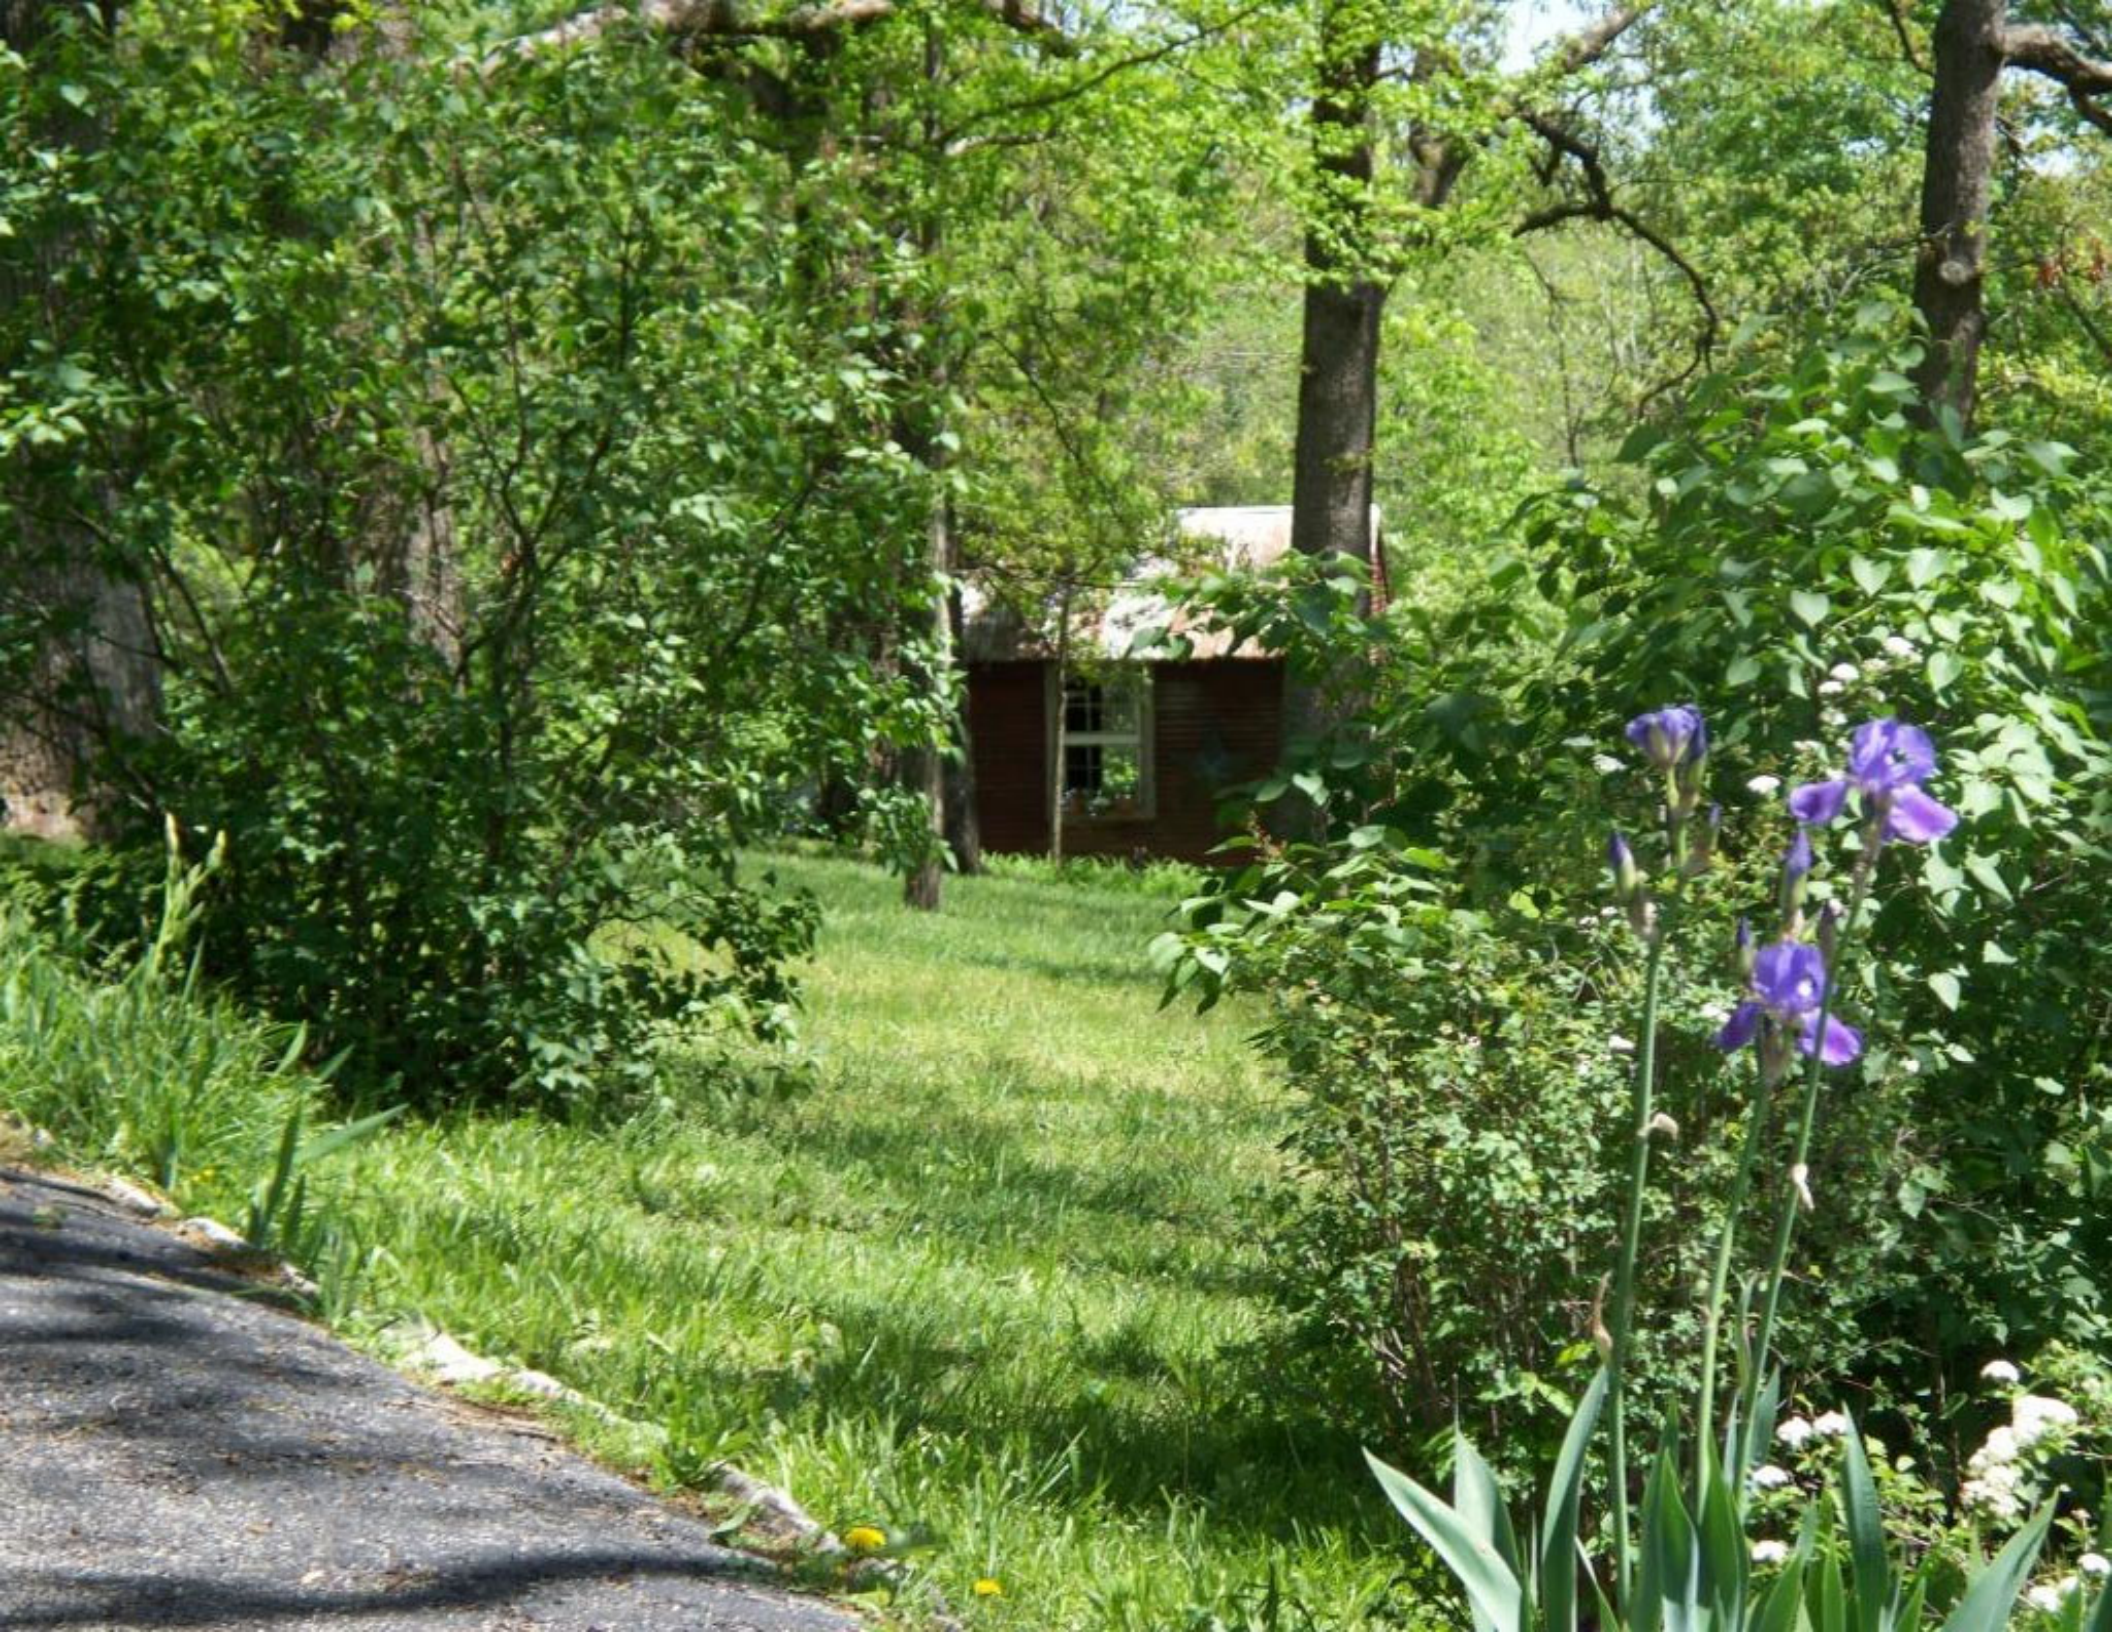
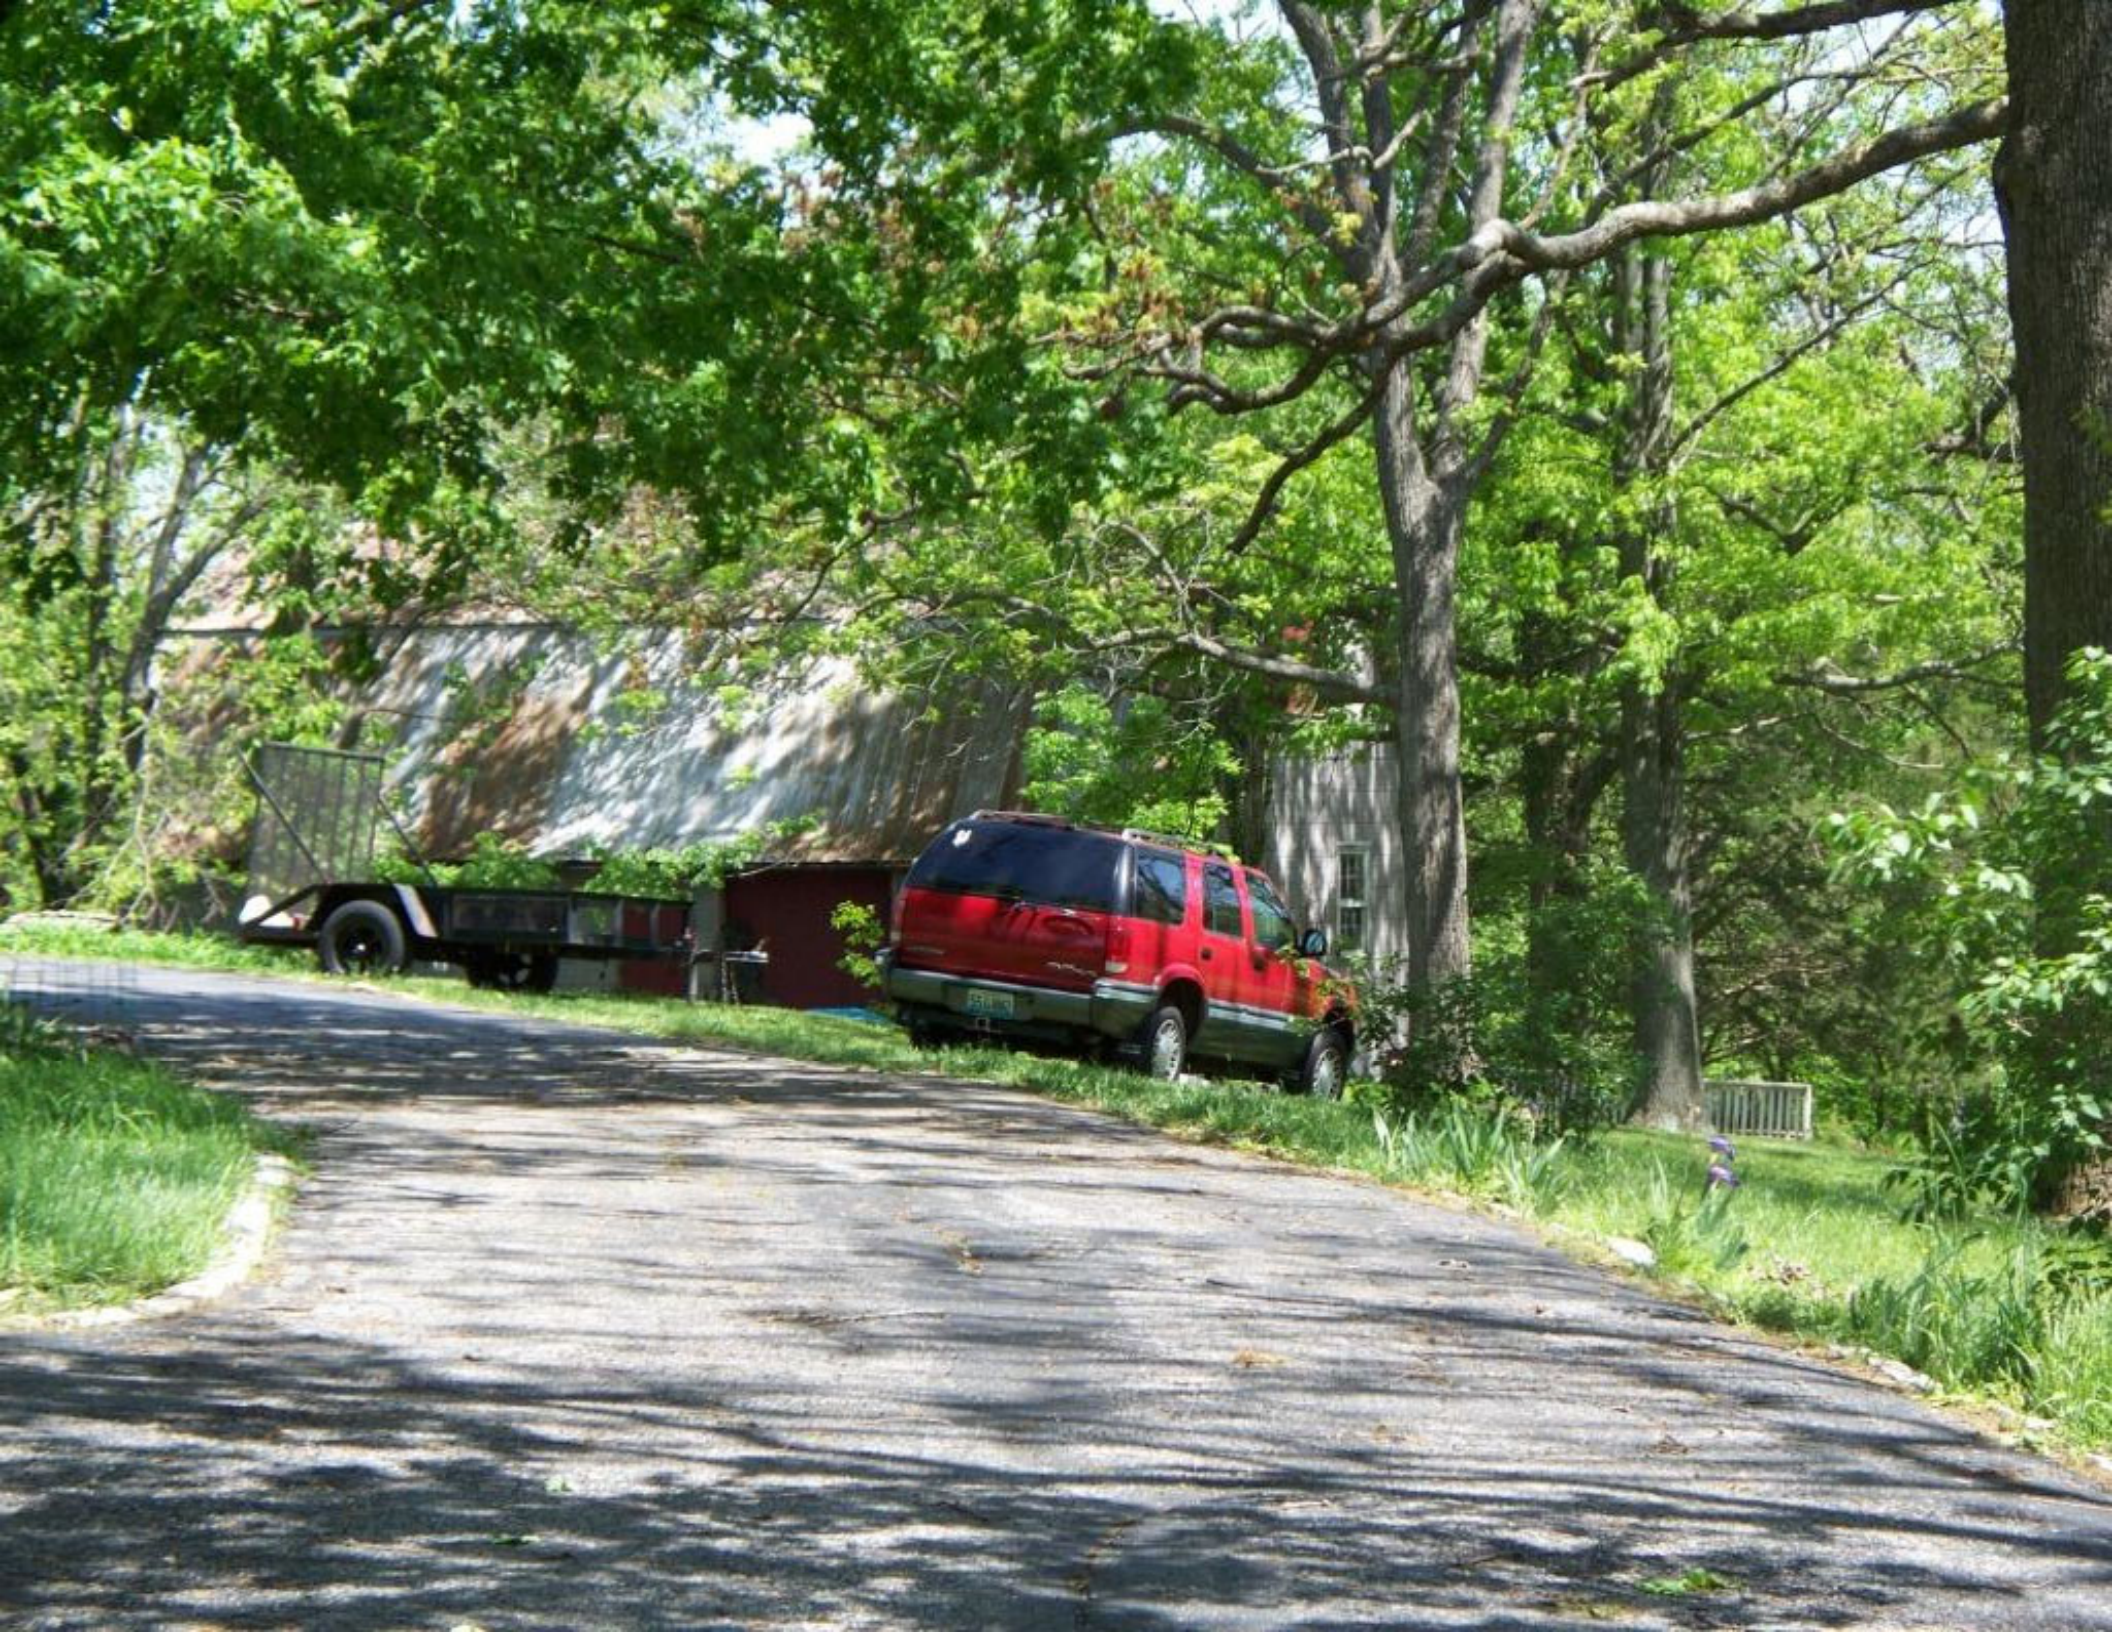
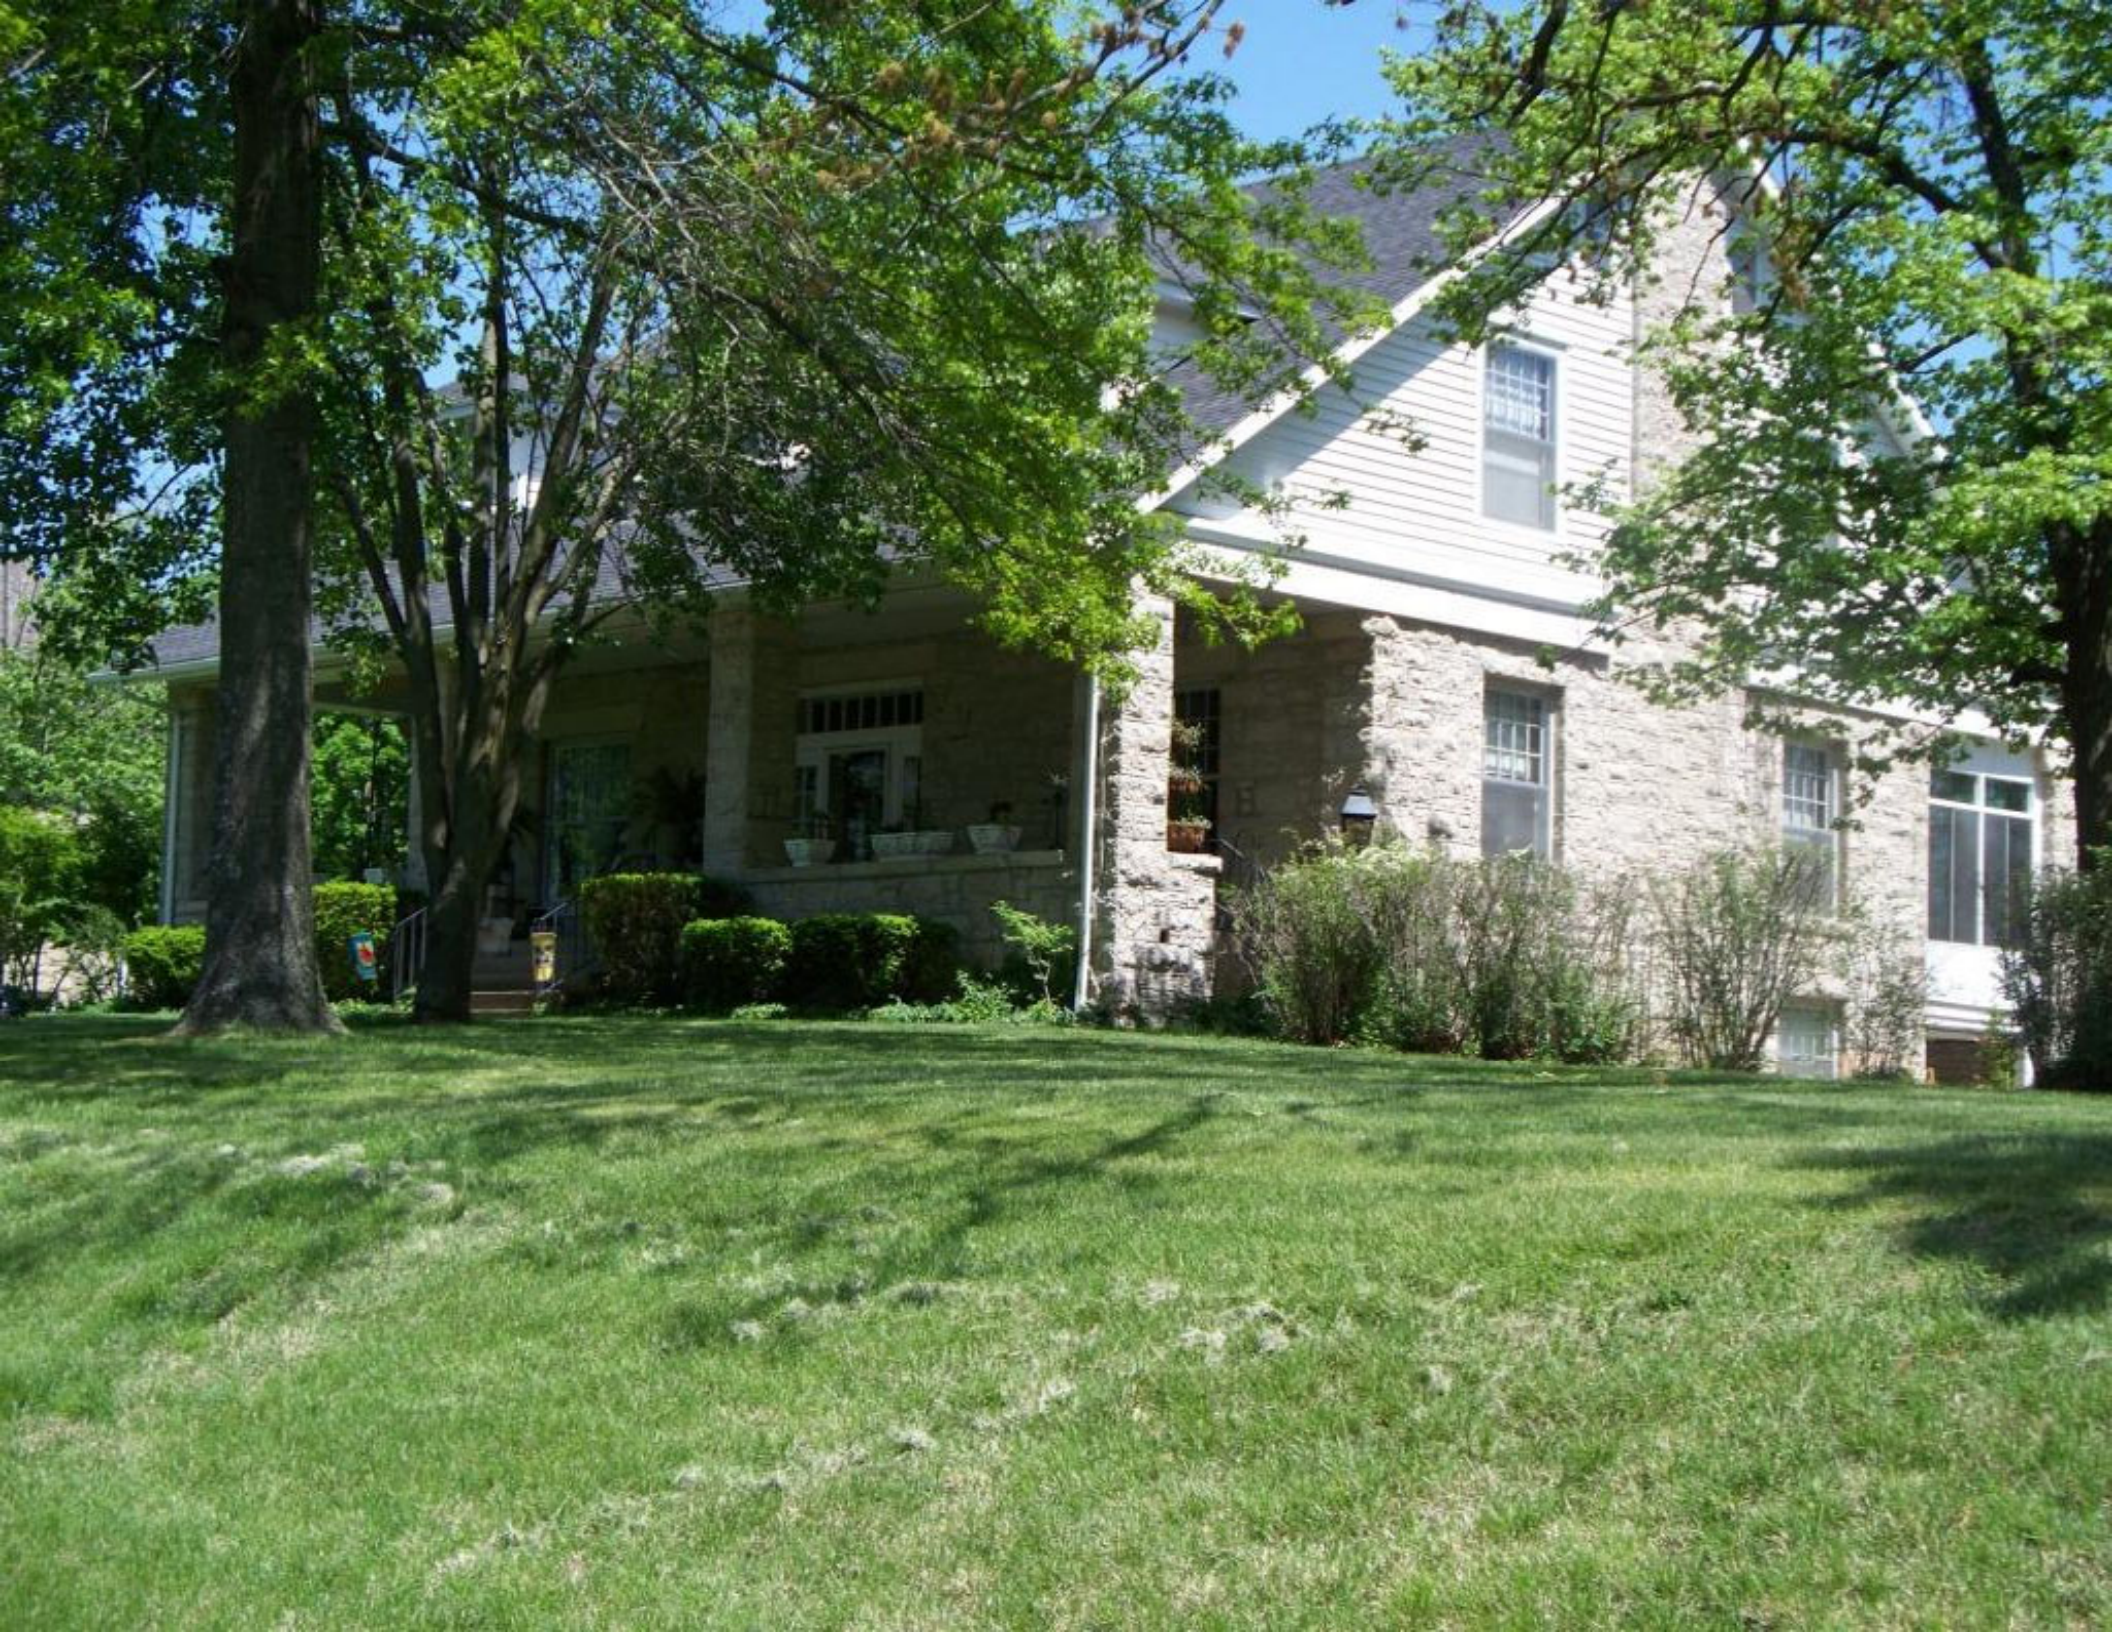
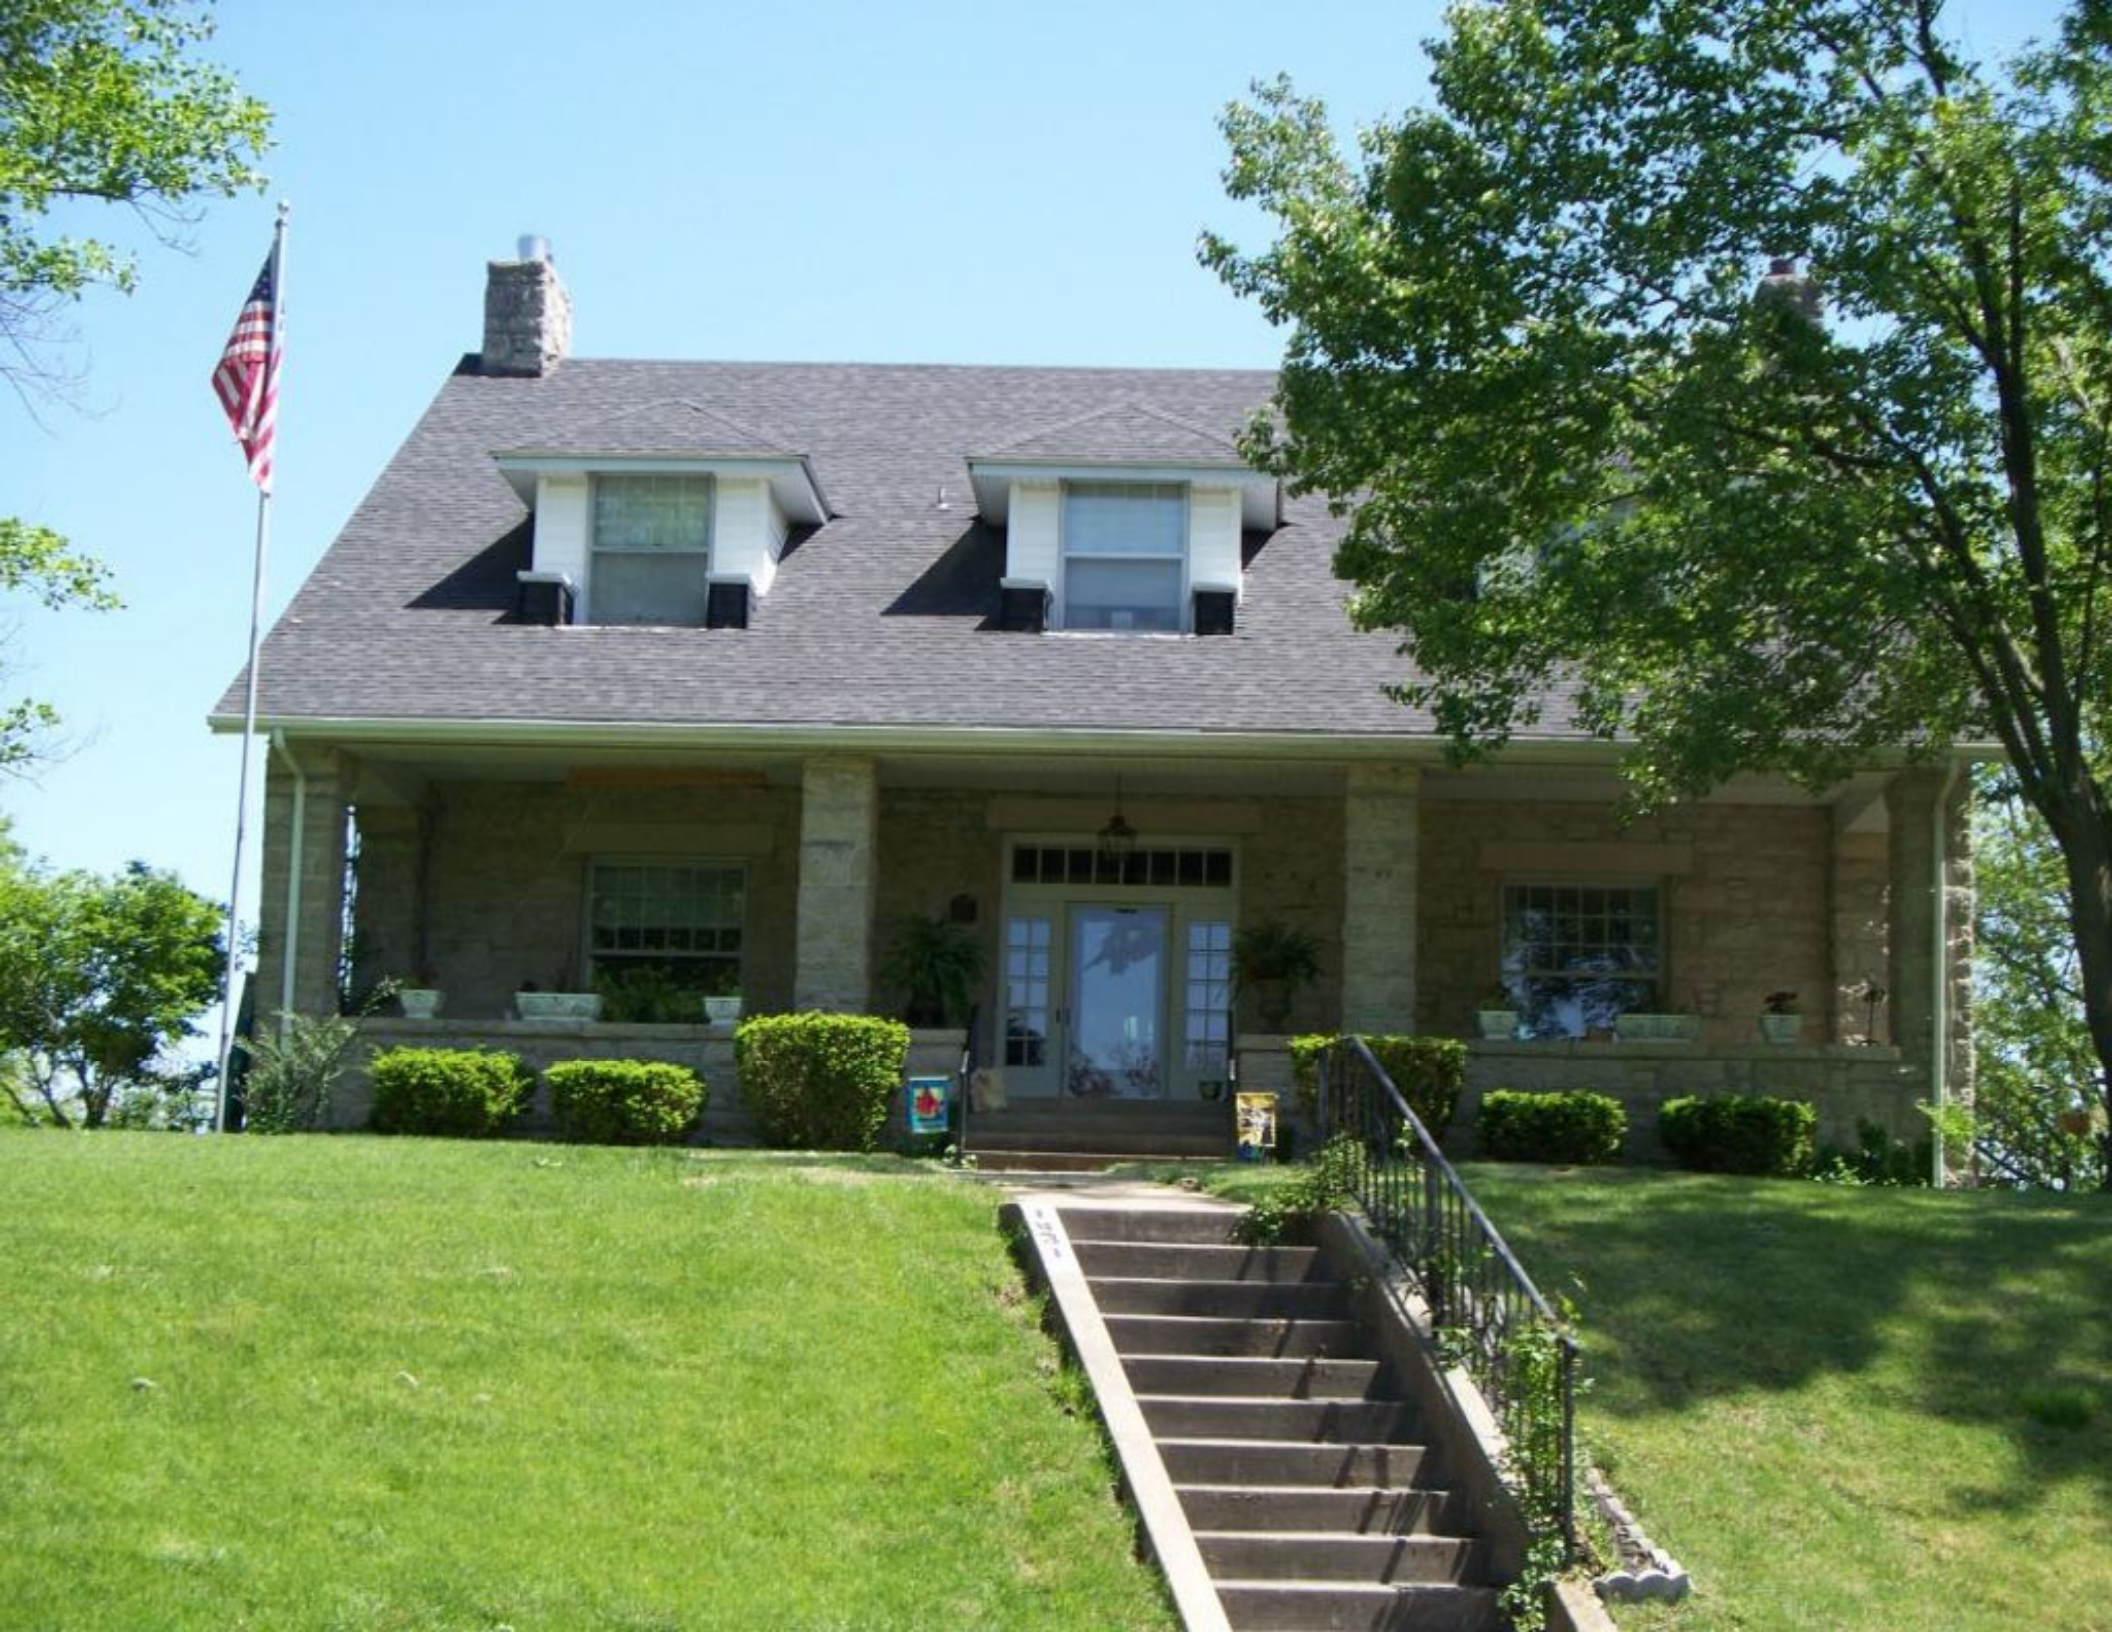
This sizable stone bungalow is 1 ½ to 2 stories tall and features a deeply pitched side gable roof with three hipped dormers clad in vinyl. The dormers have shelves (half walls) clad in shingle and capped in wood or vinyl that extend forward from the sides of each dormer which contain a single 12/1 non-historic window. Two large 18/1 windows with thick stone lintels flank the entrance, which has multi-light sidelights and a multi-light transom. The roof extends to cover the full width porch which features stone piers and half walls. Stone chimneys rise from both ends of the roof. While probably not individually eligible it could fit into a small district of Frank. Miller homes with its neighbors (three buildings in total).

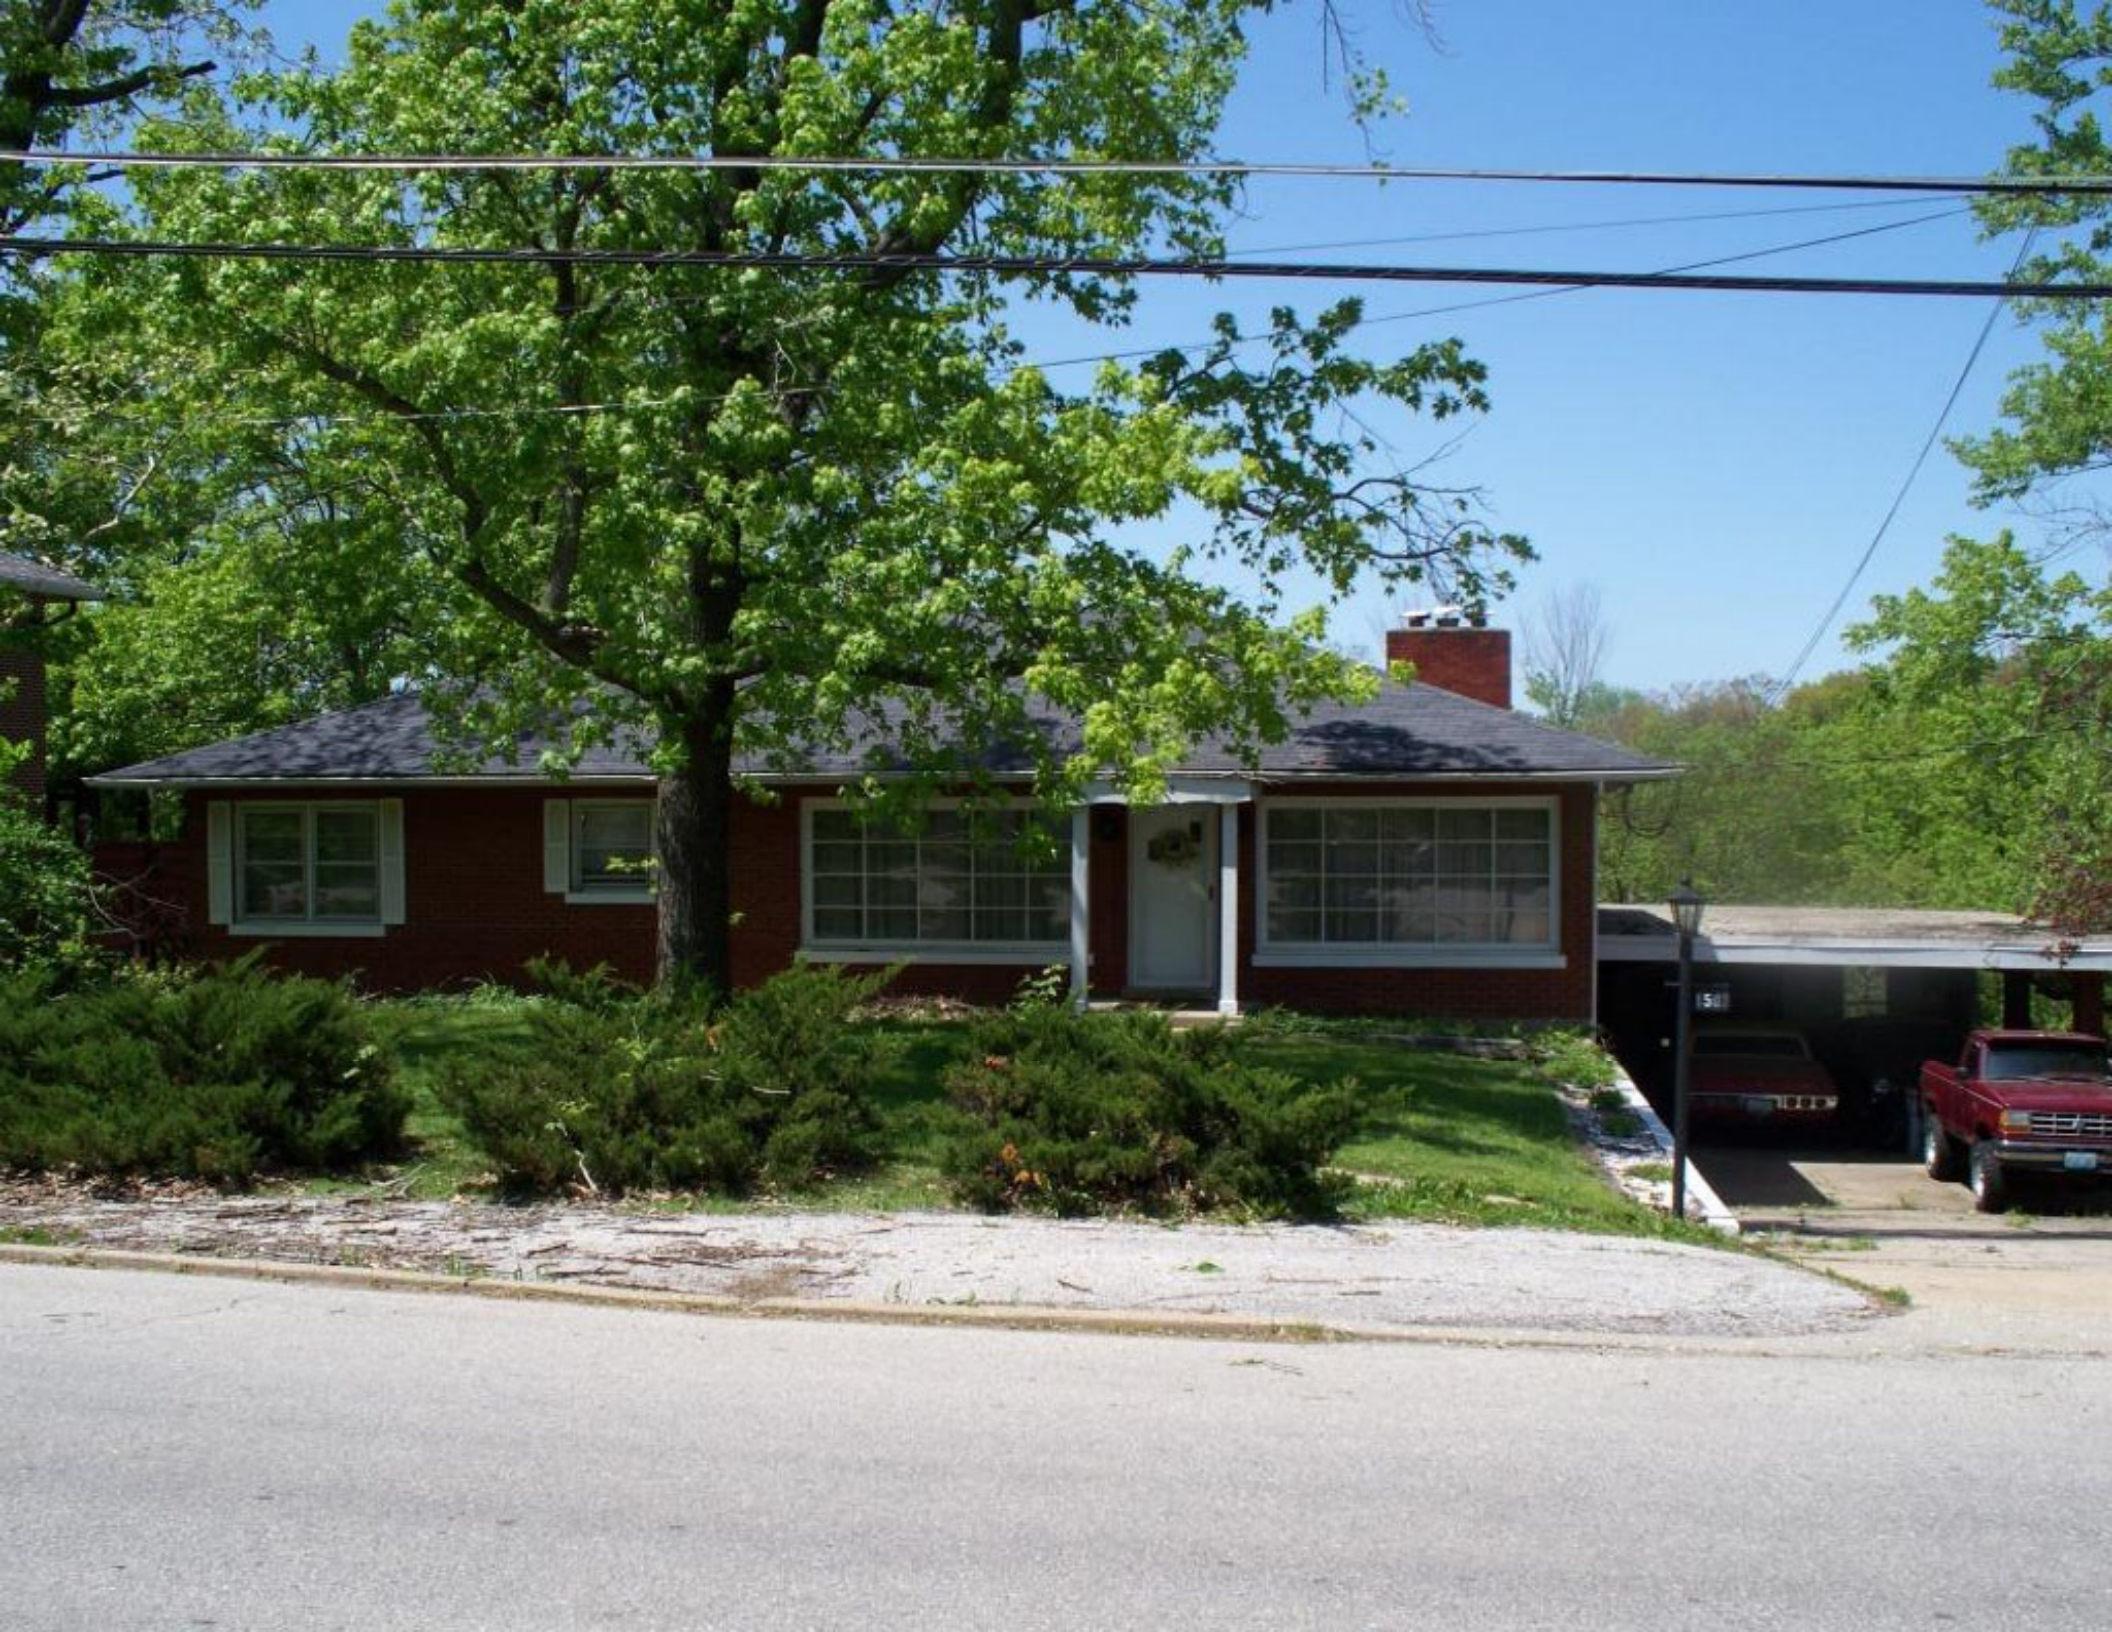
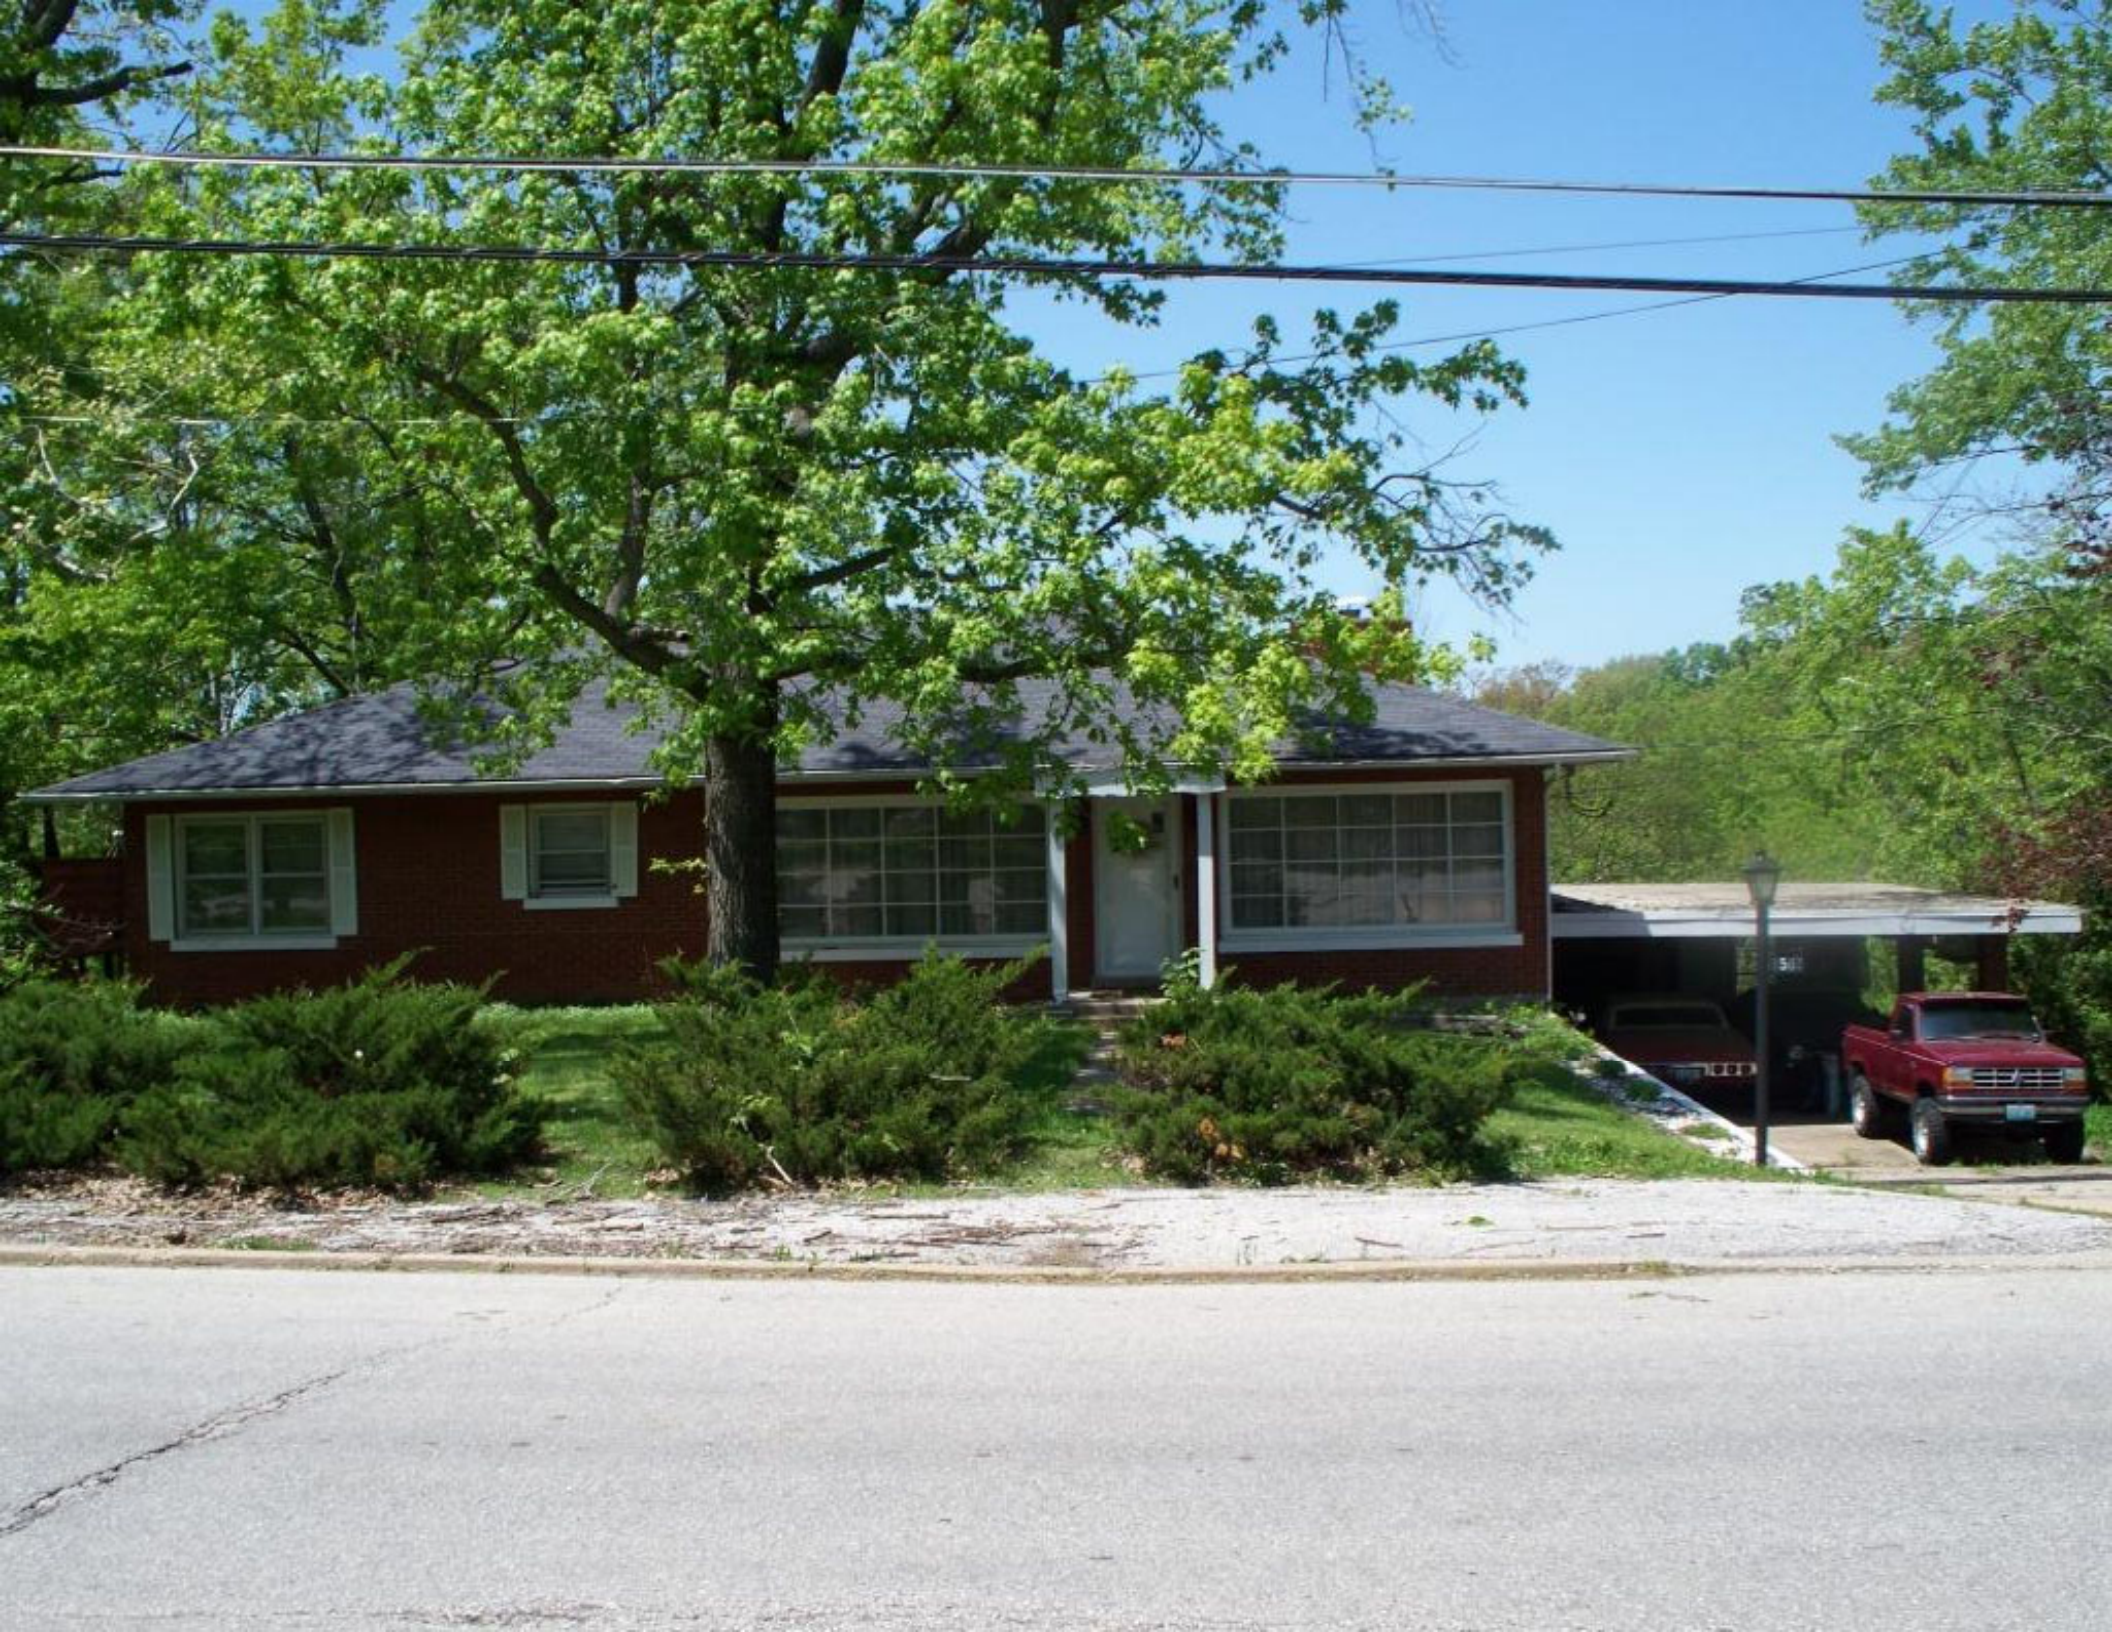
This one story brick ranch has a hipped roof. From the left the first bay has paired 1/1 picture windows with shutters. The next bay contains a shorter 1/1 with smaller shutters. Next is a large multi-light picture window. The fourth bay contains the entrance and features a portico with square posts and a flat roof. The final bay contains a large picture window identical to that in the third bay. Set back and below grade is a two car carport with a flat roof.
