ARCHITECTURAL/HISTORIC INVENTORY FORM

1. Survey No. CO-AS-005-001		2. Survey name: Moreau Drive Neighborhood Survey	
3. County: Cole		4. Address: 1202 Elmerine Ave.	
5. City: Jefferson City	Vicinity: <input type="checkbox"/>	6. UTM: / /	7. Township/Range/Section: T: R: S:
8. Historic name (if known):		9. Present/other name (if known):	
10. Ownership: <input checked="" type="checkbox"/> Private <input type="checkbox"/> Public		11. Historic use (if known): Residential	11. Current use: Residential

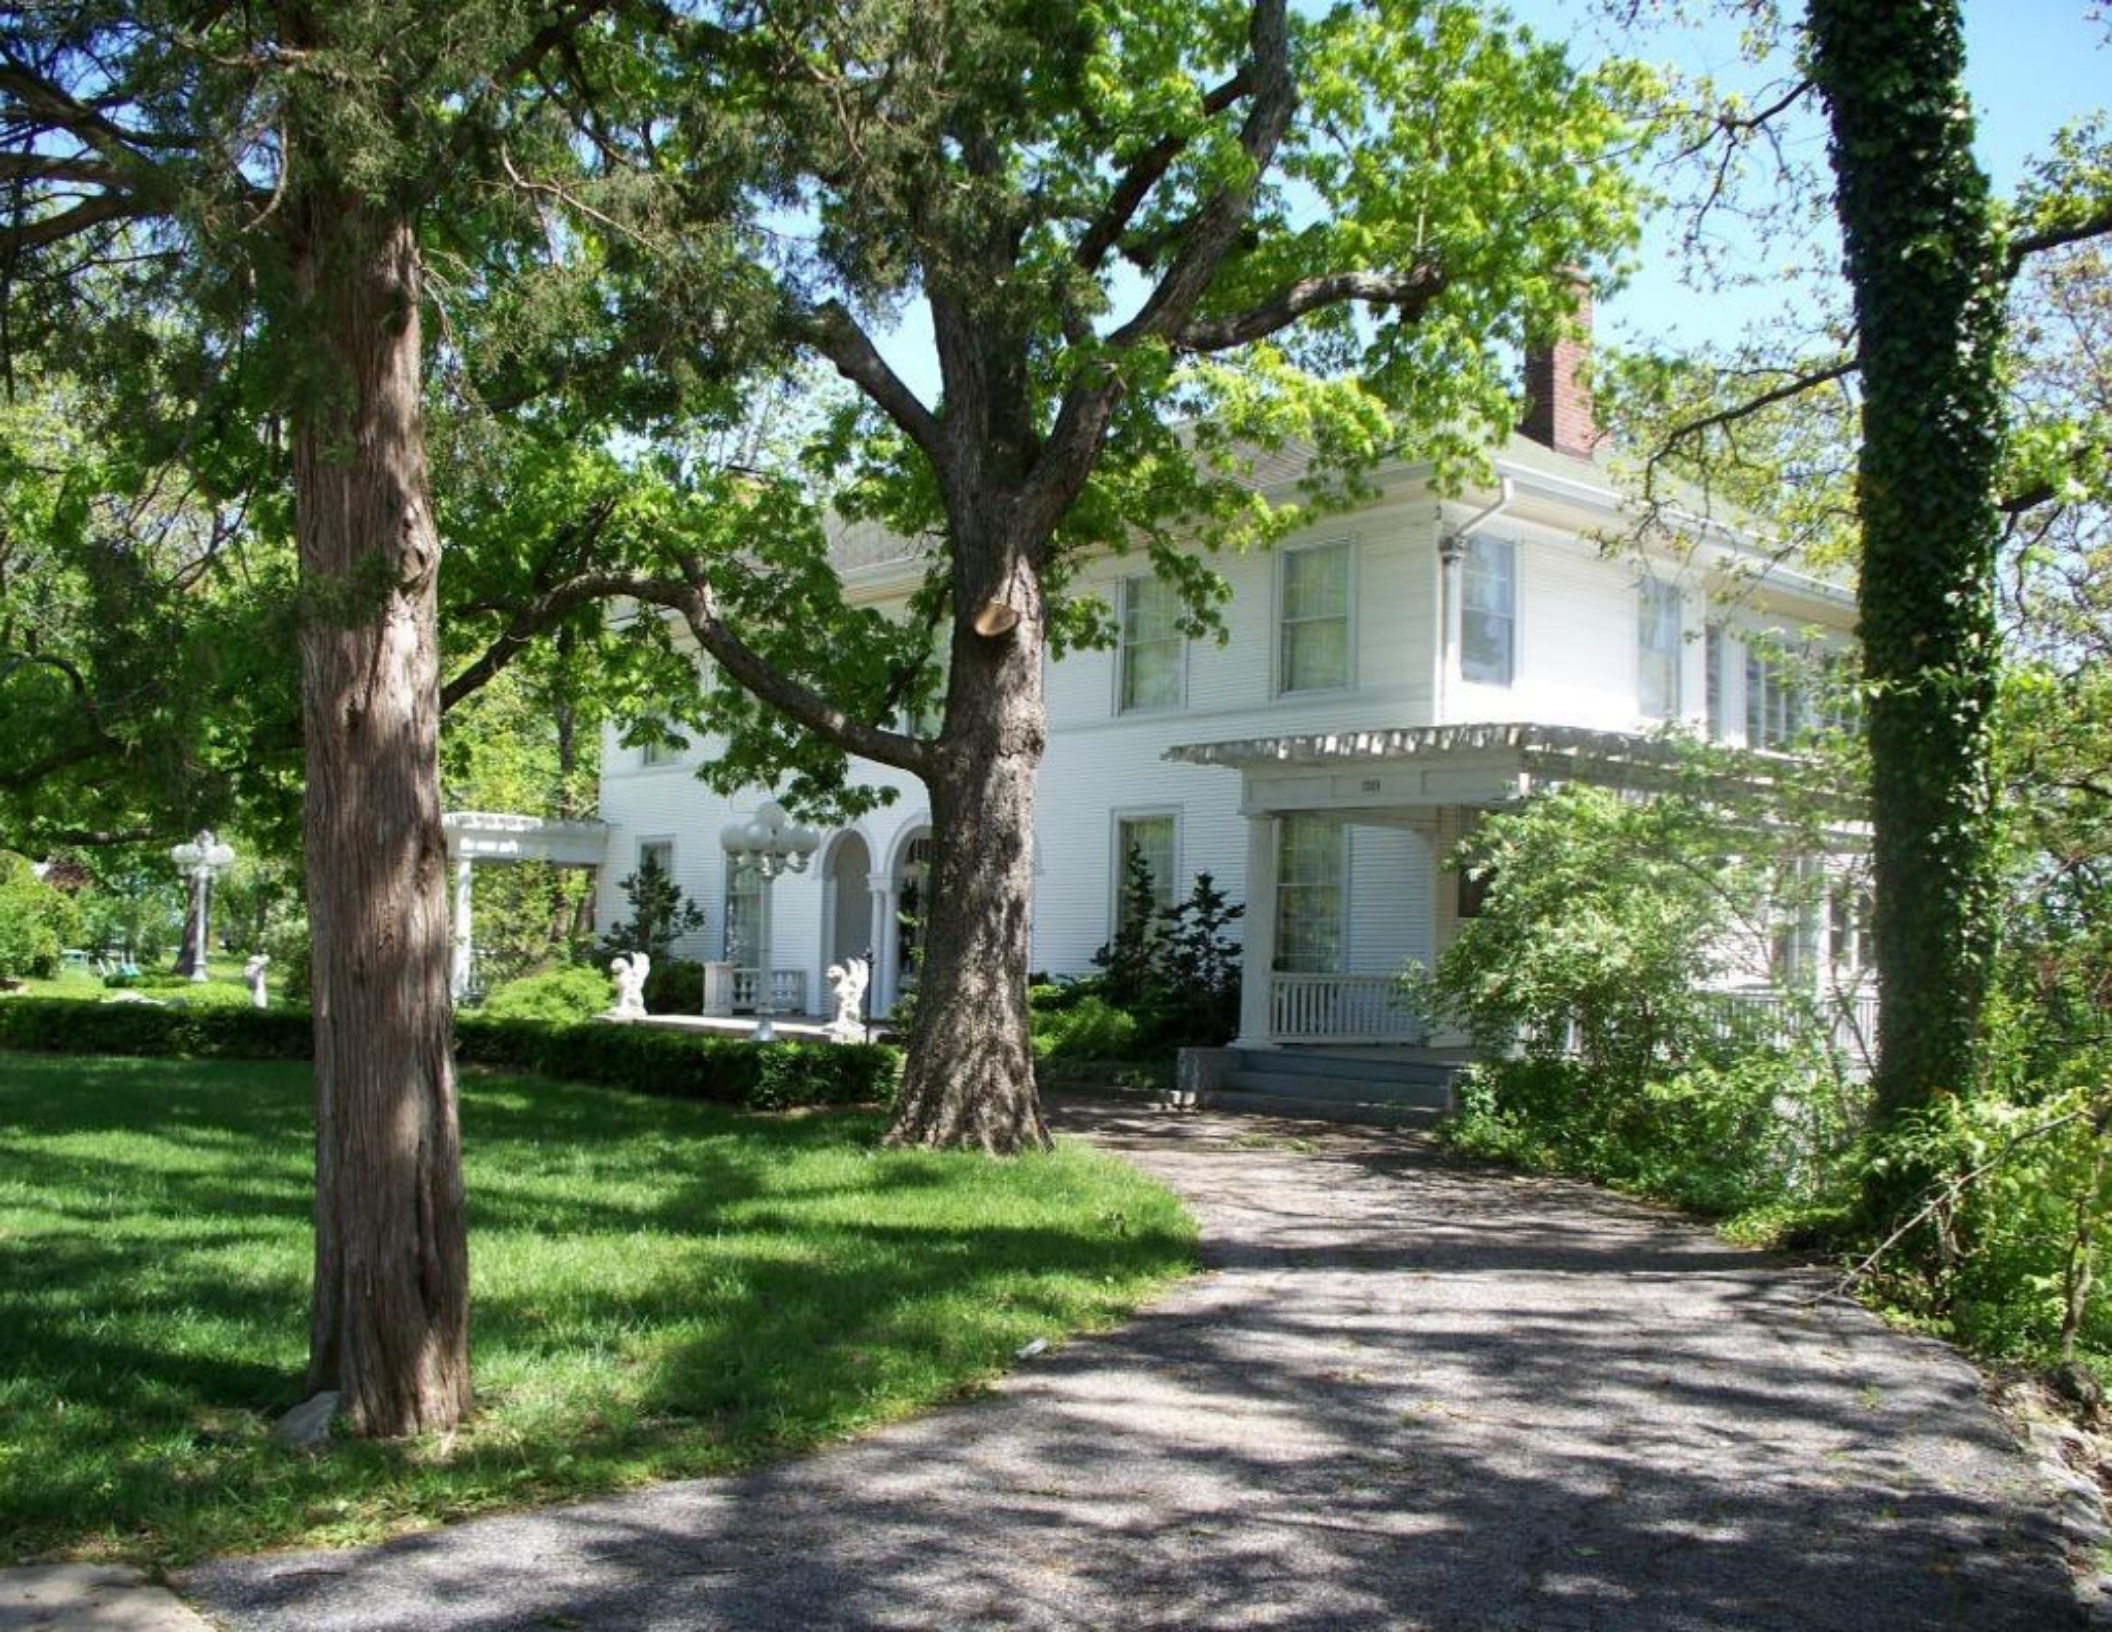
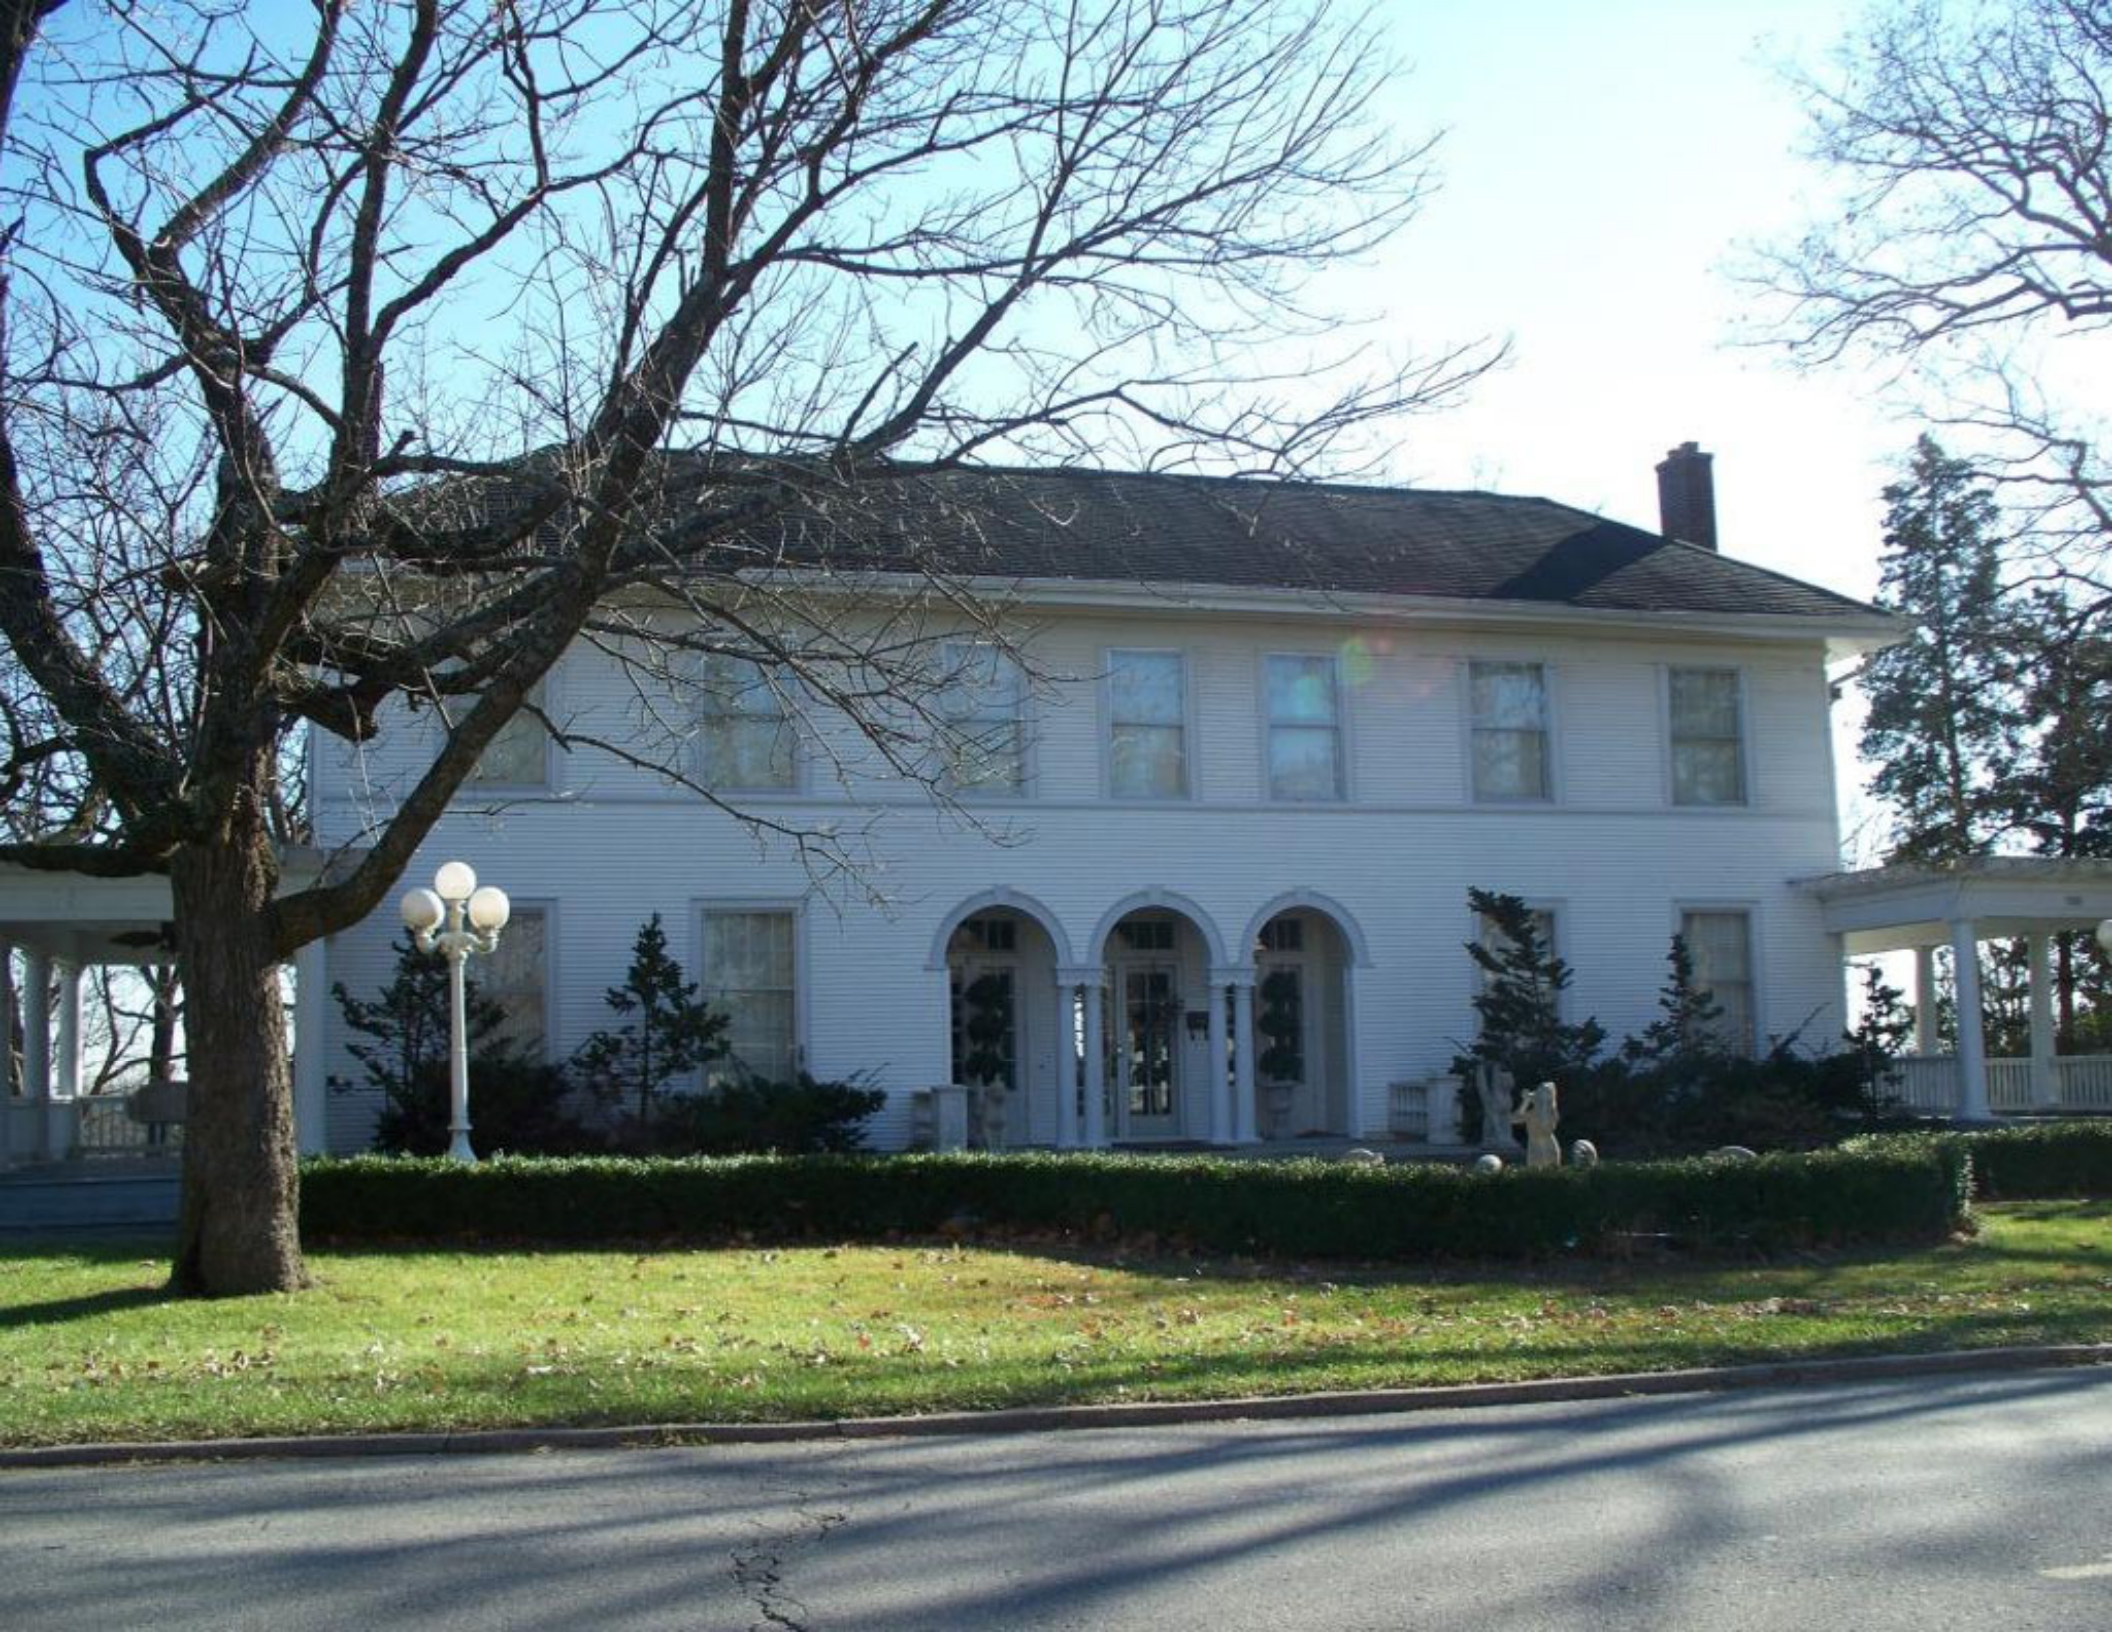
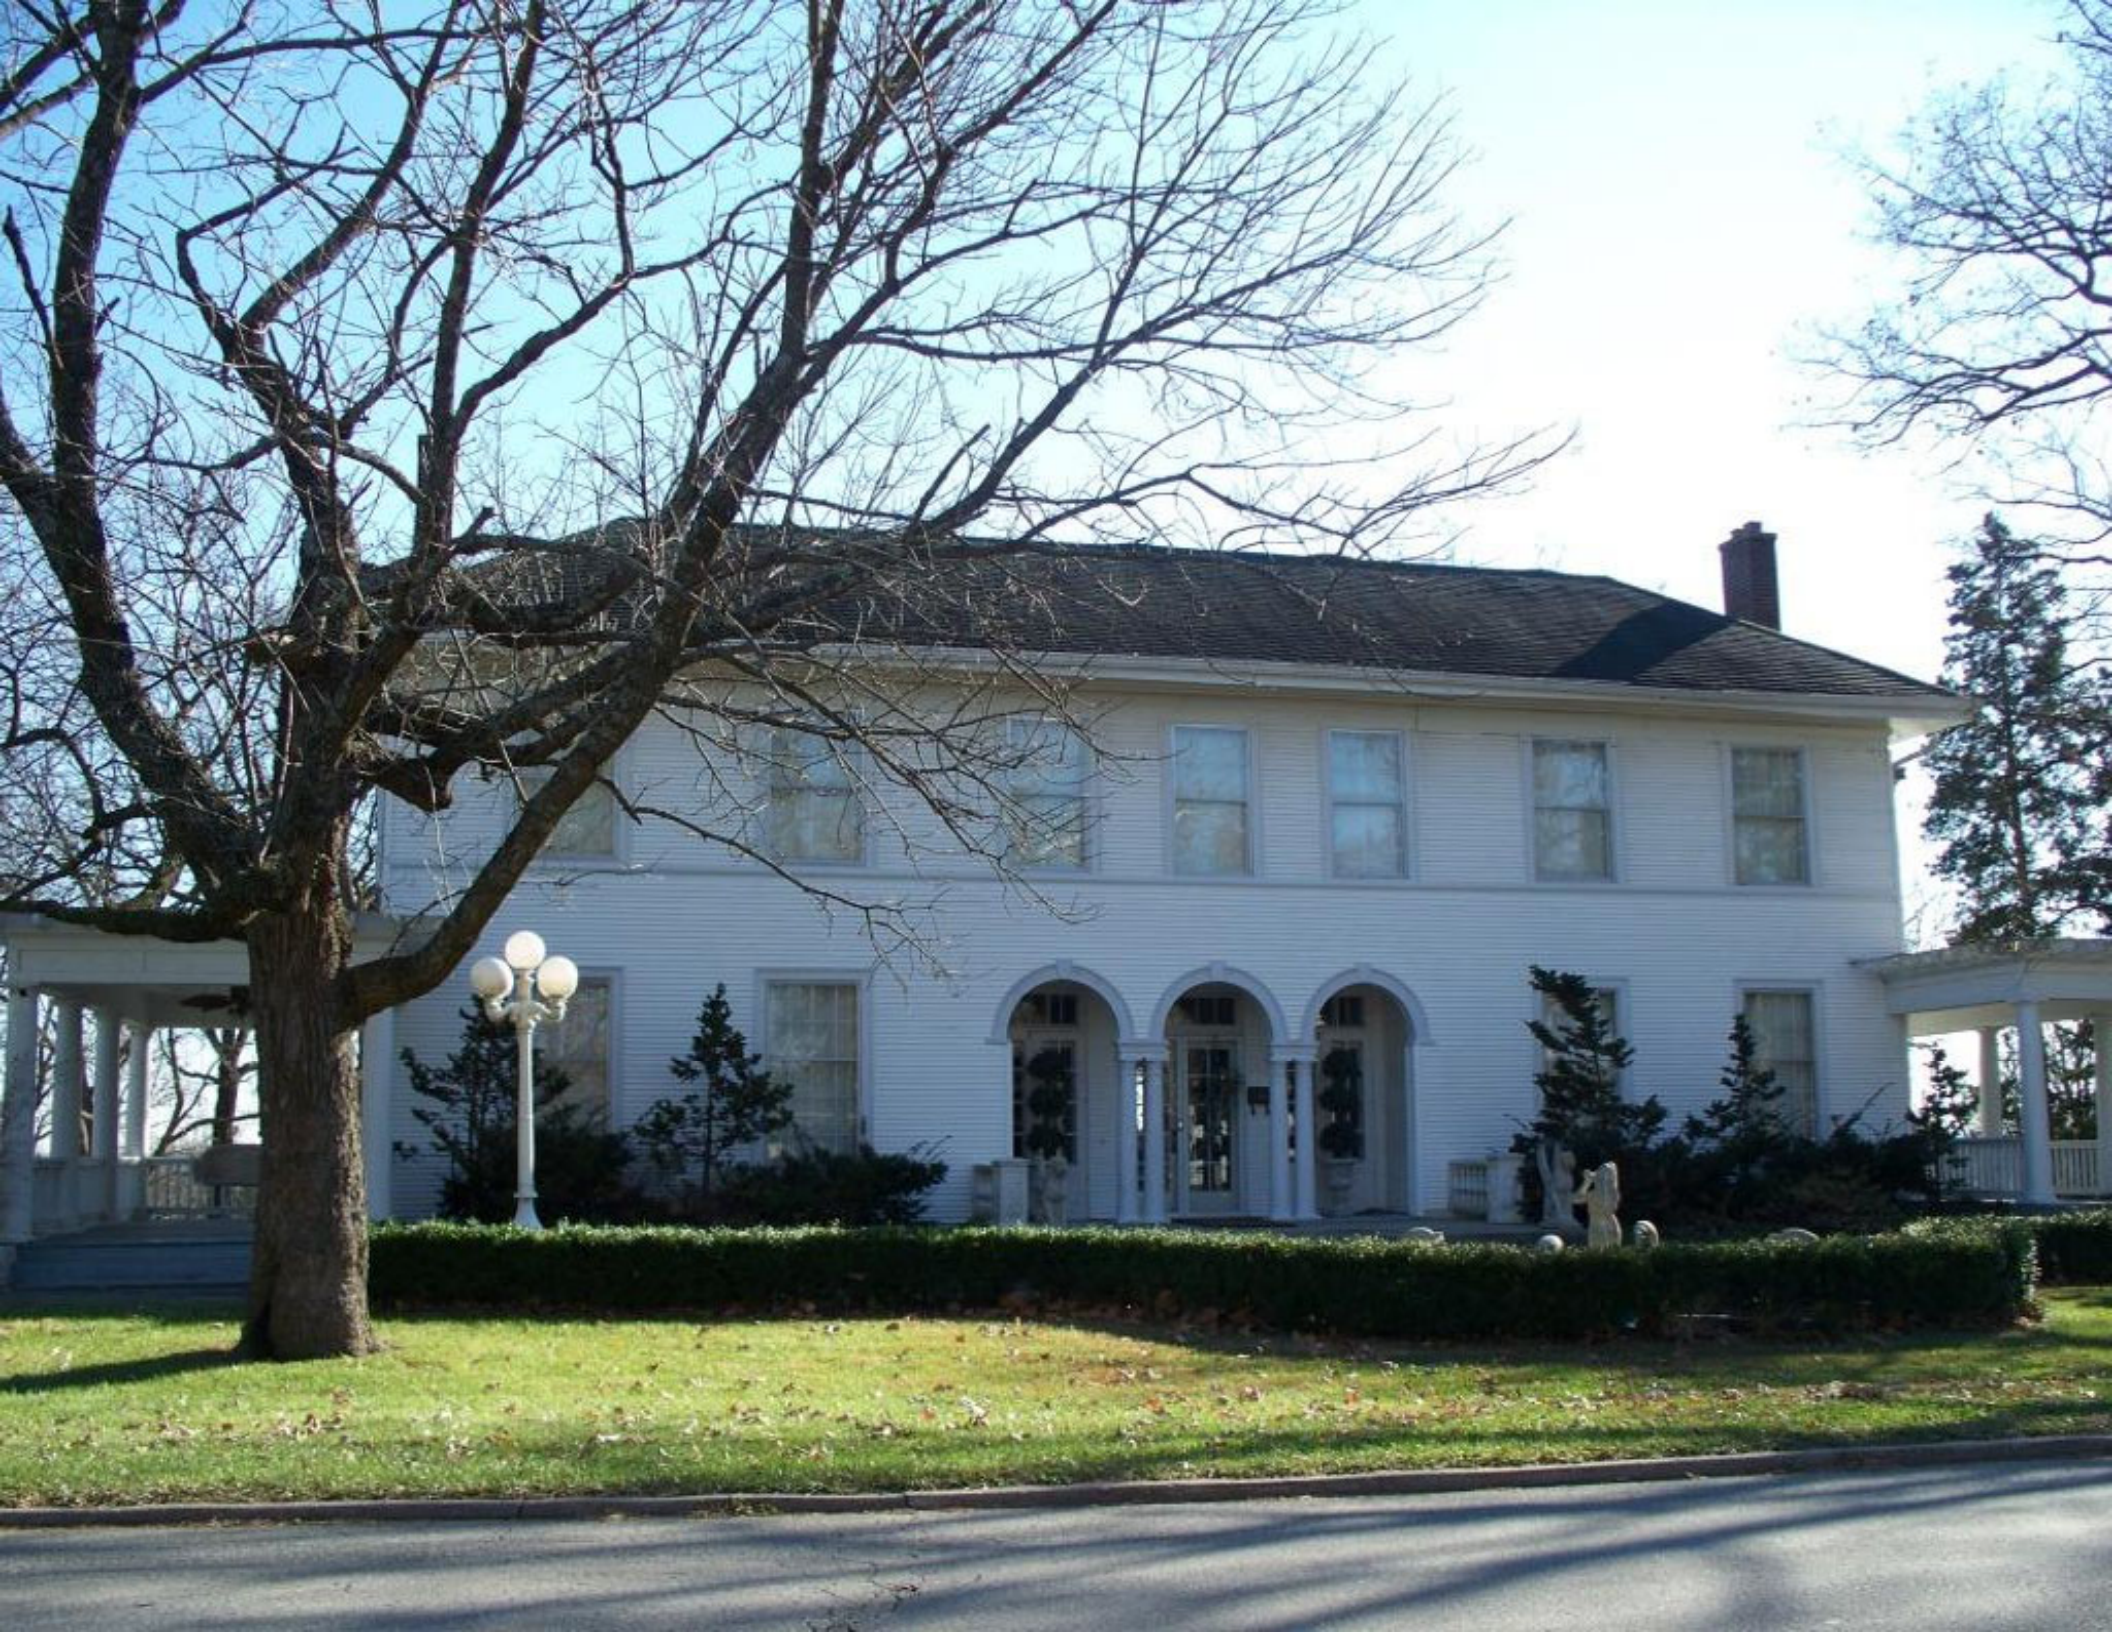
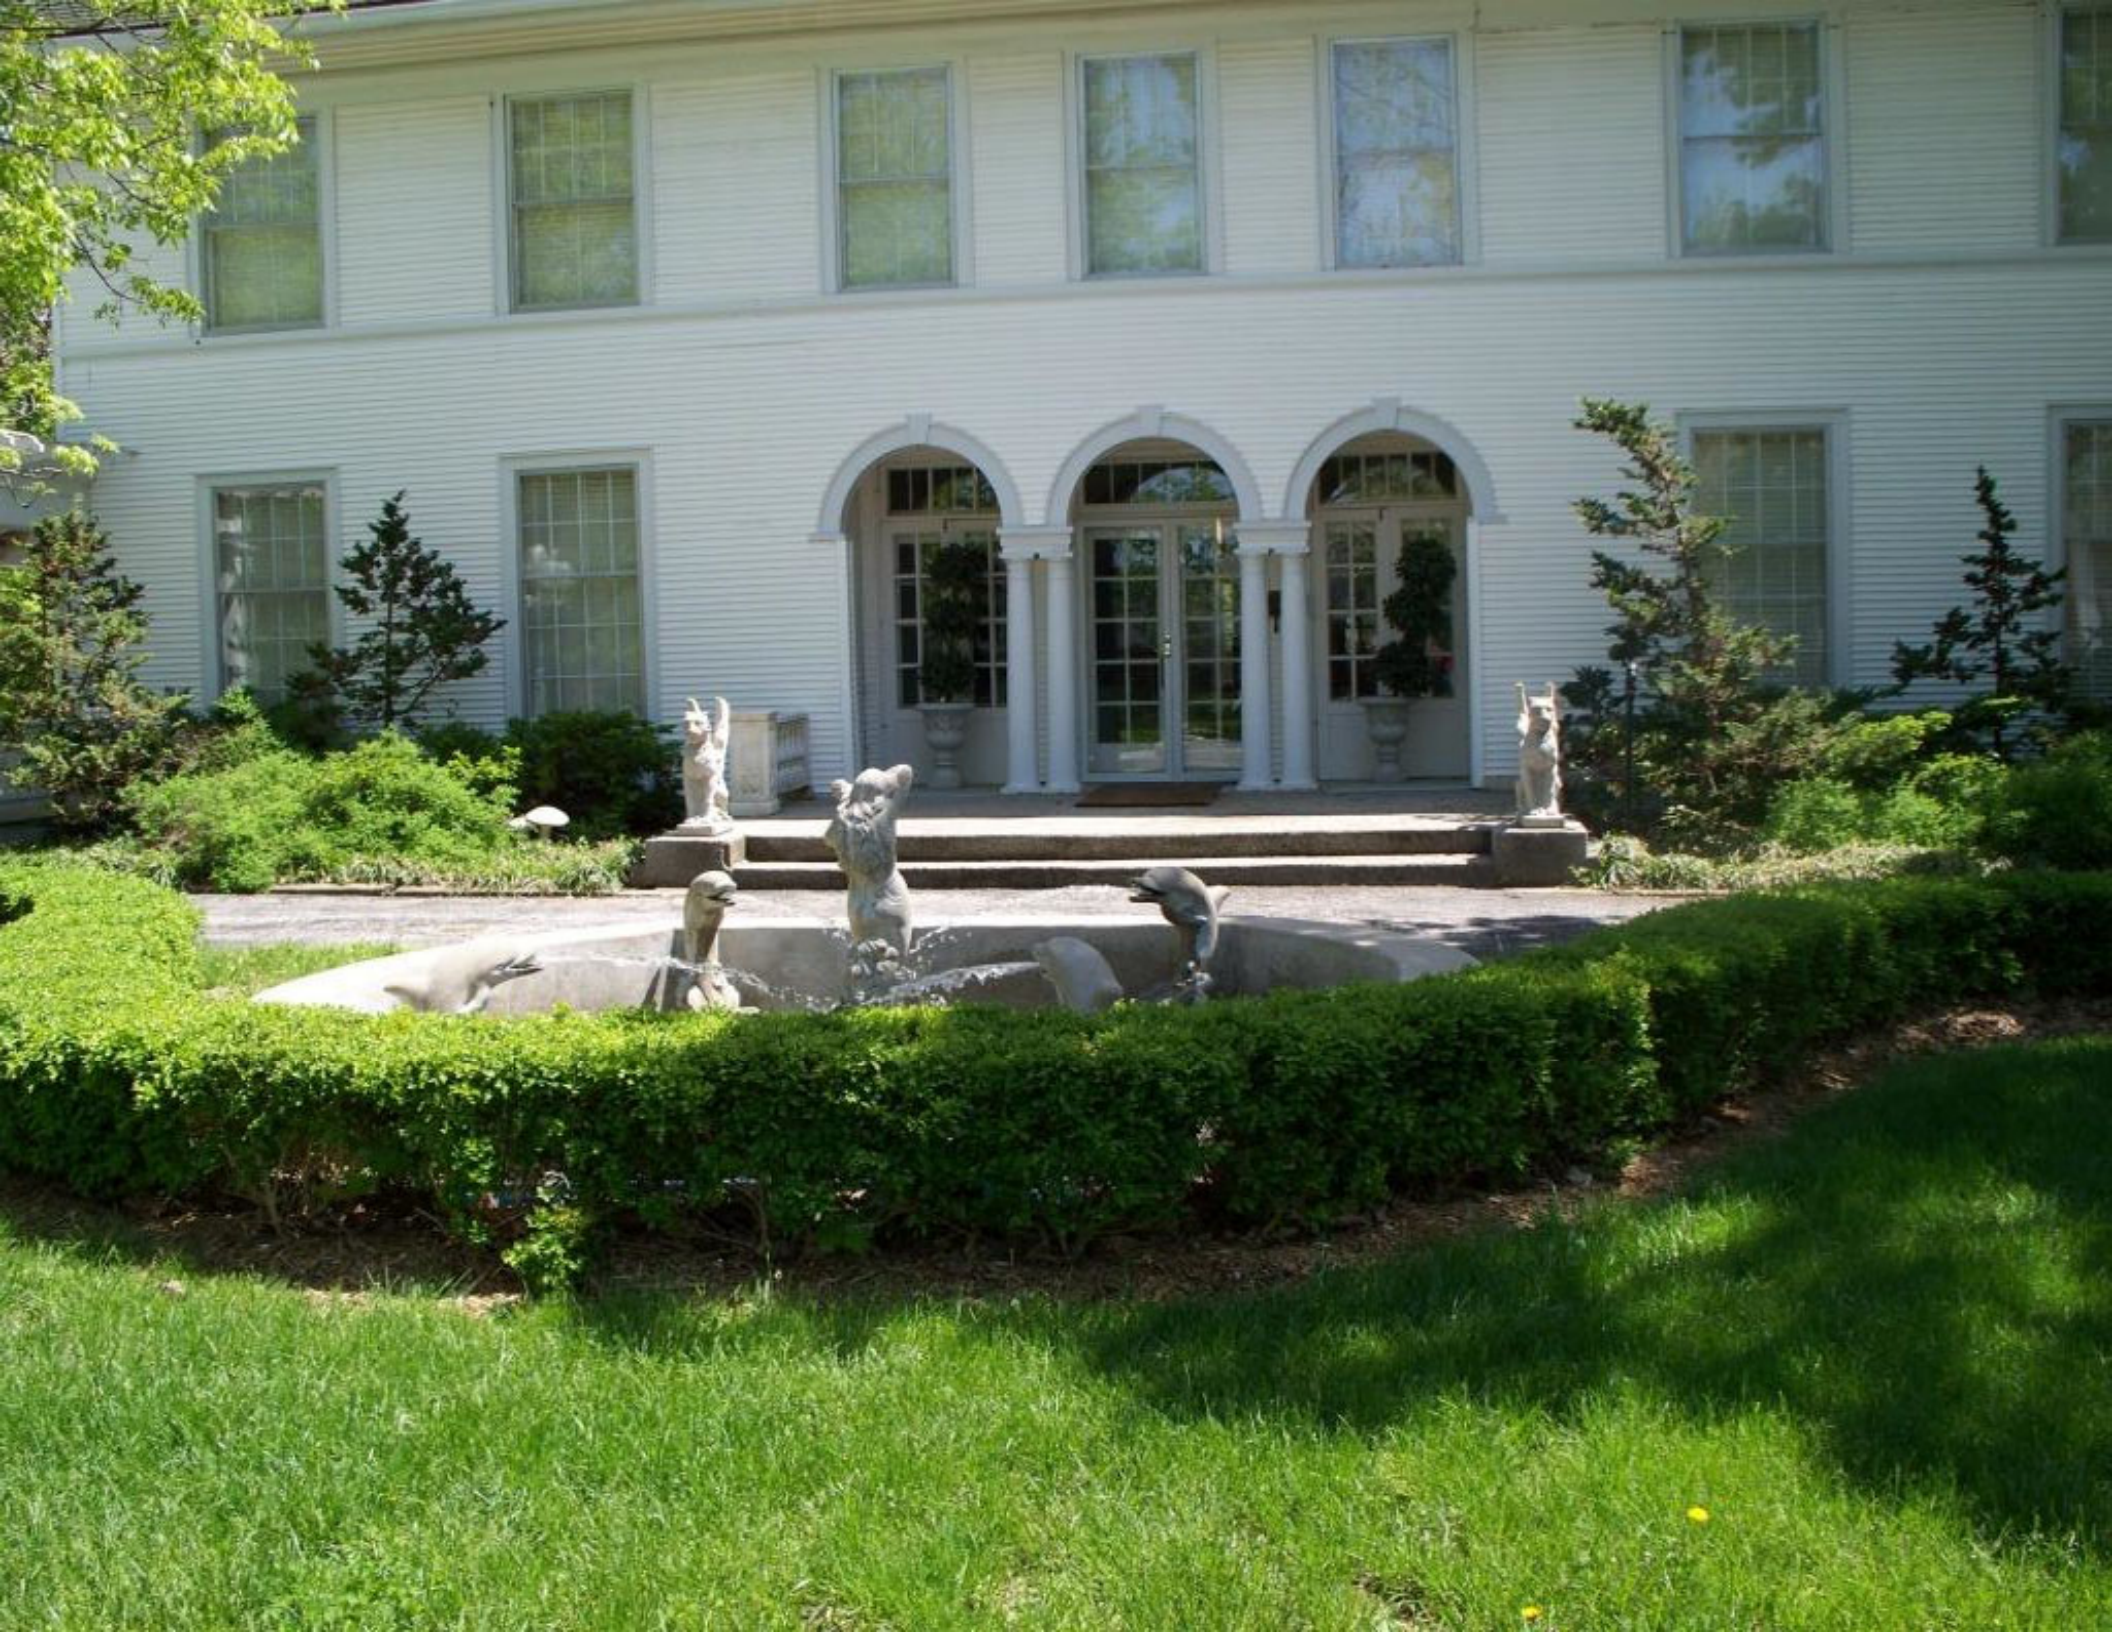
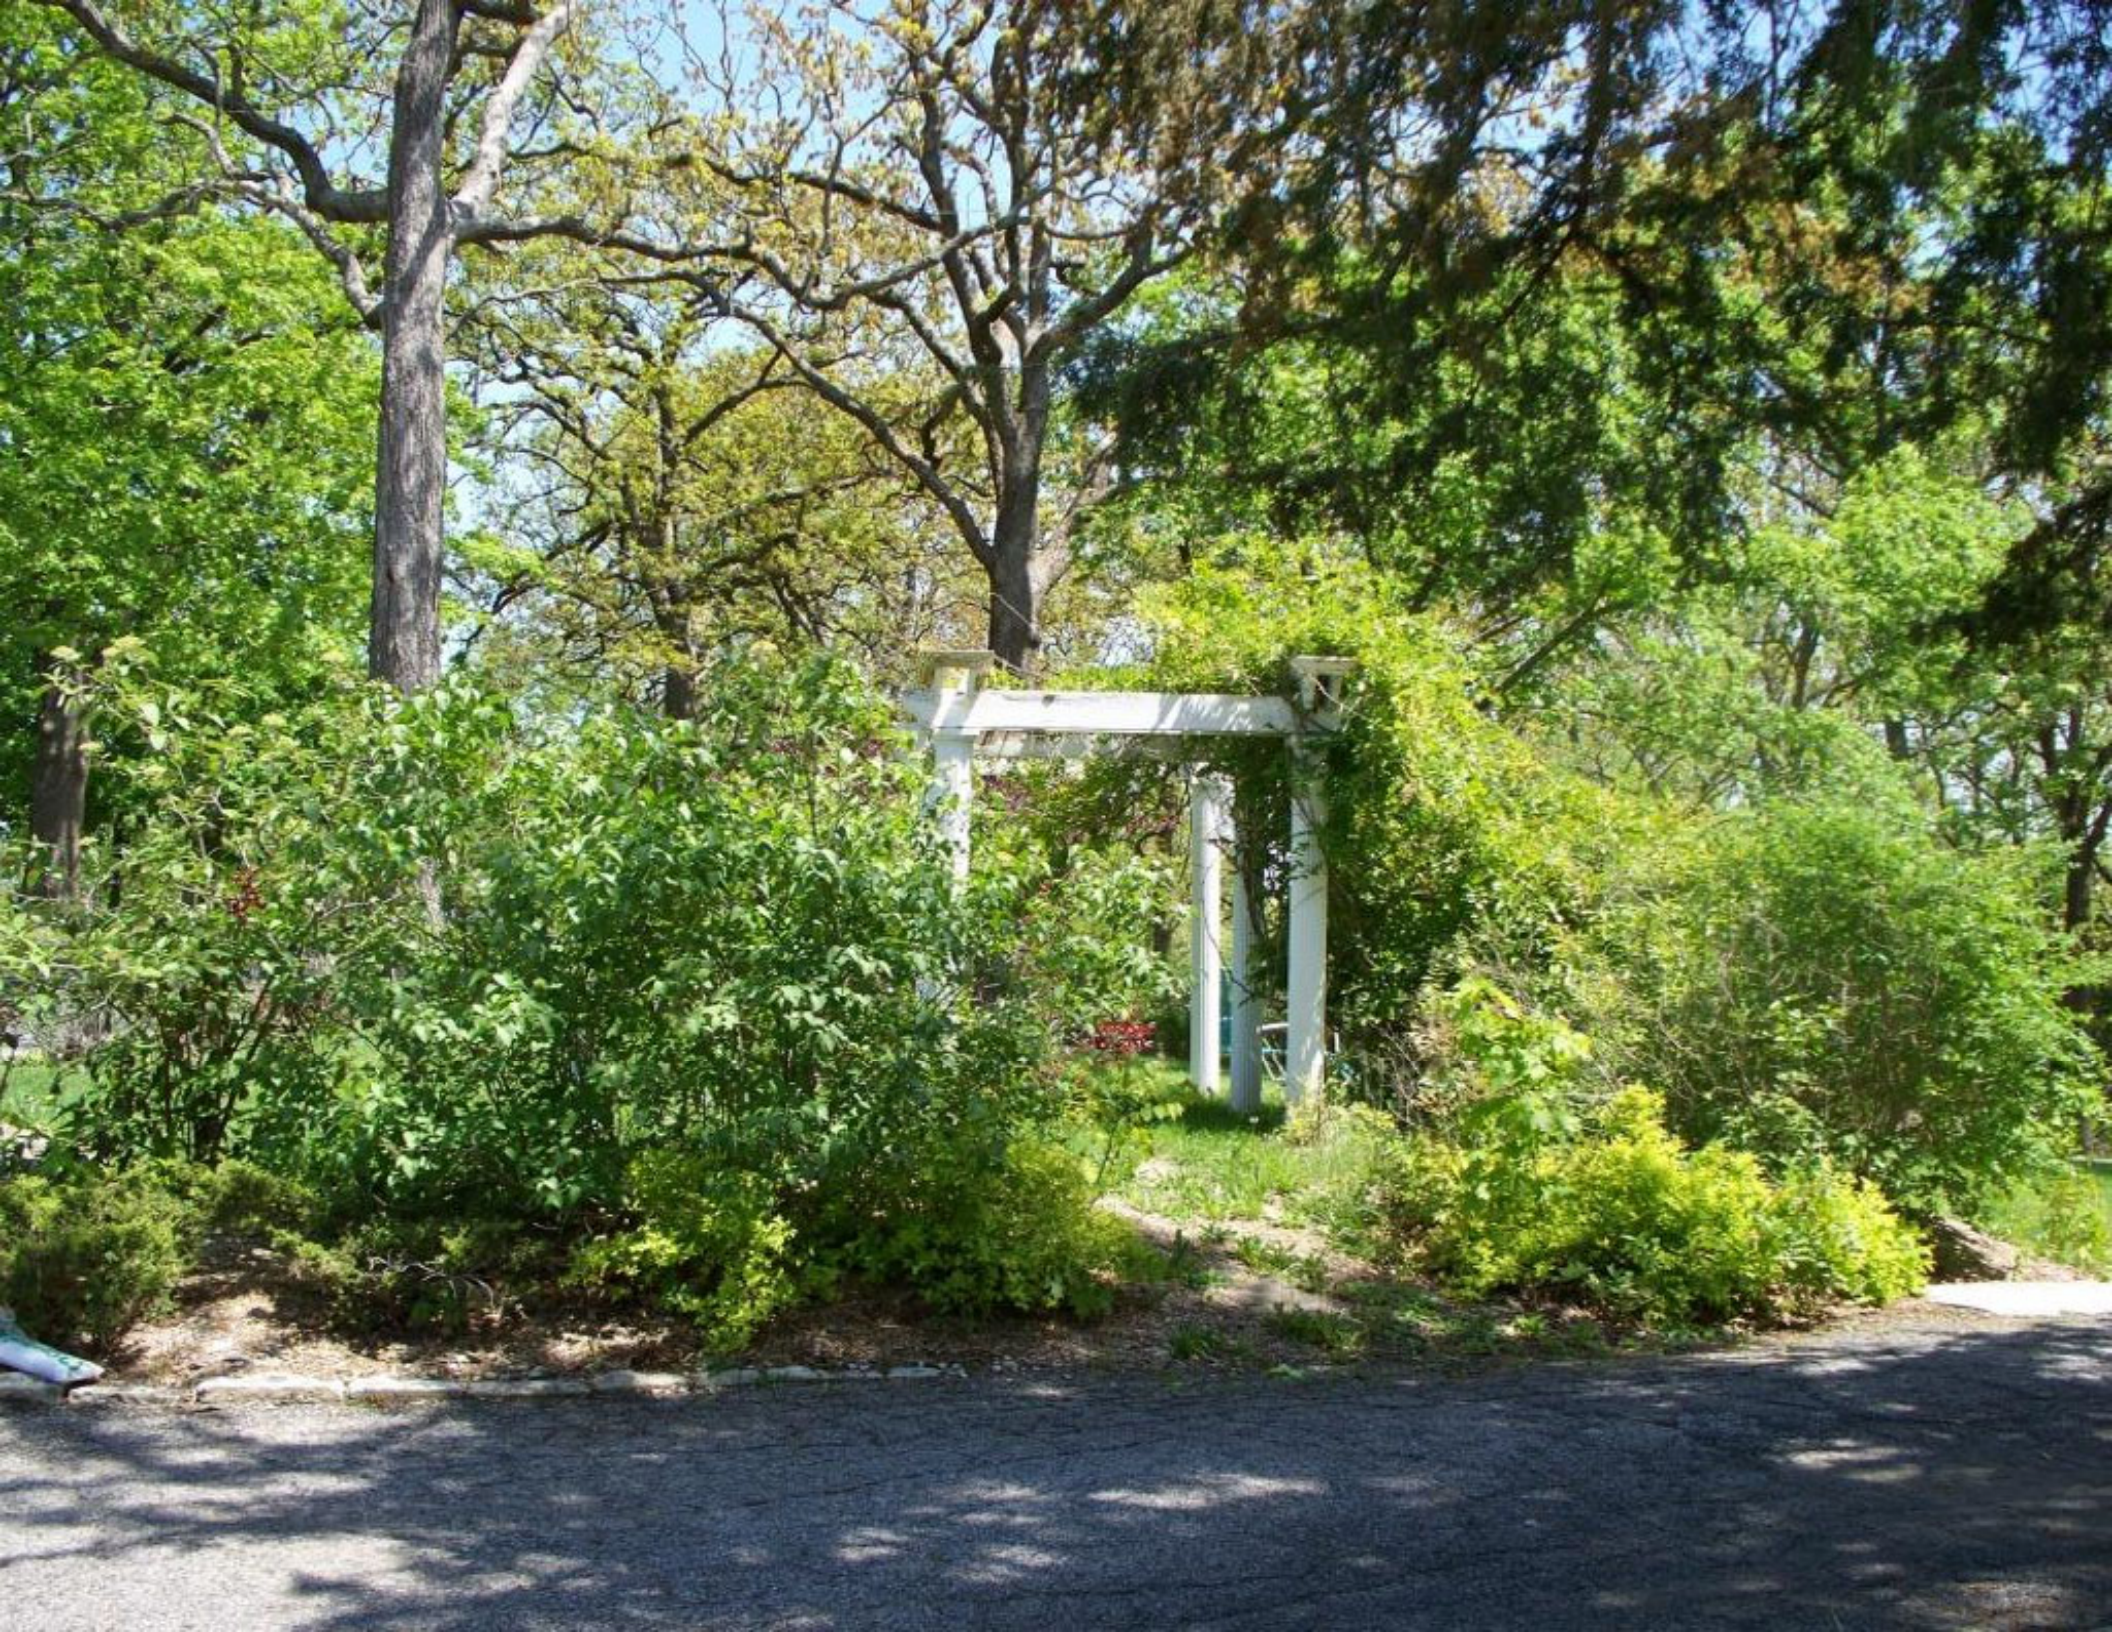
This could easily be among the grandest homes in Jefferson City if not for the vinyl siding and replacement windows. Still, since it was built by Frank B. Miller and retains its configuration (a historic photo would be useful to compare) it may be individually eligible. The modern windows are at least sympathetic as they have multi-light "divisions" (could be snap-in muntins or taped). The two story property has a hipped roof and is crowned by two brick chimneys on either end. It features seven 6/1 windows on the second floor. On the first floor are two long 8/9 windows on each side of the center bays, which are recessed behind three archways with keystones. The center arch is supported by two paired Doric columns. Multi-light French doors are flanked by paired doors with wooden multi-light storms. Each opening has a multi-light transom. The entrance is guarded by two stone griffins on the edge of the concrete pad that extends towards the fountain. A polished stone half wall sits on the left side of the concrete pad and may have been brought in from another location or could possibly be original to the house. Off each side of the building is a one story porch with a flat roof with wide overhanging eaves, exposed rafter tails, a large boxed entablature, Doric pillars and wooden railing. The lawn is neatly landscaped with hedges. This would be an easy list if the vinyl was removed but may stand as is. Could also C to a small district for F. Miller.
