ARCHITECTURAL/HISTORIC INVENTORY FORM

1. Survey No. CO-AS-005-001		2. Survey name: Moreau Drive Neighborhood Survey	
3. County: Cole		4. Address: 1202 Elmerine Ave.	
5. City: Jefferson City	Vicinity: <input type="checkbox"/>	6. UTM: / /	7. Township/Range/Section: T: R: S:
8. Historic name (if known):		9. Present/other name (if known):	
10. Ownership: <input checked="" type="checkbox"/> Private <input type="checkbox"/> Public		11. Historic use (if known): Residential	11. Current use: Residential

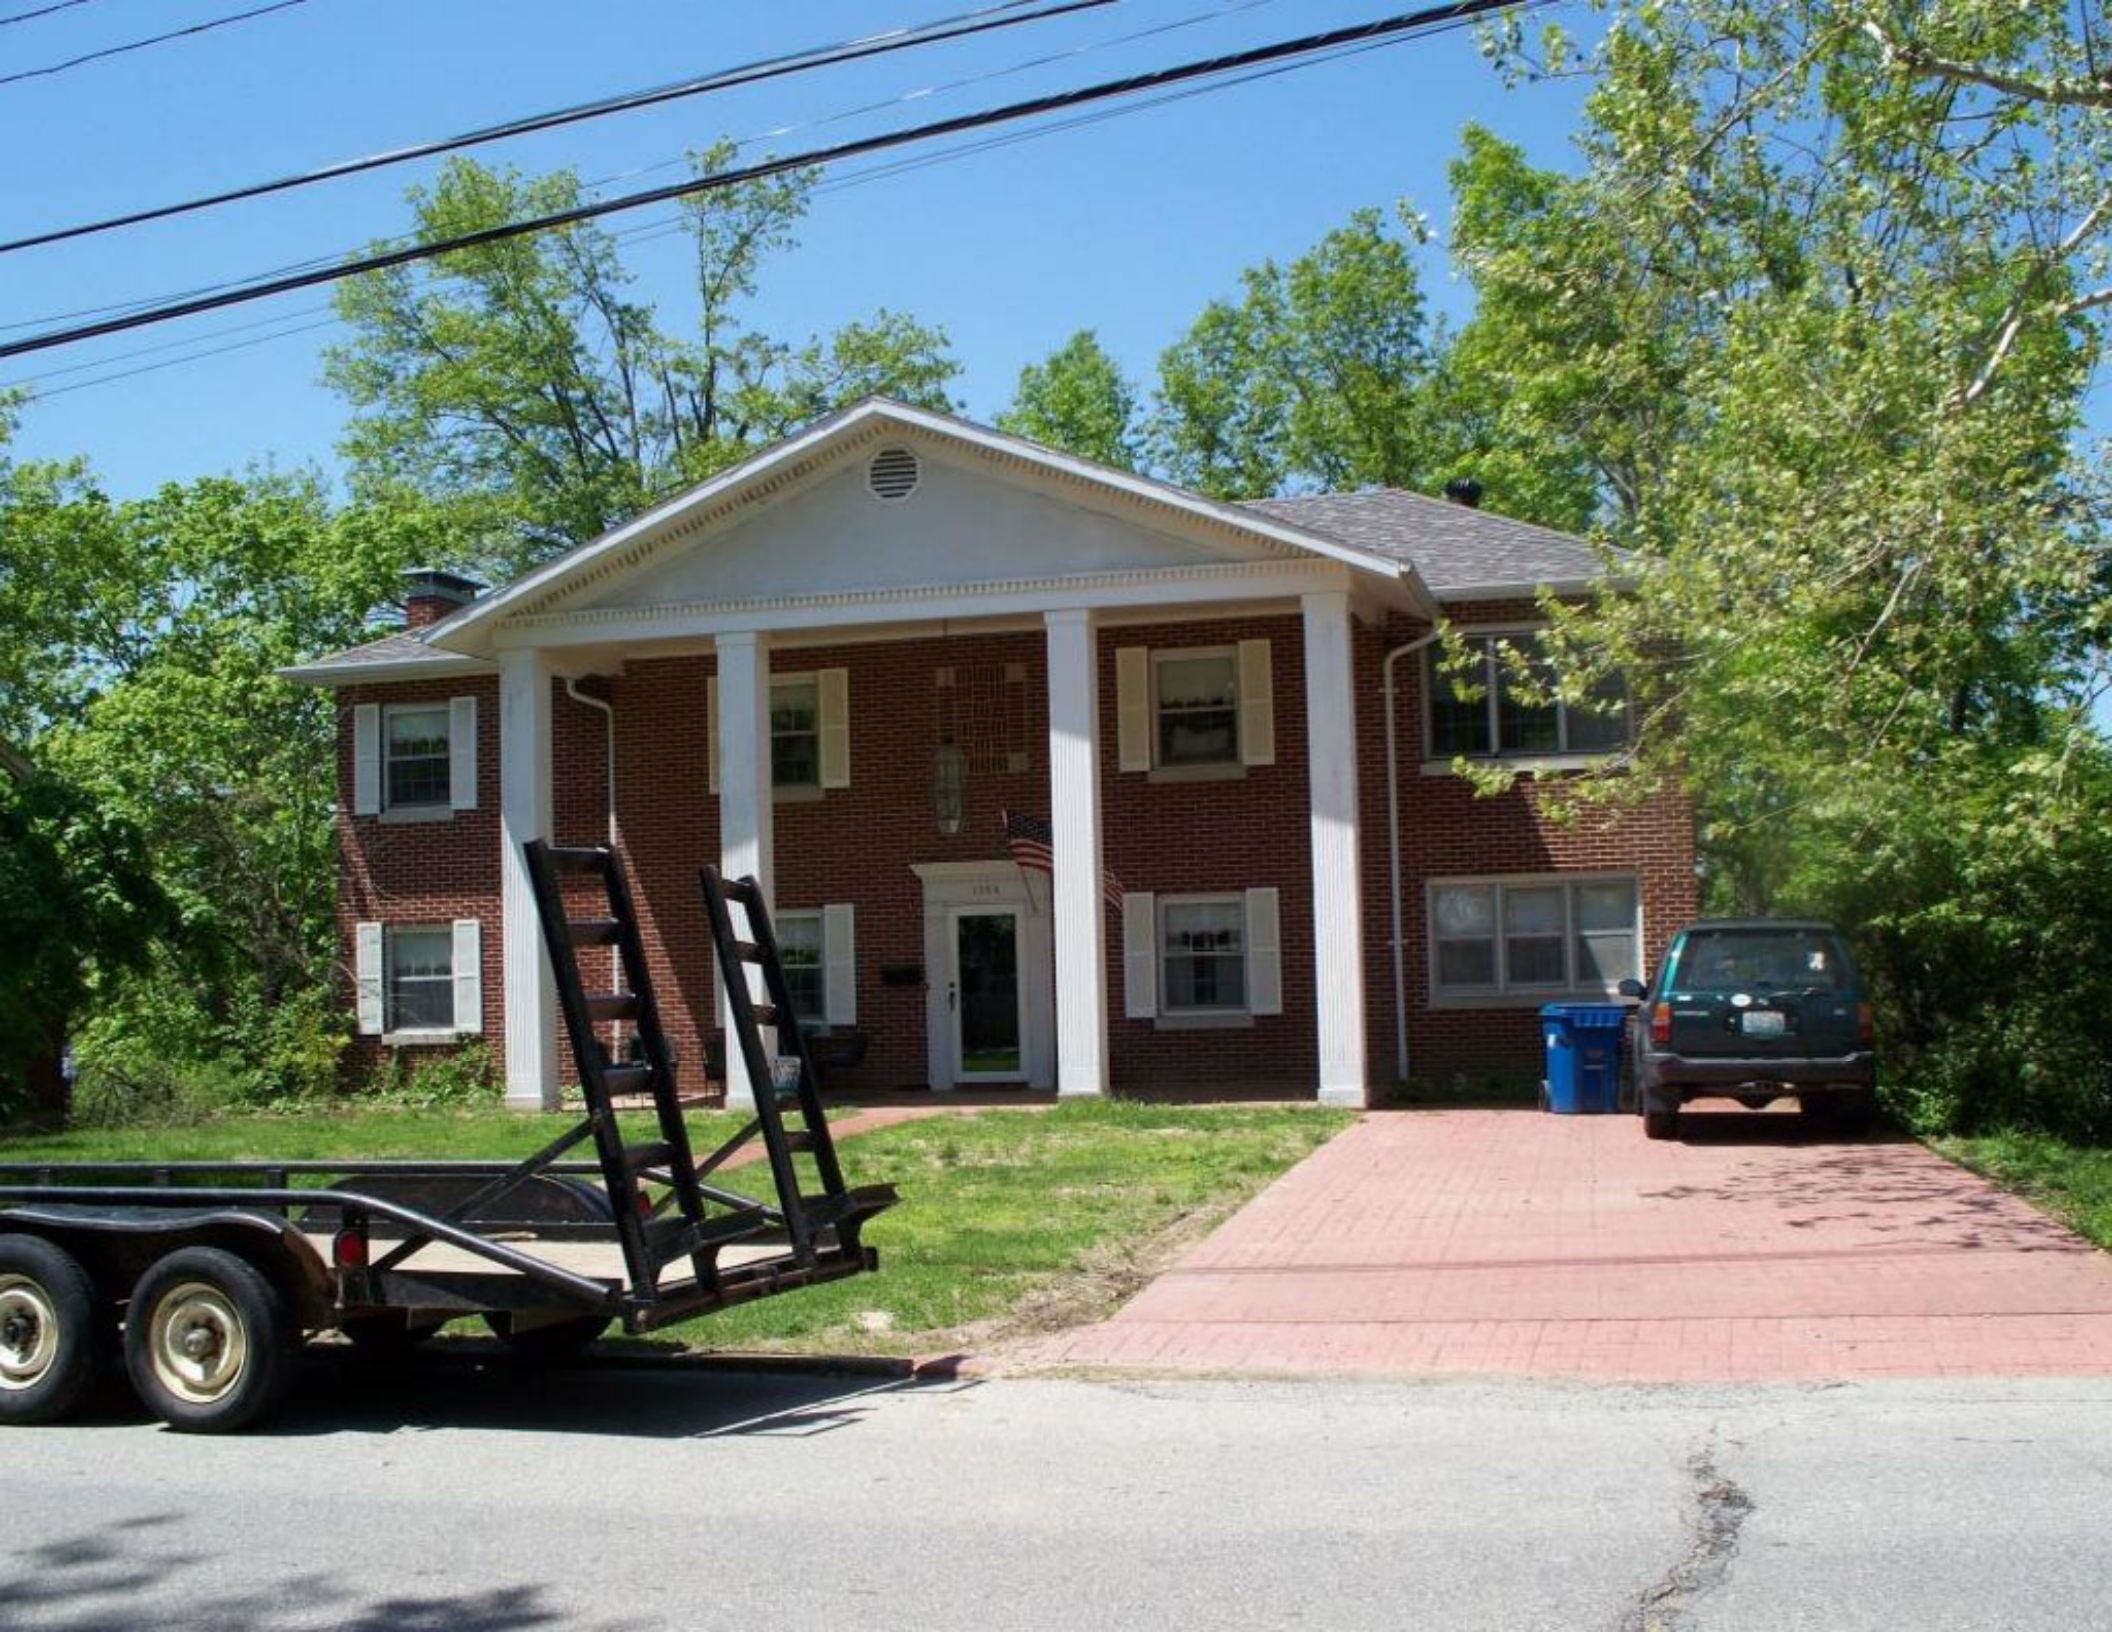
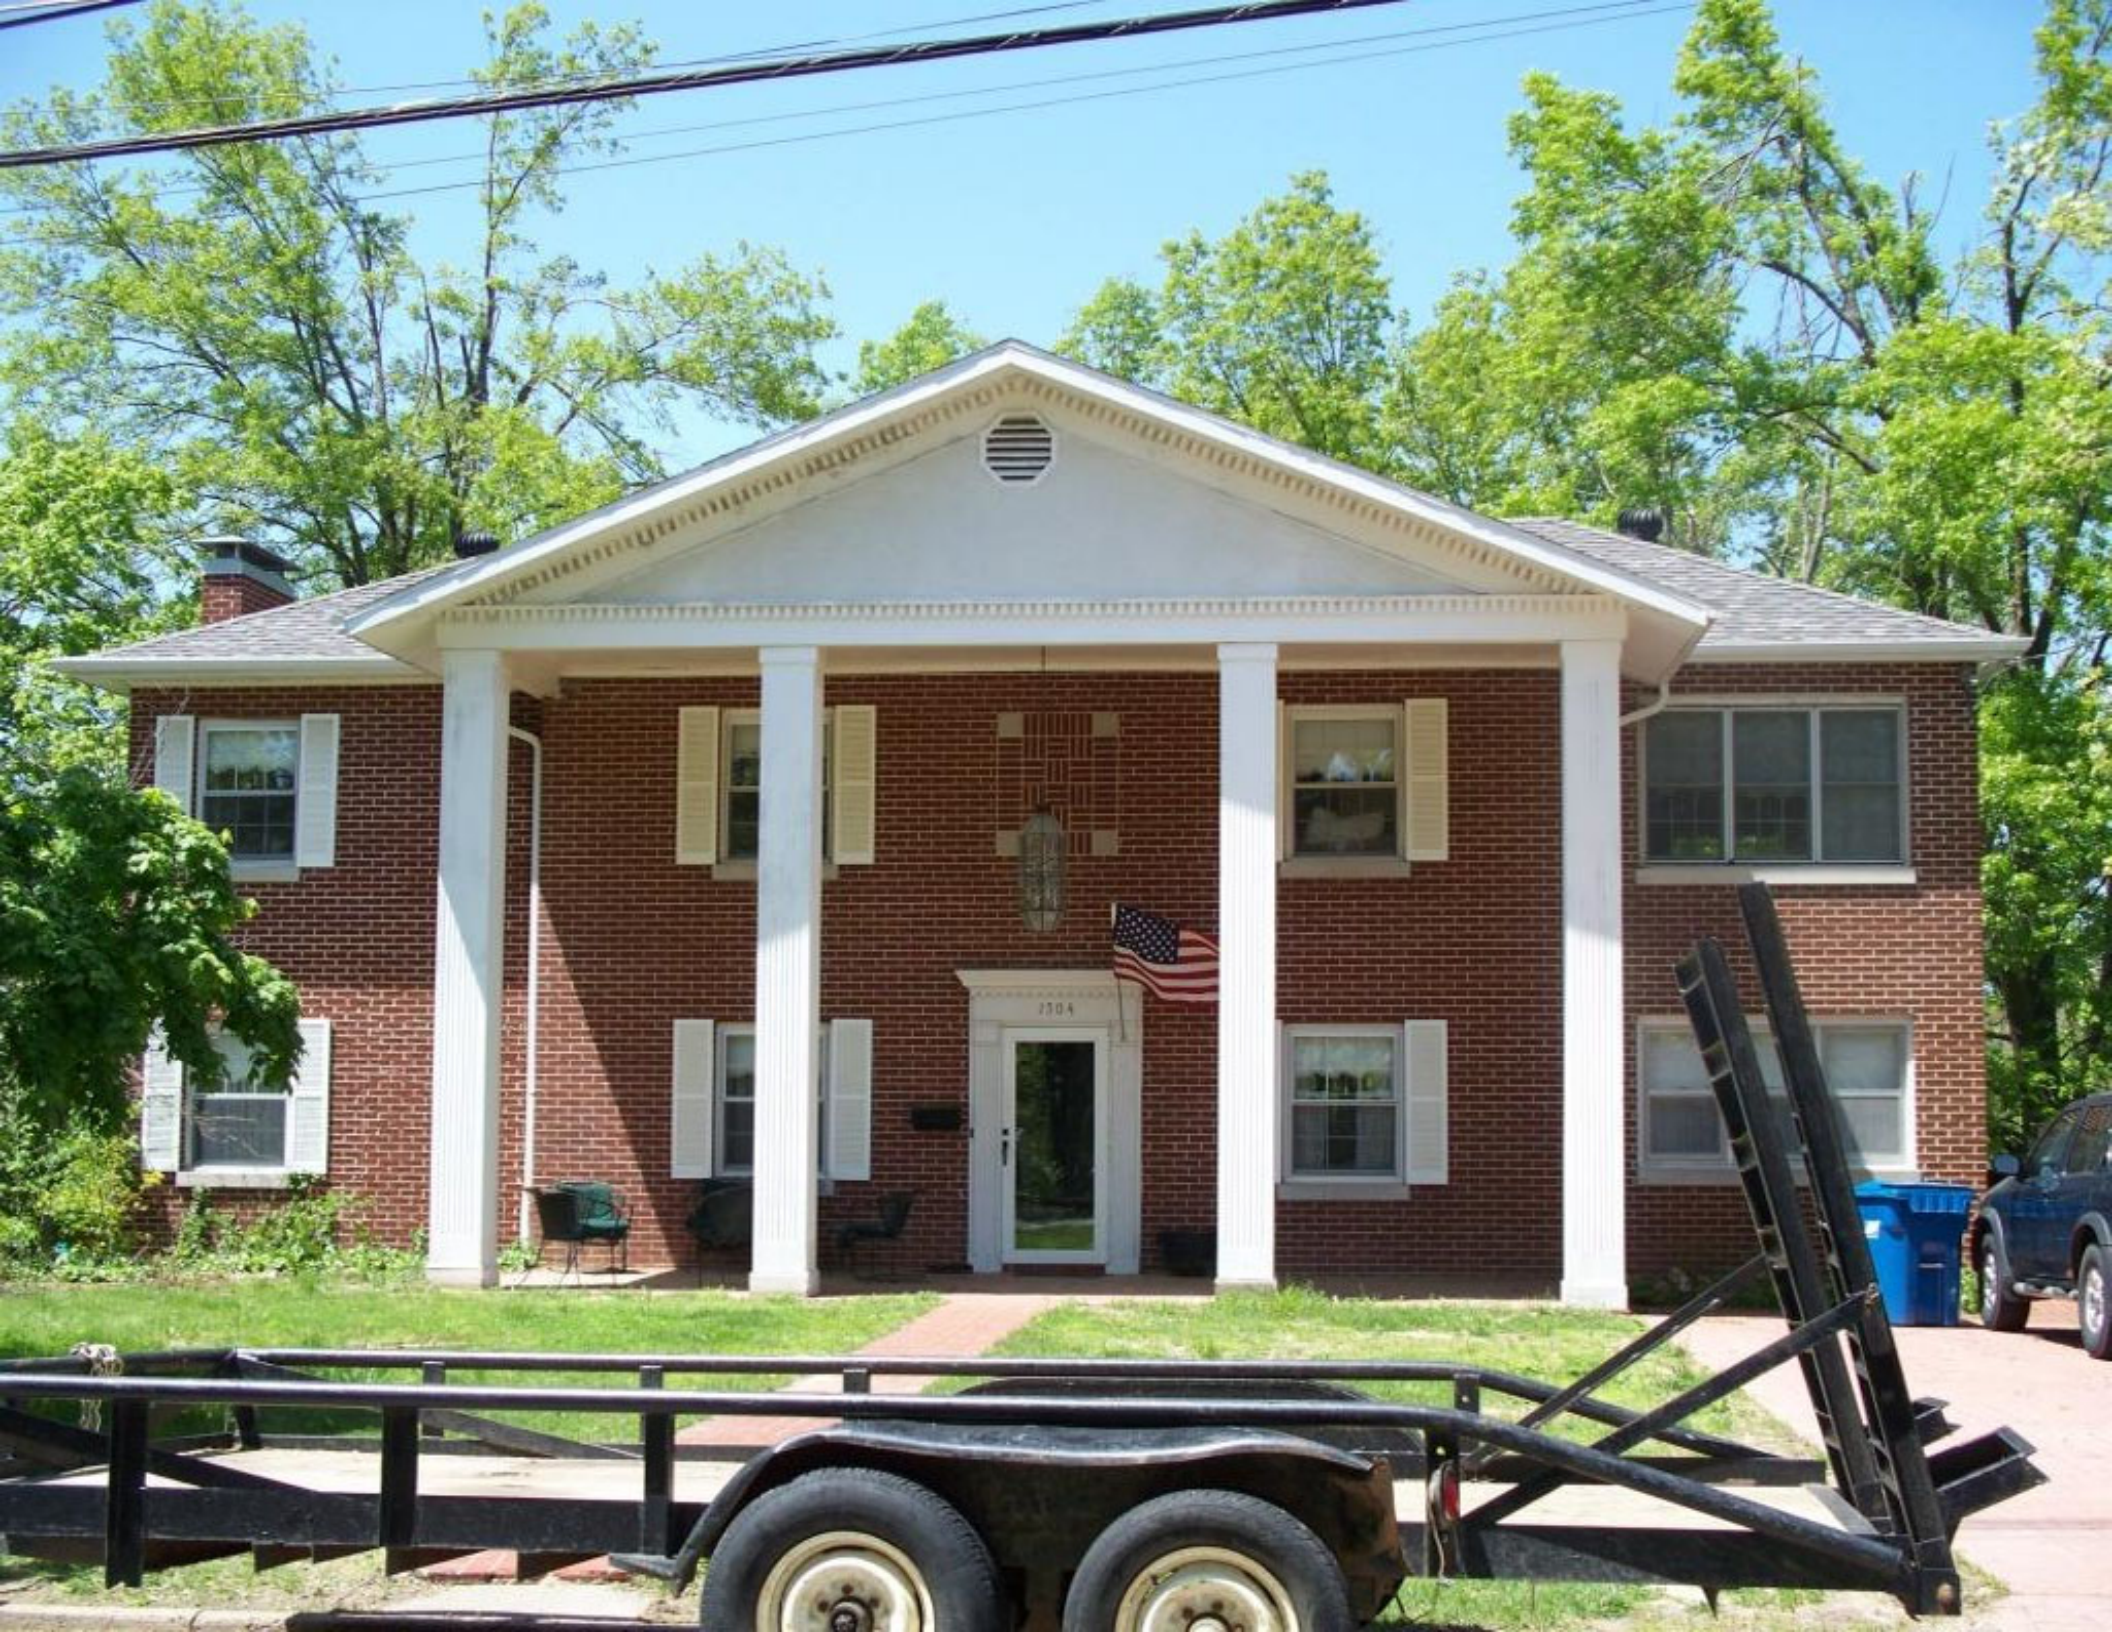
This large two story Greek Revival has a hipped roof with a large front gable that extends over the center three bays. The gable has deep overhangs and has dentil detailing under the eaves and across the top of the entablature. It is in-filled with stucco or plaster and has an octagonal vent in its peak. The open two story porch has four great square fluted columns that support the entablature. From the left the second story of this home has two 6/6 windows (all of the windows appear to be modern replacements) with shutters. In the center bay is a square of decorative brick work in a quilt design. The next bay contains another 6/6 window with shutters with the final bay containing a larger row of three 6/6 windows. All of the windows on the home have concrete sills. The ground floor fenestration is identical to the upper floor save that the center bay contains the entrance with an ornate door surround and entablature and the final row of window are shorter than those on the second floor.

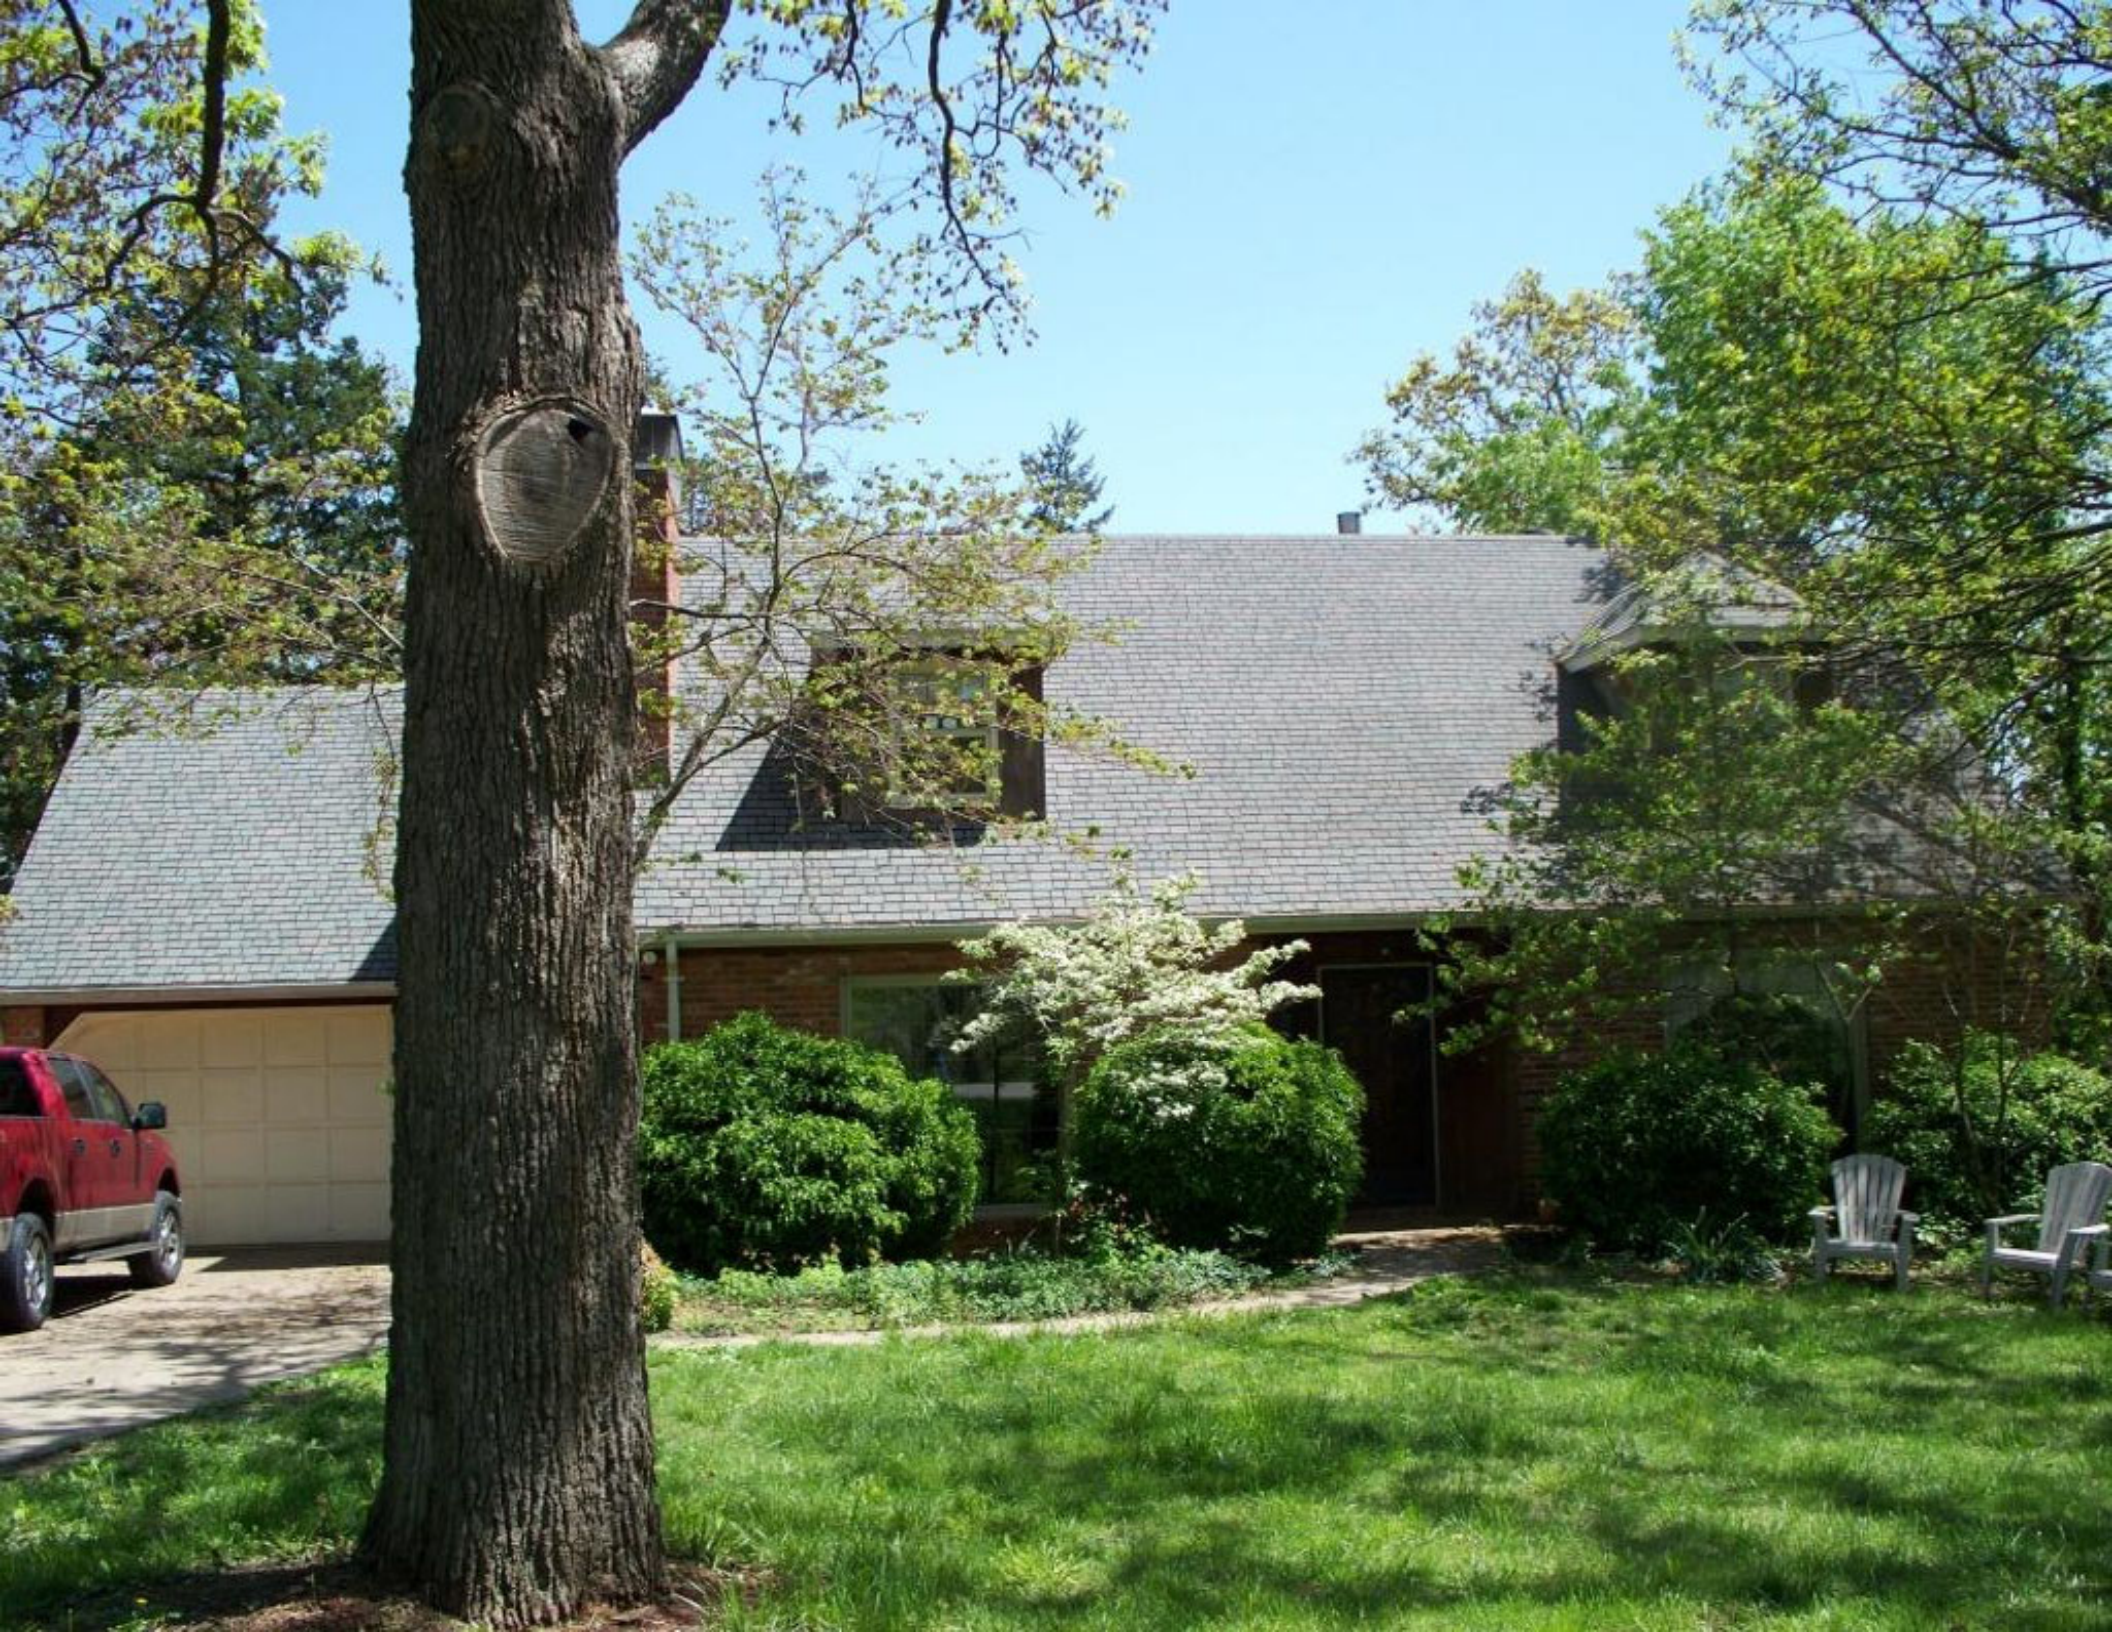
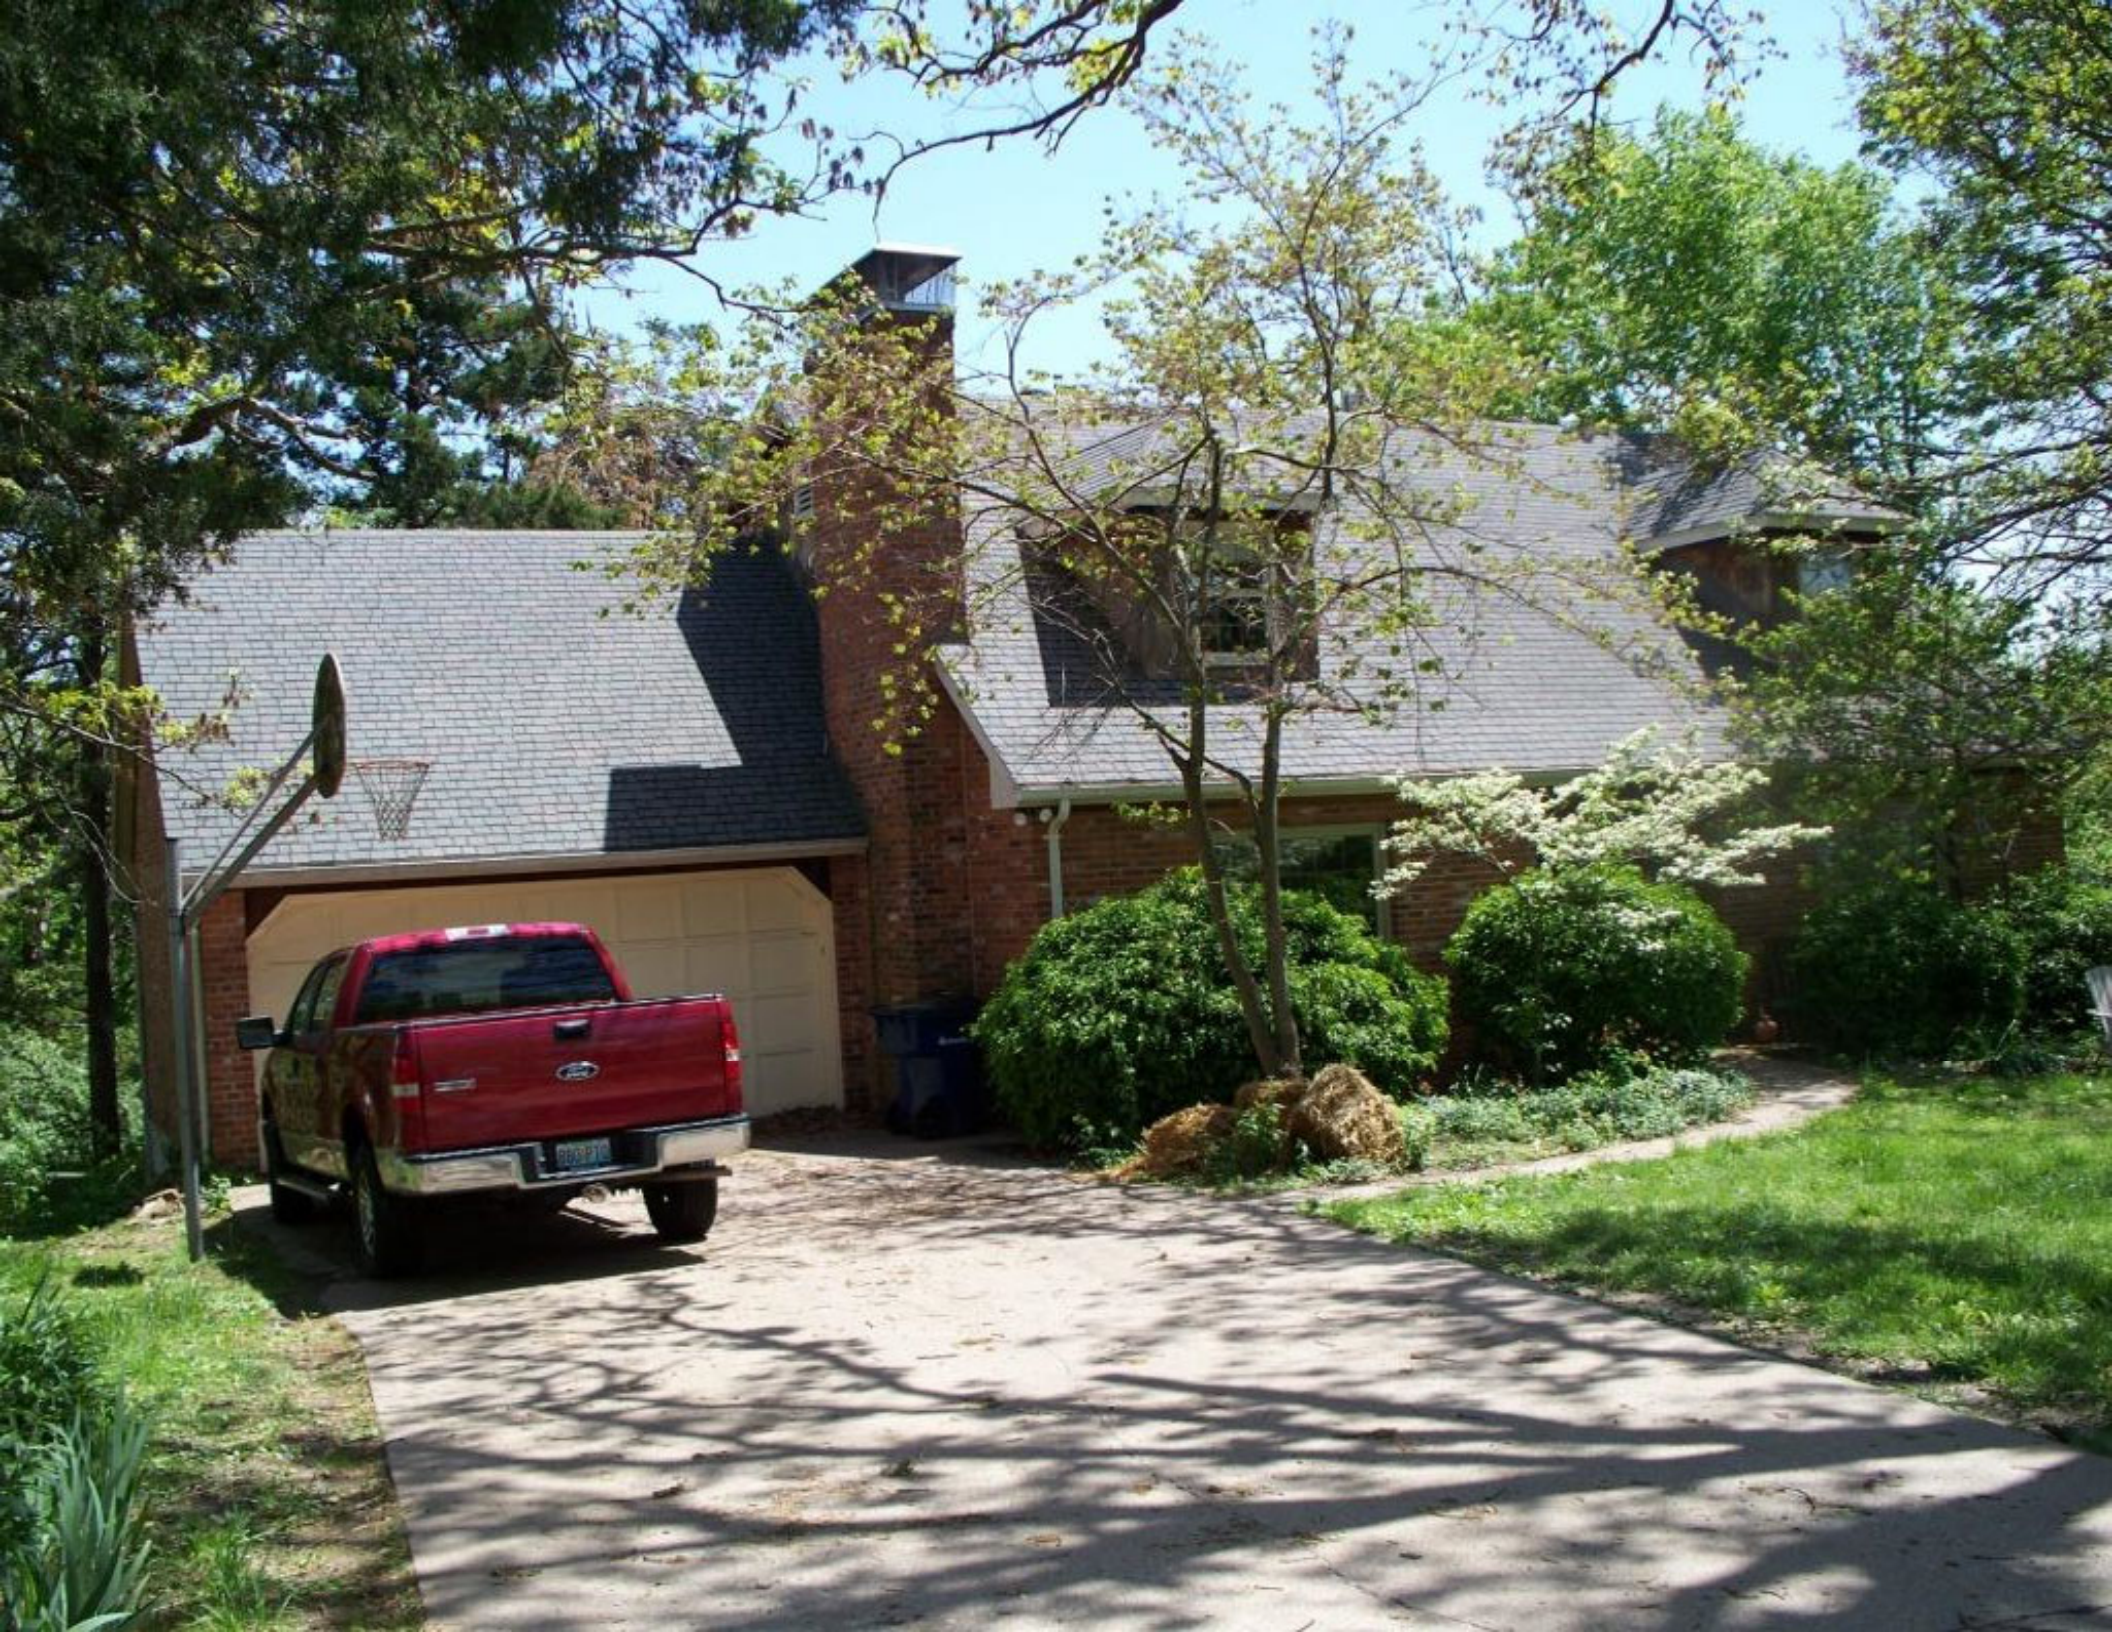
41. (cont.)
This brick side gable property is a 1 ½ stories and has two hipped dormers with 6/6 windows. The first floor has two large multi-light picture windows flanking the recessed entrance. To the left and set back is a single door two car garage with a steeply pitched side gable roof.

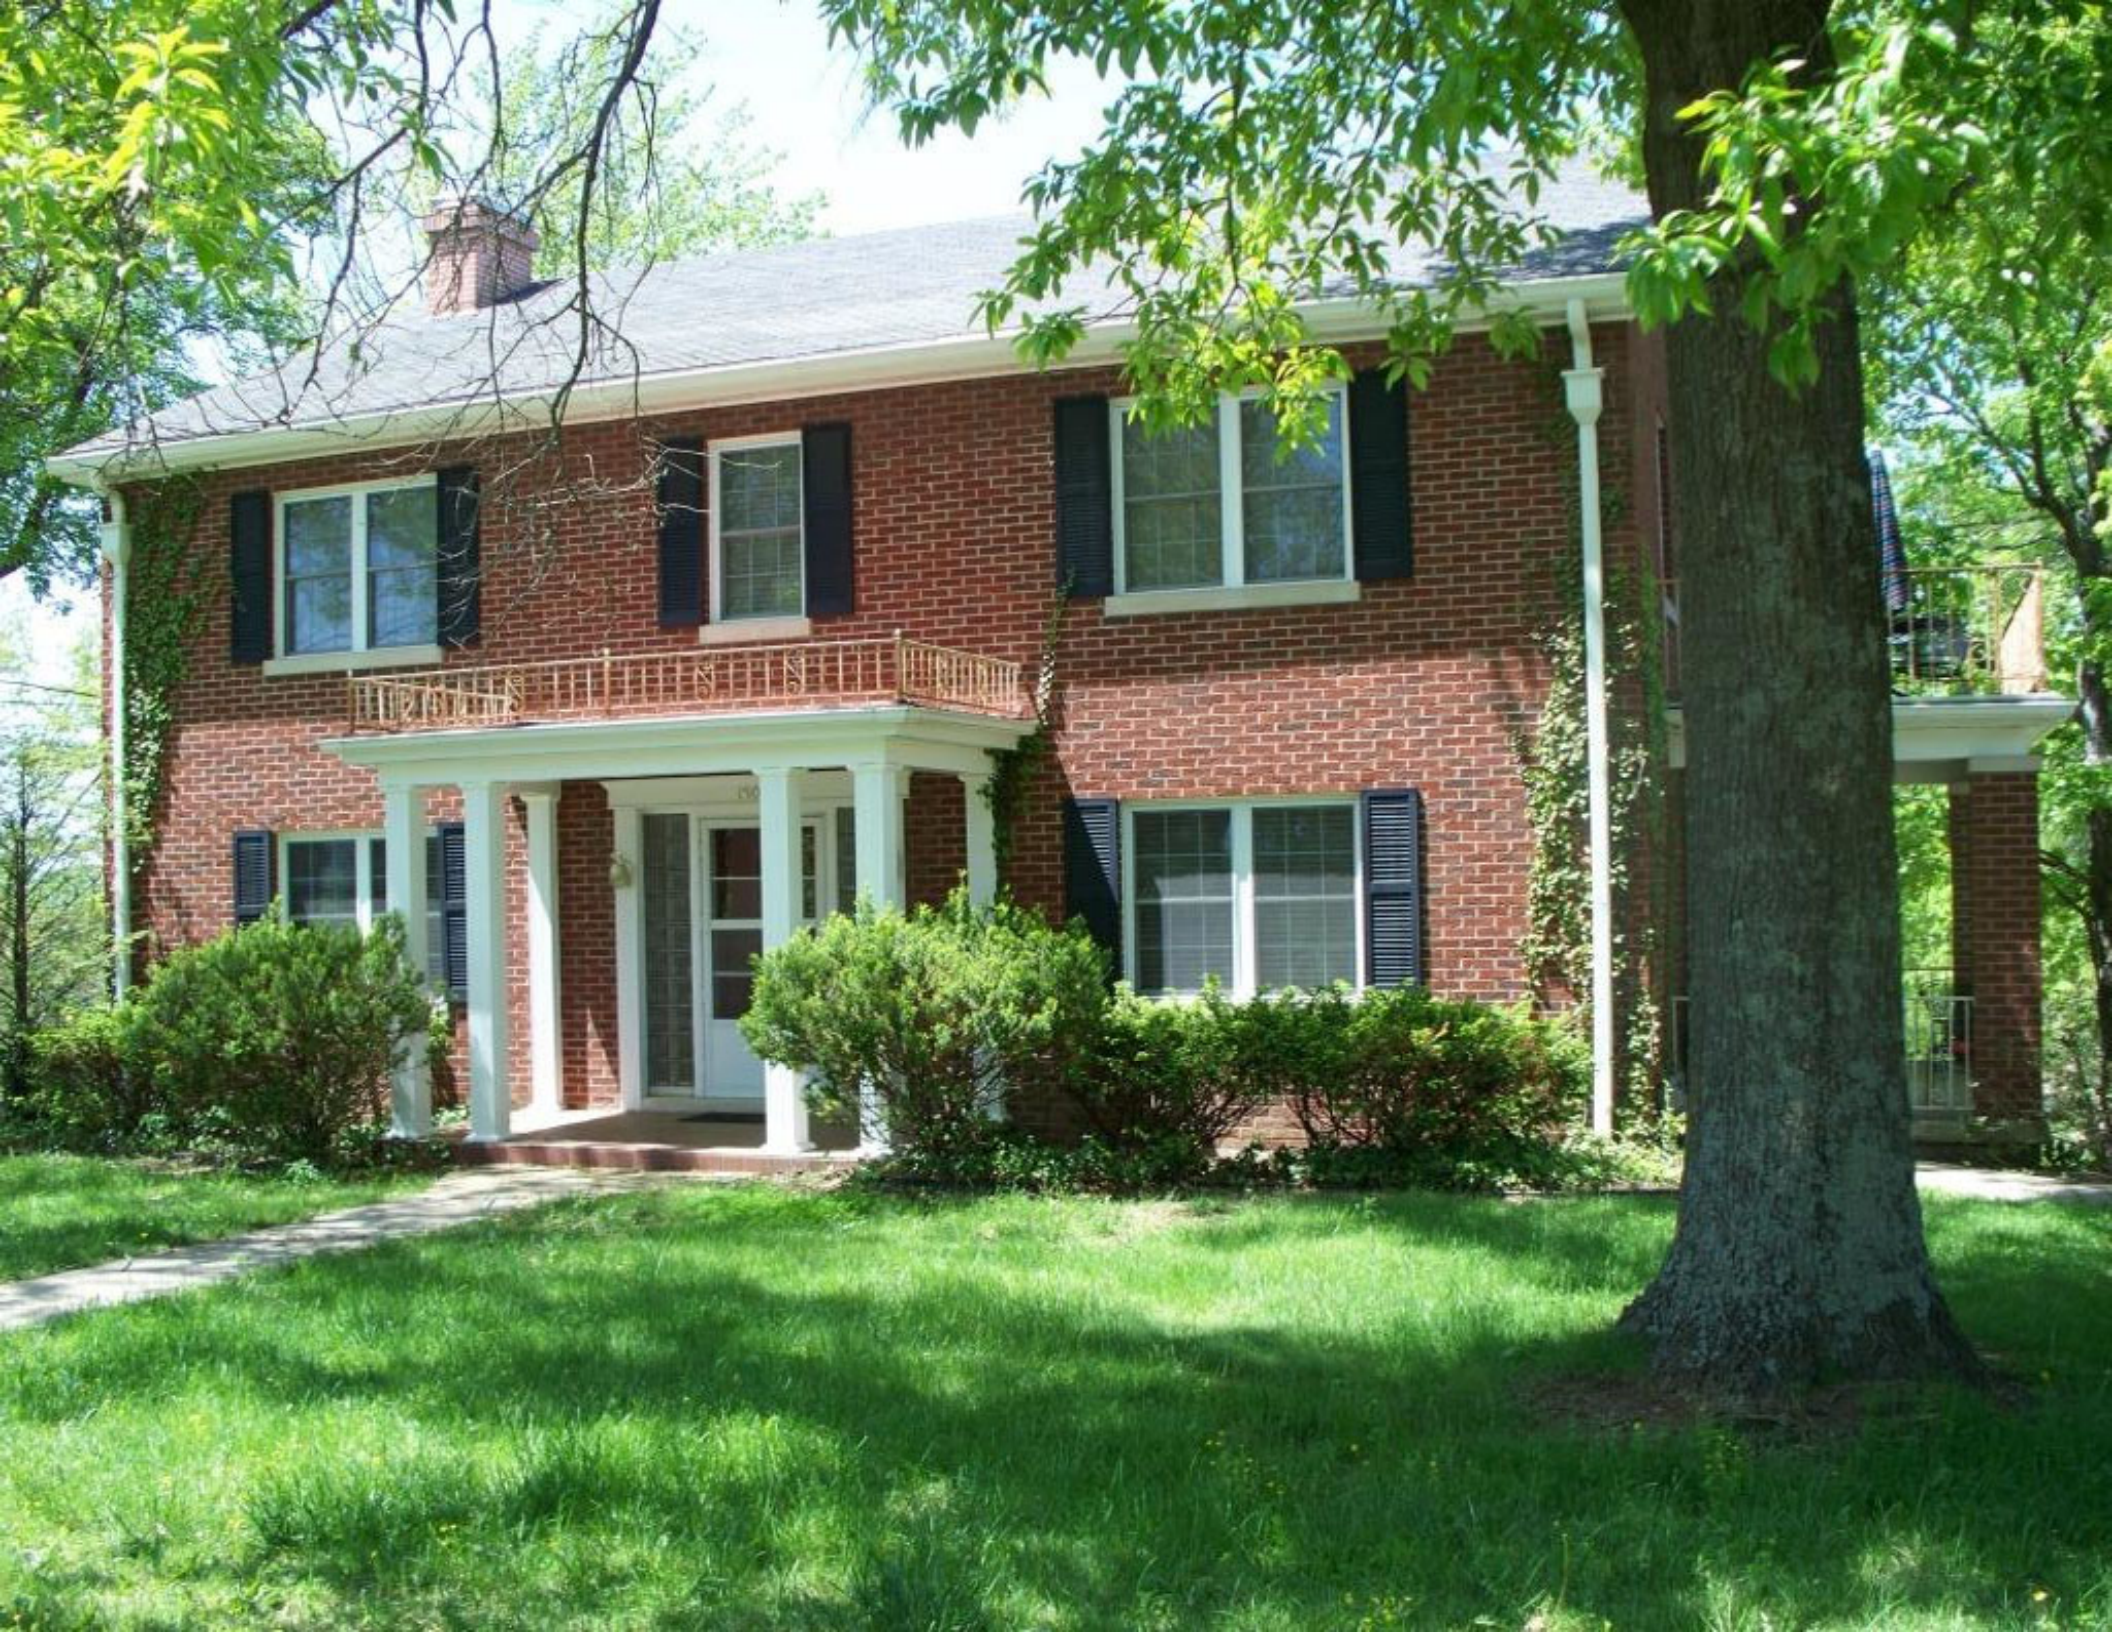
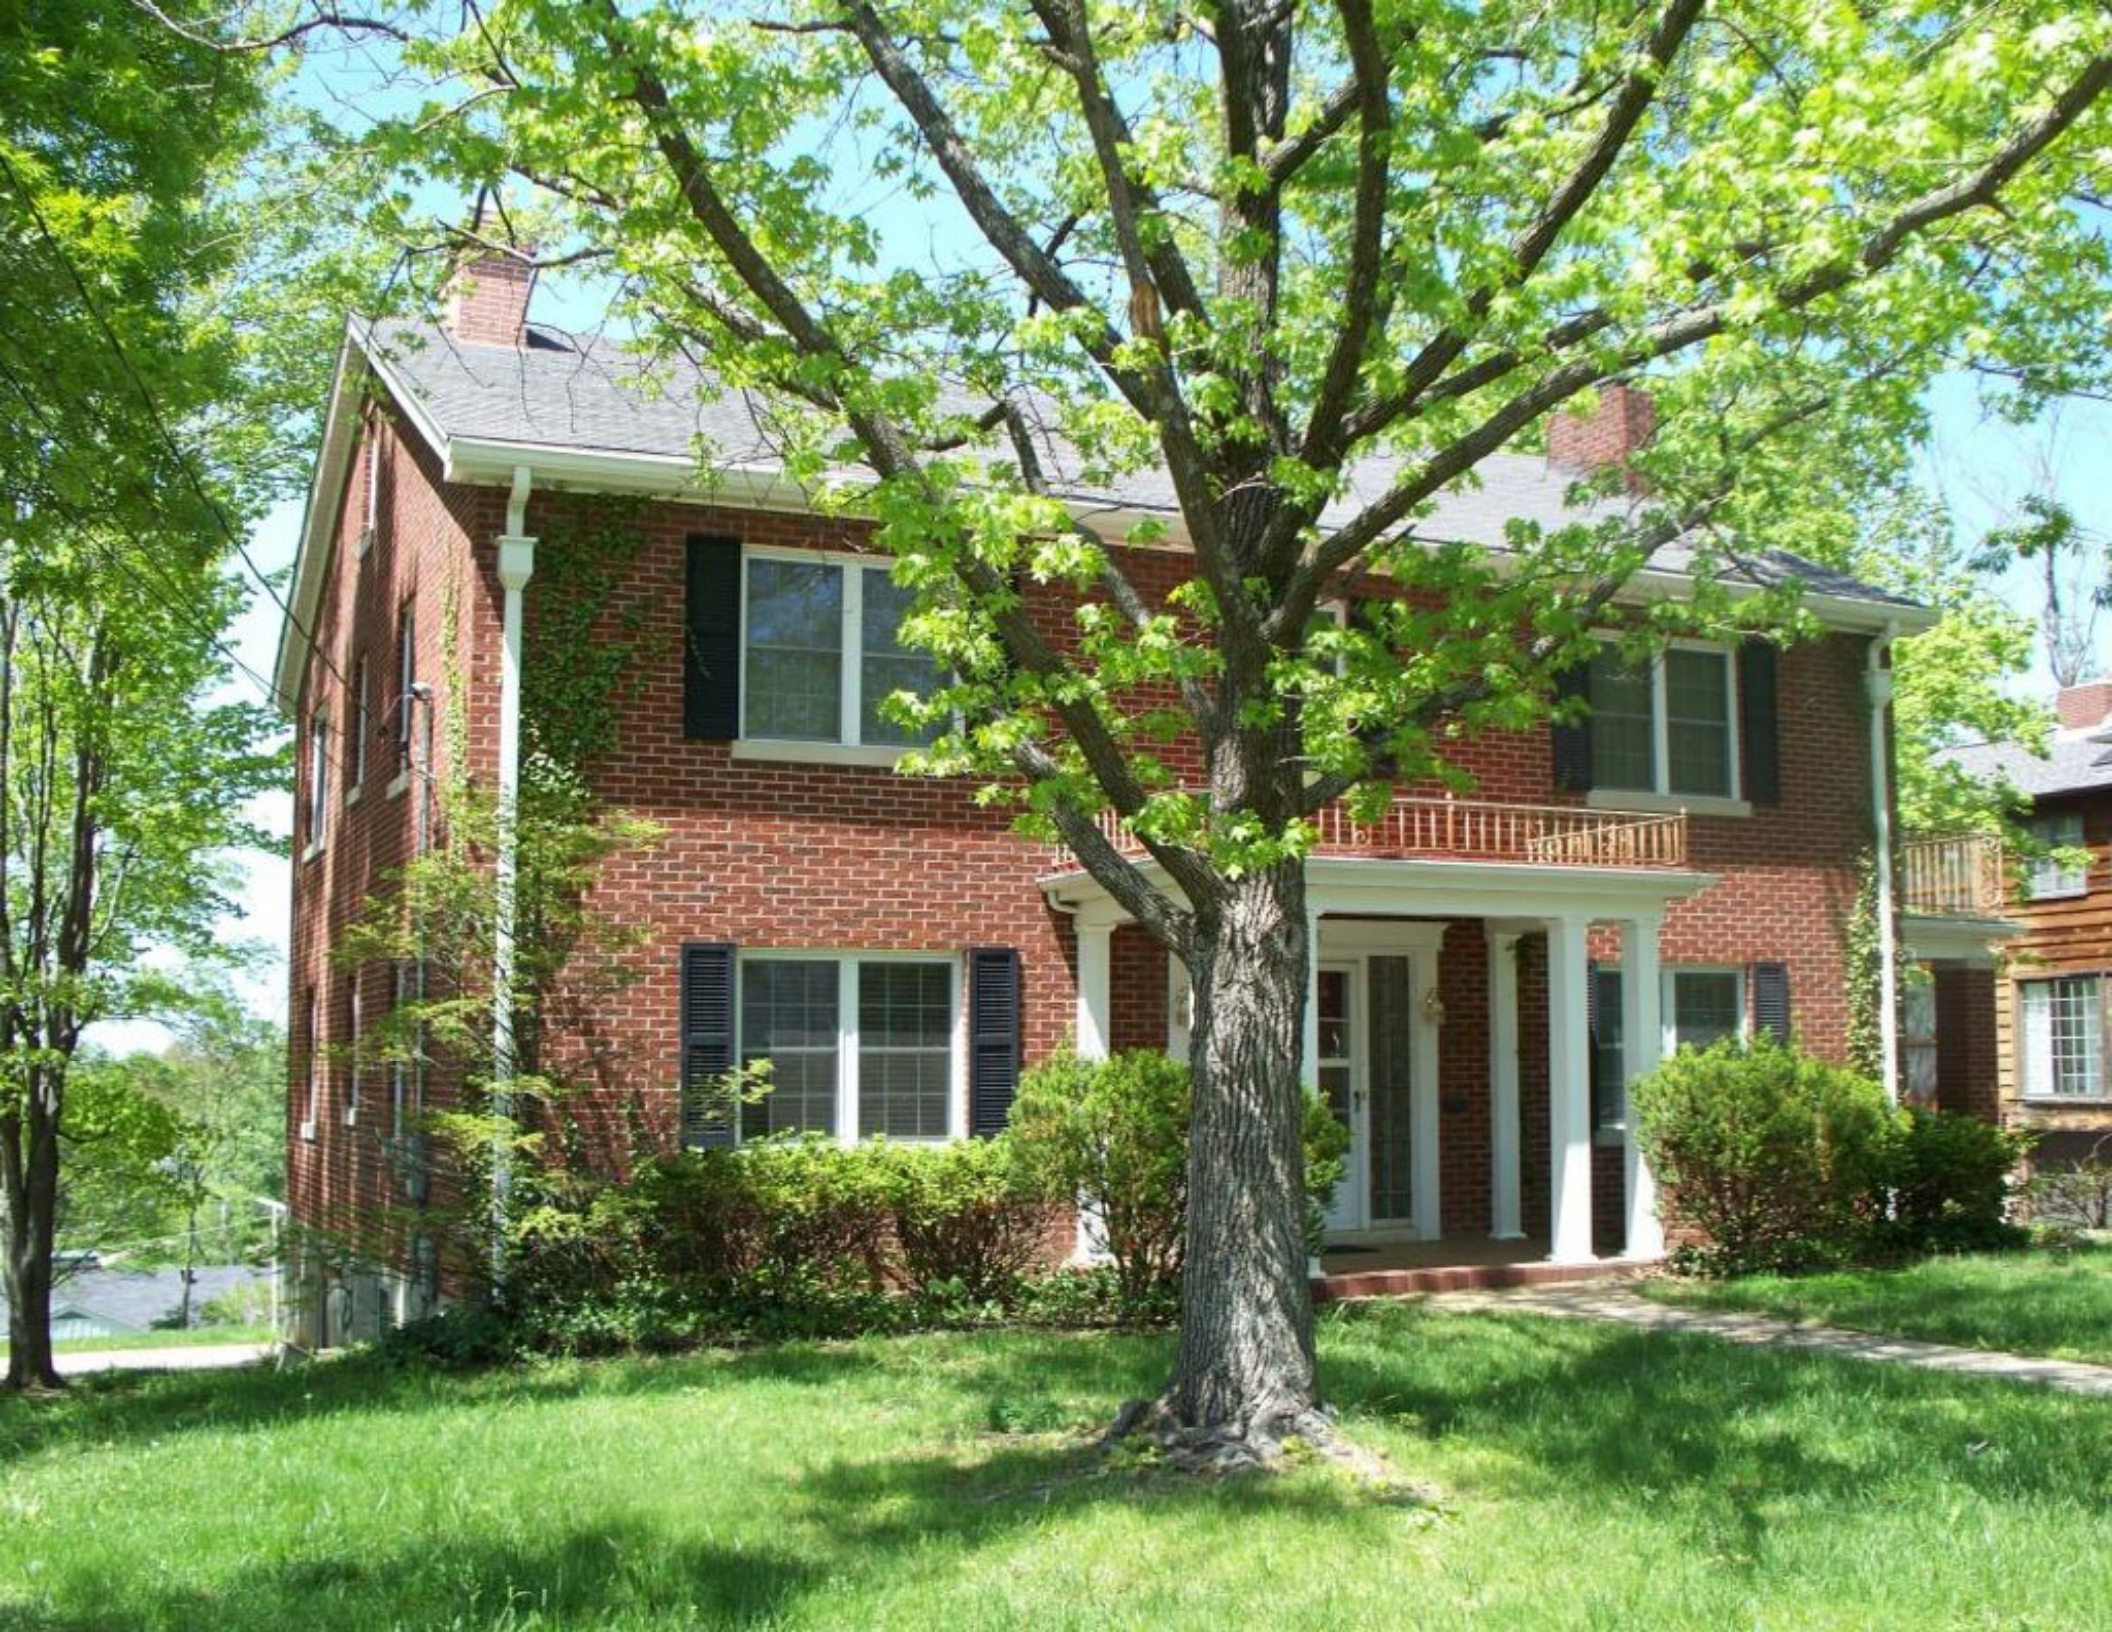
41. (cont.)
This two story brick Colonial Revival has a side gable roof with two paired 6/6 windows on the second floor flanking a smaller 6/6 window. All of the windows have shutters and concrete sills and appear to be modern. The first floor has identical windows save the center bay which contains the entrance. The entrance appears to contain glass block sidelights and is surrounded by a portico with a flat roof and railing. It features paired square columns with square pilasters against the building. The portico adds a Classical or Greek Revival flare to this home and may have been inspired by their neighbor at 1504 Green Berry.
