ARCHITECTURAL/HISTORIC INVENTORY FORM

1. Survey No. CO-AS-005-001		2. Survey name: Moreau Drive Neighborhood Survey	
3. County: Cole		4. Address: 1202 Elmerine Ave.	
5. City: Jefferson City	Vicinity: <input type="checkbox"/>	6. UTM: / /	7. Township/Range/Section: T: R: S:
8. Historic name (if known):		9. Present/other name (if known):	
10. Ownership: <input checked="" type="checkbox"/> Private <input type="checkbox"/> Public		11. Historic use (if known): Residential	11. Current use: Residential

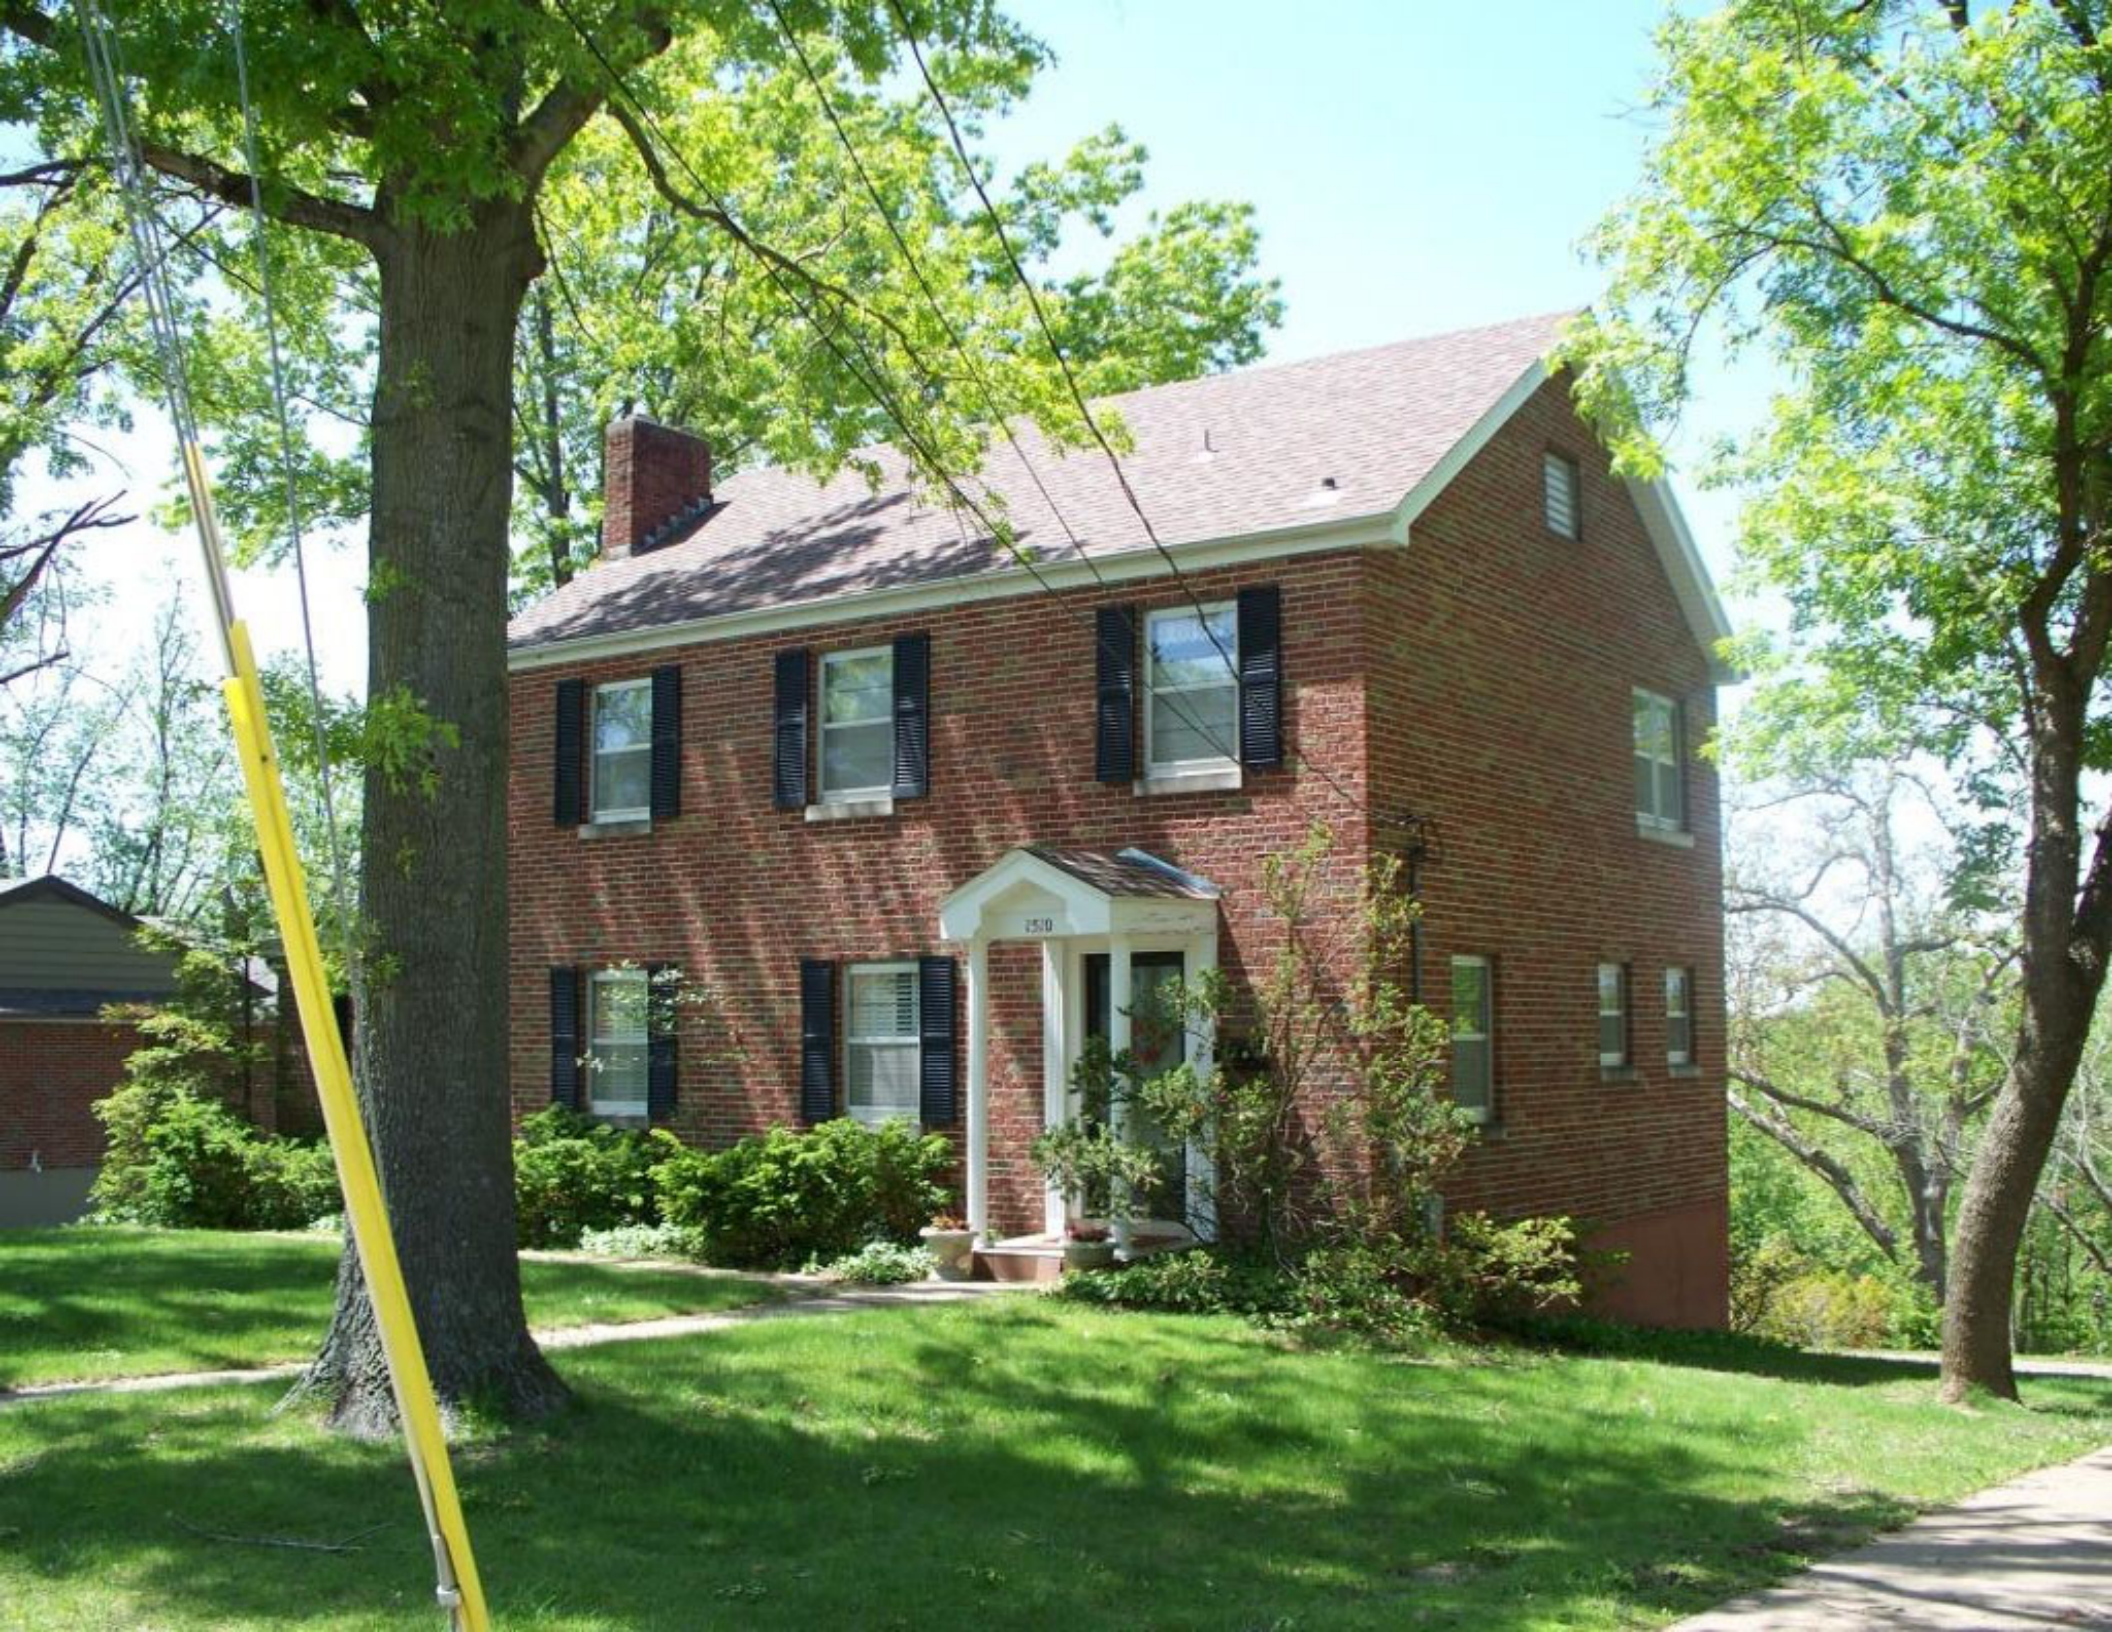
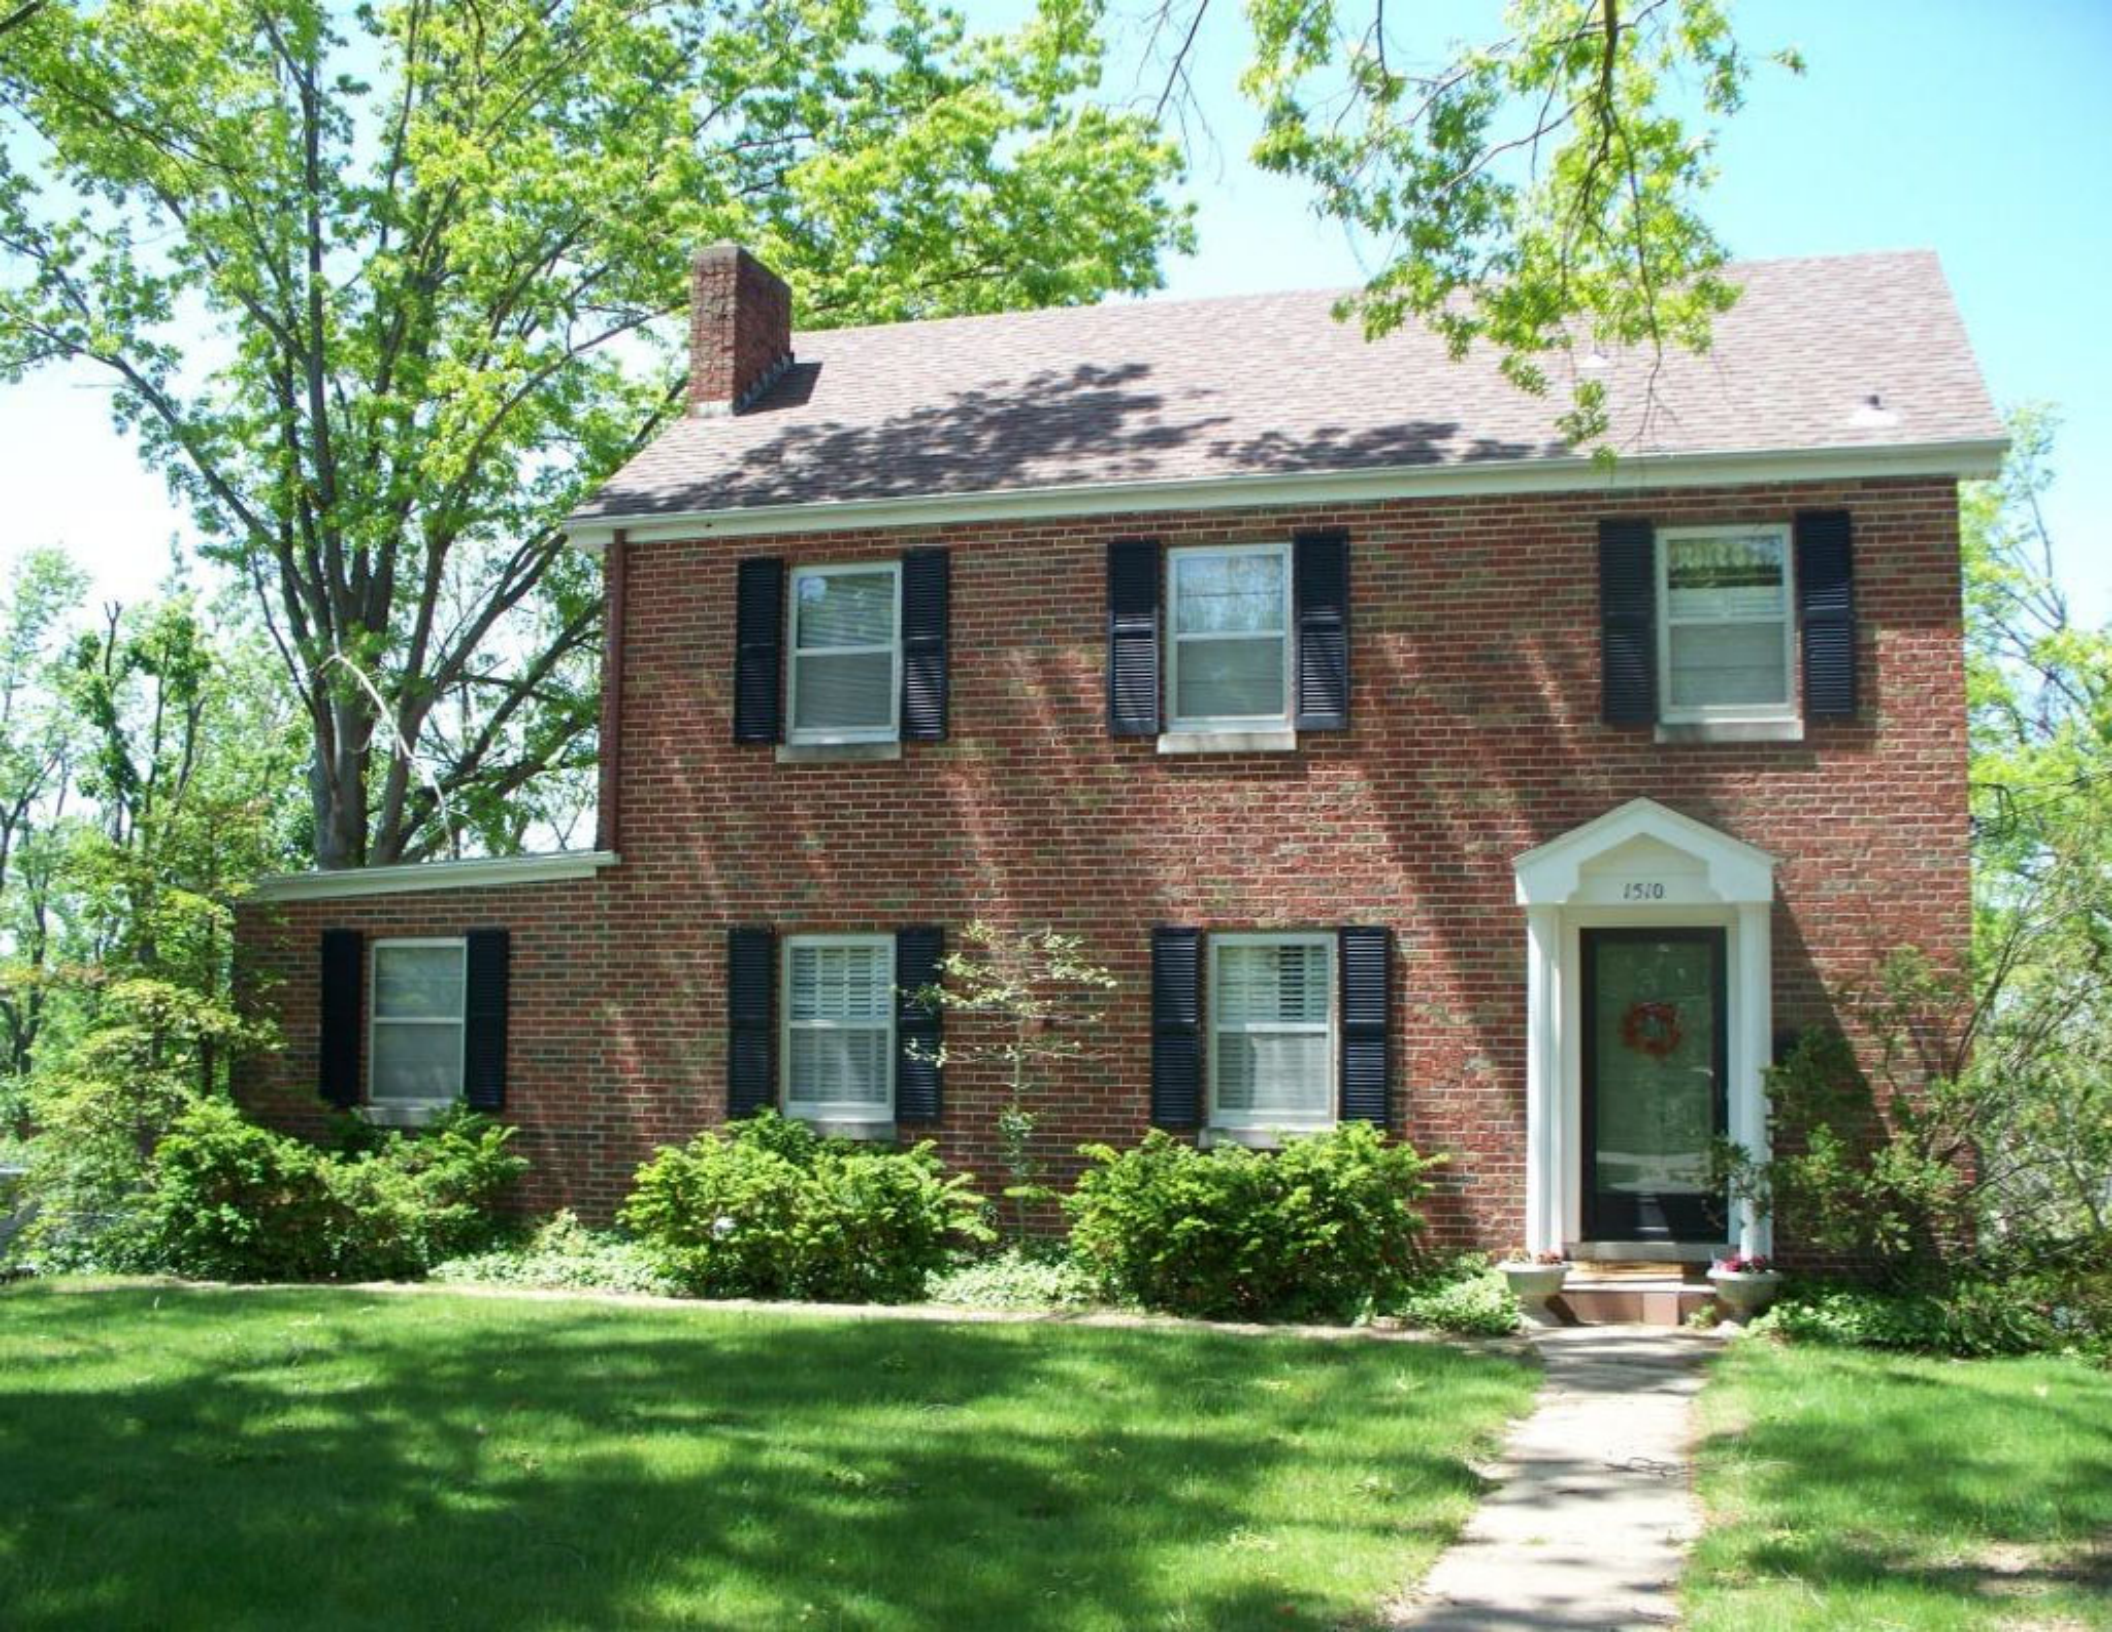
41. (cont.)
This two story brick Colonial Revival has a side gable roof with three 1/1 windows. All of the windows have concrete sills and shutters. The first floor has a one story bay on the left hand side with a shed roof and 1/1 window. There are two more 1/1 windows and the entrance is in the final bay on the right, which has a gabled portico with two pillars and is likely not original to the house.

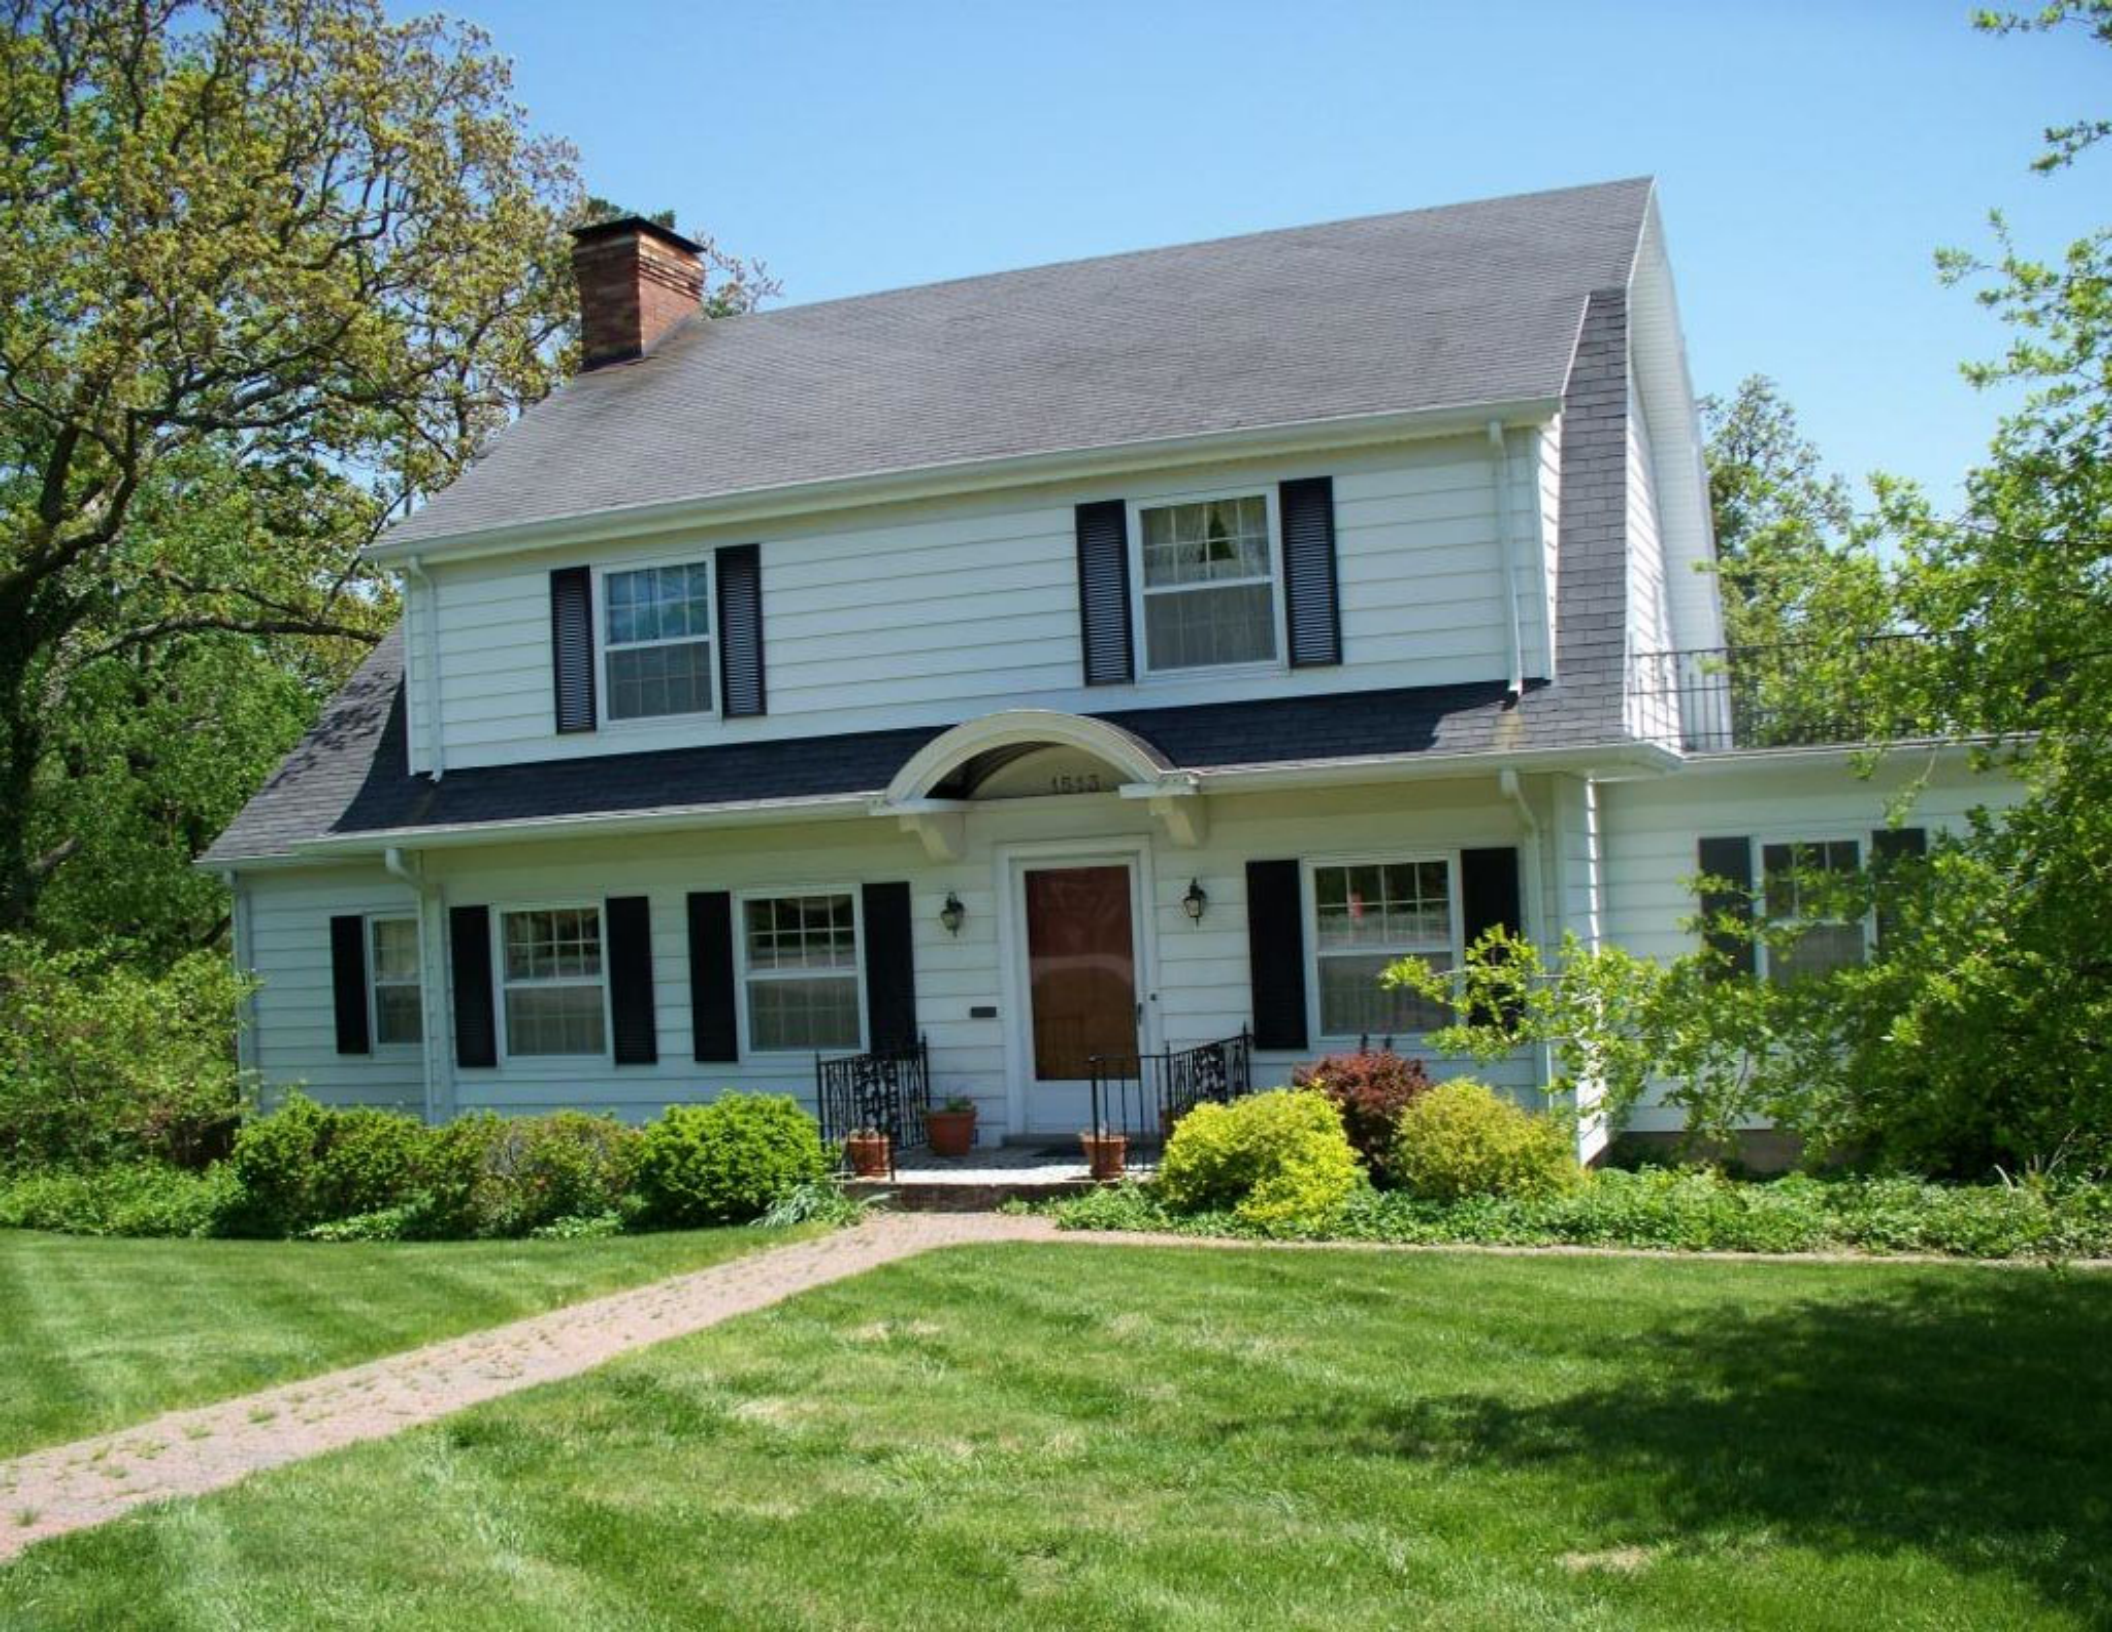
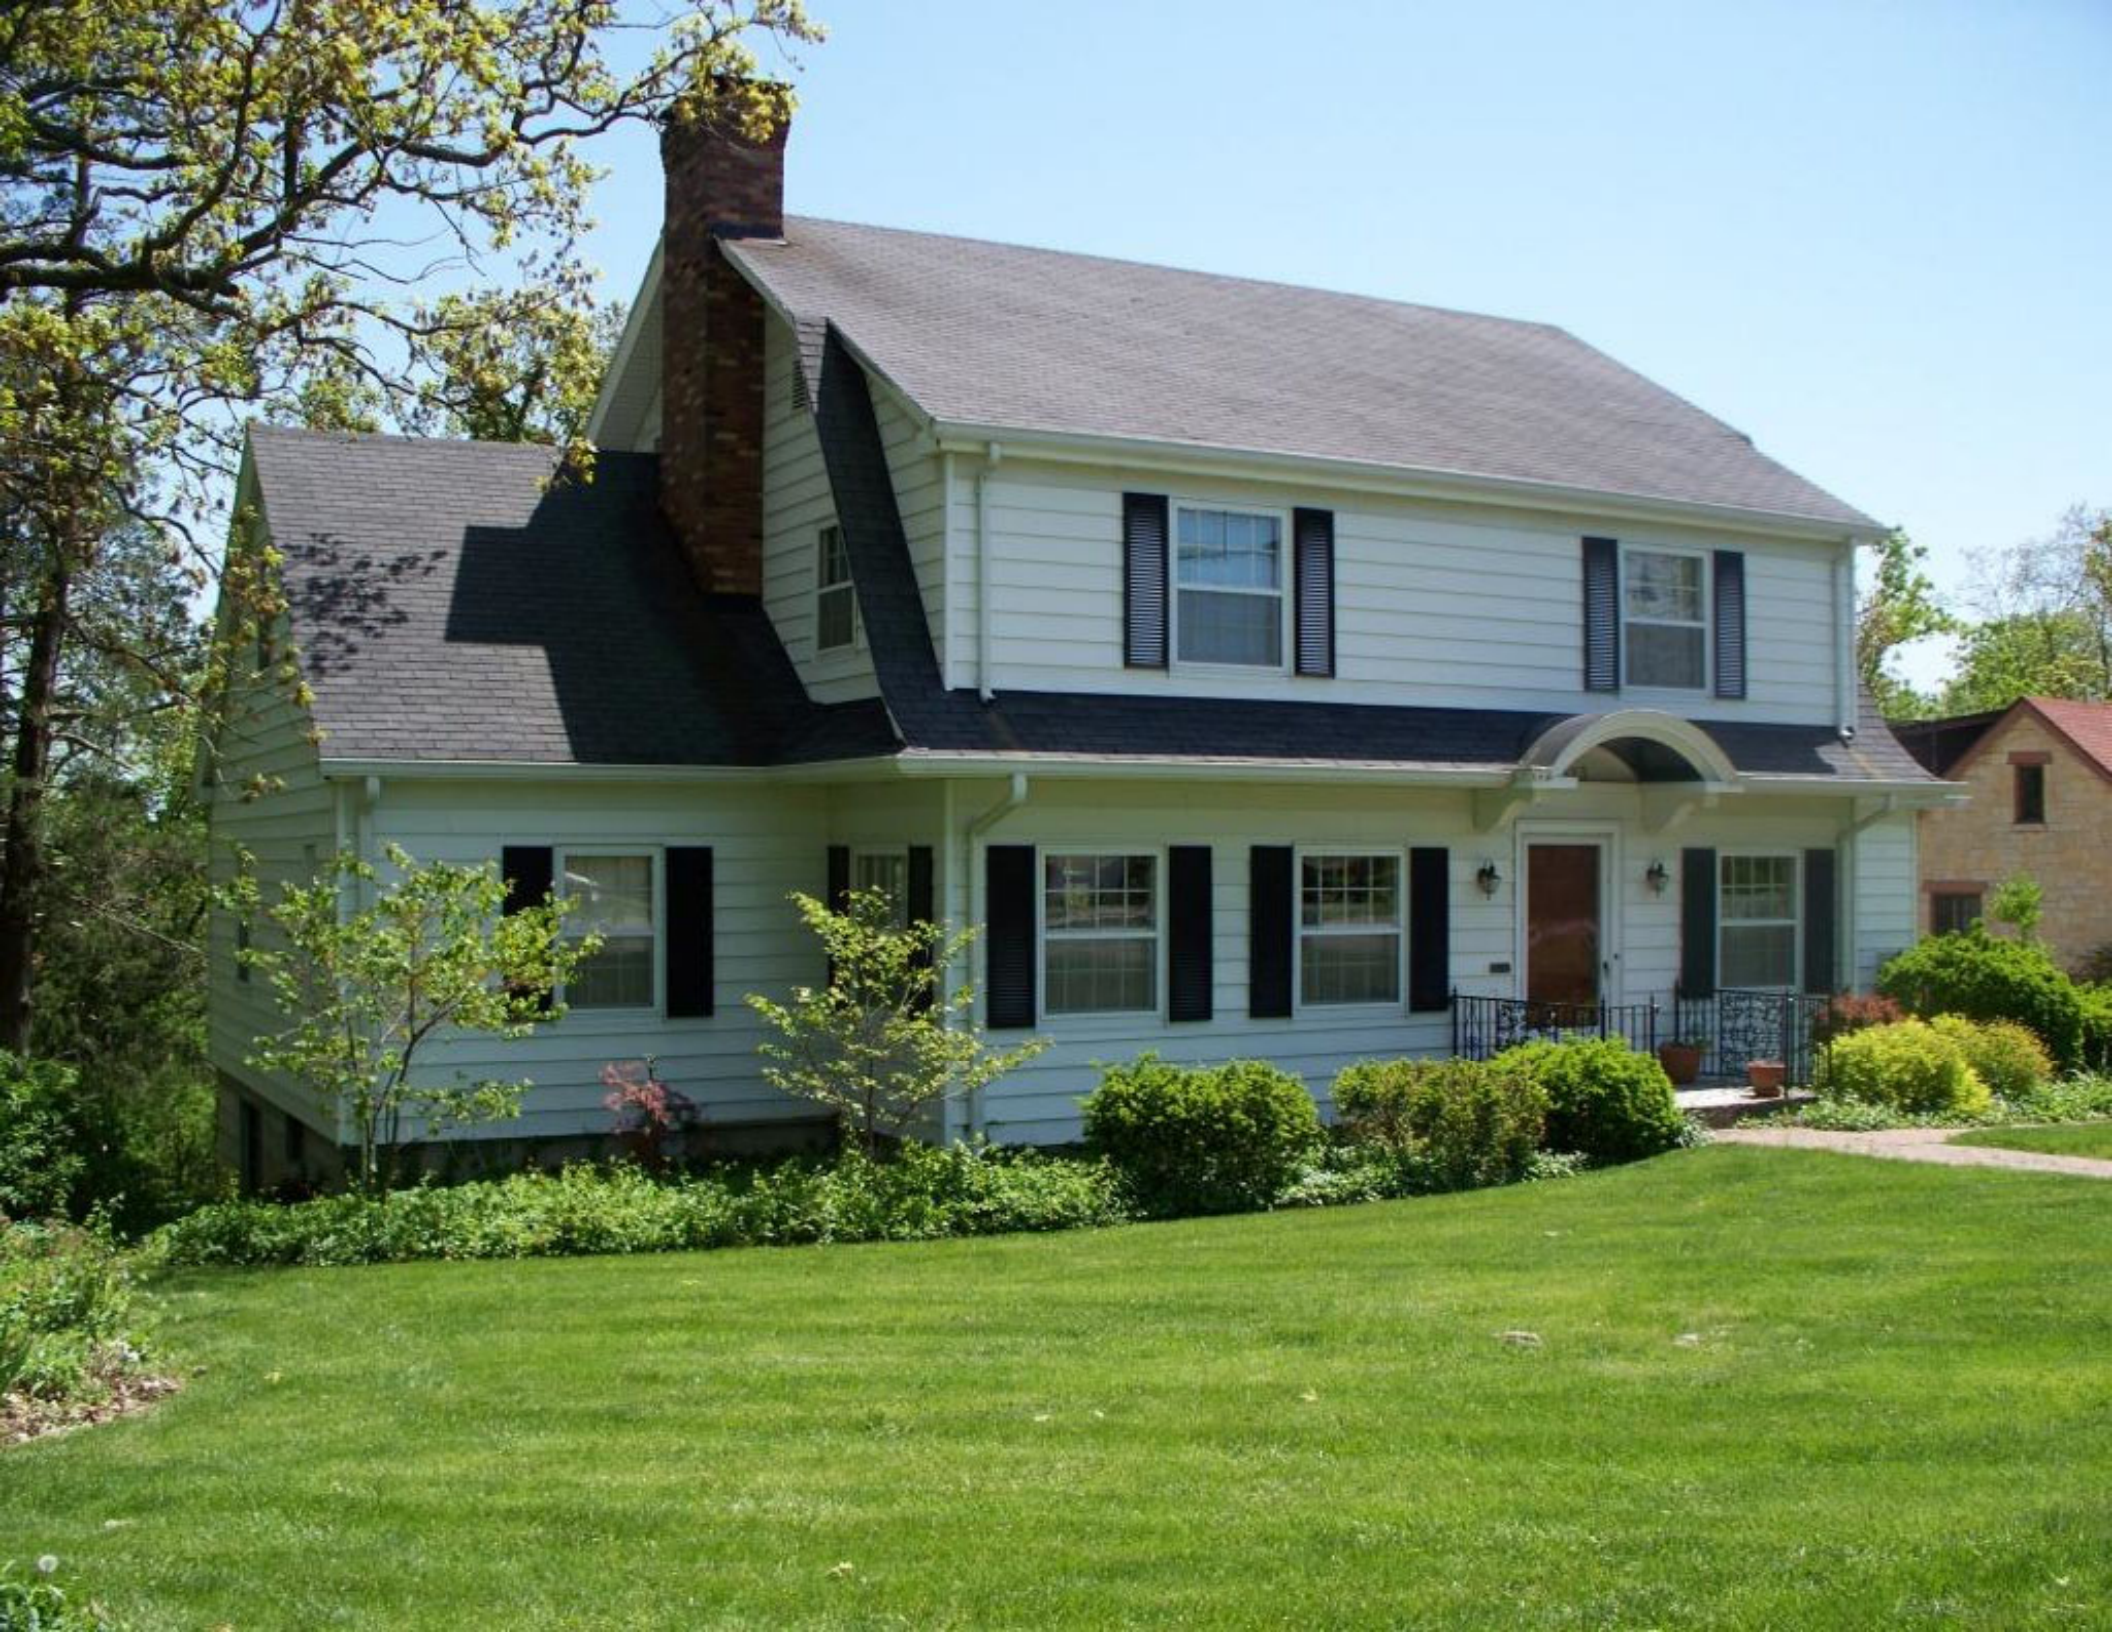
41. (cont.)
This two story Dutch Revival is clad vinyl and has a side gambrel roof and a continuous shed dormer with two 8/8 modern windows with shutters. The first floor has an additional high pitched side gable bay on the left with a single 6/6 window with shutters. From the right the main portion of the house has two 8/8 modern windows with shutters. The next bay contains the entrance which is covered by an eyebrow hood with returns supported by soft scroll brackets. The next bay contains a single modern 8/8 window with shutters. An additional one story bay to the left is set back and has a flat roof with metal railing and contains a single 6/6 window with shutters. A brick pad with metal railing serves as the stoop.

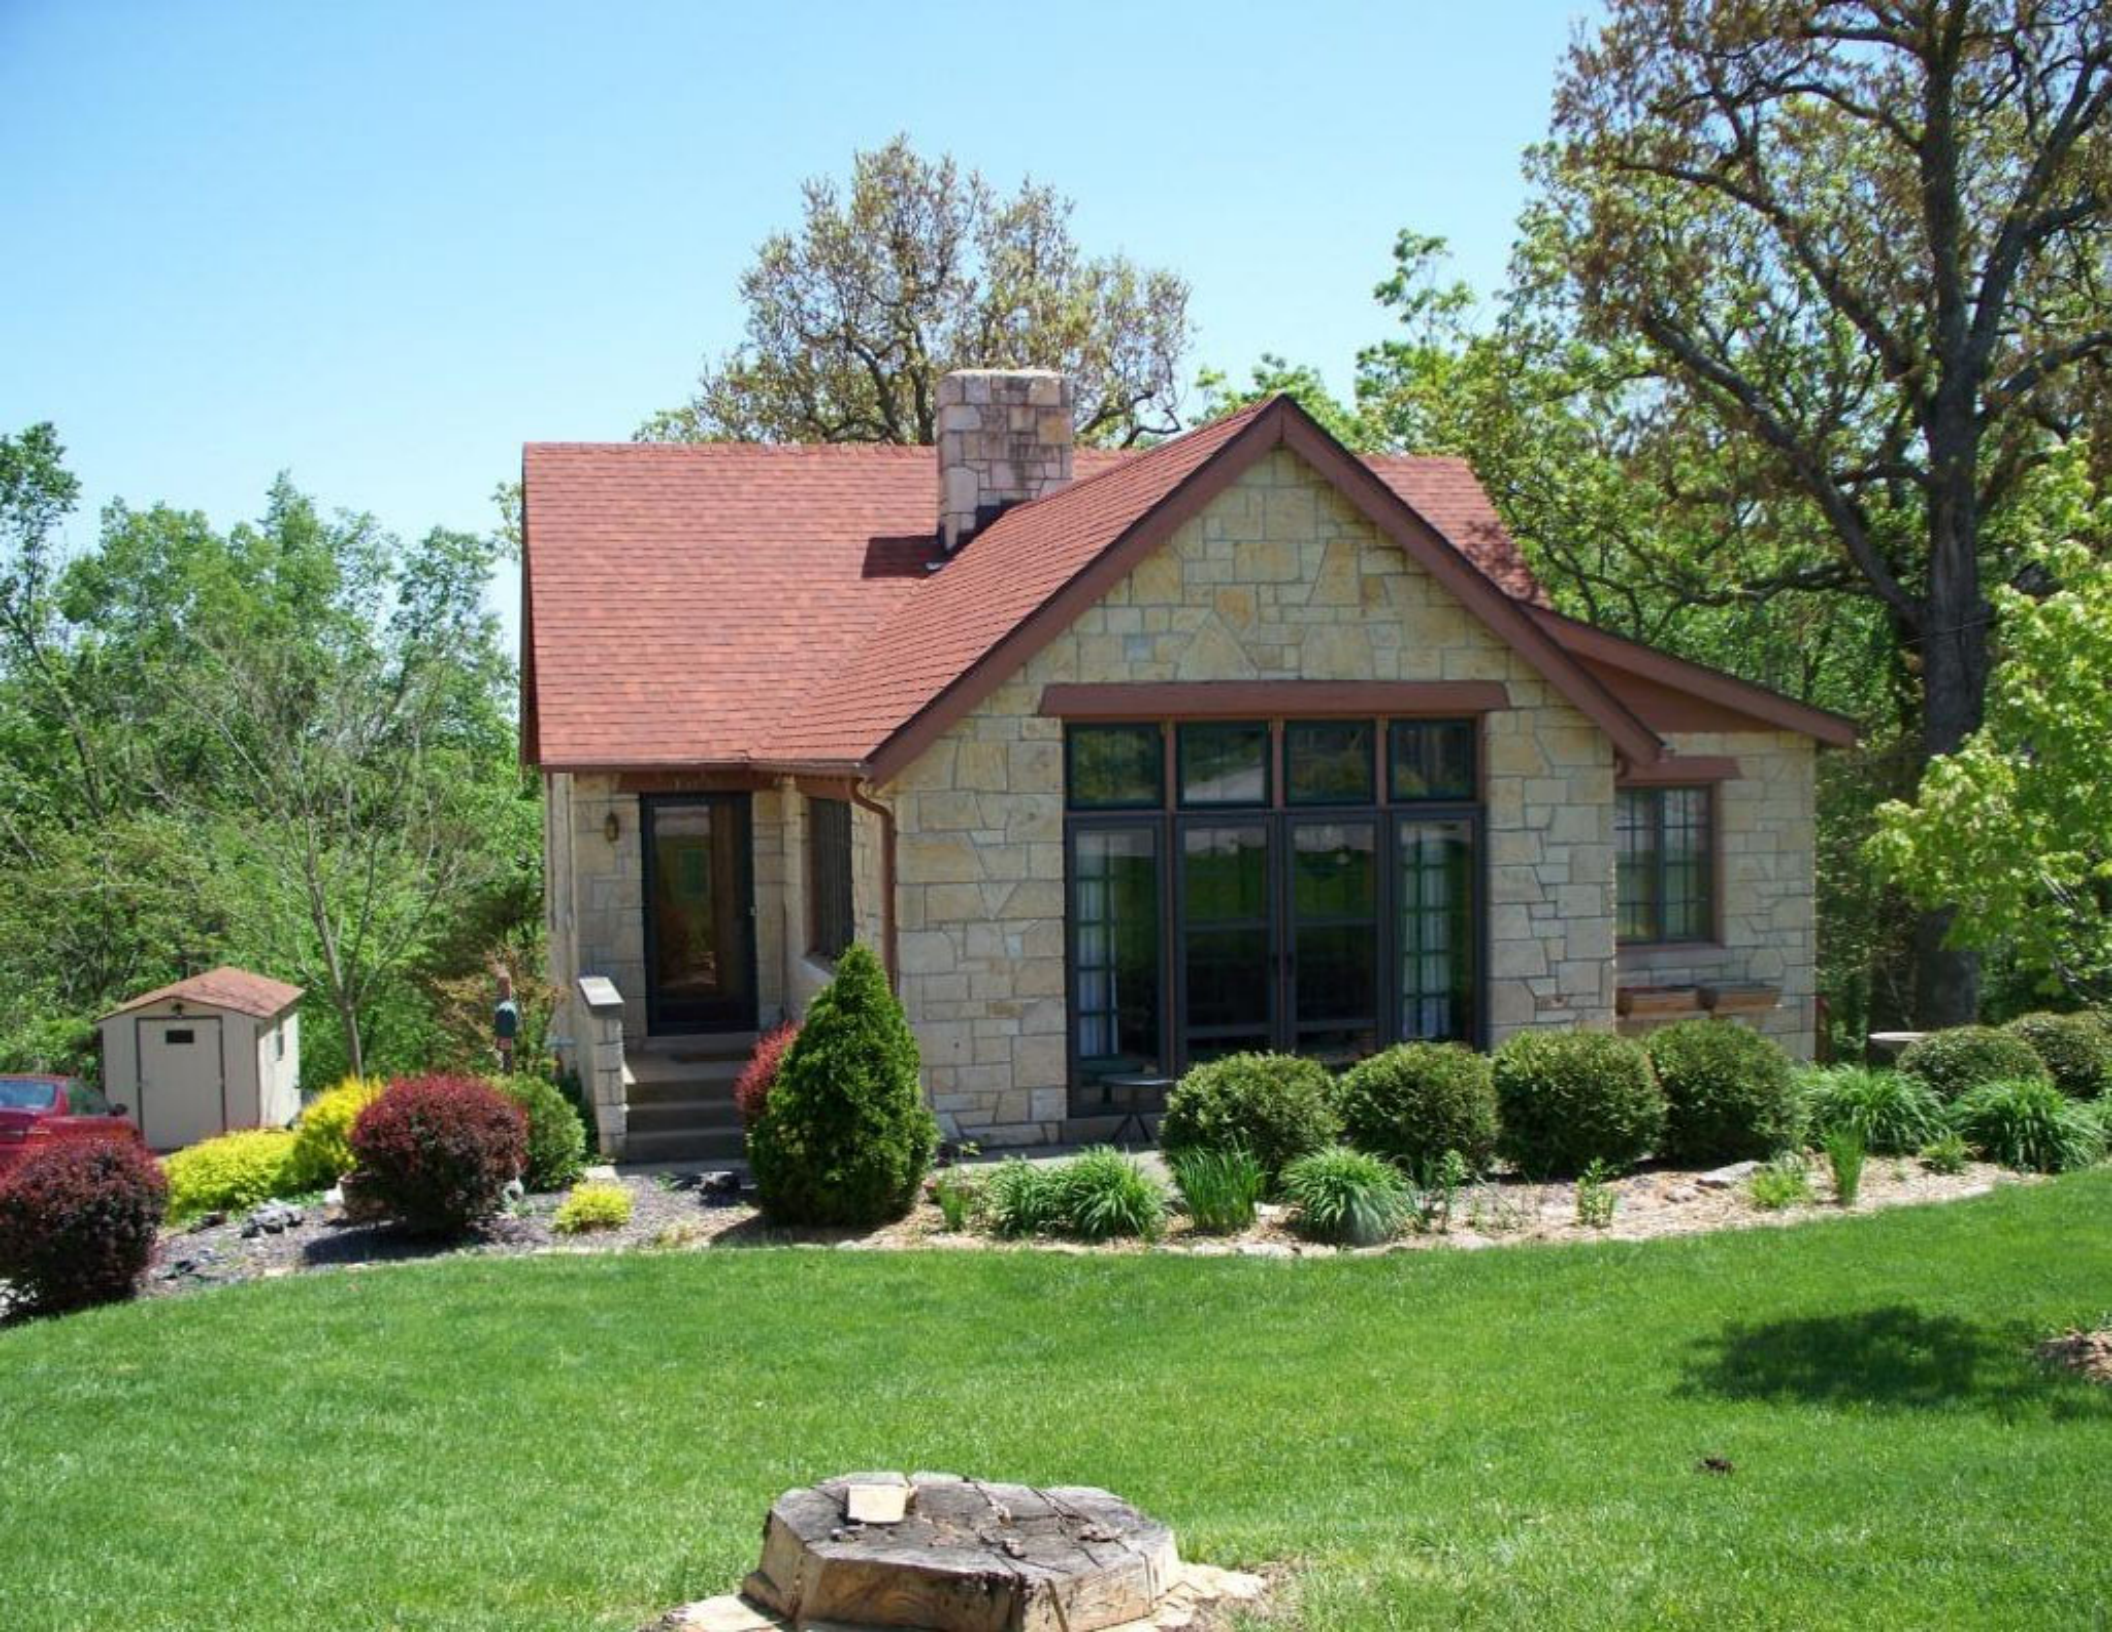
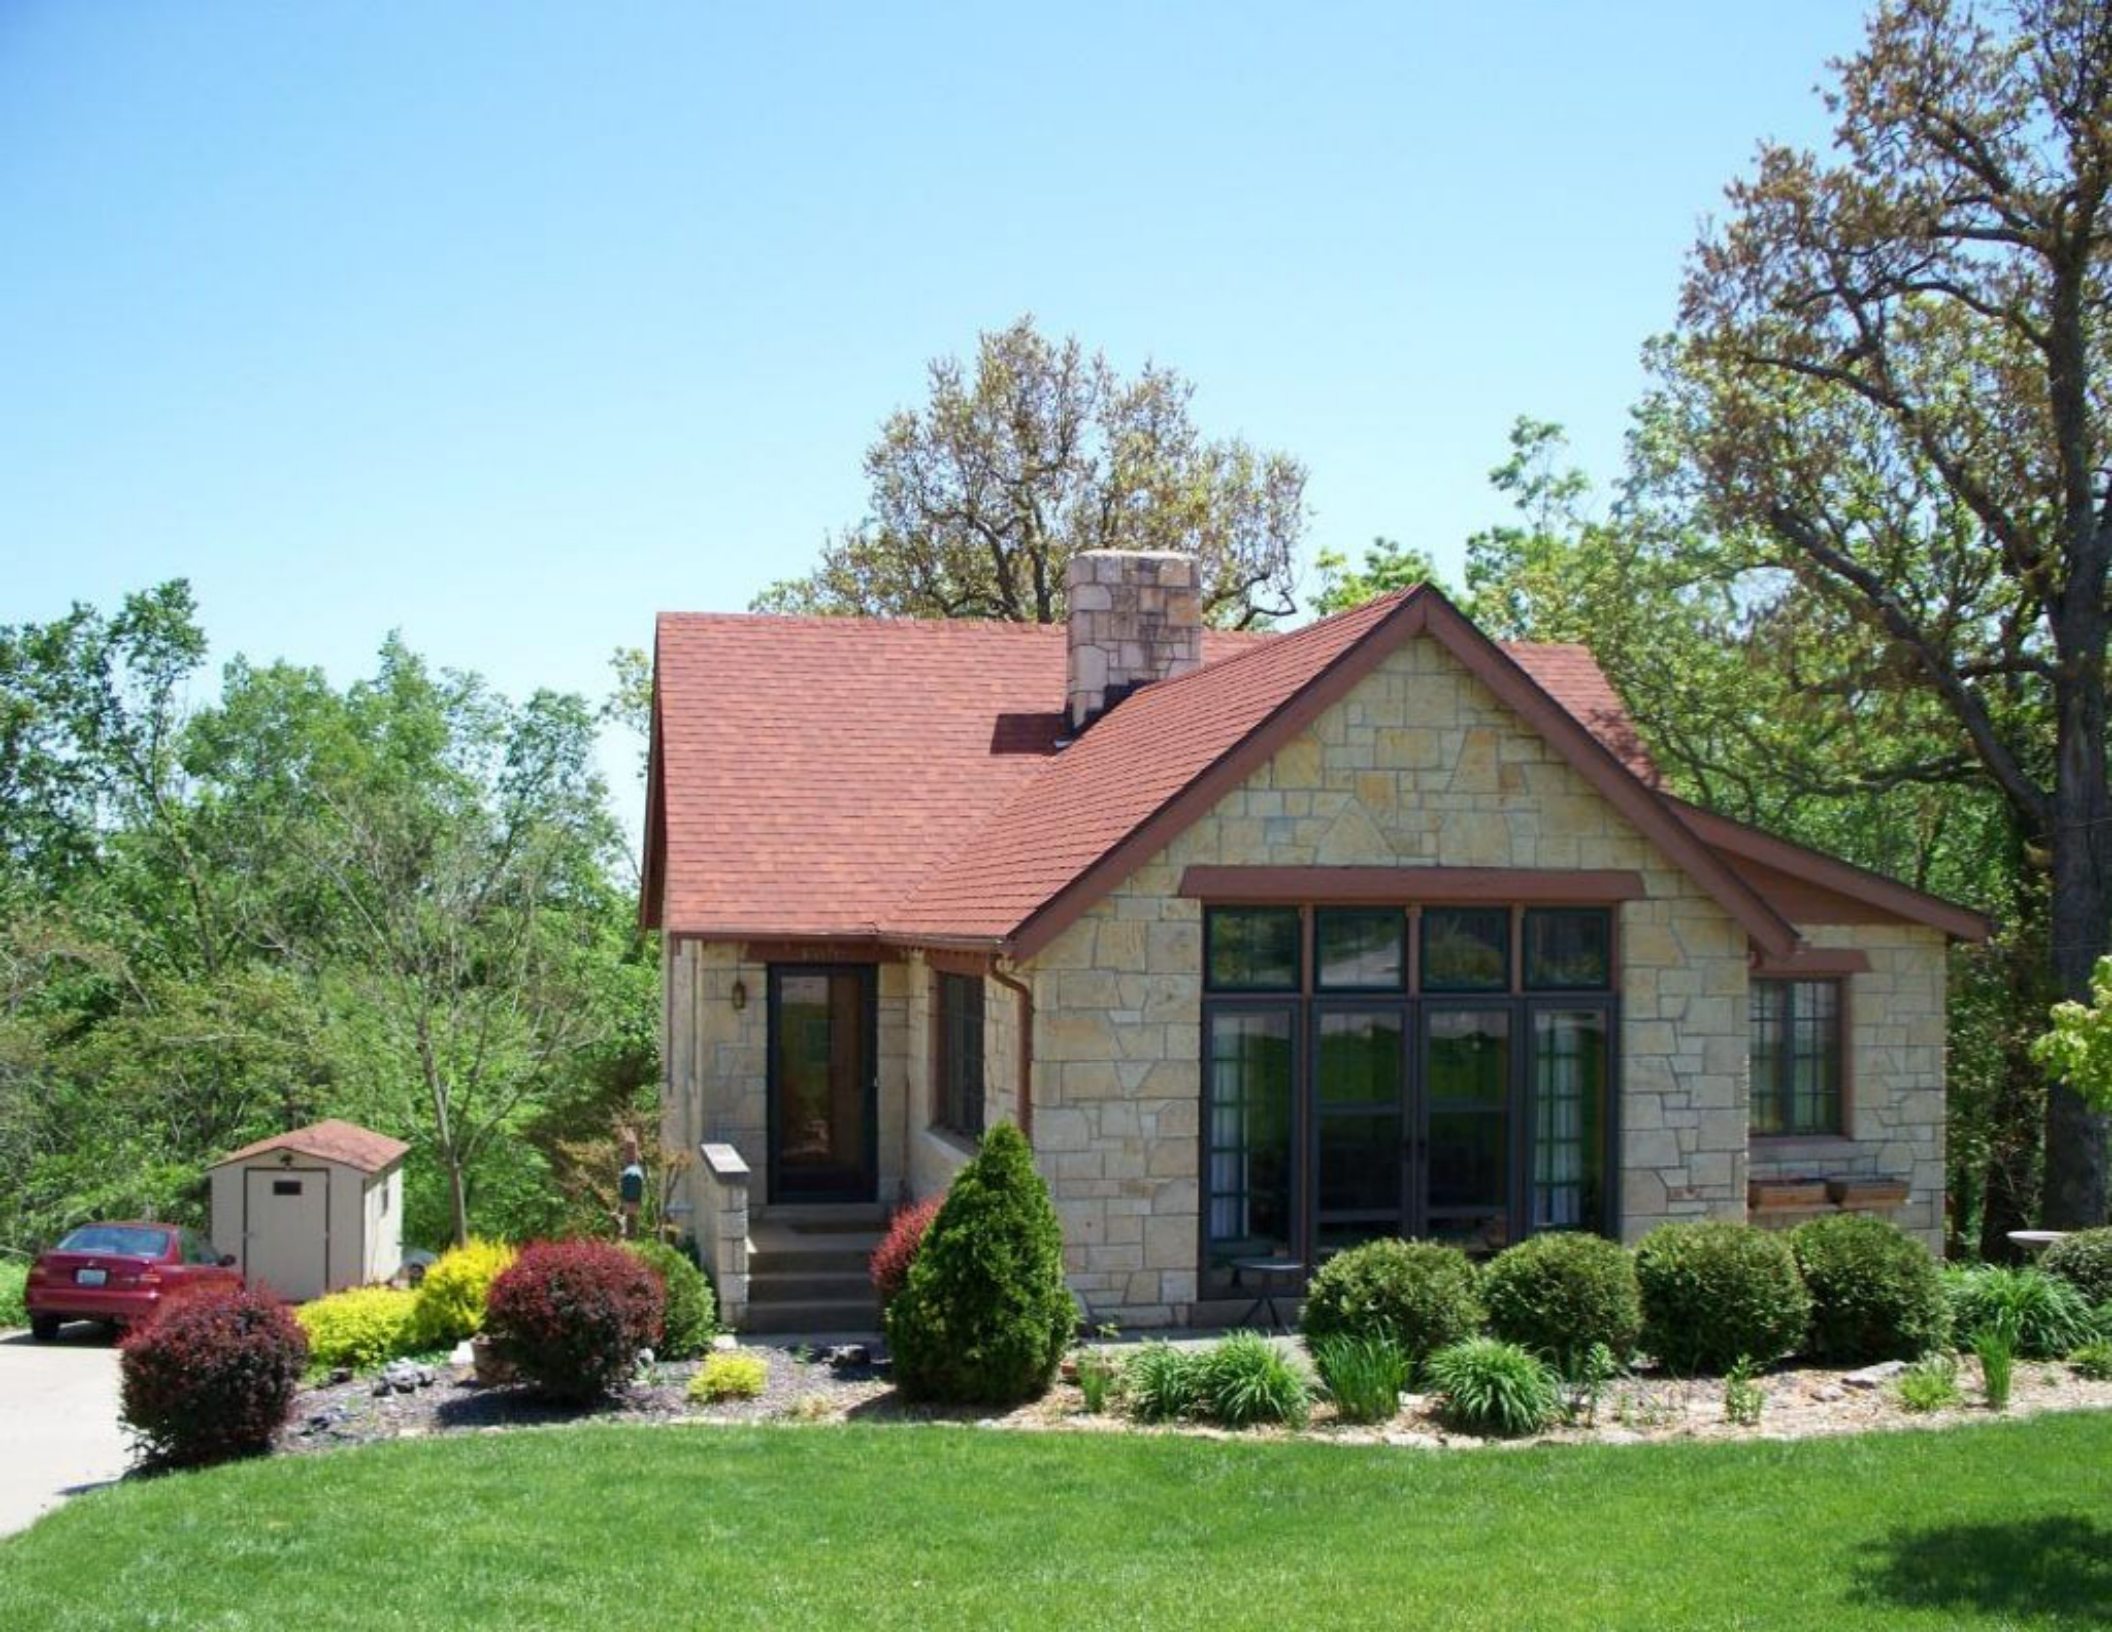
40. (cont.) Description of environment and outbuildings. Expand box as necessary, or add continuation pages.
There is a small modern shed with a gable roof behind the property.

41. (cont.)
This charming one story stone cottage has a side gable roof with the front gable projecting from the center bay. The right wing is slightly set back from the center gable and has a shed roof and a row of historic windows with a wide wooden lintel and flower boxes beneath. The center bay has large French doors (obscured by screen doors), multi-light sidelights and four 4-pane casement windows for a transom. This is all capped by a wide wooden lintel and is the focal point of the home. The left bay is deeply recessed and contains the main entrance and seems to retain its original wooden door with narrow art glass opening. A set of concrete stairs and a half wall of stone serves as the stoop.
