ARCHITECTURAL/HISTORIC INVENTORY FORM

1. Survey No. CO-AS-005-001		2. Survey name: Moreau Drive Neighborhood Survey	
3. County: Cole		4. Address: 1202 Elmerine Ave.	
5. City: Jefferson City	Vicinity: <input type="checkbox"/>	6. UTM: / /	7. Township/Range/Section: T: R: S:
8. Historic name (if known):		9. Present/other name (if known):	
10. Ownership: <input checked="" type="checkbox"/> Private <input type="checkbox"/> Public		11. Historic use (if known): Residential	11. Current use: Residential

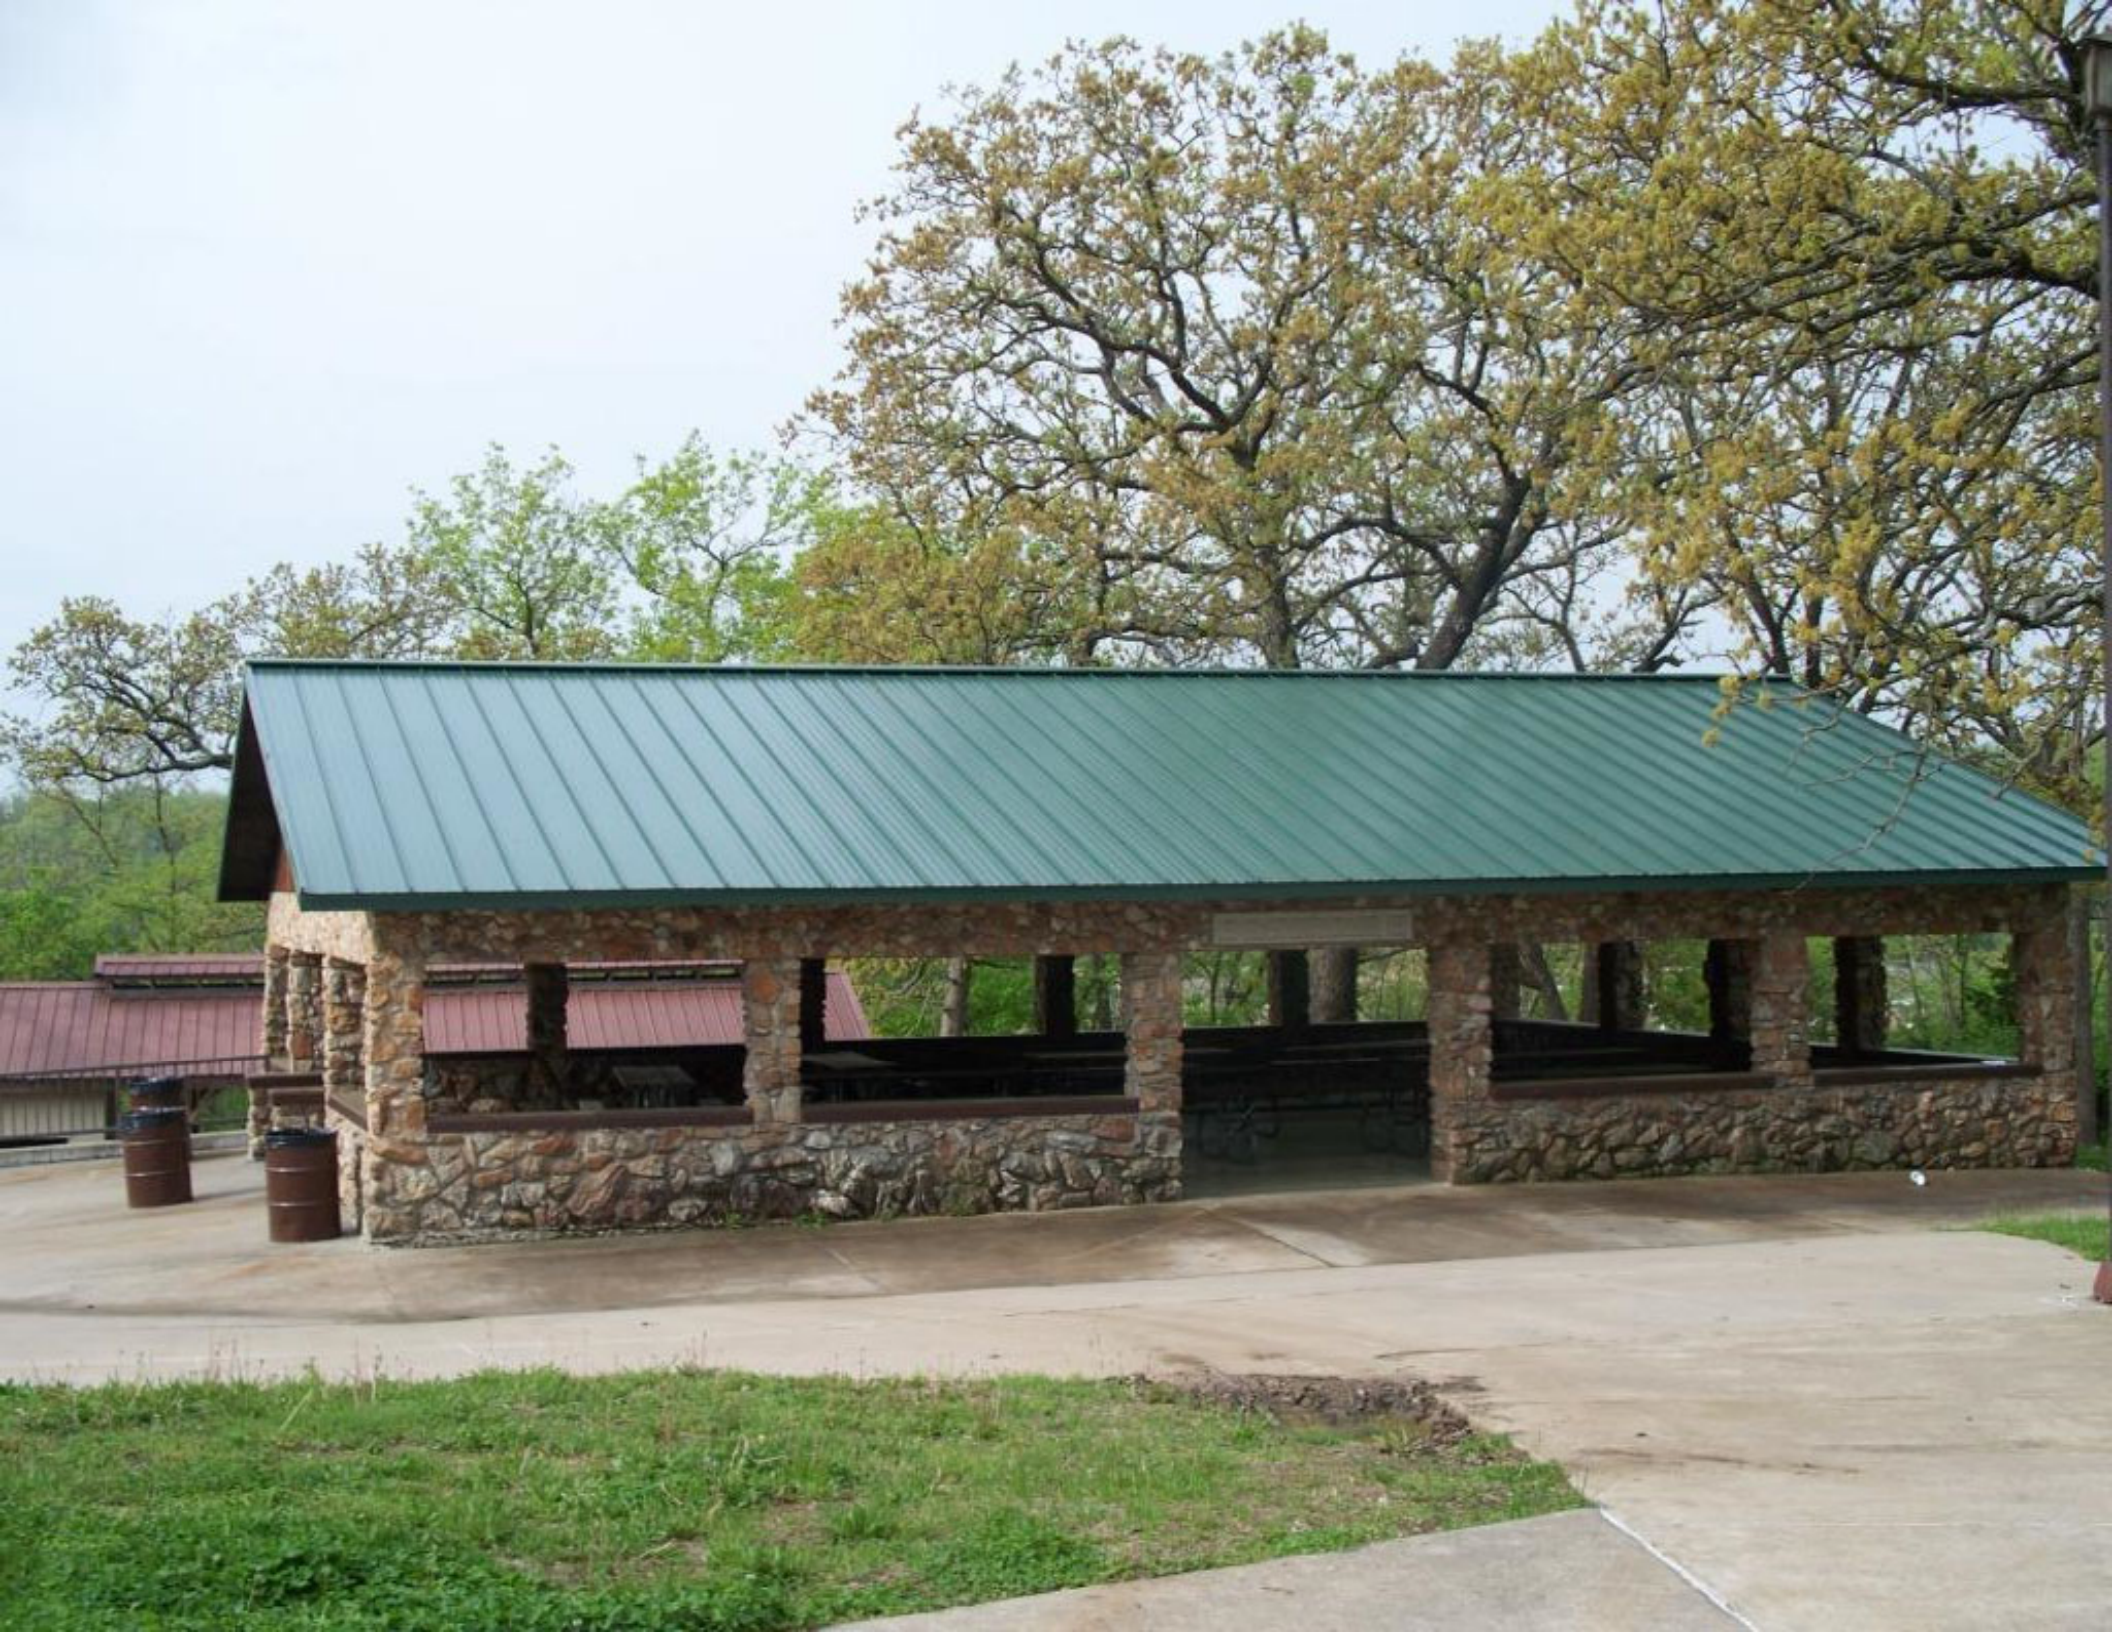
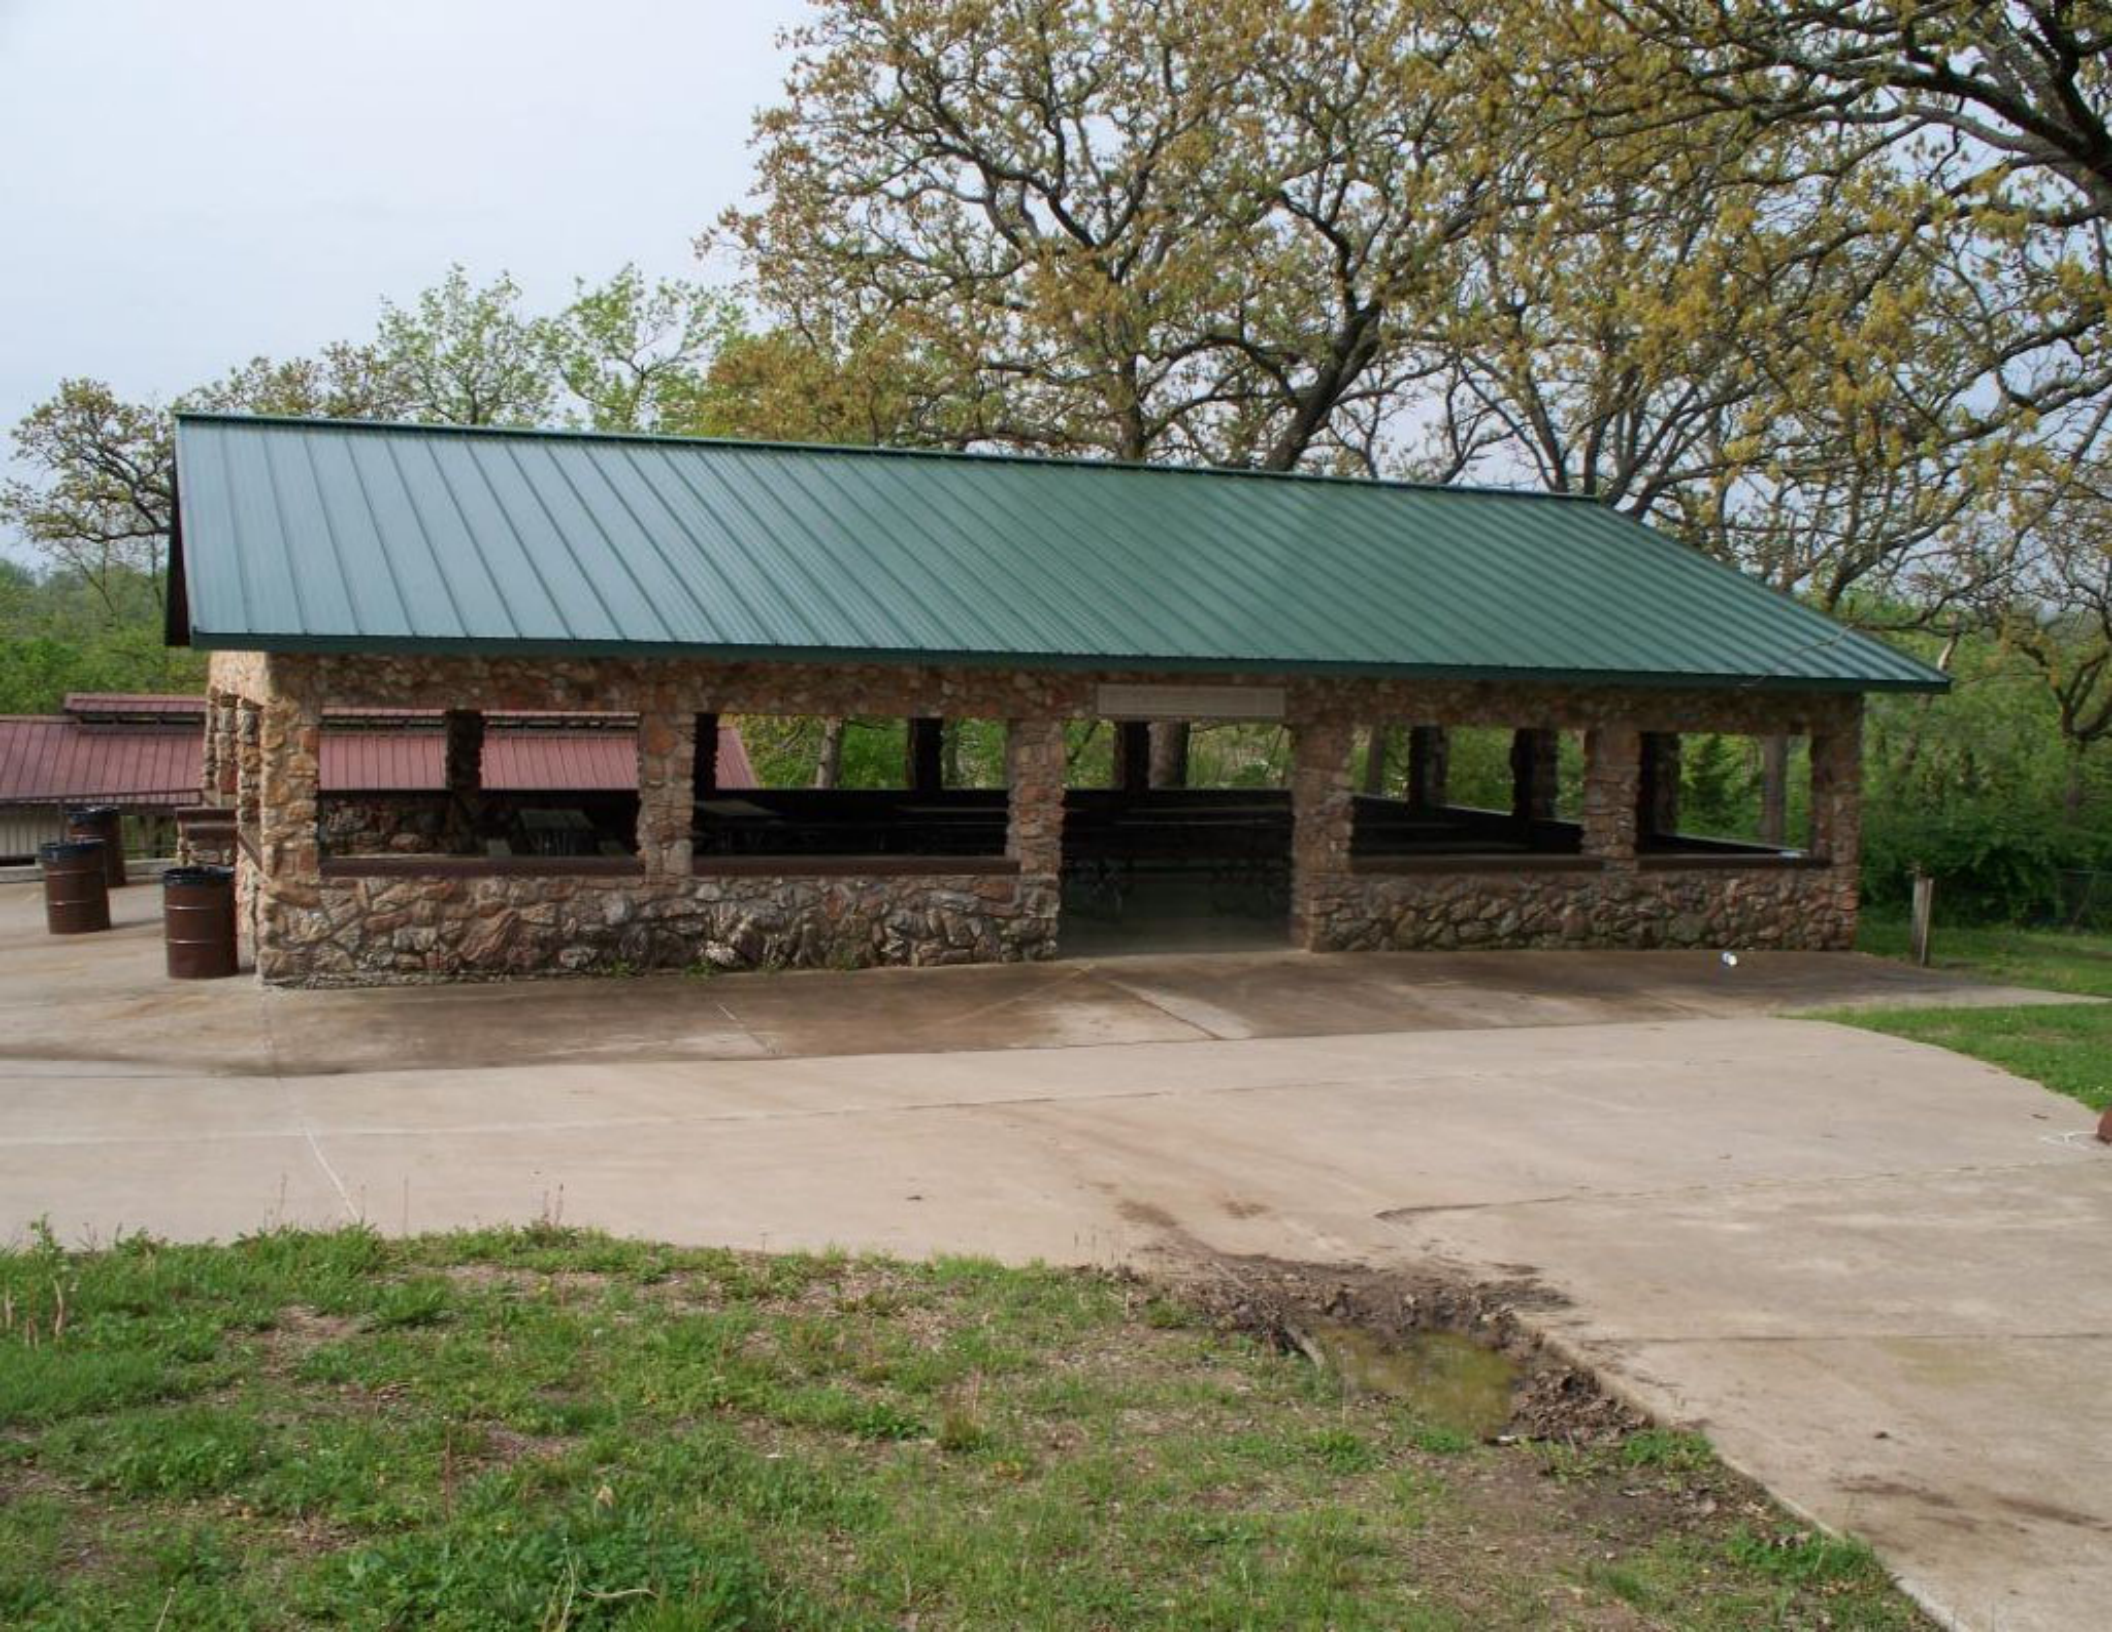
This pavilion is constructed out of rubble stone and features rubble half walls and piers with large square openings. It is considered contributing to the district. The landscape may also contribute but more research is necessary.

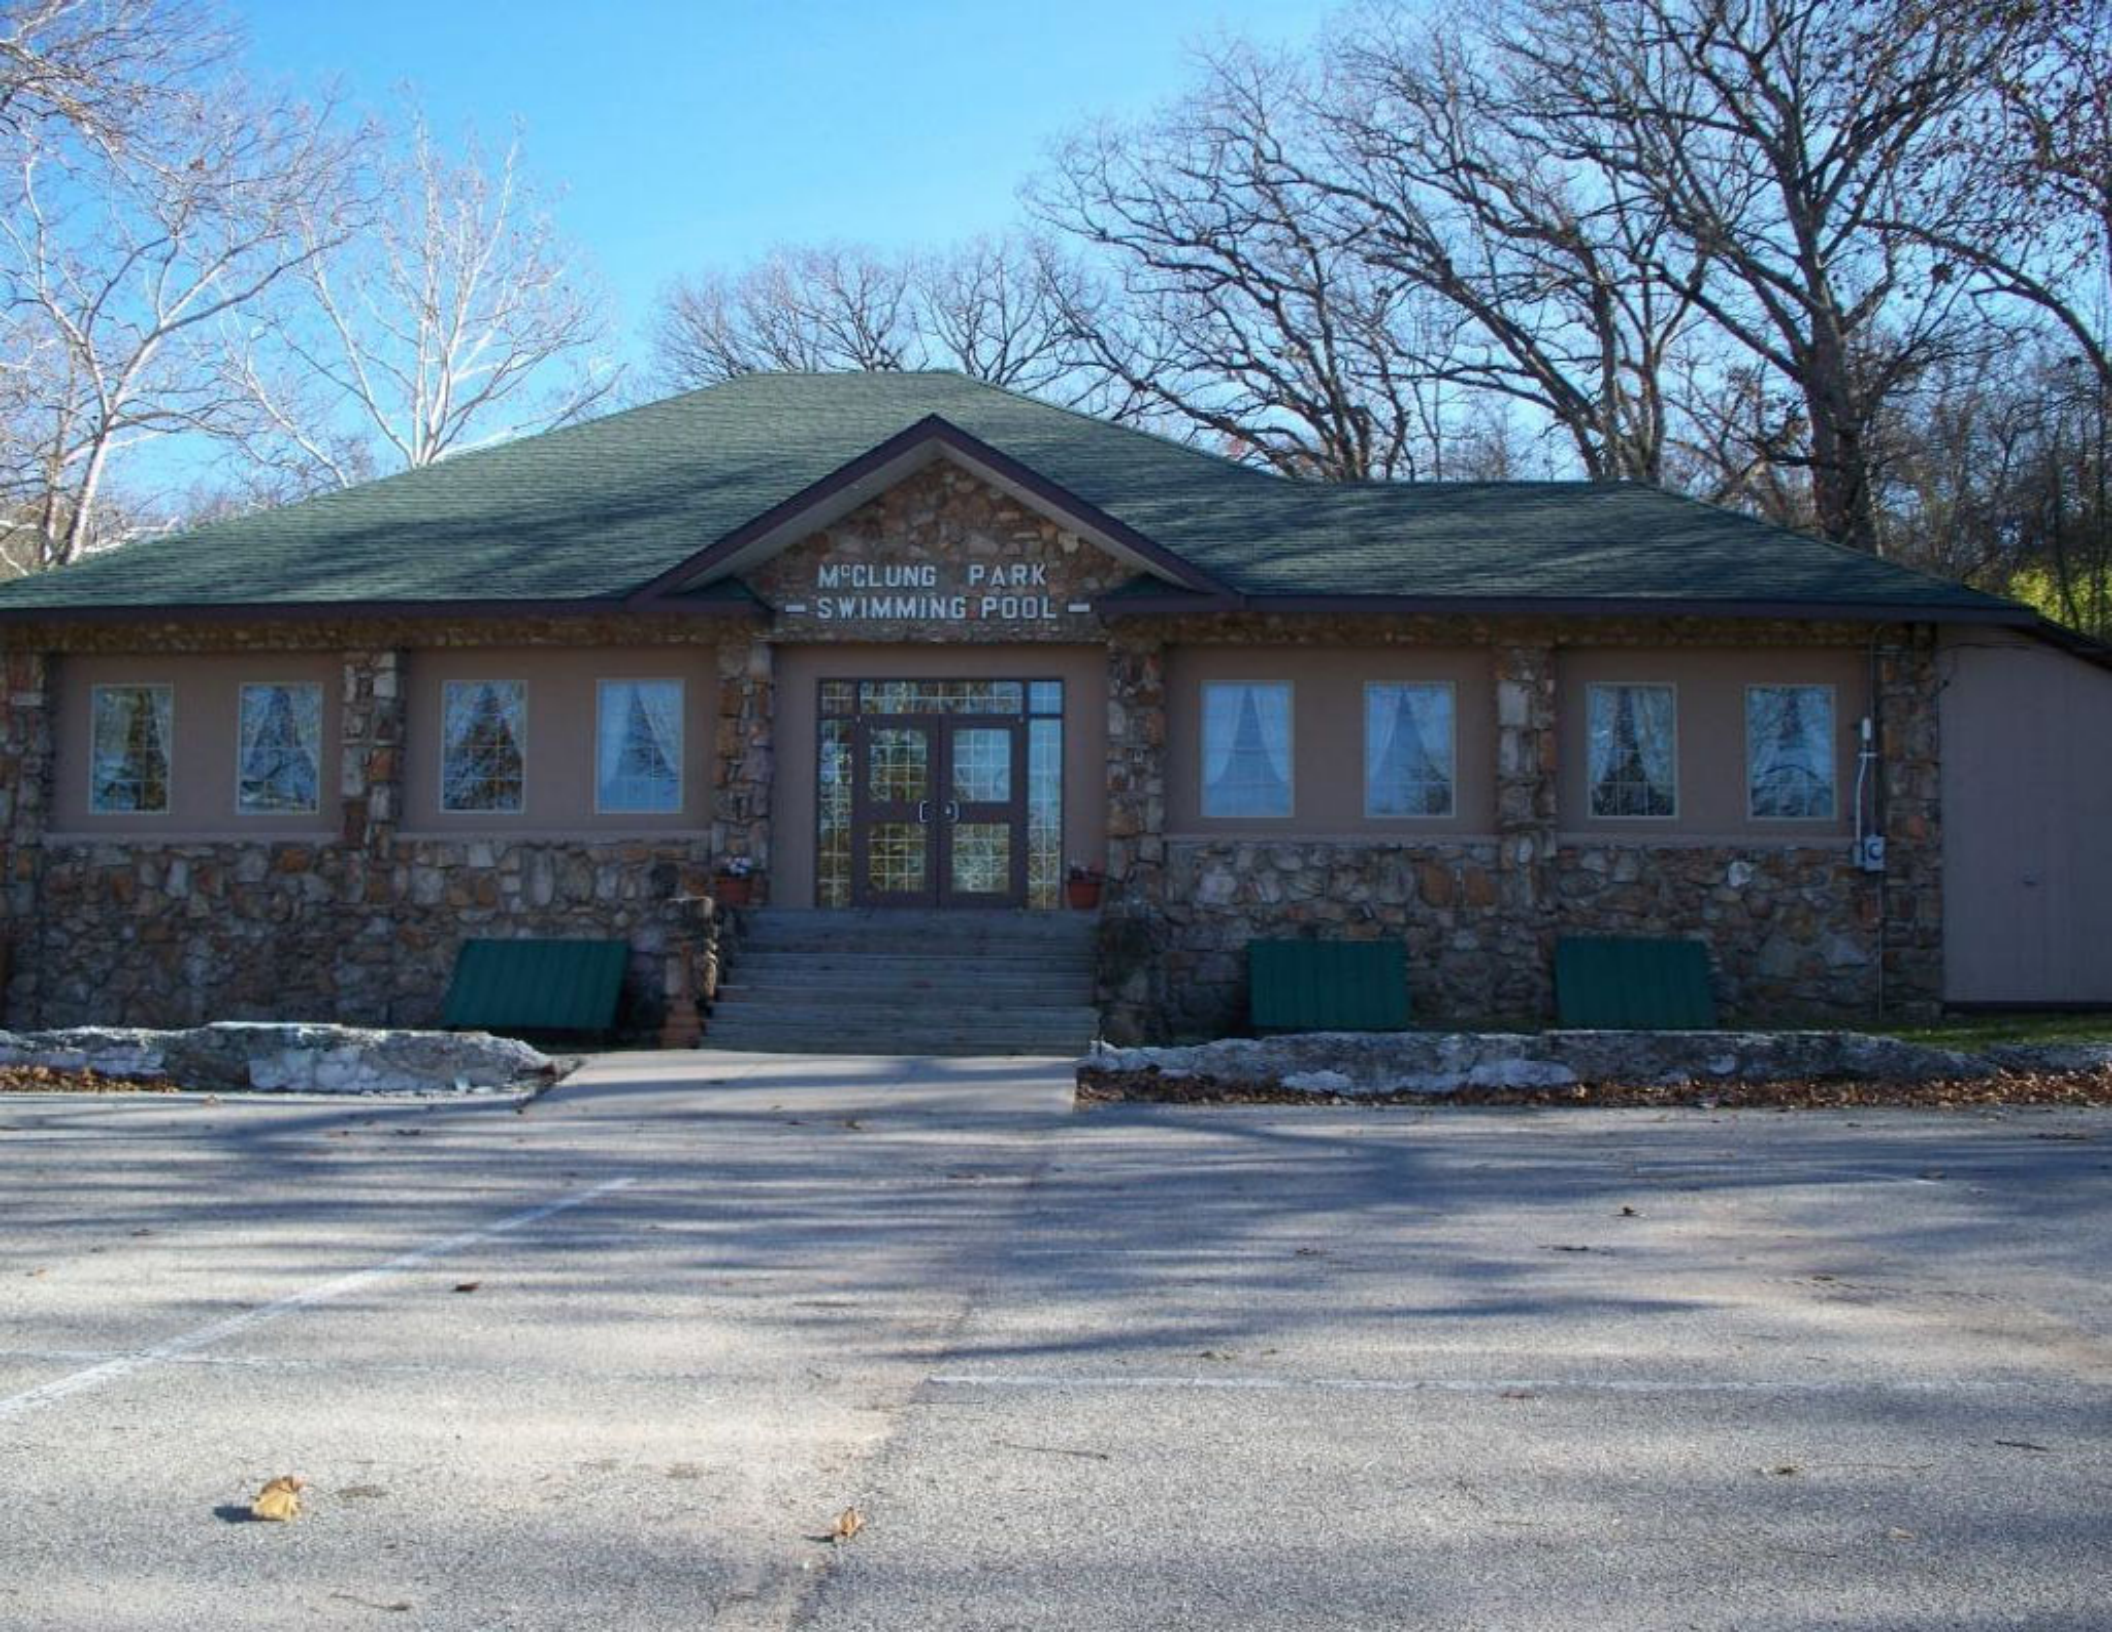
This old swimming site has been paved over and the outbuildings have been converted into a local theater. It has been separated from the rest of the park and is outside the study area.

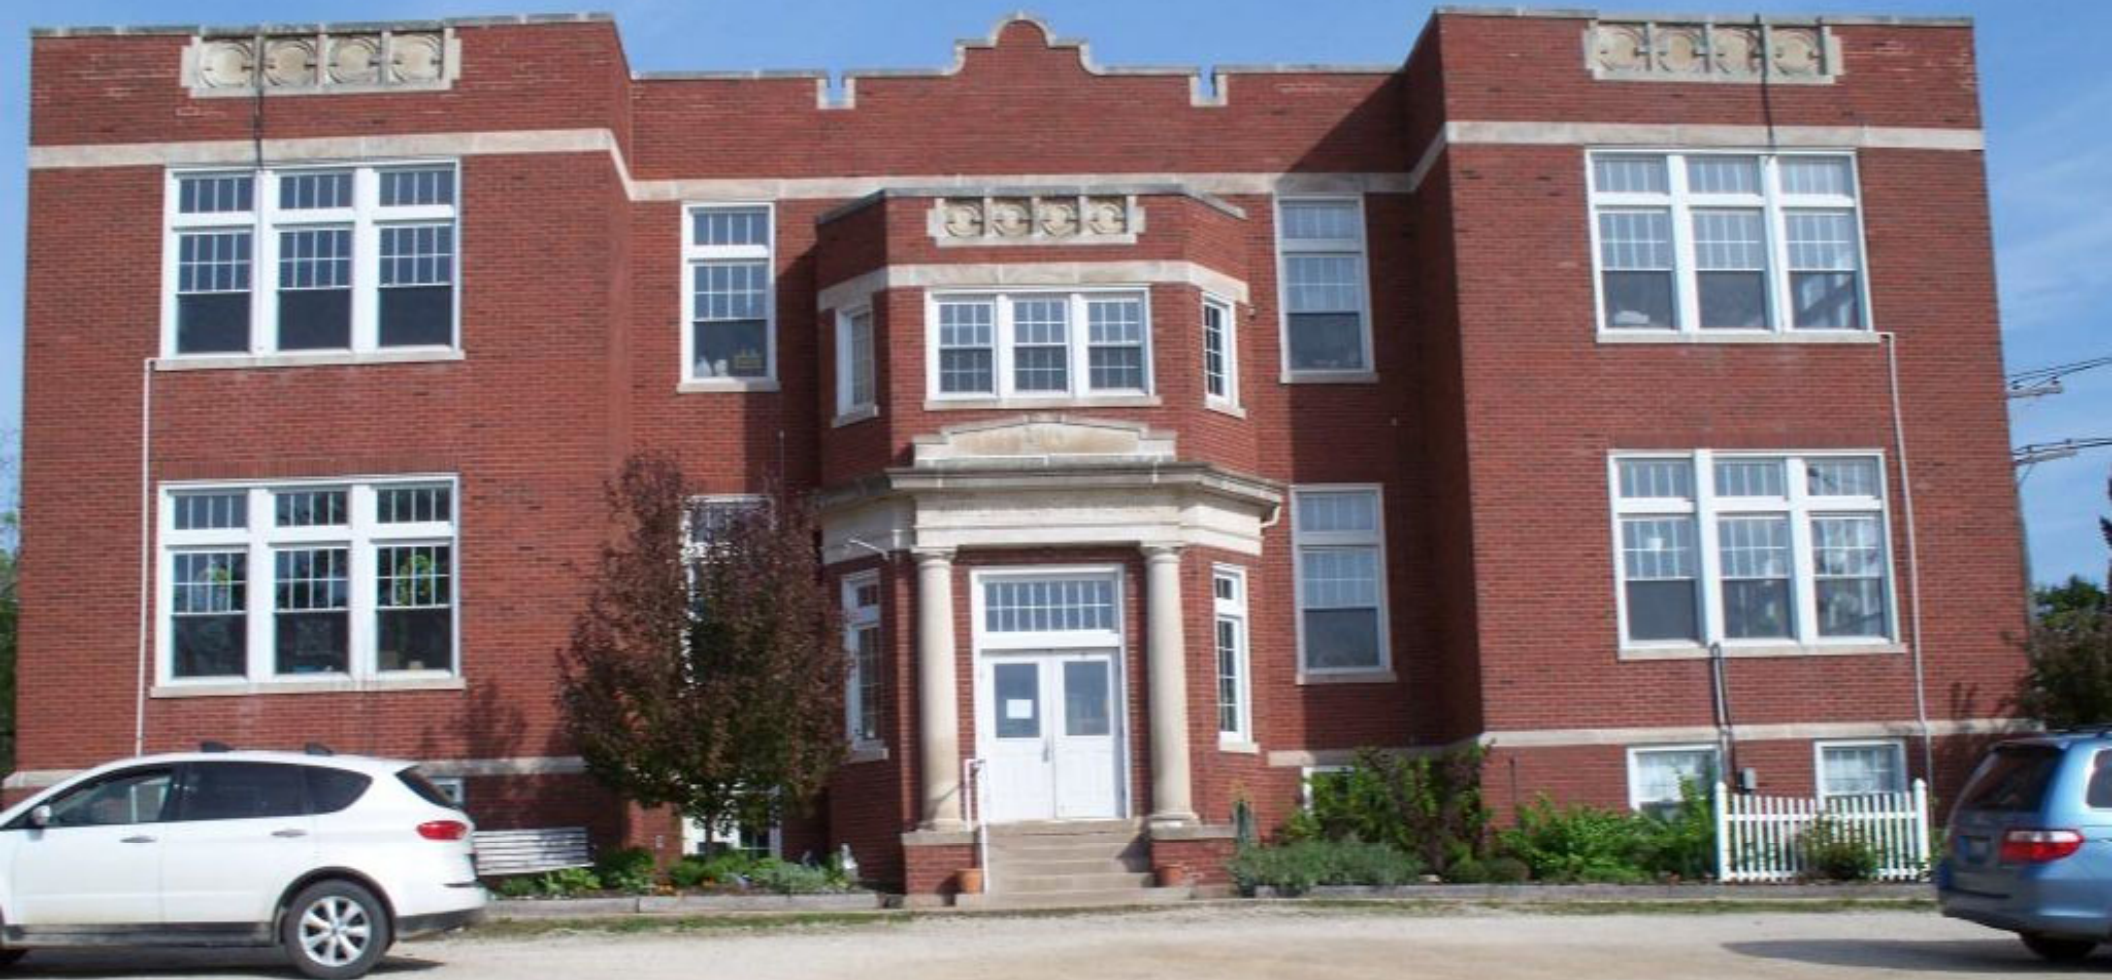
41. (cont.) This two story brick building has a rough “U” shape due to the extending north and south wings and the recessed central bays. Beginning from the north bay (right) there is a row of three eight-over-one windows with a four-light transom and stone sills on the first floor. This is repeated in the same bay on the second floor. Both windows have stone sills. On the second story there is a continuous limestone band above the windows and above that recessed limestone medallion relief topped by limestone coping at the roof. Moving south, the next three bays are set back. There is a single eight-over-one window in the second bay on both floors. The following projecting entrance bay is two stories tall, terminating with a flat roof at the limestone band. Above this is a shaped parapet with limestone coping. The entrance had double doors and a multi-light transom which is flanked by Doric pillars and a shaped entablature with the date “1914” and cornice bearing the building’s historic name “Moreau Heights School.” The cornice extends to each end of this bay and multi-light windows with transoms flank the entablature. The second story of this bay has smaller multi-light windows on the side and a row of three six-over-six windows in the center. Above this is a wide stone band that extends over the entire bay and a stone relief of medallions, identical to the first bay, is above this. The next recessed bay and final projecting bay mirrors the second and first bay. There are multi-light windows visible at the basement level with a continuous limestone band above. Although sympathetic, all of the windows are likely modern replacements.

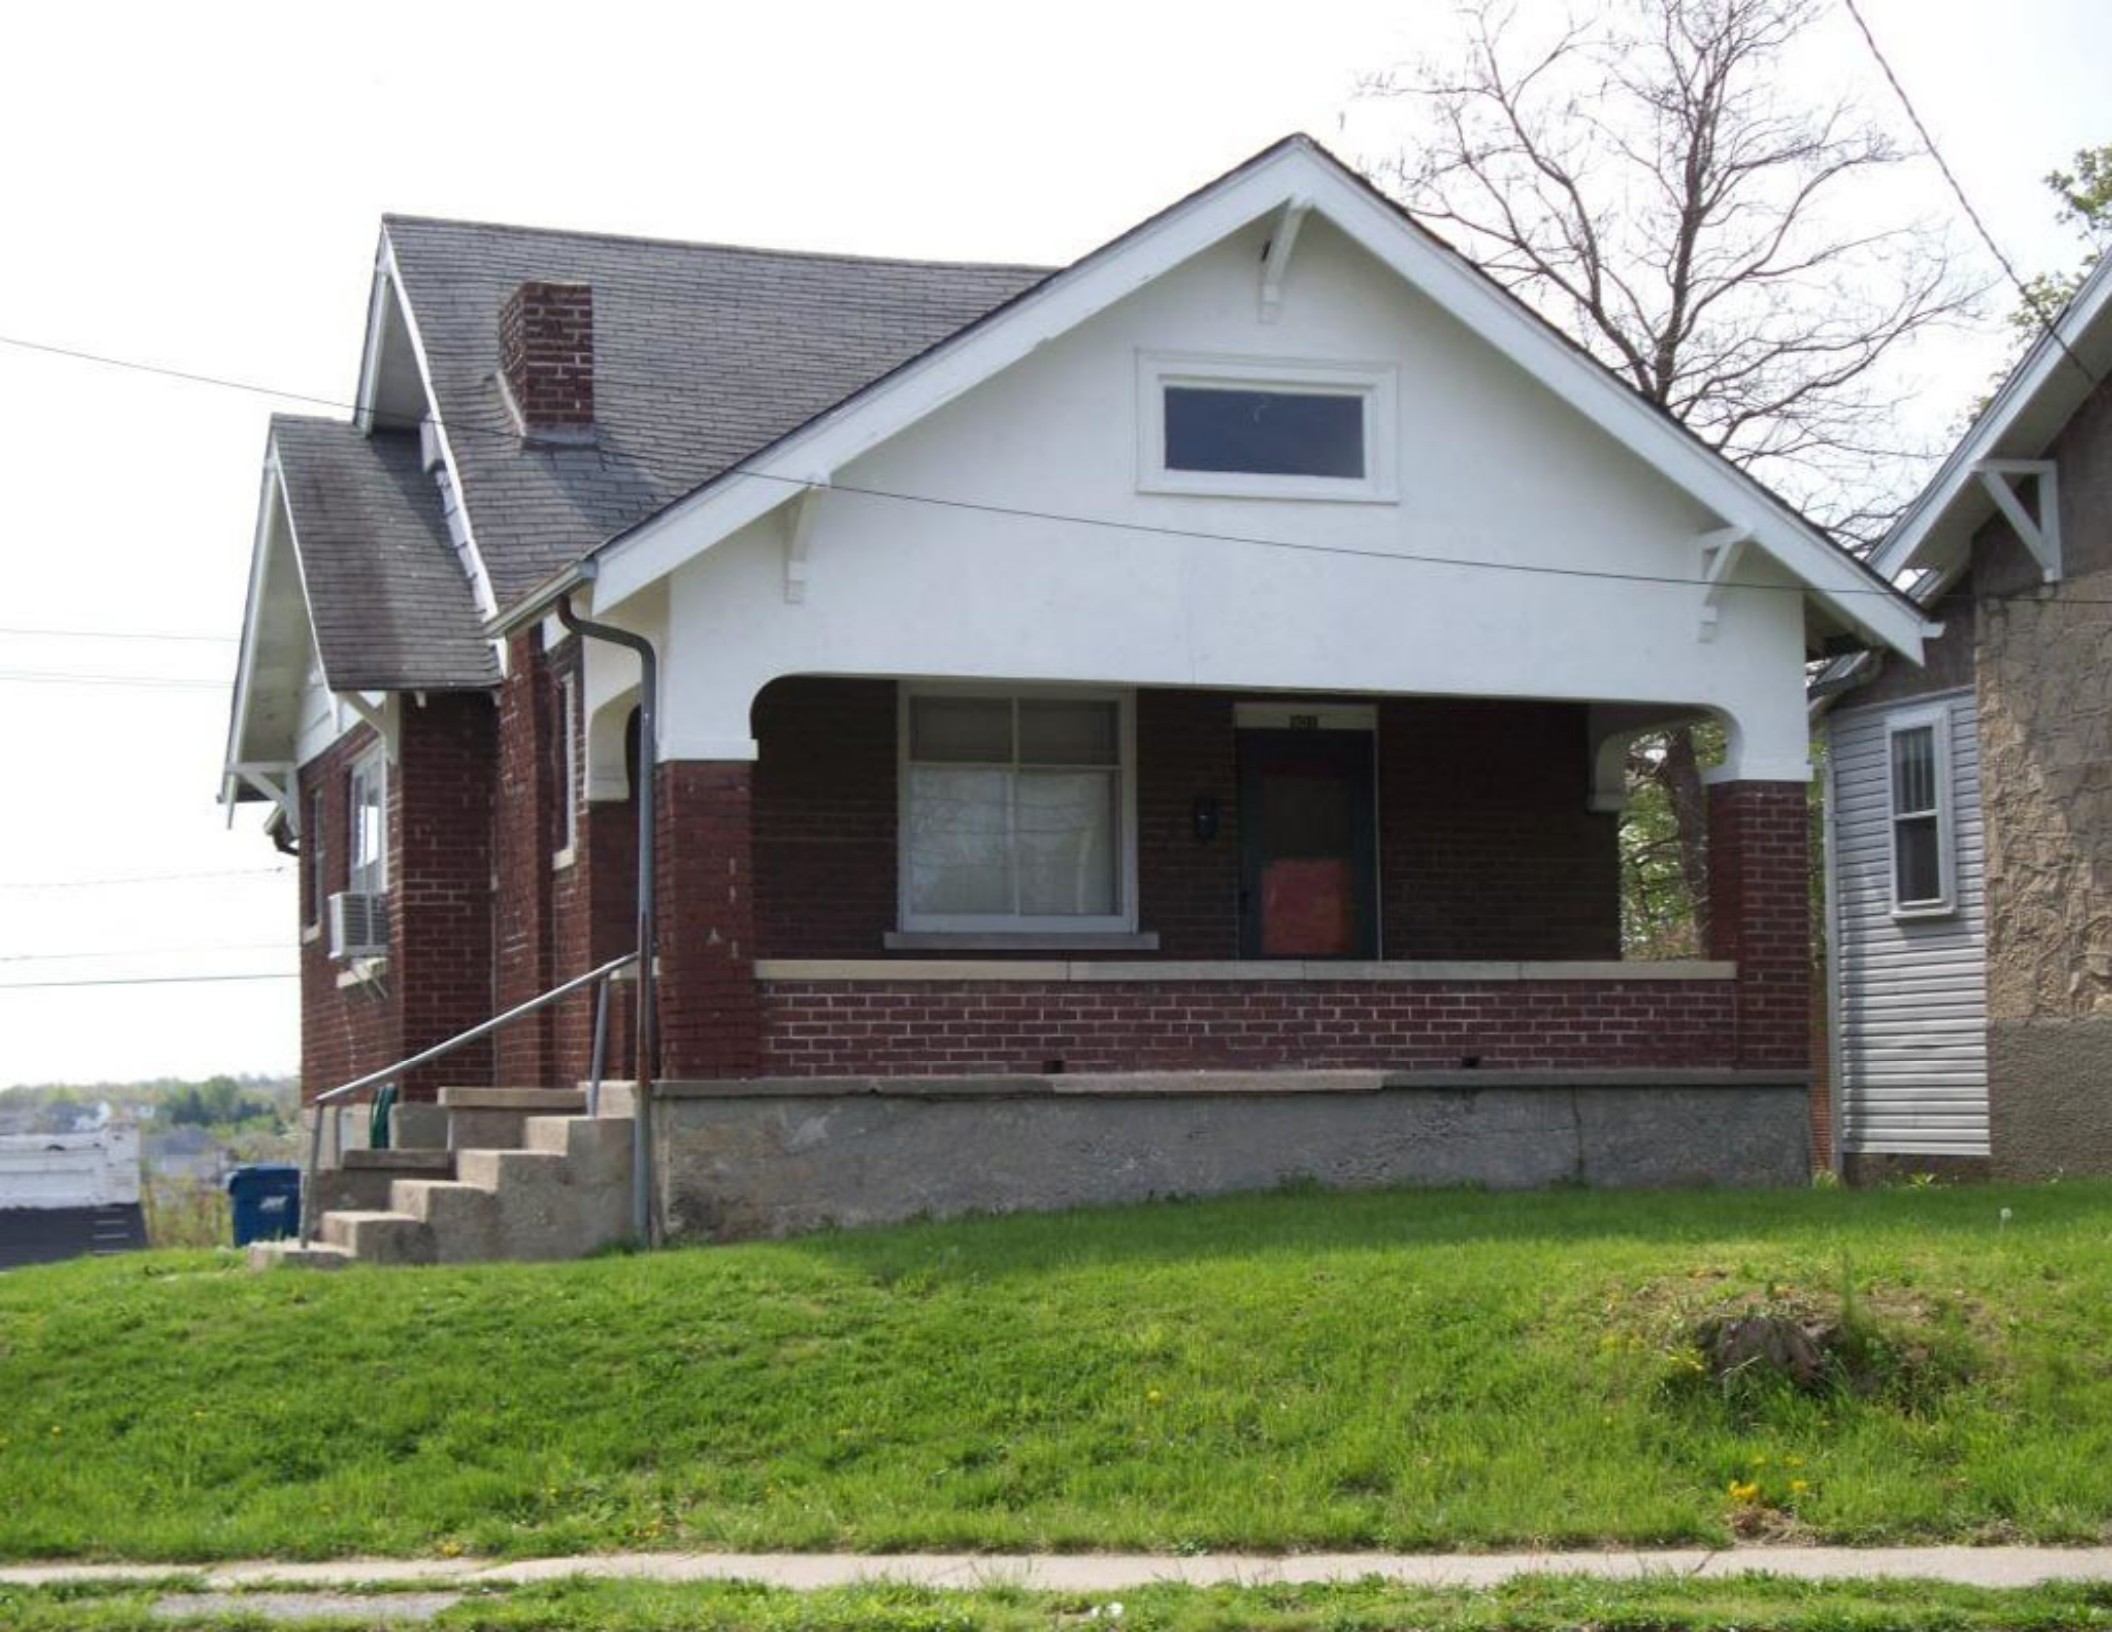
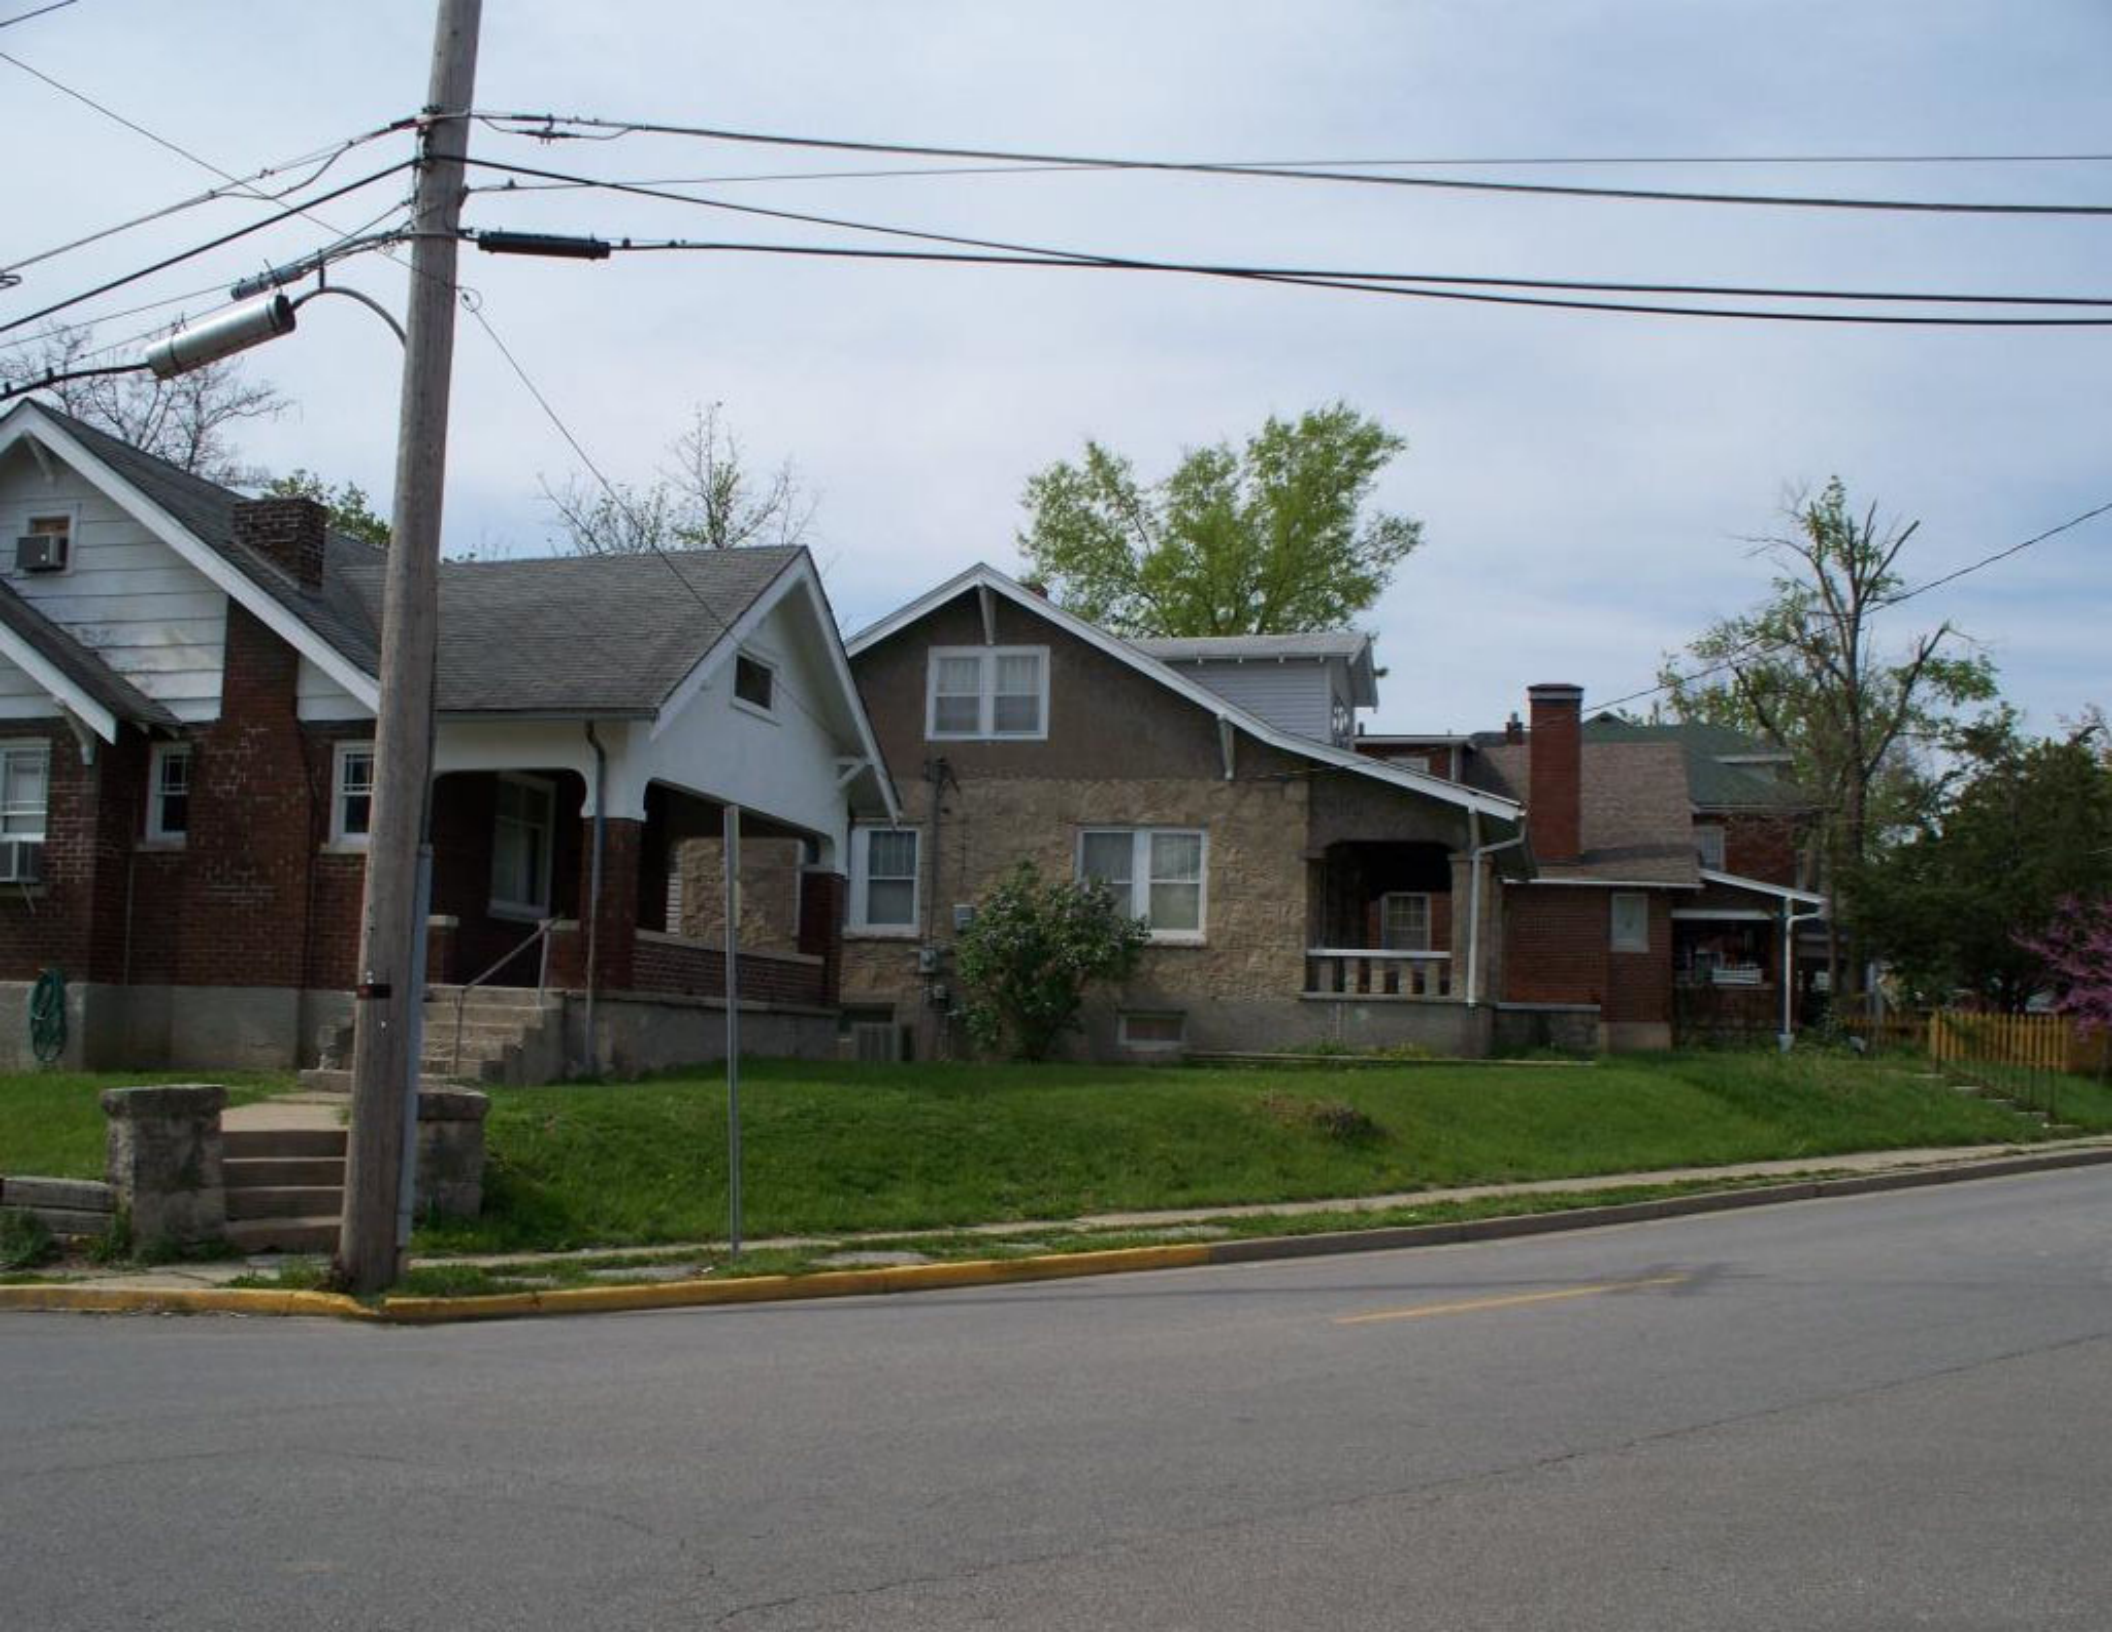
This small one and a half story brick bungalow sits on the southeast corner of Moreau Drive and East Atchison. It has a full width porch accessed from the left (east) by a small concrete stair. The front gable porch is supported by thick brick piers and a low brick wall with a limestone sill. The gable of the porch is composed of what appears to be stucco or plaster. A single rectangular fixed window (possibly historic) is centered in the gable. Below the roofline are three decorative brackets at the ends and center of the primary façade. Additional brackets are visible on the side of the house, which give the property minimal Craftsman stylistic detail. It is difficult to determine if the first floor window is historic or modern, regardless, it appears to be a large fixed 2/2 window in a single opening. To the right (west of the window) is the front door. The property has a cross gable asphalt shingle roof with an offset chimney placement to the left and a concrete foundation.
