ARCHITECTURAL/HISTORIC INVENTORY FORM

1. Survey No. CO-AS-005-001		2. Survey name: Moreau Drive Neighborhood Survey	
3. County: Cole		4. Address: 1202 Elmerine Ave.	
5. City: Jefferson City	Vicinity: <input type="checkbox"/>	6. UTM: / /	7. Township/Range/Section: T: R: S:
8. Historic name (if known):		9. Present/other name (if known):	
10. Ownership: <input checked="" type="checkbox"/> Private <input type="checkbox"/> Public		11. Historic use (if known): Residential	11. Current use: Residential

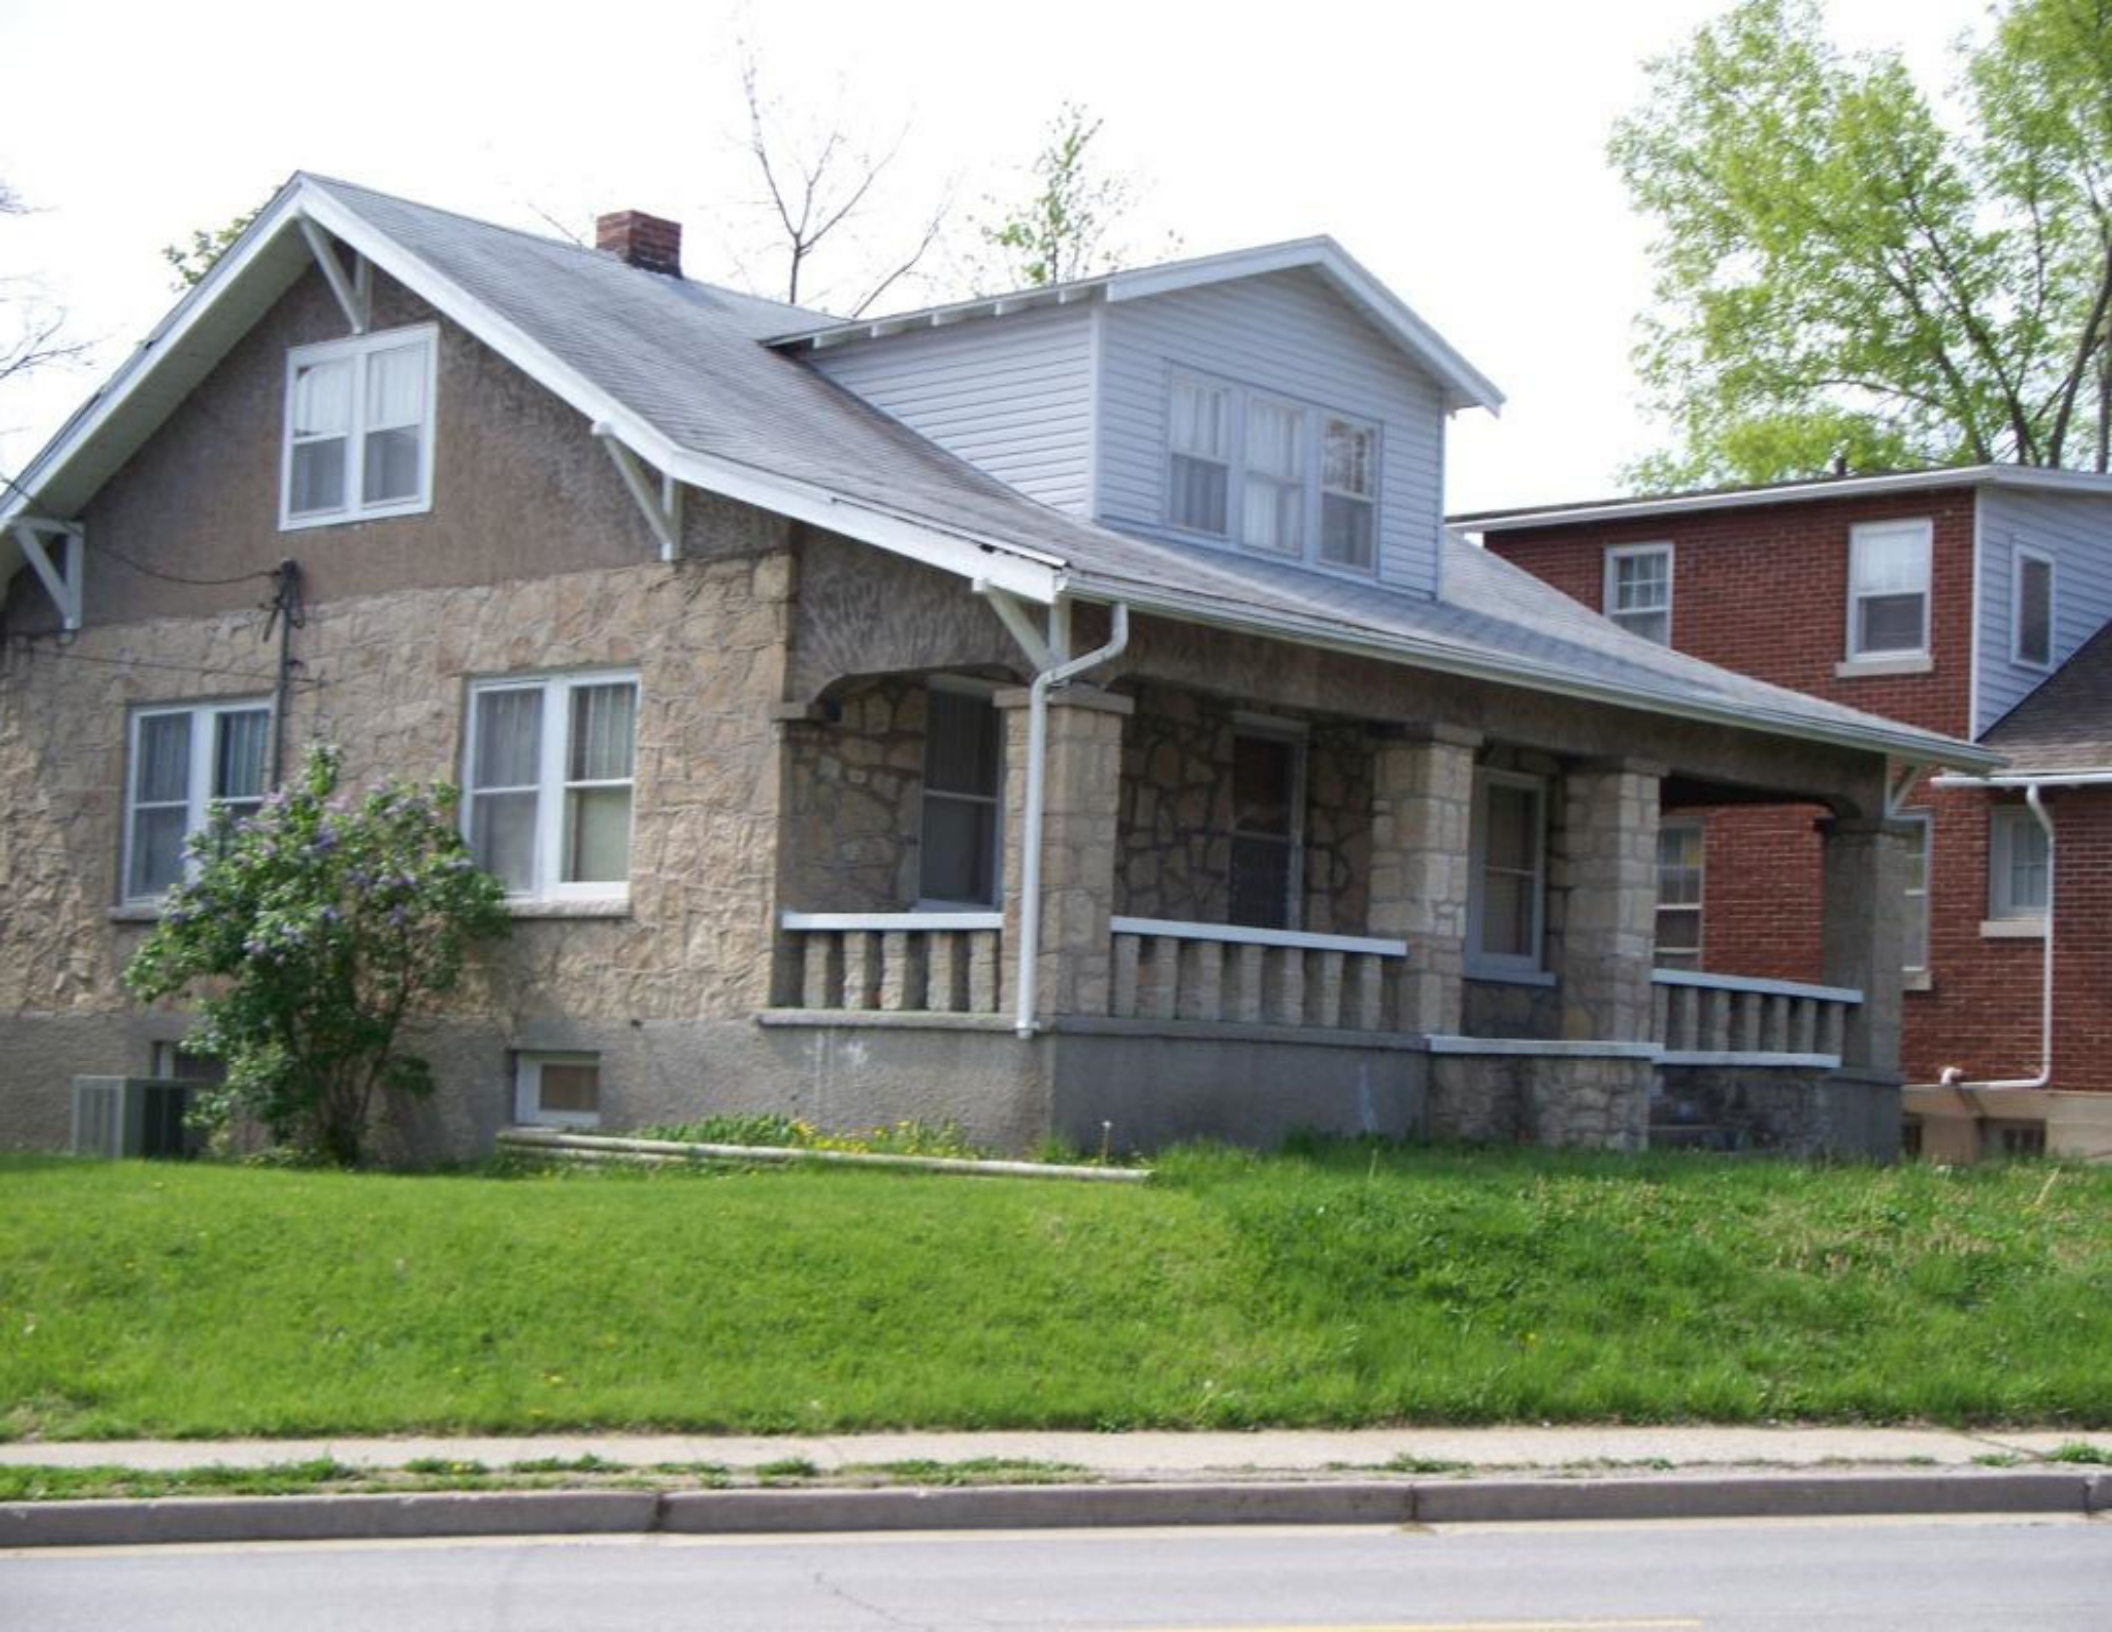
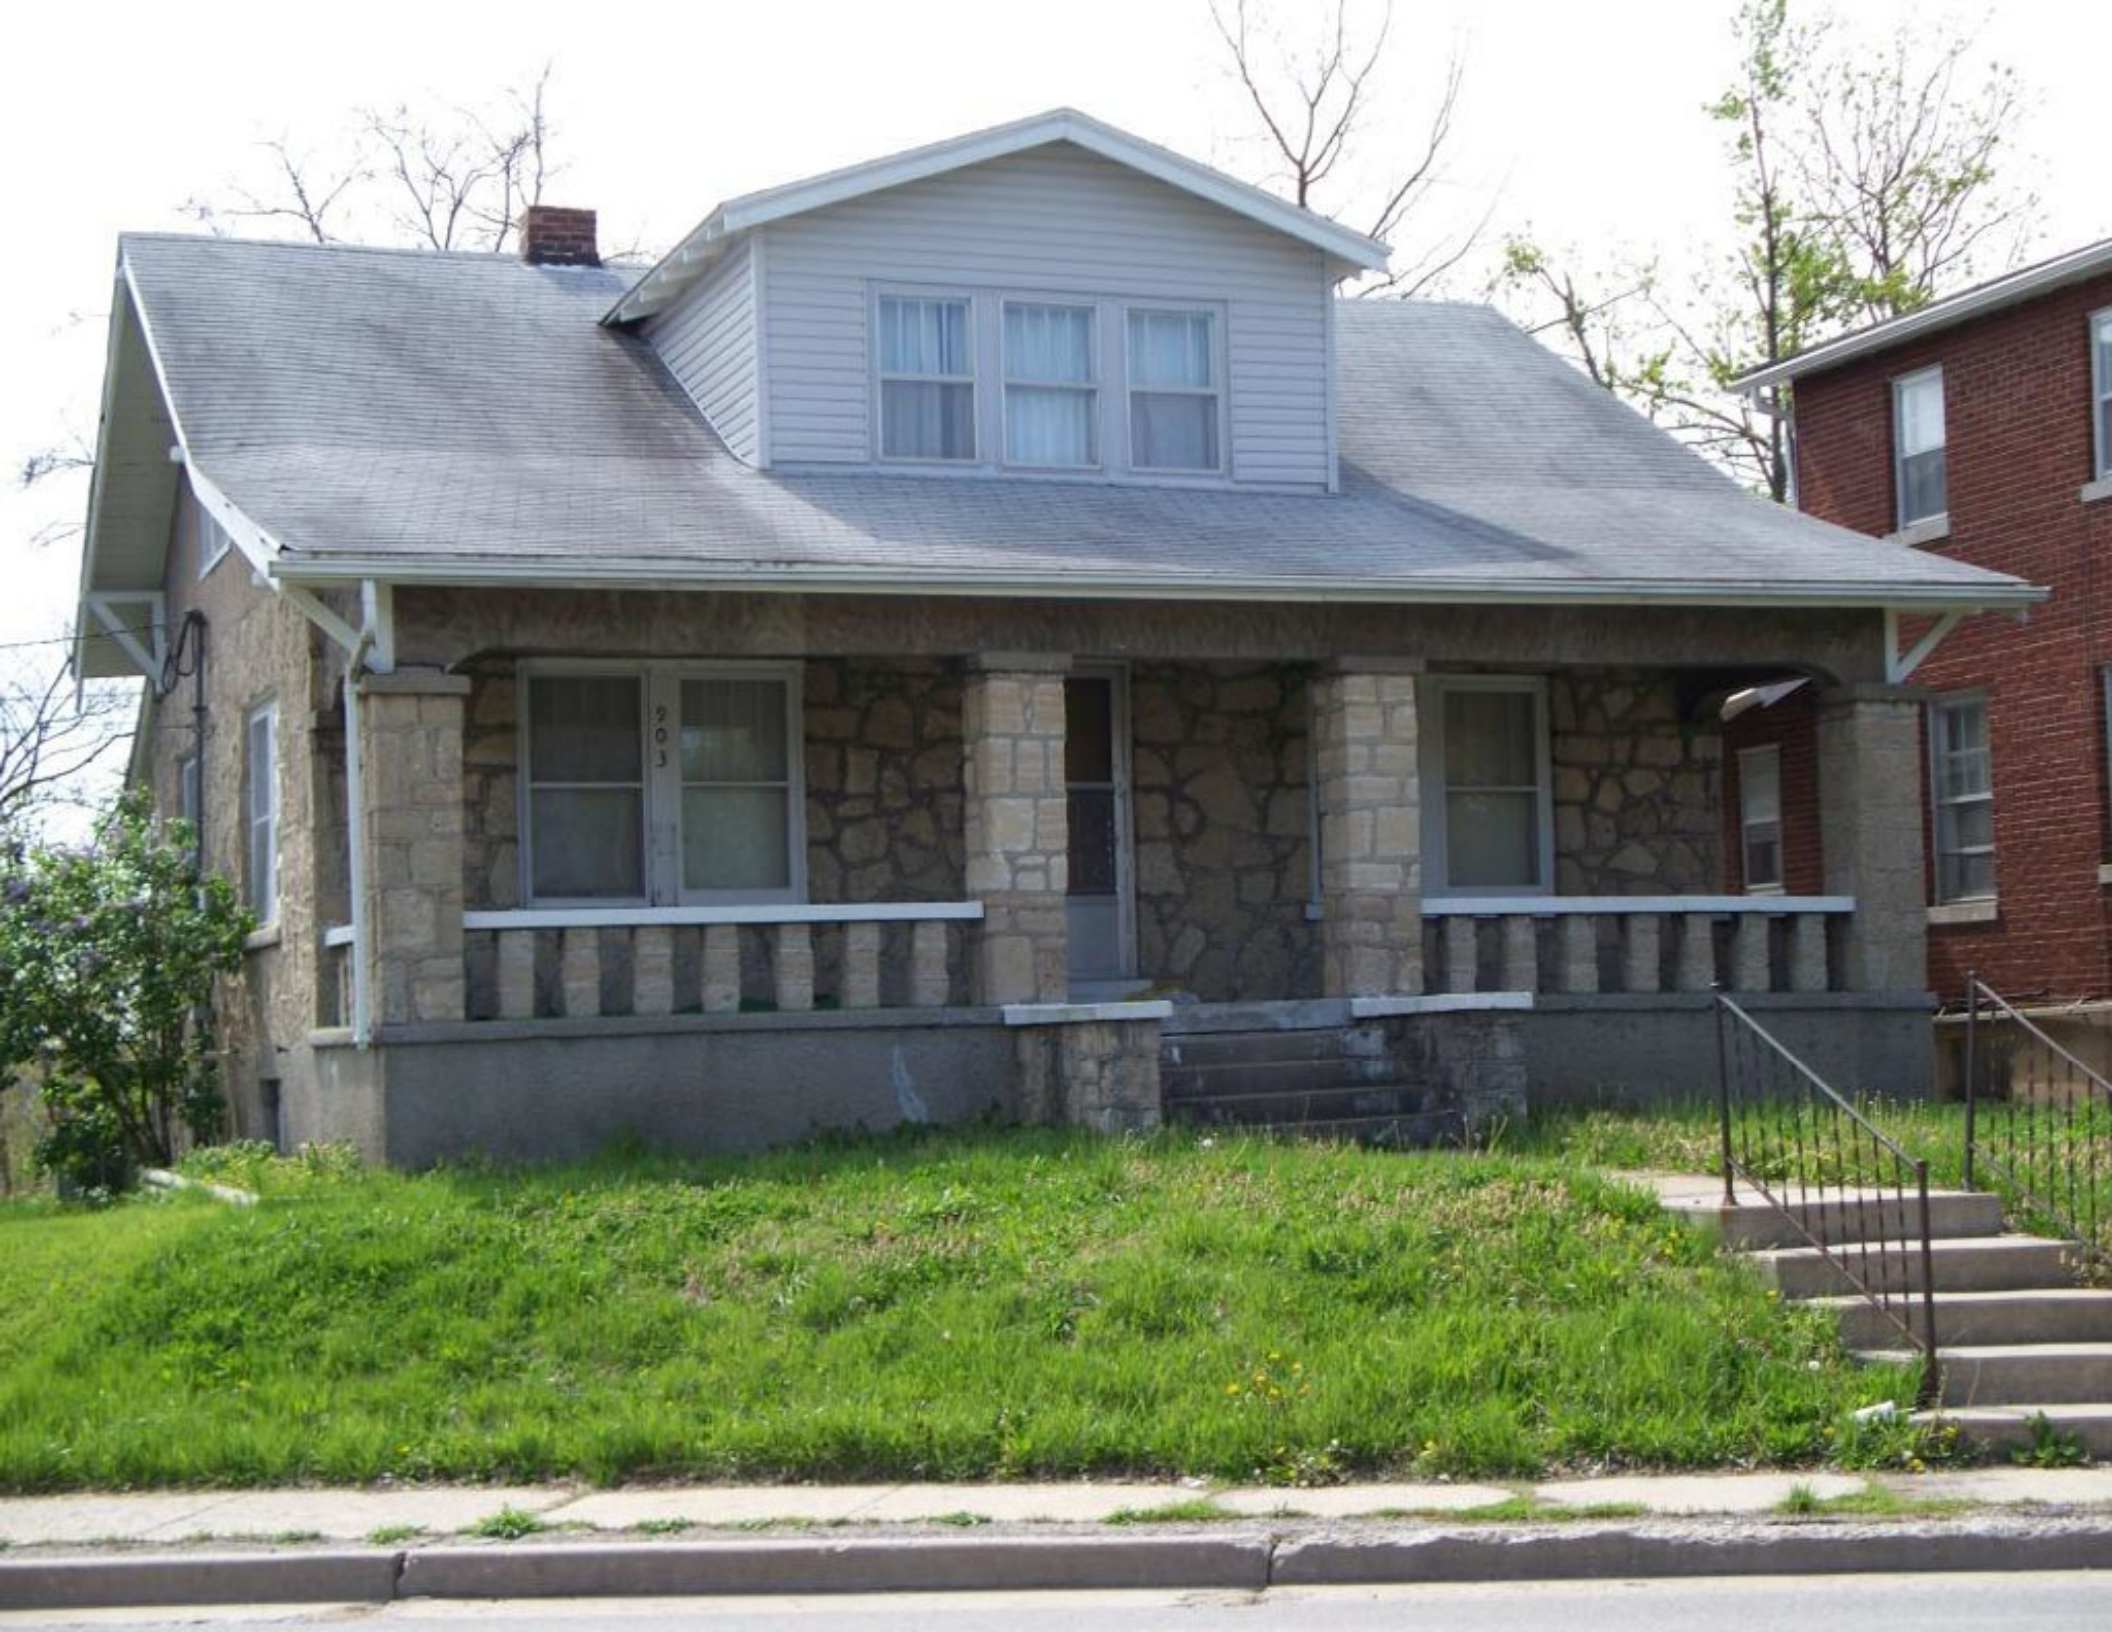
This stone 1 ½ story bungalow has minimal Craftsman features in the form of brackets visible beneath the side gabled asphalt shingled roof. A one-bay gabled dormer is centered on the half story. Although the dormer has been covered with vinyl, the three, three-over-one windows in it appear historic as do the decorative exposed beams visible beneath the gable. The first floor is three bays wide. The entrance is centered and to each side there is a pair of 4/1 historic windows. The full width porch features large stone pillars and a balustrade of smaller stone pillars supporting a stone sill. The porch is accessed by a short concrete stair flanked by another pair of stone pillars.

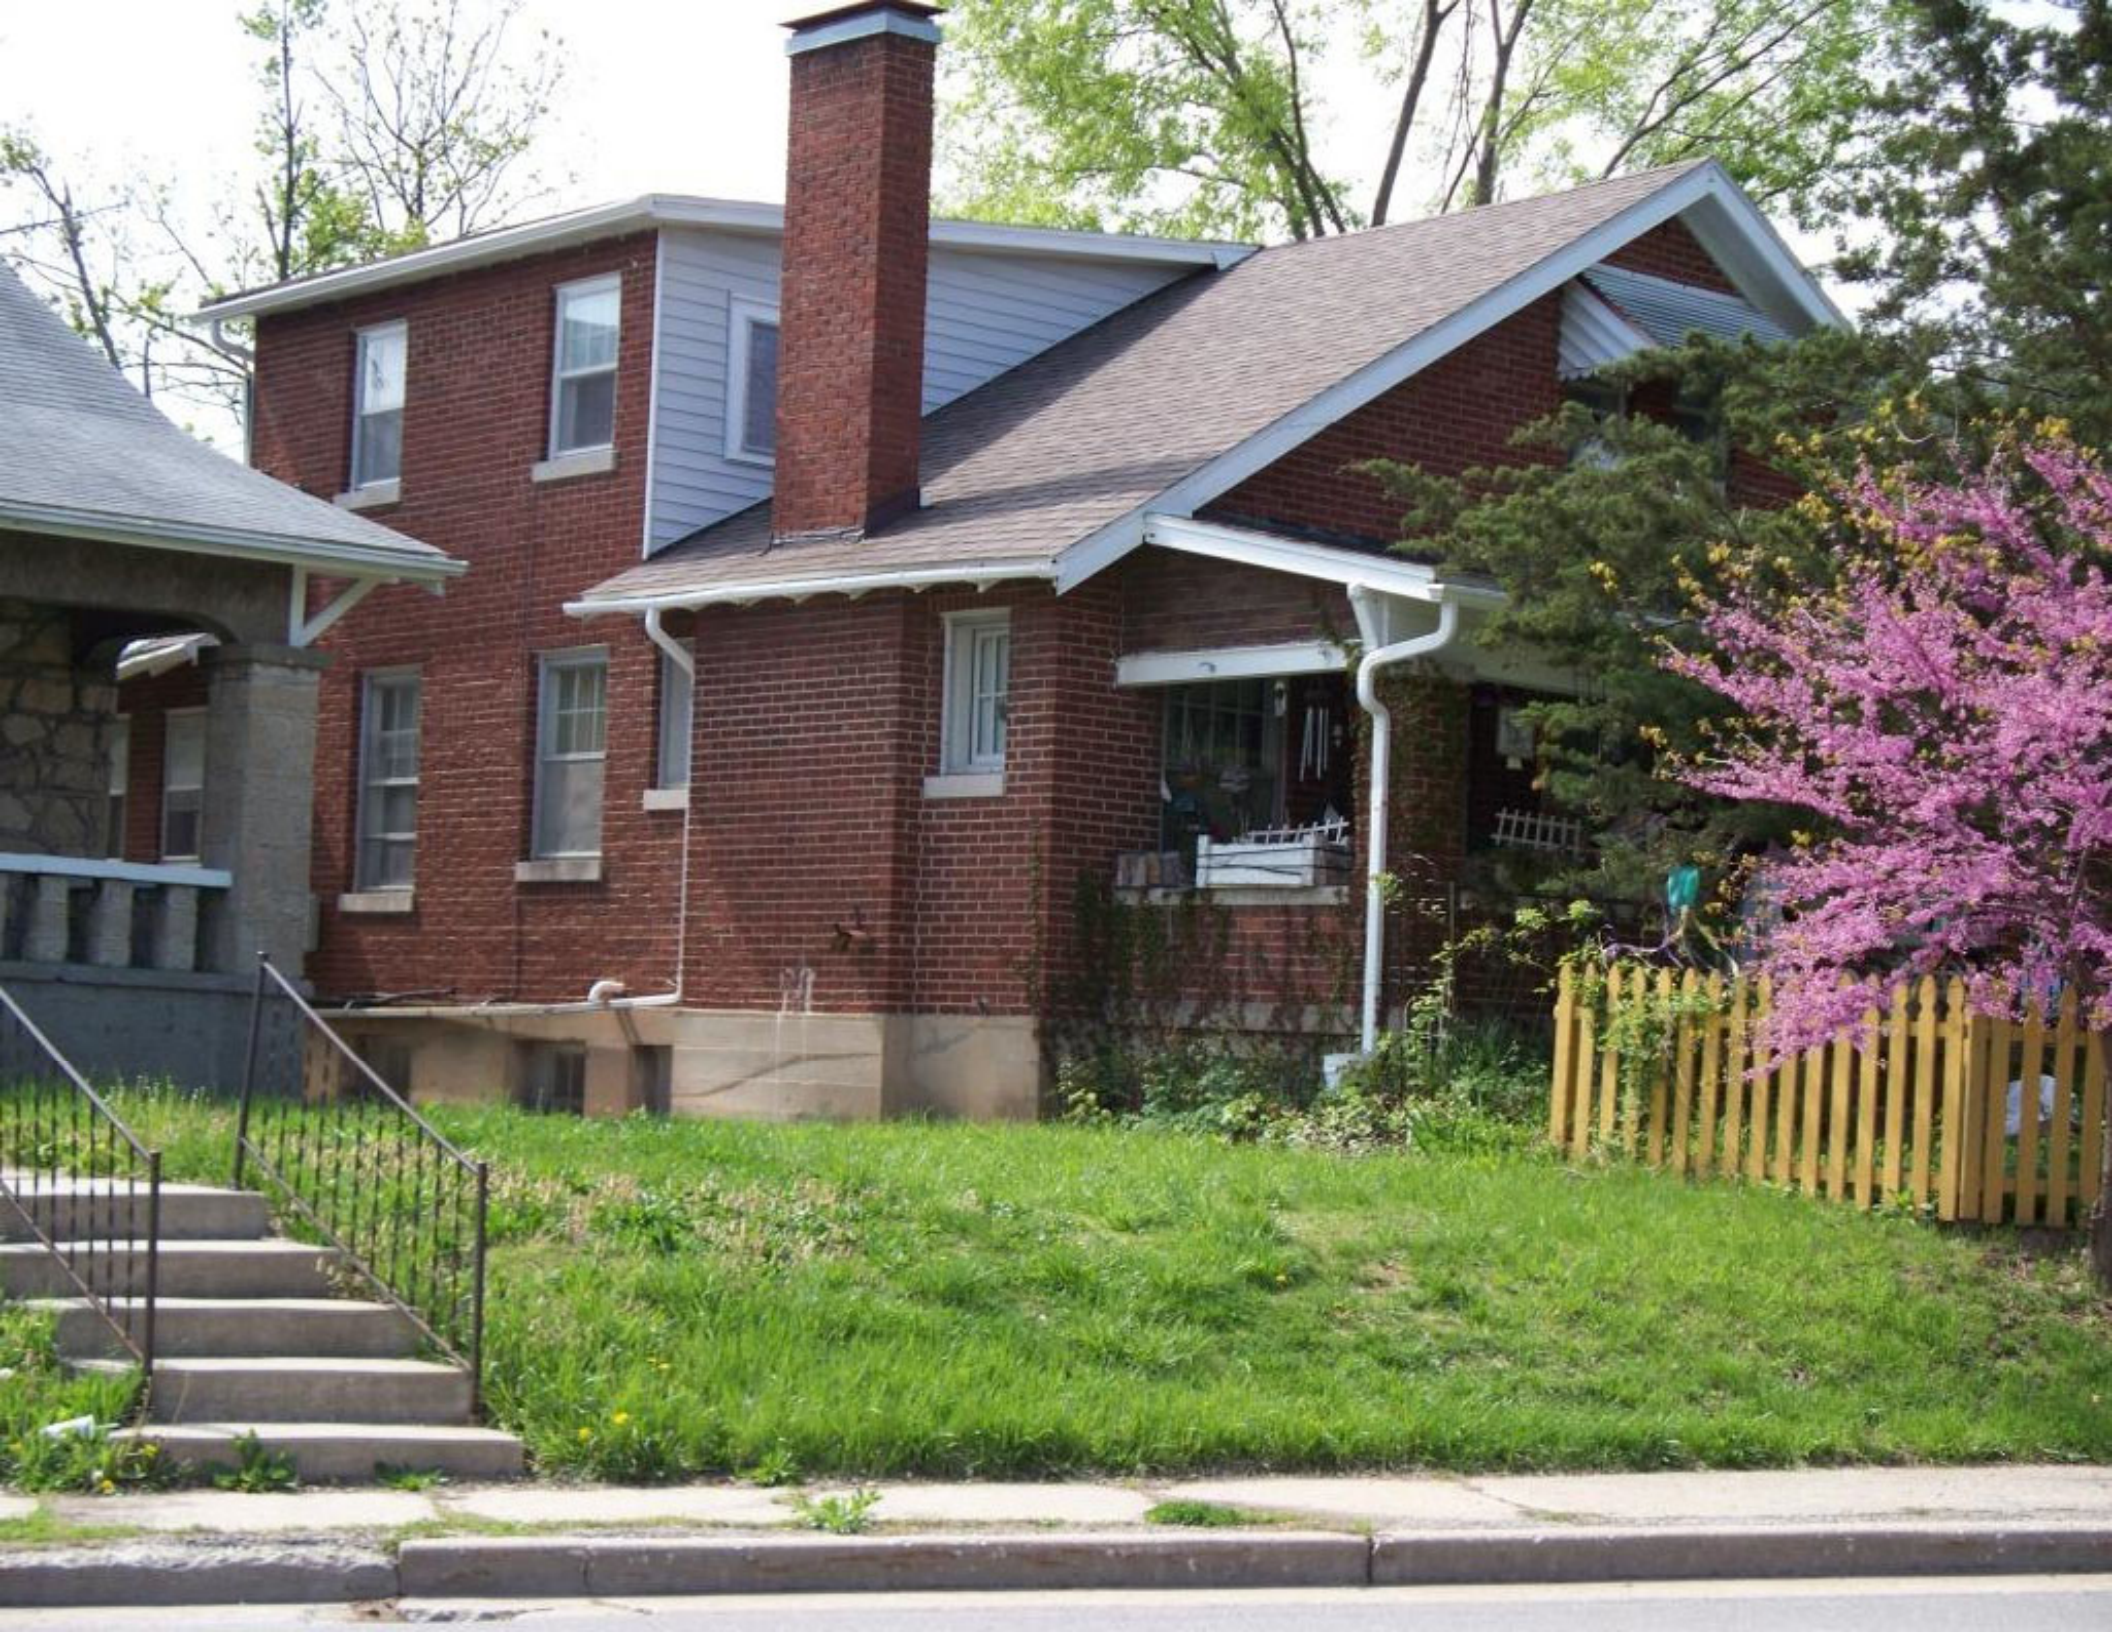
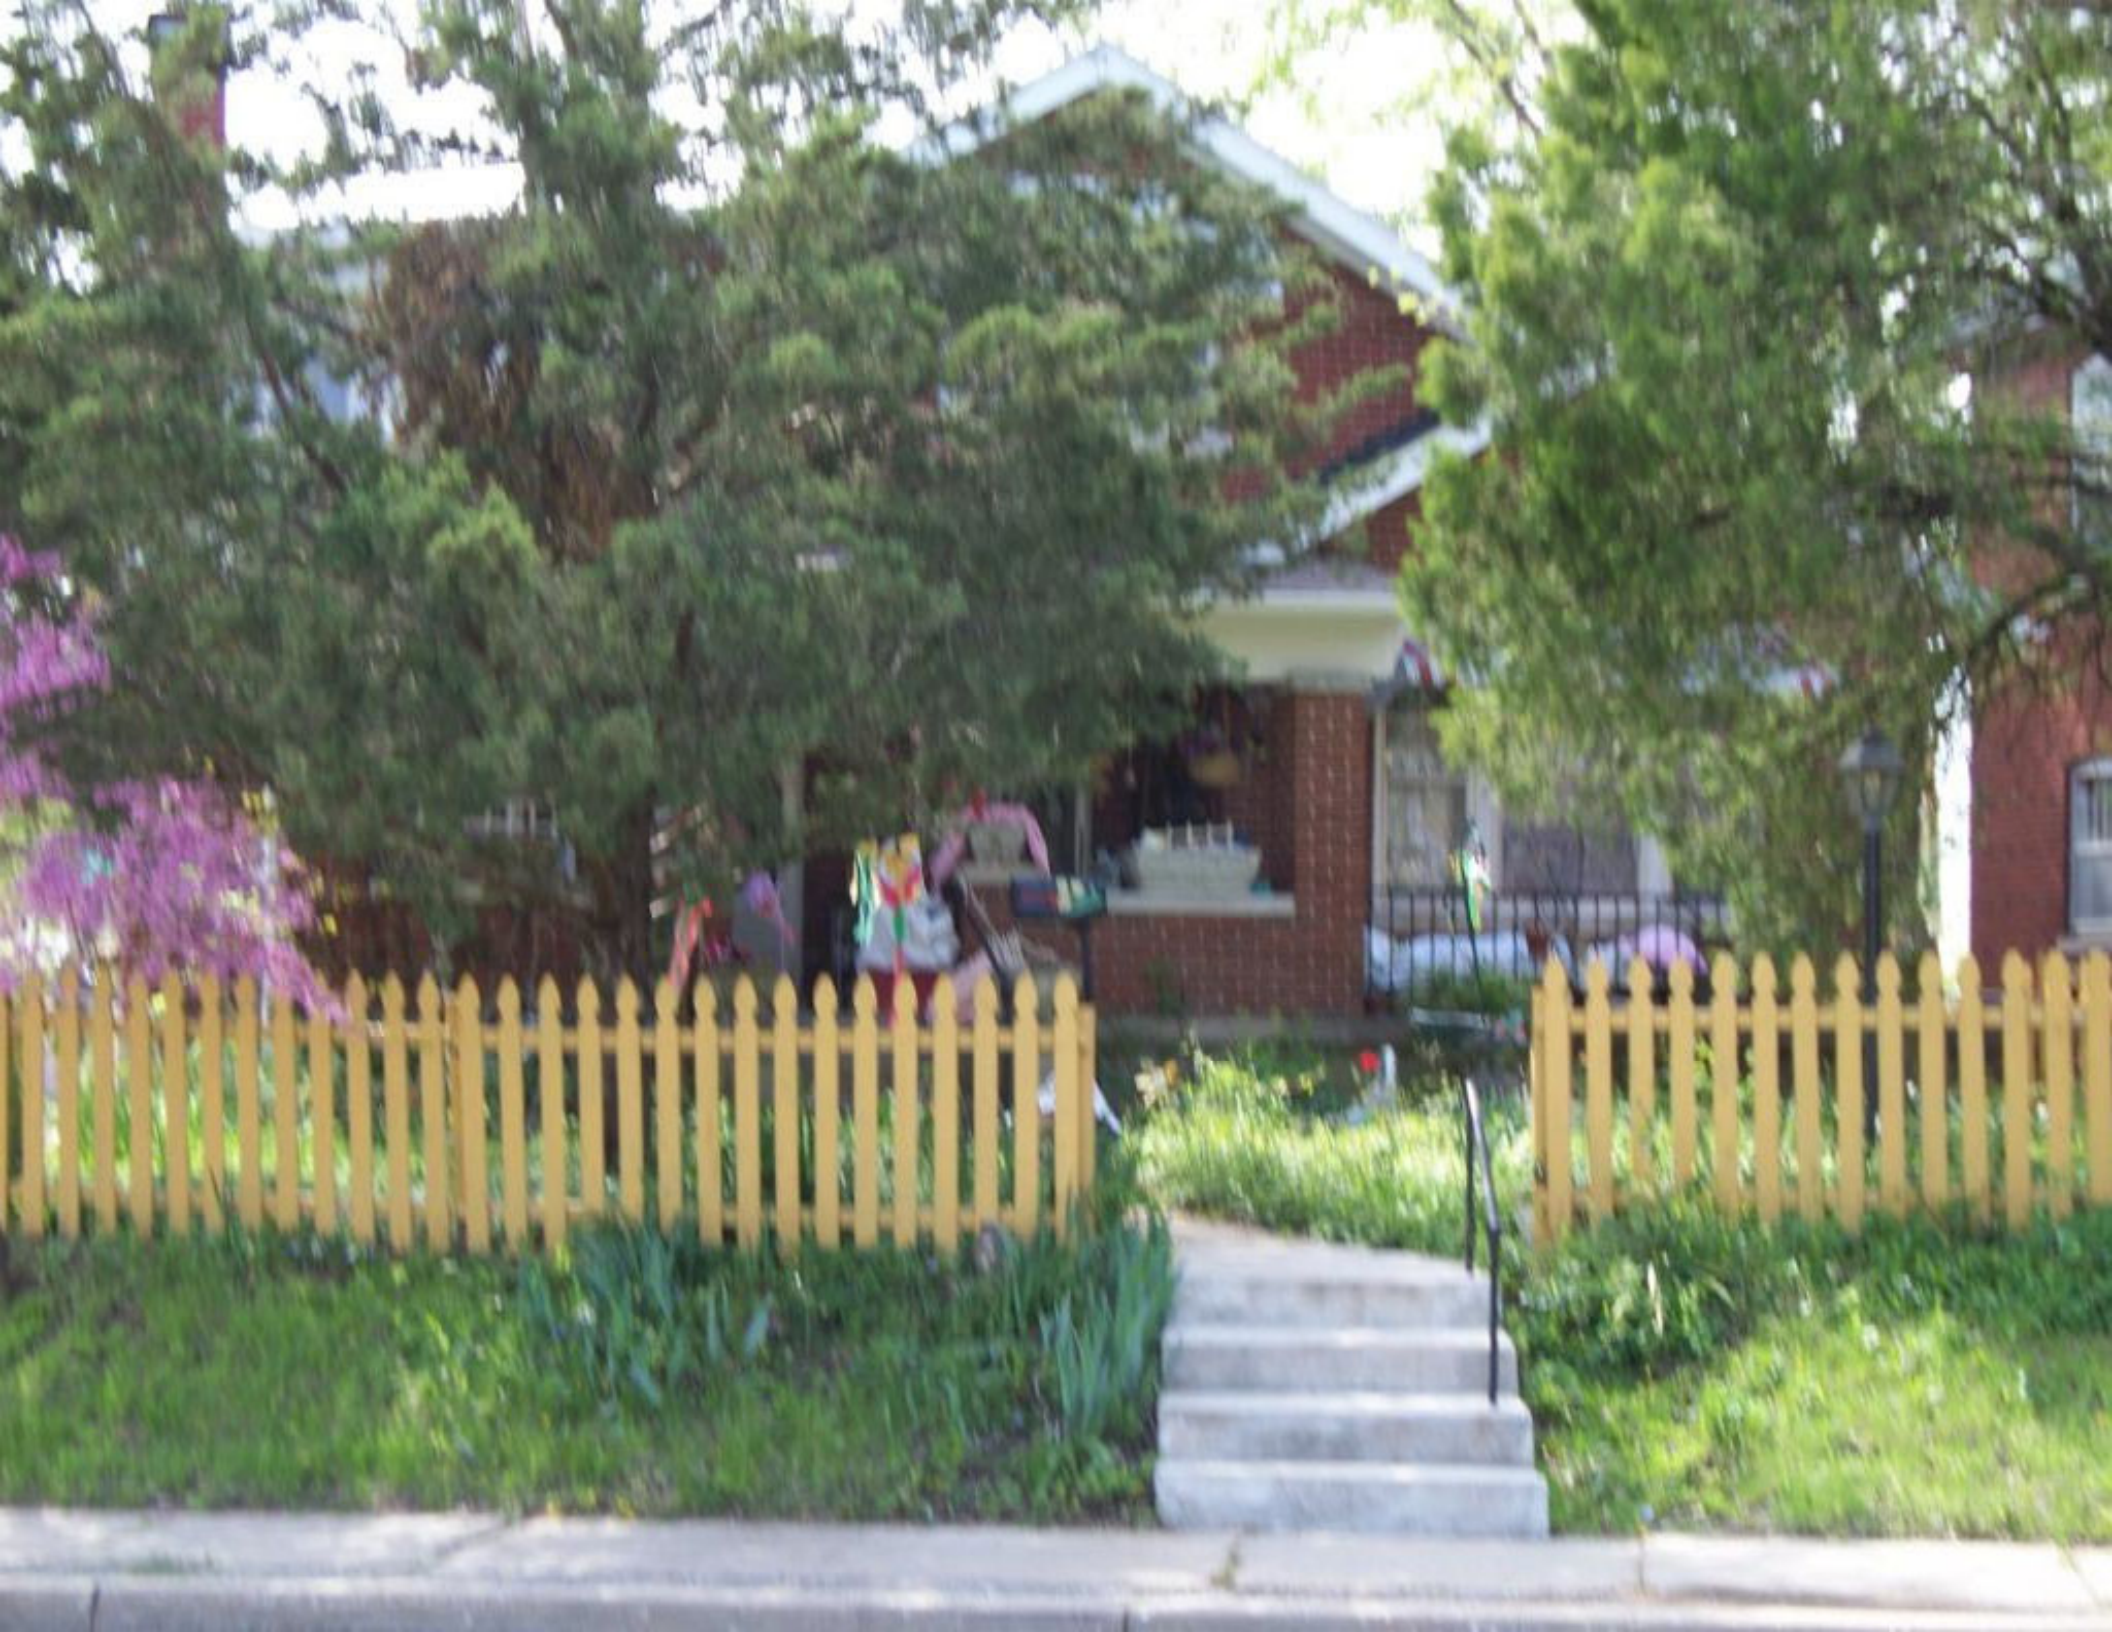
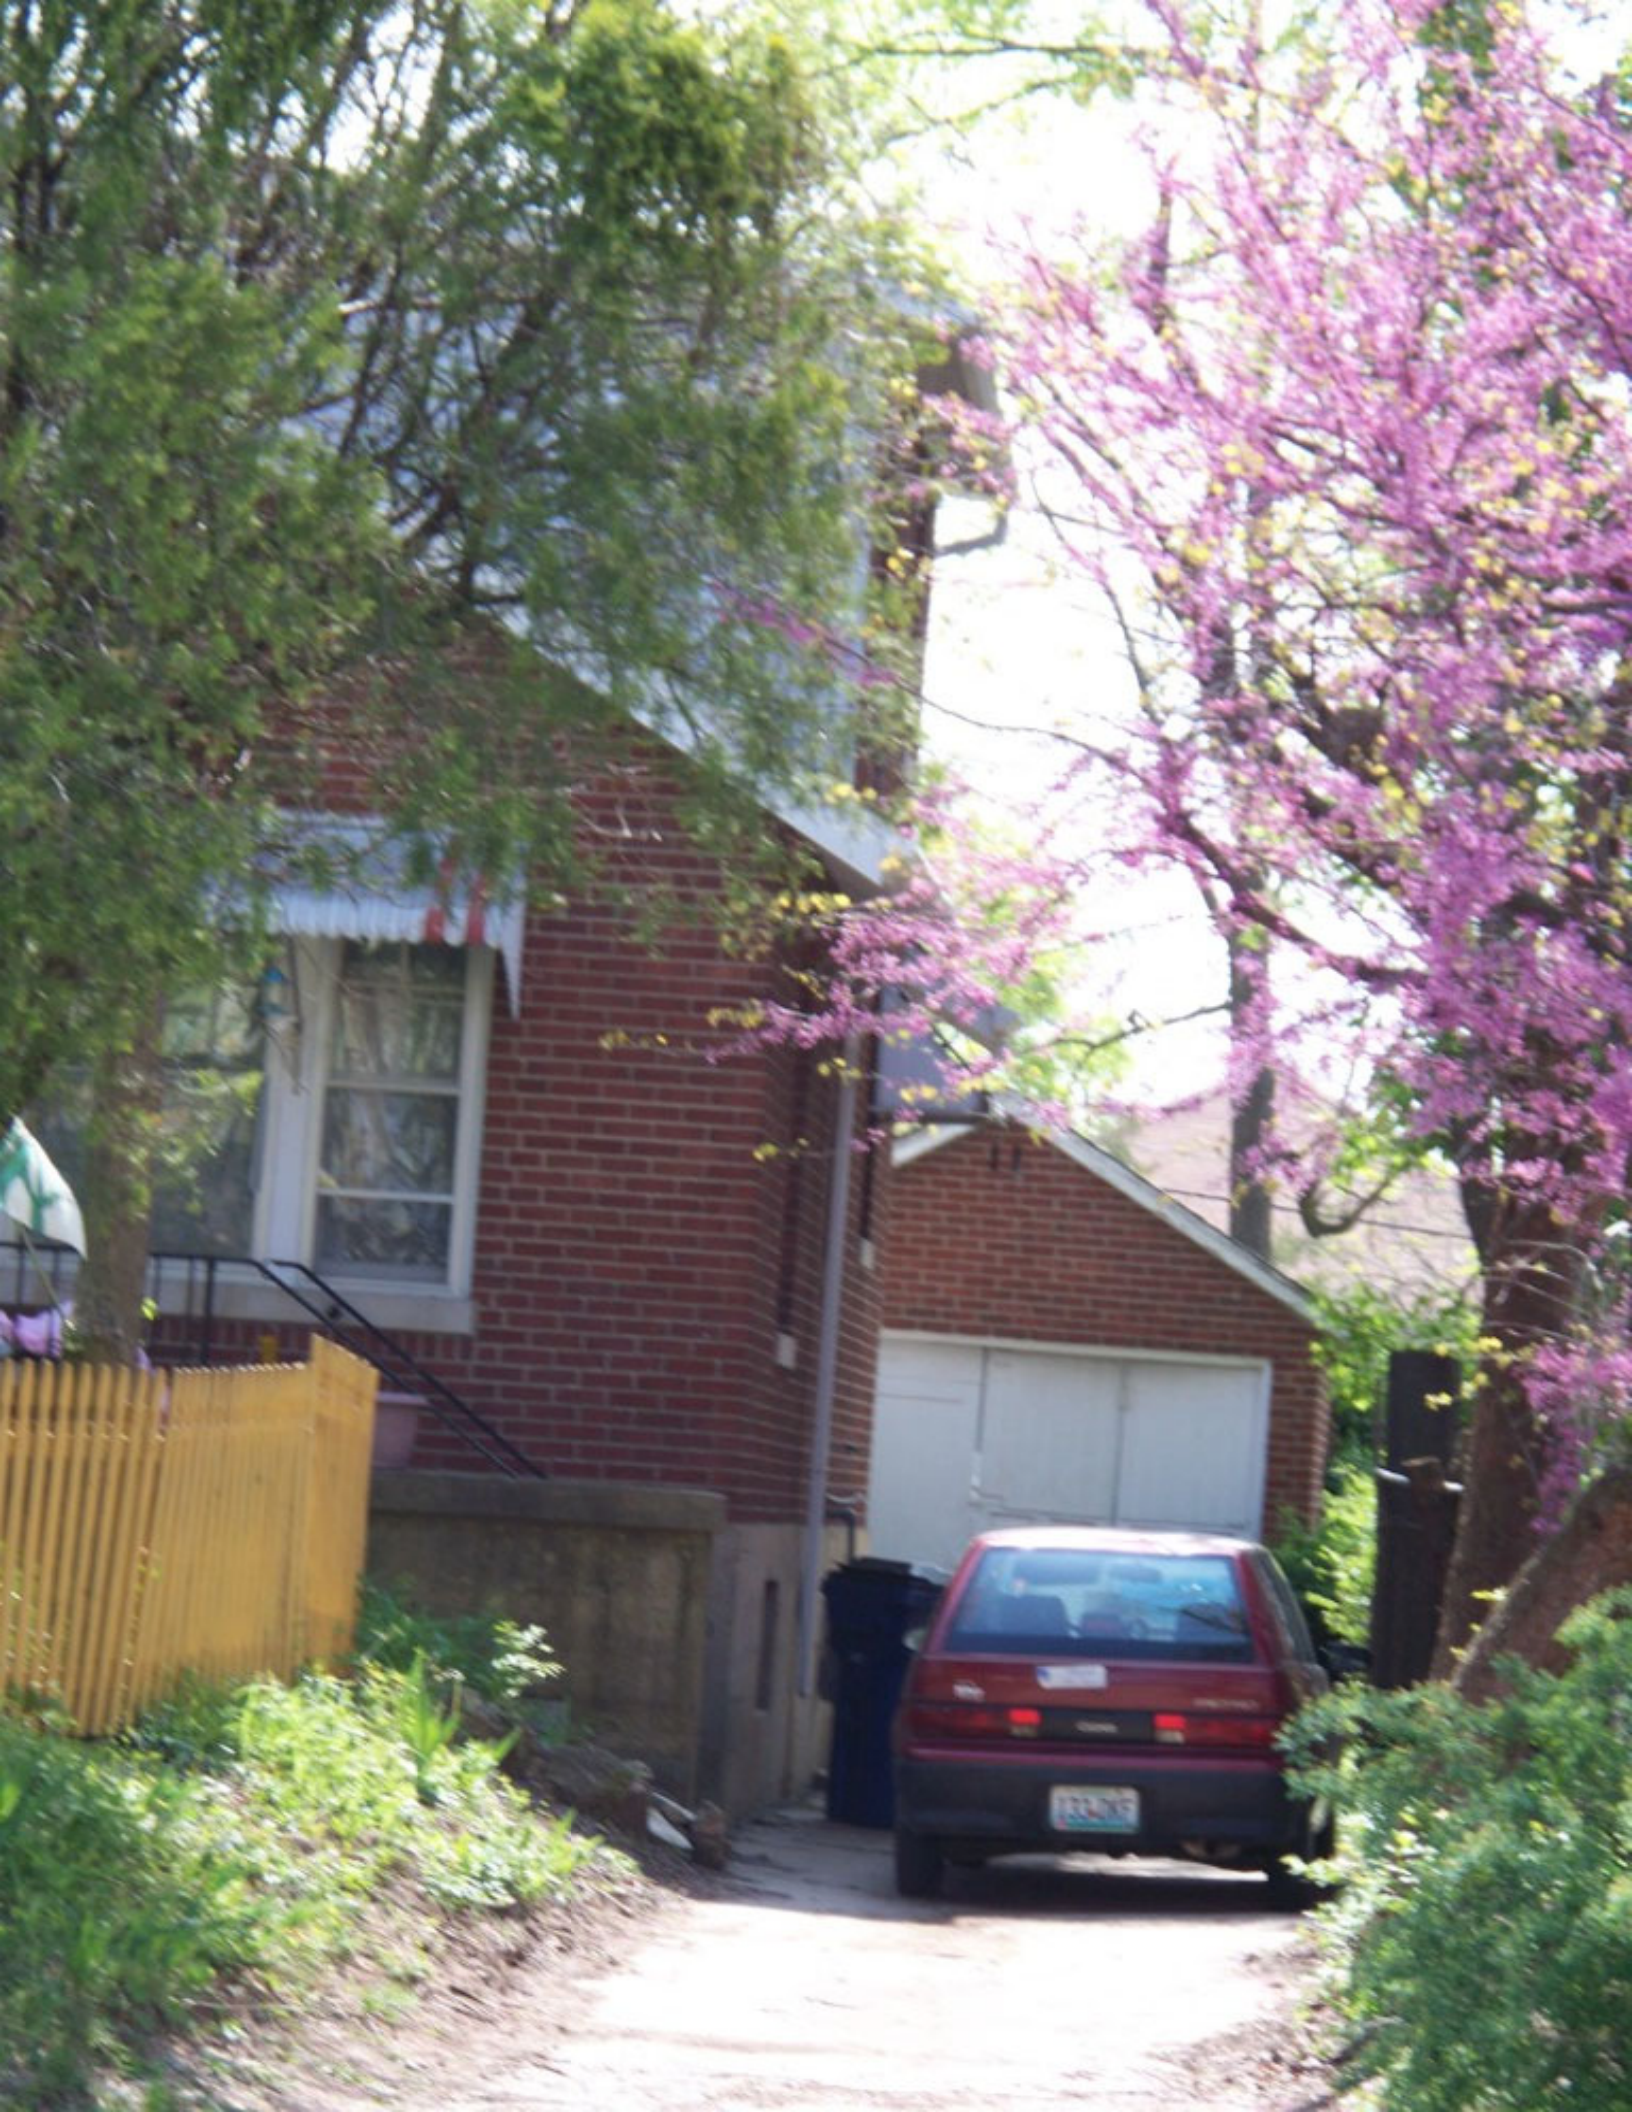
This 1 ½ story brick bungalow has a two-story addition. The addition is in brick and was most likely added within the first few decades of the build date. The slight change in foundation is the primary indicator the two-story portion is an addition. Vinyl has been added to the visible façade of the addition but does not detract from the historic character of the property. The front façade has an offset partial porch to the left (north) of the property. A window with hood is centered in the upper floor within the gable. The windows are 8/1 may or may not be historic. Due to year-round foliage issues, further detail is obscured.
