ARCHITECTURAL/HISTORIC INVENTORY FORM

1. Survey No. CO-AS-005-001		2. Survey name: Moreau Drive Neighborhood Survey	
3. County: Cole		4. Address: 1202 Elmerine Ave.	
5. City: Jefferson City	Vicinity: <input type="checkbox"/>	6. UTM: / /	7. Township/Range/Section: T: R: S:
8. Historic name (if known):		9. Present/other name (if known):	
10. Ownership: <input checked="" type="checkbox"/> Private <input type="checkbox"/> Public		11. Historic use (if known): Residential	11. Current use: Residential

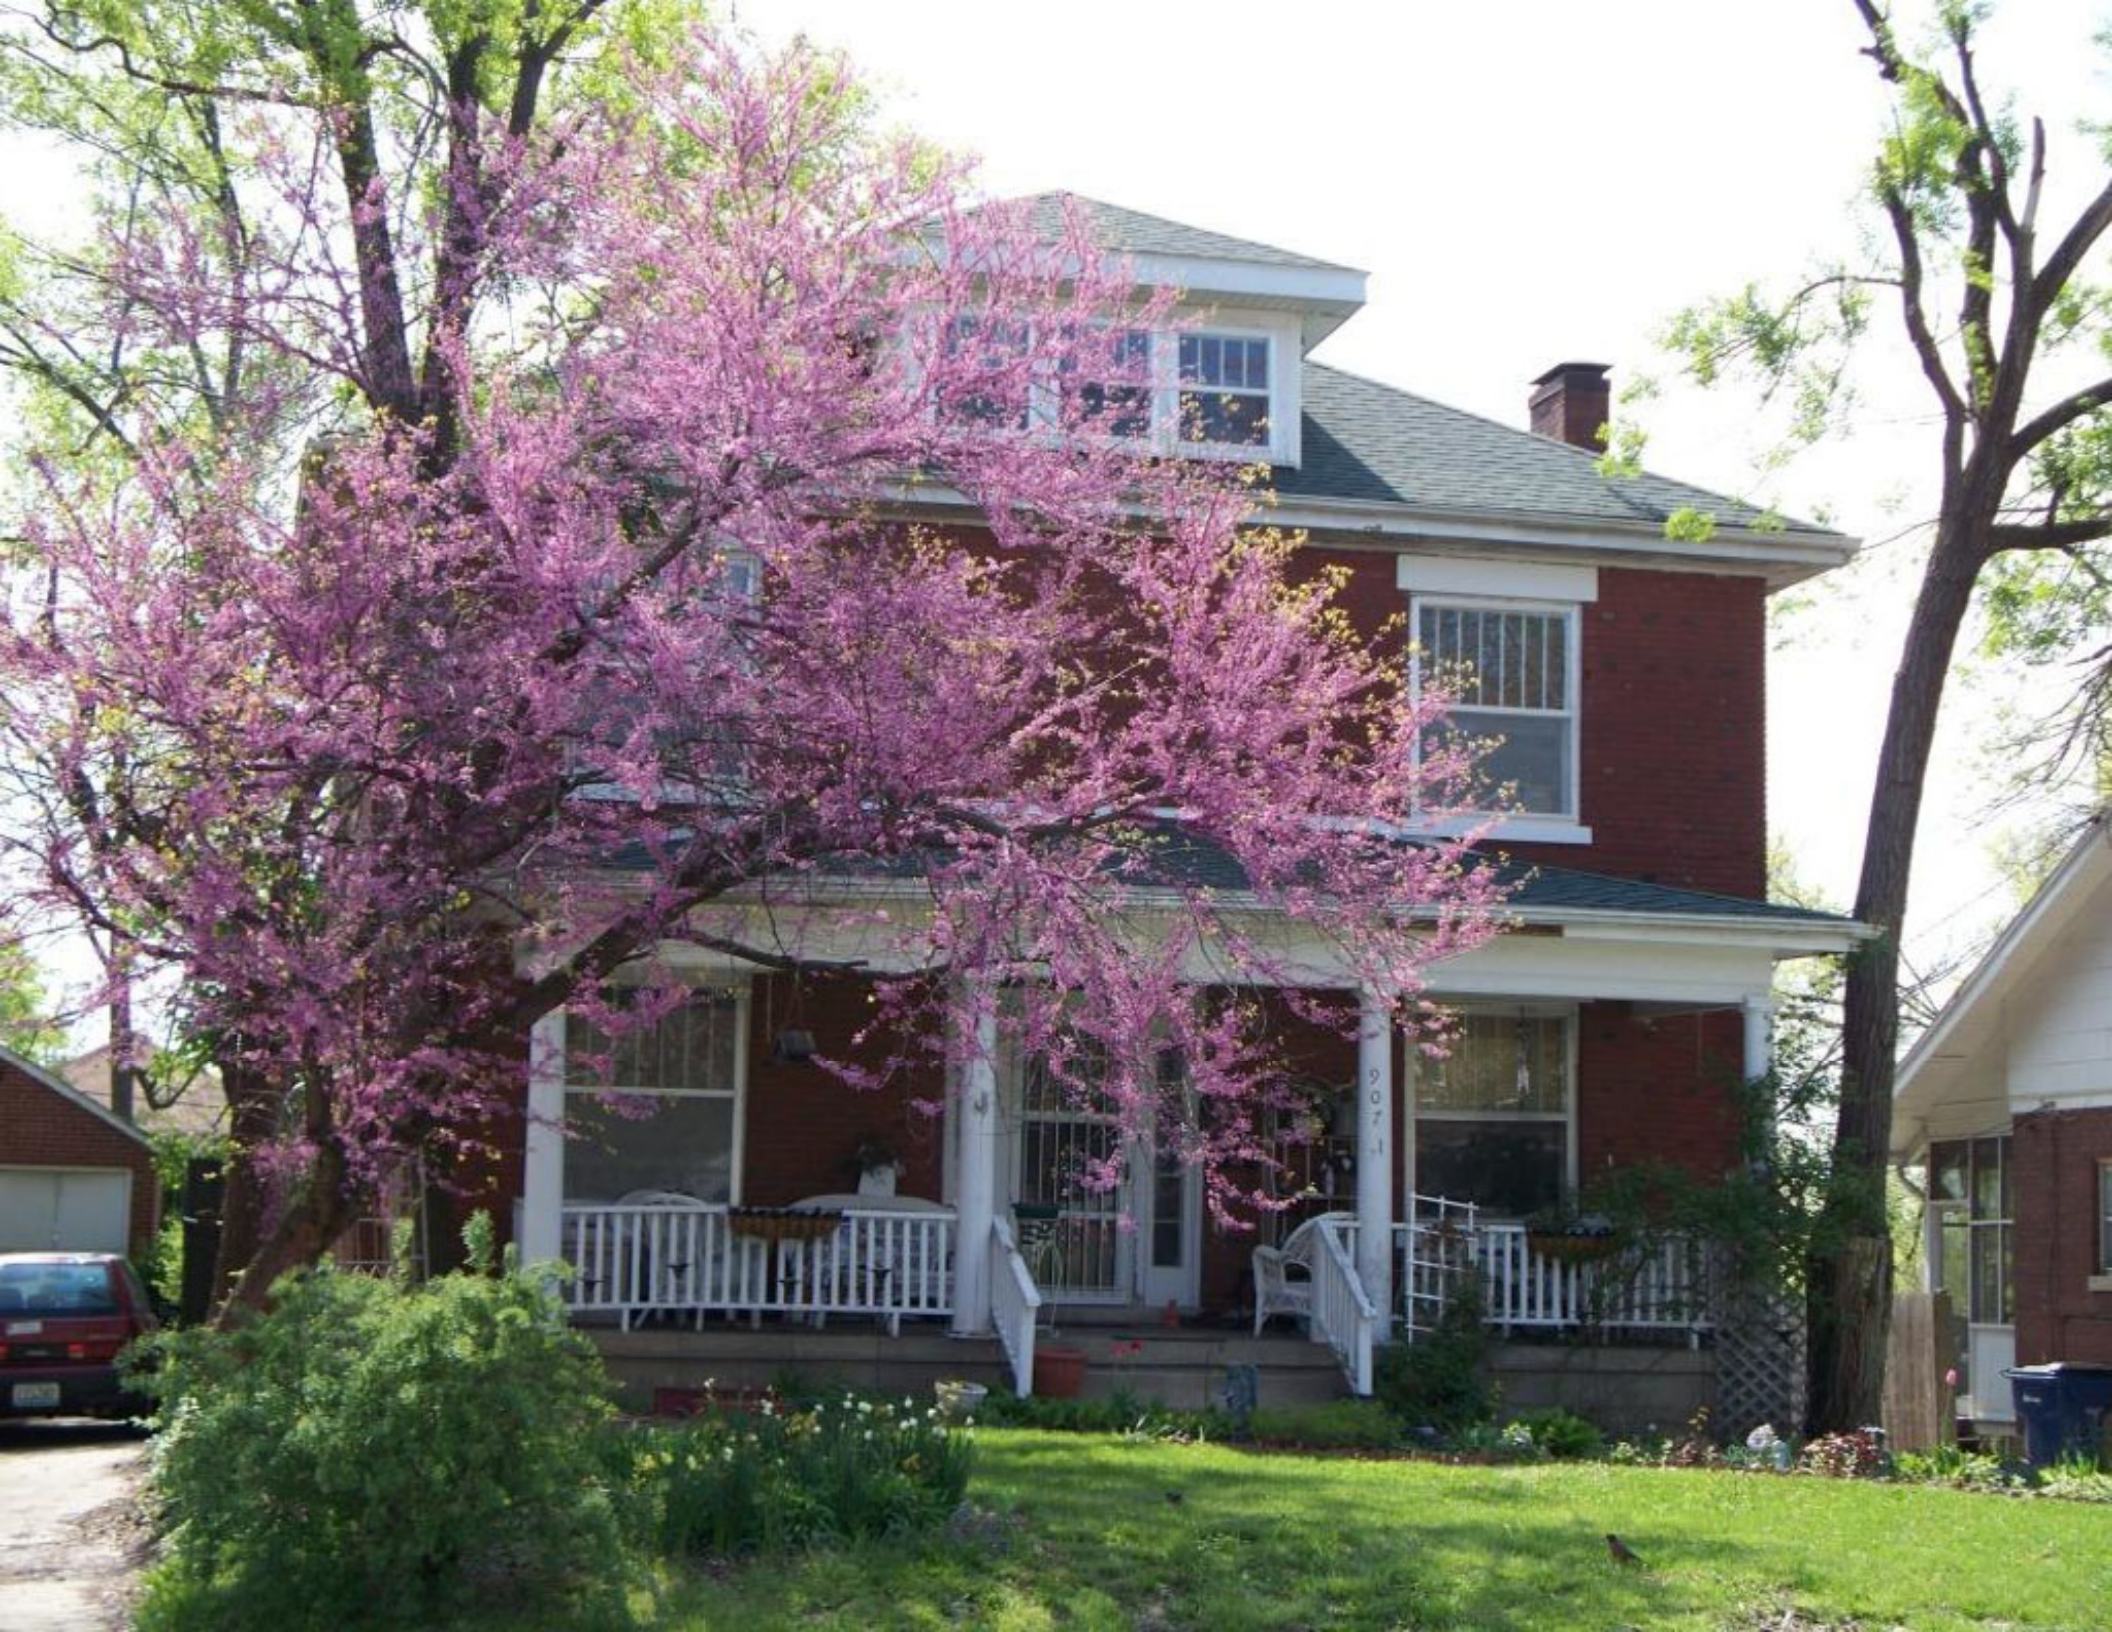
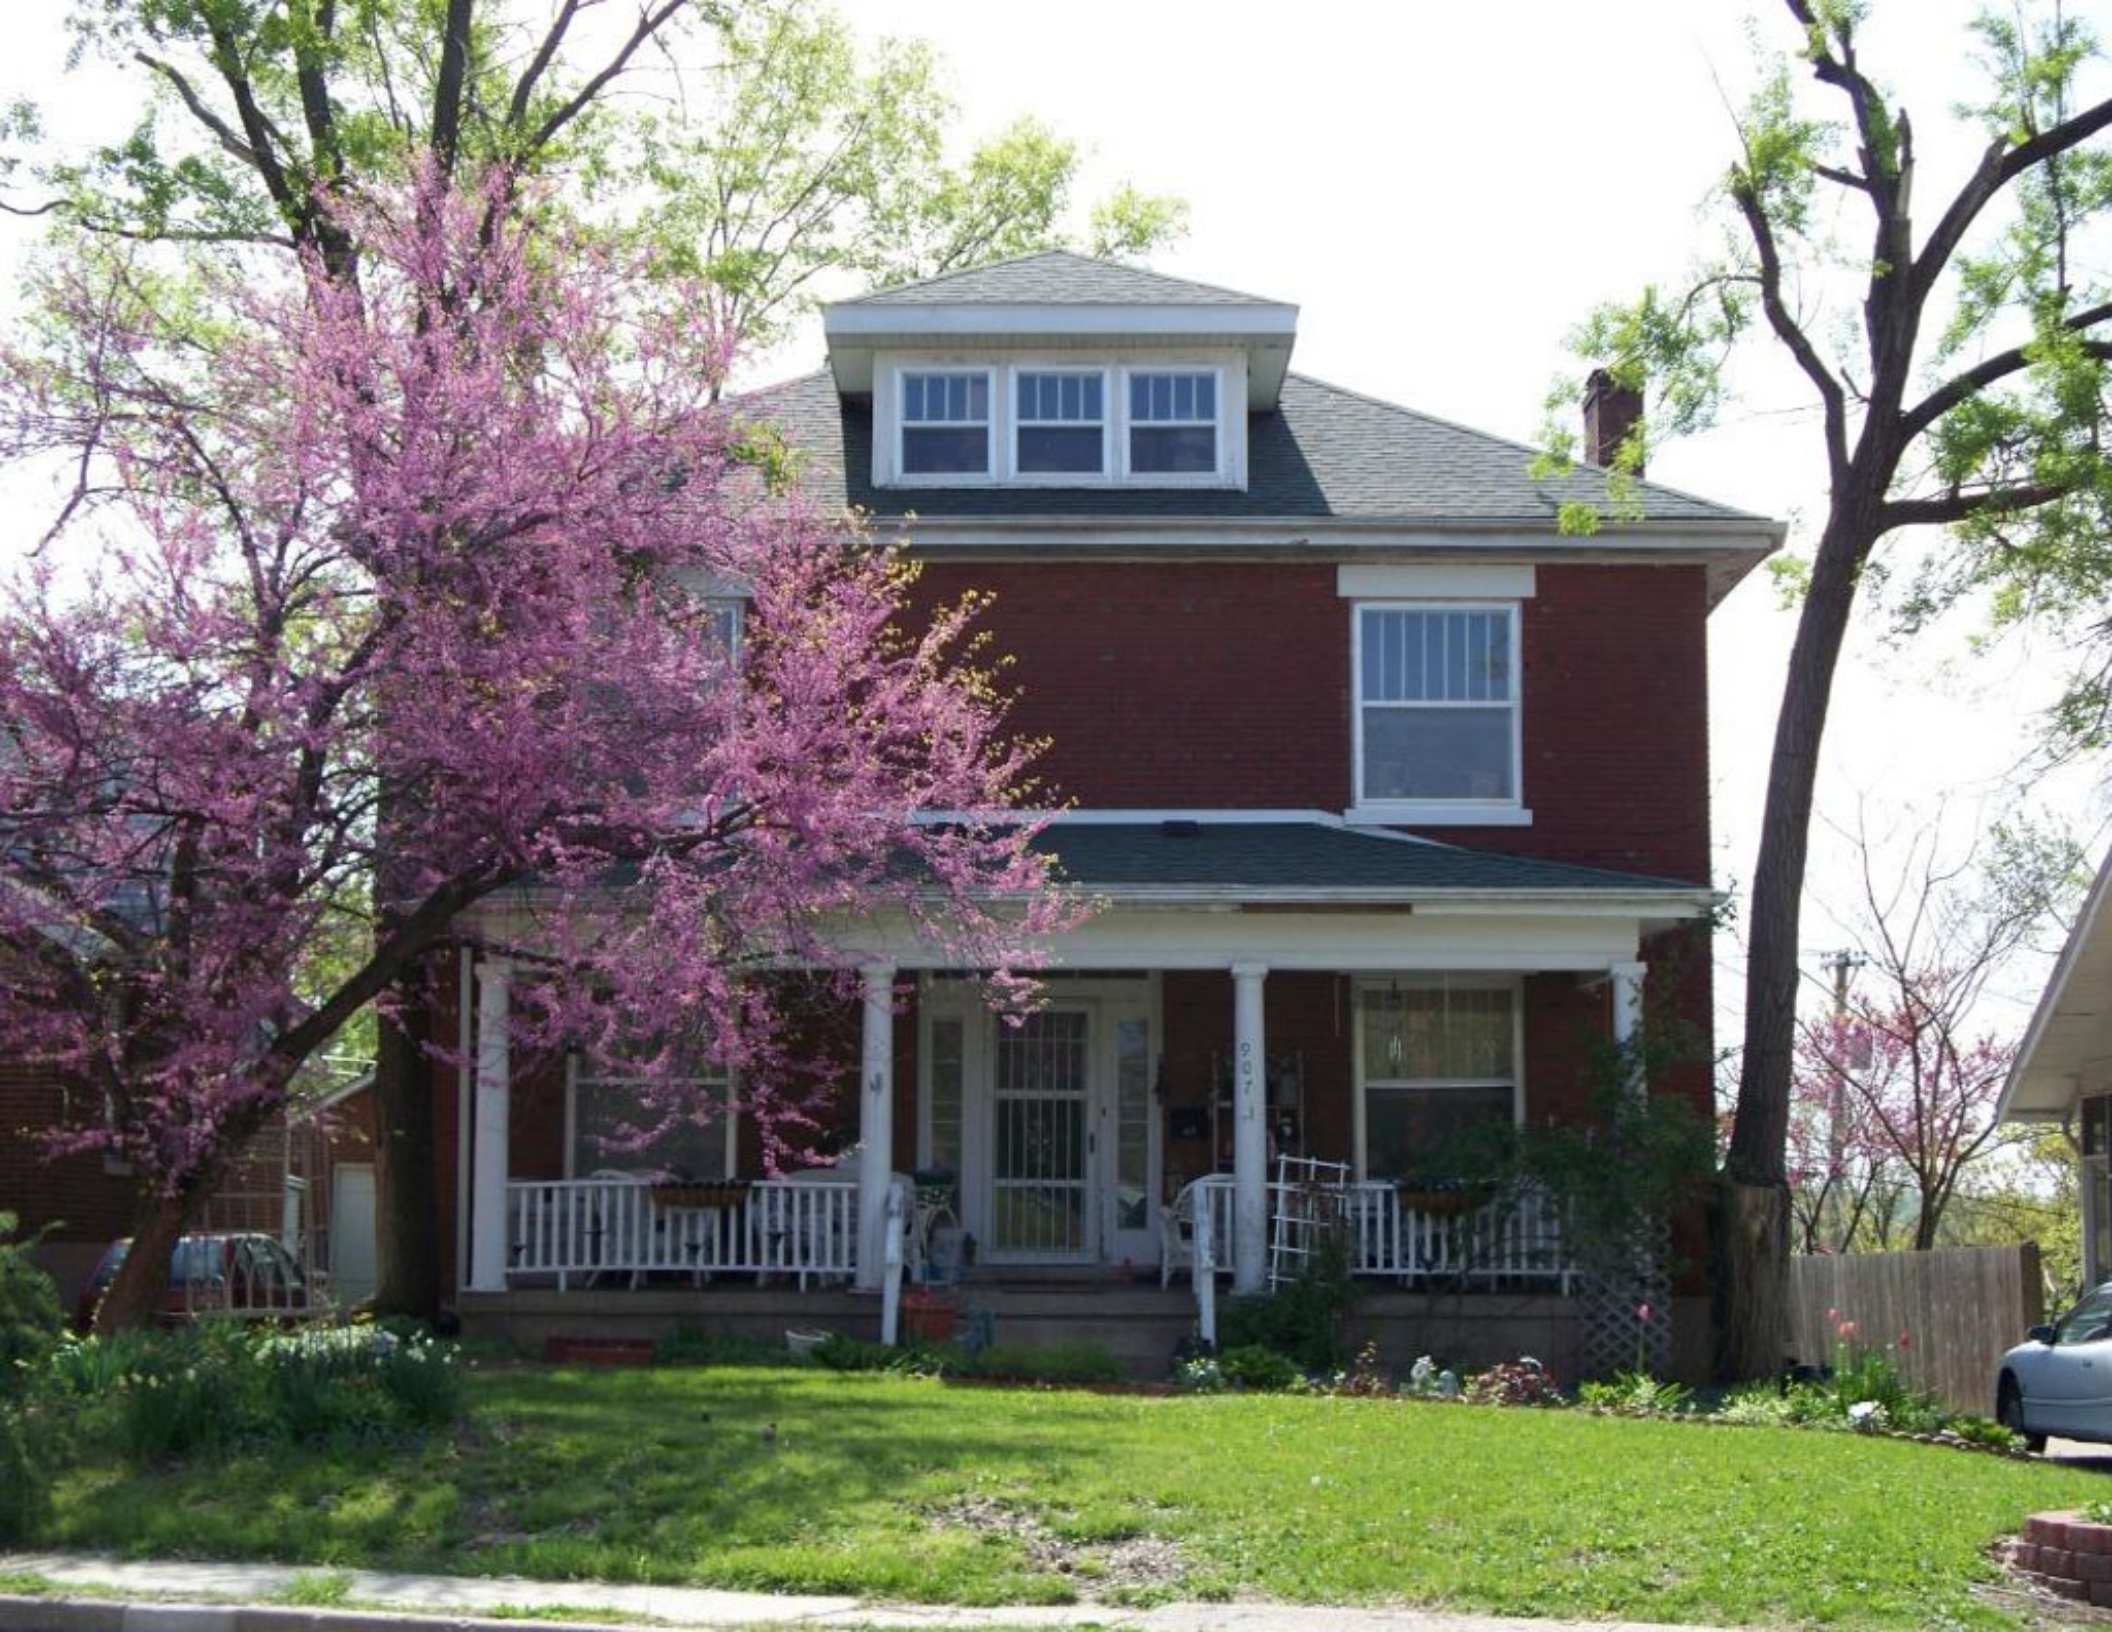
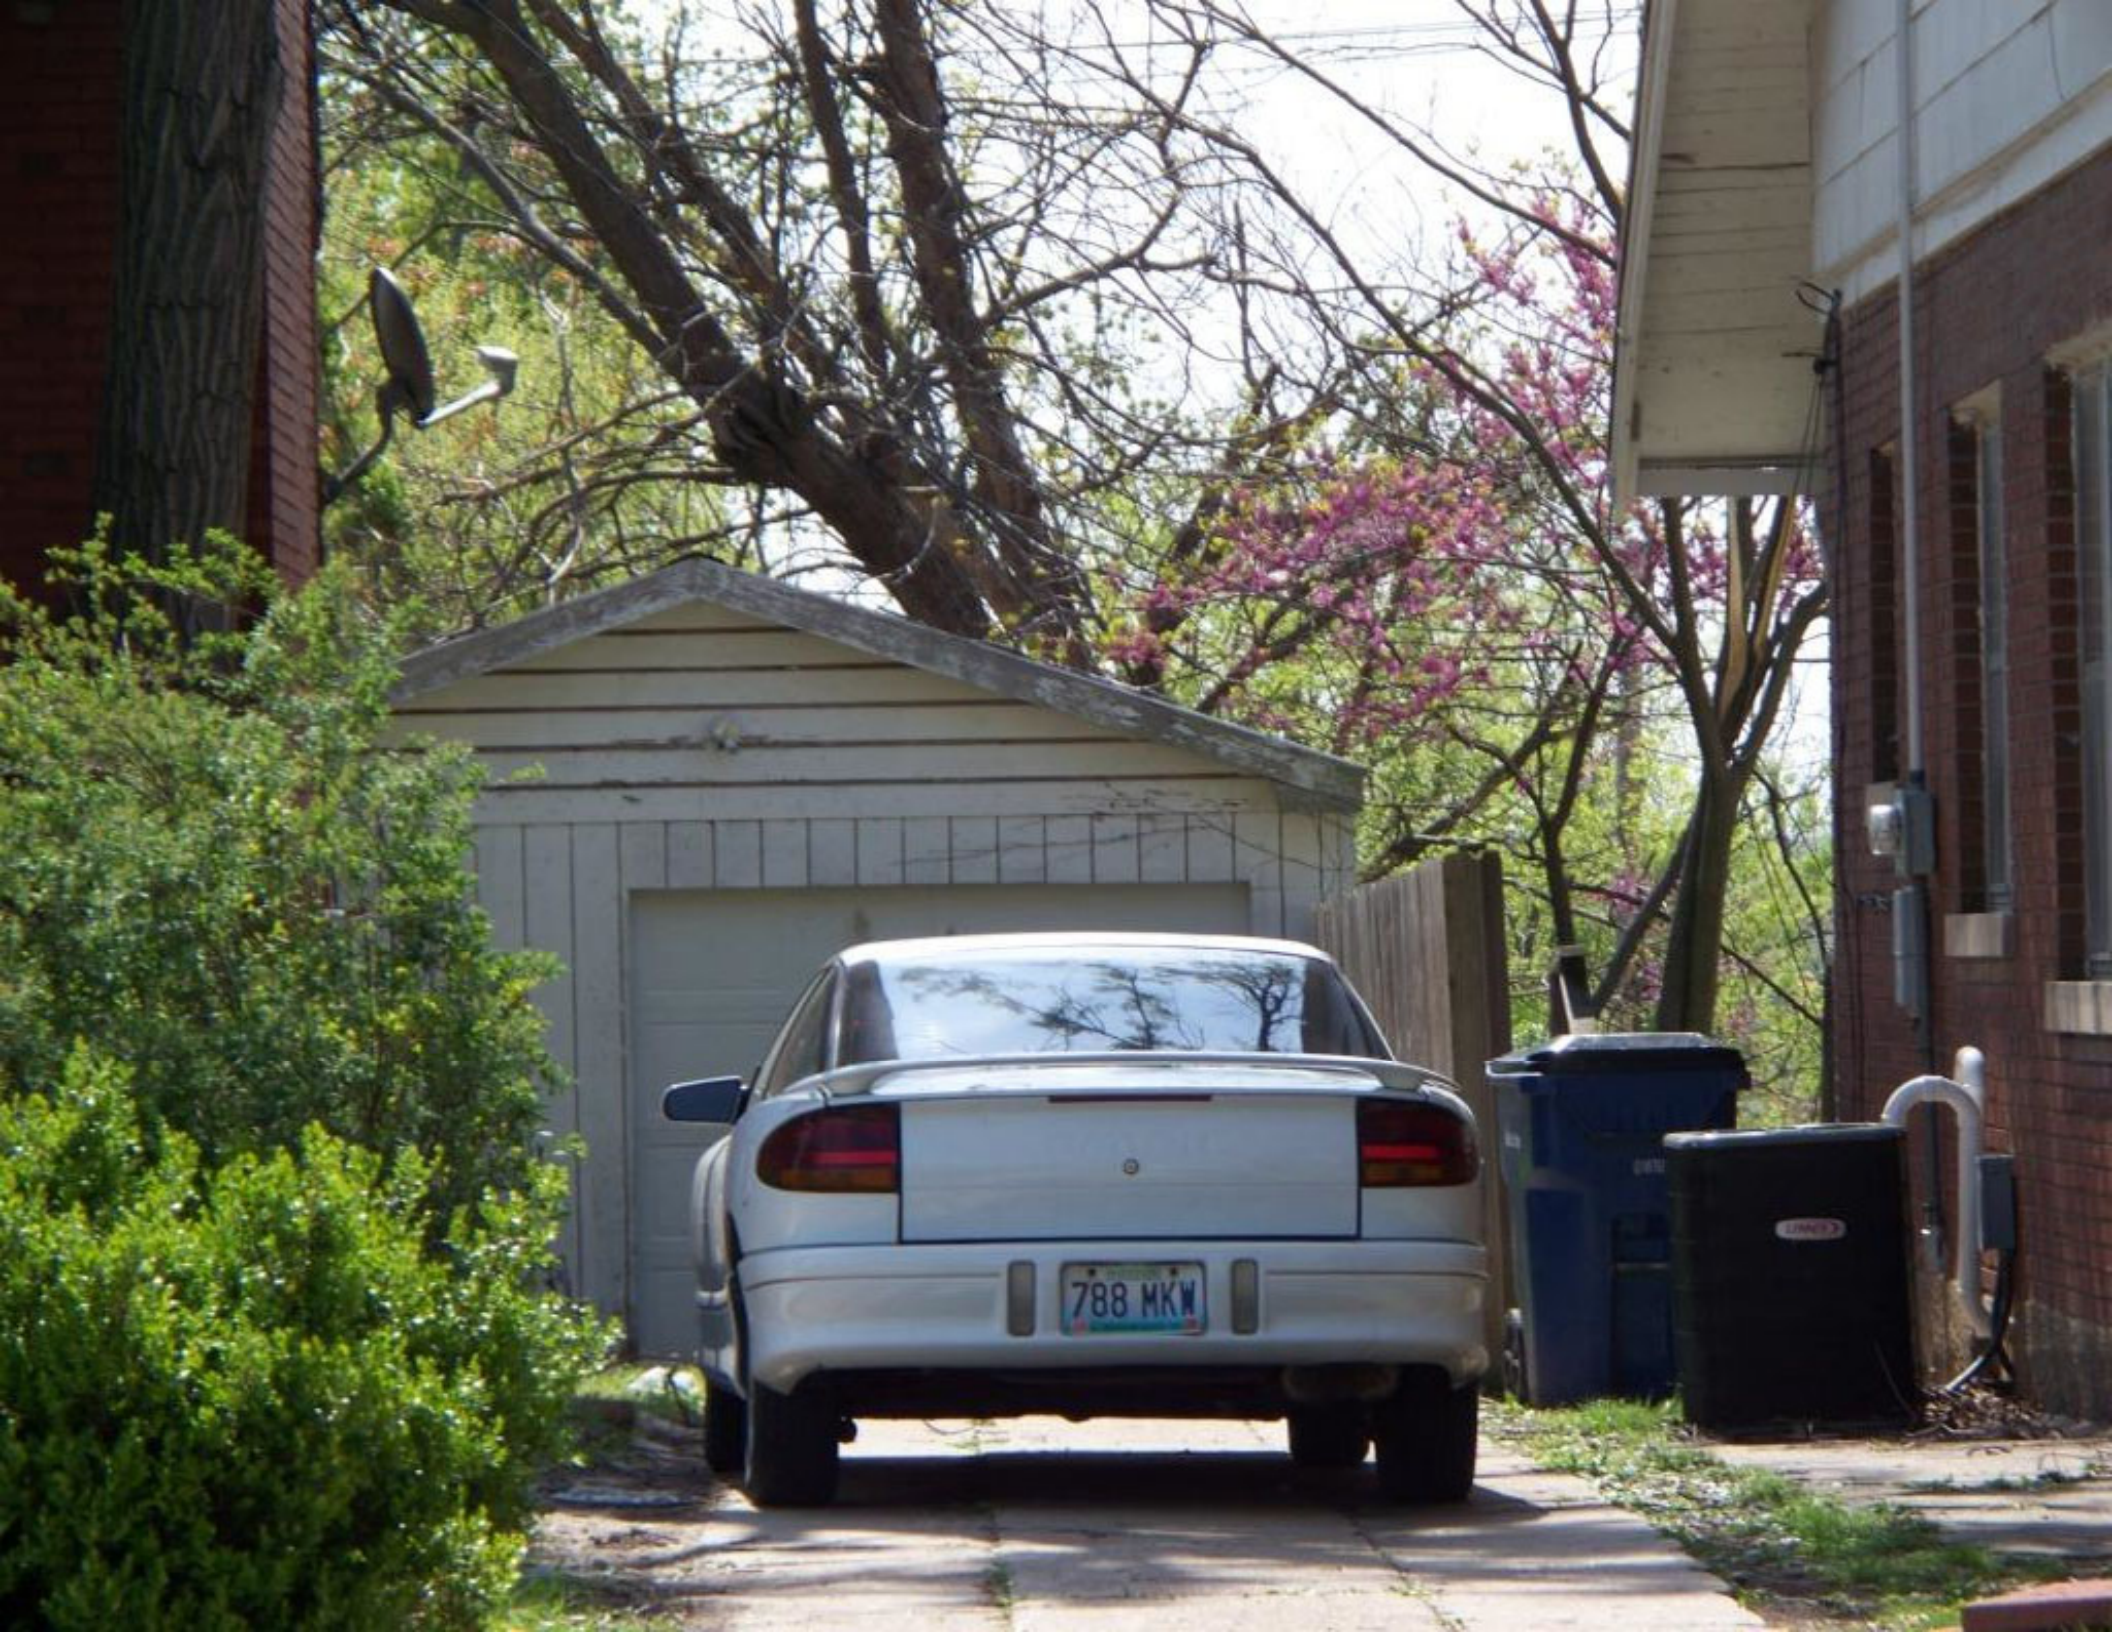
This symmetrical 2 and ½ story brick four square does not feature many stylistic details. The full-width gallery style porch has a simple wooden balustrade and four Doric columns and there are stone lintels visible above the second story windows but they are the only decorative details. A dormer with a pyramidal roof and three 4/1 historic windows are centered in the pyramidal roof of the property. There are a total of four historic 4/1 windows on the main façade of the house, two on each floor centered over the other. The decorative glass door denotes the central bay and features sidelights. The property has a concrete foundation and a basement is present.

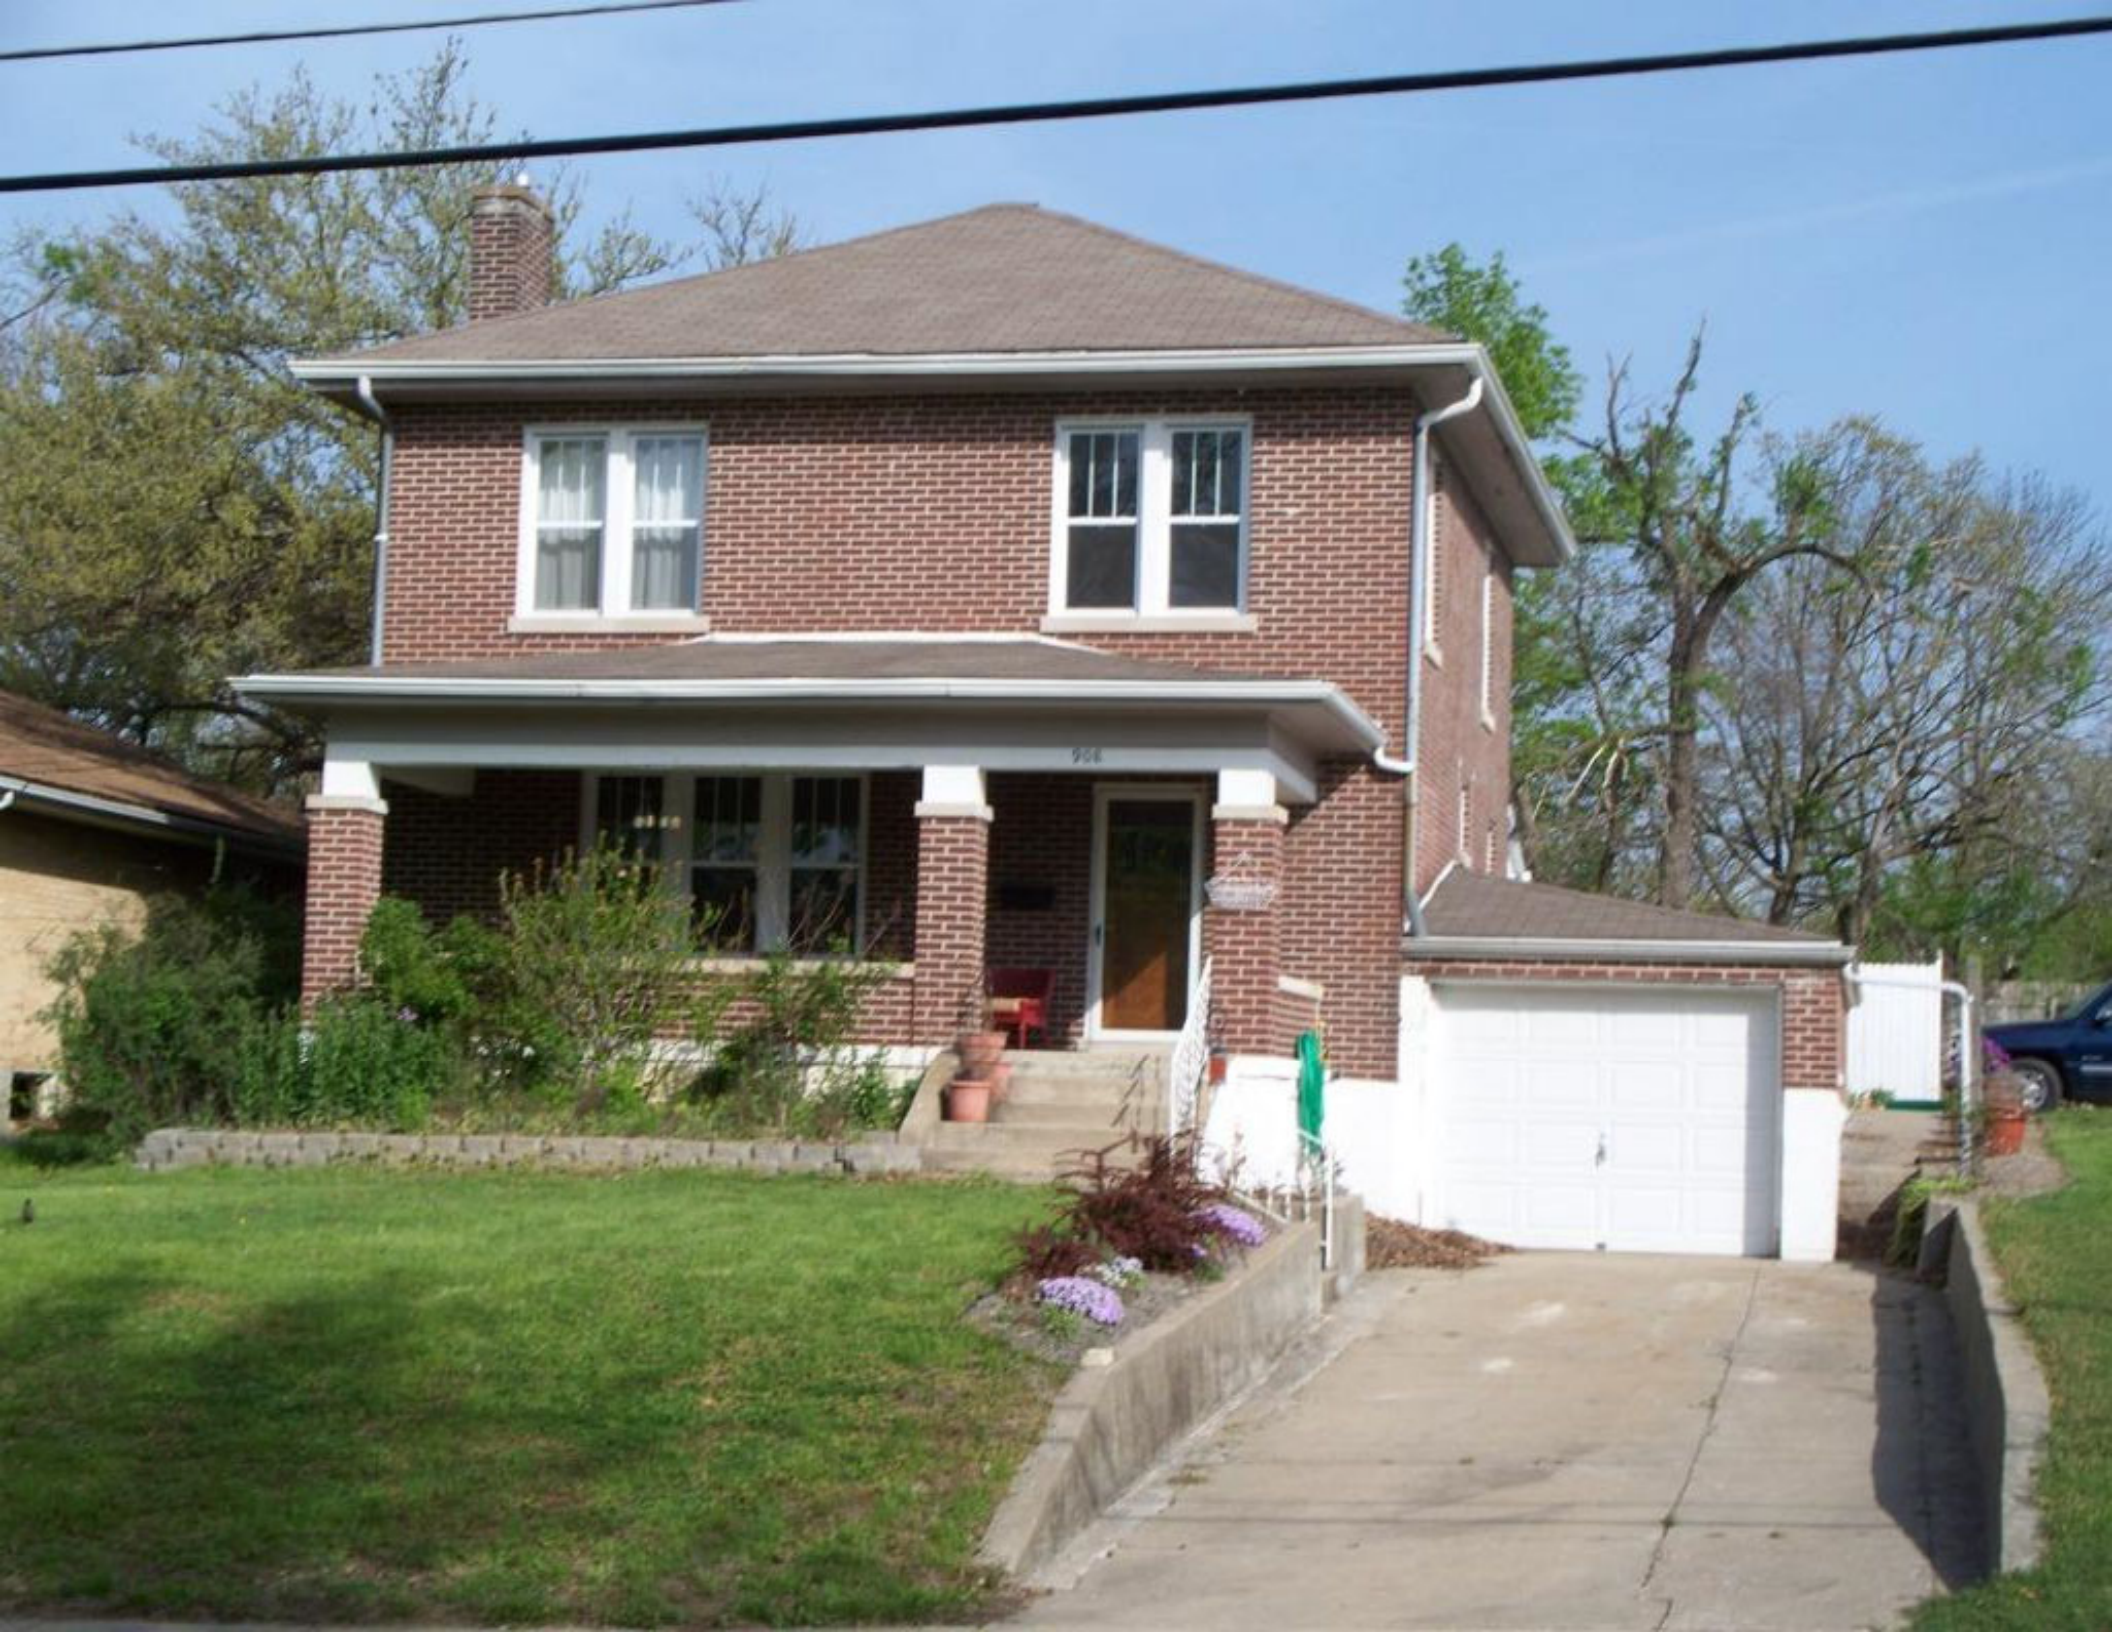
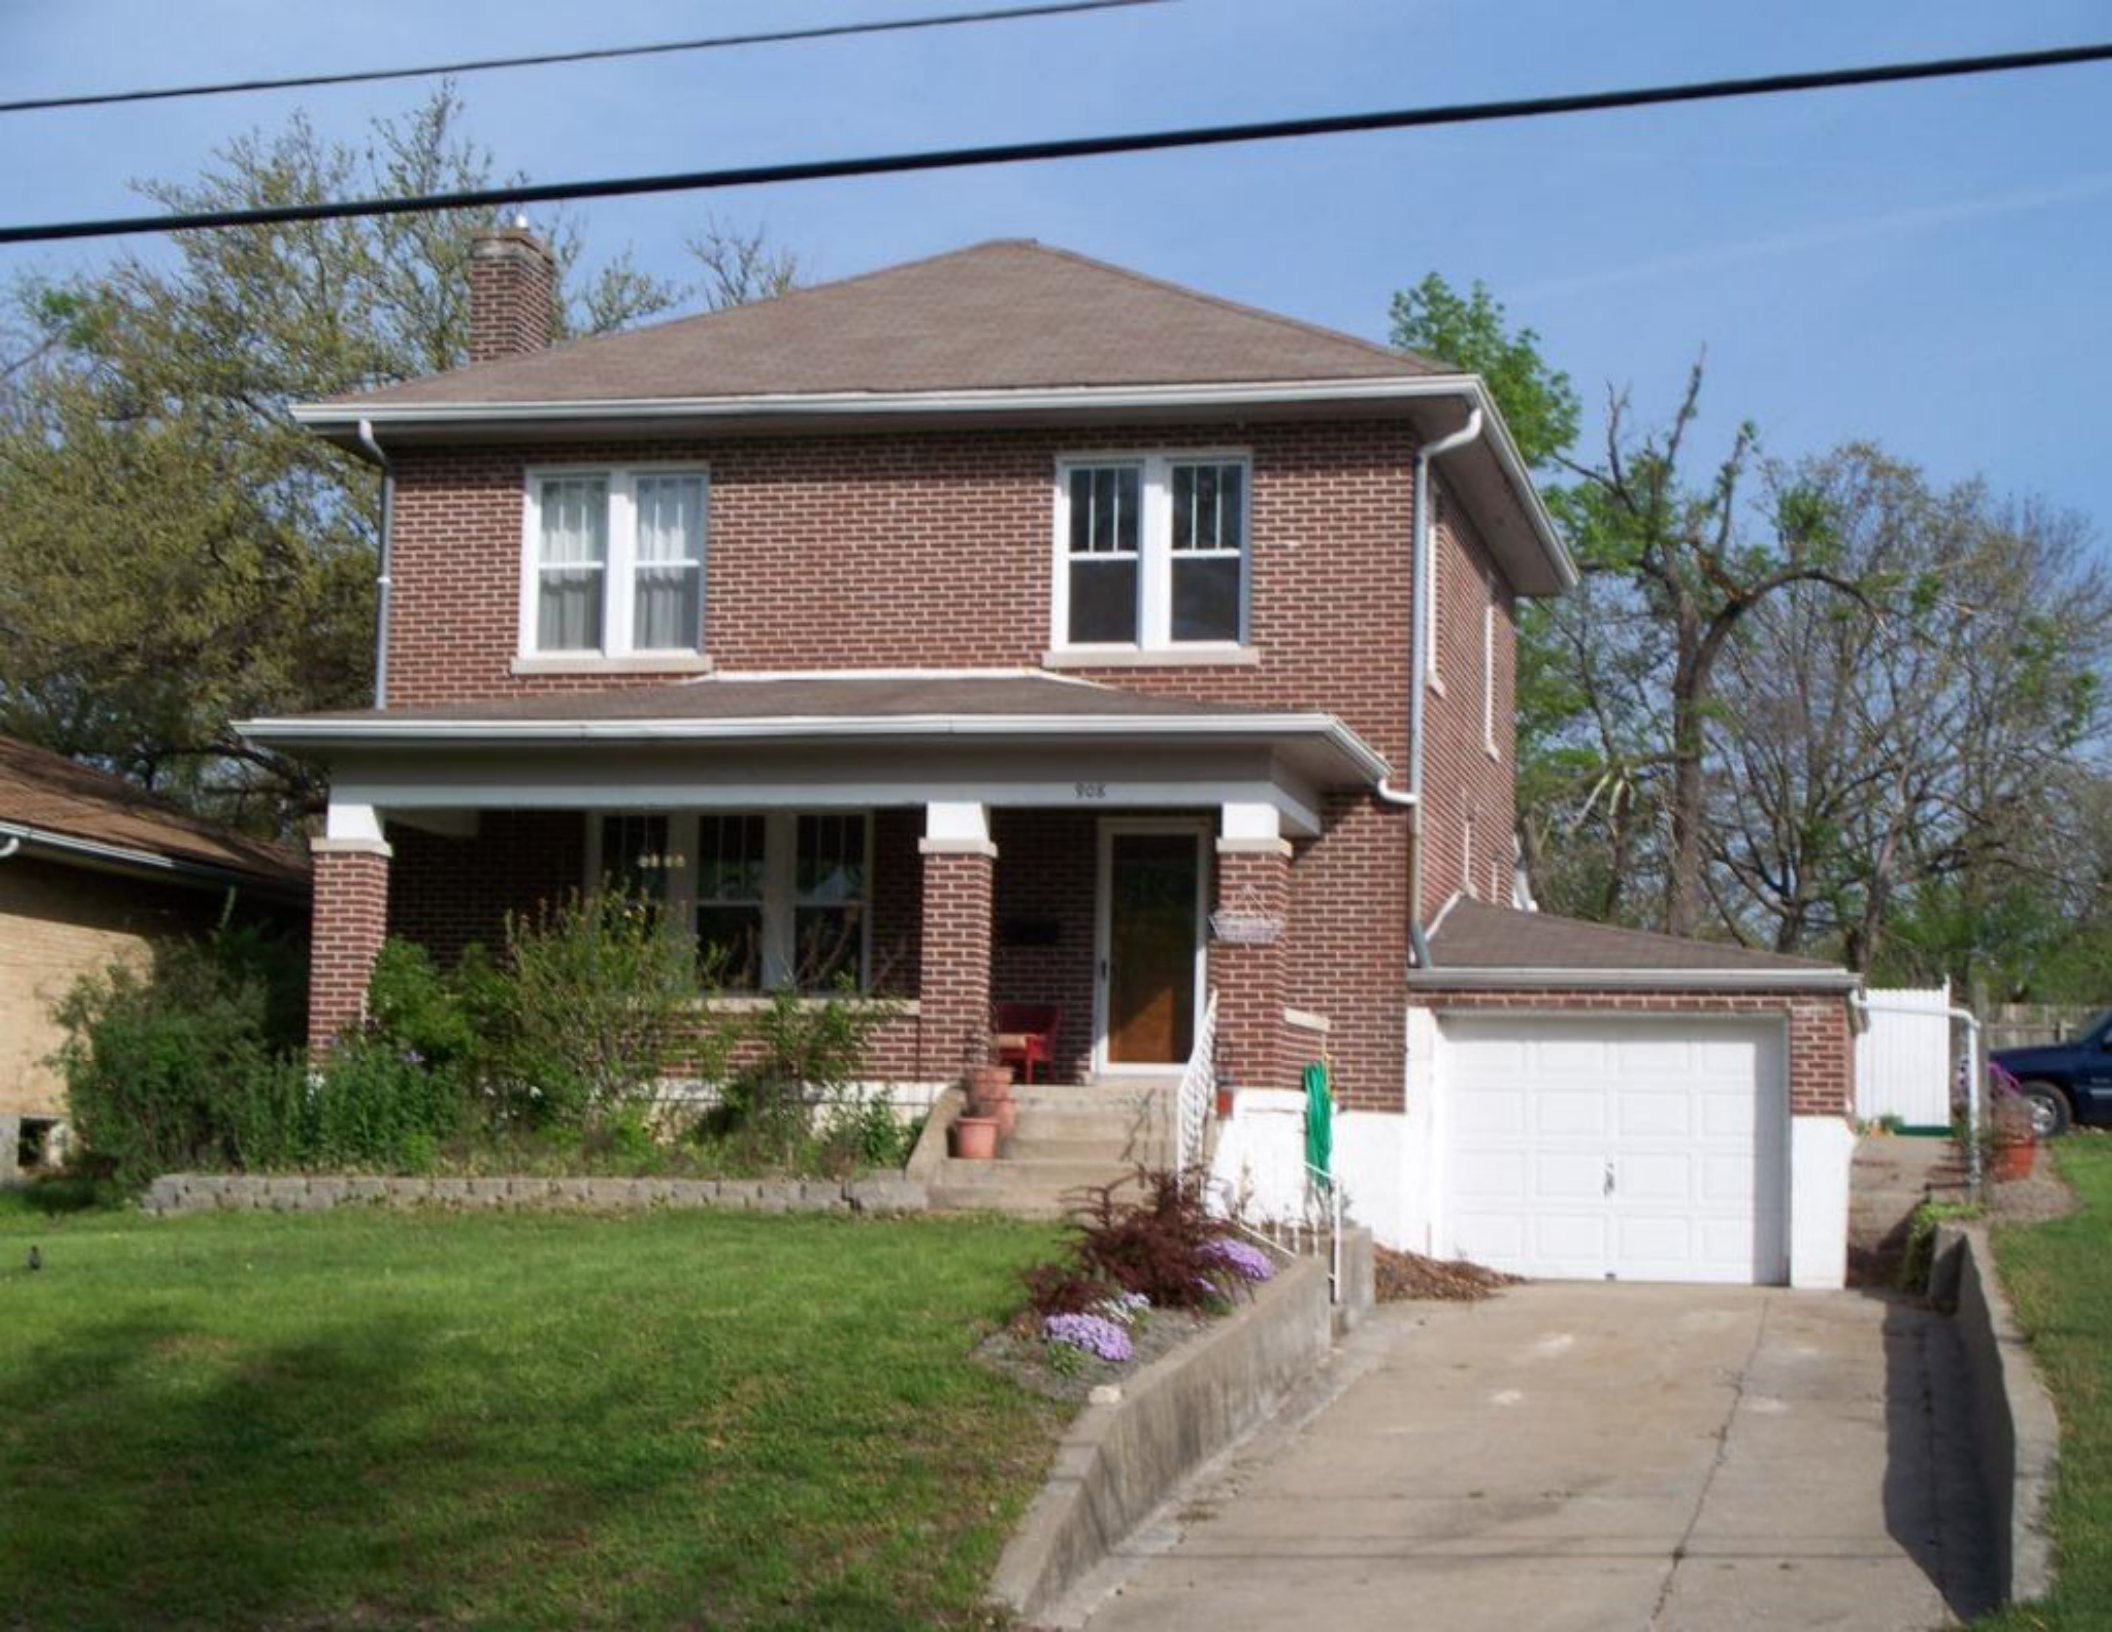
41. (cont.) This two-story brick four square has an attached one-car garage that appears historic (appears on the 1939 Sanborn.) It accessed by a concrete drive with retaining walls. The full-width porch is accessed by a short stone store and features brick piers and a flared hipped roof. The entrance is off-set to the left and appears to have its original wooden door. A row of three three-over-one historic windows makes up the other bay of the first story. The second story has two pairs of symmetrical three-over-one windows with stone sills. The chimney extends from the left of the pyramidal roof.
