ARCHITECTURAL/HISTORIC INVENTORY FORM

1. Survey No. CO-AS-005-001		2. Survey name: Moreau Drive Neighborhood Survey	
3. County: Cole		4. Address: 1202 Elmerine Ave.	
5. City: Jefferson City	Vicinity: <input type="checkbox"/>	6. UTM: / /	7. Township/Range/Section: T: R: S:
8. Historic name (if known):		9. Present/other name (if known):	
10. Ownership: <input checked="" type="checkbox"/> Private <input type="checkbox"/> Public		11. Historic use (if known): Residential	11. Current use: Residential

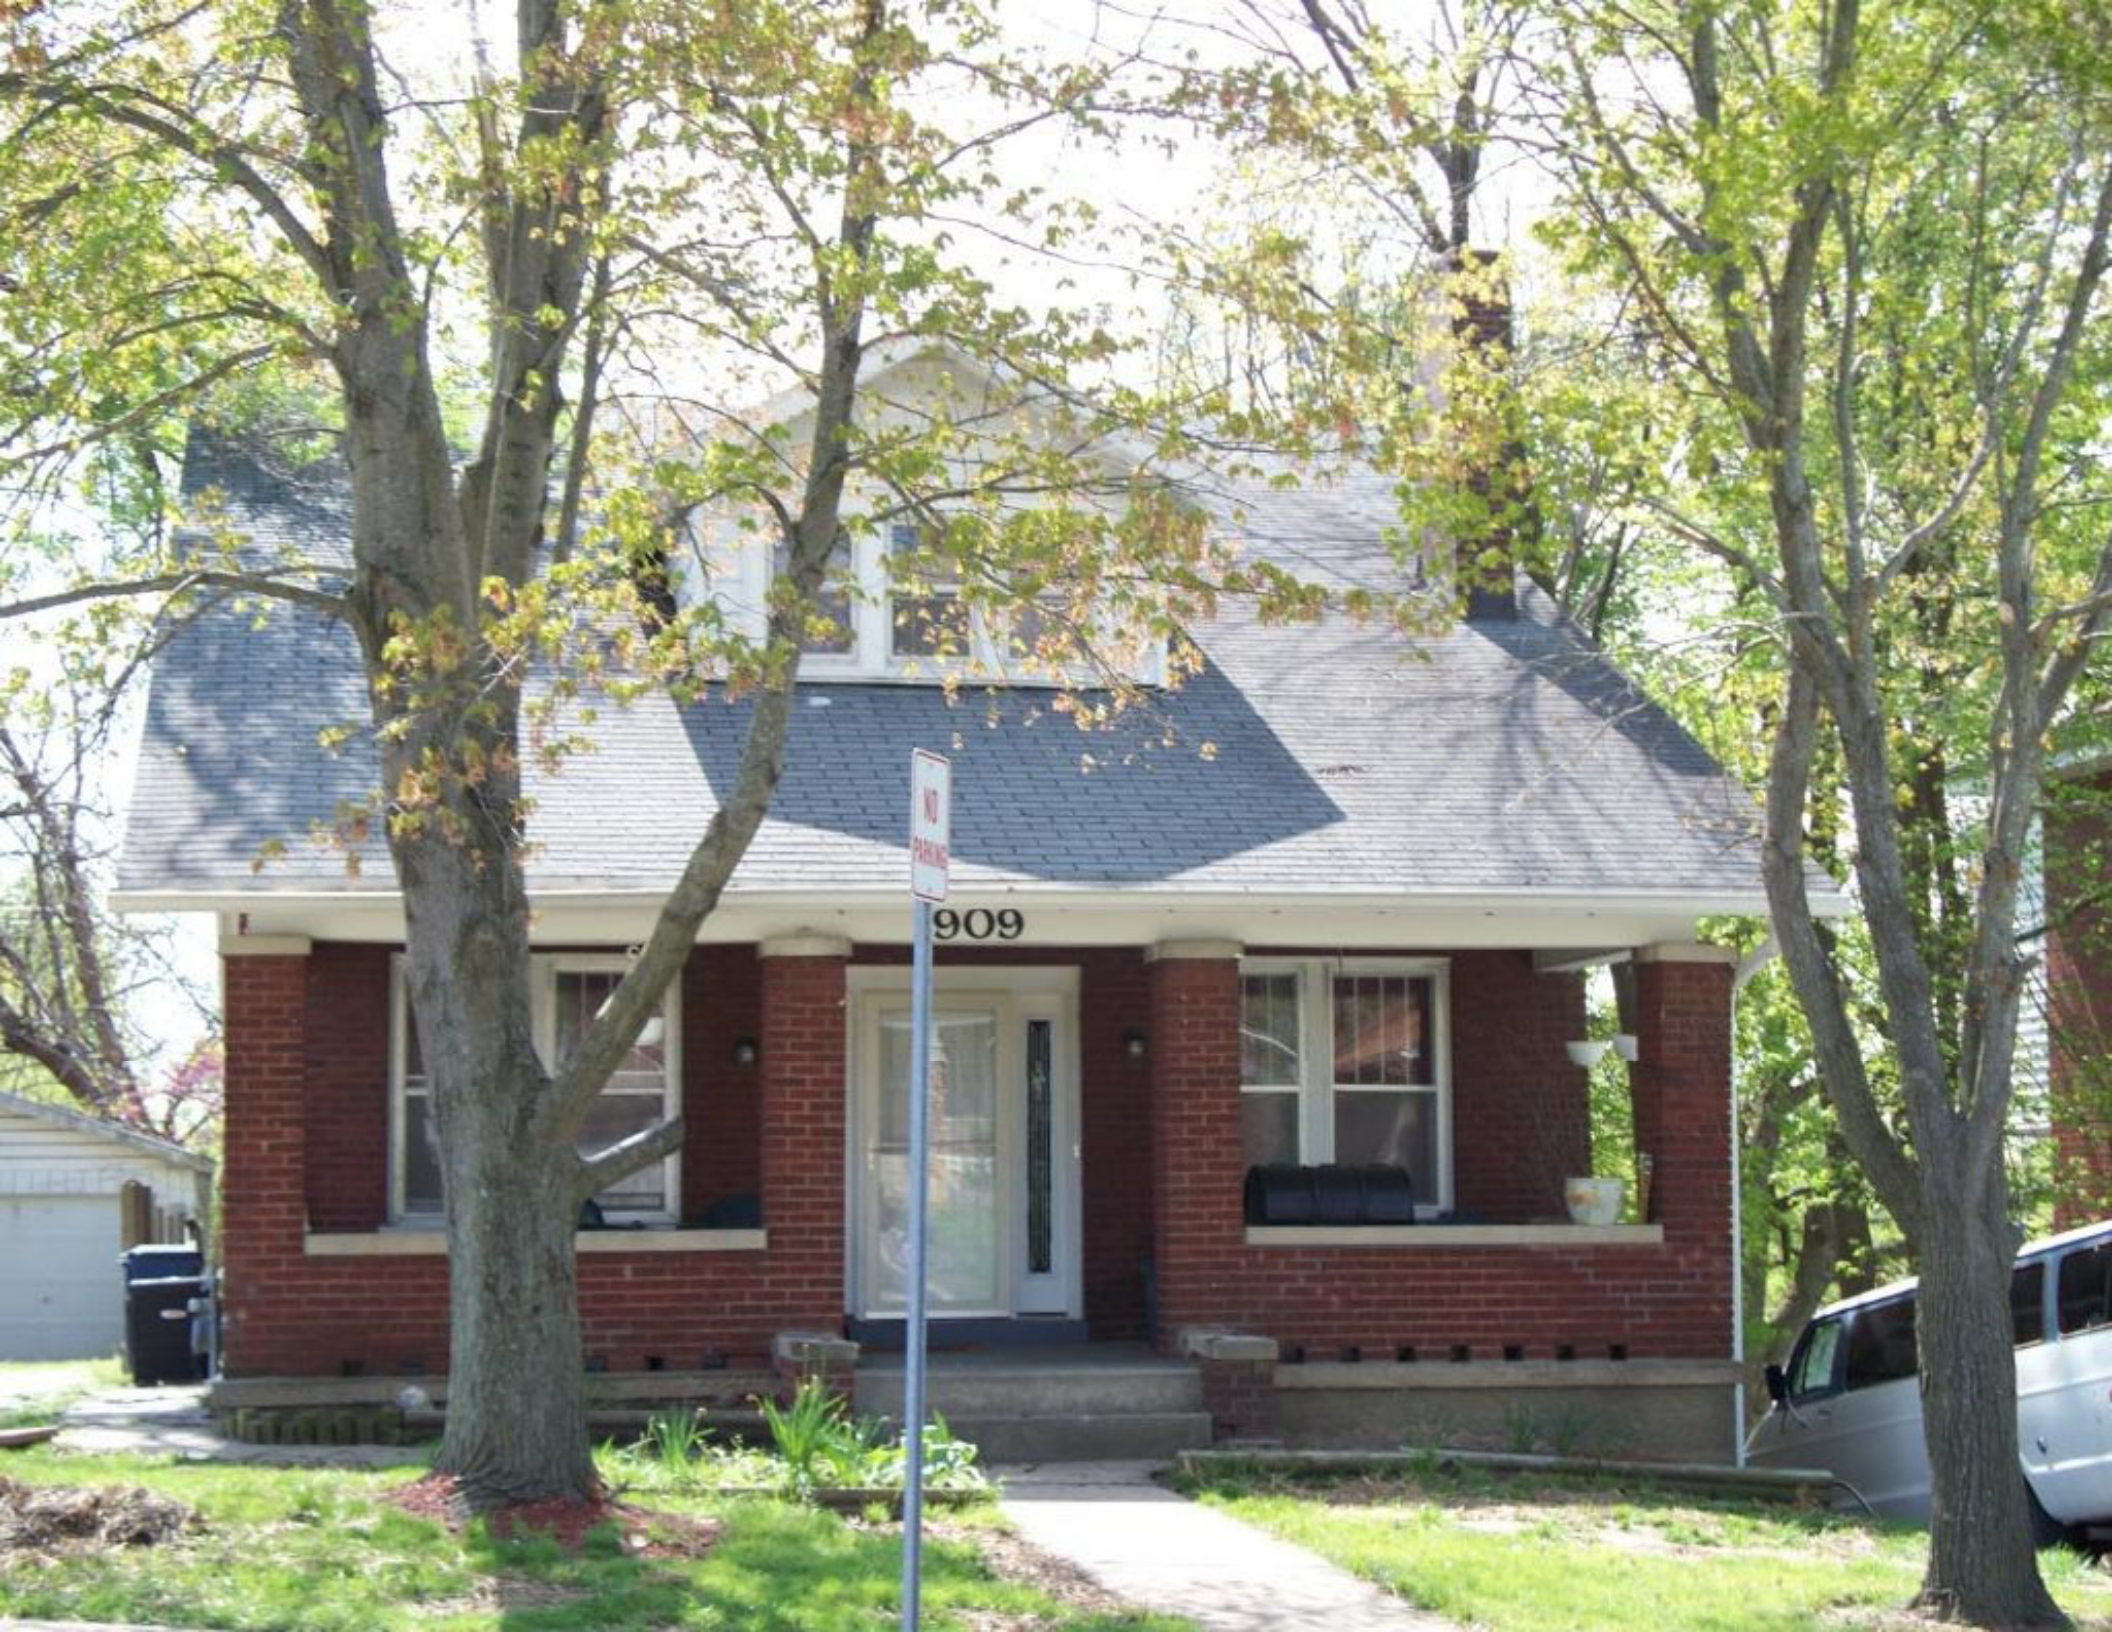
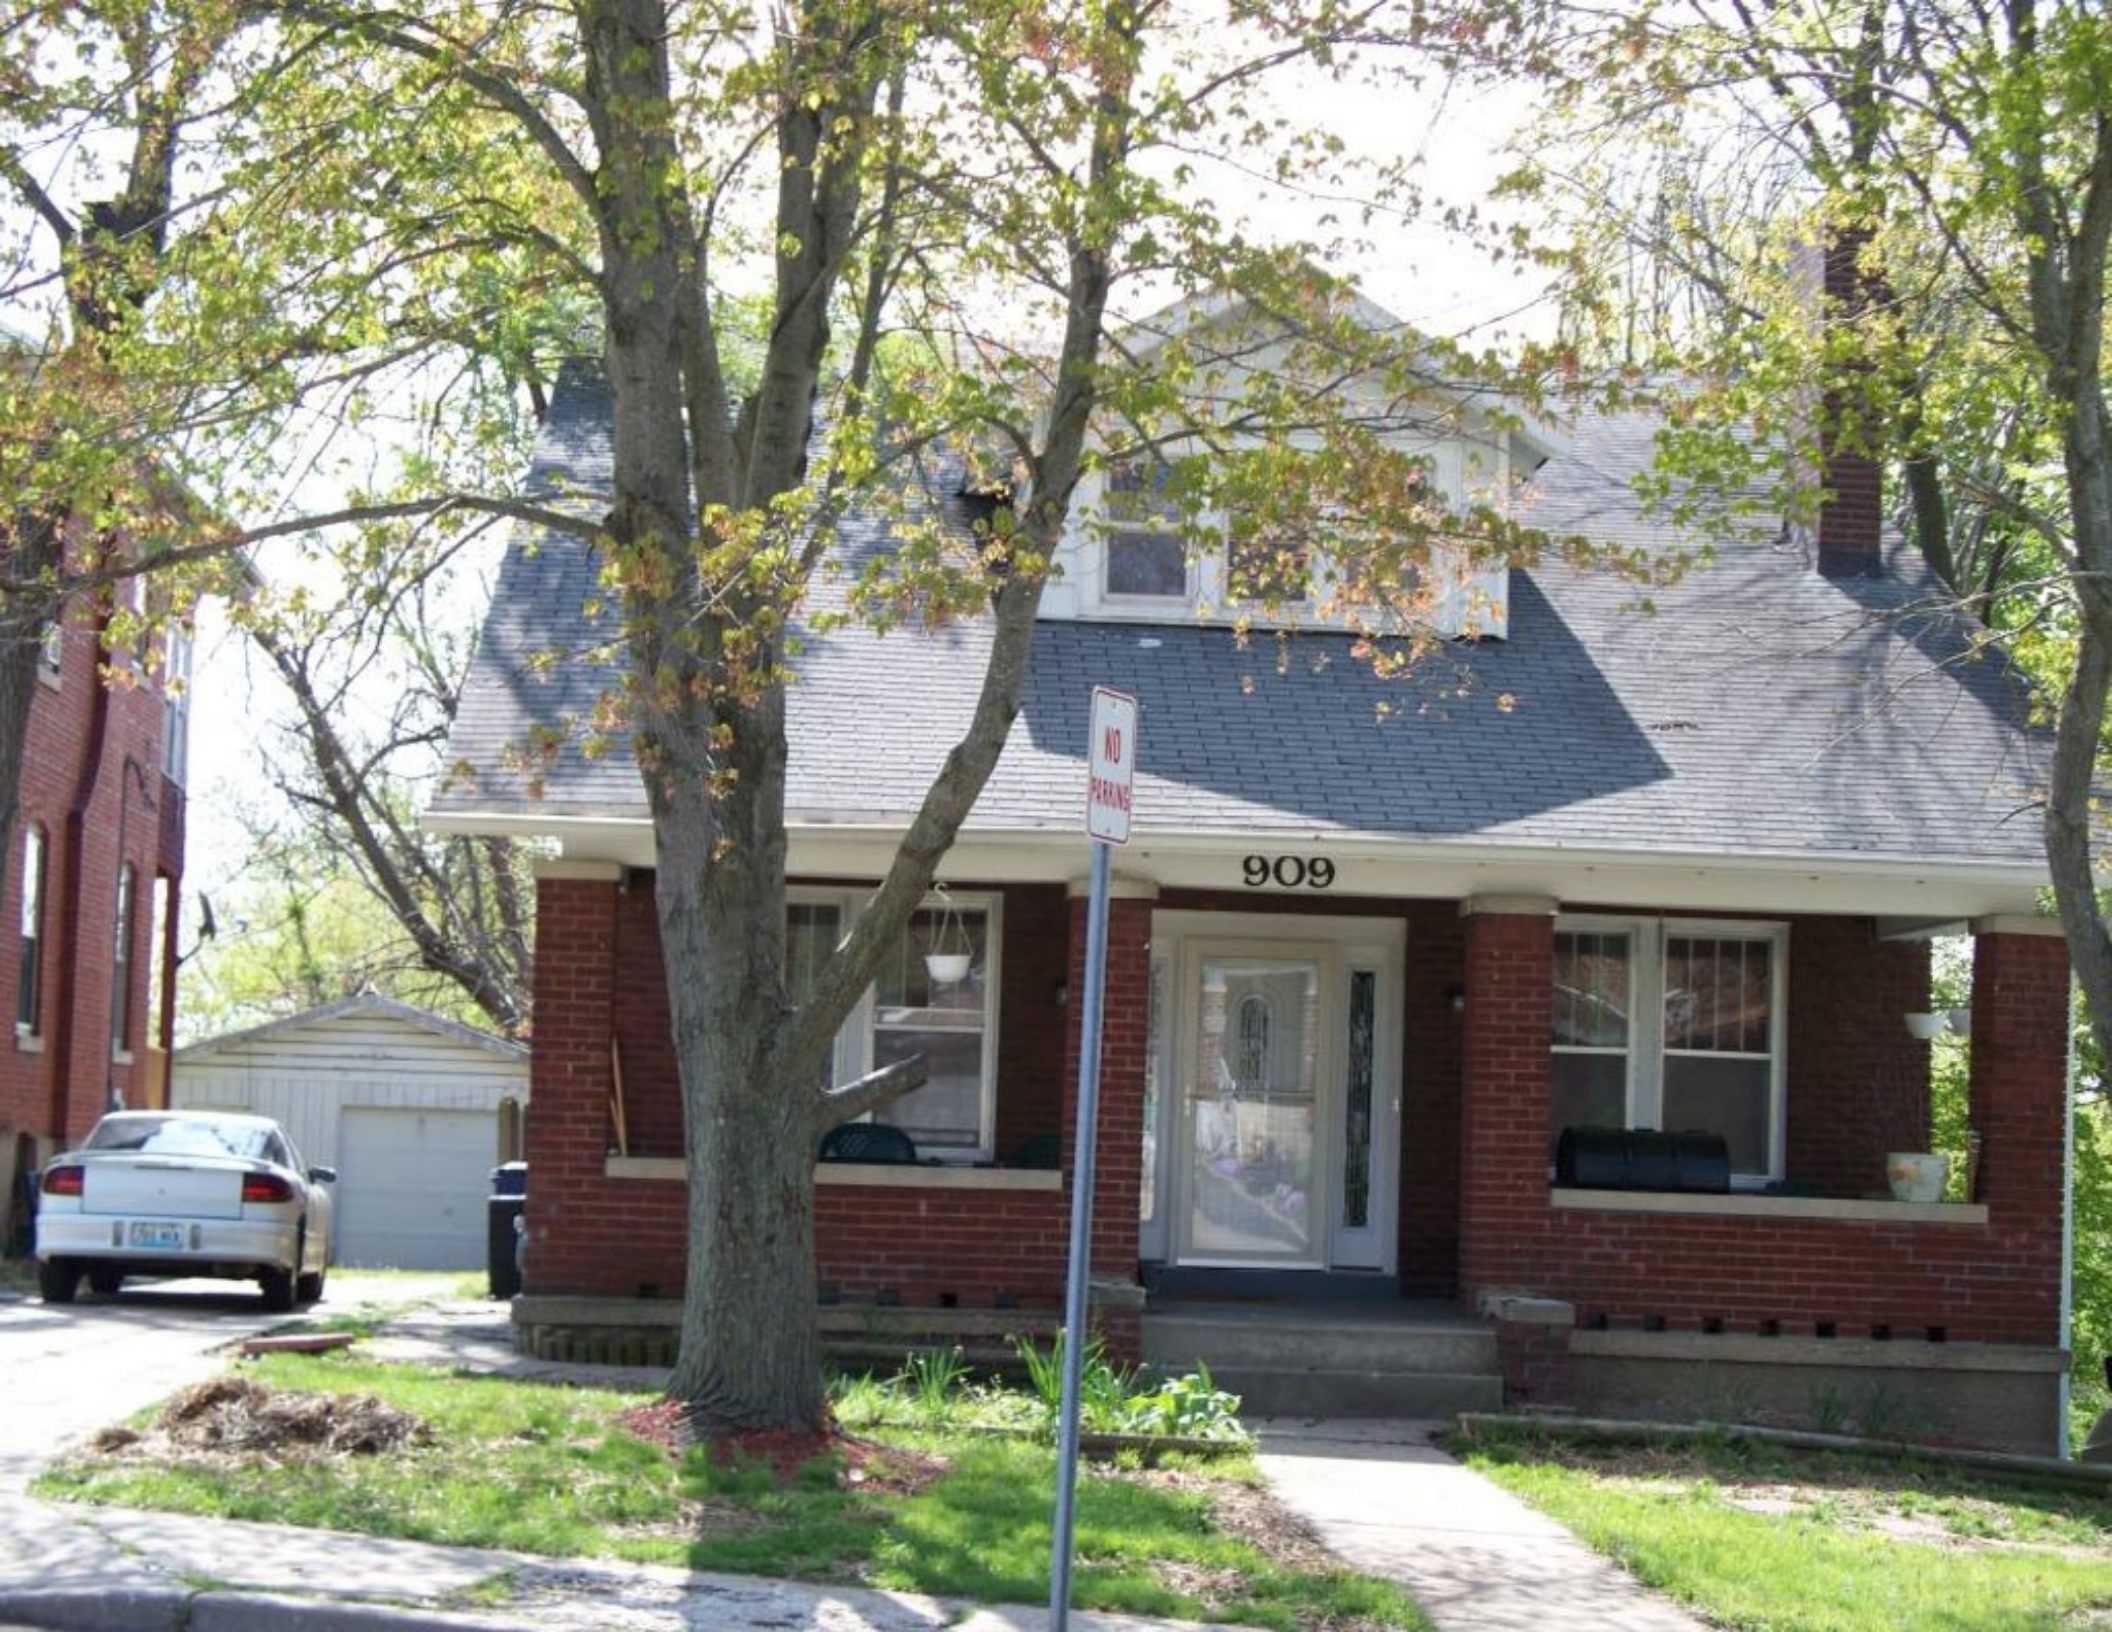
This simplistic brick 1 and a half story bungalow has a full-width porch with thick square brick piers and closed brick half-walls capped by limestone sills. The entrance is centered and features sidelights these are flanked on each side by a pair of historic 4/1 windows (total of 4 on 1st floor.) There is a dormer centered on the ½ floor and features a row of three 1/1 windows that may be historic.

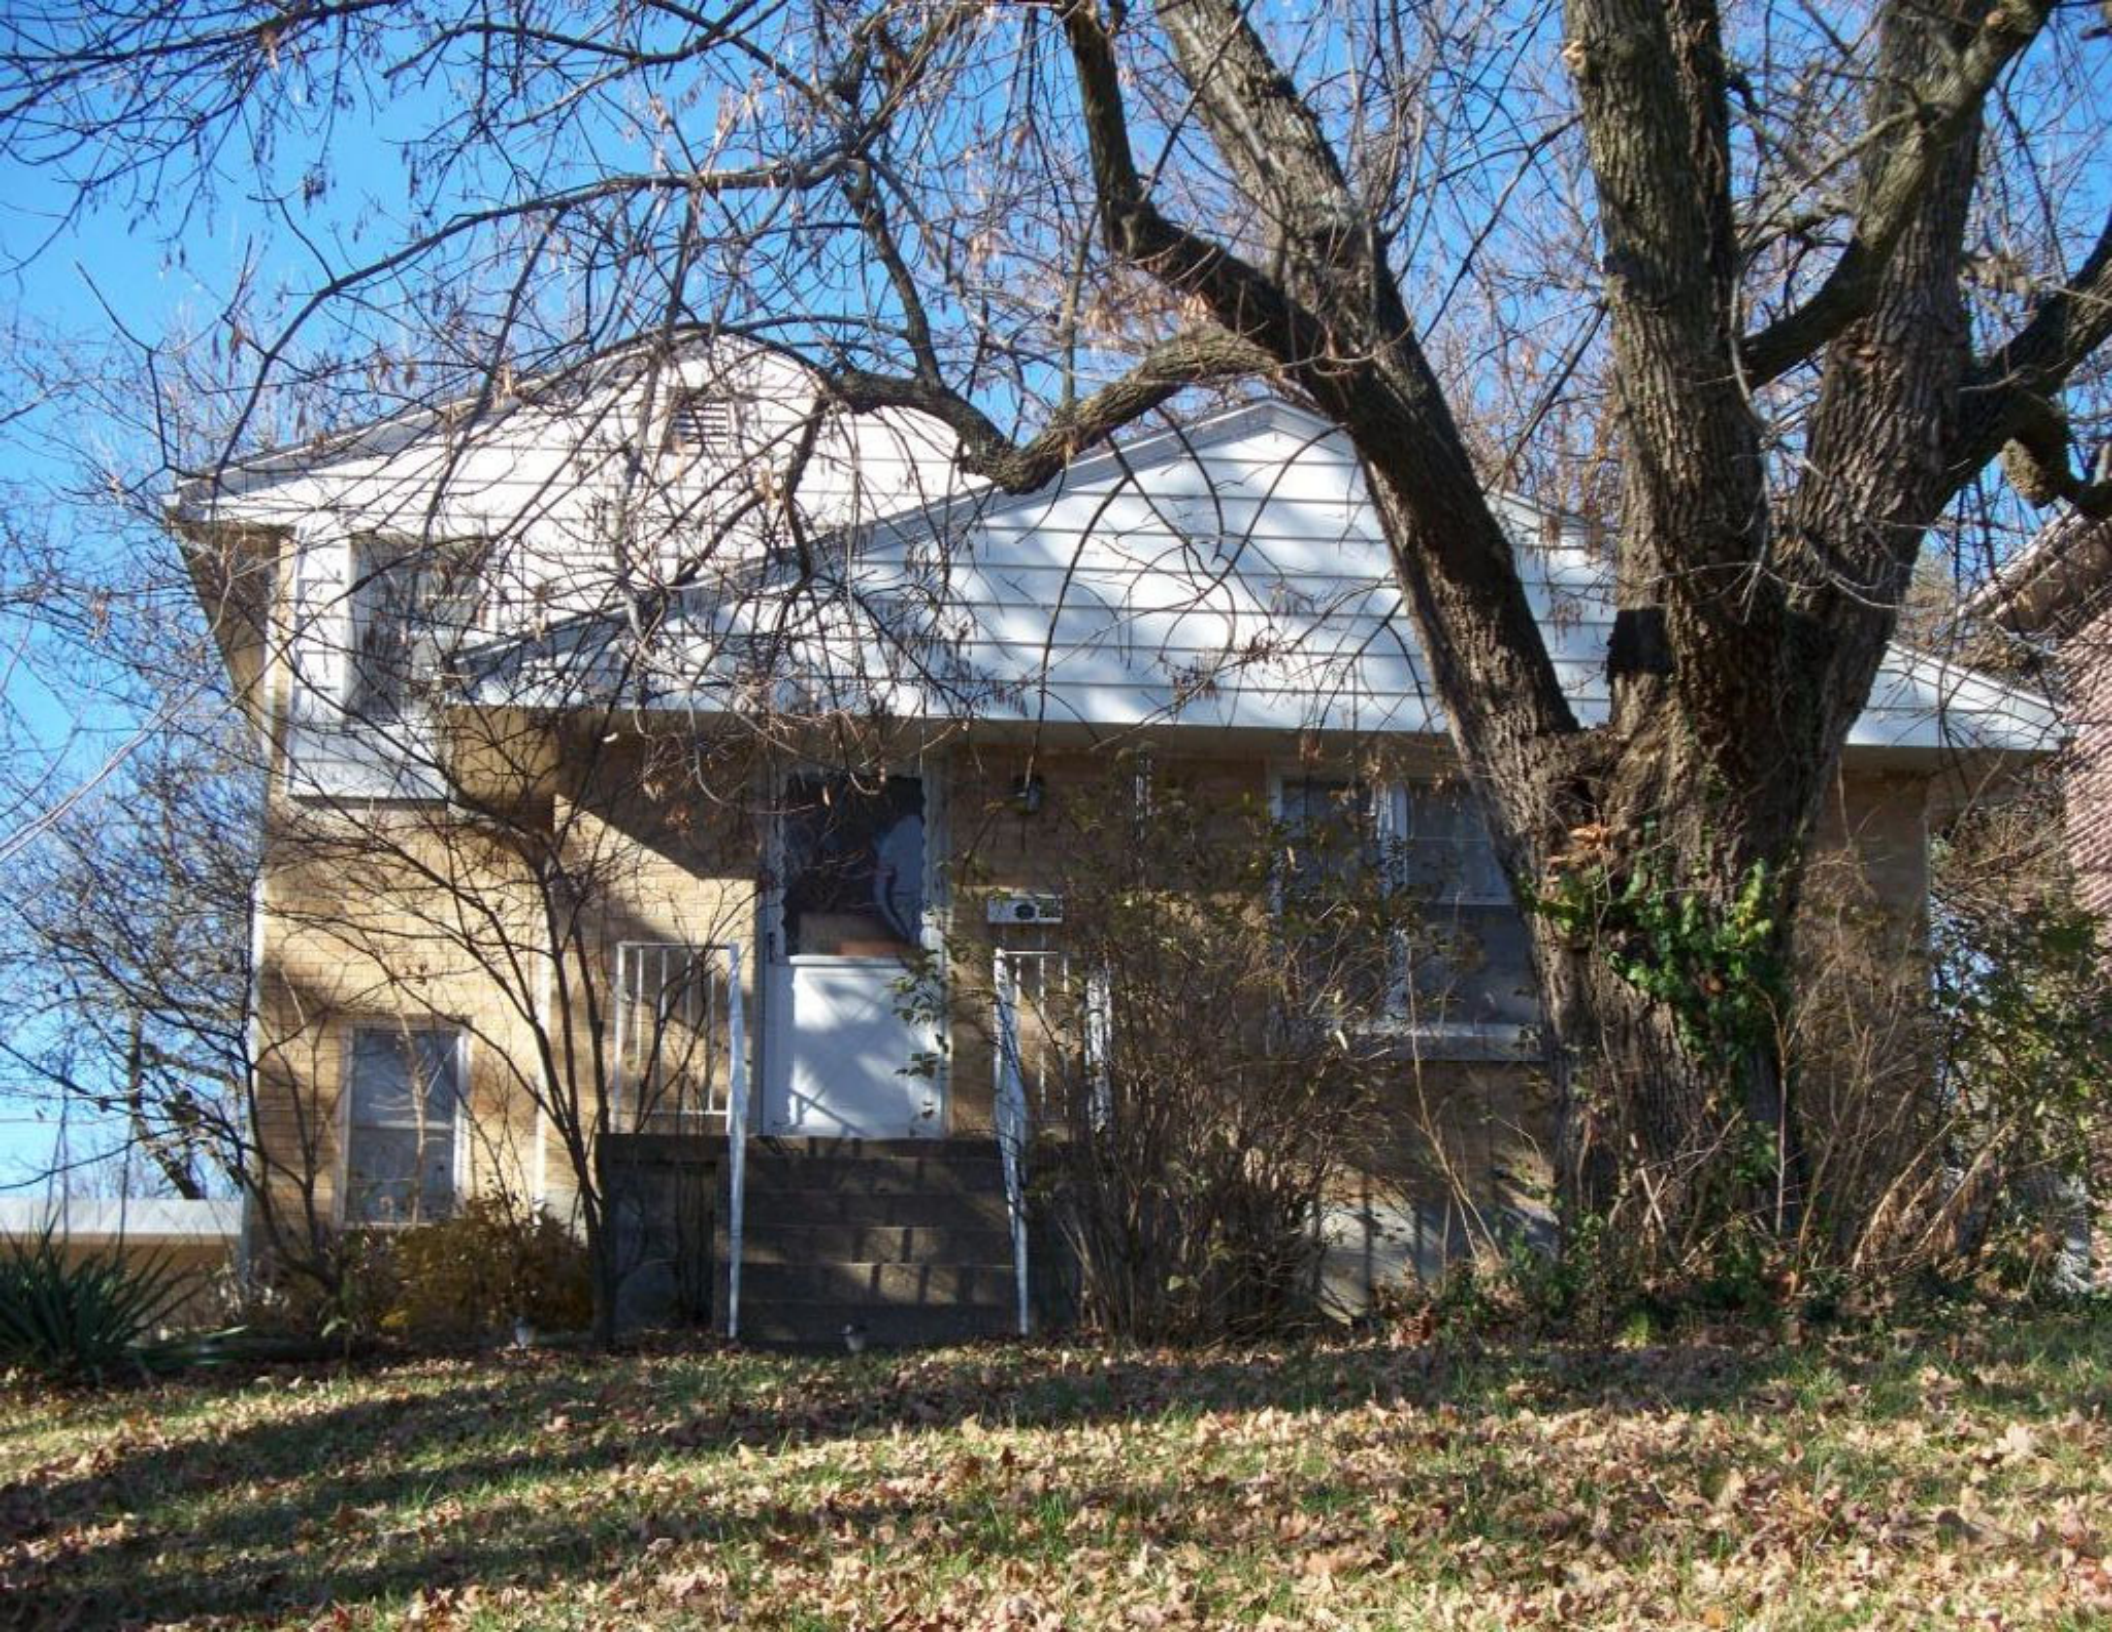
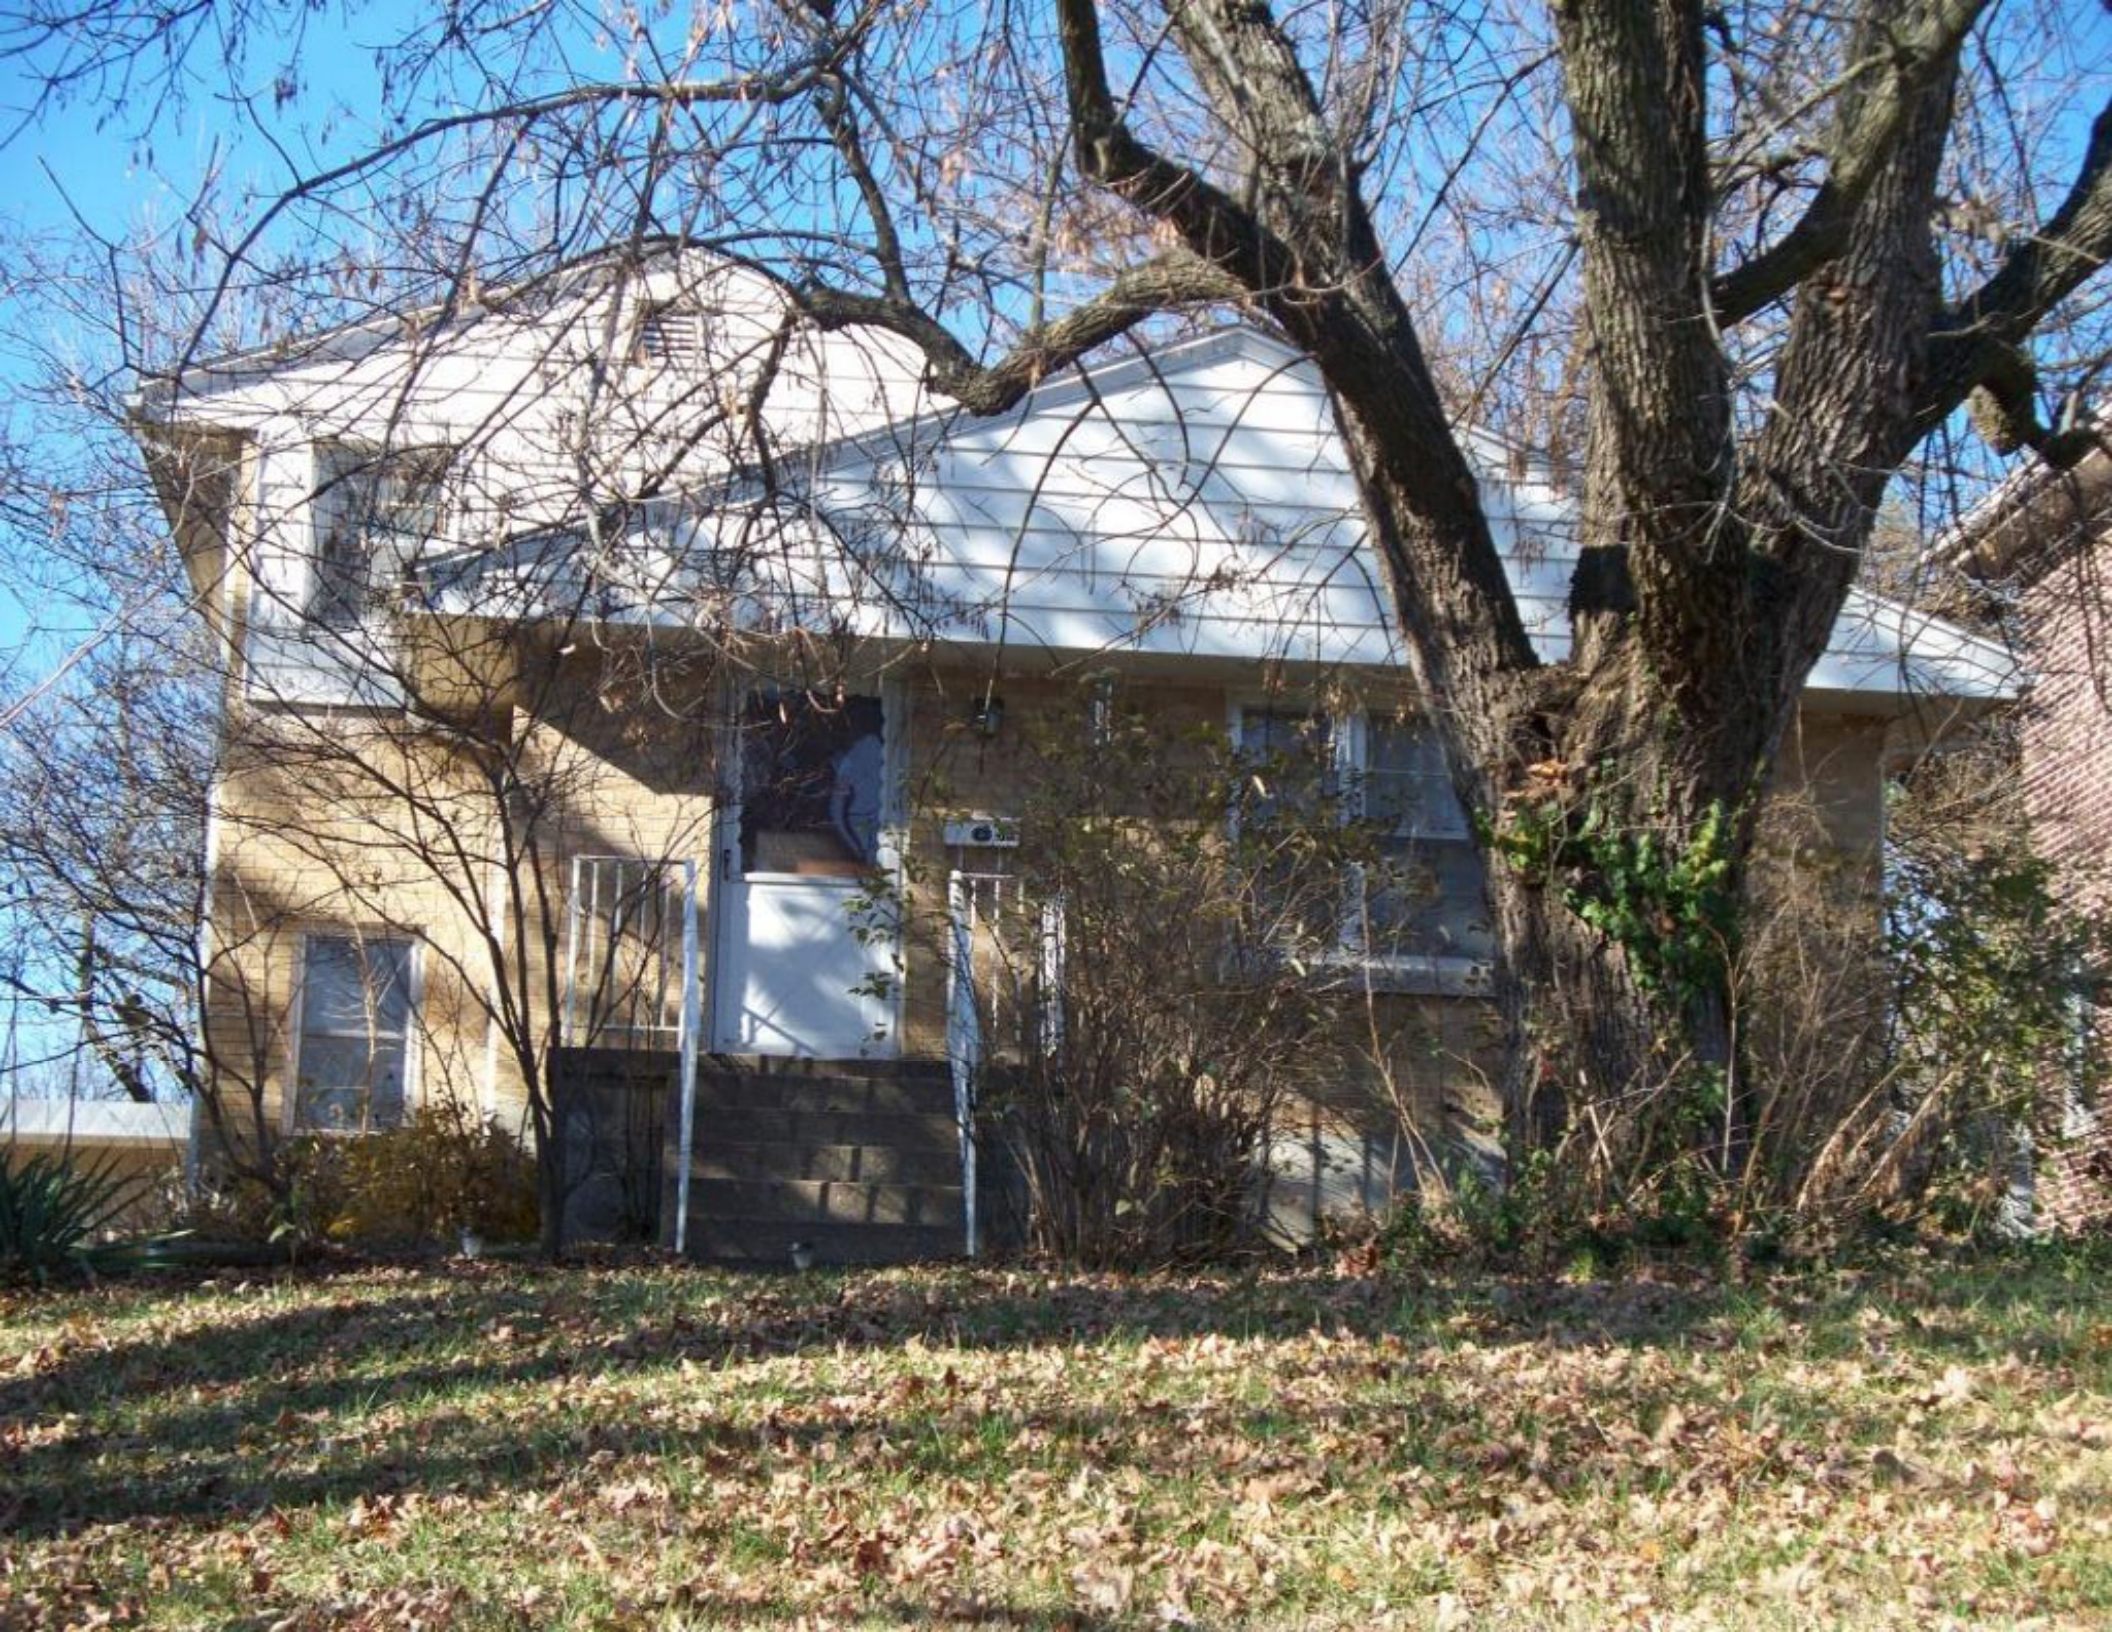
41. (cont.) The date of this two-story split level is undetermined. The Tax Assessor's website dates it as 1930s but it does not appear on the Sanborn maps. It may have been built in the late 1950s or the 1960s; further research is needed. The primary façade is one-story with two bays, it projects from the two-story portion of the house. Both parts have vinyl siding in the upper gables. As it was likely built after the recommended period of significance and is out of character with the rest of the neighborhood, it is considered non-contributing to the recommended historic district.
