ARCHITECTURAL/HISTORIC INVENTORY FORM

1. Survey No. CO-AS-005-001		2. Survey name: Moreau Drive Neighborhood Survey	
3. County: Cole		4. Address: 1202 Elmerine Ave.	
5. City: Jefferson City	Vicinity: <input type="checkbox"/>	6. UTM: / /	7. Township/Range/Section: T: R: S:
8. Historic name (if known):		9. Present/other name (if known):	
10. Ownership: <input checked="" type="checkbox"/> Private <input type="checkbox"/> Public		11. Historic use (if known): Residential	11. Current use: Residential

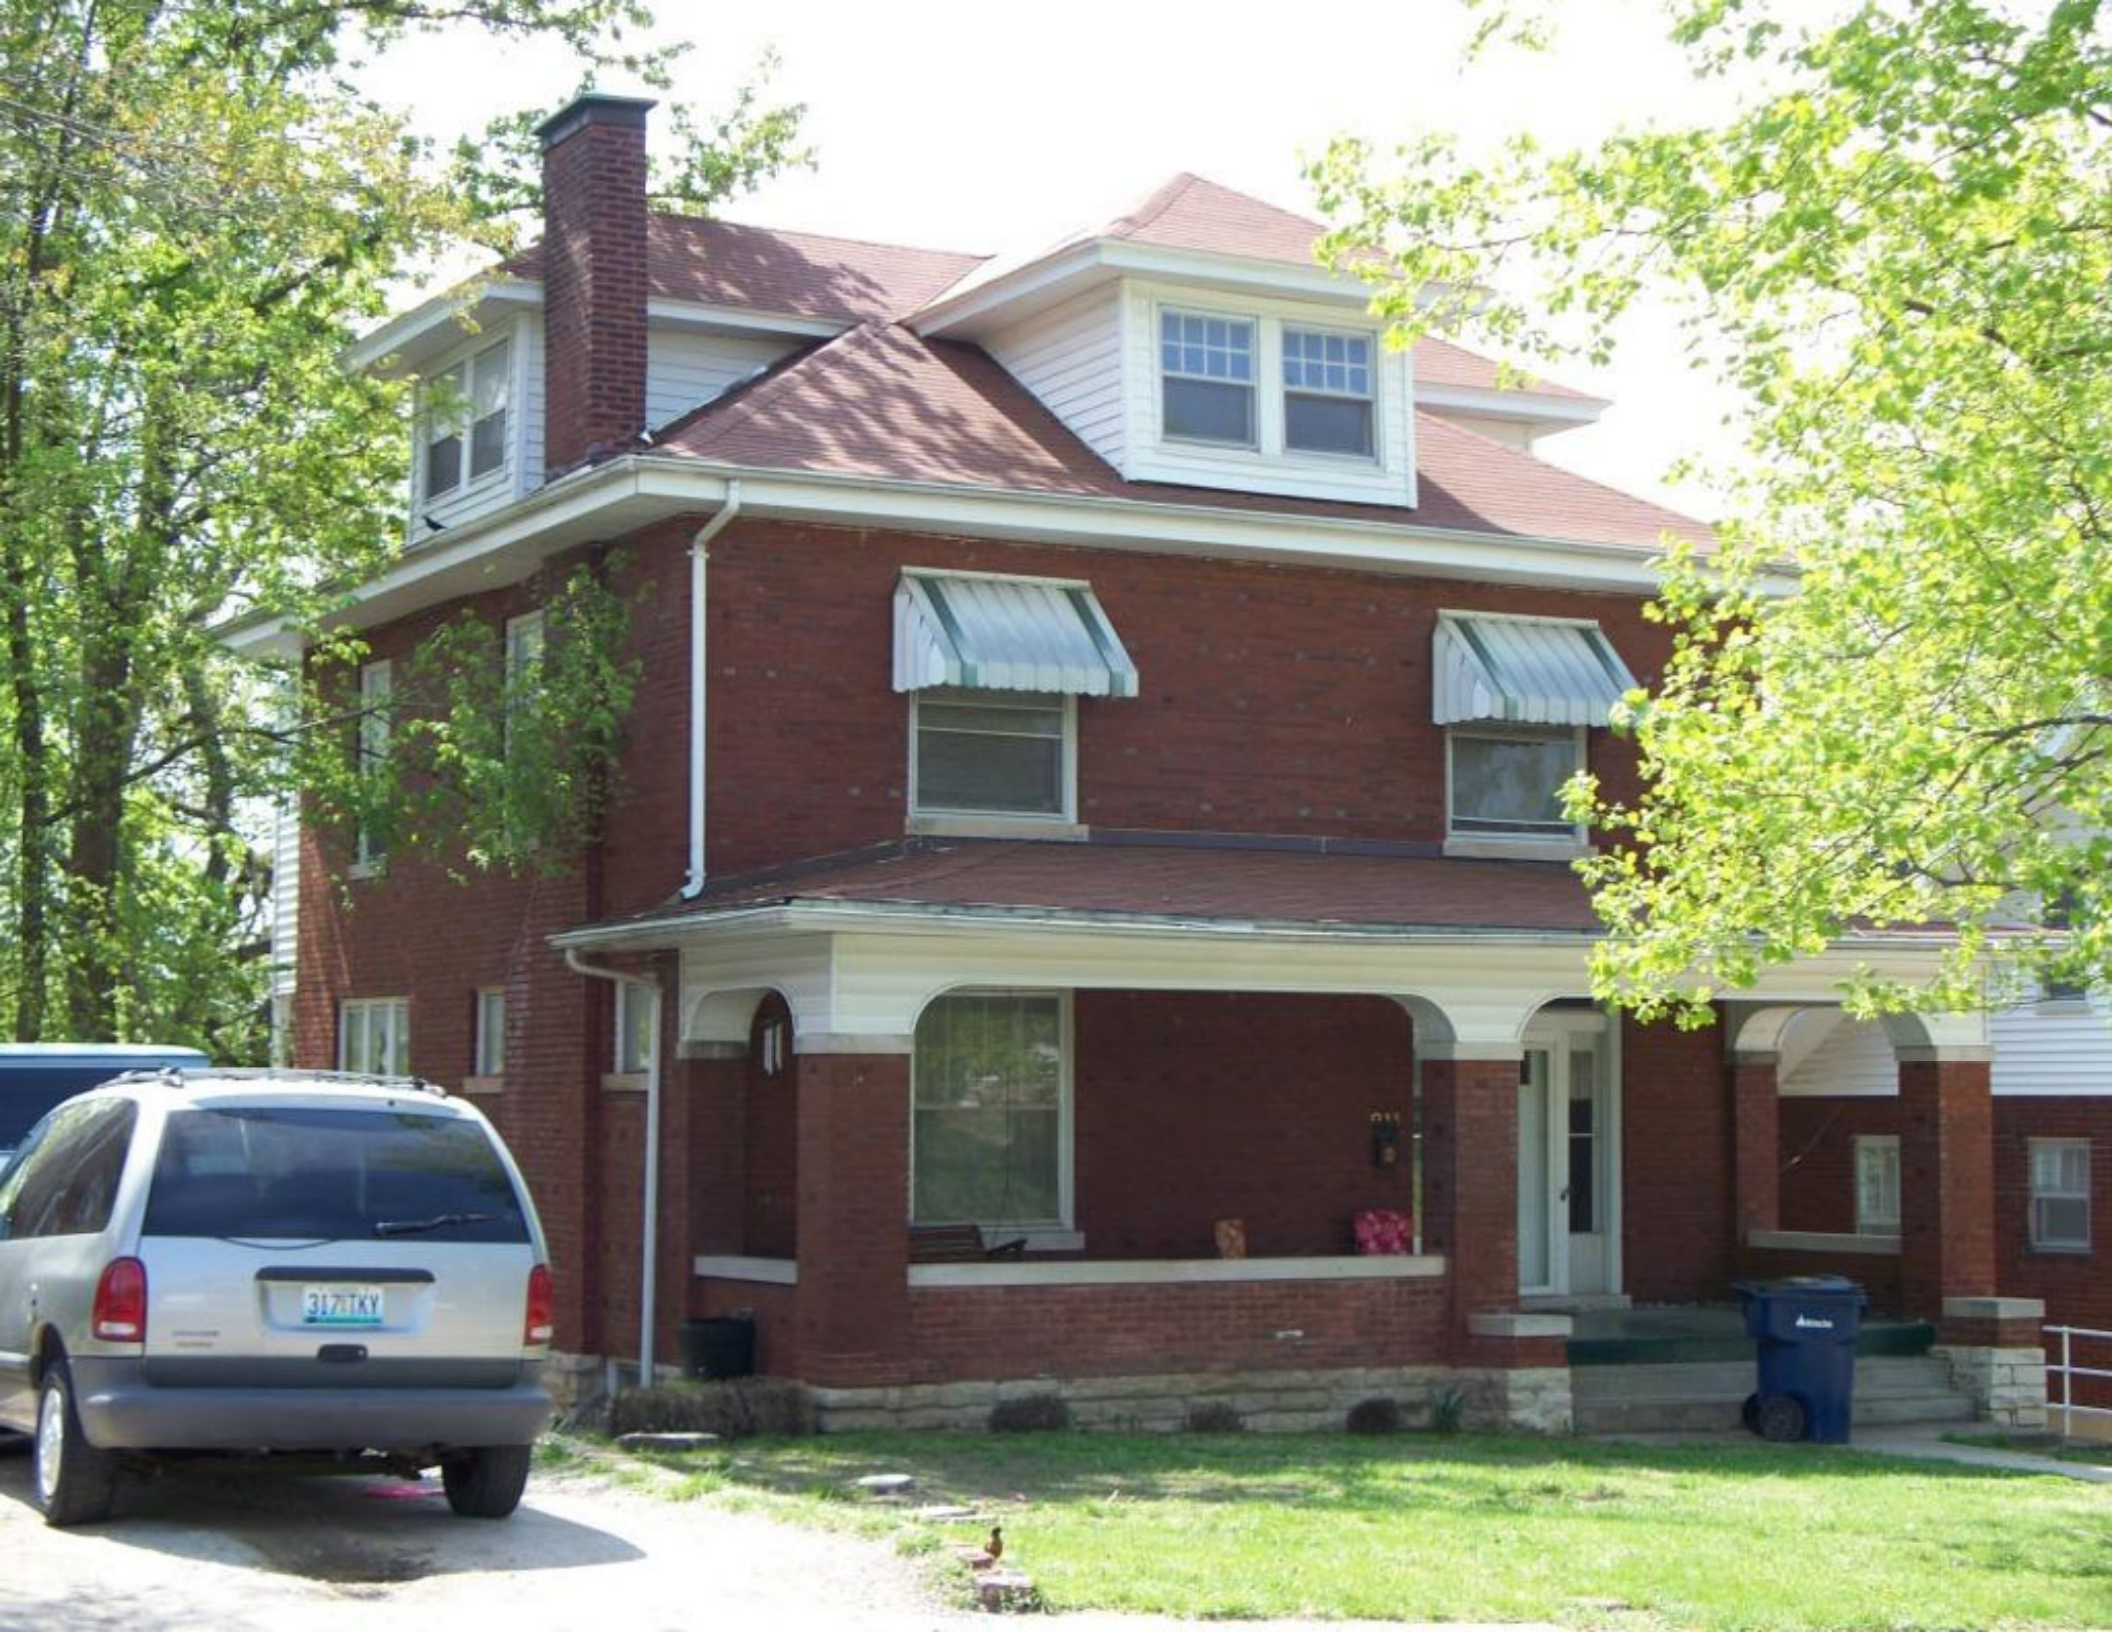
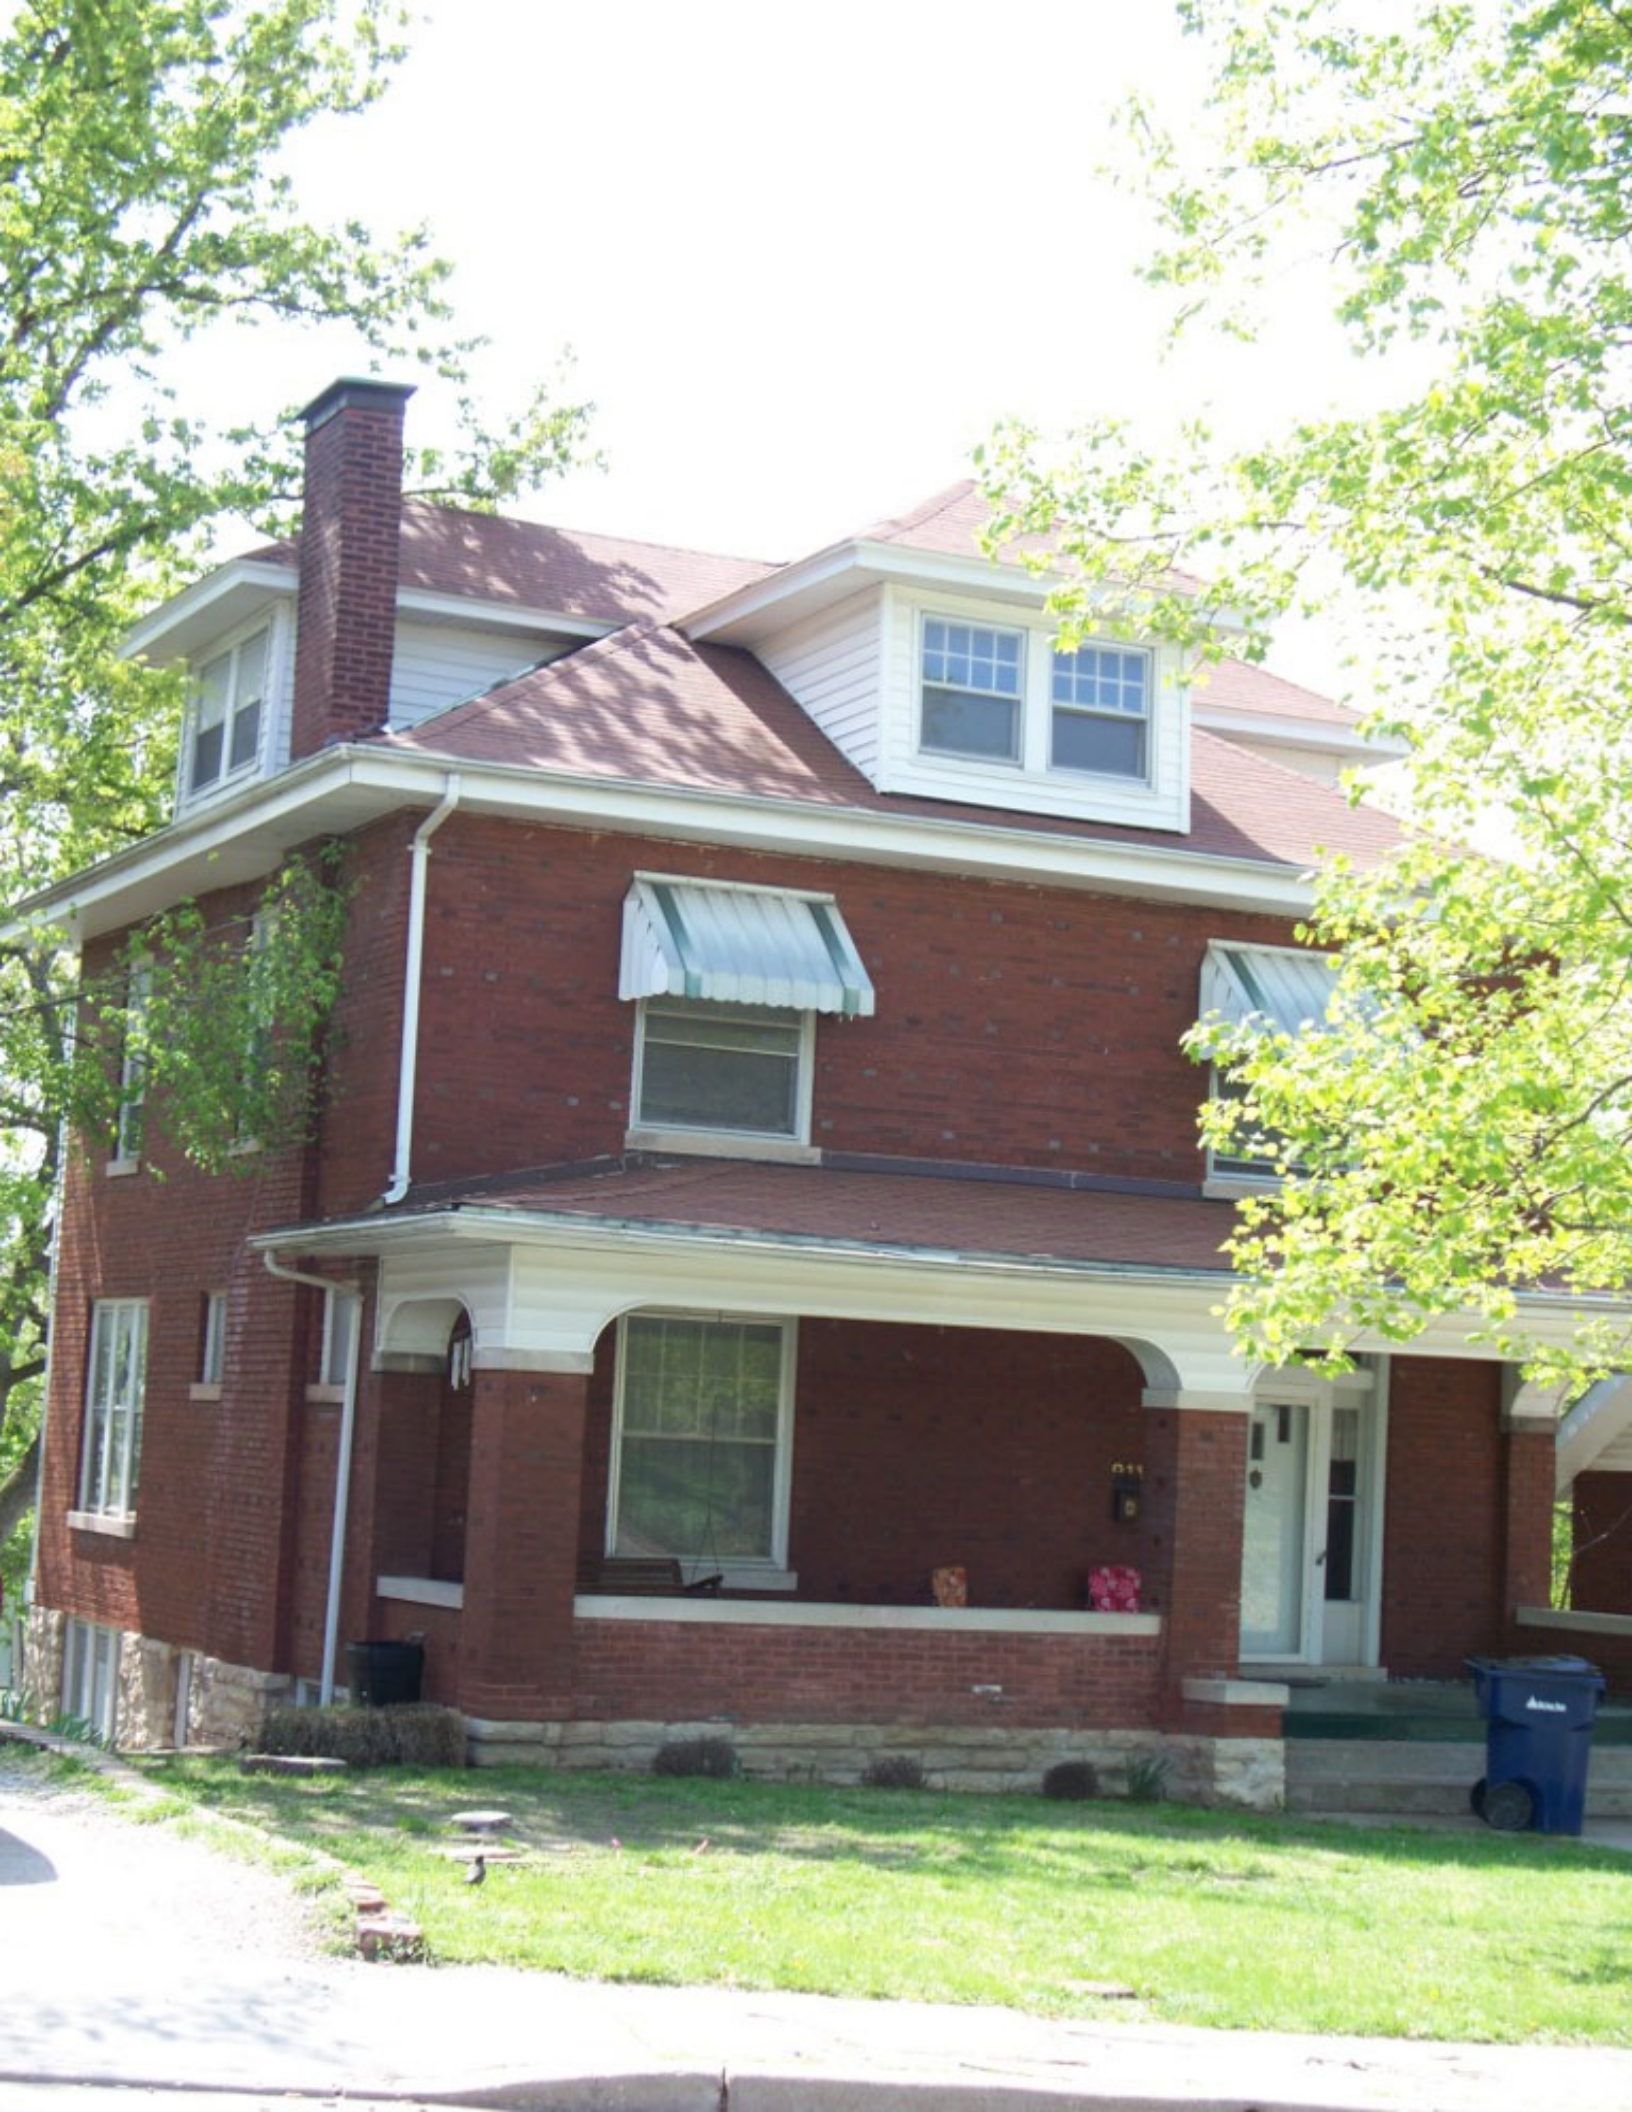
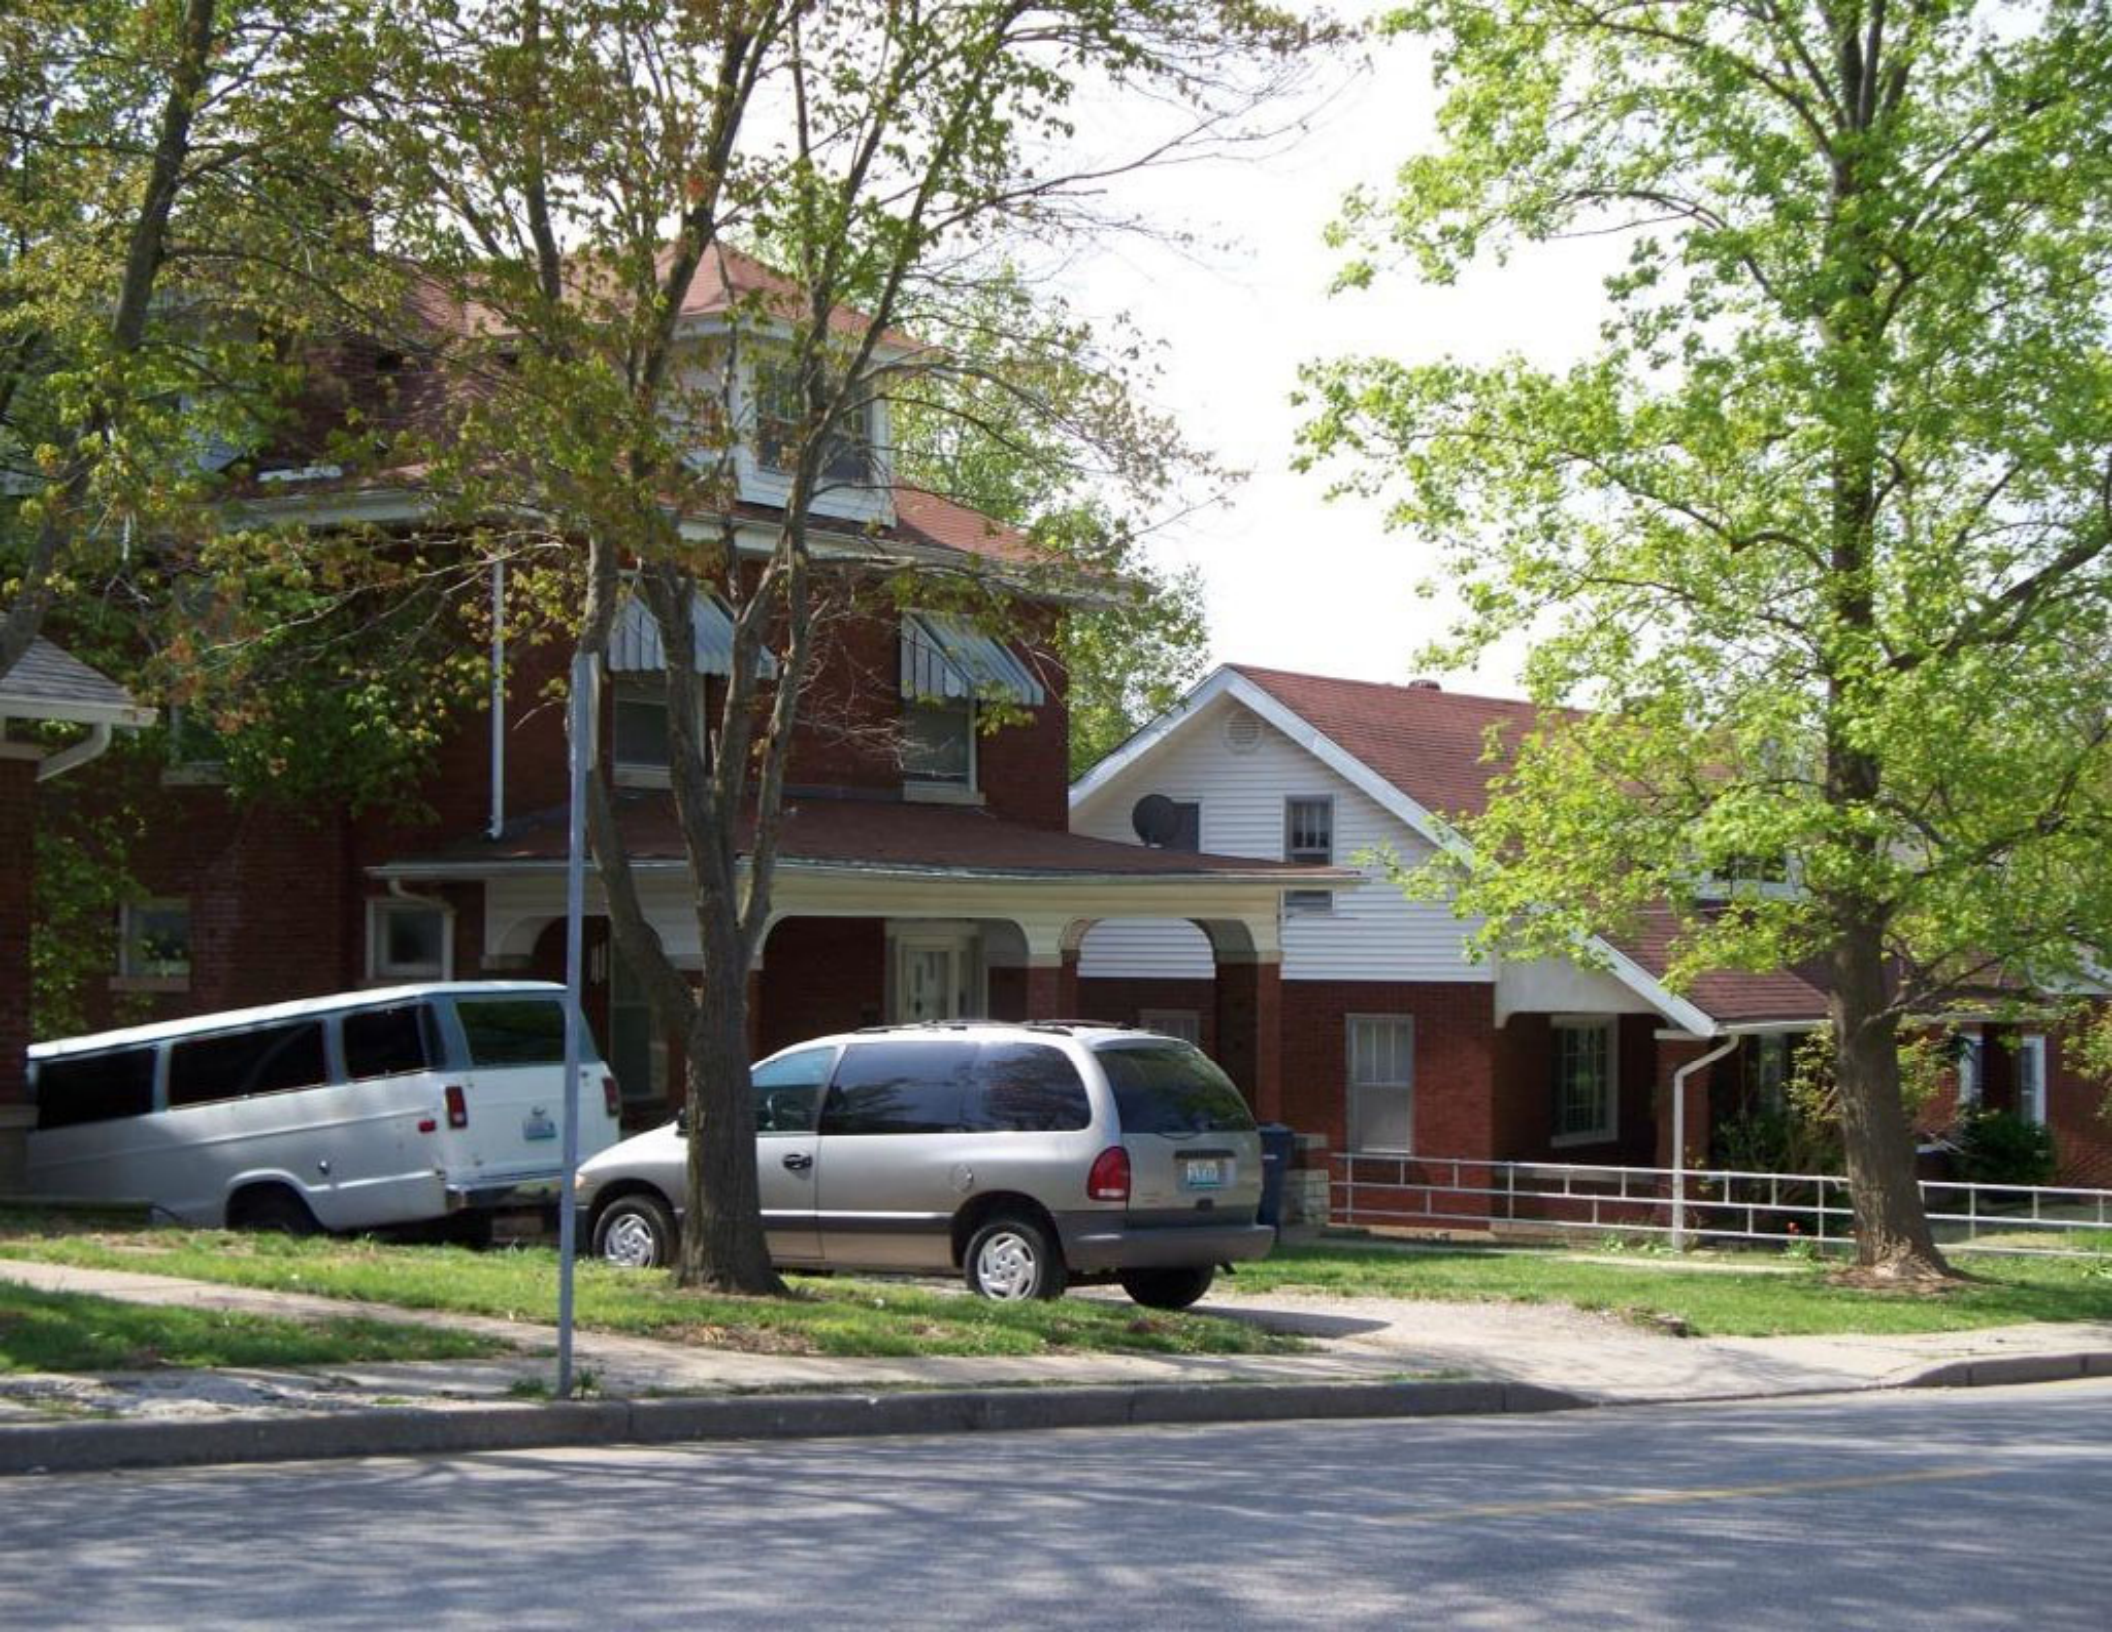
This 2 ½ story four square has a stone foundation, full width porch with thick brick piers and half walls, aluminum hoods over the two second story windows and a centered pyramidal roof dormer at the top with two 8/1 windows. The entrance is offset to the right (south) of the frontal façade and has sidelights and possibly a transom (difficult to assess from street, porch roof obscured view). A single 8/1 window that may be historic is on the other side of the façade. The upper most story has a cross hip consisting of two dormers facing the adjacent properties, each with two windows.

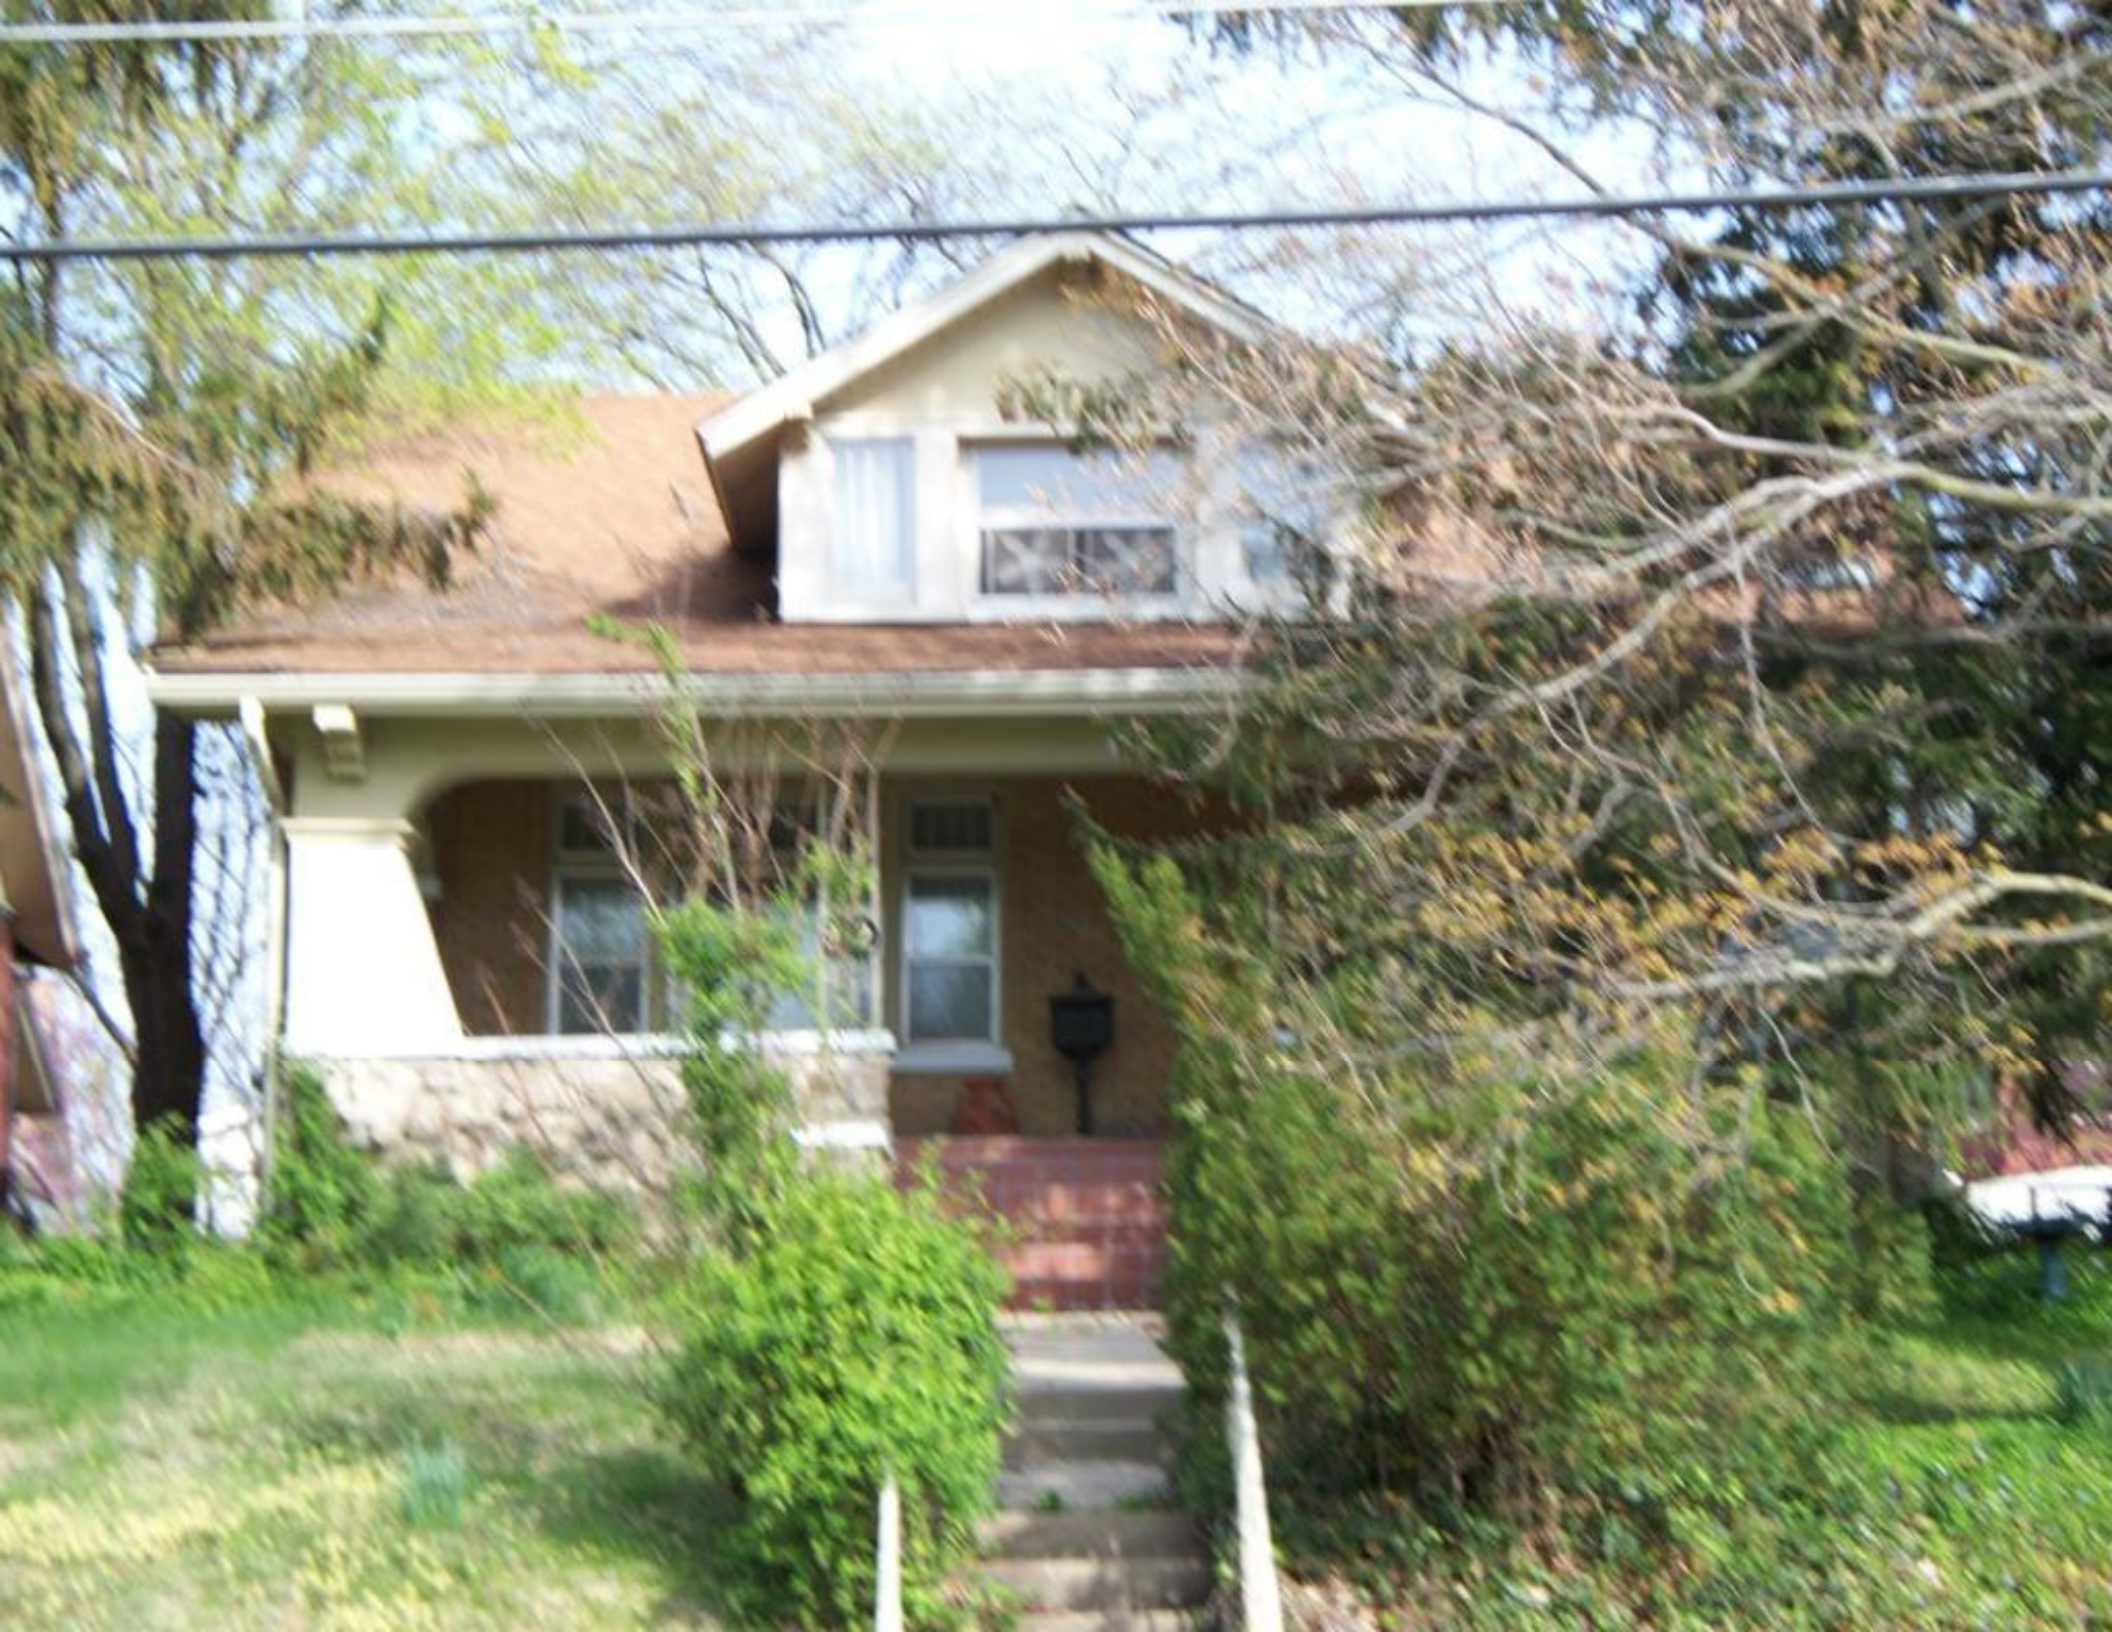
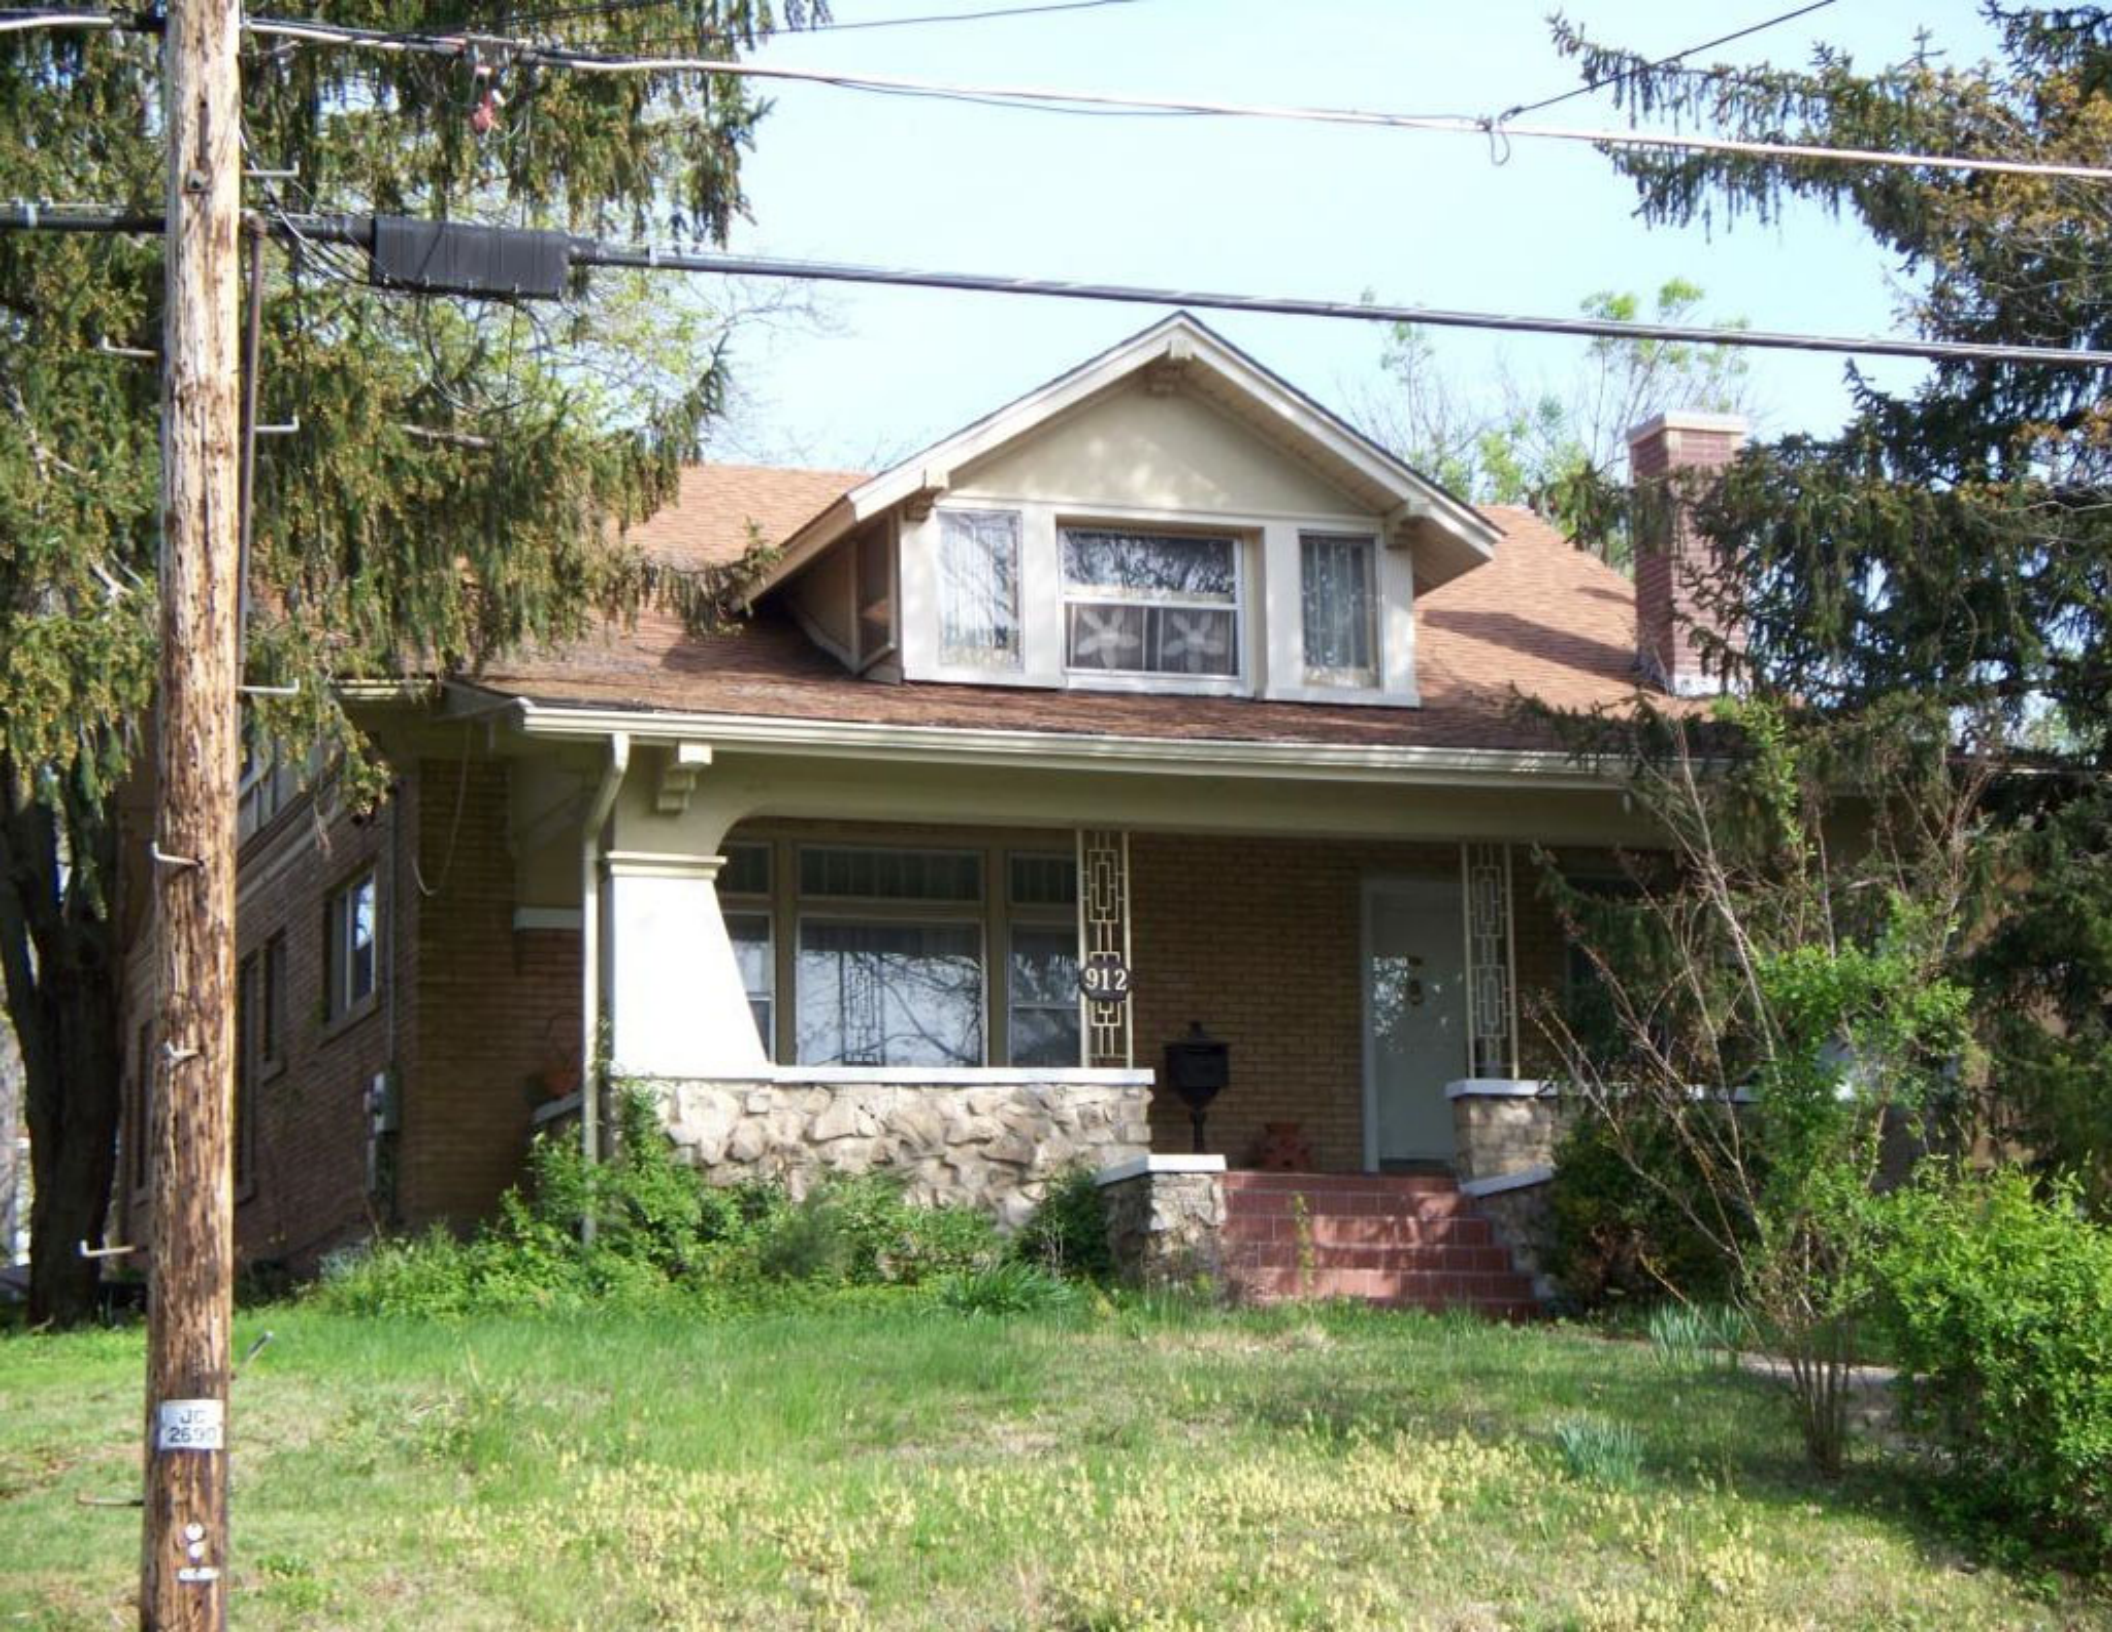
41. (cont.) This one-and-a-half story brick bungalow has a side gable roof and central dormer with a 1/1 window flanked by sashed casement windows. The windows appear historic and seem to have storms. The porch has stone walls and half-walls capped in limestone with decorative metal posts. The entrance is off-set to the right with a window at the end a large picture window, flanked but two smaller windows to the left. These windows have storms and multi-light transoms. The property displays some Craftsman features such as the large battered piers and decorative brackets on the porch and dormer rooflines.
