ARCHITECTURAL/HISTORIC INVENTORY FORM

1. Survey No. CO-AS-005-001		2. Survey name: Moreau Drive Neighborhood Survey	
3. County: Cole		4. Address: 1202 Elmerine Ave.	
5. City: Jefferson City	Vicinity: <input type="checkbox"/>	6. UTM: / /	7. Township/Range/Section: T: R: S:
8. Historic name (if known):		9. Present/other name (if known):	
10. Ownership: <input checked="" type="checkbox"/> Private <input type="checkbox"/> Public		11. Historic use (if known): Residential	11. Current use: Residential

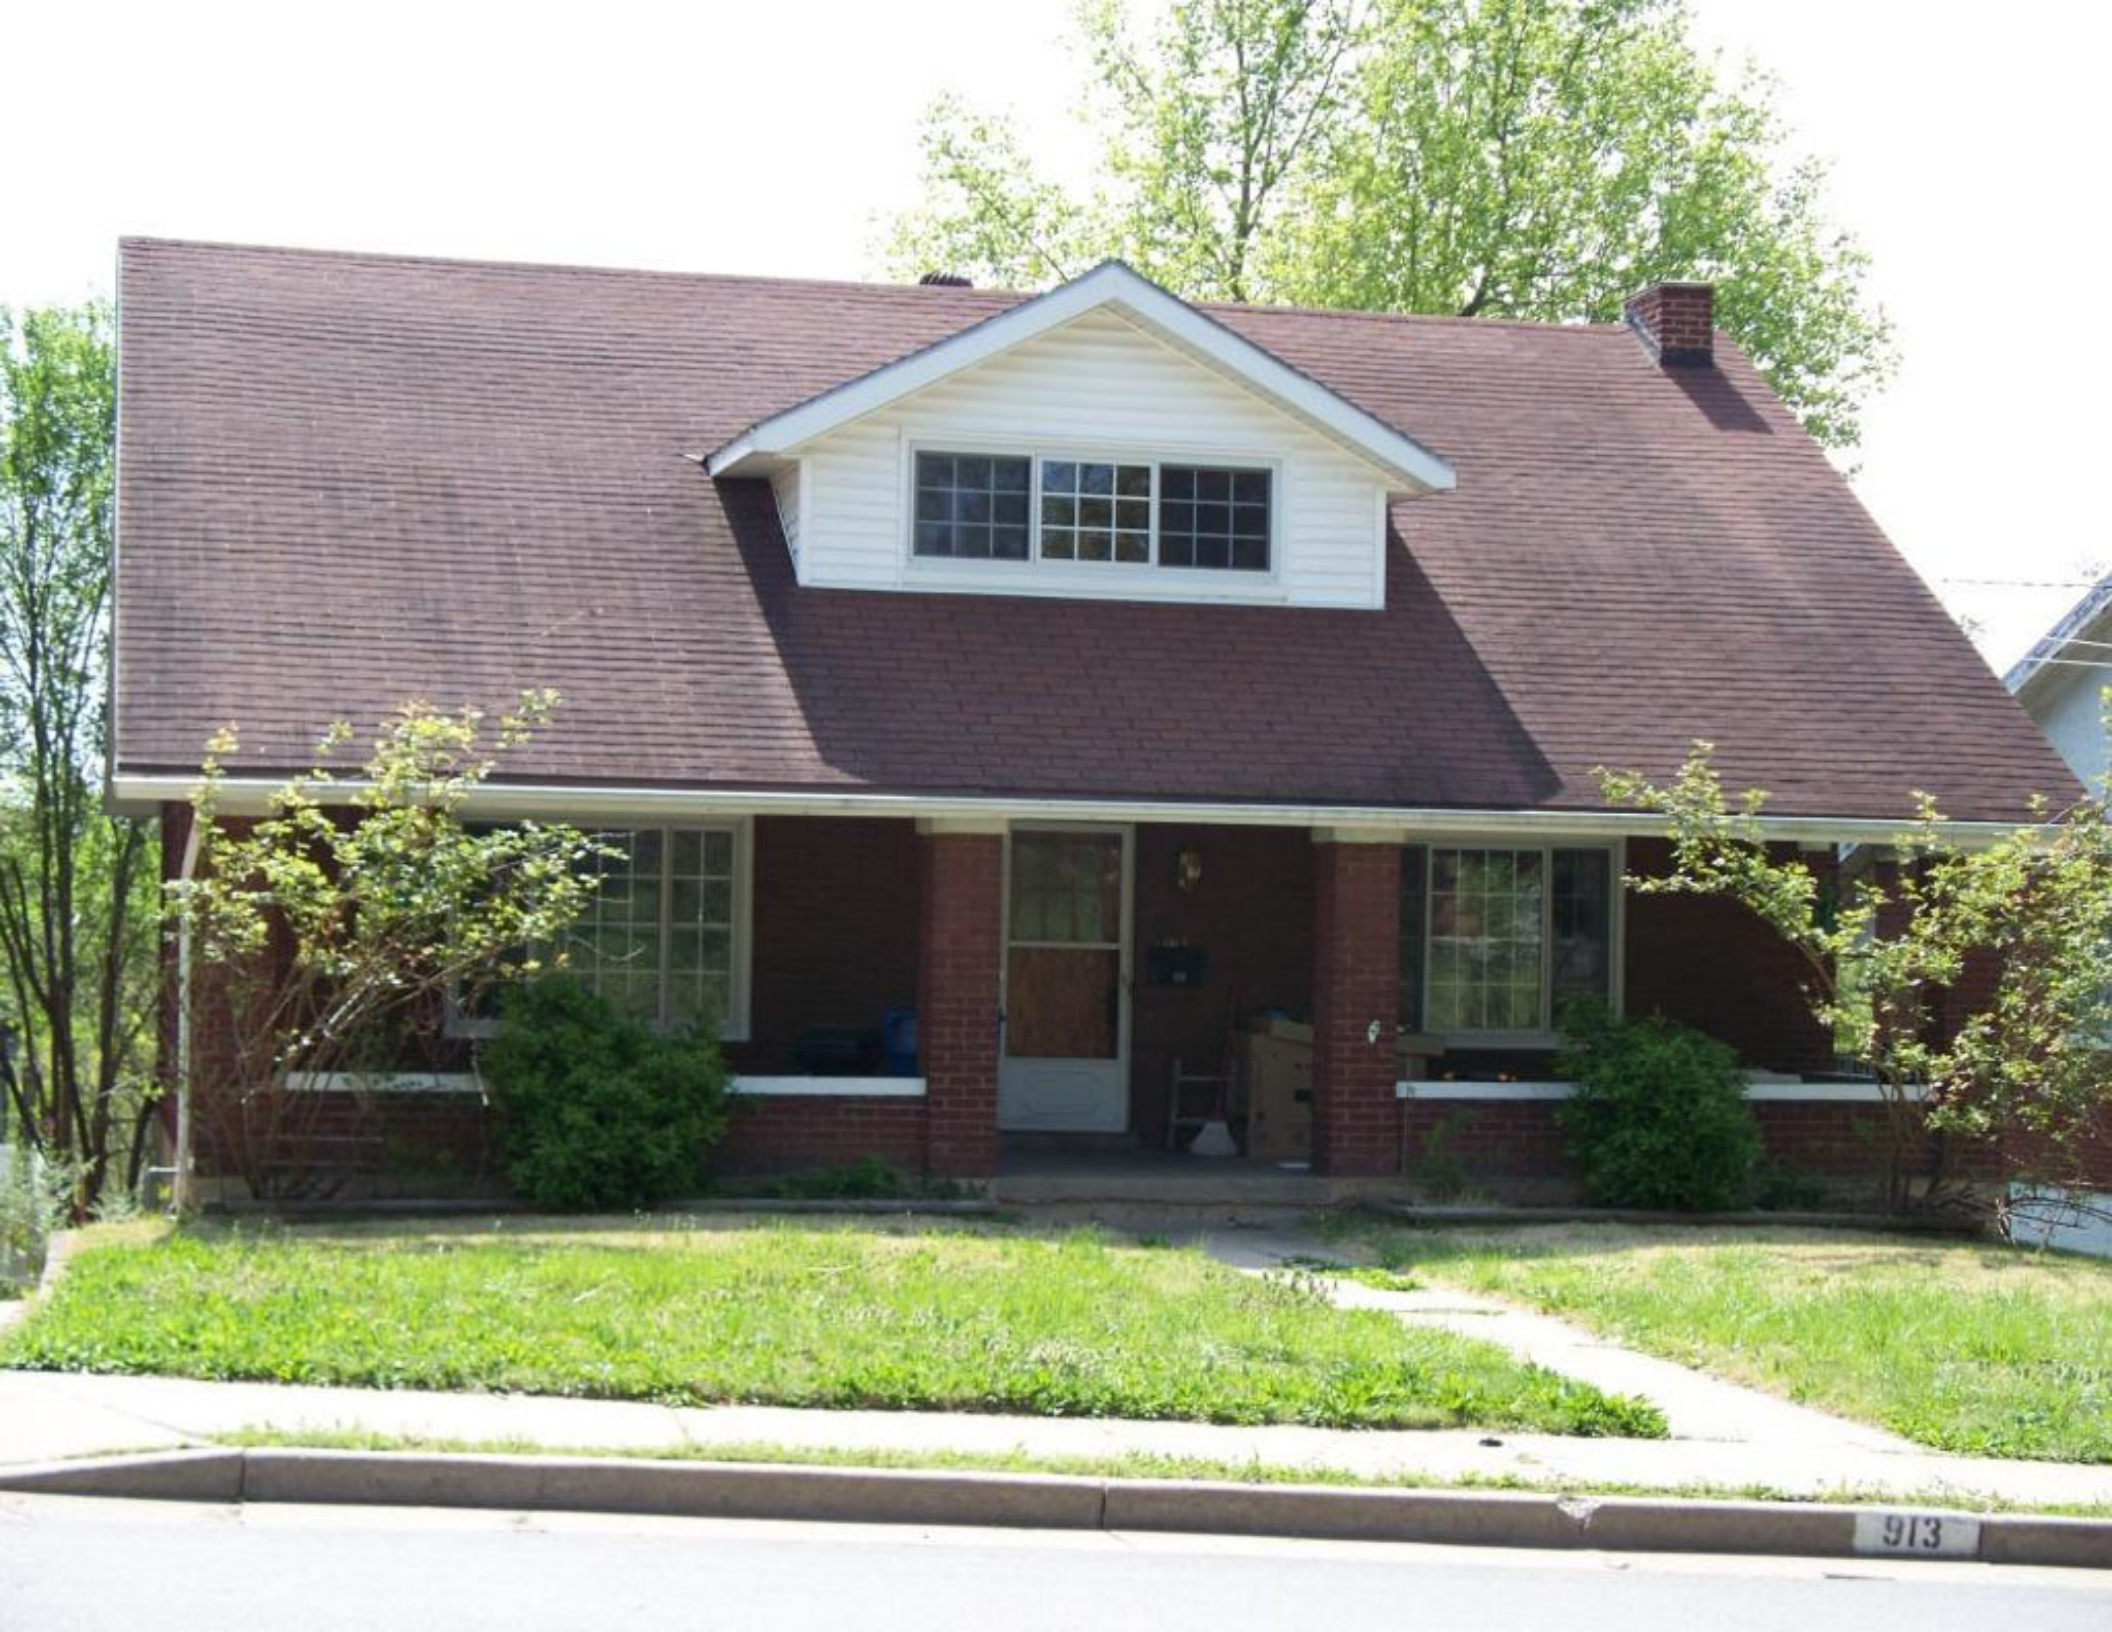
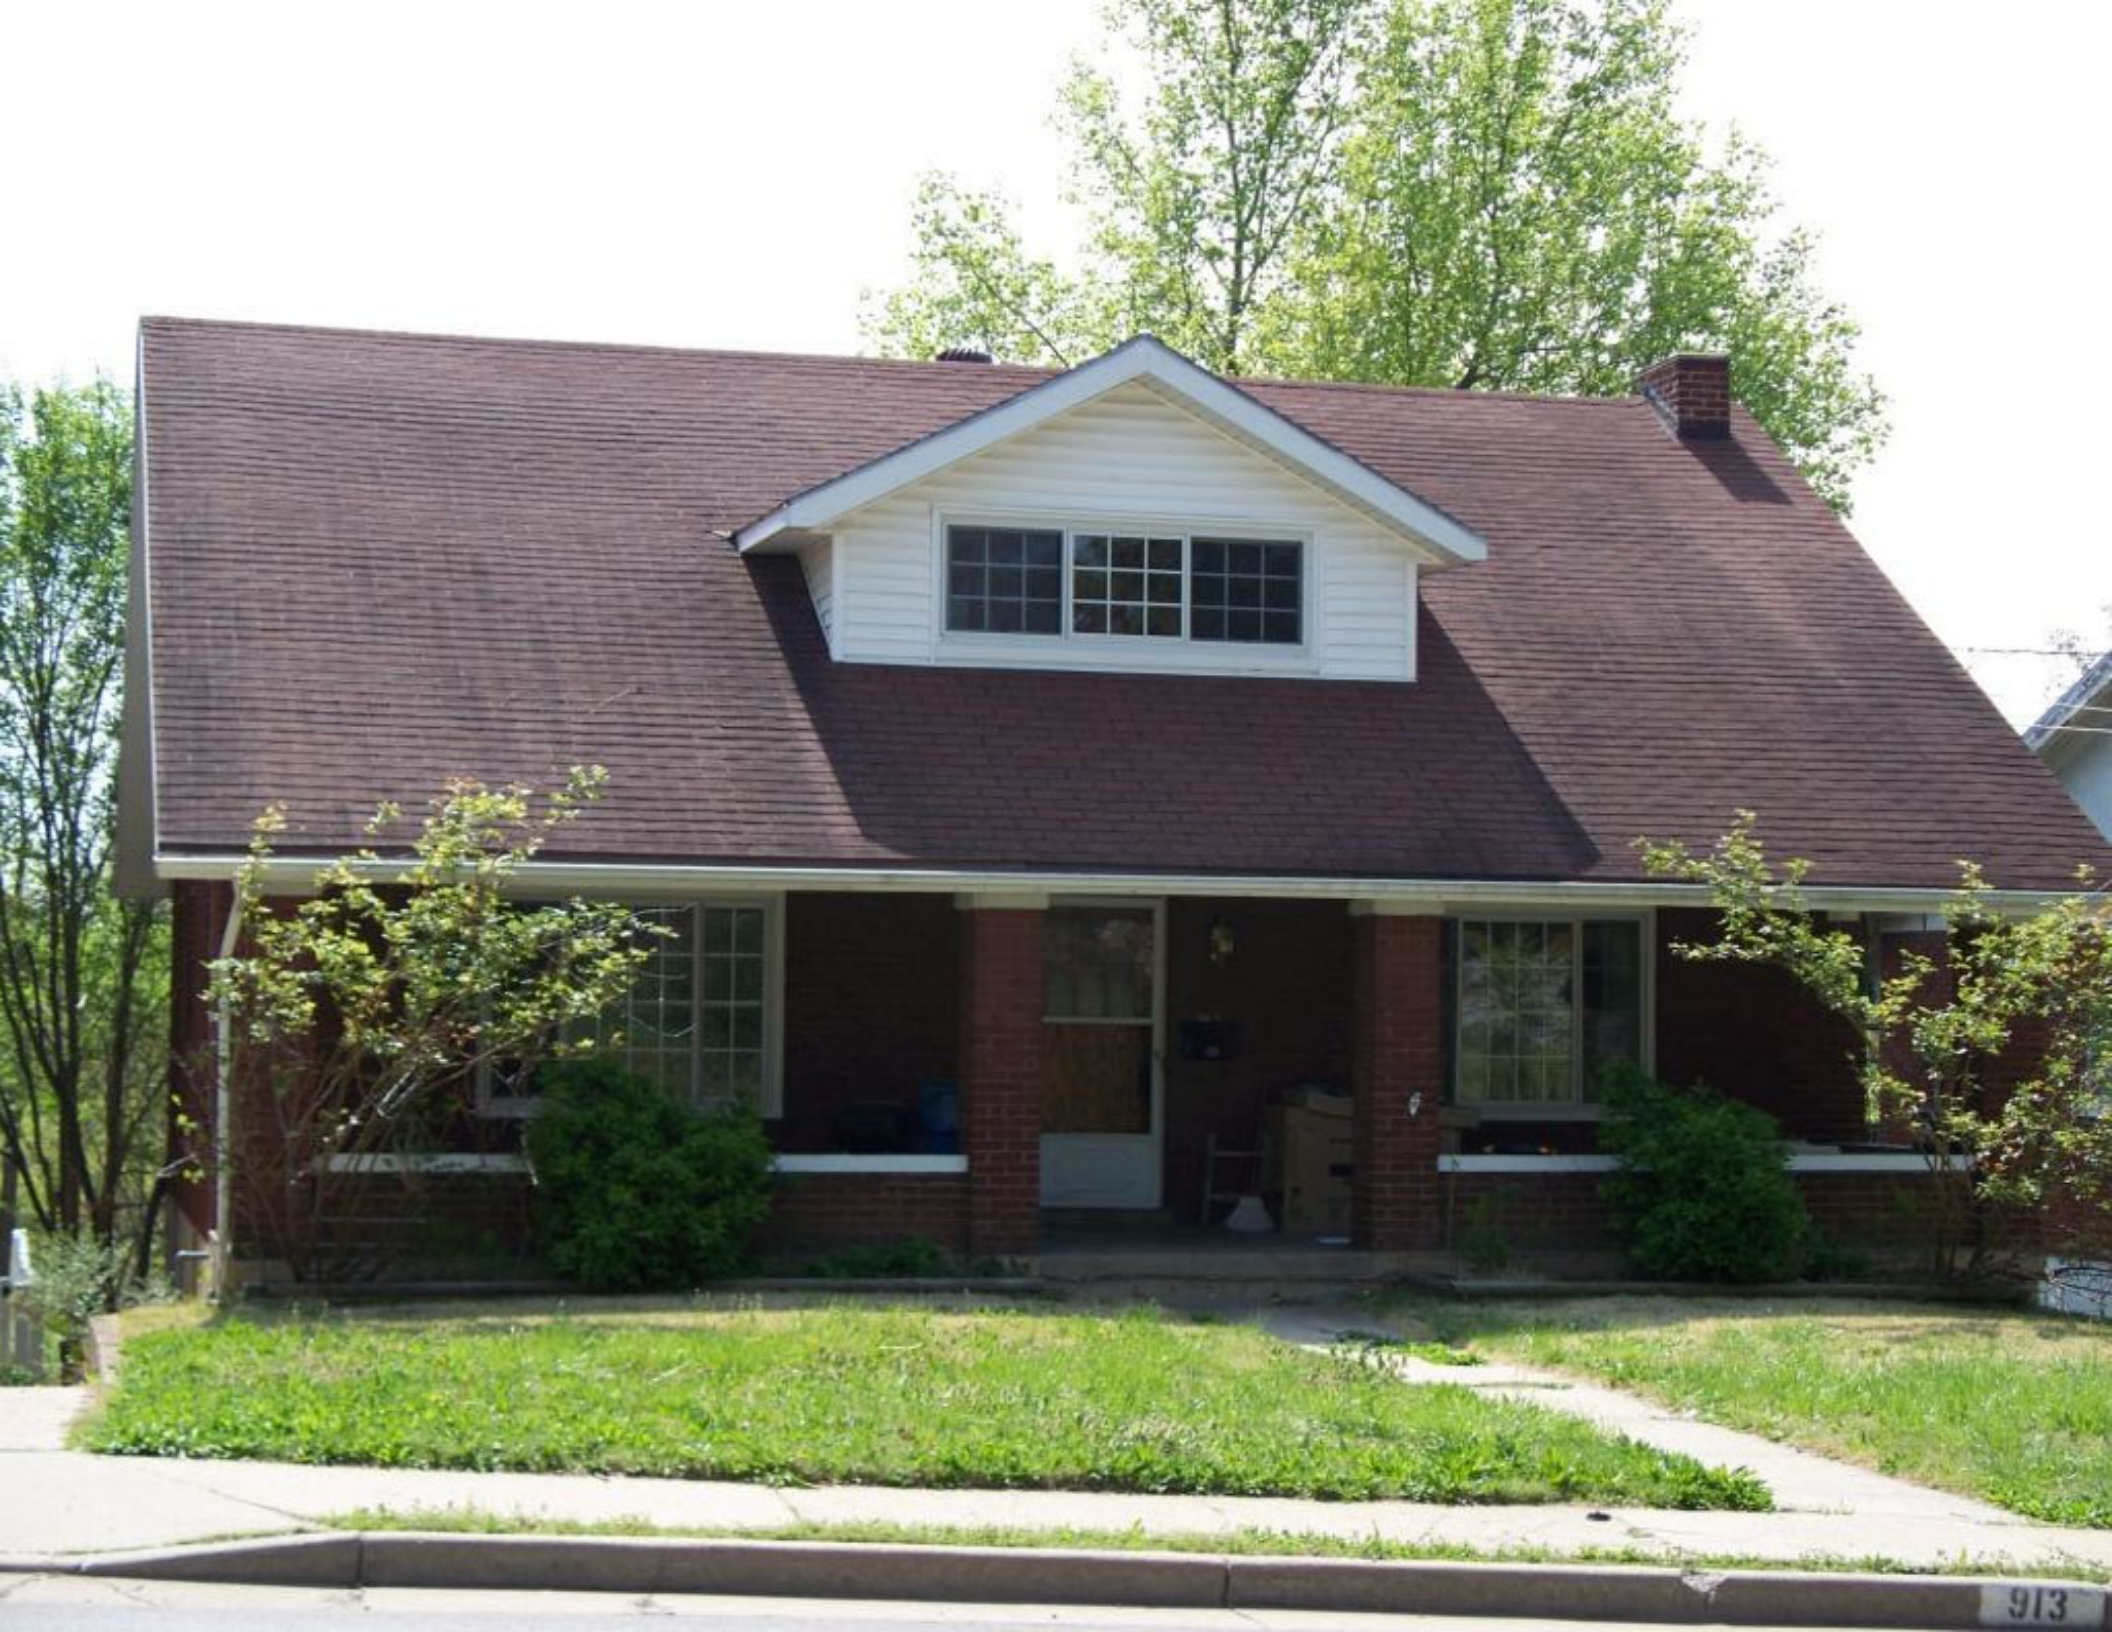
This three bay one and a half story bungalow is long with a prominent side gable roof. The gallery porch features thick square brick piers and half brick walls that are capped with a limestone (or possibly concrete) sill. The large fixed windows on the lower floor flank the central entrance. They appear to be modern grid with a central panel of 9, and flanking panels of 8 squares on each side. There is a gabled squat dormer on the ½ story covered in vinyl with a row of three fixed windows with a similar grid pattern (9 squares each). The mullions of the windows may or may not be genuine.

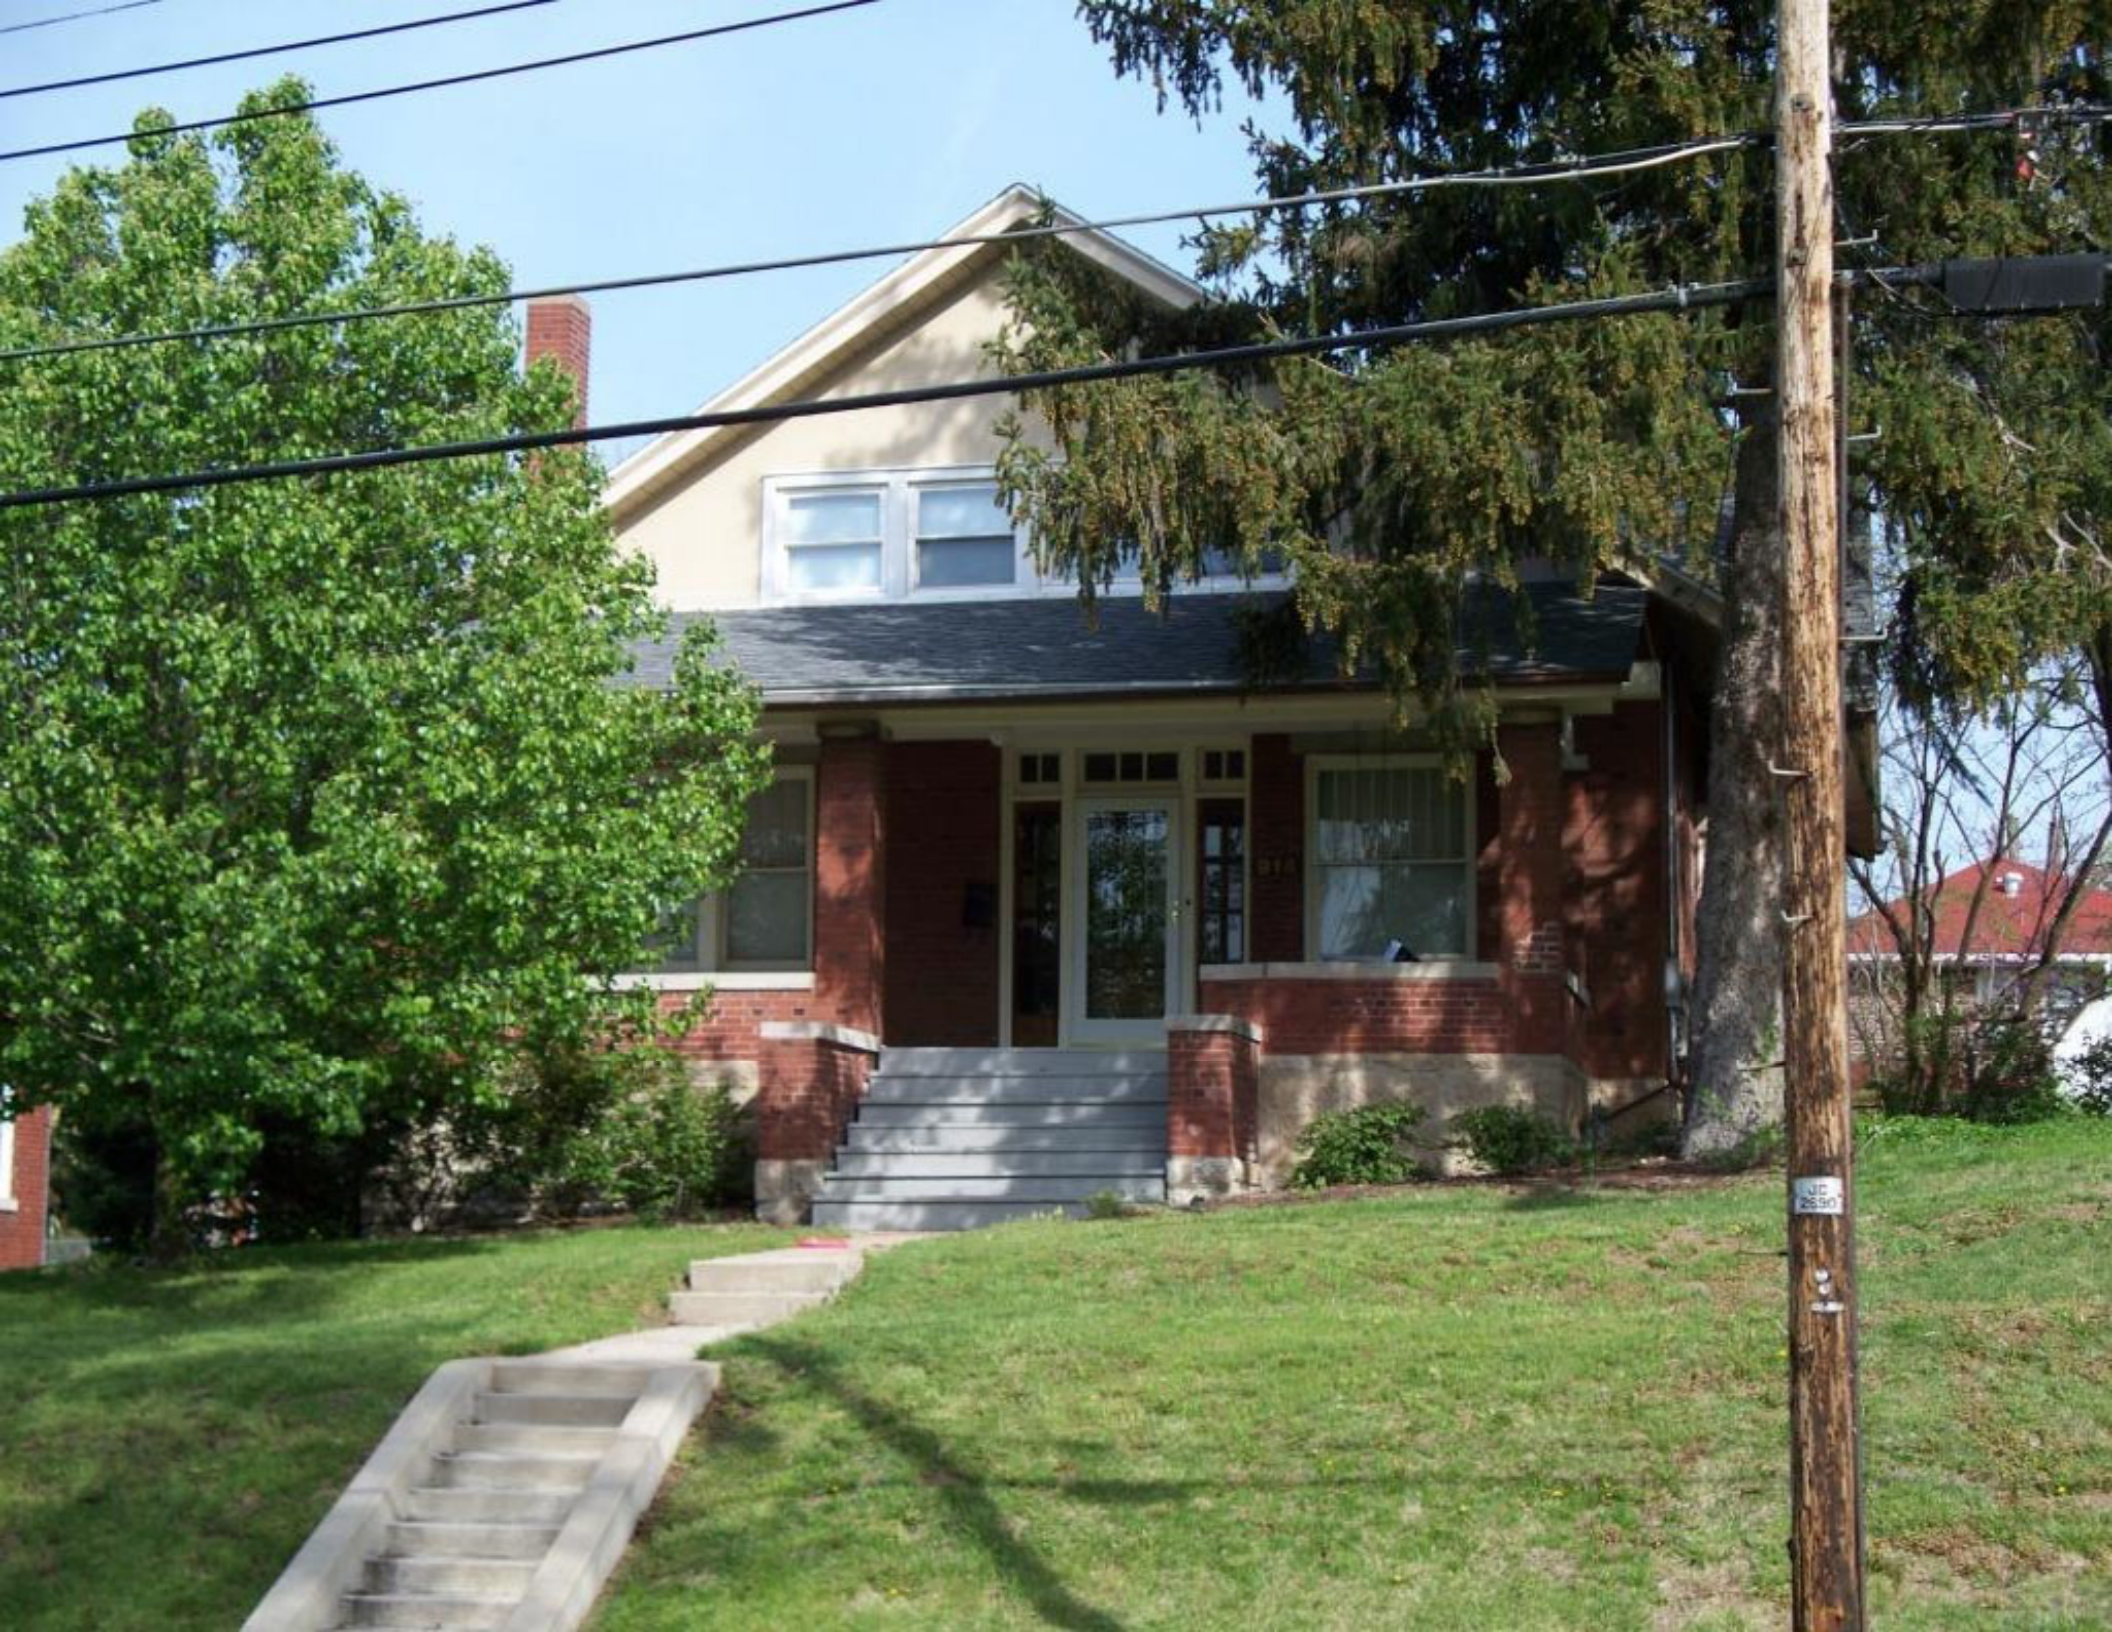
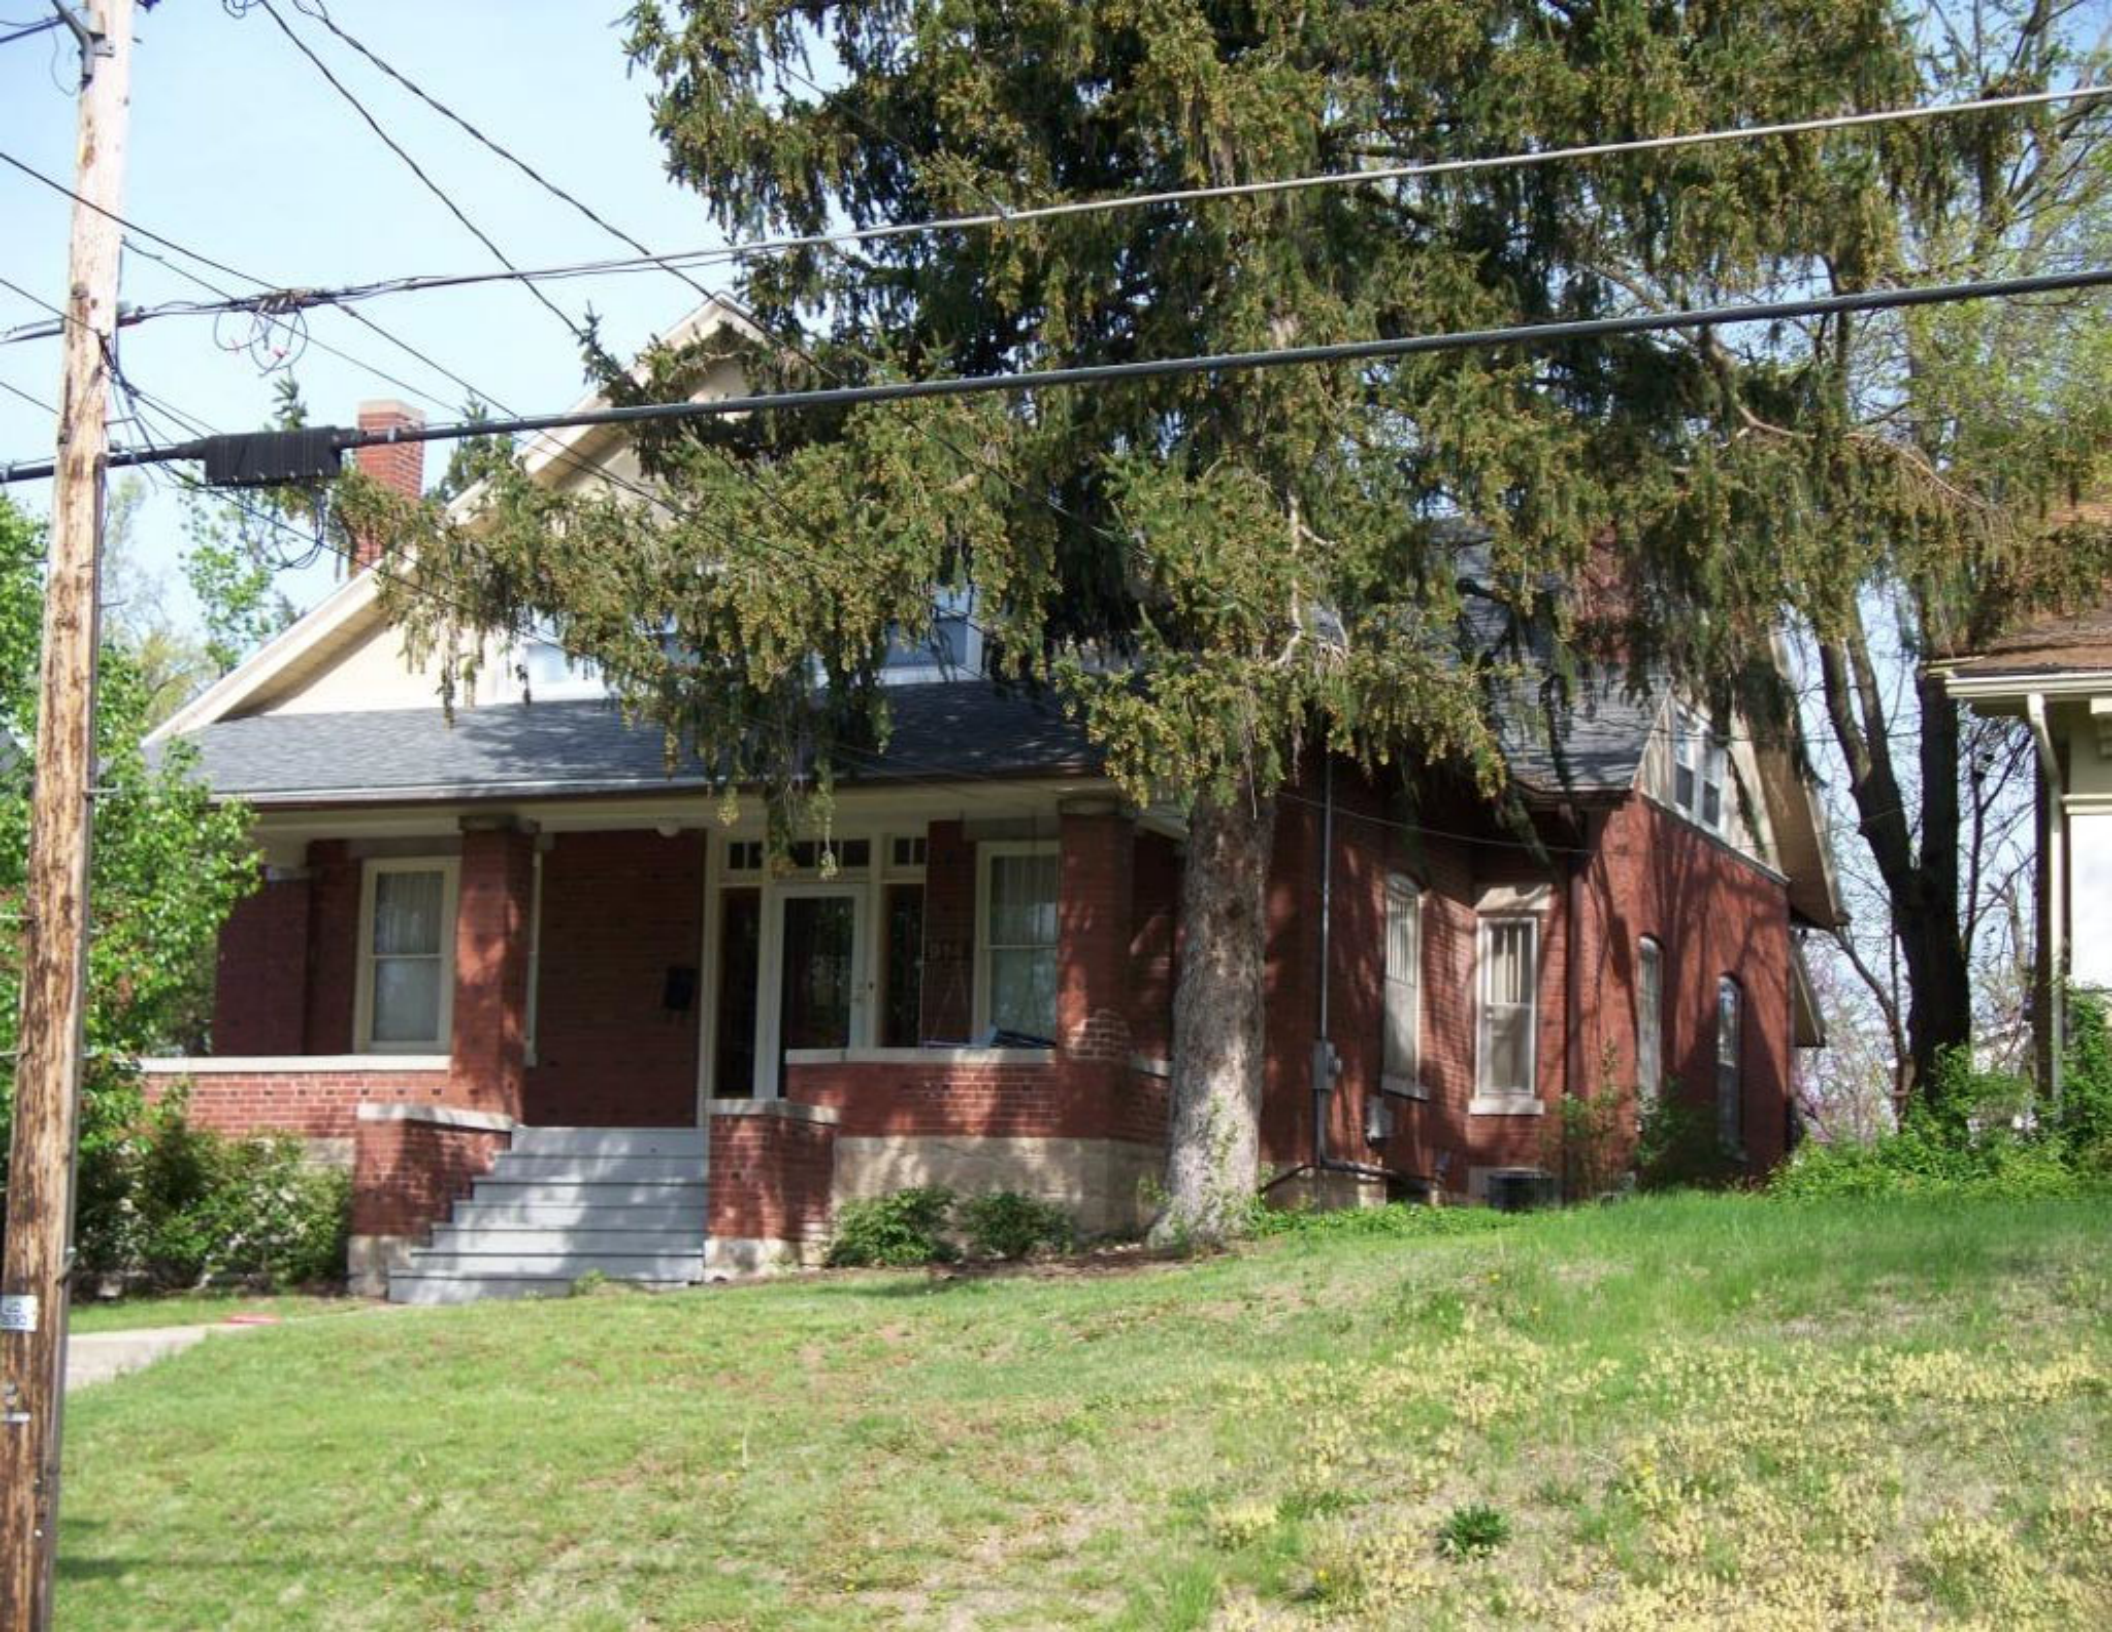
41. (cont.) This front-gable 1 ½ story bungalow features a stone foundation and a full-width brick porch with piers and half-walls, capped in limestone. The entrance is located in the center of the property and appears to retain its original wood door (there is a modern screen door in front of it) with multi-light transom and sidelights. The window to the right of the entrance is 8 over 1, to the left are paired four-over one windows. The windows on this level are wood and appear to be original to the building. The gable has stucco or plaster applied to it and a row of four one-over-one replacement windows.

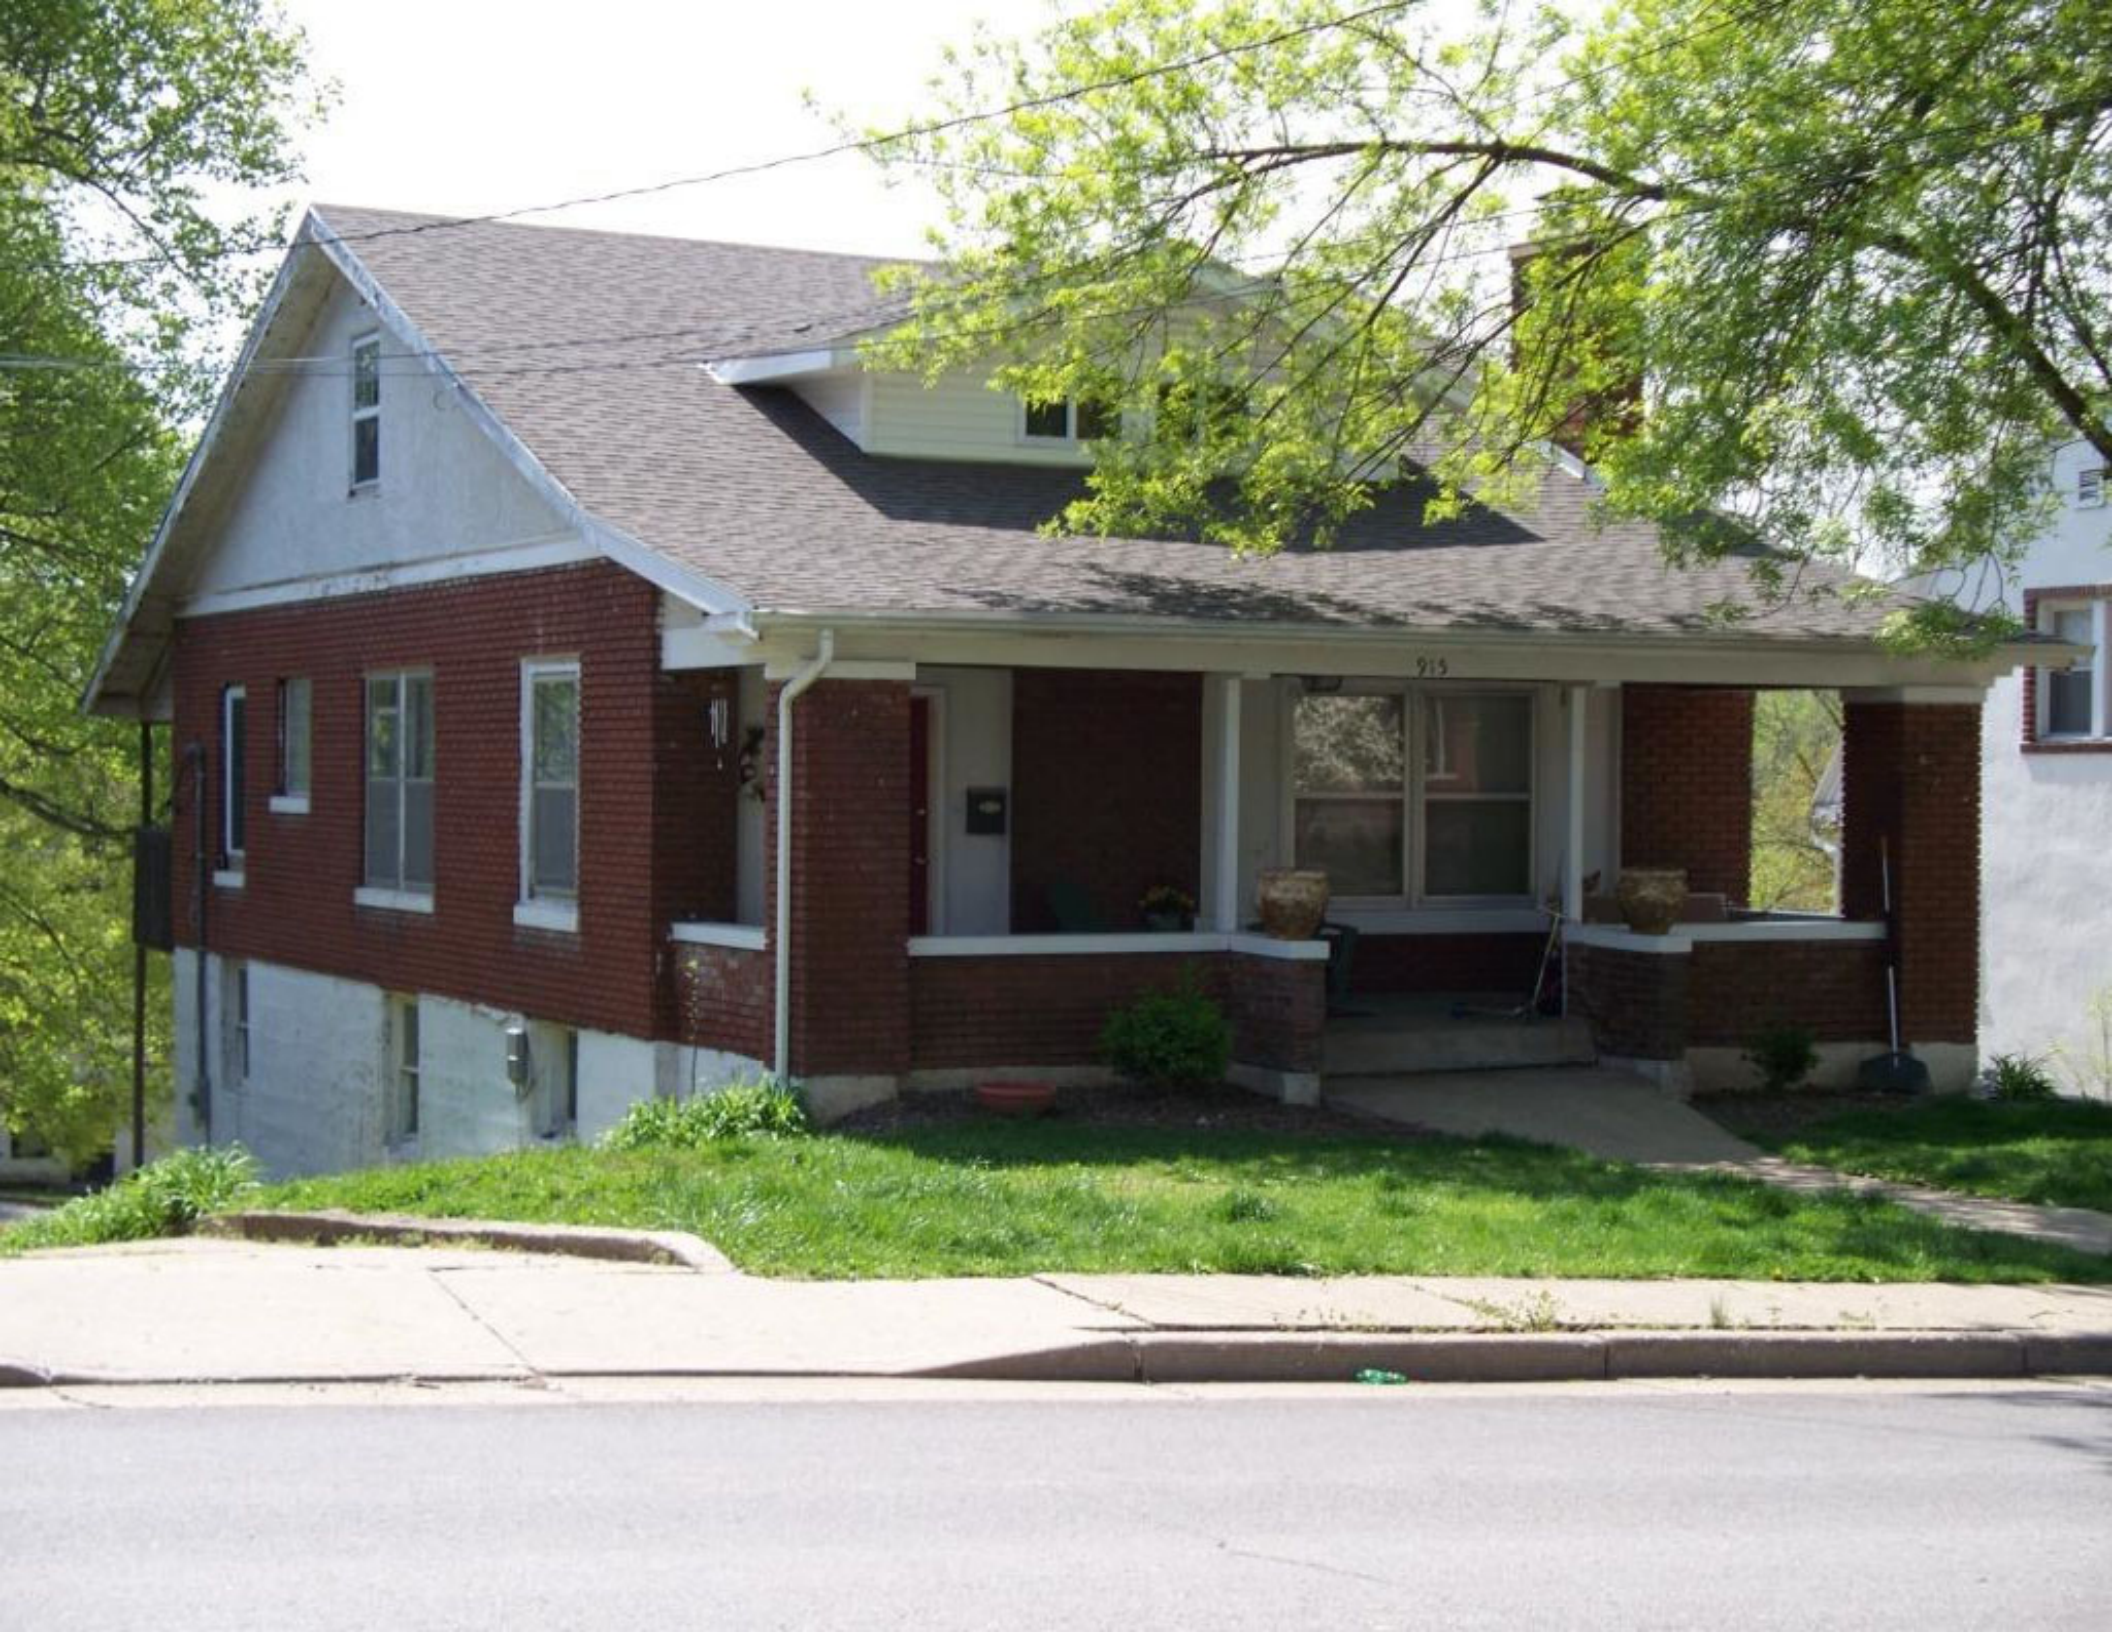
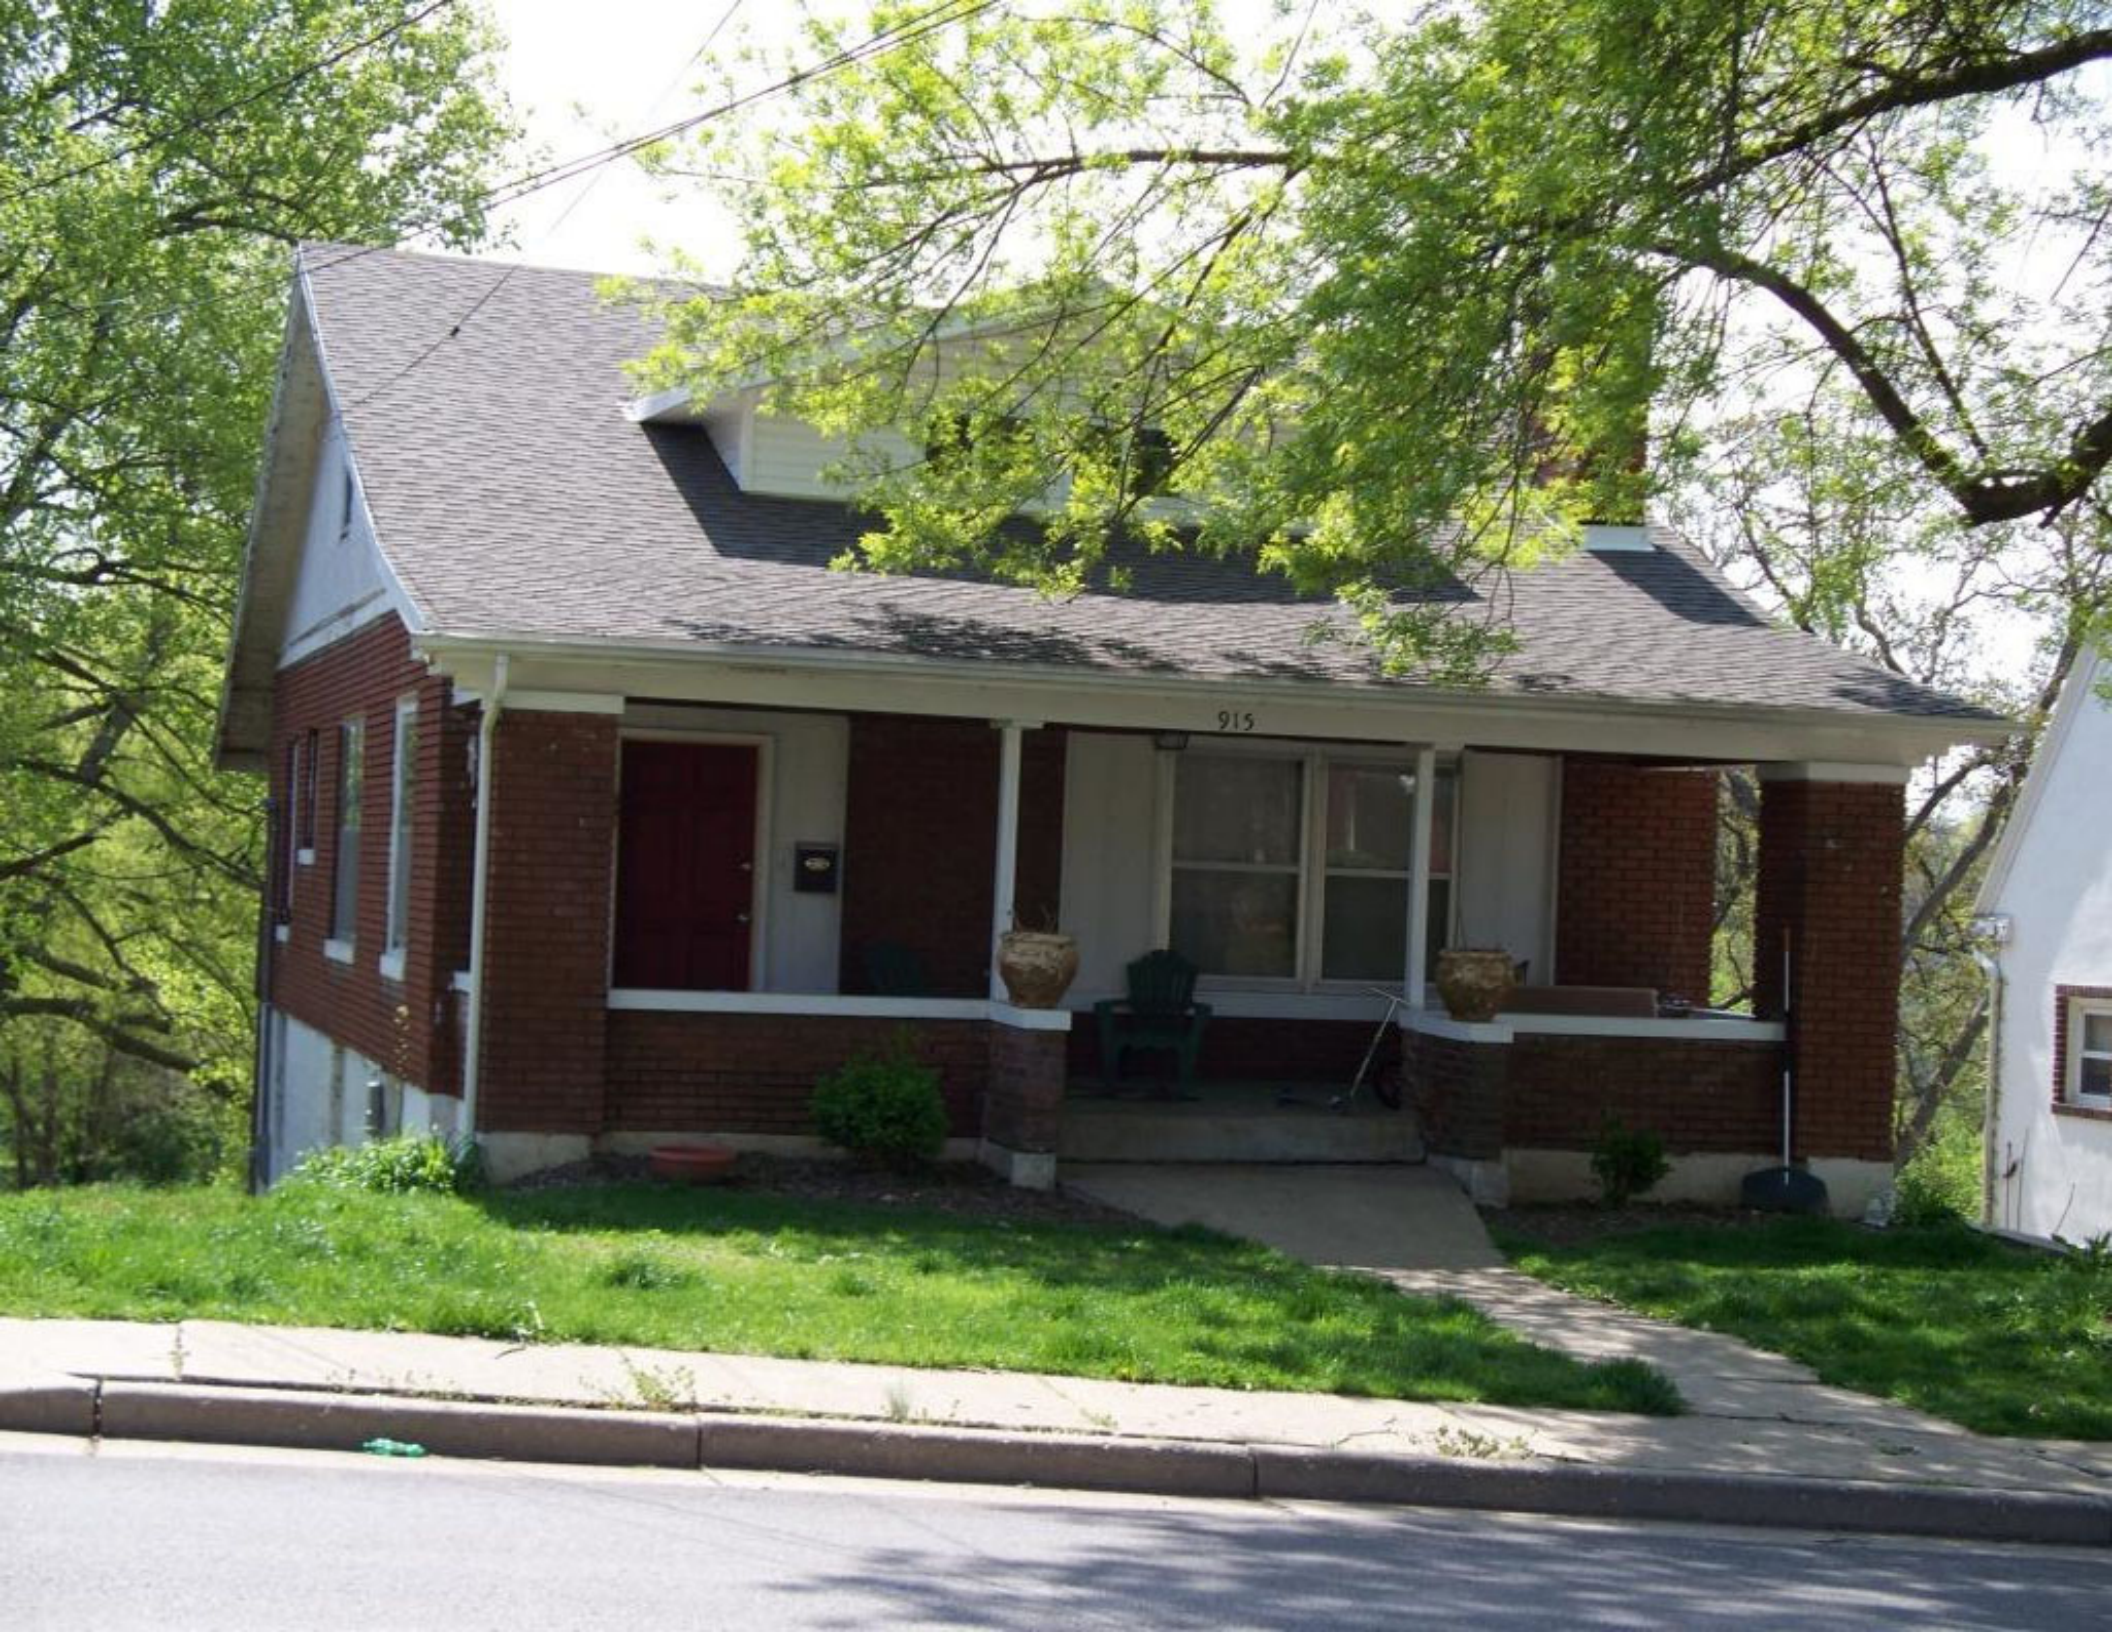
This 1 ½ story bungalow has had alterations to the full width porch. The porch appears to originally have four brick piers; however the center piers have been replaced with thin poles. Likewise the offset entrance to the left and the paired replacement 1/1 windows are immediately surrounded with modern siding. The dormer, centered in the ½ story, is covered in vinyl and has a pair of replacement 1 by 1 windows. Despite these many changes the building retains its form and historic character and would be considered contributing to a possible district.
