ARCHITECTURAL/HISTORIC INVENTORY FORM

1. Survey No. CO-AS-005-001		2. Survey name: Moreau Drive Neighborhood Survey	
3. County: Cole		4. Address: 1202 Elmerine Ave.	
5. City: Jefferson City	Vicinity: <input type="checkbox"/>	6. UTM: / /	7. Township/Range/Section: T: R: S:
8. Historic name (if known):		9. Present/other name (if known):	
10. Ownership: <input checked="" type="checkbox"/> Private <input type="checkbox"/> Public		11. Historic use (if known): Residential	11. Current use: Residential

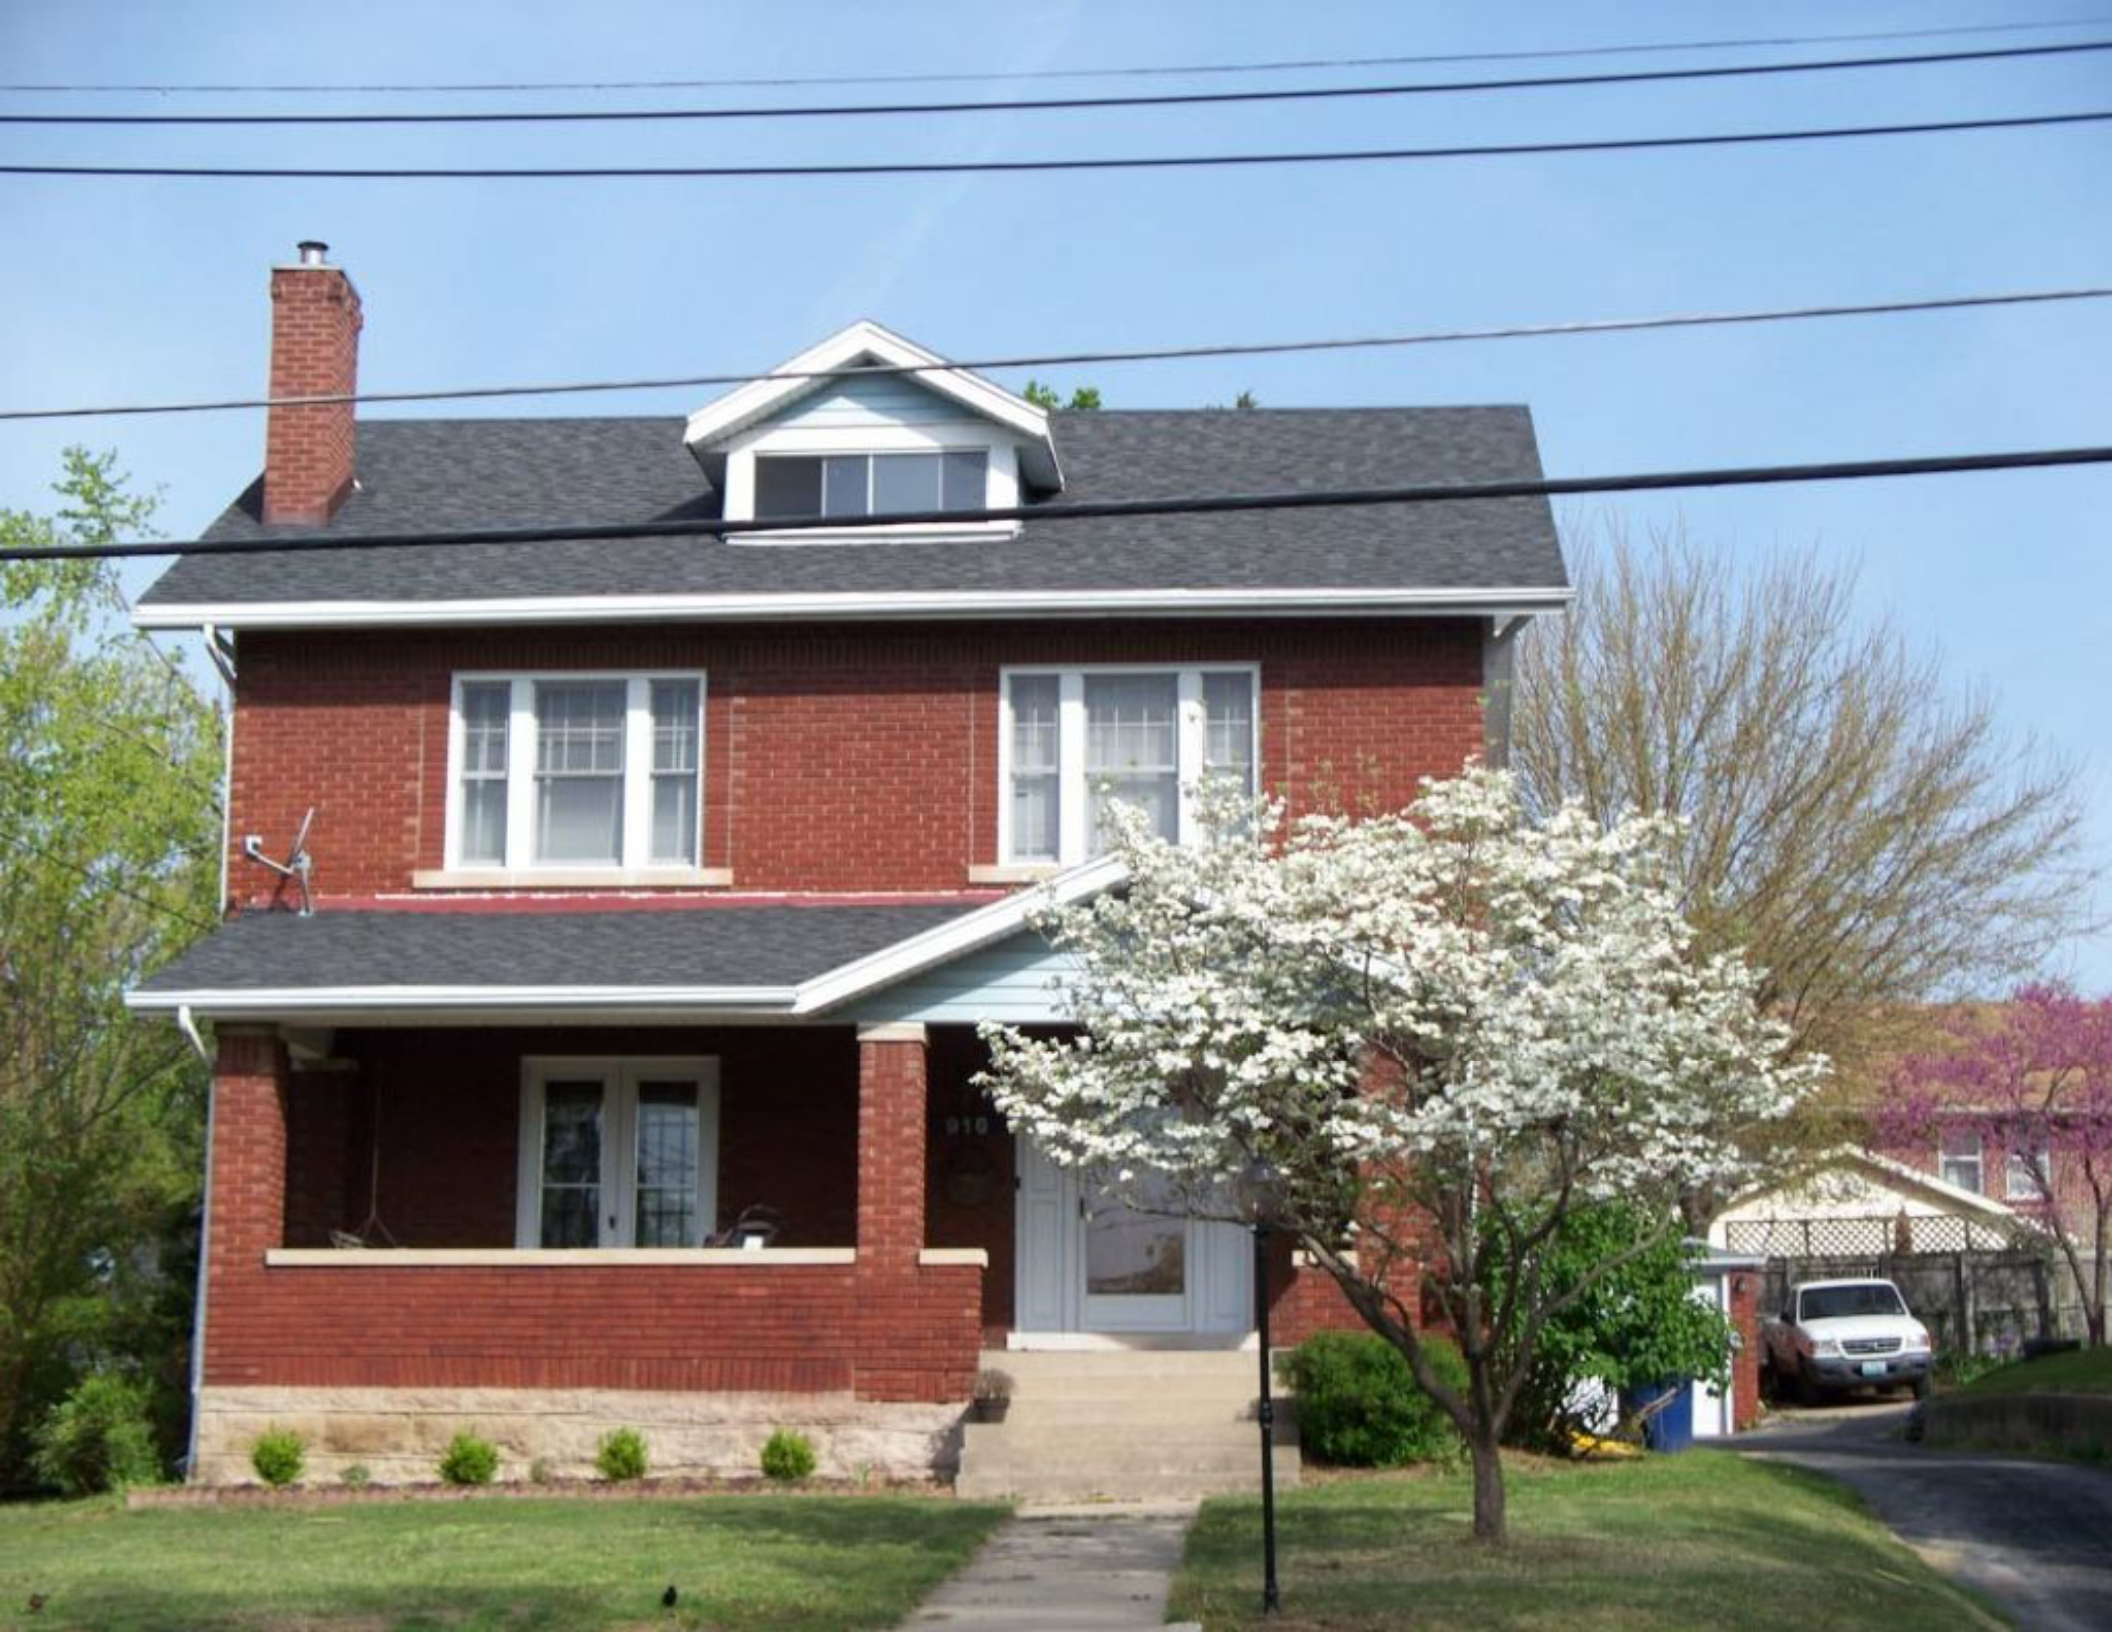
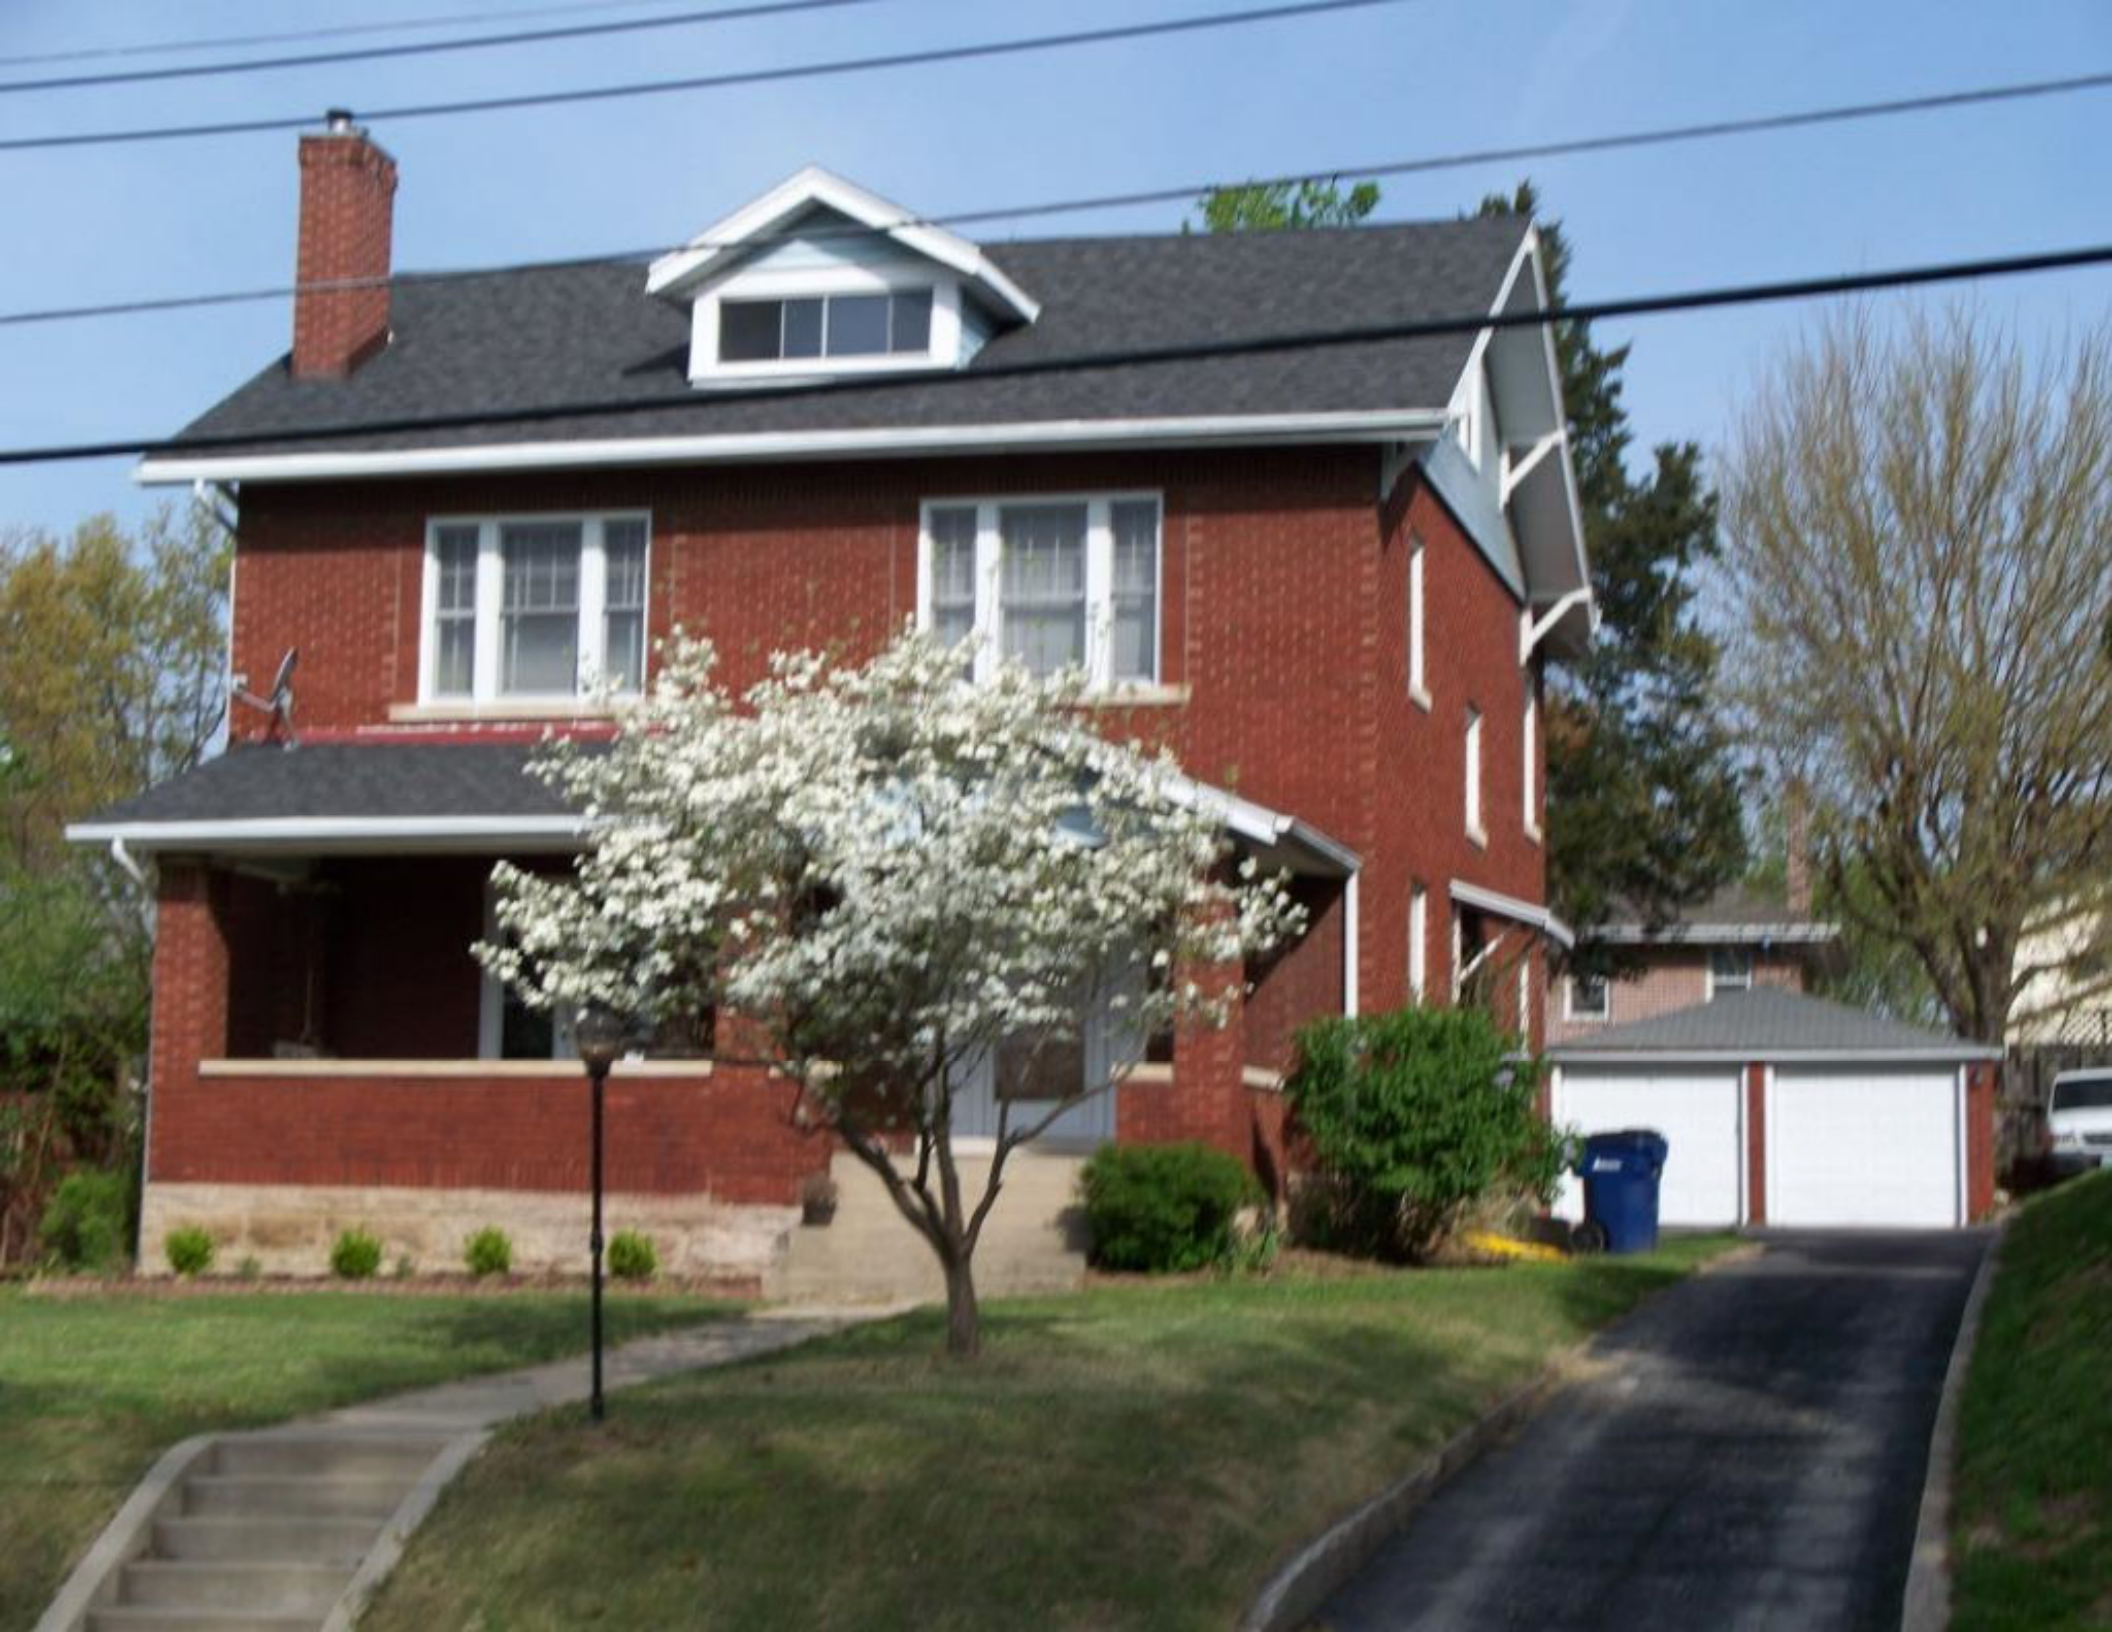
41. (cont.) The property is a two-and-a-half brick four square. The porch is full width and features a shed roof with a partial gable over the entrance. The gable appears to be filled in with vinyl siding. The porch features brick piers and a brick half-wall capped with limestone. The entrance is off-set to the right and appears to retain the original wooden door but the decorative surround may have in-filled the side-lights or could possibly be original. There is a set of double, multi-light doors on the left side of the building. It's not unclear if this was a modification to a window opening or was original to the building. The second floor has two tri-part window openings with a 6/1 central window flanked by smaller 4/1. All of the openings have storm windows or screens. The top half-floor features a central vinyl dormer with a sliding slash one by one window. The dormer and window on this floor do not appear historic. The building features some minimal Colonial Revival detailing in the decorative brick on the façade and the window arrangement. However it also features brackets and a full-width brick porch, which brings to mind more Craftsman detailing.

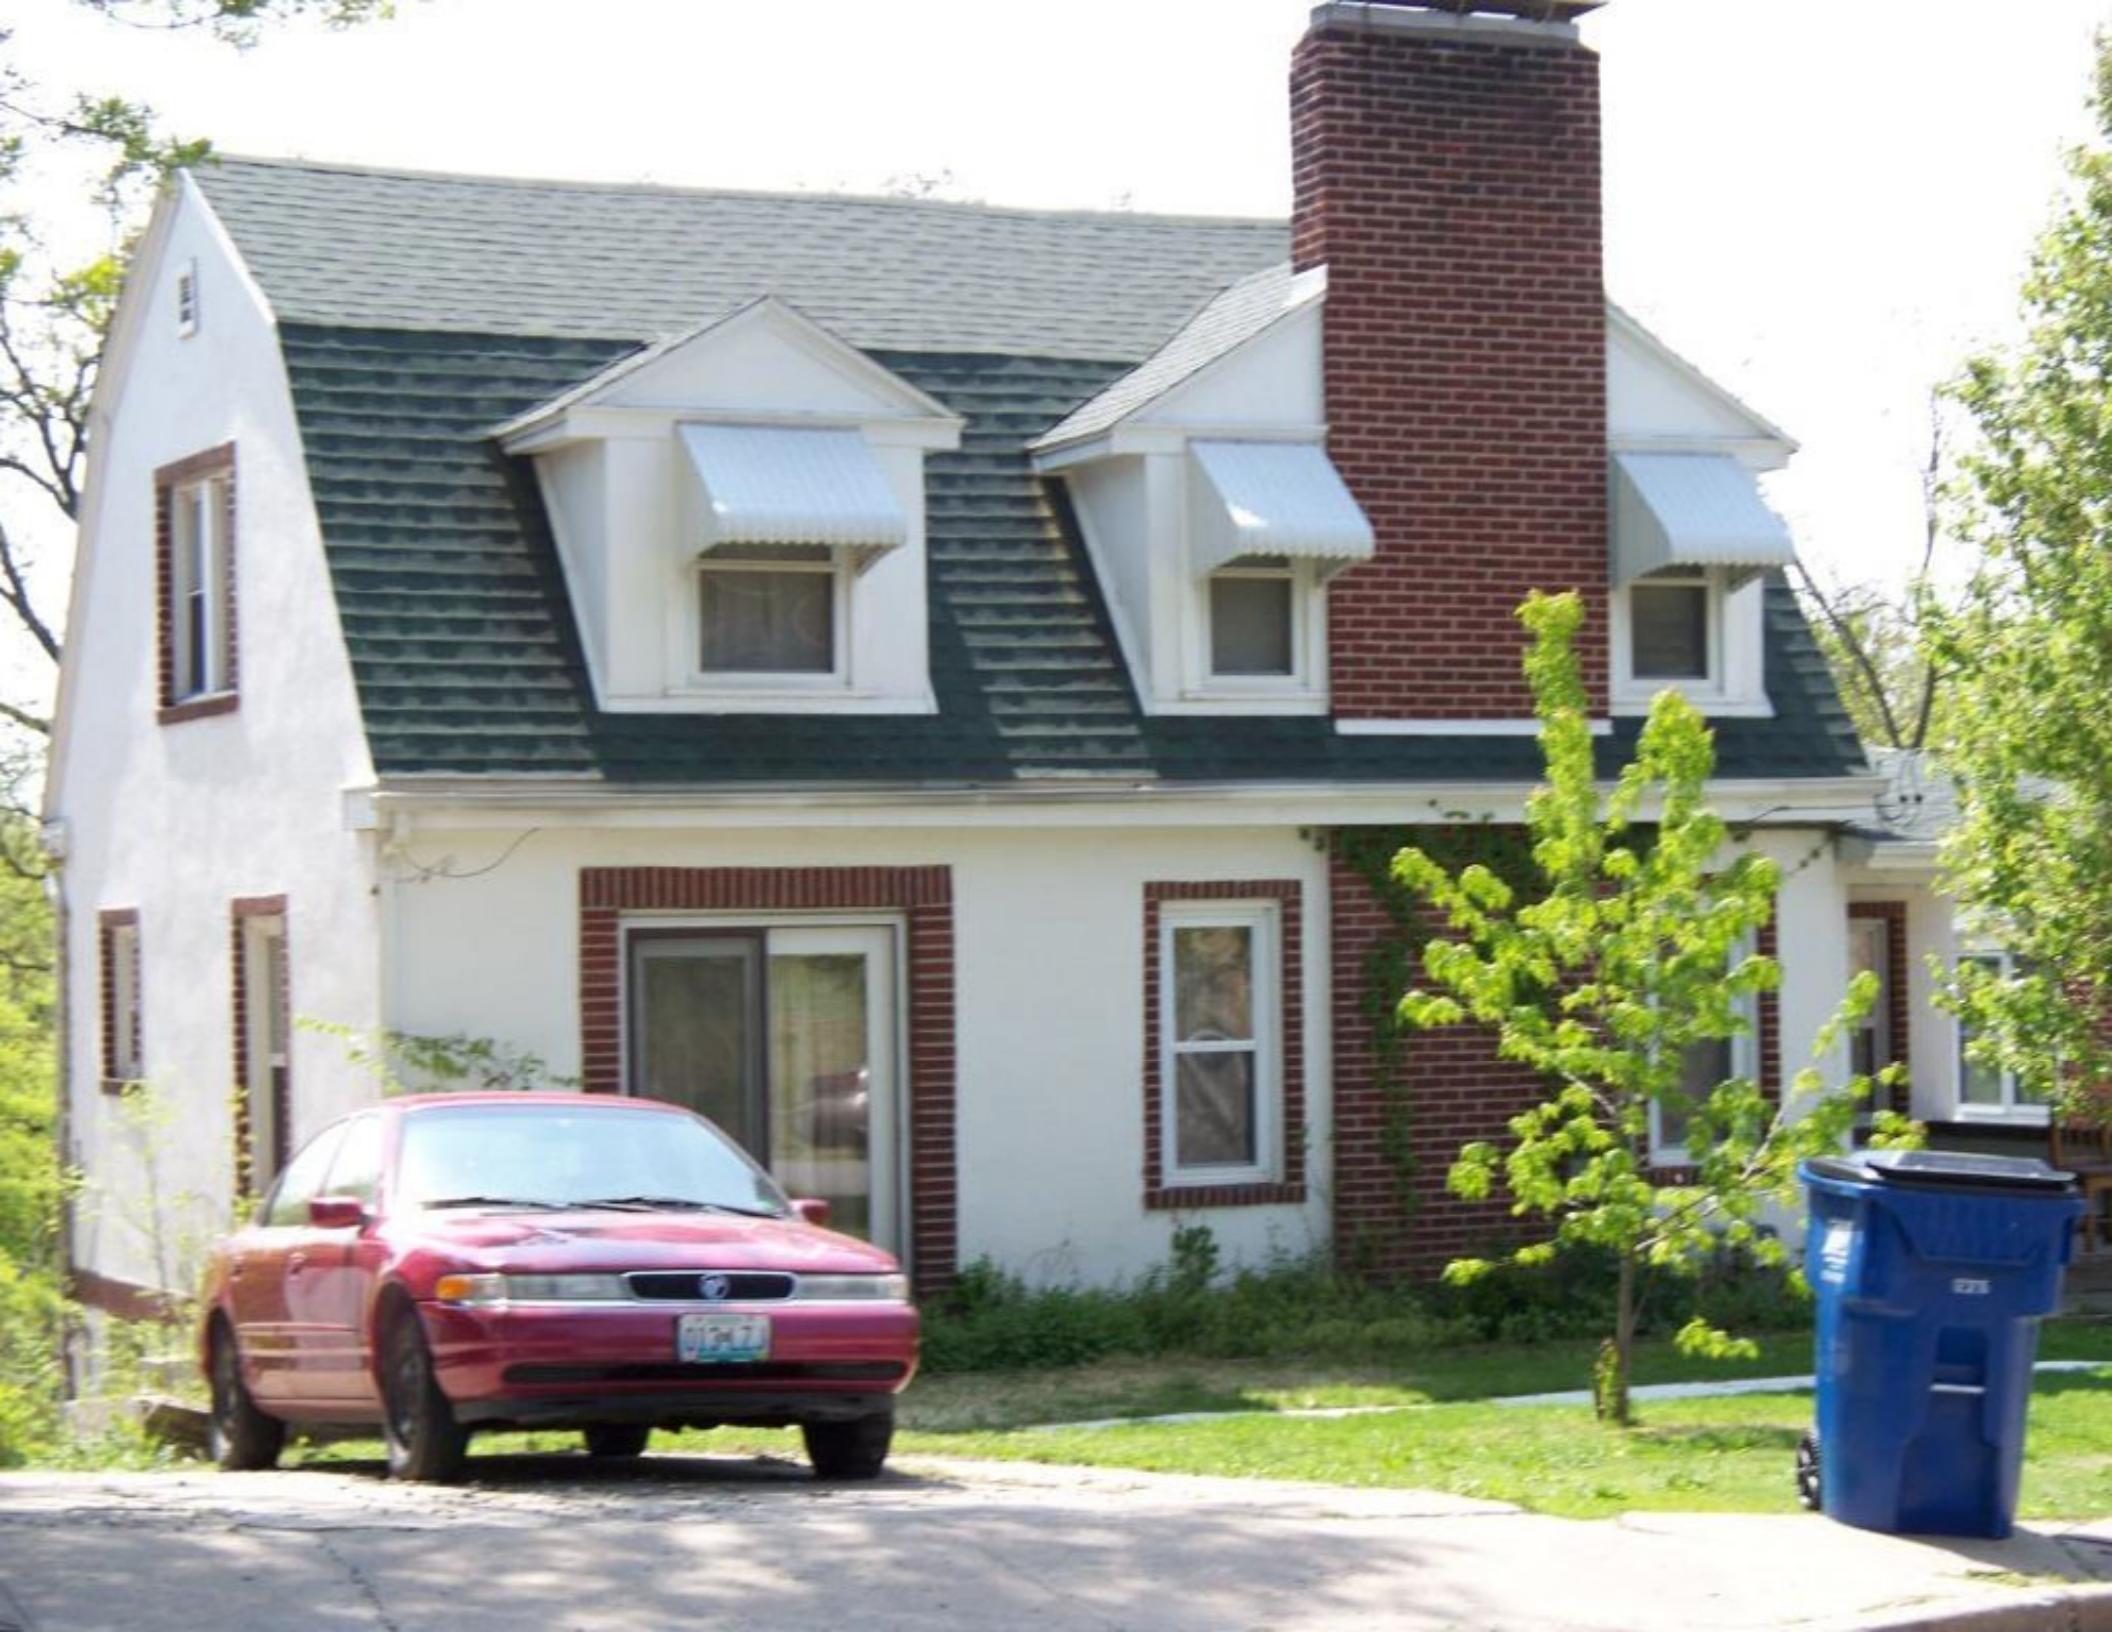
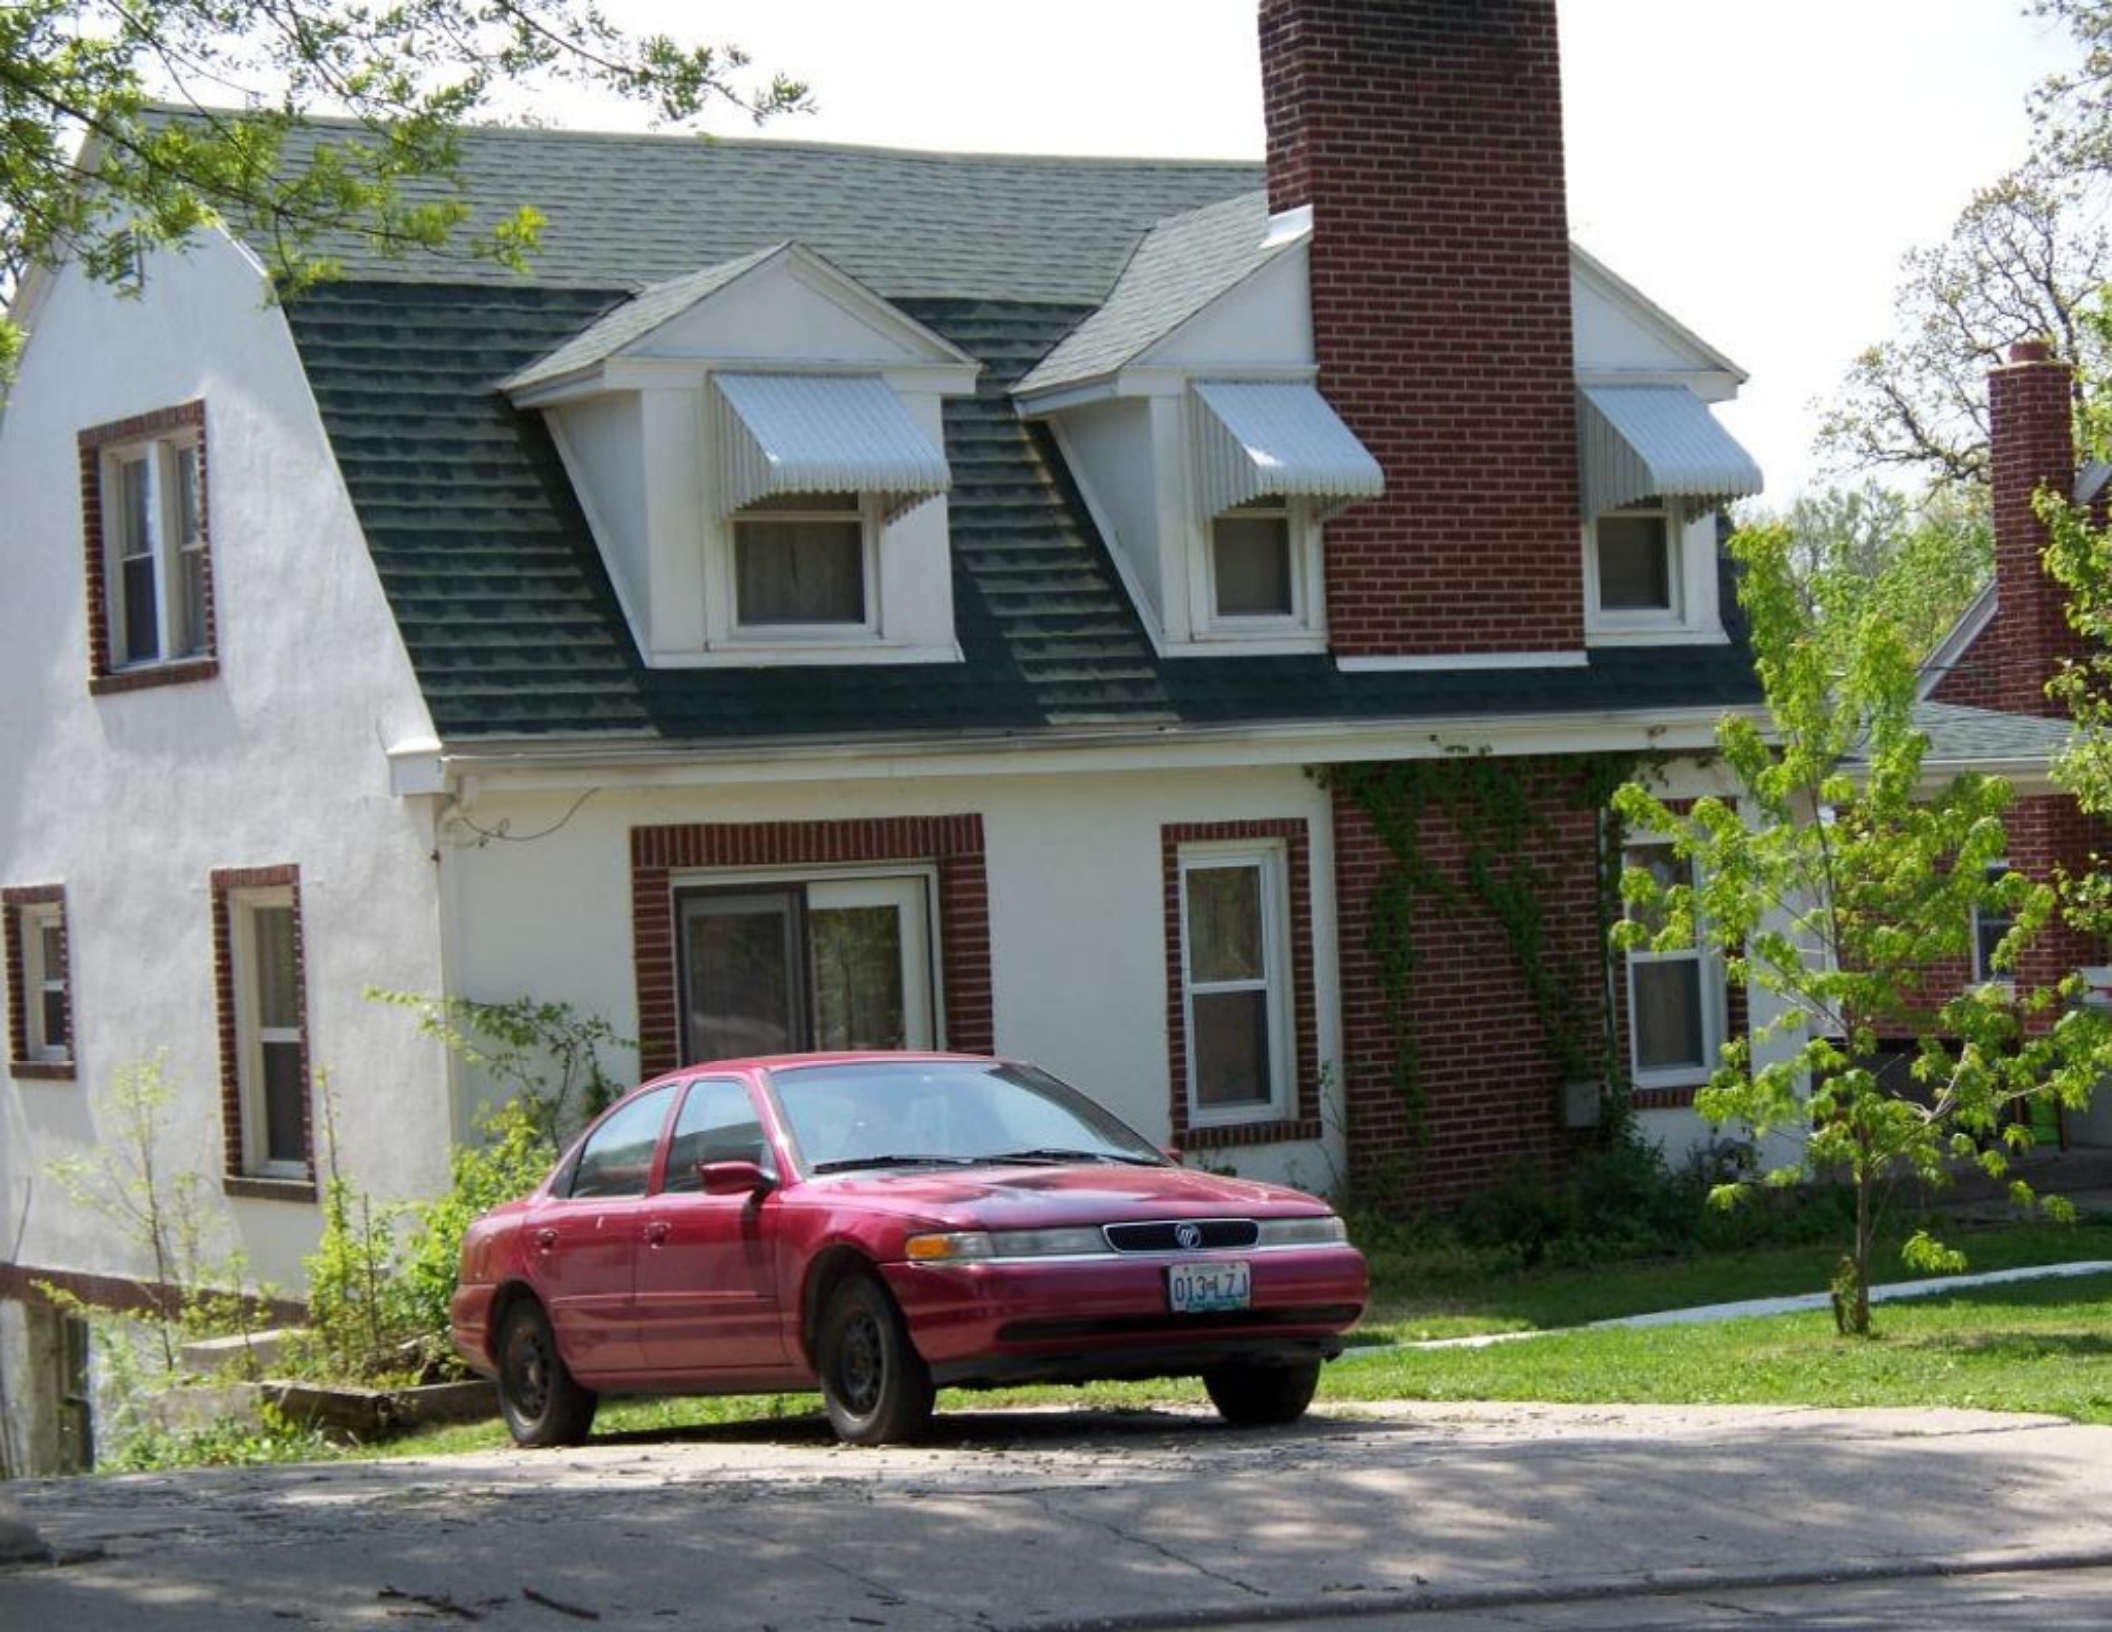
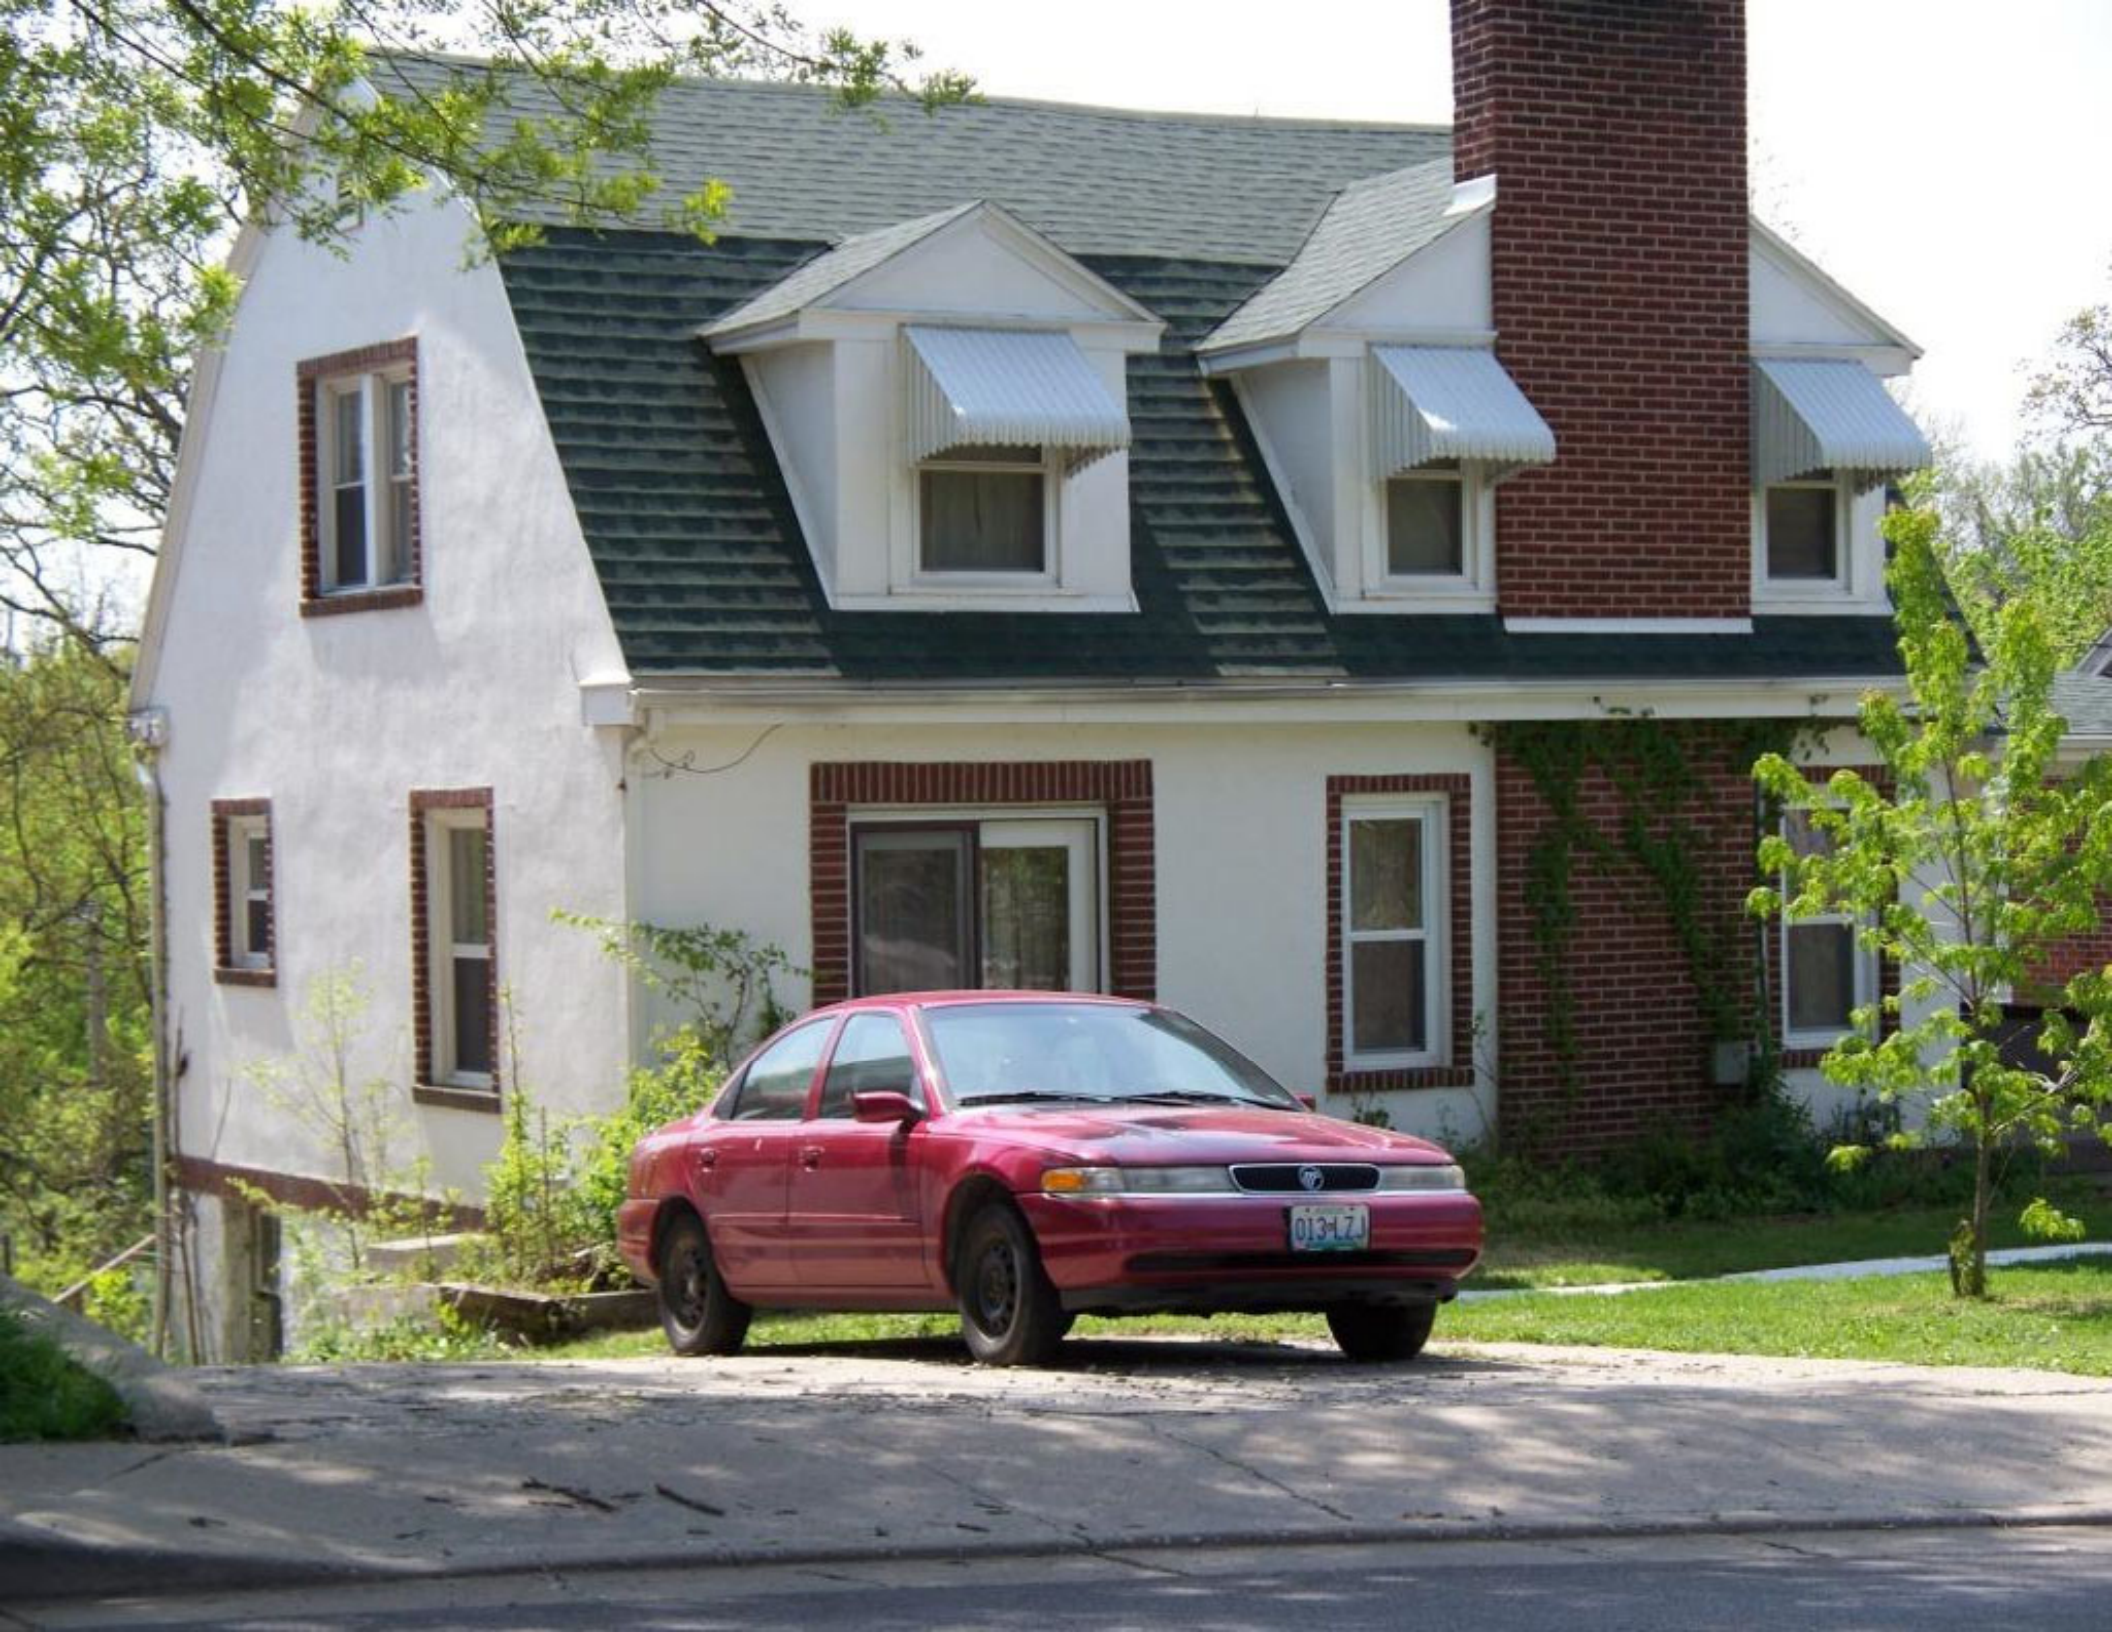
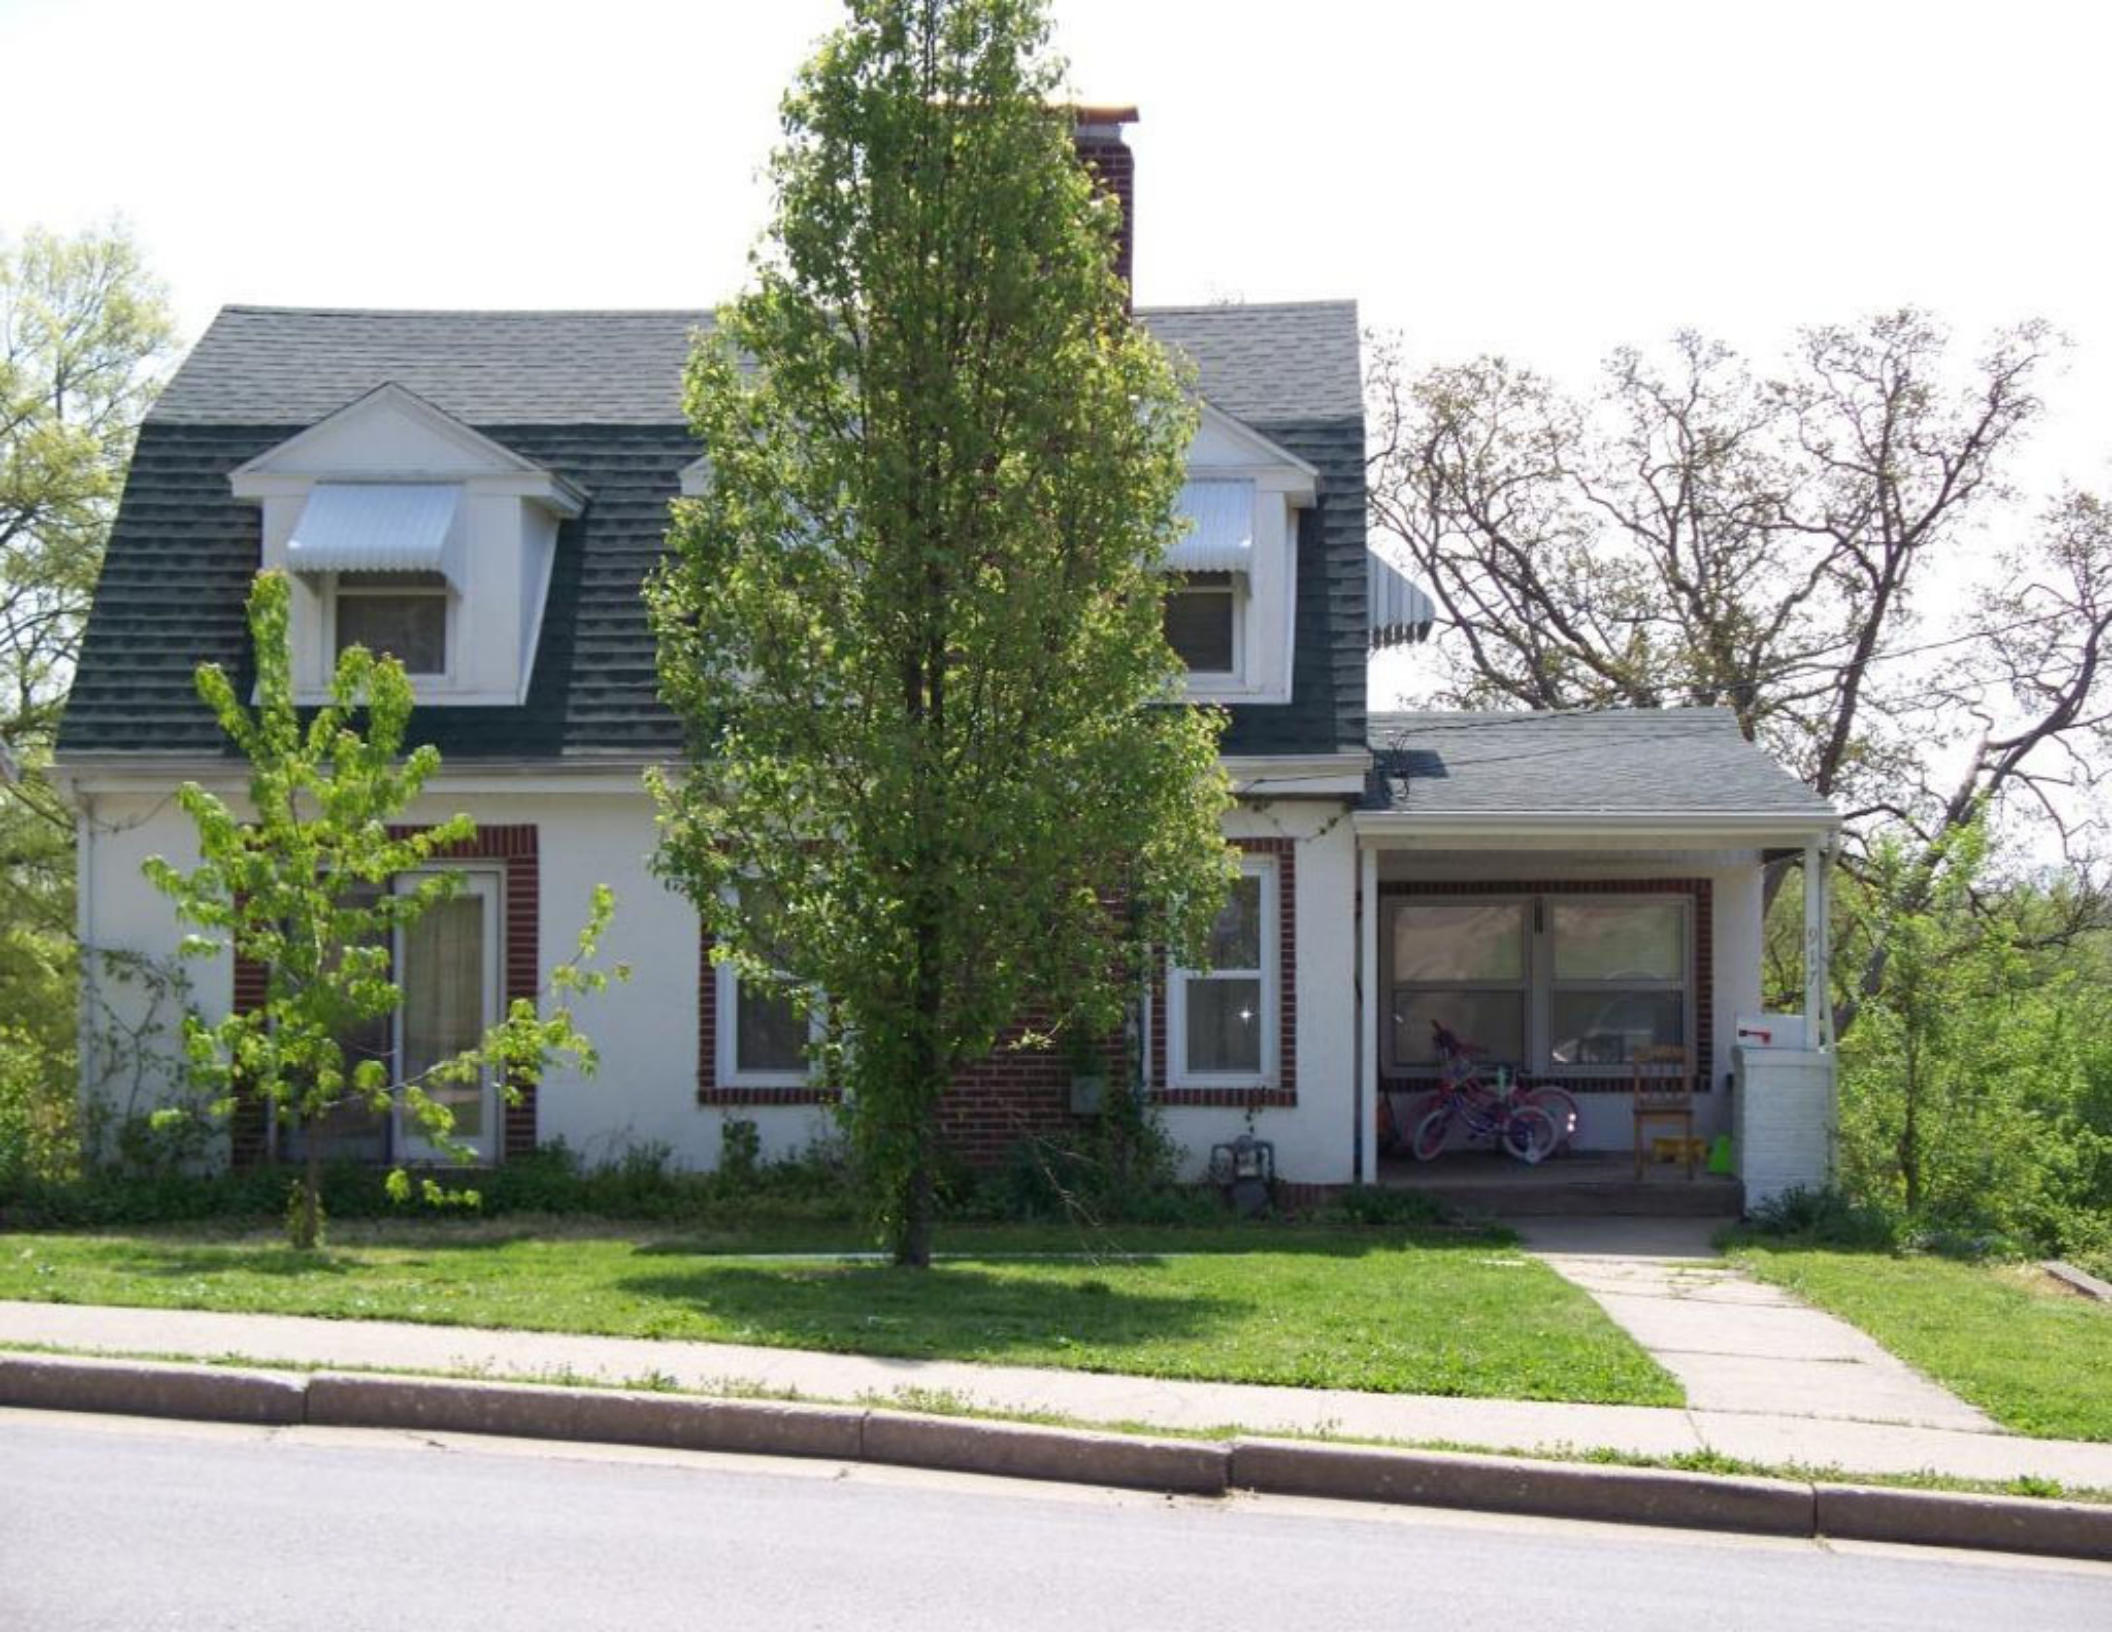
This unusual stucco 2 story Dutch Revival has a side gambrel roof with two dormers. The first pedimented dormer to the left has a single one over one aluminum window, the second to the right has a pair of similar one over one windows. Each dormer has an aluminum hood under the pediment. The main entrance to the property is on the right side of the property instead of the front. A single story one room historic addition appears to have become the backing of the recessed 'porch' by value of an added shed roof and single brick pier (right). The front façade has a sliding glass door and one 1/1 windows flanking each side of the wide, front sloped brick chimney. Both the sliding glass door and the windows have decorative brick work around them.
