ARCHITECTURAL/HISTORIC INVENTORY FORM

1. Survey No. CO-AS-005-001		2. Survey name: Moreau Drive Neighborhood Survey	
3. County: Cole		4. Address: 1202 Elmerine Ave.	
5. City: Jefferson City	Vicinity: <input type="checkbox"/>	6. UTM: / /	7. Township/Range/Section: T: R: S:
8. Historic name (if known):		9. Present/other name (if known):	
10. Ownership: <input checked="" type="checkbox"/> Private <input type="checkbox"/> Public		11. Historic use (if known): Residential	11. Current use: Residential

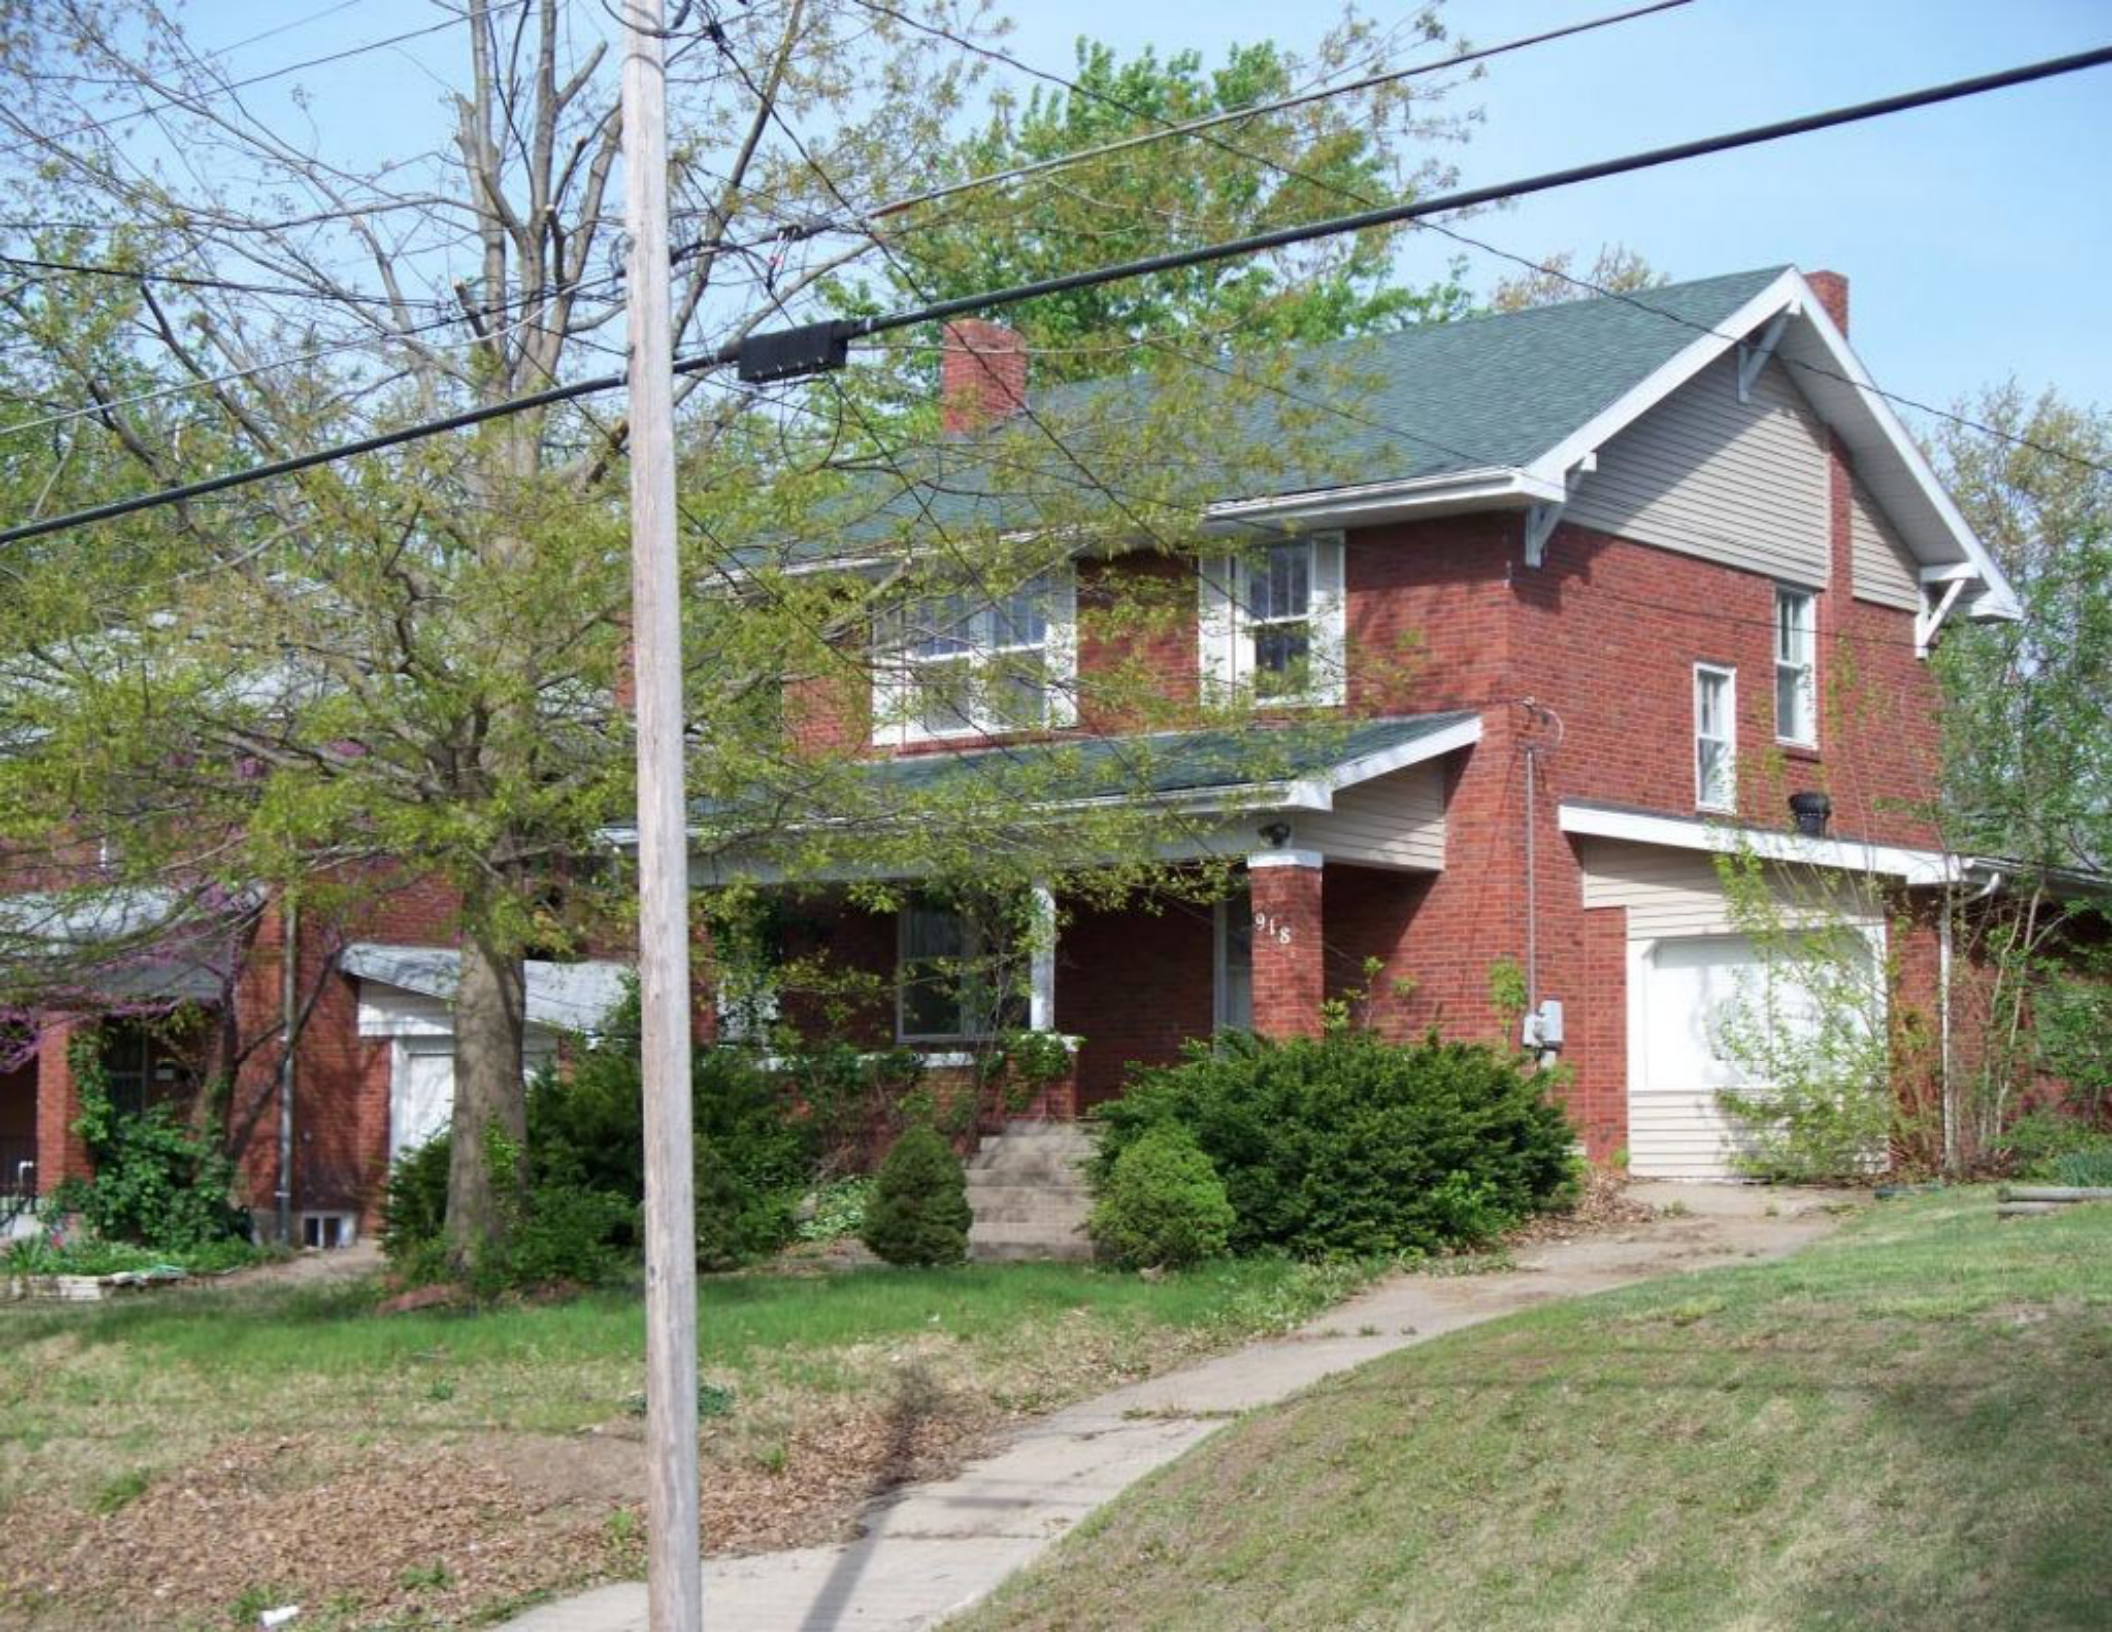
41. (cont.) This brick two story four square has a side gable roof and attached one car garage to the right side of the property. The garage appears to have been enclosed due to the vinyl roof and siding blocking off the bottom of the garage entrance. The property has a full-width brick porch with the entrance off-set to the right and a pair of 3/1 windows to the left. The property has minimal Colonial Revival features in the upper floor's two historic 3/1 windows and shutters. Like its neighbor (916 Moreau Drive) brackets are on the side of the house under the roofline.

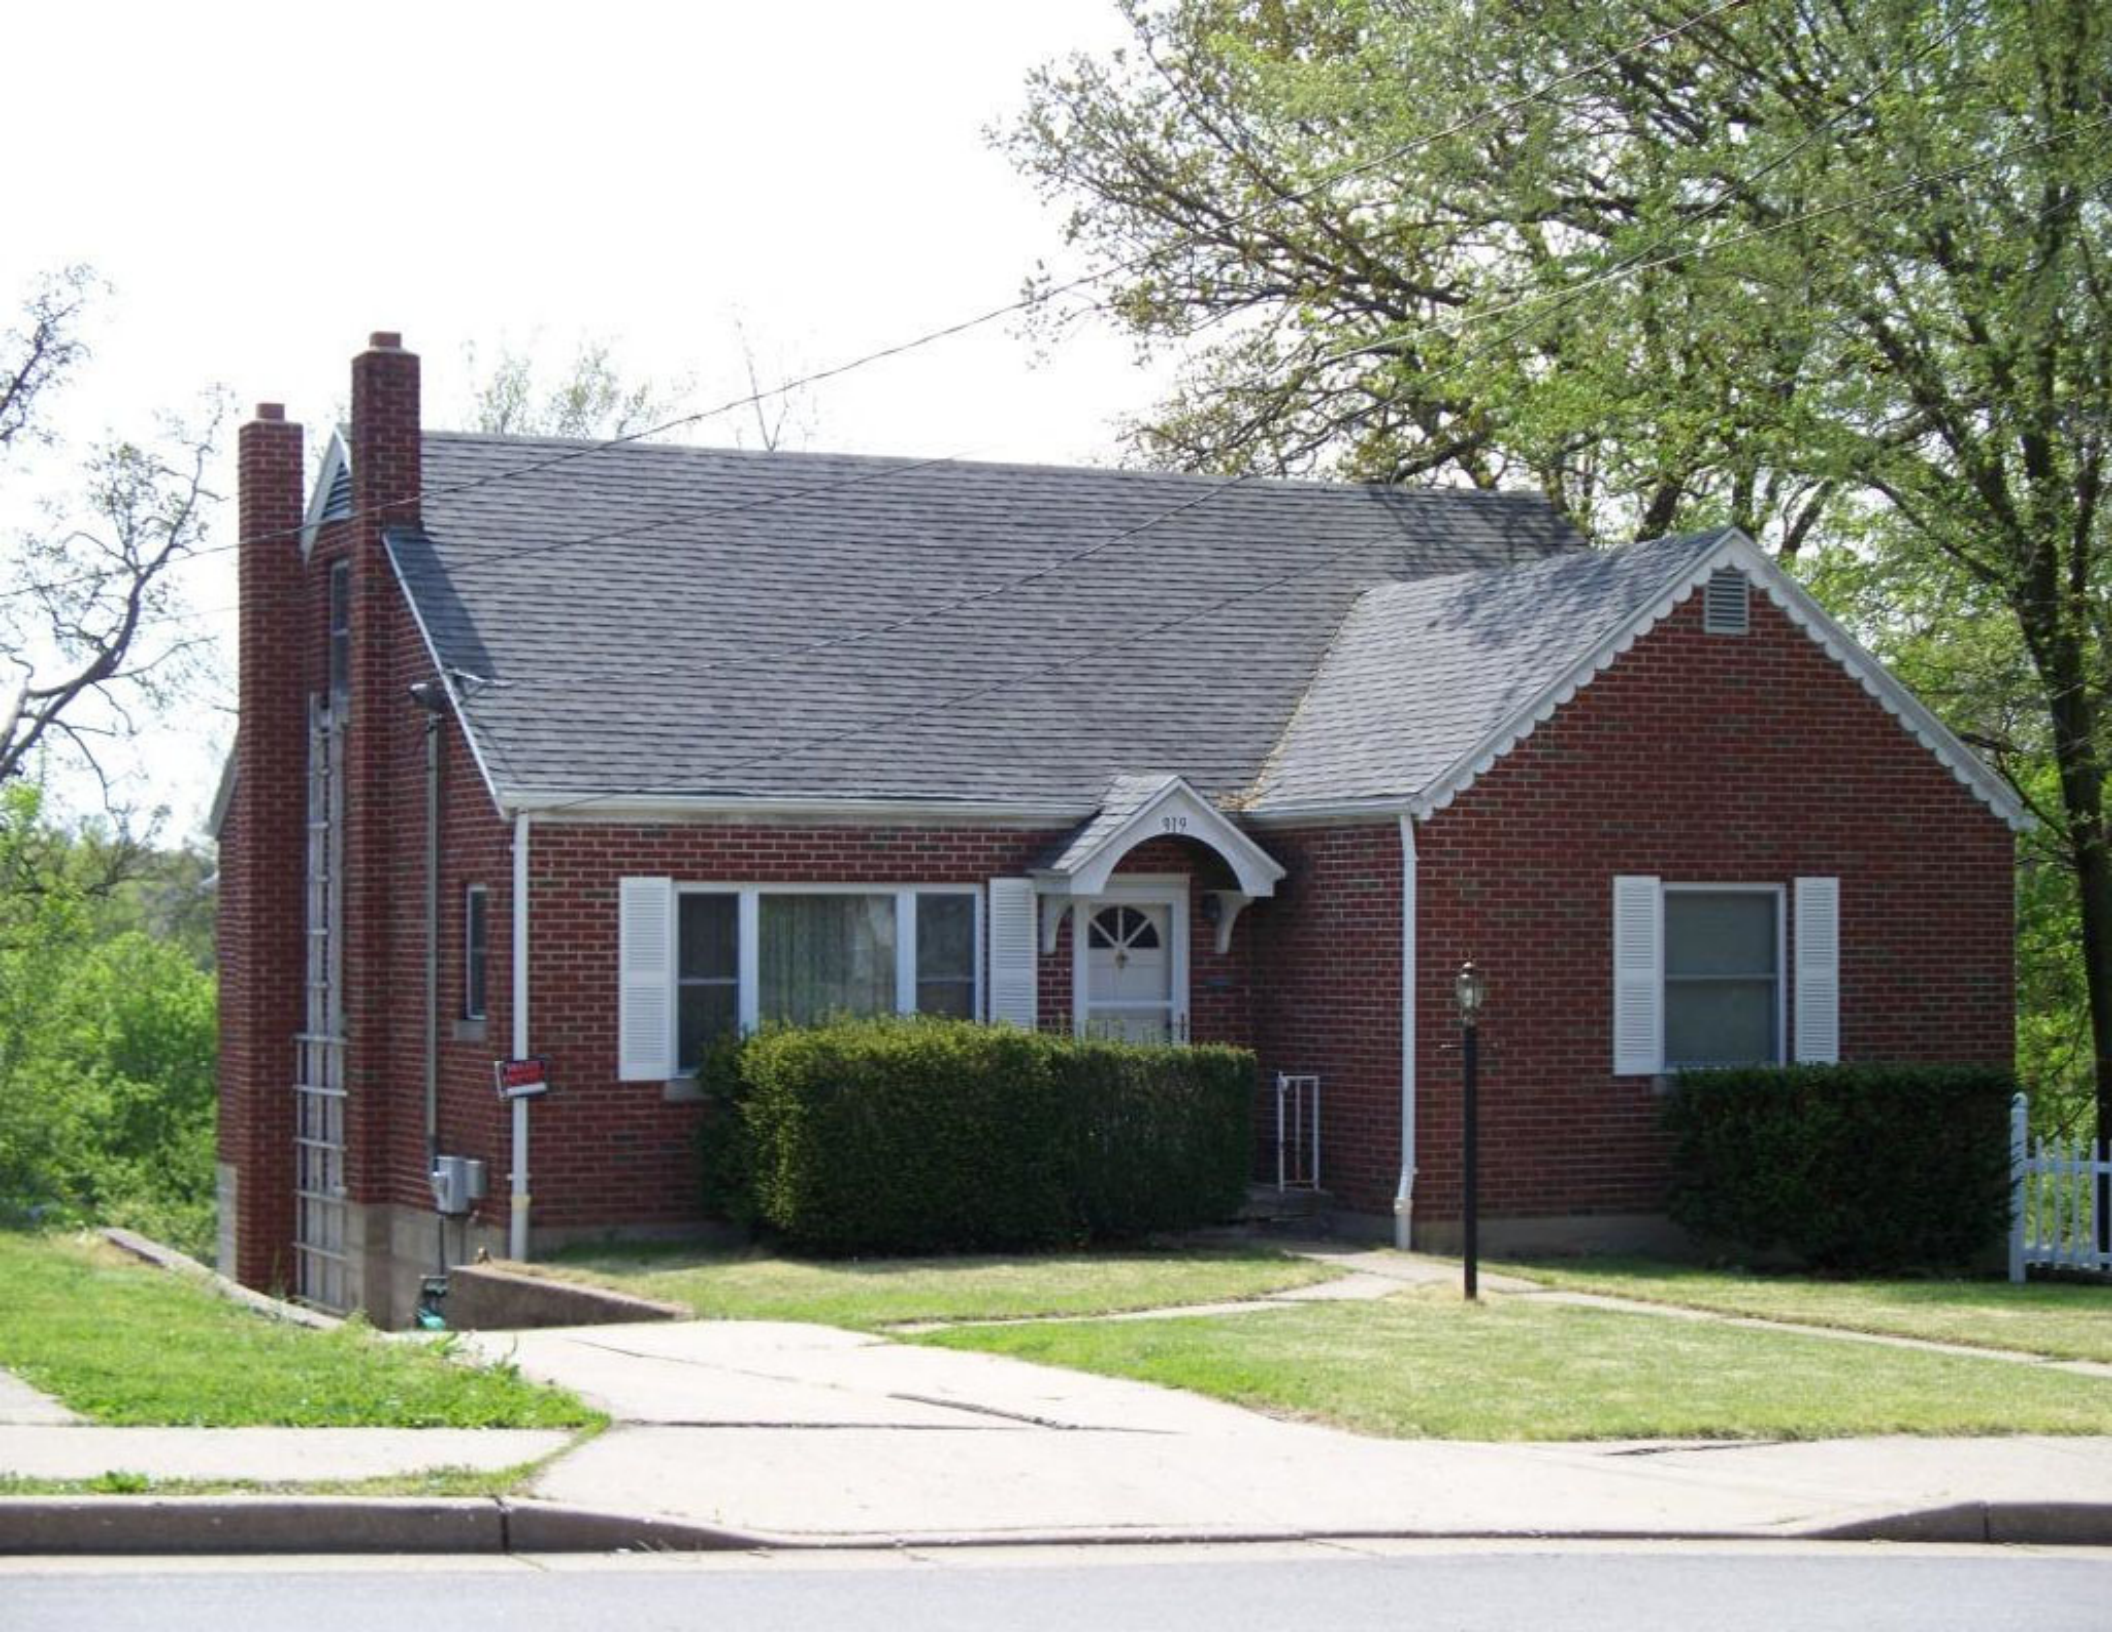
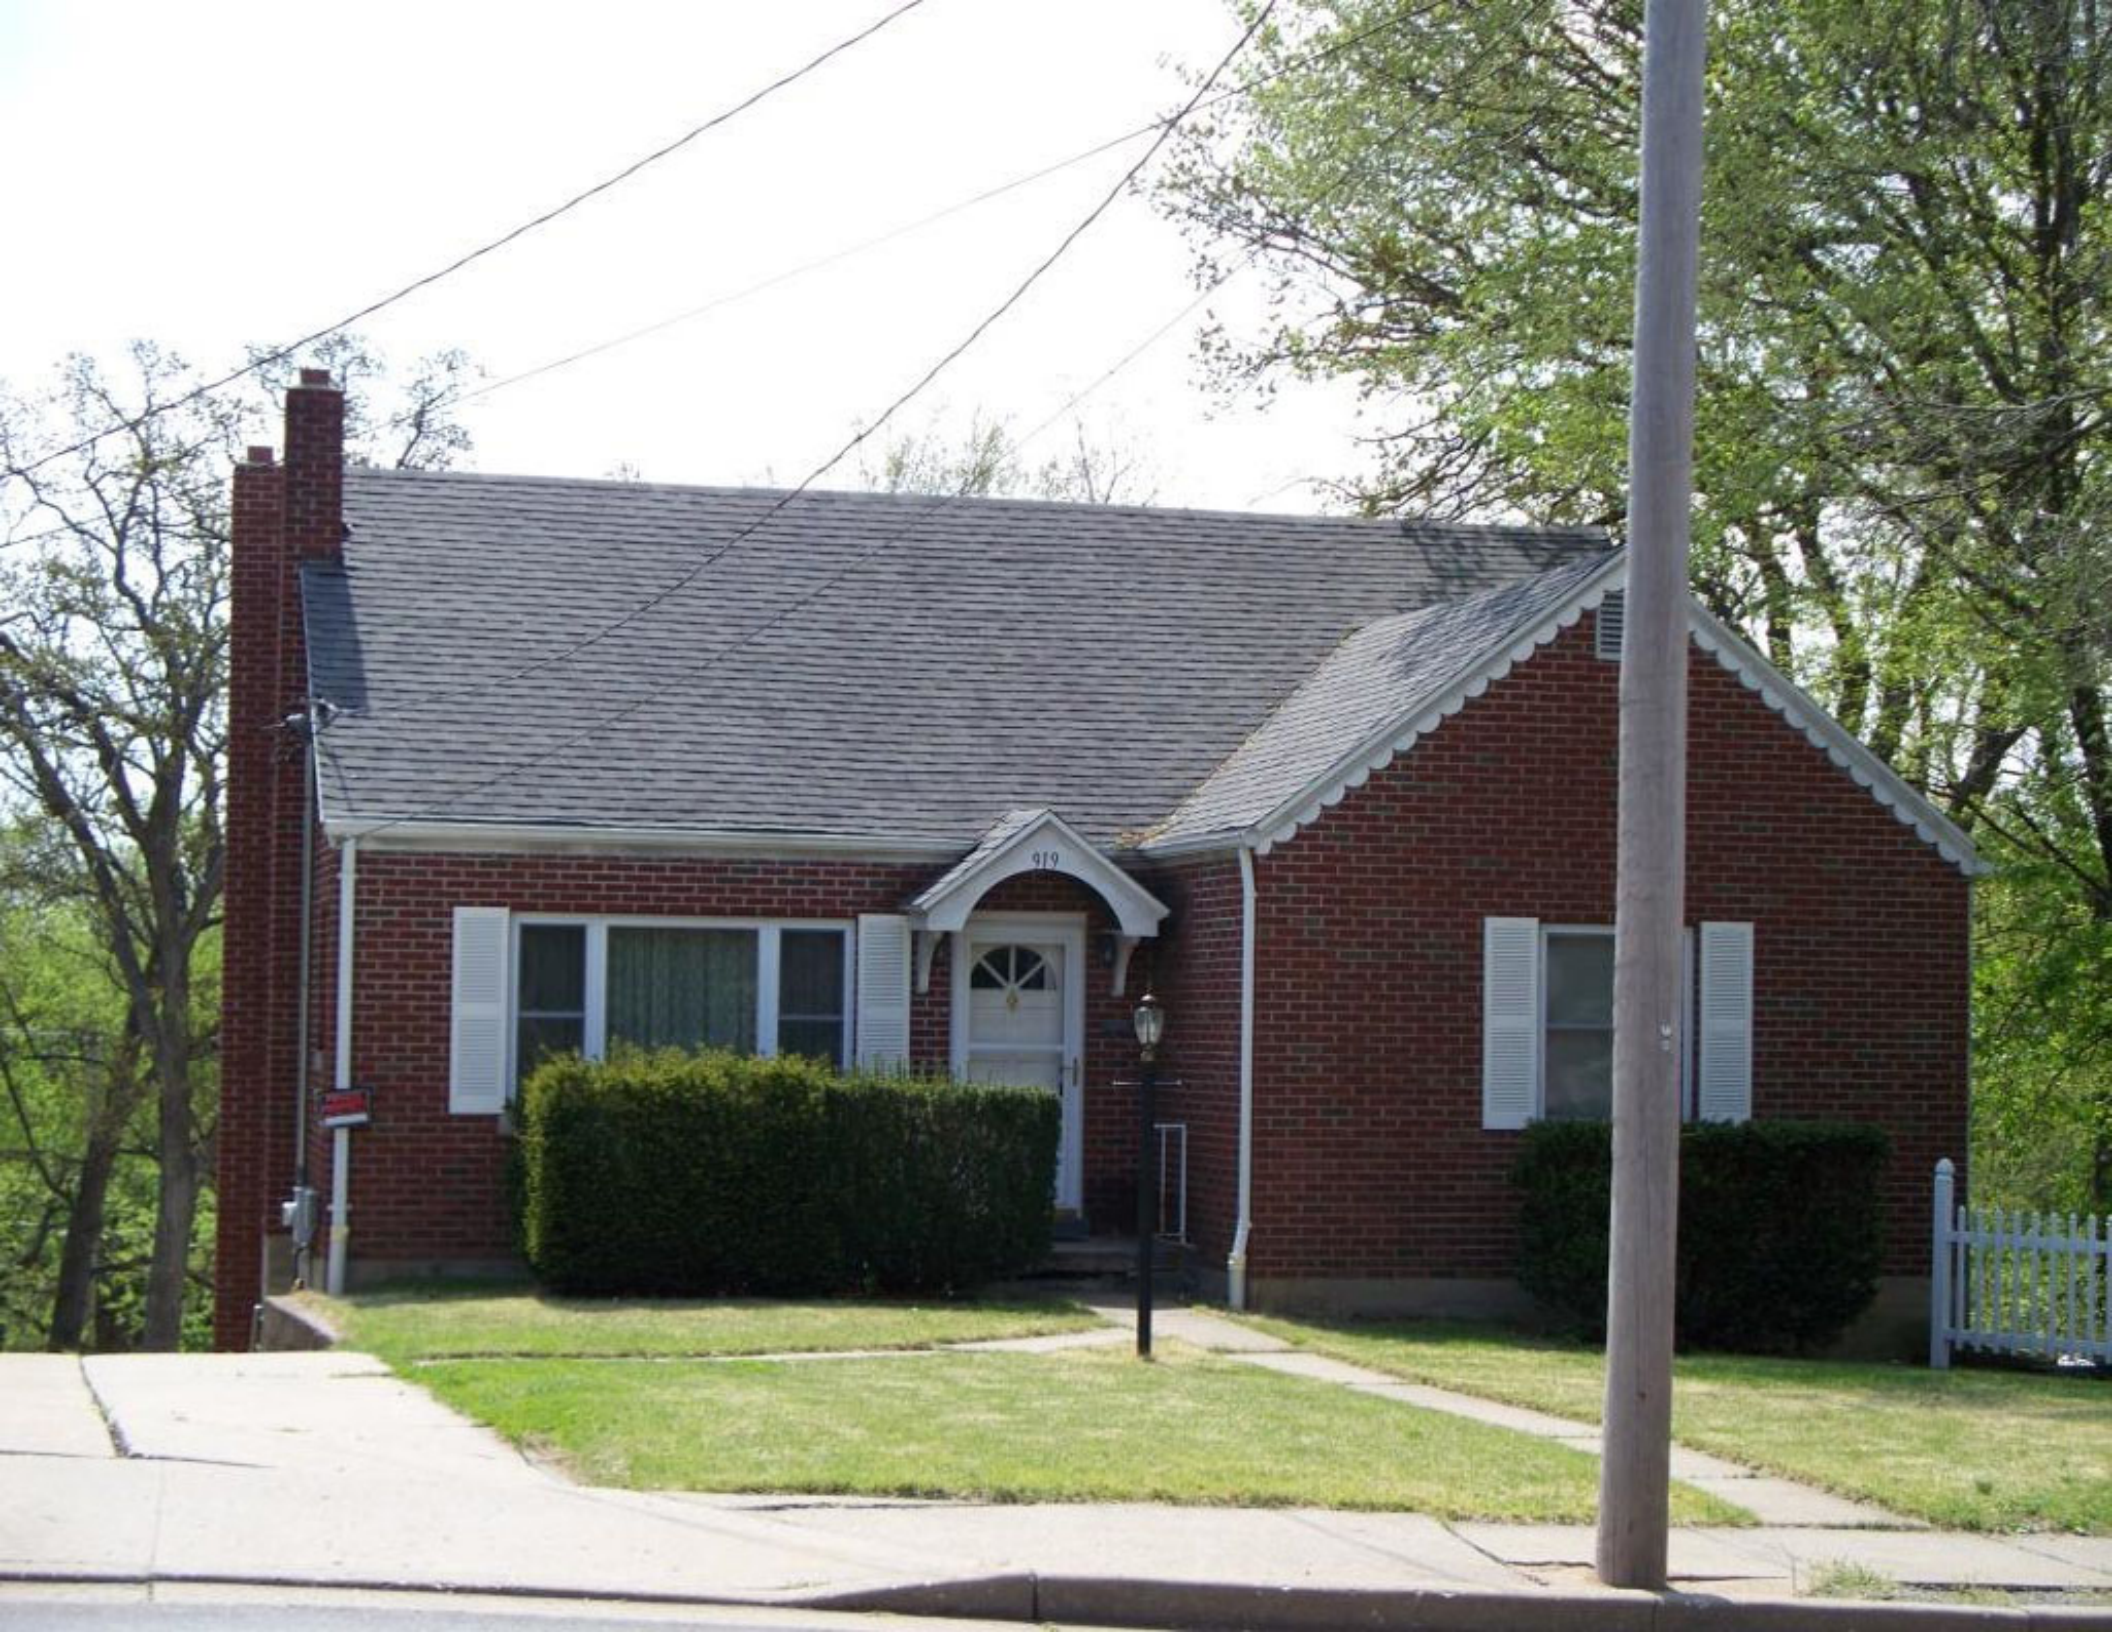
This brick gable and wing is one story although the attic may have been converted to make an additional half story. The entrance and stoop is located at the junction of the protruding wing and is sheltered by a gable hood with brackets. The picture window is flanked by 1/1 windows and is surrounded by wooden shutters. Likewise, the single 1/1 window in the protruding wing has shutters, there is also decorative scalloping under the gable of the wing. The right side of the property features a pair of thin chimneys flanking the peak of the roof, due to these features the property is considered Minimal Traditional.

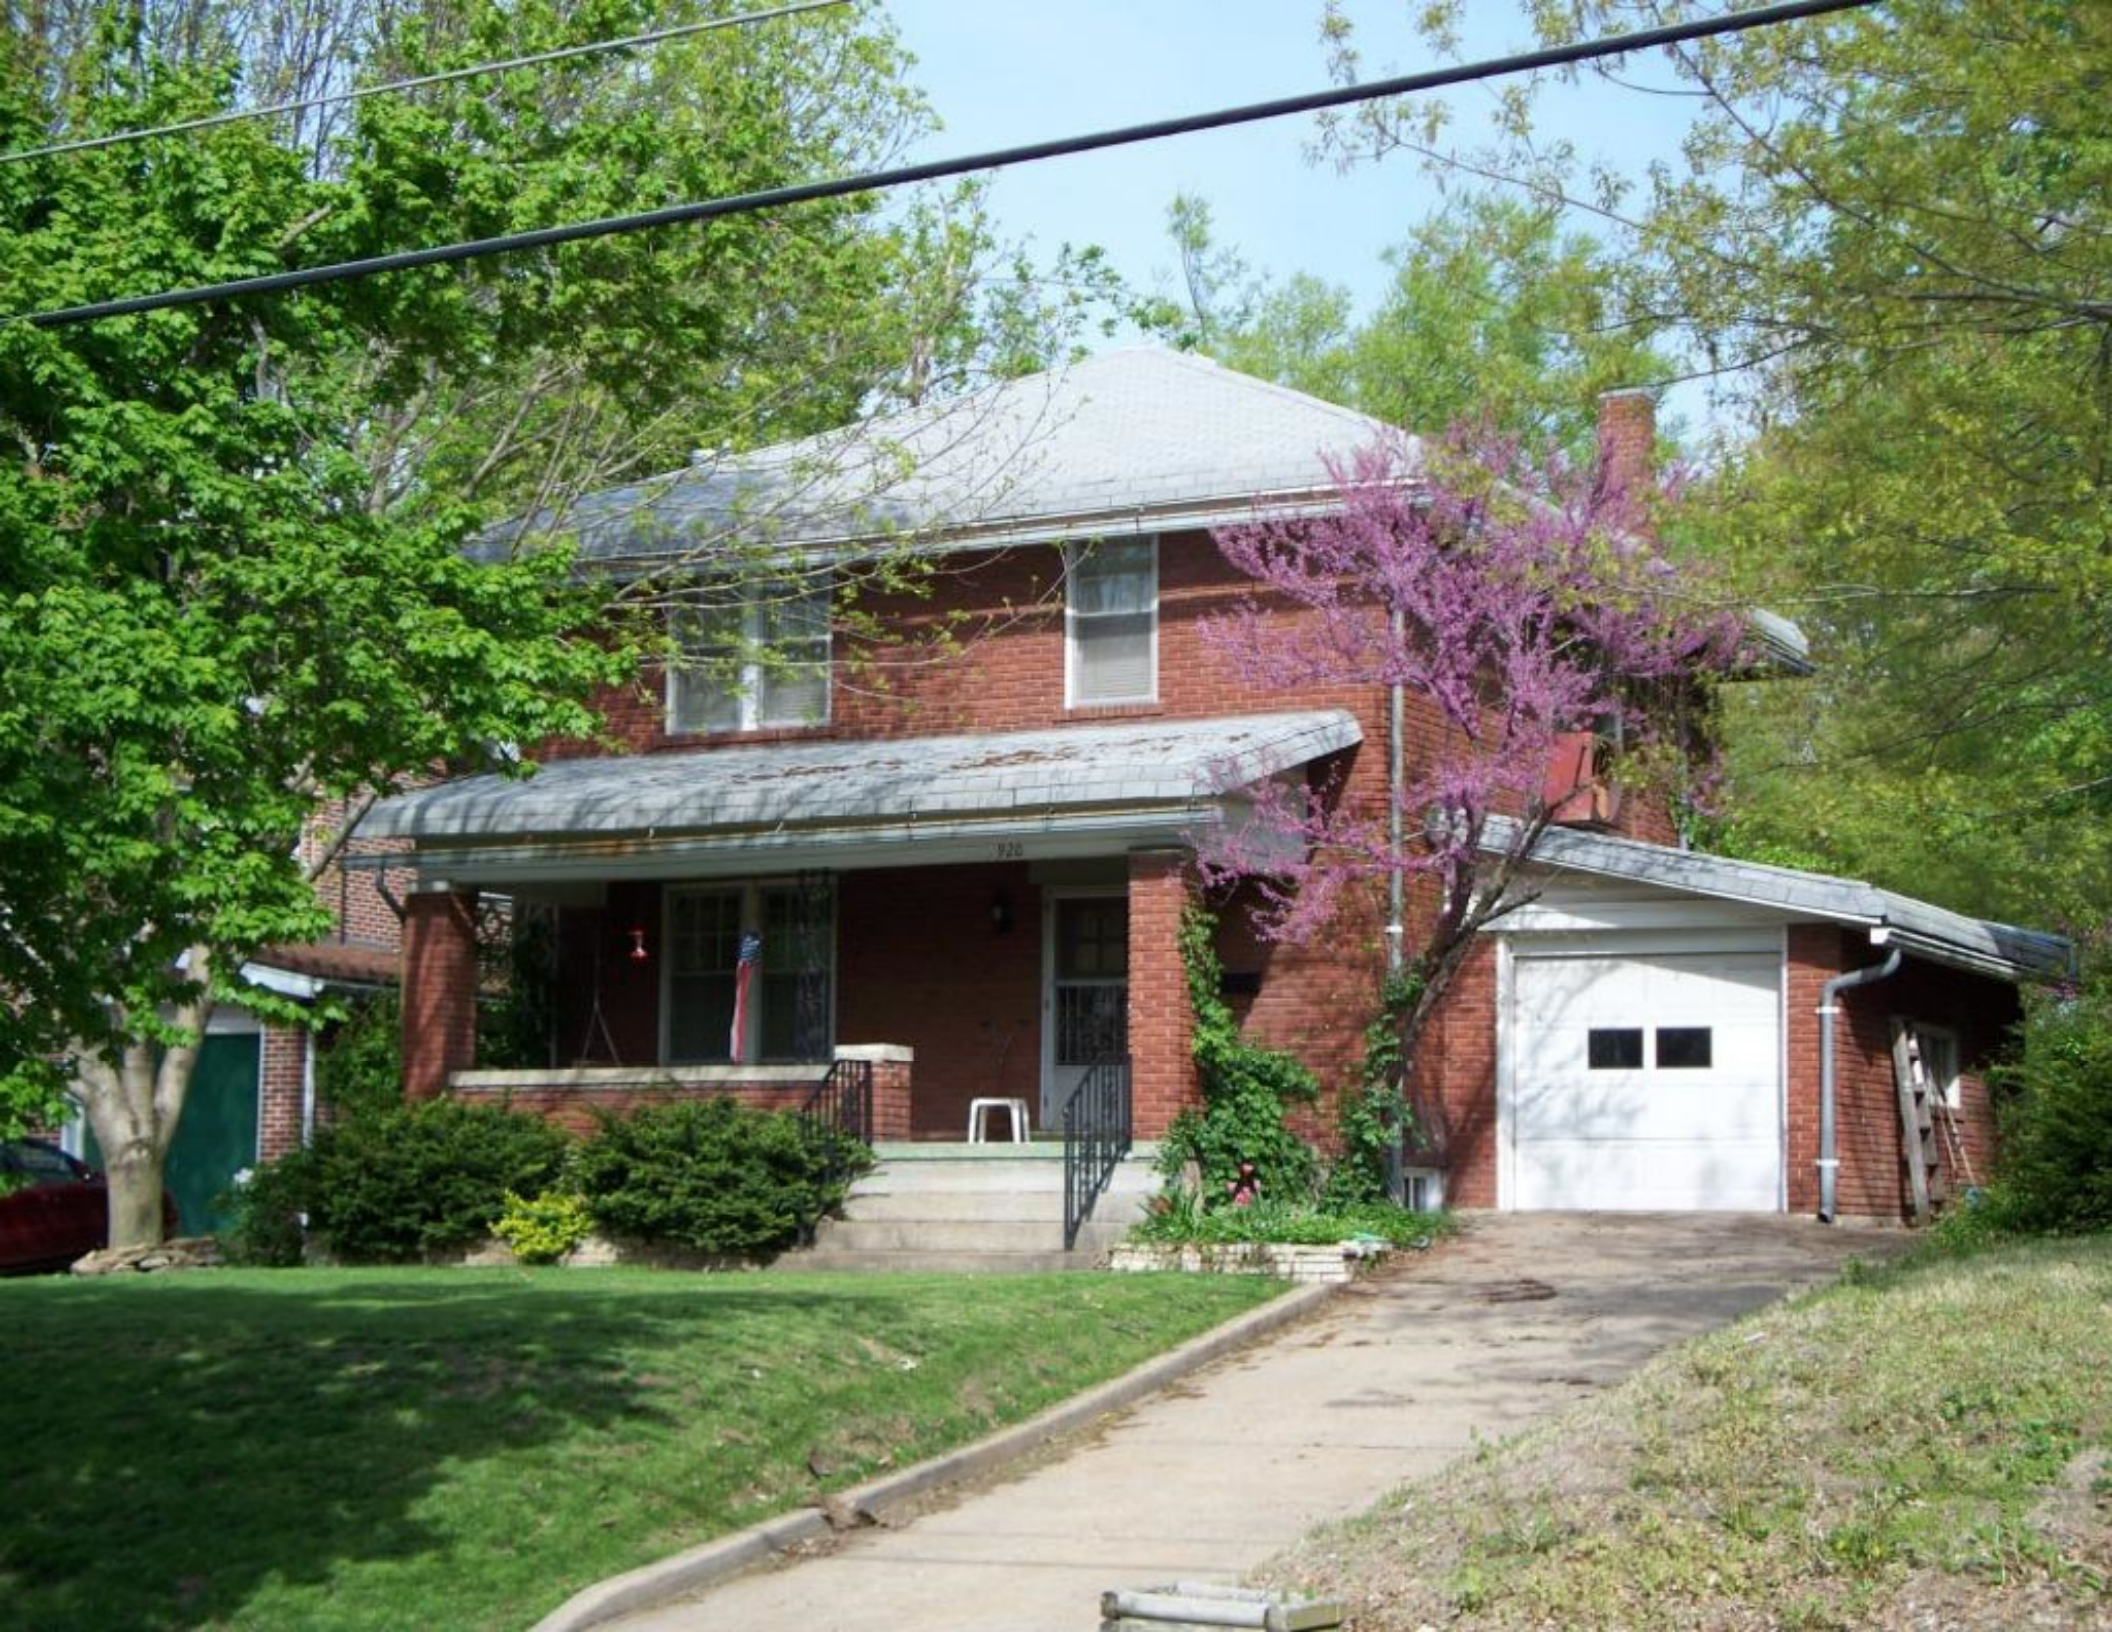
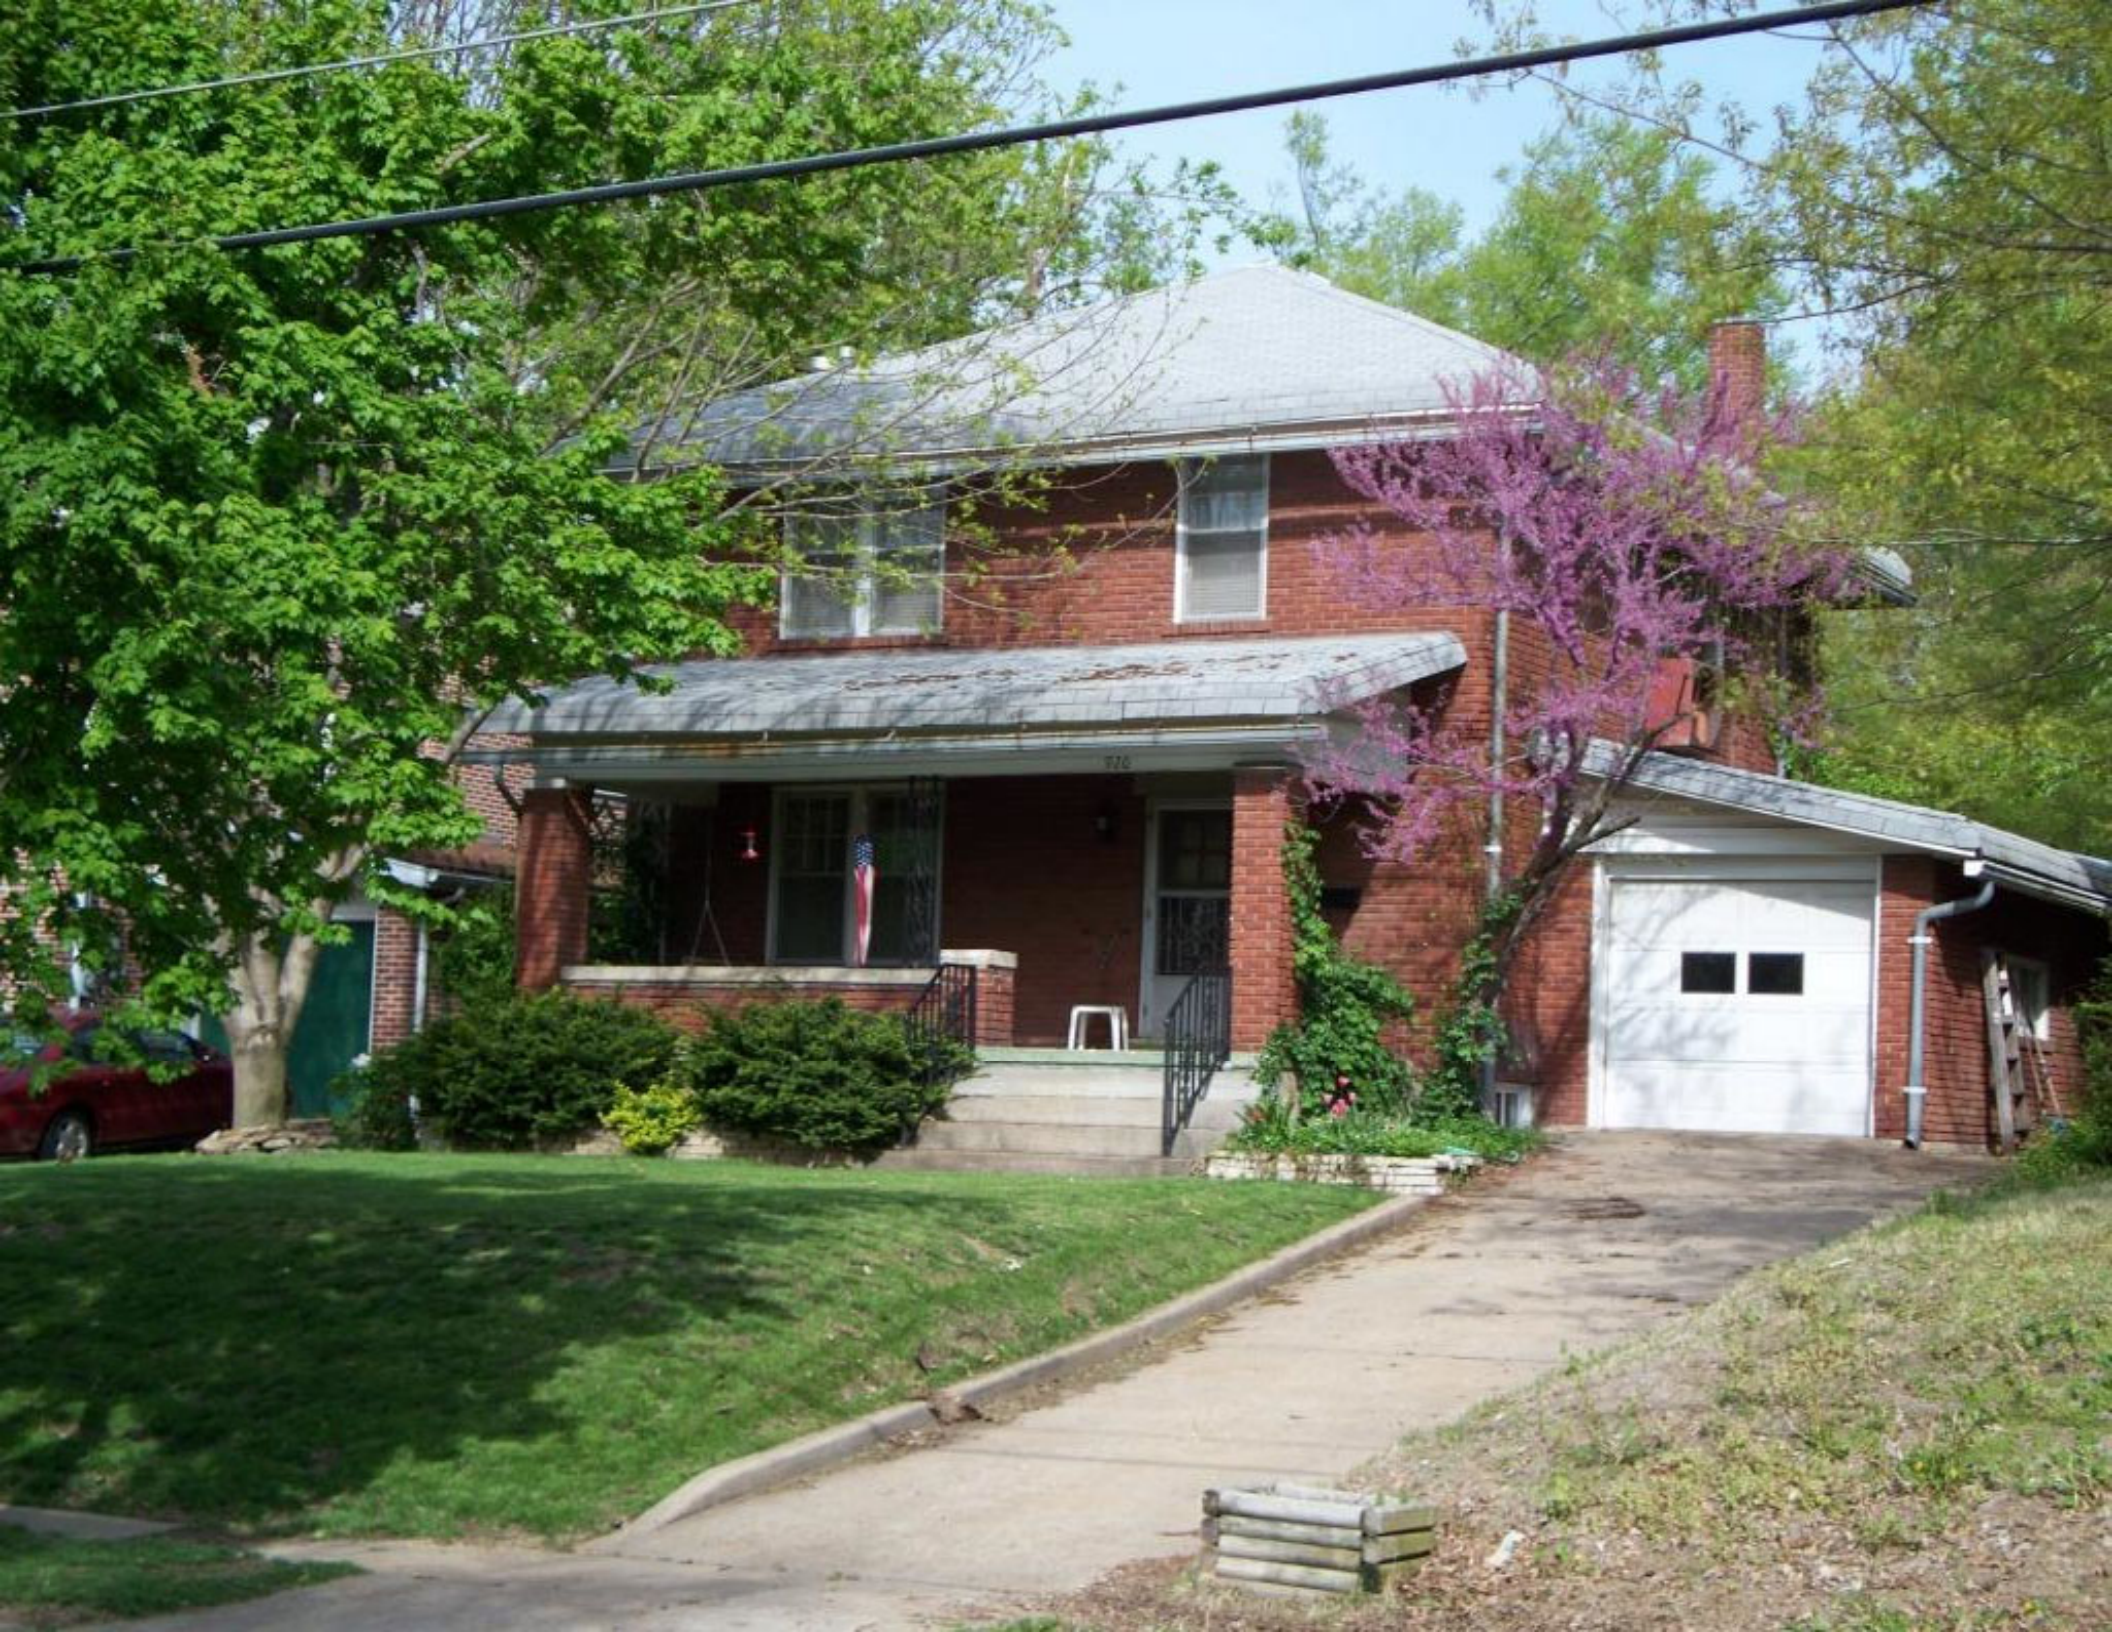
41. (cont.) The tax assessor's office states this property was built in 1900. However due to the type and attached garage it was more likely built c 1910s-1920s. It's very similar to its neighbors as it is a two-story four square with a full-width porch. It has an attached one-car garage with a shed roof, an offset entrance and a pair of 6/1 windows on the first floor. The porch has a shed roof and the second floor has paired 6/1 windows to the left and a single window on the right. It's unclear if the windows or historic or modern replacement. The asphalt shingle roof is pyramidal and features a chimney on the back right side.
