ARCHITECTURAL/HISTORIC INVENTORY FORM

1. Survey No. CO-AS-005-001		2. Survey name: Moreau Drive Neighborhood Survey	
3. County: Cole		4. Address: 1202 Elmerine Ave.	
5. City: Jefferson City	Vicinity: <input type="checkbox"/>	6. UTM: / /	7. Township/Range/Section: T: R: S:
8. Historic name (if known):		9. Present/other name (if known):	
10. Ownership: <input checked="" type="checkbox"/> Private <input type="checkbox"/> Public		11. Historic use (if known): Residential	11. Current use: Residential

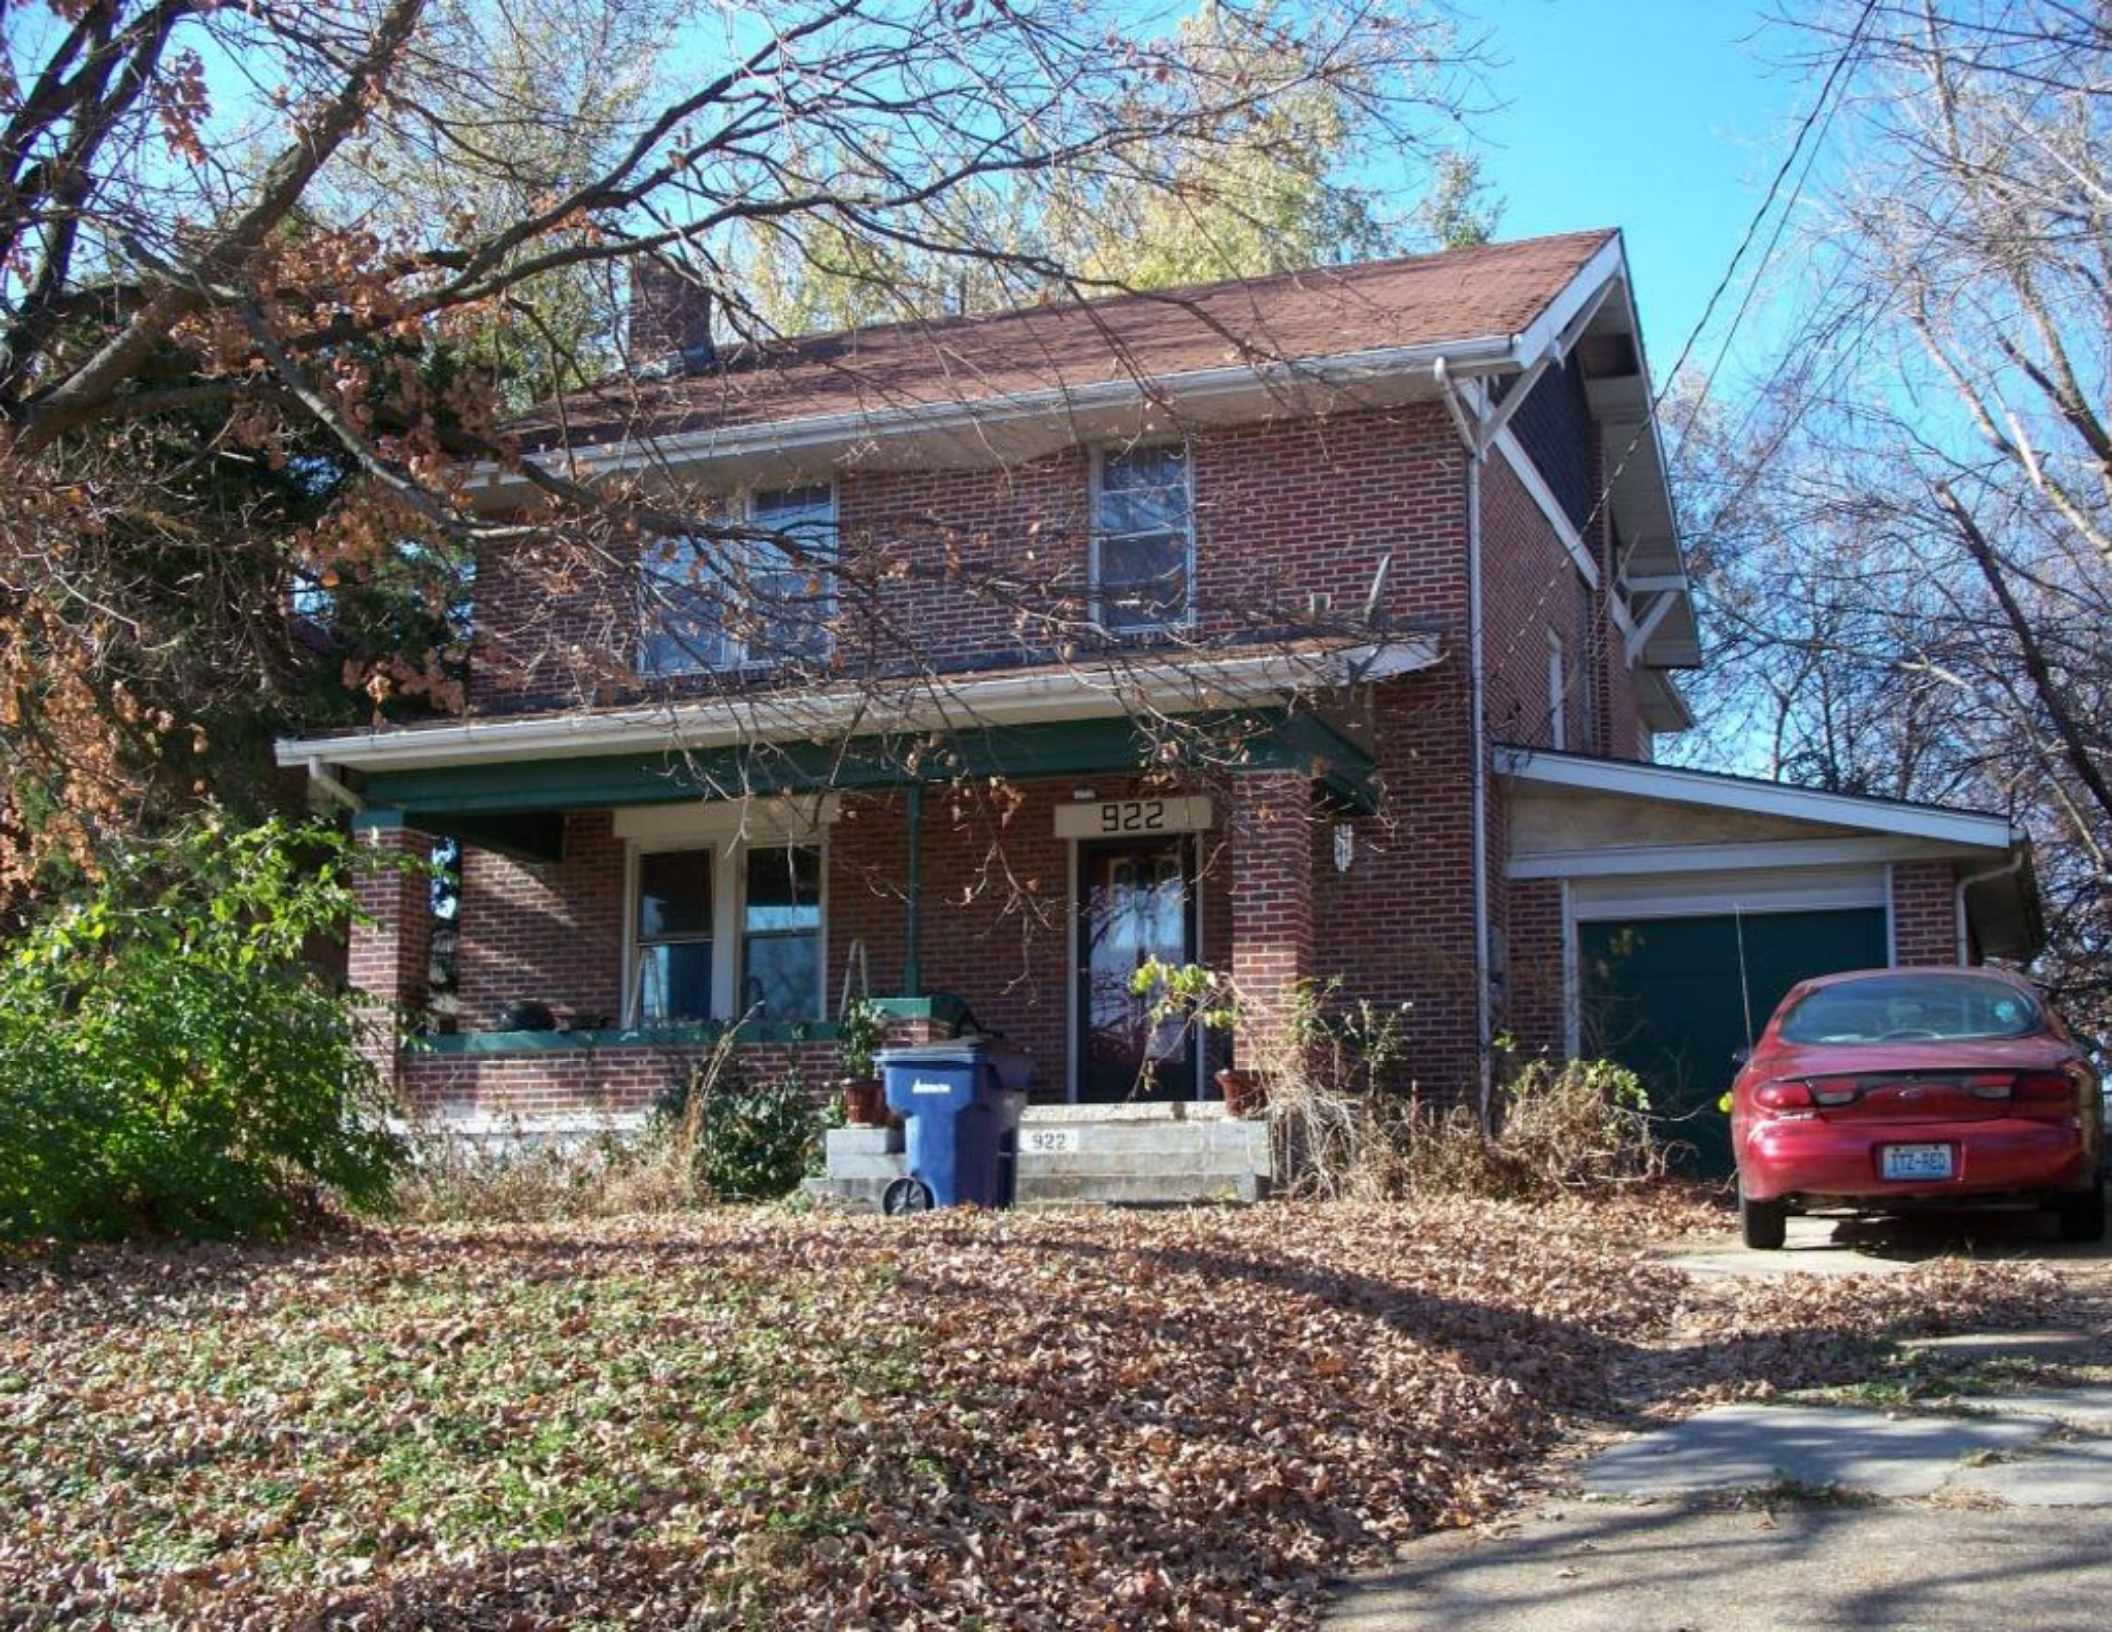
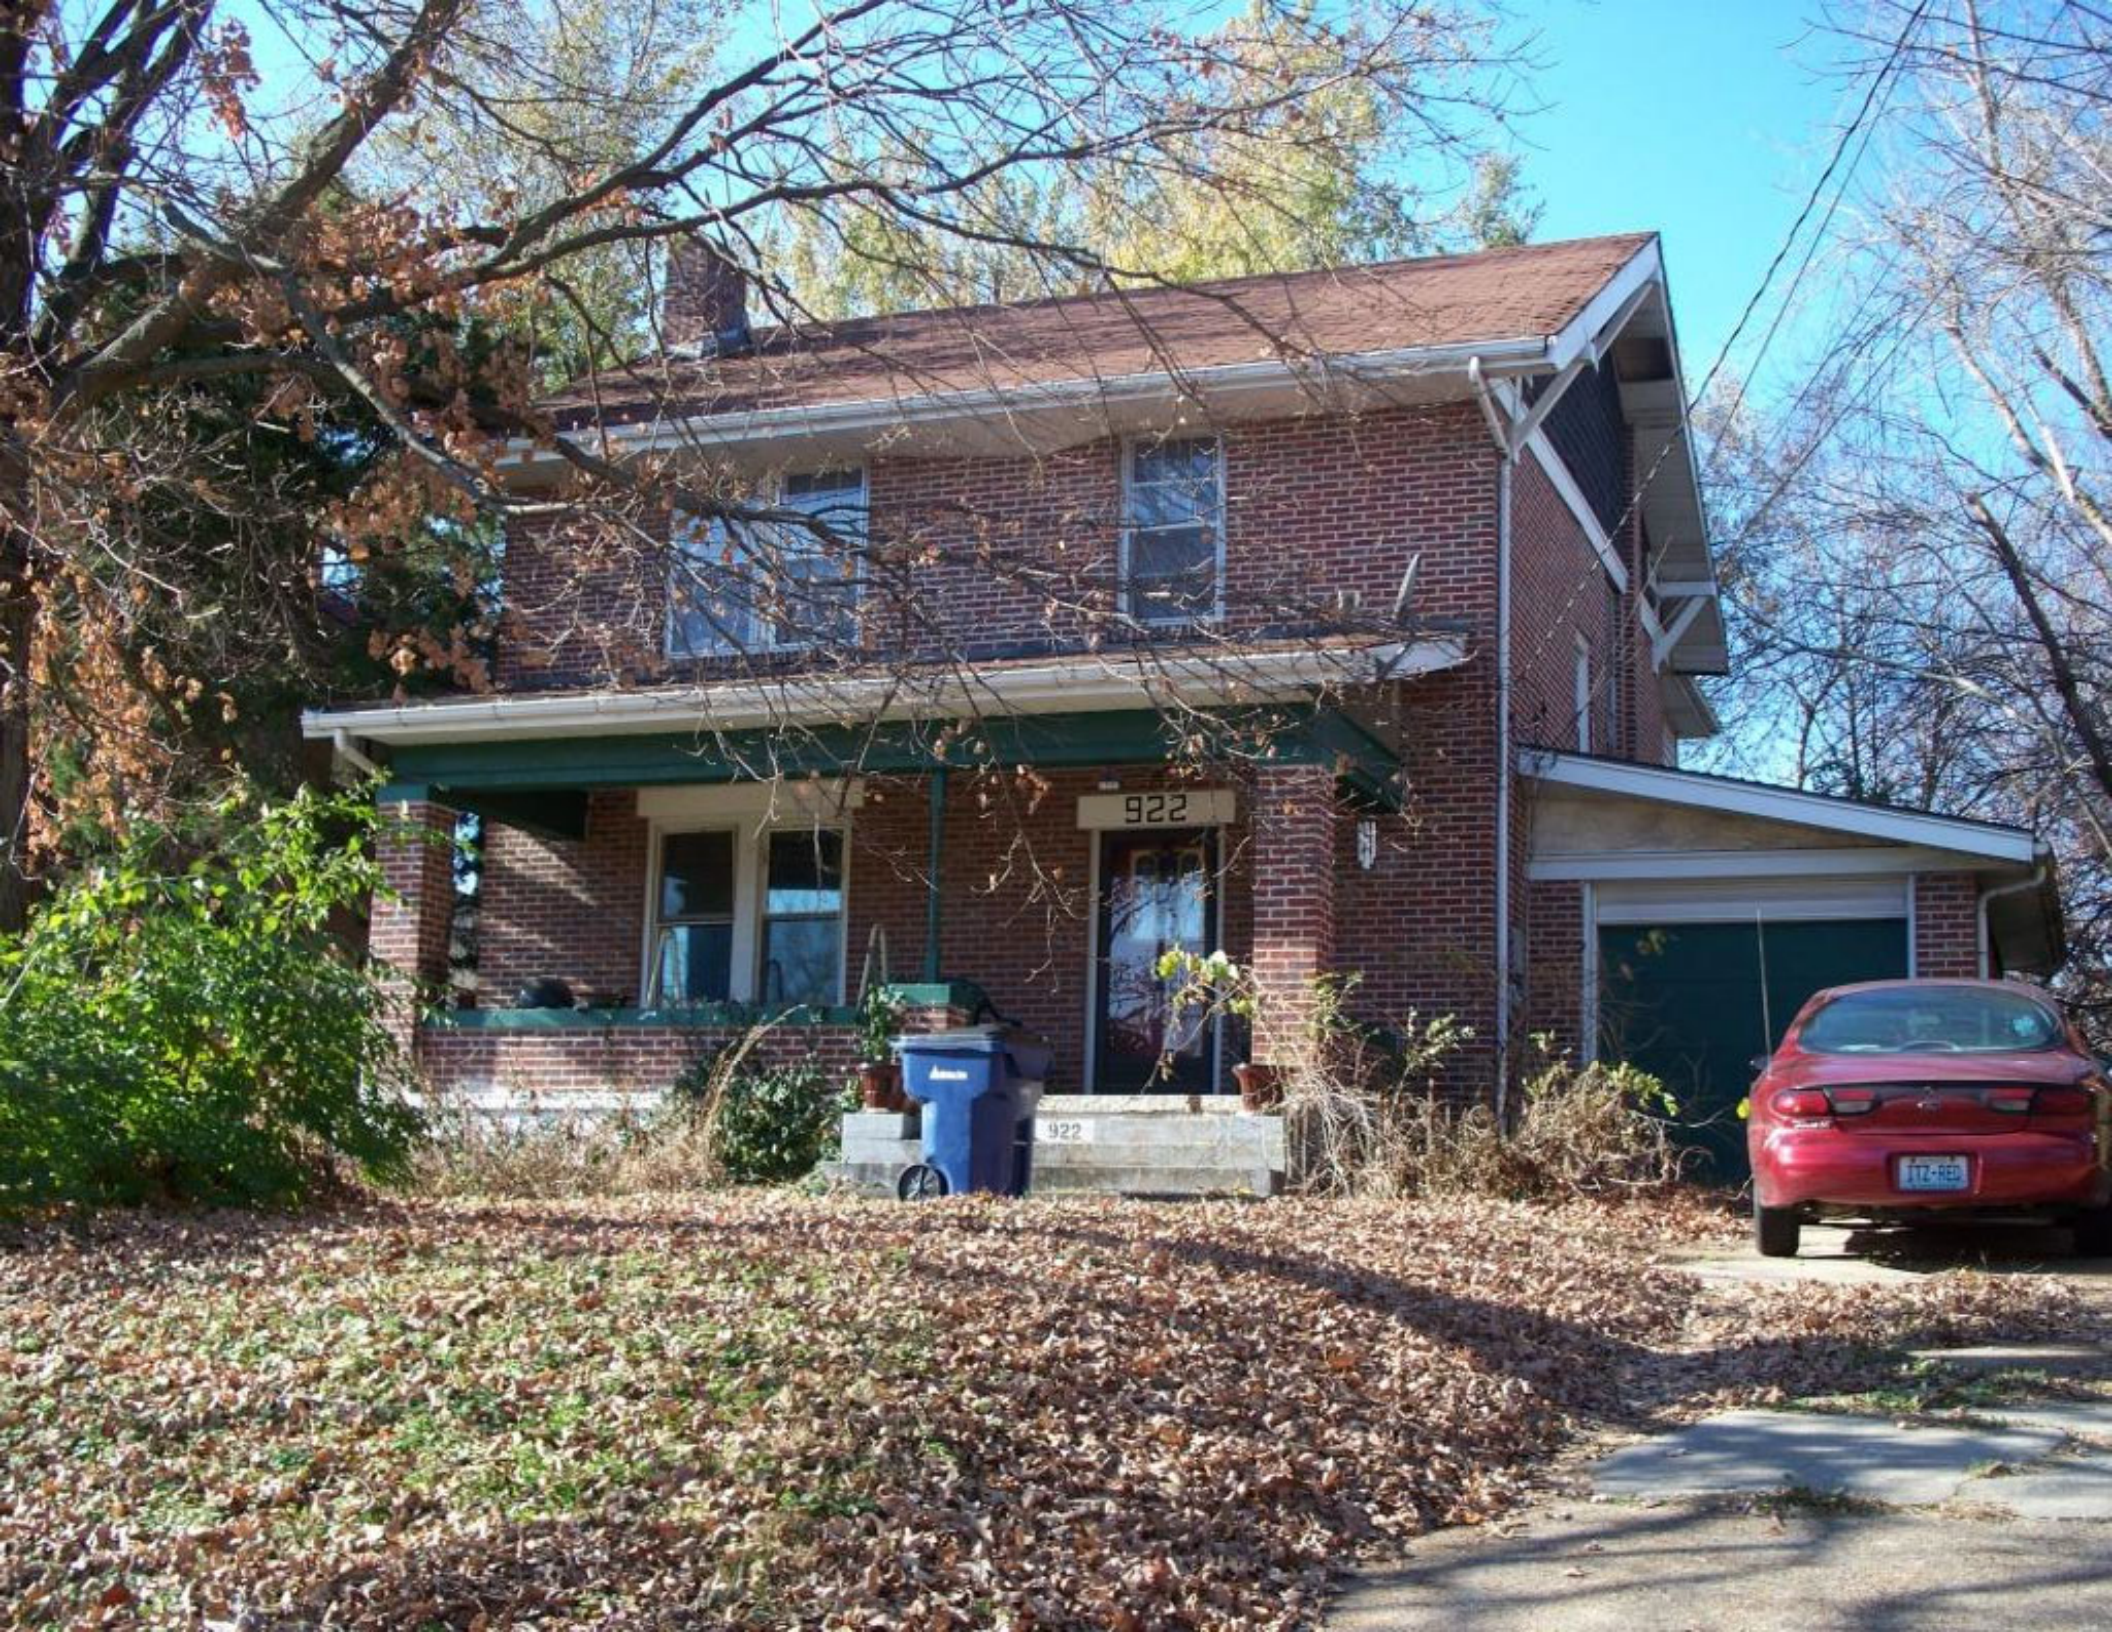
922

41. (cont.) This brick four square has a side gable roof a three six-over-one windows on the second floor (two are paired on the left side.) The full width open porch has a shed roof and brick piers save for one wooden spindle that was likely added later. Paired one-over-one aluminum windows are on the left side of the first floor. They feature a wide stone lintel. A similar stone lintel is over the entrance with “922” painted on it. A single car garage is attached to the house on the right side; it has a shed roof similar to its neighbors.

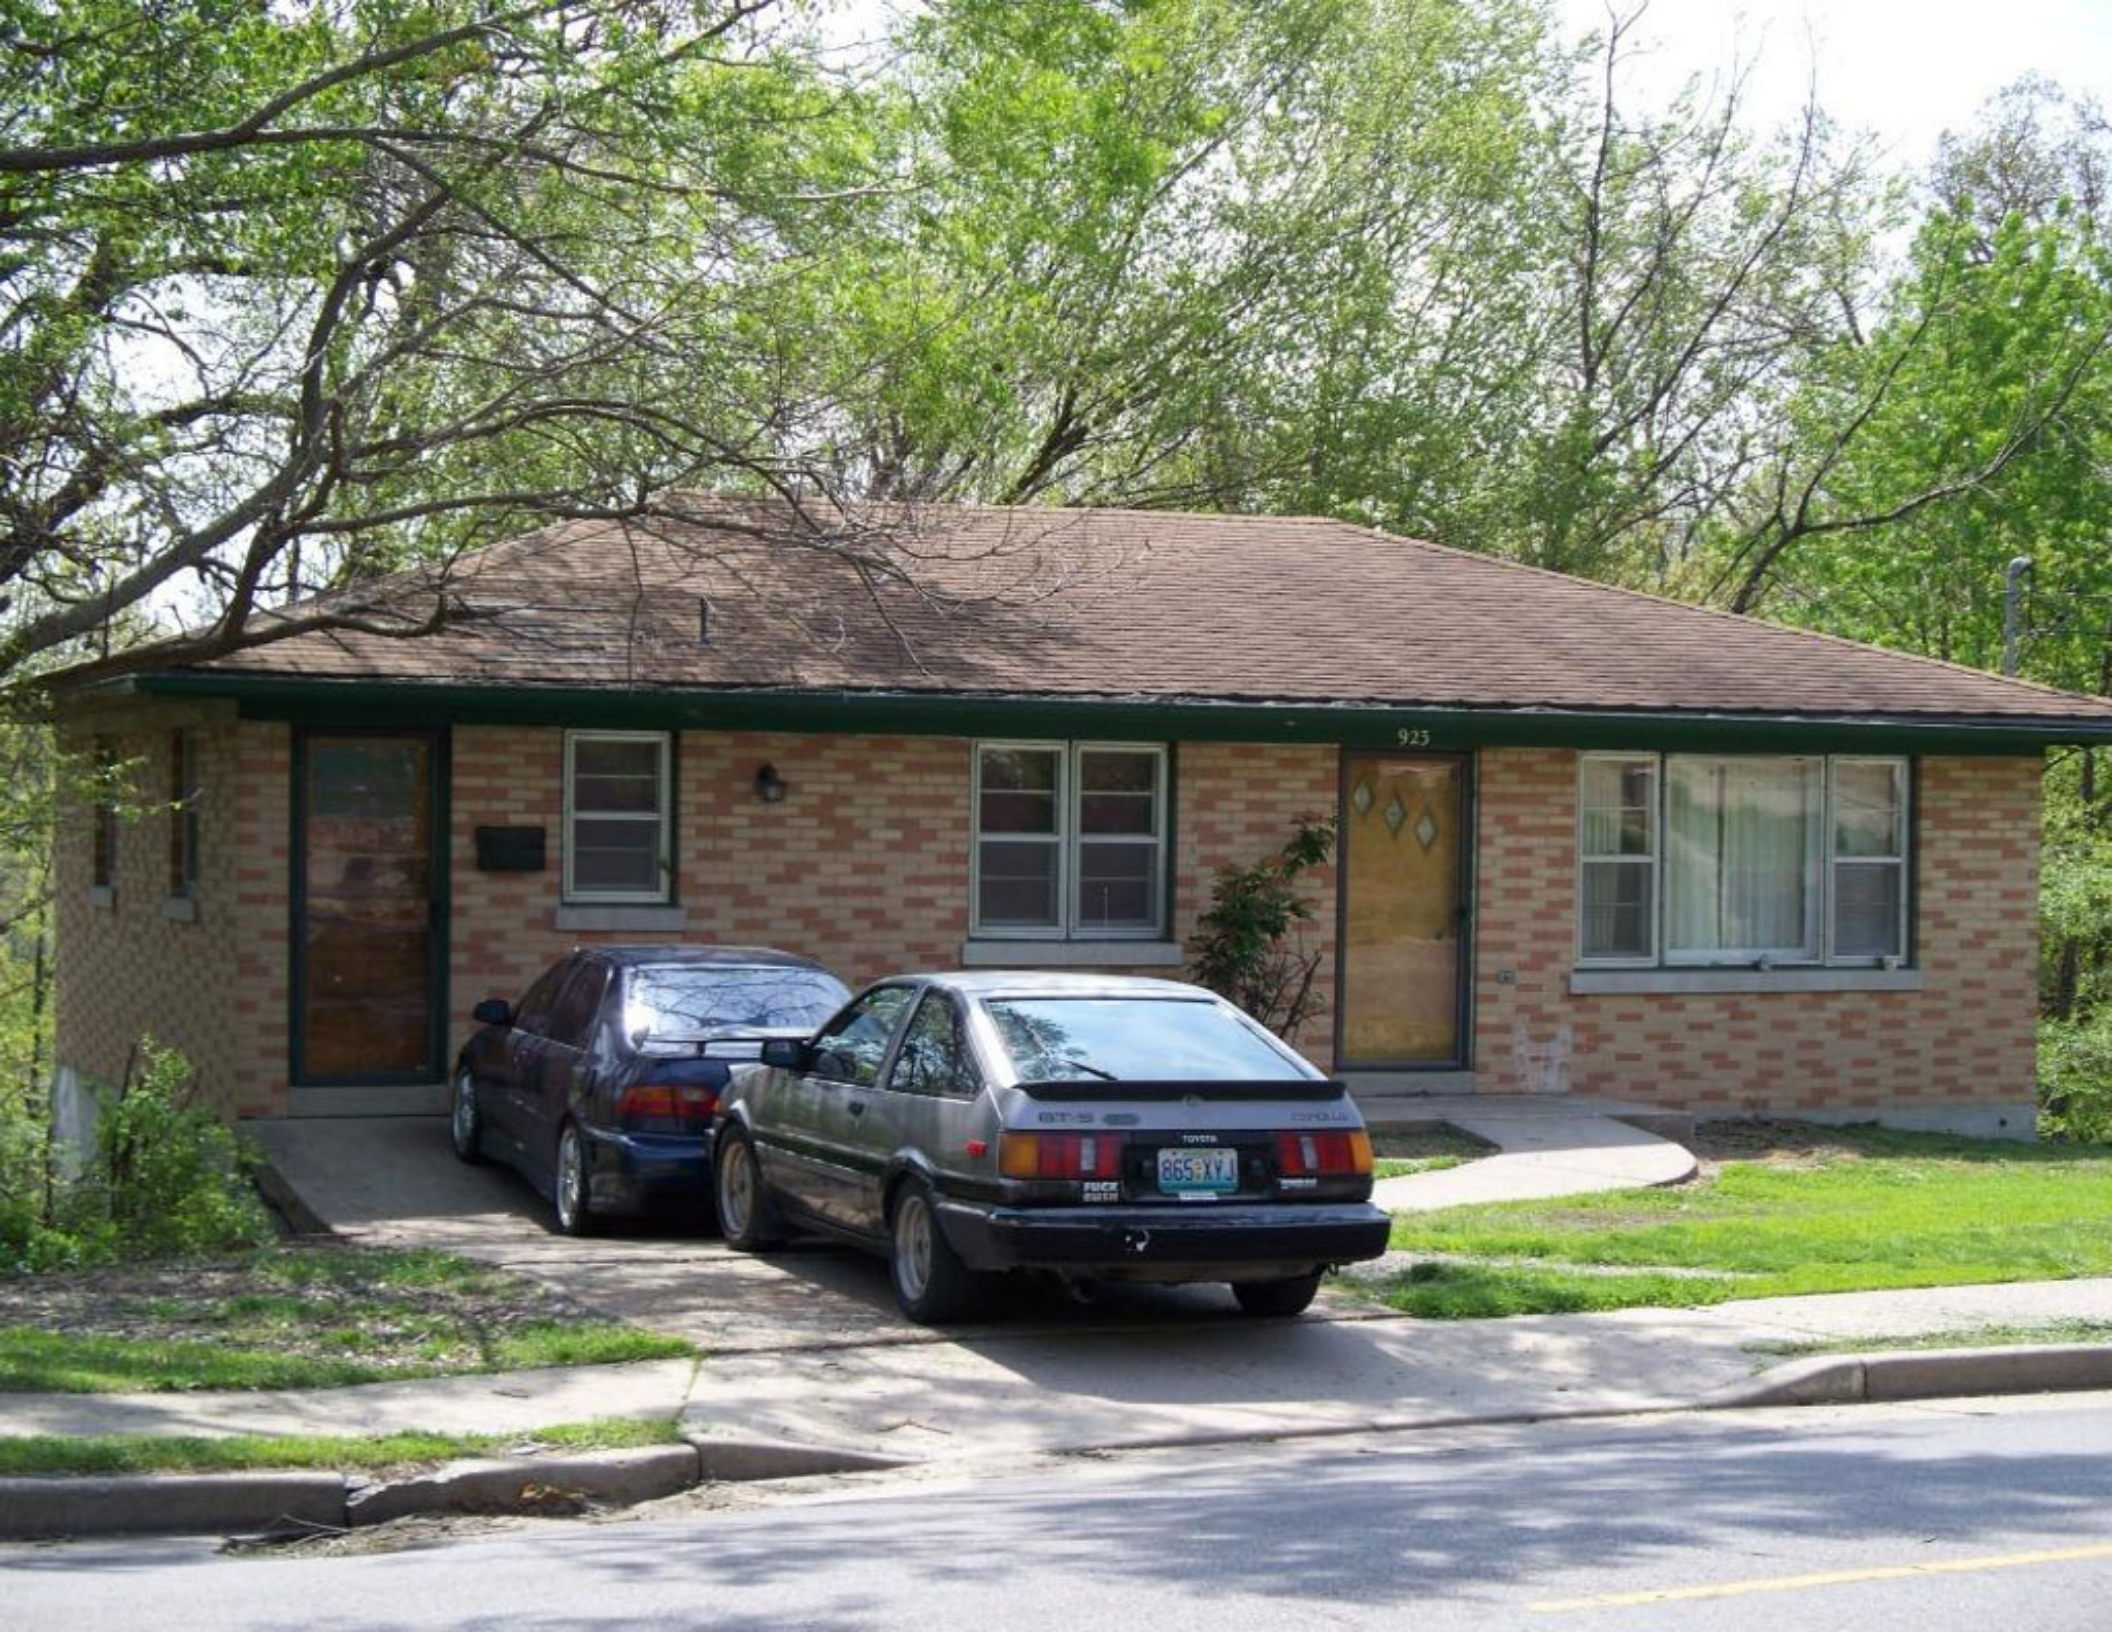
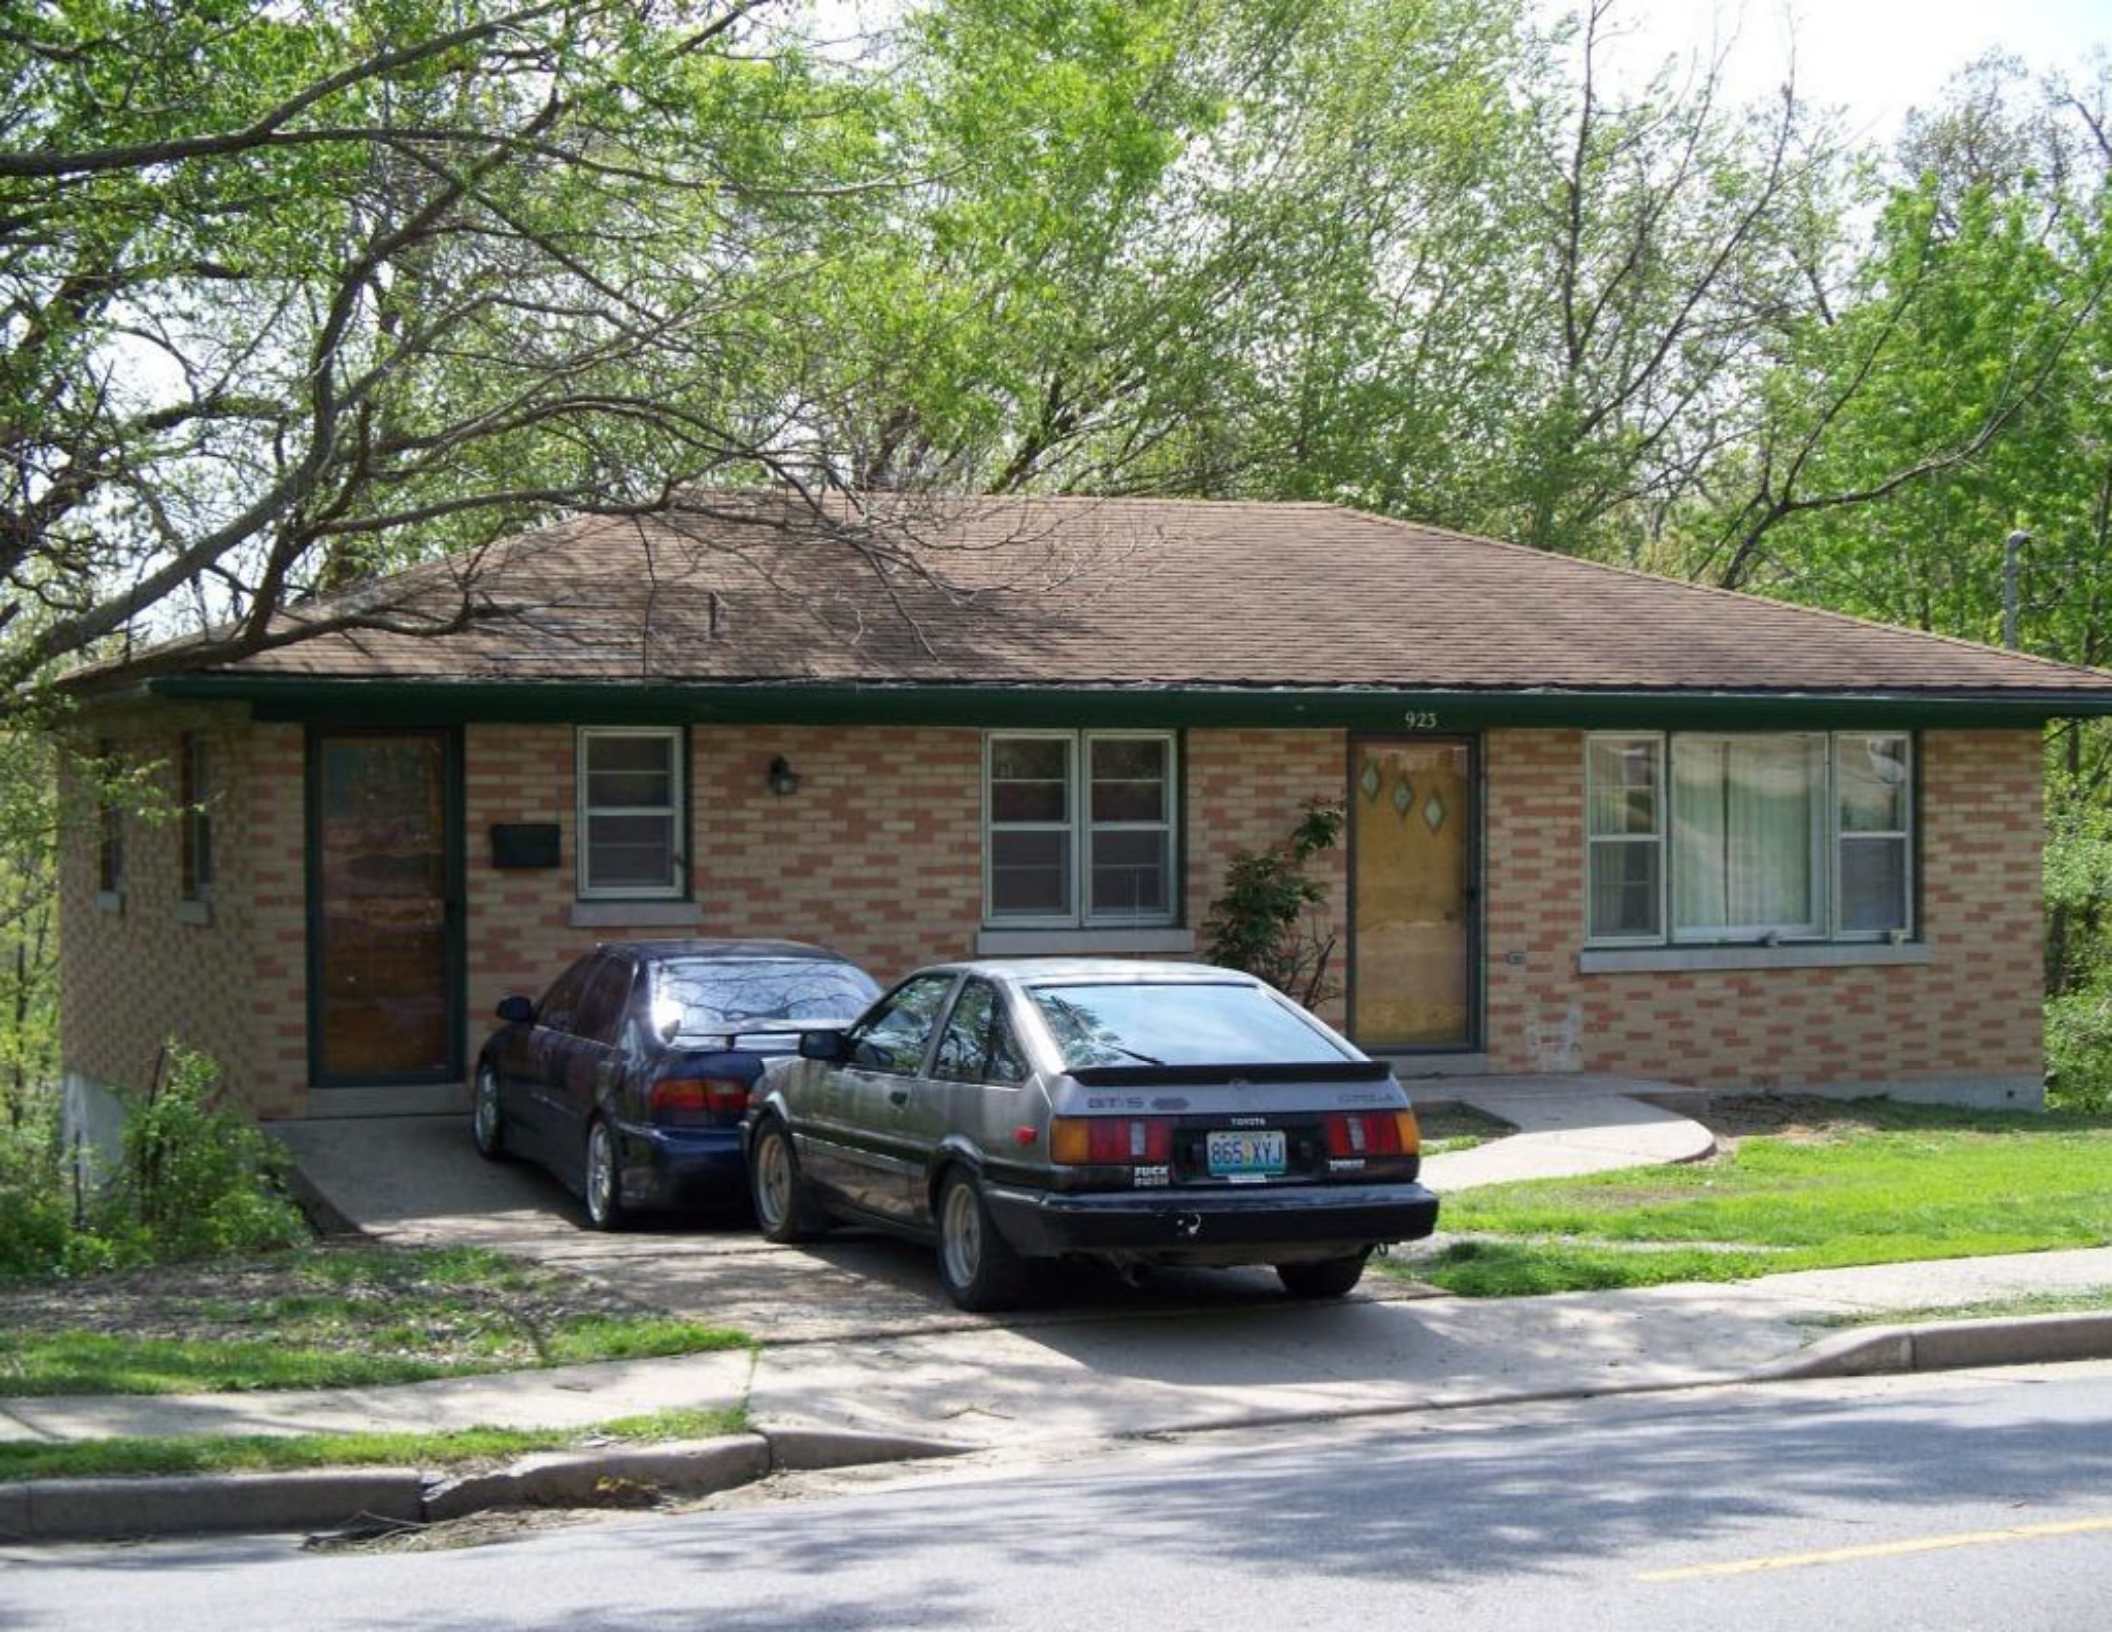
925

One story brick ranch house built c 1963 is considered non-contributing as it is outside the period of significance. It has a hipped roof and two entryways on the central façade.
