ARCHITECTURAL/HISTORIC INVENTORY FORM

1. Survey No. CO-AS-005-001		2. Survey name: Moreau Drive Neighborhood Survey	
3. County: Cole		4. Address: 1202 Elmerine Ave.	
5. City: Jefferson City	Vicinity: <input type="checkbox"/>	6. UTM: / /	7. Township/Range/Section: T: R: S:
8. Historic name (if known):		9. Present/other name (if known):	
10. Ownership: <input checked="" type="checkbox"/> Private <input type="checkbox"/> Public		11. Historic use (if known): Residential	11. Current use: Residential

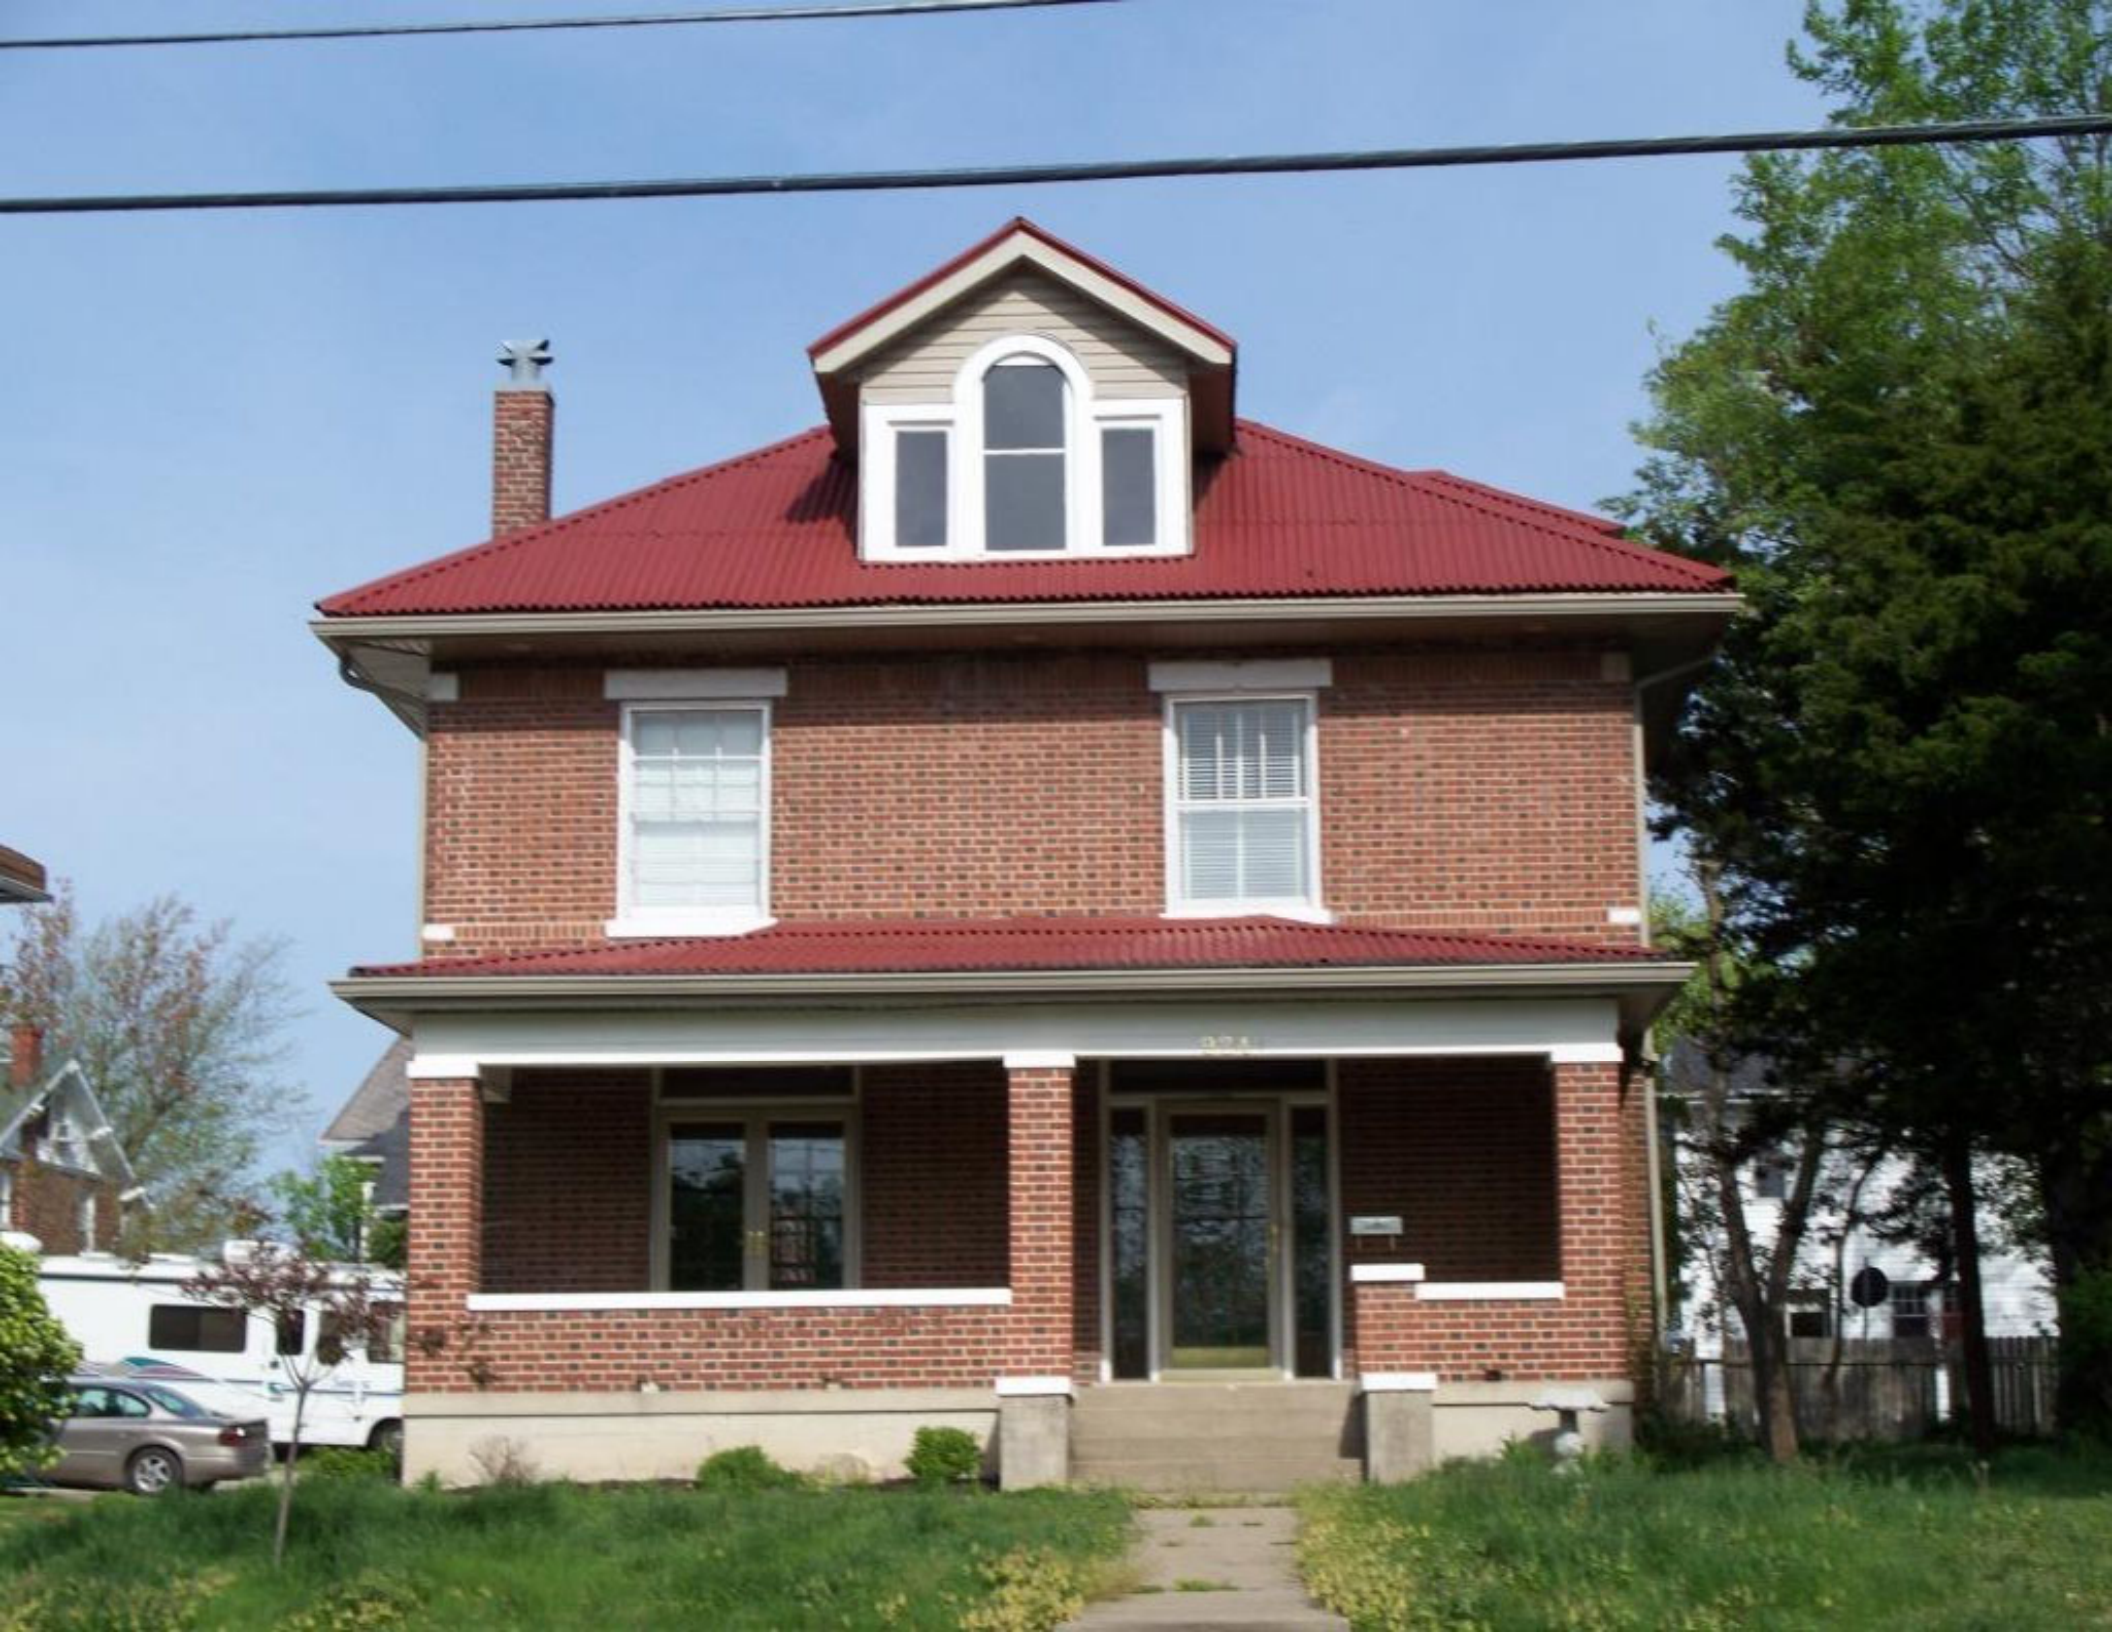
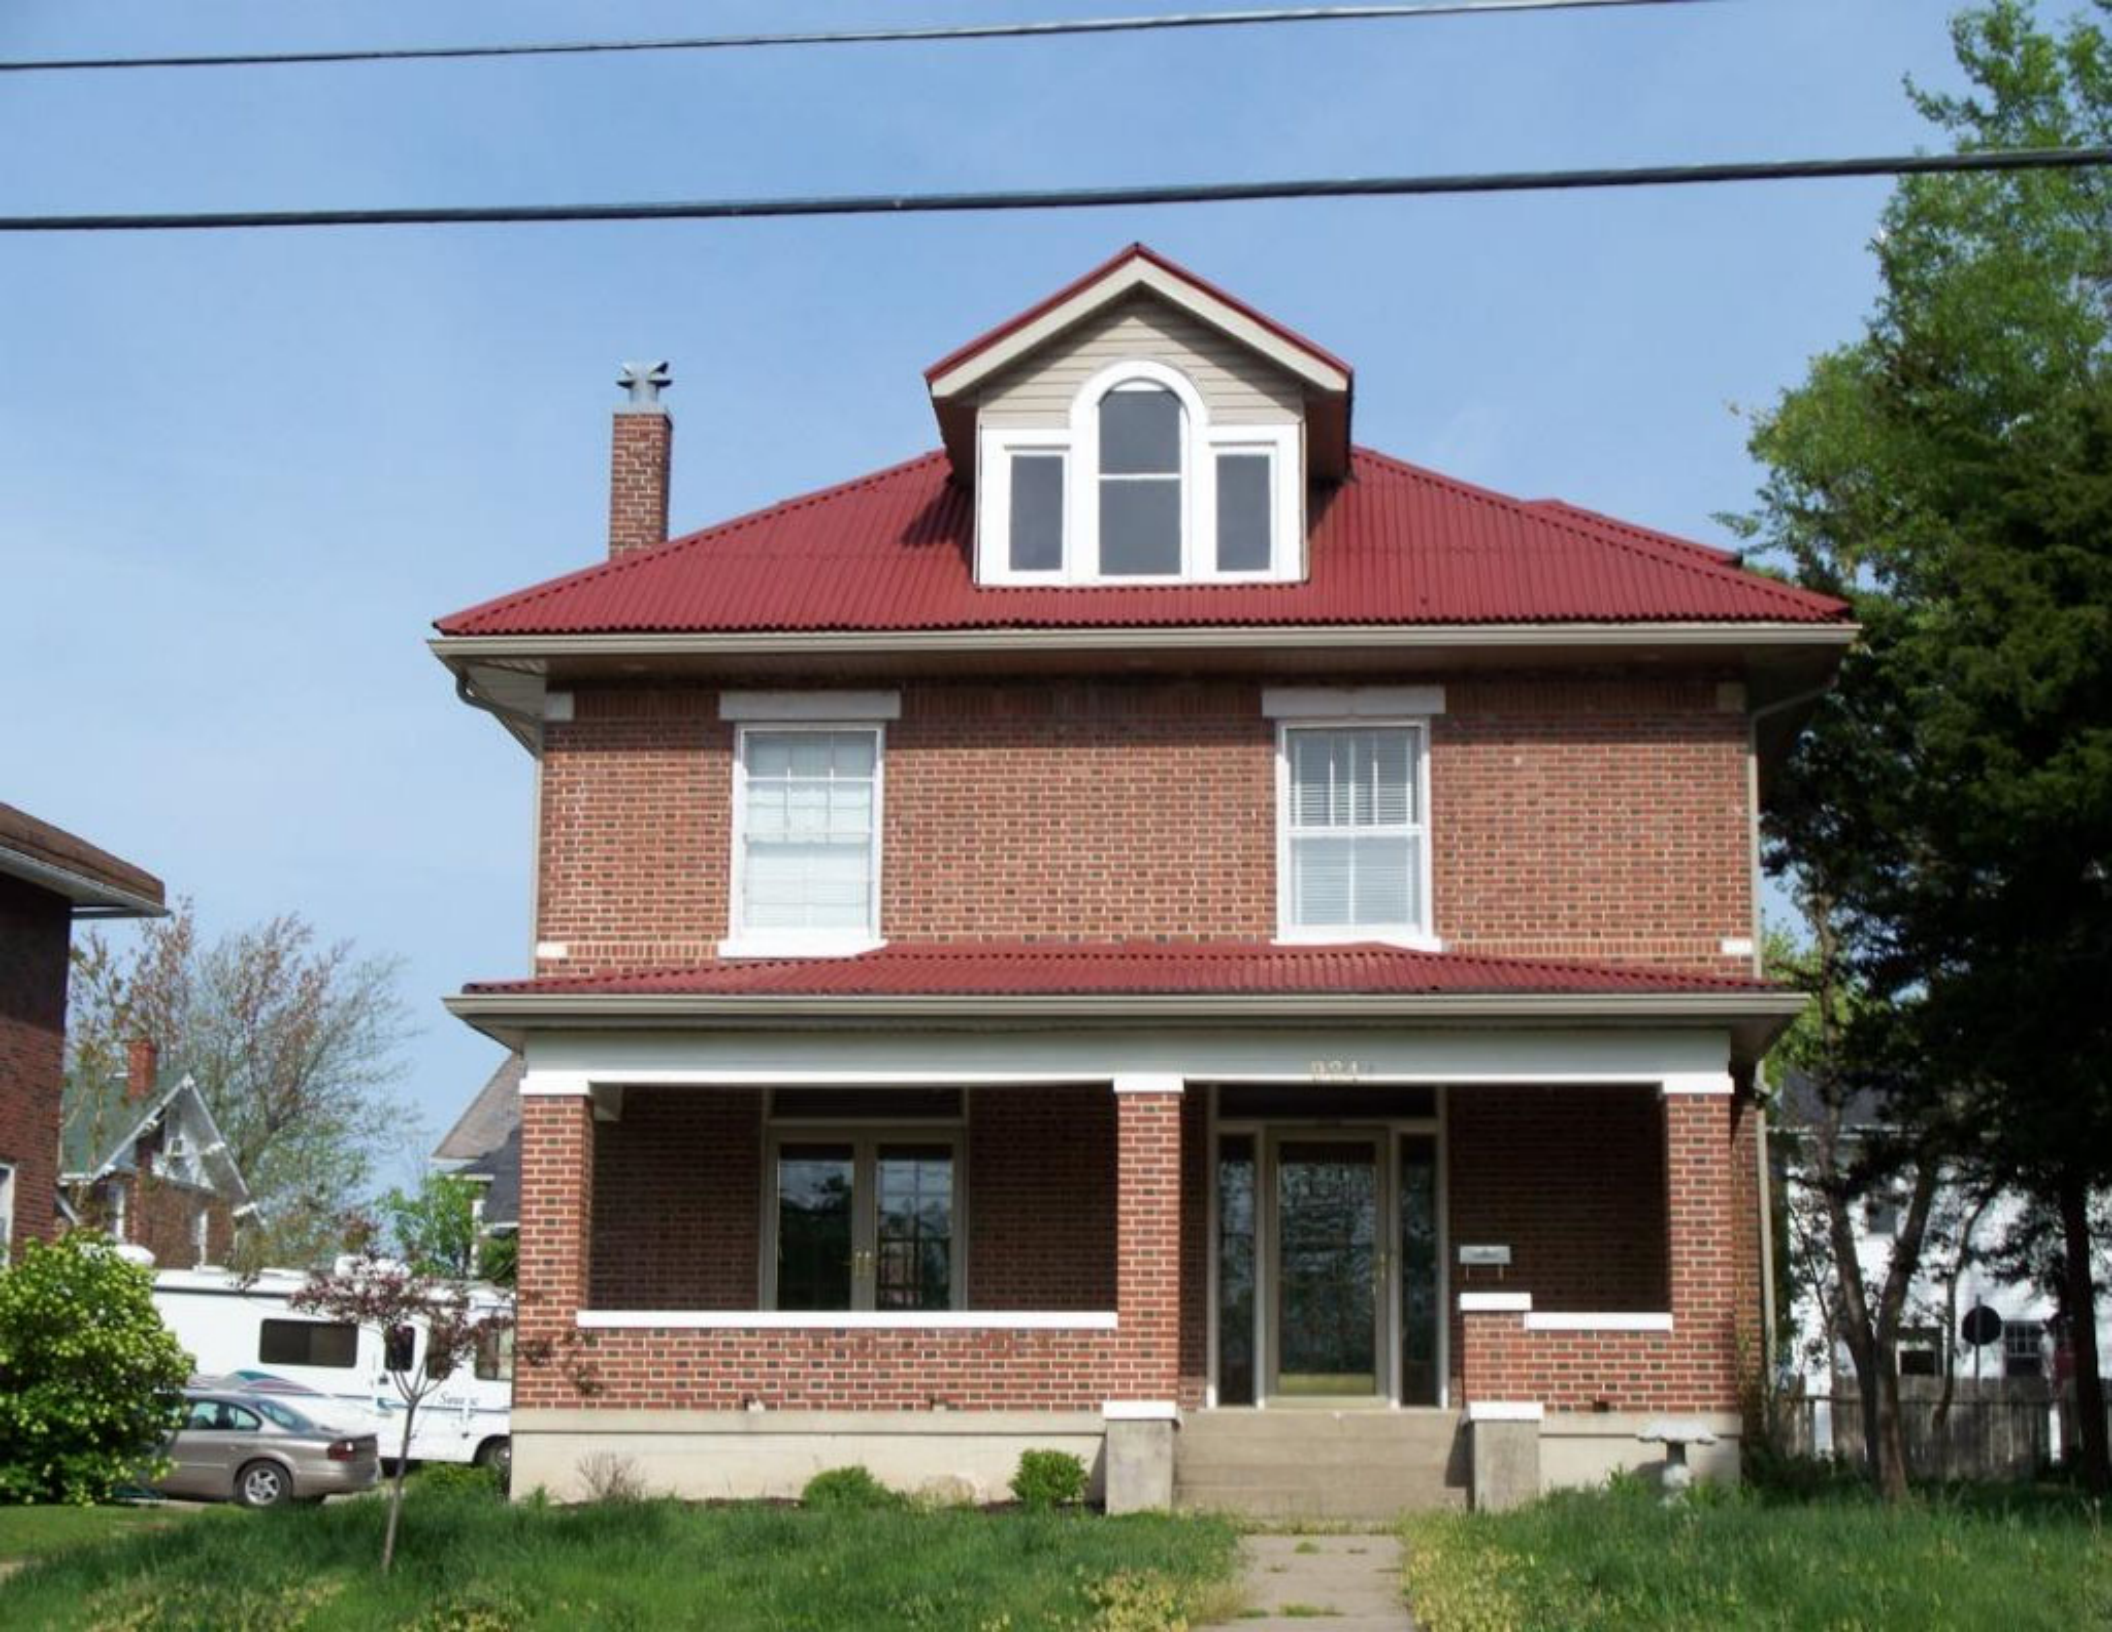
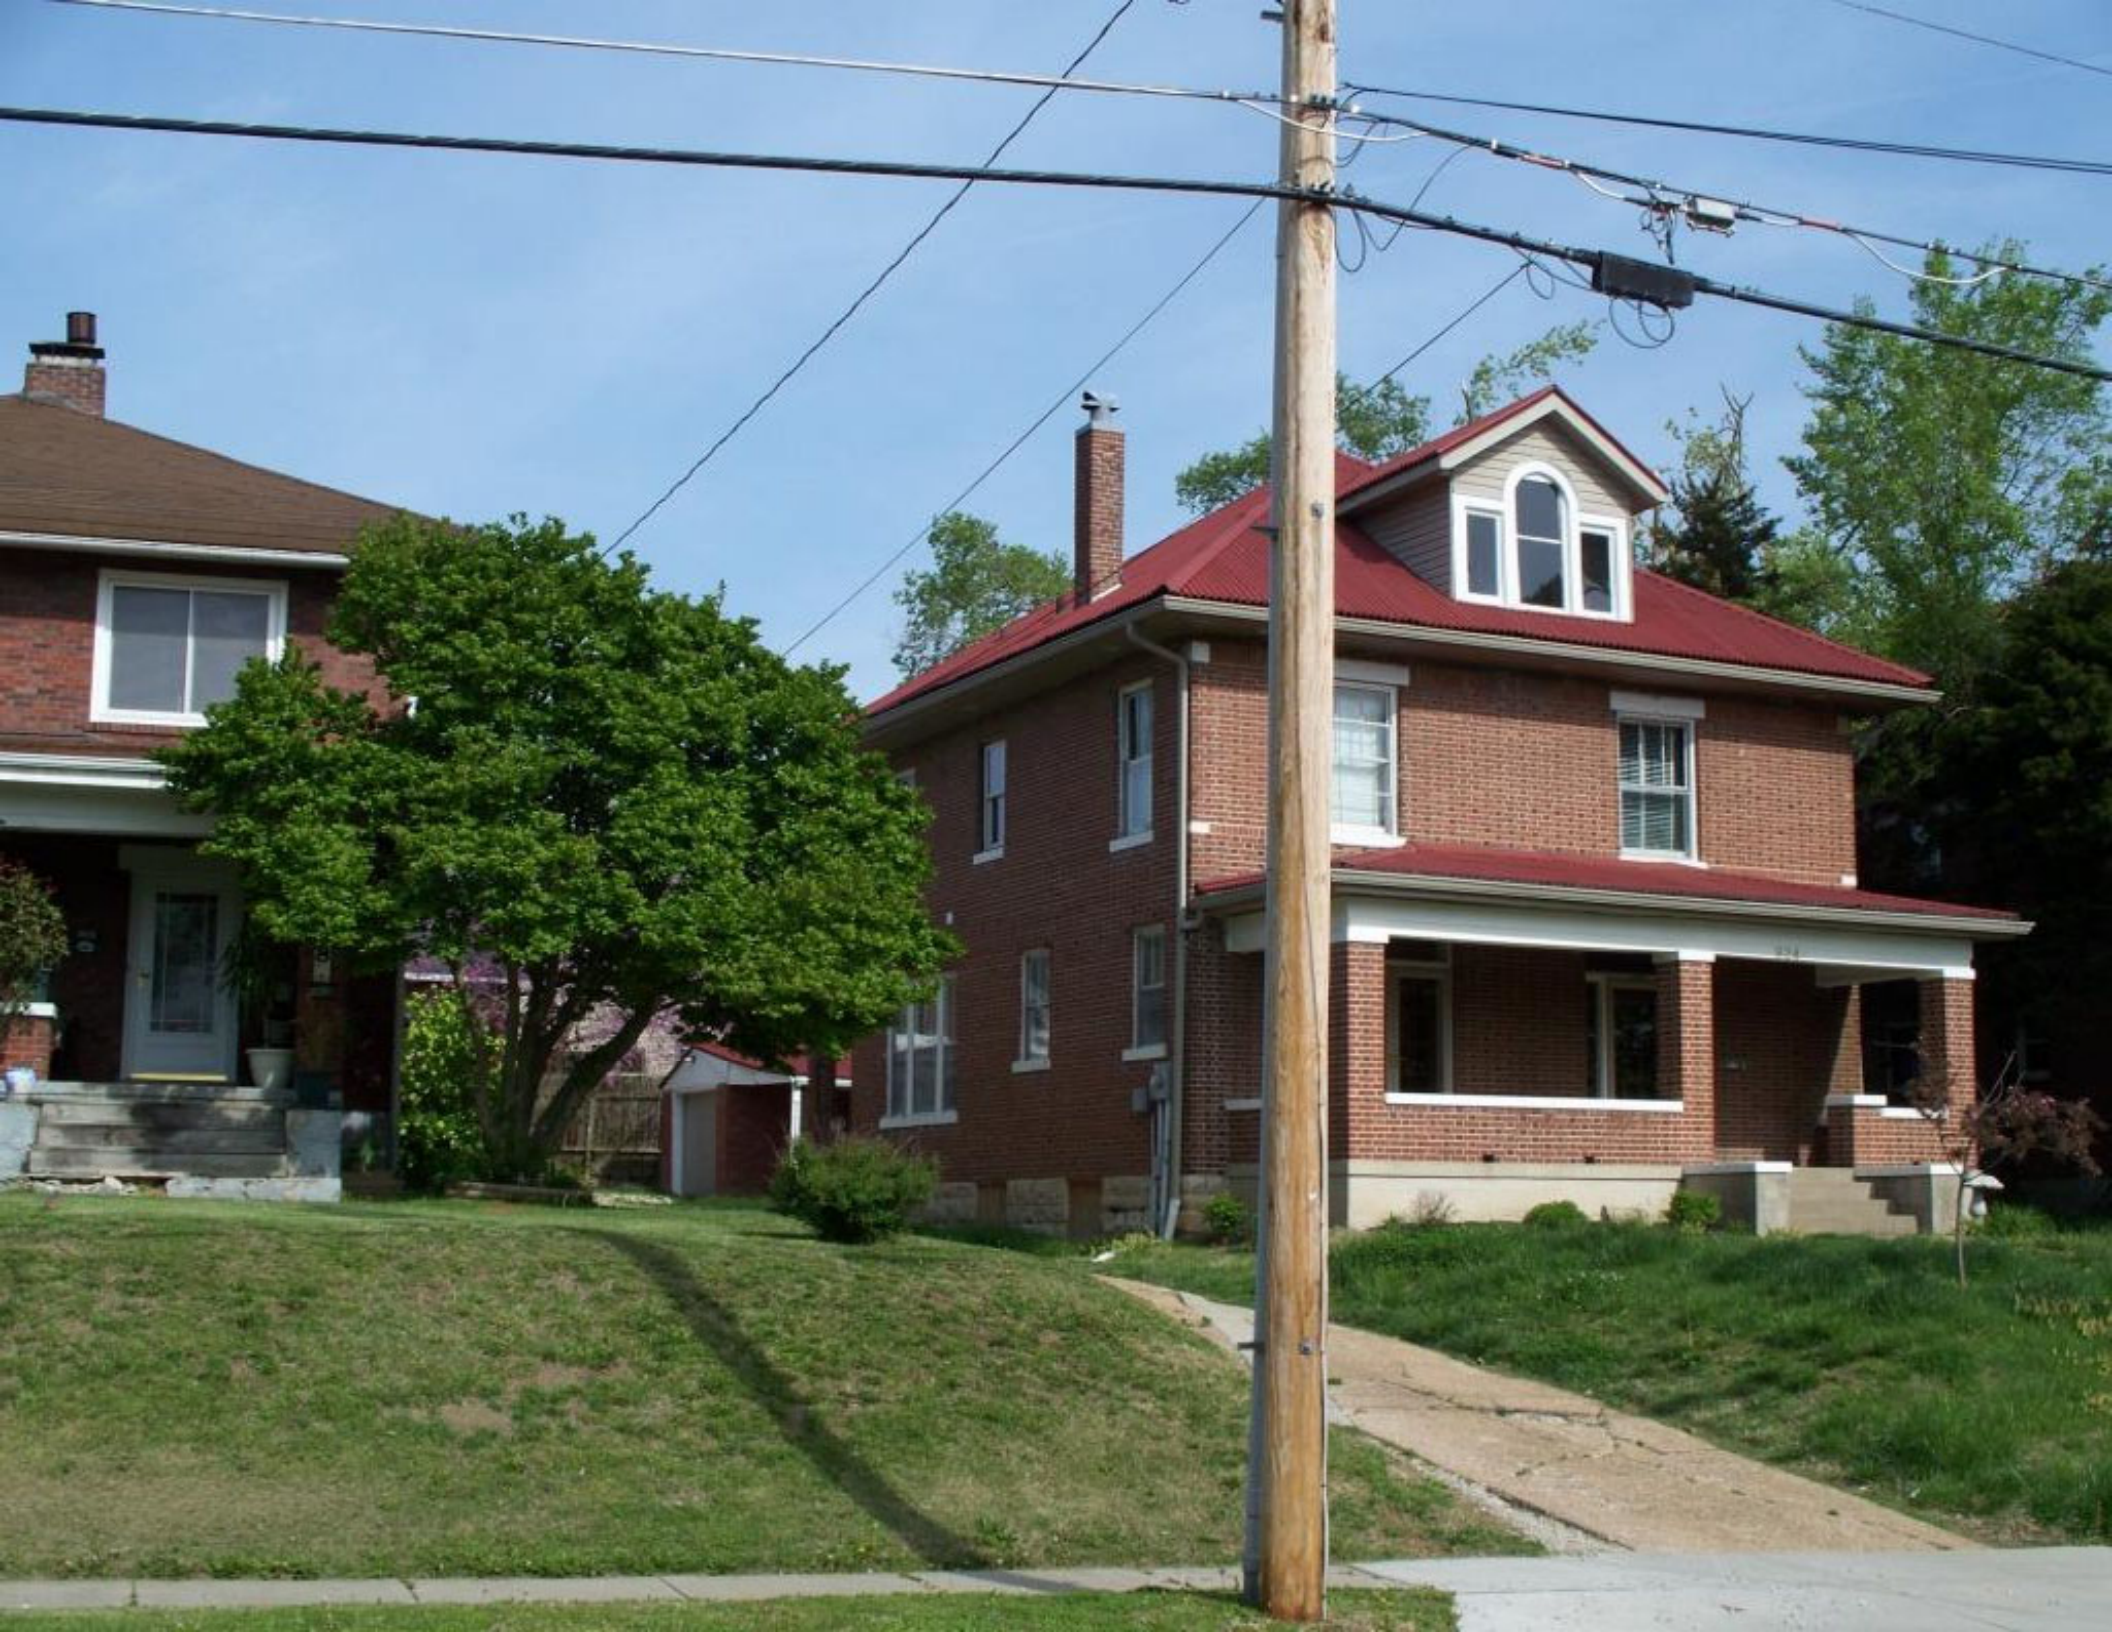
40. (cont.) Description of environment and outbuildings. Expand box as necessary, or add continuation pages.
There is a one-car garage with an attached carport behind the property. The garage appears historic, thus is considered contributing.

41. (cont.) This four square has a central dormer clad in vinyl siding on the uppermost story. It has arched openings however the original wooden square one-over-one windows are visible behind it. The roof of the property, dormer, and porch is modern corrugated red metal, likewise the porch foundation is cement and appears as if it has recently been added (the rest of the foundation of the house is stone.) Despite these changes the house retains what appears to be the original door, with sidelights and transom. The secondary wooden double door entrance on this floor also has a transom and appears historic. The full width open porch has brick piers with limestone caps. The two windows on the second floor appear to be original three-over-one wood windows with stone lintels and sills. Unlike its neighbors, this property does not have an attached garage, but a separate one-car garage with attached carport is situated behind the property. It also features decorative brick work via Flemish headers and stretchers in each row and a row of headers in the upper and lower portion of the second story.

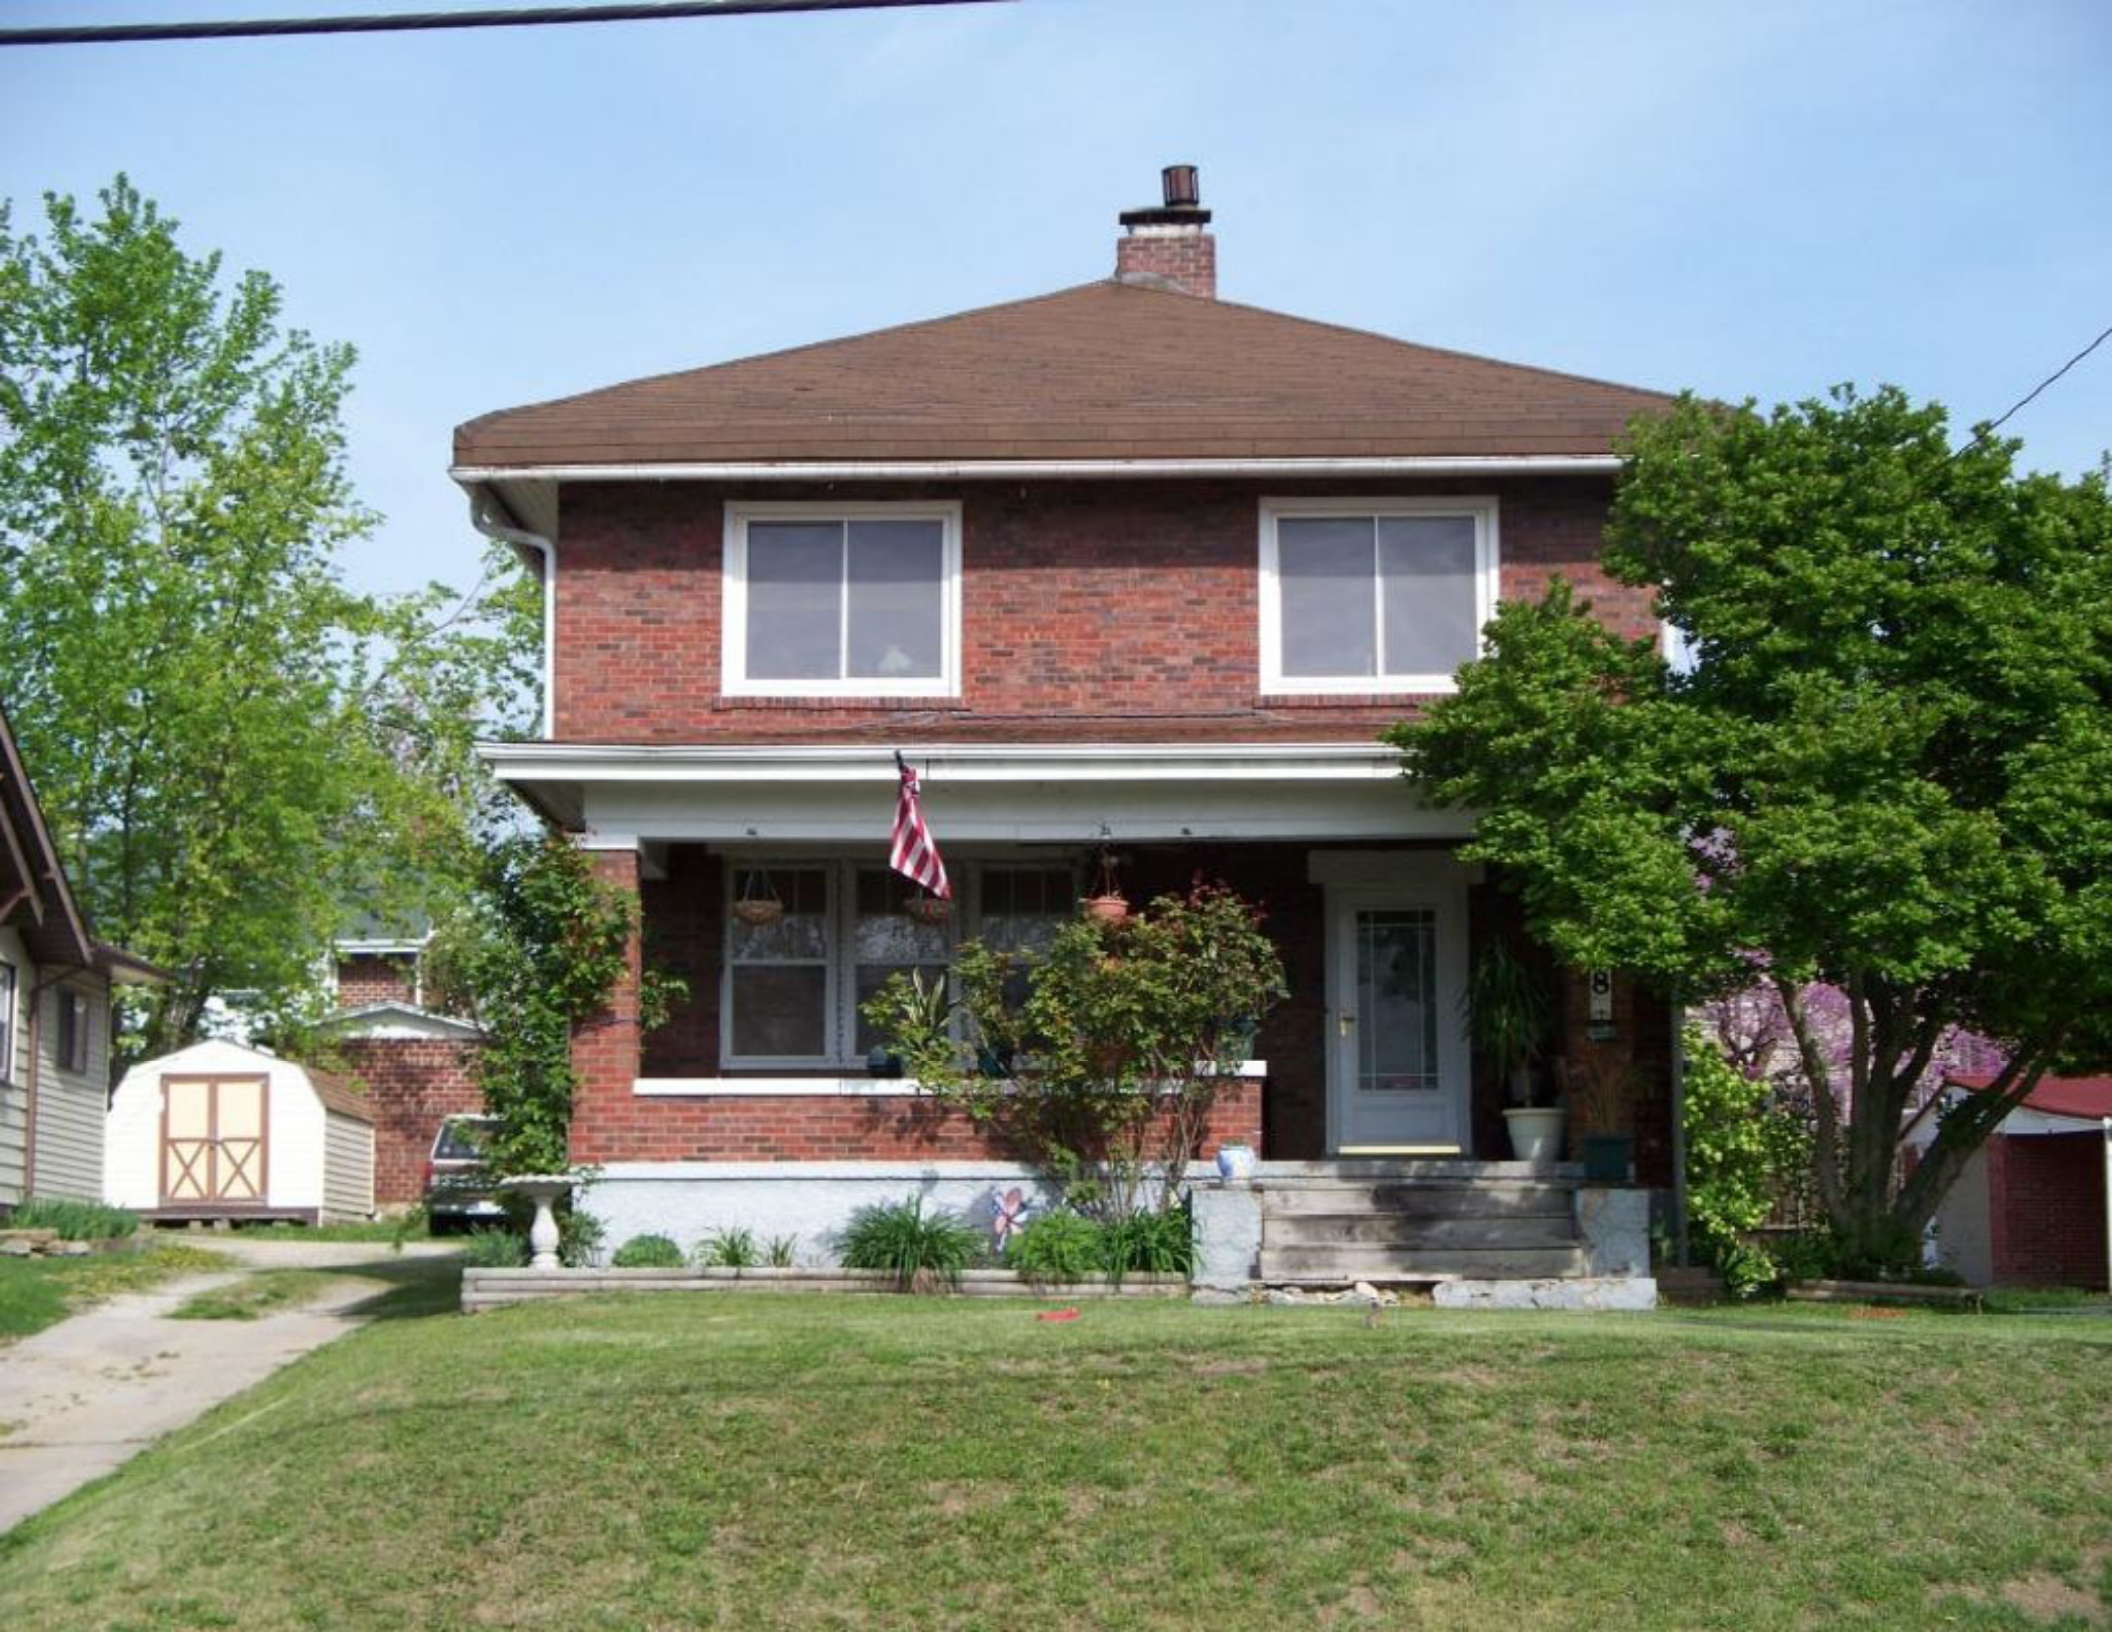
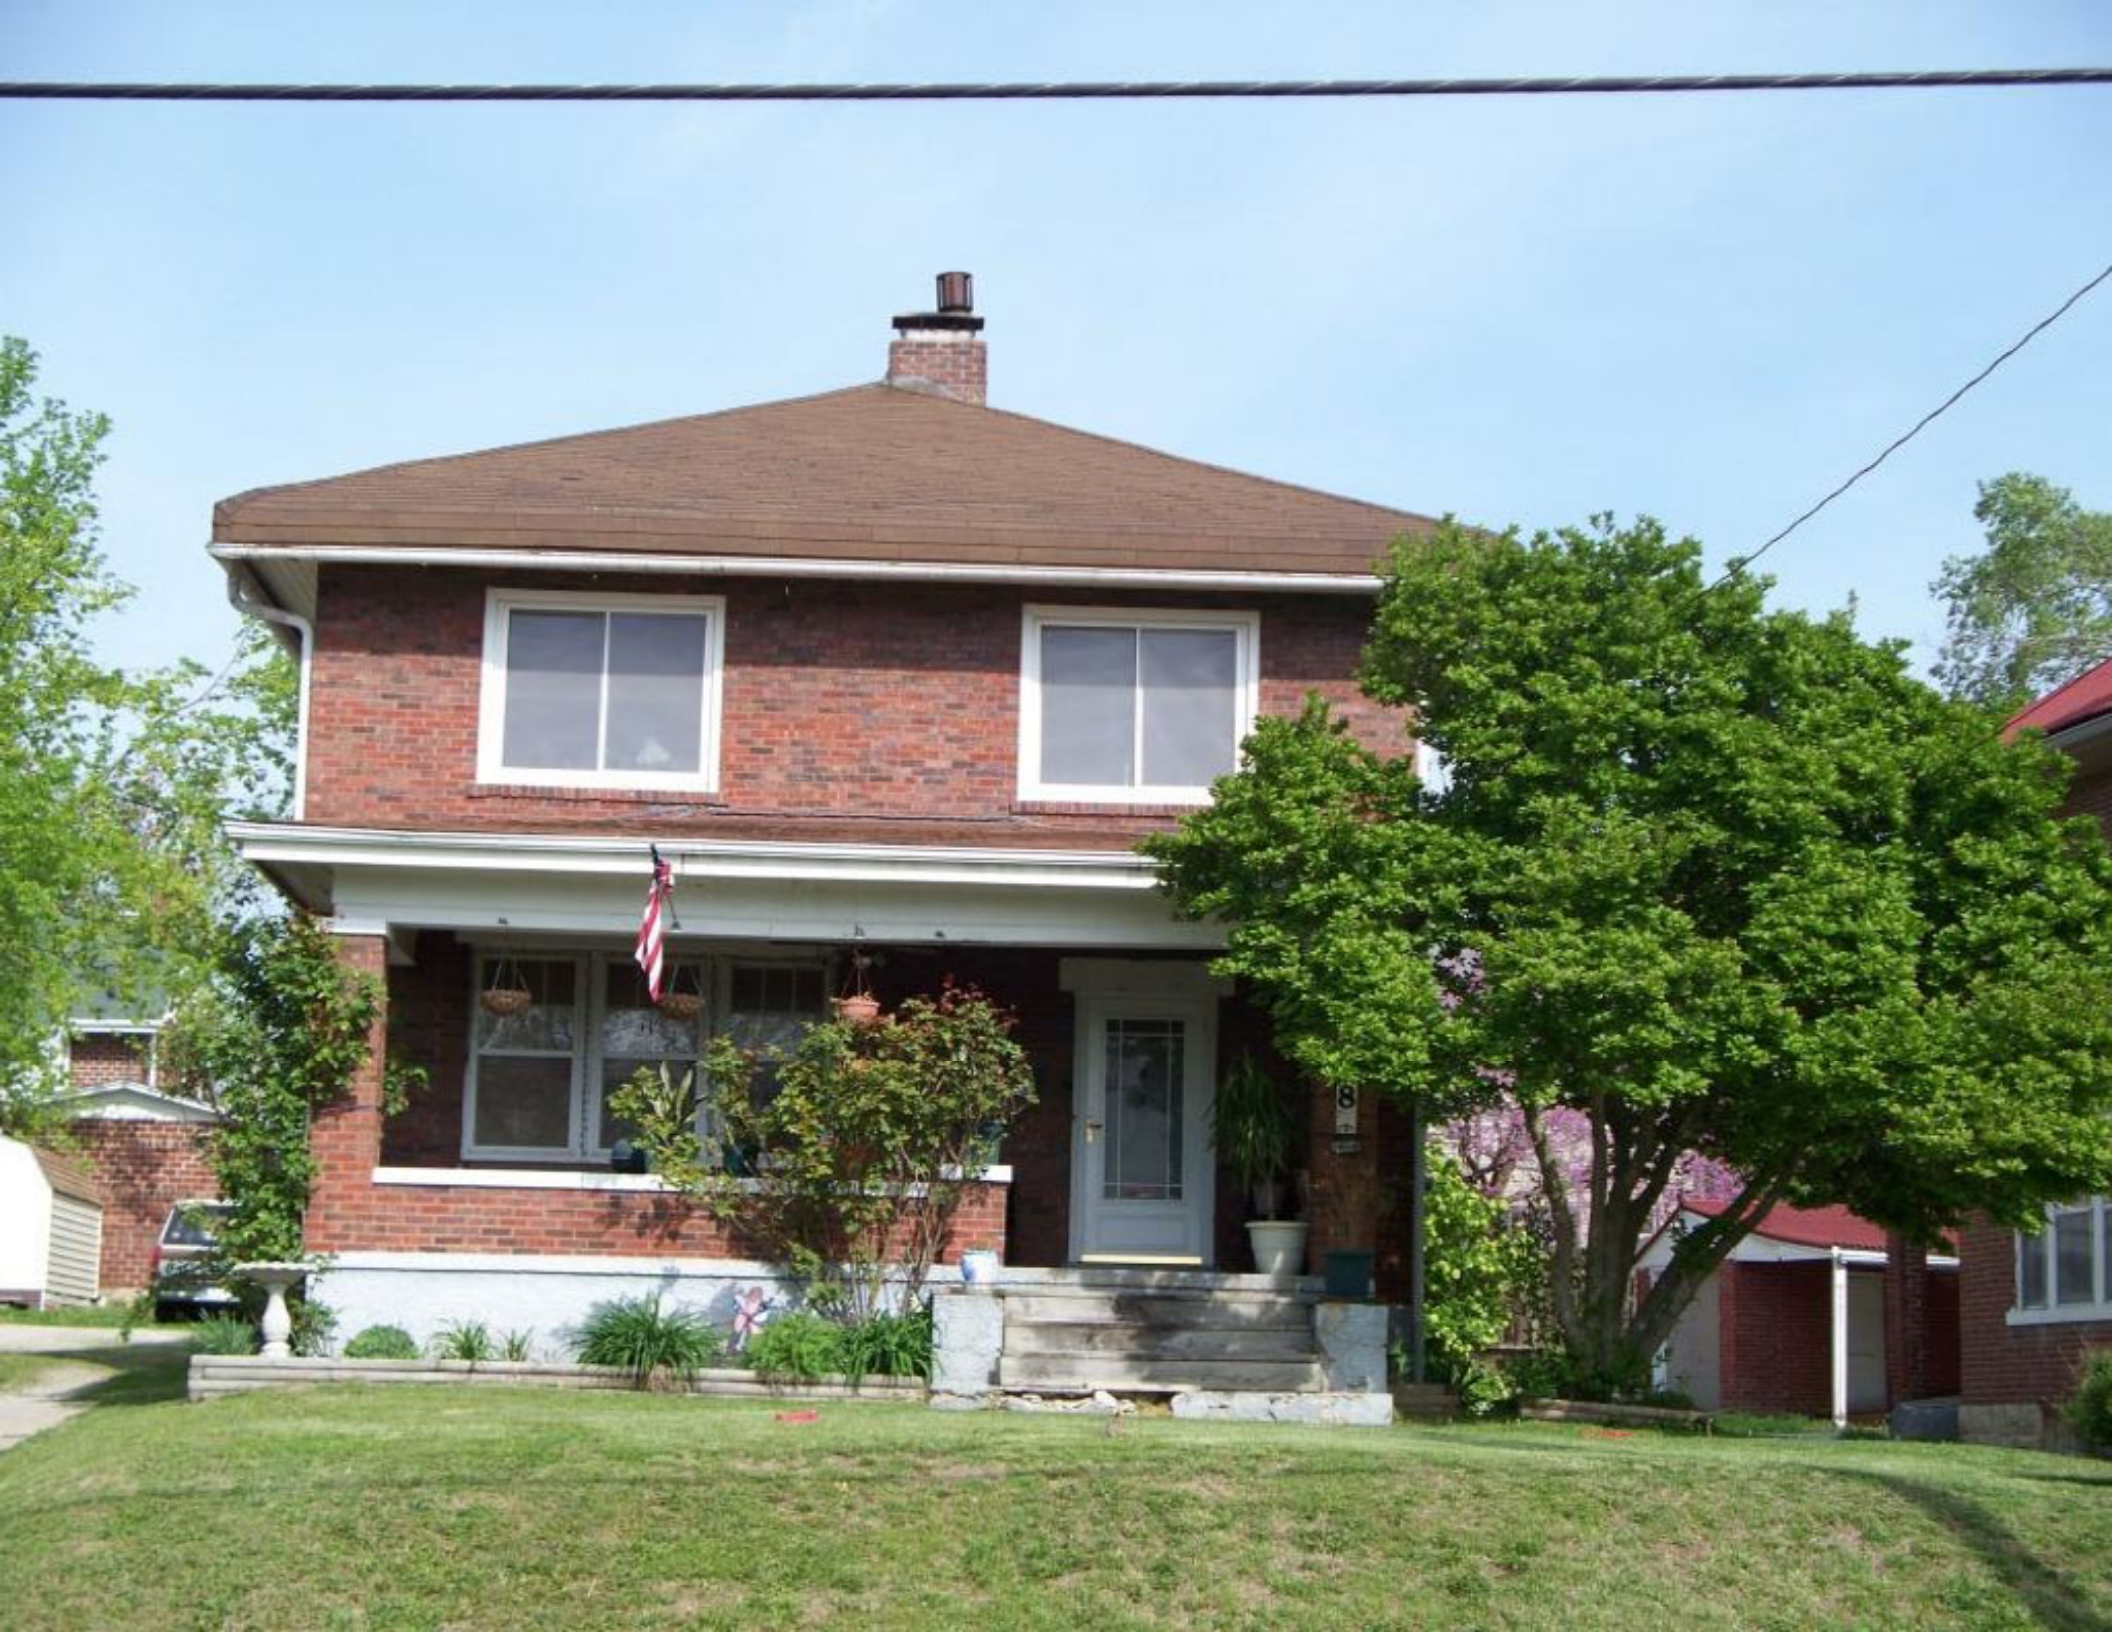
41. (cont.) This two-story brick four square has a pyramidal roof with central chimney. The two windows on the upper floor have been replaced with modern one-by-one horizontally sliding windows. The row of three wooden 3/1 windows on the first floor appear to be original, however, and retain its thick stone lintel. The entrance, which is off-set from the left, also has a stone lintel. The full-width brick porch features brick piers with limestone coping and a frieze beneath the shed roof. Beneath the porch it appears the foundation has been covered with stucco or may have been parged. The foundation is likely stone or cement.
