ARCHITECTURAL/HISTORIC INVENTORY FORM

1. Survey No. CO-AS-005-001		2. Survey name: Moreau Drive Neighborhood Survey	
3. County: Cole		4. Address: 1202 Elmerine Ave.	
5. City: Jefferson City	Vicinity: <input type="checkbox"/>	6. UTM: / /	7. Township/Range/Section: T: R: S:
8. Historic name (if known):		9. Present/other name (if known):	
10. Ownership: <input checked="" type="checkbox"/> Private <input type="checkbox"/> Public		11. Historic use (if known): Residential	11. Current use: Residential

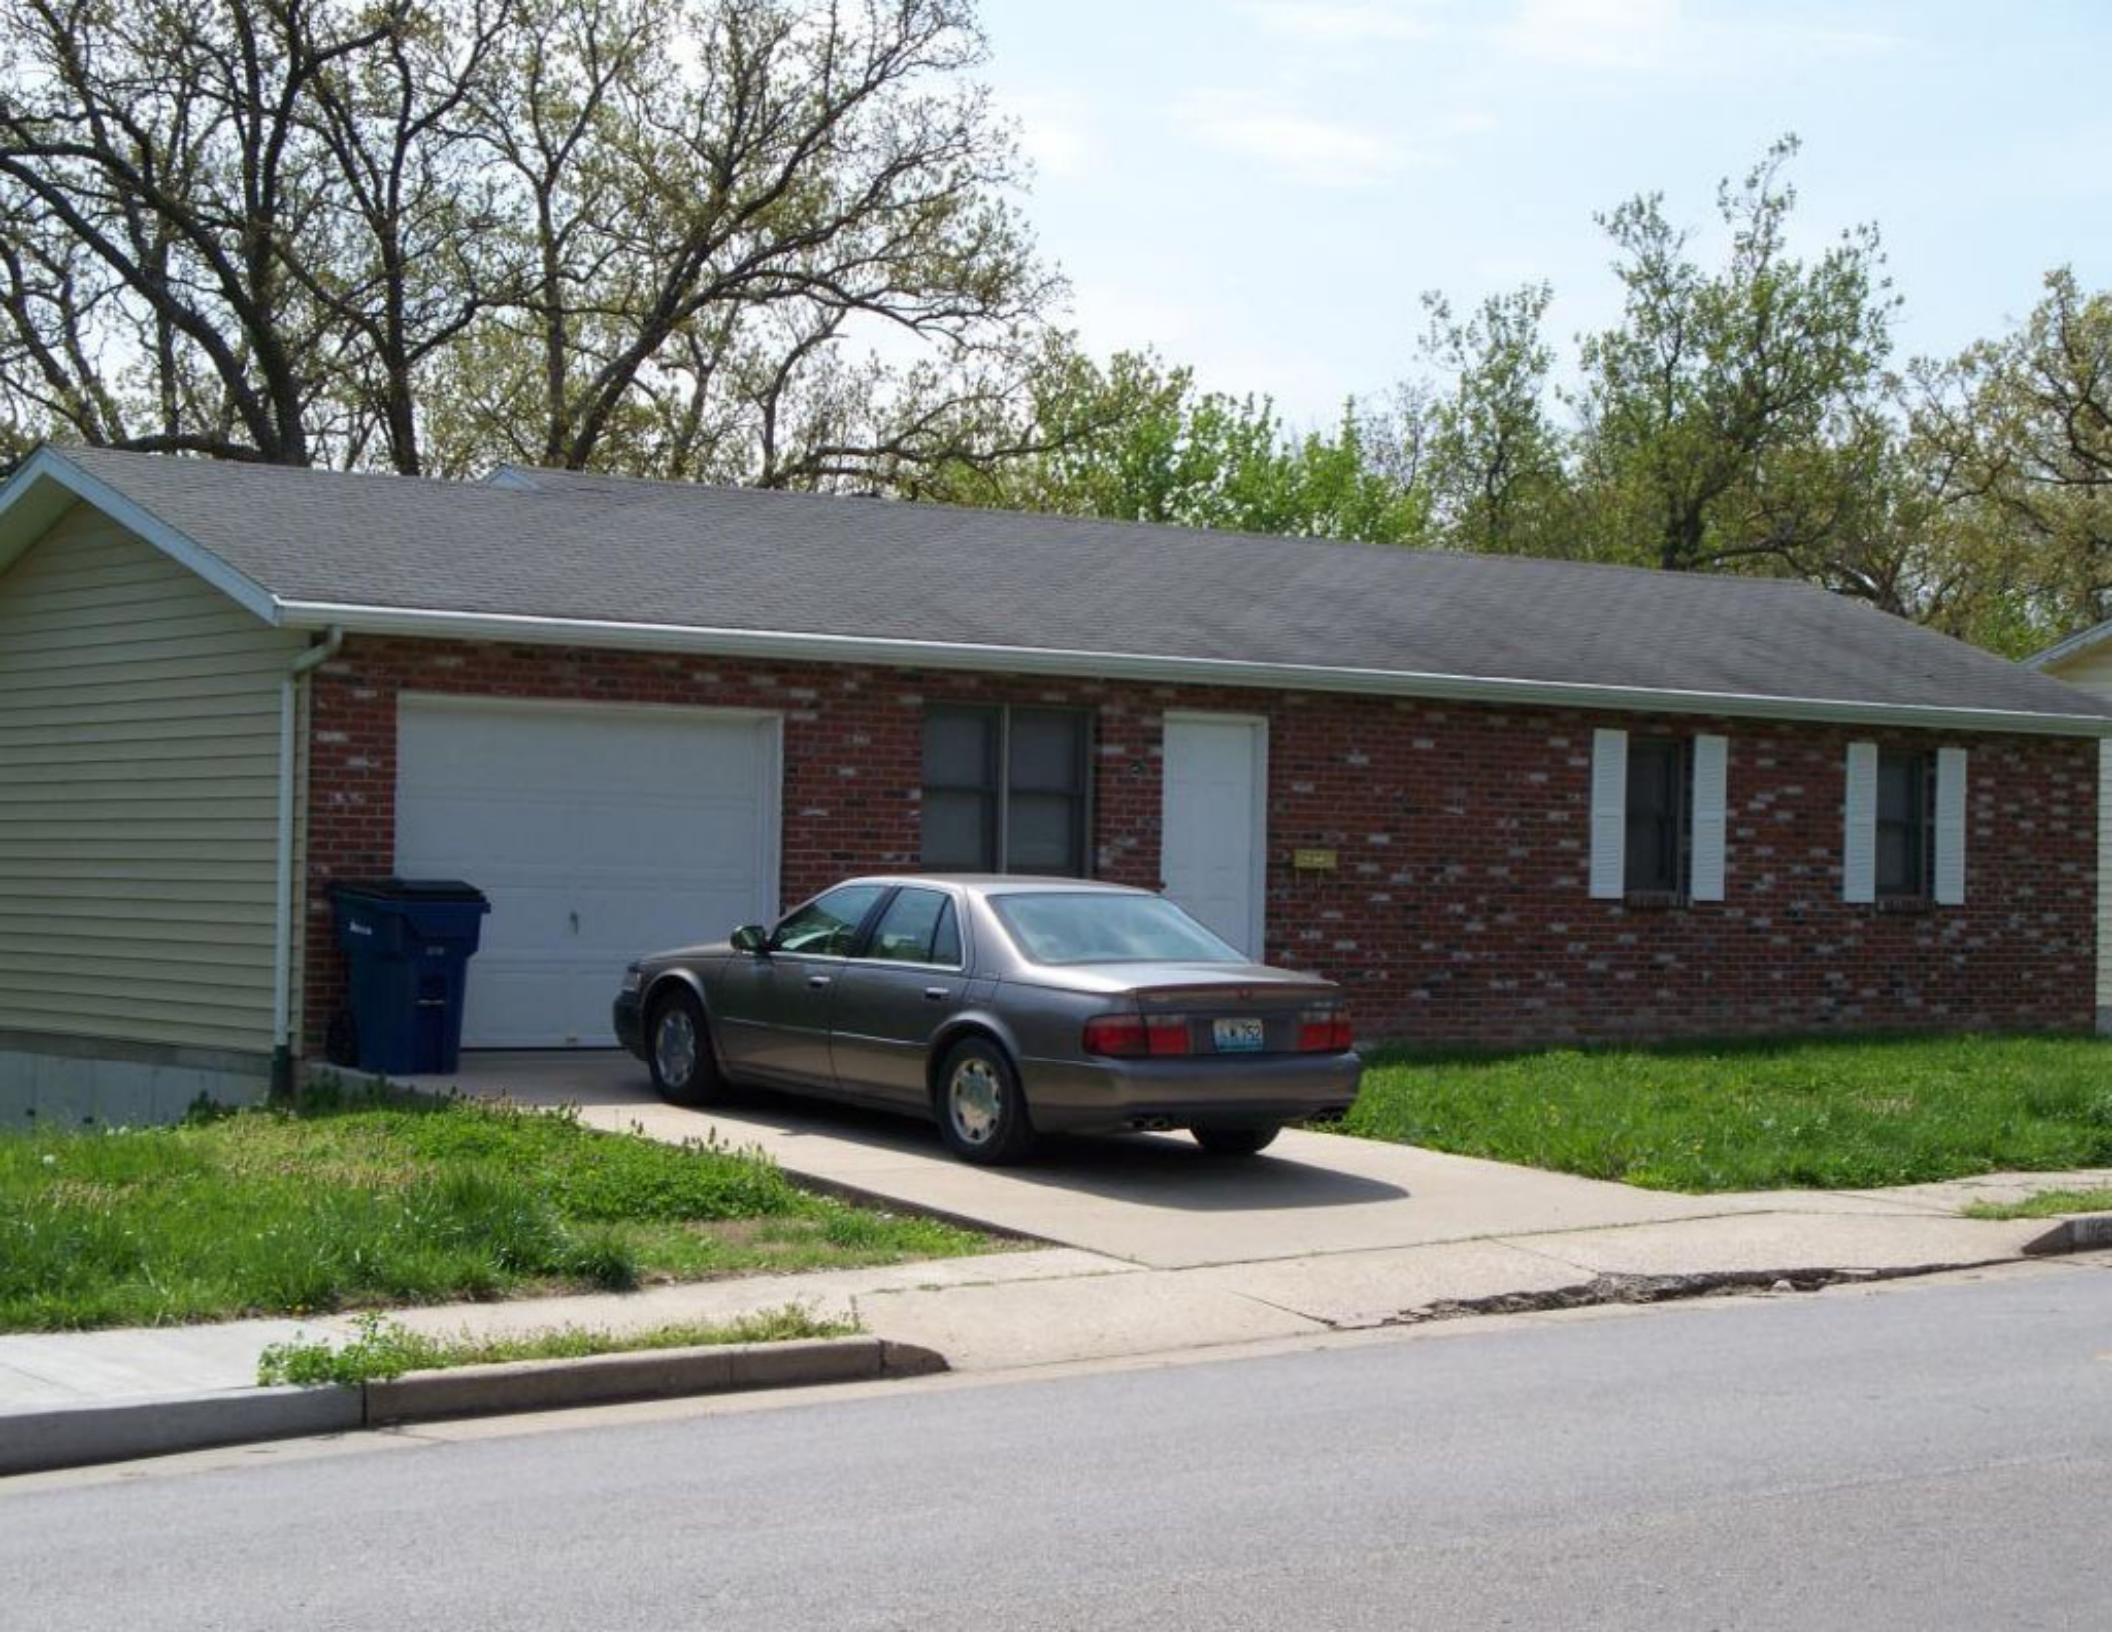
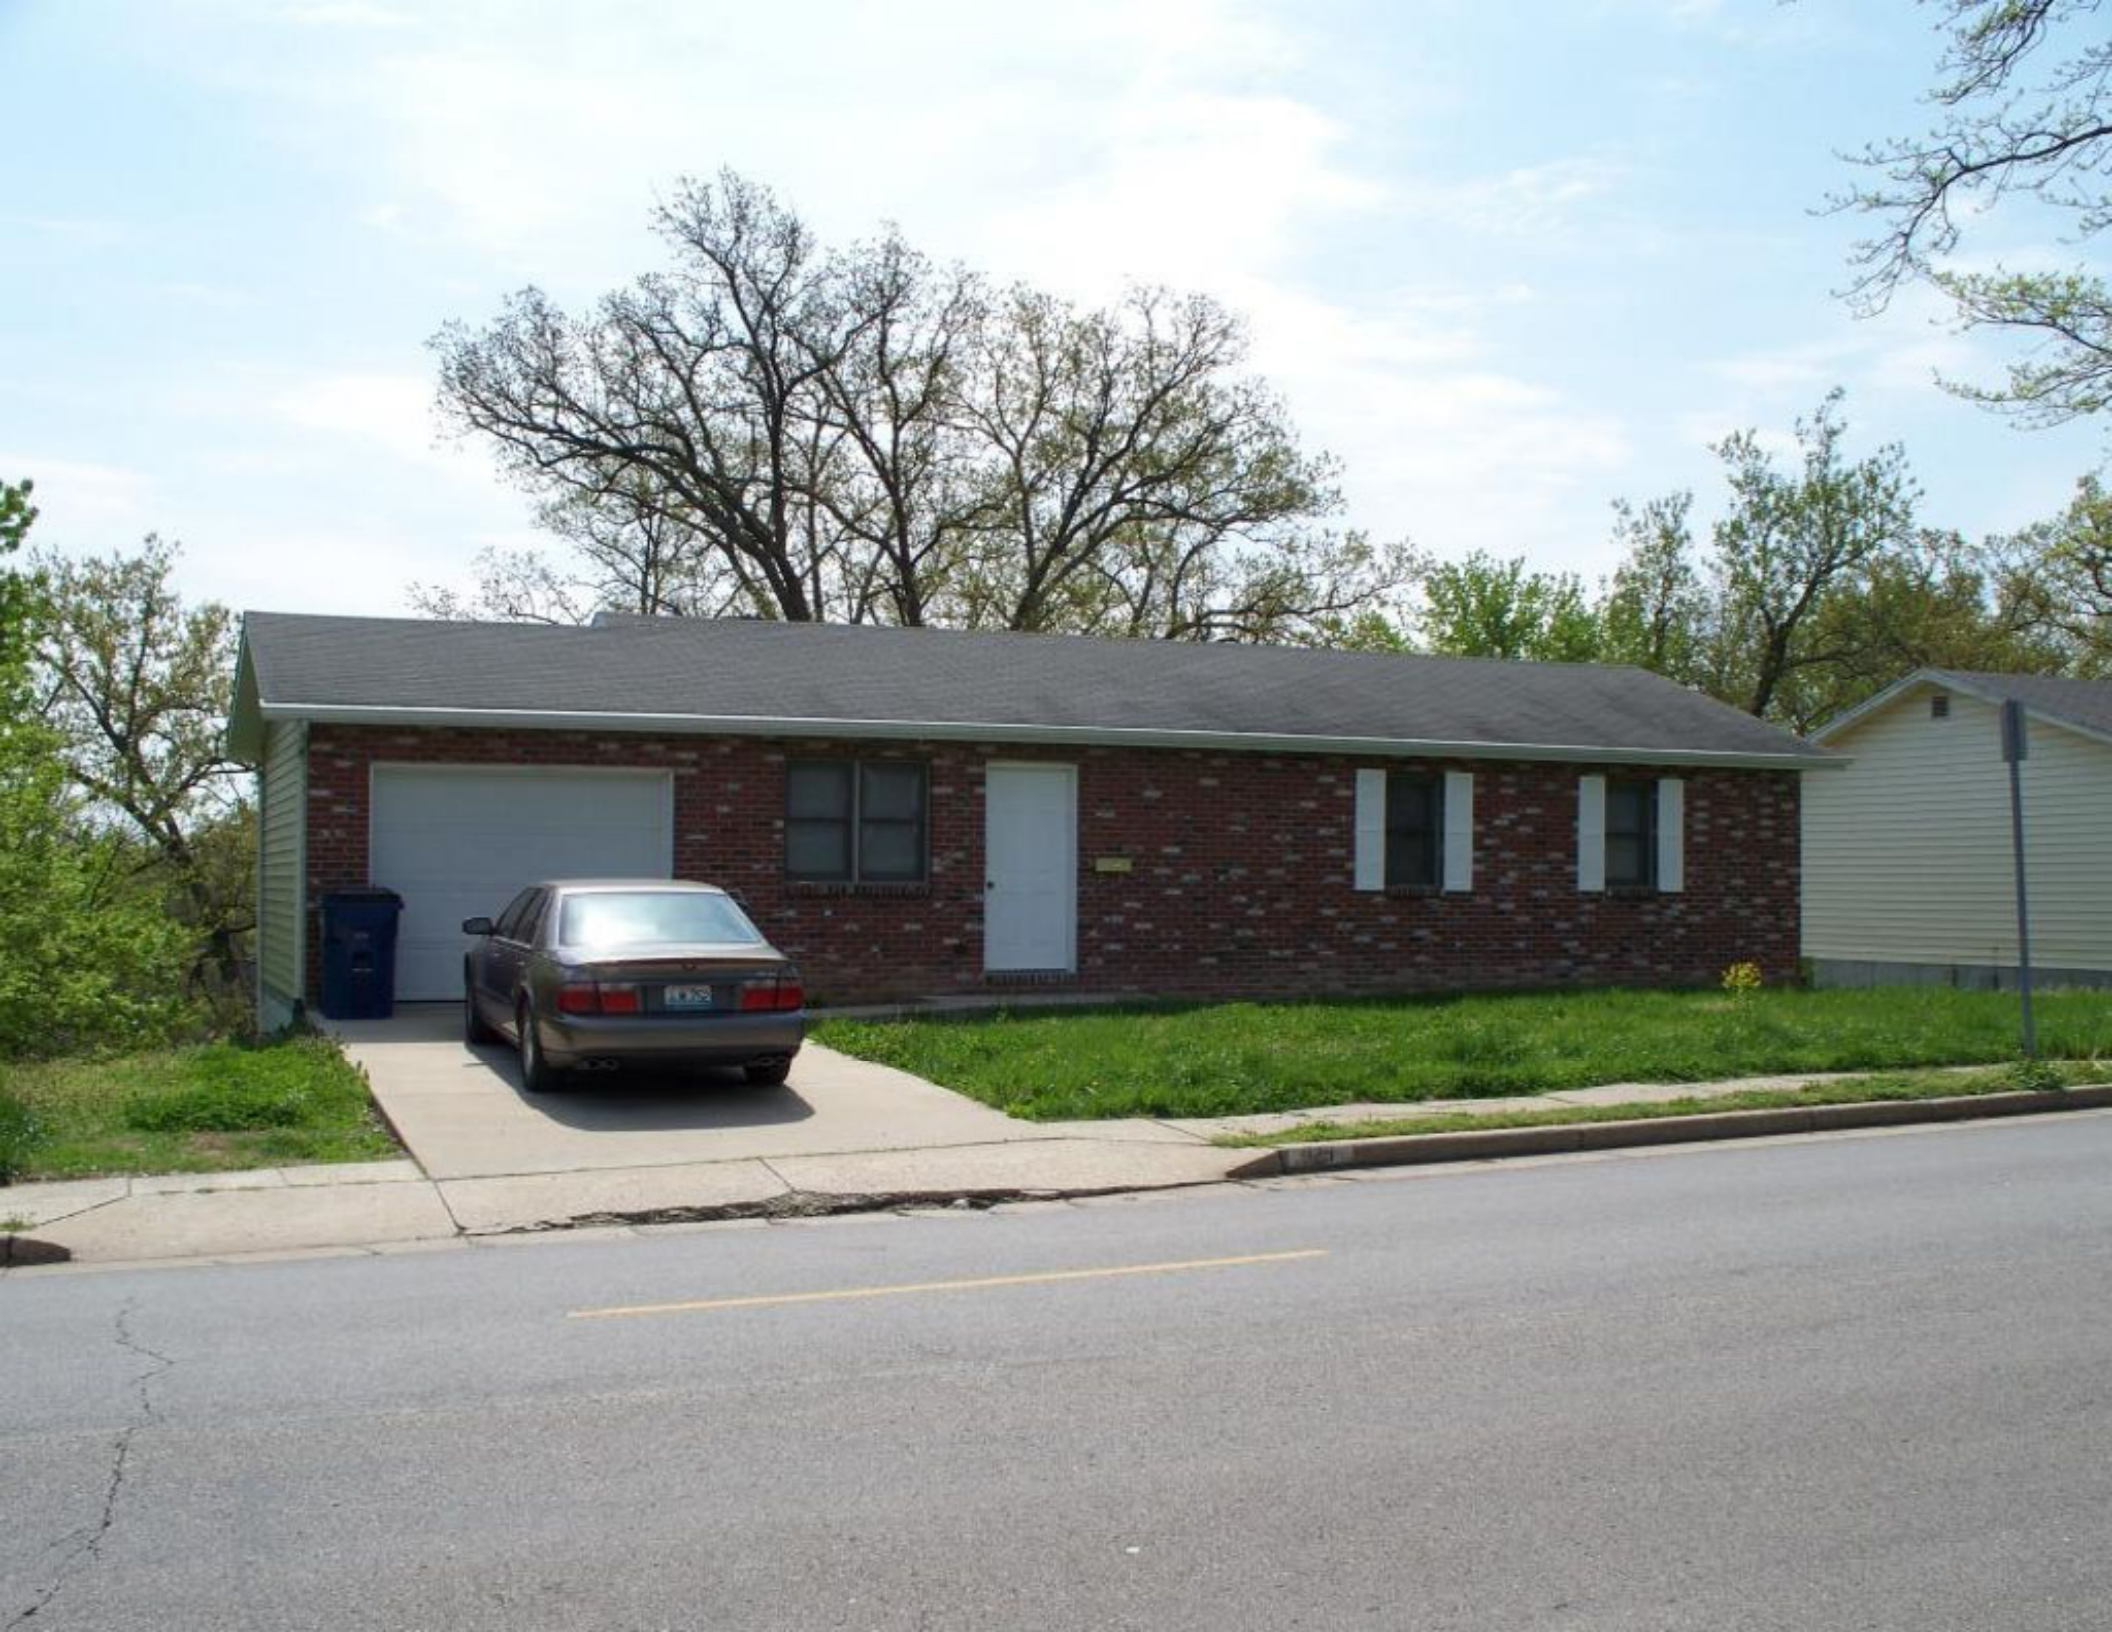
One story brick ranch house built c 1992 is considered non-contributing as it is outside the period of significance. It has a side gable roof and garage on the front façade.

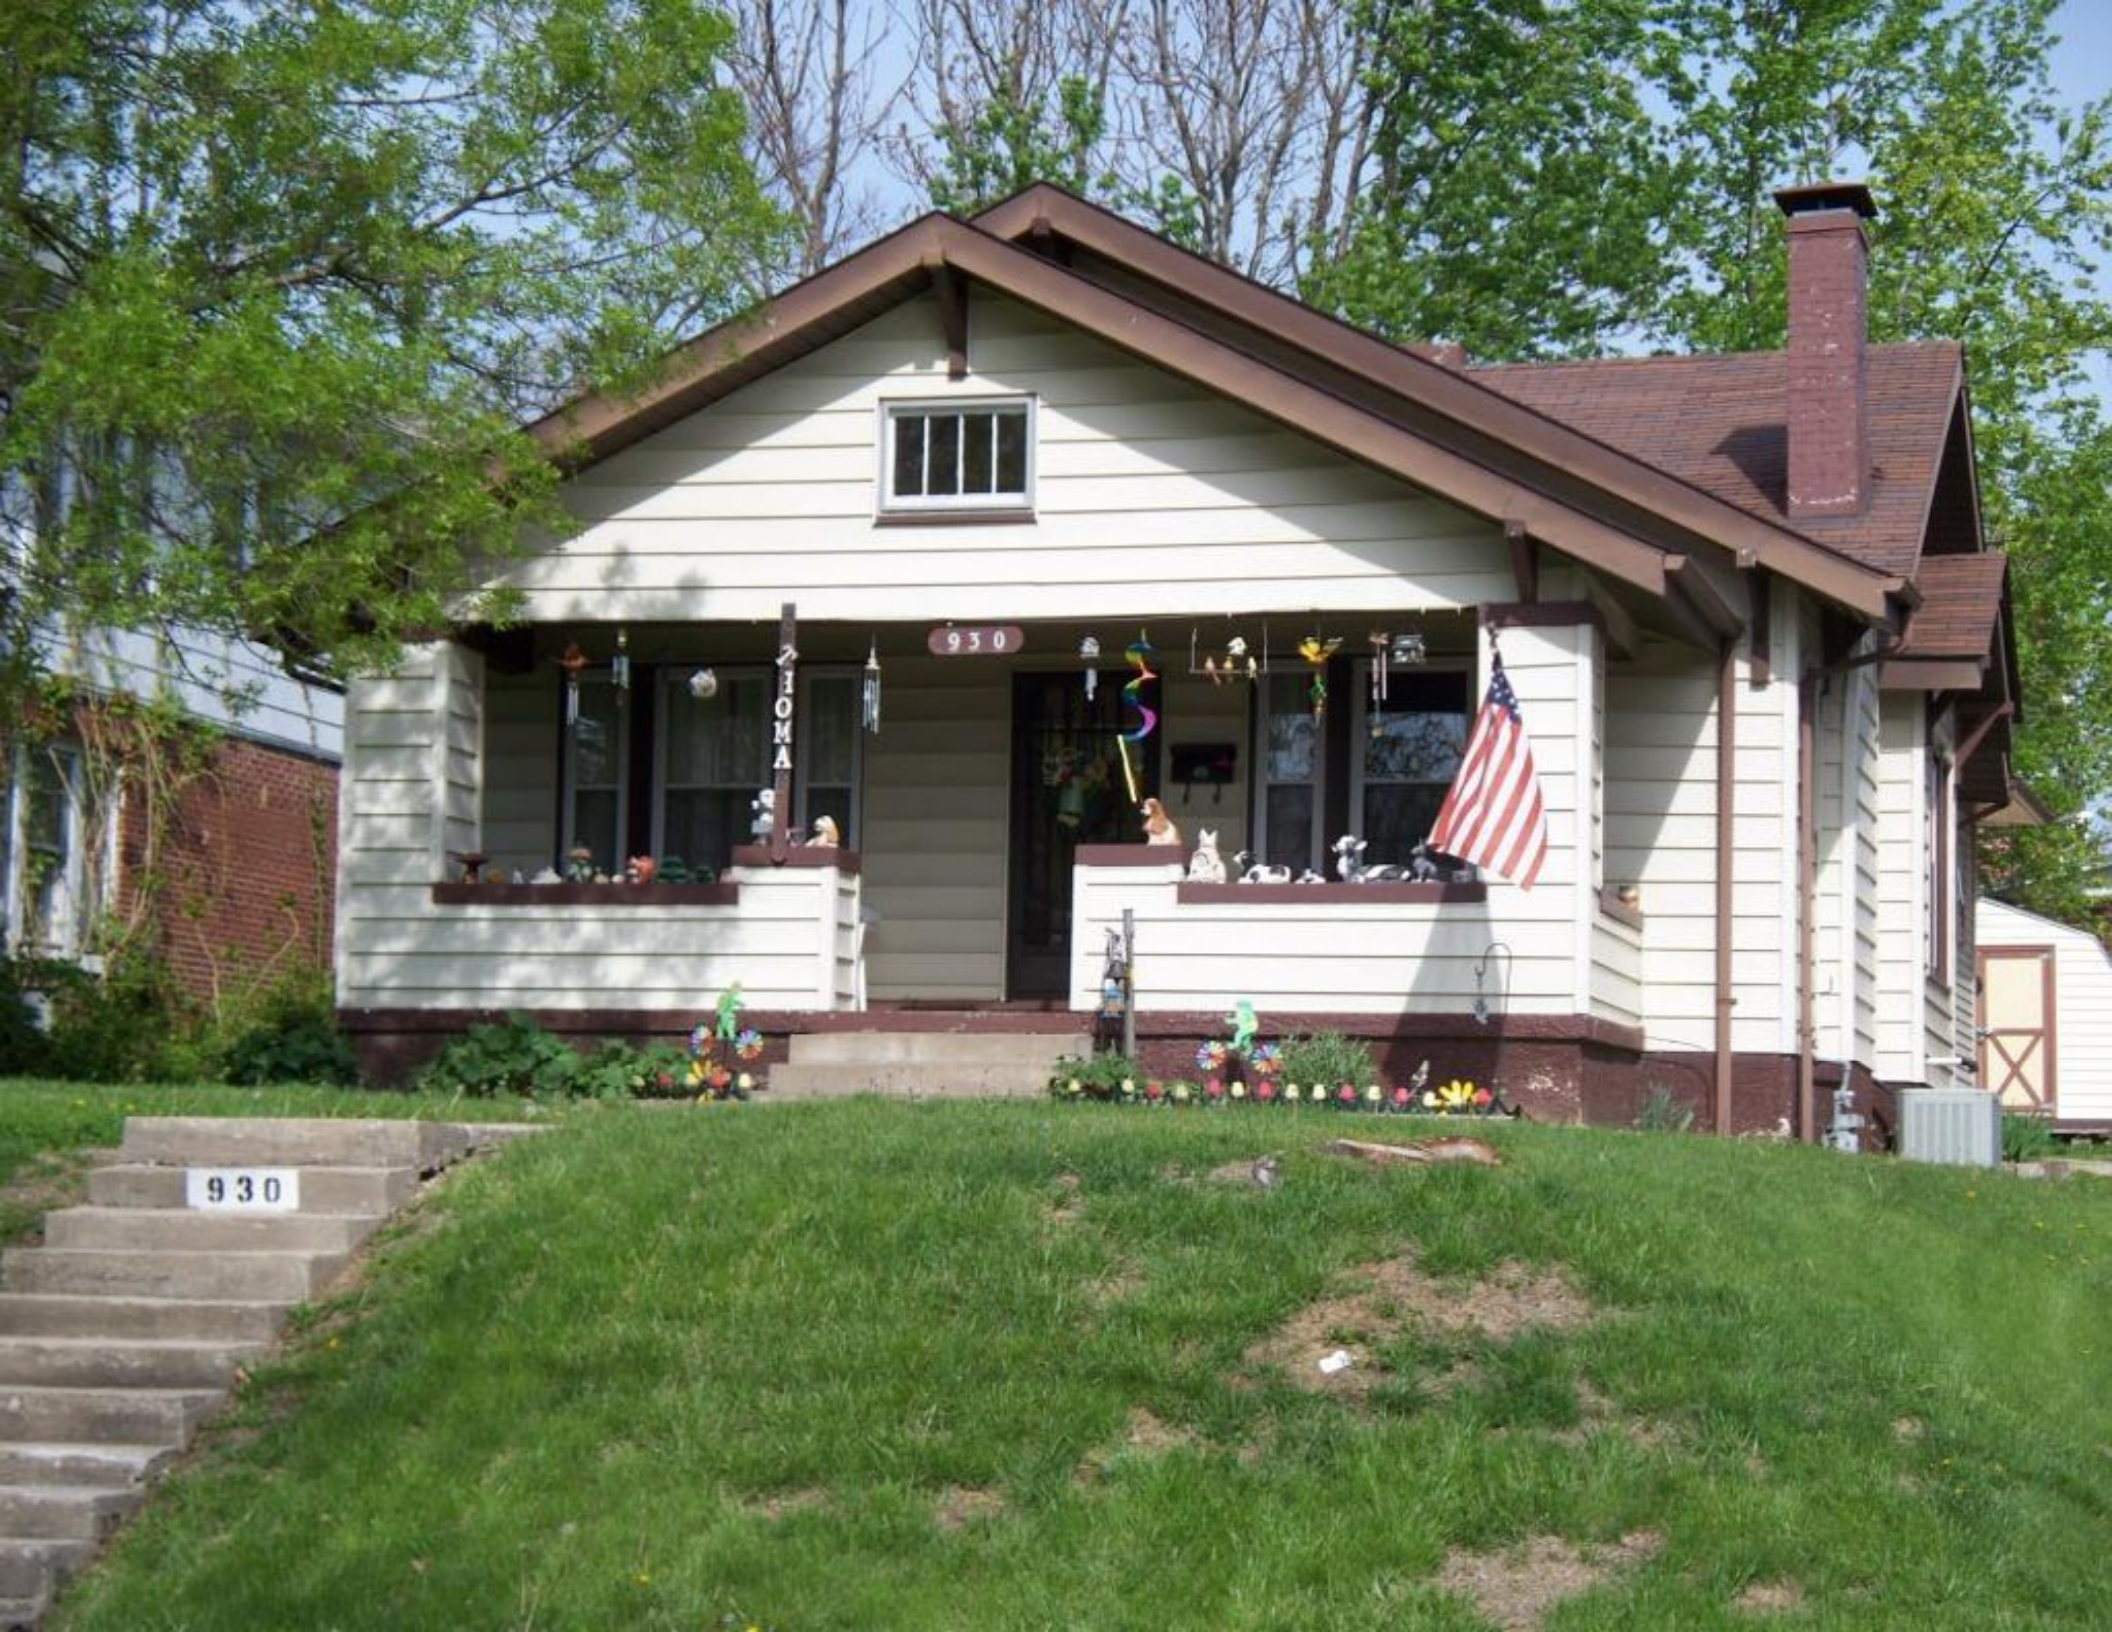
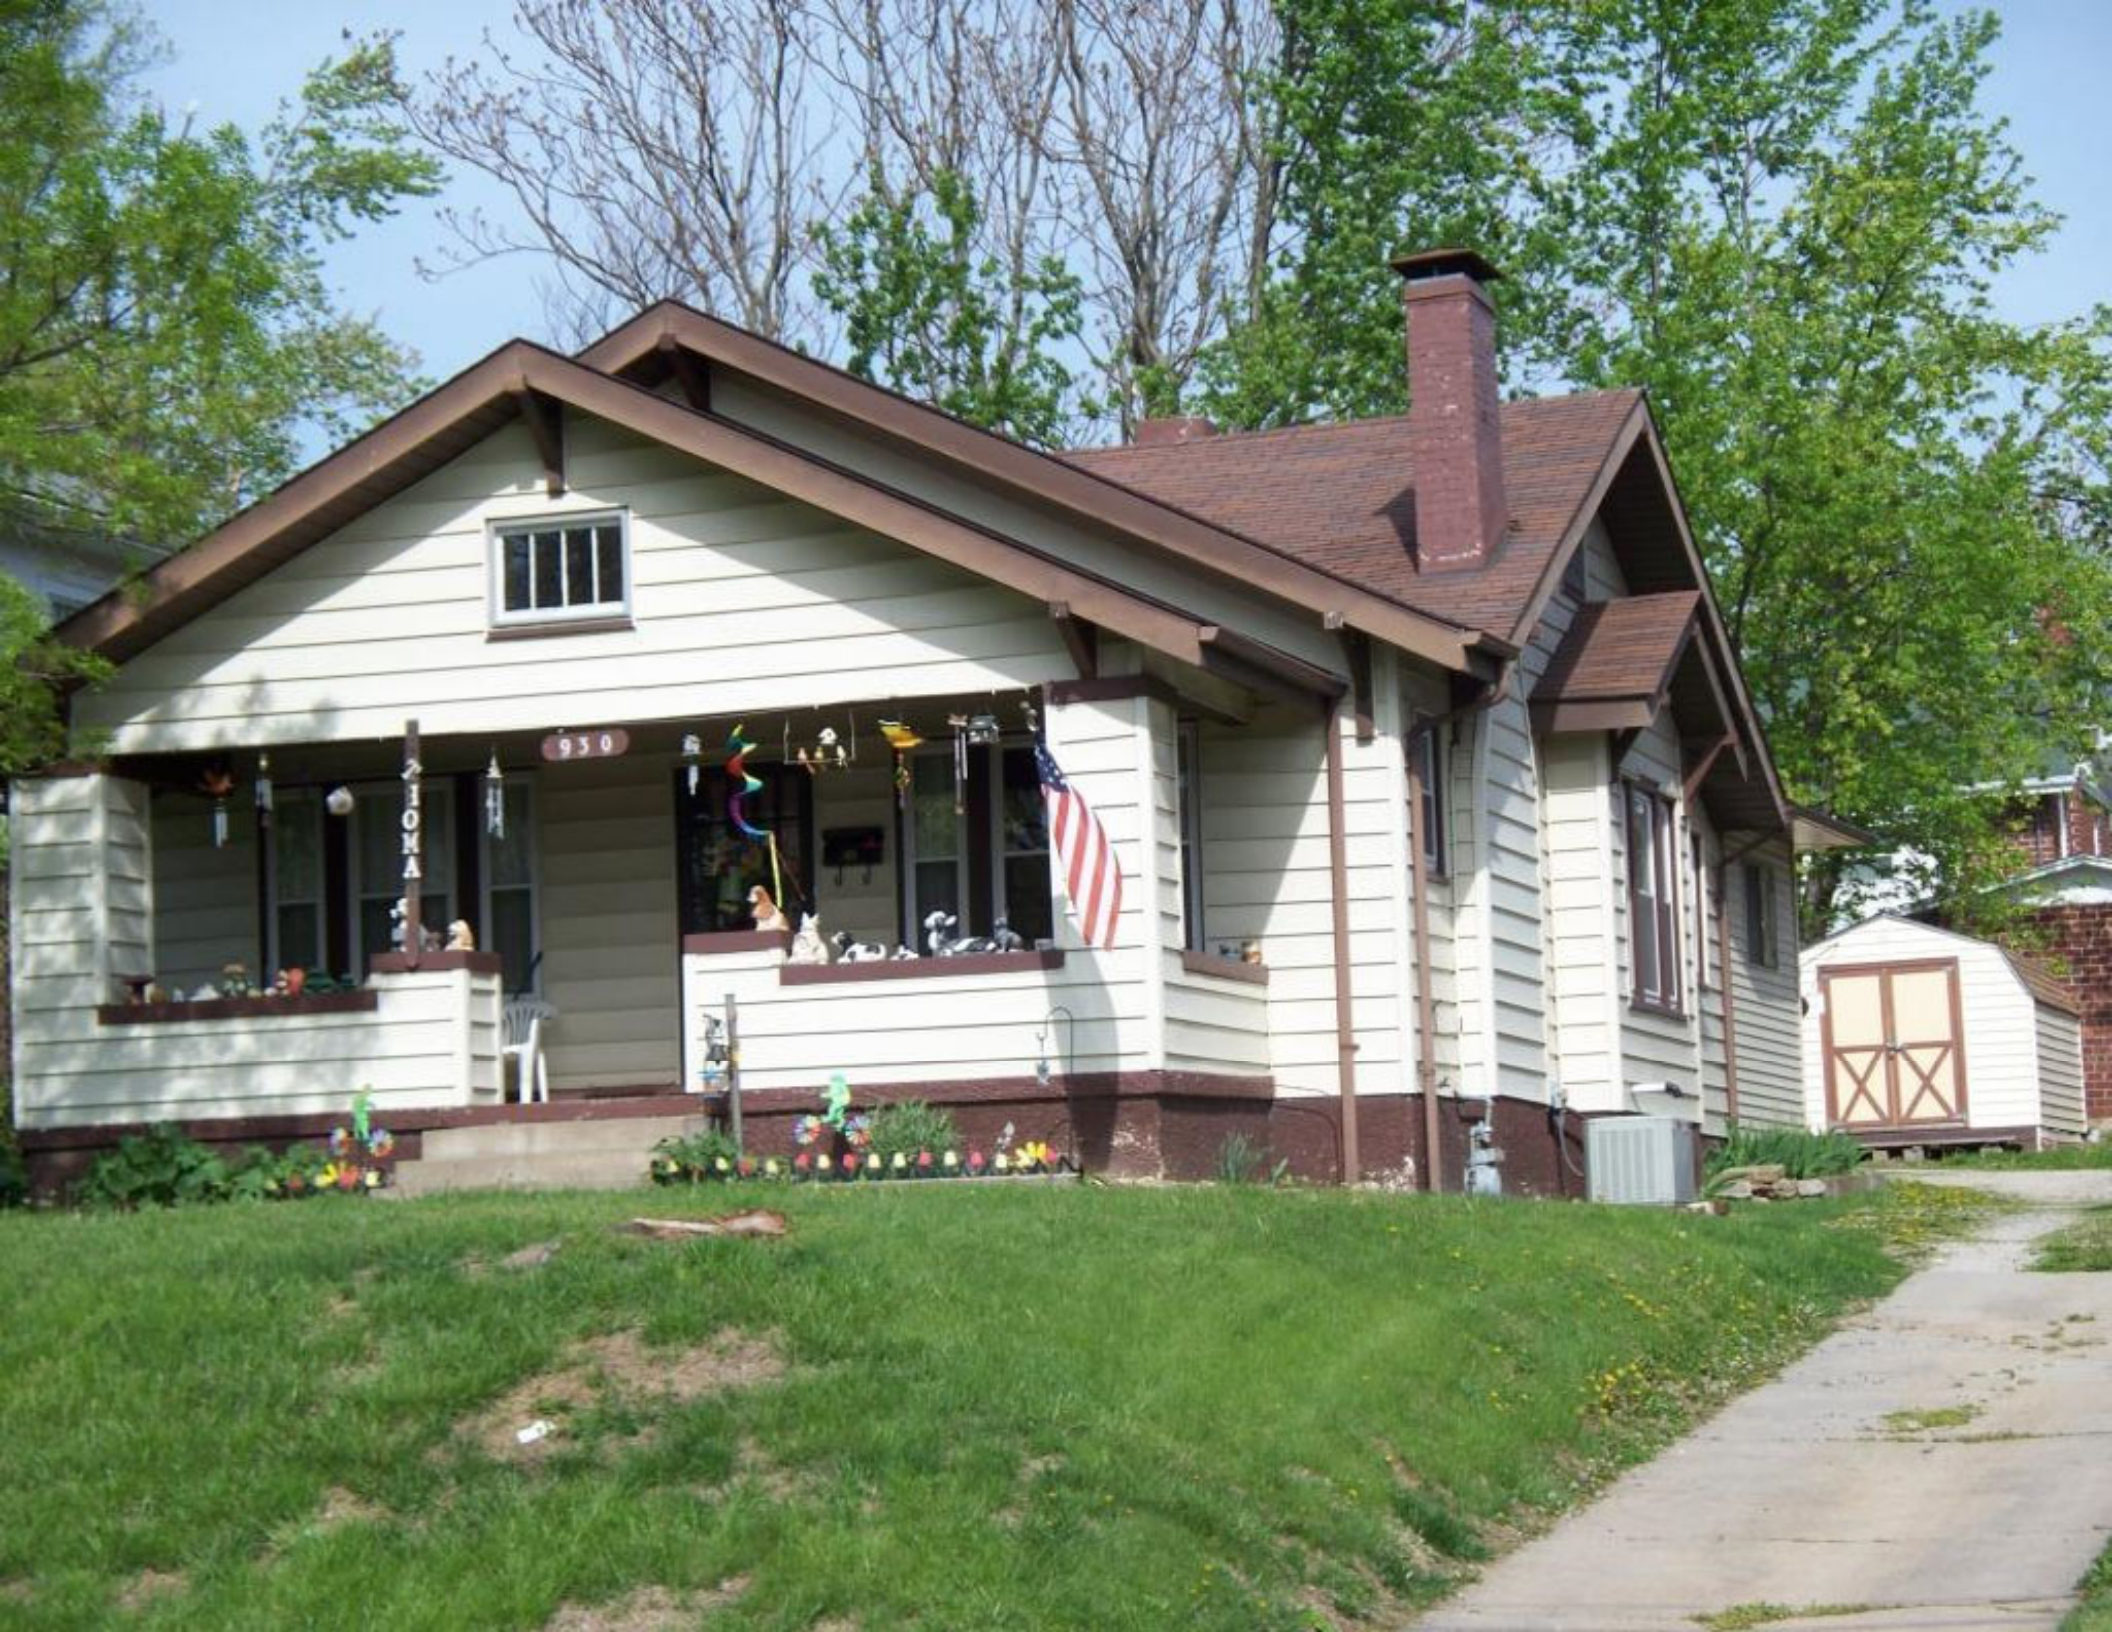
930

40. (cont.) Description of environment and outbuildings. Expand box as necessary, or add continuation pages.
There is a modern, non-contributing shed behind the property with a gambrel roof.

41. (cont.) The integrity of this property has been affected by the vinyl siding and what appears to be modern replacement windows on the first floor. Despite these changes the one-and-a-half-story bungalow retains its shape and mass, such as the full width porch, so it likely is still contributing to the district. It also retains the original four-light casement window in the gable on the upper floor and the brackets underneath the double gables of the rooflines.

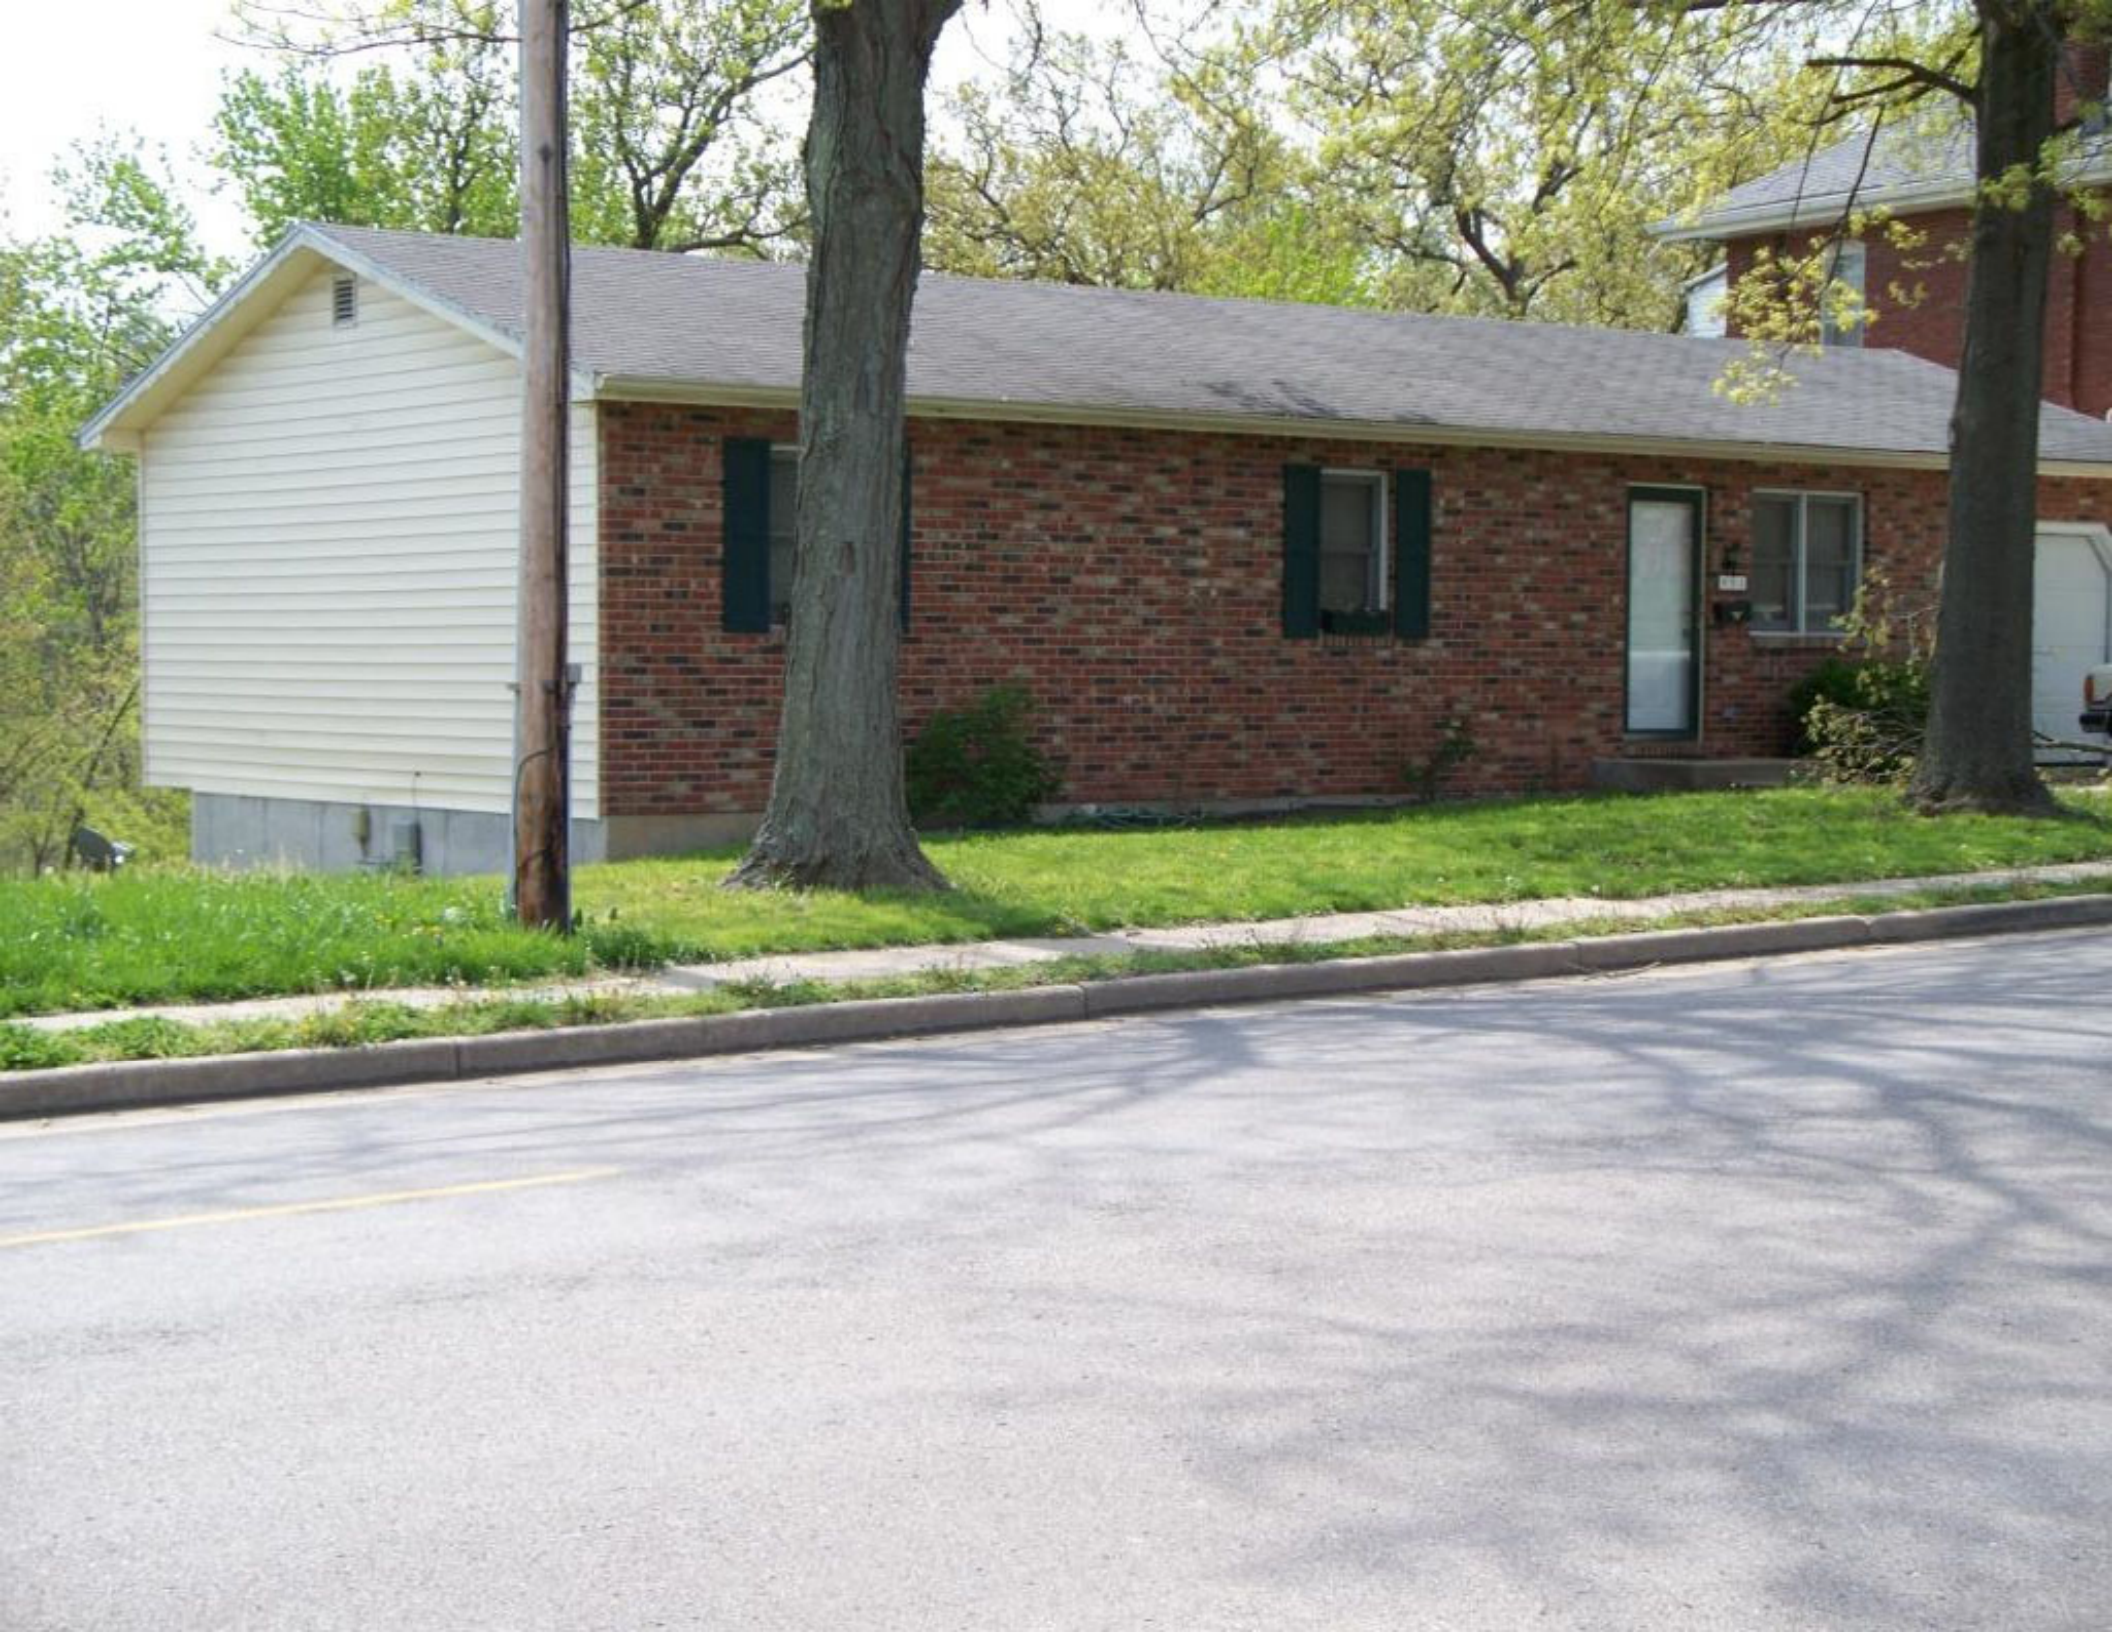
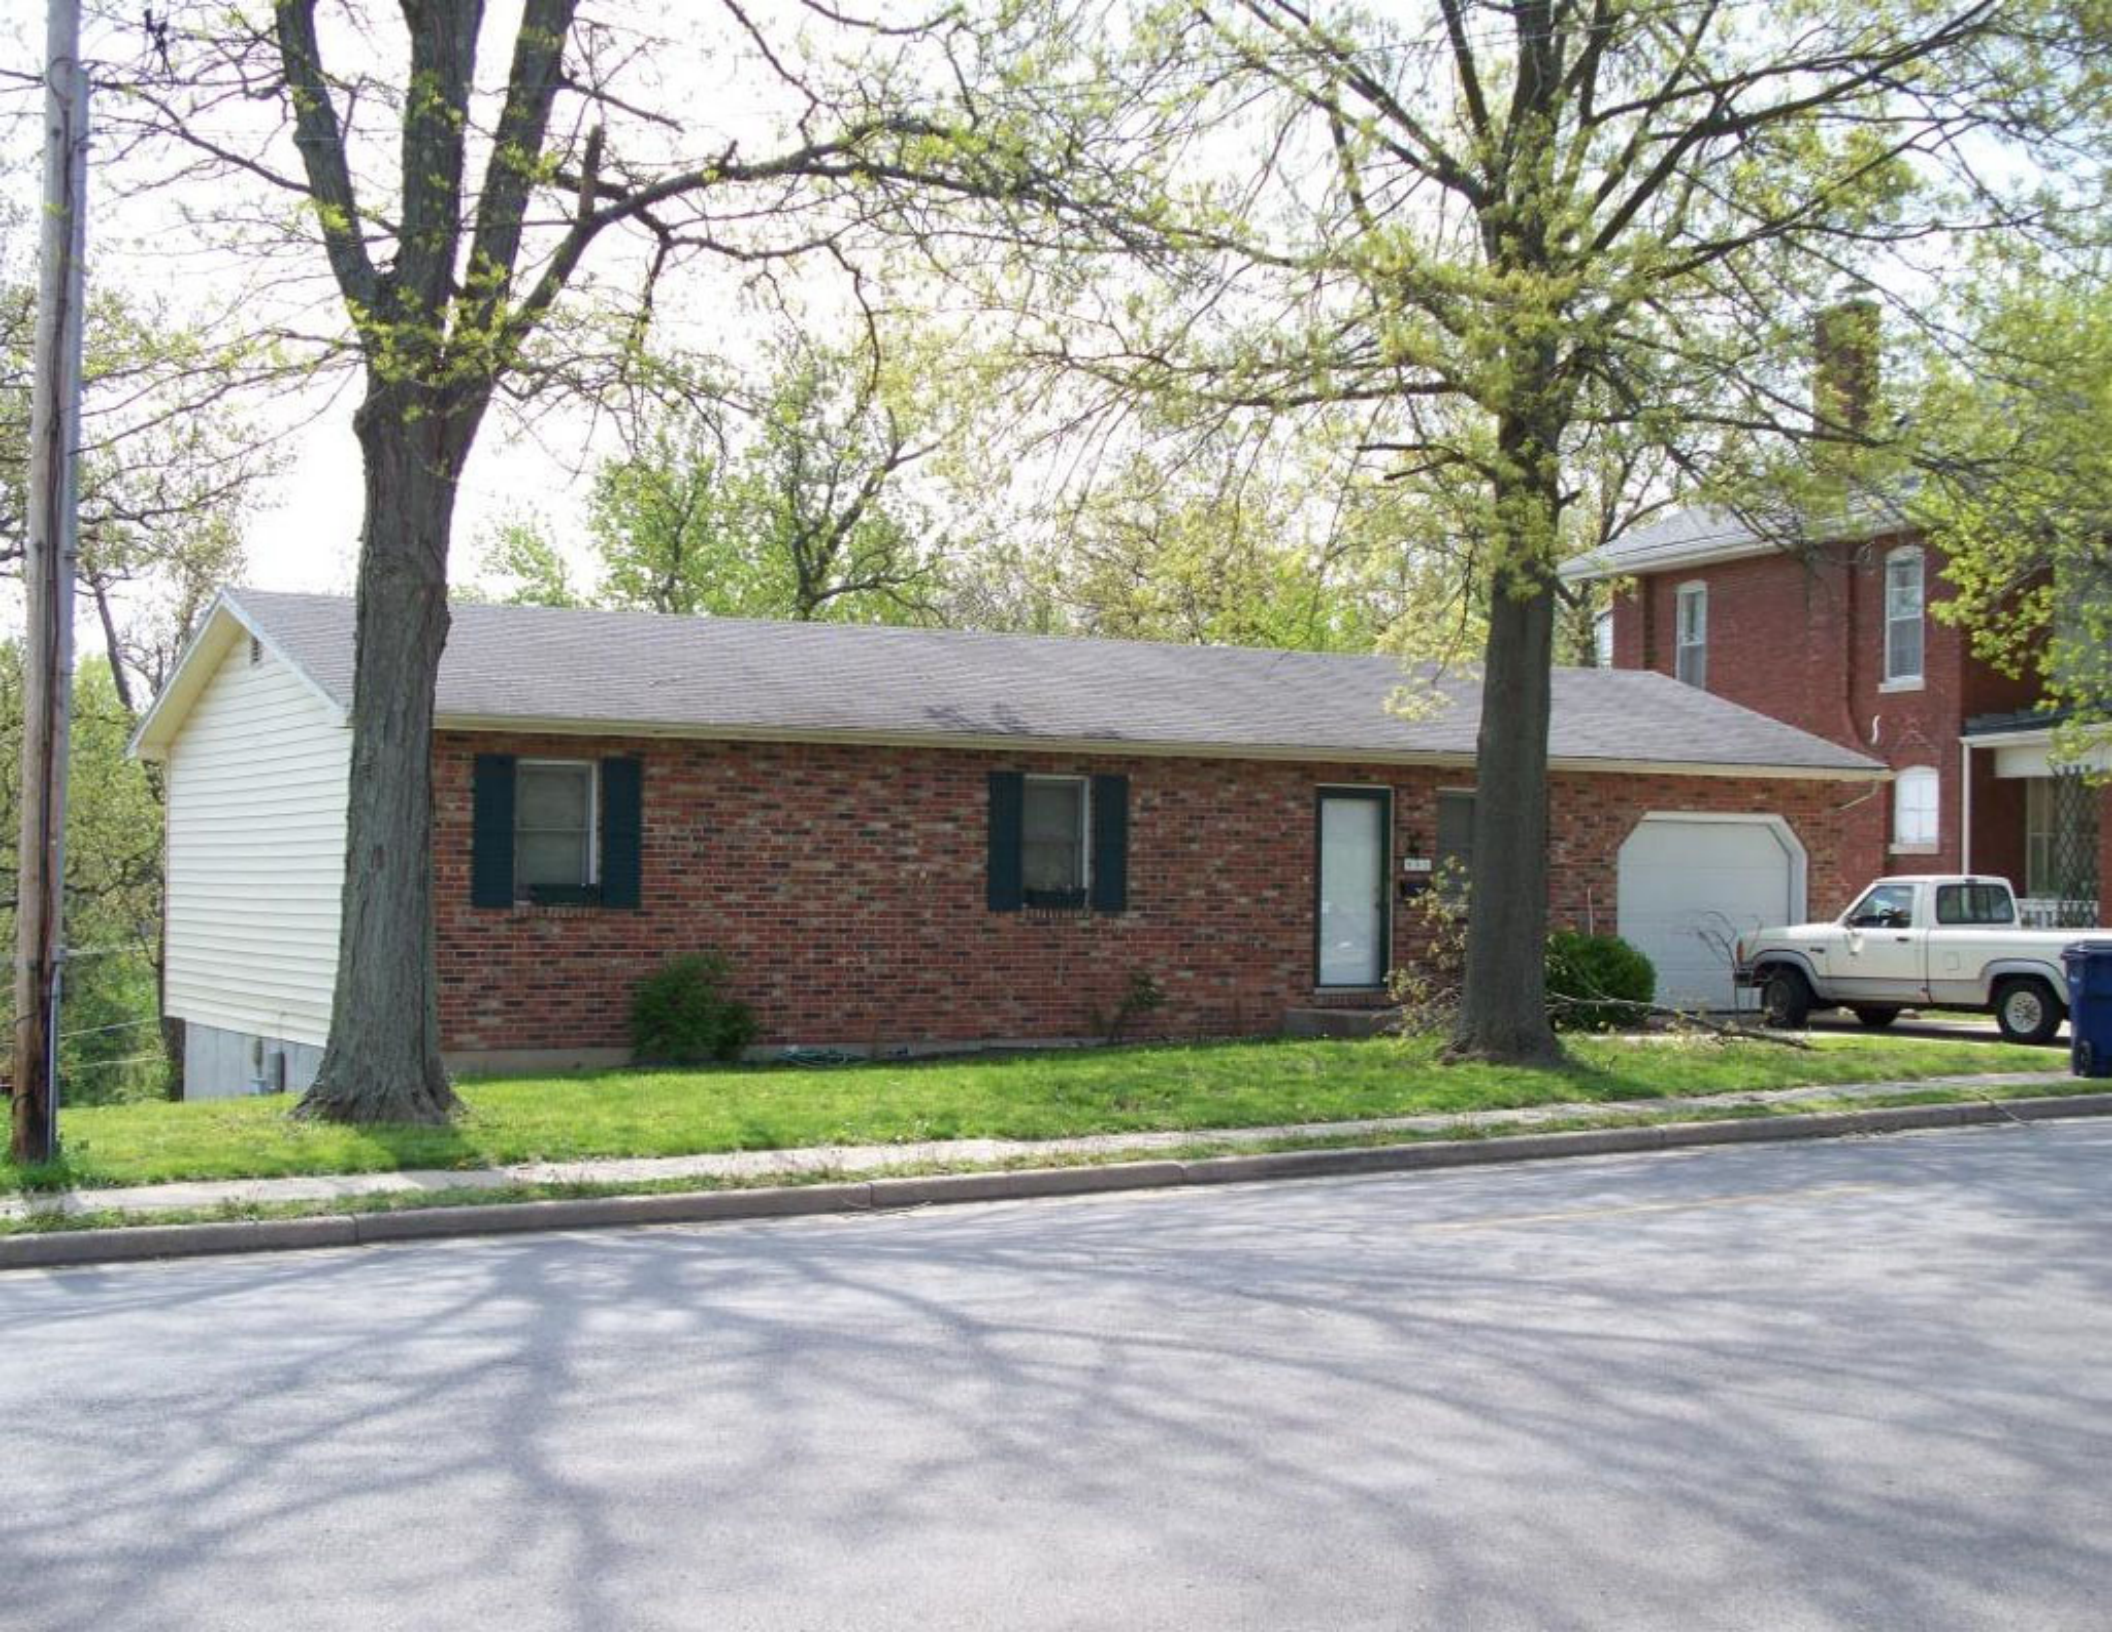
One story brick ranch house built c 1992 is considered non-contributing as it is outside the period of significance. Similar to 929 Moreau Drive, it has a side gable roof and garage on the front façade.
