ARCHITECTURAL/HISTORIC INVENTORY FORM

1. Survey No. CO-AS-005-001		2. Survey name: Moreau Drive Neighborhood Survey	
3. County: Cole		4. Address: 1202 Elmerine Ave.	
5. City: Jefferson City	Vicinity: <input type="checkbox"/>	6. UTM: / /	7. Township/Range/Section: T: R: S:
8. Historic name (if known):		9. Present/other name (if known):	
10. Ownership: <input checked="" type="checkbox"/> Private <input type="checkbox"/> Public		11. Historic use (if known): Residential	11. Current use: Residential

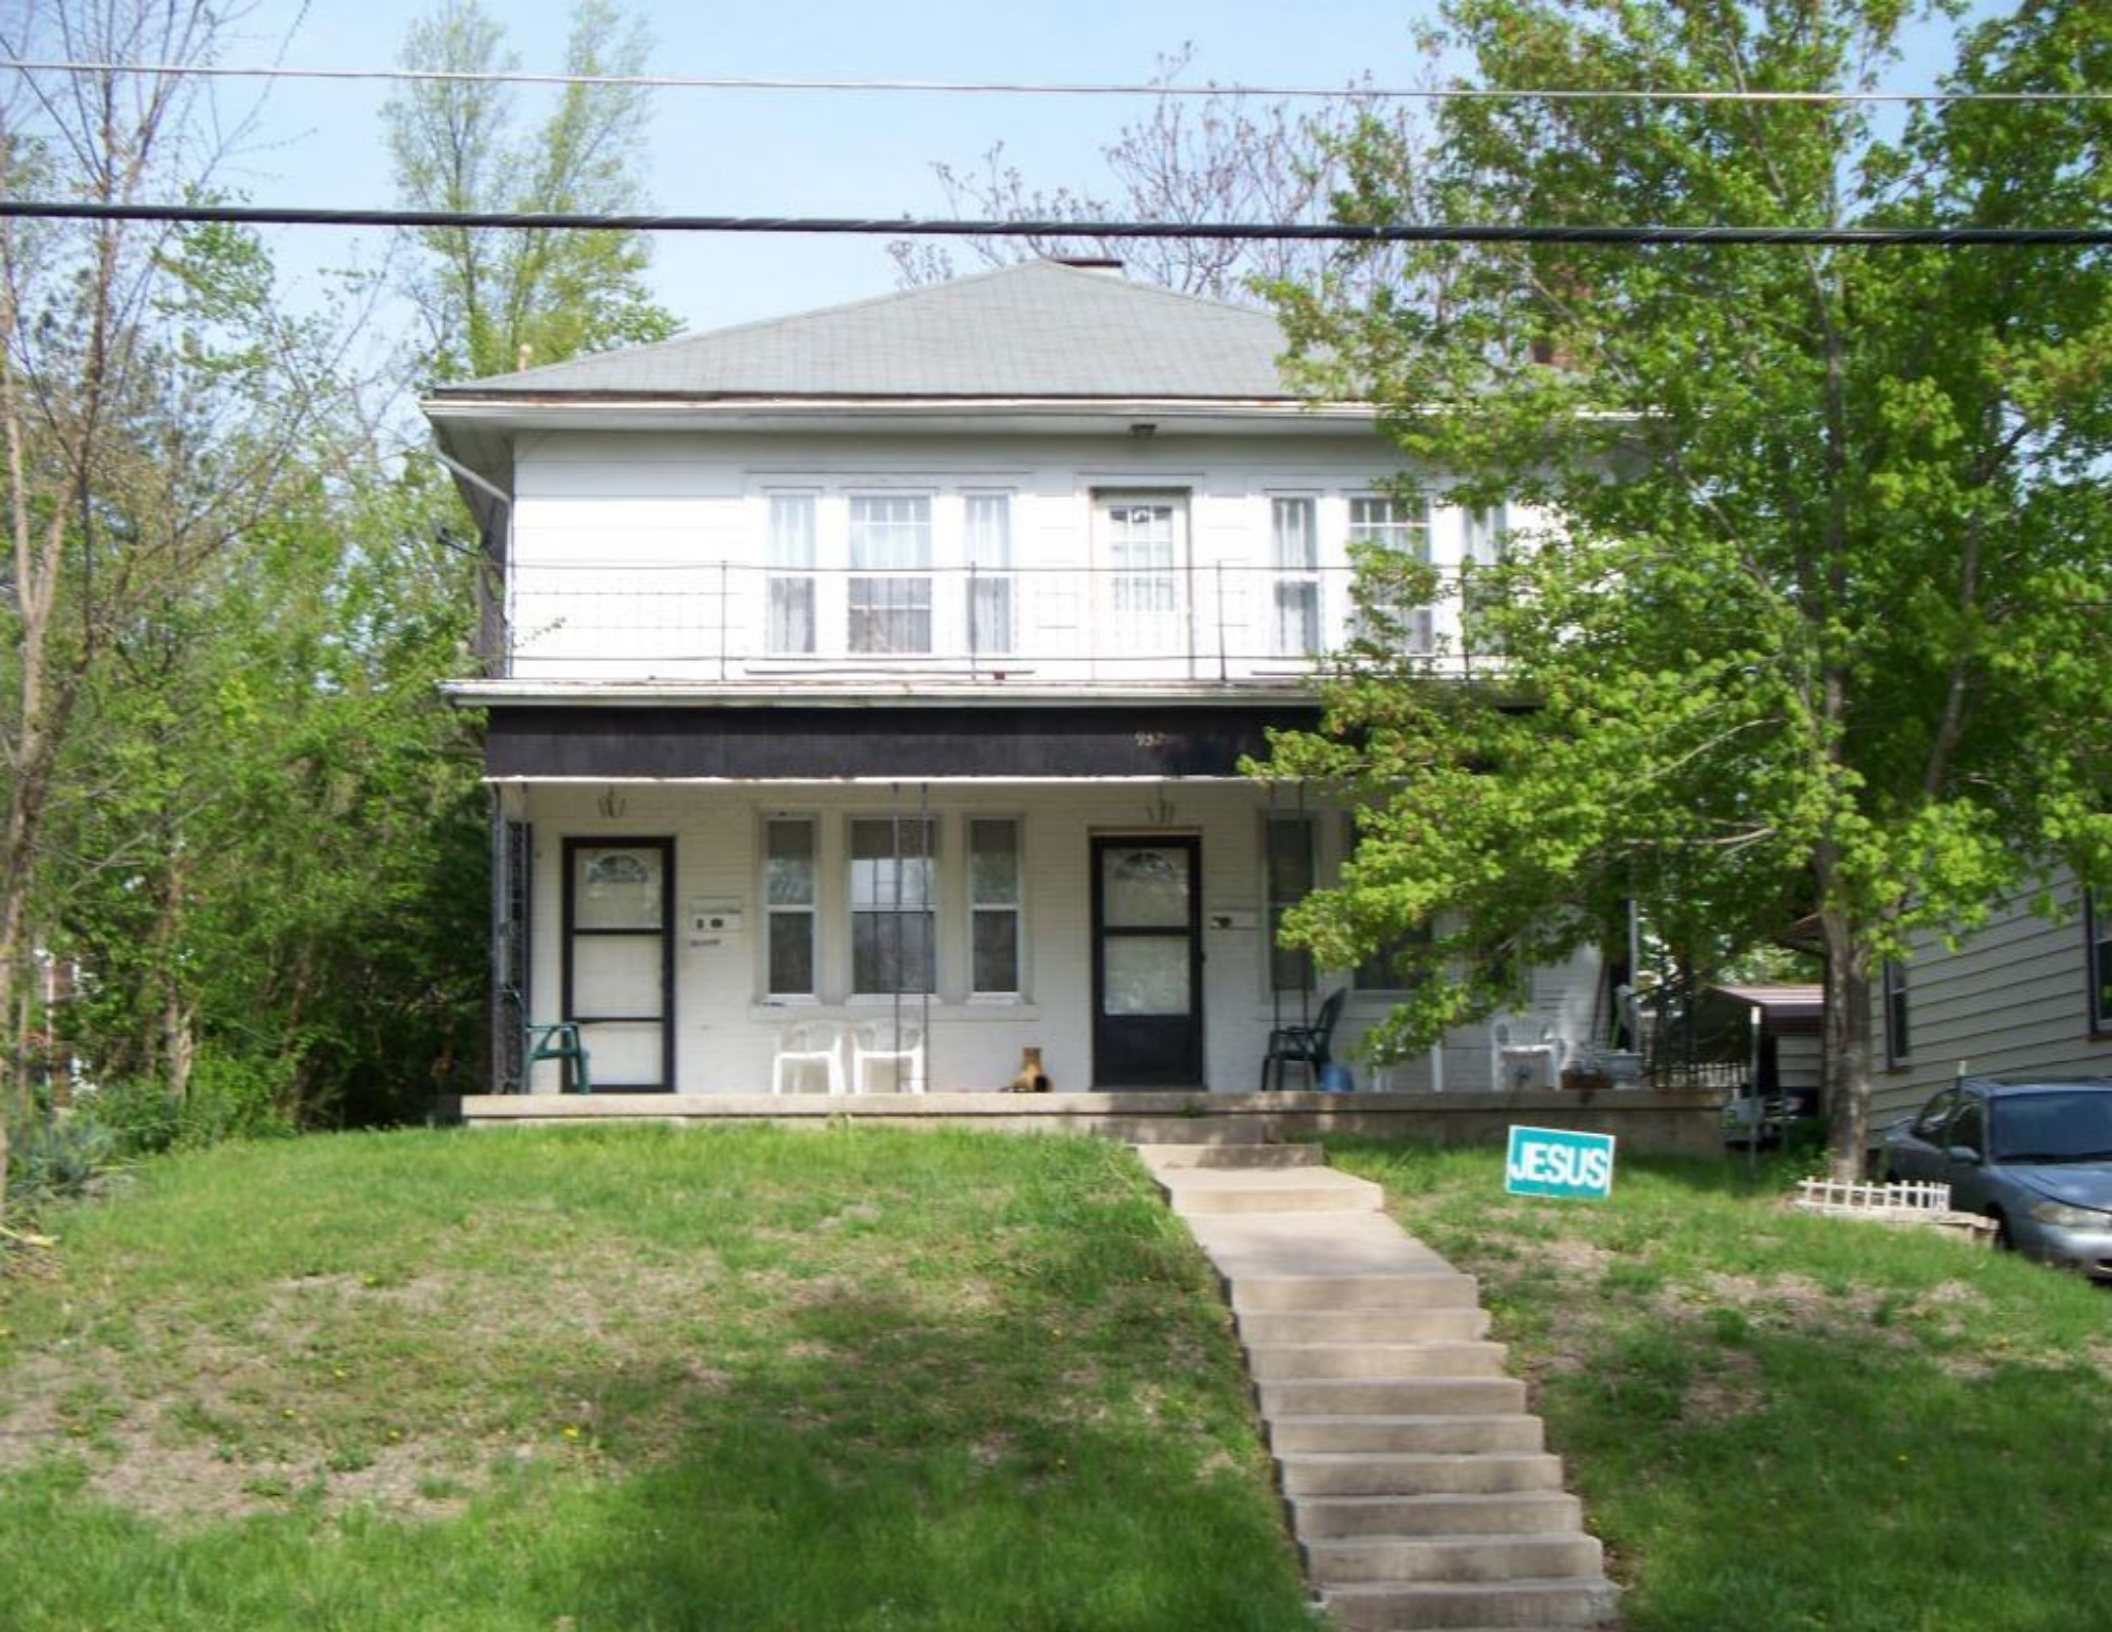
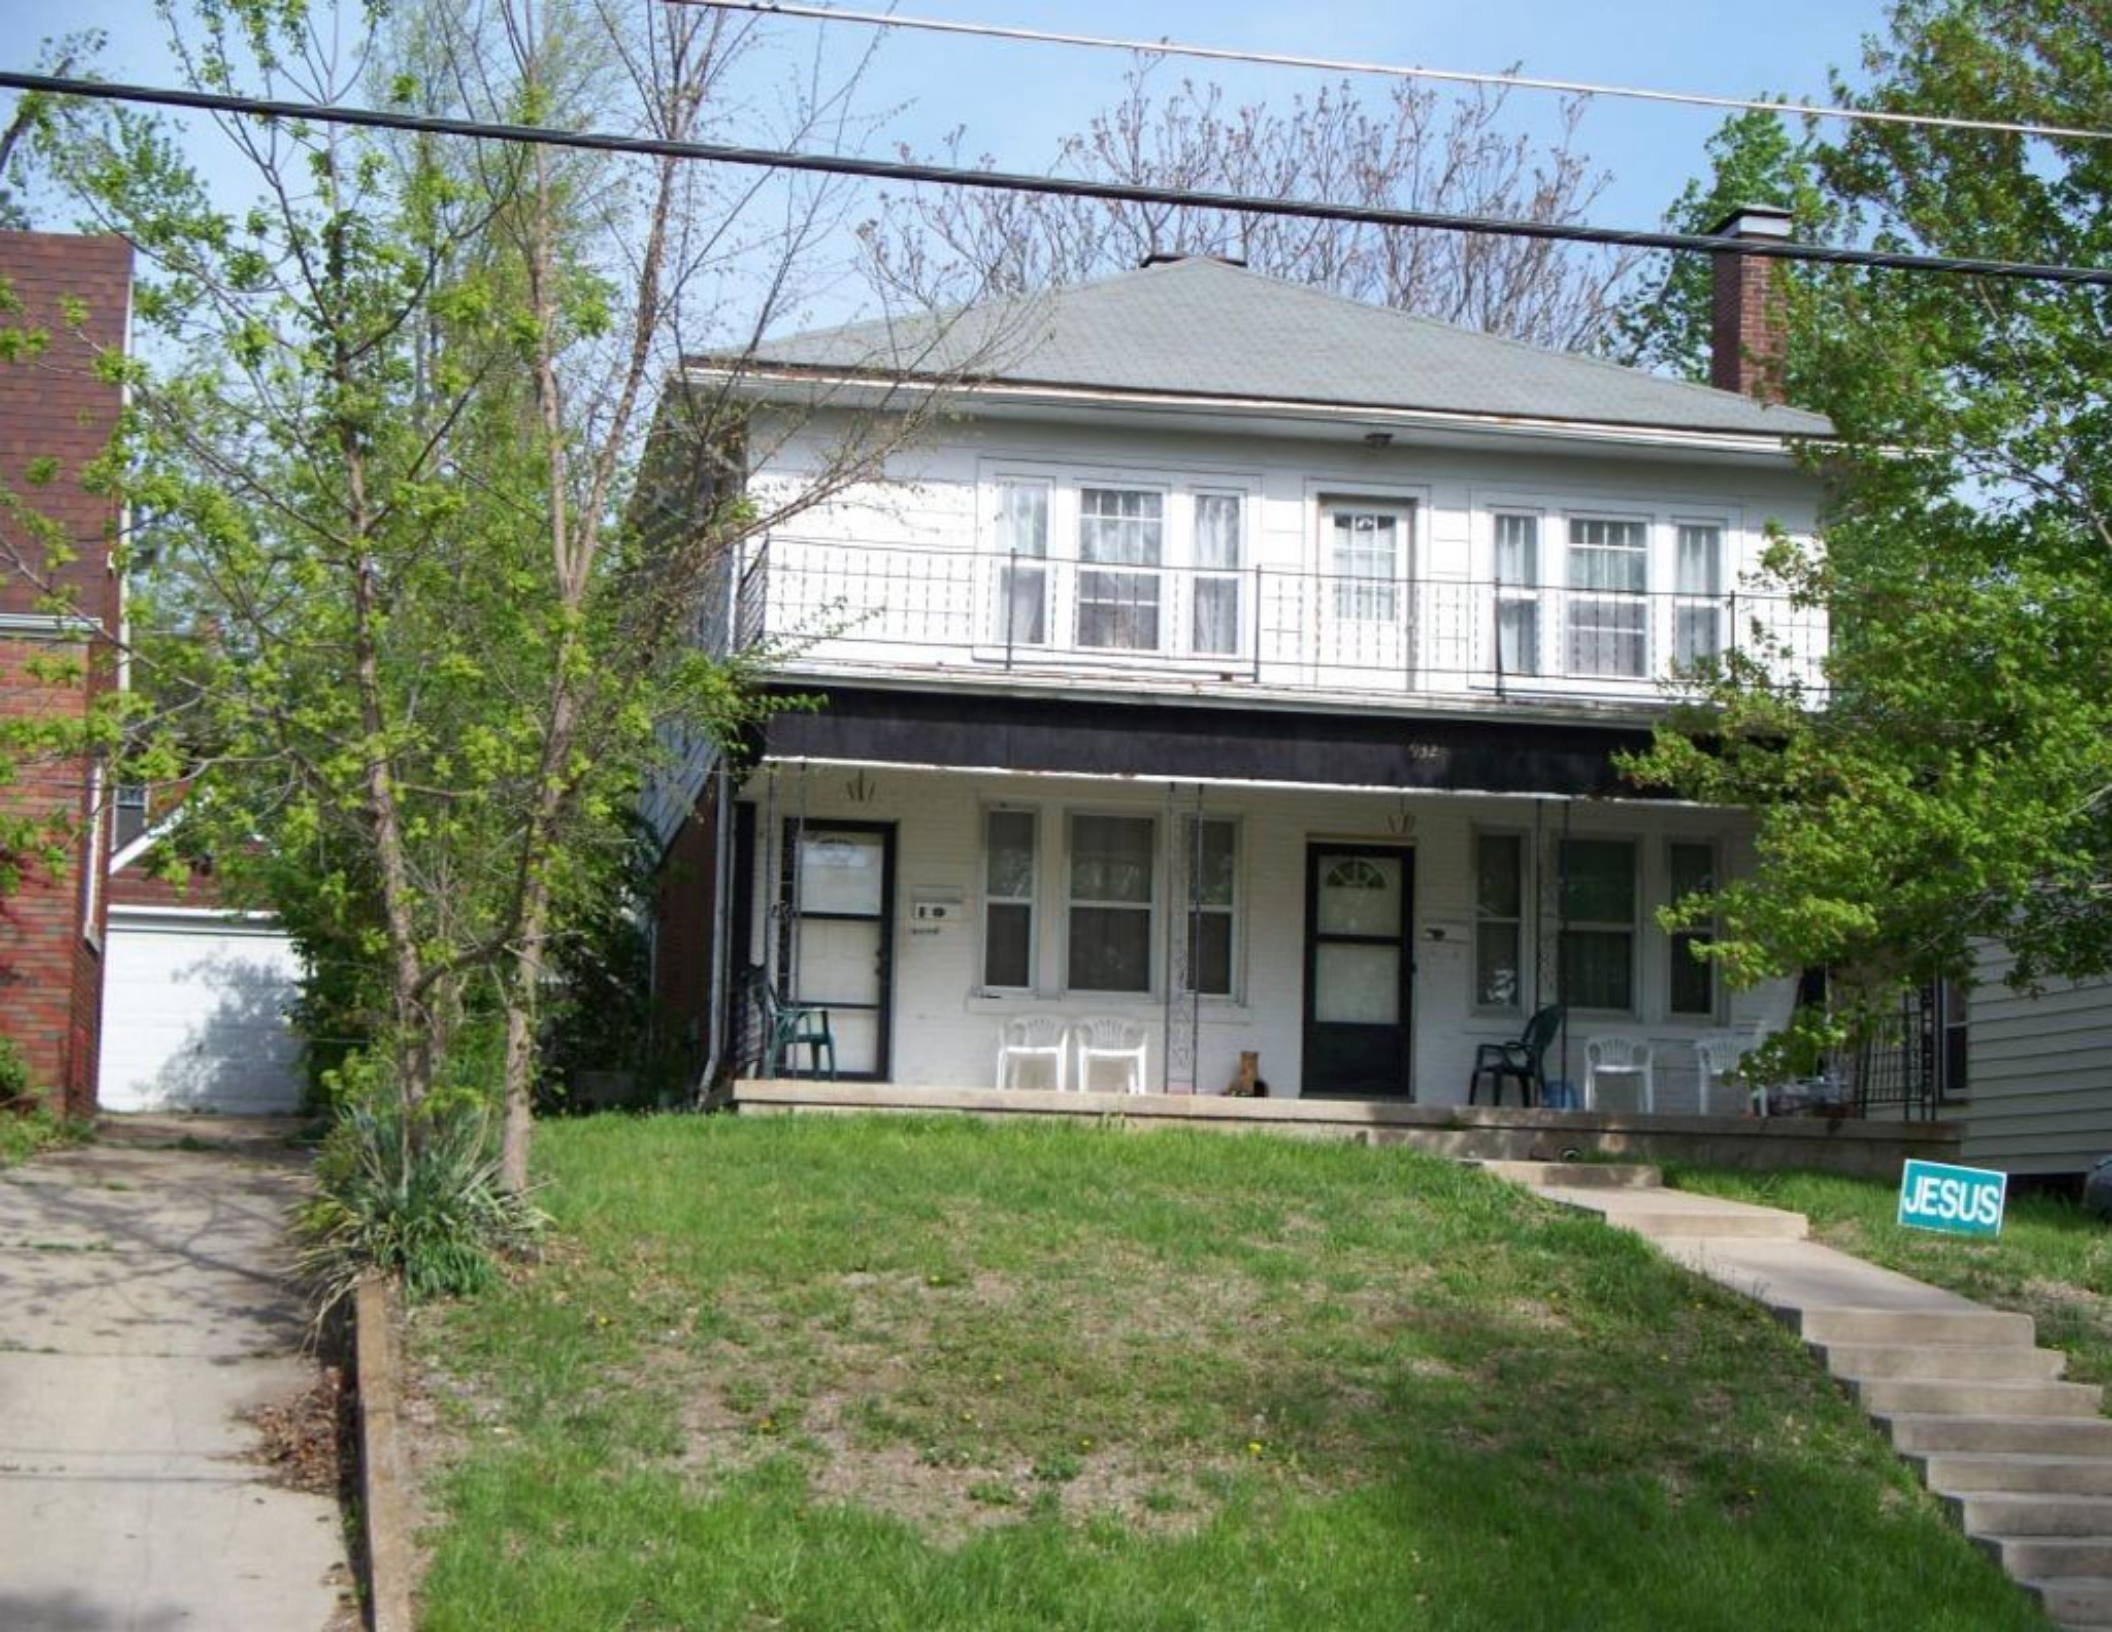
41. (cont.) Sanborn maps from this time were difficult to make out, but it appears this property was always, or at least historically, a two-unit flat. The two-story building has a pyramidal roof and full porches on both stories. The upper 'deck' appears to be clad in clapboard and has iron railing and two tri-part windows (2 smaller 3/1 flanking a larger 8/1) flanking a central opening. The windows on this level appear historic. Starting from the left, the lower floor is brick and features a door that is likely the staircase to the second apartment, next are two tri-part windows flanking an entrance to the first unit. The windows on this floor are aluminum replacement, all of the doors are modern. The porch on the first level has decorative metal posts and railing on the sides.

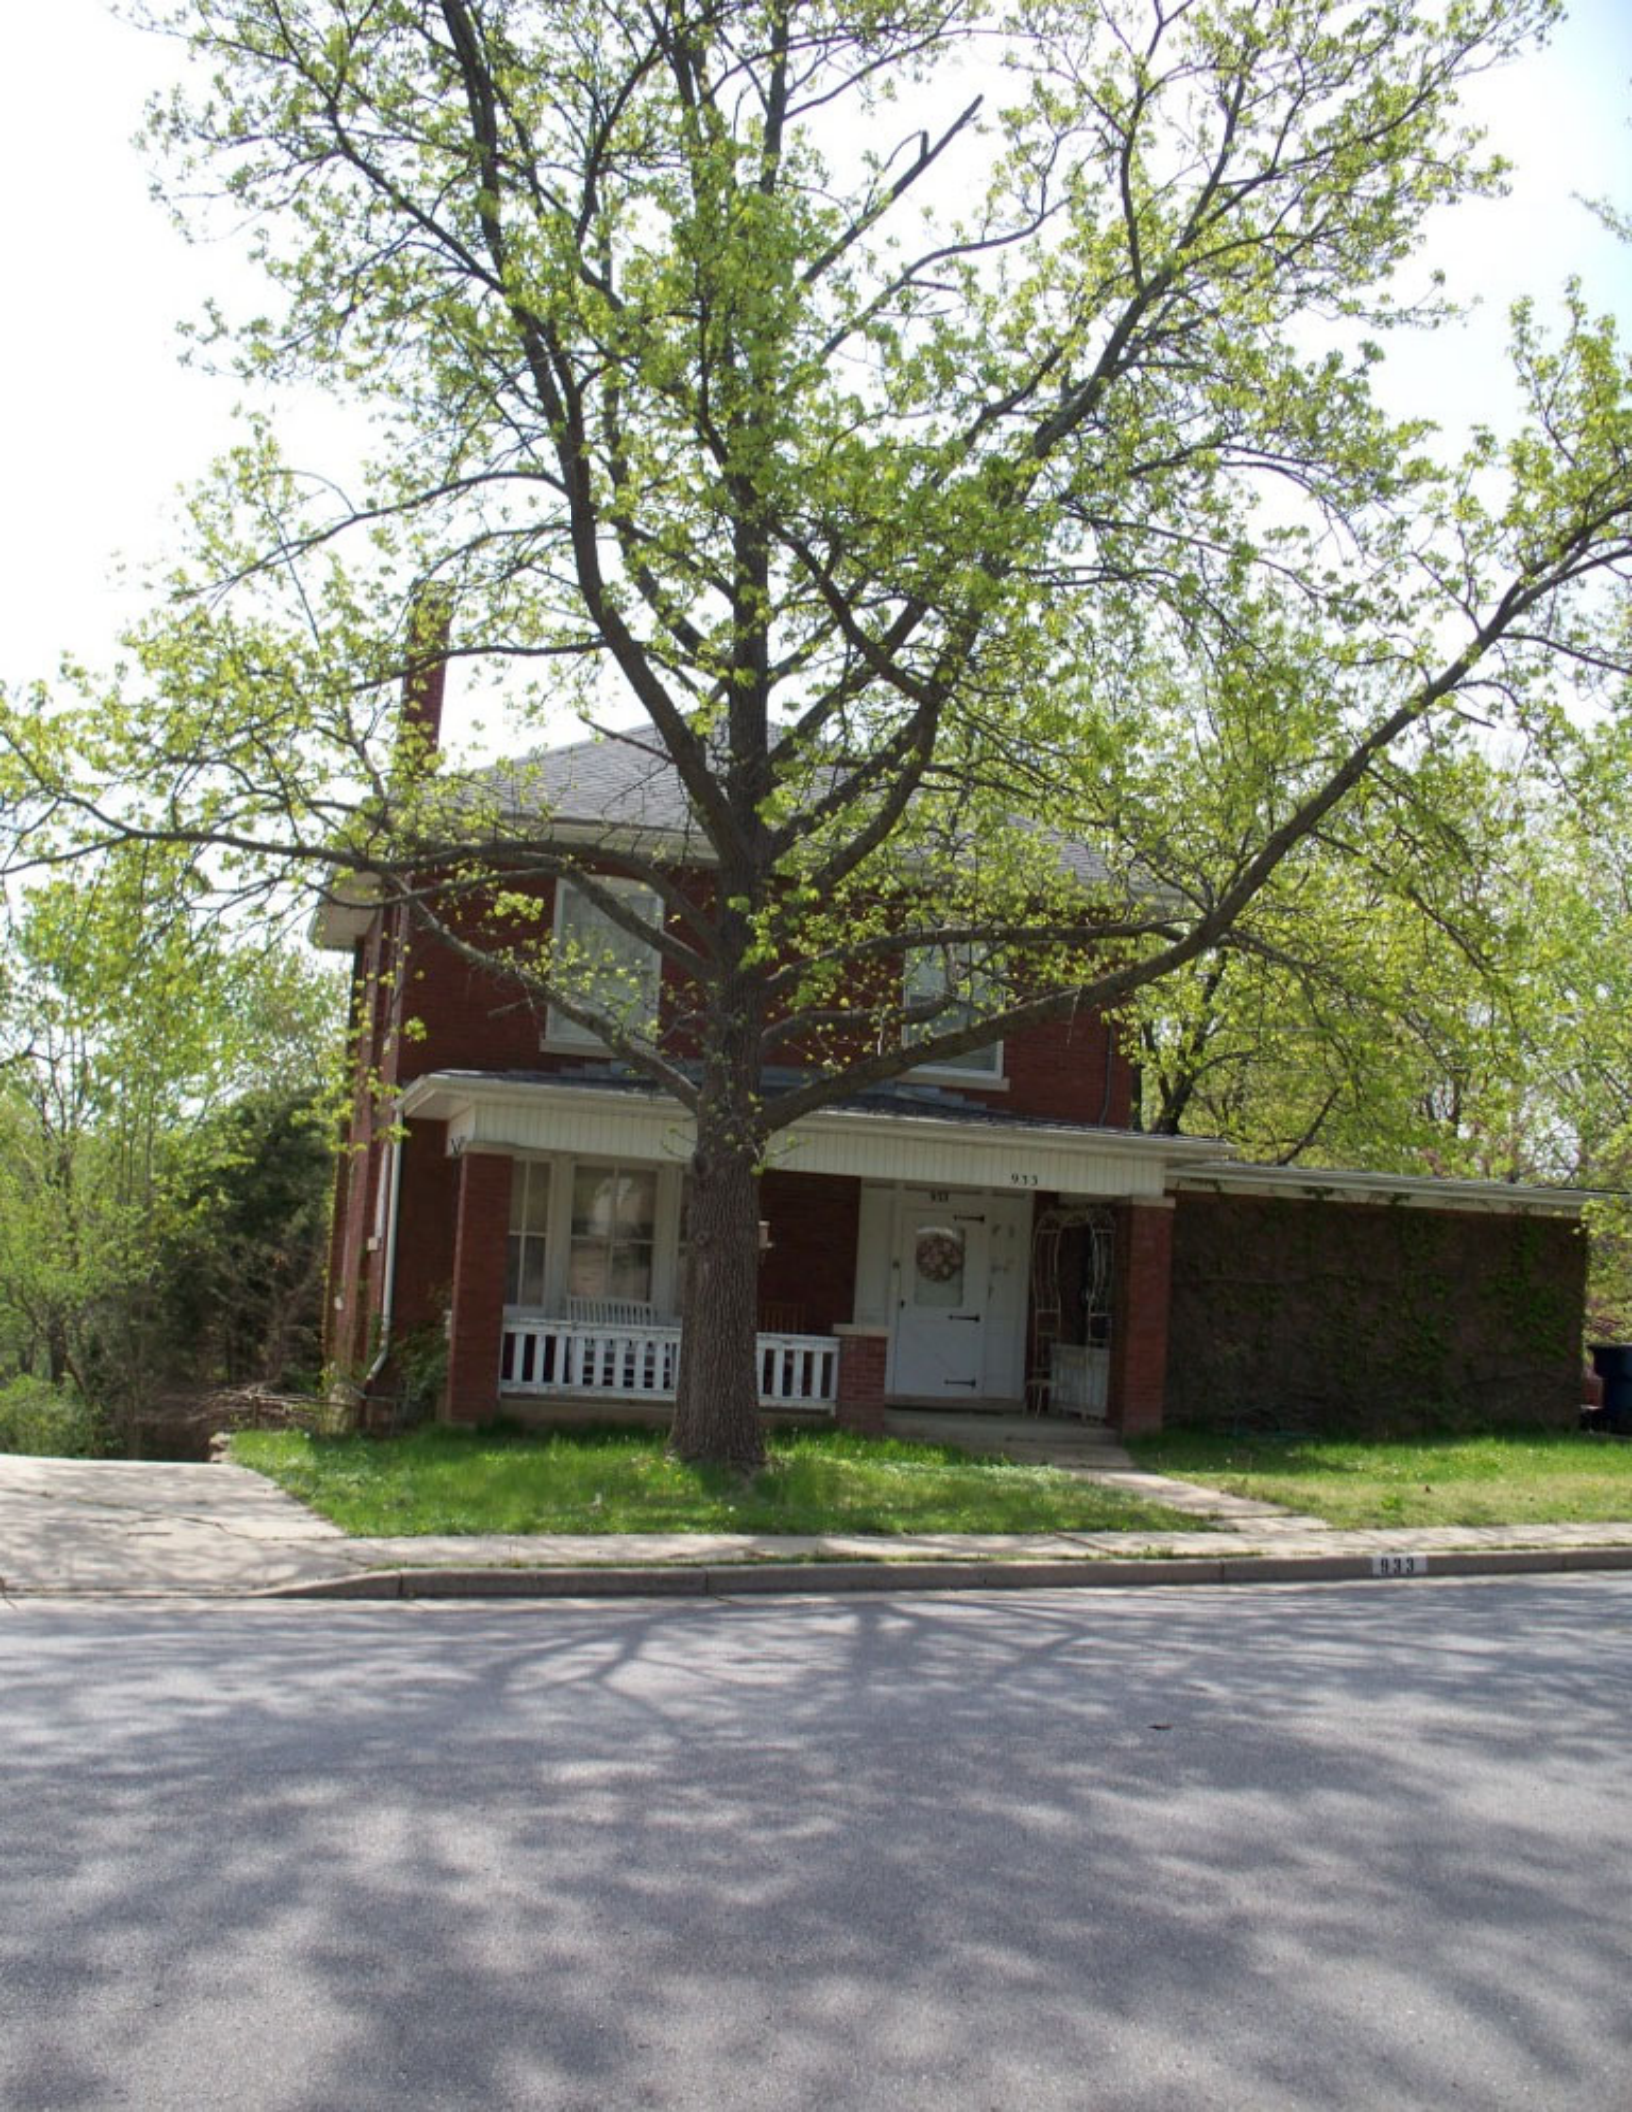
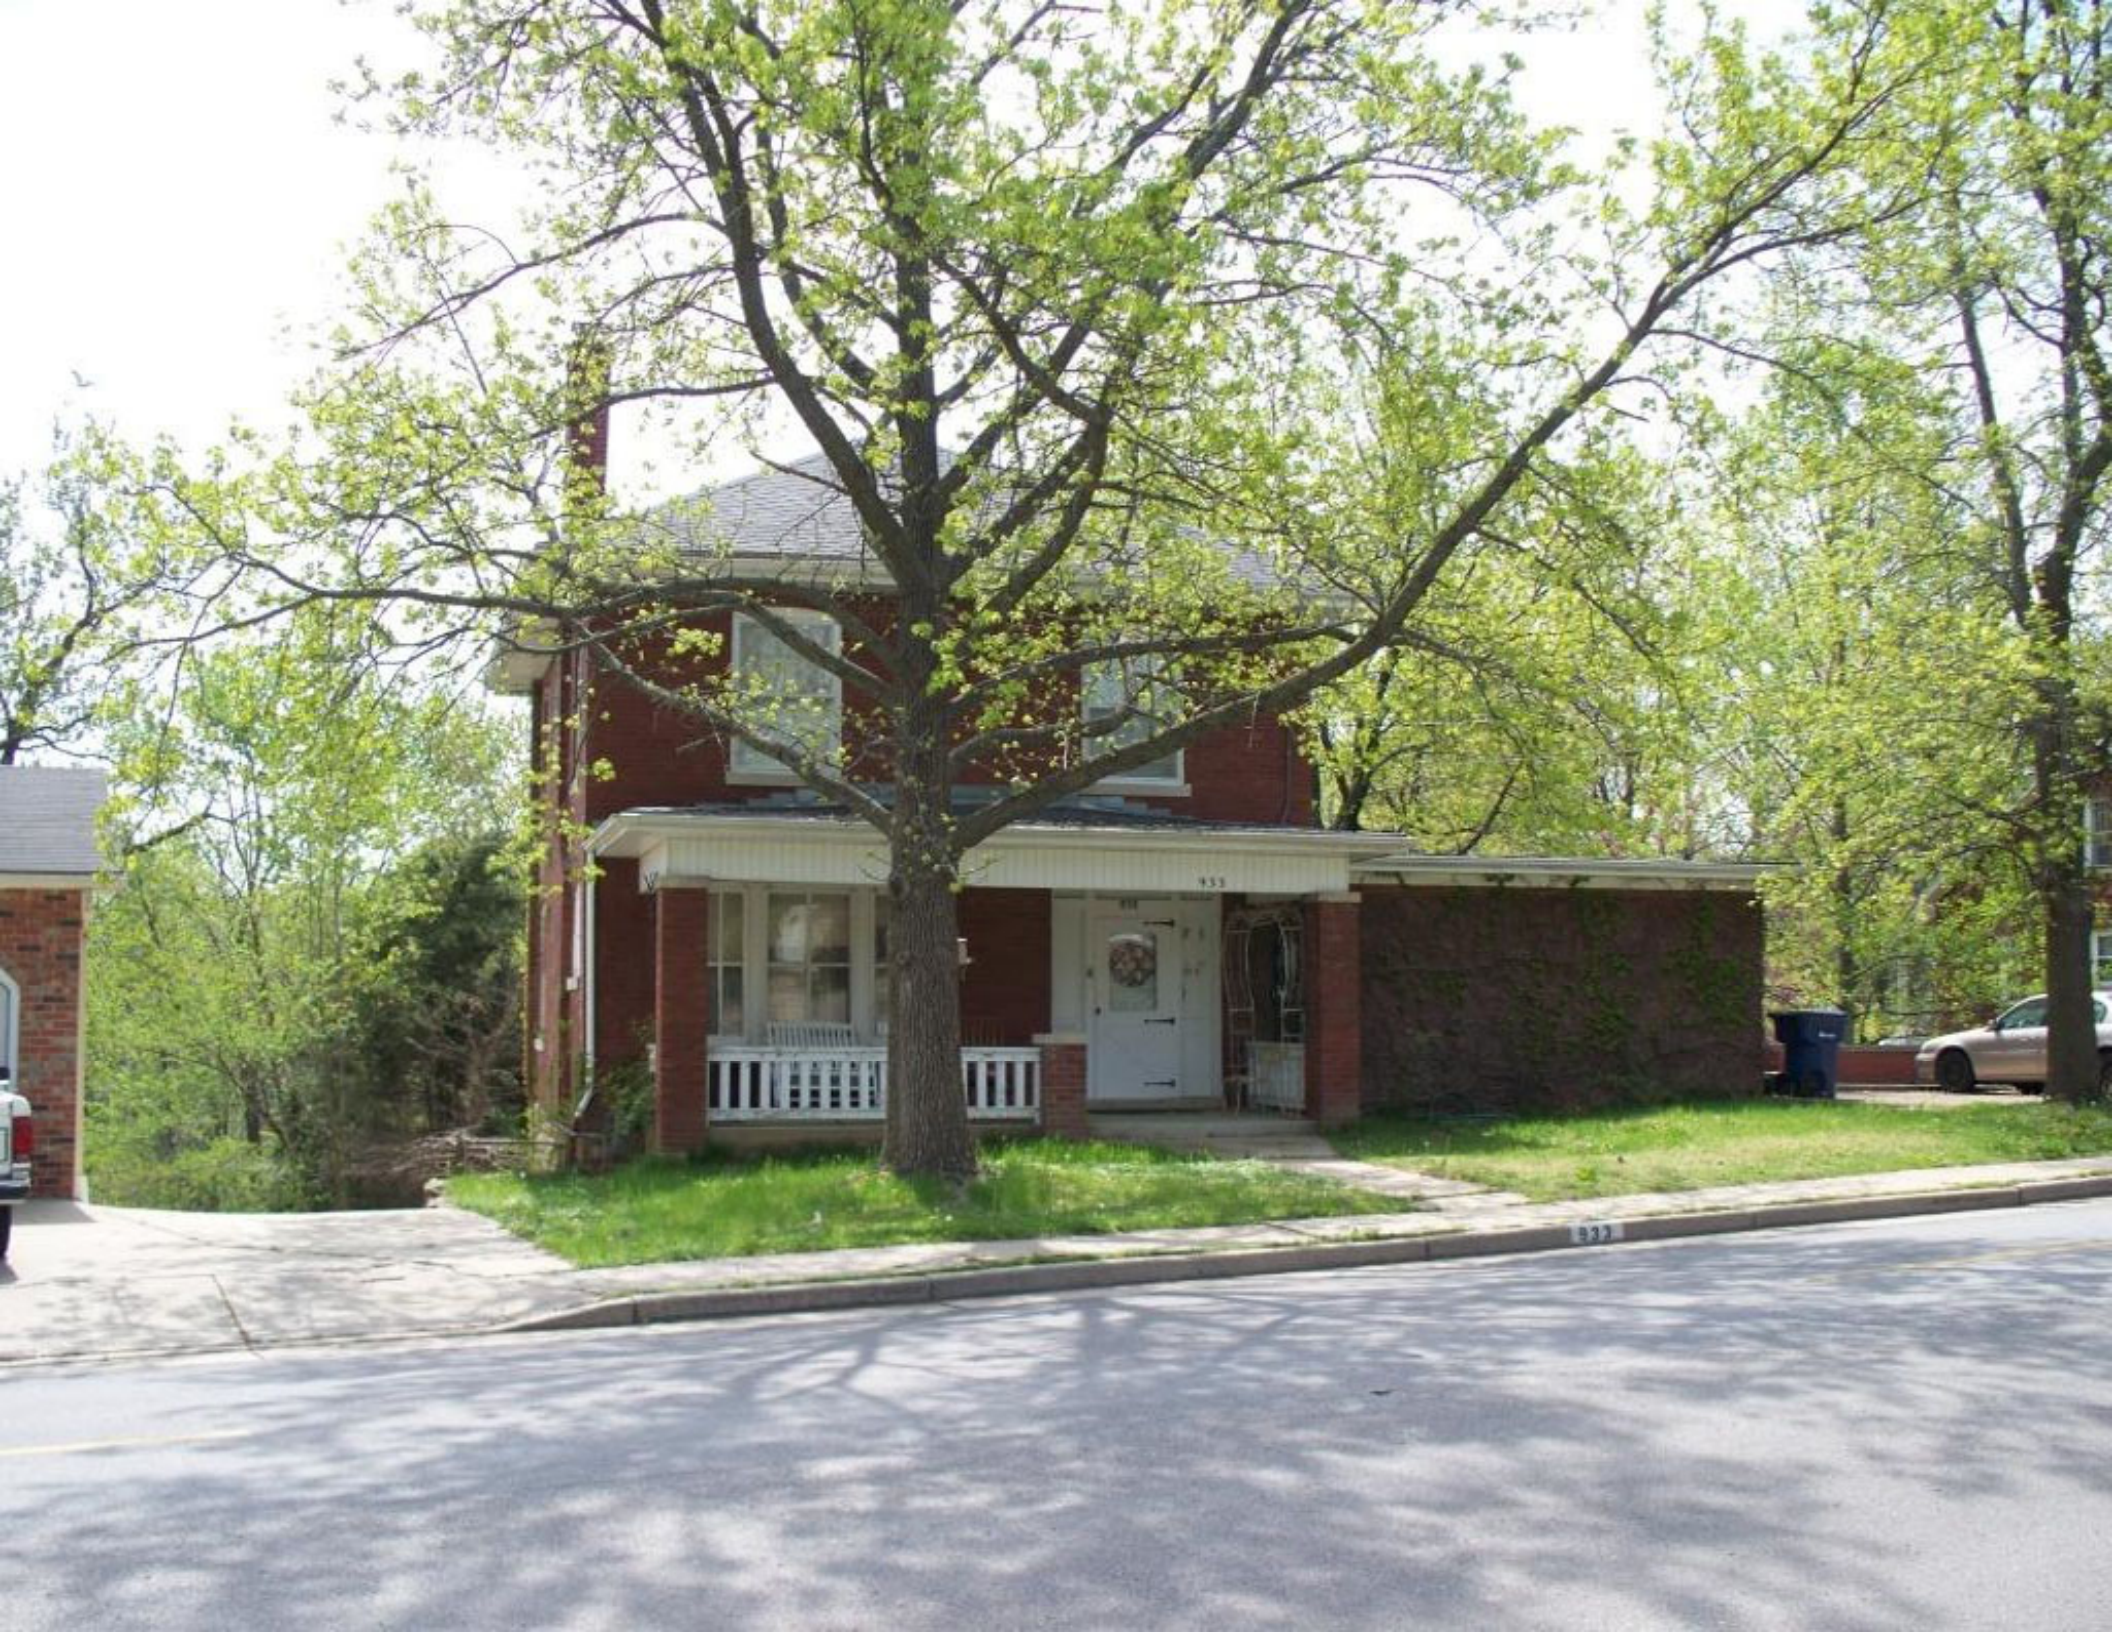
This two-story brick four square has a pyramidal roof, full width porch with brick piers and wooden balustrade, and a panel of three 2/2 fixed historic windows to the left (north) of the façade. The entrance is off centered to the right (south) and originally had a transom and sidelights but these appear to have been in-filled with wooden panels. The upper floor has two replacement 1/1 windows and is otherwise plain. A brick carport is attached to the right (south) of the building and is accessed by the side of the building as it faces south. This creates a one-story blank wall, extending from the central façade. Although this is no small alteration, the building continues to convey its historic character thus it would be considered contributing to a district.

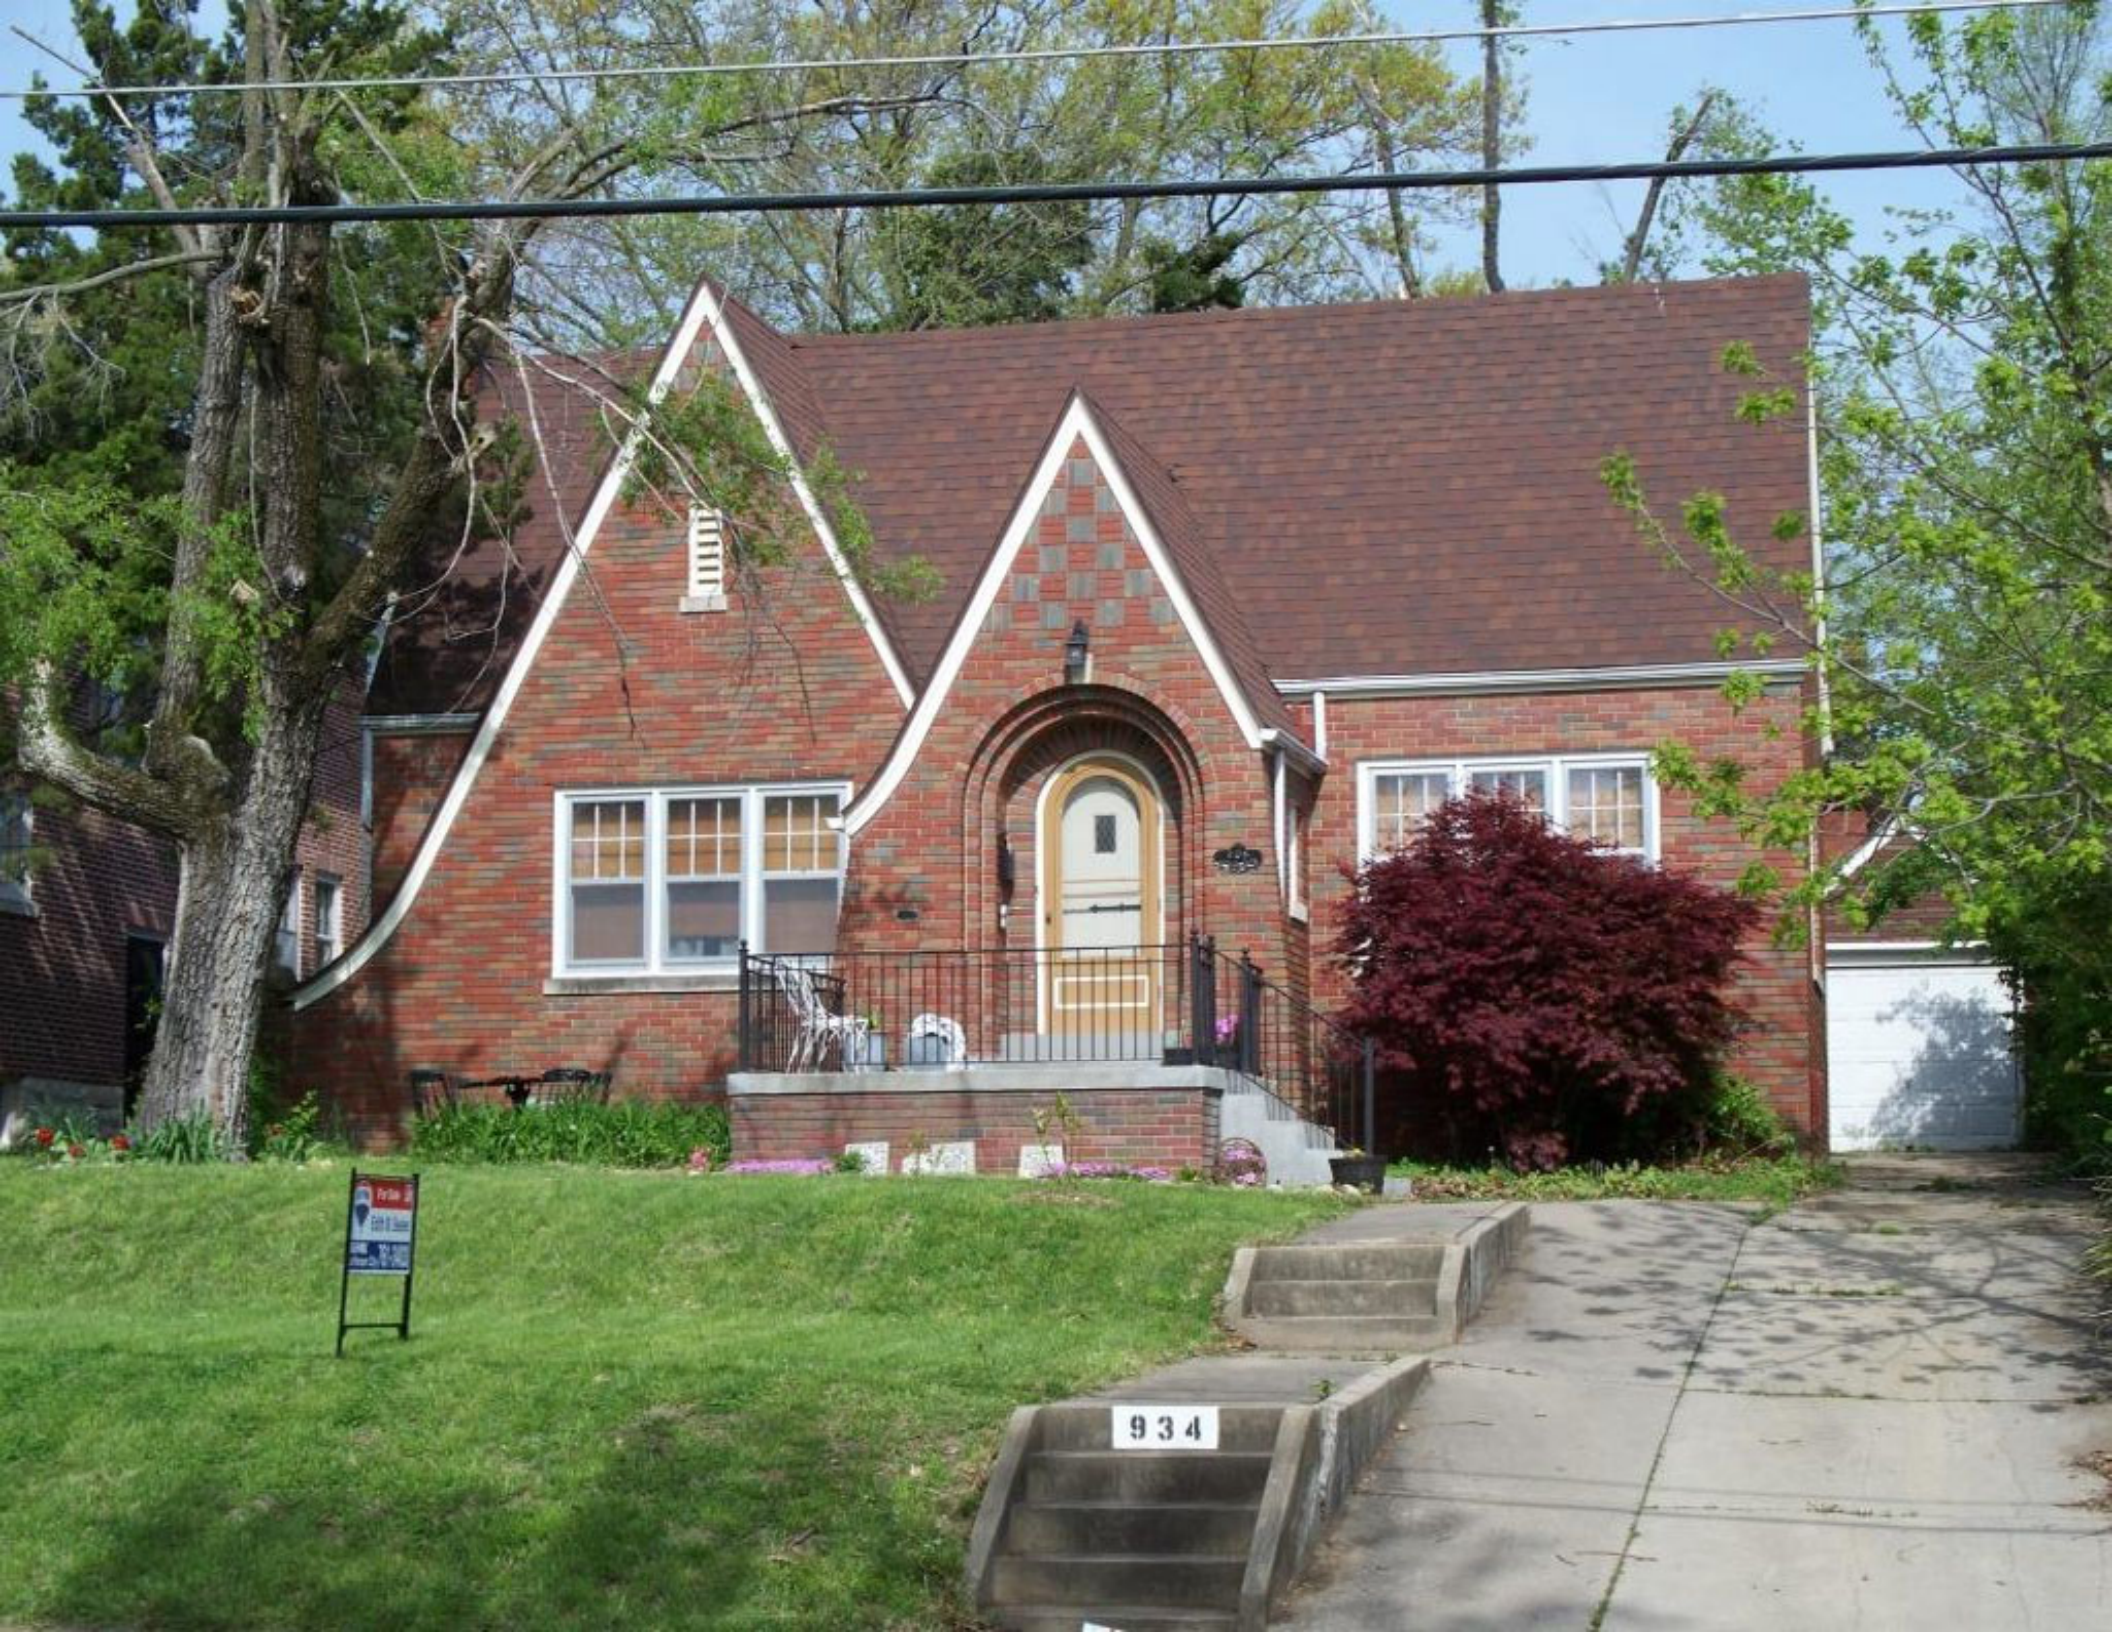
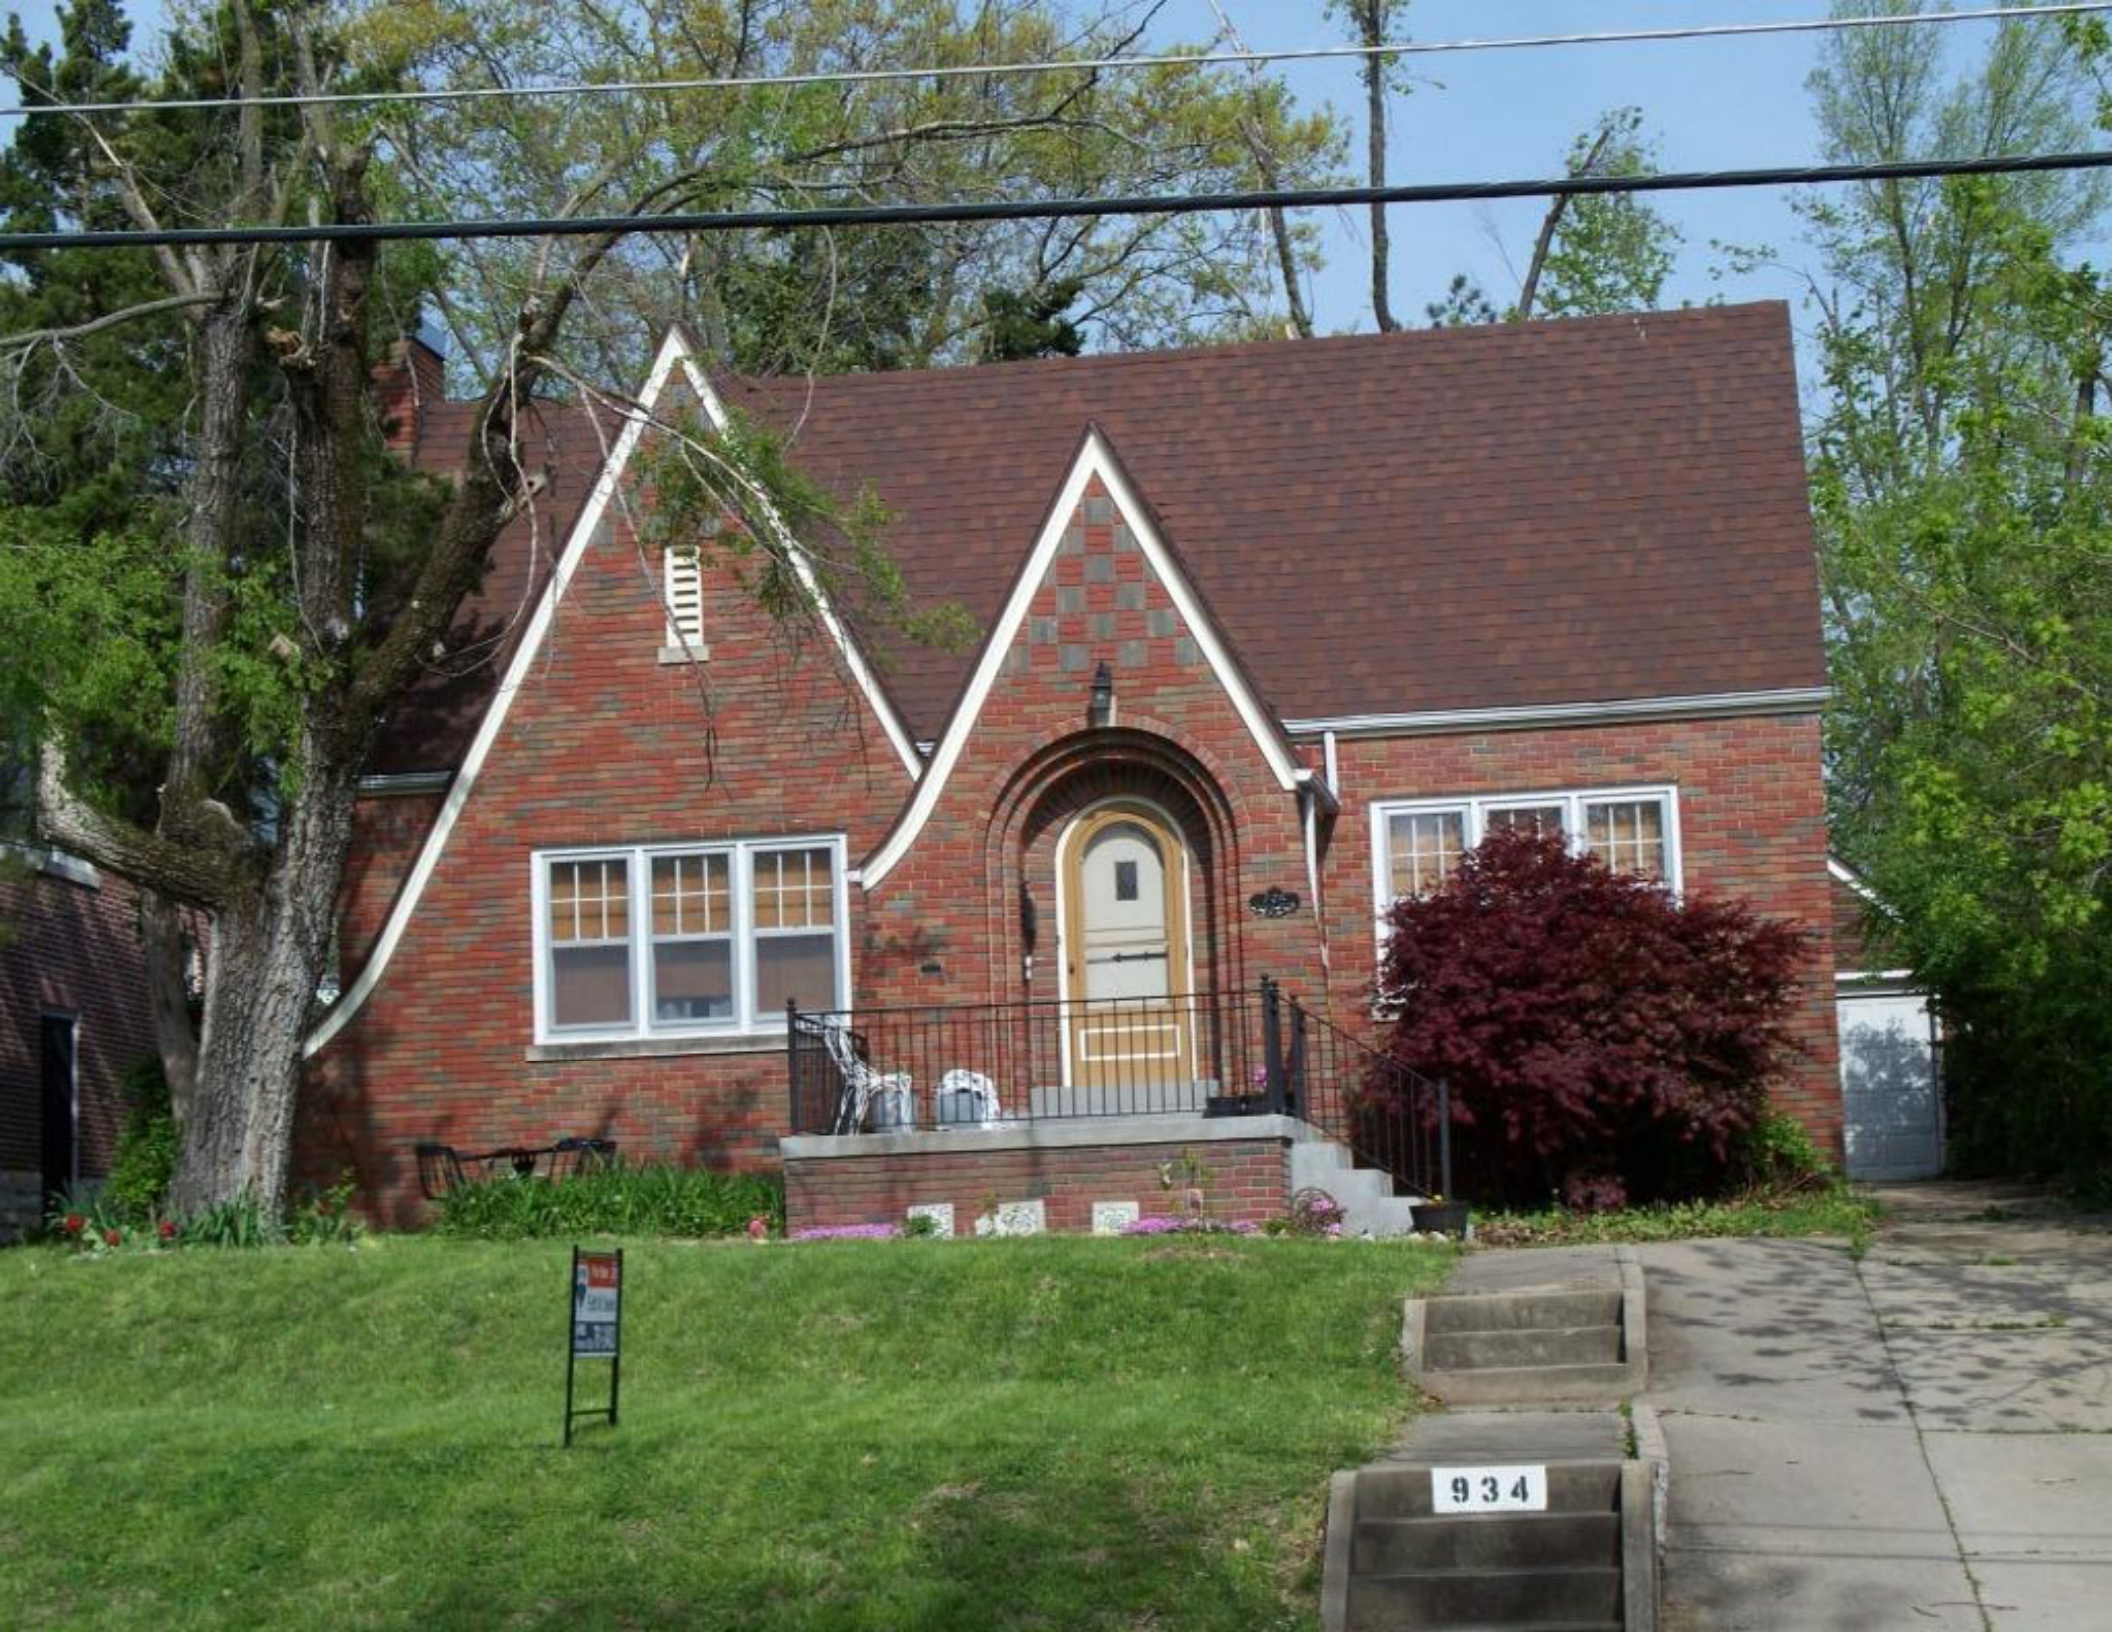
934

40. (cont.) Description of environment and outbuildings. Expand box as necessary, or add continuation pages.
This is a historic detached one-car brick garage with a gable roof. It would contribute to the district.

41. (cont.) This one-and-a-half story Tudor has multi-color brick with a decorative pattern applied to the entrance gable. The property has two steeply pitched gables, both protrude from the side-gabled portion of the property. The larger of the gables flares slightly and contains a row of three windows that appear to be modern or exceptionally well-kept 6/1. There is also a small rectangular vent in the apex of the gable, both it and the windows have a limestone or concrete sill. The second gable contains a recessed and repeating segmented arched entrance and appears to retain the original arched door. The last bay (to the right) has an identical row of three windows as was in the first bay.
