ARCHITECTURAL/HISTORIC INVENTORY FORM

1. Survey No. CO-AS-005-001		2. Survey name: Moreau Drive Neighborhood Survey	
3. County: Cole		4. Address: 1202 Elmerine Ave.	
5. City: Jefferson City	Vicinity: <input type="checkbox"/>	6. UTM: / /	7. Township/Range/Section: T: R: S:
8. Historic name (if known):		9. Present/other name (if known):	
10. Ownership: <input checked="" type="checkbox"/> Private <input type="checkbox"/> Public		11. Historic use (if known): Residential	11. Current use: Residential

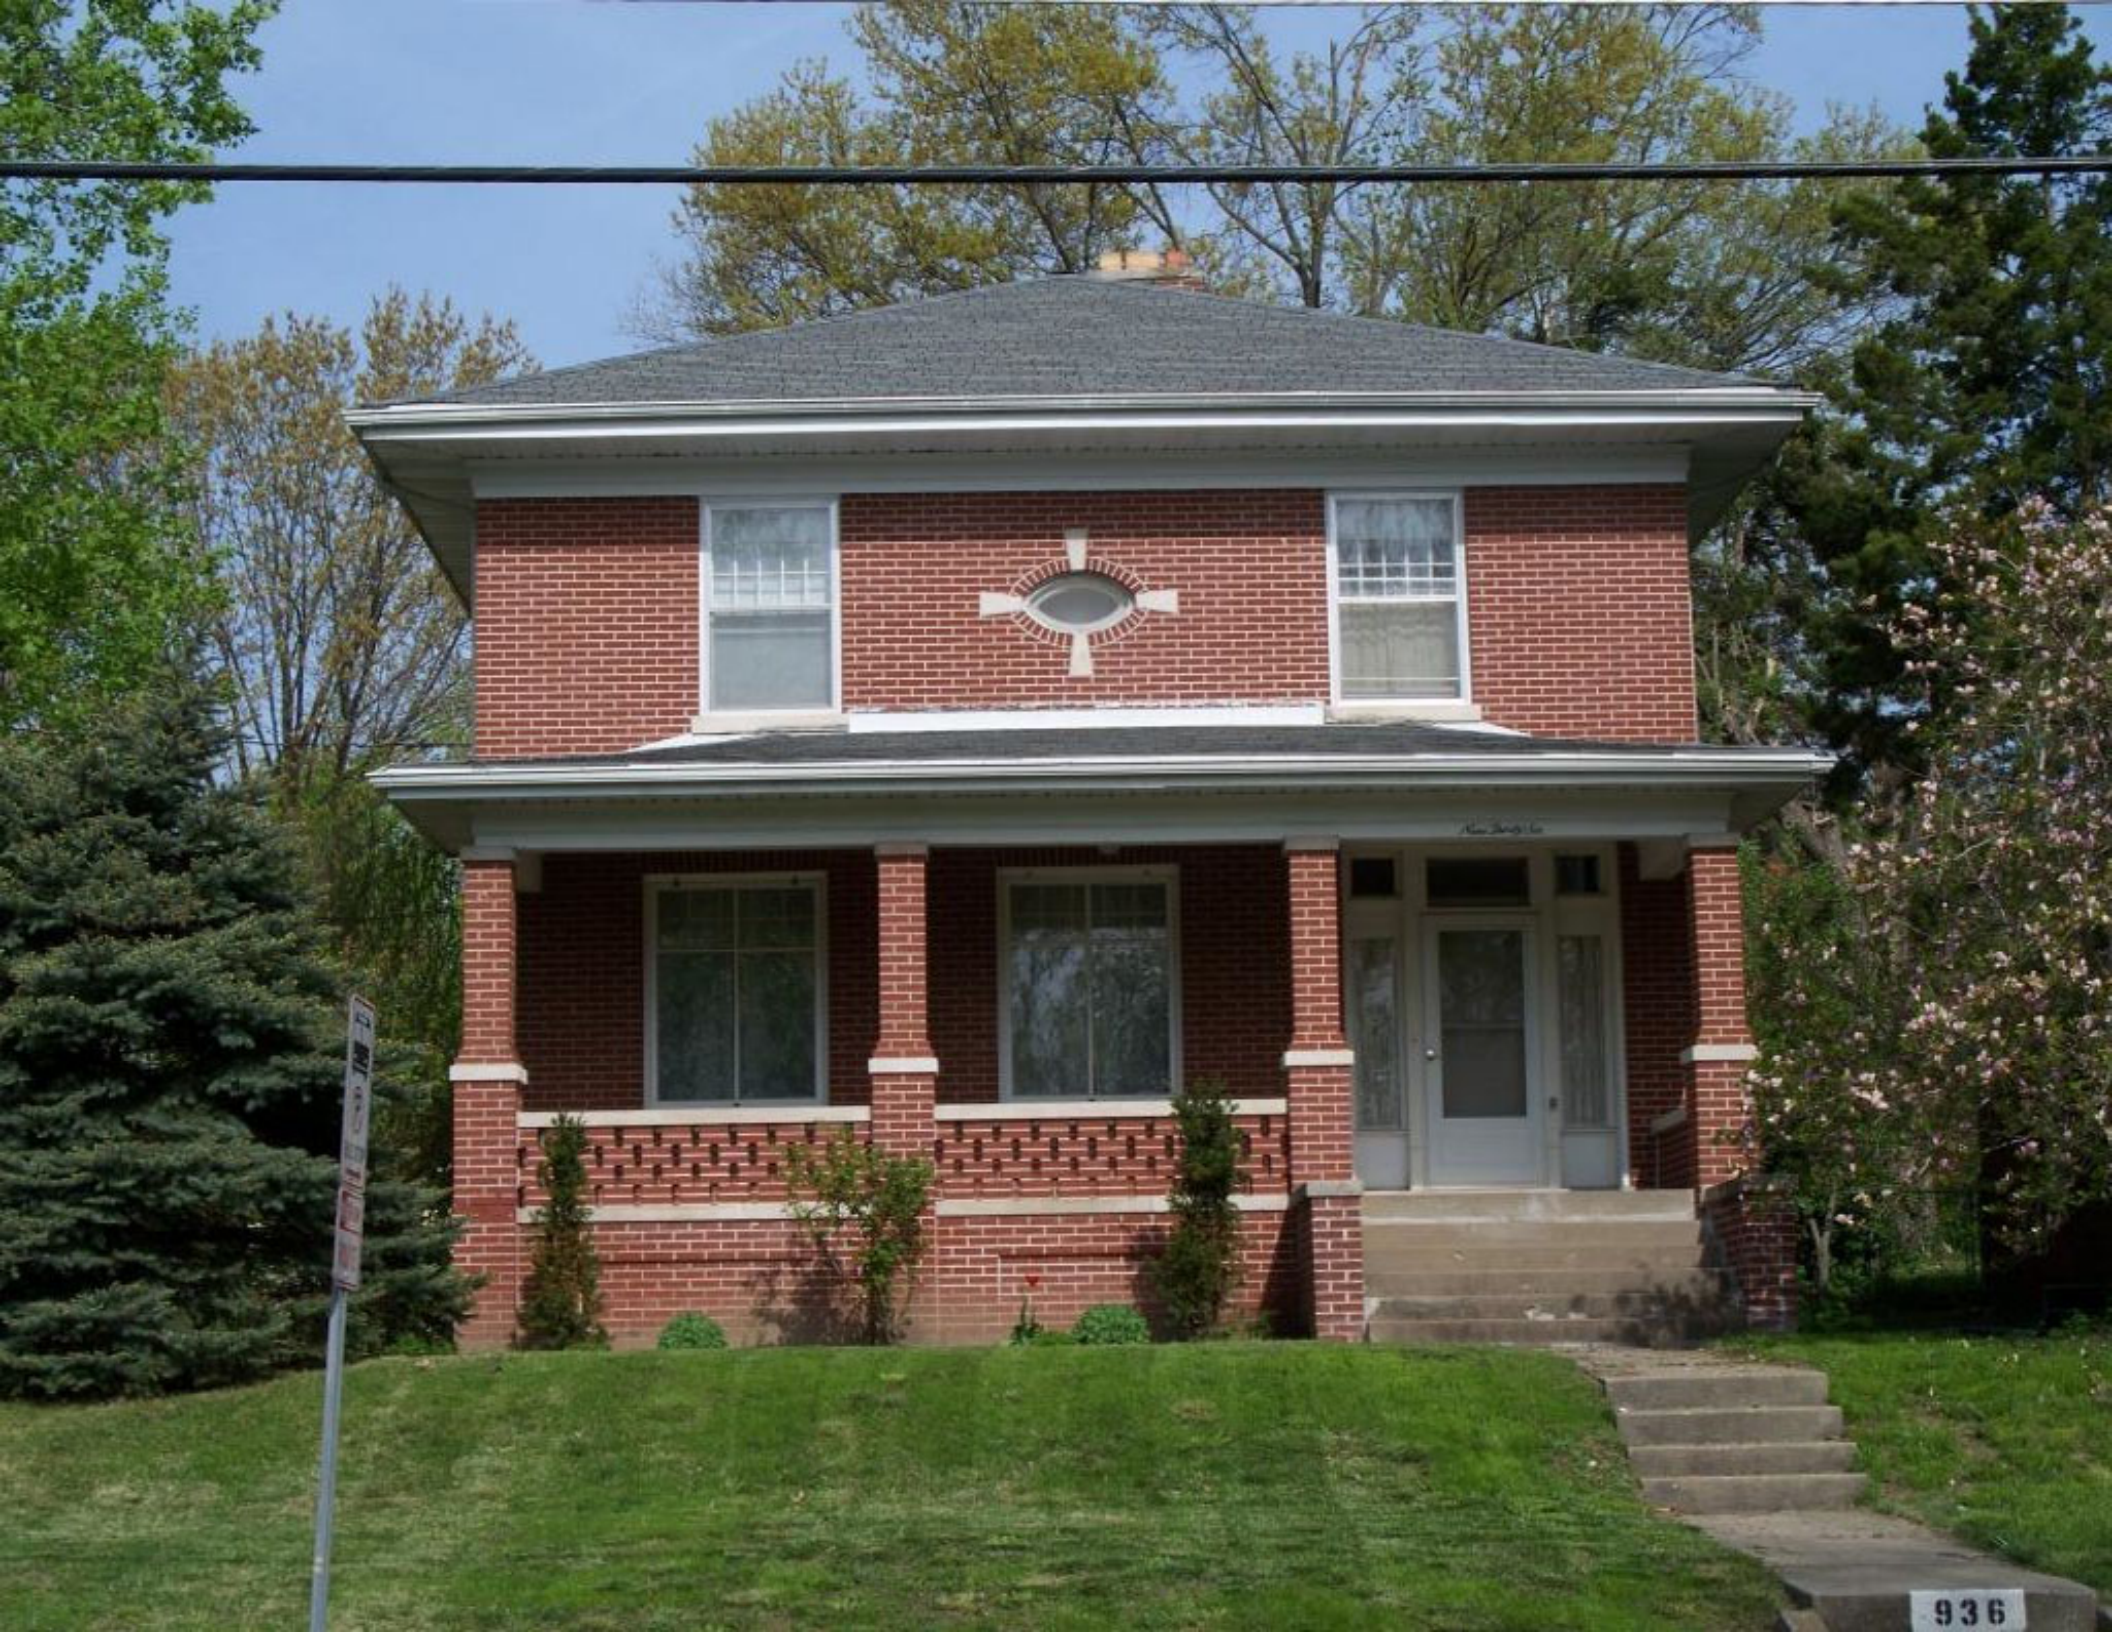
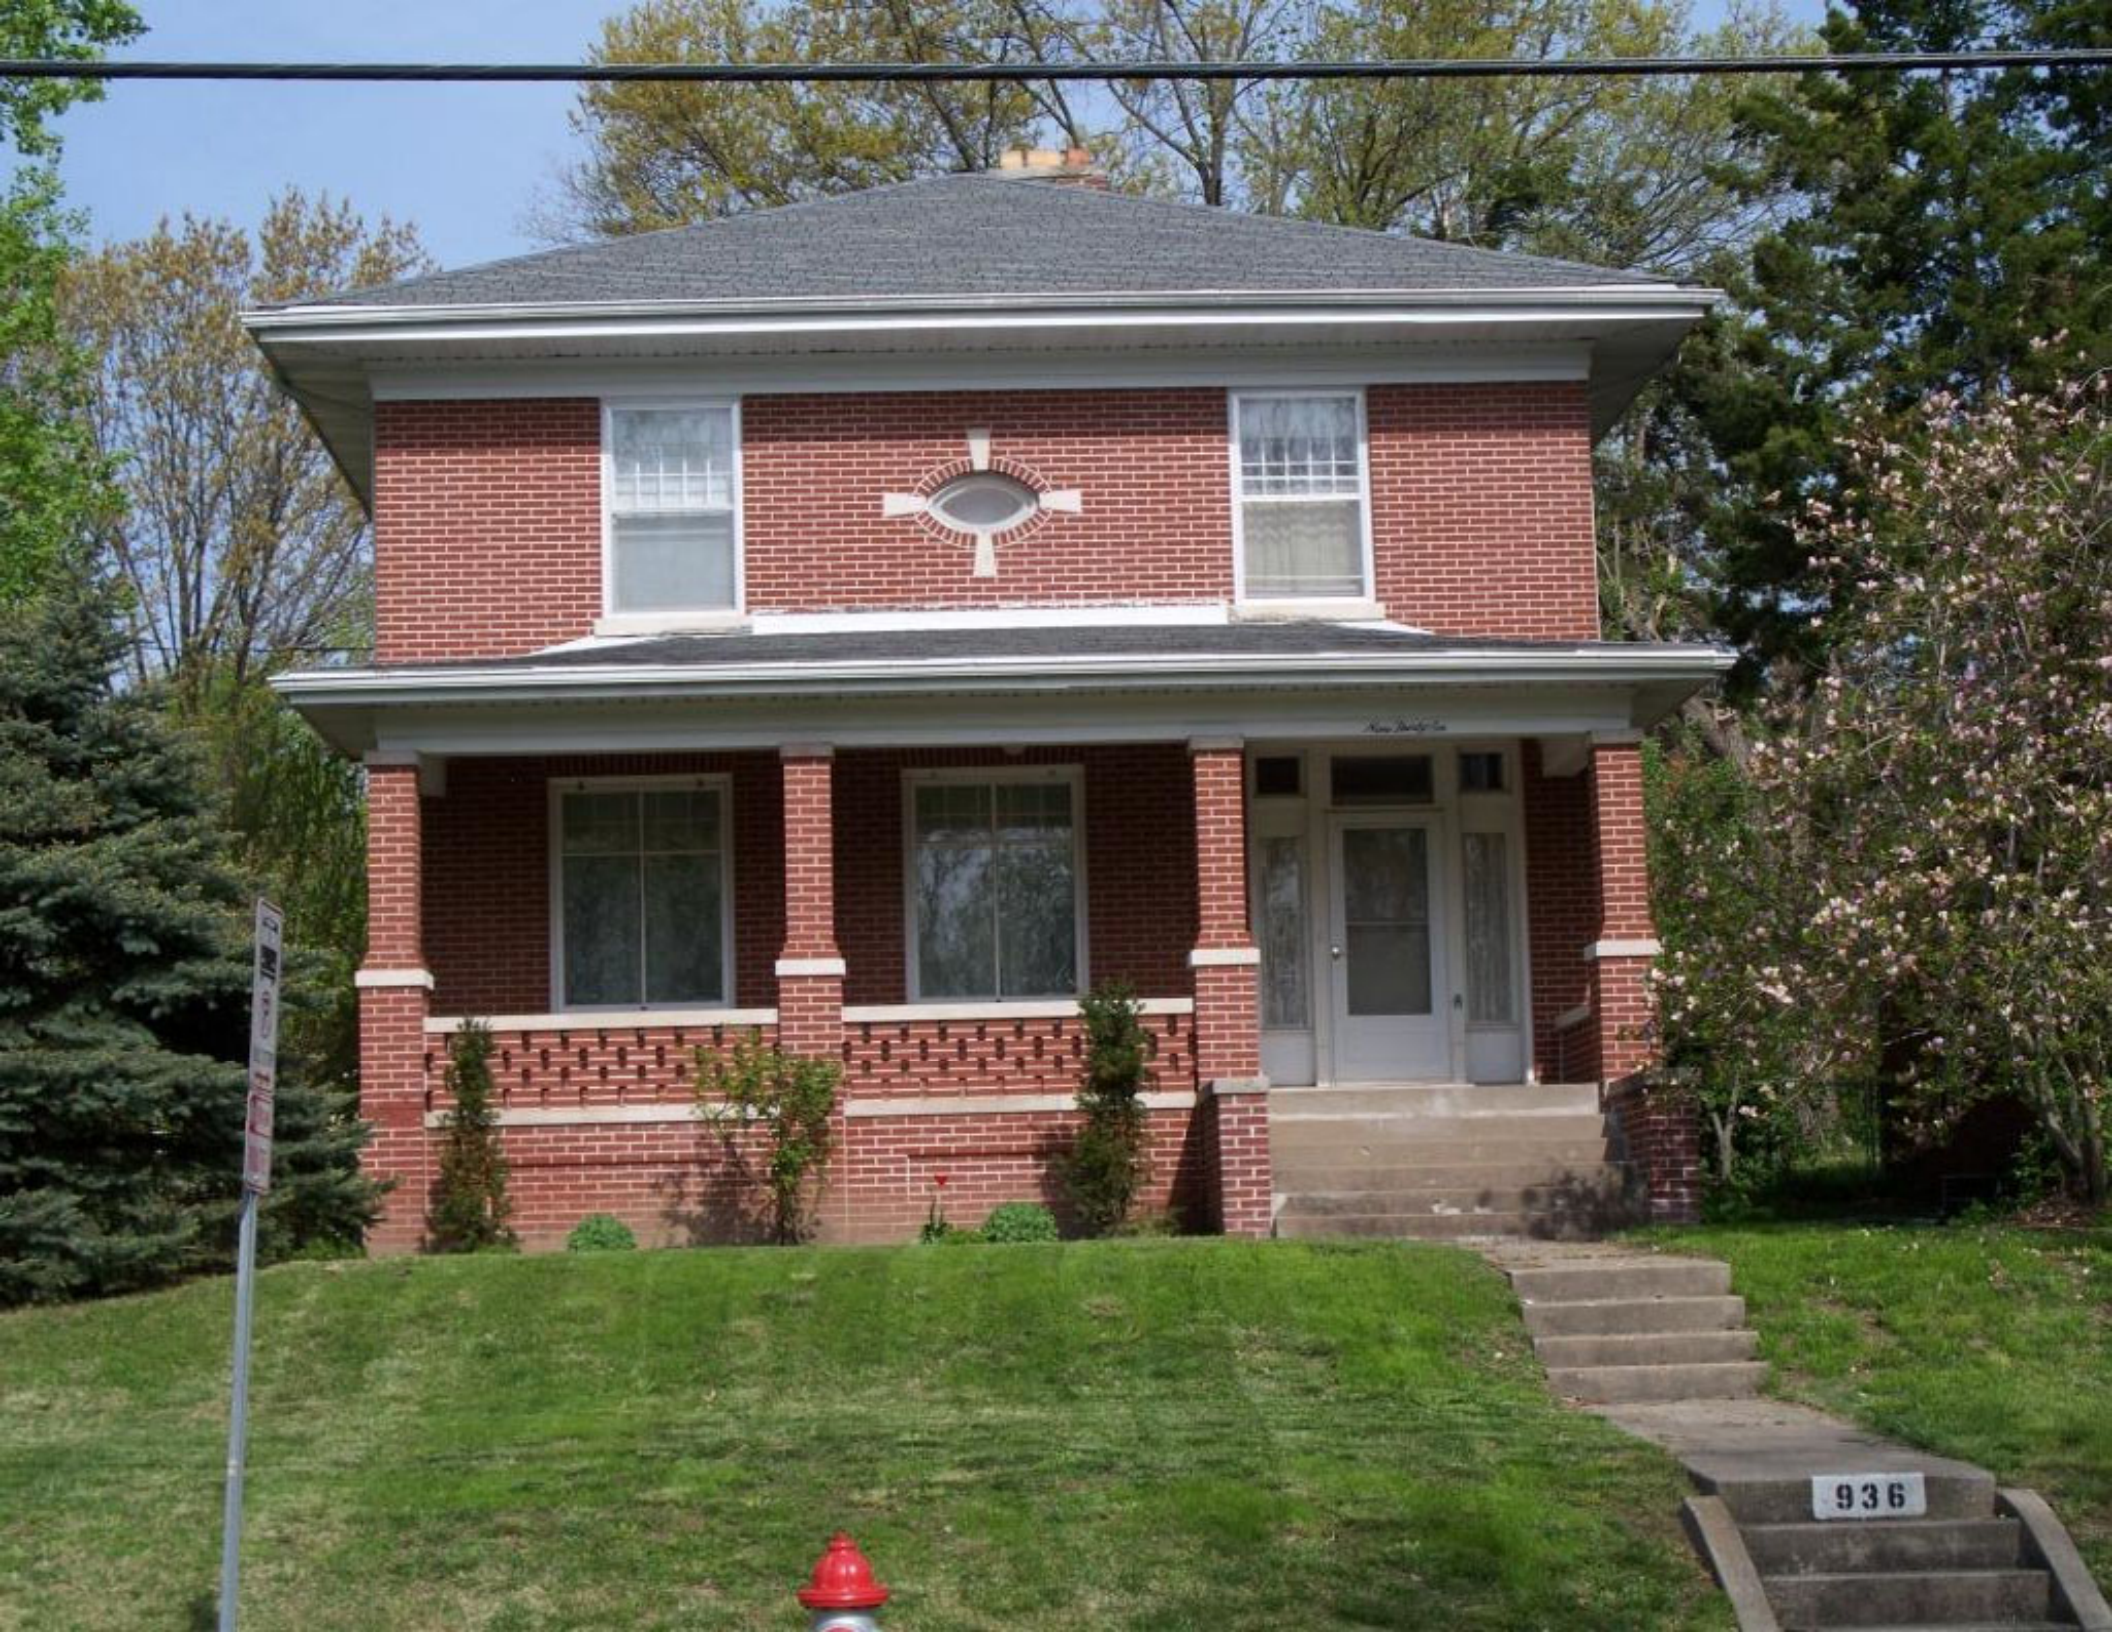
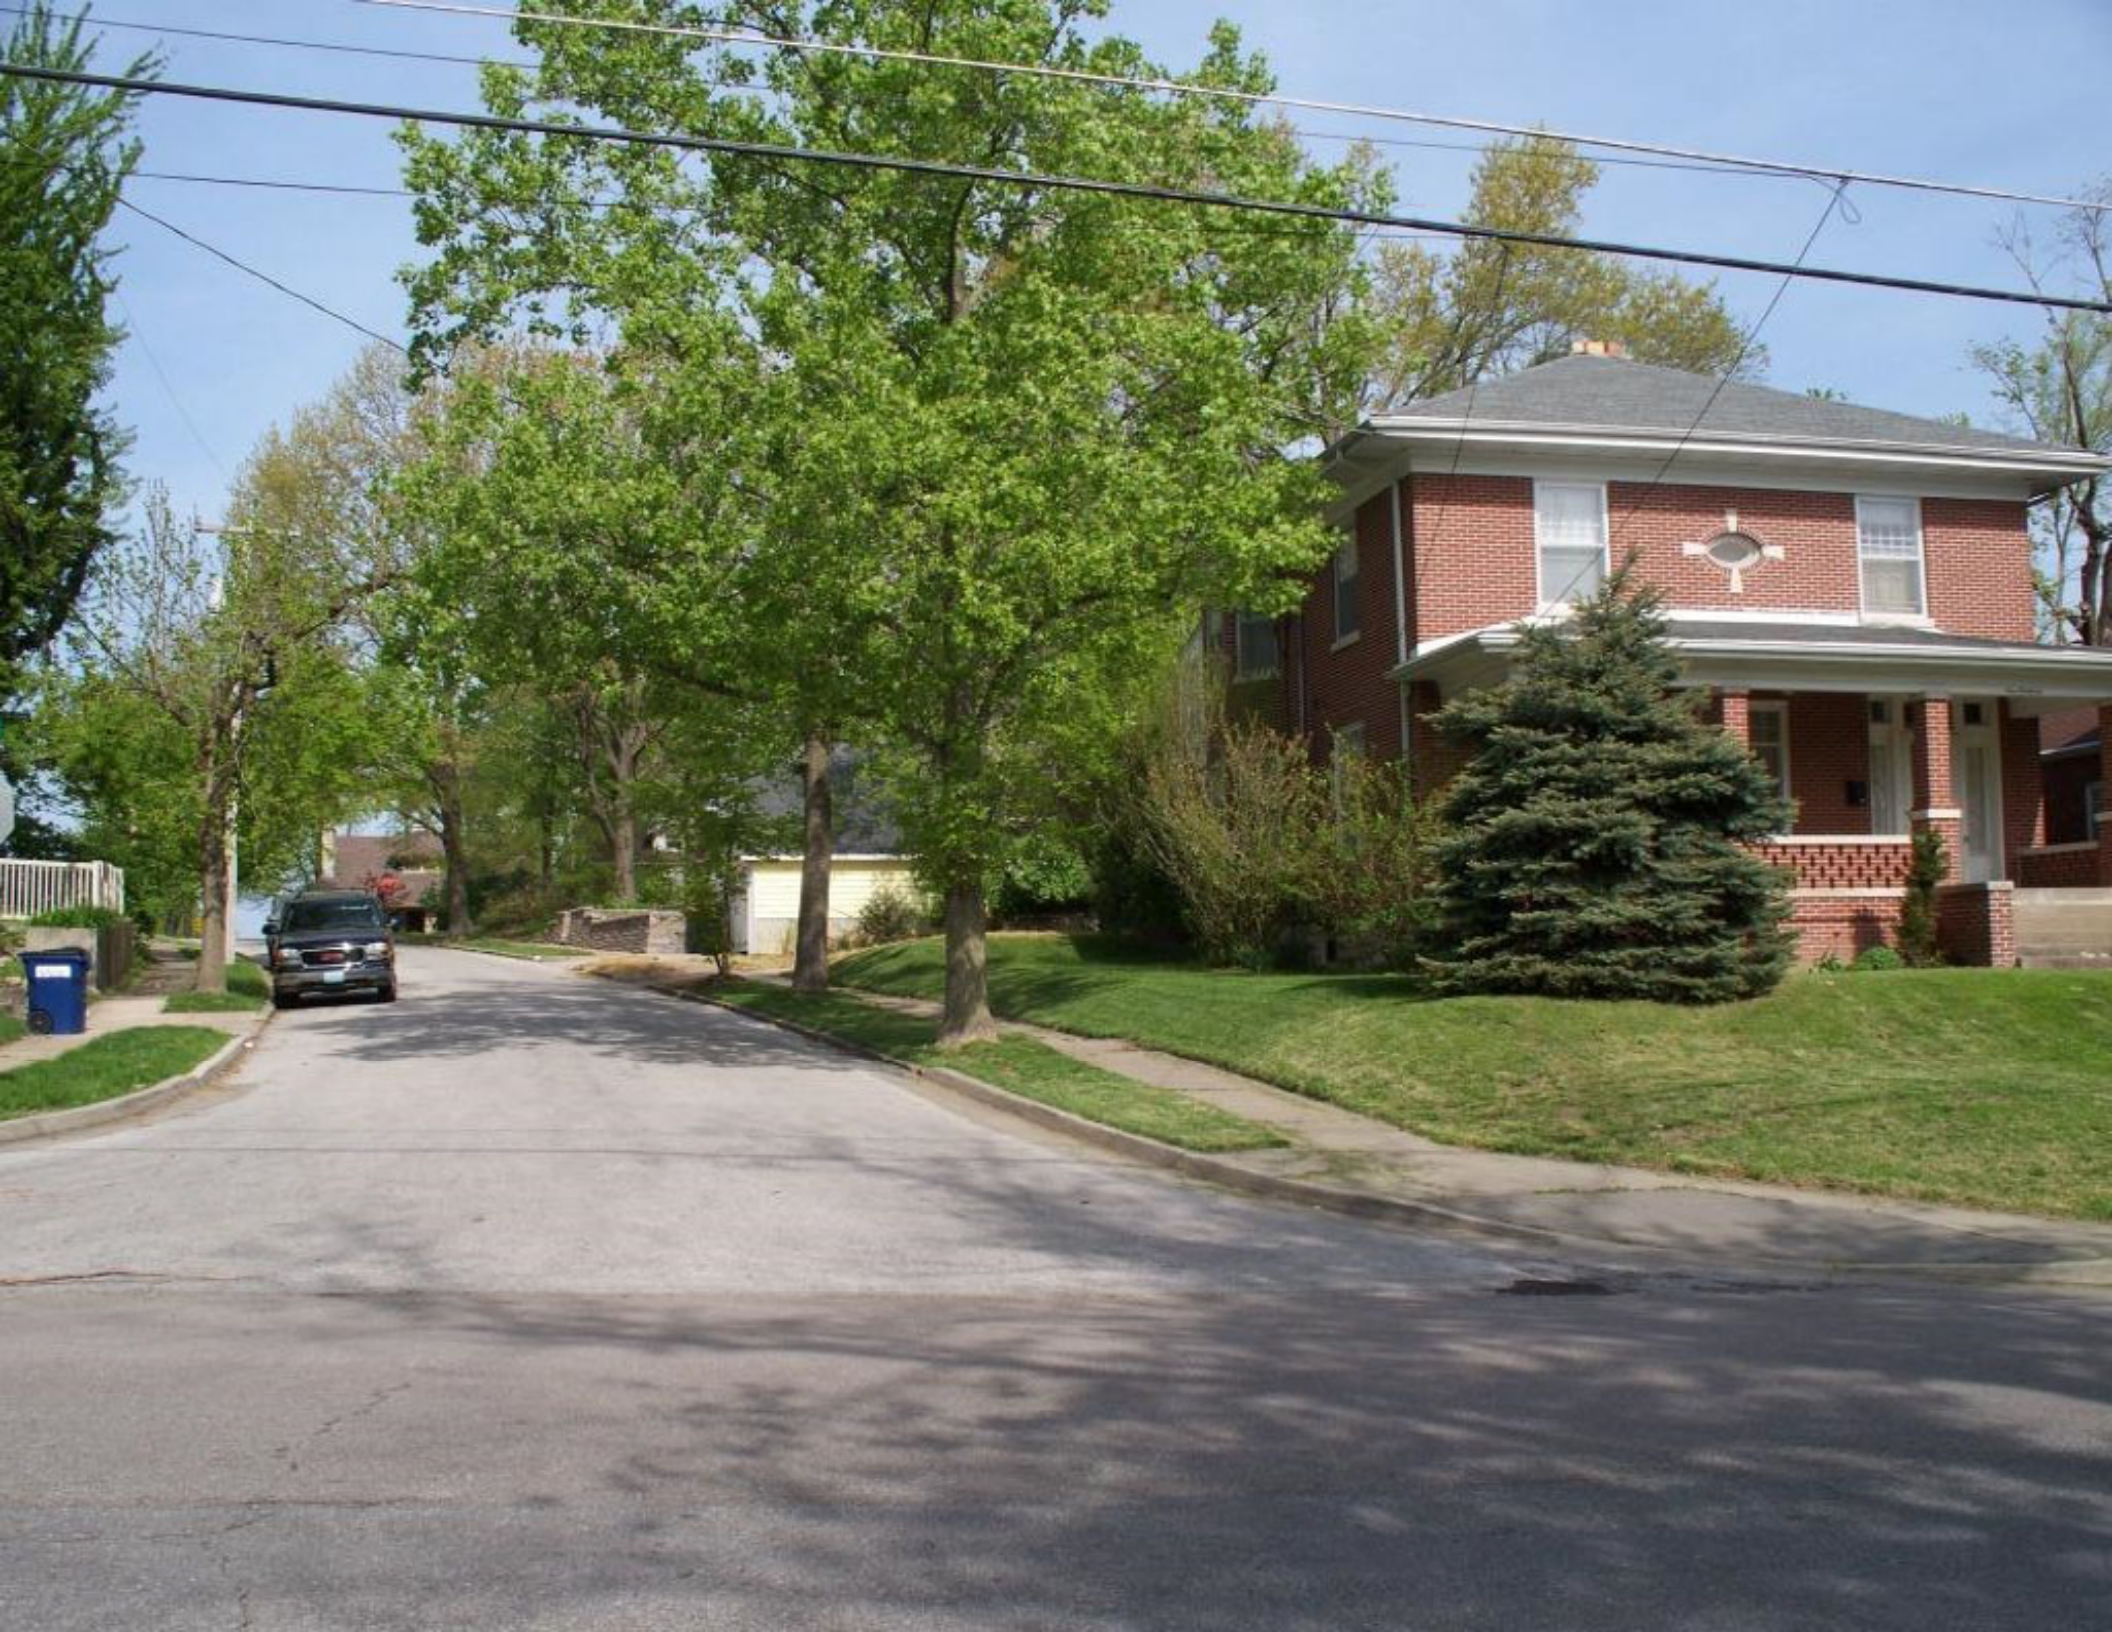
936

40. (cont.) Description of environment and outbuildings. Expand box as necessary, or add continuation pages.
There is a vinyl-sided shed with a gable roof, it is considered non-contributing to the district.

41. (cont.) Two-story brick four square with pyramidal asphalt shingle roof and a chimney in the back that looks to be slightly off center. The second story has two multi-light (15/1) modern windows. Between them is an oxeye with brick detailing and four limestone keystones. The first floor has a slightly flared shed roof over the porch, which is a full-width and has brick piers and pediments capped with limestone. The decorative (lattice) kneewall is also capped in limestone.

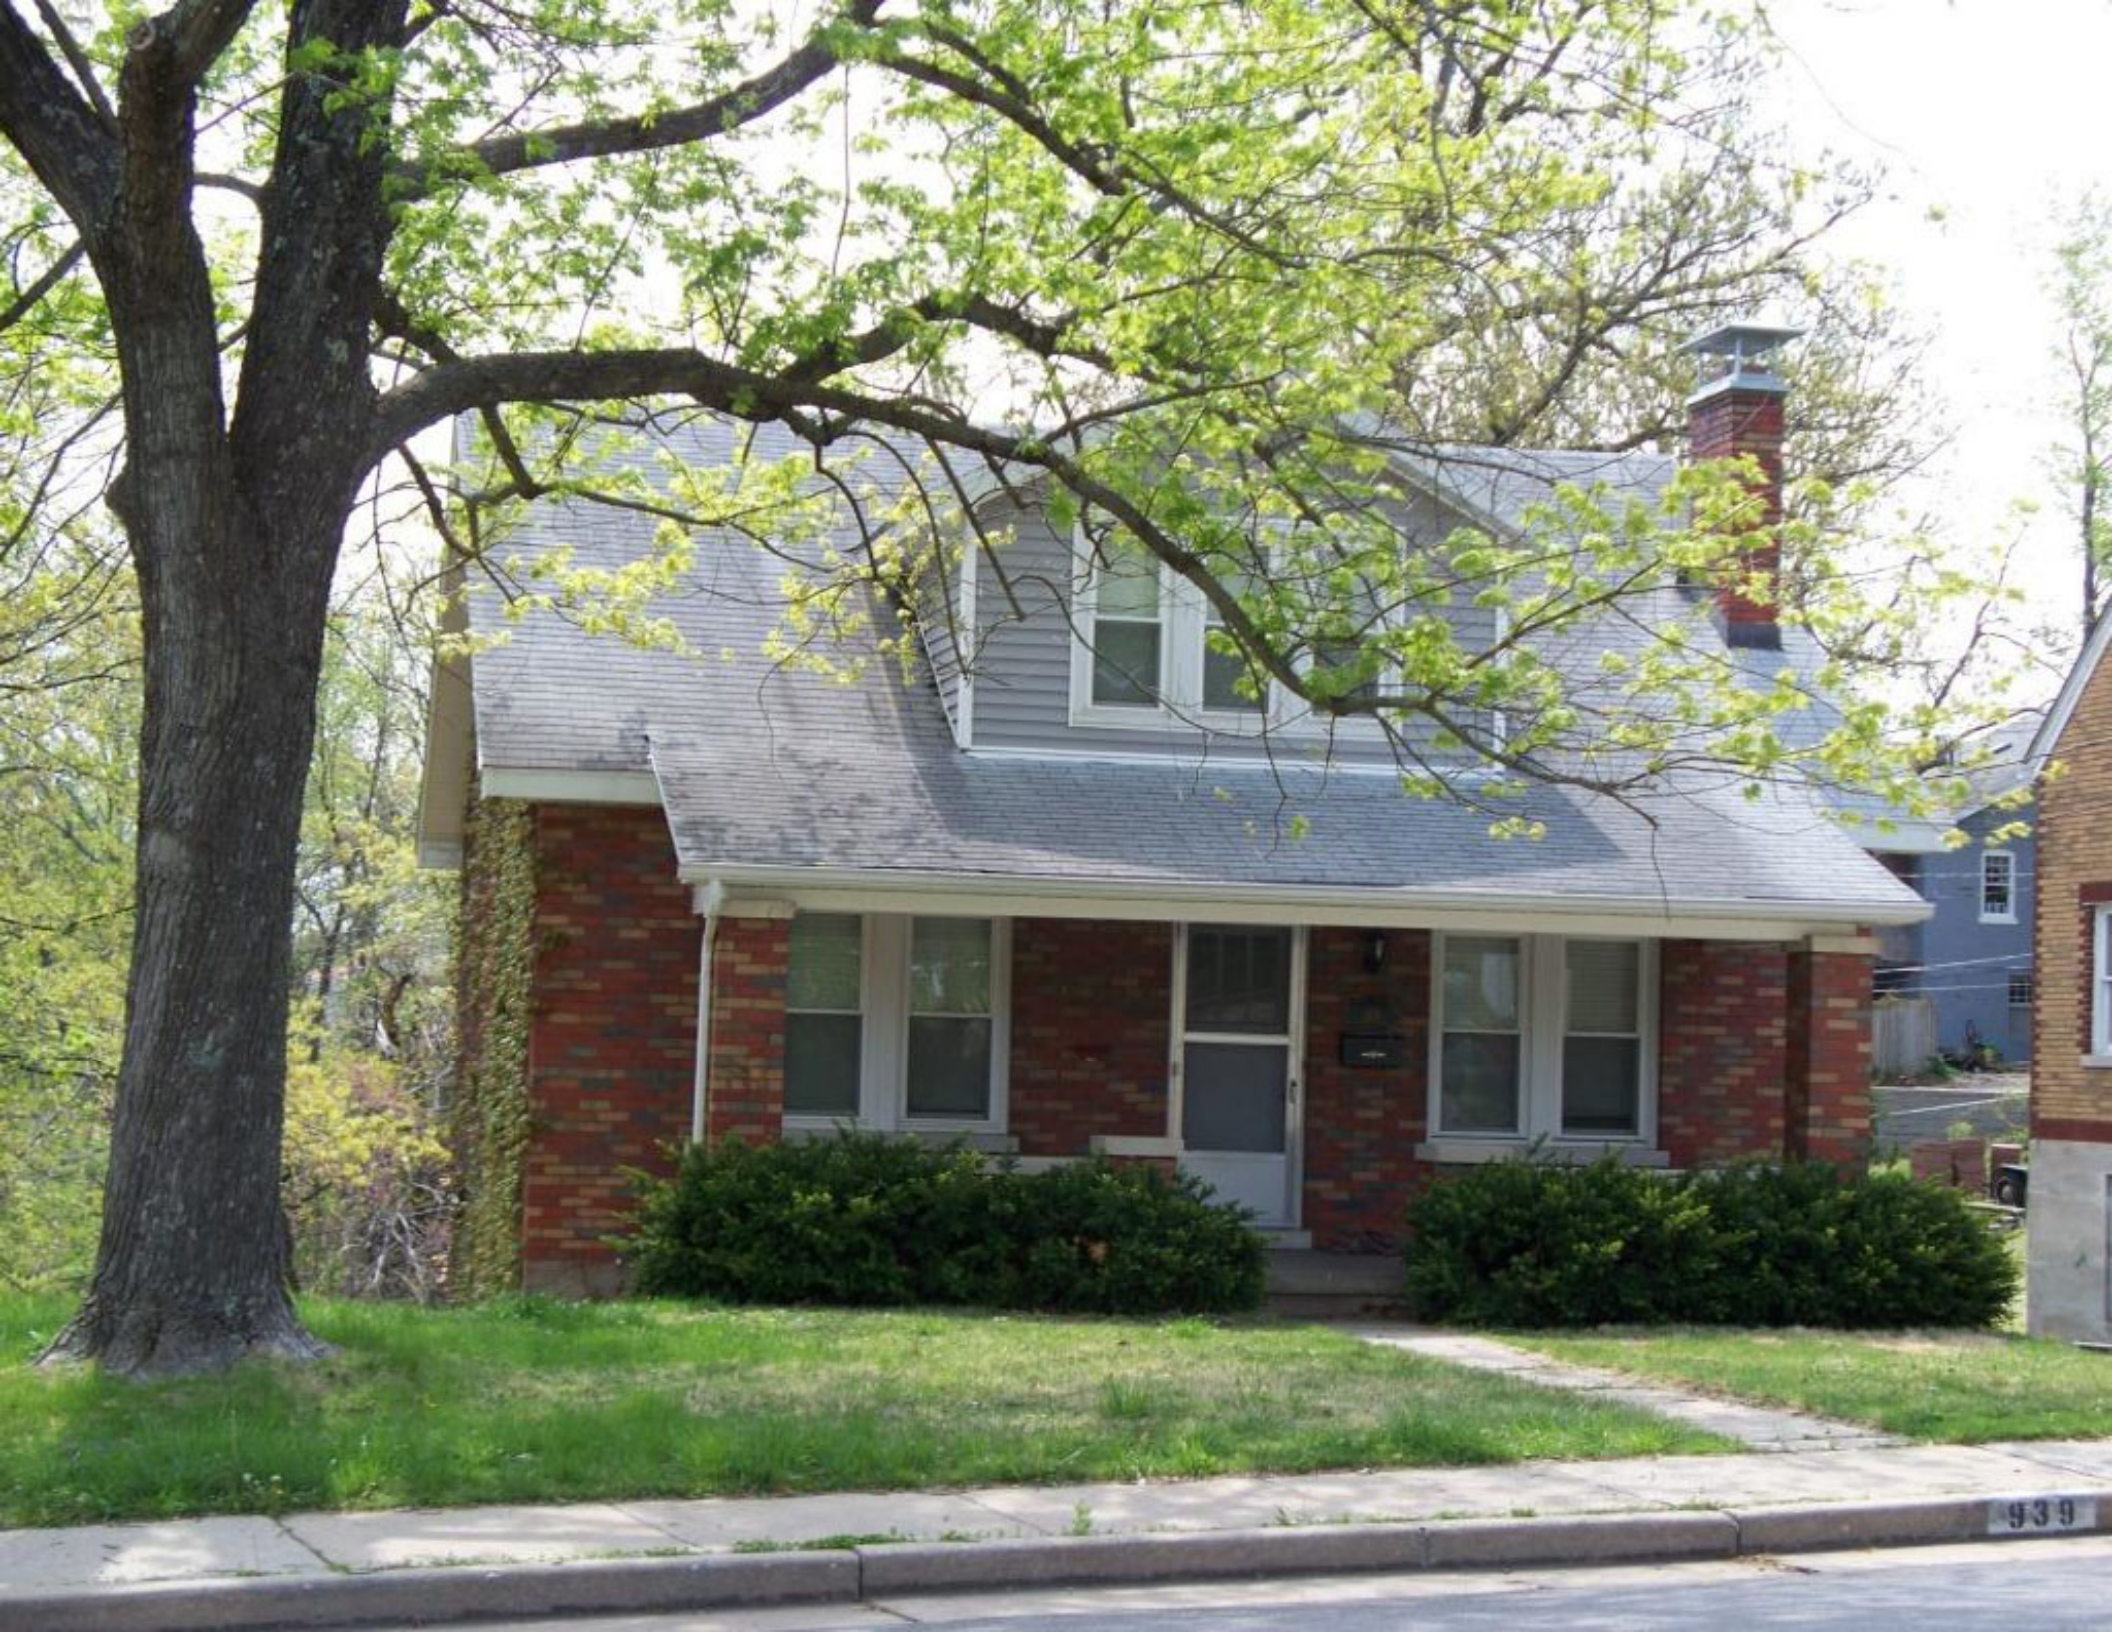
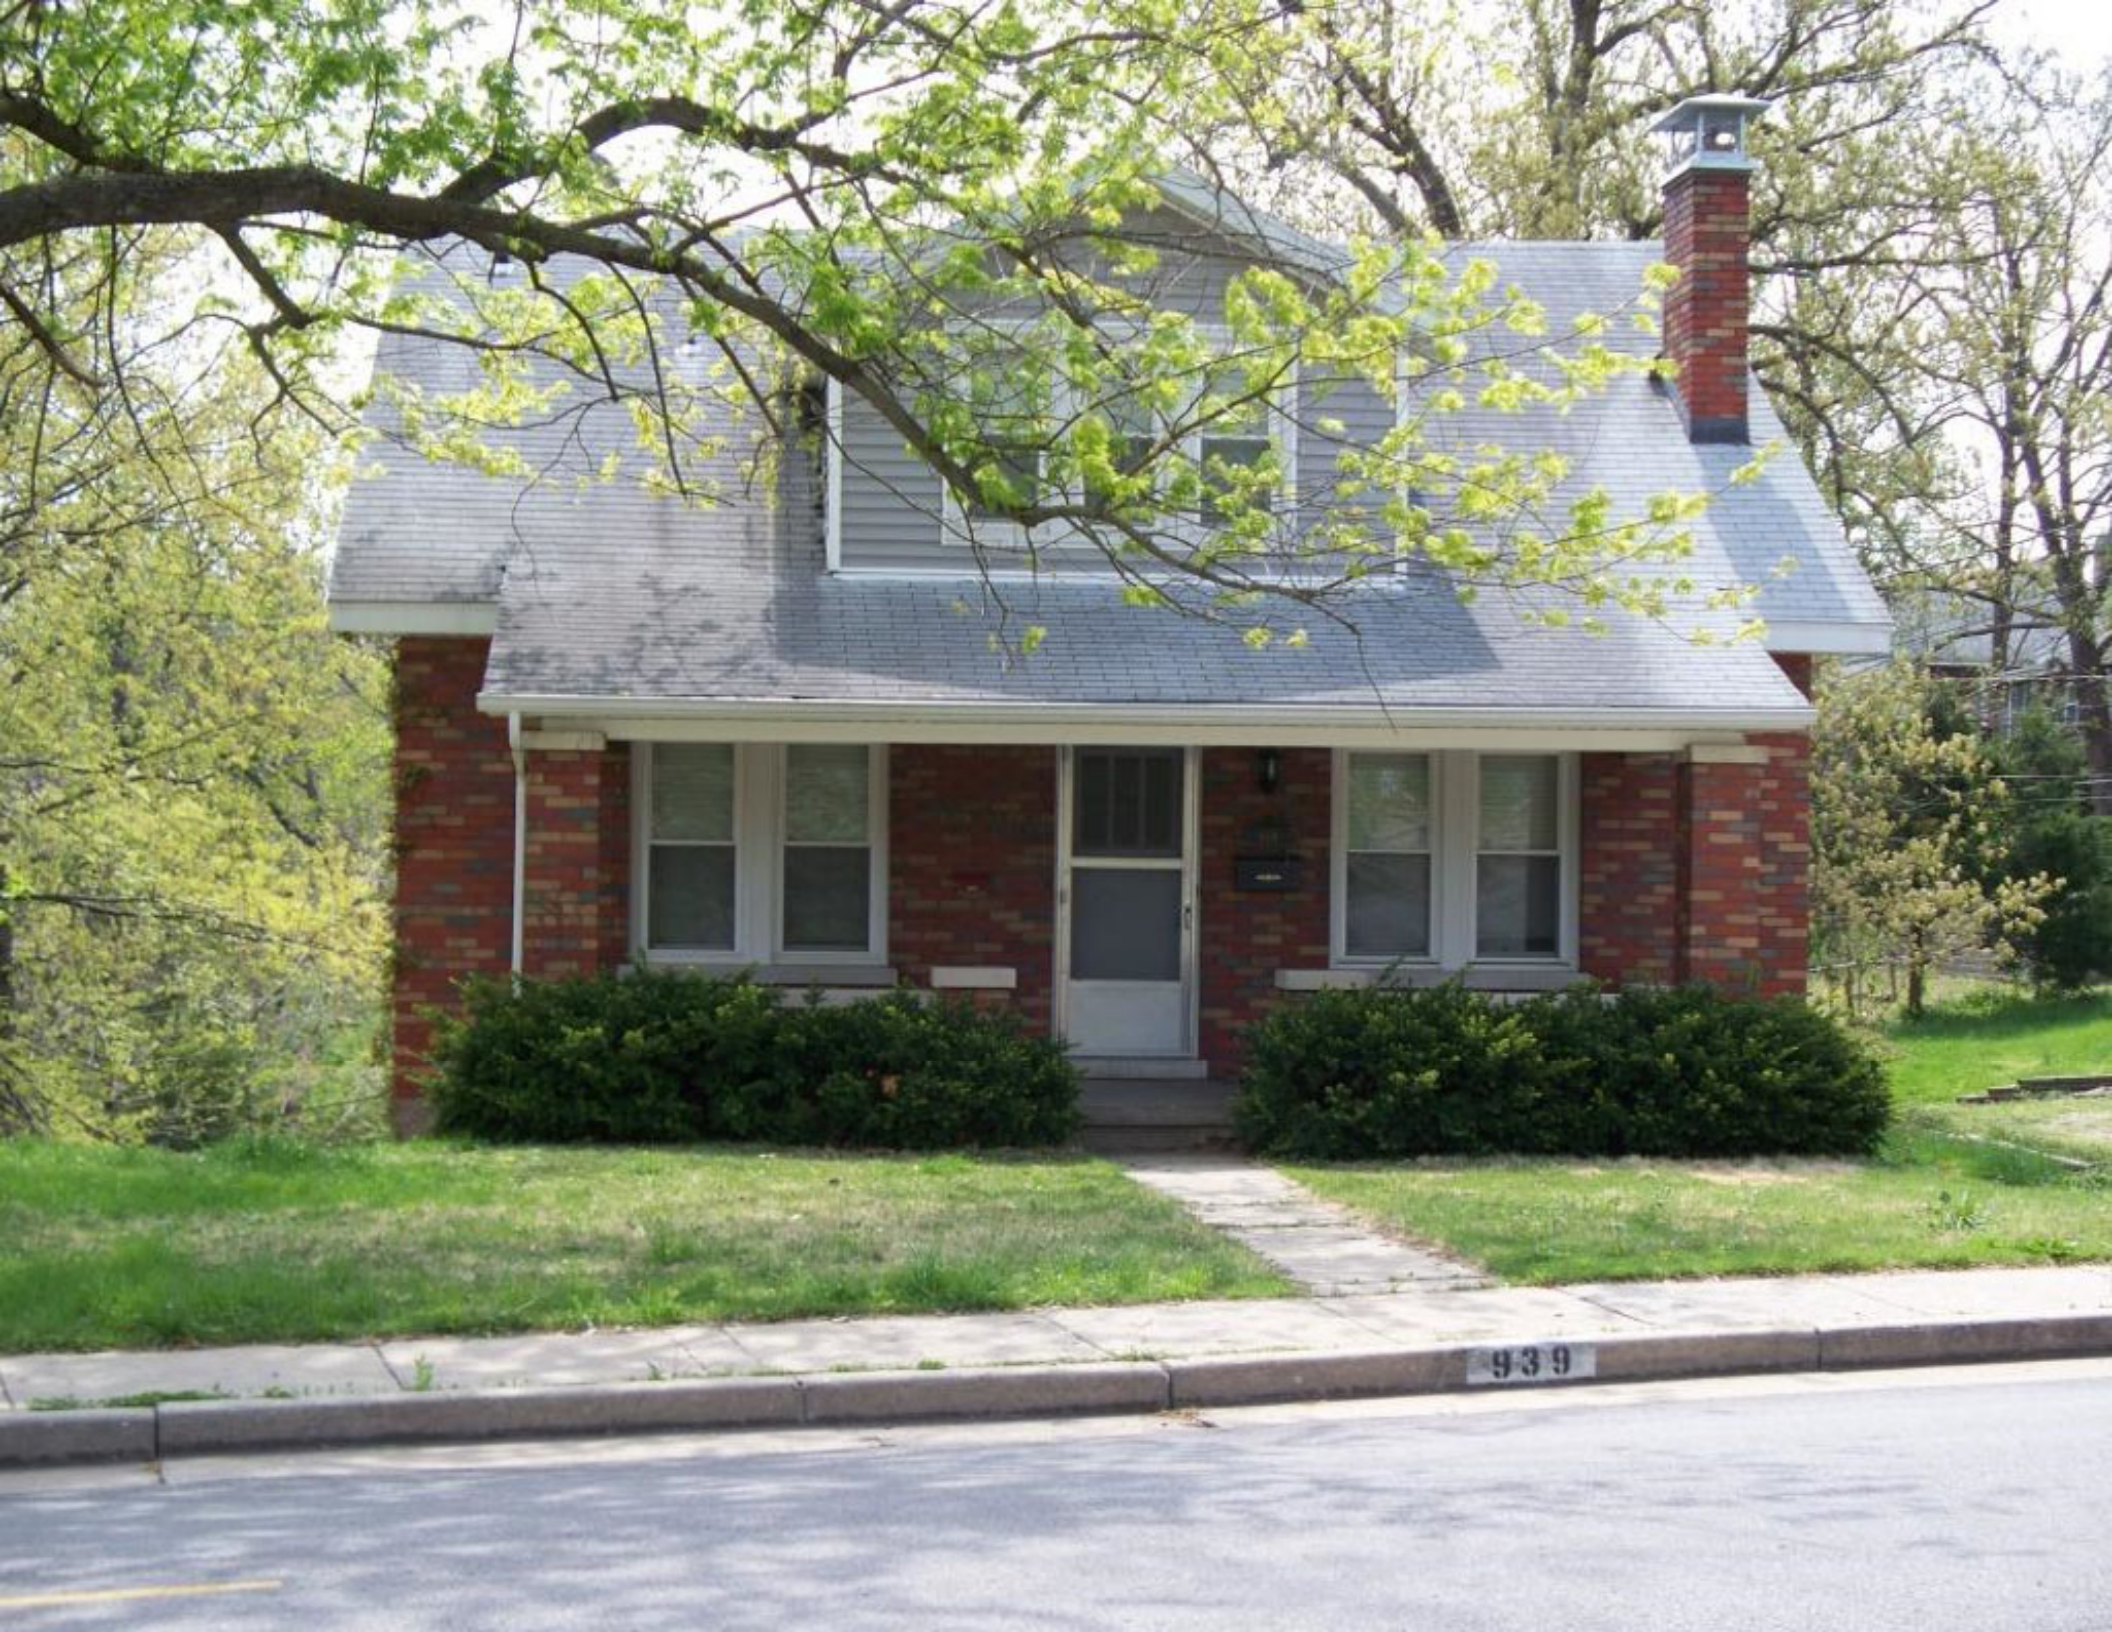
939

One-and-a-half story multi-color brick bungalow with side-gable shed roof. The first story features a full open porch with large square pillars and has two one-over-one paired windows that flank the entrance. The door appears original and is behind an aluminum screen door. The second story has a large vinyl-sided dormer with three one-over-one paired windows. The chimney is placed in the interior right of the property. This house is in the Wagner Place Subdivision.
