ARCHITECTURAL/HISTORIC INVENTORY FORM

1. Survey No. CO-AS-005-001		2. Survey name: Moreau Drive Neighborhood Survey	
3. County: Cole		4. Address: 1202 Elmerine Ave.	
5. City: Jefferson City	Vicinity: <input type="checkbox"/>	6. UTM: / /	7. Township/Range/Section: T: R: S:
8. Historic name (if known):		9. Present/other name (if known):	
10. Ownership: <input checked="" type="checkbox"/> Private <input type="checkbox"/> Public		11. Historic use (if known): Residential	11. Current use: Residential

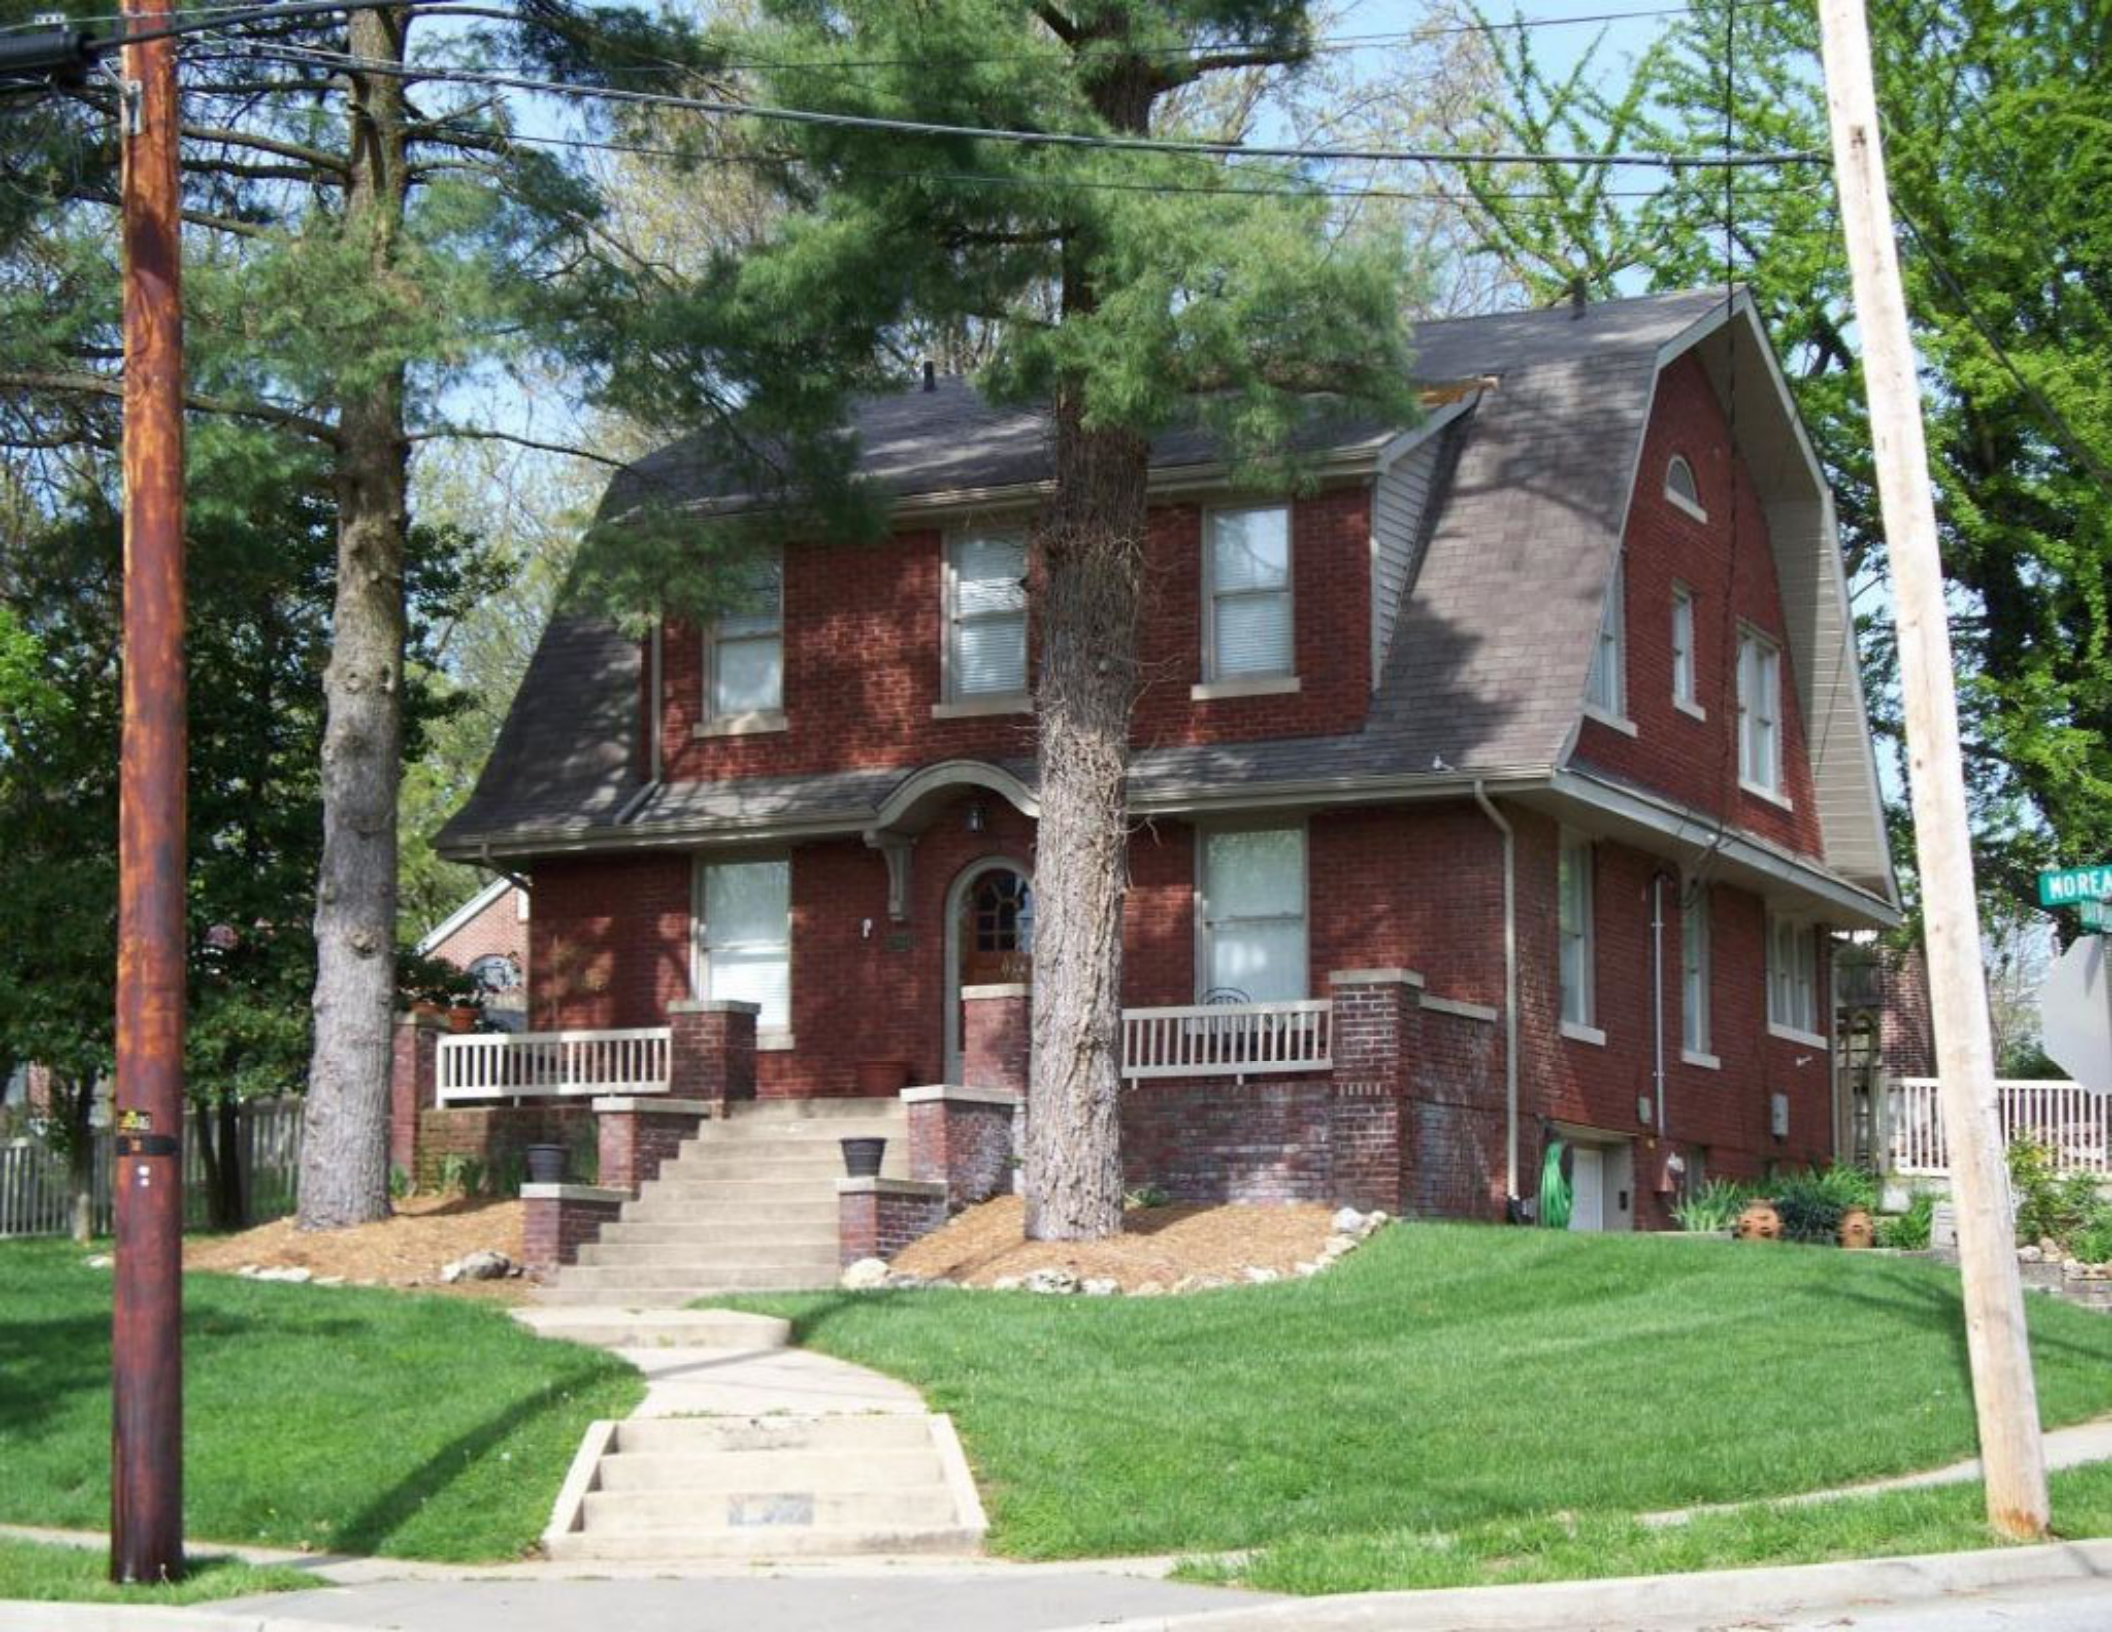
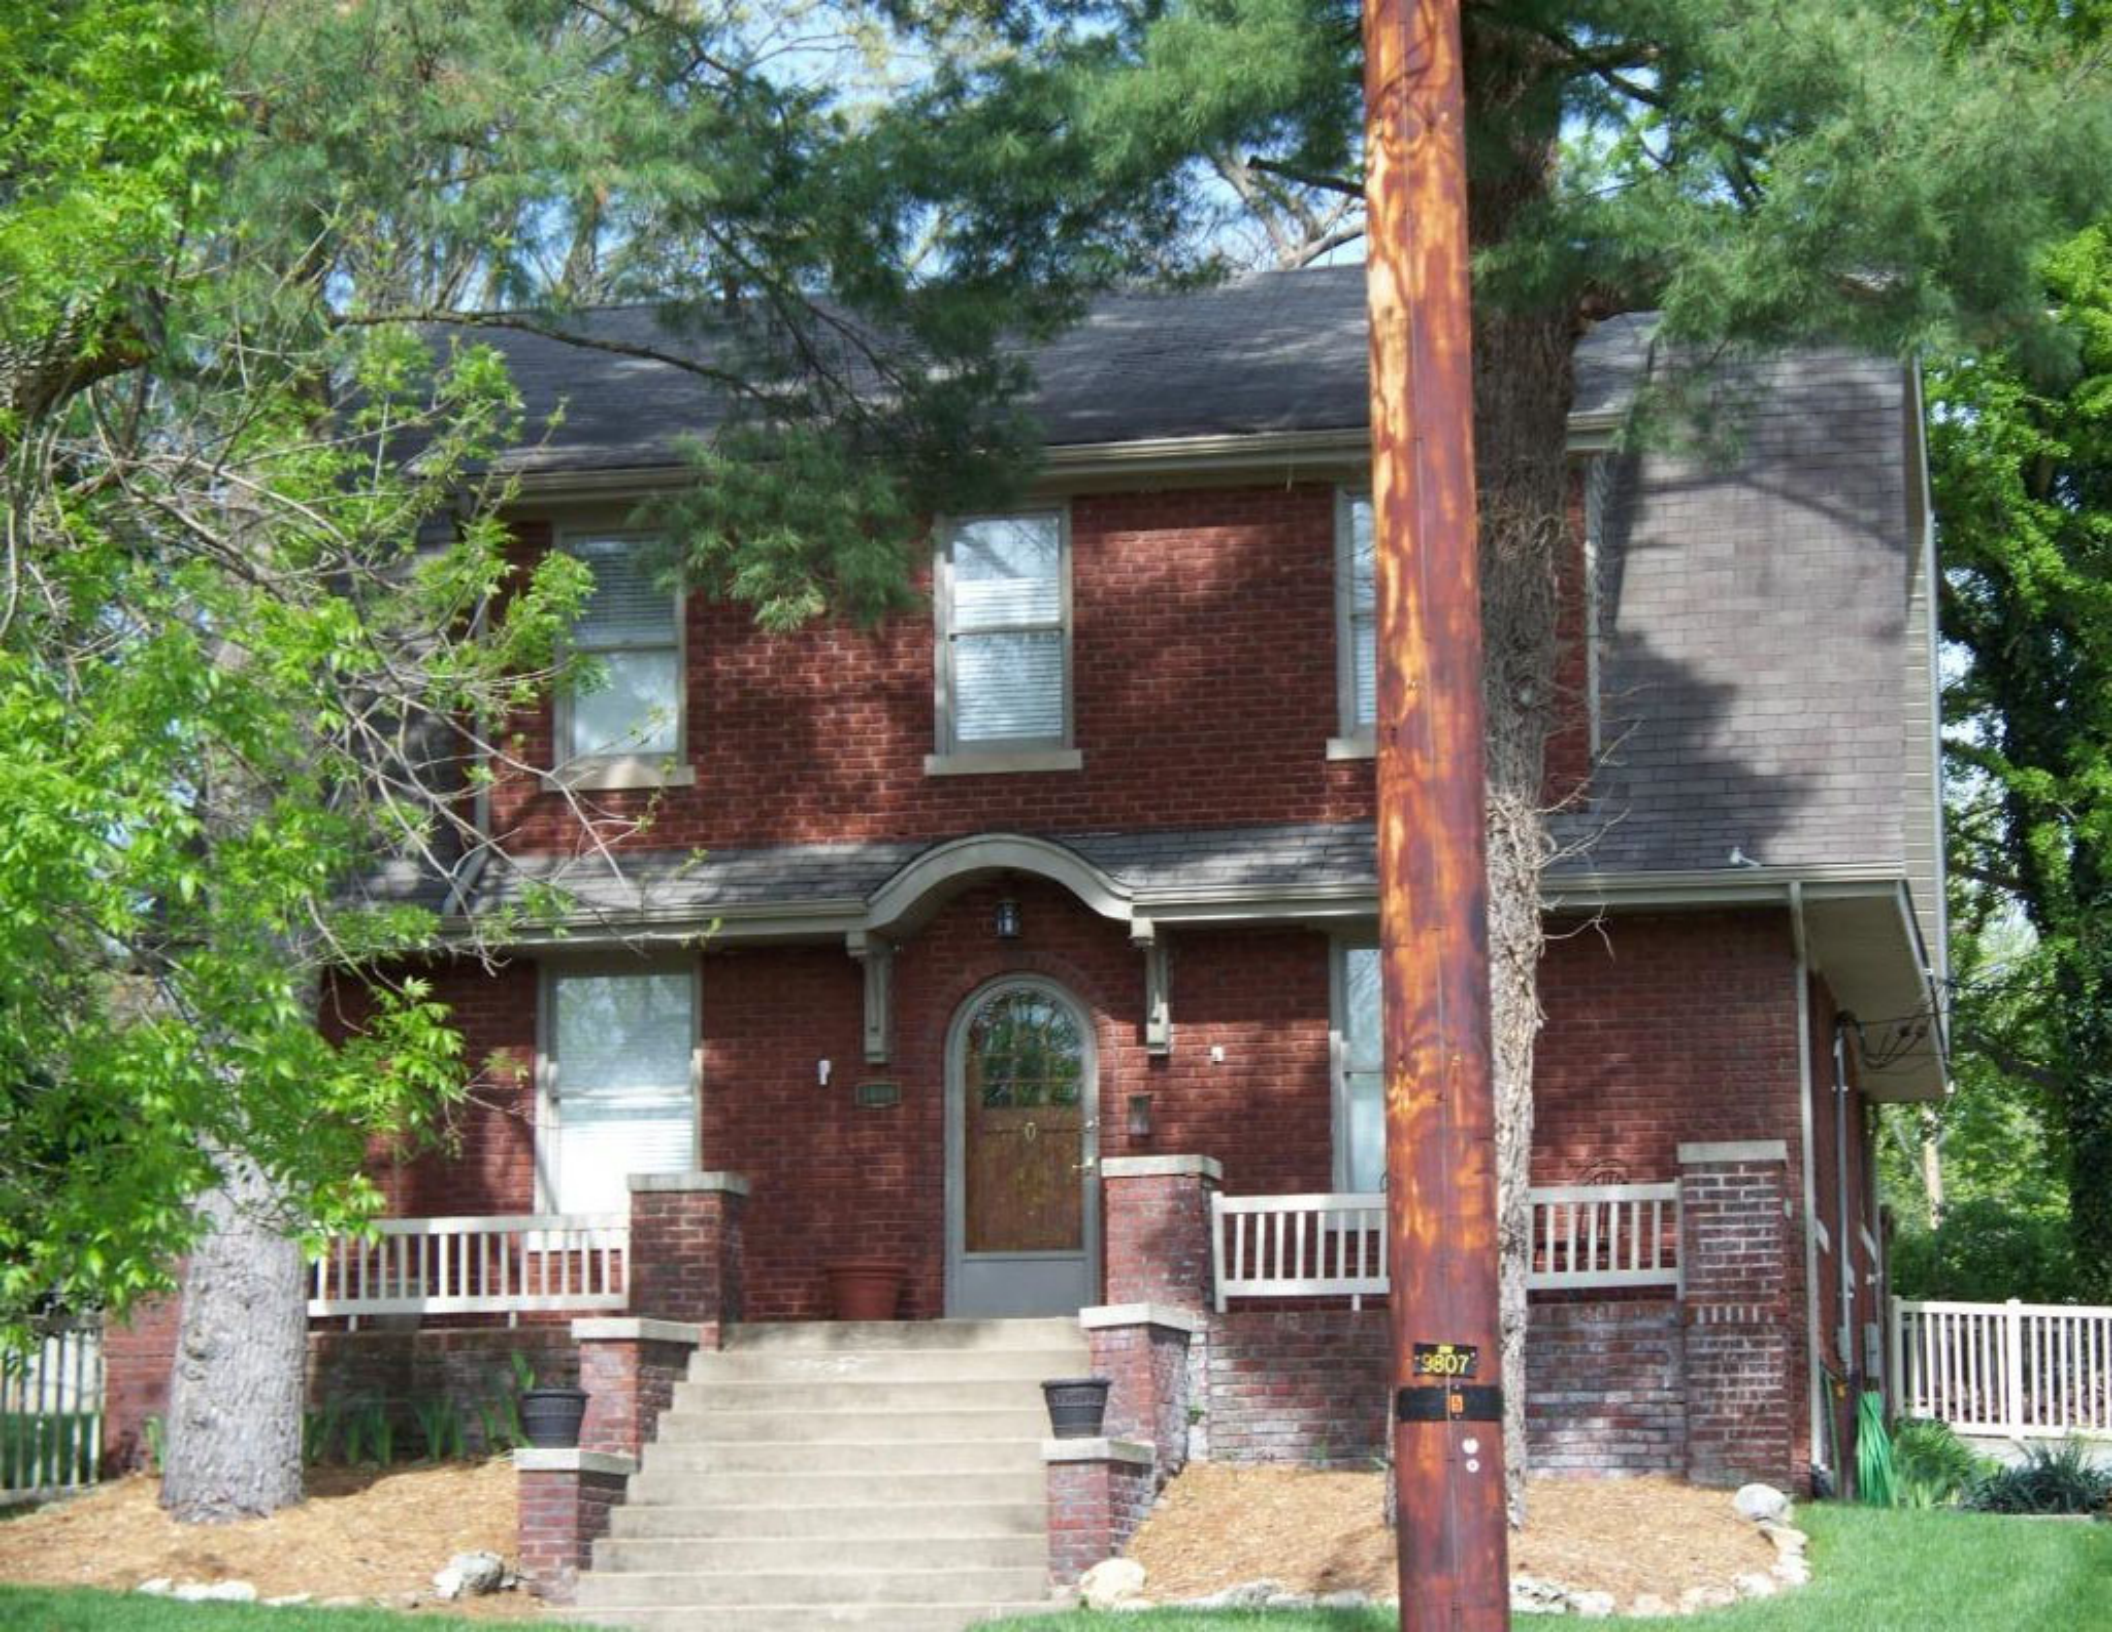
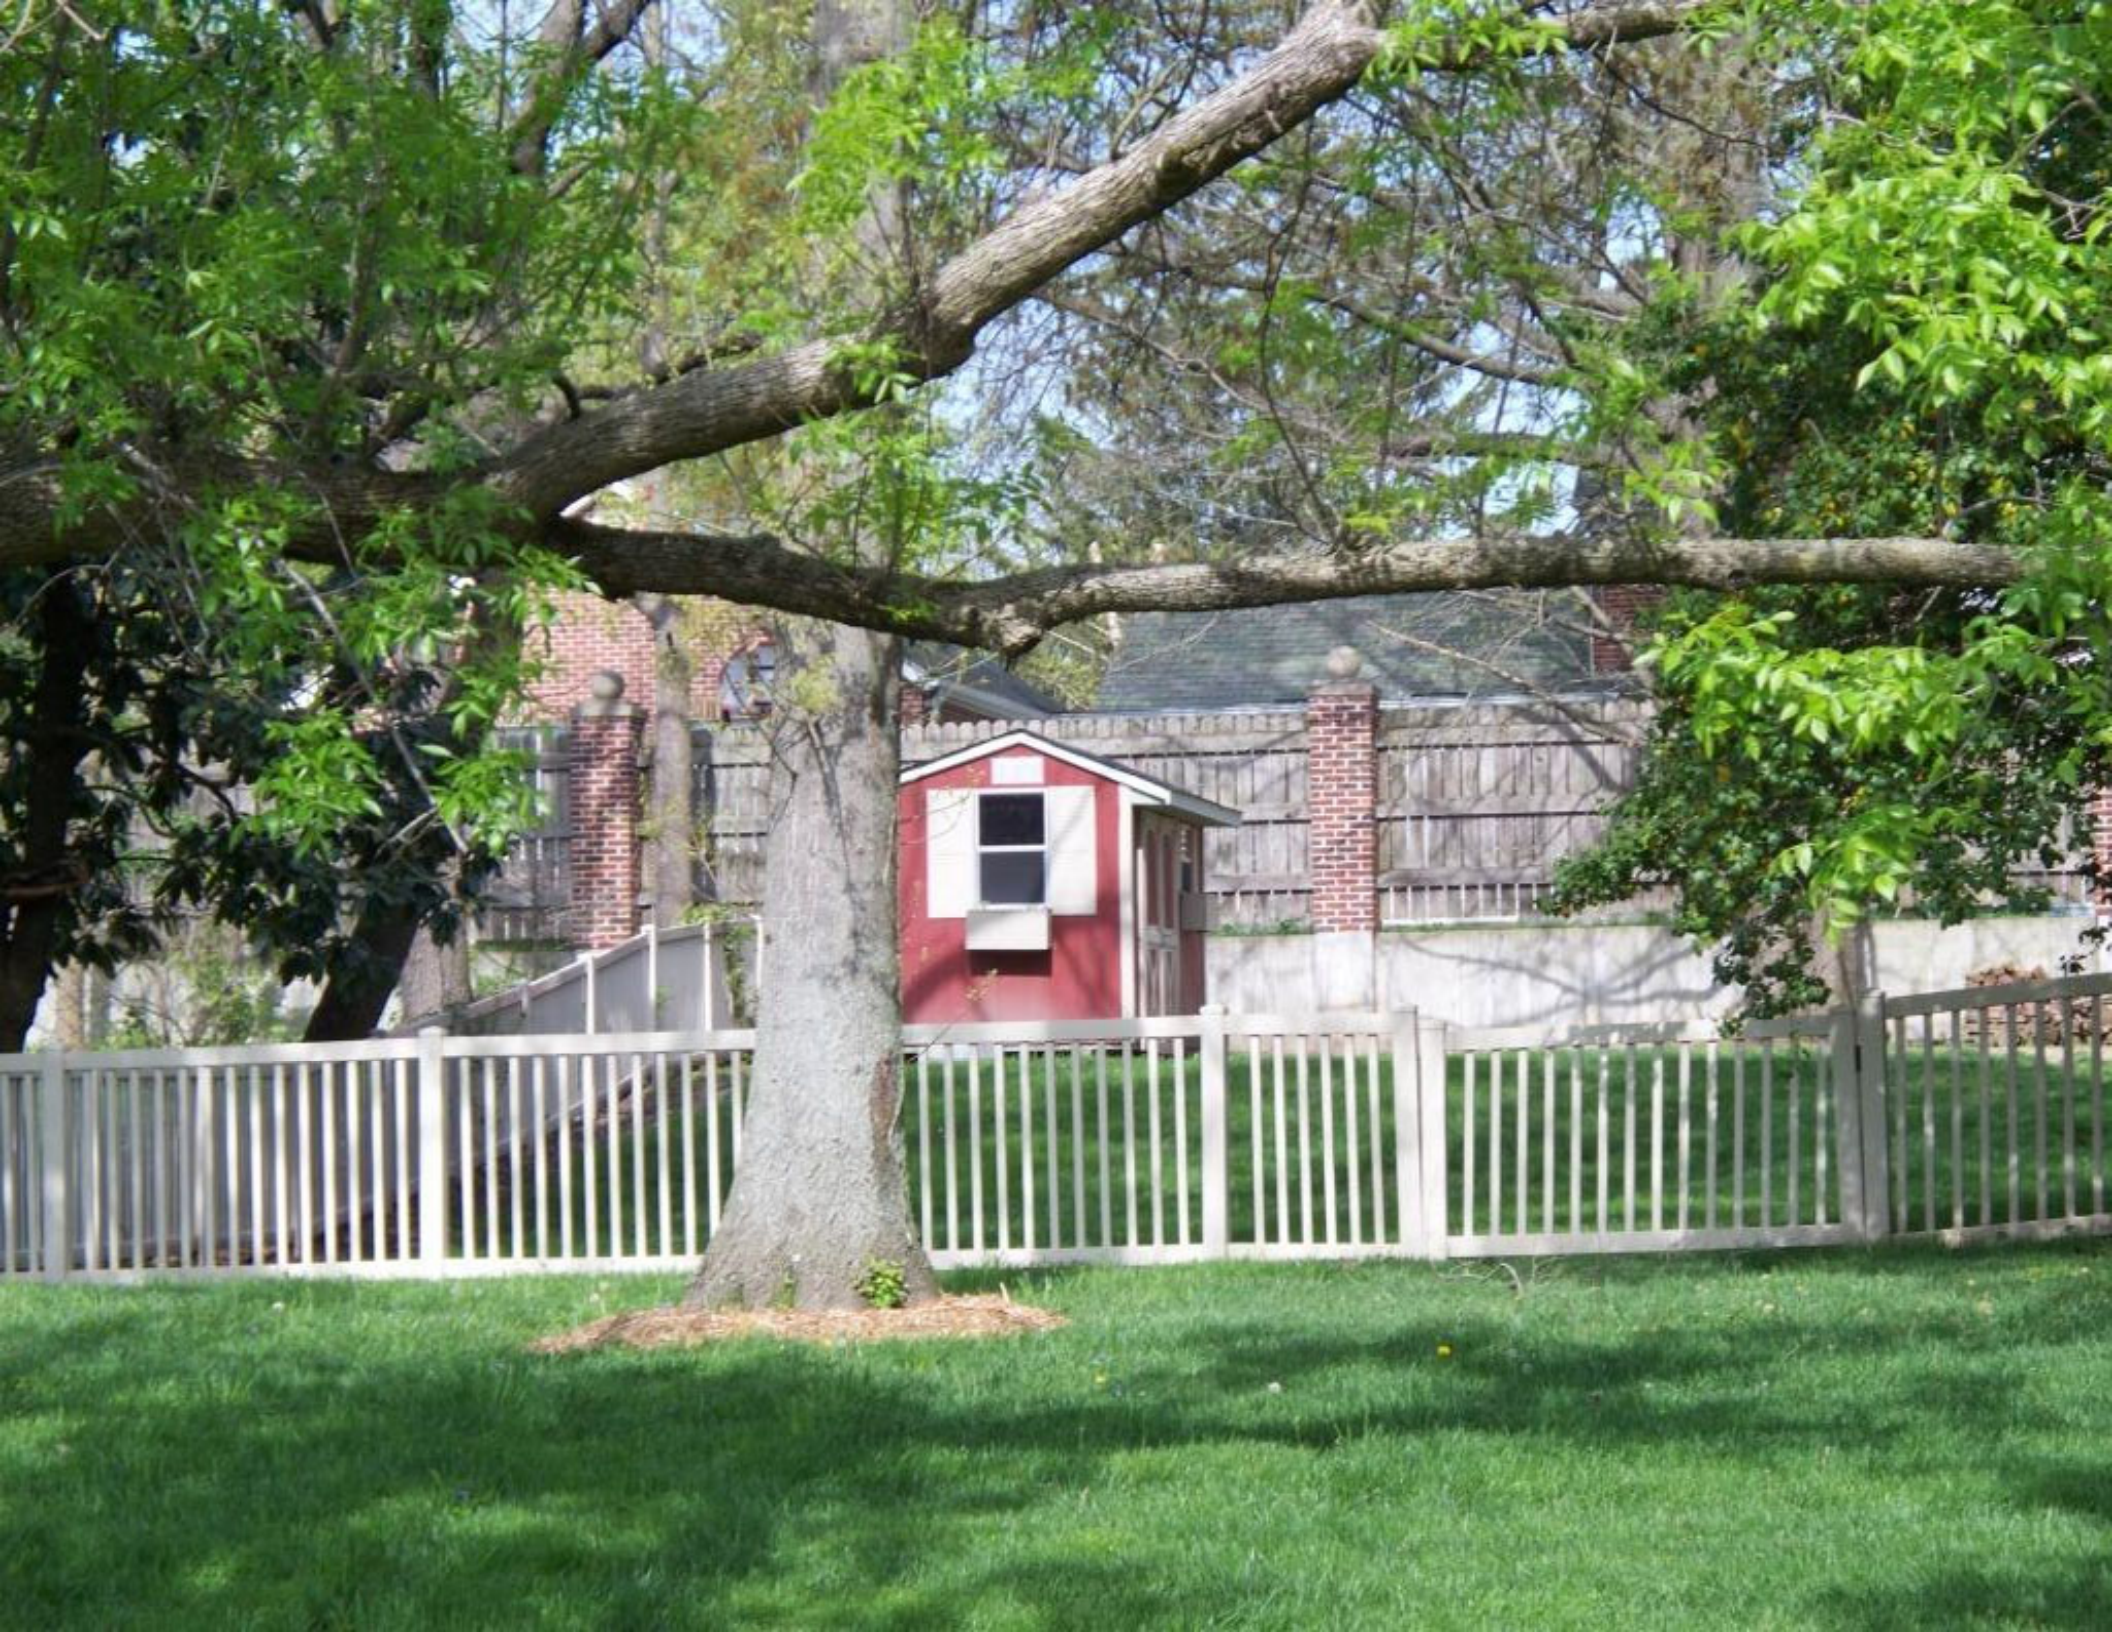
40. (cont.) Description of environment and outbuildings. Expand box as necessary, or add continuation pages.
There is a modern shed/playhouse that is considered non-contributing to the district.

41. (cont.)
This side-gambrel two-story brick house has a large three-bay central dormer on the second floor with a shed roof. The dormer contains three one-over-one windows with stone sills that could be historic. The first floor has a narrow shed awning across the length of the building with a central eyebrow. The eyebrow has brackets and covers an arched entry and what appears to be the original wooden door with multi-pane lights. The full width porch has brick half-piers with limestone caps and wooden rails.

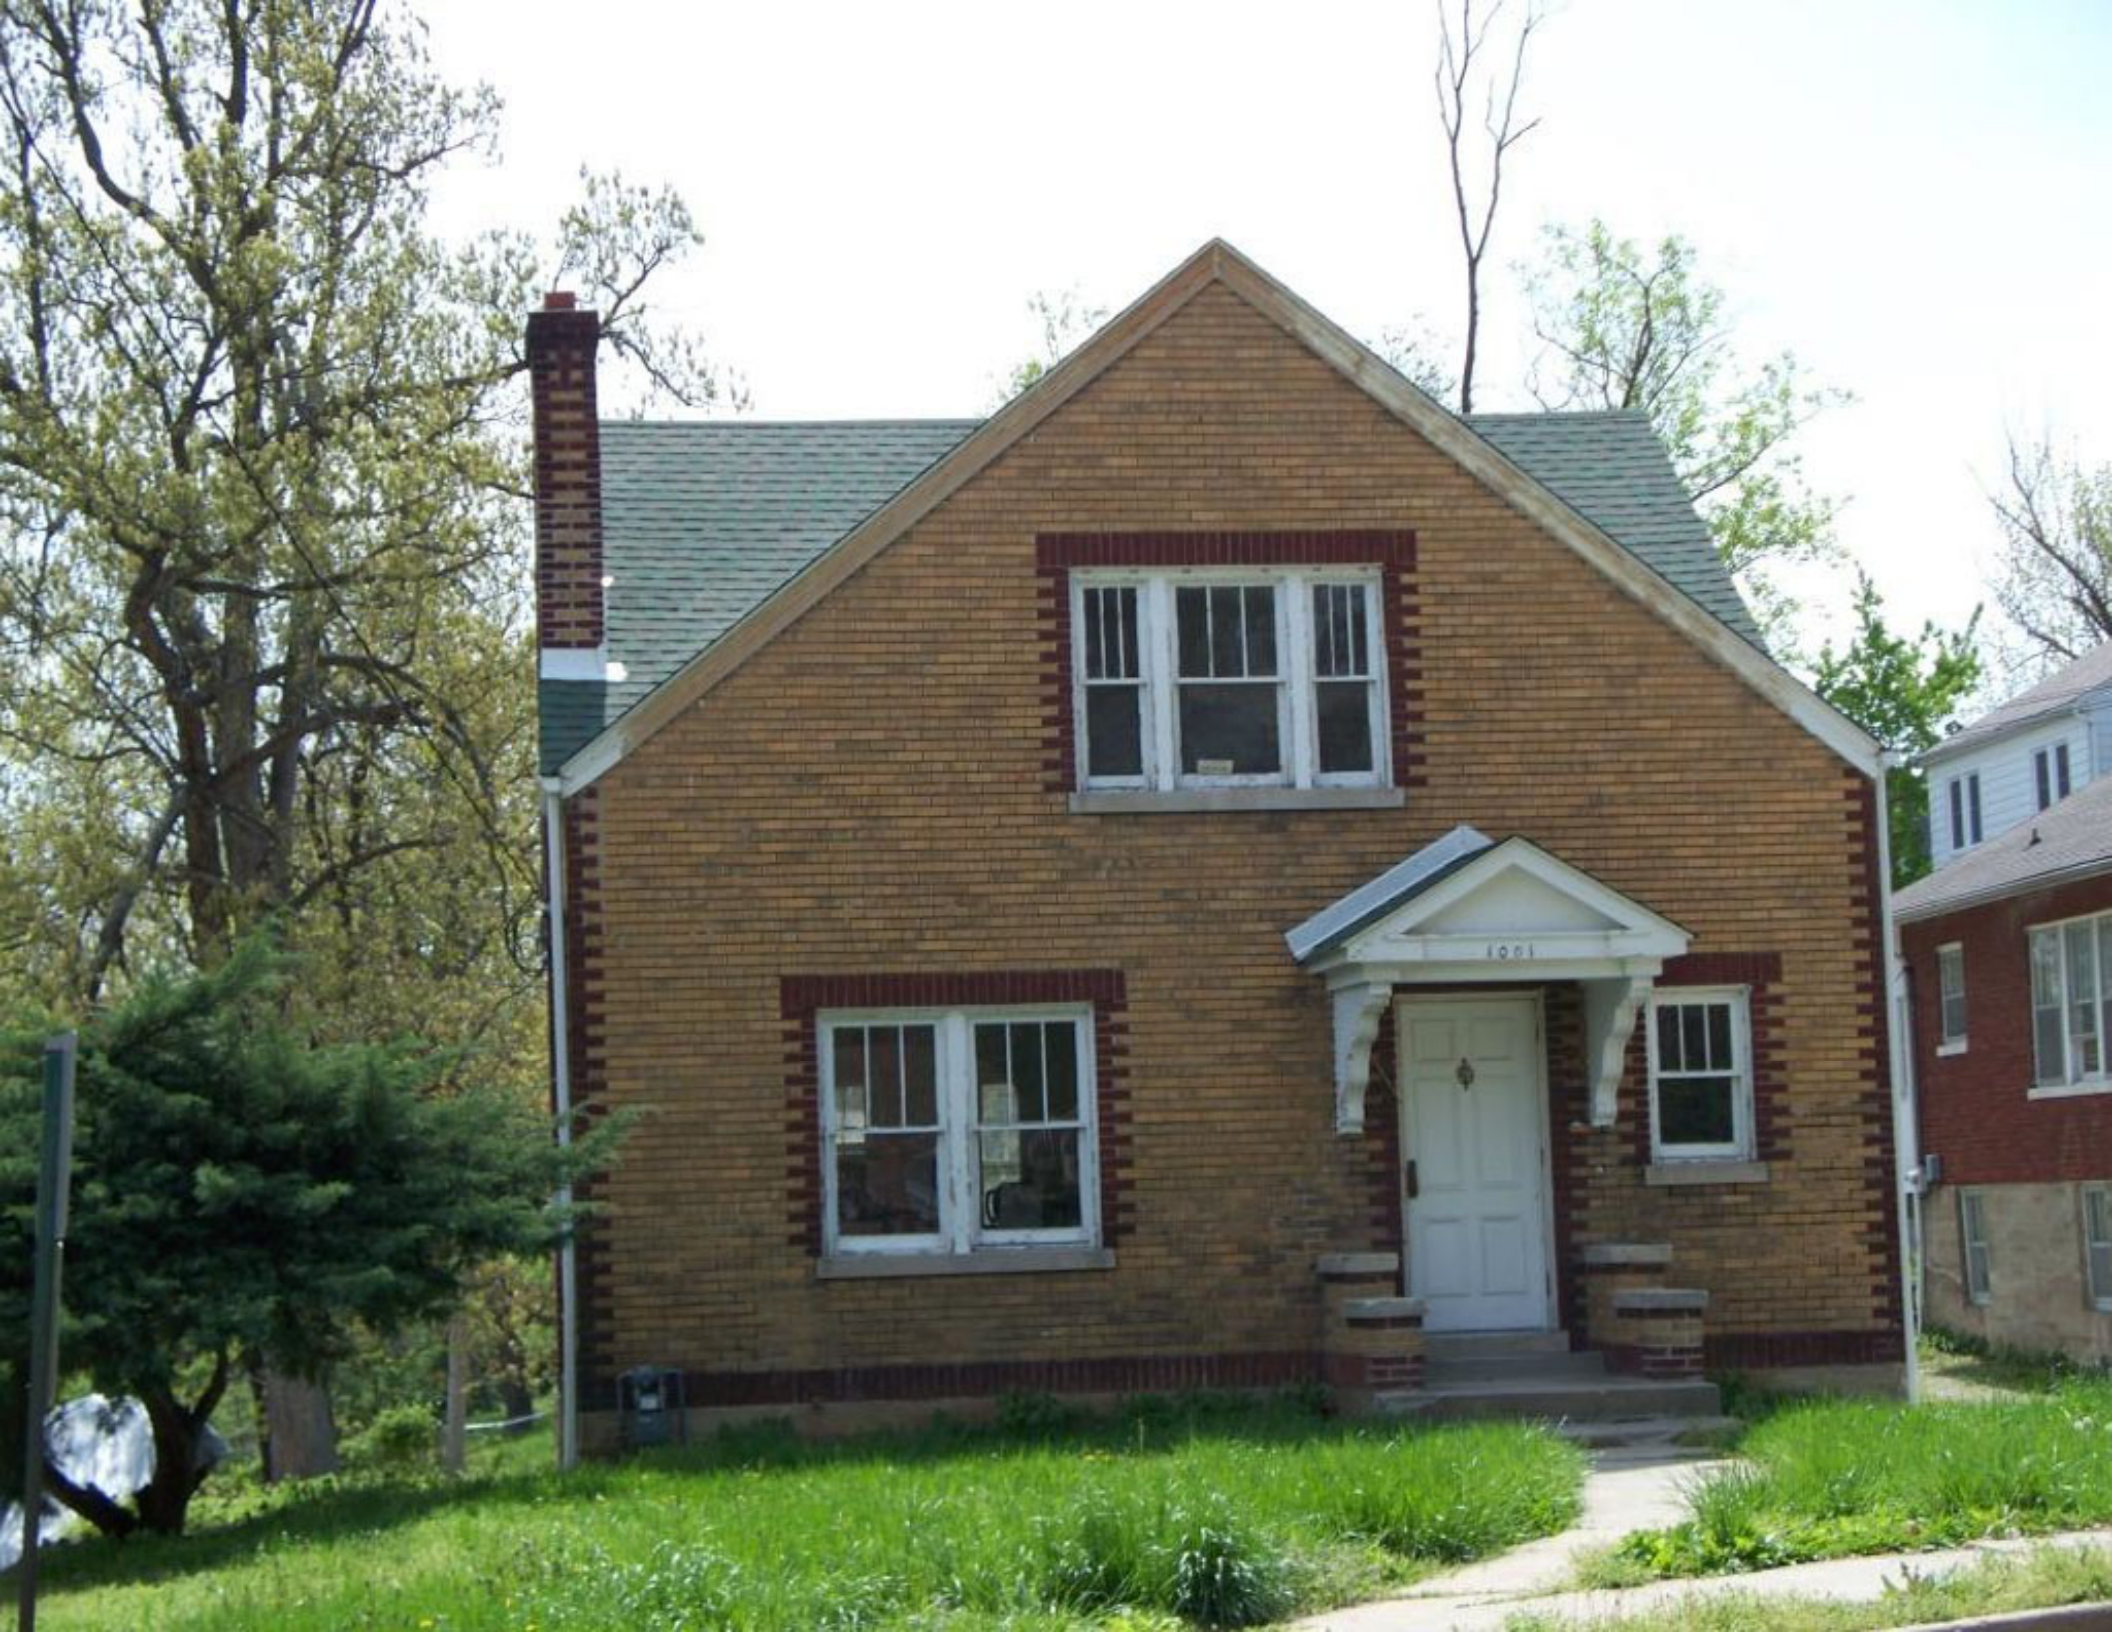
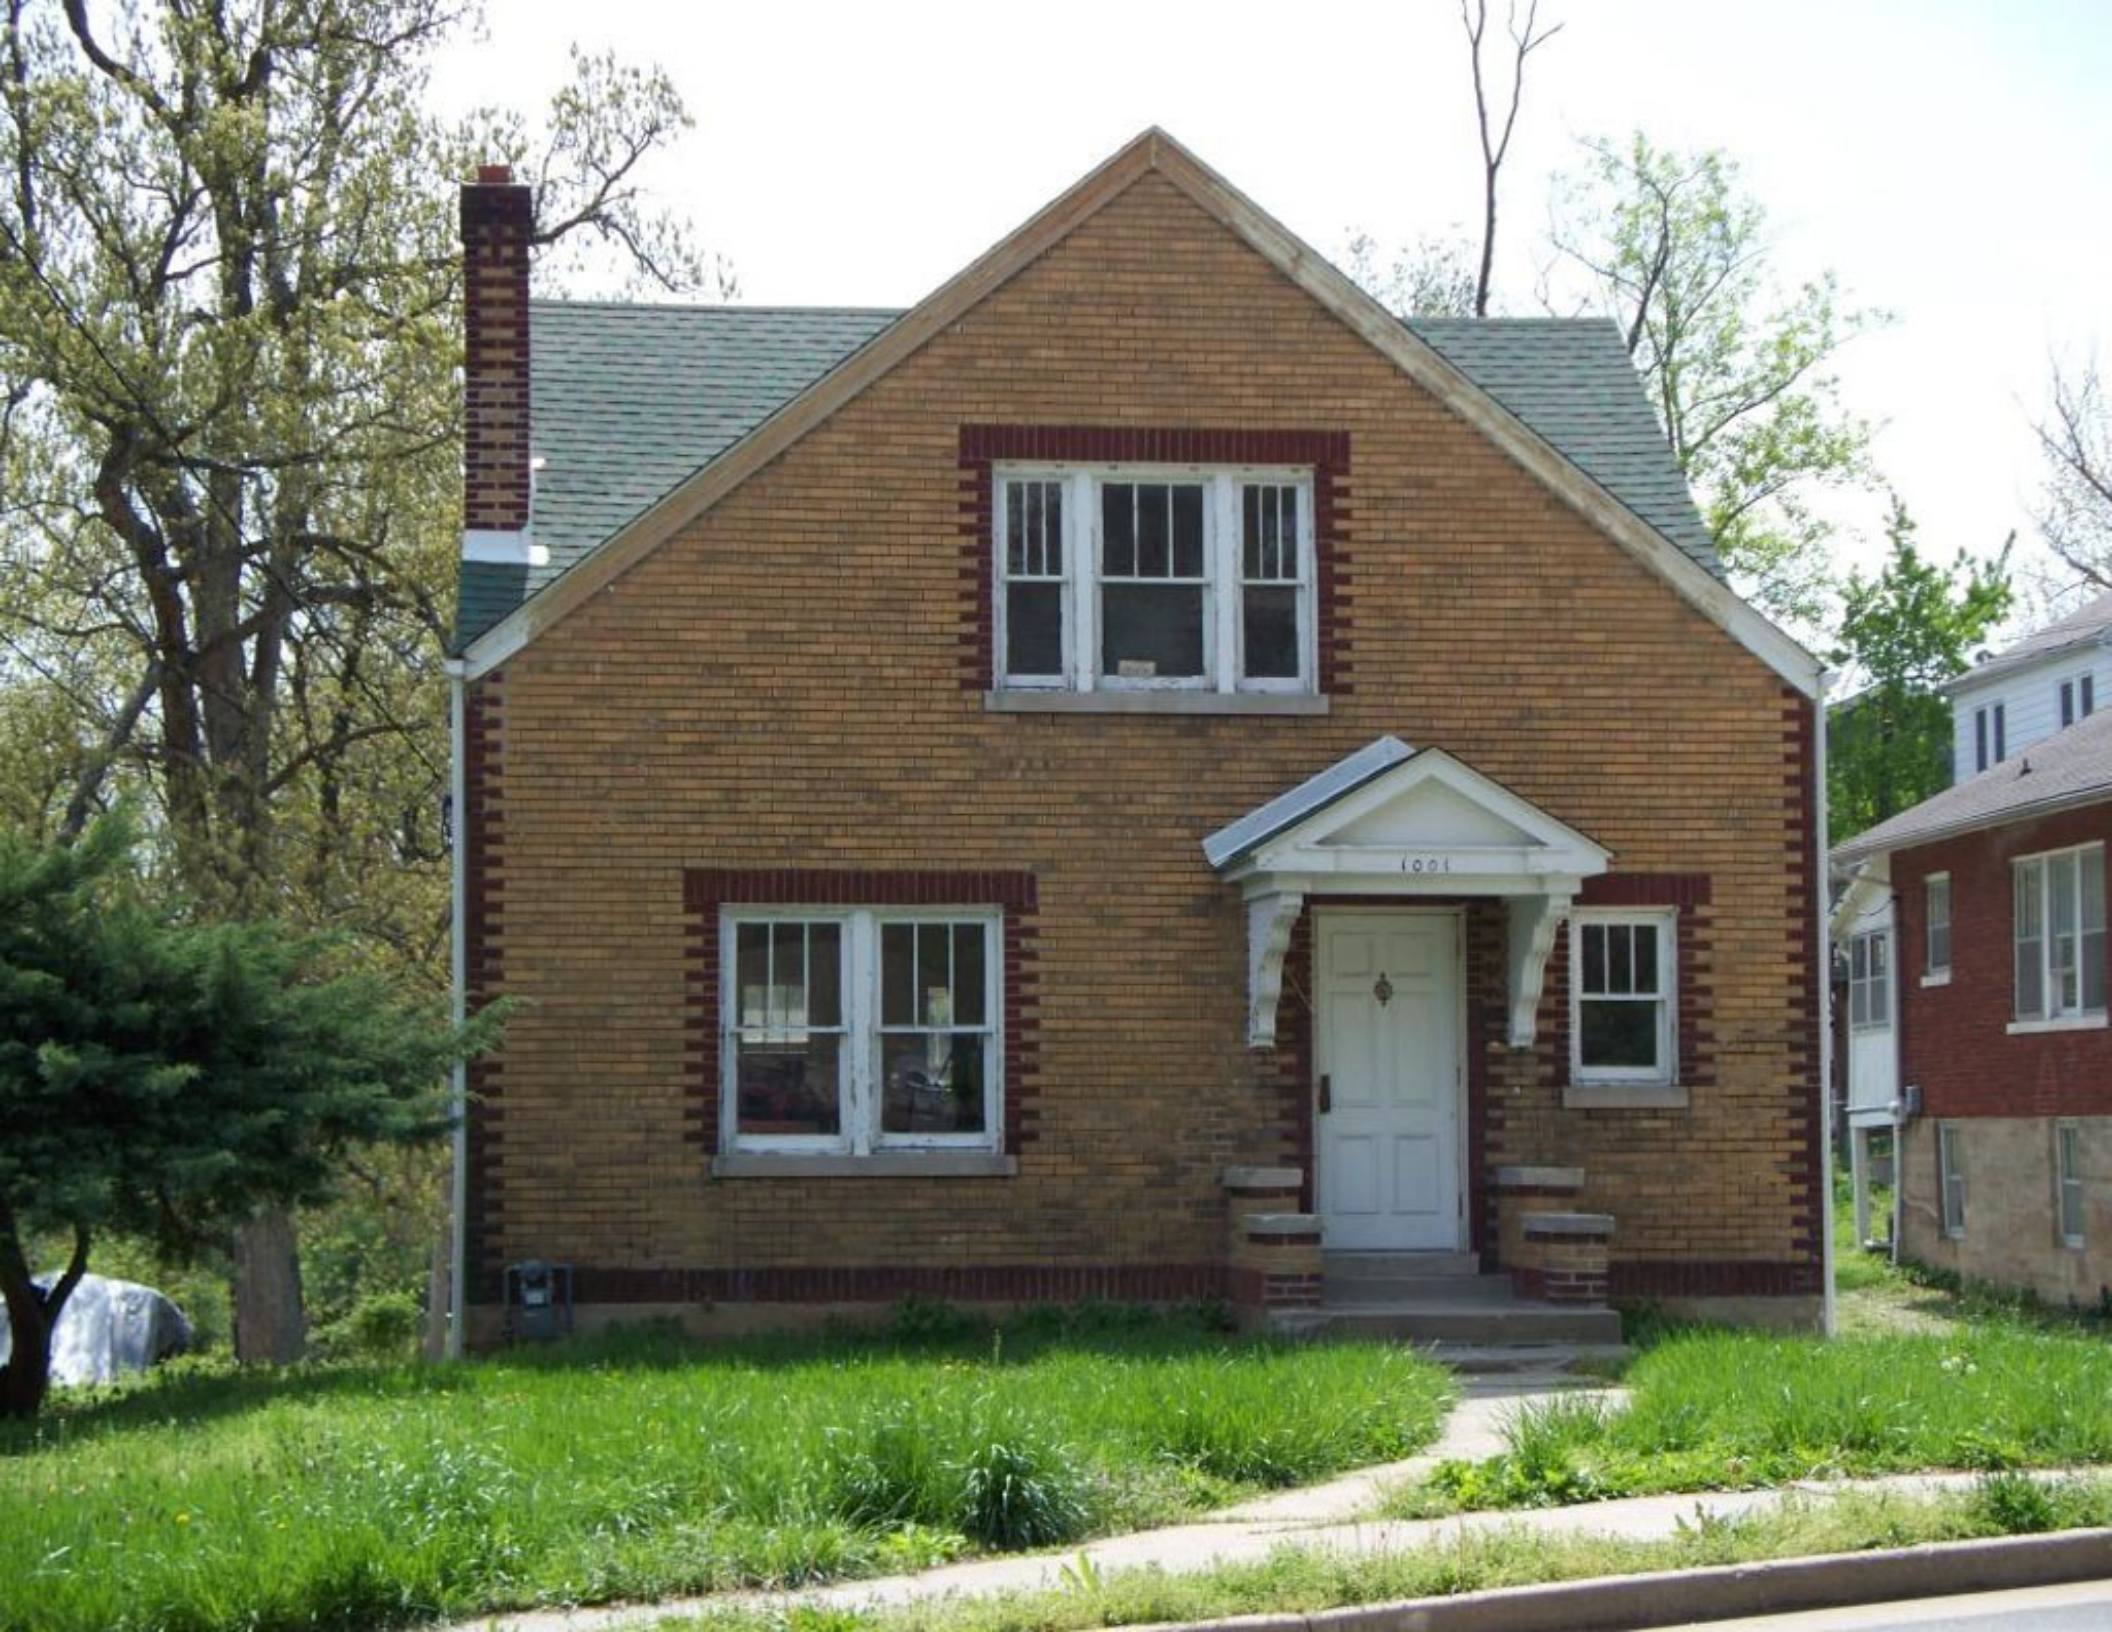
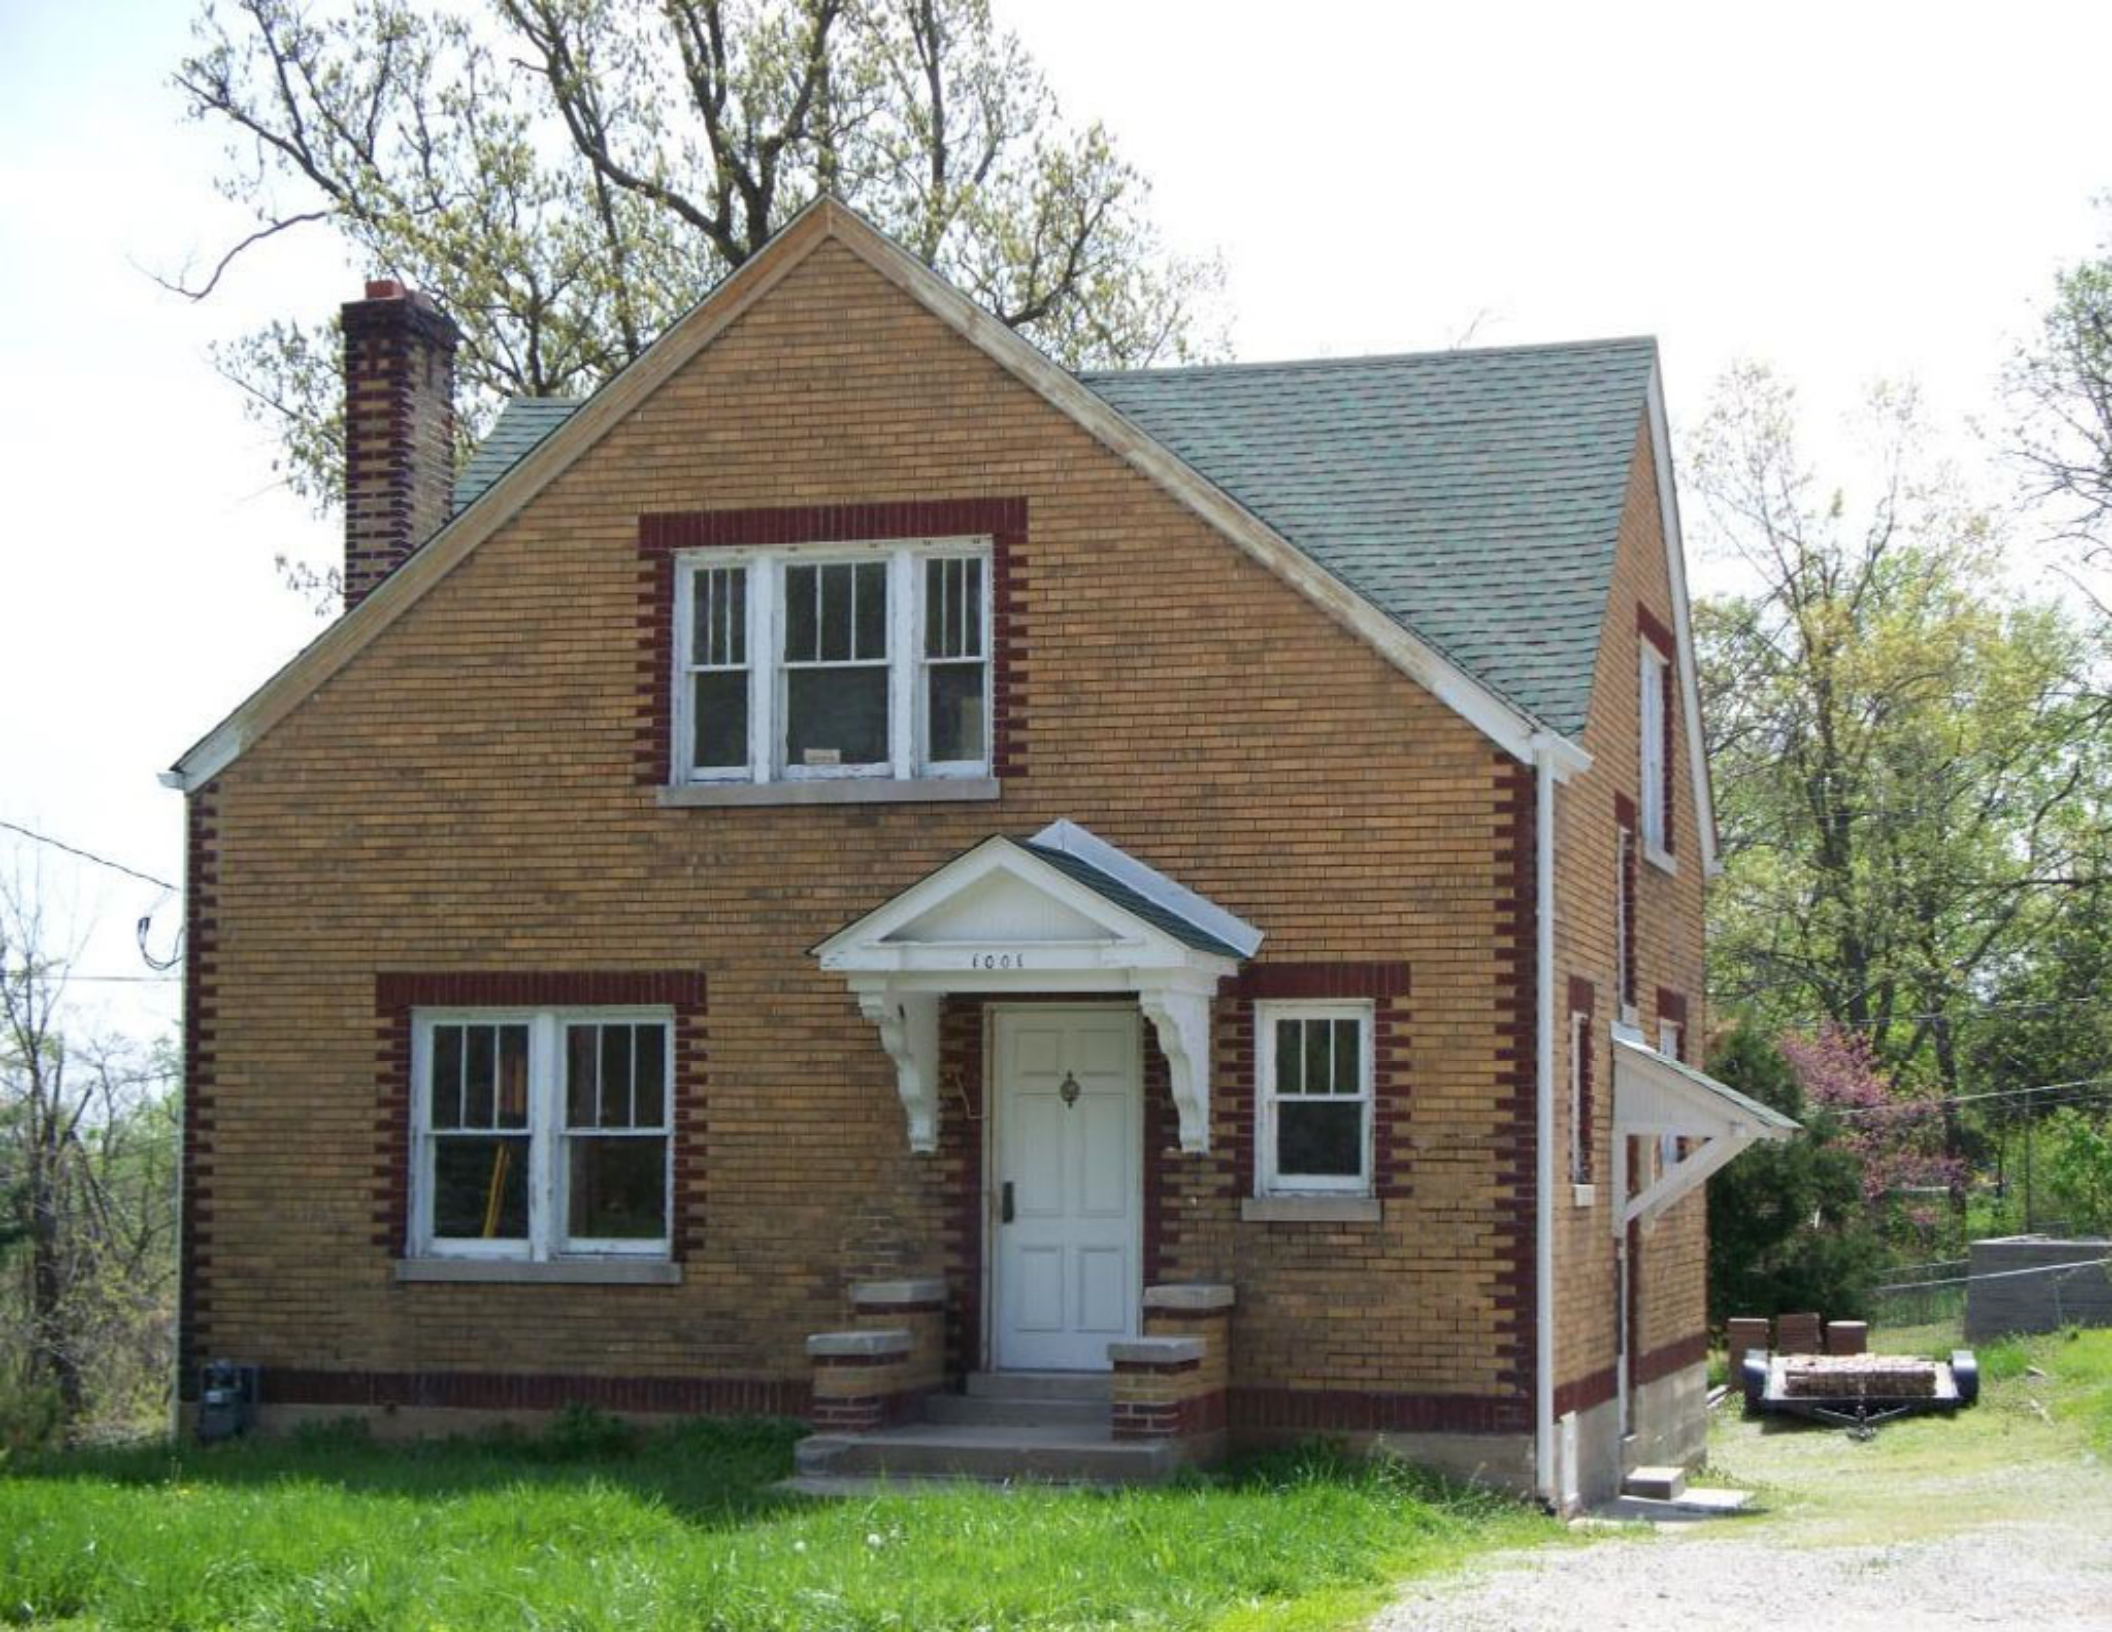
This one-a-half – two-story home features yellow brick trimmed in red brick around the bottom of the façade and red quoining around the windows, chimney, door, and sides of the property. The door is off-centered to the right and features a classical pediment hood with brackets and stoop with short brick piers with limestone caps. There are paired original or historic three-over-one windows to the left of the door and a single smaller three-over-one window to the left. On the second story there is a three-over-one window flanked by matching three-over-one windows centered in the gable. The chimney is located on the outside of the cross-gable roof on the left side of the property.
