ARCHITECTURAL/HISTORIC INVENTORY FORM

1. Survey No. CO-AS-005-001		2. Survey name: Moreau Drive Neighborhood Survey	
3. County: Cole		4. Address: 1202 Elmerine Ave.	
5. City: Jefferson City	Vicinity: <input type="checkbox"/>	6. UTM: / /	7. Township/Range/Section: T: R: S:
8. Historic name (if known):		9. Present/other name (if known):	
10. Ownership: <input checked="" type="checkbox"/> Private <input type="checkbox"/> Public		11. Historic use (if known): Residential	11. Current use: Residential

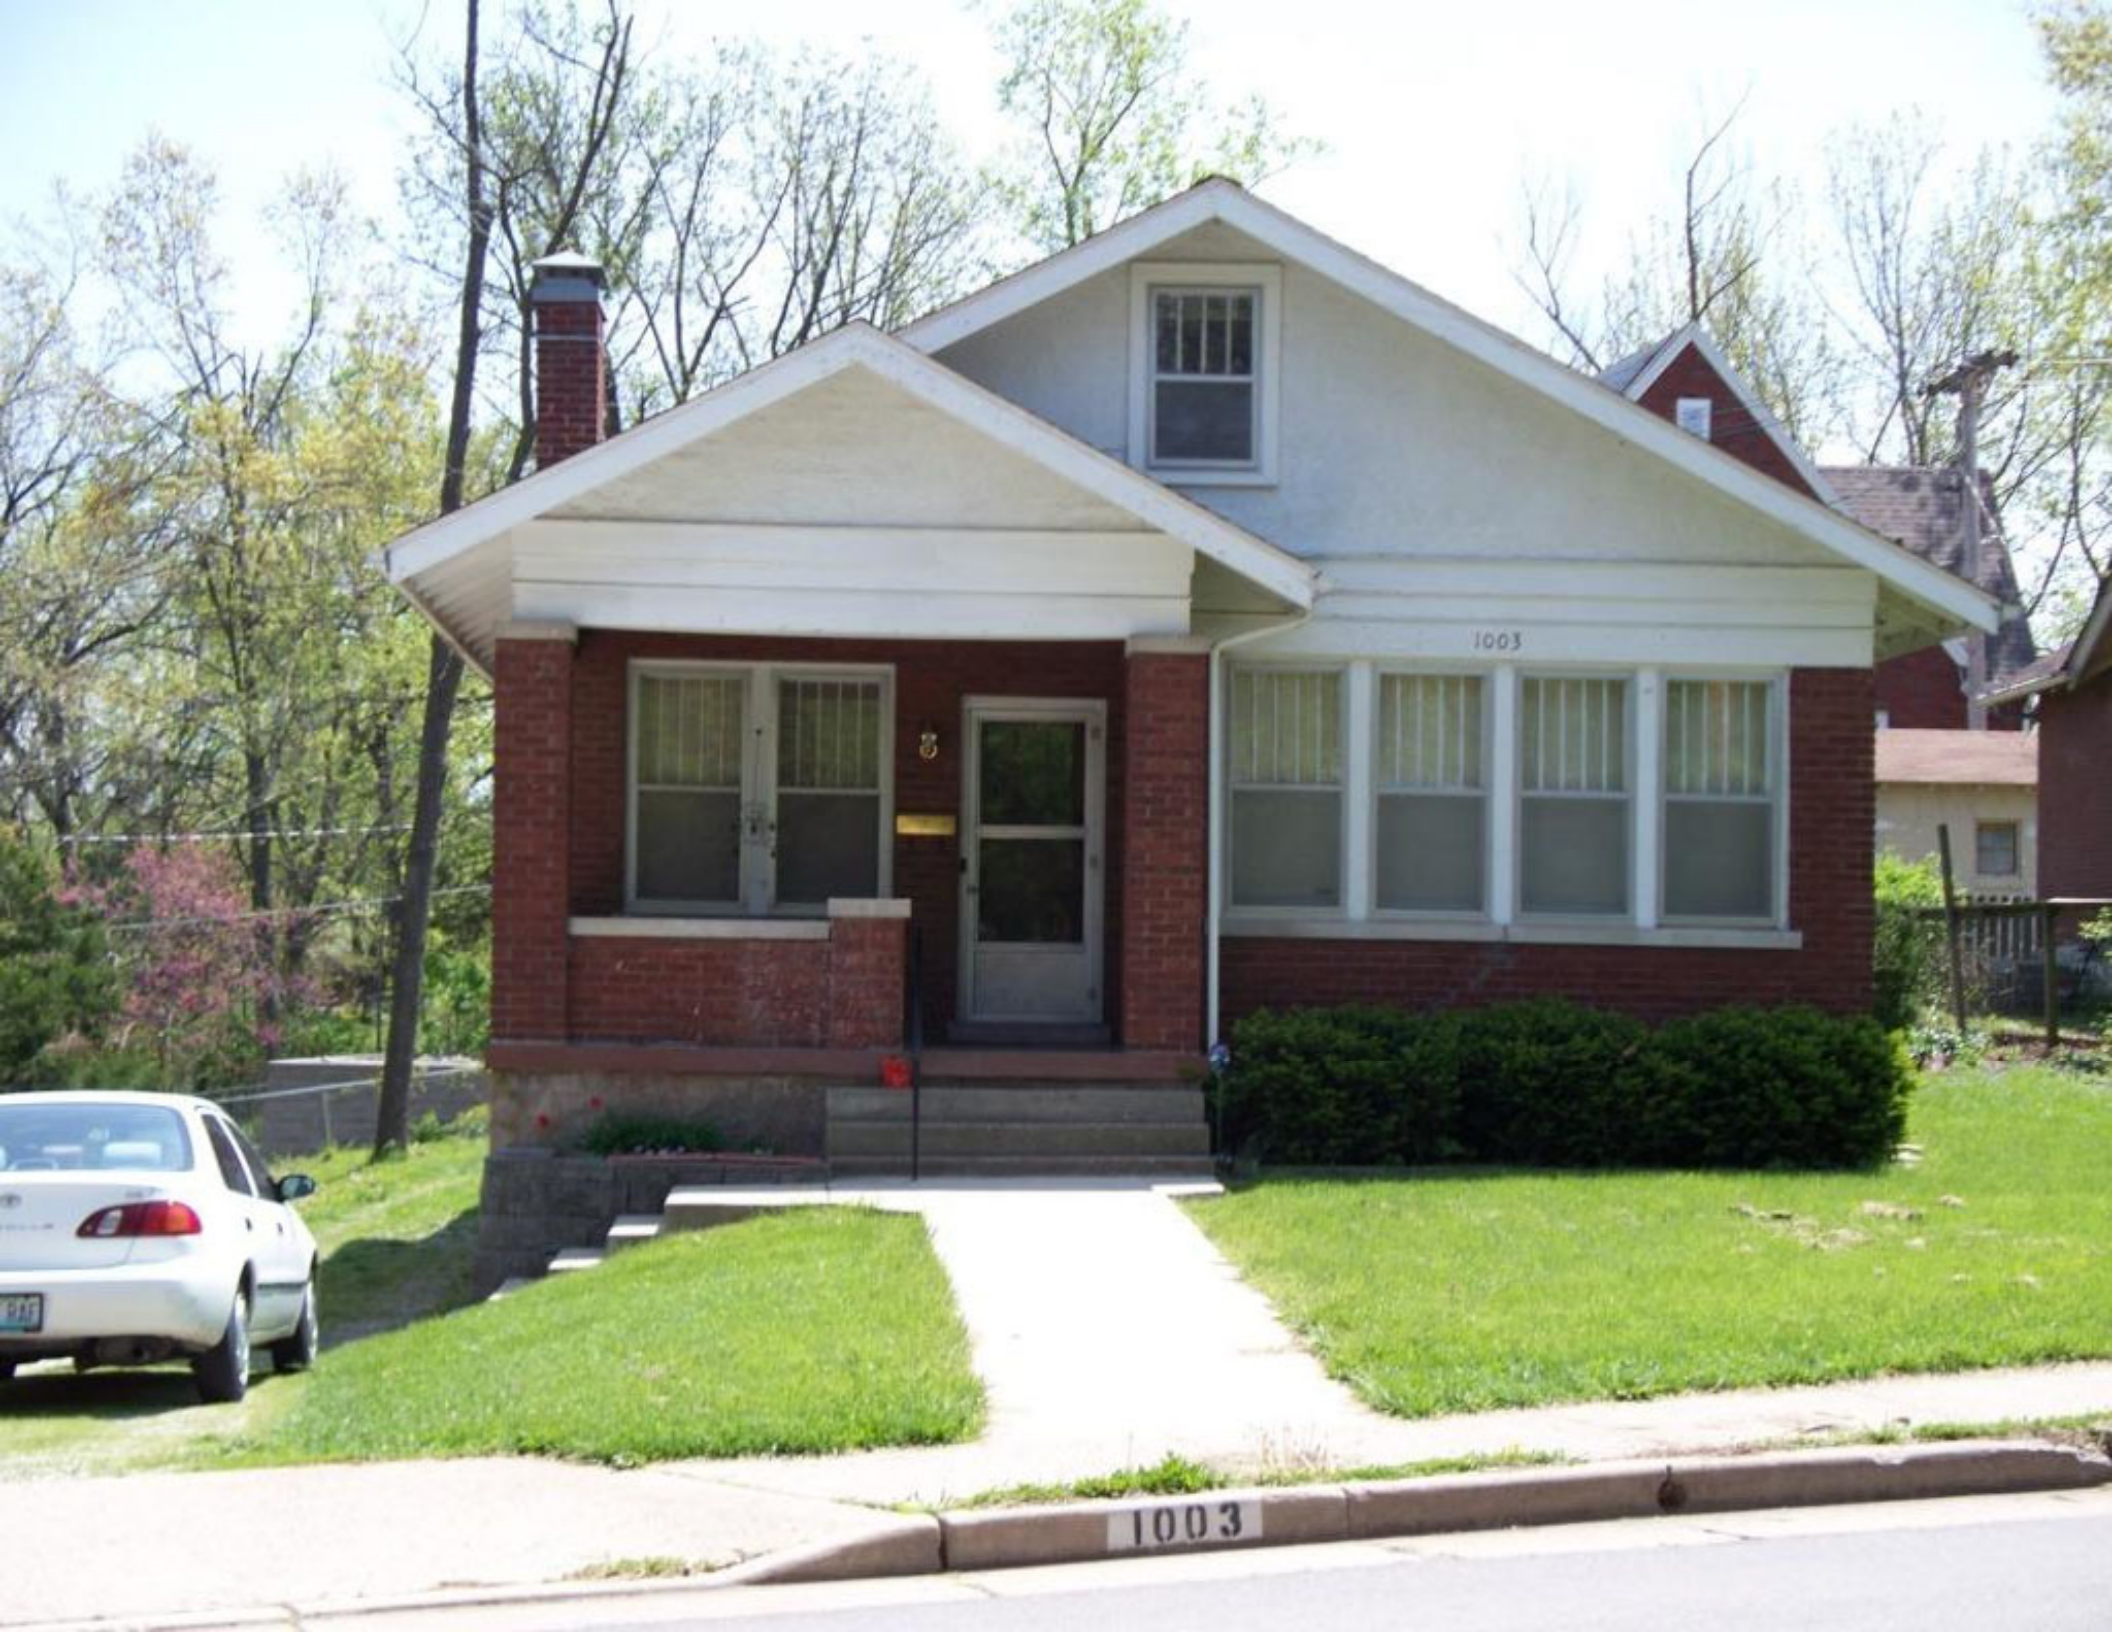
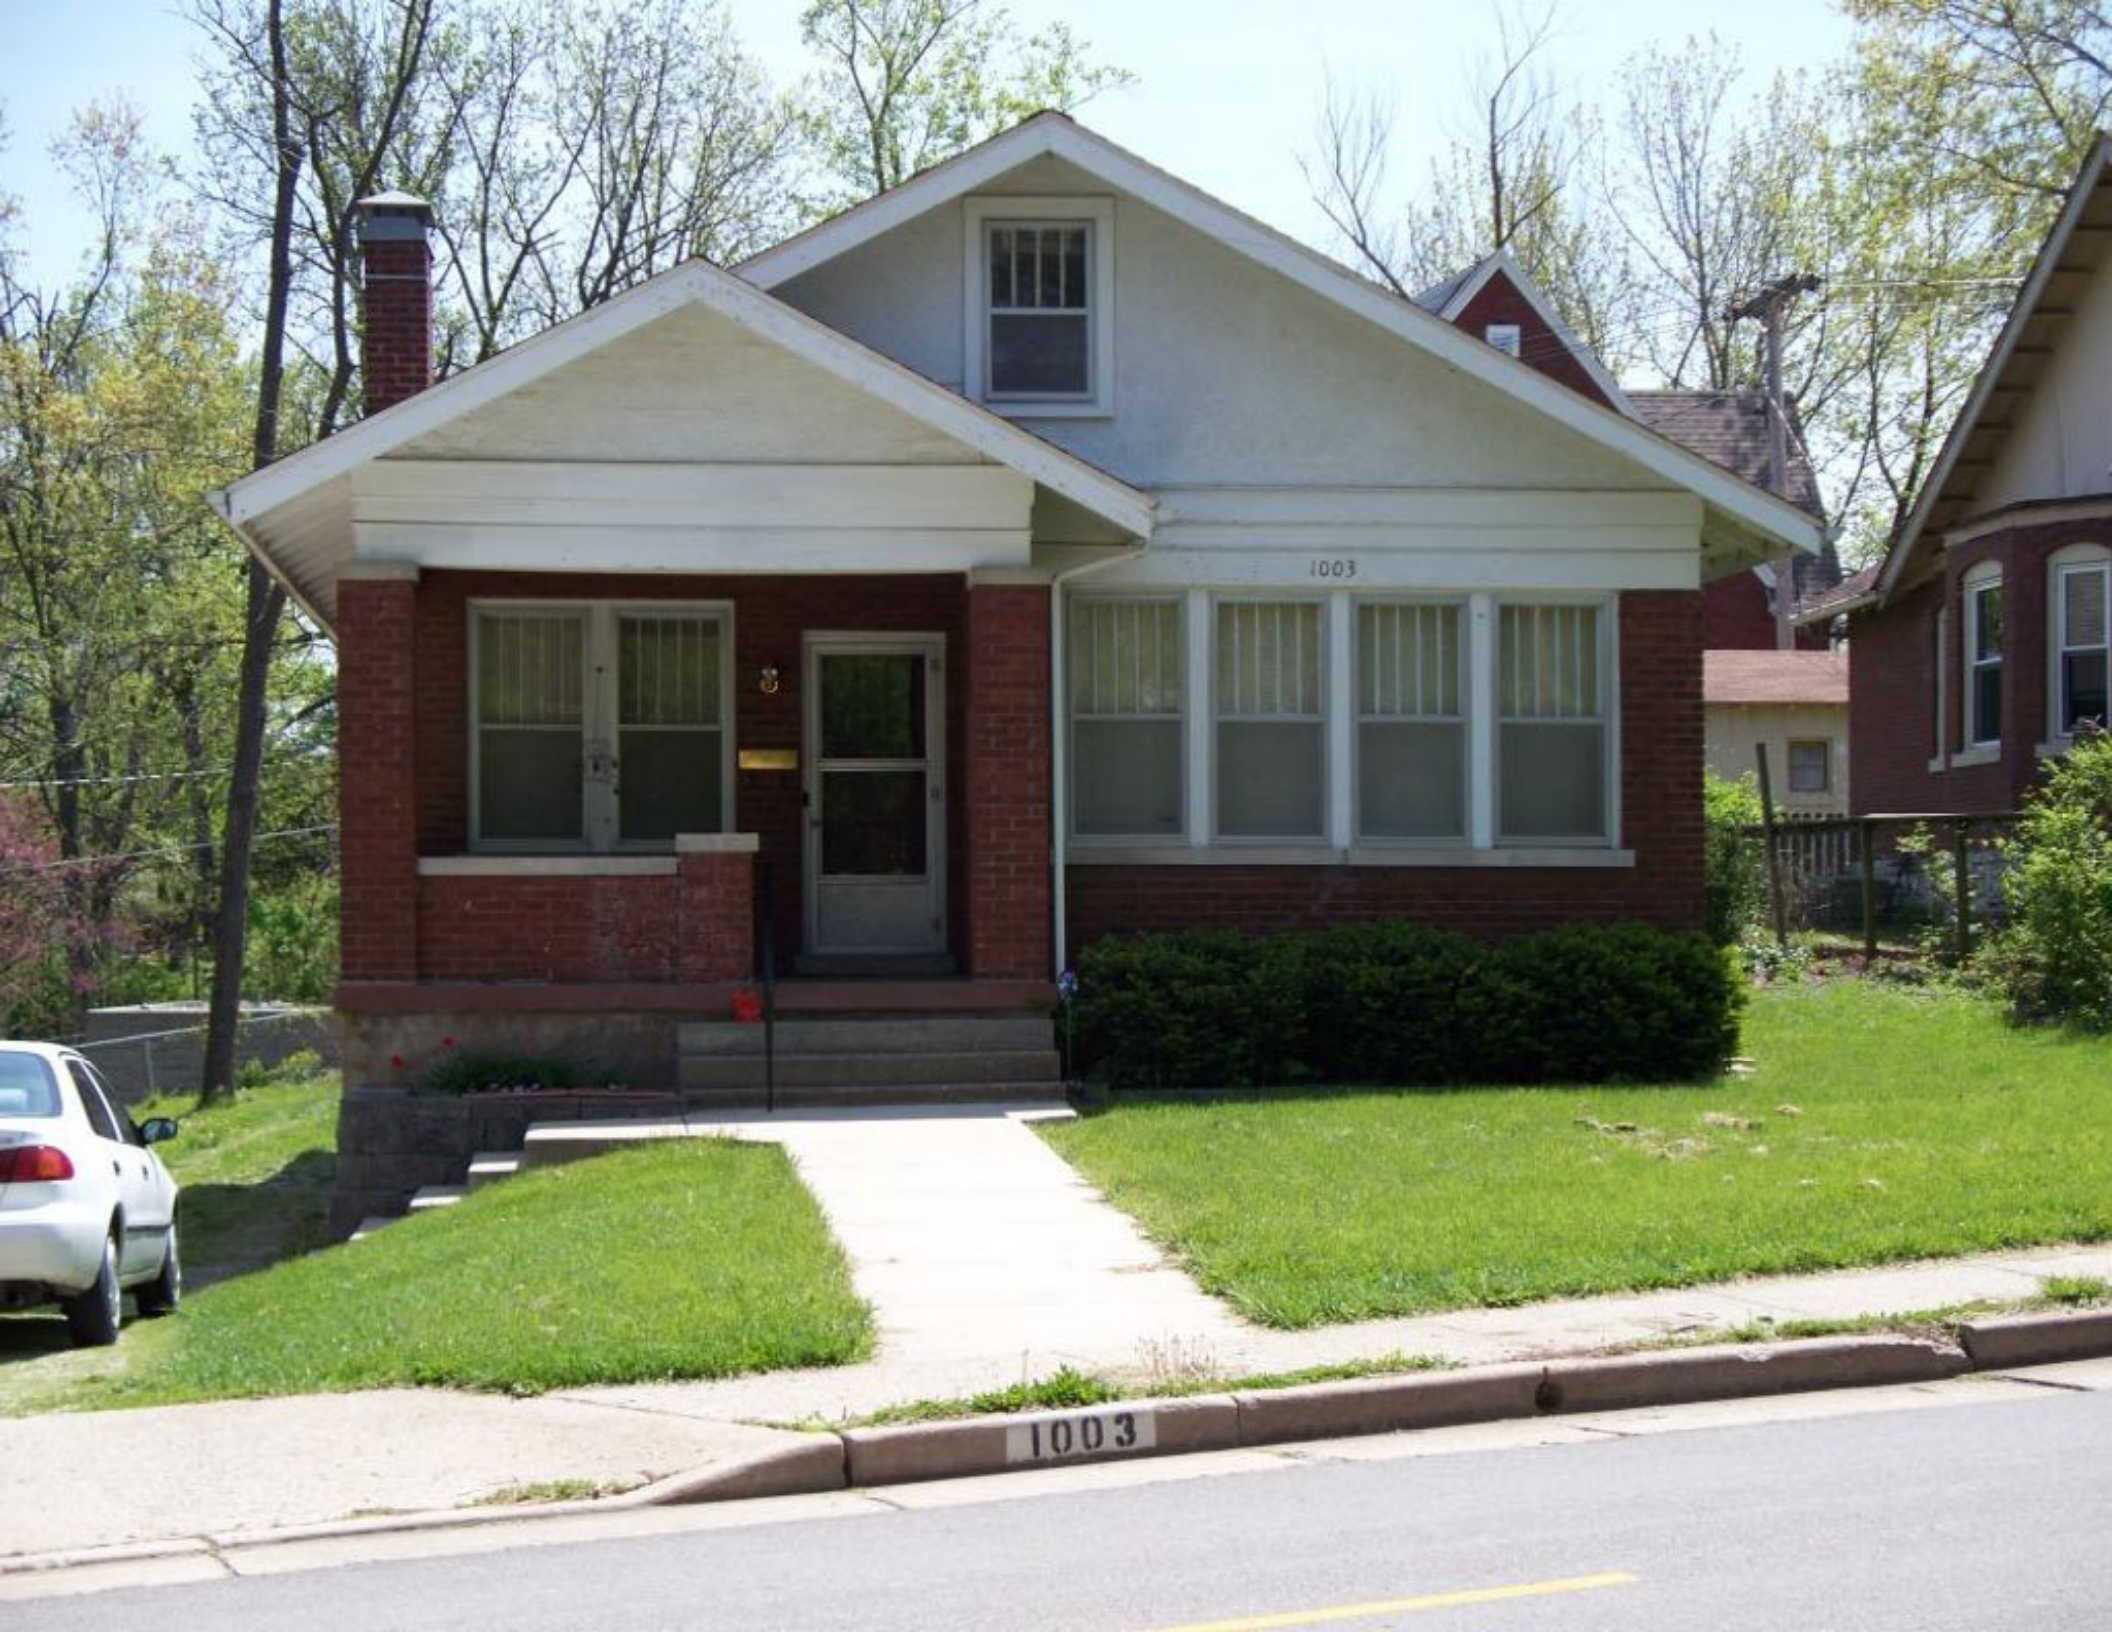
1003

This one-and-a-half story brick bungalow has a partial open porch to the left of the property featuring brick piers and a half wall capped in limestone. The door appears to be original and is slightly off-center on the left. Four historic paired five-over-one windows take up most of the space of the right side of the home's first floor. Similar paired windows are on the right side of the door. Both sets of windows have limestone sills. The house features stacked stucco front-gable roofs with a small four-over-one window centered in the largest gable. The home is in the Wagner Place Subdivision.

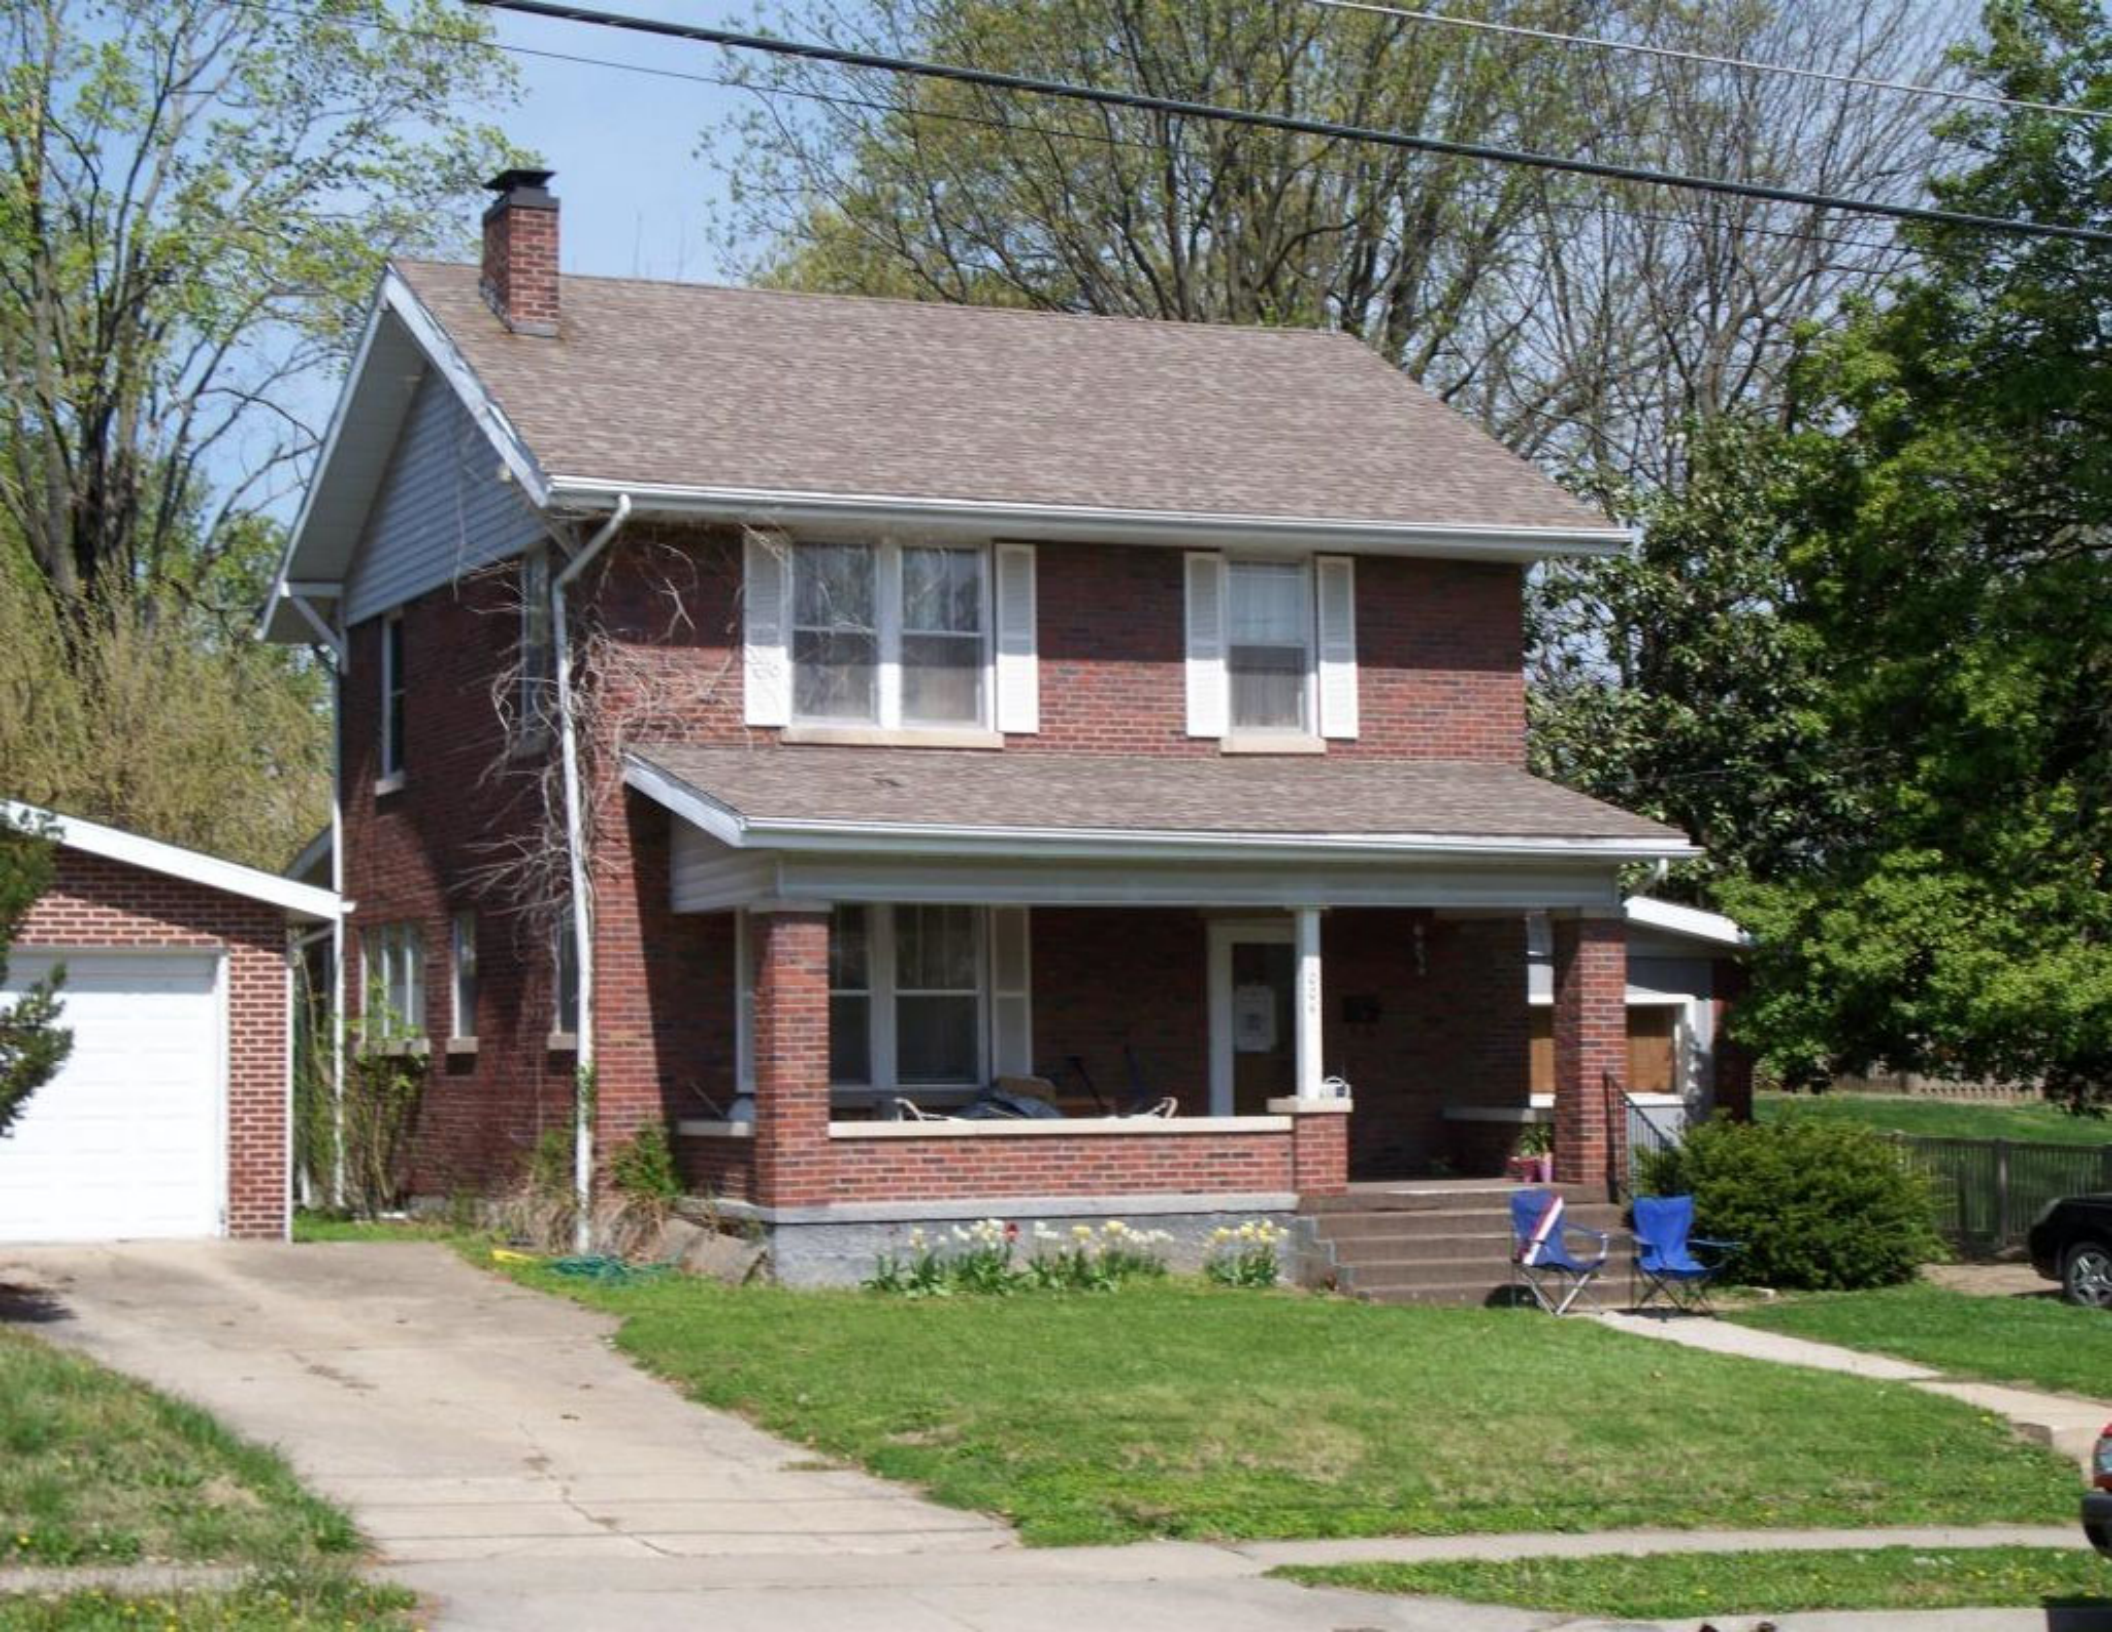
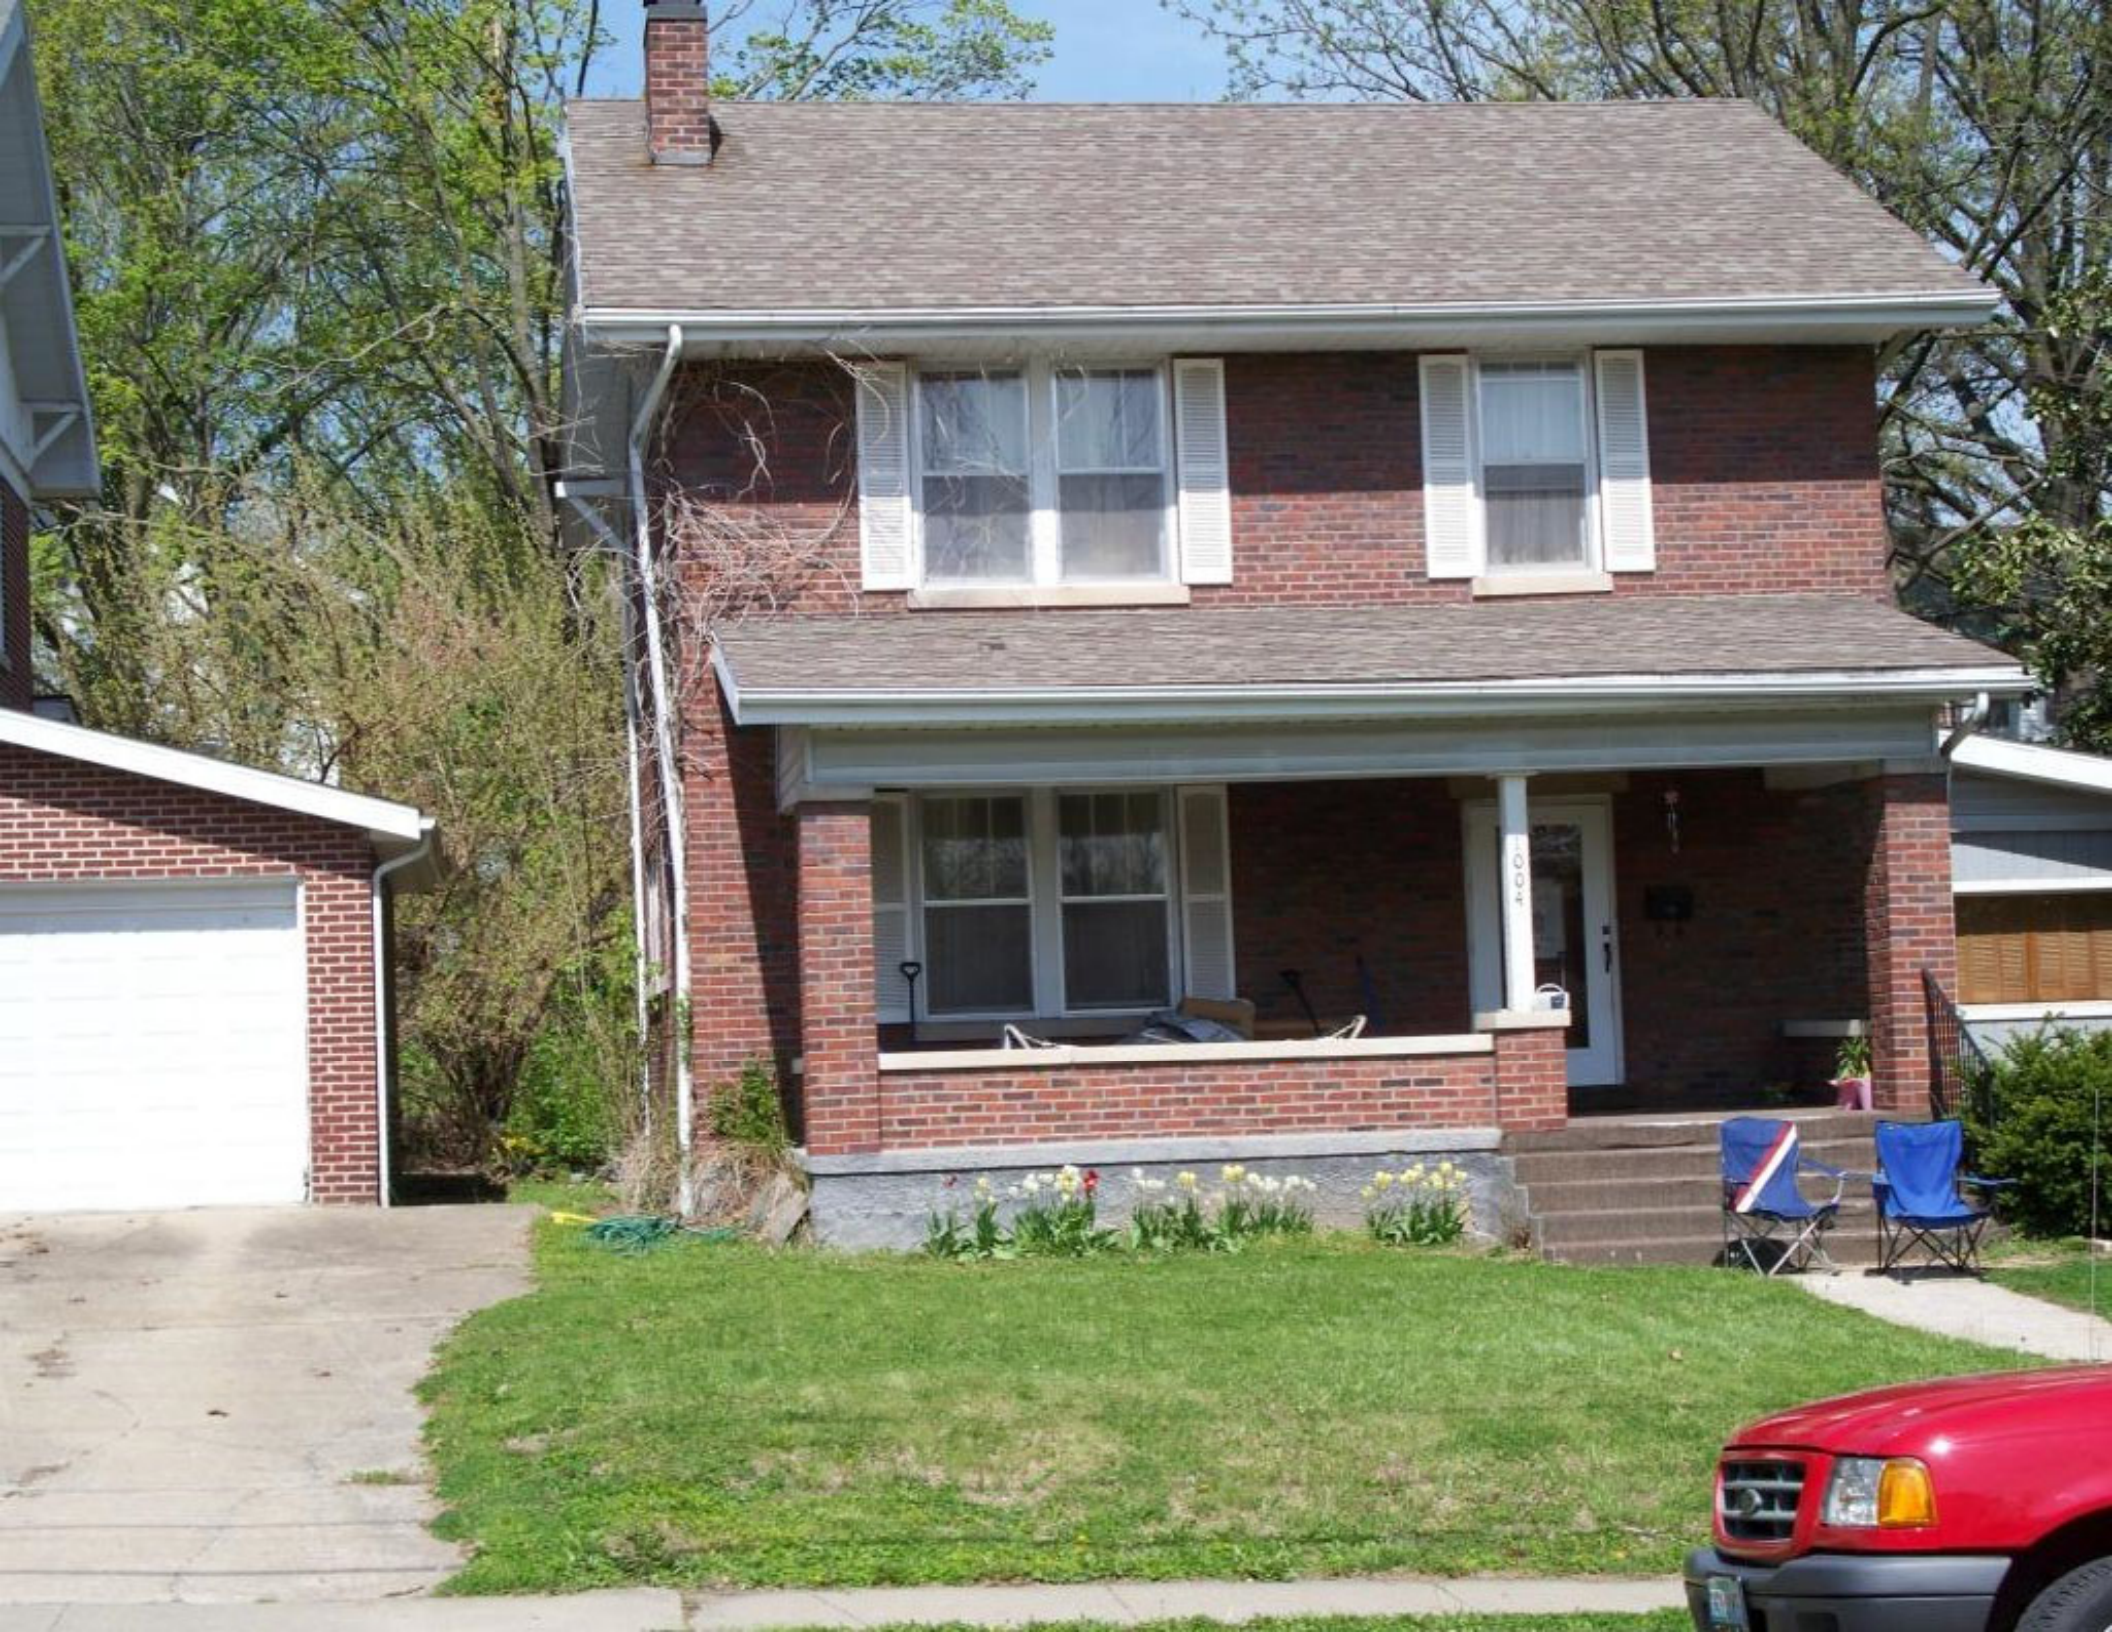
This is a two-story brick four square with a side gable roof. The second story has paired 3/1 historic windows and a single 3/1; both have wooden shutters. The full-width porch has a brick knee-wall and a shed roof supported by brick piers and a single (wooden?) post. There are paired 3/1 windows with shutters on the left side, the entrance is on the right and appears to retain its original wooden door.

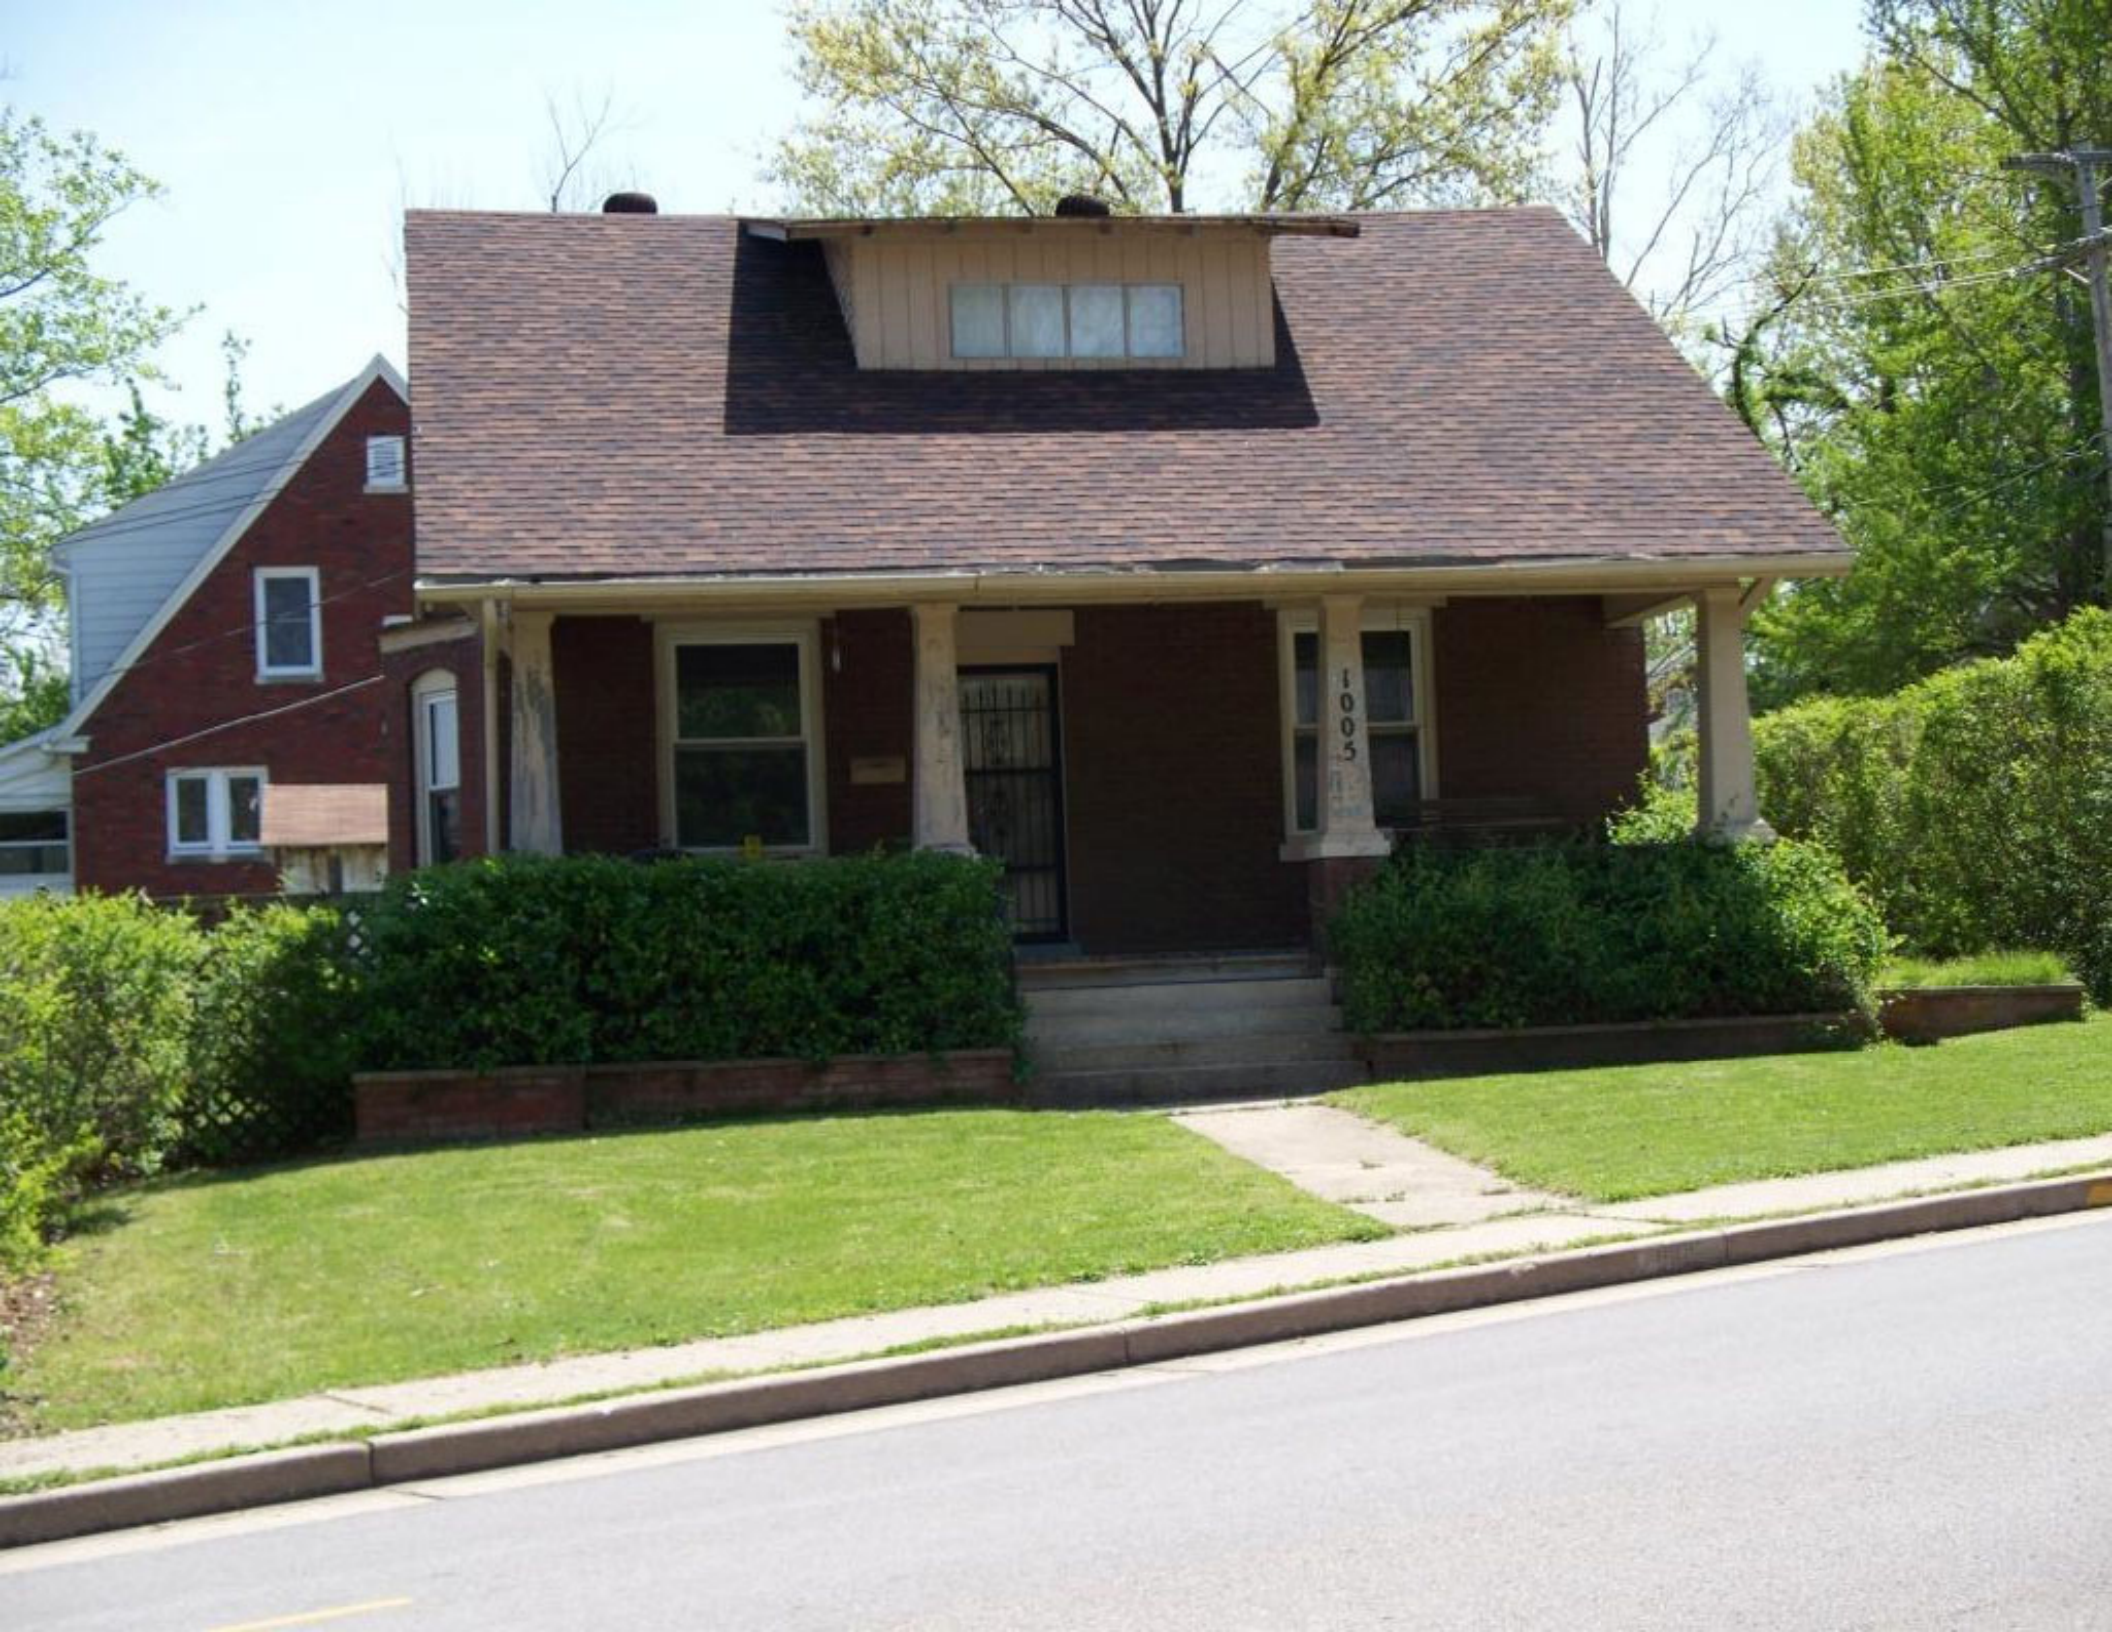
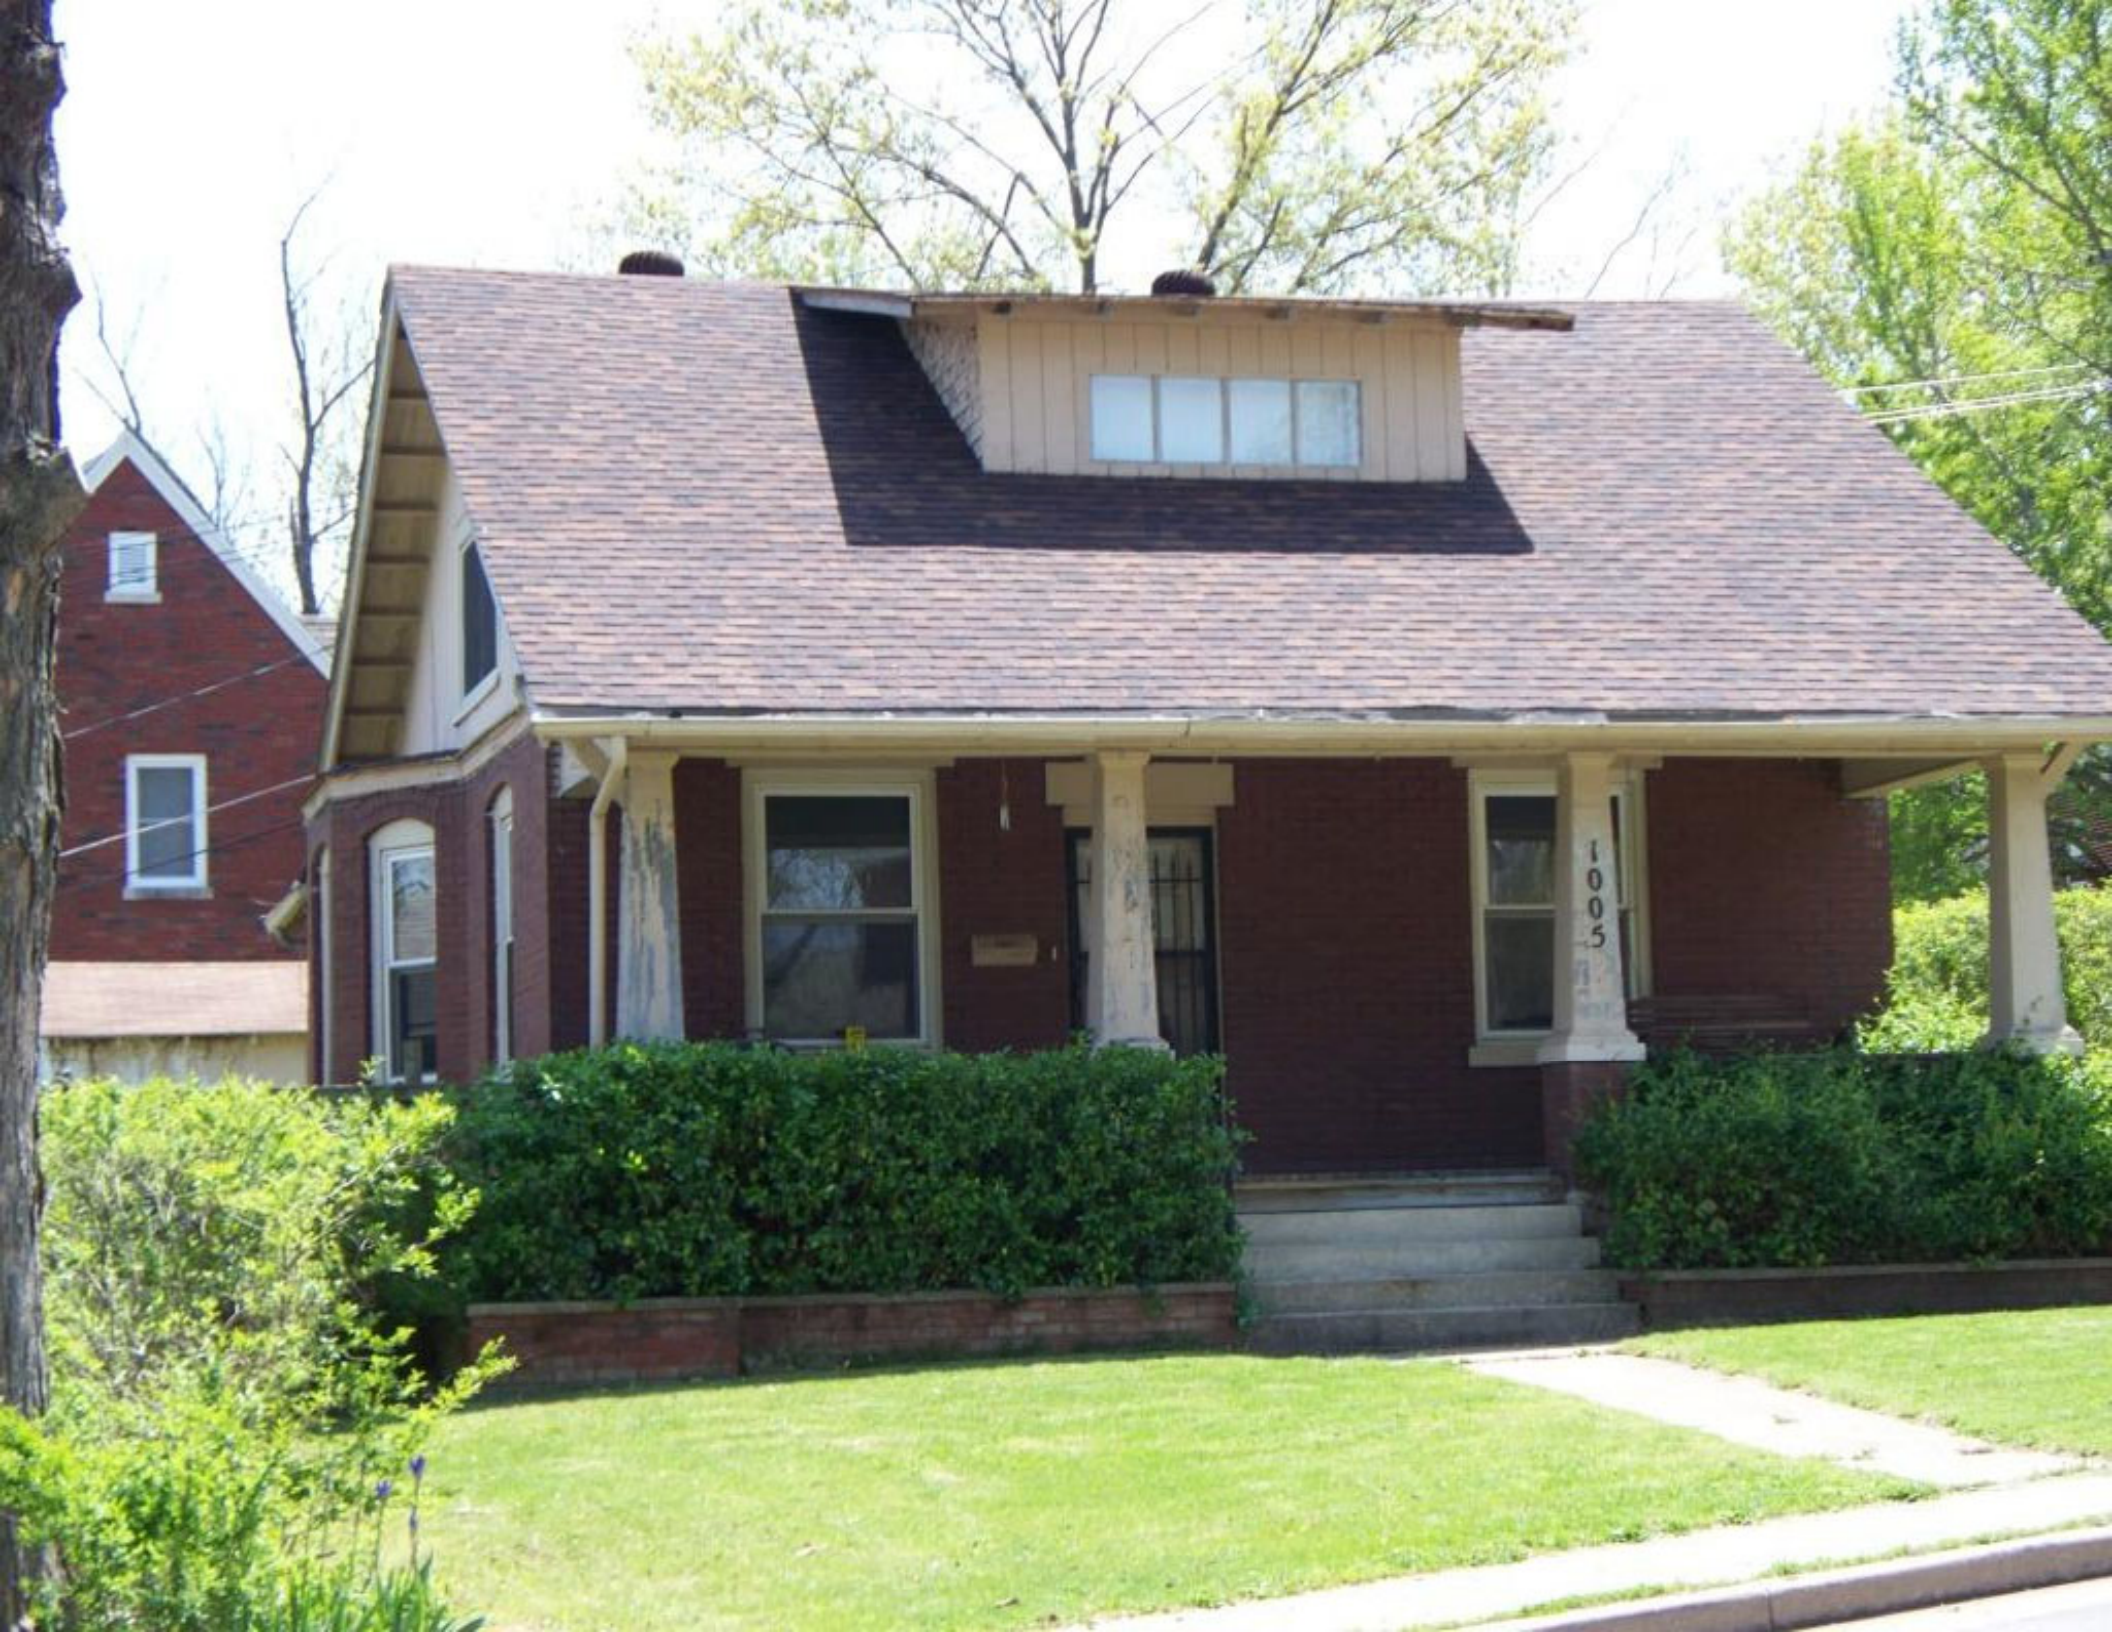
This is a one and a half story brick bungalow with a side gable roof and shed dormer with four fixed lights, rafter tails, and what appears to be clapboard siding. There are large planters at ground level that span the width of the house, save the entrance. They currently contain hedges. Concrete stairs lead up to the open porch, which has four thick square tapering pillars that sit atop short brick piers. The entrance has a security door and is slightly off-centered to the left. It is flanked by one-over-one vinyl replacement windows. A canted bay window extends from the left side of the house. It also has vinyl replacement windows, which are inset into the original openings. The home is in the Wagner Place Subdivision.
