ARCHITECTURAL/HISTORIC INVENTORY FORM

1. Survey No. CO-AS-005-001		2. Survey name: Moreau Drive Neighborhood Survey	
3. County: Cole		4. Address: 1202 Elmerine Ave.	
5. City: Jefferson City	Vicinity: <input type="checkbox"/>	6. UTM: / /	7. Township/Range/Section: T: R: S:
8. Historic name (if known):		9. Present/other name (if known):	
10. Ownership: <input checked="" type="checkbox"/> Private <input type="checkbox"/> Public		11. Historic use (if known): Residential	11. Current use: Residential

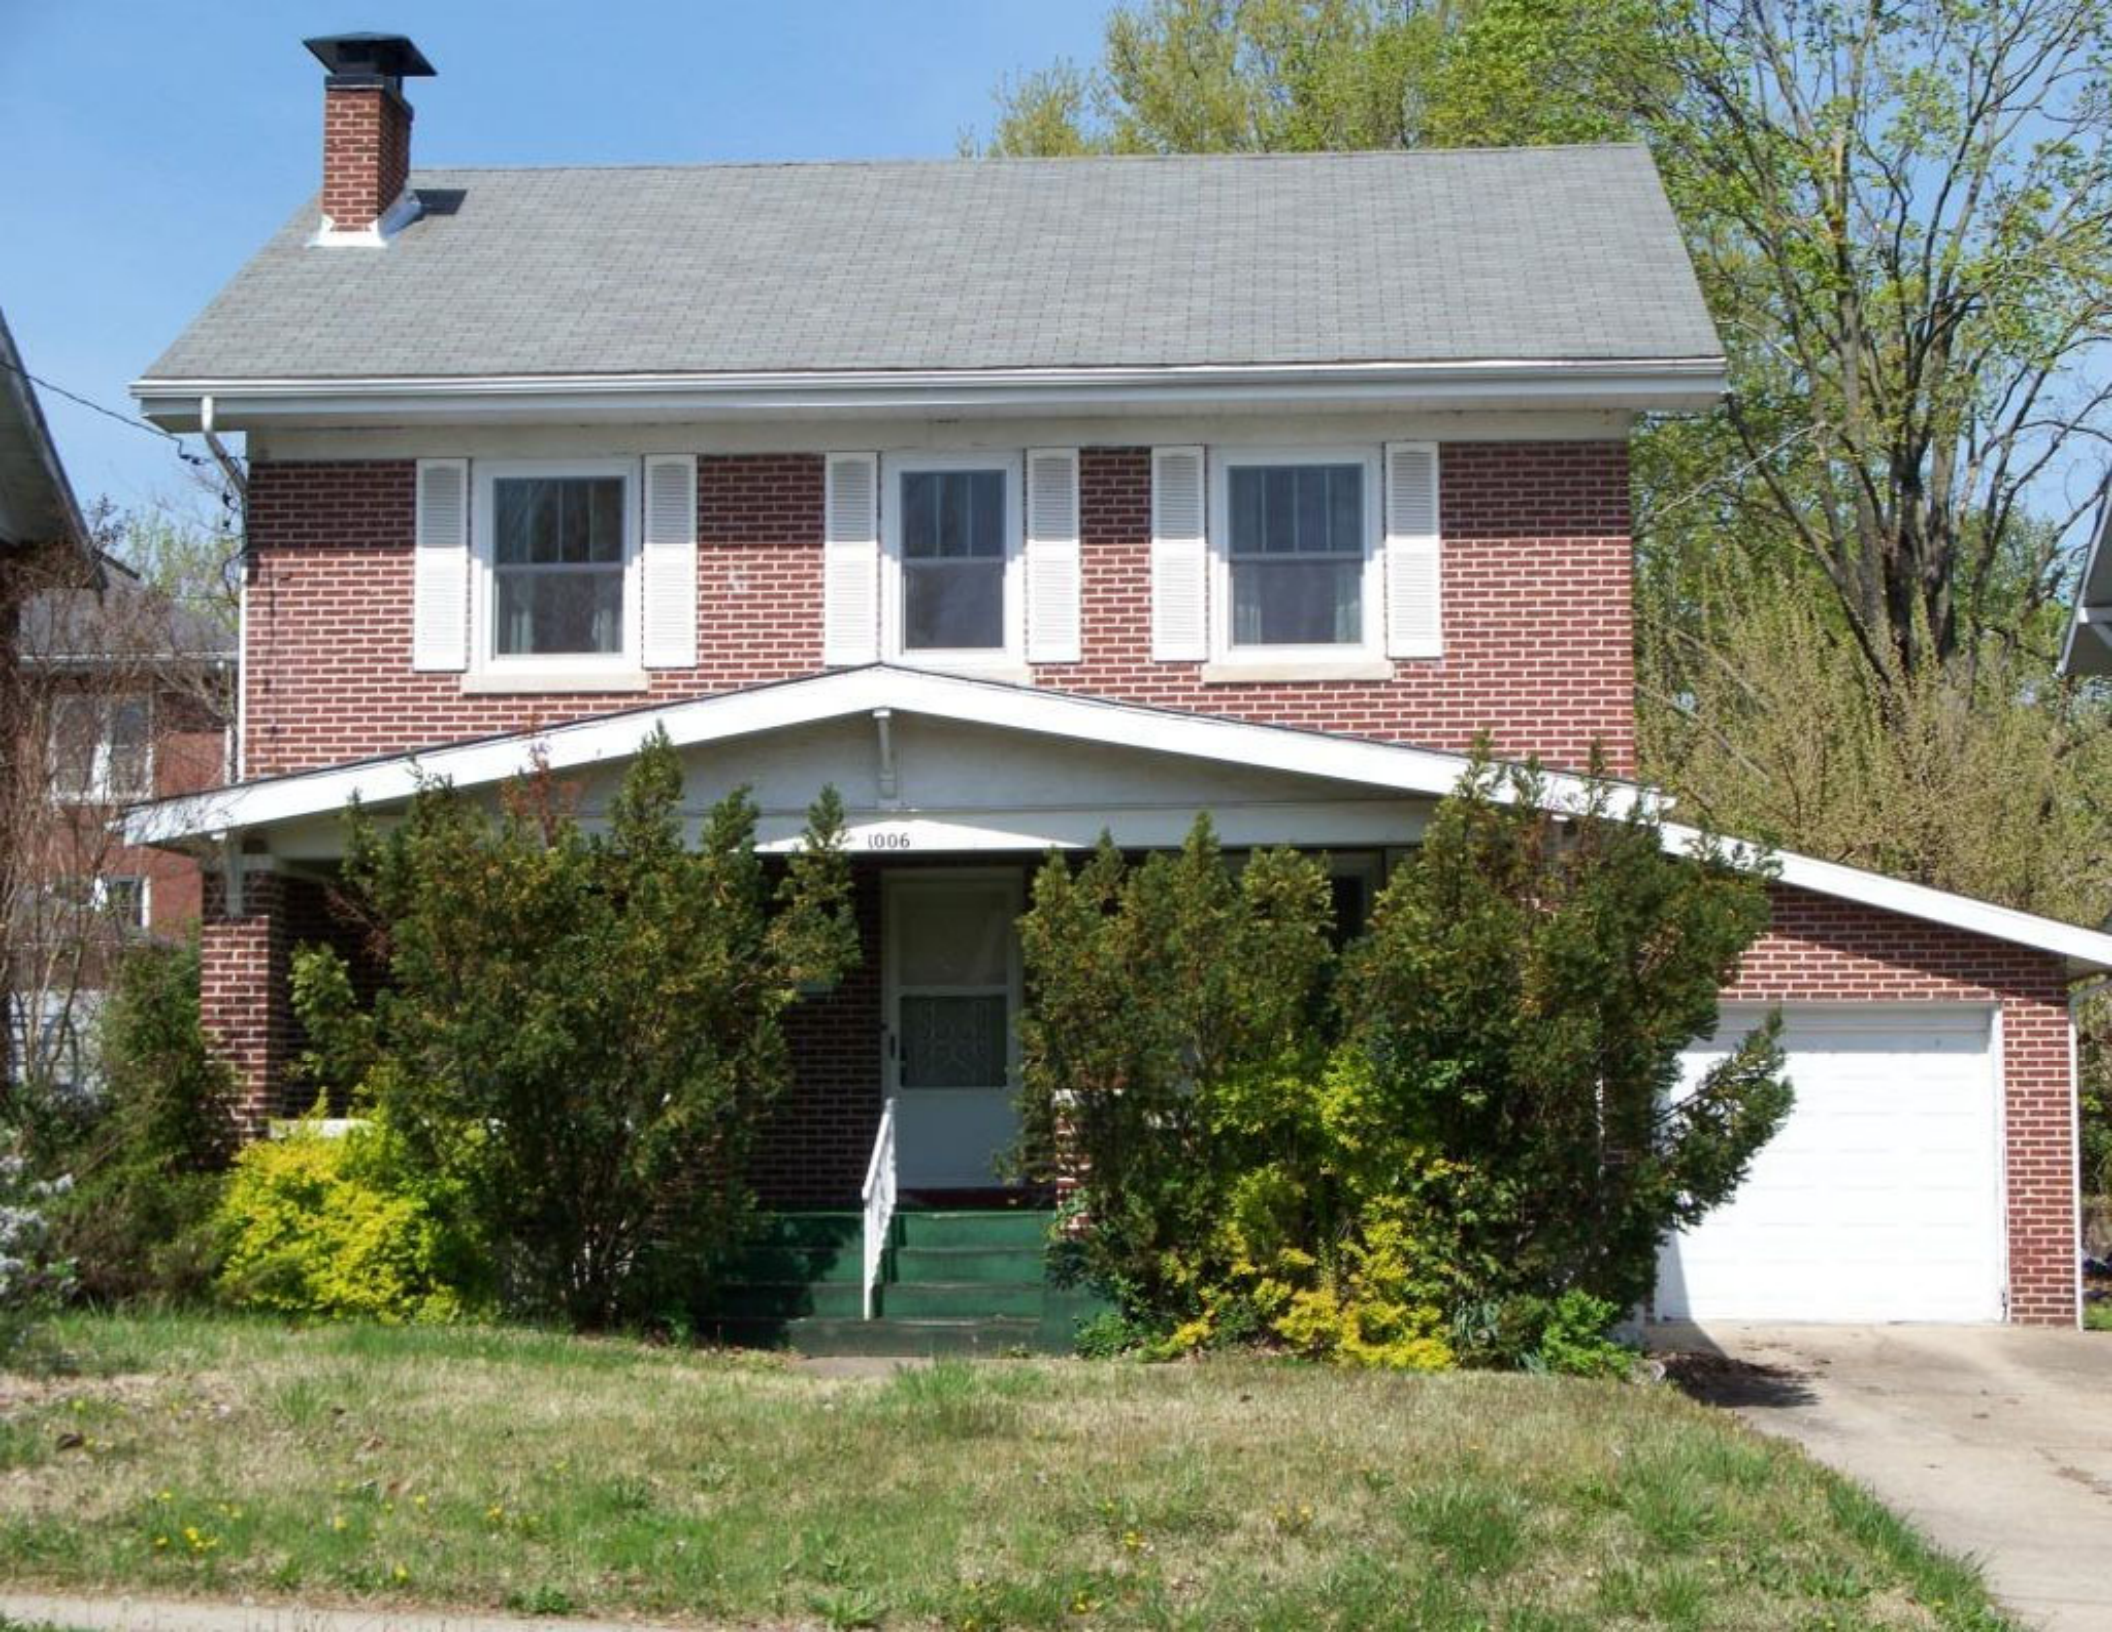
This is a two-story brick four square with a side gable roof. There are three window openings on the second floor, two 4/1 windows flank a 3/1 window. All appear historic, have shutters and stone sills. The full porch has a large gable pediment roof with supporting brick piers and half walls. Vegetation obscures the windows but the entryway is in the center. A one-car garage with a sloping roof (perhaps to give the appearance of the continuation of the first story gable porch roof) is attached to the right of the property.

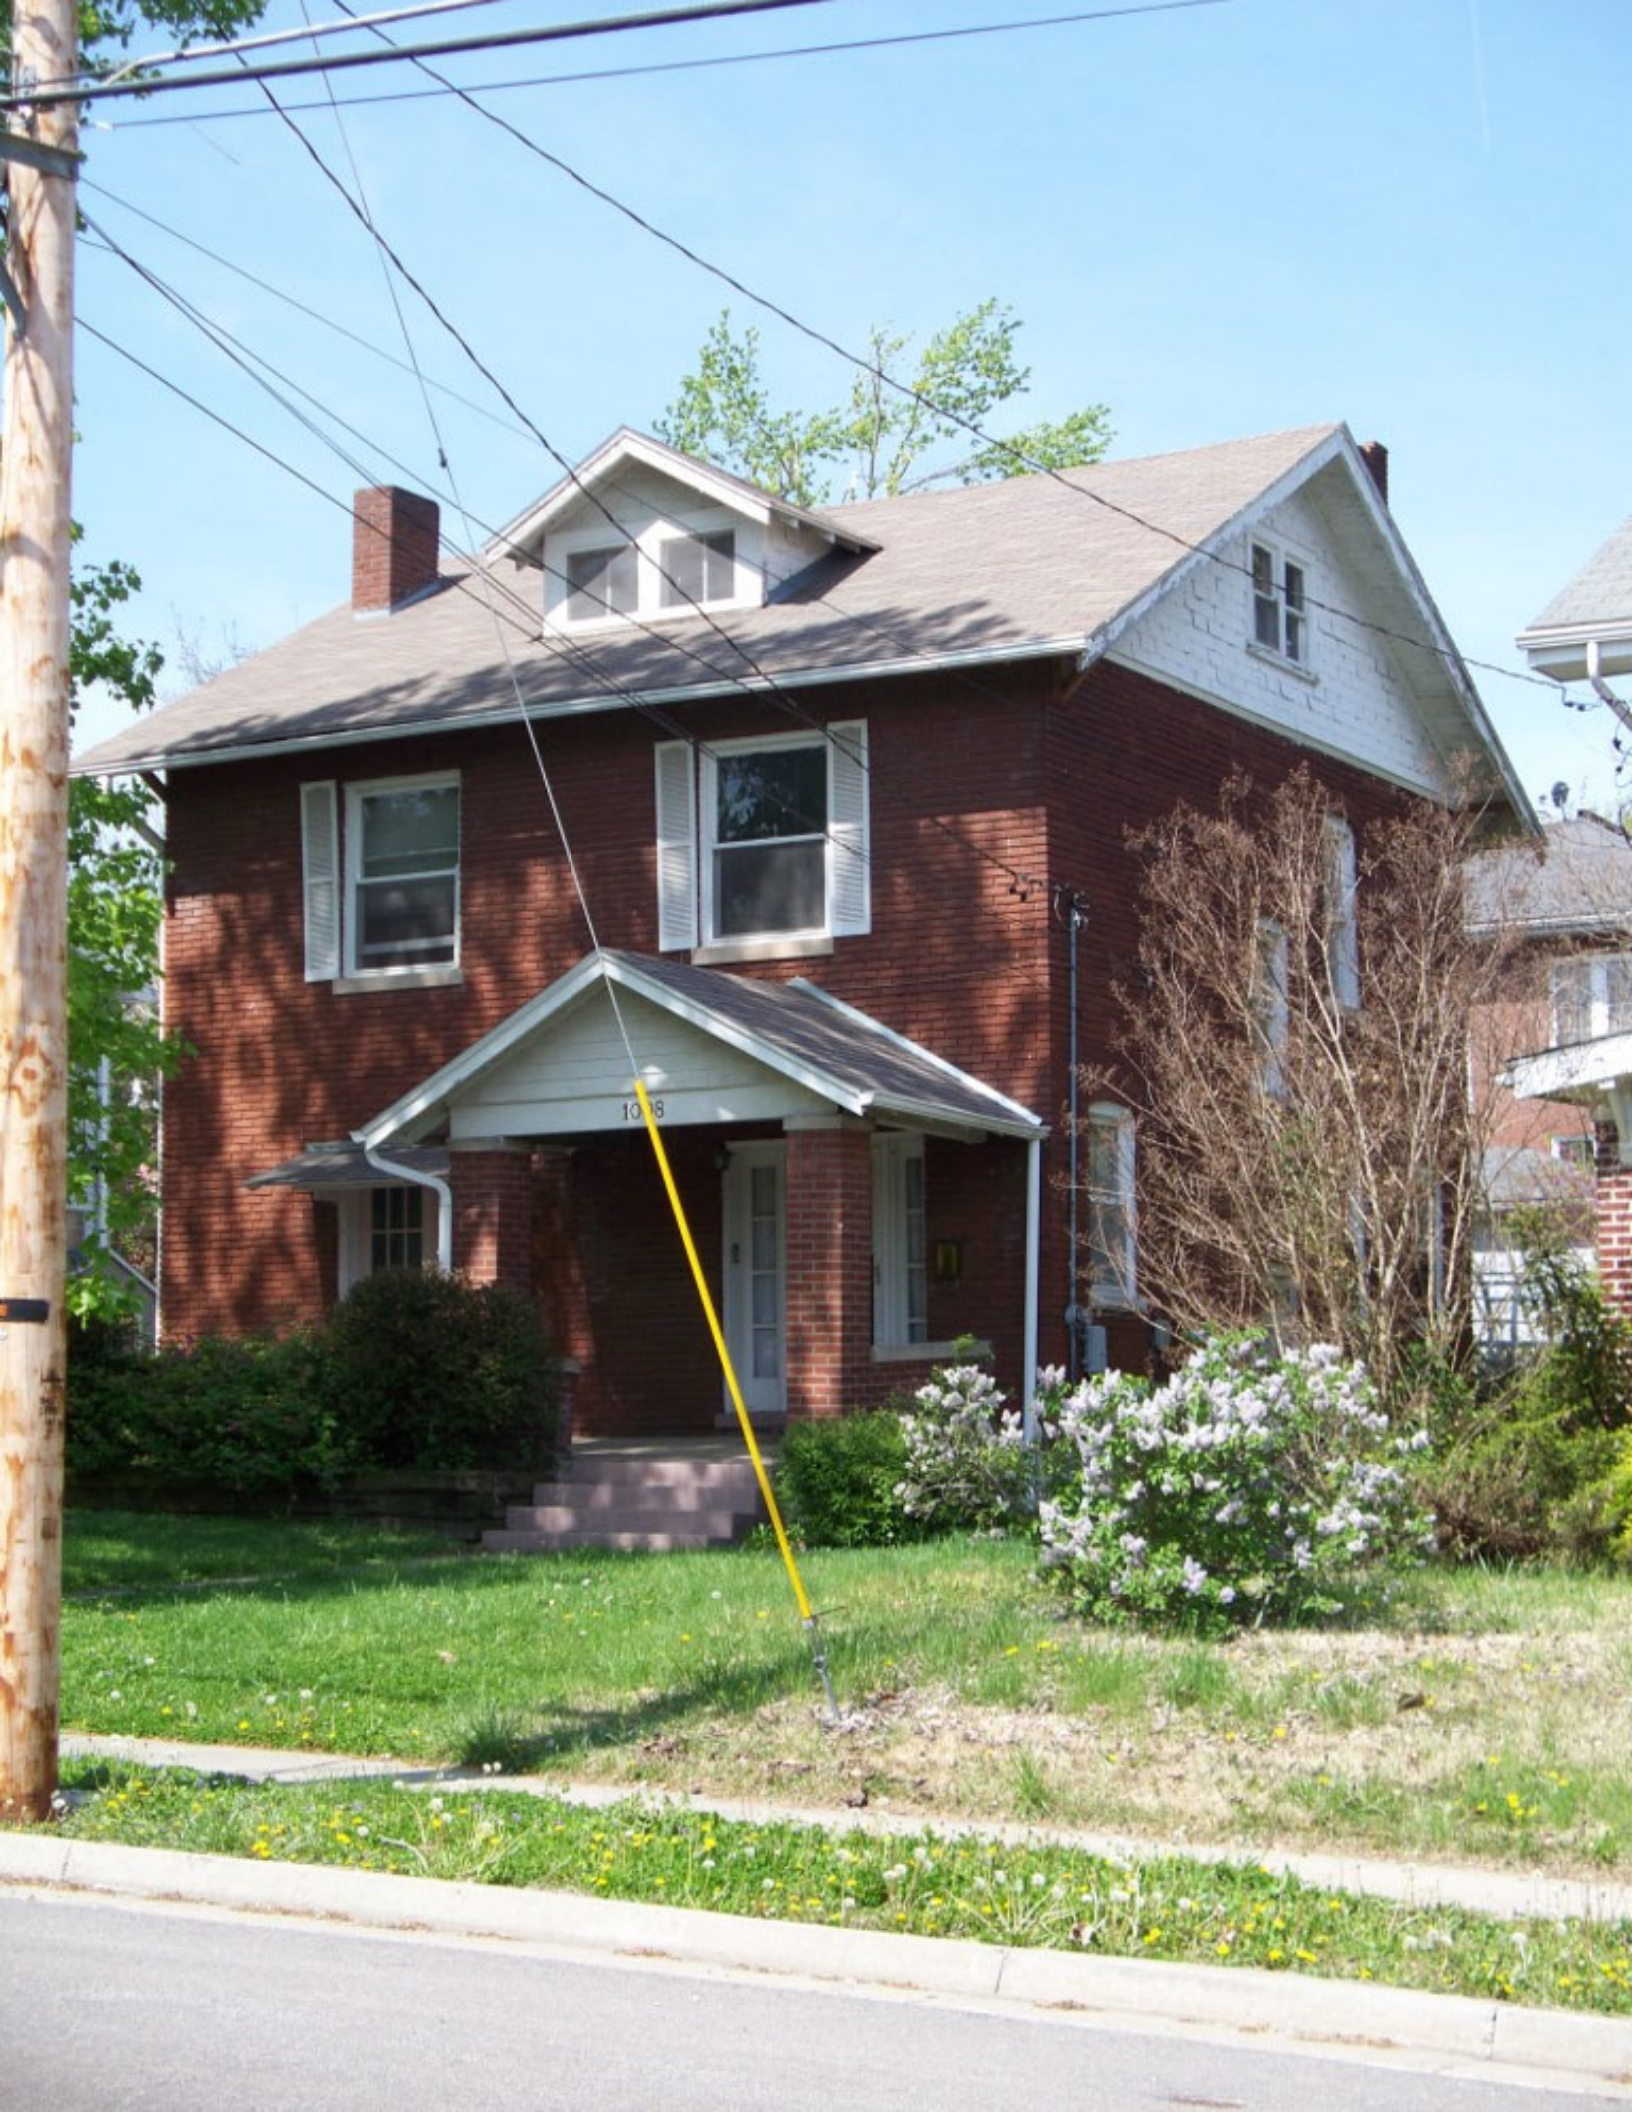
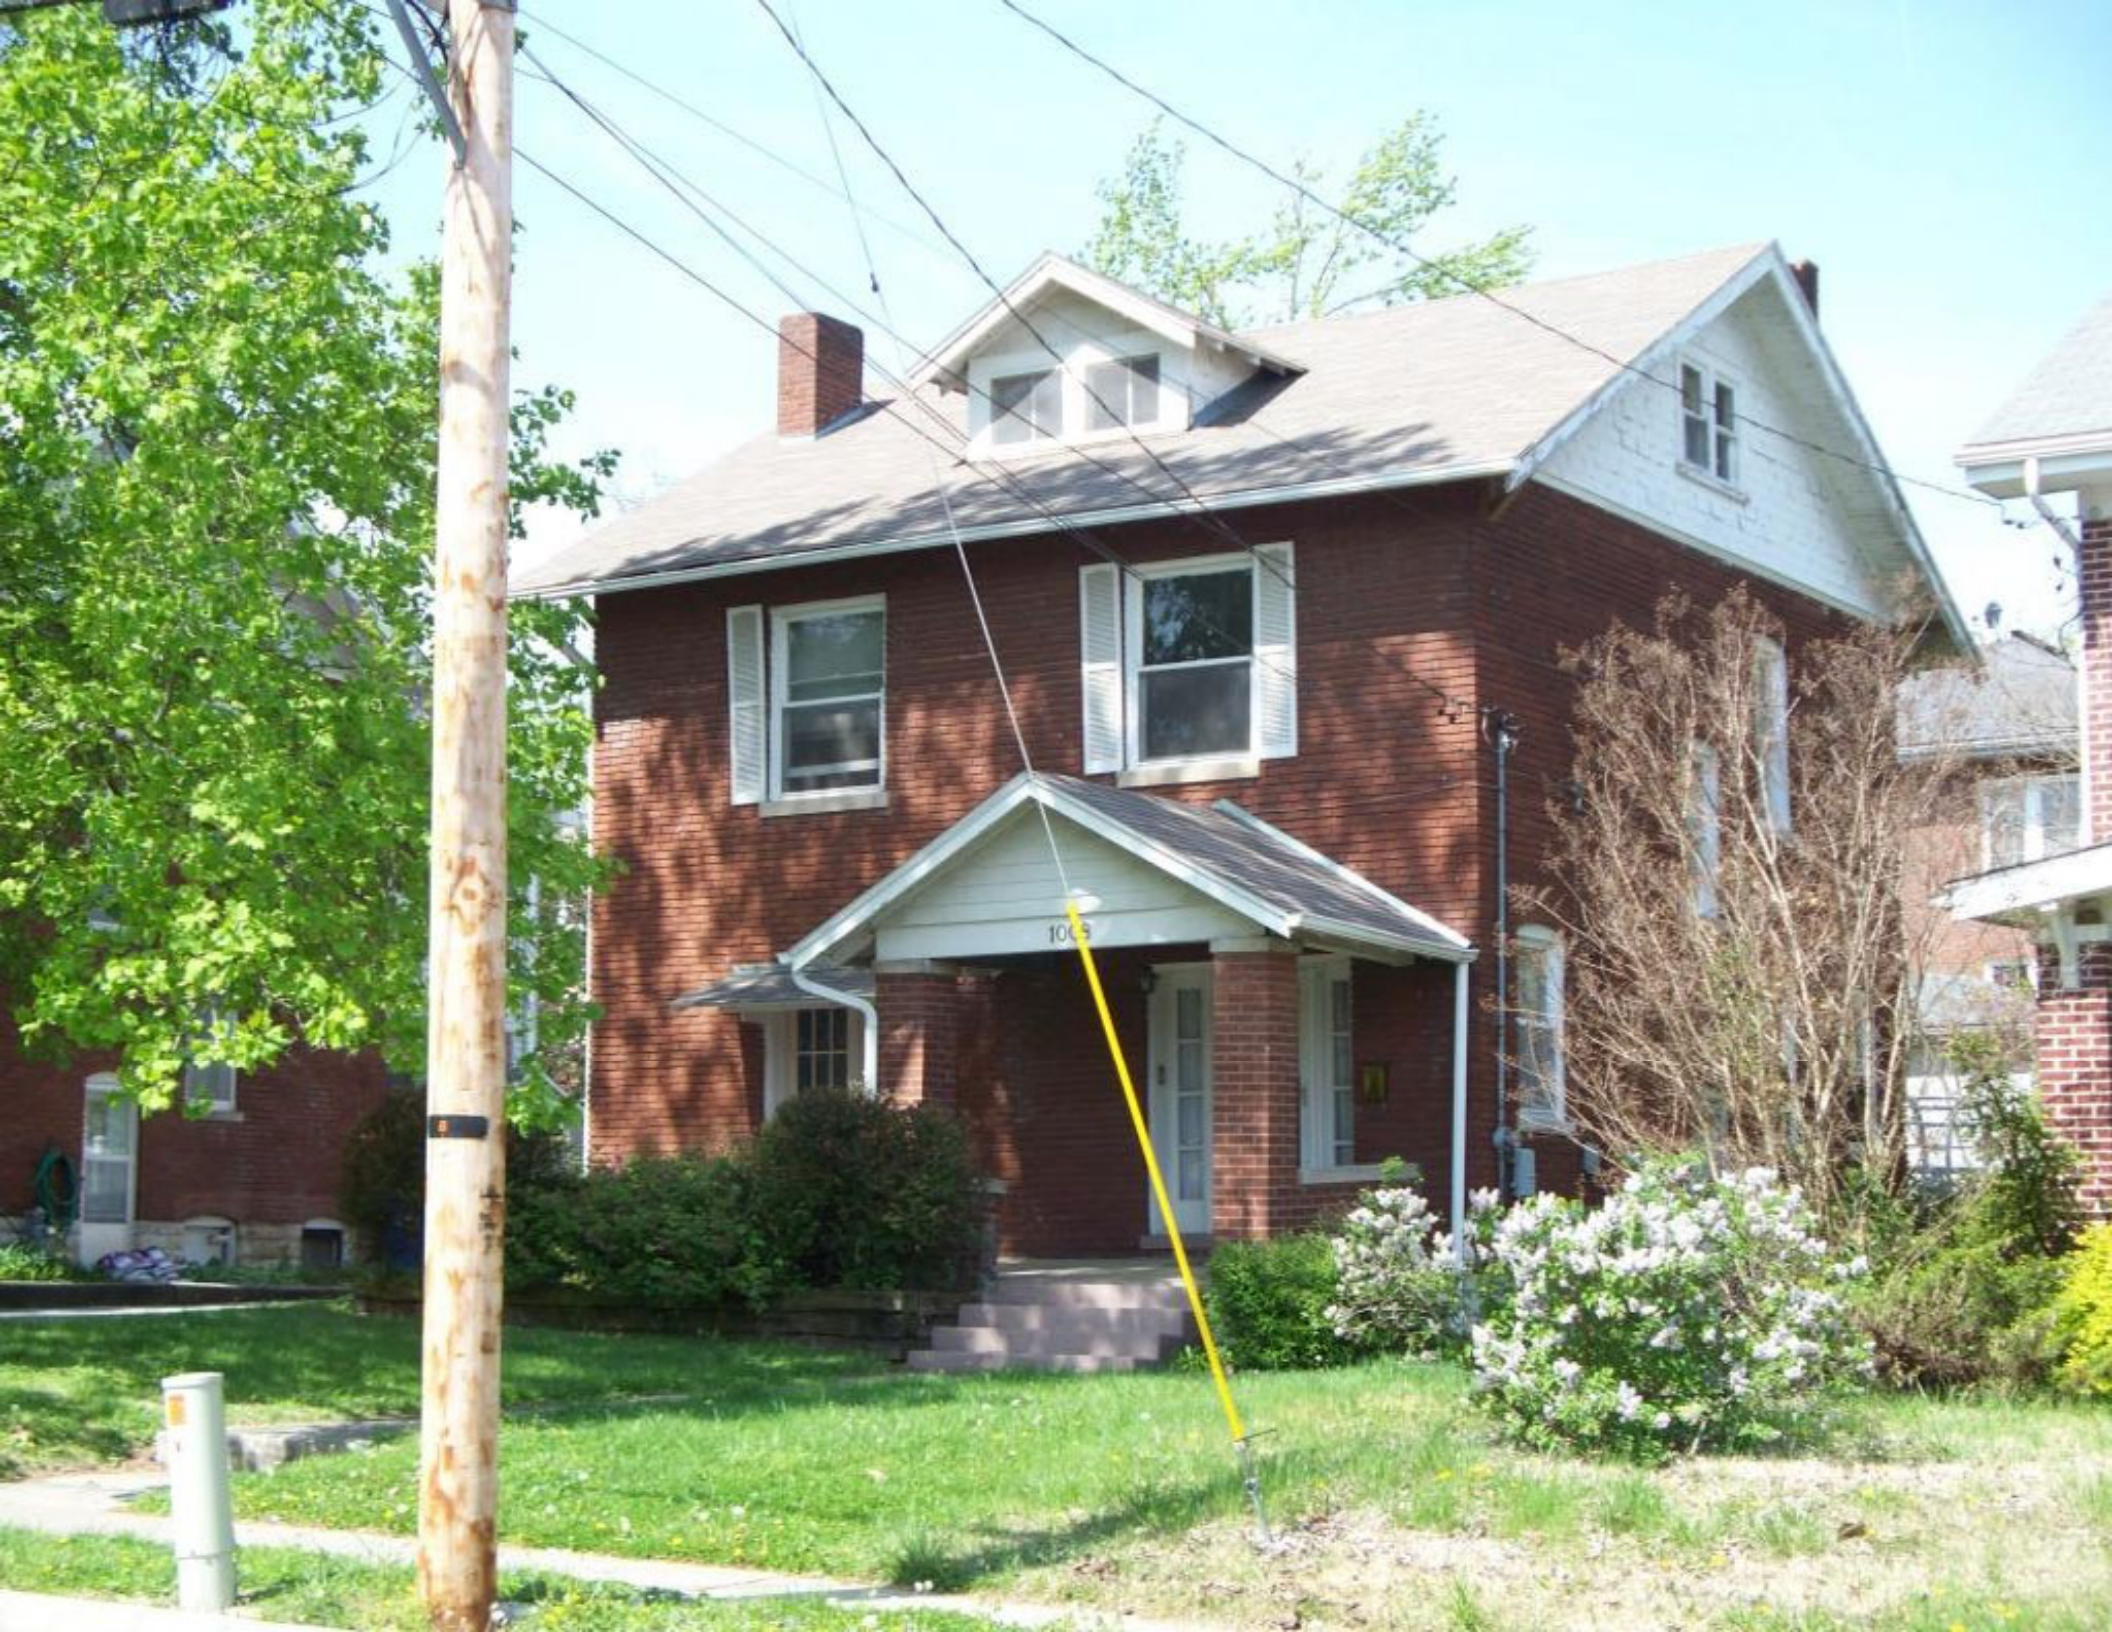
40. (cont.) Description of environment and outbuildings. Expand box as necessary, or add continuation pages.
There is a historic brick garage with two stalls, may have originally been shared with 1010 Moreau. There does not appear to be any doors and there is some metal coping and decorative brick work. There are stone lintels above each opening. It is considered contributing to the district

41. (cont.)
Two-and-a-half-story brick four square with side gable roof pierced by a central dormer. The dormer has a gable roof with rafter tails and two two-by-two wooden casement windows. The second story has two 1/1 wooden windows that appear historic. Both have shutters although the window on the left is missing one side. The first story has a large brick portico with a pediment roof offset to the right. The entrance has large sidelights. It is unknown if the door is original or not. The opening to the left may have been altered, vegetation obscured the photo but this window may have been enlarged to an entrance. A shed roof covers this bay. Comparing this property to its neighbor at 1010 Moreau, the porch may have at one time been full-width.

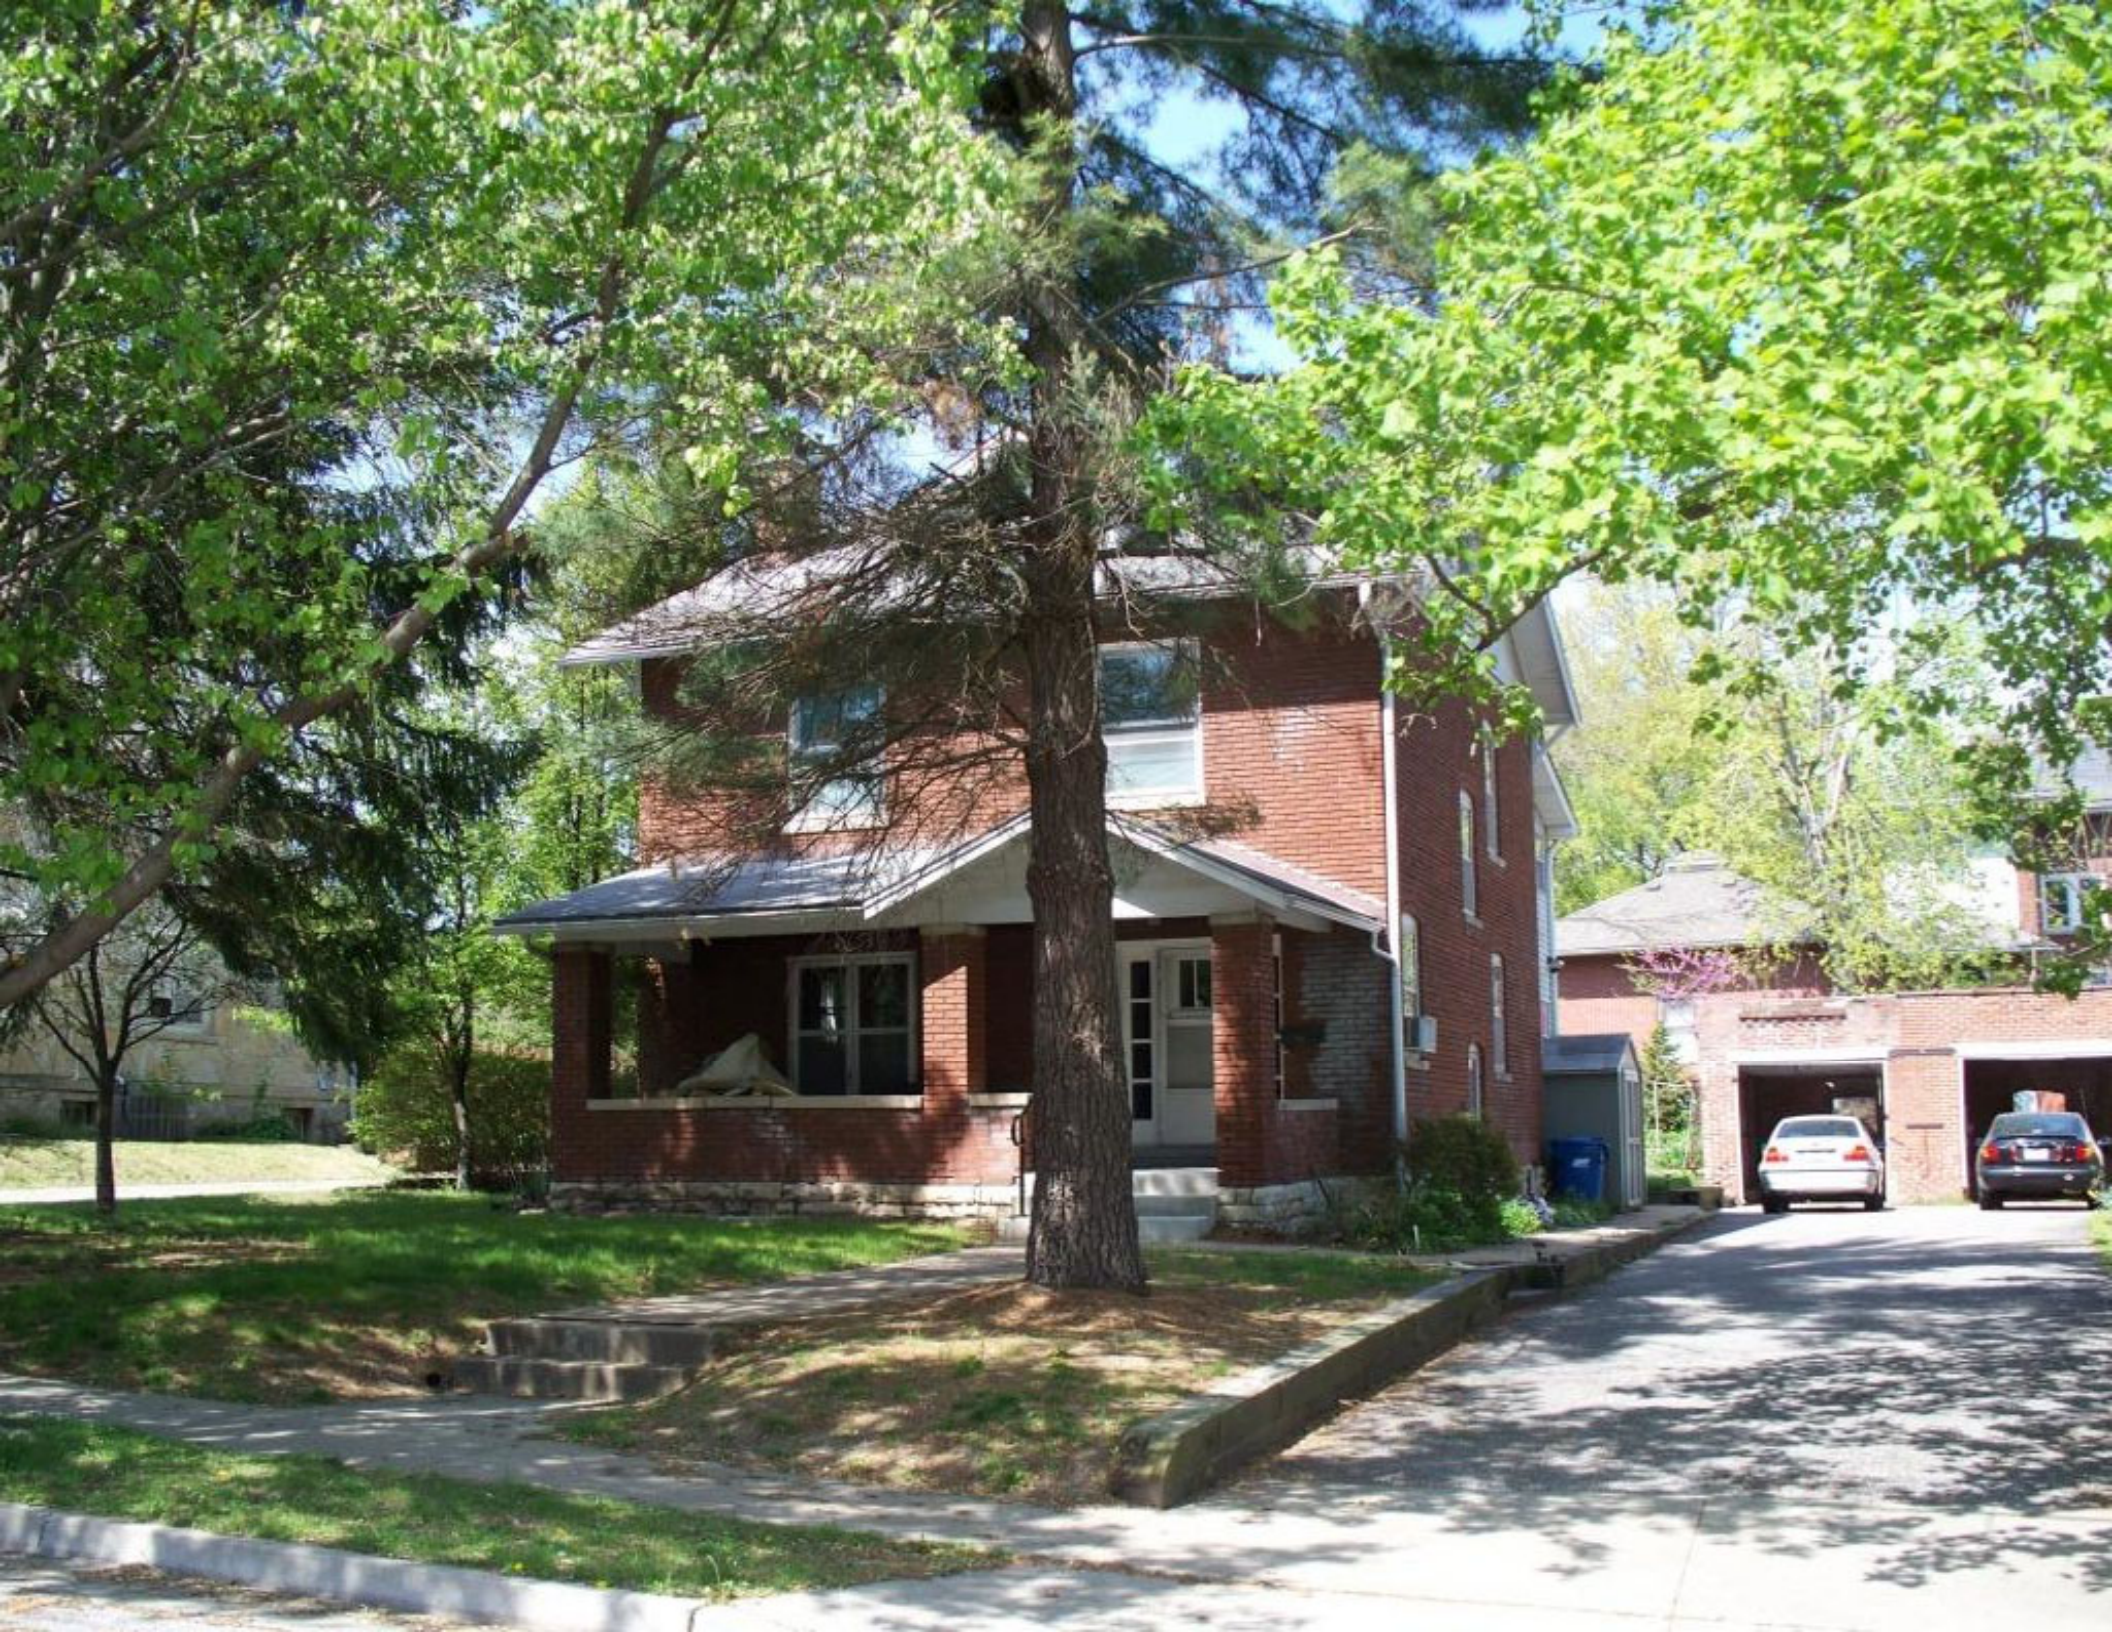
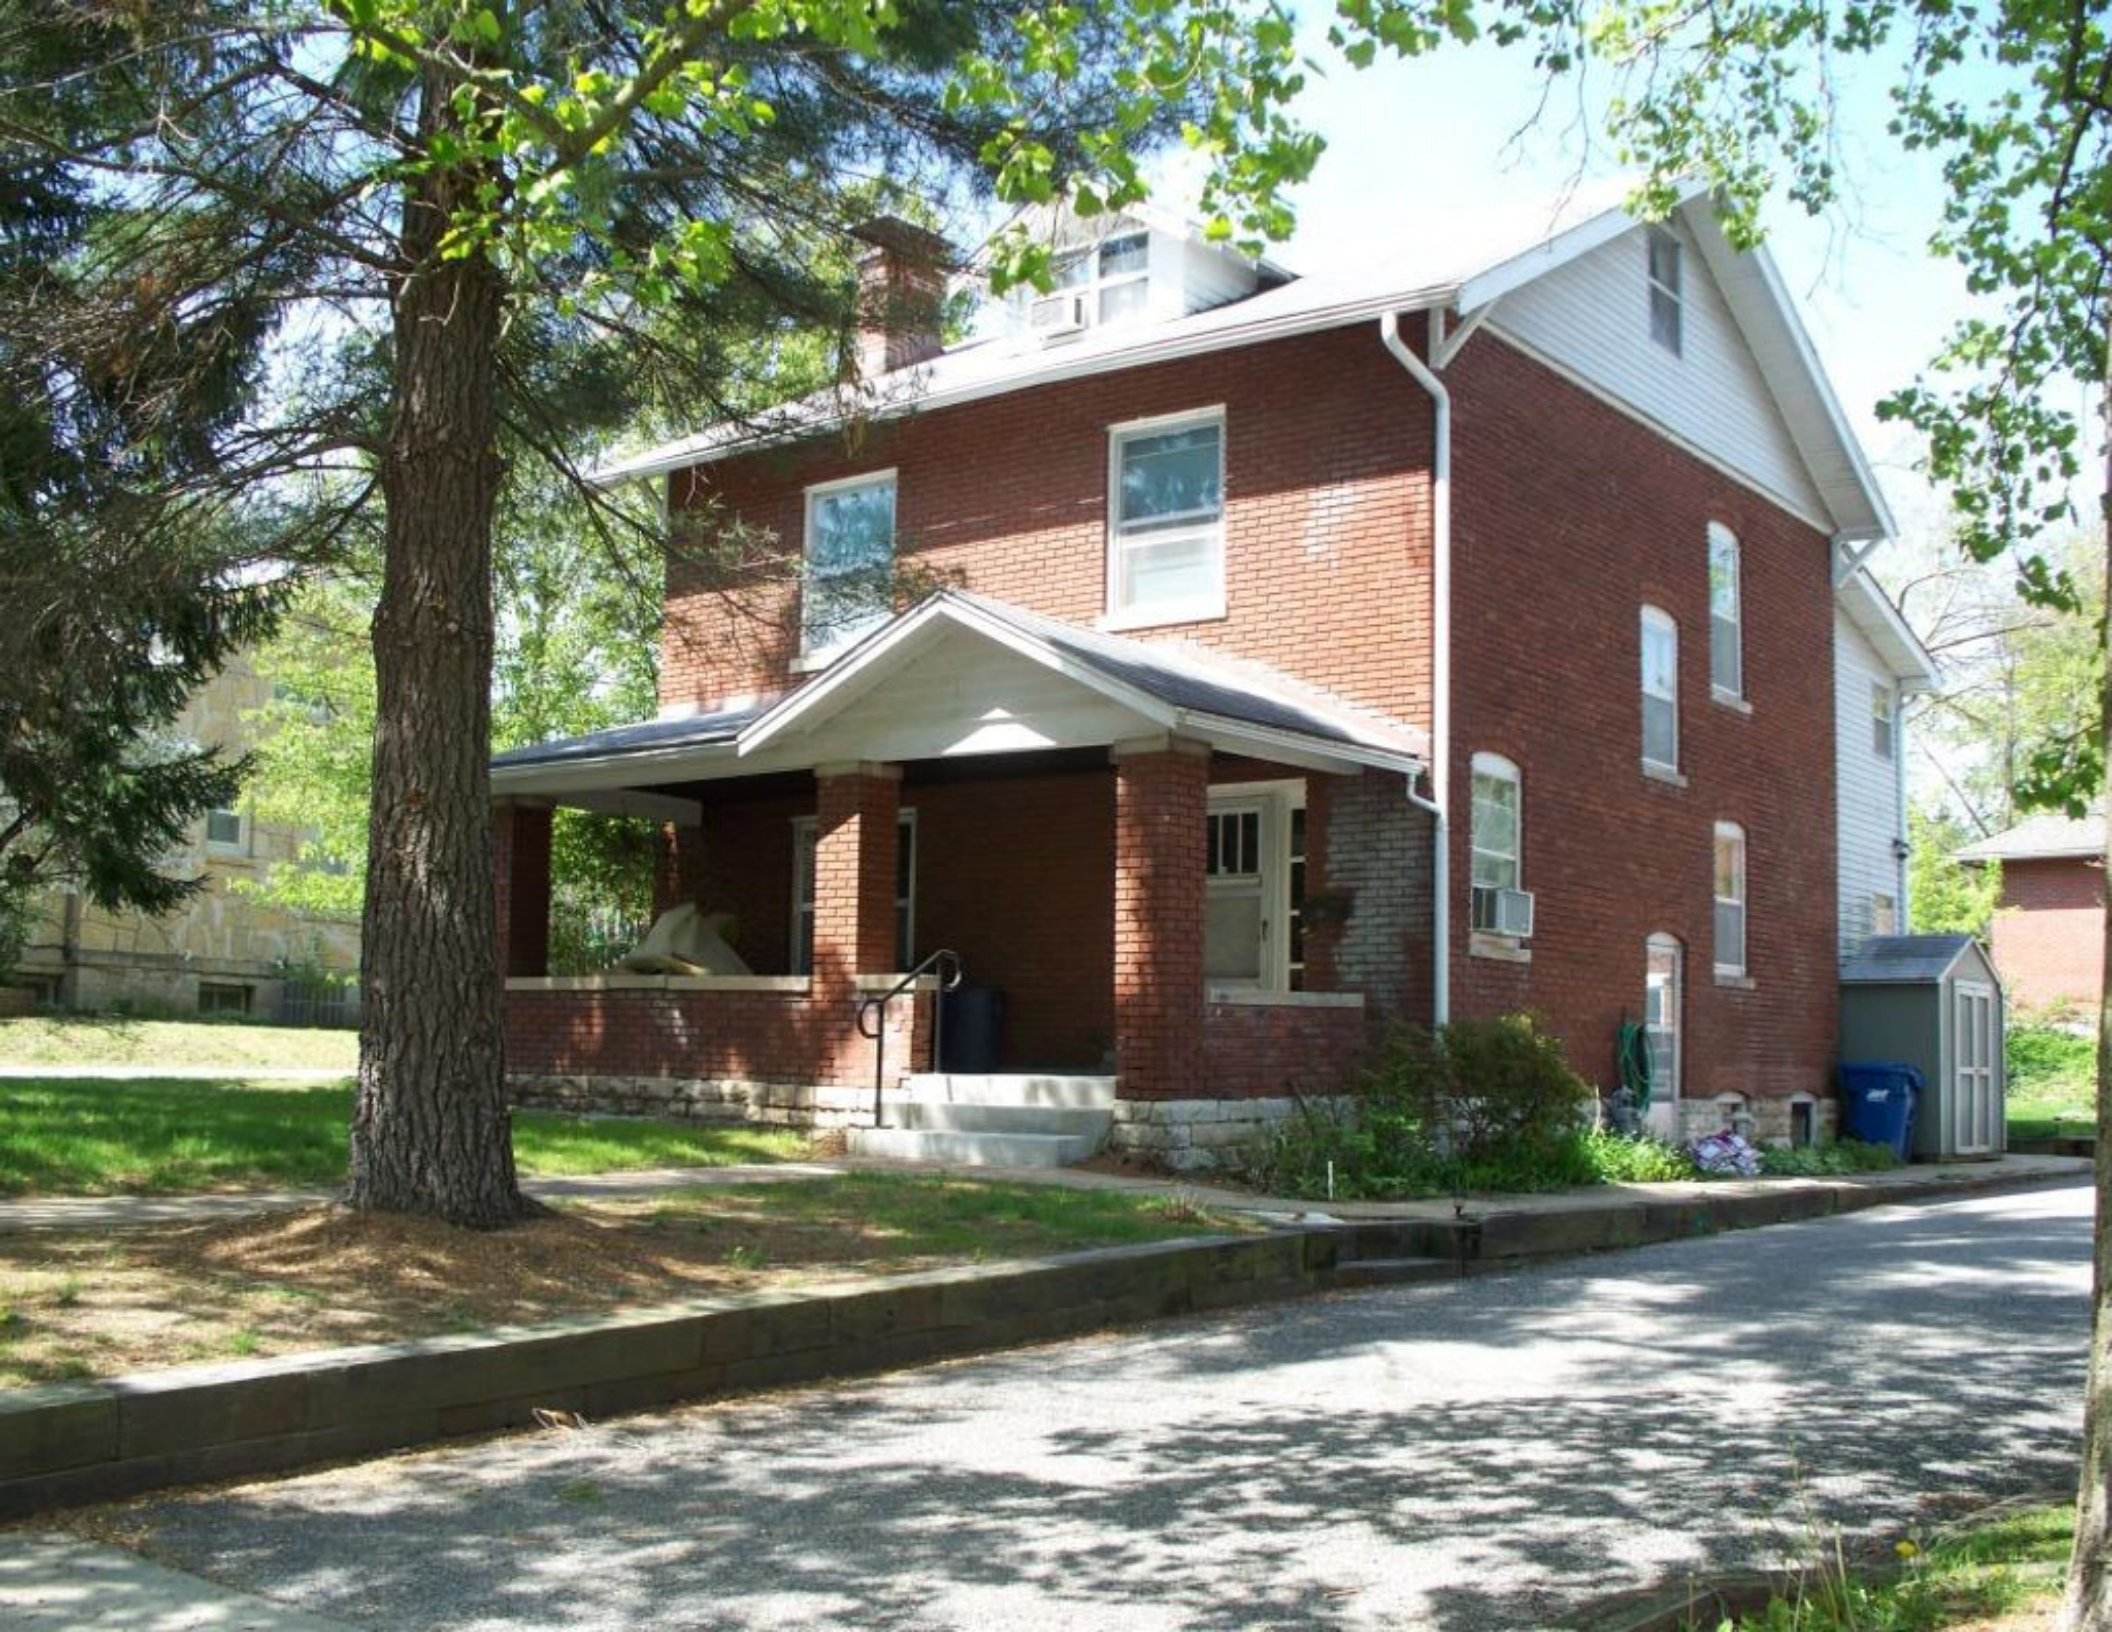
40. (cont.) Description of environment and outbuildings. Expand box as necessary, or add continuation pages.
Two car historic brick garage that may be shared with 2008 Moreau Drive (see 2008 Moreau Drive inventory form.)

41. (cont.)
This property is very similar to 2008 Moreau Drive. It is a two-and-a-half-story brick four square with side gable roof pierced by a central dormer. The dormer has a gable roof with rafter tails and paired 1/1 windows that could be replacements. There is currently an air conditioning unit placed in the left opening. The second story has two 1/1 aluminum windows. The first story has a full width shed roof that turns into a pediment roof over the entrance on the right. The entrance has large sidelights and appears to retain its original wooden door with three fixed lights. The opening to the left appears to be a French door. The porch has brick knee walls and piers that are capped in limestone.

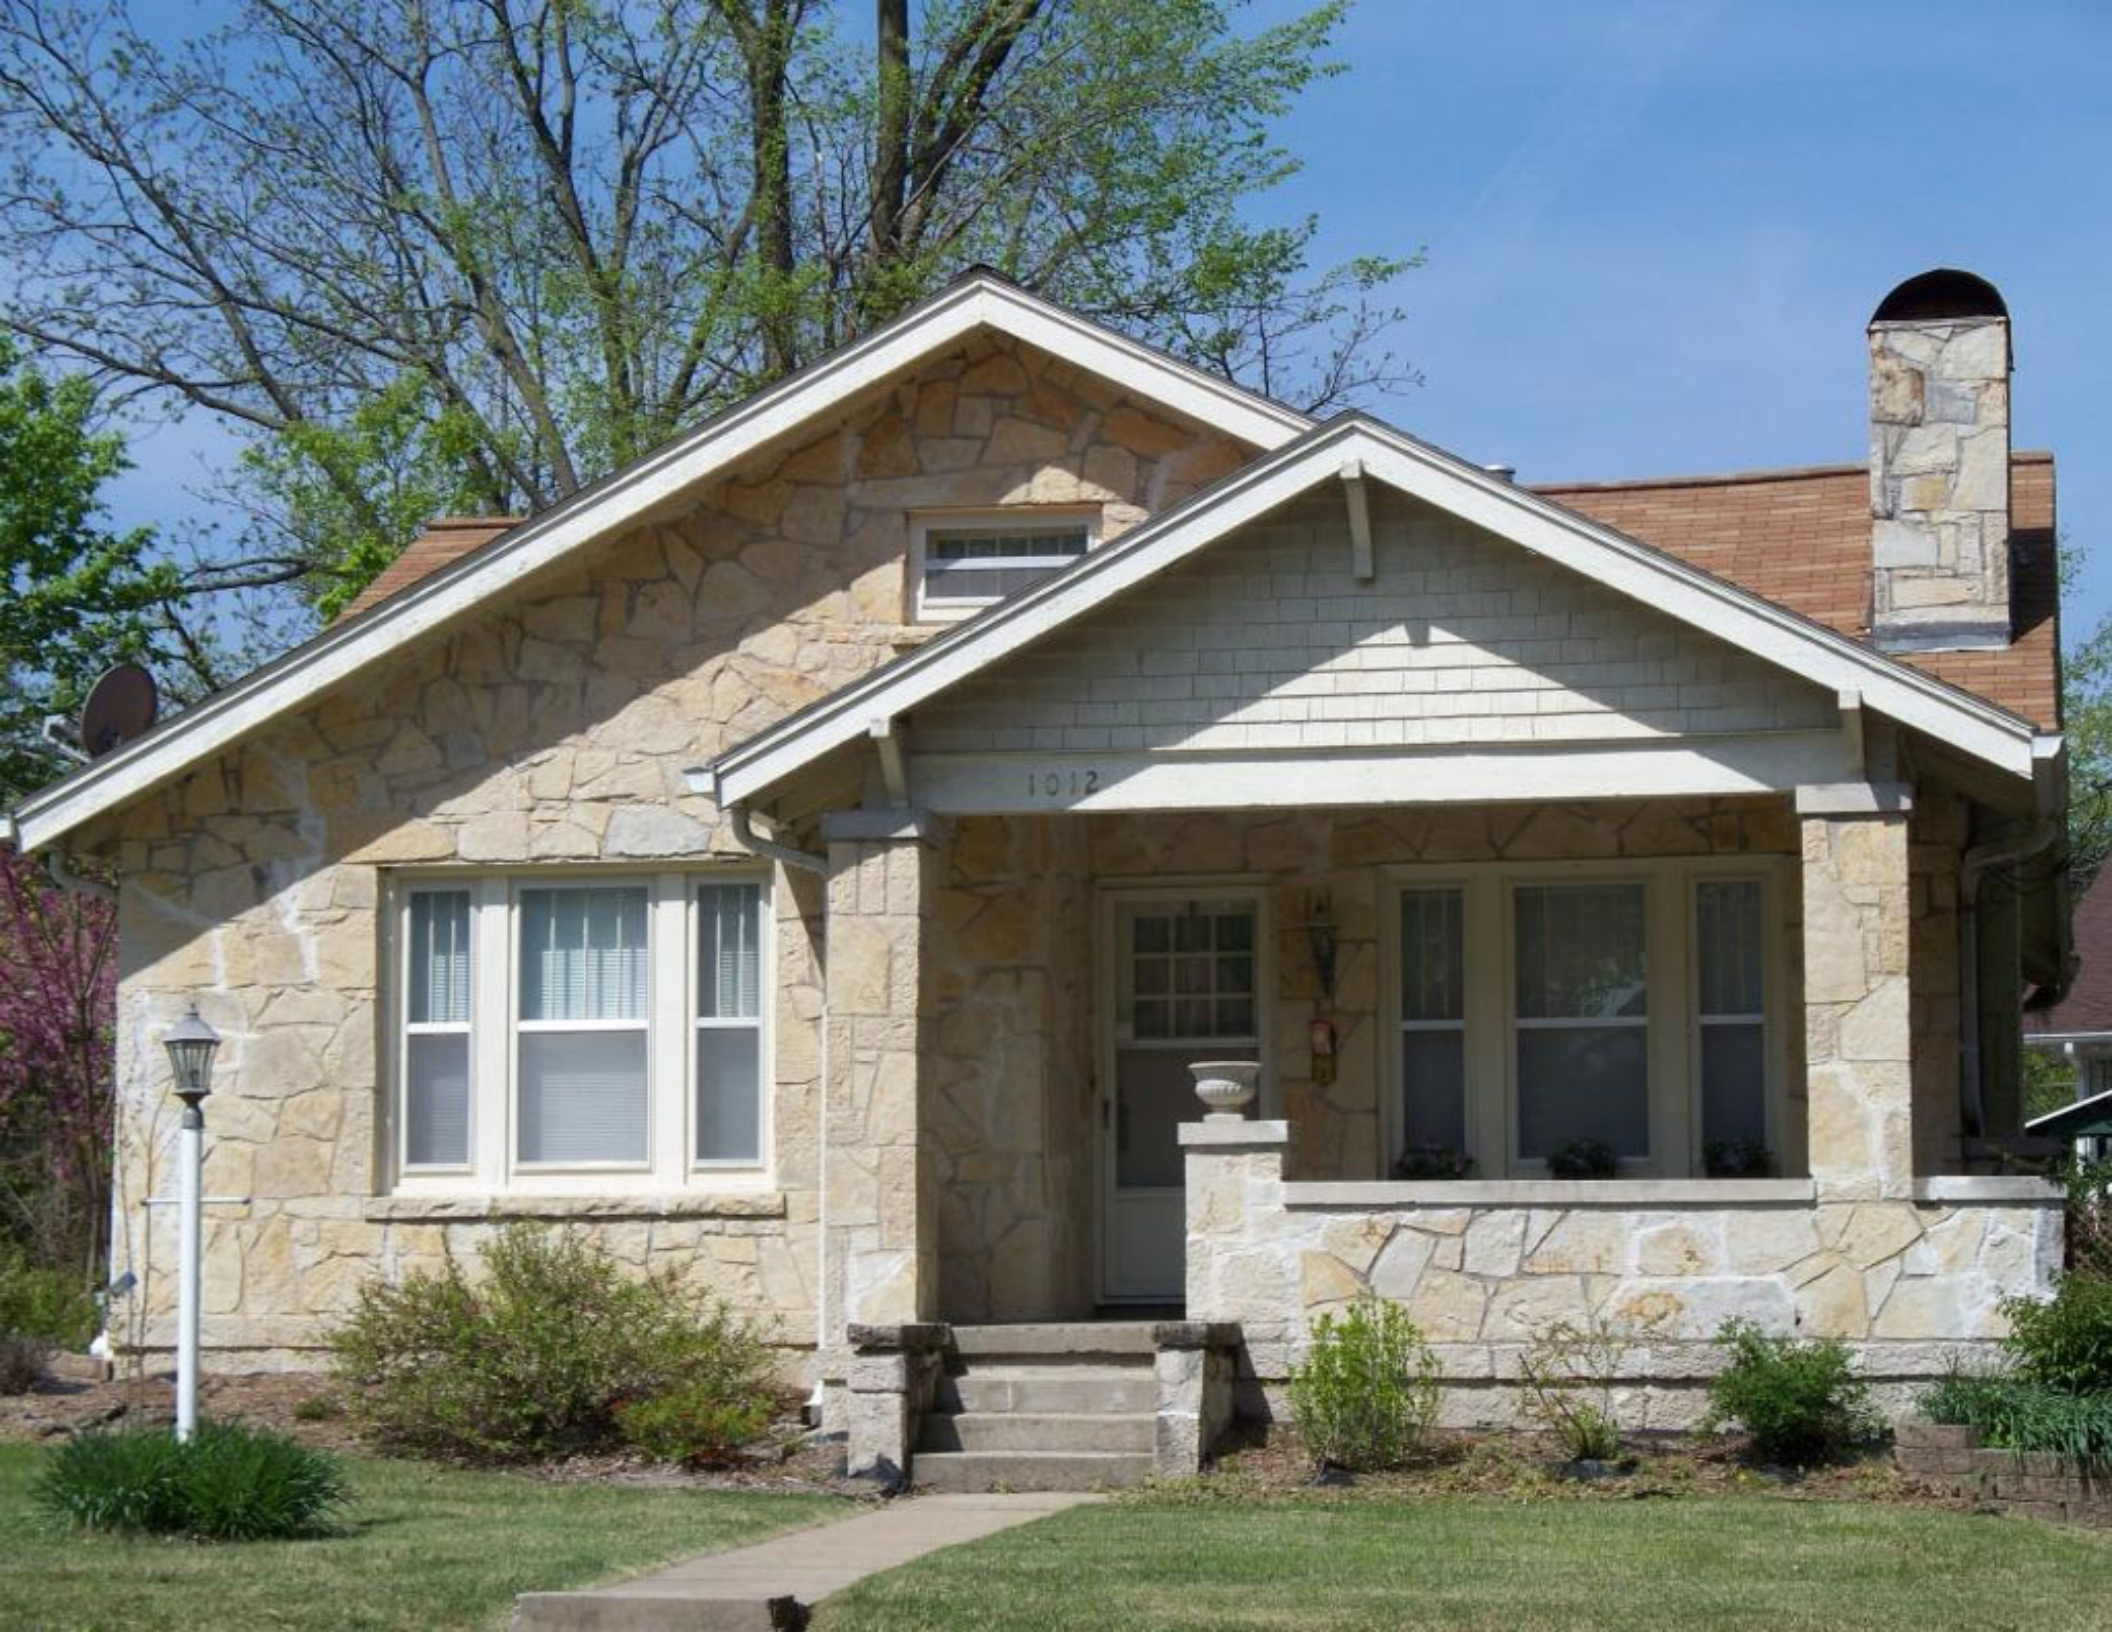
This one-and-a-half-story stone bungalow has a gable roof with a small fixed five-light window (with storm) in the gable. The left bay on the first story has tri-part historic window with two 3/1 flanking a larger 4/1. The entrance and right bay is slightly recessed and has a gable roof with brackets that extends from the rest of the property. It is supported by stone piers that connect to a stone knee wall; all are capped with limestone. The right bay has a tri-part window identical to the window in left bay. The entrance appears to retain its historic nine-light wooden door.
