ARCHITECTURAL/HISTORIC INVENTORY FORM

1. Survey No. CO-AS-005-001		2. Survey name: Moreau Drive Neighborhood Survey	
3. County: Cole		4. Address: 1202 Elmerine Ave.	
5. City: Jefferson City	Vicinity: <input type="checkbox"/>	6. UTM: / /	7. Township/Range/Section: T: R: S:
8. Historic name (if known):		9. Present/other name (if known):	
10. Ownership: <input checked="" type="checkbox"/> Private <input type="checkbox"/> Public		11. Historic use (if known): Residential	11. Current use: Residential

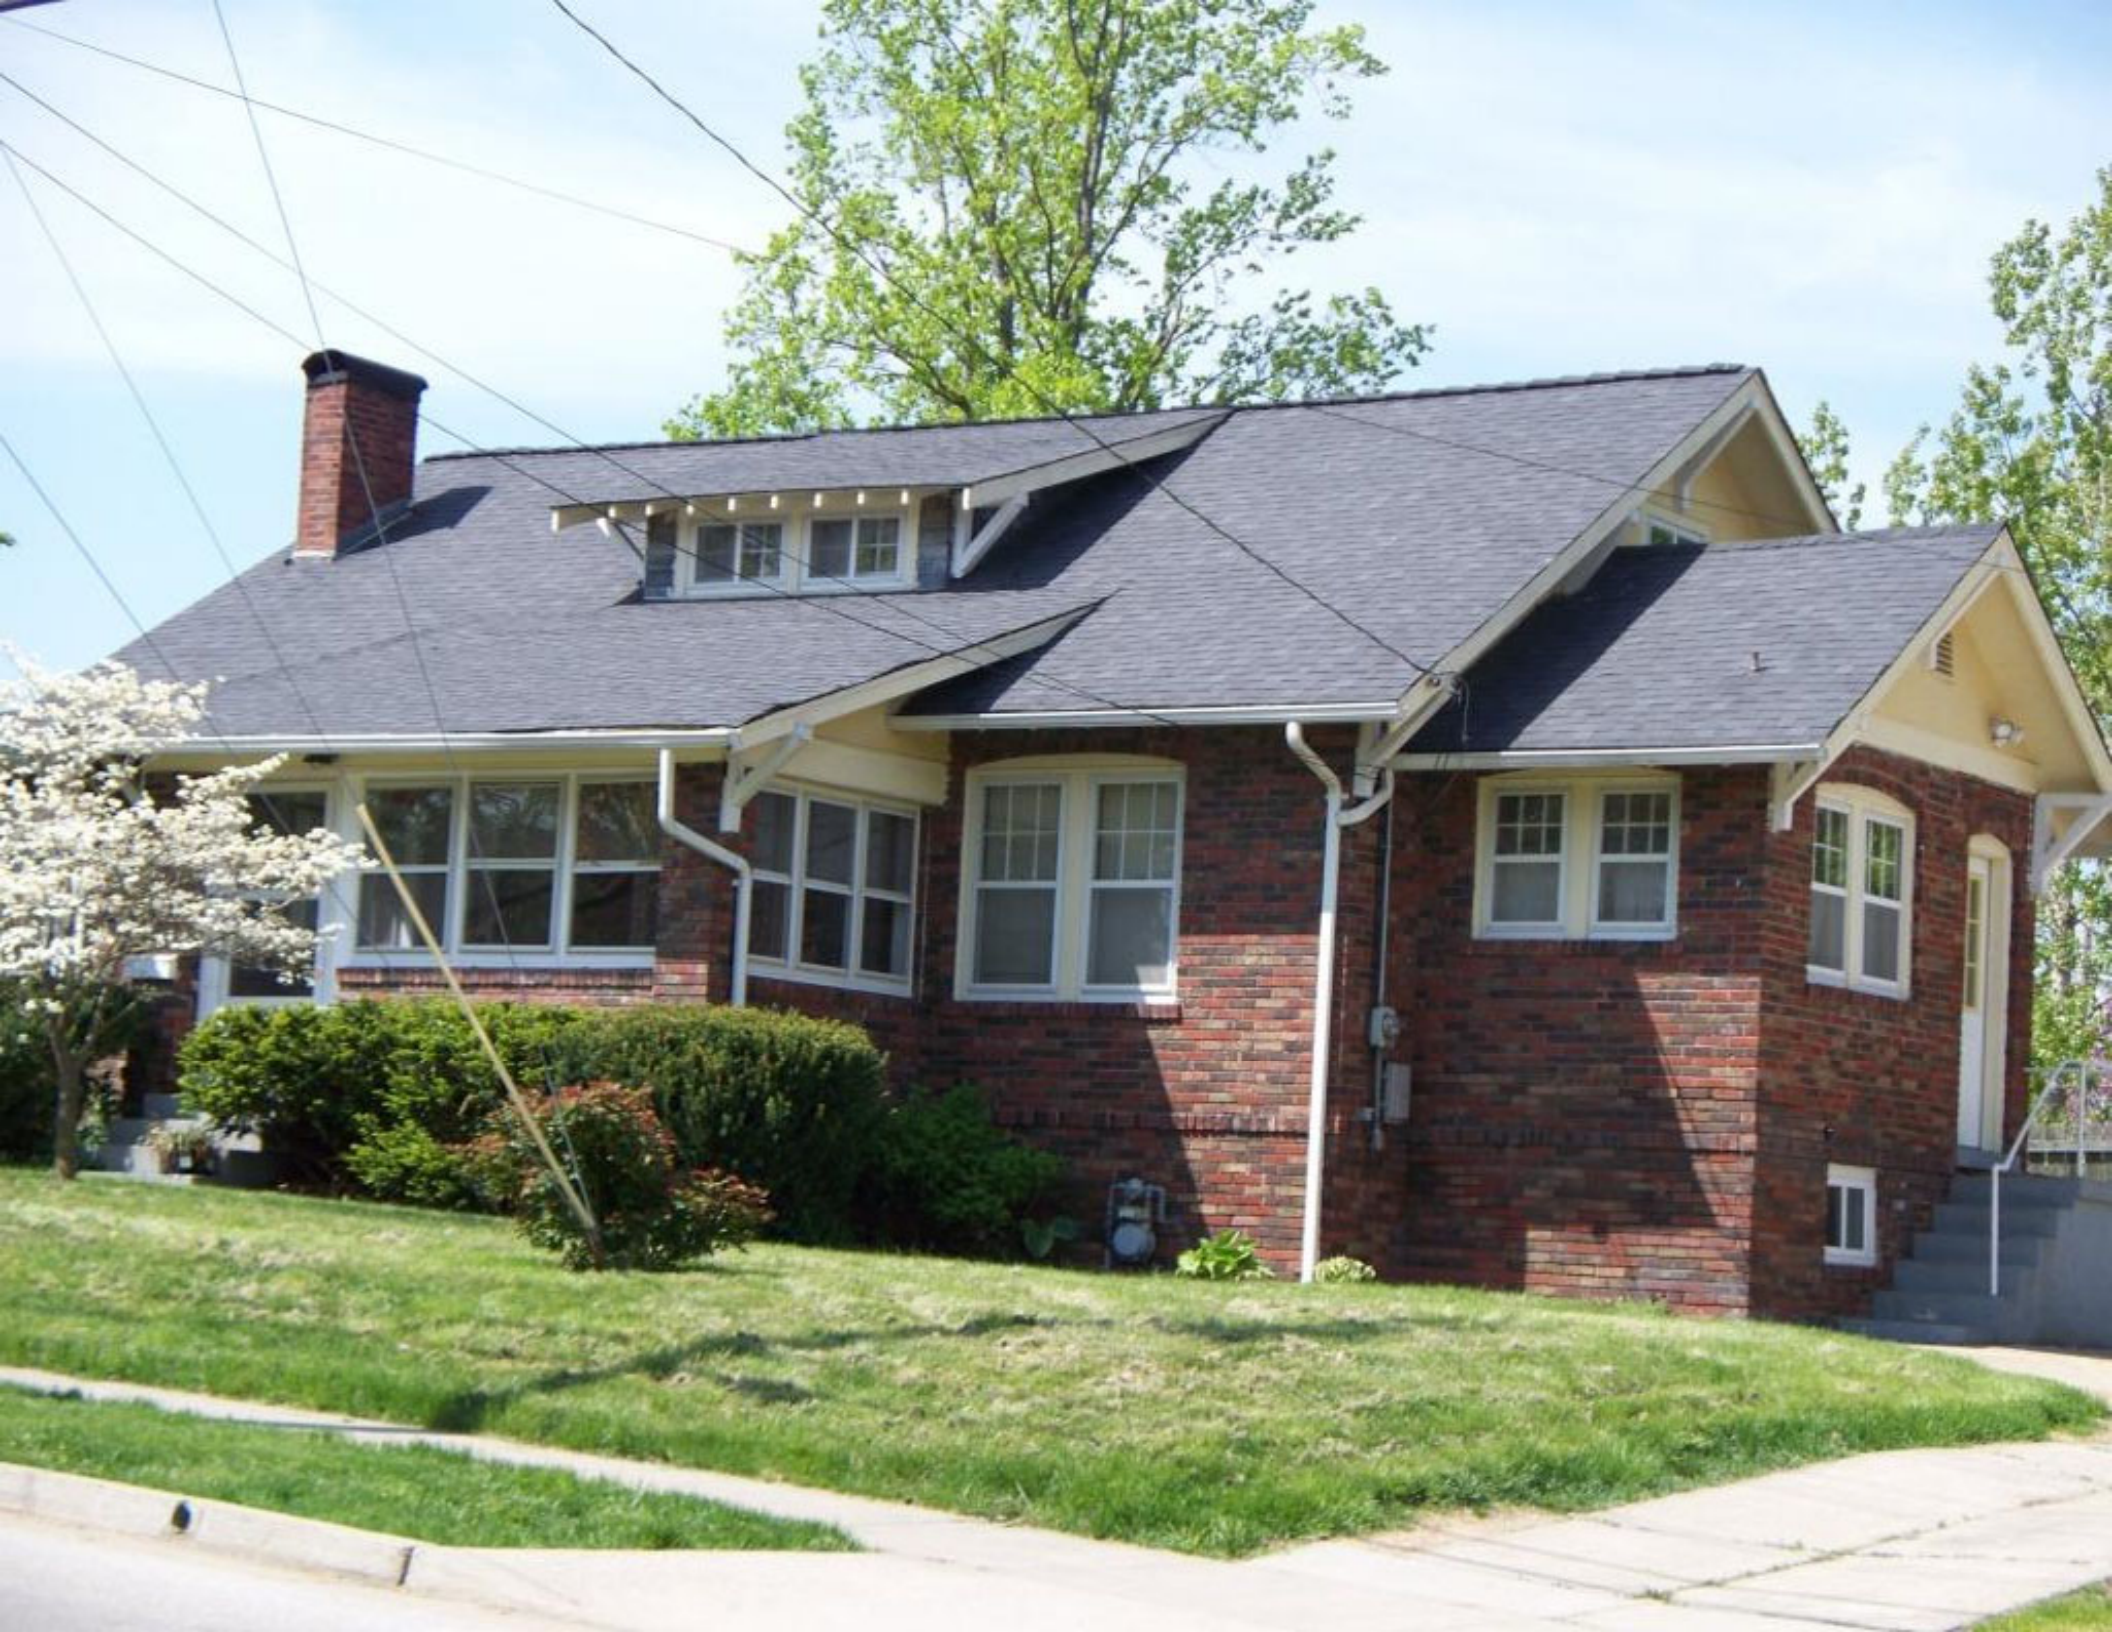
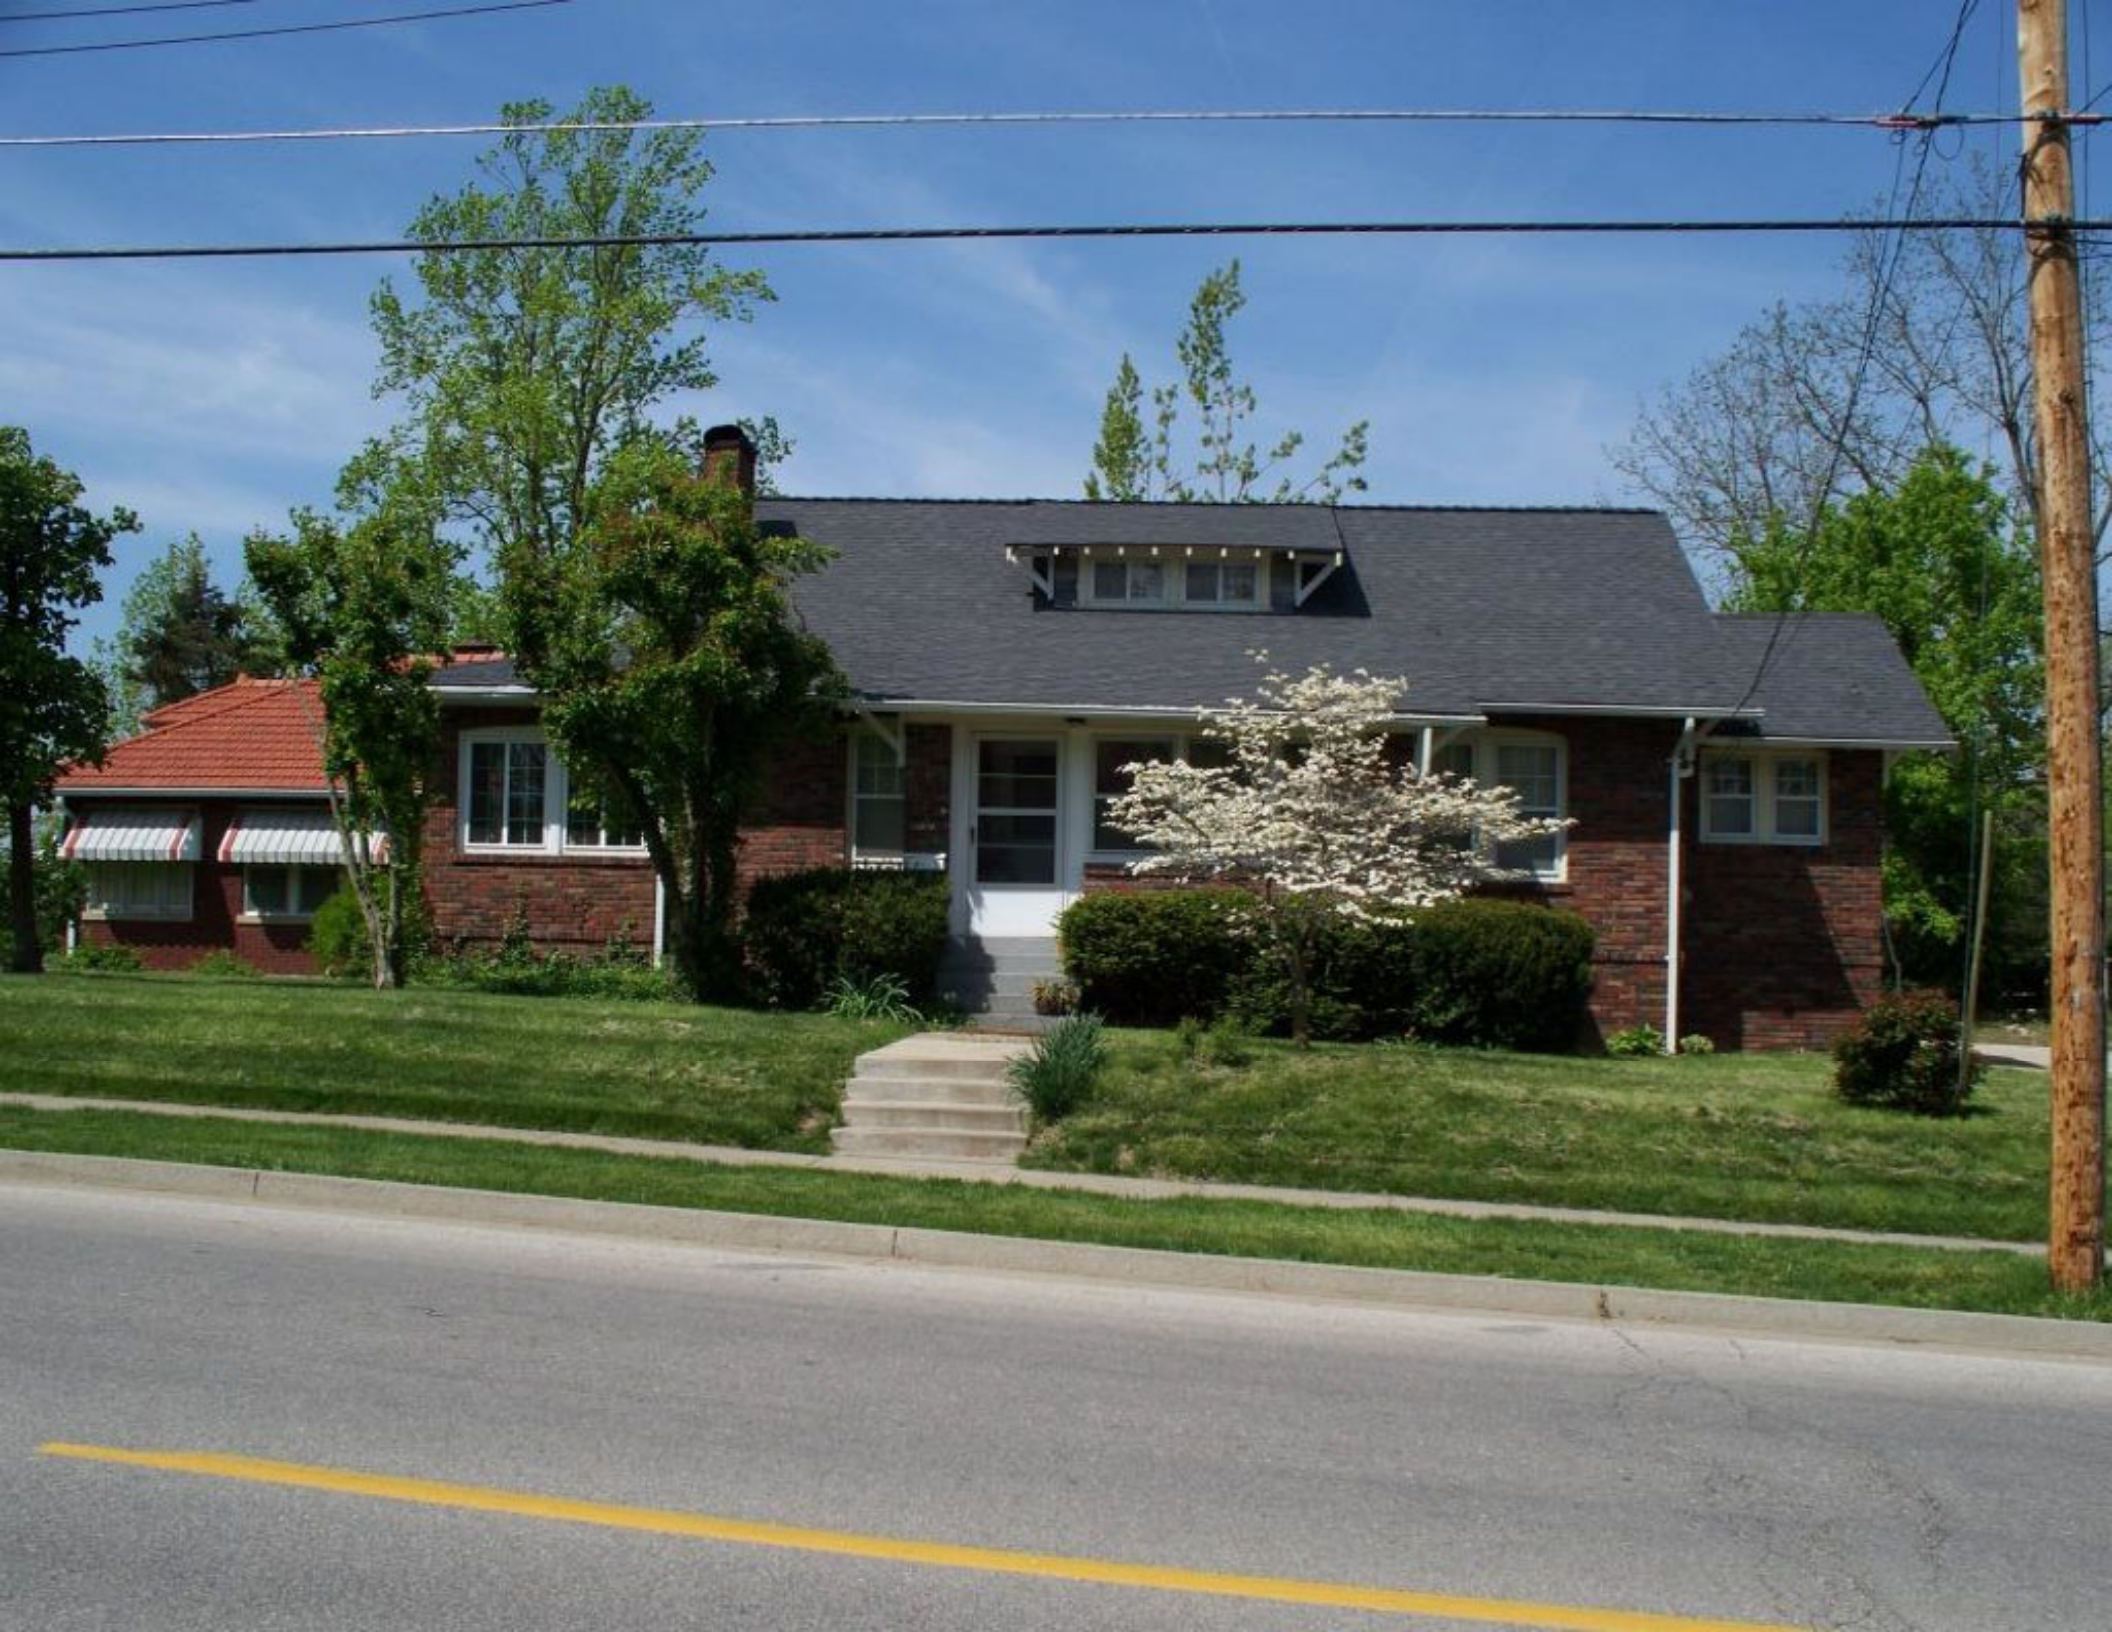
This one-and-a-half-story brick bungalow has a side gable roof with a central shed dormer with rafter tails. It contains two six-light windows with storms. The roof flares out to a slightly extended porch with brick piers that have been enclosed with windows. To the right are paired 6/1 windows. Although it appears like an addition, the furthestmost right bay is probably original to the building. Smaller than the central portion of the property it has its own gable roof and brackets and side entrance and is likely a mudroom. The front façade of this “addition” has smaller paired 6/1 windows. There is a decorative brick band across the front façade of the entire property.

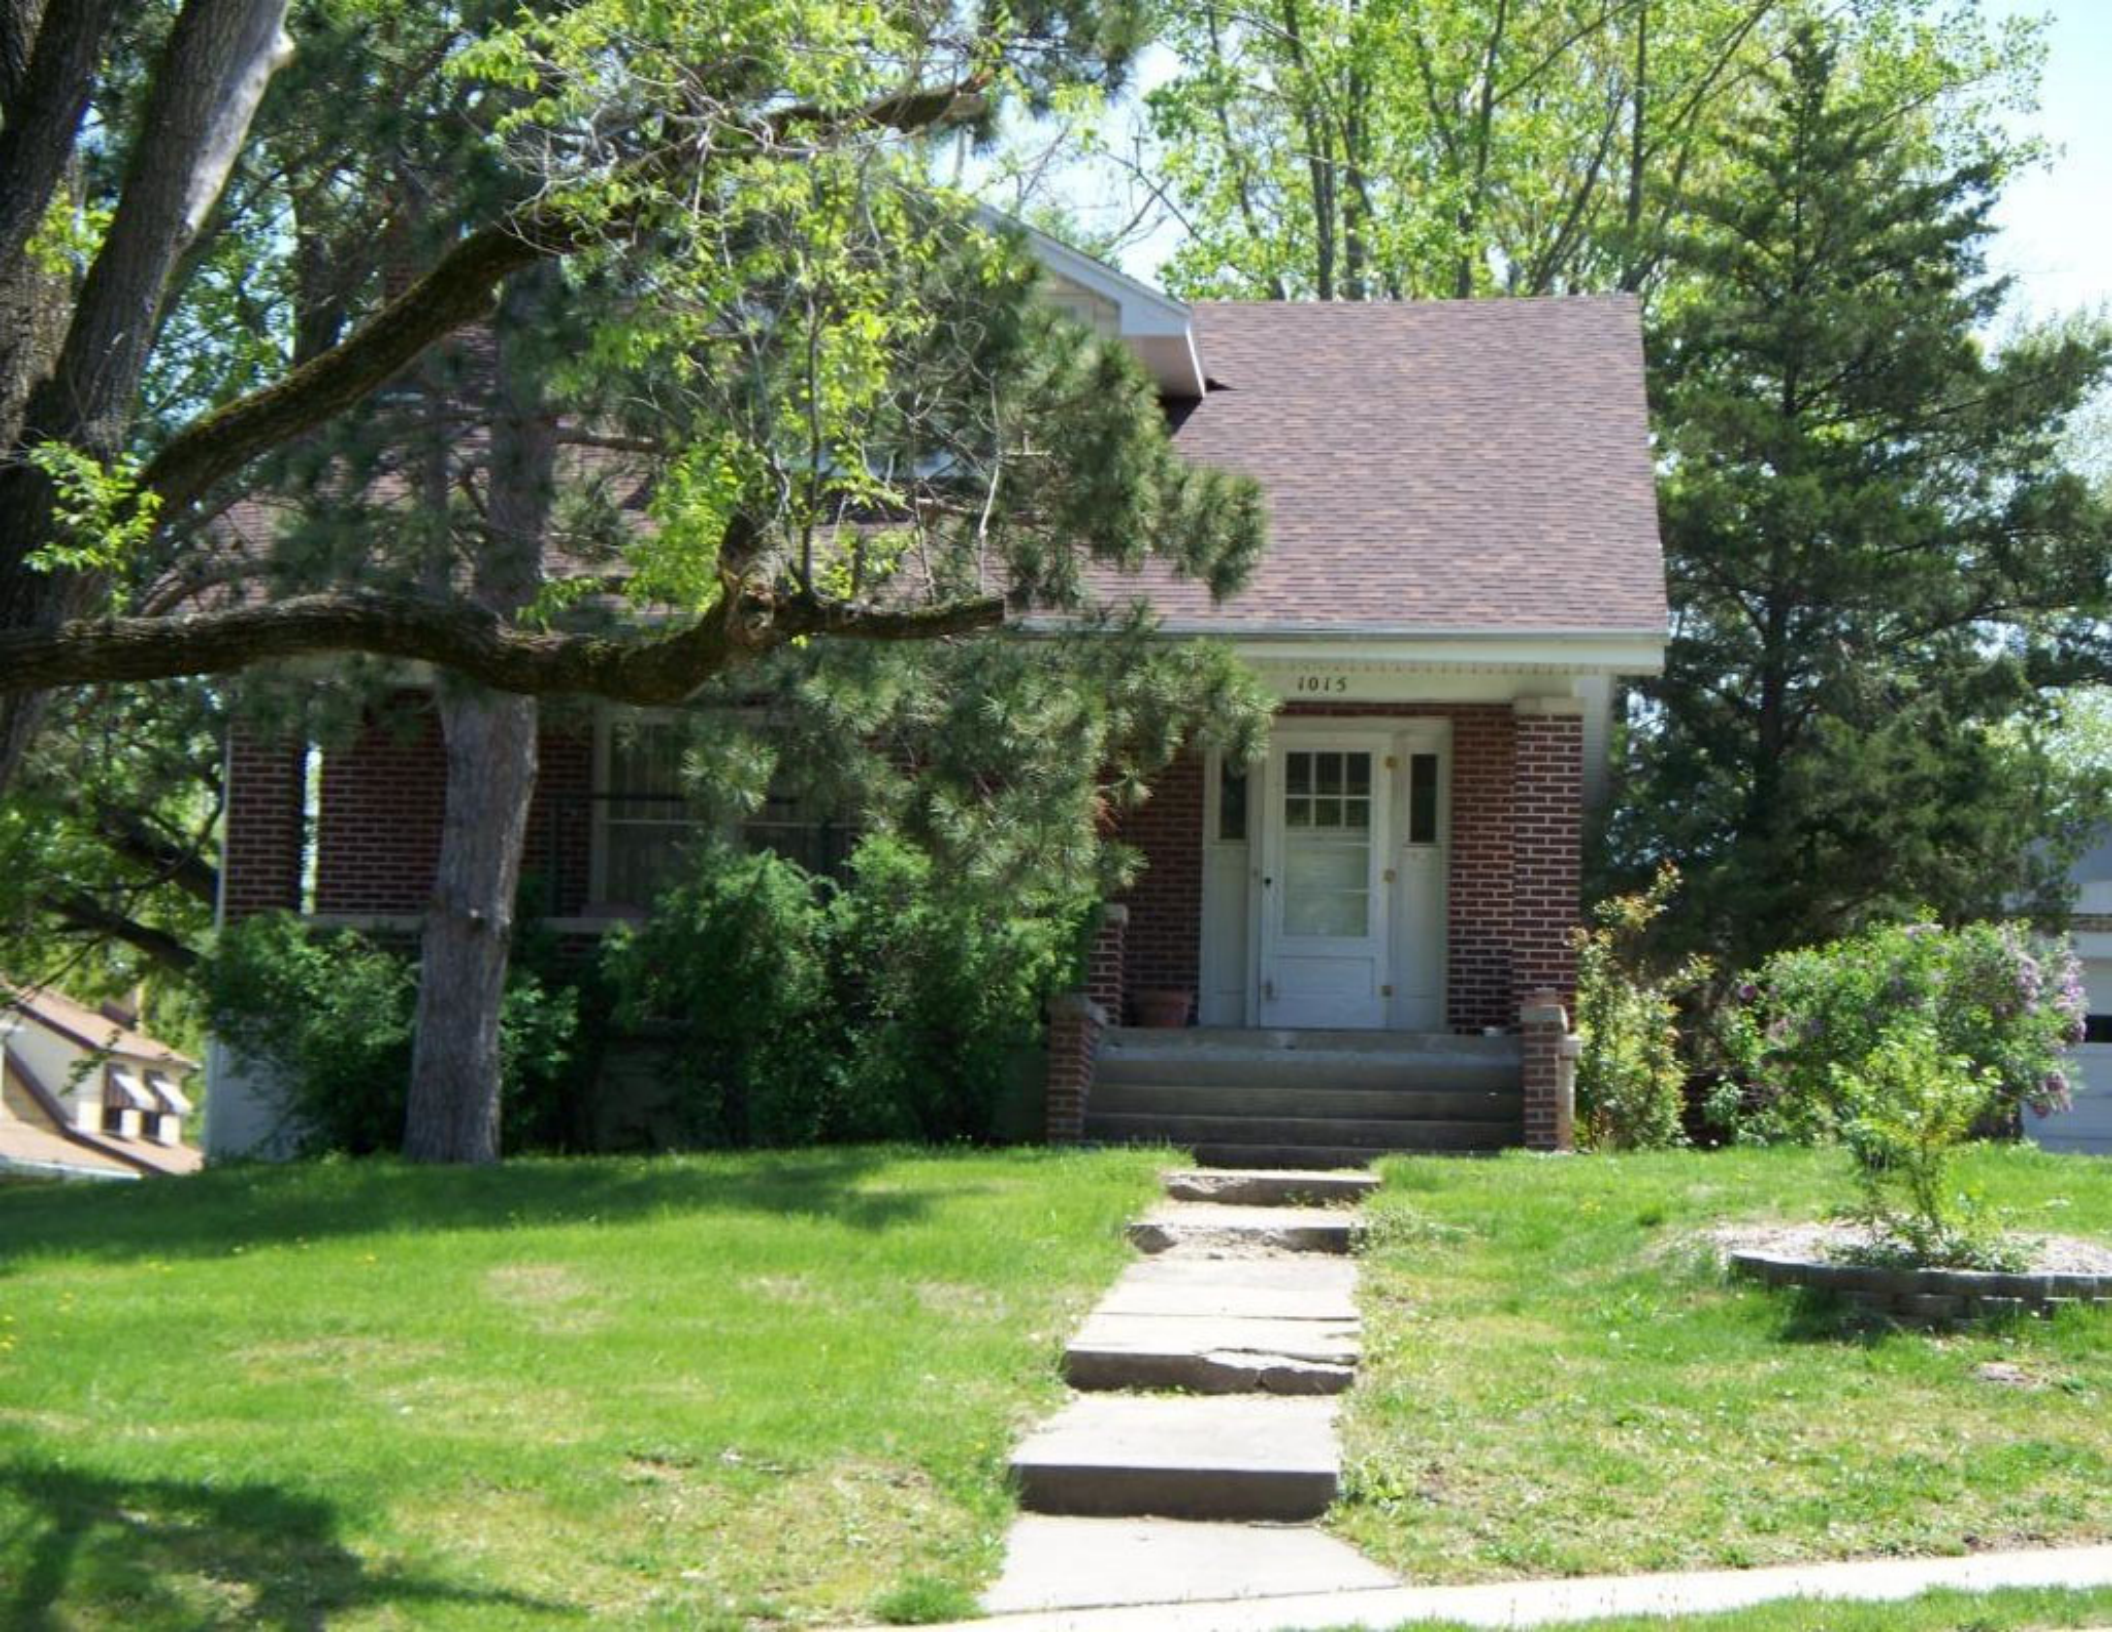
This is a one-and-a-half story brick bungalow with side gable roof and central dormer. The dormer had a front-gable roof and is in-filled with vinyl. There are two small five-over-one windows that appear original. The porch spans the width of the house and features a brick half-wall and short brick piers and brick columns all with limestone caps. The door appears original and is off-center to the right of the building. It has top sidelights that are likely original but may have been altered to include a screen door. The home is in the only home within the survey boundary in the Virginia Place Subdivision.

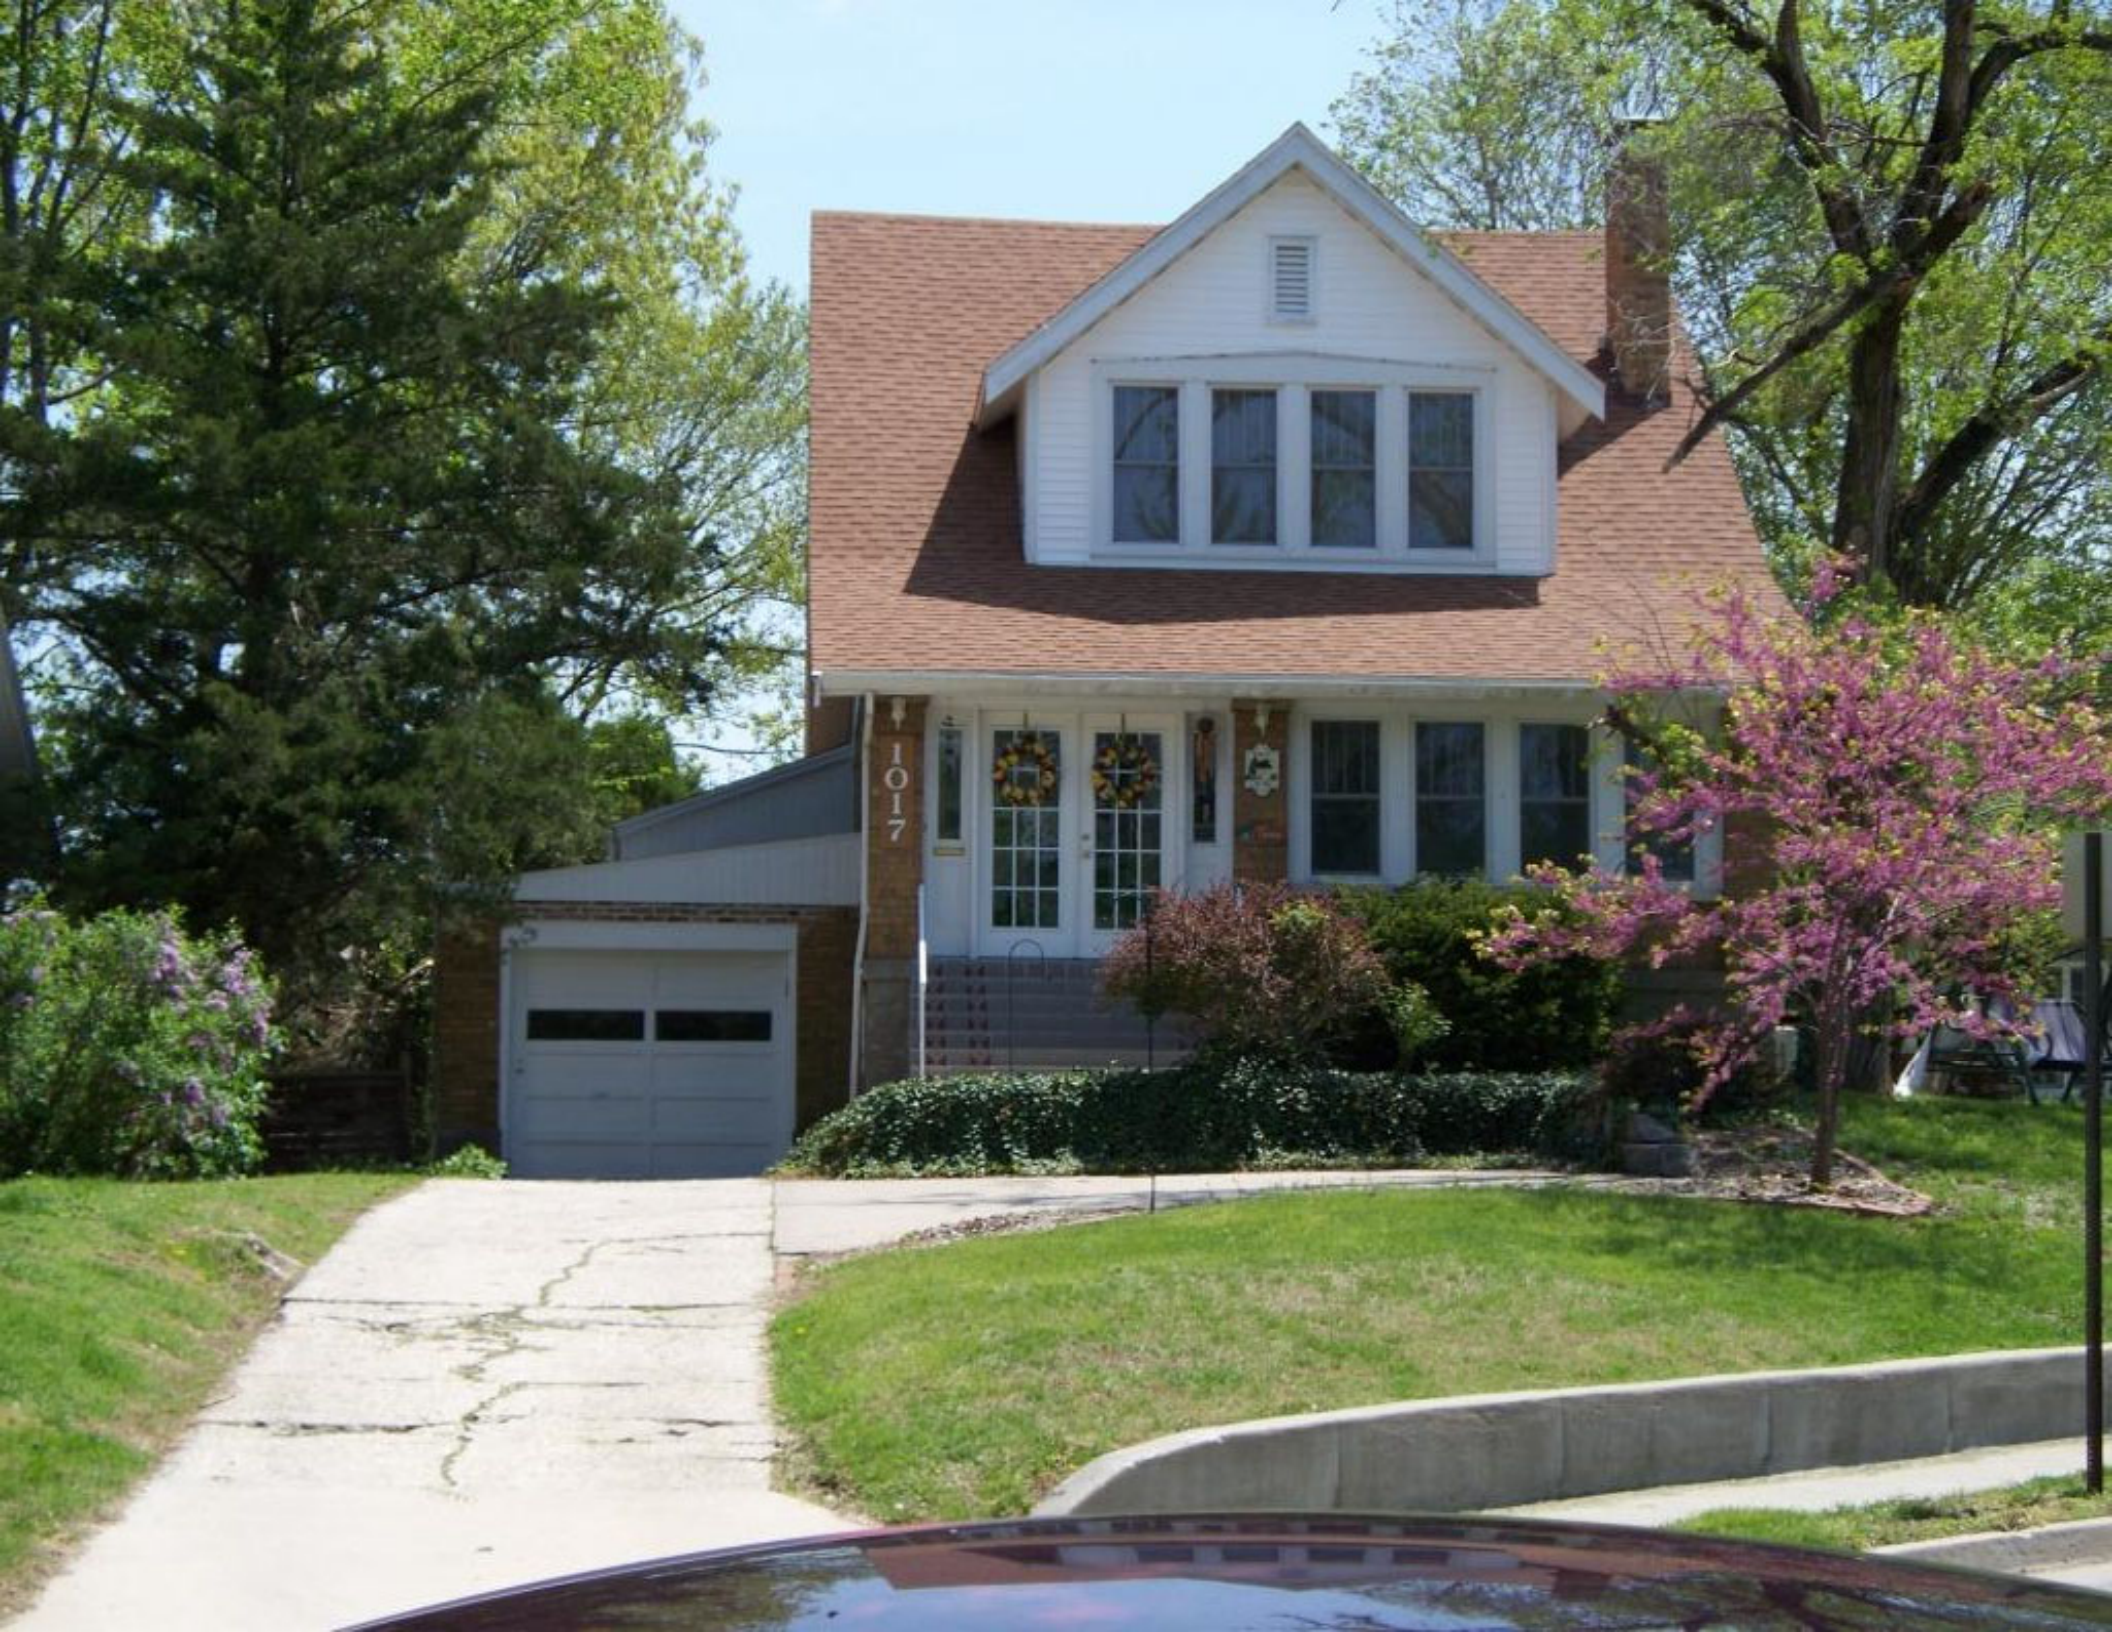
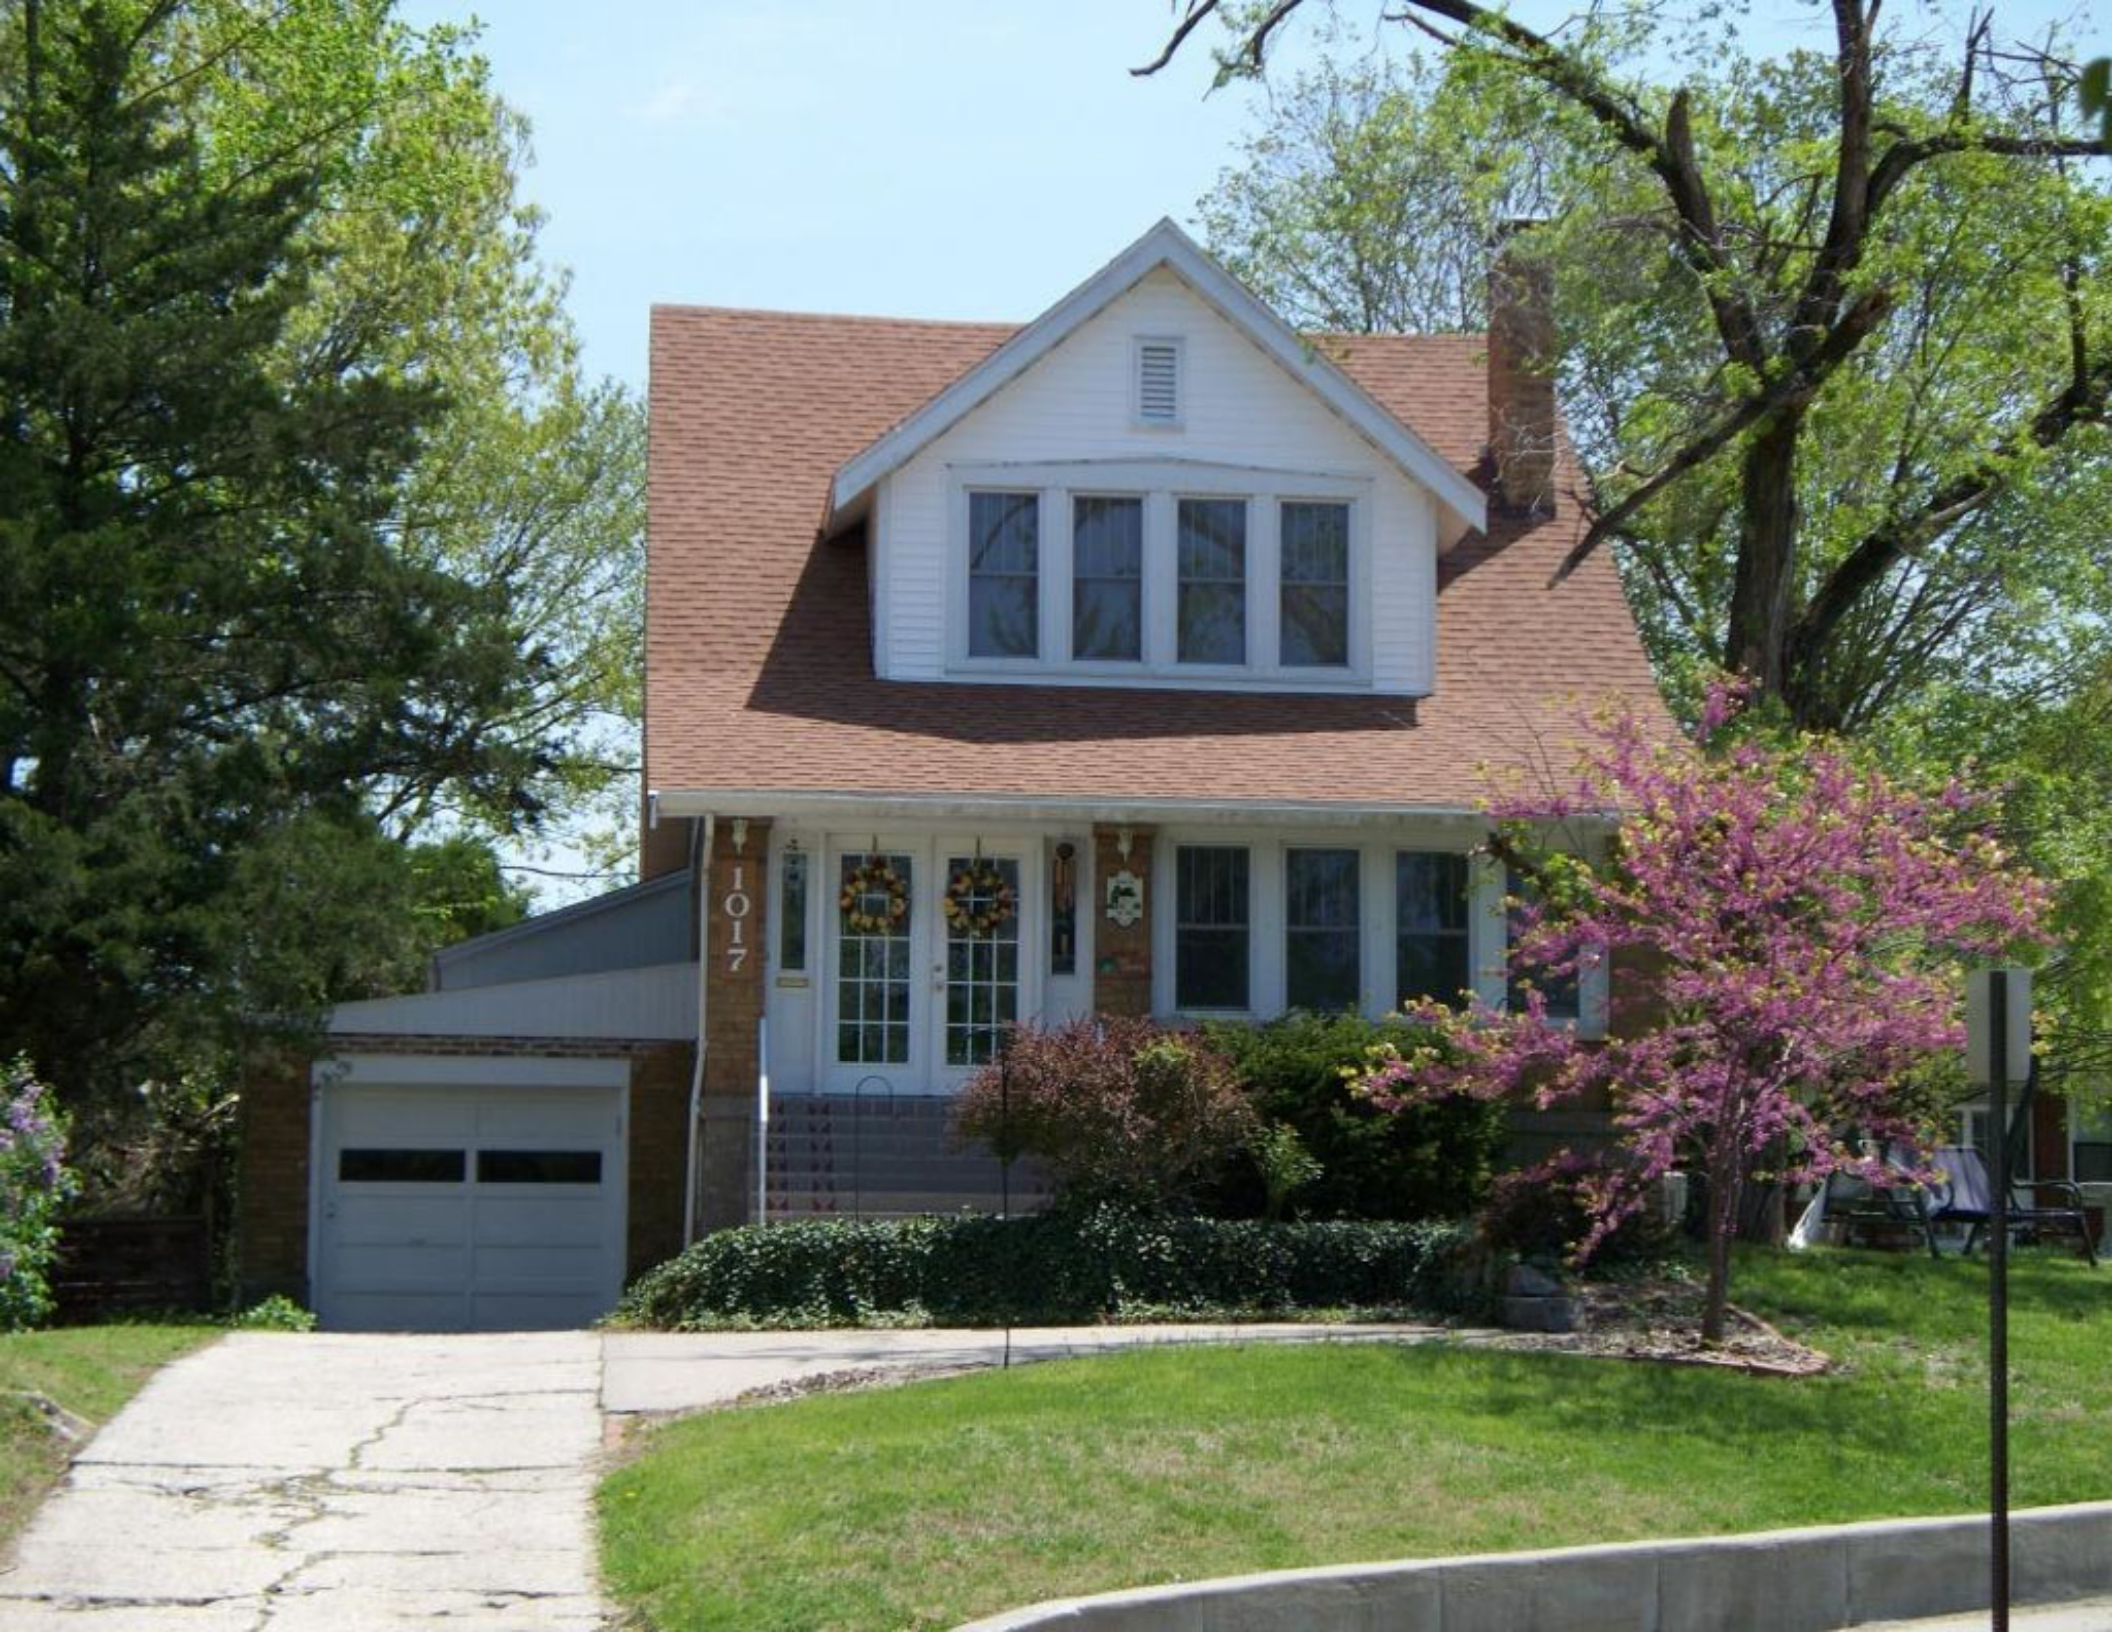
This yellow-brick home has a steeply pitched side-gable roof that flares over the entrance. The porch, which may have been originally open, currently has a group of four four-over-one windows that appear historic. They currently have storm windows over them so it is difficult to determine the age, but it is likely the porch was in-filled early or perhaps built this way. Likewise the off-center double door entrance has side lights. The side lights appear original but the large French doors may be replacement. A concrete stair has some decorative detailing and may be a replacement. The large dormer has been in-filled with vinyl however it appears to have the same four, four-over-one windows as on the first floor. The trim has been left and storm windows have been applied but these are likely original. This house is somewhat unique as it has a one-car attached front-facing garage that appears original to the home.
