ARCHITECTURAL/HISTORIC INVENTORY FORM

1. Survey No. CO-AS-005-001		2. Survey name: Moreau Drive Neighborhood Survey	
3. County: Cole		4. Address: 1202 Elmerine Ave.	
5. City: Jefferson City	Vicinity: <input type="checkbox"/>	6. UTM: / /	7. Township/Range/Section: T: R: S:
8. Historic name (if known):		9. Present/other name (if known):	
10. Ownership: <input checked="" type="checkbox"/> Private <input type="checkbox"/> Public		11. Historic use (if known): Residential	11. Current use: Residential

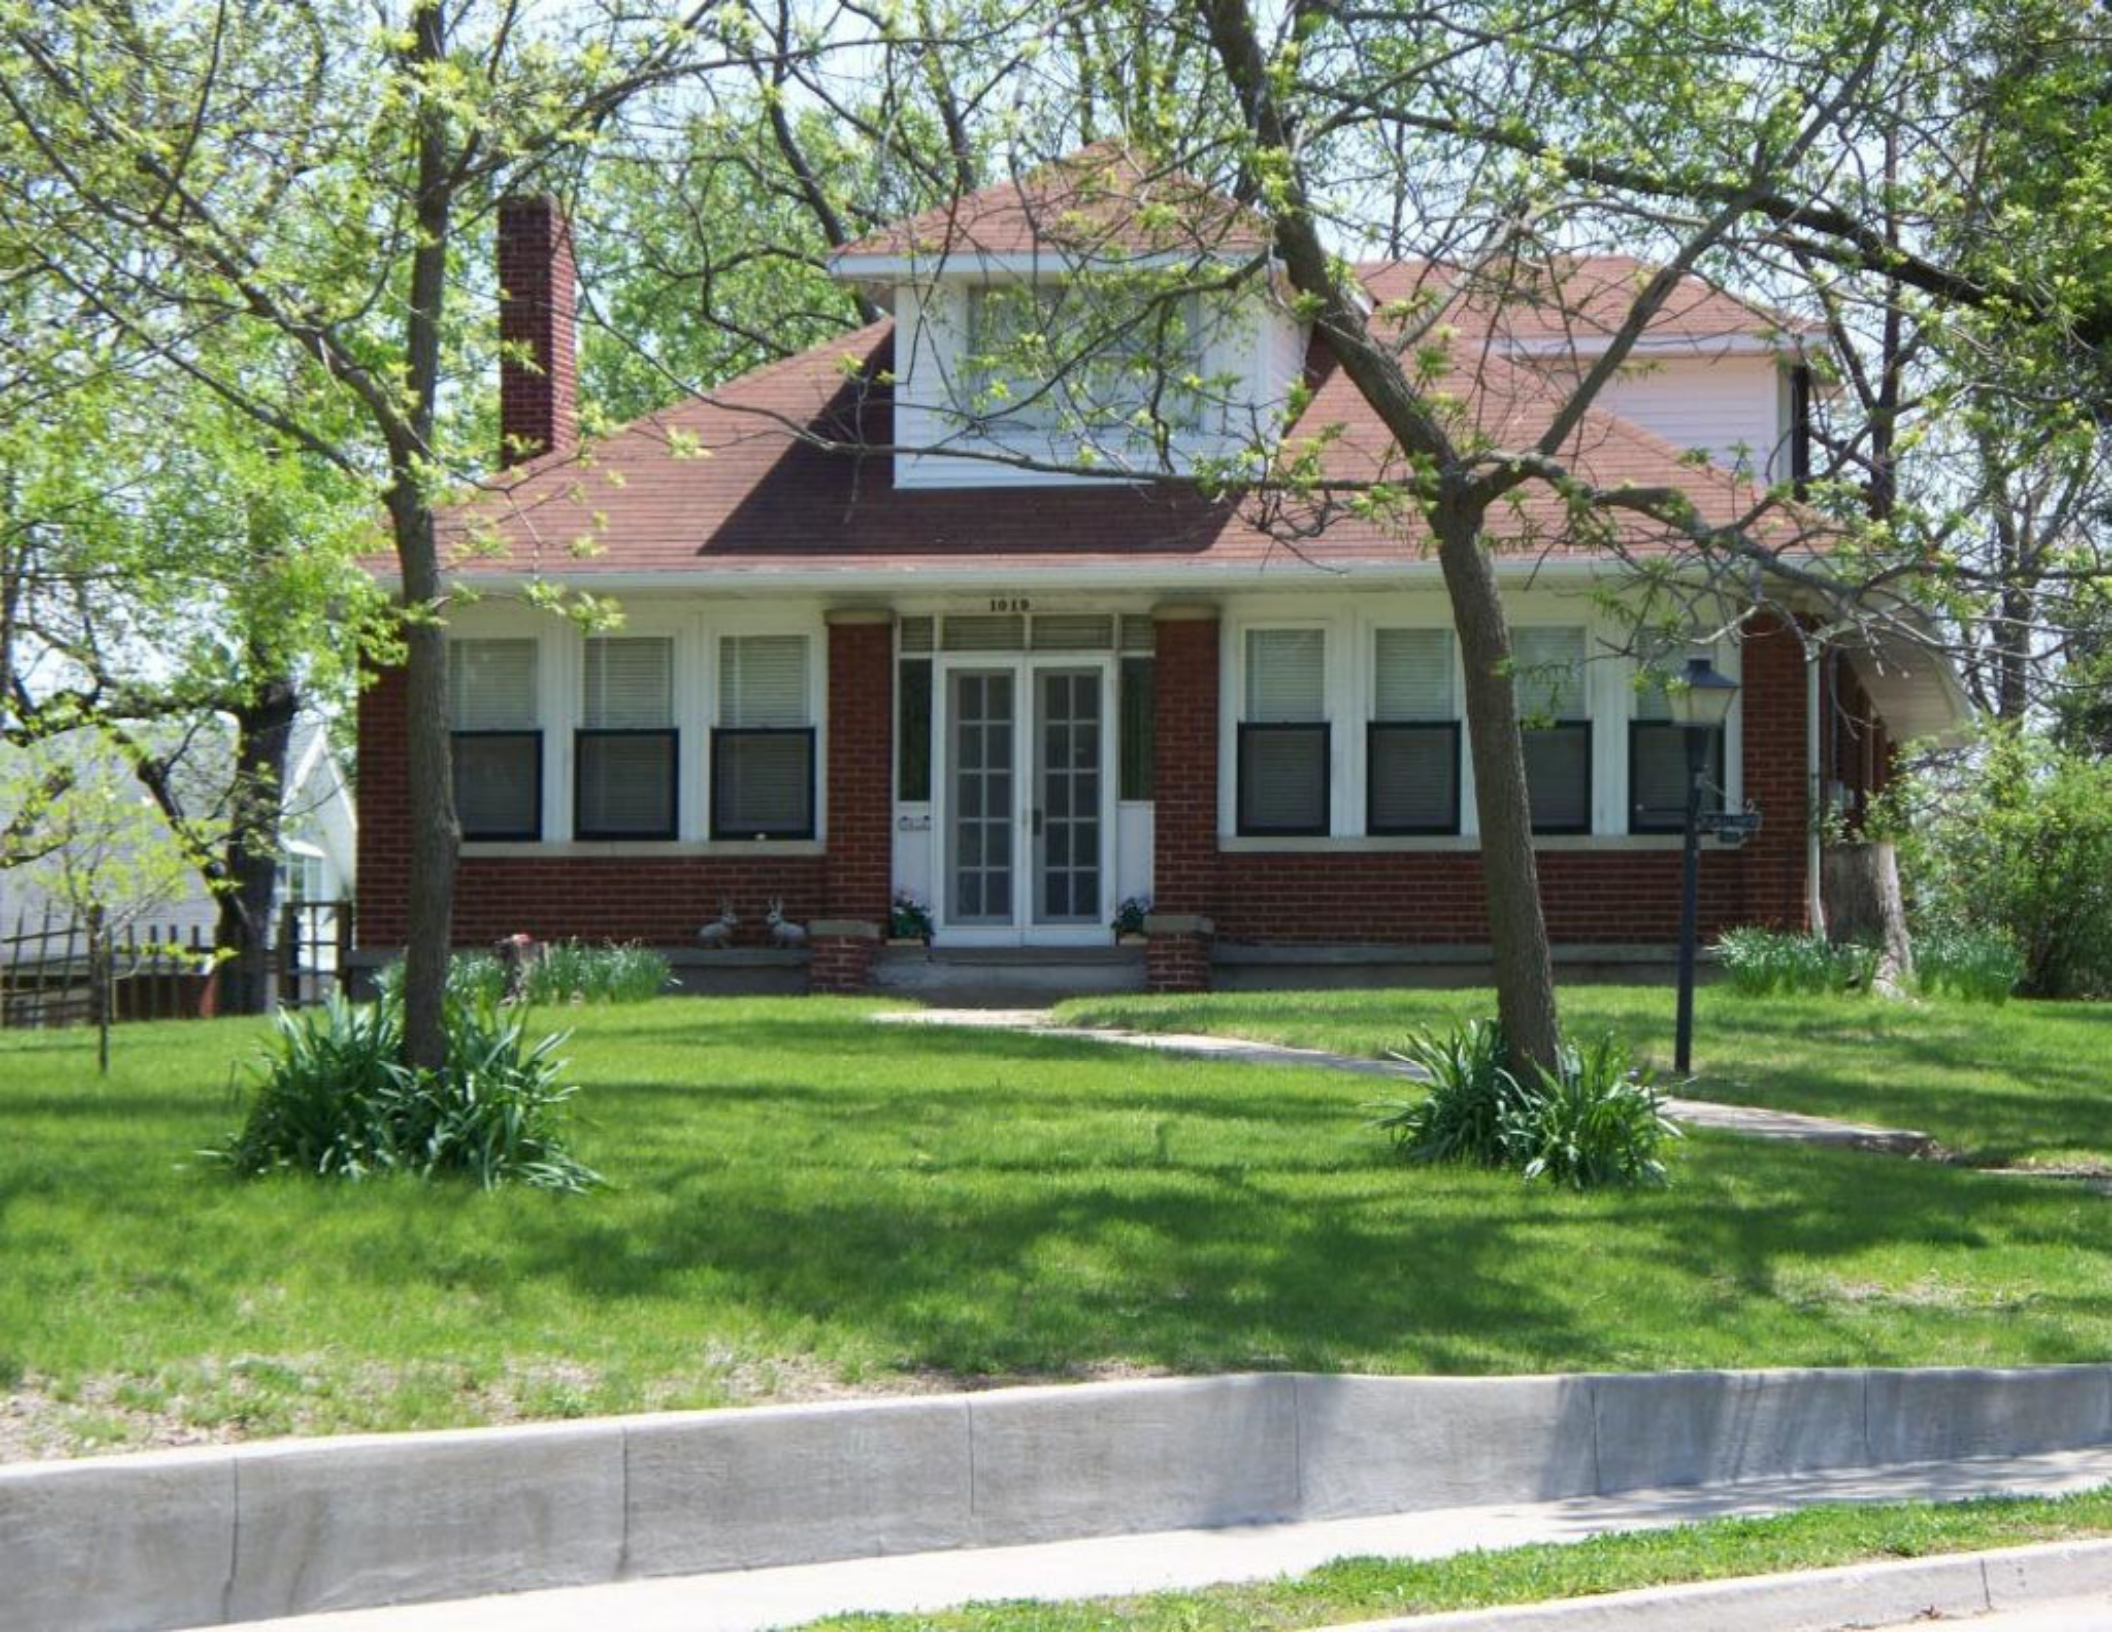
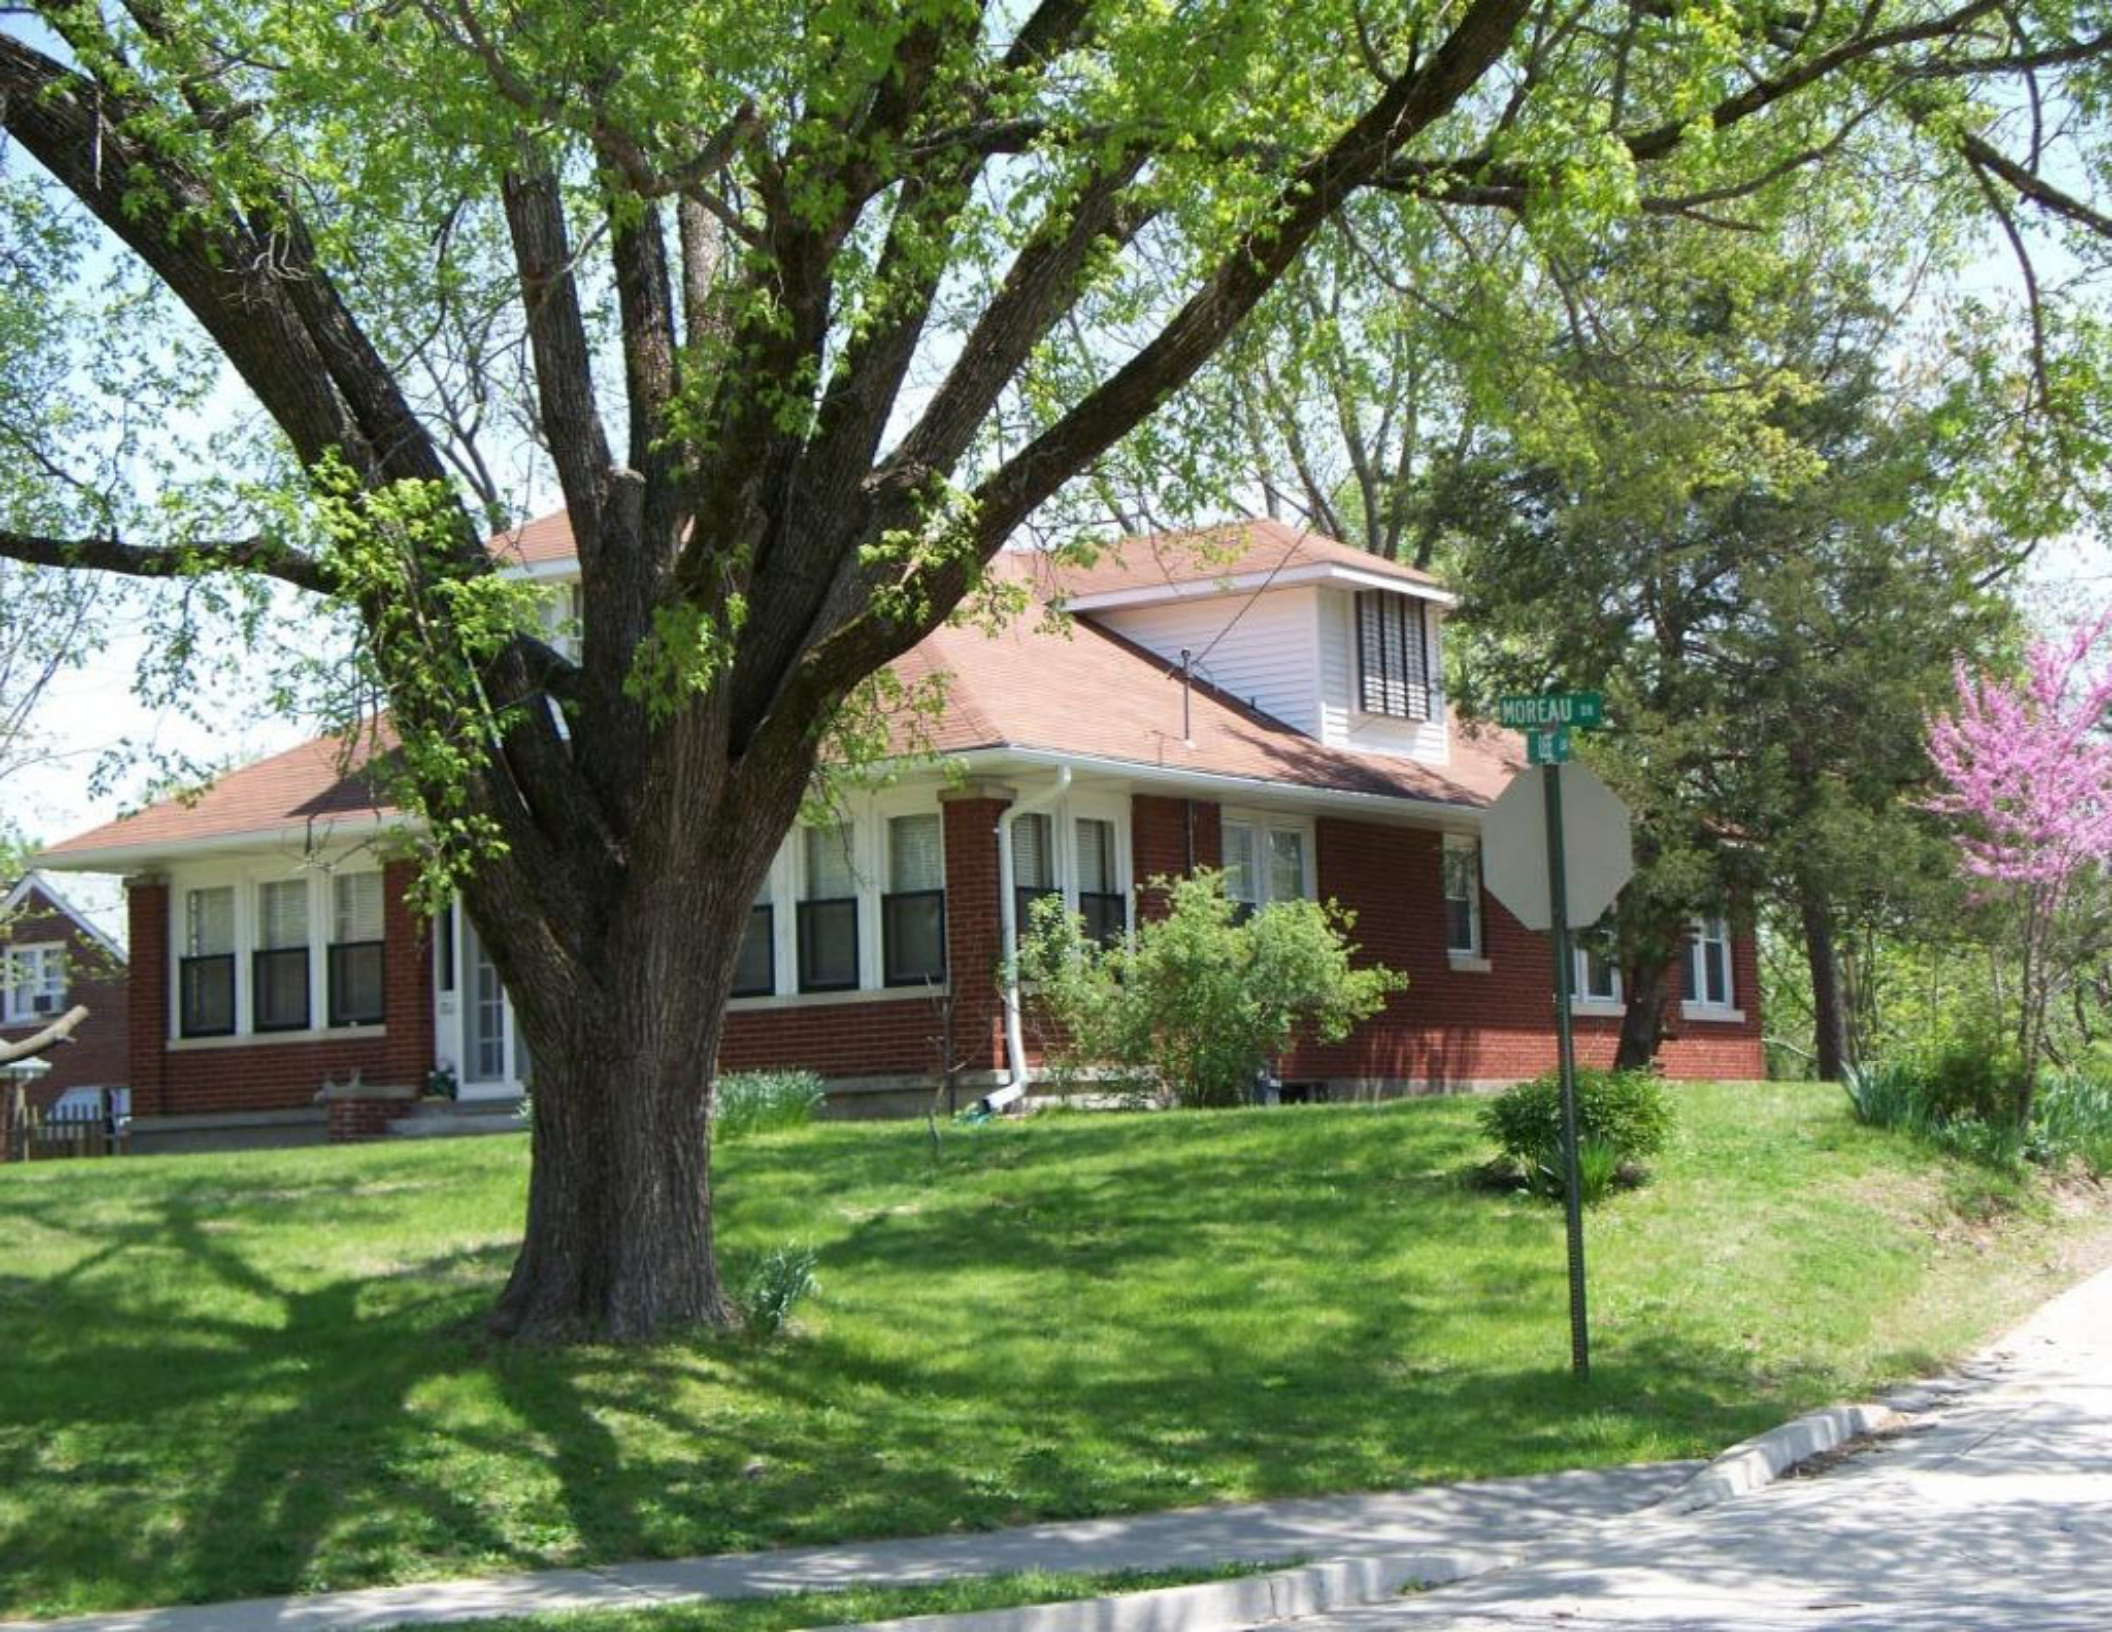
This is a one and a half story brick bungalow with a prominent cross-hipped roof with wide eaves. There is a central dormer with a pyramidal roof on the front of the building and another dormer with a hipped roof on the right. The central dormer has been in-filled with vinyl and has paired four-over-one windows that are likely original. The side dormer is also clad in vinyl and appears to be covered with some kind of modern shutters. This dormer may not be original to the house. The porch was once full width with brick pillars but has been enclosed with vinyl one-over-one windows, eight in total. The entrance has similar French doors and sidelights as its neighbor at 1015 Moreau but these have an additional screen door. As the porch has a similar design to its neighbor the porch may have been enclosed early, however the windows are modern. Despite these alterations, the property retains its basic form and is in keeping with the feel of the neighborhood and therefore would be contributing to the district.

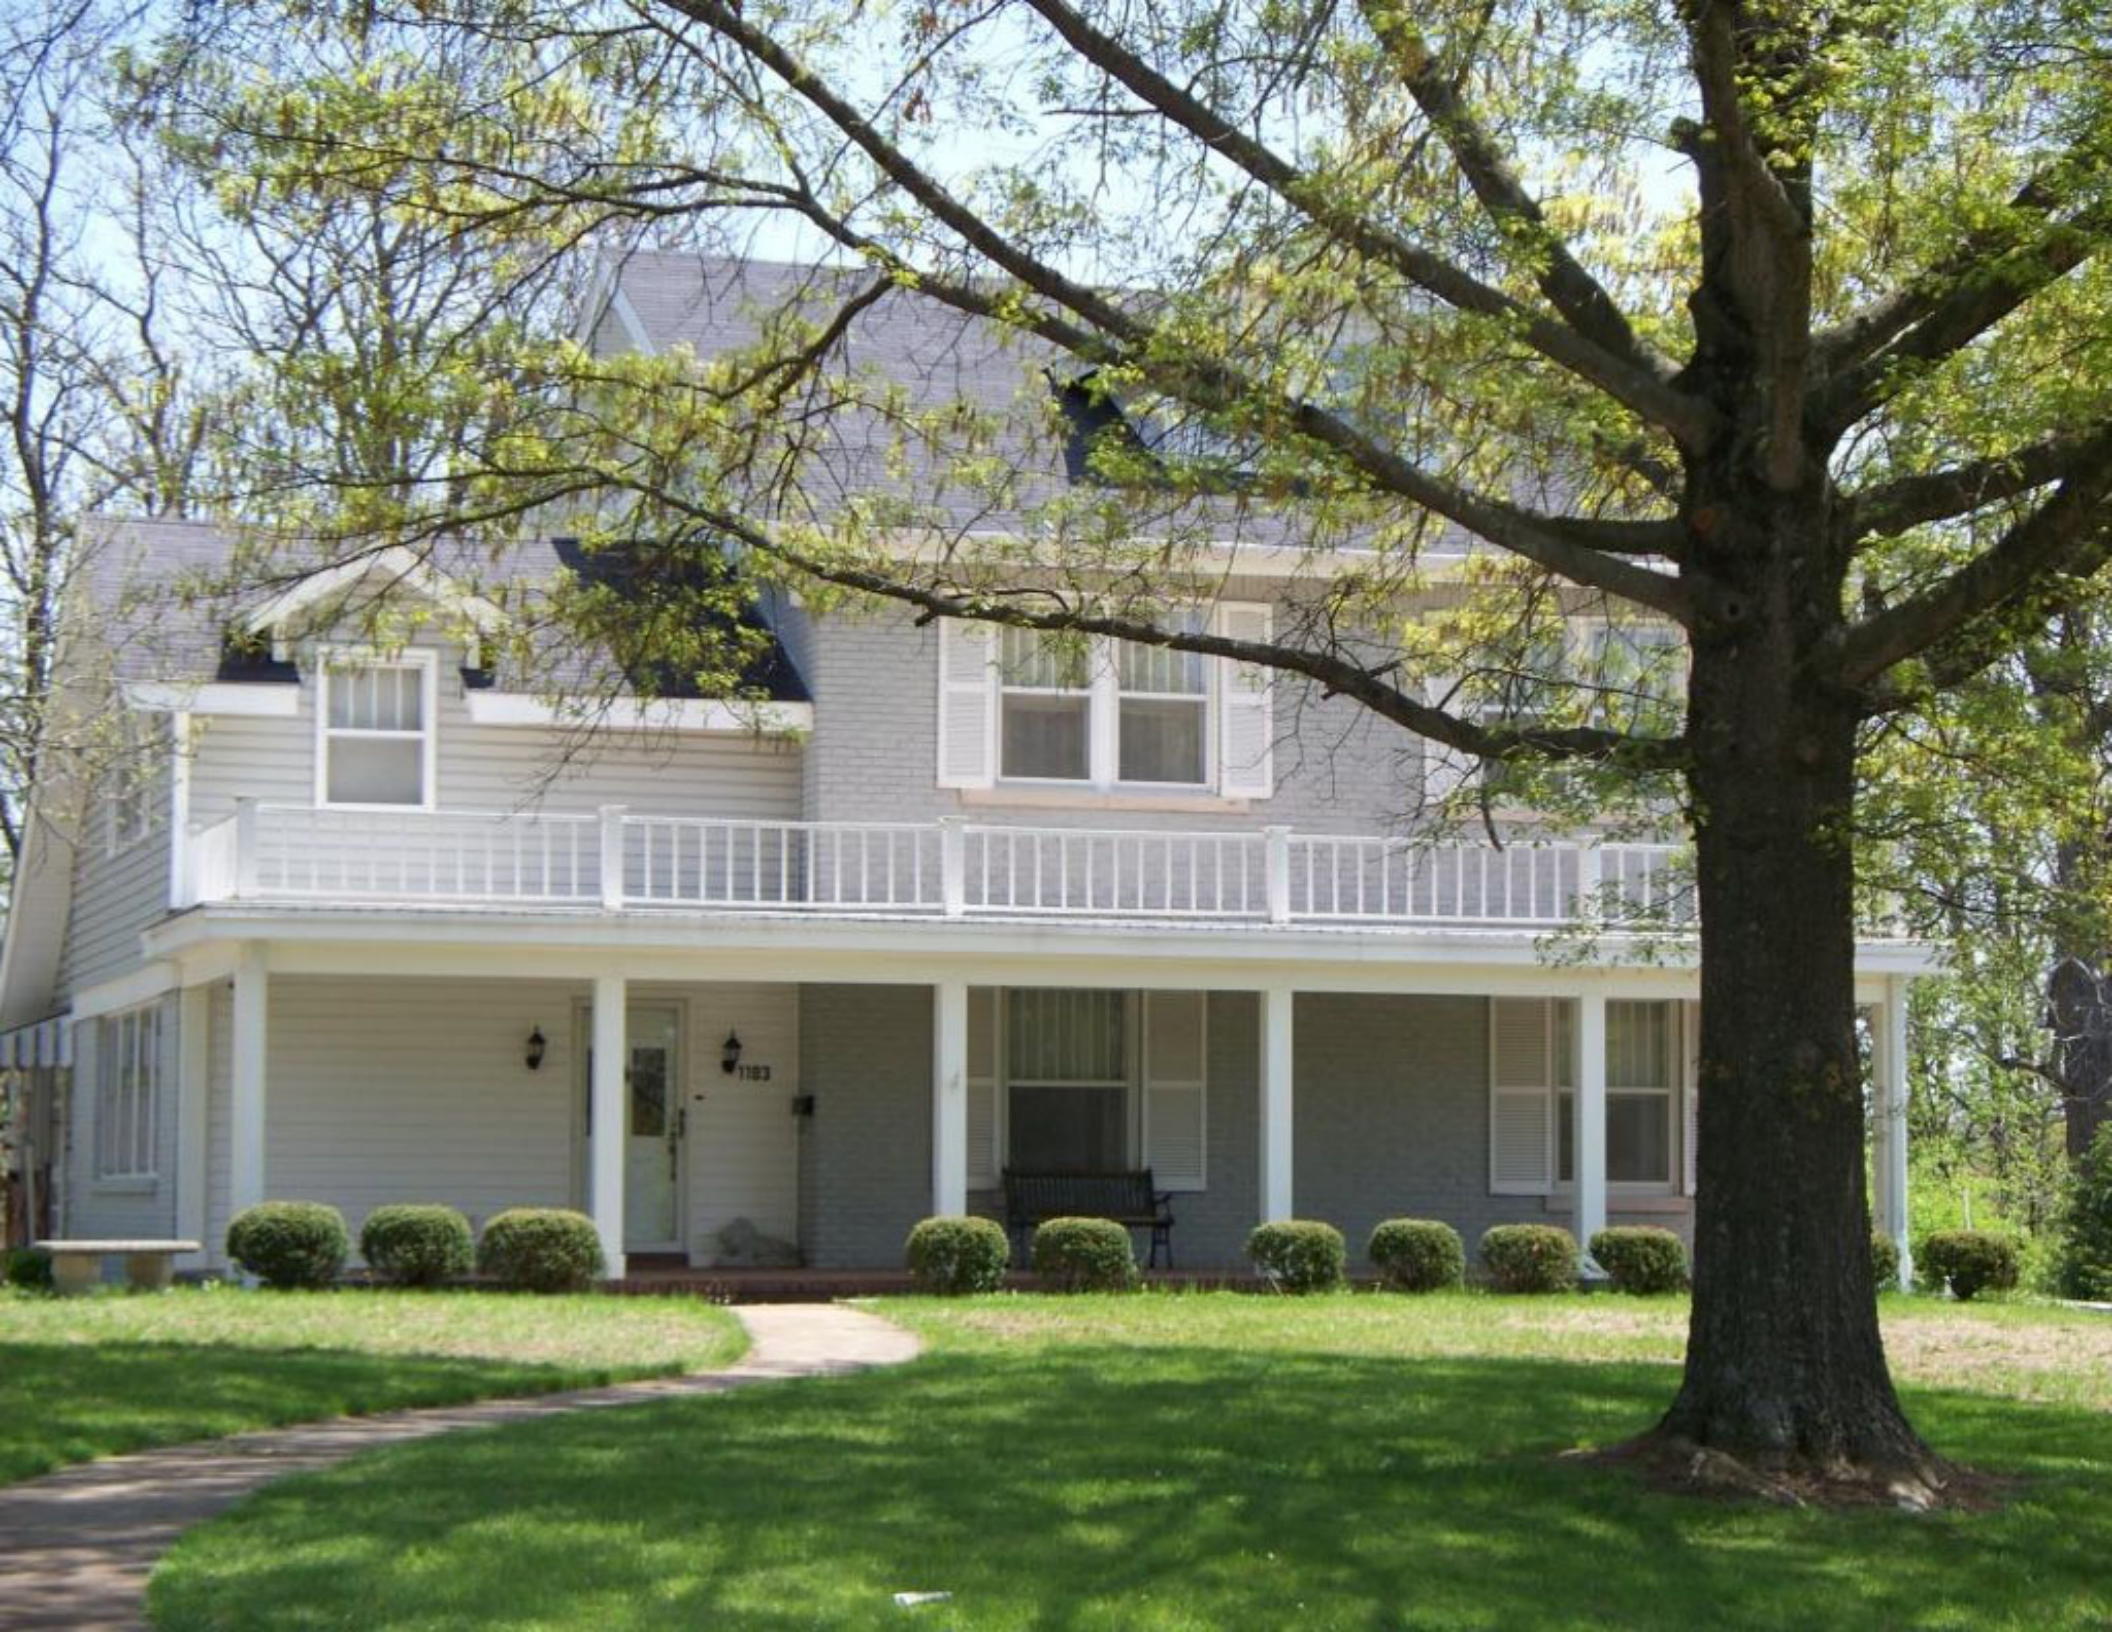
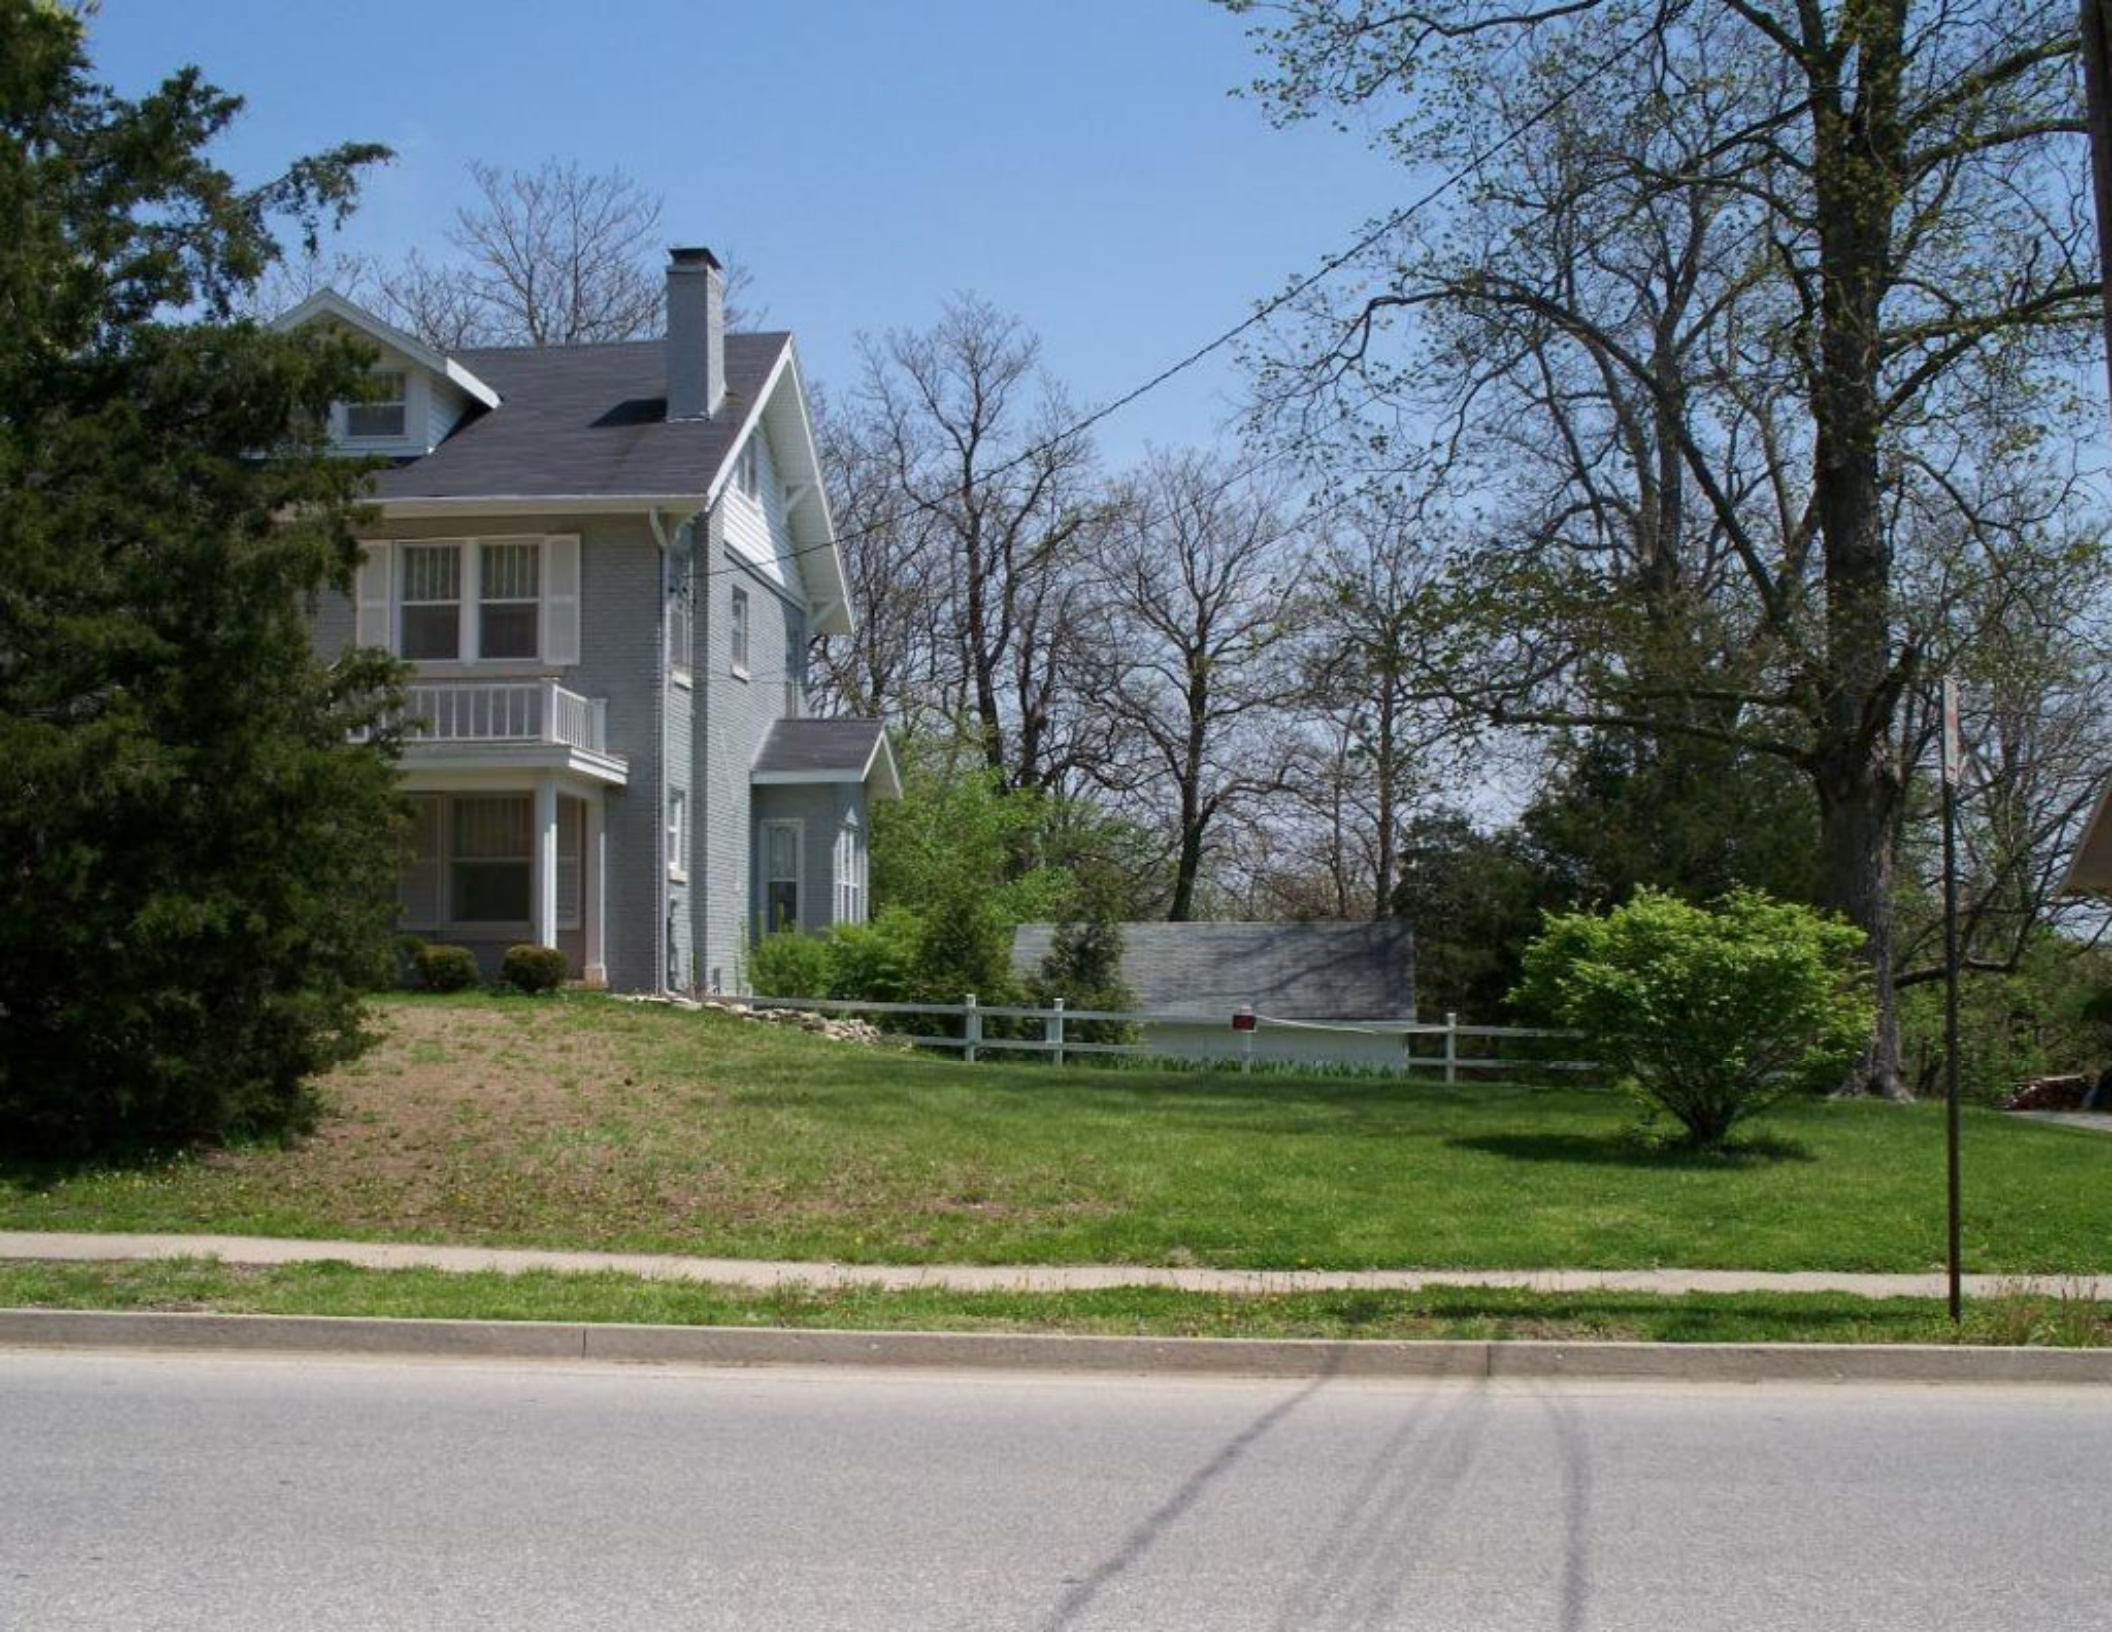
This two story brick property appears to be a foursquare with Colonial Revival detailing. The brick portion of the property appears to have a shorter two-story addition to the left. The addition is entirely clad in vinyl but it appears to have a historic four-over-one window on the upper floor. However, this is likely a modern replacement since the addition does not appear on the 1943 Sanborn map. Likewise there is a full porch that spans the width of the building. It has six square pillars and a railing on the upper floor, the Sanborn map indicates there was a full width porch here although it has been extended or replaced to include the vinyl addition. The brick portion of the house retains its historic windows; 2 sets of paired five-over-one windows on the second floor and two seven-over-one windows on the lower floor, all have shutters. The addition is smaller and slightly set back and since the windows are retained in the central building, the property is considered contributing to the district.

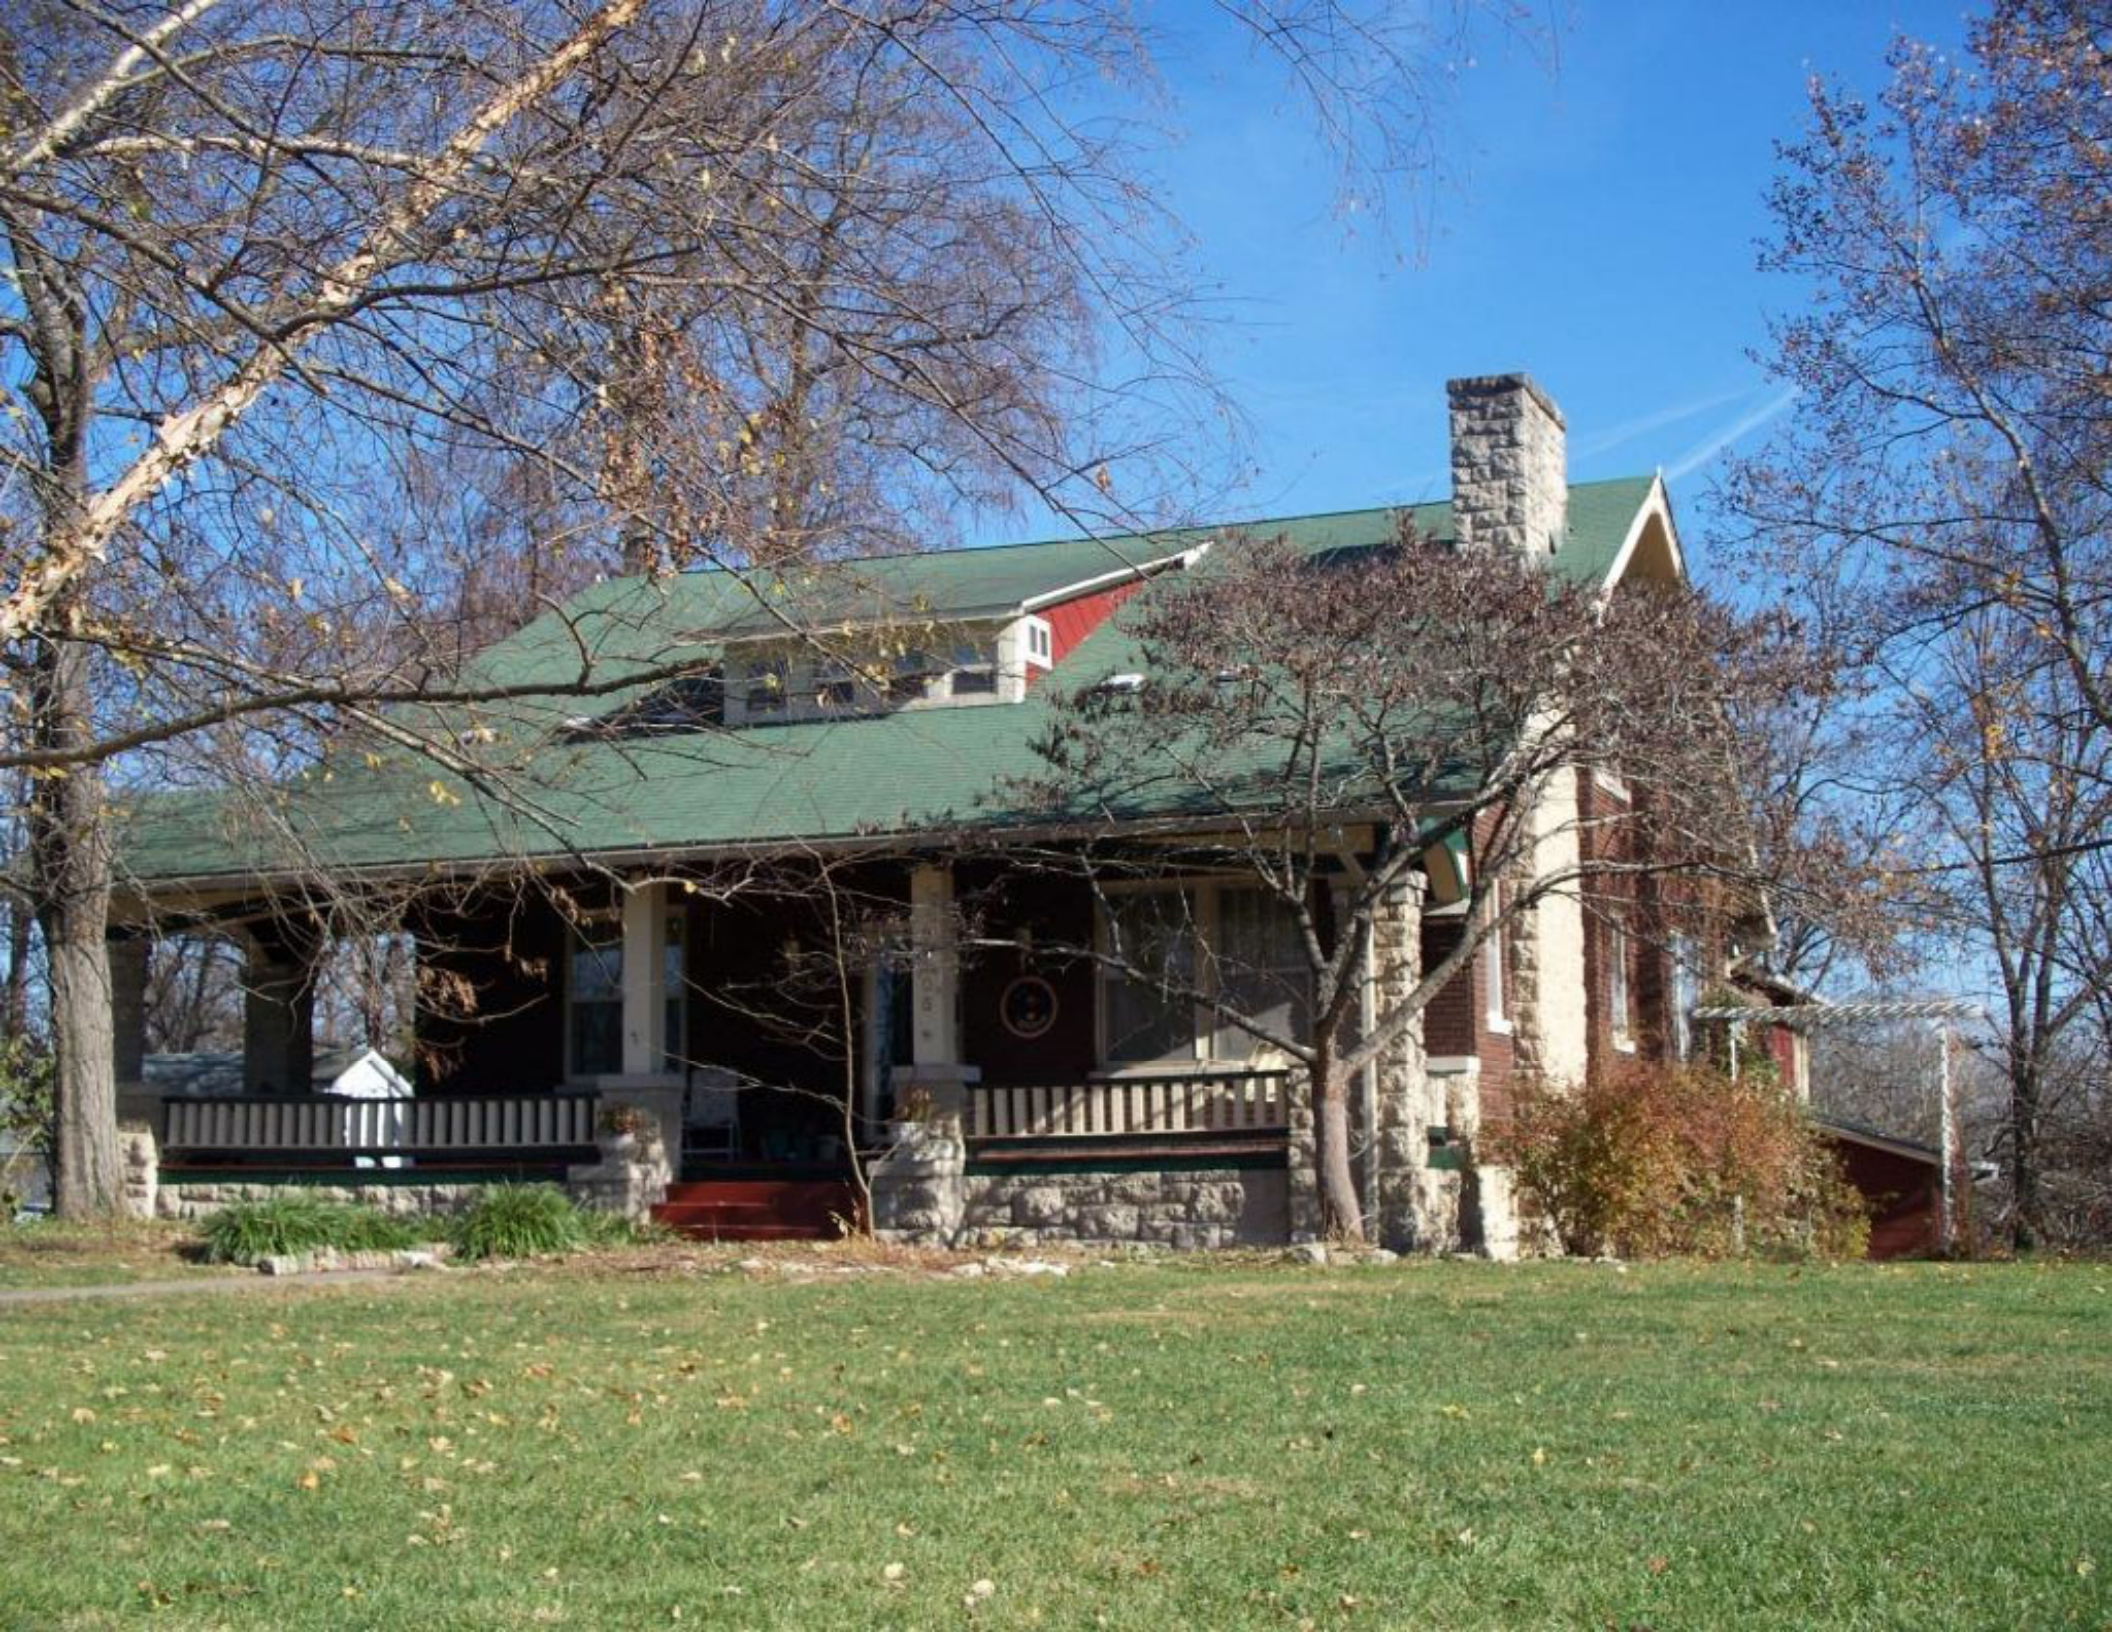
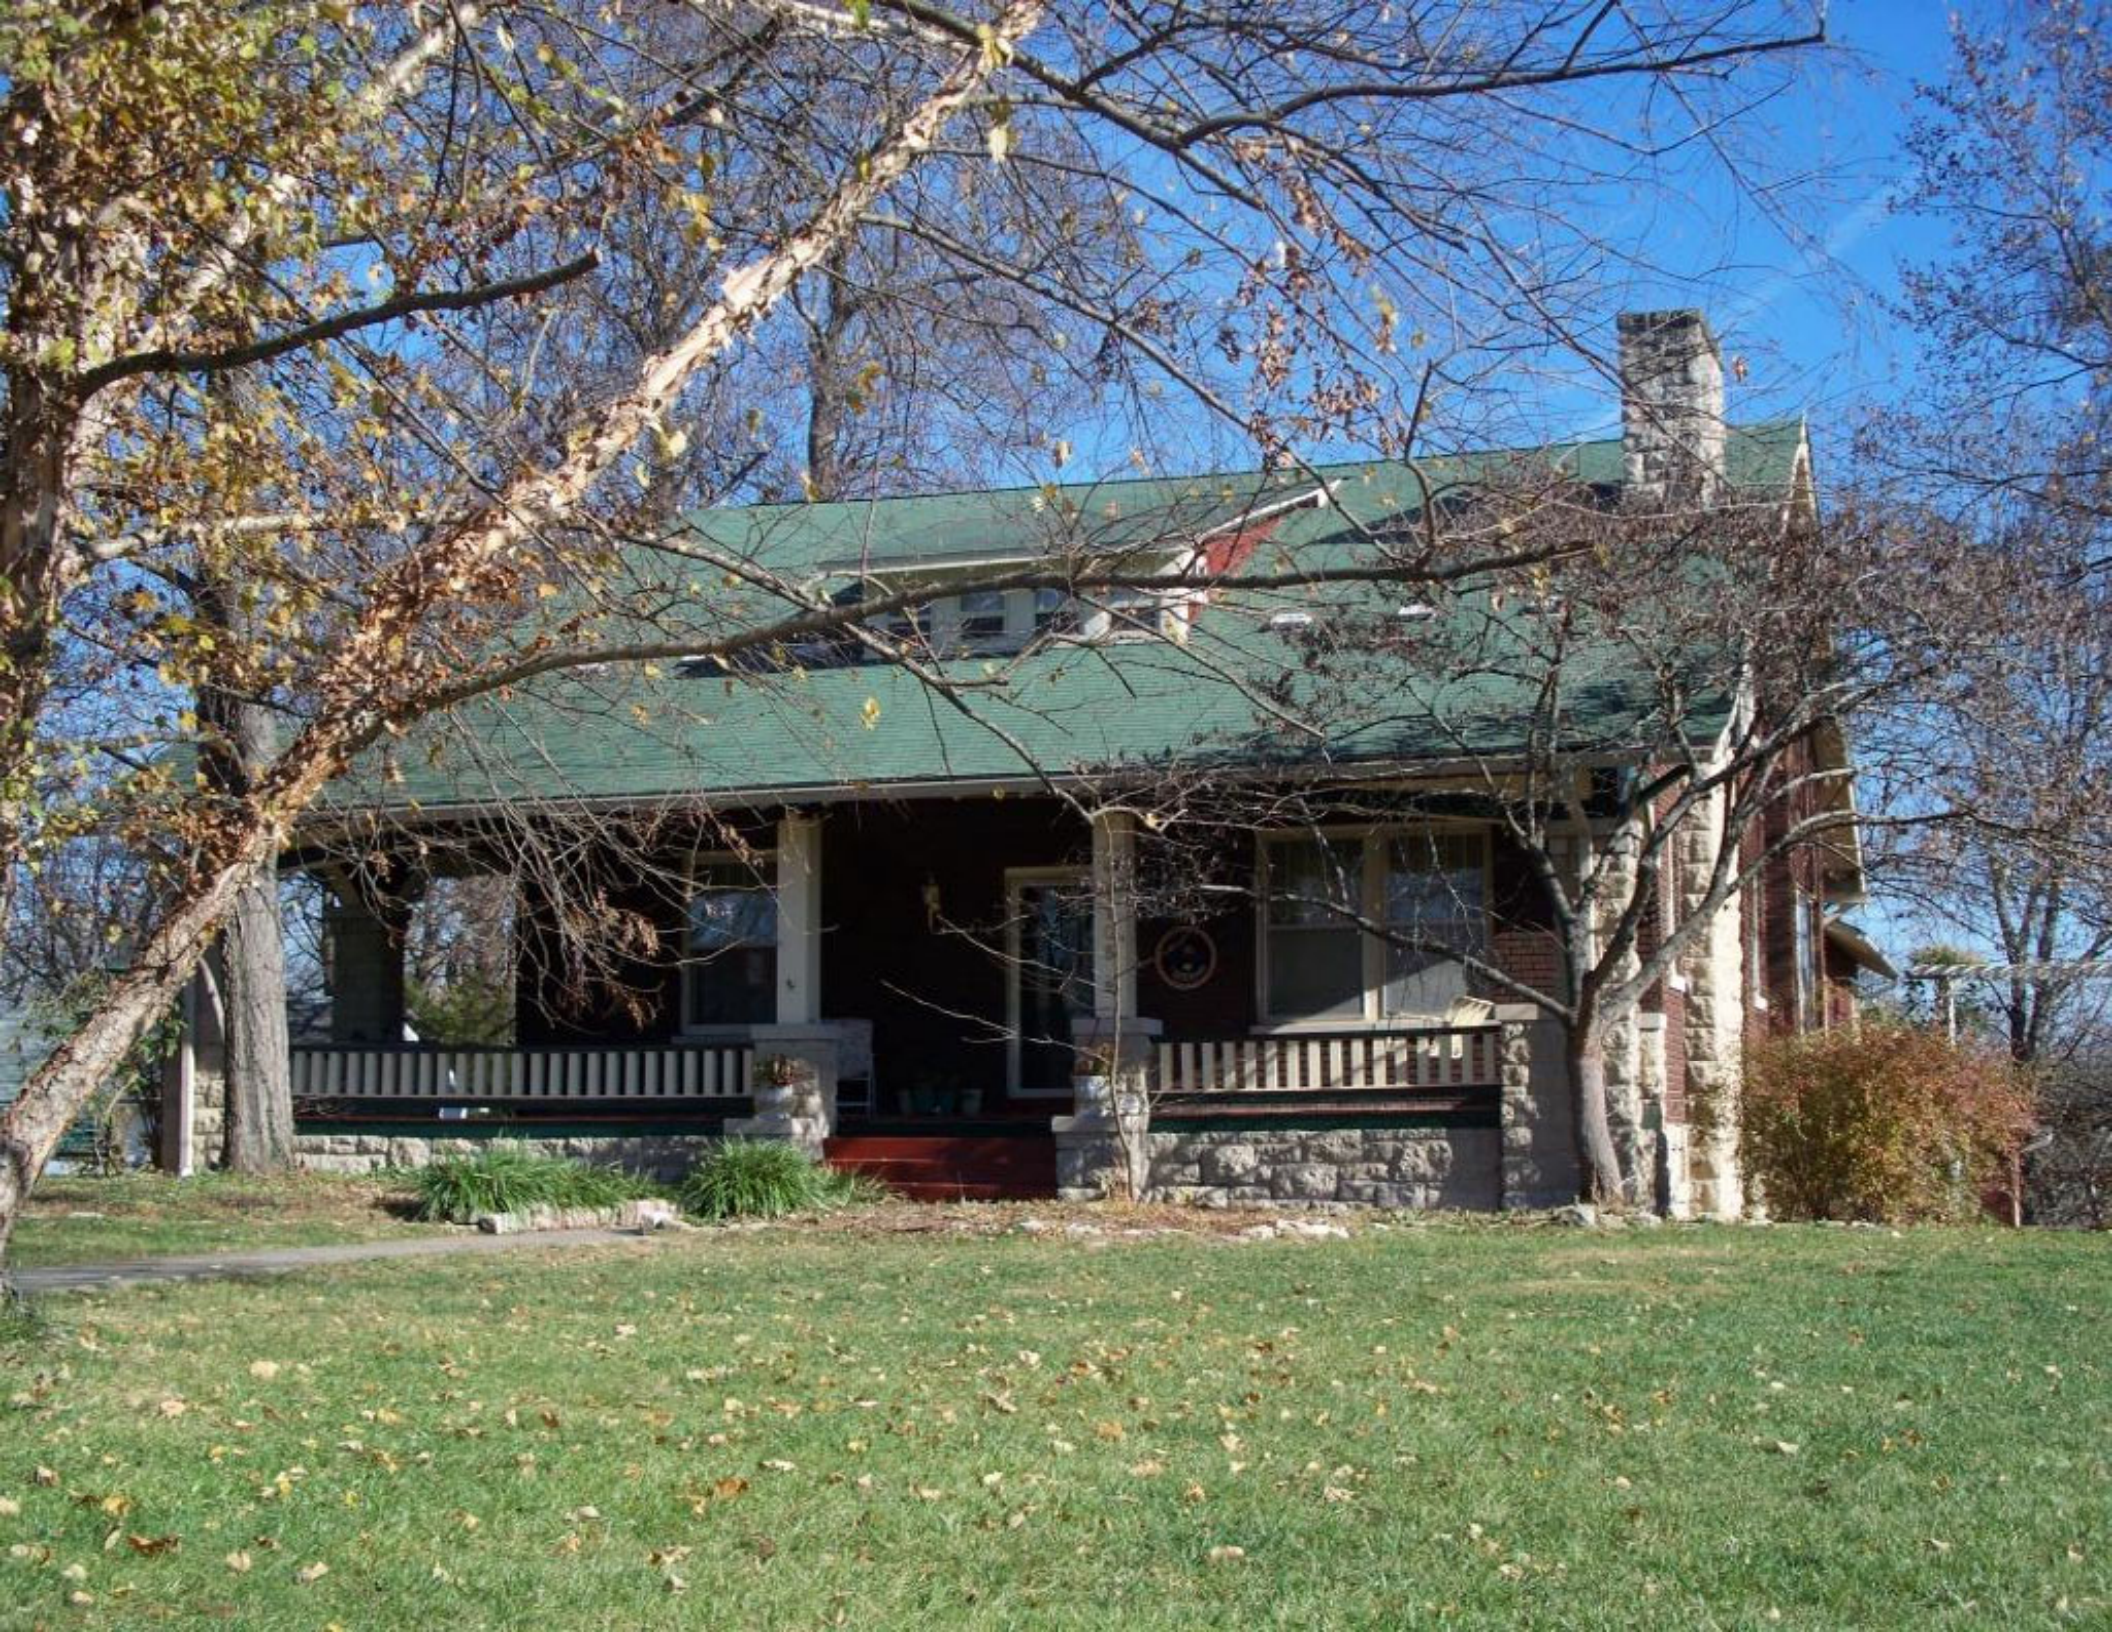
This is one of the most attractive bungalows in the neighborhood. It features square stone pillars and piers in the porch as well as a stone foundation and chimney. The porch wraps around the property to the left and includes painted brackets and a wood railing. It also features two square wood columns on top of the central stone piers capped in limestone leading to the entrance. The door appears original as does the windows that flank it. There is a single six-over-one window to the left of the entrance and paired five-over-one windows to the right. There is a low shed central dormer with four original windows and two decorative small fixed windows that wrap to its side. The dormer is flanked on each side by what appear to be three fixed sun-lights in the roof. Although the tax assessor dated this property at 1910, the Moreau Heights Bungalow Tour dated this property in the 1920s.
