ARCHITECTURAL/HISTORIC INVENTORY FORM

1. Survey No. CO-AS-005-001		2. Survey name: Moreau Drive Neighborhood Survey	
3. County: Cole		4. Address: 1202 Elmerine Ave.	
5. City: Jefferson City	Vicinity: <input type="checkbox"/>	6. UTM: / /	7. Township/Range/Section: T: R: S:
8. Historic name (if known):		9. Present/other name (if known):	
10. Ownership: <input checked="" type="checkbox"/> Private <input type="checkbox"/> Public		11. Historic use (if known): Residential	11. Current use: Residential

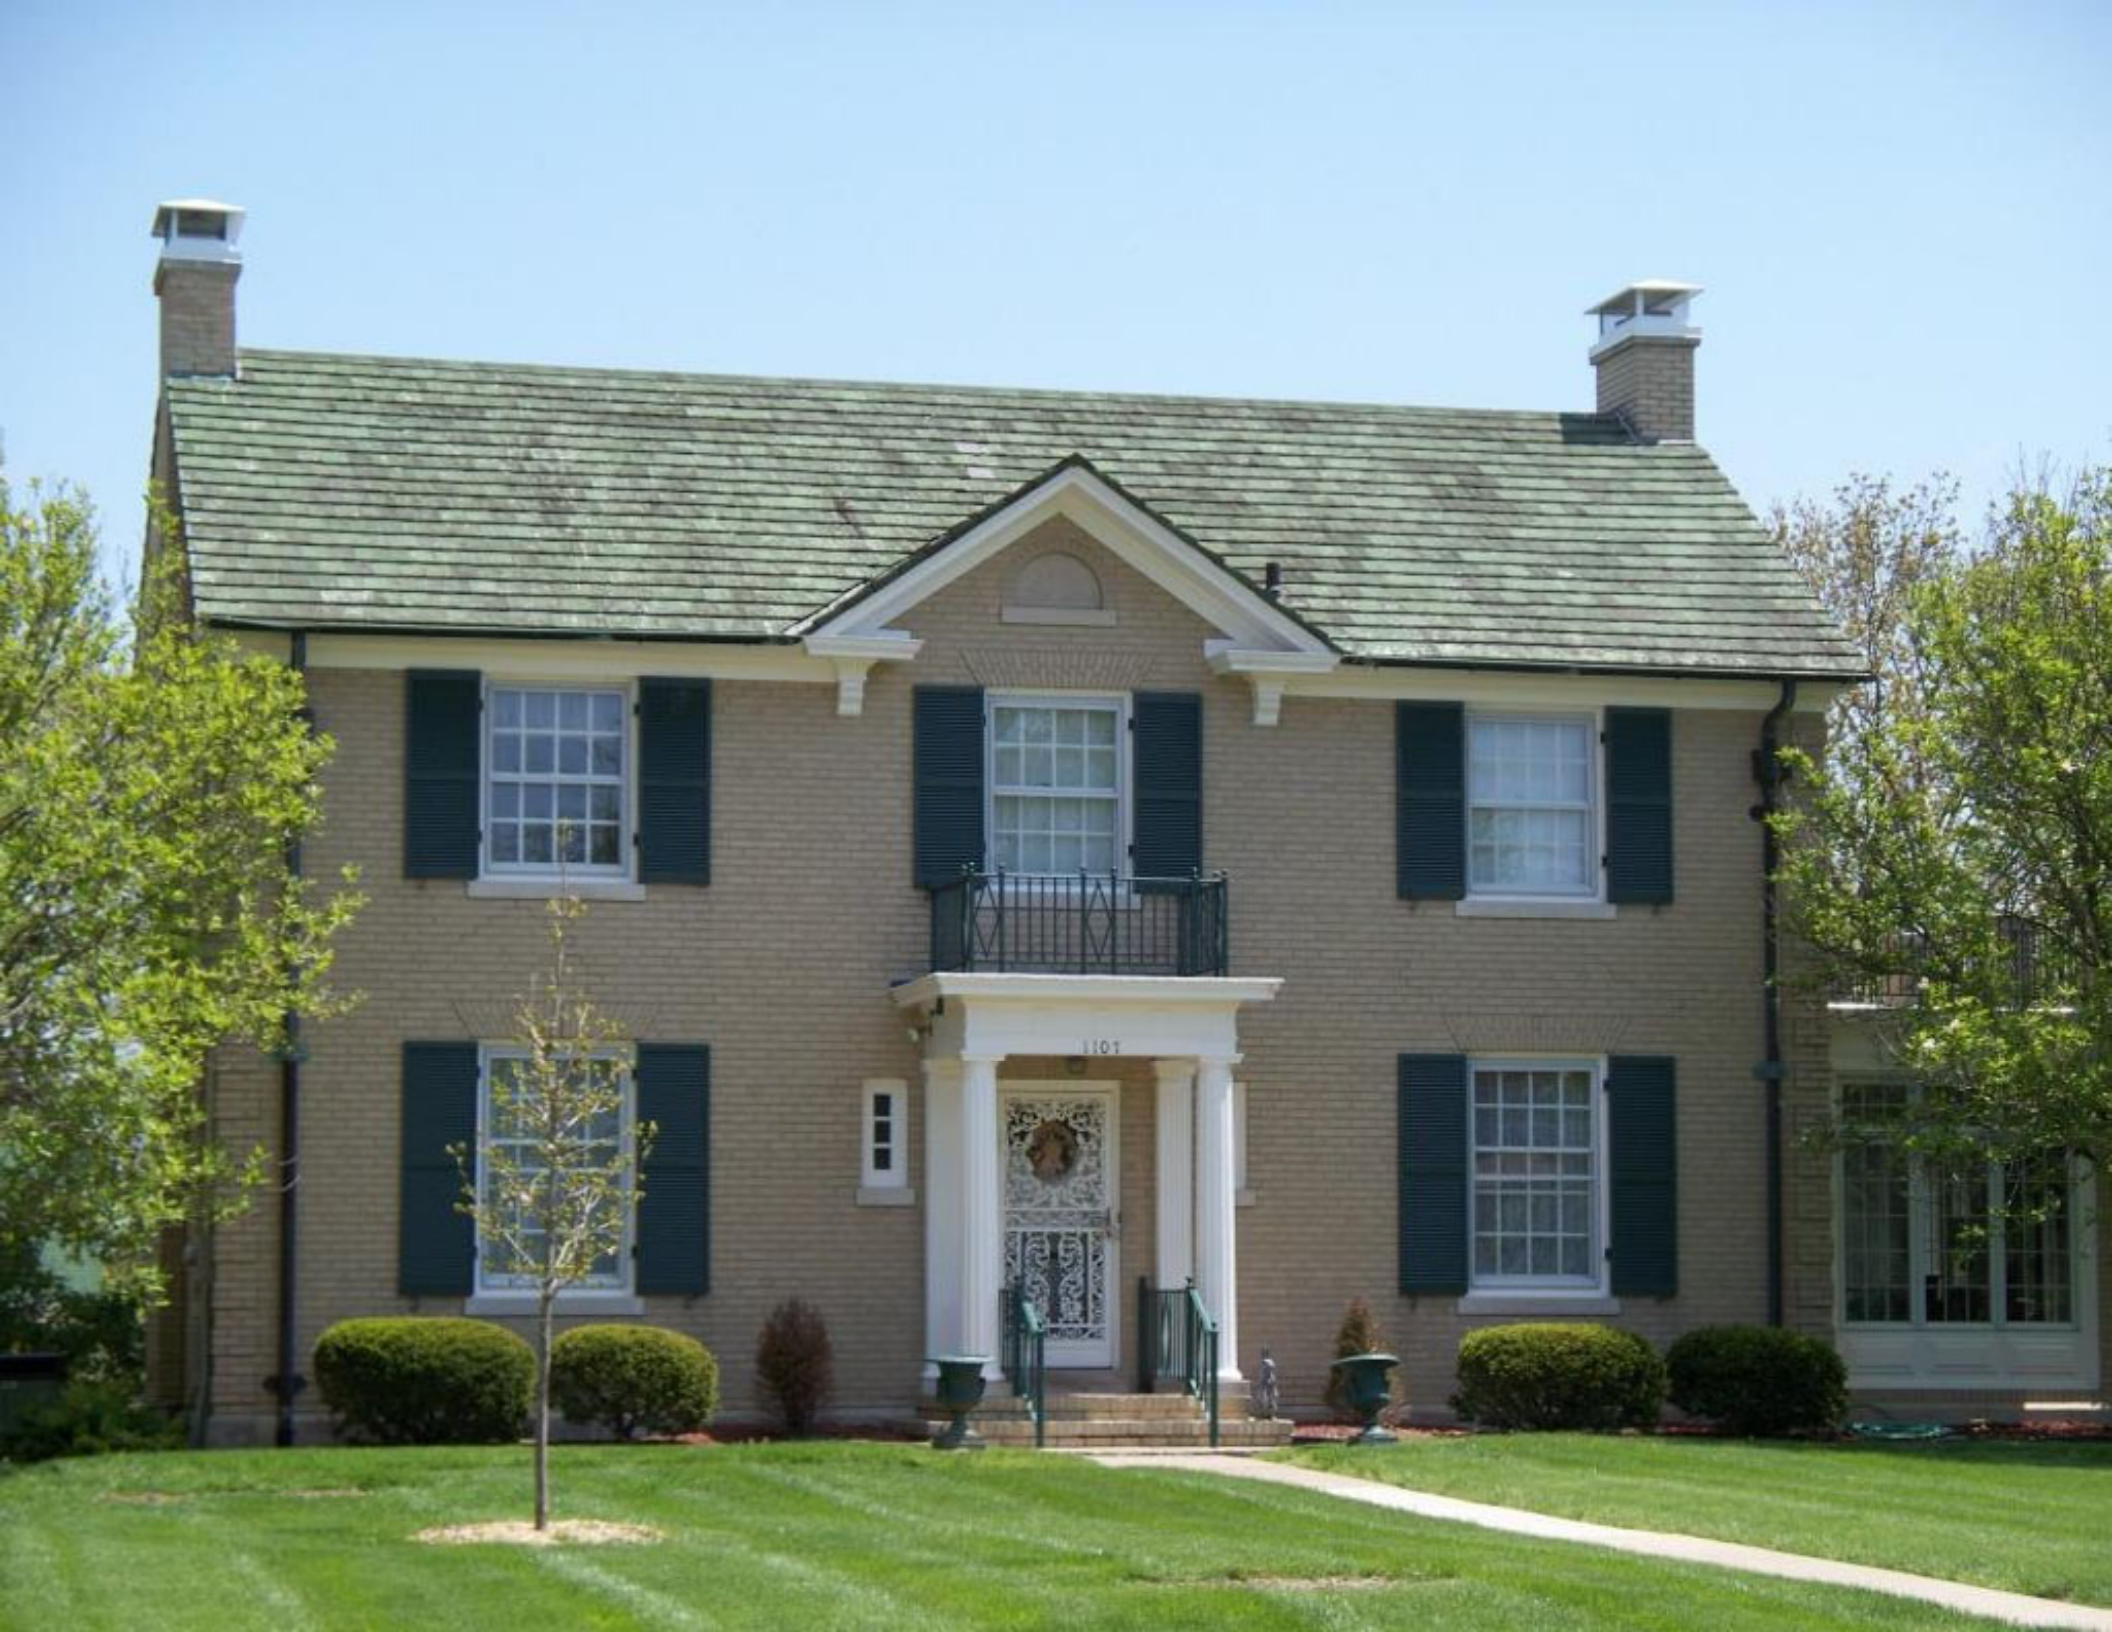
There is a garage made of the same brick behind the house, the door appears to be a replacement but it contributes to the district.

This two story brick Colonial Revival has several decorative features. A gabled pediment rises from the center roofline with crown molding that extends across the width of the building. The pediment frames an inset ornamental sun relief on a stone sill and decorative brick surround. Decorative brickworks fans from the lintel of the central window and those on the lower floor. Brick quoining is featured on the sides of the building. The entryway is centered and flanked by two thin casement windows. A portico with fluted Doric columns, decorative entablature, and upper decorative metal railing serves as the property's porch. The multi-paned windows appear to be replacement but are sympathetic. Two flank the entrance which has a decorative metal screen door, and three are symmetrically placed on the upper floor. Chimneys are placed at the sides of the property. A one-story sunroom with fixed windows and decorative surrounds is attached to the right of the property. The iron railing on top of the sunroom mimics that on the portico. The sunroom appears to be original or at the very least historic. This property is an excellent example of a Colonial Revival and could perhaps be individually eligible as well as contributing to a potential district.

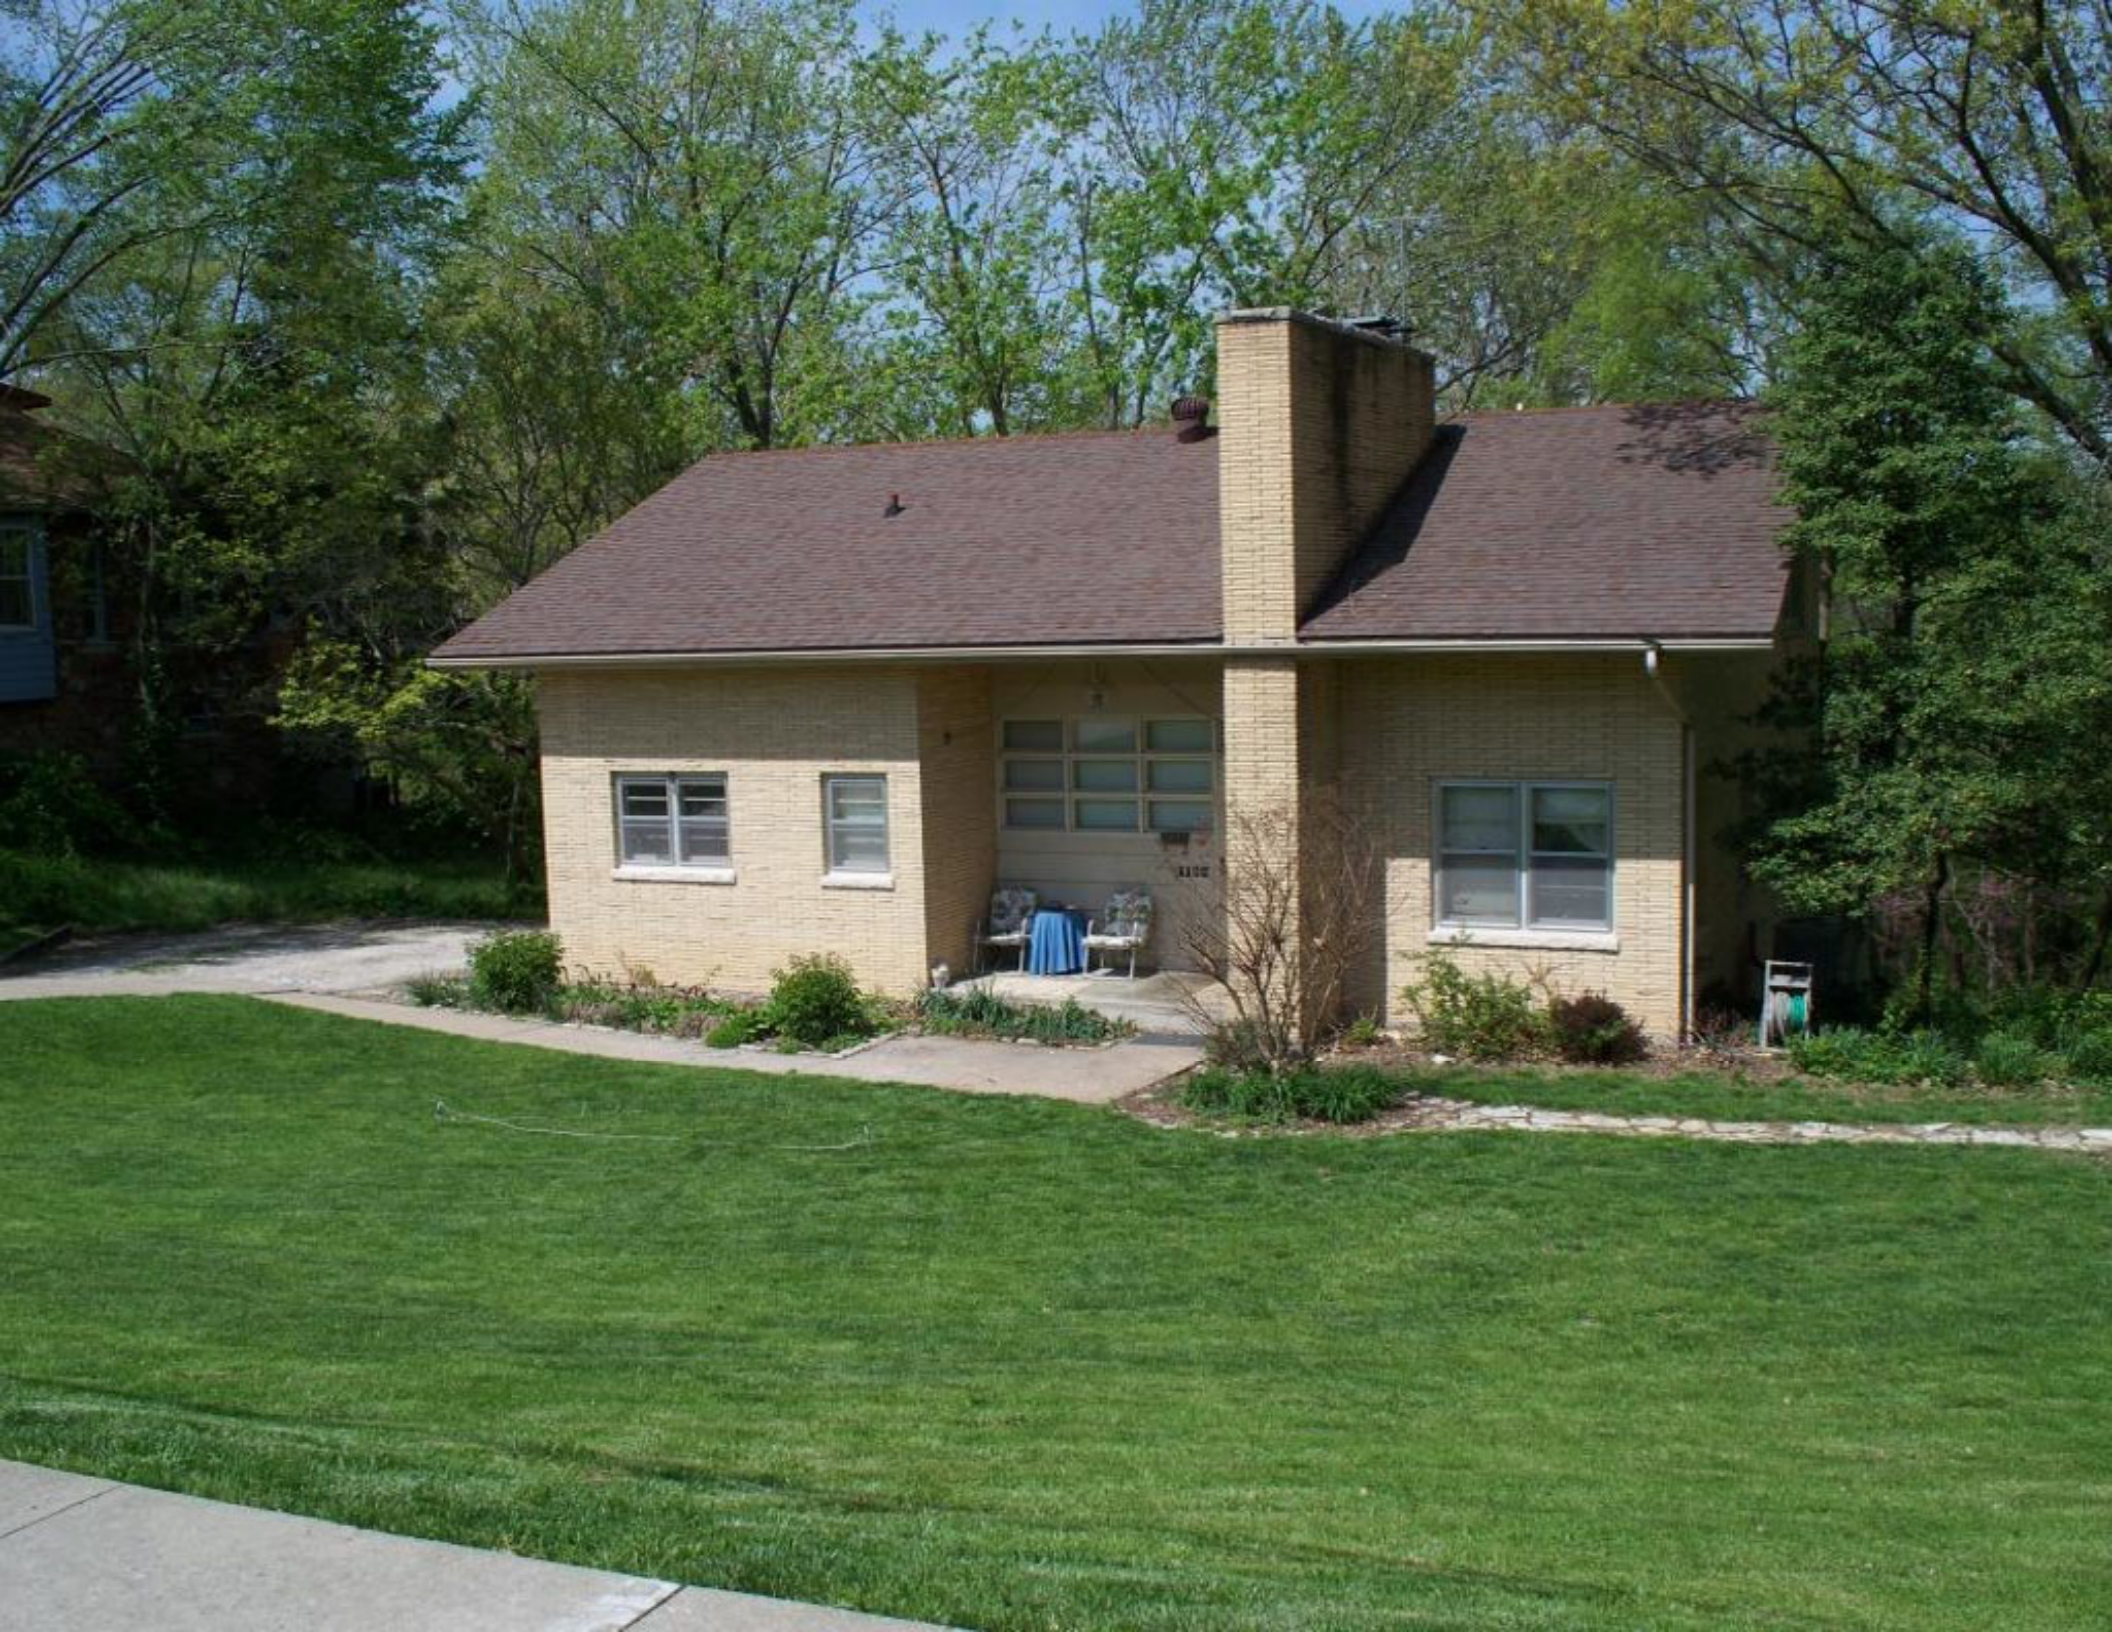
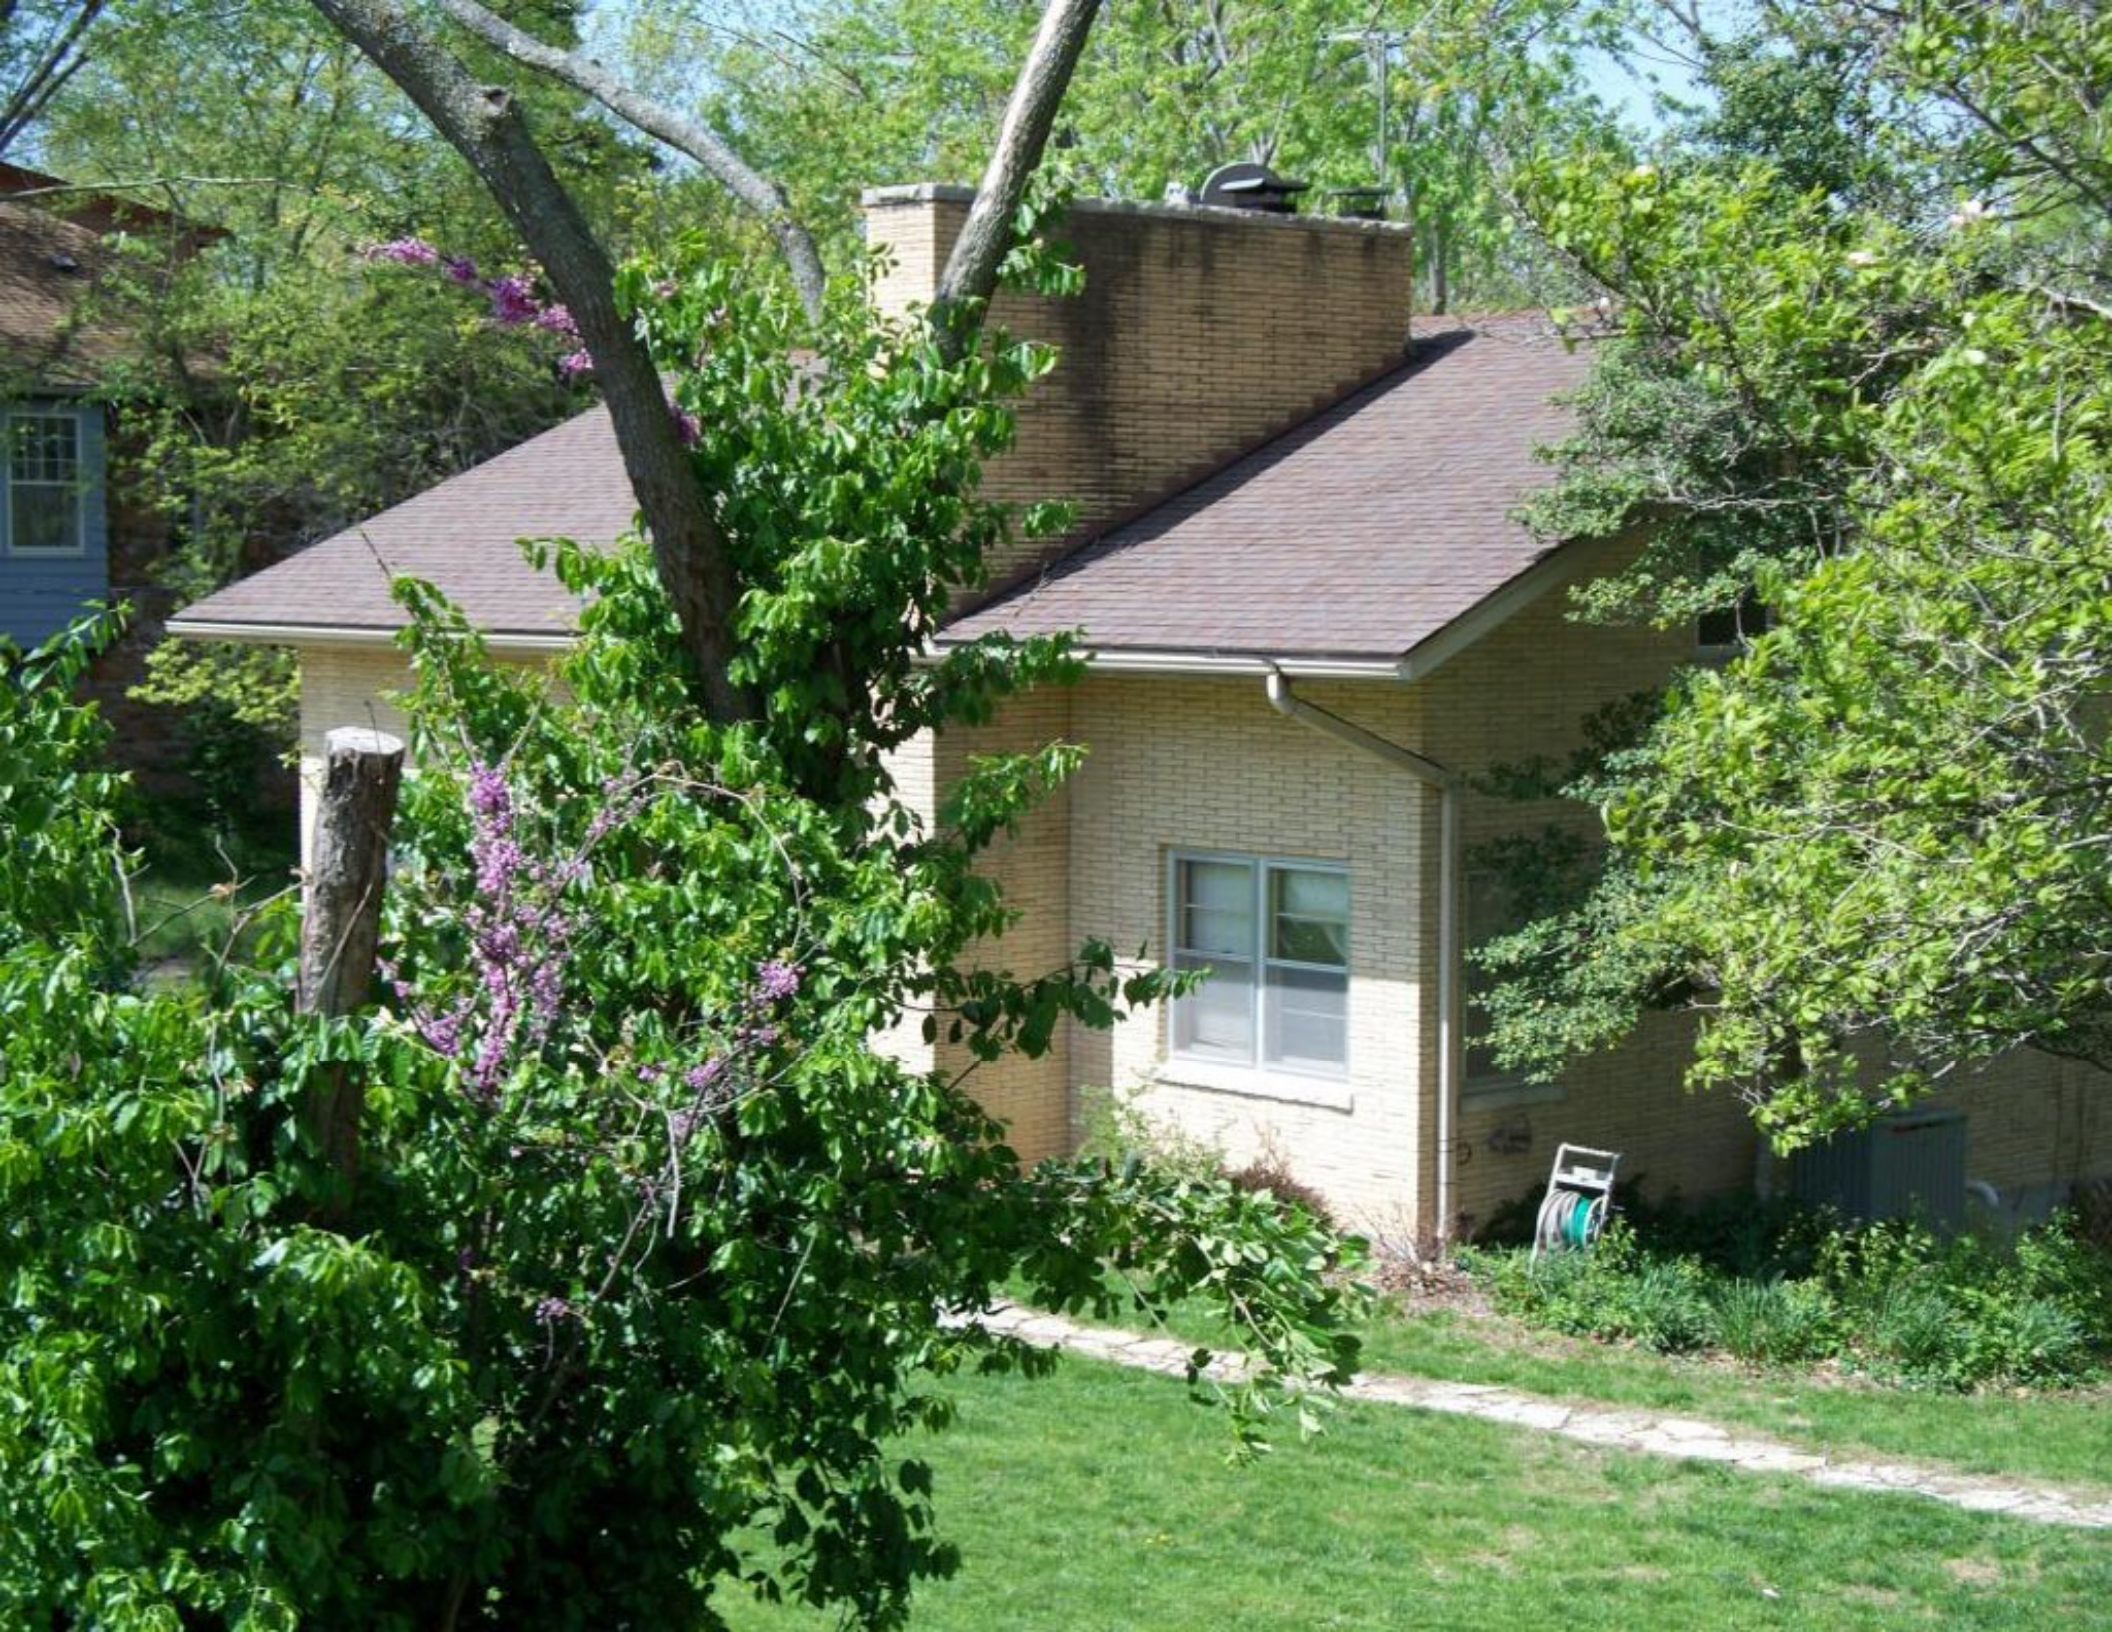
This property is a little difficult to define. It could be a variation of a ranch or minimal traditional house. It is a one-story brick home with a side gable roof. The central bay is recessed and is utilized as a patio/porch area that leads to the entrance. This bay has a large nine-light picture window with shingles beneath. The most distinctive characteristic of this house is the wide chimney that projects from the exterior of the home defining the first and second bays. It rises well above the roof line and extends to the interior of the house, nearly to the apex of the roof. The furthestmost left bays contain paired 1/1 windows and a single 1/1 window. The first bay (right) has similar paired 1/1 windows. Due to its construction date it could potentially be non-contributing. However if the period of significance is extended to 1960 it would be contributing.

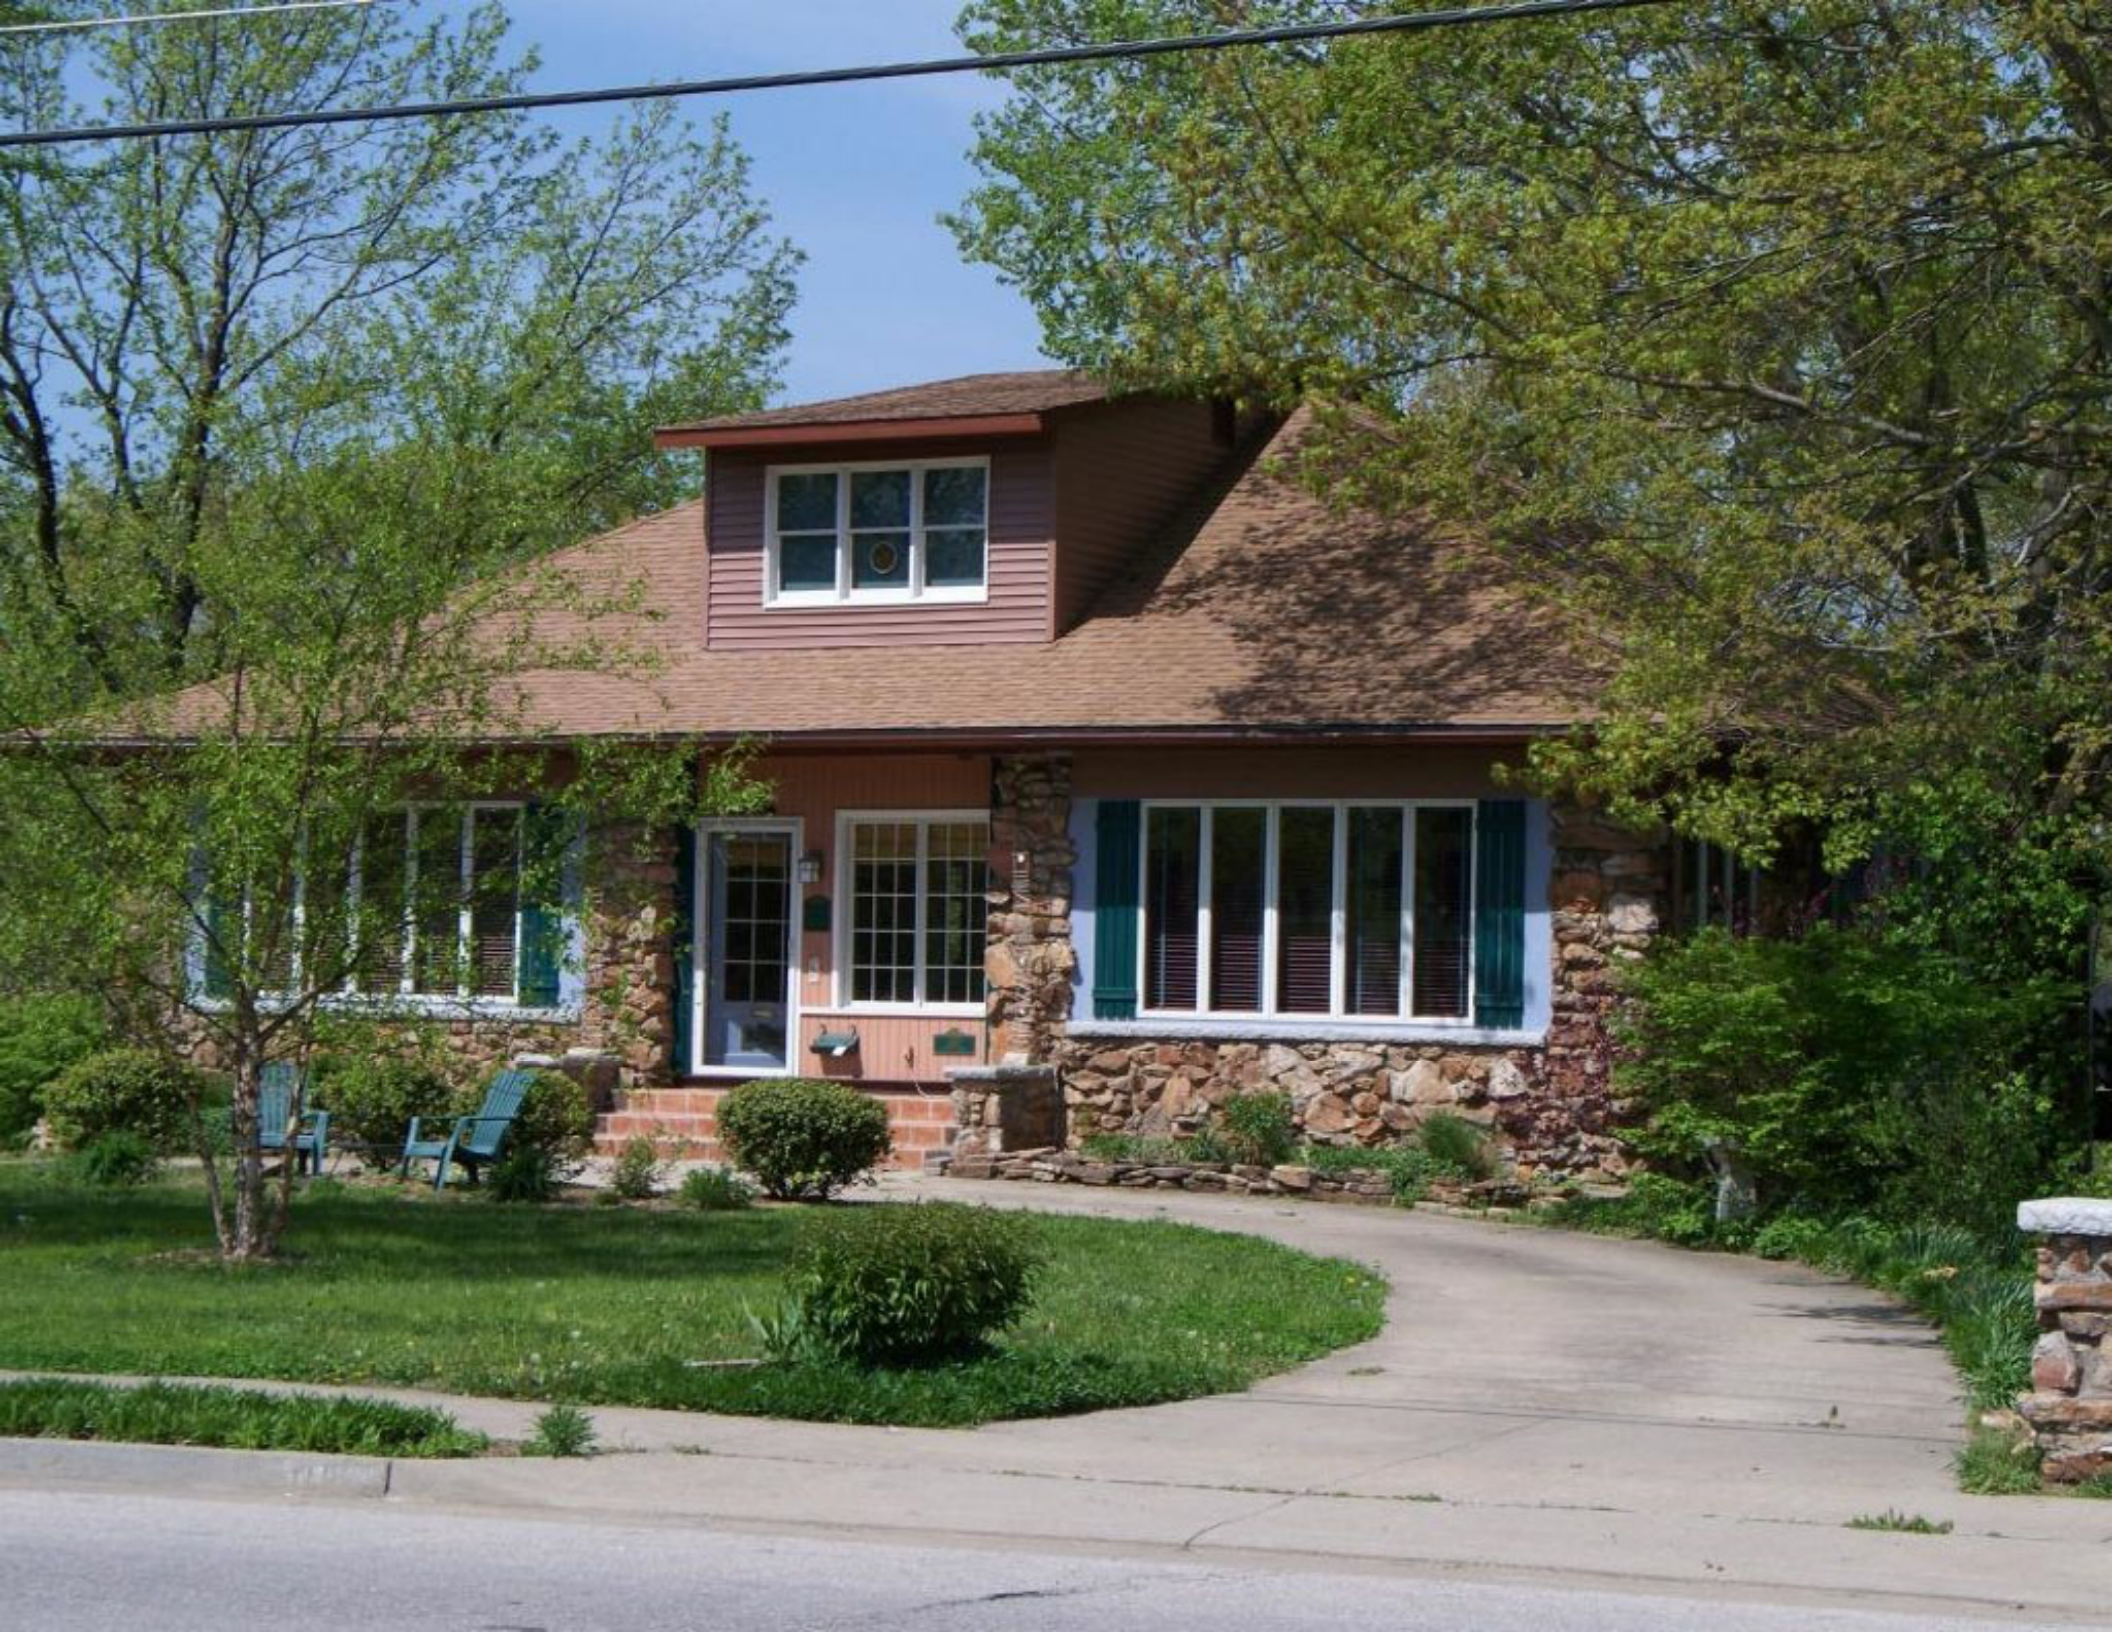
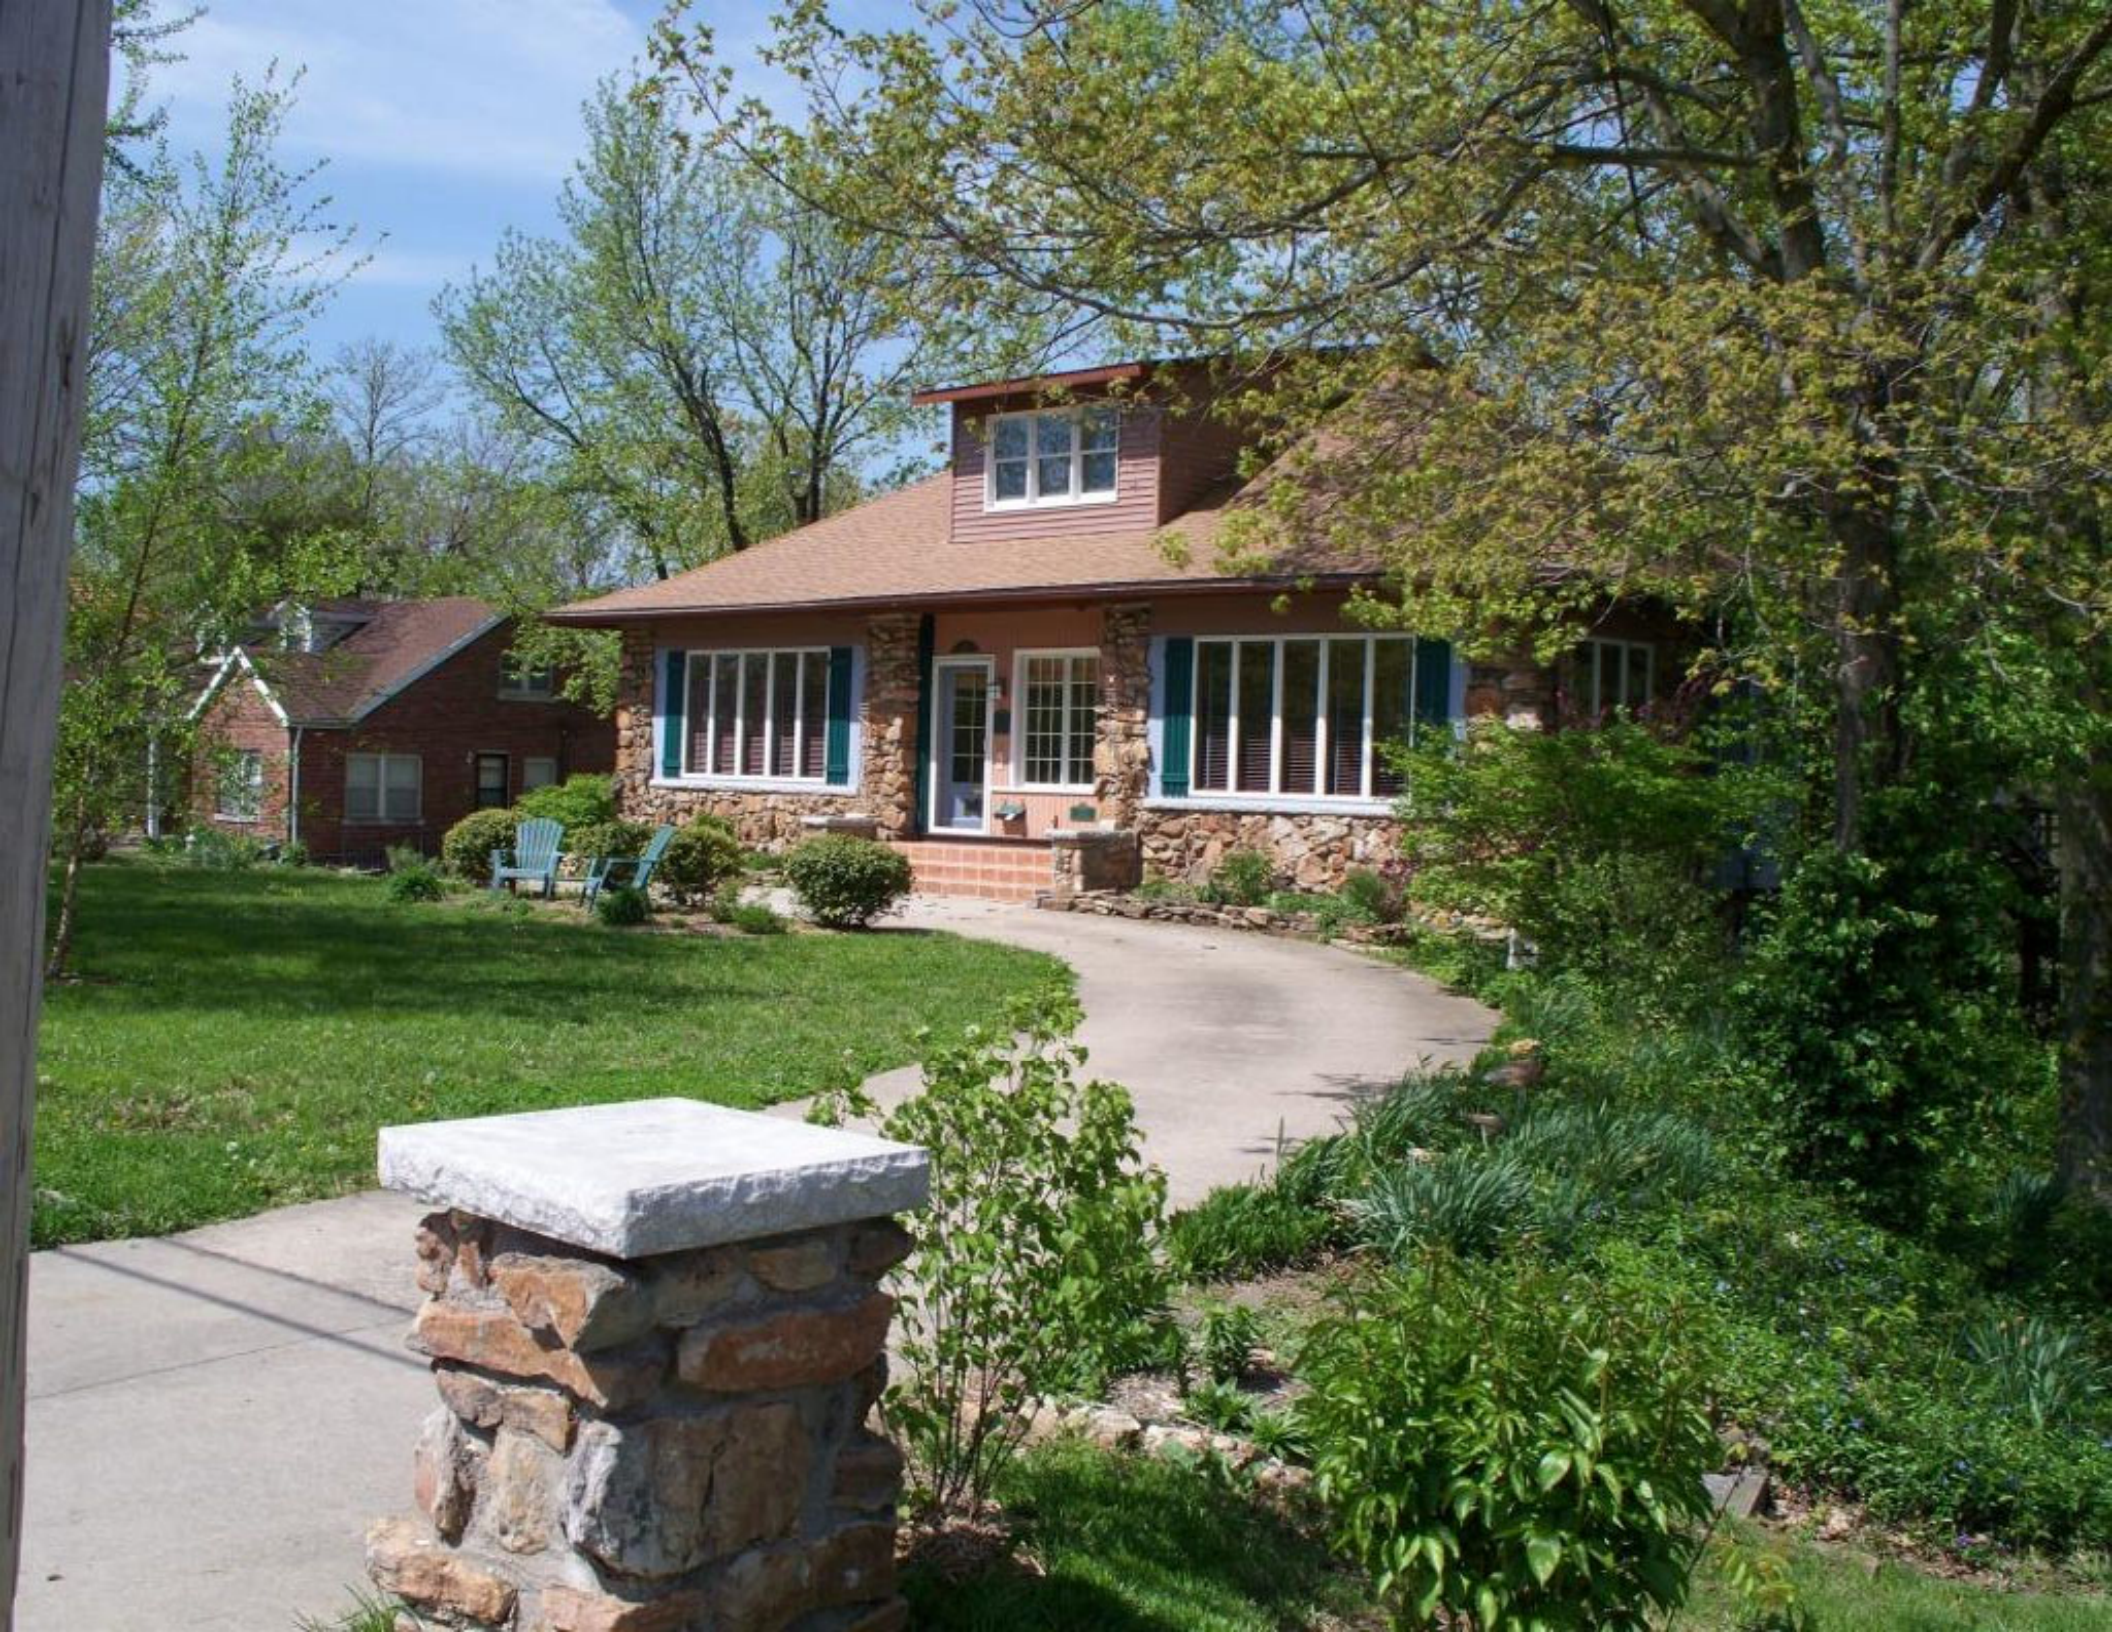
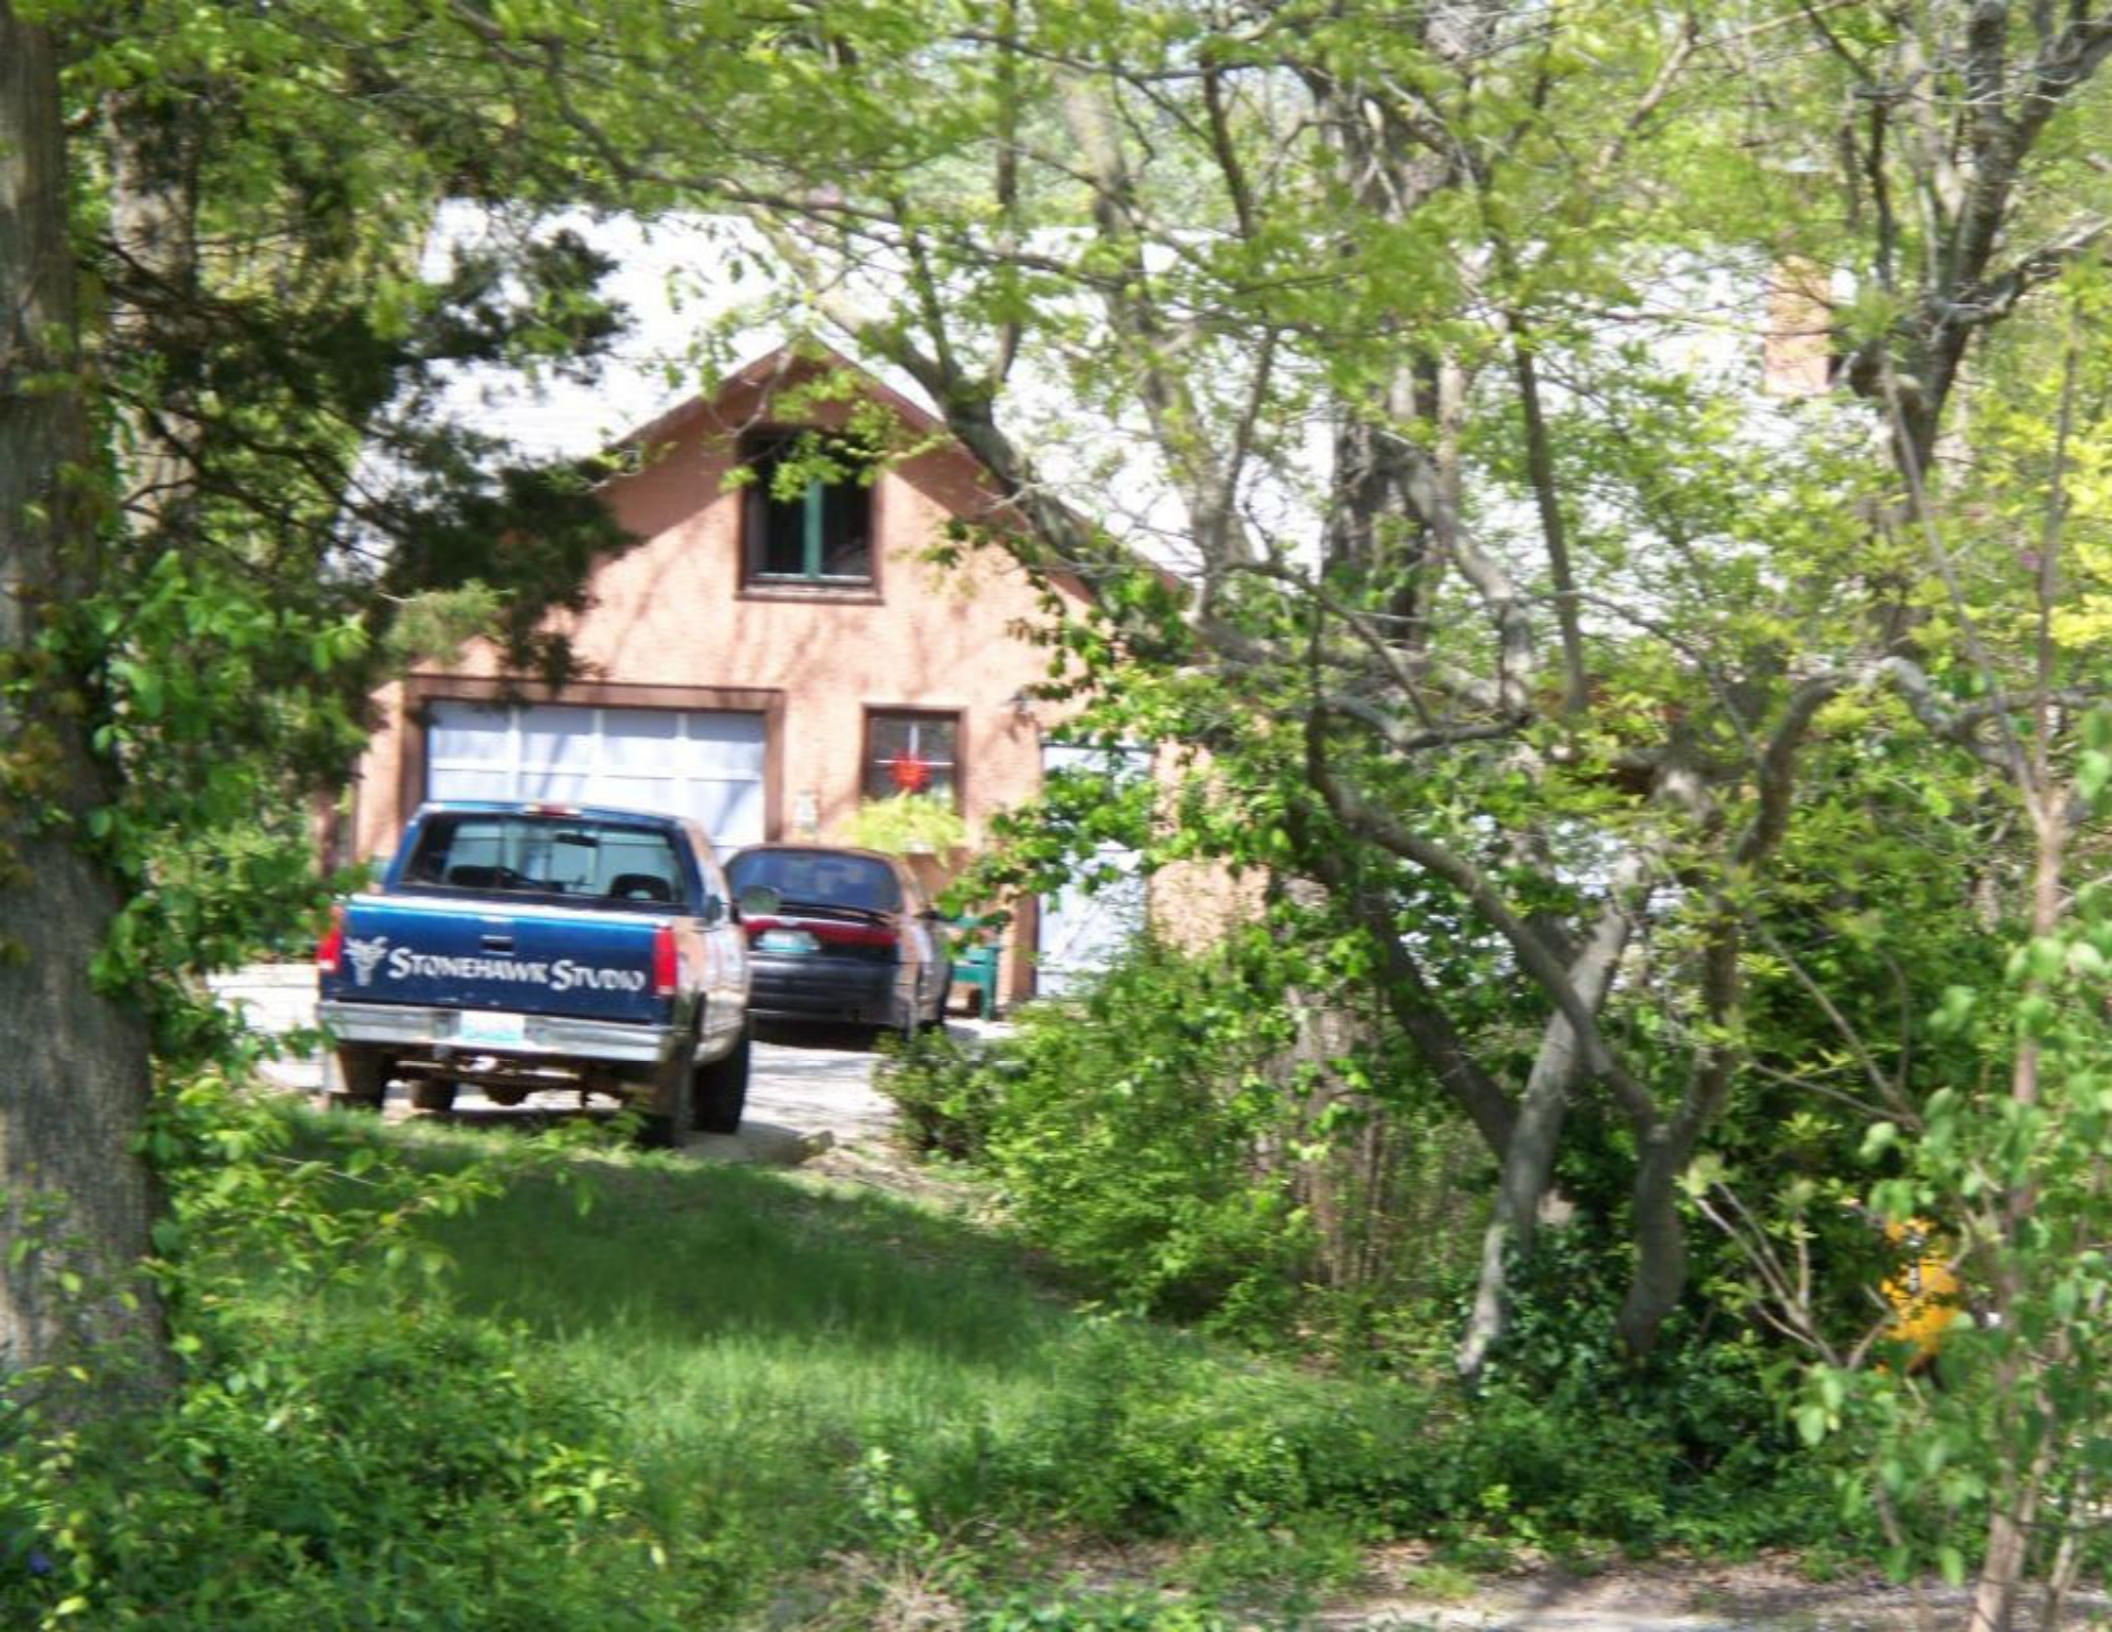
40. (cont.) Description of environment and outbuildings. Expand box as necessary, or add continuation pages.
Behind the house is a large outbuilding that features a one-car garage and entry. It looks to be one-a-half stories and has a cross gable roof, stone chimney and stucco-clad walls. According to the 1939 Sanborn map an outbuilding of this size was in this location. It therefore is considered contributing to the district.

41. (cont.)
This one-a-half story stone bungalow has what appears to be a full-width porch that has been in-filled with modern windows and wood siding around the central entrance. The large window openings on the first and third bays have vinyl casement windows. There are paired multi-paned windows in the central bay to the right of the entrance. The central dormer has three 1/1 windows, it's not clear if they're modern or historic however the dormer appears to be clad in vinyl. Due to the amount of alterations, the historic integrity of the property is adversely impacted. It is considered non-contributing to the historic district.
