ARCHITECTURAL/HISTORIC INVENTORY FORM

1. Survey No. CO-AS-005-001		2. Survey name: Moreau Drive Neighborhood Survey	
3. County: Cole		4. Address: 1202 Elmerine Ave.	
5. City: Jefferson City	Vicinity: <input type="checkbox"/>	6. UTM: / /	7. Township/Range/Section: T: R: S:
8. Historic name (if known):		9. Present/other name (if known):	
10. Ownership: <input checked="" type="checkbox"/> Private <input type="checkbox"/> Public		11. Historic use (if known): Residential	11. Current use: Residential

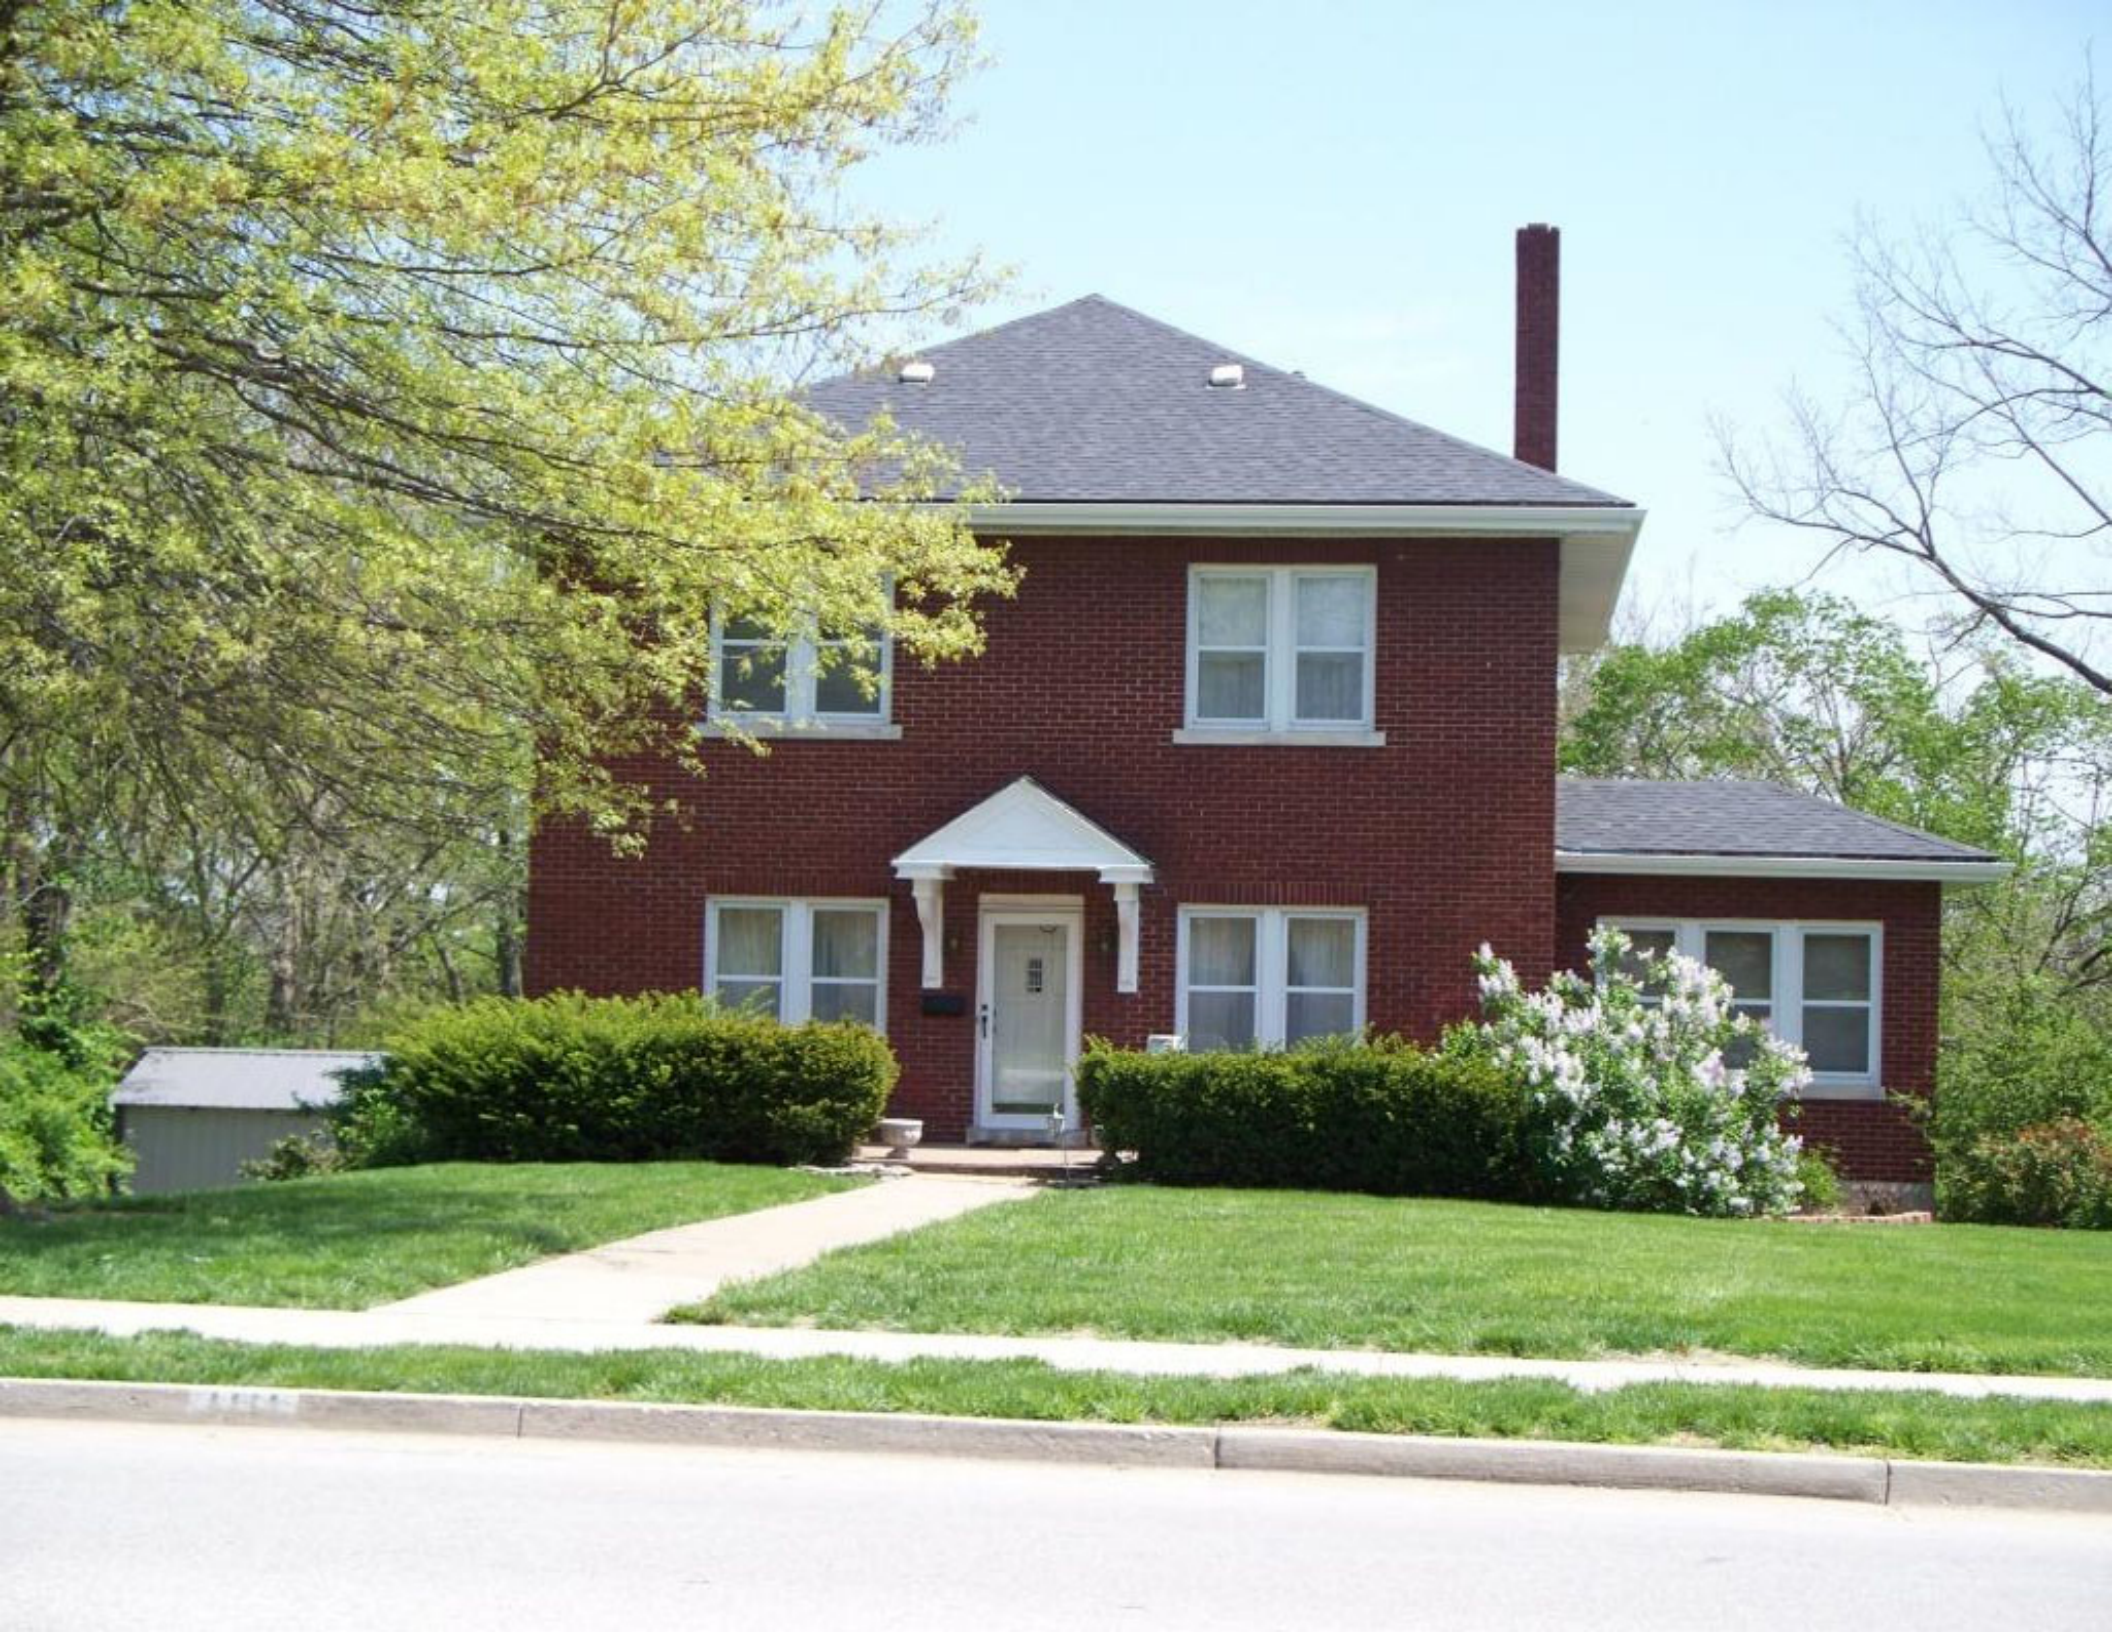
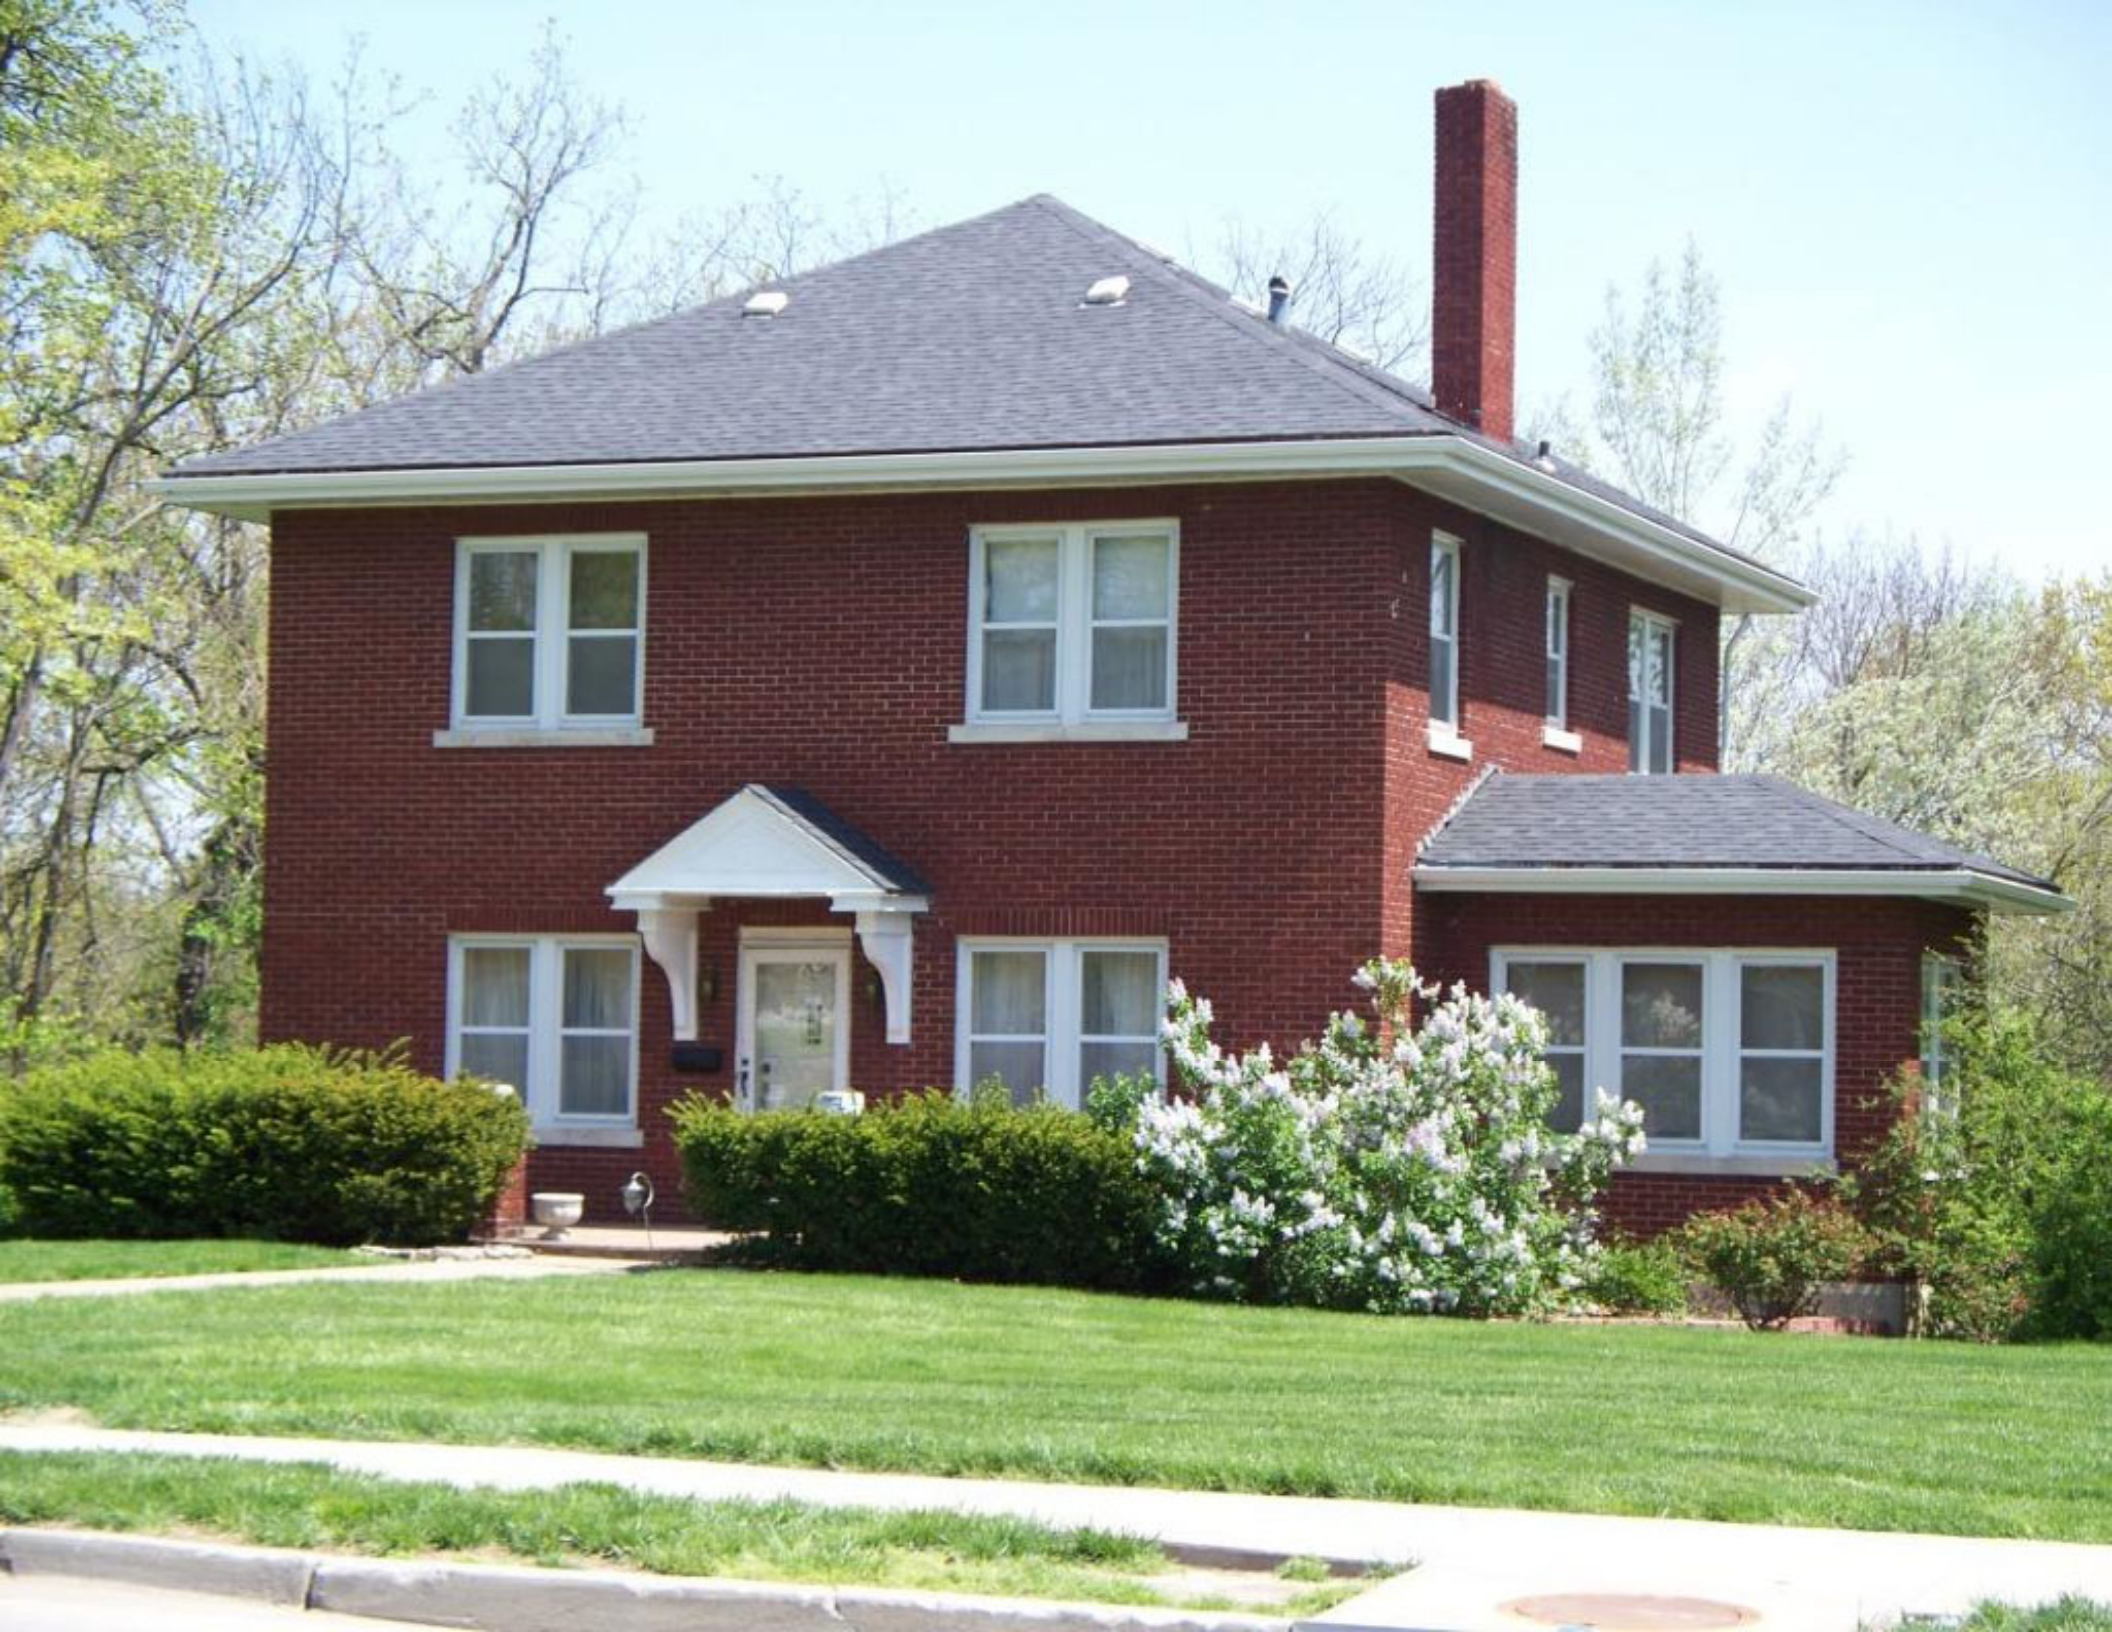
This red brick foursquare has a pyramidal roof and attached sunroom on the first floor. The fenestration is symmetrical and consists of paired one-over-one replacement vinyl windows on stone sills flanking the door on both floors. There little detailing on this building other than some minor brick detailing over the window openings and the Classical pediment and bracket hood over the door. The windows in the sunroom have been replaced with a band of three one-over-one vinyl windows. The door also appears to be a replacement, despite these changes the property still reflects its original character and is considered contributing to the district.

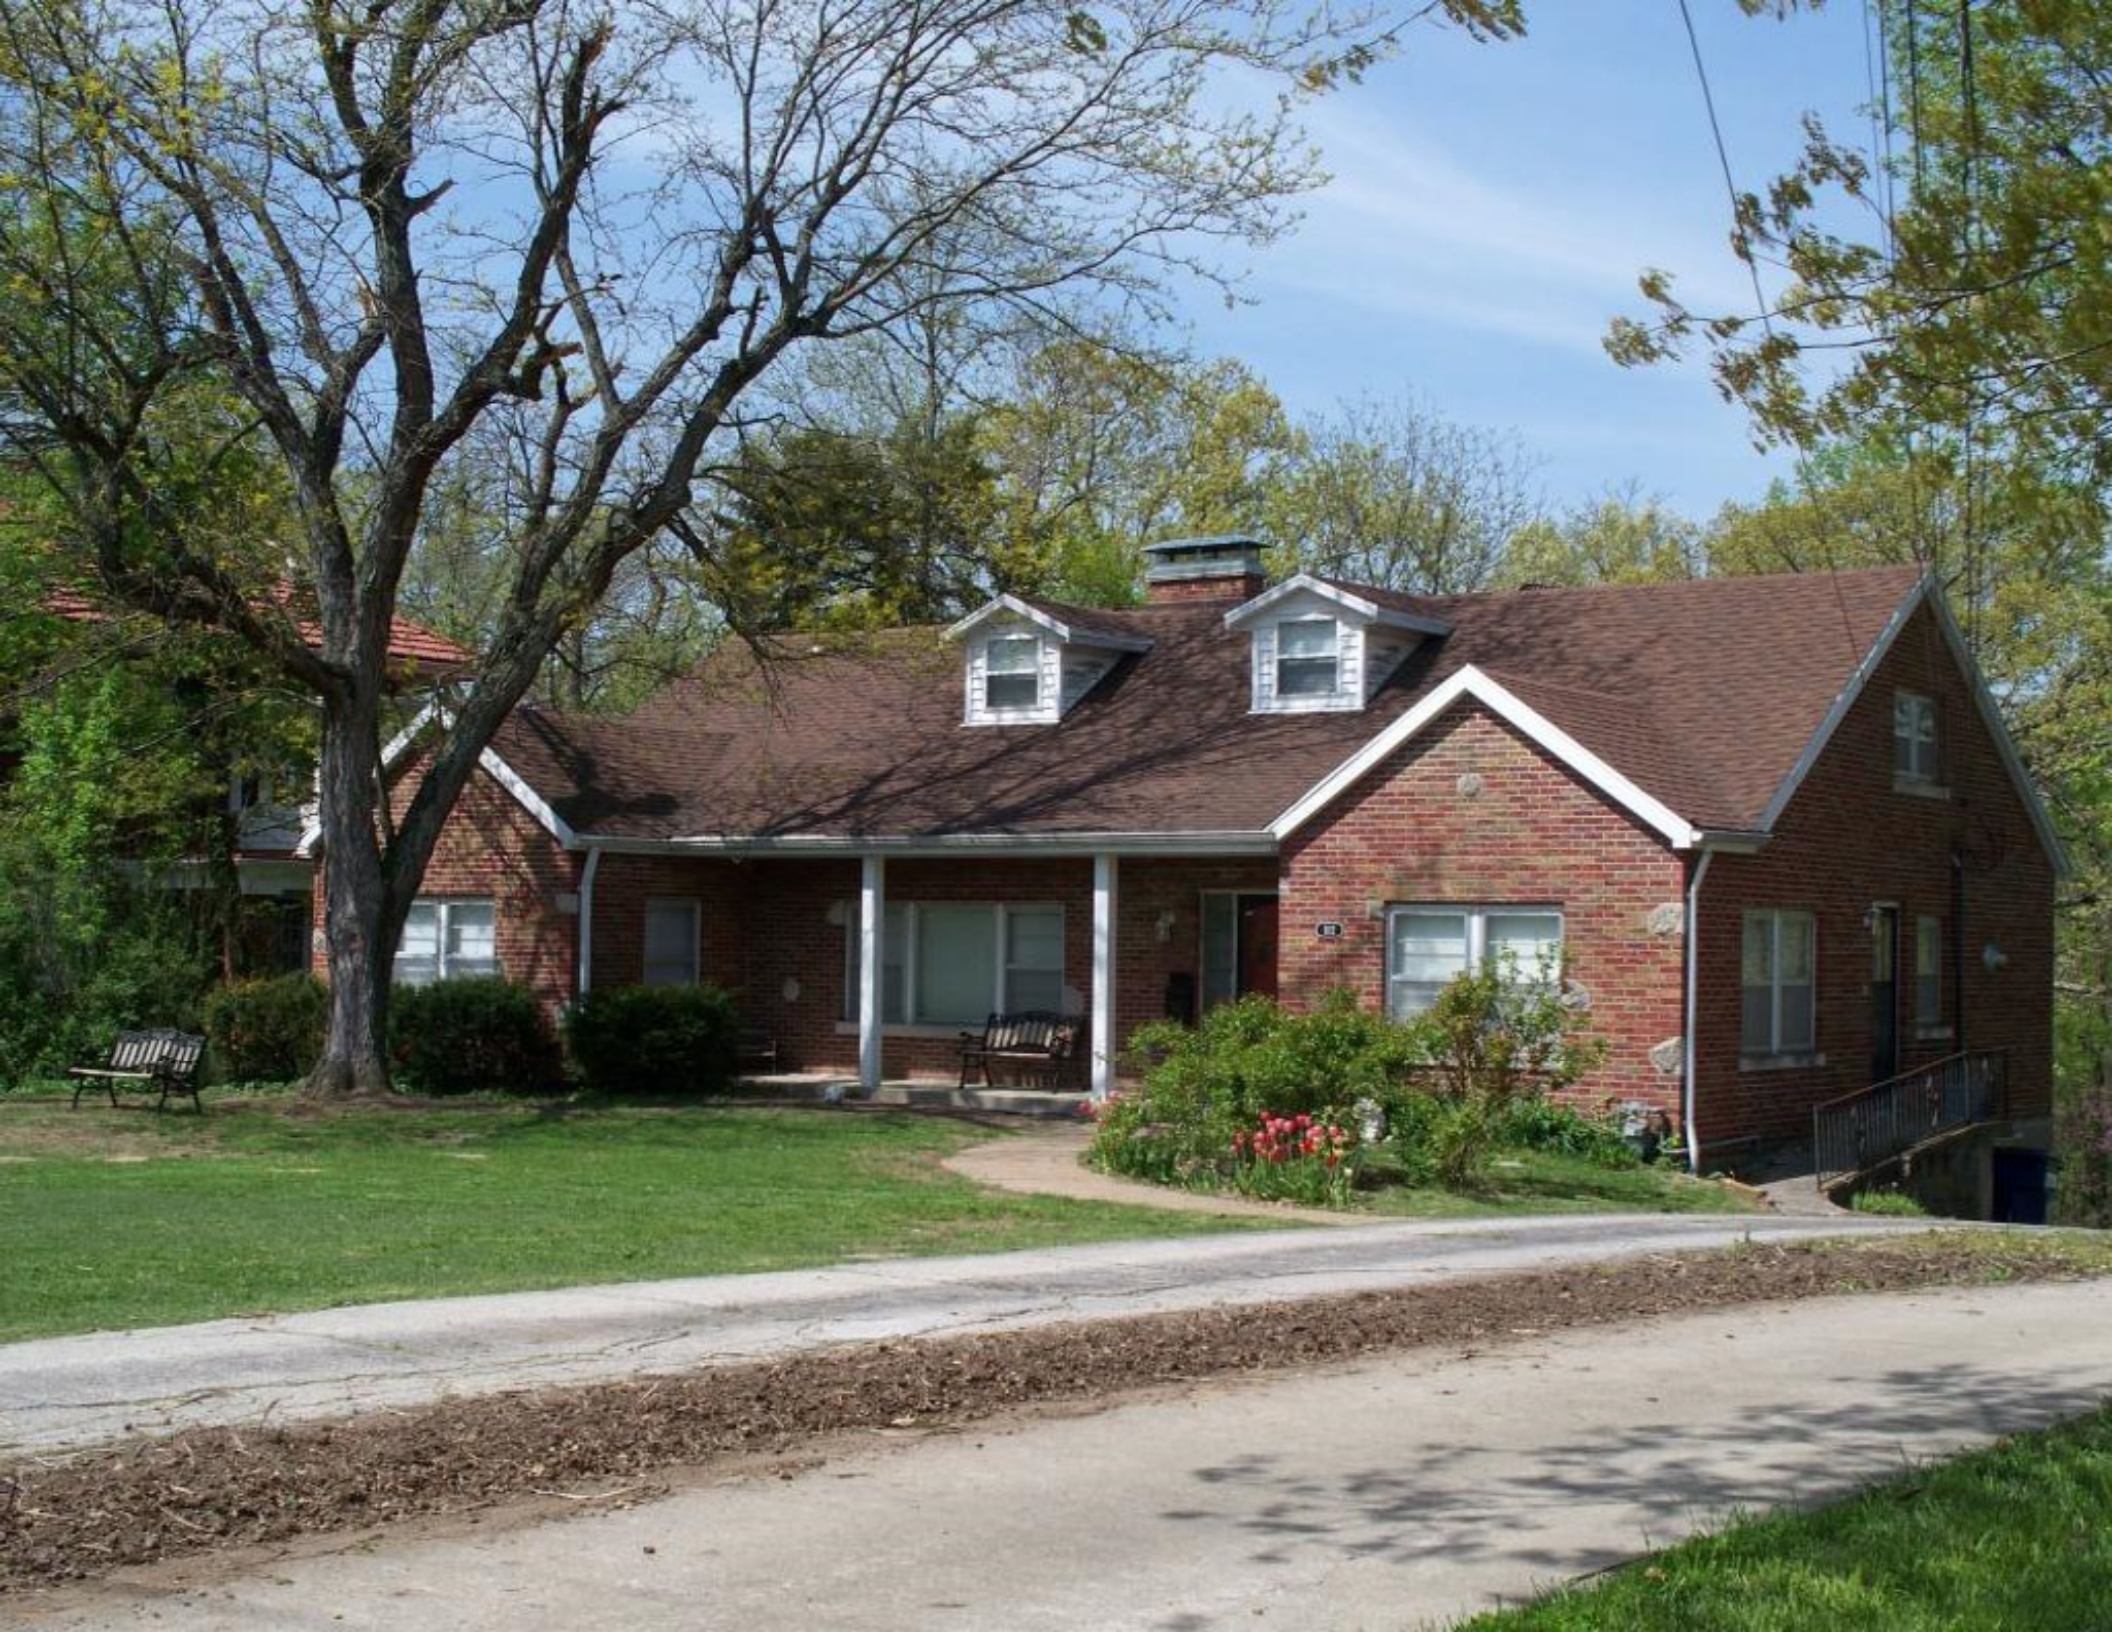
This one-and-a-half-story ranch house has a side gable roof over the central portion of the house. The first and fourth bays fully extend from the property with their own front gabled roofs. These bays feature paired 1/1 aluminum windows. The central bays contain the entrance with sidelights and a tri-part window with 1/1 aluminum flanking a solid picture window. The roof partially extends over the second and third bay which creates a porch and is supported by two square posts. There are two small gabled-dormers centrally located on the roof, each with a single 1/1 window. The house is clad in multi-color brick that is occasionally broken by stone detailing.

Due to its construction date it is currently considered non-contributing to the district, however, if the period of significance is extended to 1960, this property would contribute.

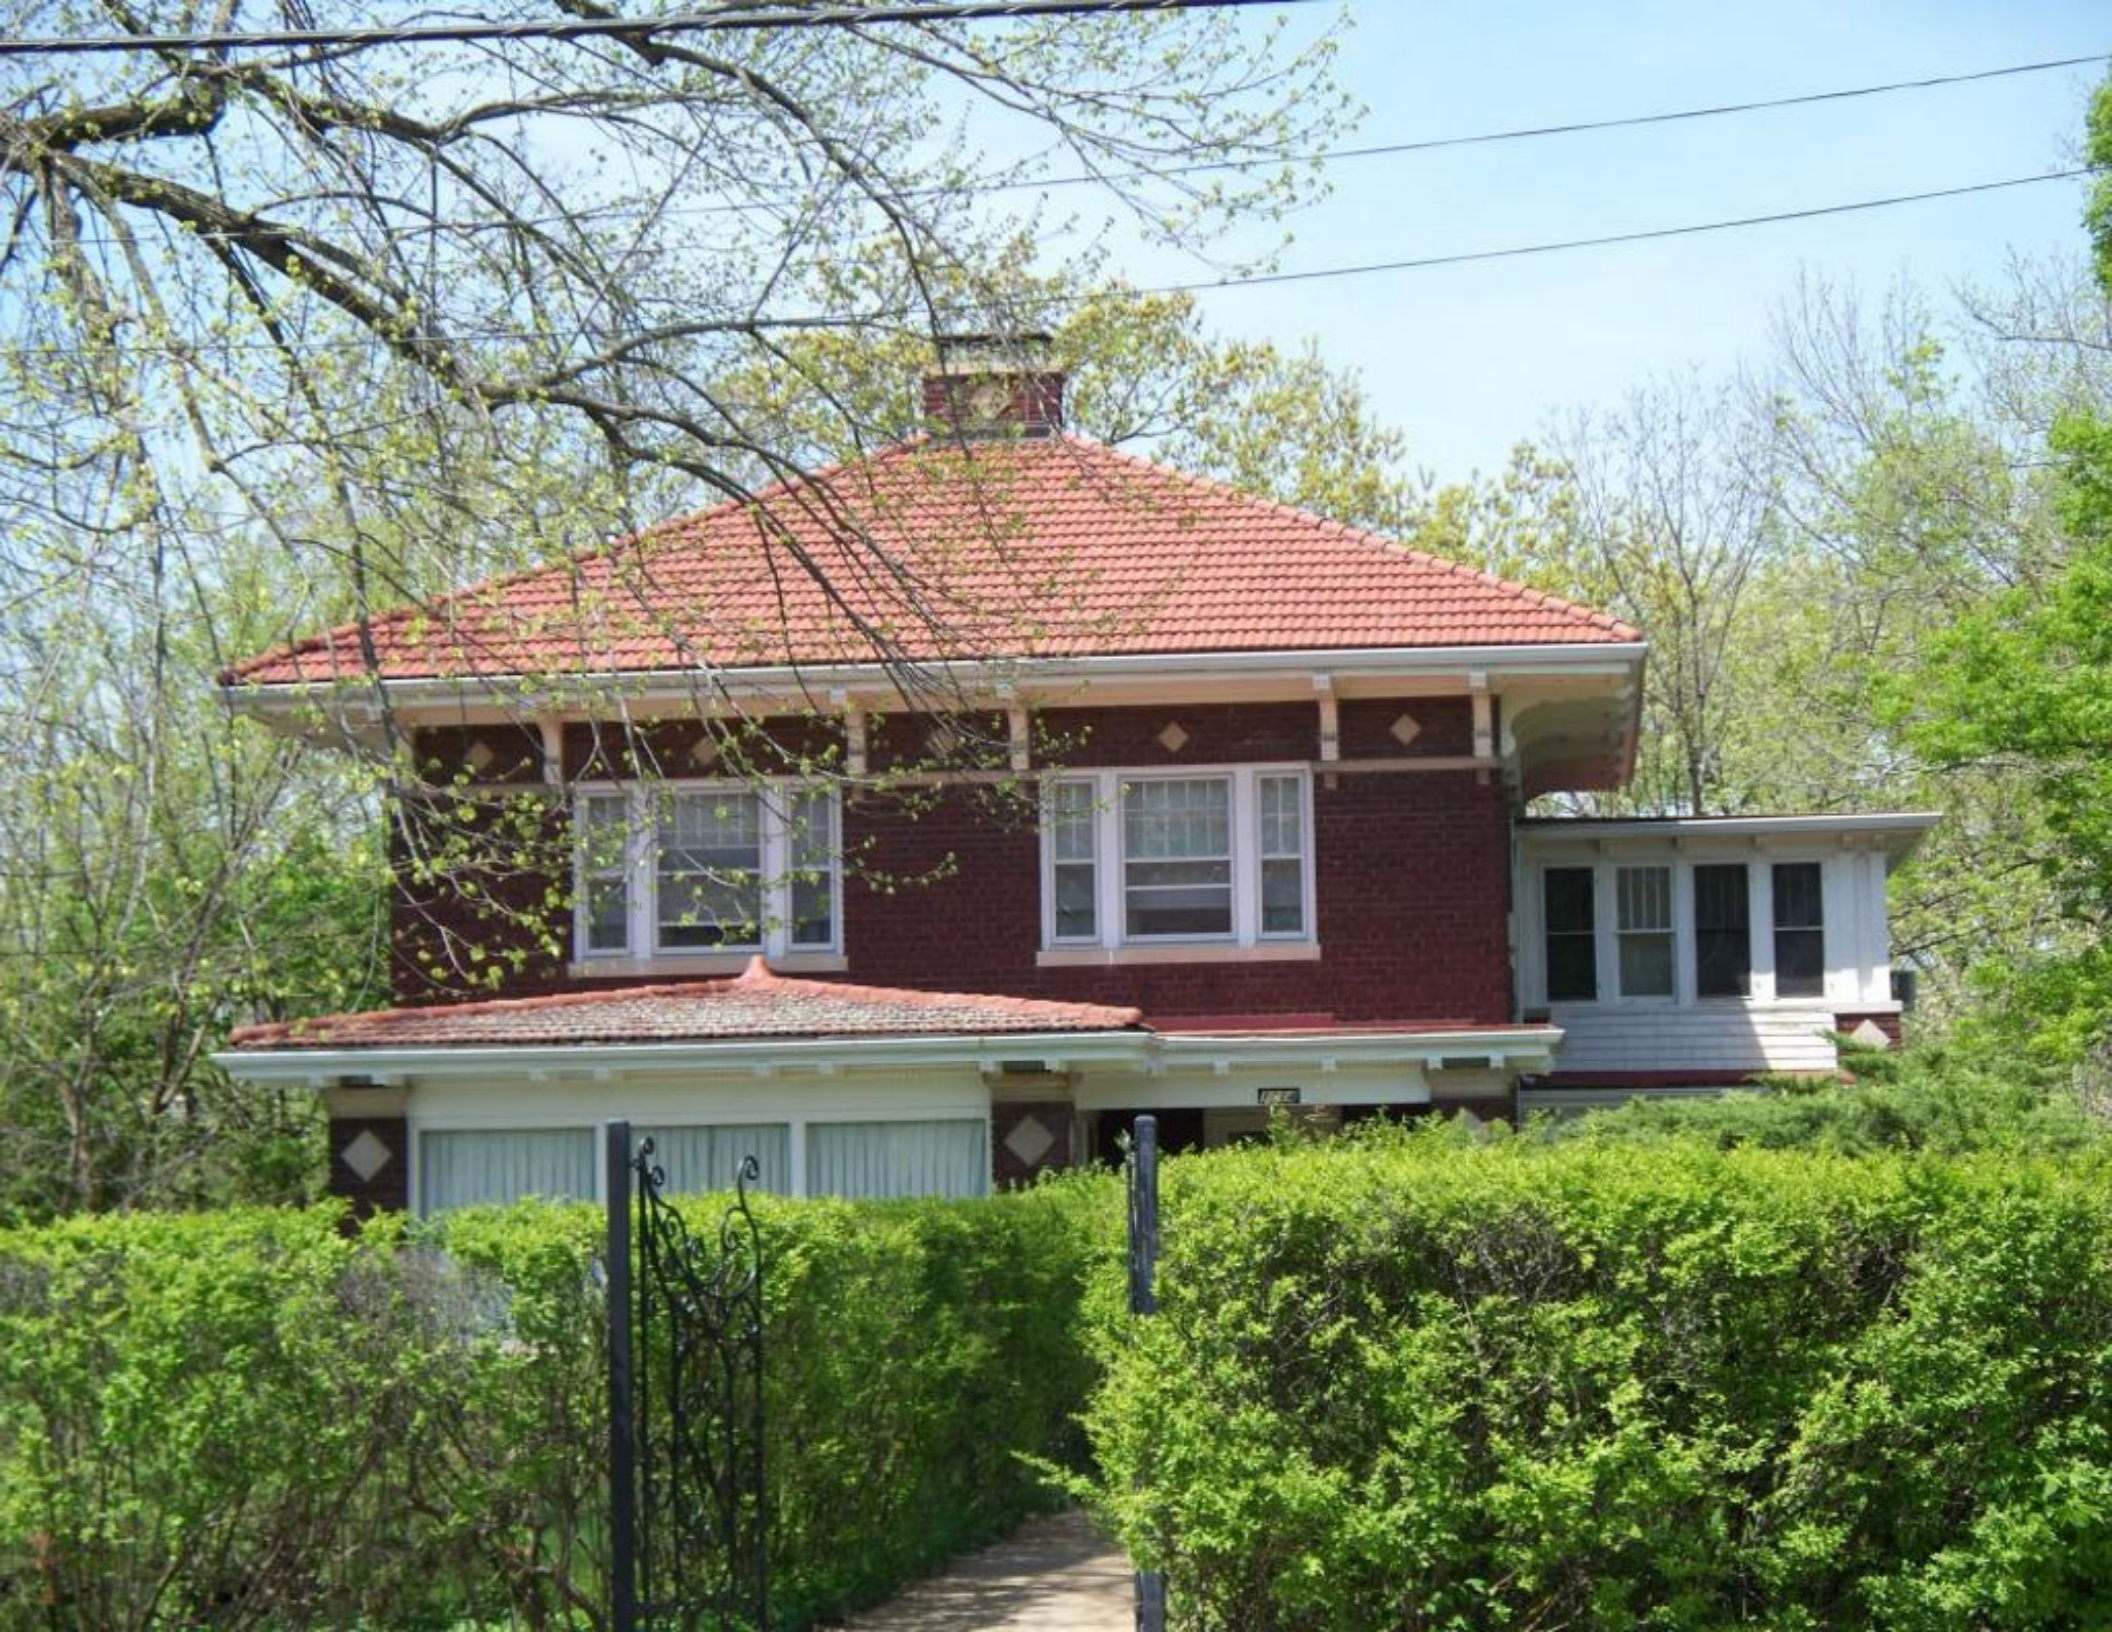
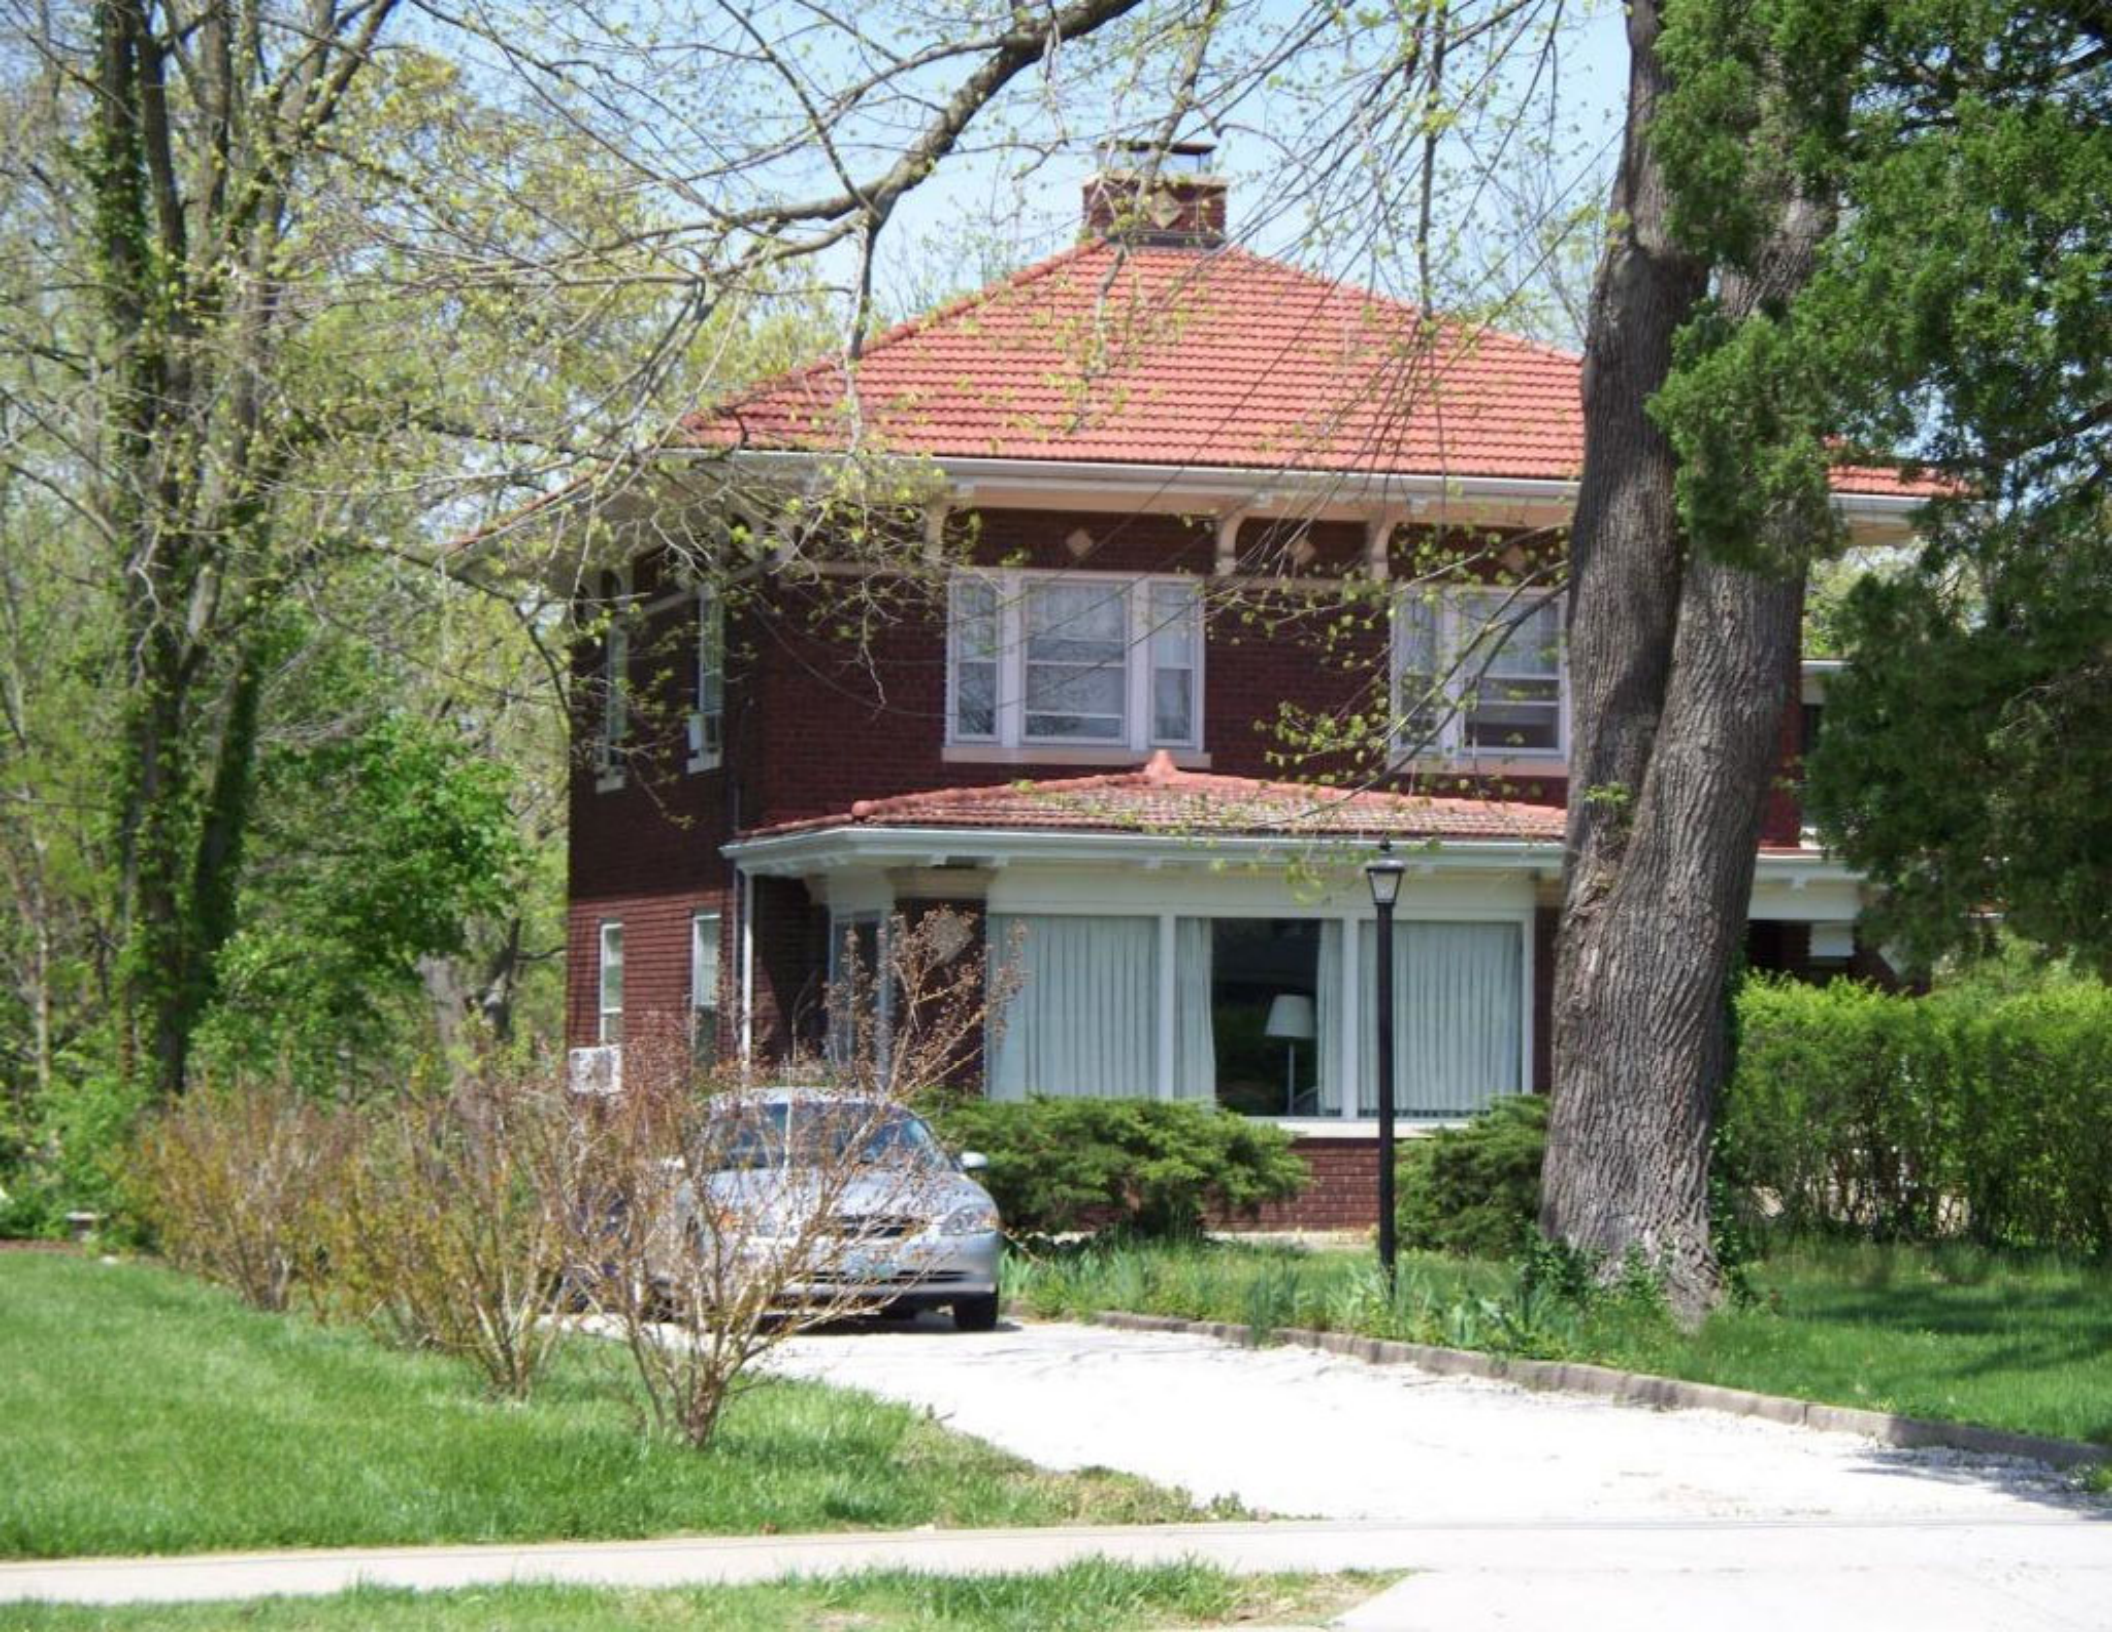
This two-story brick four square has several decorative features that suggest minimal Italian Renaissance stylization. The first is the tile pyramidal roof with the chimney located at the apex with a stone diamond accent. Additionally, there are brackets under the wide eaves of the roof that meet a stone band, both stretch around the perimeter of the home. Between the brackets are decorative stone diamonds. The sun porch extends from the property also has a tile roof and rafter tails. At one time this may have been part of a full open porch but according to Sanborn maps this section was enclosed as far back as 1939 and thus it's possible it was built this way. The second story has two tri-part historic windows that have 2/1 flanking 5/1. They both have storms. The first floor sun room has three large fixed panes set between square brick pillars with diamond stone accents. The porch, which is more of a portico, is set slightly back but also has a tile roof with rafter tails and brick pillars that are in line with the sun porch. To the right of the main façade is a two-story sleeping porch/sun porch with tile roof. The upper story of this section has been clad in shingle but it also features the rafter tails and brick pillars present in the central porch.
