ARCHITECTURAL/HISTORIC INVENTORY FORM

1. Survey No. CO-AS-005-001		2. Survey name: Moreau Drive Neighborhood Survey	
3. County: Cole		4. Address: 1202 Elmerine Ave.	
5. City: Jefferson City	Vicinity: <input type="checkbox"/>	6. UTM: / /	7. Township/Range/Section: T: R: S:
8. Historic name (if known):		9. Present/other name (if known):	
10. Ownership: <input checked="" type="checkbox"/> Private <input type="checkbox"/> Public		11. Historic use (if known): Residential	11. Current use: Residential

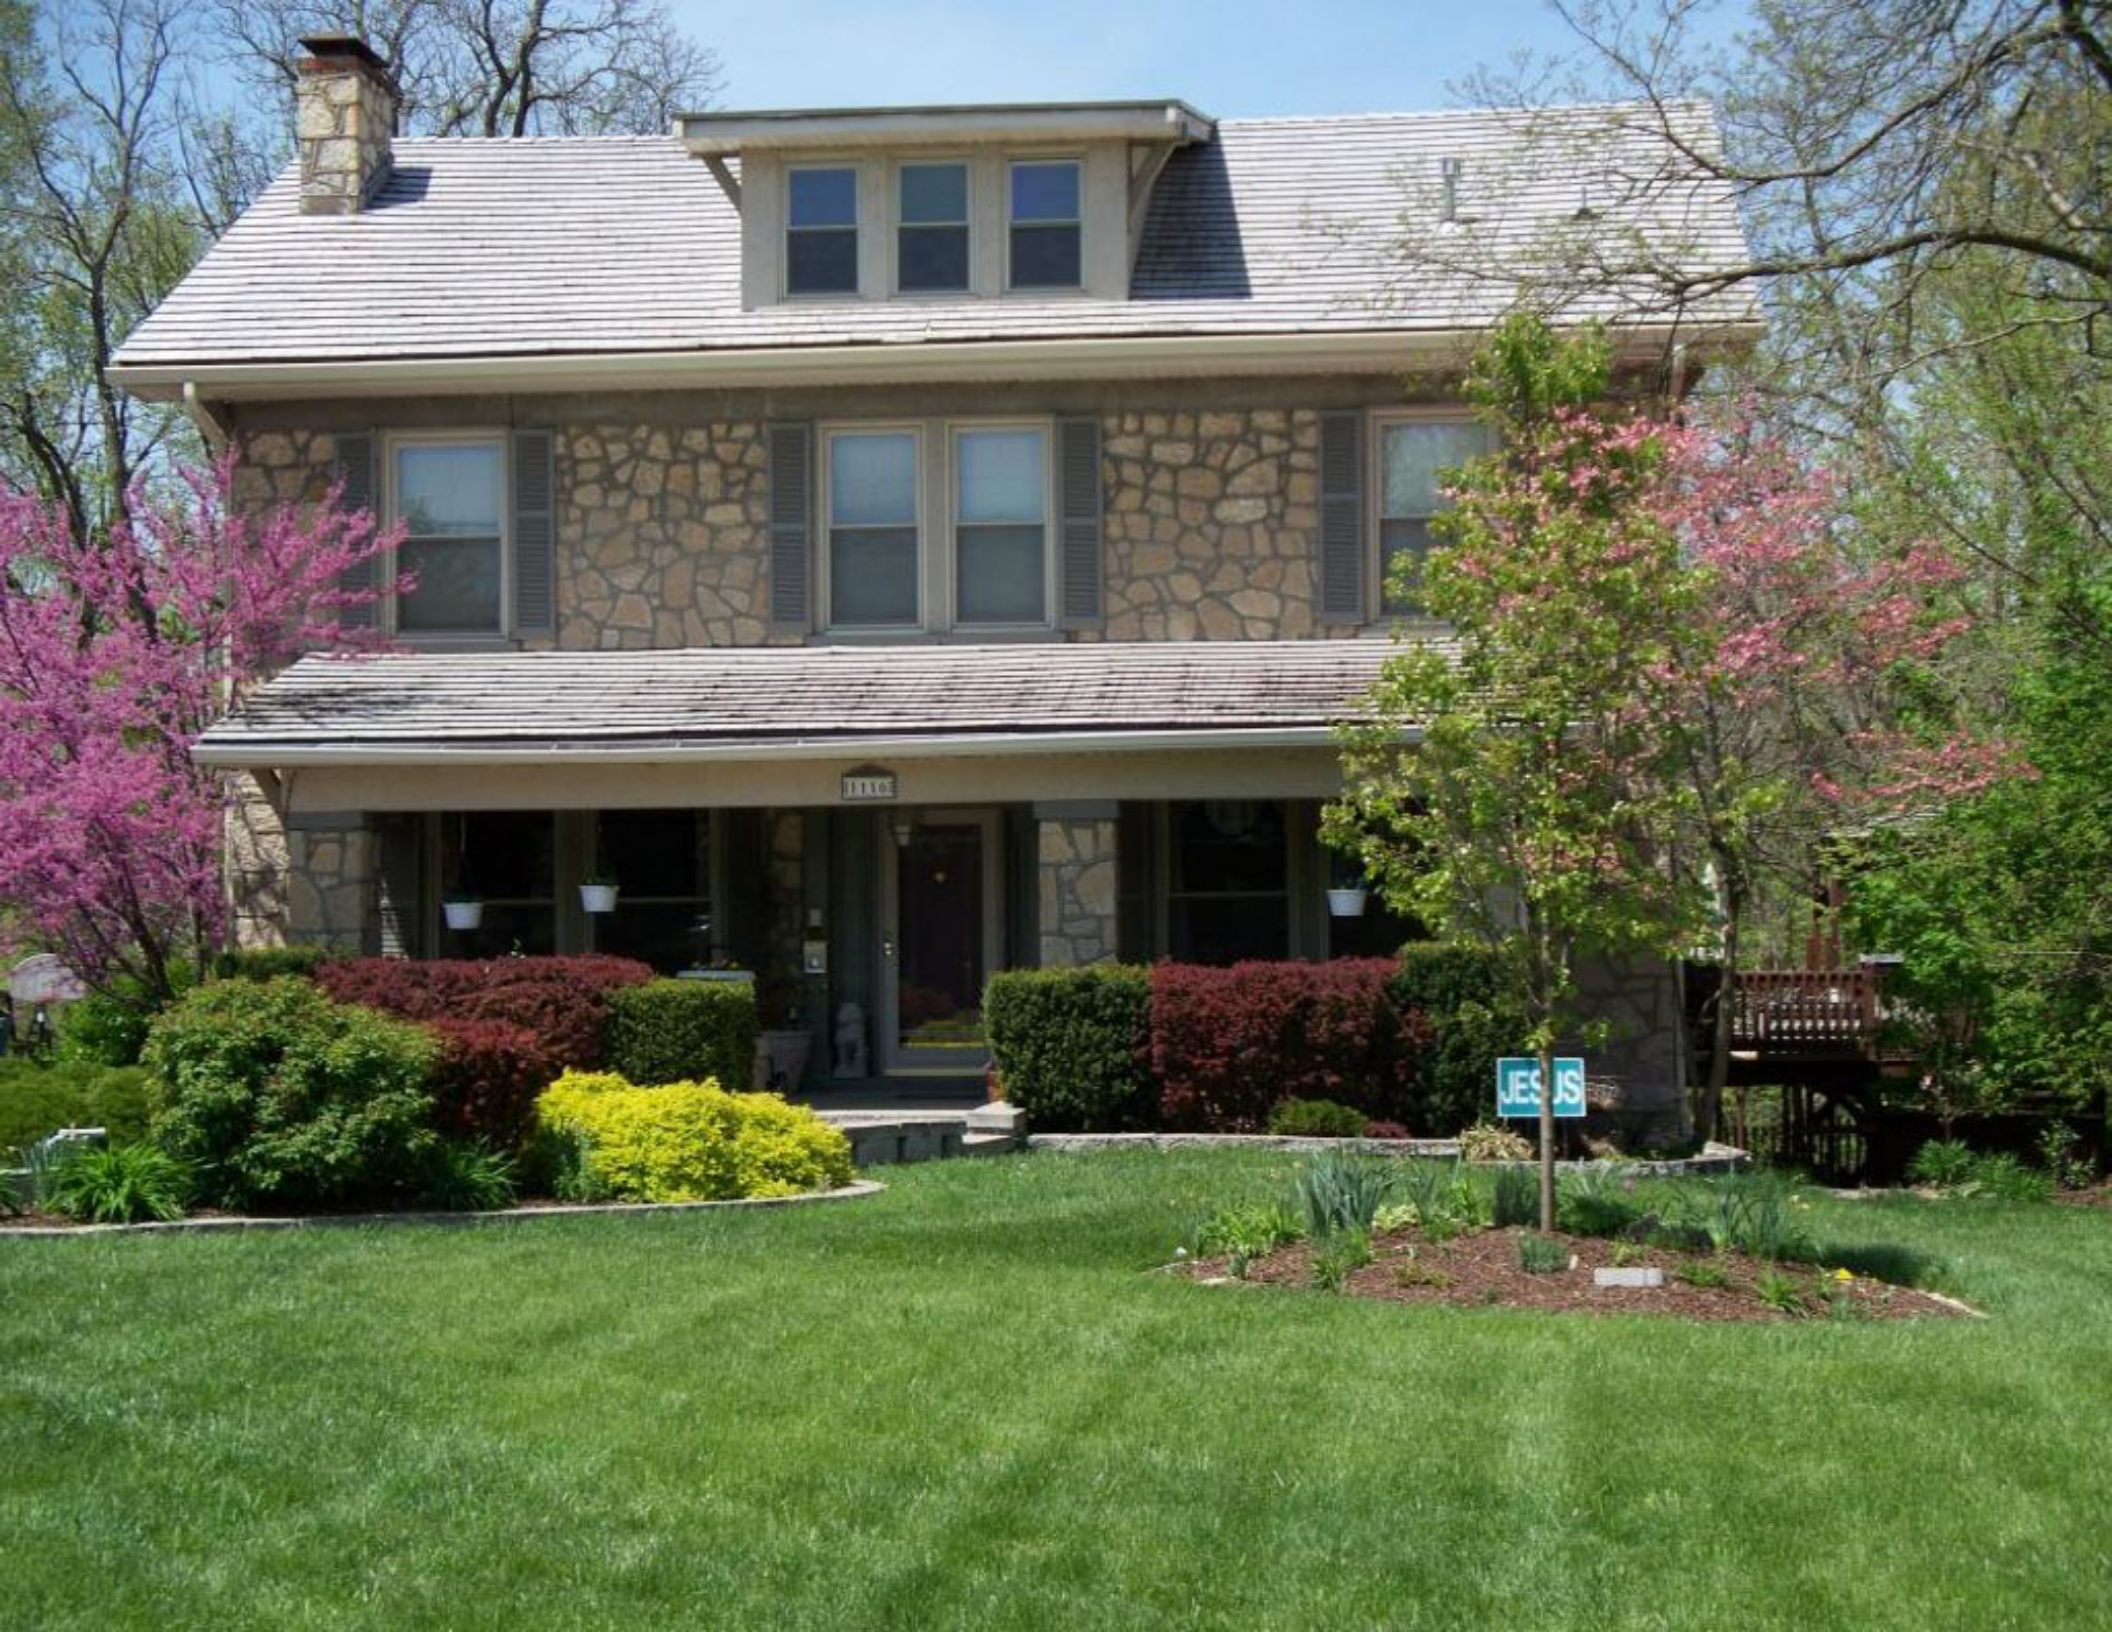
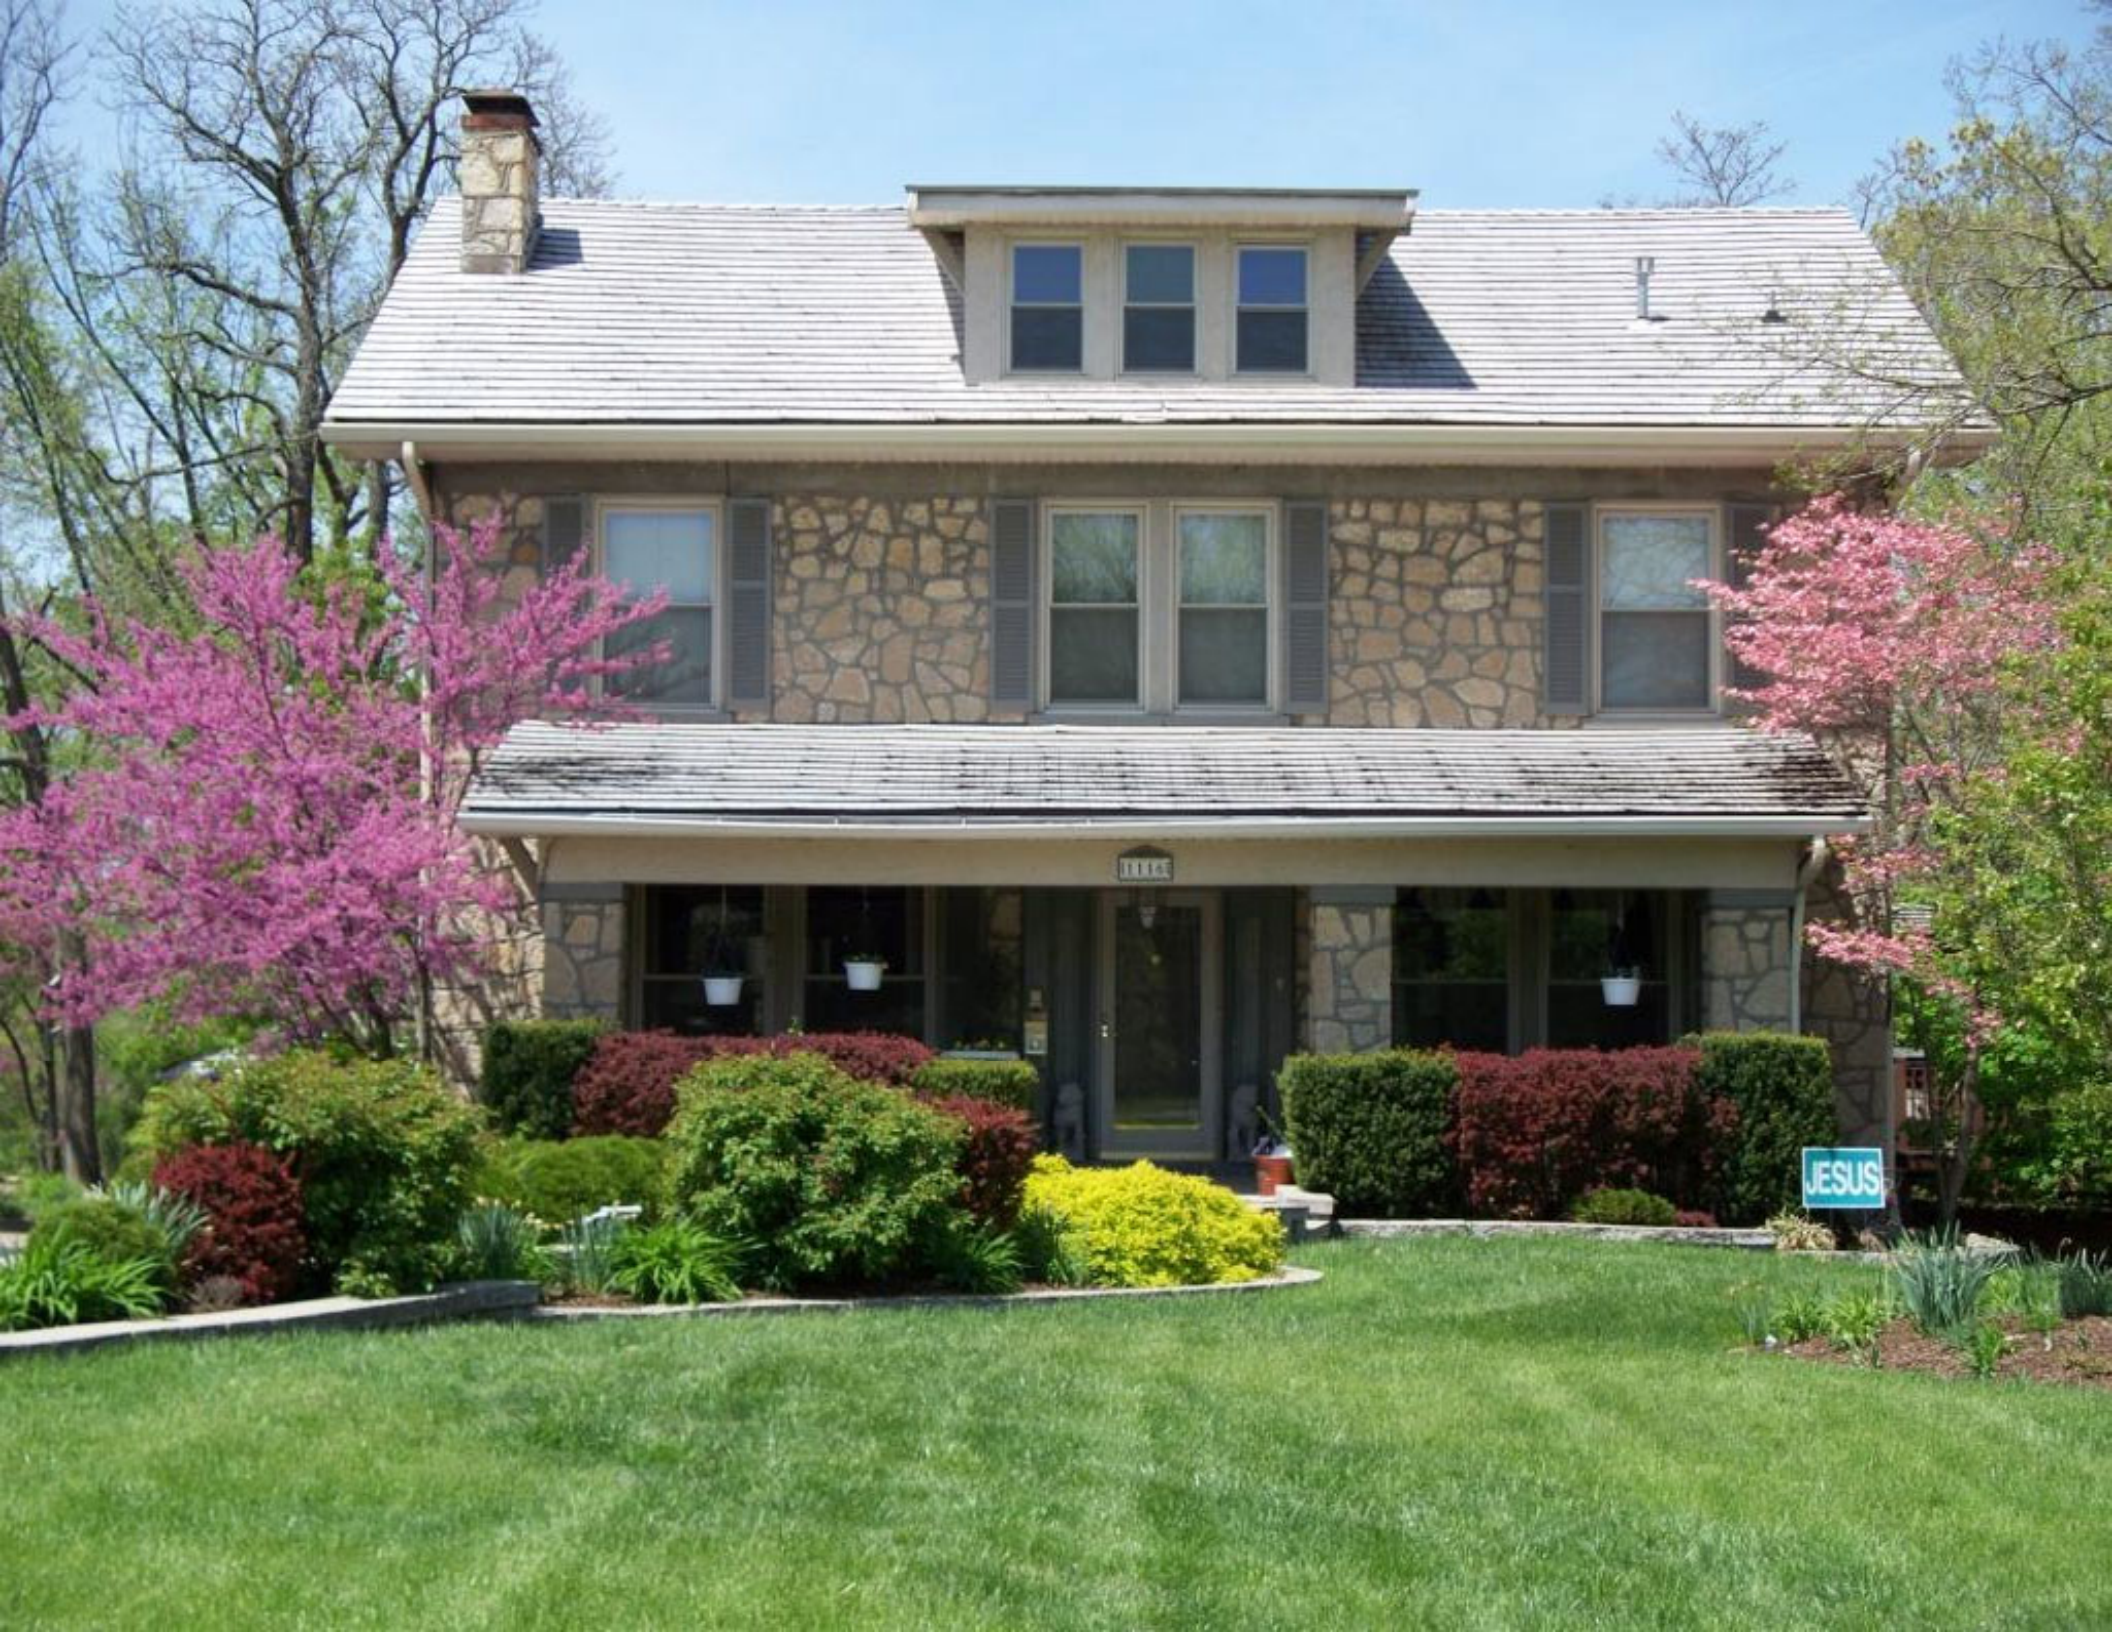
This two-a-half-story stone Colonial Revival has a central dormer with side brackets and a shed roof and three 1/1 windows that may or may not be historic. The second floor has three window openings, the central having paired windows. The storm windows make it difficult to determine if they are historic although it's possible they are decorative replacements. All windows on the property have shutters. The first floor has a full width porch with stone pillars that support a shed roof. Paired windows flank the central entrance.

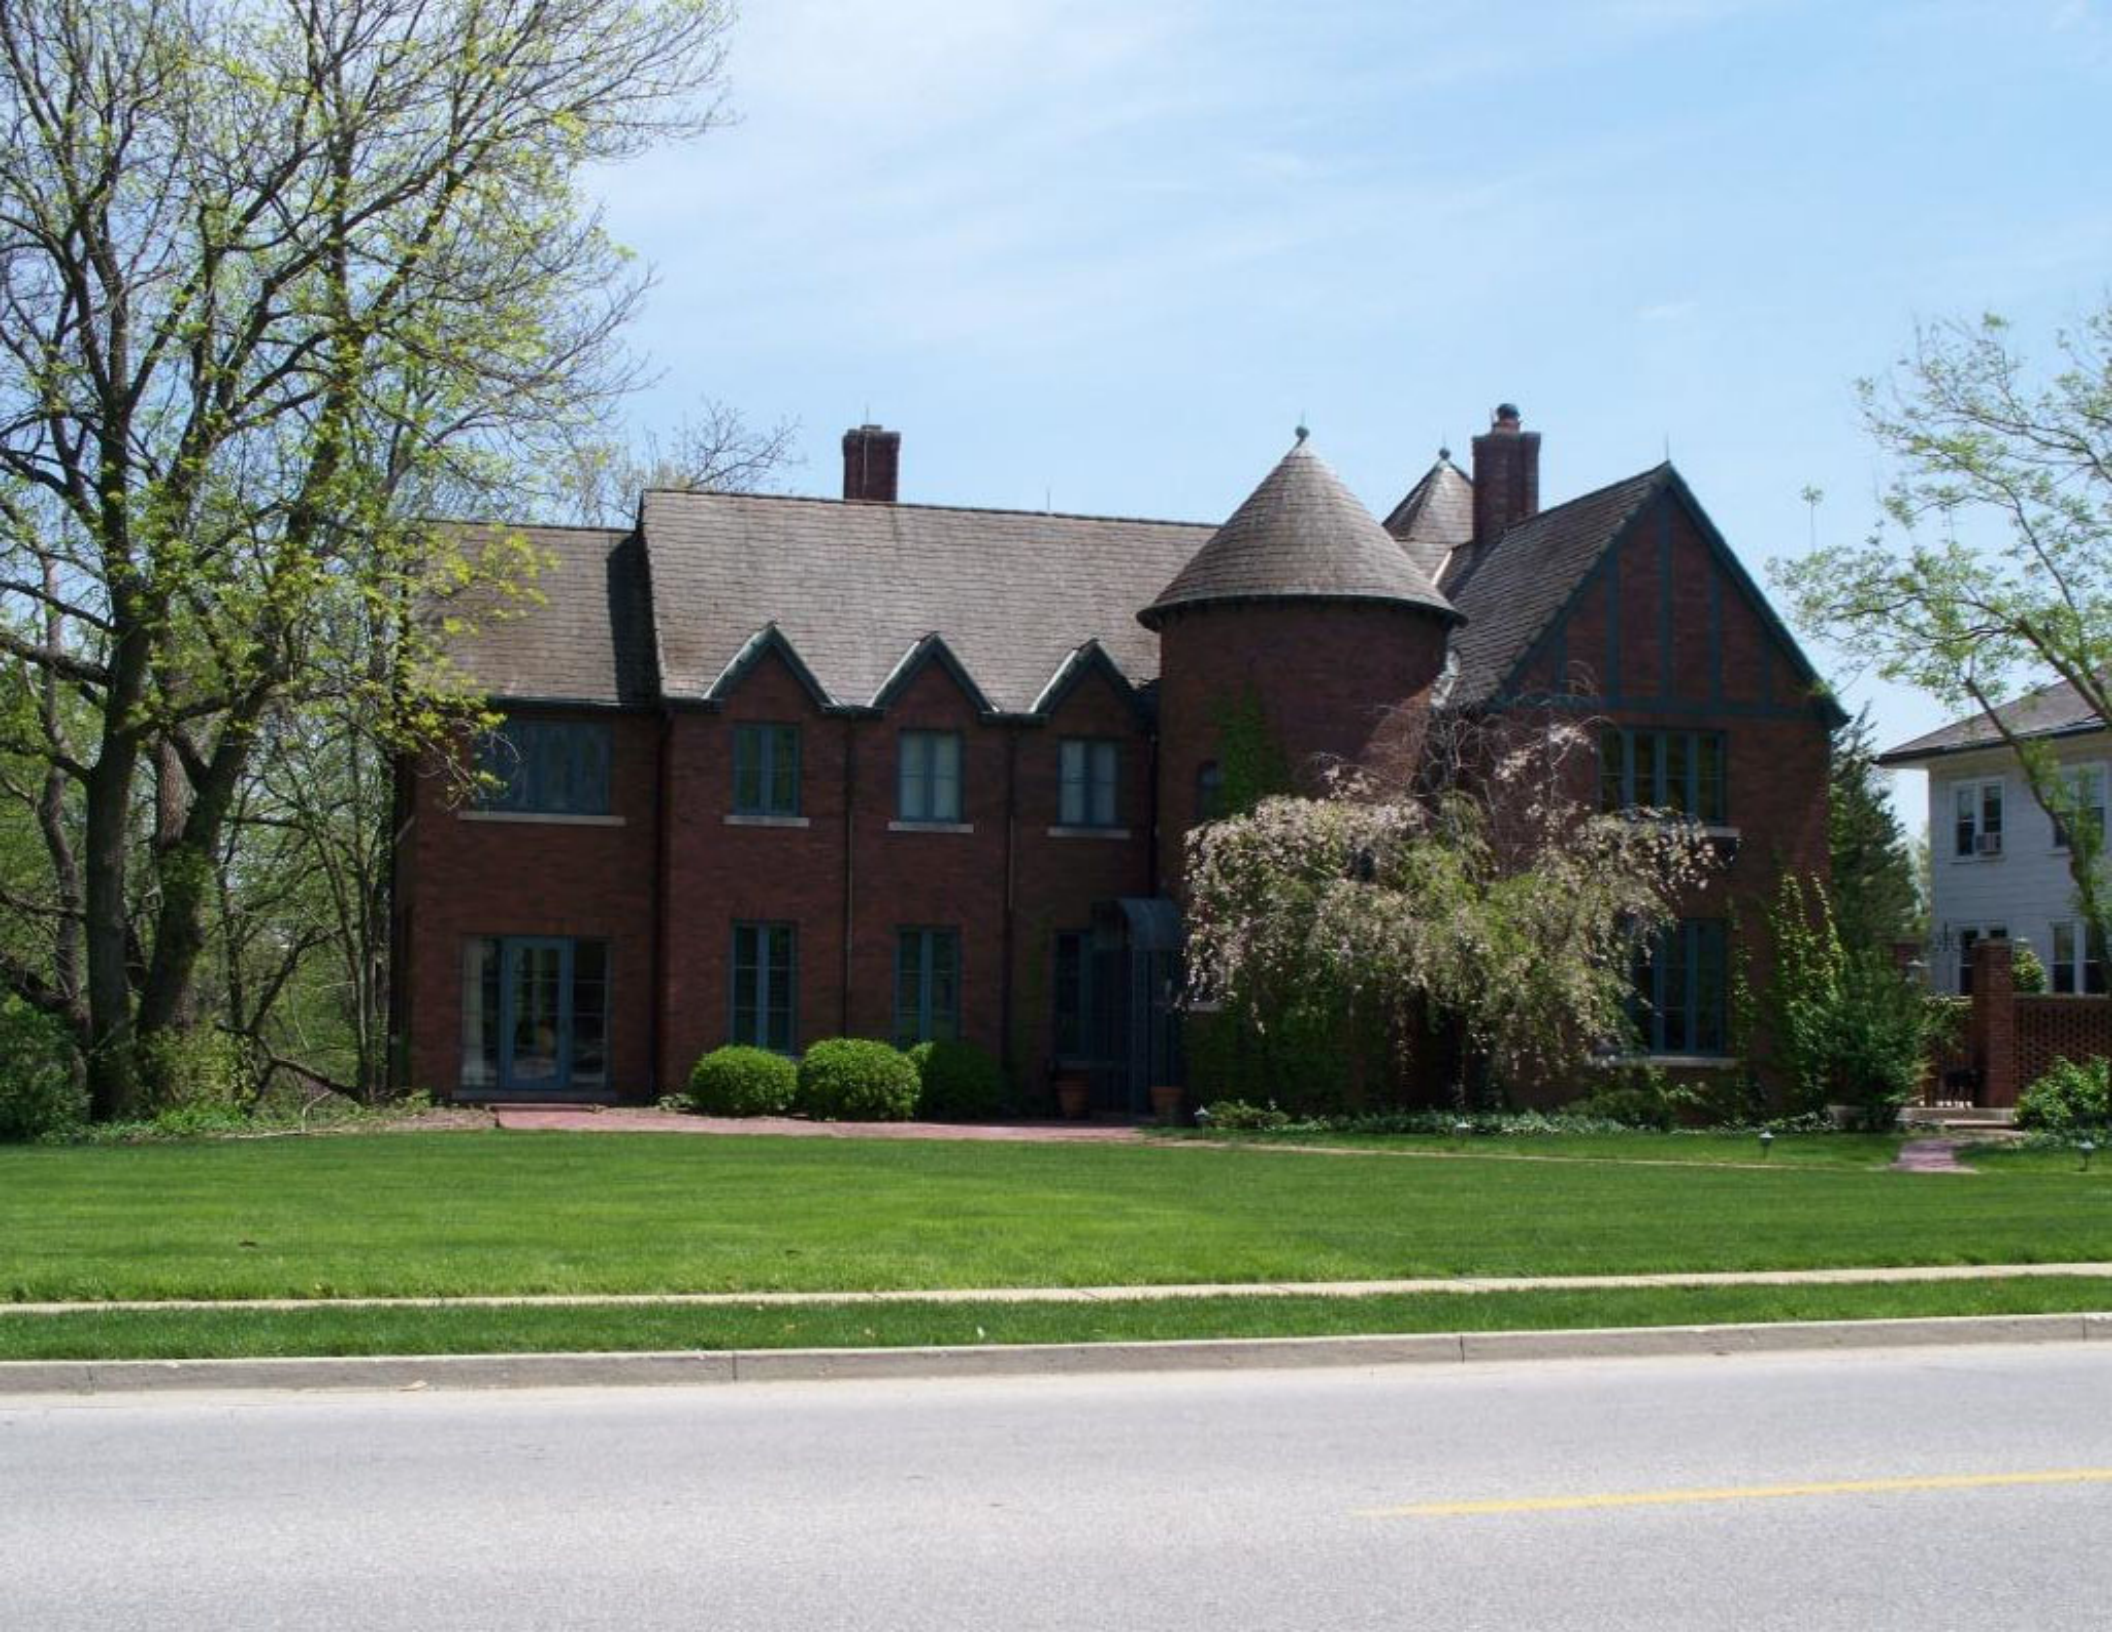
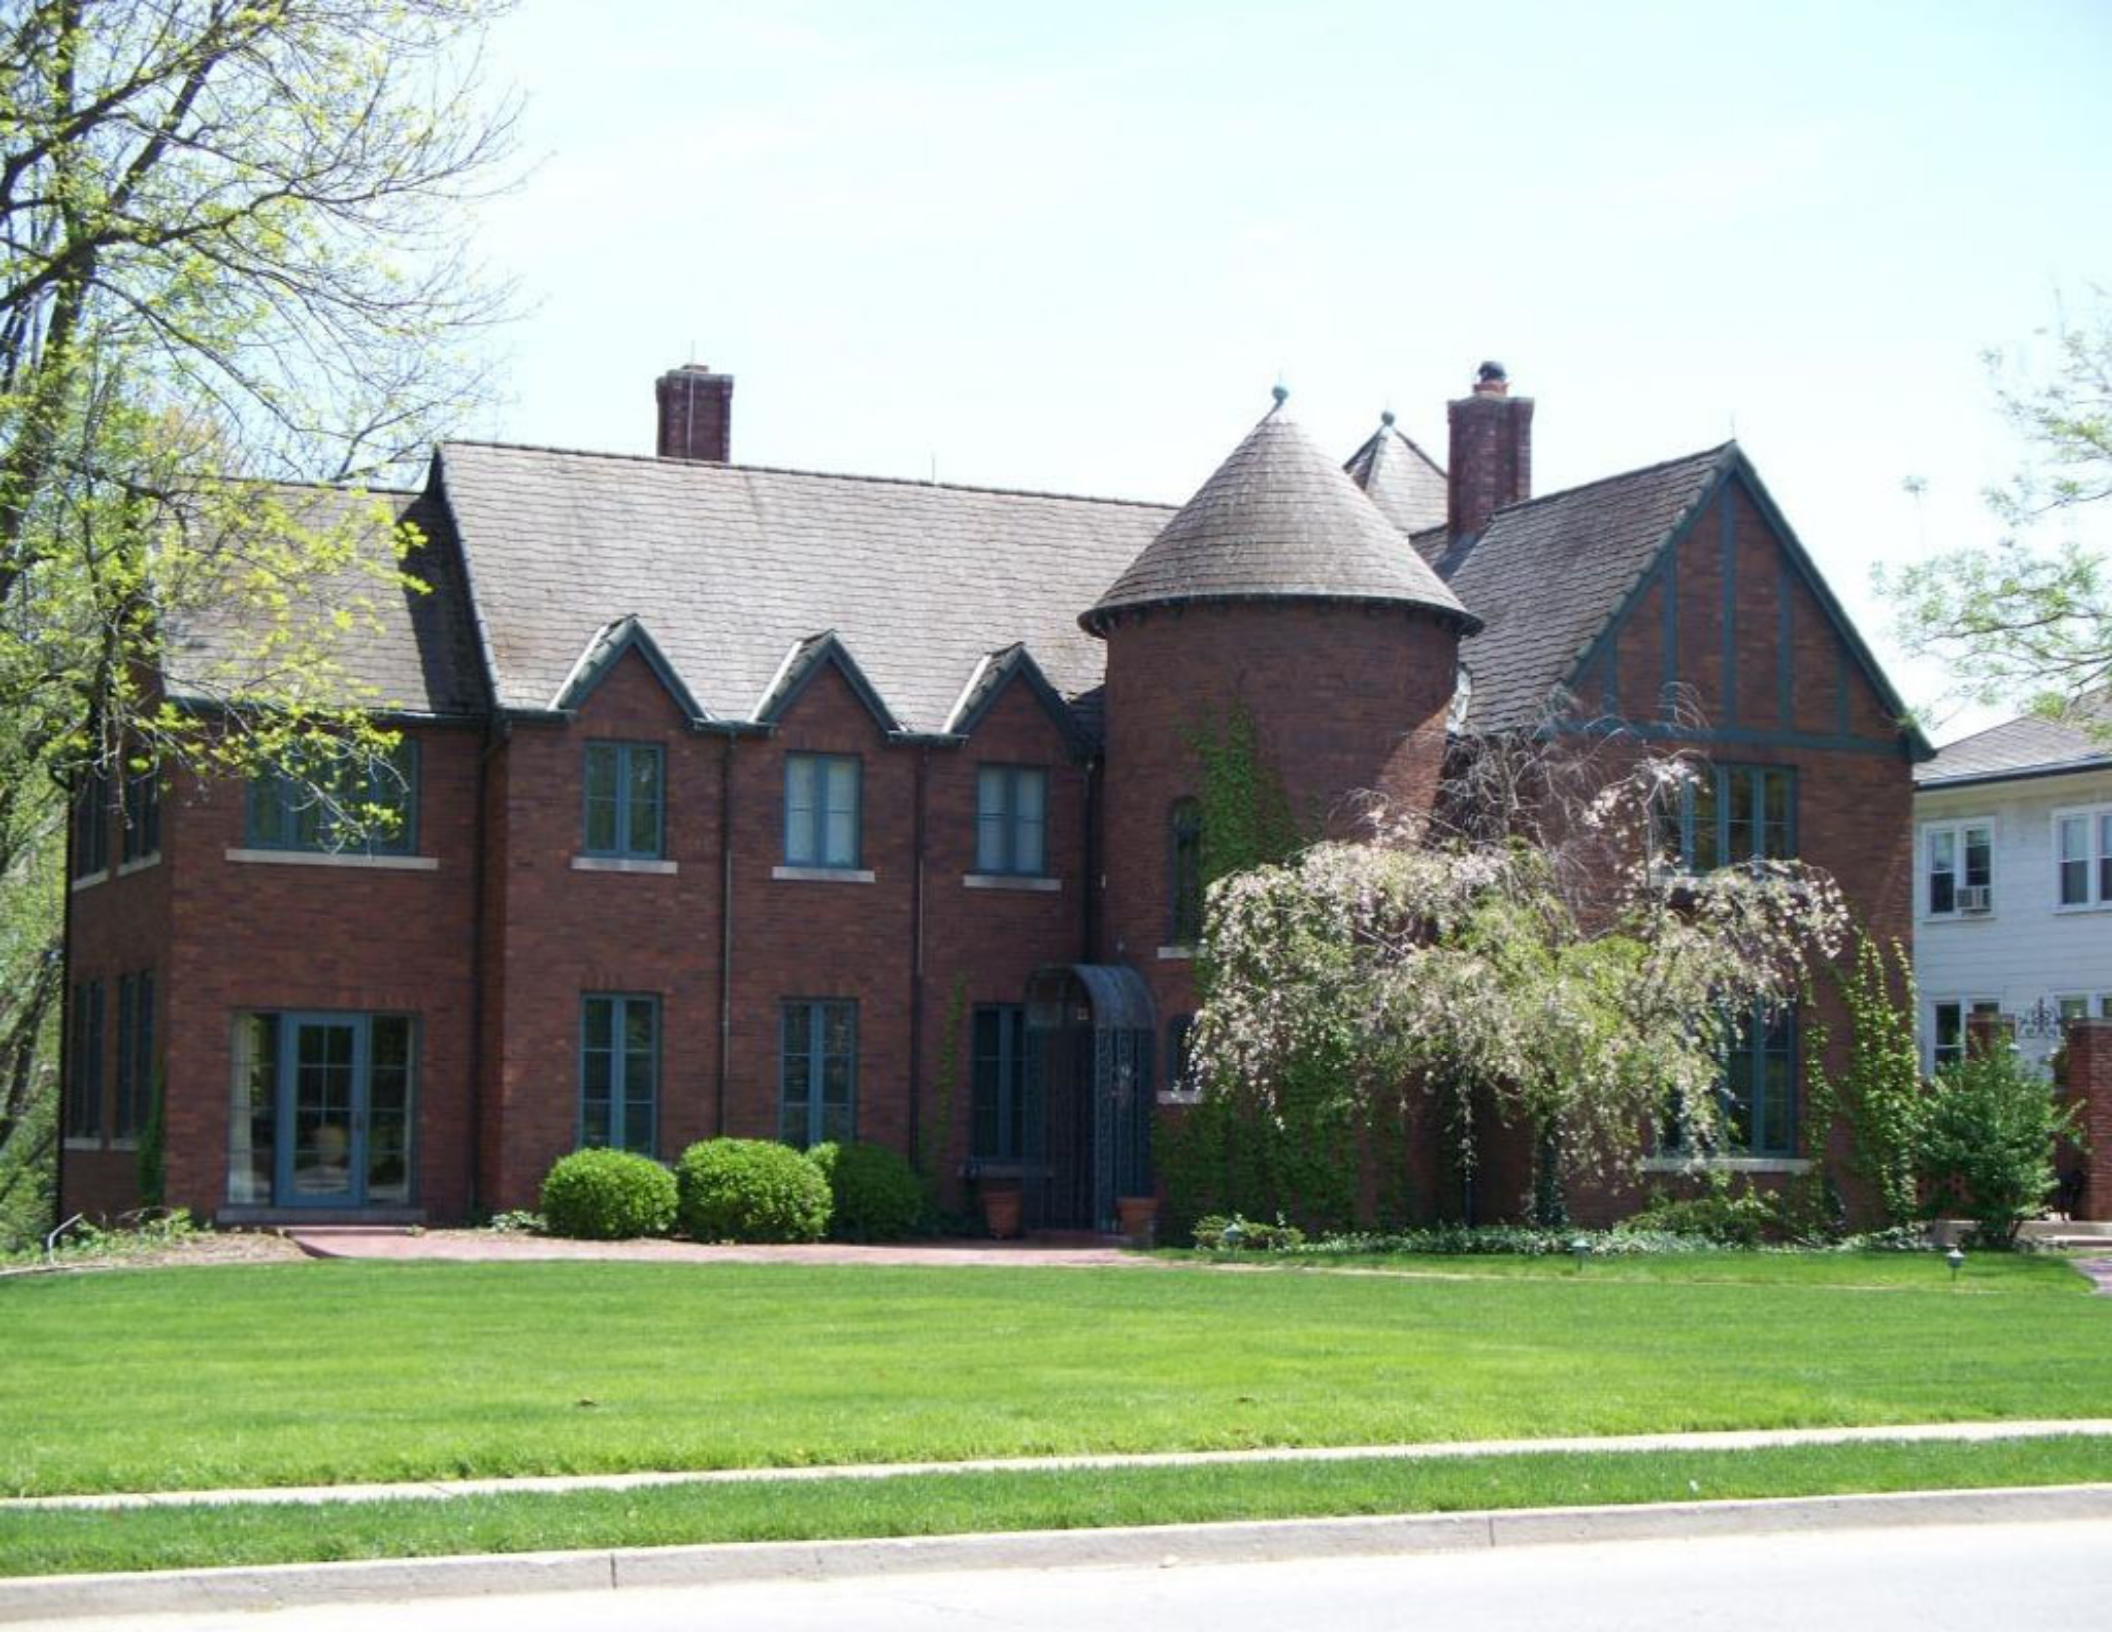
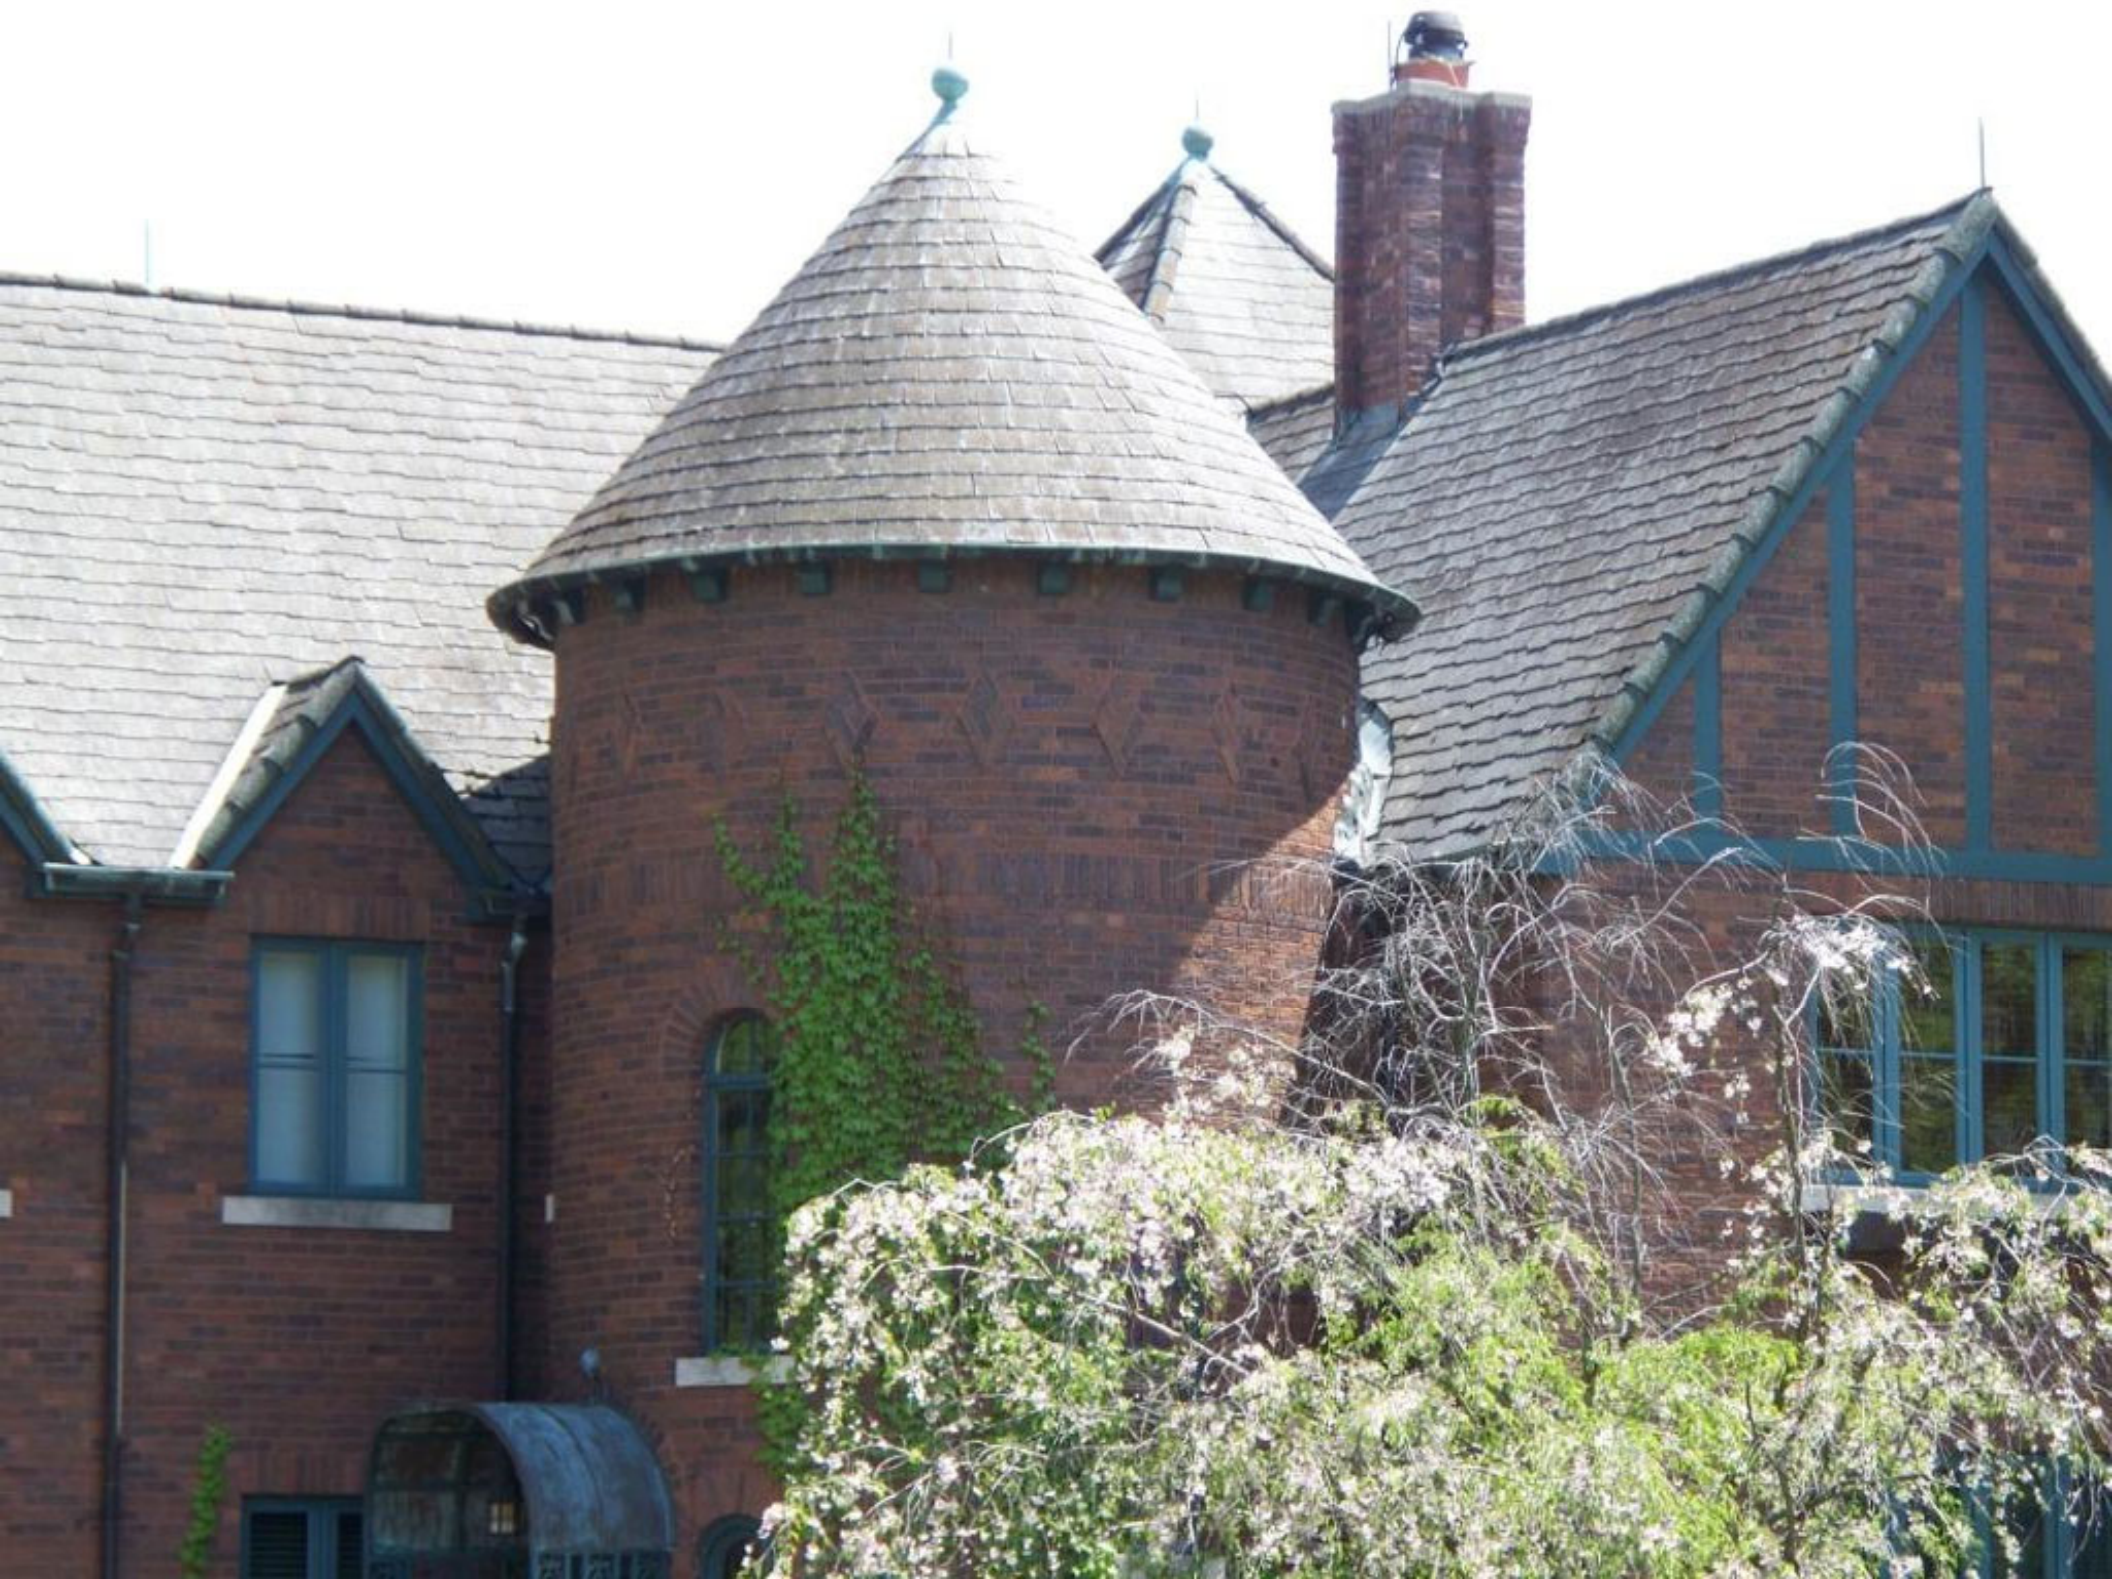
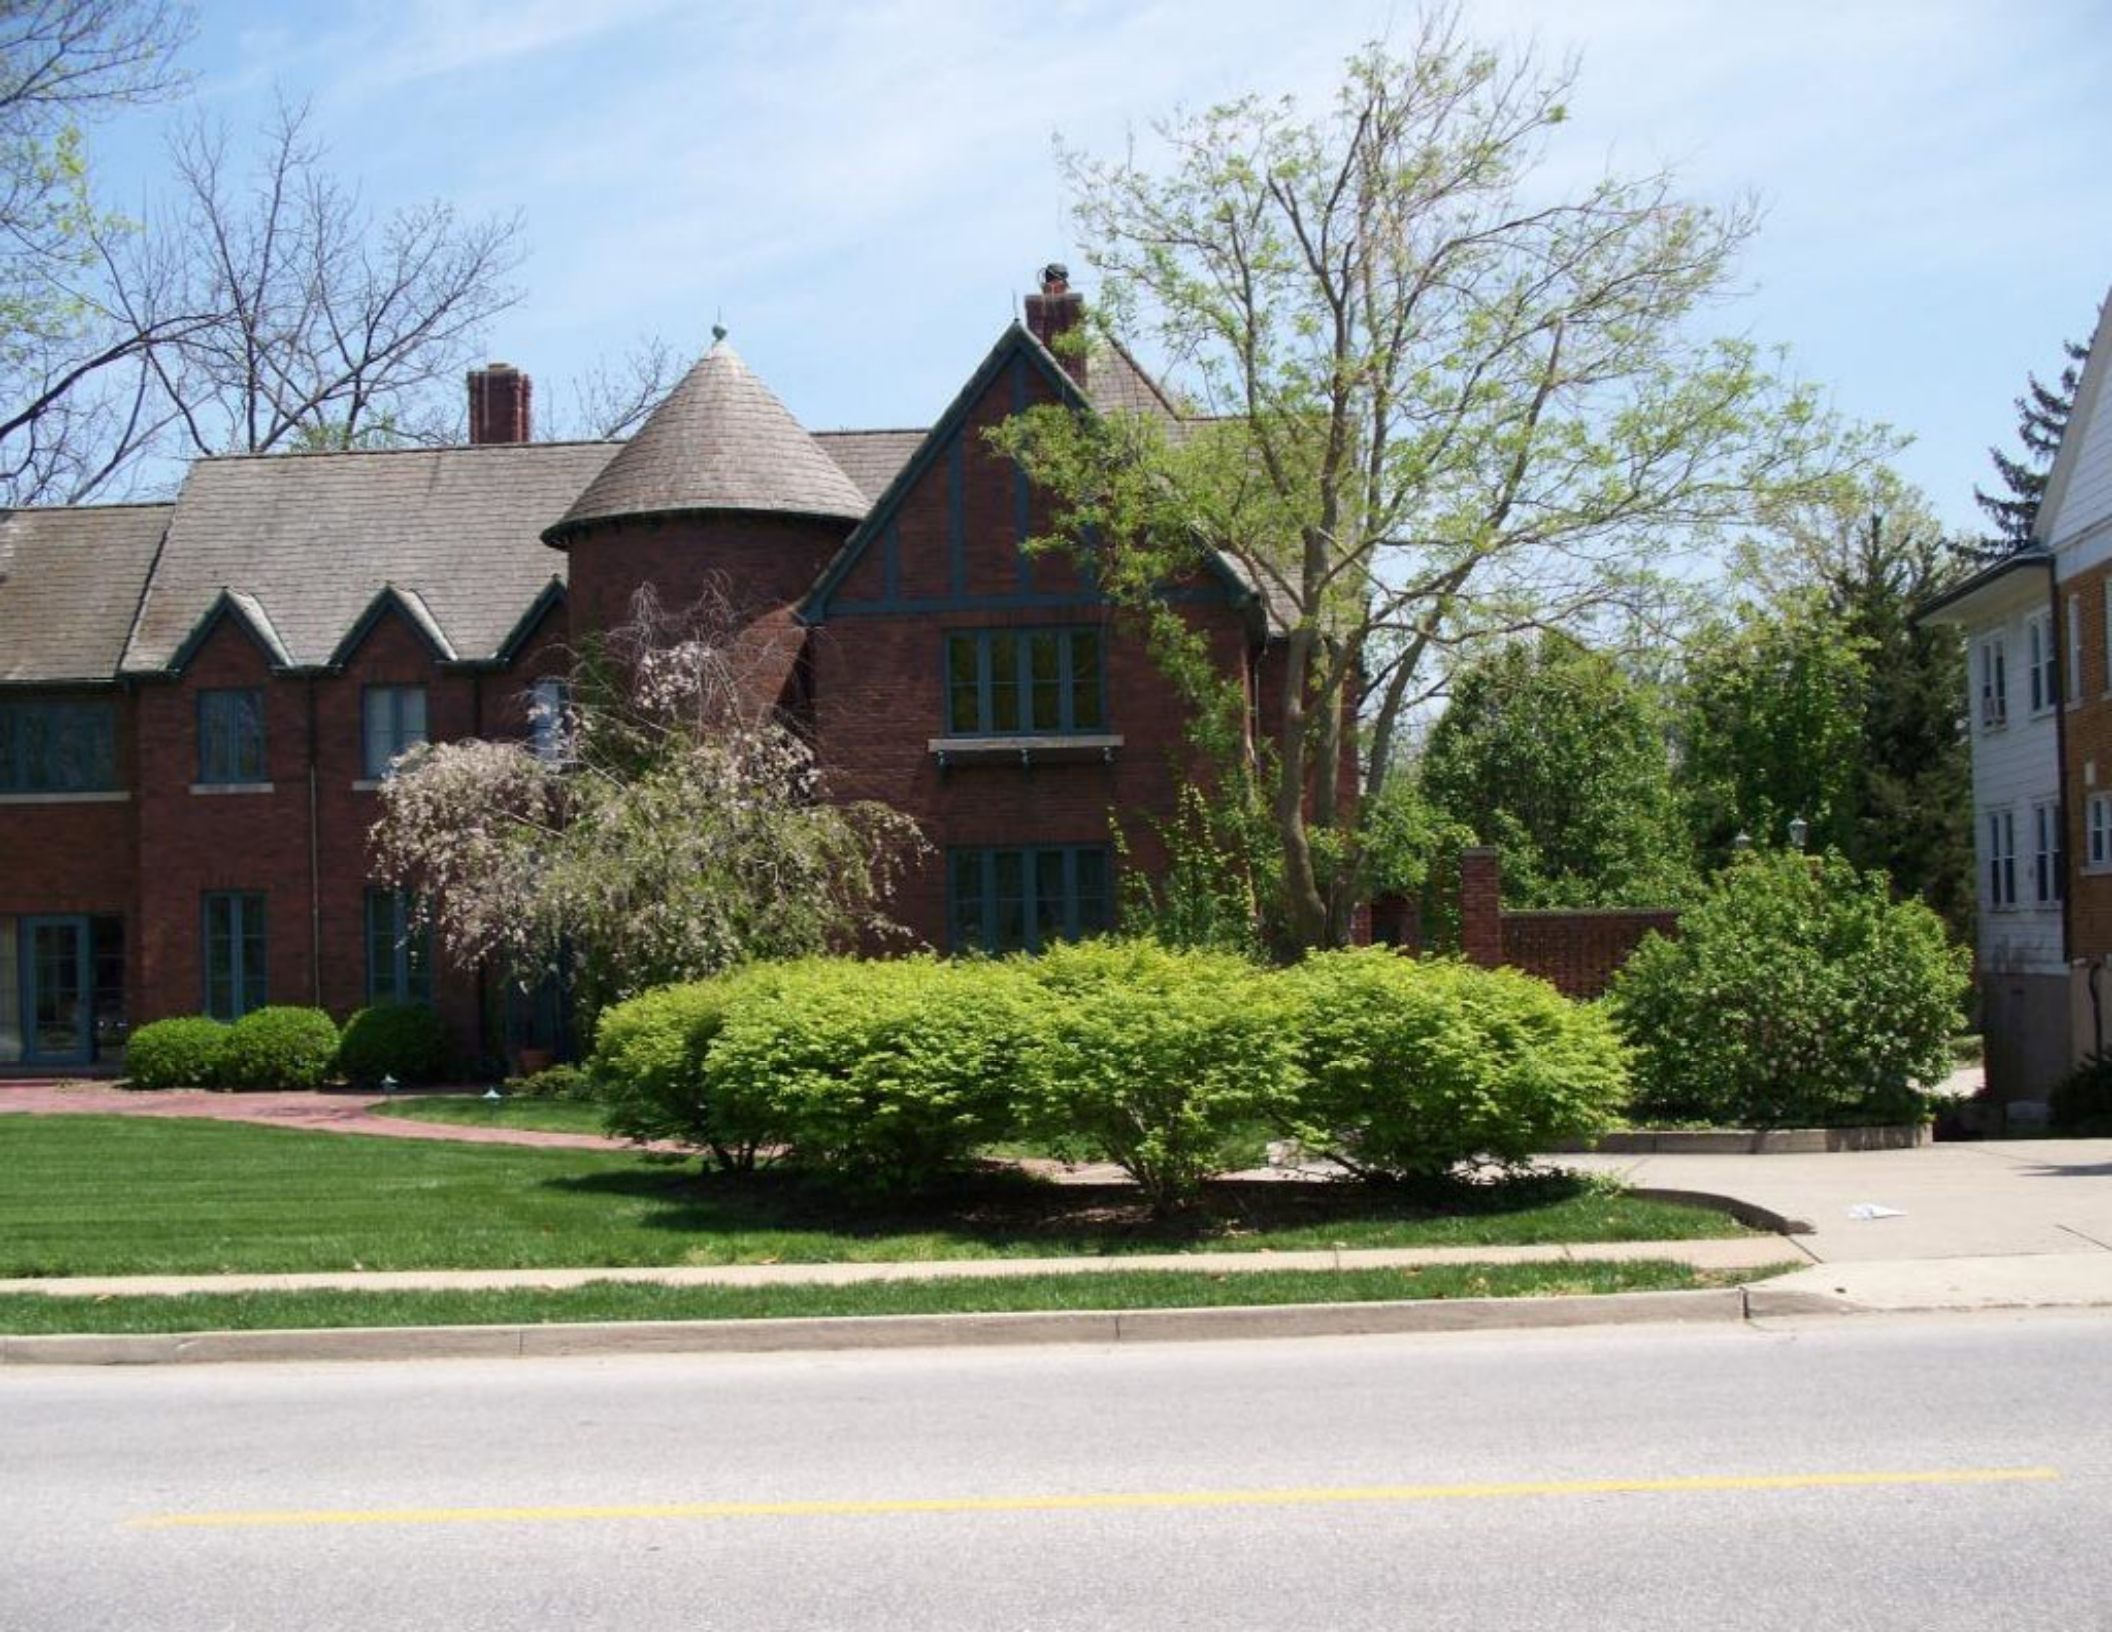
This is one of the, if not the most, grand houses in the neighborhood and the City. It is a two story dark brick French Eclectic home that feature a prominent tower in the primary façade. An additional tower may be in the back of the building as there is a secondary peak towards the back of the roof. Both peaks are topped by decorative finals, likely copper. This is a rare example of a slate roof in the district. The roofline also features tile coping. Façade descriptions: Starting from the south, this is the largest bay of the building. It has a large gable with painted half-timbering in the gable and a decorative spike at the apex. There are four wooden three pane casement windows on the second floor and four larger three pane casement windows on the ground floor. The tower is ornamented with decorative brick diamonds and a long narrow arched multi-paned fixed window in the upper story and a similar smaller window on the first floor. What looks like a decorative metal garden arbor has been attached to the entryway. The next three bays feature paired two pane casement windows on the upper floor under short wall gables and three pane windows on the lower floor. The final bay has four two pane casement windows on the second floor and a patio door and sidelights on the lower floor. Two chimneys, one with a decorative cap are staggered on the roofline.
