ARCHITECTURAL/HISTORIC INVENTORY FORM

1. Survey No. CO-AS-005-001		2. Survey name: Moreau Drive Neighborhood Survey	
3. County: Cole		4. Address: 1202 Elmerine Ave.	
5. City: Jefferson City	Vicinity: <input type="checkbox"/>	6. UTM: / /	7. Township/Range/Section: T: R: S:
8. Historic name (if known):		9. Present/other name (if known):	
10. Ownership: <input checked="" type="checkbox"/> Private <input type="checkbox"/> Public		11. Historic use (if known): Residential	11. Current use: Residential

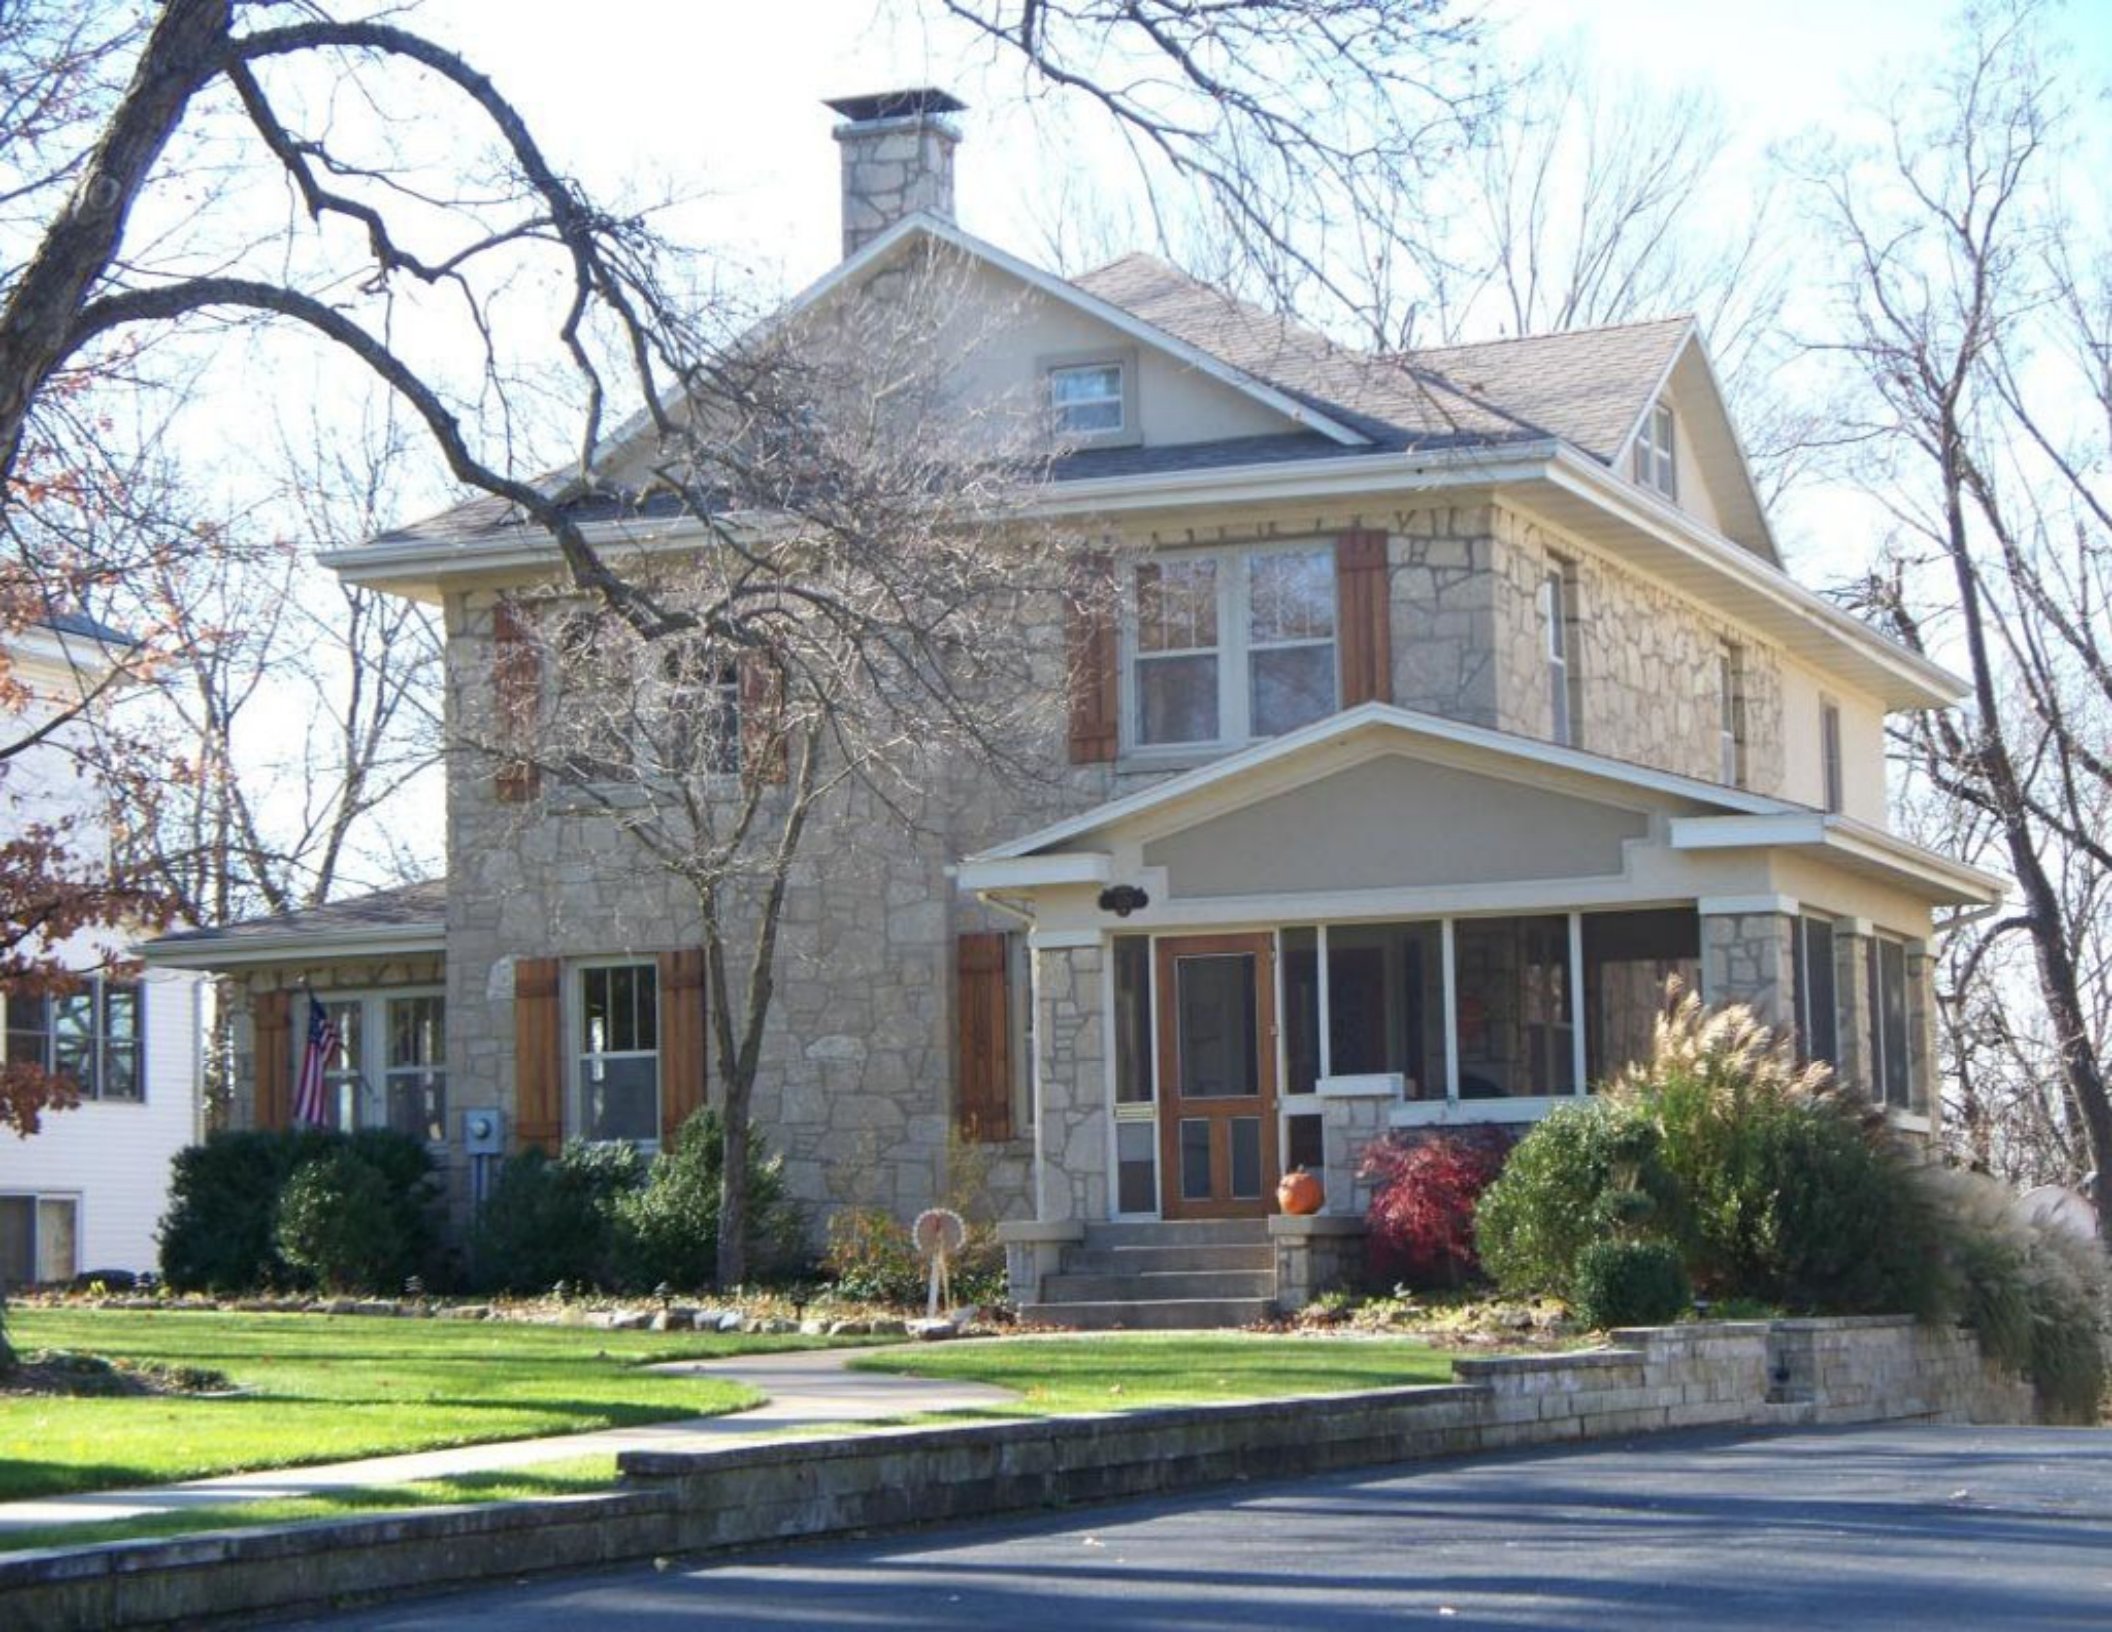
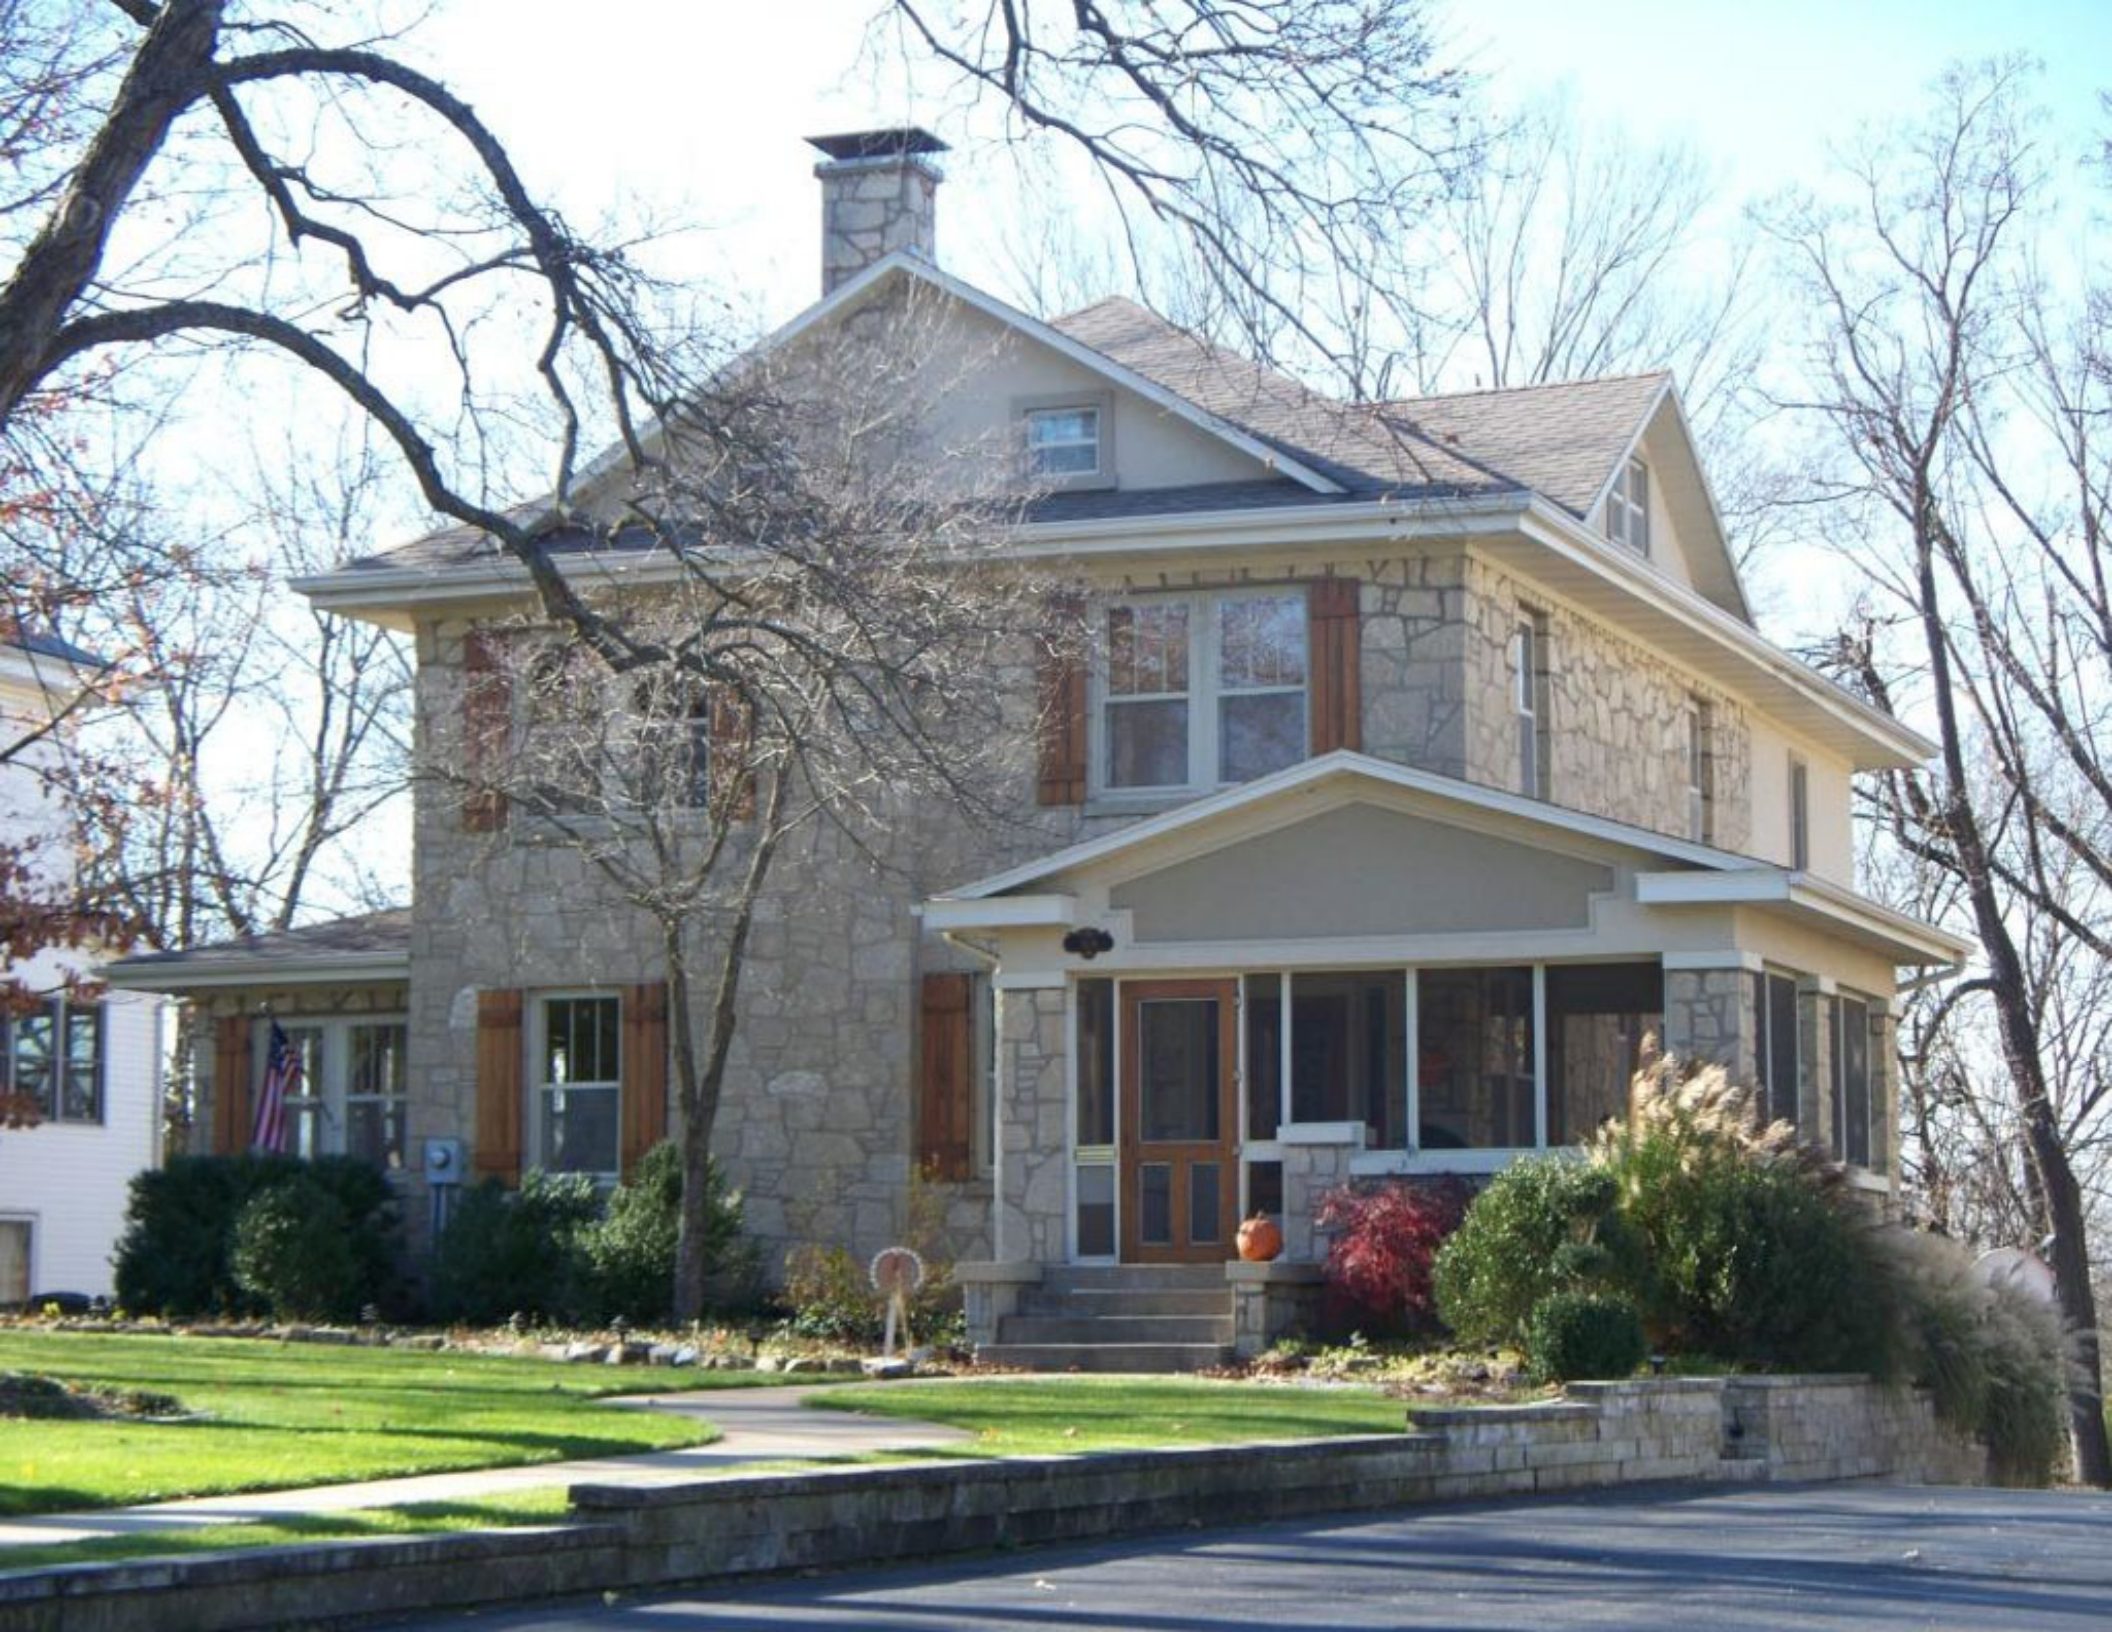
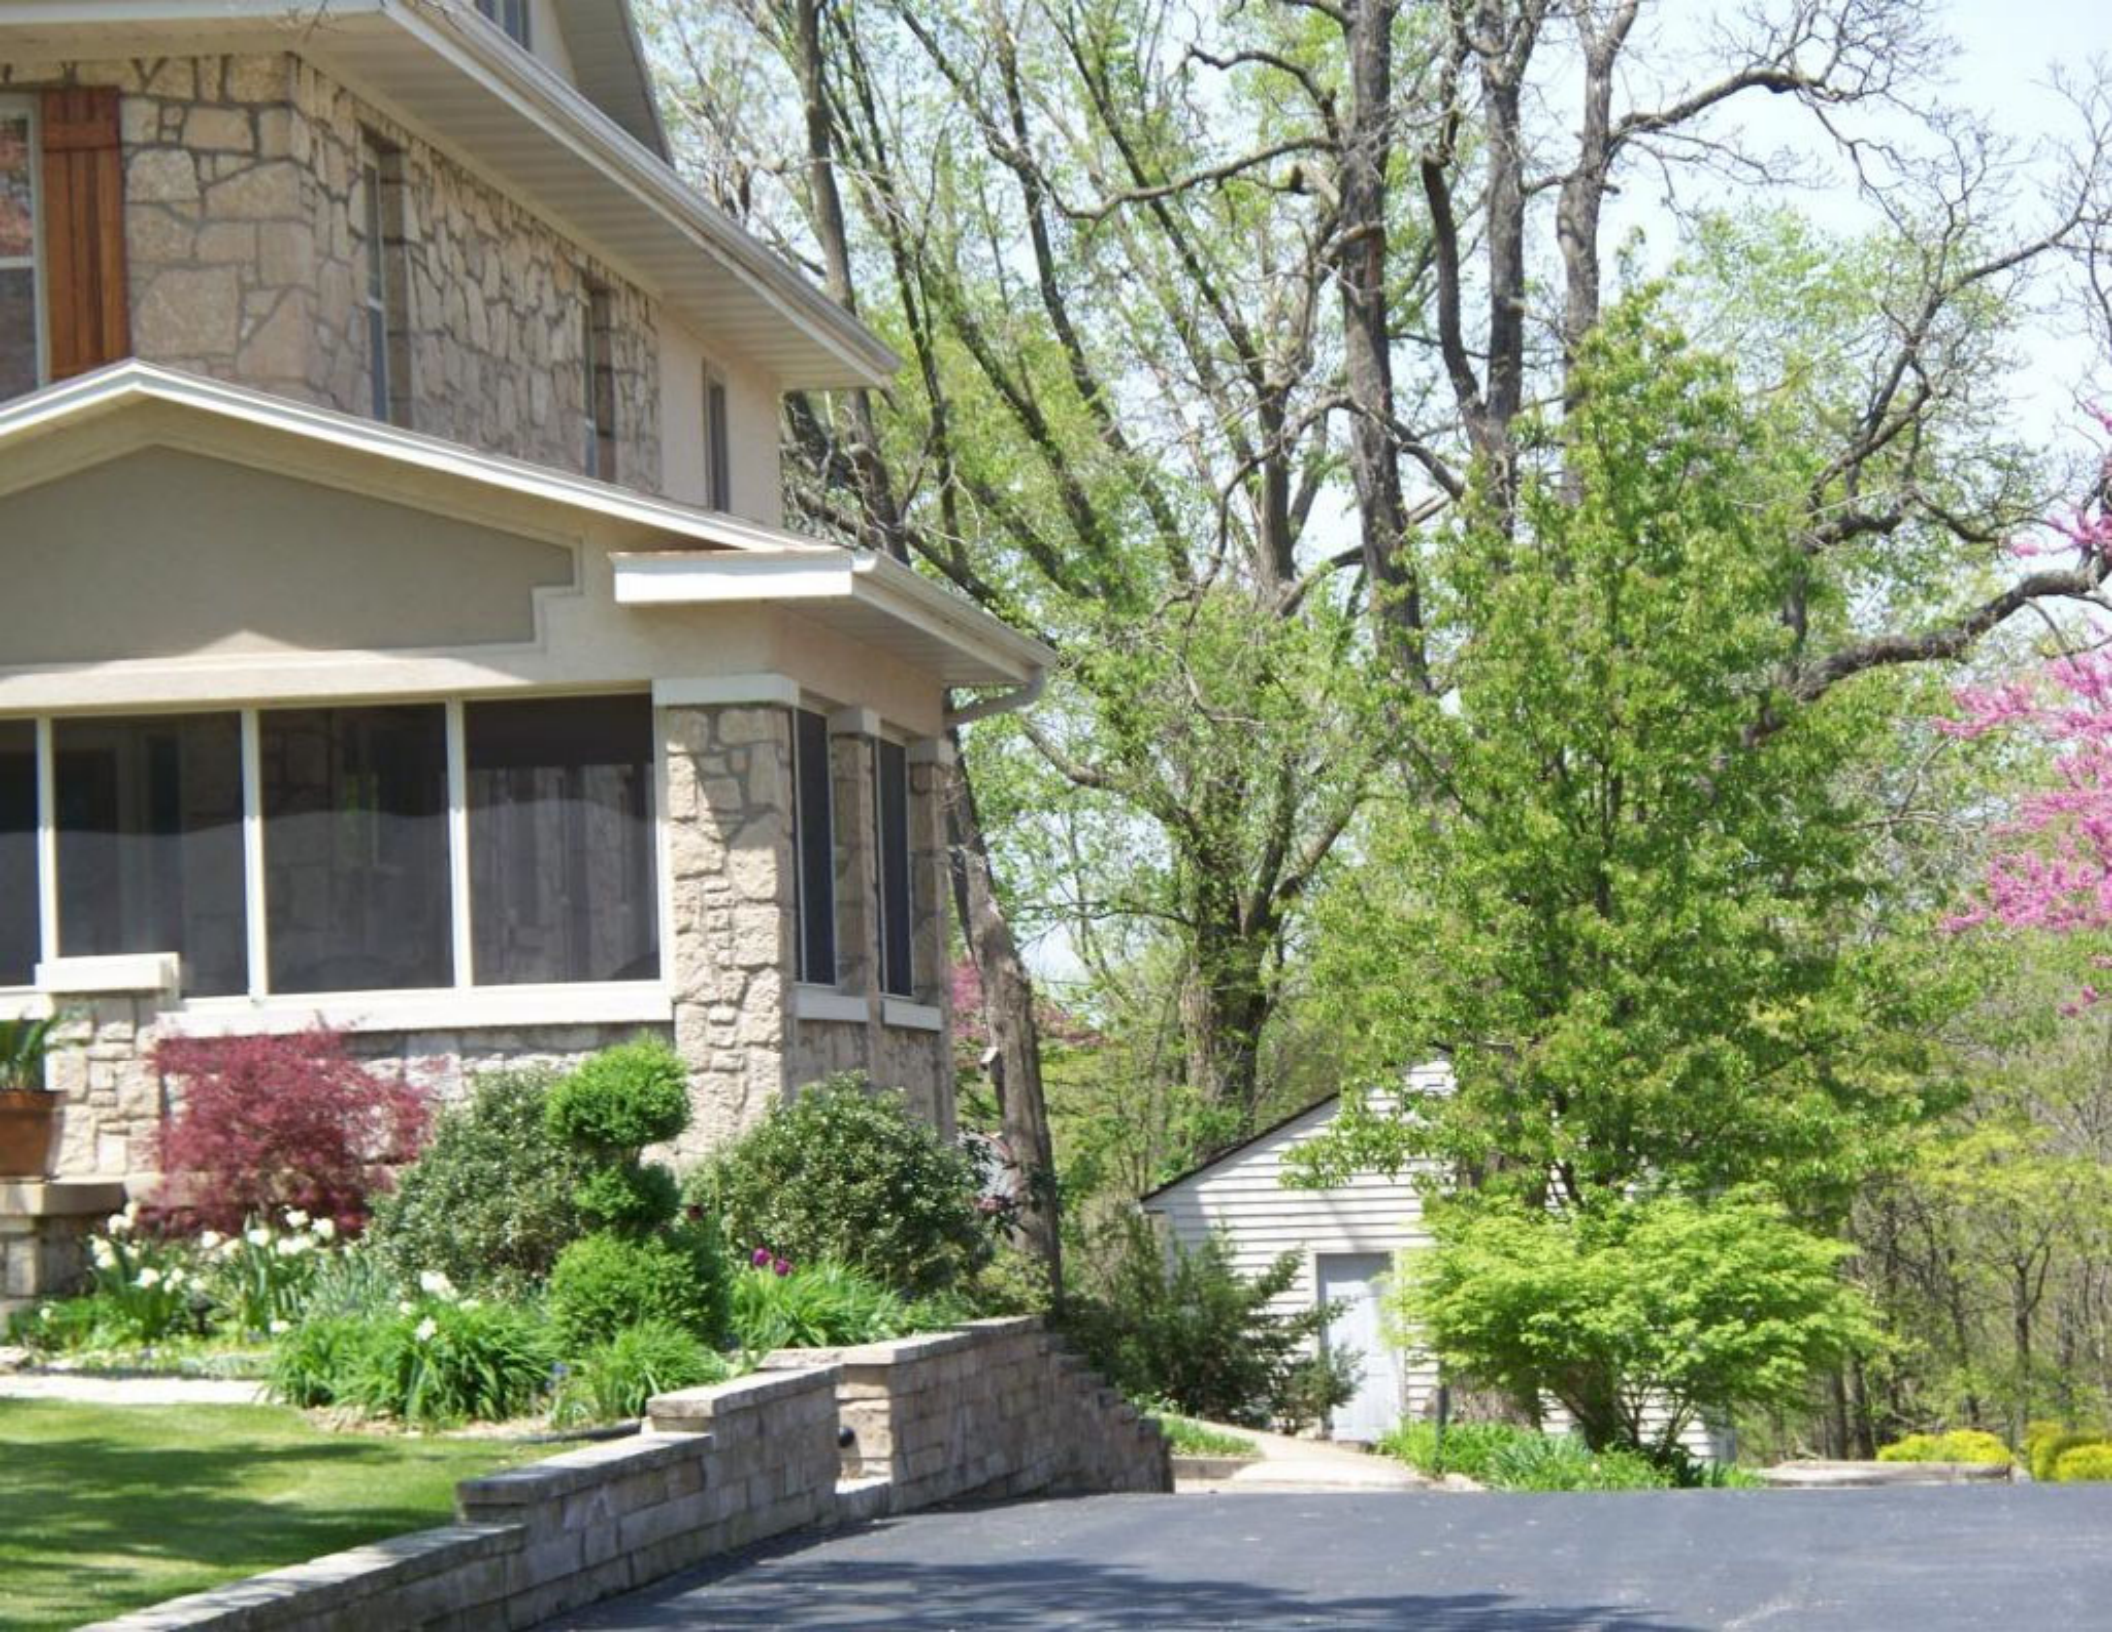
40. (cont.) Description of environment and outbuildings. Expand box as necessary, or add continuation pages.
There is a non-contributing shed behind the house. It has vinyl siding and appears to be modern.

41. (cont.)
This is one of the properties that falls somewhere between Prairie and Colonial Revival (see survey report for discussion). The large overhanging eaves, the one-story sunroom and porch wings are typical of the Prairie style (according to McAlester.) However, the shutters and composition of the fenestration is more in keeping with the Colonial Revival style. The two-and-a-half-story property has a central chimney in the main façade of the building. The uppermost floor has two windows in a gable end (it appears too large to be considered a dormer). The second floor has two sets of paired 3/1 historic windows with wooden shutters, while the first has a single 3/1 windows and another opening on the other side of the chimney. They also have shutters. The right bay of the property has a projecting one-story partial wrap around porch with stone columns and a gabled roof that has been screened-in. On the opposite side to the left there is a one-story sunroom that is slightly set back.

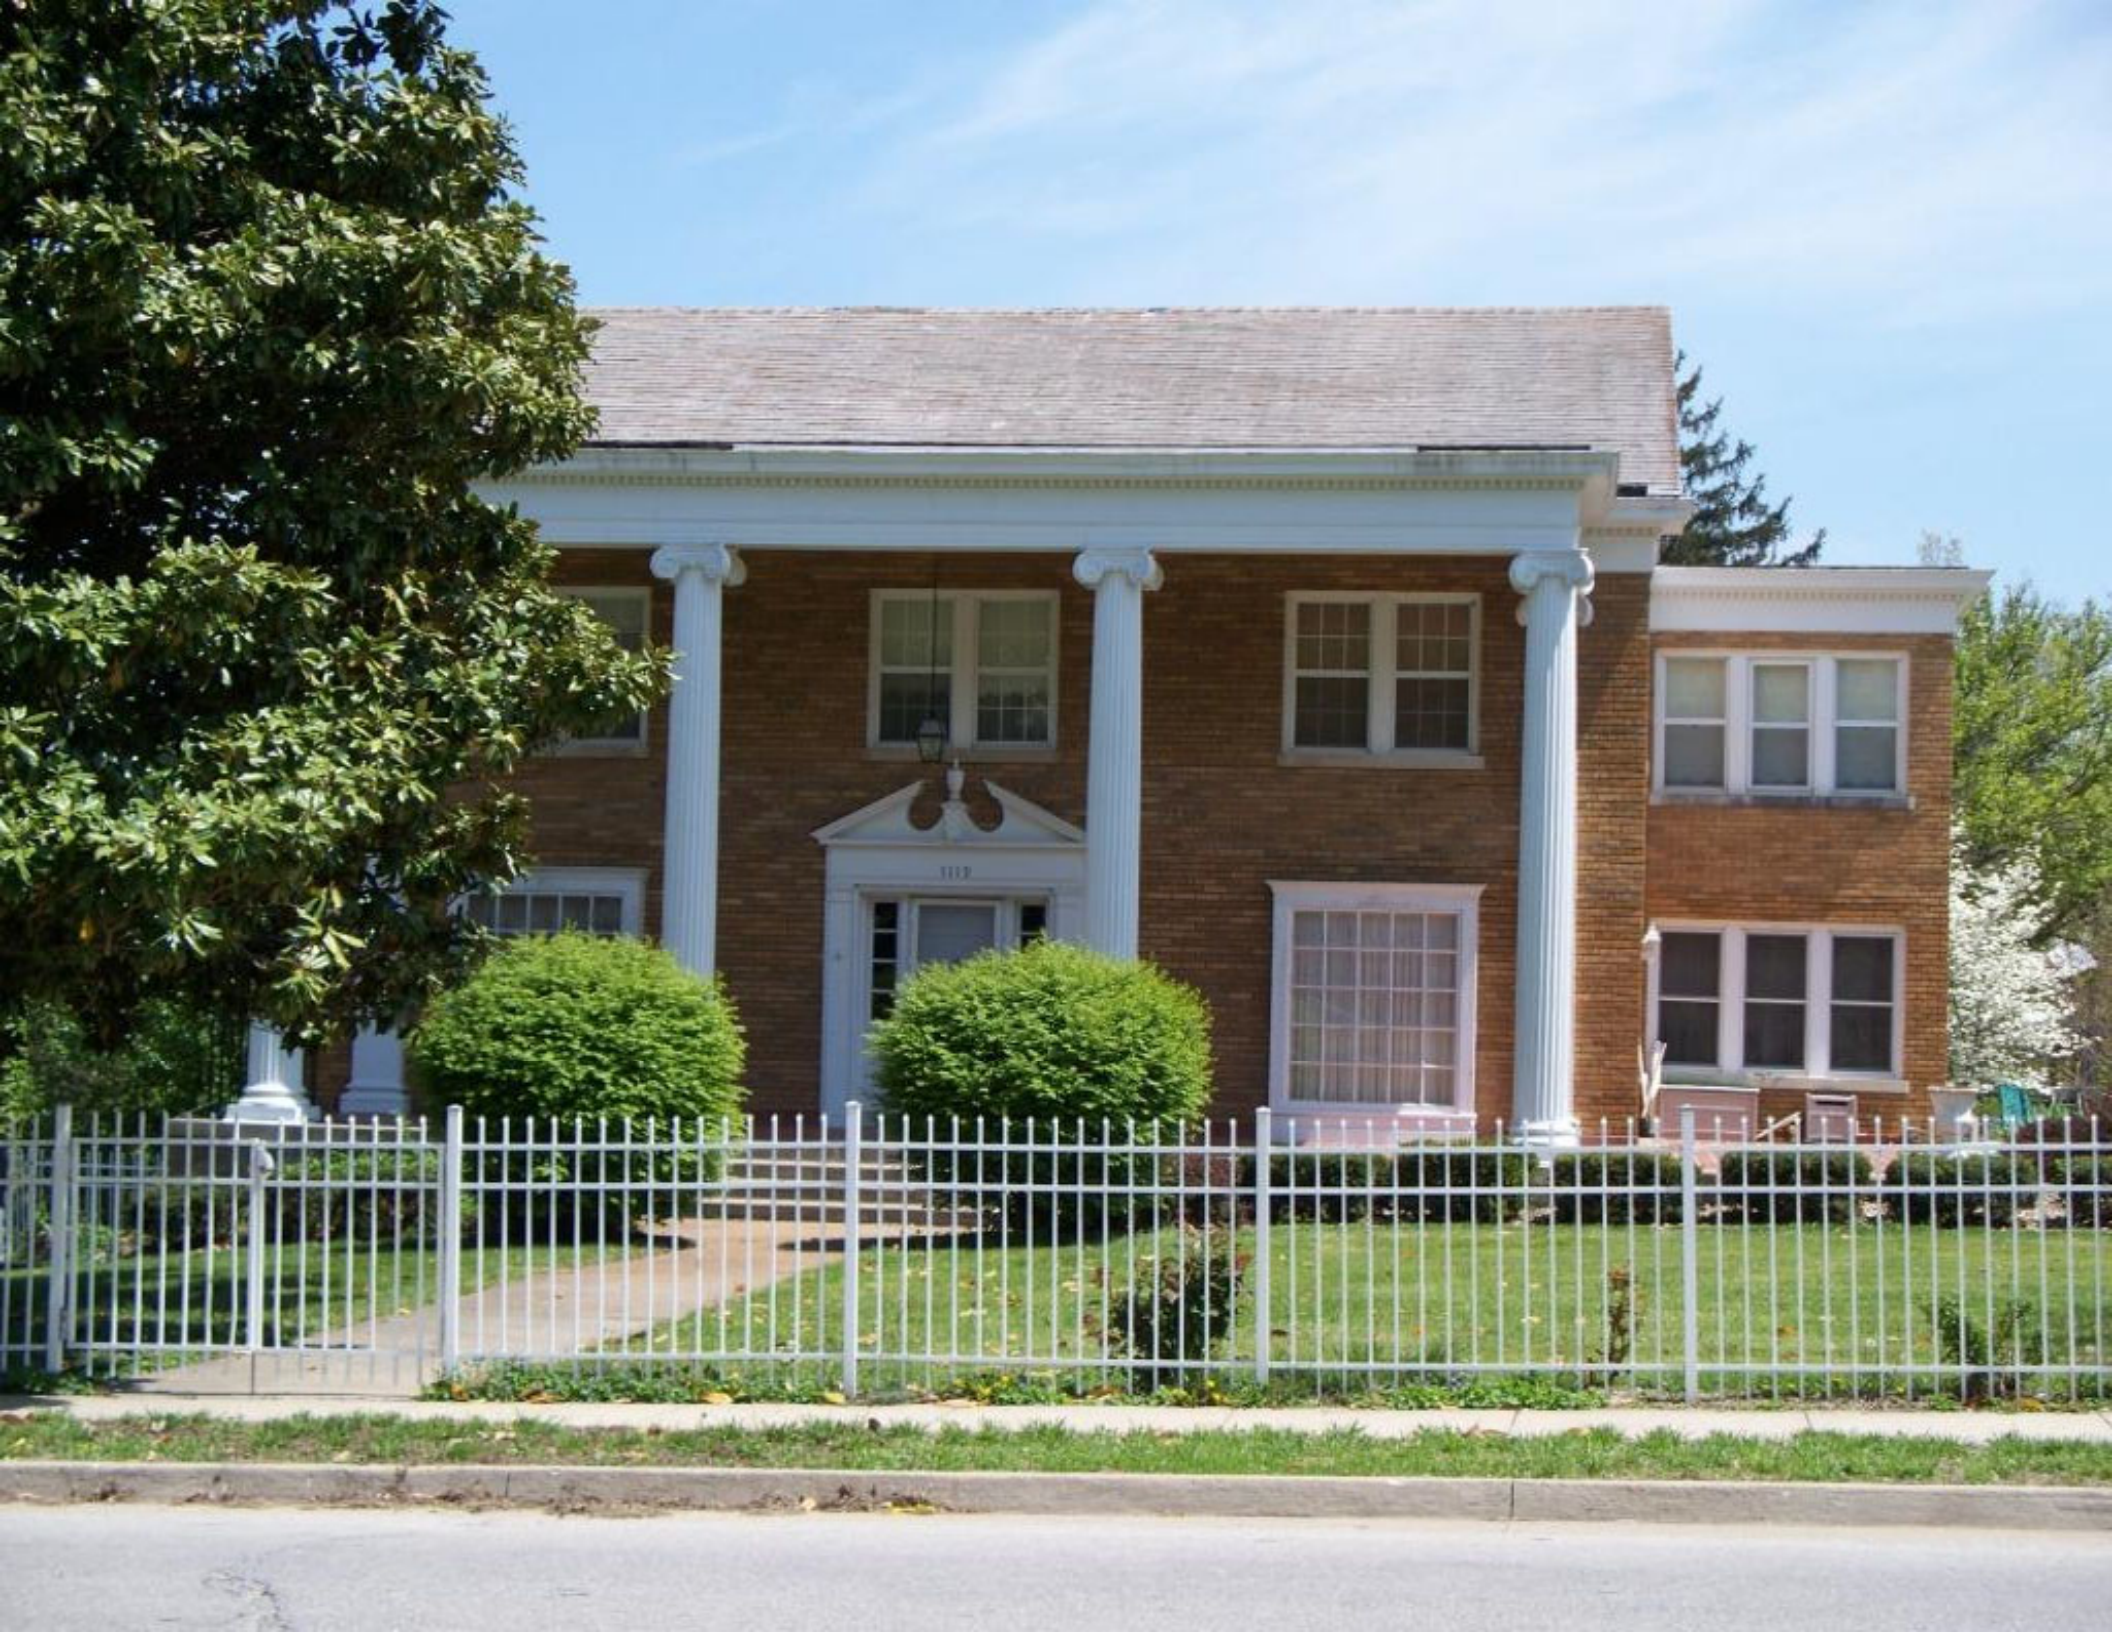
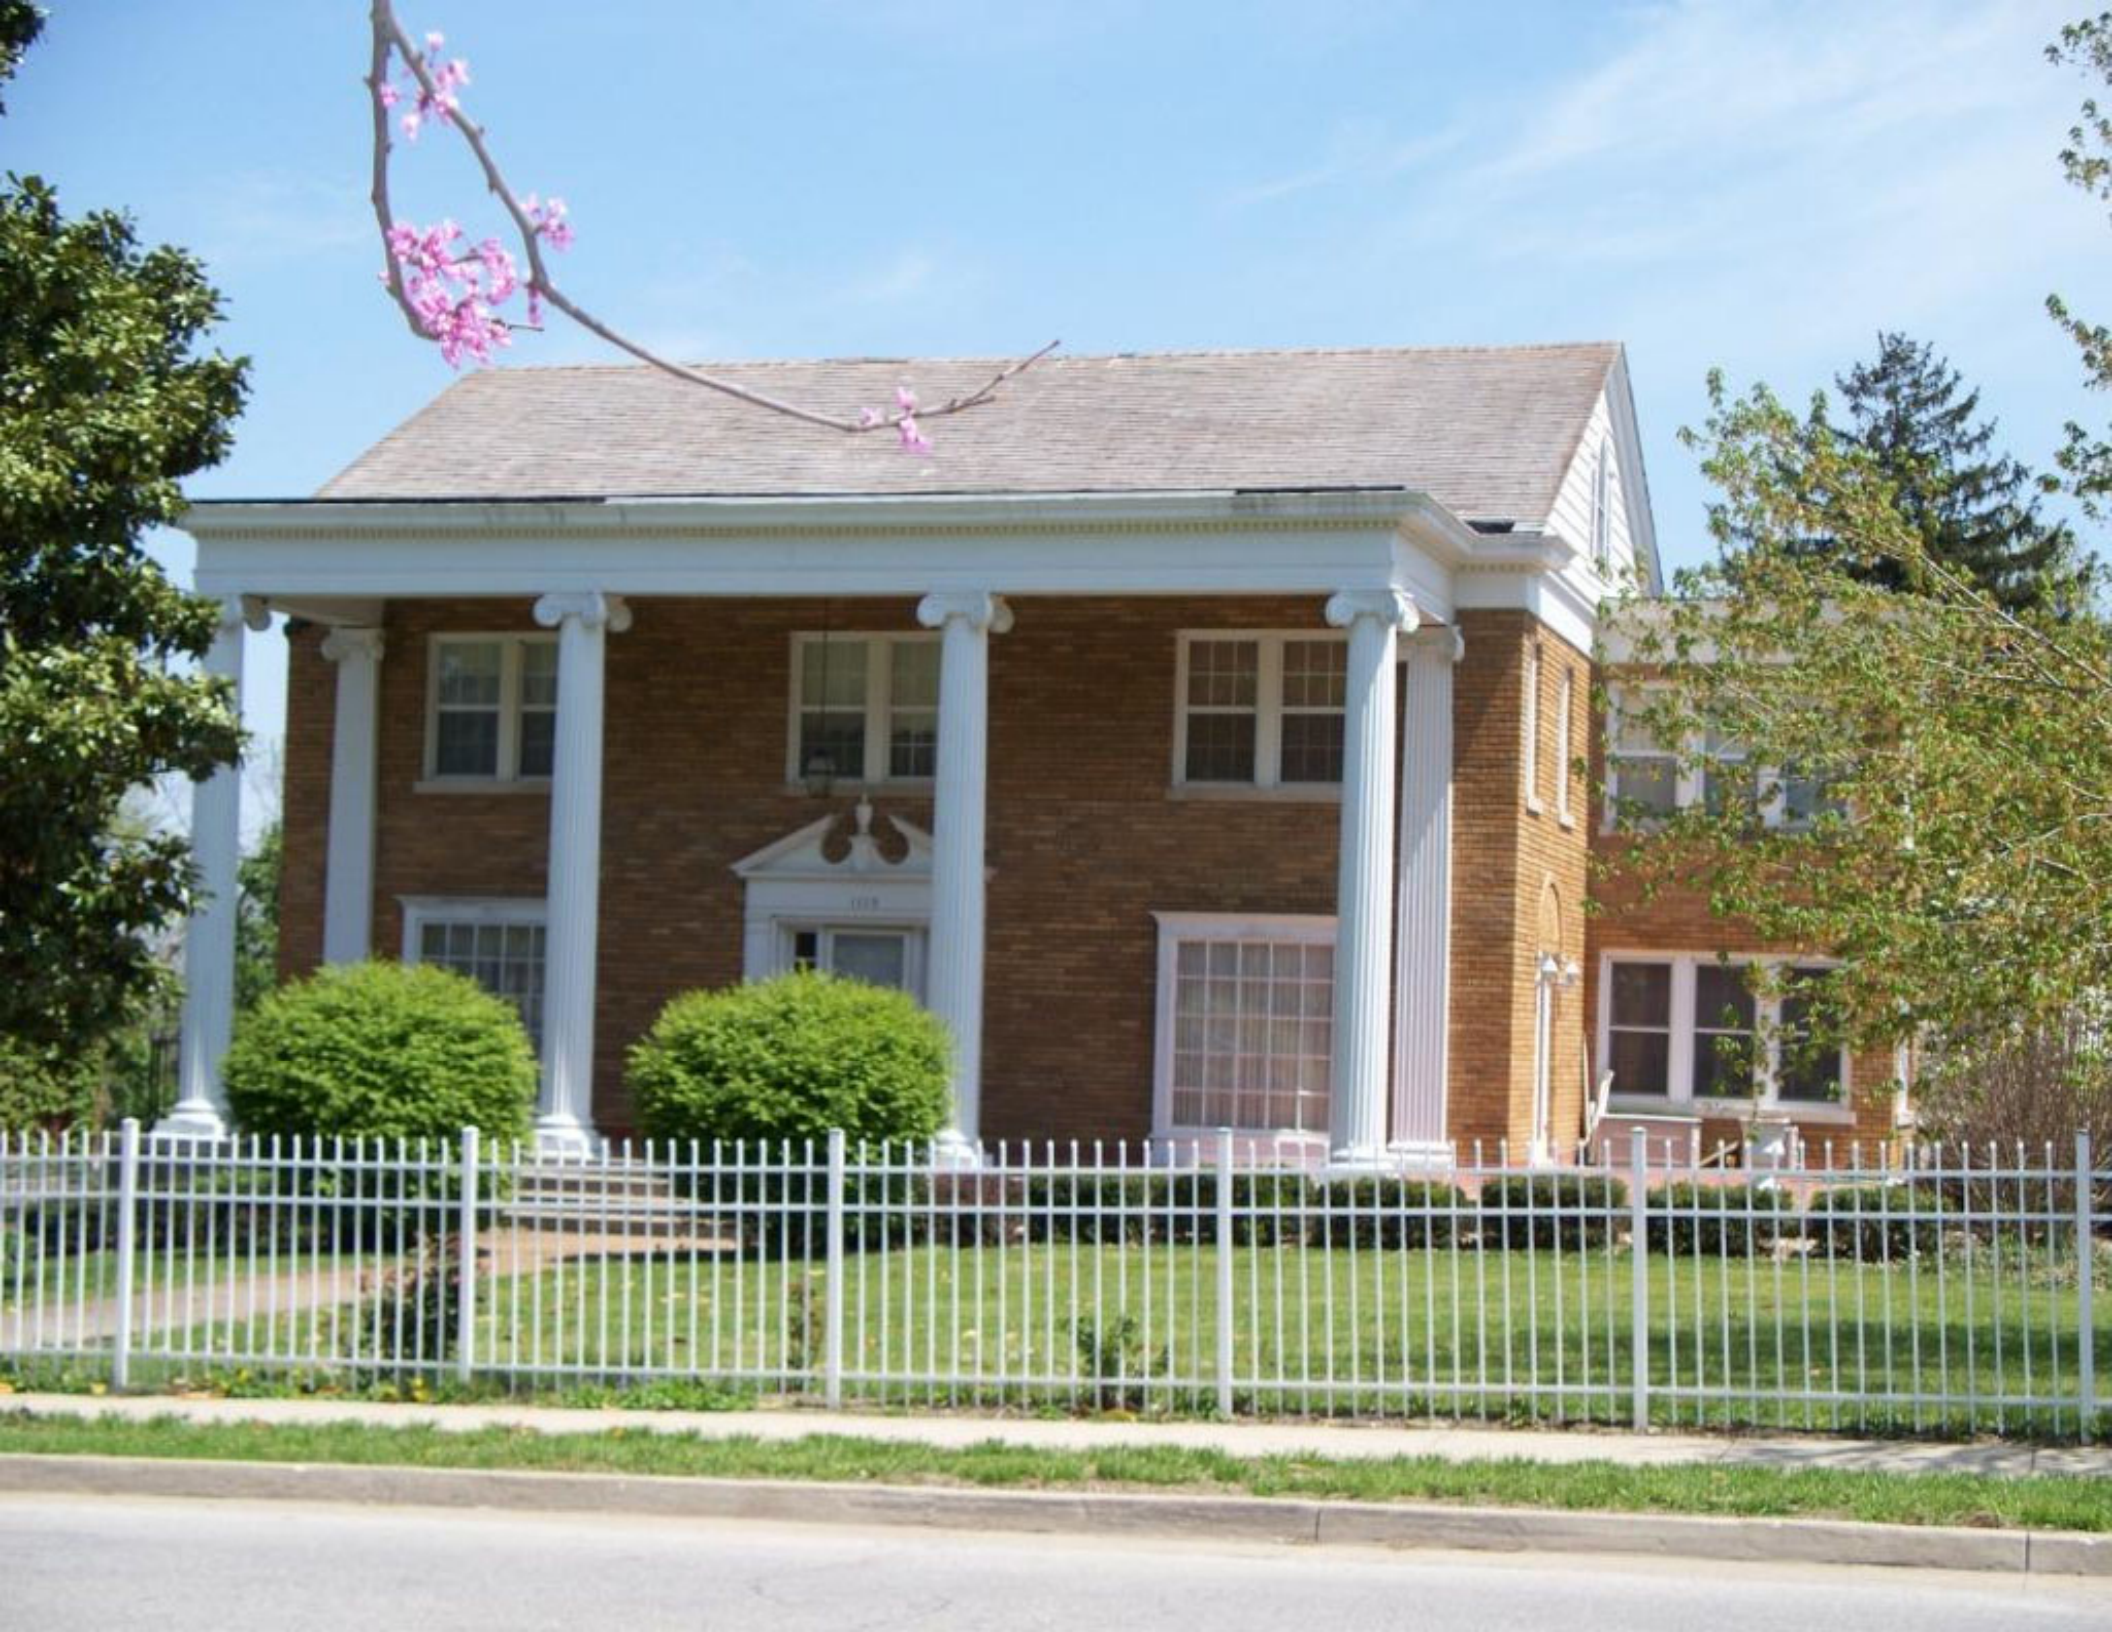
This two story brick Greek Revival has four large fluted Ionic columns that meet a large entablature that makes up the full façade porch. Similar fluted pilasters are flush against the building at either end with projecting Ionic capitals. The first story has two large multi-pane picture windows (likely replacement) with decorative molding surrounds that flank the entrance which appears to be the main focal point of the building. An opulent broken pediment door surround takes up a large portion of the façade. It was difficult to get a clear view of the door but the sidelights and surround appear historic. The upper story has three symmetrical paired single hung windows with snap 'multi-light' mullions with stone sills. Although the windows are modern they are sympathetic to the character of the building. An enclosed sleeping porch and sunroom are set back off the right of the building. The entablature wraps around the property and serves as the cornice of this wing, which has a row of three vinyl one-over-one windows on stone sills on both floors. As noted above, this may have been a bungalow at one time but currently shows no evidence of it. If this is the case, the significant date for this property should be in the 1940s, when the changes took place.
